AMMRC CTR 72-19

BRITTLE MATERIALS DESIGN, HIGH TEMPERATURE GAS TURBINE

Arthur F. McLean, Ford Motor Company, Dearborn, Michigan 48121  
Eugene A. Fisher, Ford Motor Company, Dearborn, Michigan 48121  
Raymond J. Bratton, Westinghouse Electric Corporation, Pittsburgh, Pennsylvania 15235

Interim Report, January 1, 1972 to June 30, 1972

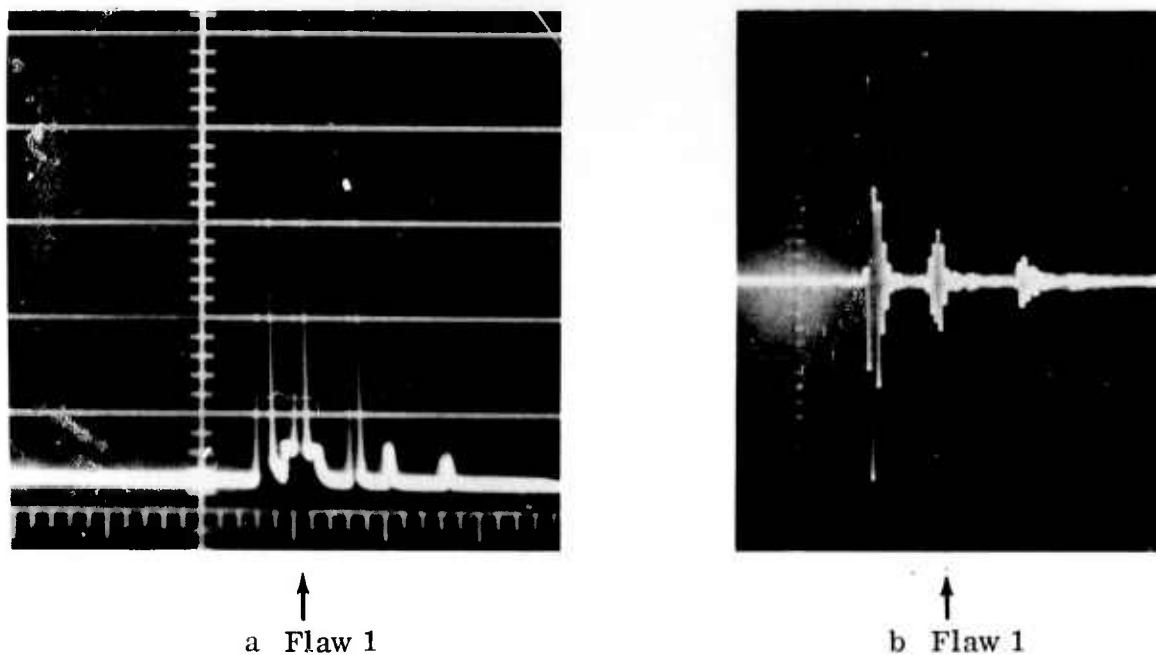
Figure 5.93 — Flaw Signals (Arrow) from Segment of LAS Spin Test Specimen No. 13, a) — Display Unit, b) — Oscilloscope

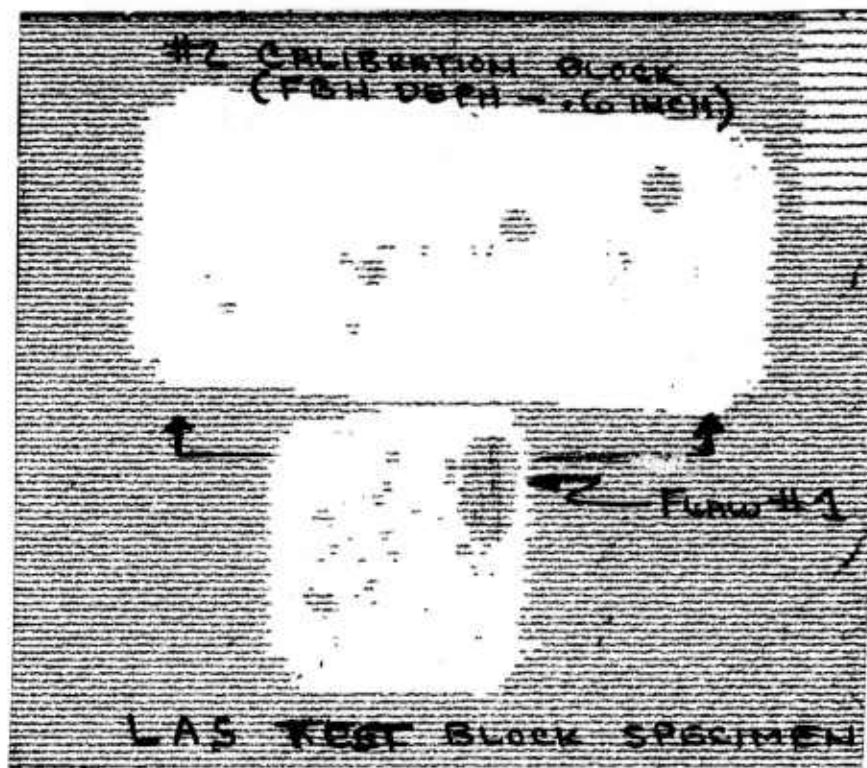
Figure 5.94 — C-Scan of LAS Calibration Block and LAS Test Block Specimen with the Flaw Analysis View Direction Shown

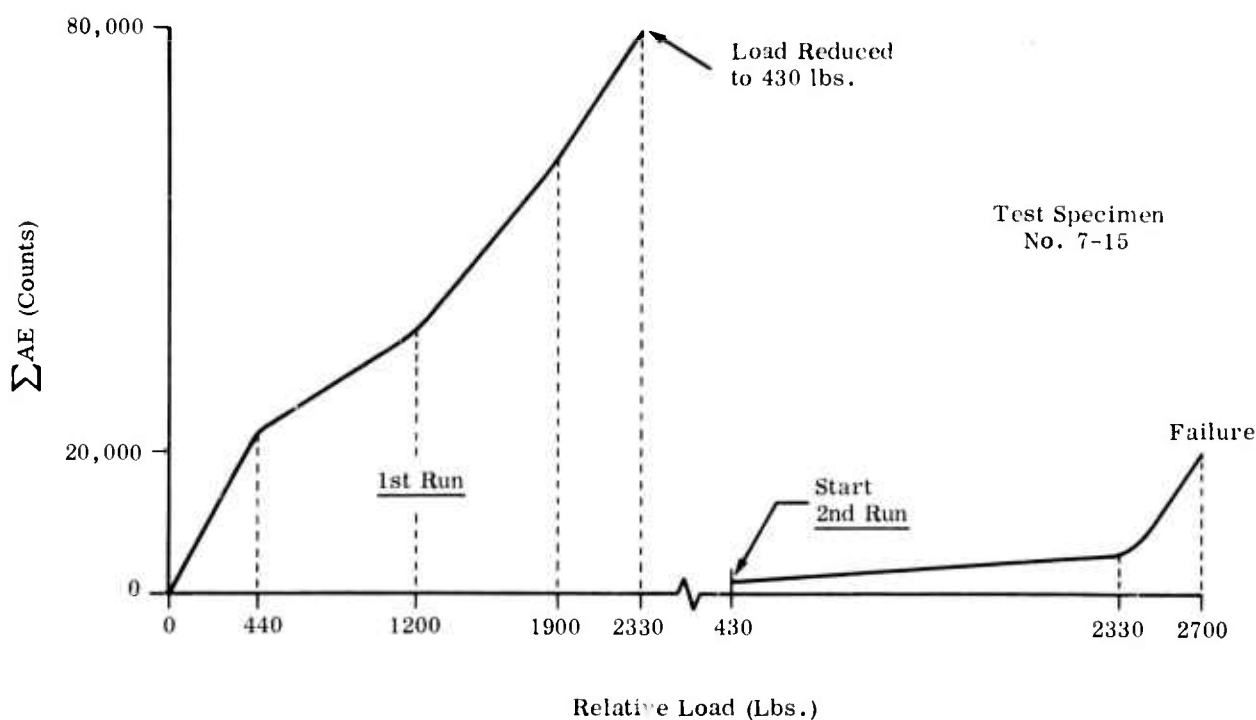
Figure 5.97 — Reproduction of AE vs Relative Load Curve Showing the Magnitude of Events Occurring at Low Loads

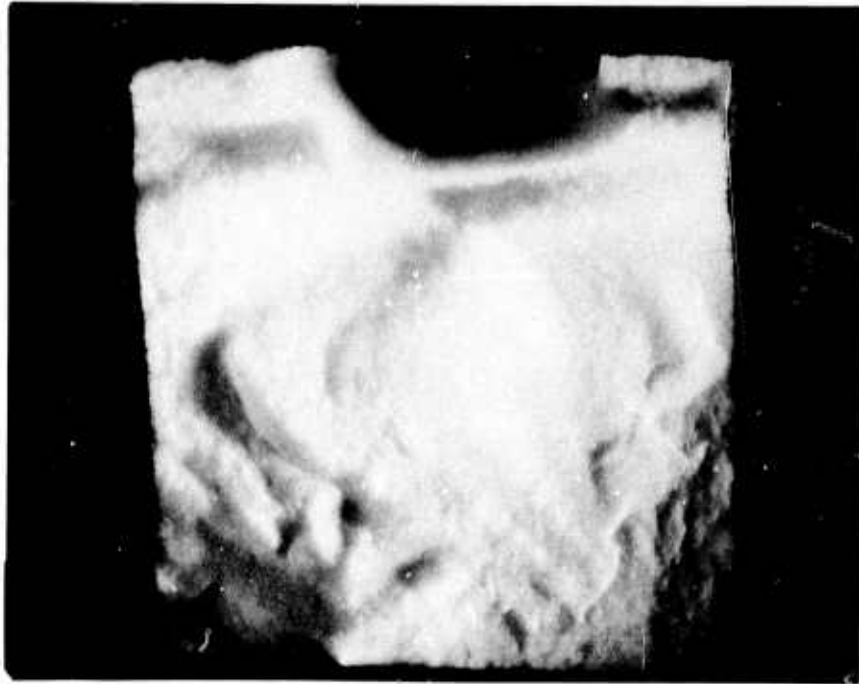
Figure 5.98 — Fracture Surface of Test Specimen No. 7-15 Showing the Crack Initiation Site in the Lower Right Hand Corner

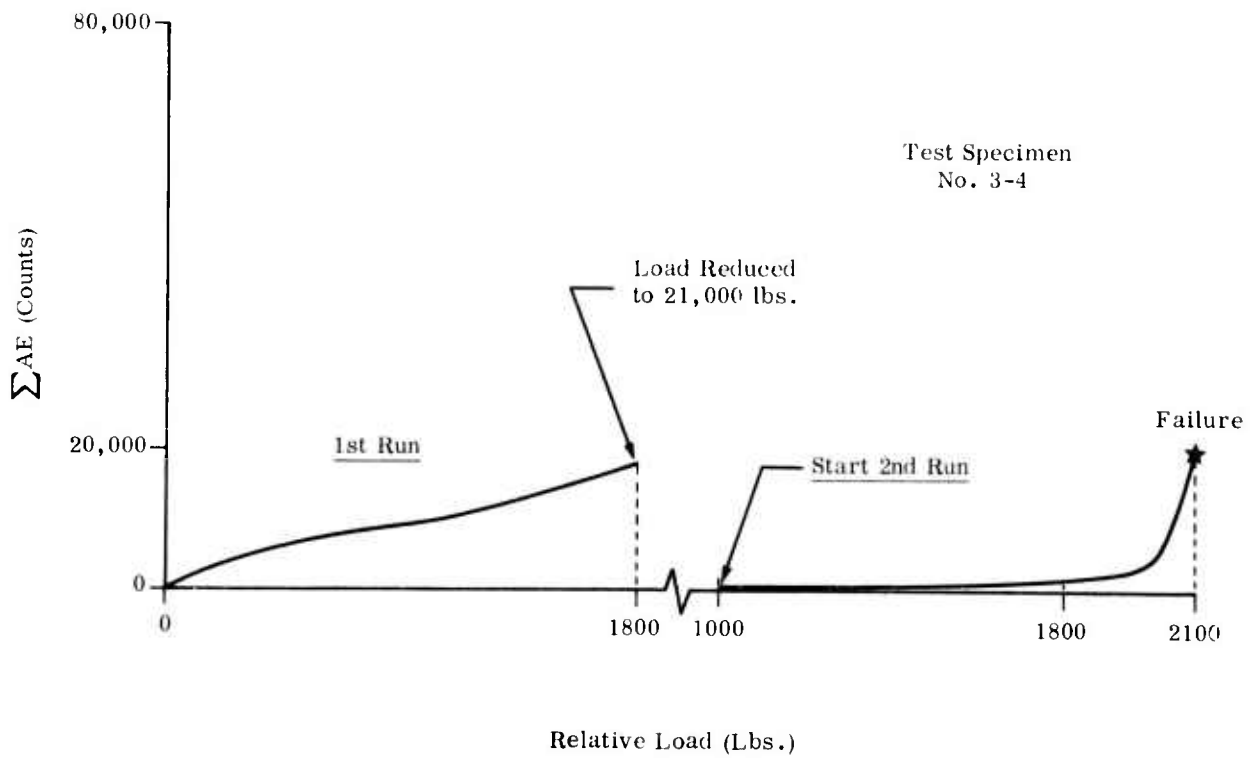
Figure 5.99 — Reproduction of AE vs Relative Load Curve Showing the Magnitude of Events Occurring at Low Loads

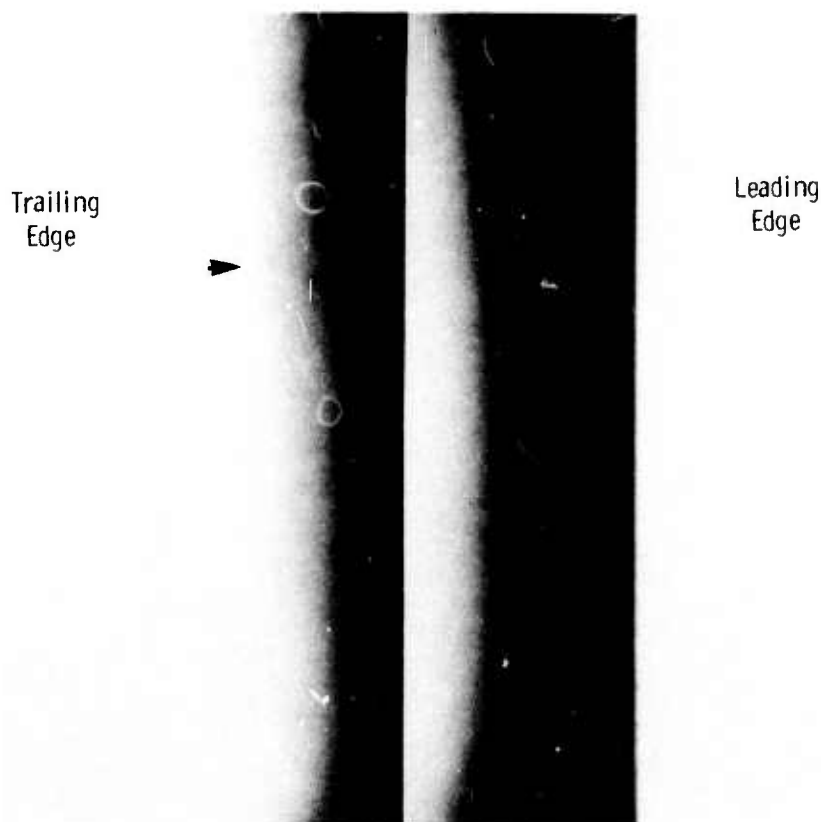
Figure 5.102 — Adjusted Positive Print of Radiographed Air Foil. Norton Company Vane #5 (Overall Intensity Variations not Real)
