# ESKIMO I Magazine Separation Test

by  
Frederick H. Weals  
*Engineering Department*

## Naval Weapons Center

CHINA LAKE, CALIFORNIA ■ APRIL 1973

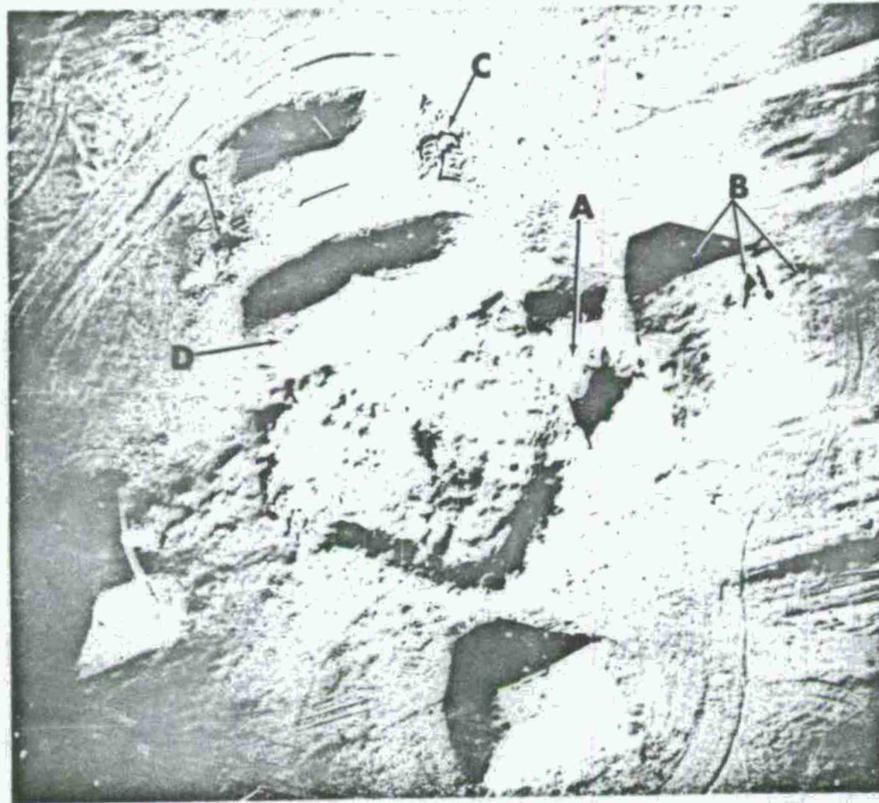
FIG. 31. Aerial View of Test Site After Detonation. Note (A) void in earth cover over remains of east igloo; (B) parts of steel arch of east igloo in front of and on east slope of the 59-foot magazine; (C) collapse pattern of reinforced elements of concrete block structures; and (D) erosion pattern on south slope of earth barricade.

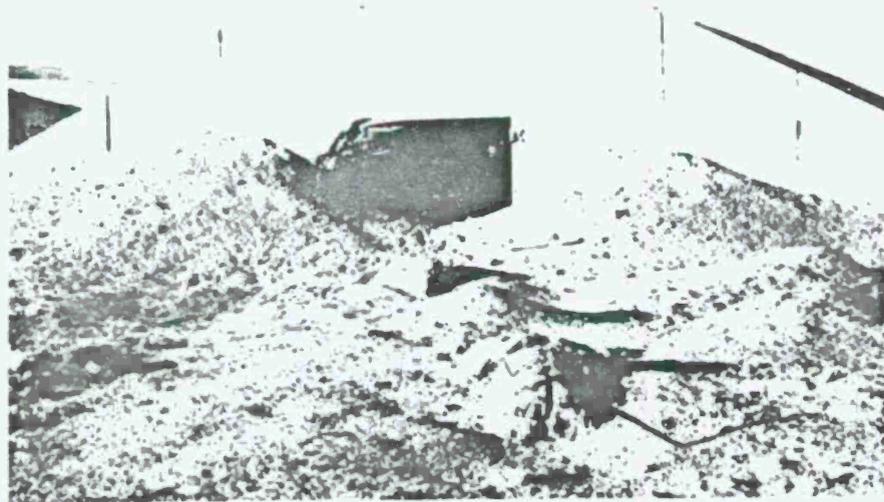
FIG. 35. Headwall of West Igloo. Note greater damage to left doorjamb than to right one; this was probably caused by large fragments from the donor magazine, such as those in the foreground.

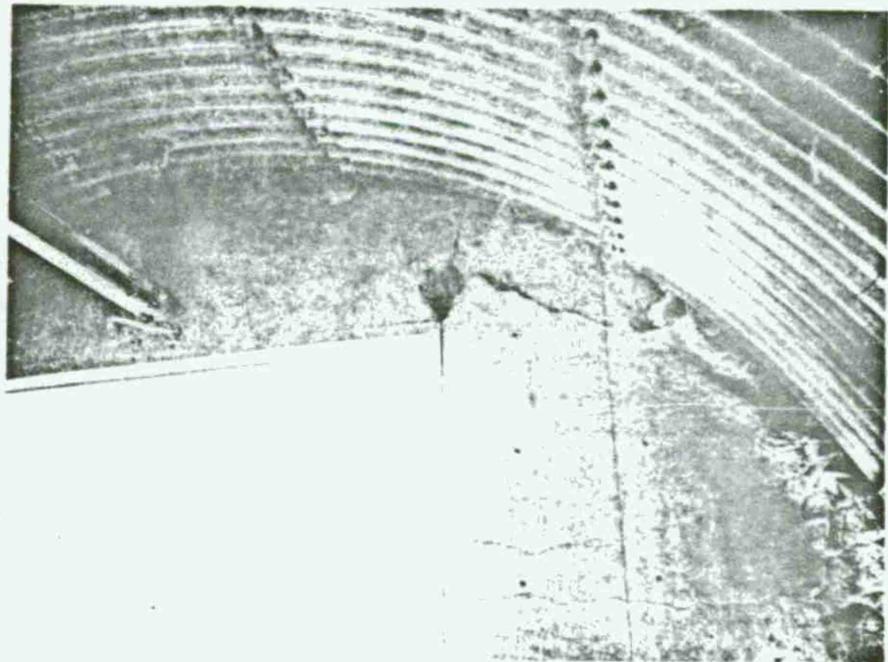
FIG. 41. Upper Headway of North Cross. Shows Position of Metal Rod and Its Pendulum Mounting.

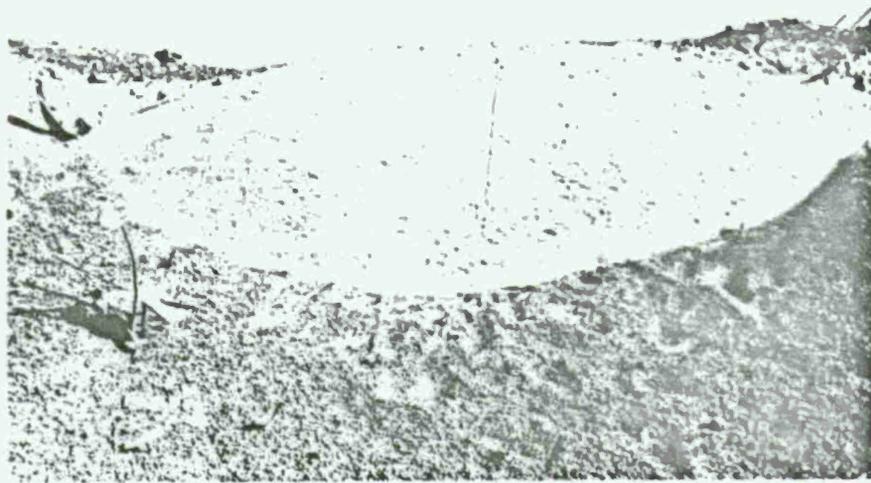
1. No fragments of the steel doors or the concrete headwall, or debris identifiable as such, could be found.
2. The concrete rear wall was severely pitted (Fig. 42) and was thrown backward at the top, coming to rest at an angle several degrees from vertical (Fig. 43).
3. The steel arch was separated into several sections, the largest of which came to rest in front of and on the east slope of the 59-foot-long magazine remaining from a 1963 test. Another piece (Fig. 44) fell in front of the door.
4. The igloo floor was covered with earth.

FIG. 42. Interior View of Concrete Rear Wall of East Igloo, Showing Acceptor Fragment Impacts.

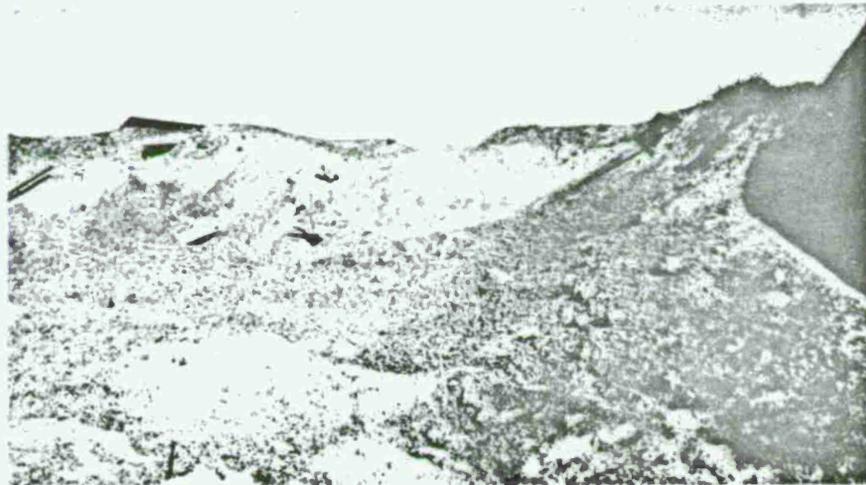
FIG. 43. Rear Wall of East Igloo, With Part of Steel Wing Wall at Right.

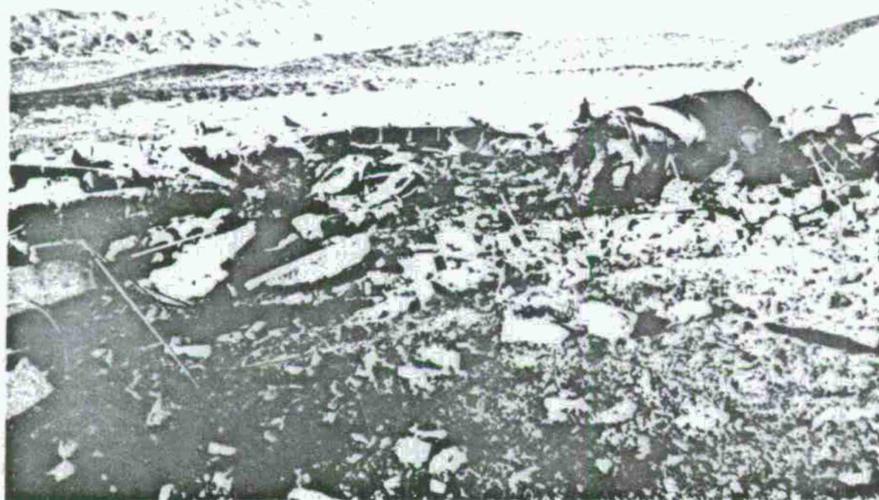
The concrete block structure was leveled, with the walls generally collapsing inward from the top. Portions of reinforced vertical cells and the reinforced horizontal bond beams remained tied together although extensively cracked and sheared. Figure 45 shows the remains.

FIG. 45. Remains of Northwest Concrete Block Structure, Burned out case of Polaris motor is at right; parts of Minuteman motor are at left.

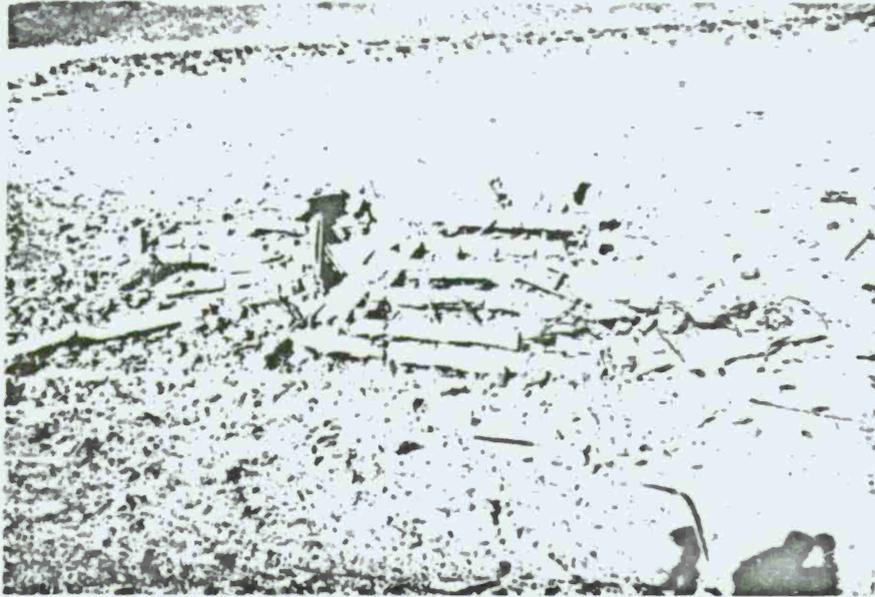
The structural response was generally similar to that encountered by the other concrete block building (Fig. 46), except that reinforced elements appeared to retain their integrity and relative positions slightly better than in the northwest structure. A direct comparison is not entirely valid because of the motor-burning effects in the northwest pile of debris.

FIG. 46. Remains of Northeast Concrete Block Structure. With Unexploded Acceptor Charges Removed. Note pattern of reinforced vertical and horizontal elements that remained connected in some parts of the walls.
