# Critical Strain Energy Density from Tensile Specimens

by G.R. Pelletier and J.R. Matthews

Defence Research Establishment Atlantic  
P.O. Box 1012, Dartmouth, Nova Scotia, B2Y 3Z7

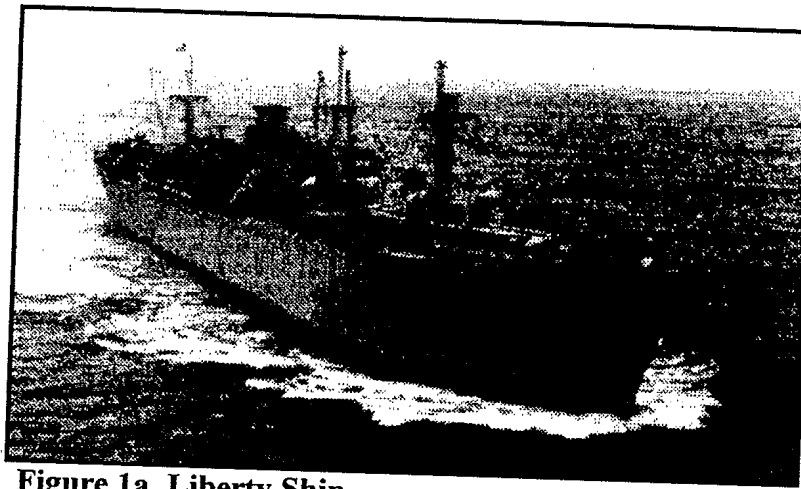
**Figure 1a. Liberty Ship.**

less than 60 days to construct [3]. One yard actually built a Liberty ship in four days, 15 hours and 30 minutes [4]. Figure 1a is a photograph of a Liberty Ship.

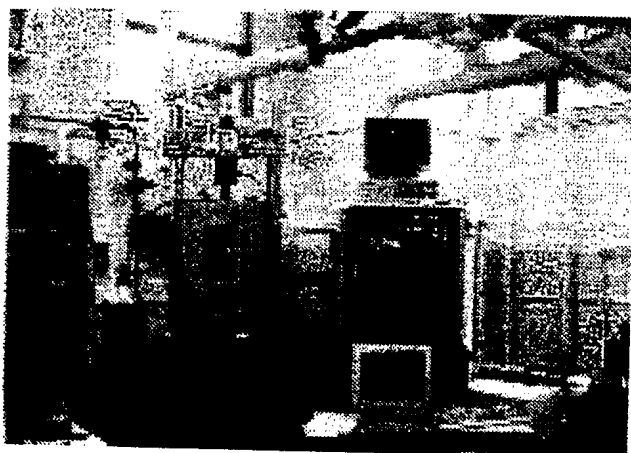
Tension tests were performed on an Instron interfaced with "daqware" software. Figures 10a & b are photographs of the apparatus. The specimens were fractured inside an enclosed compartment so that the temperature could be controlled. The specimens were cooled with CO<sub>2</sub> gas. Specimens with two different gauge lengths (1 & 2 inch) were tested at five different temperatures (-40 to 10°C). Three different parameters were recorded during testing: strain, stroke, and load. The computer was set for analog input, at a maximum (100%) of 10 volts. This related 10 volts to 22000 lb. load, 2-inch stroke, ½-inch strain. The strain was recorded with the use of an extensometer gauge. One hundred data points were recorded per second. Conversion of the data was necessary from volts to pounds and inches.

Figure 10a. Tensile Test Set-up.

Figure 10b. Grips with Specimen & Extensometer.

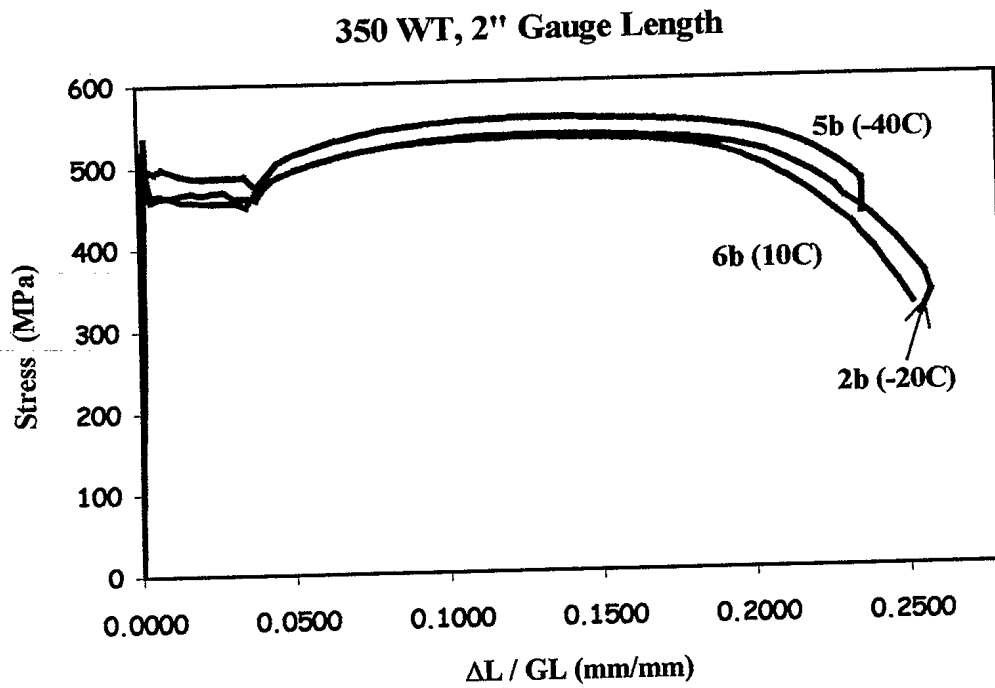
Figure 11. Two Inch Gauge Length Tensile Test Data.

Two sets of data were generated. The first set was the extensometer and applied load readings, while the second set was the grid spacing measurements. Shown in Figure 11 is the stress-strain curve for the 2 inch gauge length specimens.

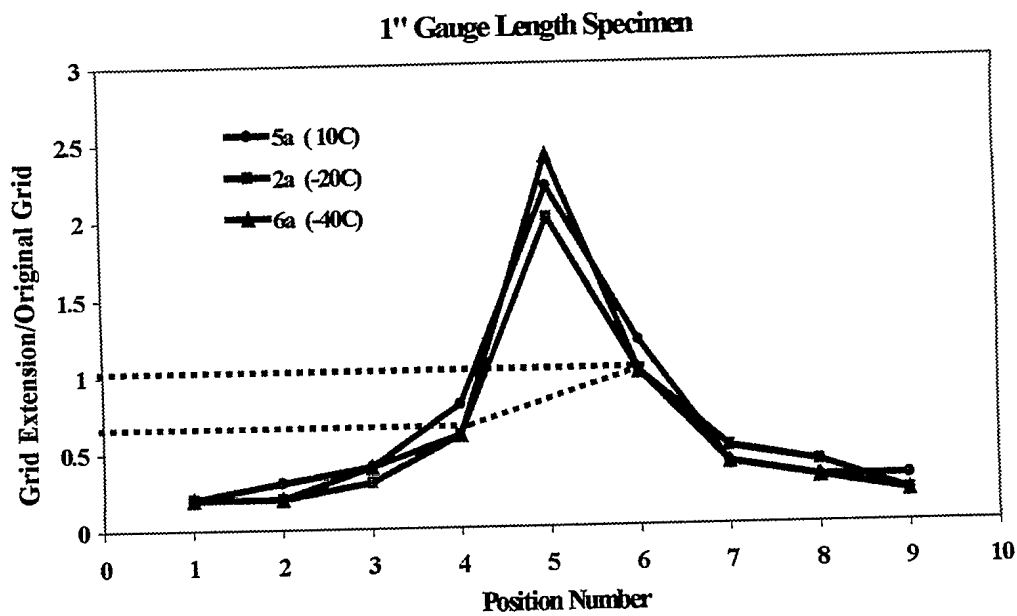
Figures 12a & b represent the grid extension after testing (plastic strain) versus the fracture location on the specimen. Position 5 is where the specimens fractured. From these graphs, it appears that there was no direct relationship with temperature. However, it became apparent that the magnitudes of the curves were influenced by the position where failure occurred with respect to the grid line. The unsymmetrical points of each curve provided this clue. What is meant by unsymmetrical, is that the relative points on the opposite sides of the individual curves experienced different strains. For example, specimen 5a, from Figure 12a, had a distance of 0.275 mm from the first grid-line to the fracture on the left side of the fractured specimen. The right side of the fractured specimen had a distance of 0.125 mm from the first grid-line to the fracture. The red line on Figure 12a indicates this difference.

Figure 12a. One Inch Gauge Length Grid Extensions.

**Figure 12b. Two Inch Gauge Length Grid Extensions.**
