DoD Corrosion Prevention and Control Program

Demonstration of a Robust Sensor System for Remote Condition Monitoring of Heat- Distribution System Manholes

Final Report on Project F09-AR03

February 2016

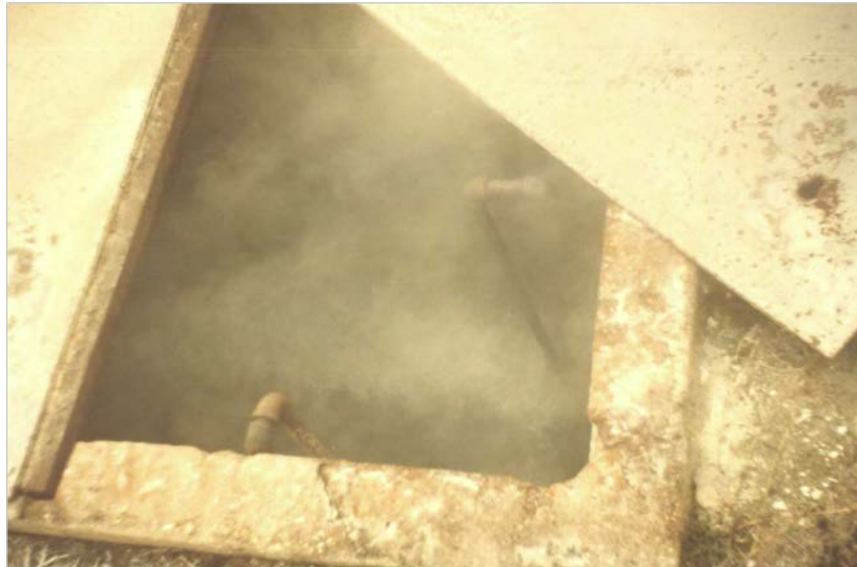
Figure 1. Continuous manhole boiling caused by submerged HDS piping.

The Department of Defense (DoD) is the largest operator of district heating systems. When functioning properly, these are cost effective and allow for the adaptive contingency of fuel switching at the central boiler plant. District heating systems require considerable expense to build and maintain, however, typically costing \$750 – \$1,000 per foot of piping plus ongoing operational costs to heat water and supply it to buildings (Marsh 1998). The heat-distribution system (HDS) consists of a network of steel pipes, valves, and appurtenances. In below-grade systems, these components are accessed for maintenance through below-grade manholes (also called *valve pits*). The environment in HDS manholes is hot and humid during normal operation. Often, due to the failure of sump pumps and/or the leakage of carrier fluid, manholes become flooded with water (Figure 1). When this occurs, pipe insulation is defeated and heat is transferred out of the HDS due to continuous boiling inside the manhole. At very least, this wastes a considerable amount of energy, estimated conservatively to cost \$50,000 – \$125,000 per year (Marsh 1998).

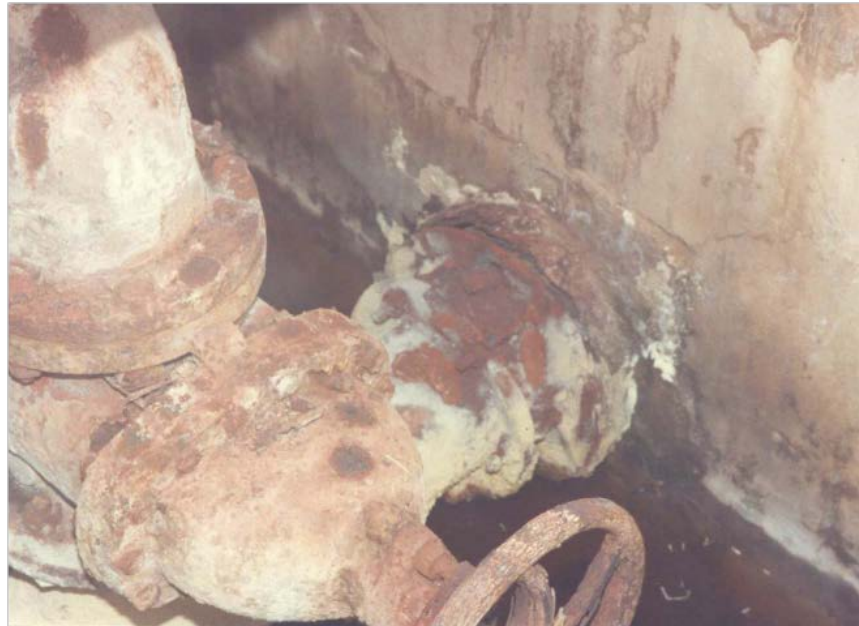
Figure 2. Accelerated corrosive degradation caused by manhole flooding.

Flooded manholes also create optimal conditions for aggressive and accelerated corrosion. As degradation accelerates, it can quickly lead to component failure and safety hazards. Figure 2 and Figure 3 show examples of

accelerated corrosive degradation caused by the ingress of water into manholes.

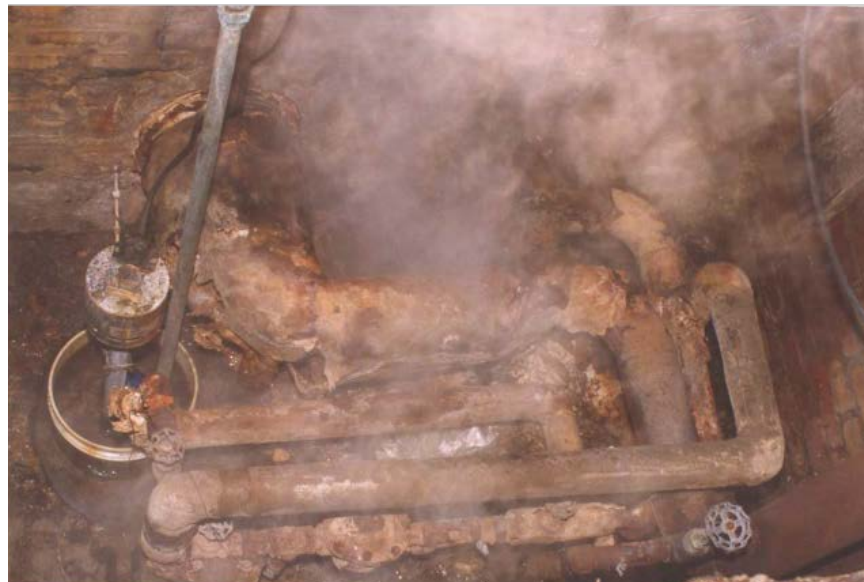
Figure 3. Accelerated corrosive degradation from manhole flooding, including severe damage to insulation, insulation sheathing, and carrier pressure piping.

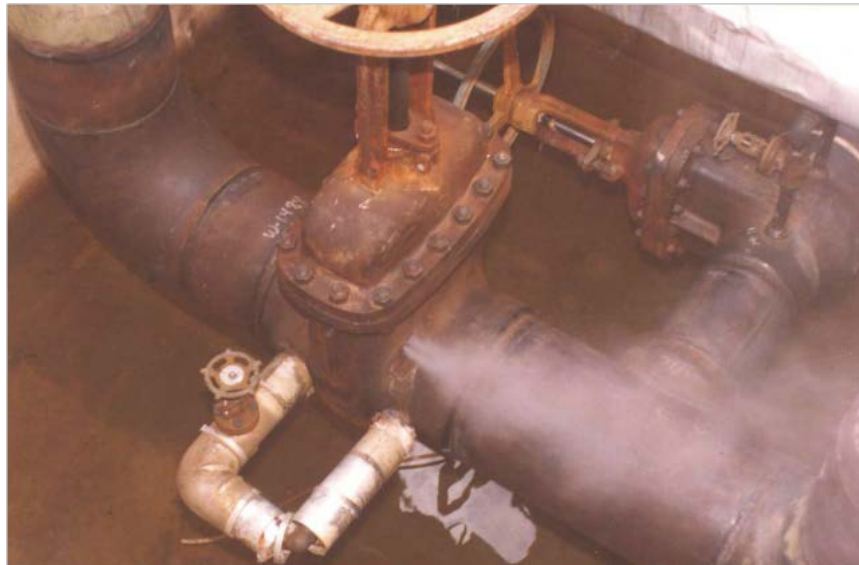
Figure 4 shows a failed valve body, which could scald or asphyxiate a manhole inspector. Depending on metal thinning around the steam jets shown in the figure, such a leak could greatly increase at any random time.

Figure 4. Leaking valve body in pressurized HDS, posing burn and asphyxiation hazard to system maintenance personnel.

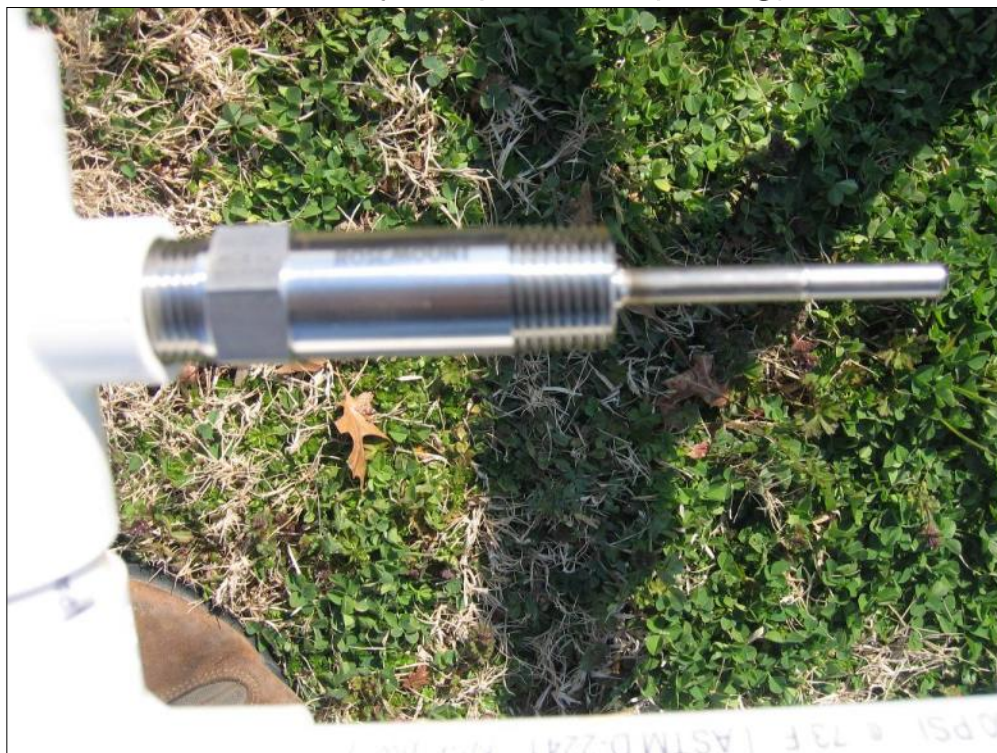
The temperature sensors chosen were Series 68 resistance temperature detectors (RTDs) manufactured by Emerson Rosemount Measurement Division* (see Figure 5) These sensors are rated for operation between -58 and 752 °F.

Figure 5. RTD temperature sensor. (Note: the pictured PVC piping was used in the manhole only in the proof-of-concept testing.)

RTD temperature sensors operate by taking advantage of the predictable nature of the change in electrical resistance of some materials (in this case, platinum) as temperature changes. The Series 68 RTD has a nominal resistance of 100 ohms. The RTD element is encased in a AISI 316 stainless

steel sheath in order to provide durability and corrosion resistance. The sensor leads are American wire gauge (AWG) 22 nickel-plated copper wire. As the RTD is, in effect, a precision resistor, polarity is not a concern; the RTD may be wired in the monitoring circuit without regard for which lead is connected to signal or which lead is connected to ground. The configuration of the Series 0068 RTDs chosen for this project includes 0.5 in. NPT threads for attachment to standard piping.

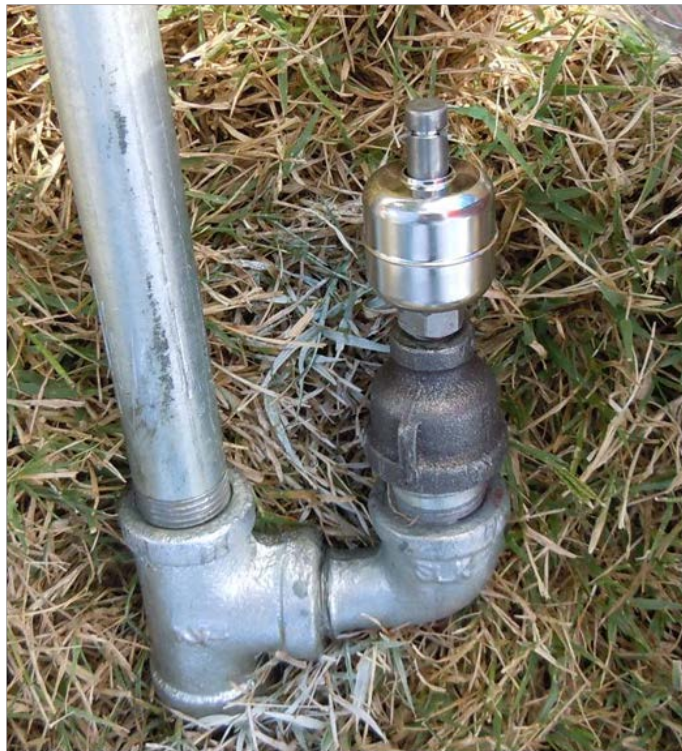
In order to detect the presence of water in the pits, float switches were installed. One switch was installed at the bottom of each pit (no farther than 6 in. from the bottom of the pit). This switch was intended to provide an initial warning when water begins accumulating in the pit. A second switch was installed 24 in. from the bottom of the pits. This is intended to provide a final warning before pipes or valves begin to be submerged. A miniaturized float switch (FS11-001) from SMD Fluid Controls* was chosen for this application (see Figure 7). The switch is constructed from AISI 304 stainless steel for temperature and corrosion resistance. The switch has 0.125 in. pipe threads for mounting, and the lead wires are AWG 22 copper wires with a PTFE coating, and can operate at temperatures up to 125 °C (257 °F) and pressures up to 75 psig (517.1 kPa).

Figure 7. Float switch.

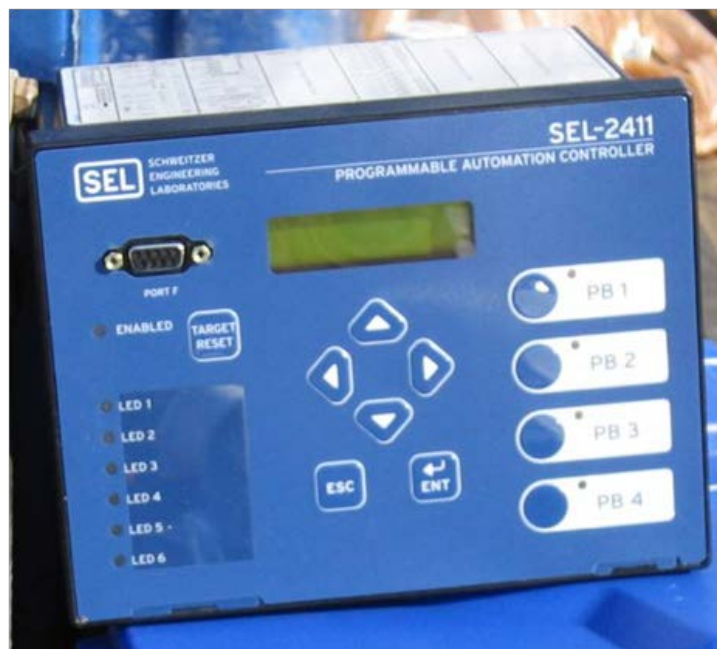
The RTU chosen for the SCADA-monitored pits was the SEL-2411 from Schweitzer Engineering Laboratories (SEL)*. The SEL-2411 was chosen because it has sufficient digital inputs to read the float switches, and is capable of interfacing directly with the RTD temperature sensors (see Figure 8). In addition, the existing electrical control equipment on Redstone Arsenal's SCADA network is manufactured by SEL, so personnel were already familiar with that brand of equipment. Finally, it possesses a built-in Ethernet port that allows it to interface with the Ethernet radio used for Redstone Arsenal's SCADA network.

Figure 8. RTU for manholes monitored by the SCADA system.

The SEL-2411 configuration chosen for this project (p/n SEL-241101A0X9X0X0X0130) features ten RTD inputs and two digital inputs. In addition, it features a front-mounted serial port for easy programming, and an RJ-45 Ethernet port for connection to the Ethernet radio.

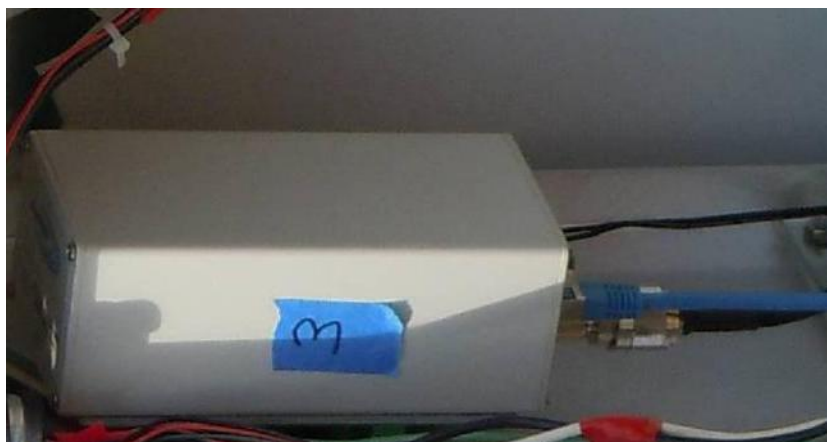
The SEL-2411 communicates with Redstone Arsenal's network through a 900-MHz line of sight Ethernet radio manufactured by Freewave, Inc* (see Figure 9). The HTP-900RE is capable of transferring Ethernet data over a distance of up to 15 miles with a clear line of sight, and is programmable through a standard web browser. It was chosen primarily because it is in use as the radio for Redstone's other SCADA-connected equipment, so compatibility with their network was assured.

Figure 9 Ethernet radio used at SCADA site.

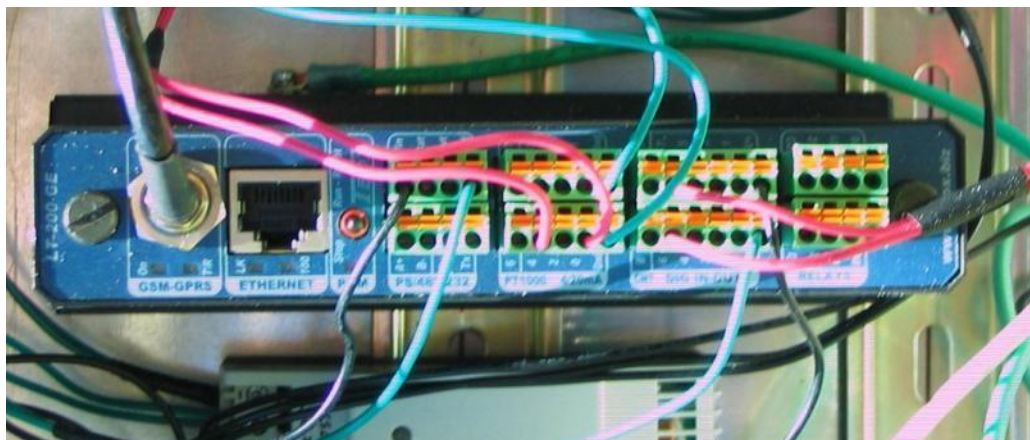
For the cellular remote-monitoring phase of the project, the T-Box Lite from CSE Semaphore Inc.† was chosen (see Figure 10). Although the T-Box is capable of interfacing with a SCADA system, it was chosen for this application because it has an integrated GSM (cellular) modem. With this modem, the T-Box Lite can be configured to send emails or SMS messages directly to the party responsible for monitoring without routing through a central monitoring station as used in a SCADA system.

Figure 10. T-Box Lite unit used for monitoring at sites using cellular communication.

The T-Box Lite has eight digital input/output pins, six analog inputs (4 – 20 mA), and two RTD temperature inputs. Although the device is capable of directly interfacing with RTD temperature sensors, it requires a base resistance of 1000 ohms. Since the sensors used for this project have a base resistance of 100 ohms, they were not compatible with these inputs, and were connected to the Rosemount 248 temperature transmitter. The transmitter converted the RTD signal into a 4 – 20 mA analog signal that could be read by the analog inputs on the T-Box Lite.

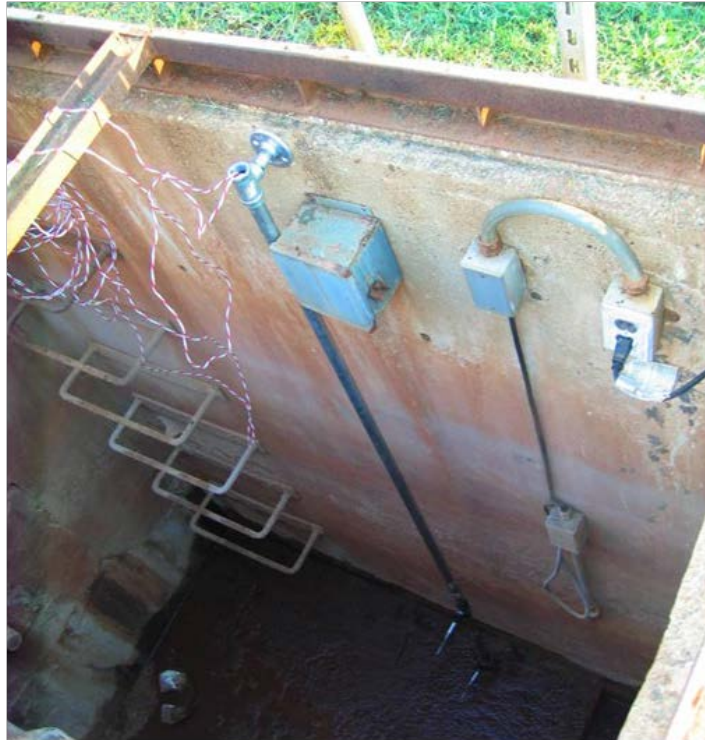
The next step was installing the temperature sensors in the pits. Because the temperature sensors had NPT pipe threads cut into their stainless steel casing, it facilitated mounting them onto galvanized steel pipe (see Figure 16). The sensor leads were threaded through the pipe, and the sensors were screwed into the end of the pipe (after doping compound was applied to the threads). Because of the difficulty of accessing some of the pits (due to crowding, confined-space entry issues, or lack of ladder access), the pipe was designed in such a way that it could be installed without entering the pit. One end of the pipe was capped, and the sensors were installed on tee fittings near that end (see Figure 17). This end of the pipe was placed on the pit floor. Near the other end of the pipe, also attached to a tee fitting, a flange was installed. The flange was attached to the pit wall (see Figure 18). This left an open pipe within reach of the top of the pit, with sensor leads

Figure 16. Temperature sensor wires routed into galvanized steel piping.

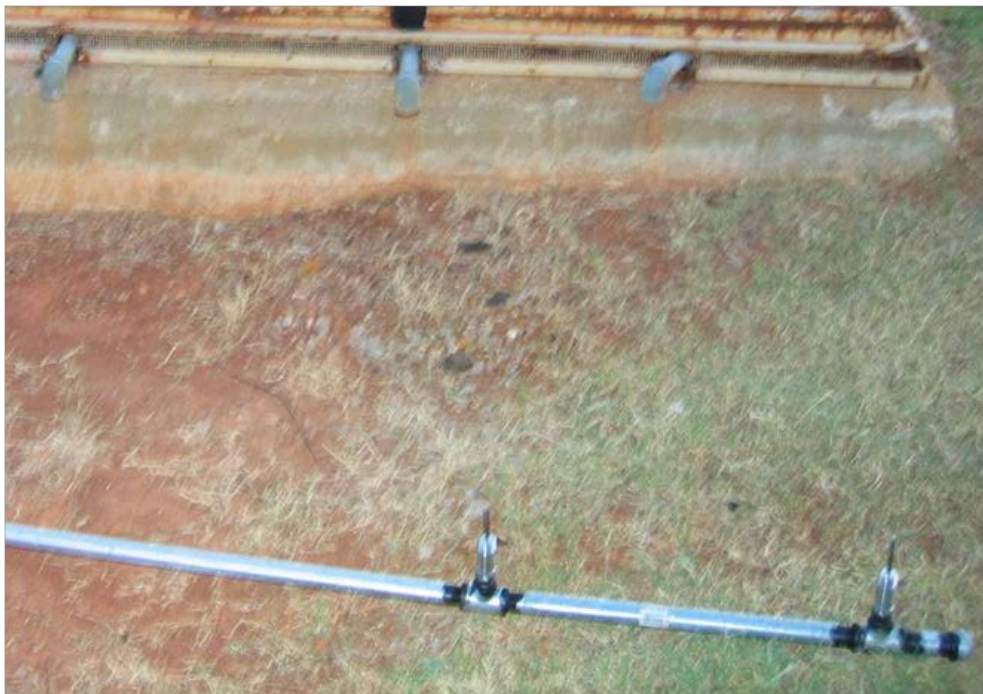
Figure 17. Temperature sensors installed in capped galvanized pipe.

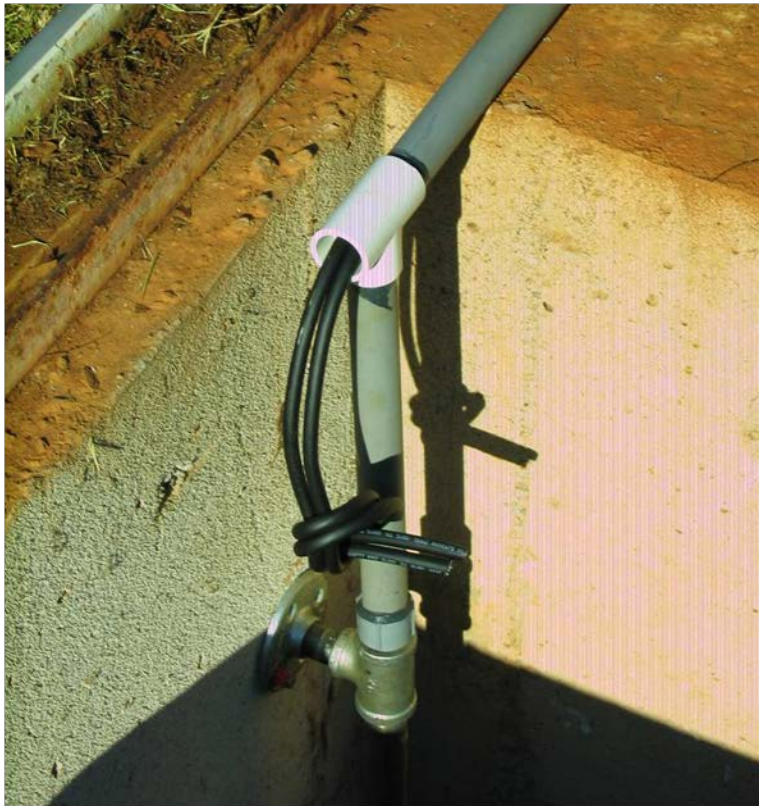
Figure 18. Flange mounting to wall.

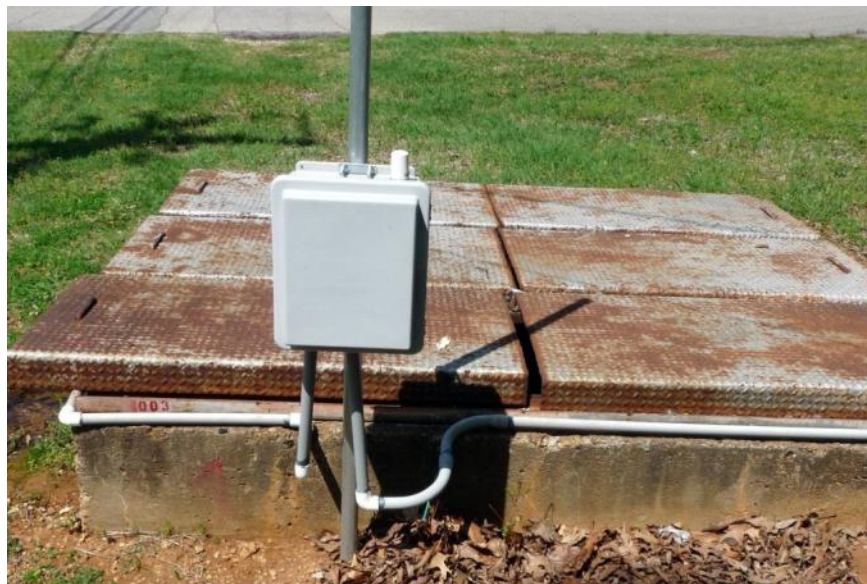
Once the flange was attached to the pit wall, a conduit run was installed to connect the sensor mount to the RTU enclosure, which was installed on a pole outside the pit (see Figure 19).

Figure 19. RTU unit enclosure mounted to pole.

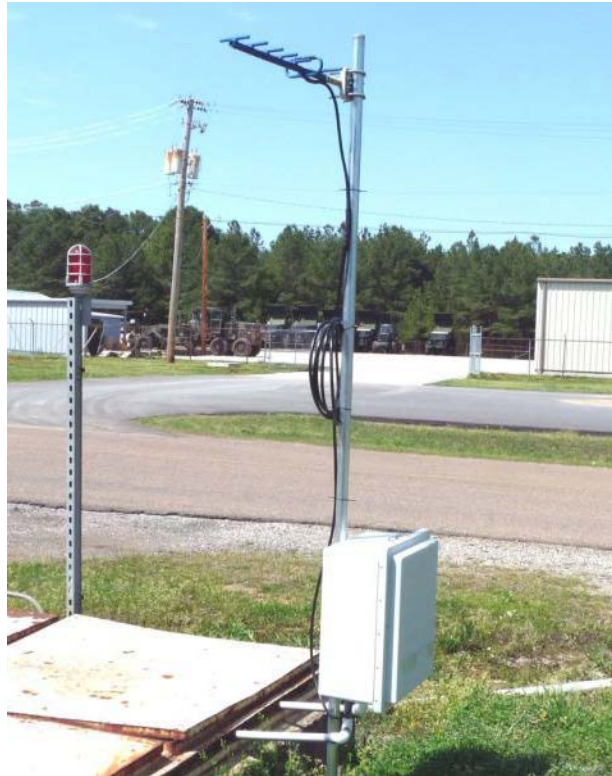
For the SCADA pits, directional Yagi antennas were mounted on the top of the poles used for mounting the enclosure, and visually aligned with the SCADA repeater on Madkin Mountain (see Figure 20).

Figure 20. Yagi antenna used for SCADA communications.

Three of the originally specified omnidirectional antennas installed to support the wireless Ethernet system for eight pits could not connect with the SCADA system repeater antenna due to their locations. Those antennas were replaced with directional Yagi antennas (see Figure 20). A larger problem for the wireless Ethernet system, however, was that Redstone facility-management priorities ultimately did not allow for the pits to be fully integrated into the SCADA system. Consequently, the project team was not able to conduct regular polling of the SCADA pits during the scheduled demonstration period.

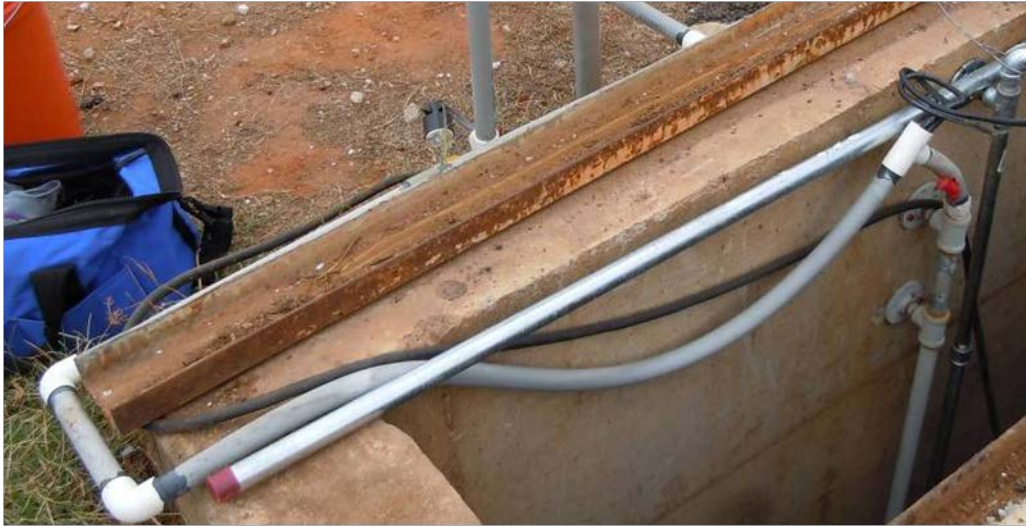
It was not possible to find commercially available RTUs that could withstand the necessary range of temperatures and pressures inside heat distribution system manholes. Thus it was necessary to locate the RTU and associated hardware outside of the manhole. Even conduit that transitions from within the manhole to its exterior at the very top of the manhole must be able to withstand boiling temperatures. In at least one case, PVC conduit located at the top of a manhole softened and deformed significantly (Figure 23).

Figure 23. Deformed PVC conduit at top of manhole.
