FOREDUNE CLASSIFICATION AND STORM RESPONSE: AUTOMATED ANALYSIS OF TERRESTRIAL LIDAR DEMS

KATHERINE L. BRODIE¹, NICHOLAS J. SPORE¹

1. *U.S. Army Engineer Research and Development Center, Coastal & Hydraulics Laboratory, Coastal Observation & Analysis Branch, 1261 Duck Rd, Duck, NC 27949, USA. Katherine.L.Brodie@usace.army.mil; Nicholas.J.Spore@usace.army.mil*

**Coastal Sediments 2015 – San Diego, CA
“Understanding and Working with Nature”**

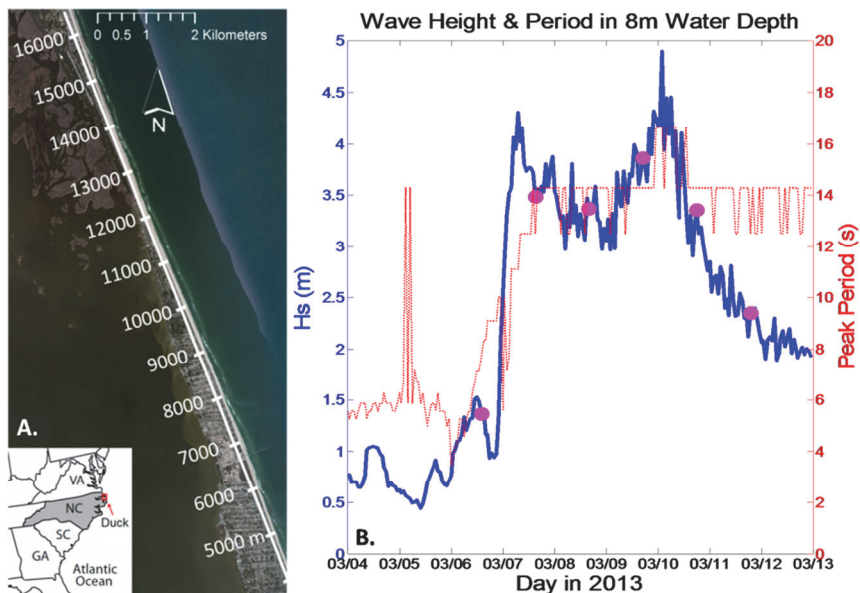
Figure 1. A. The study site in Duck, NC showing the alongshore coordinates of the local coordinate system. B. Significant wave height (blue) and peak wave period (red) during the storm, with survey times shown in magenta circles.

A nor’Easter impacted the study site beginning on March 6, 2013 (Figure 1B). Waves remained above 3 m in 8 m of water depth for 4 days, with the largest waves occurring on March 10, 2013 ($H_s = 4.8$ m at 16 s in 8 m of water depth). This storm marked the first significant dune collision event since Hurricane Sandy.

Mobile lidar surveys were conducted daily during the storm event (magenta circles, Figure 1B) using a Riegl VZ-1000 terrestrial laser scanner and a POS-LV 220 GNSS navigation system mounted on Coastal Lidar and Radar Imaging System (CLARIS). The VZ-1000 has a wavelength of 1550 nm (near-infrared) with a laser power of 300 kHz and scans at a fixed perpendicular angle to the direction of movement at approximately 60 lines/second. This creates a three-dimensional point cloud as the vehicle advances forward, illuminating 100-1000 points per square meter depending on vehicle speed and topography. The vehicle trajectory is measured by the POS-LV system which includes two GNSS GPS antennas and an L1/L2 GPS receiver, an inertial motion unit (IMU), and a distance measurement instrument (DMI) mounted to the wheel, to provide the best estimate of trajectory. The survey is completed in two alongshore passes: one driving north near the toe of the dune scanning down the profile to the shoreline and the other driving south near the shoreline scanning up the profile to the dune crest. This typically provides an area of overlap between the two passes that is used to assess the accuracy and integrity of the navigation data

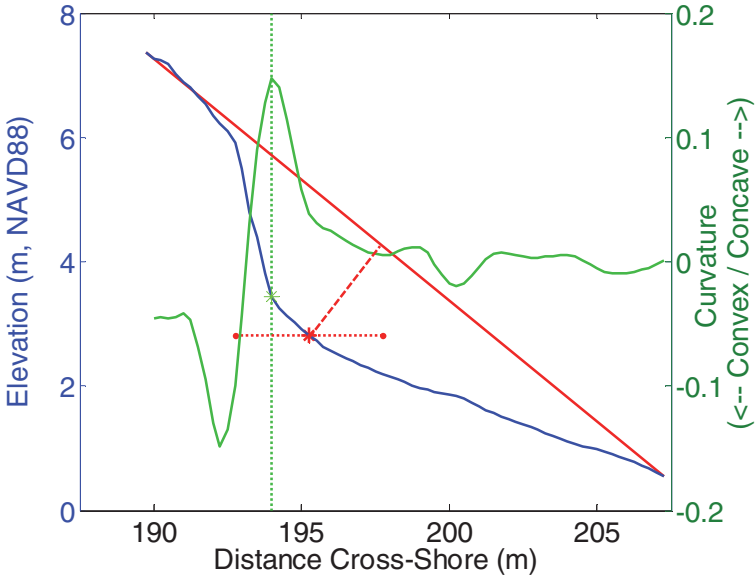
Figure 2 Dune-toe schematic showing elevation profile (blue), linear-fit (red line), first guess D_{low} (red star), dune-toe region (red-dotted line), curvature (green line), and final picked D_{low} (green star).

Morphologic features are extracted along each cross-shore transect every 50 cm along the coastline. The cross-shore curvature for each transect was also calculated to assist in defining morphologic features. The elevation of the dune toe (D_{low}) was found in a two step process (Figure 2), and was the most difficult parameter to extract robustly. The "first guess" D_{low} (red star, Figure 2) was found by finding the point on the cross-shore profile that was the farthest point from a linear fit (red line, Figure 2) between the position of the MHW contour (0.5 m NAVD88) and the maximum observed elevation on that profile (Mitasova et al., 2011). This location was then refined by selecting the point with the maximum positive curvature (green star, Figure 2) within +/- 10m in the cross-shore direction of the "first guess" (red dotted line, Figure 2). This second refinement was necessary because the true dune-crest is often not observed or easily identifiable from ground-based lidar due to the view of the scanner, making the linear fit between the dune crest and shoreline potentially unstable. To that end, the dune crest elevation (D_{high}) was defined as the point with the maximum peak in negative curvature (convex) landward of D_{low} or as the maximum observed elevation in that transect if no local minima in curvature

were observed. The average slope of the dune (β_{dune}) was defined as the slope of the best-fit linear trend in dune elevations between D_{low} and D_{high} . Foredune volume (V_{dune}) was similarly the integral under the points on the dune-face between D_{low} and D_{high} . The number of peaks in curvature (κ_{pks}) between D_{low} and D_{high} was used as a metric to describe the morphology and roughness of the foredune face. Future work will focus on developing algorithms that make use of the point cloud data in addition to the bare-earth DEM to incorporate vegetation coverage and the presence of sand-fencing and other constructive or destructive structures.

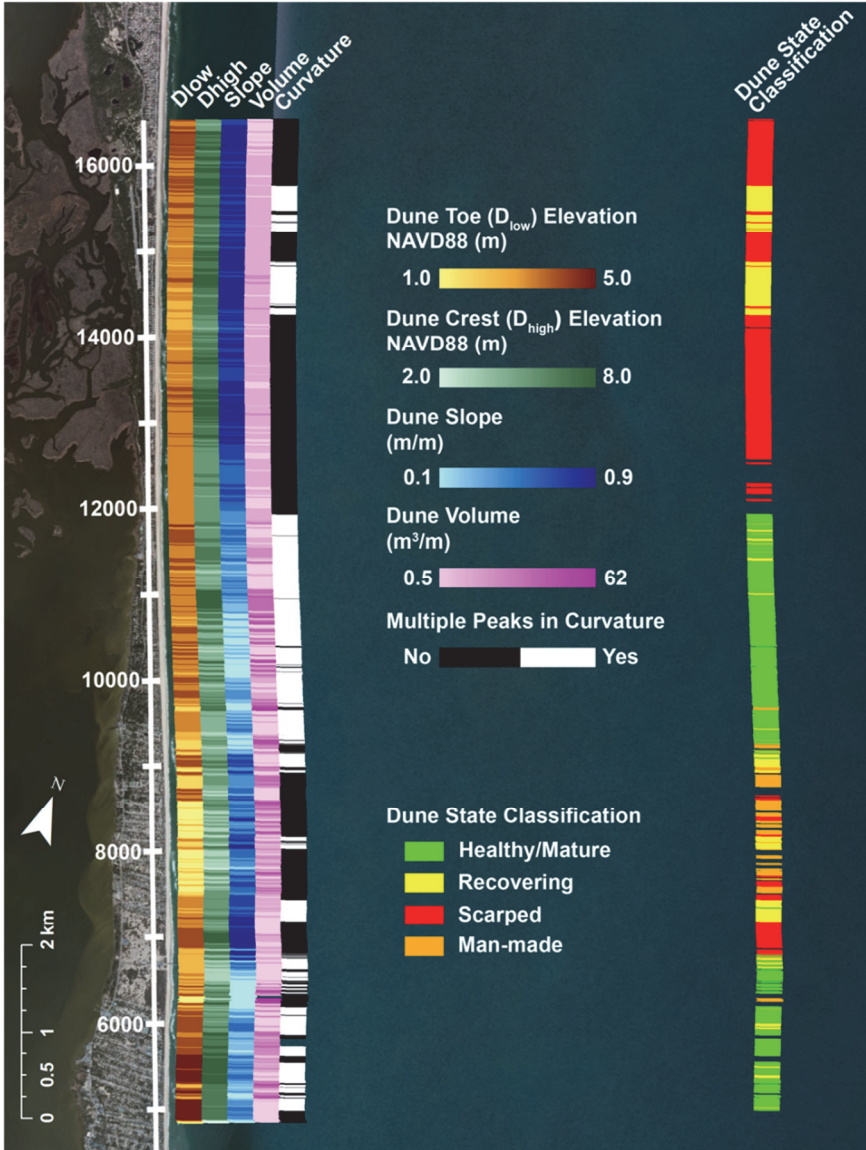
Figure 3 Dune morphology parameters (left) and classification (right).

The morphology of the foredune face varied with location along the study site (Figure 3, left colors). The pre-storm dune morphology will be described in detail in the following paragraph. D_{low} was fairly constant at ~ 4 m in the northern section of coastline between 10000 and 16000 m alongshore. Between 9000 and 7500 m alongshore D_{low} was highly variable, oscillating between 2 and 4 m. South of the FRF pier (~ 7000 m), D_{low} slowly increased from 4 to 5 m.

D_{high} averaged 6.6 m along the study site with a higher variance between 6000 and 12000 m alongshore. The lowest D_{high} elevations were found between 6000 and 9000 m alongshore. β_{dune} ranged between 0.2 and close to 1 (near vertical) with slopes >0.6 occurring primarily between 12000 and 16000 and between 7000 and 7500 (just north of the FRF pier). South of the FRF pier (<7000 m alongshore), and between 7500 and 12000 m alongshore slopes varied around 0.4, near the angle of repose for sand. Between 7500 and 9000 m, there were also some locations with steeper slopes (>0.6). V_{dune} was much lower (< 10 m³/m) in the northern portion of the study site between of 12000 and 16000 m alongshore. South of 12000 m, V_{dune} was more variable, oscillating between < 10 and > 30 m³/m. κ_{pks} ranged between 0 and 2 along the study site. Regions with $\kappa_{pks} > 0$ were found in a small region between 14000 and 15000 m alongshore, between 12000 and 9000 m alongshore, and south of the FRF pier (< 7000 m).

The pre-storm dune-state classification is shown by the red (scarped), orange (man-made), yellow (recovering), and green (healthy) colors along the right side of Figure 3. South of the FRF pier (< 7000 m alongshore), the foredune was classified as healthy, with some locations classified as recovering. This classification is in-line with qualitative assessments of the region, as the wide-beach allows for large fetches, enabling active Aeolian processes to occur. Between 7000 and 7500 m alongshore on the FRF property the dune is classified as scarped or recovering, consistent with a narrow, steep beach, and frequent impact by waves. Between 7500 and 9000 m alongshore, dune morphology is highly variable, including man-made, scarped, and some recovering dunes. This

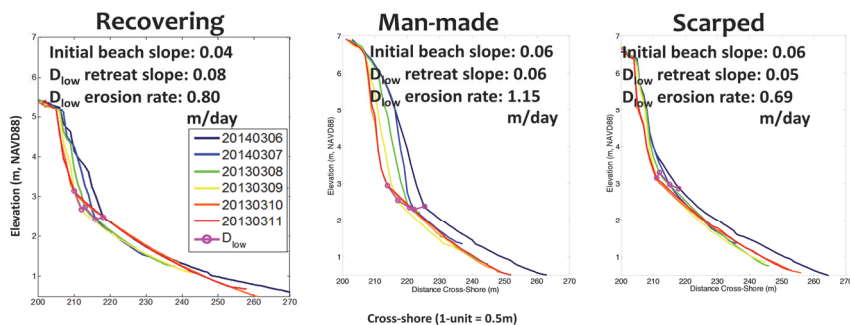
Figure 6. Example profiles during the storm.

Dune volume changes from 06 to 07 March and 06 to 11 March are shown in Figure 5. The majority of dune volume change occurred between 7500 and 10000 m alongshore. The highest dune erosion rates occurred for man-made dunes within the erosional hotspot region (note relationship between locations with red markers in Figure 5A and largest negative peaks in Figure 5B). Daily dune profiles and calculated D_{low} retreat rates are shown for three example profiles in Figure 6: A. Recovering, B. Man-made, and C. Scarped. Initial beach slopes and D_{low} retreat slopes and rates are shown for each example profile. The man-made dunes had the highest retreat rates, averaging ~ 1 m/day, however, man-made dunes also tended to have lower D_{low} elevations. In addition, the recovering dunes eroded more rapidly when compared with the scarped dunes, perhaps owing to increased volumes of unconsolidated sediment (similar to the man-made dunes) at lower elevations associated with the formation of the incipient dune. The initial trajectory for D_{low} for the recovering and man-made dunes was down (from 06-07 March), whereas the scarped dune trajectory was up and backwards, similar to prior studies (Larson et al 2004; Palmsten and Holman 2012). After the initial erosion, however, the D_{low} trajectories were all directed upward and backward. The average slope of the D_{low} trajectories was similar to the initial beach slope for the man-made and scarped dunes, however, was roughly twice the beach slope for the recovering dune.

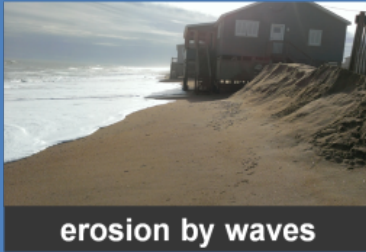
- Coastline Dynamics
- erosion by waves
 - geologic framework
 - sediment supply
 - storm magnitude/frequency
 - beach/nearshore morphology
 - barrier island response to sea level rise

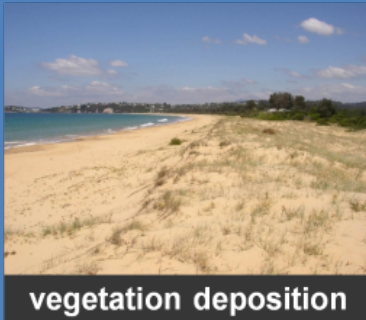
- Aeolian Processes
- fetch-controlled sediment supply
 - wind speed
 - sediment size & type
 - vegetation
 - moisture content

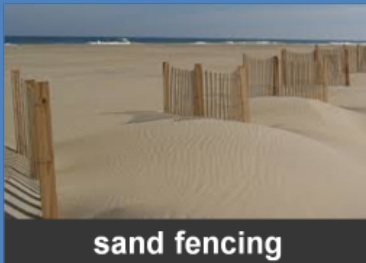
- Management
- anthropogenic sediment supply
 - dune engineering
 - planting vegetation
 - sand fencing
 - beach nourishment
 - engineering structures

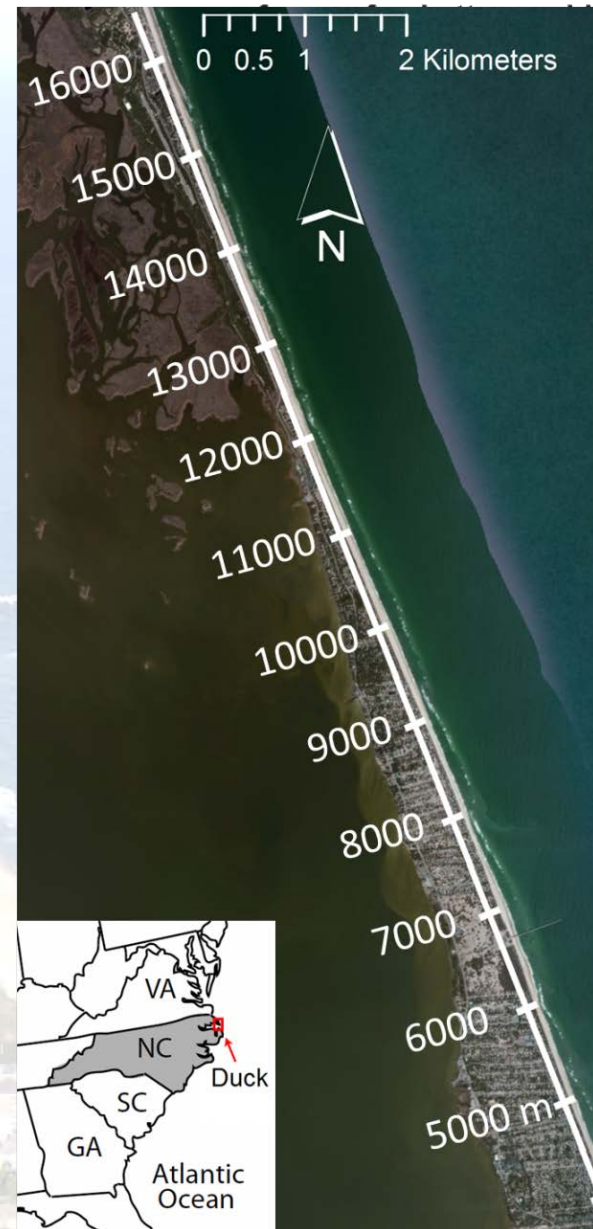
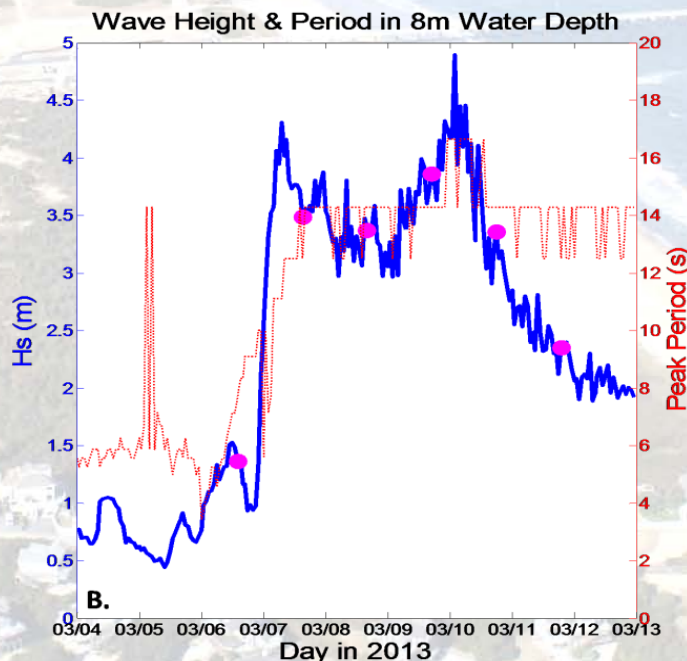
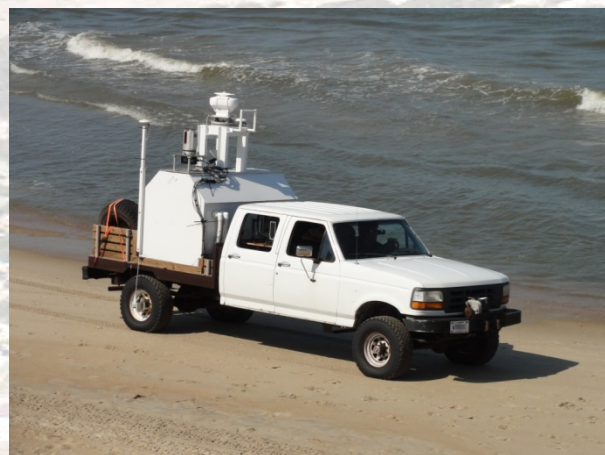
- Mobile terrestrial lidar surveys performed daily along 11km stretch of coastline during 6-day Nor'easter
- Coupled with X-band radar to produce time-averaged images of radar intensity (i.e. wave breaking)
- Centered around low-tide for maximum foreshore exposure and personnel safety
- Largest waves on March 10: $H_s = 4.8$ m at 16 sec

Coastal Lidar and Radar Imaging System (CLARIS)

Nor'easter Storm Conditions

Study Site: Duck, NC

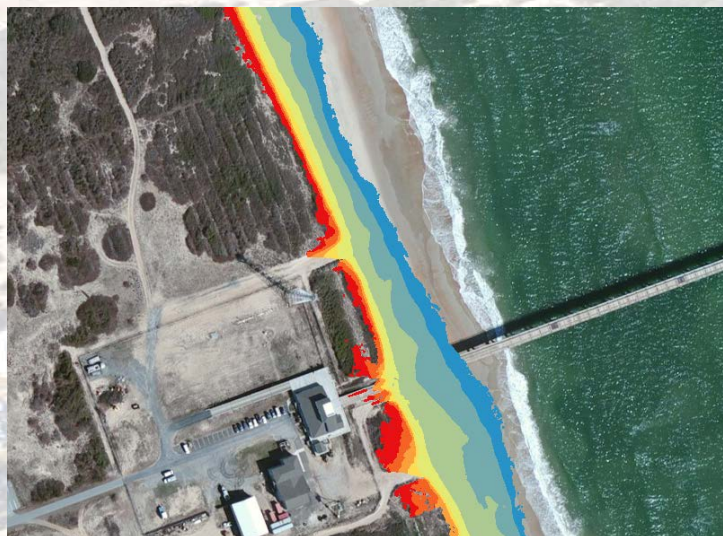
2. Bare-earth DEM at 50 cm resolution

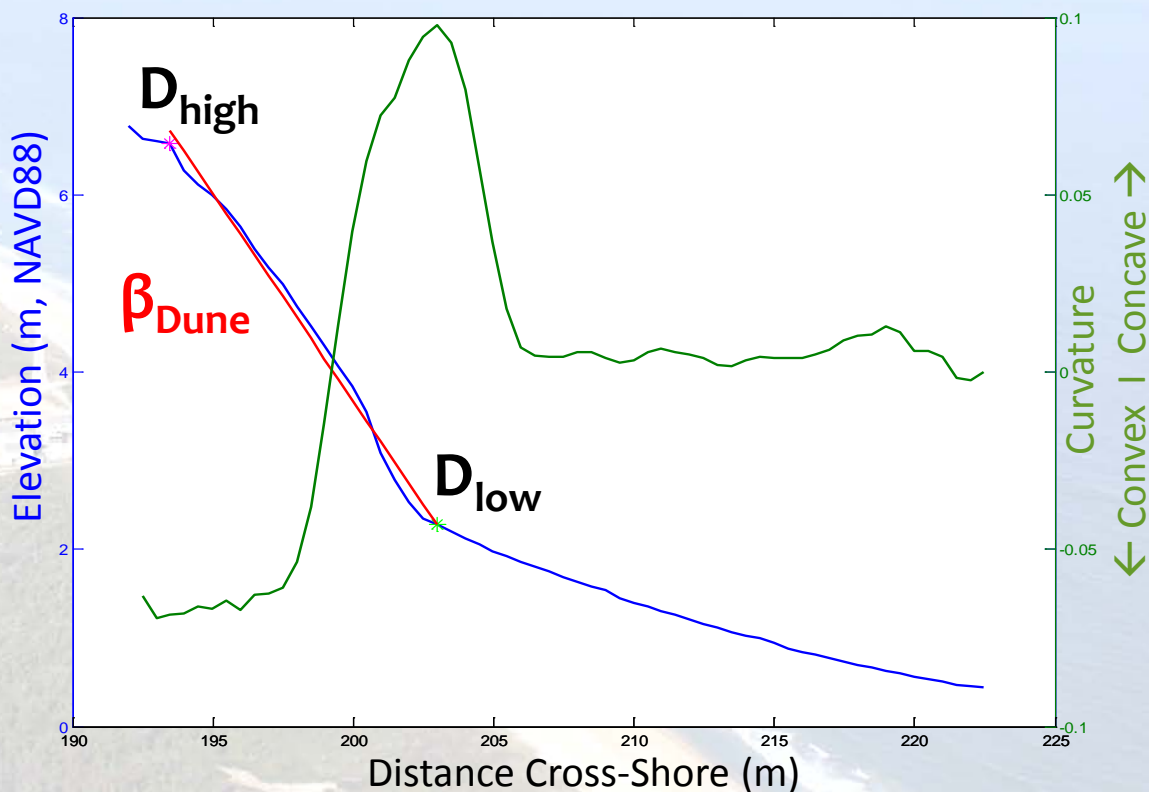
- Cross-shore Profile Curvature (κ_{pks})
- Dune Toe (D_{low}) Elevation
- Dune Crest (D_{high}) Elevation
- Dune Slope (β_{Dune})
- Dune Volume (V_{dune})

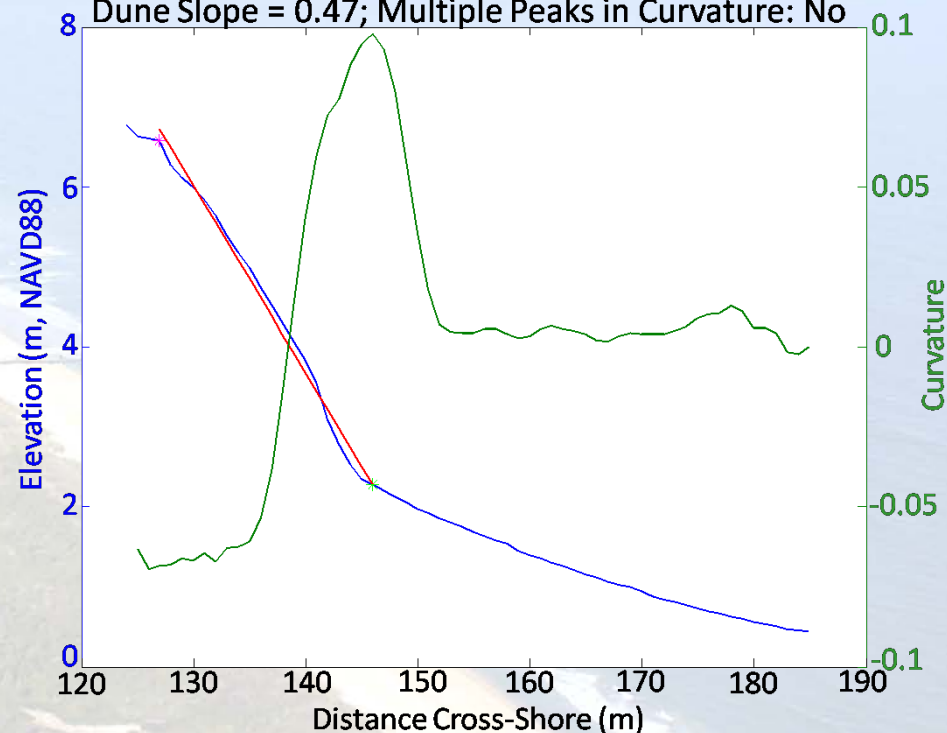
Profile at 7546m alongshore

Dune Slope = 0.47; Multiple Peaks in Curvature: No

- Larger dune volume and shallower slope approaching angle of repose typically placed as an unconsolidated pile of sediment
- Dune toe elevation often lower due to beach scraping or pushing

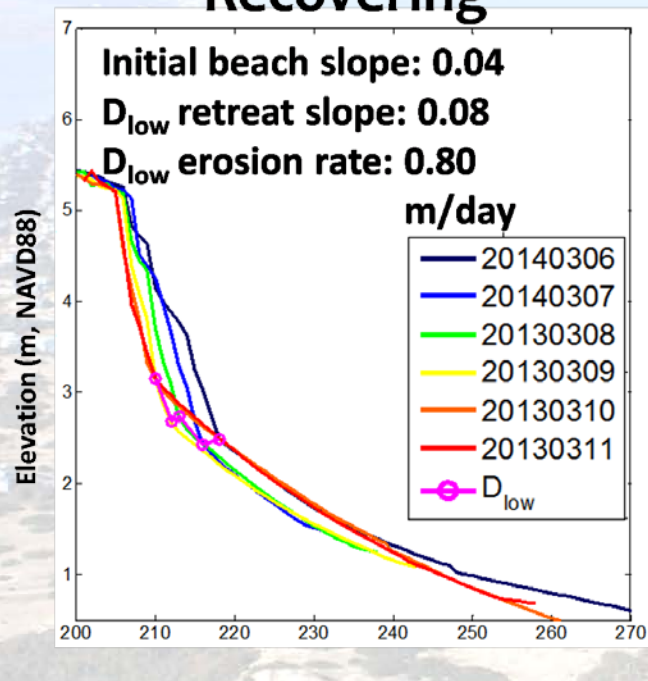
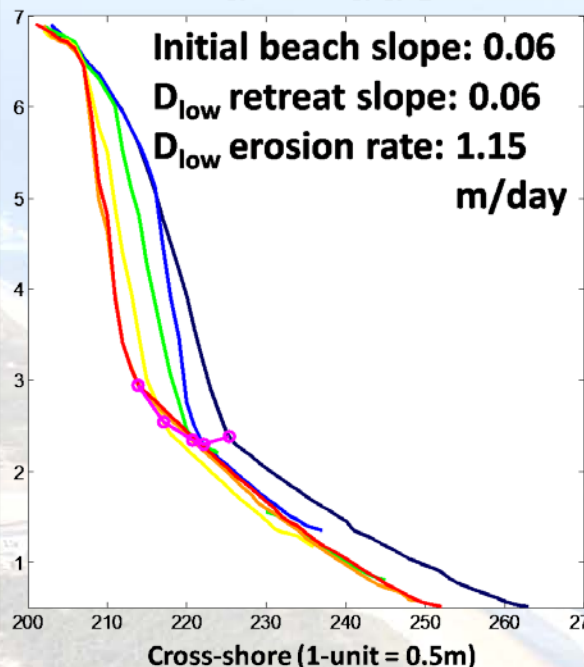
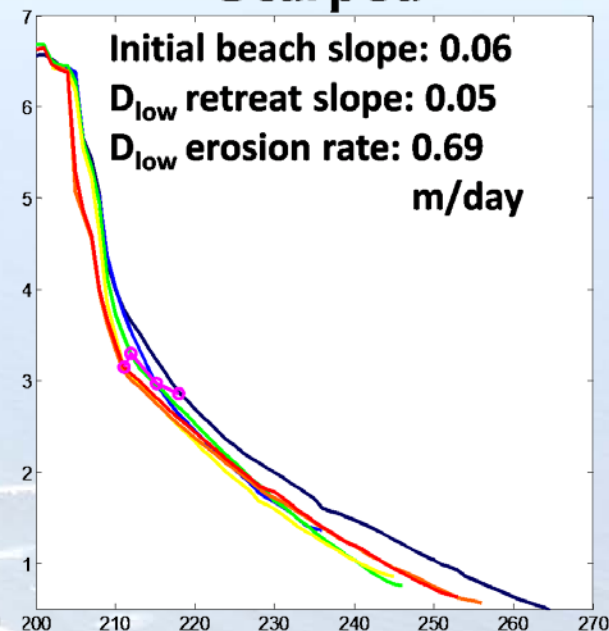
- All three dune types present in erosional hotspot and daily D_{low} erosion rates were calculated
- Recovering and man-made dunes experienced an initial drop in D_{low} elevation whereas scarped dunes retreat was directed upward
- **Hypothesis:** unconsolidated sediment present in both the incipient recovering foredune and the recently placed pile of sand by homeowners combined with lower D_{low} elevations yields higher erosion rates
