US Army Corps
of Engineers®

Development of a New Nondestructive Inspection Strategy for Corroded Multistrand Anchor Cables

by Richard Haskins, James Evans, and Robert Ebeling

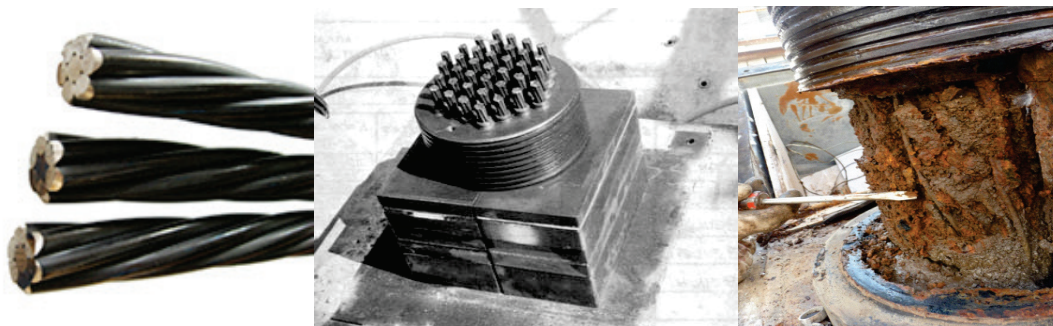
Figure 1. (left) Typical seven-strand cables; (middle) newly installed multistrand anchor head; (right) area under anchor head filled with corrosion product after 30 years of moisture intrusion.

Cable post-tensioning is a method of strengthening concrete with high-strength steel strands. These are typically referred to as tendons and are commonly used in dams, bridges, stadiums, parking structures, rock and soil anchors, houses, and many other structures. Figure 1 (left) and (middle) show a typical cable and multistrand anchor head. While corrosion protection mechanisms have improved over the years, a large inventory of cables with poor or marginal corrosion protection will remain in service for years to come. Even with a modern corrosion protection mechanism, there is a potential for corrosion in the stress-concentrated region of the grip wedge where the assemblage is in closest proximity to the environment and the jacketing materials must be cut back for the wedge-to-steel compression mechanism to function.

may or may not visibly eject wires from the exposed grip wedge. Figure 1 (right) shows a heavily corroded anchorage that was examined during this project. In dams, generally only one end of the cable is accessible. Additionally with navigation structures, the cable's path is most often deep within the concrete, and inspection methods that rely on shallow concrete cover are not applicable. These characterization technologies that are not generally applicable to locks and dams include magnetic polarity scans, corrosion potential/current measurements, impulse response of the structure, ground penetrating radar, and any form of probing or excavation. Also, in large concrete masses, there is generally less known about the cables' local environment. Literature reviews conducted in this project have confirmed that a new method must be developed if improved condition assessment of in situ post-tension cables in navigational structures is to be achieved.

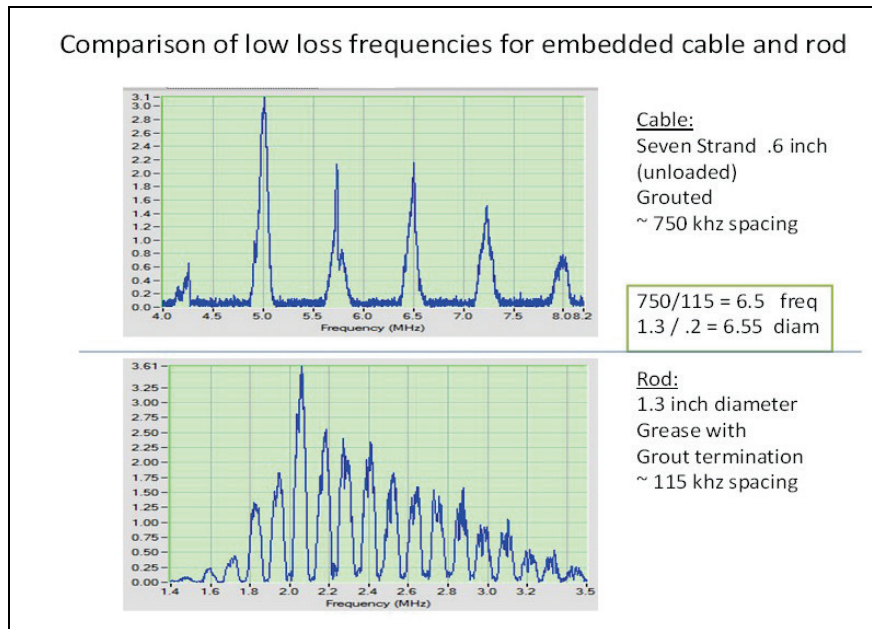
Figure 2. Higher-order, low-loss guided waves in post-tension cable (top) and rod (bottom).

Higher-Order Guided Waves. Higher-order, longitudinal-mode guided waves experience relatively lower attenuation rates in the embedded case than the lower-order modes. This observation, which agrees with published literature, was first made in trunnion anchor rod research and then in post-tension cable investigations. The low-loss, higher-order modes and their attenuation rates are a function of the inspected elements' diameter and material properties. Because material attenuation increases with frequency due to material-based grain scattering, these higher-order modes experience upper frequency limit. The two frequency plots in Figure 2 show spectral representations of lower-loss guided wave modes for both a solid rod of 1.3 in. nominal

The spectral representations in Figure 2 do not show the influence of the group velocity. Group velocity is the speed of the information packet, which in general over this range is increasing with frequency. Using a short-distance, through-transmission, broad-band impact, this can be visualized for the tensioned and embedded case. Figure 3 shows a gated energy scan (top) compared with a broad band mechanical impact (bottom). The vertical axis on the bottom figure illustrates the group velocity effect where the various modes have changing propagation velocities associated with them.

In the guided wave spectral responses shown in Figures 2 and 3, the entire cable is coupled to the ultrasonic transducer. Experiments were also conducted using a very small diameter (.2 in.) transducer coupled to either the center *king* wire, which is straight and very slightly larger (5 %), and to the perimeter wires, which are helically twisted around the center wire. Figure 4 shows the difference in propagating mode frequencies between the perimeter wire and center wire. In general, propagating energy prefers the king wire even though there are six perimeter wires. This is likely due in part to the facts that the perimeter wires are typically cut at an angle to their primary axis and also that these wires have significant surface contact with the embedding media. The angular cuts in the perimeter wire, which are an orthogonal cut of the entire cable, produce high loss levels of the reflected and transmitted propagating guided waves as described in Beard (2003).

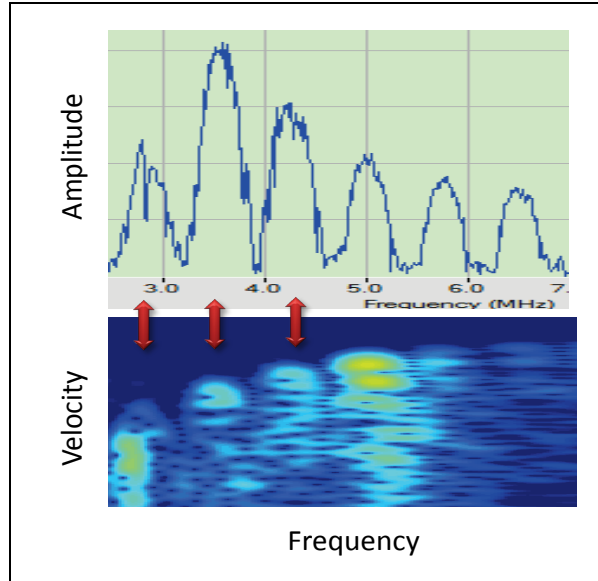
Figure 3. Group velocity of higher-order, low-loss modes.

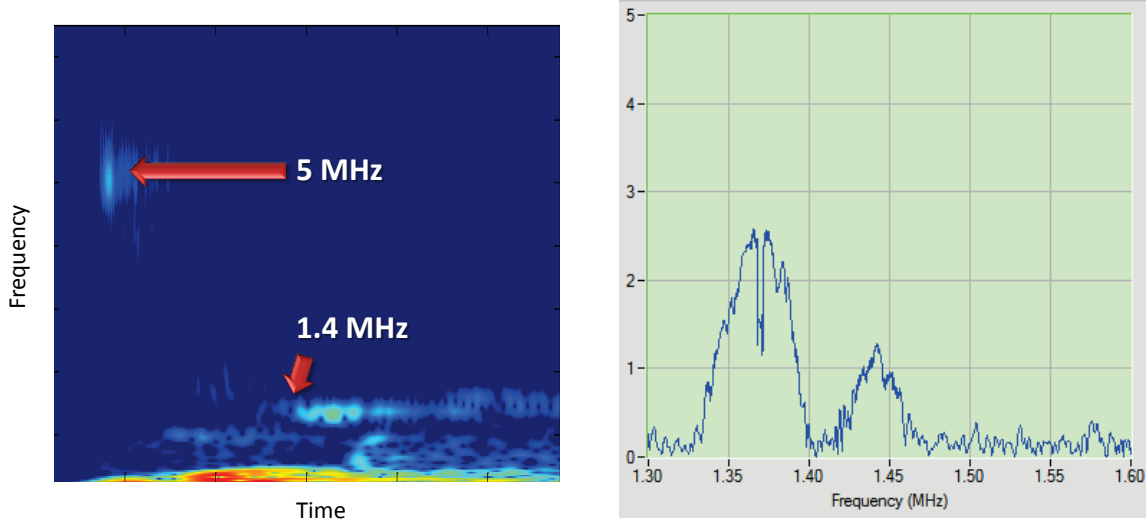
Morlet Transform showing dominate modes

Figure 5. Two visualizations of the 1.4 Mhz mode, which is thought to be a torsional mode. The cable is tensioned to 27,000 lb and embedded in grease.

Torsional Guided Wave. Experiments also indicate the presence of a propagating torsional mode approximately 1.4 Mhz. This mode is identified as torsional because it does not appear to undergo dispersion as it propagates. While this mode has been identified in a large number of tests, it does not appear to be as robust in terms of its sensitivity to transducer coupling. Torsional modes ranges have been limited to distances less than 15 ft of propagation. Figure 5 shows two visualizations of the 1.4 Mhz mode.

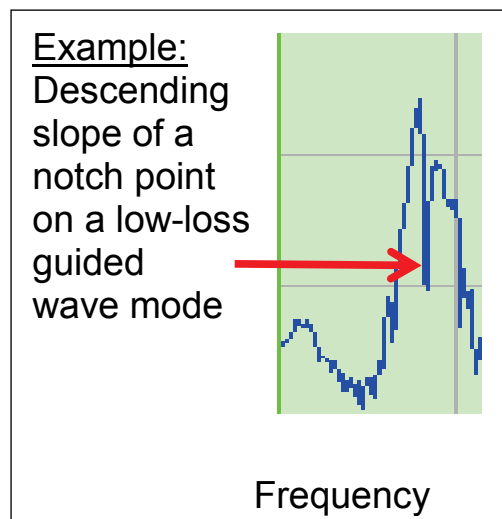
Figure 7. Optimal inspection frequency for defect detection occurring near a higher-order mode notch.

Defect indication was found to be optimal in the descending slope of these notch frequencies and was consistent regardless on which low-loss mode they occurred. This finding was achieved by monitoring the time signals in the vicinity of where an echo was expected as the inspection frequency was incremented on a fine scale. Figure 7 shows the occurrence of a higher-order, low-loss notch frequency.

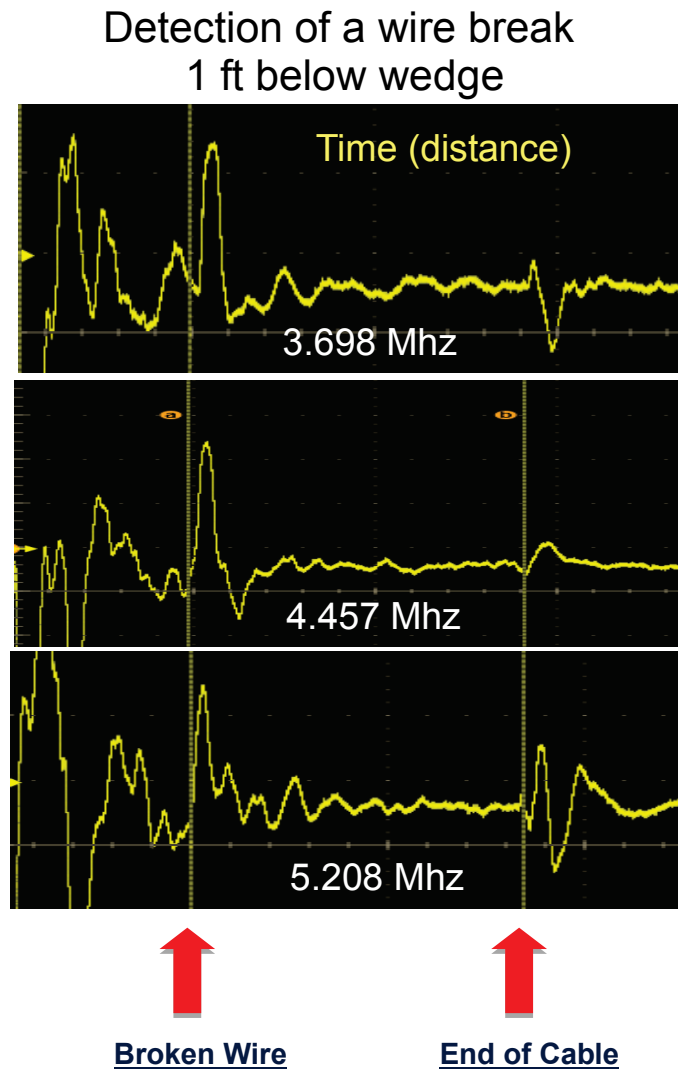
Figure 8. Broken wire detection at 16 in. performed at the higher-order notch frequencies for a tensioned and embedded cable.

In Figure 8, three time signals show the broken wire being detected across three notch frequencies that correspond to three separate low-loss higher-order modes. These defects were also detected at their proper locations when the transducer was moved to the other end of the cable. This corresponded to detection of cut wire locations corresponding to one-third and two-thirds of the cable length or 16 and 32 in., respectively. The initial energy prior to the detected defect is attributable to the gripping wedge and the transition from nontensioned-to-tensioned cable states. The inspection frequencies are also labeled in their corresponding signals in Figure 8.

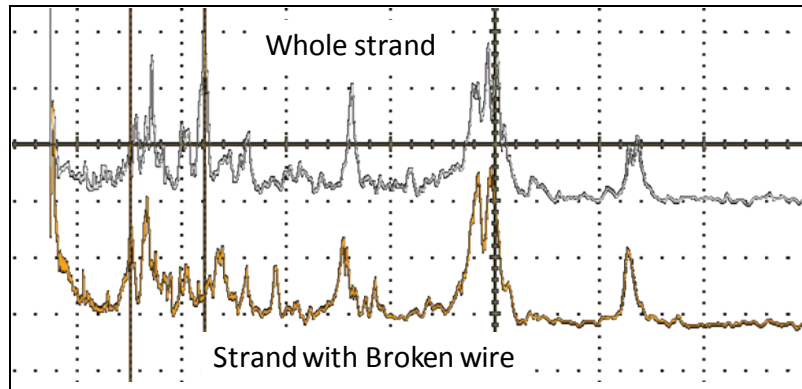
Figure 11. Spectral comparison of whole strand (top) and strand with broken wire (bottom).

The spectrum in Figure 11 shows variations in spectral response between an intact specimen (top) and a specimen of the same length and confinement containing a broken wire (bottom). ASTM E1875 Standard Test Method for Dynamic Young's Modulus, Shear Modulus, and Poisson's Ratio by Sonic Resonance, was also studied to gain additional insight into flexural and torsional resonance modes of simple geometries as well as the effects of transducer and node variations. Ideally, this inspection approach would utilize longitudinal mode resonance; however, flexural and torsional modes will most likely appear within the collected datasets.
