## **Architectural Survey of Laramie Armory, Wyoming Army National Guard**

## **Final Report**

Under Project Number 455557, "Wyoming Armories Historical Context & Bldg  
Evaluation"

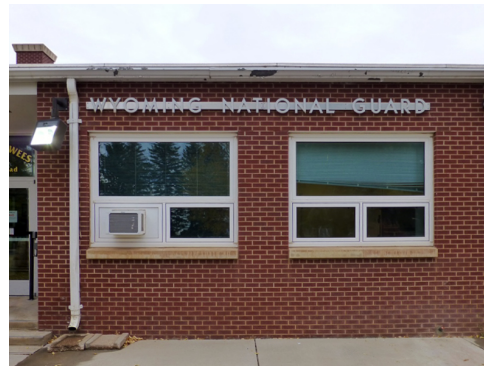
Original stainless steel letters spelling "Wyoming National Guard."

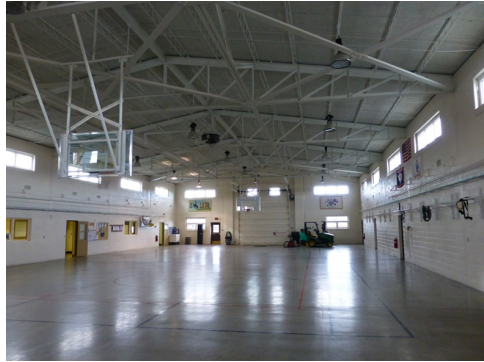
Open double-height drill hall space with concrete floors, concrete block walls, and exposed steel structure.

The drill hall is an open double-height space with concrete floor, concrete block walls, exposed steel truss system and metal roof decking, and replacement pendent light fixtures. The drill hall is the heart of the building, providing access to all of the interior rooms. Some of the architectural features include: glazed sanitary tile walls in the latrines, bottom half of the drill hall walls, and old locker room; concrete block walls; and metal doors (metal, metal and glass, and metal with louvered vent). The lobby, kitchen, latrines, and rifle range have all been modified with newer finishes (such as flooring, drop-ceilings, and light fixtures).

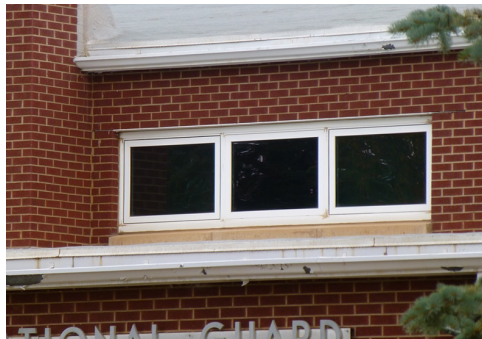
Figure 25. Examples of noncharacter-defining features for the Laramie Armory (ERDC-CERL 2015).

Group of three replacement vinyl sash, single-pane, clerestory windows (original were six-pane, steel-sash, industrial-style clerestory windows).

The building has undergone few renovations. The exterior change to the armory would be the removal of the original steel sash four-pane, six-pane, and eight-pane windows and the addition of the replacement vinyl-sash one-over-two windows (with the exception of five original windows on the east elevation). In addition, all of the clerestory windows have been removed and replaced with vinyl-sash single-pane windows. The overall window pattern did not change or alter with this modification. At an unknown date, a small brick addition was constructed on the east elevation, enclosing the original exterior access to the basement level.

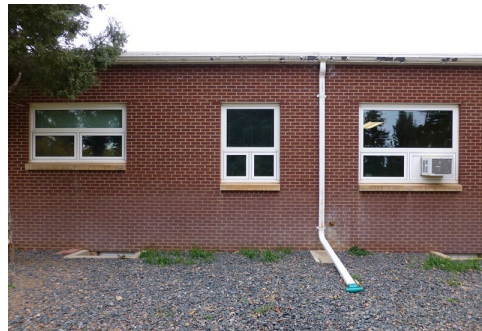
Replacement one-over-one vinyl sash awning windows (original were four-pane, six-pane, and eight-pane steel-sash windows).

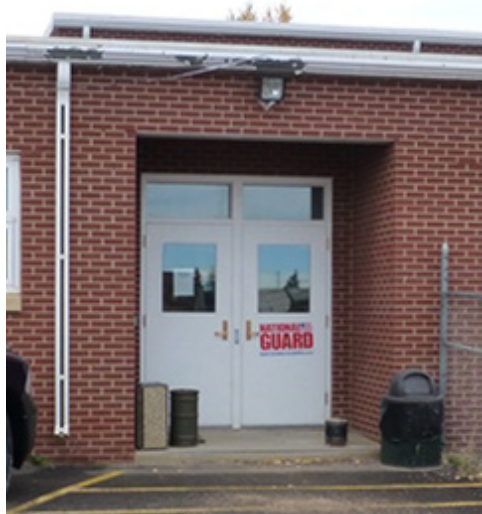
Metal entry doors (replacement).

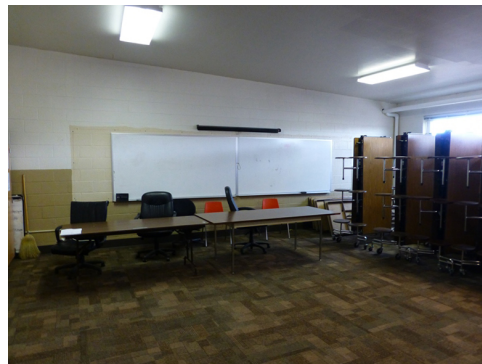
Former locker rooms (modified into smaller storage, classroom, and workout rooms).

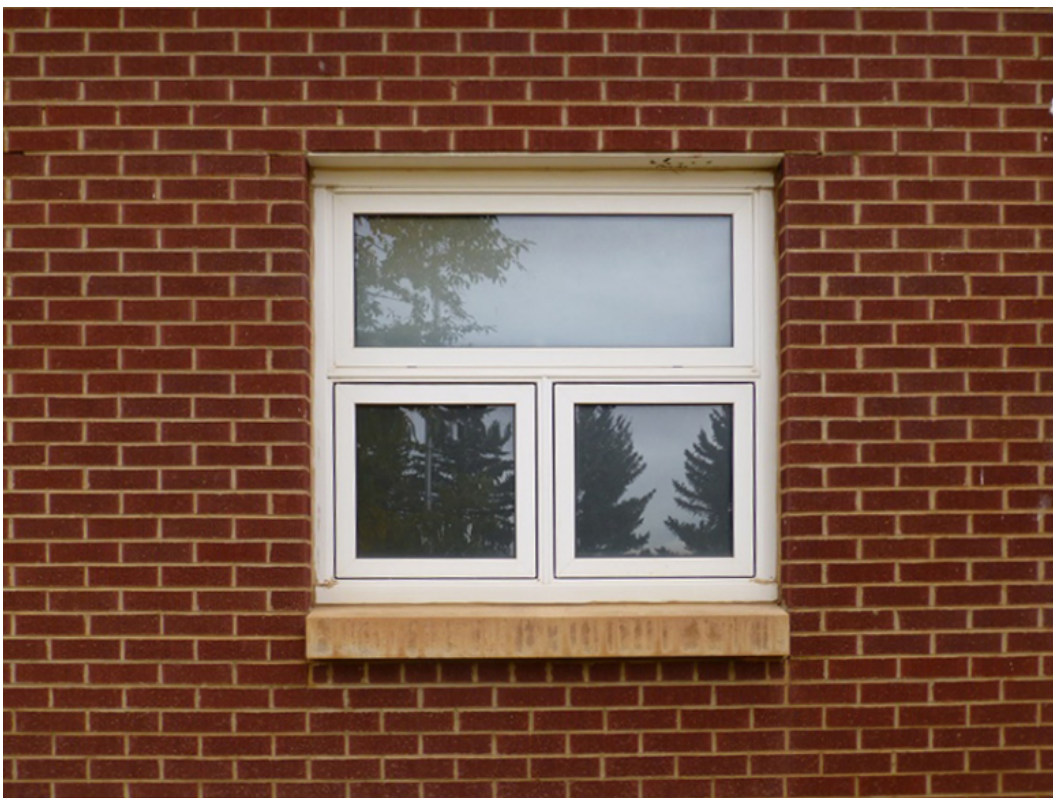
**Photo 4. Laramie Armory, close-up of one of the replacement window types on the left side of the south (front) elevation (ERDC-CERL, 2015).**

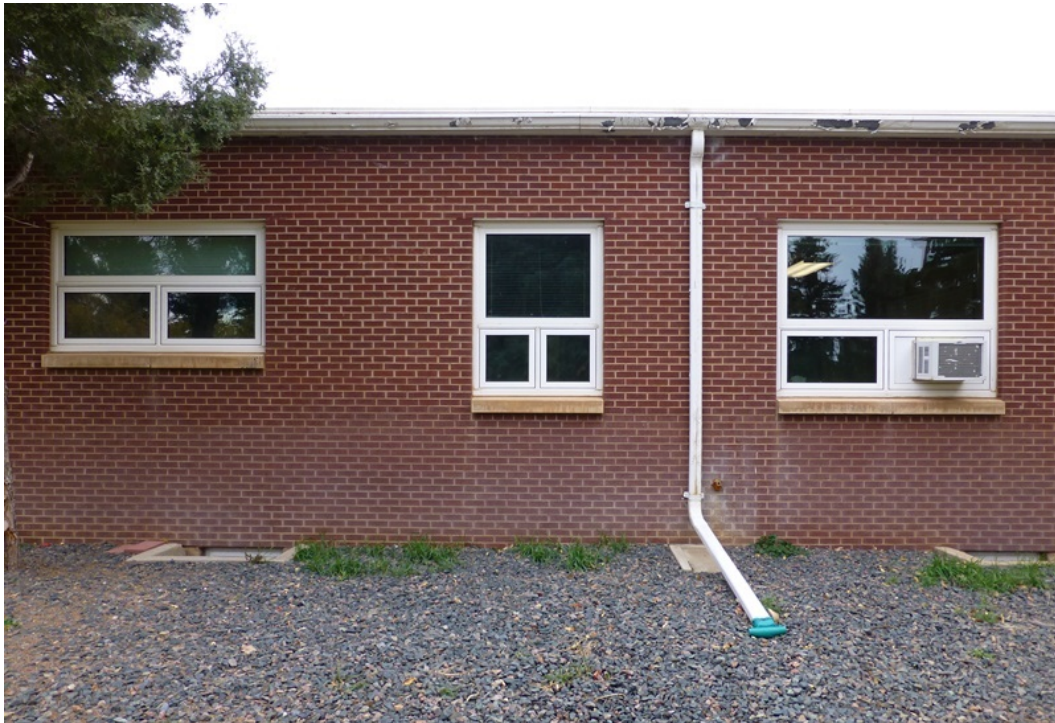
Photo 5. Laramie Armory, three window openings with replacement windows on the left side of the (front) elevation (ERDC-CERL, 2015).

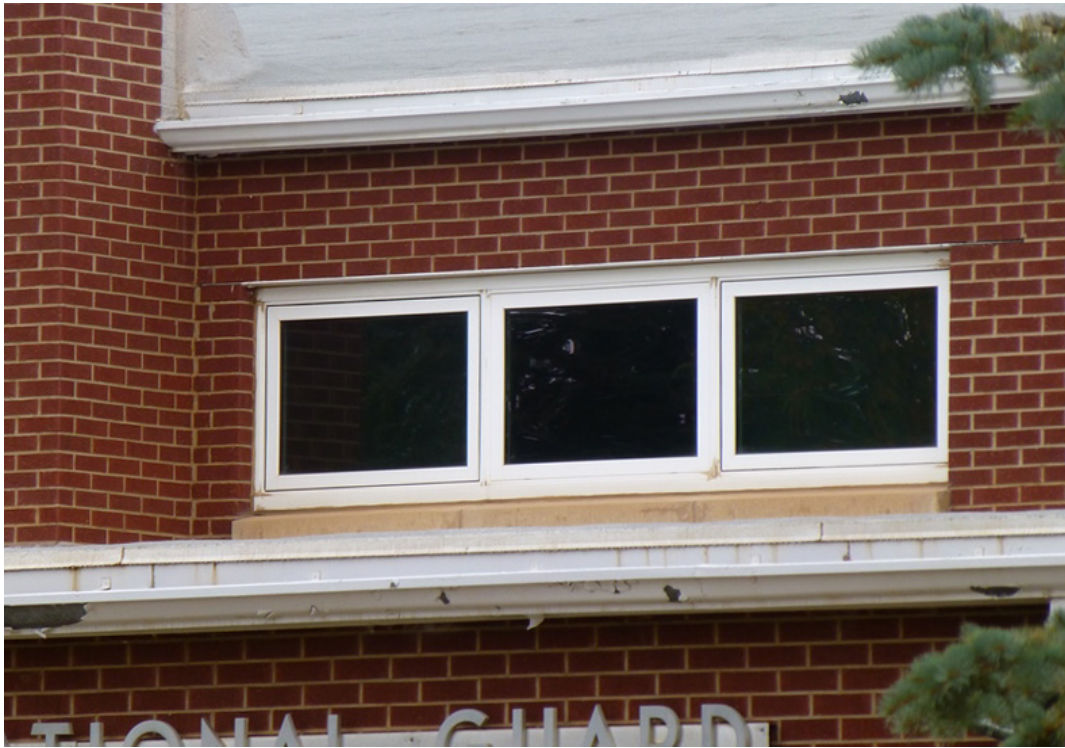
**Photo 9. Laramie Armory, close-up of the replacement clerestory windows on the right side of the south (front) elevation (ERDC-CERL, 2015).**

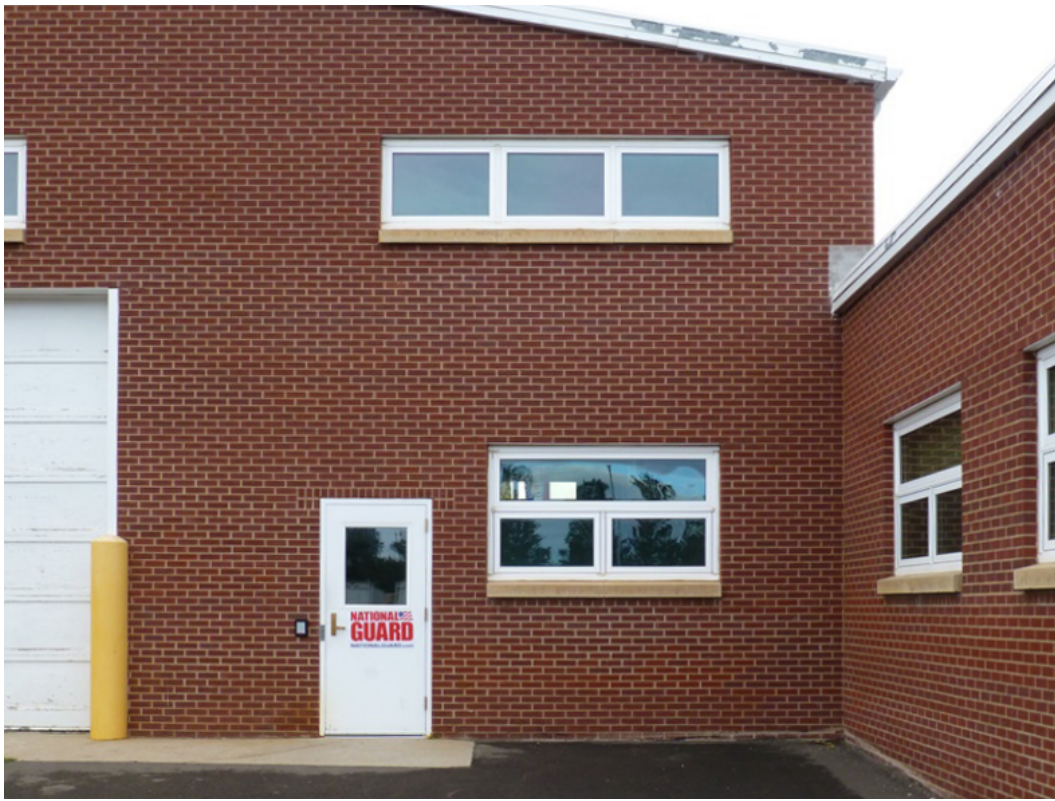
Photo 11. Laramie Armory, close-up of replacement window, clerestory window, and door on the west elevation (ERDC-CERL, 2015).

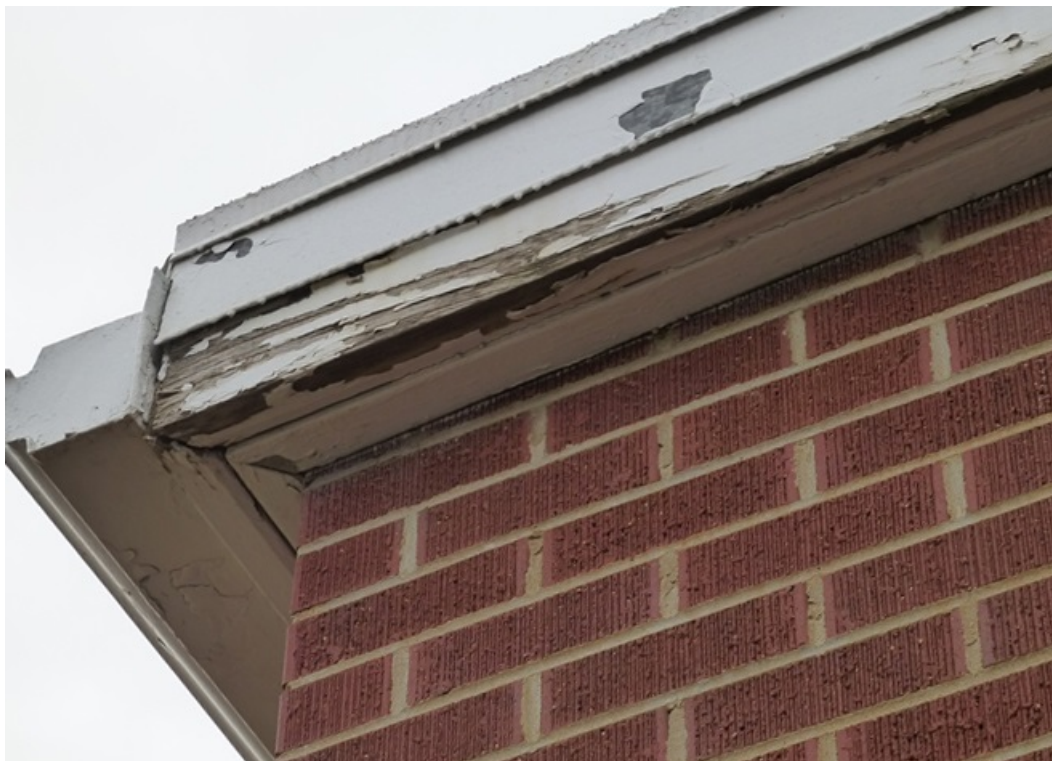
Photo 12. Laramie Armory, close-up of the wood/metal fascia and soffit system on the west elevation (ERDC-CERL, 2015).

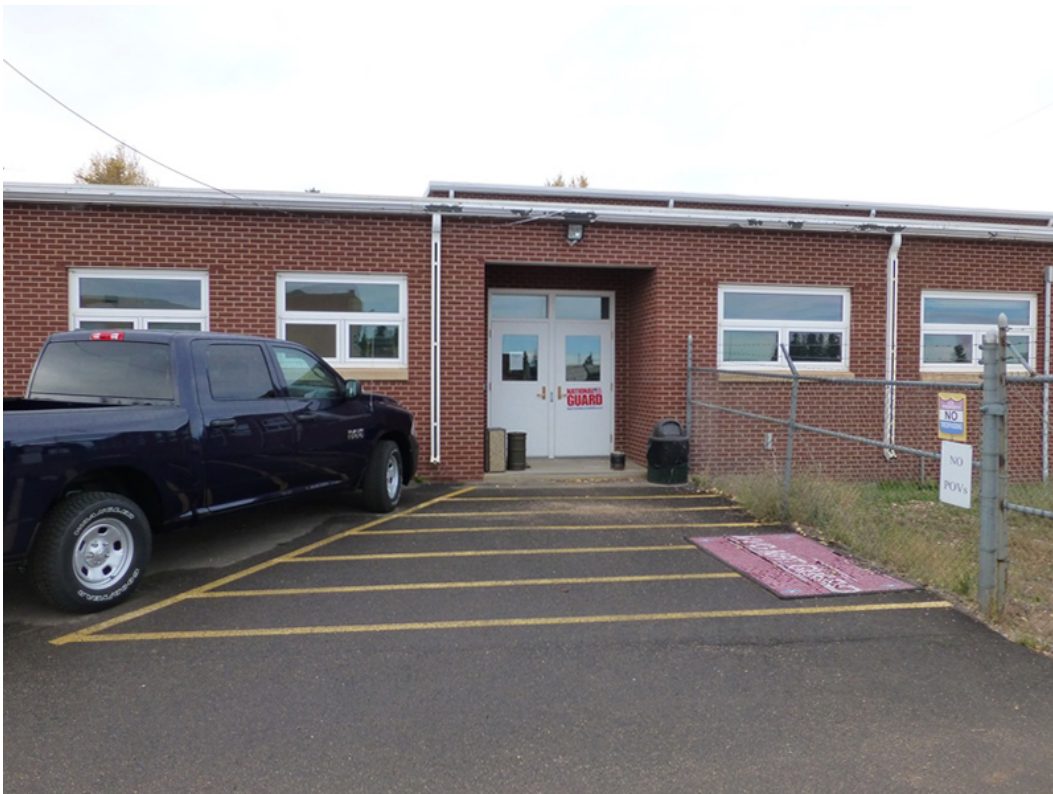
**Photo 14. Laramie Armory entry, with replacement doors and transoms and replacement windows on the north (rear) elevation (ERDC-CERL, 2015).**

The north elevation faces the fenced-in area for the military vehicles. There are sixteen evenly spaced replacement windows. Between the fifth and sixth windows (from the left) is a set of replacement metal doors. There is a small transom above each door. The far left side of the elevation is recessed. There are two replacement windows located on this portion of the elevation. The background of the north elevation is the double-height drill hall. There are six replacement clerestory windows placed on this portion of the wall.

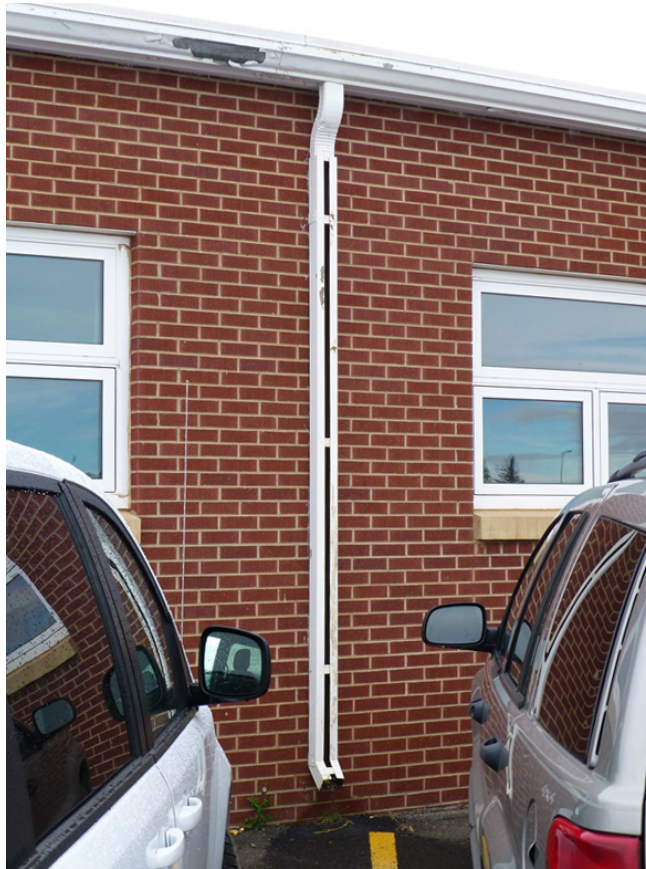
Photo 15. Laramie Armory, close-up of the gutter/downspout system on the north elevation (ERDC-CERL, 2015).

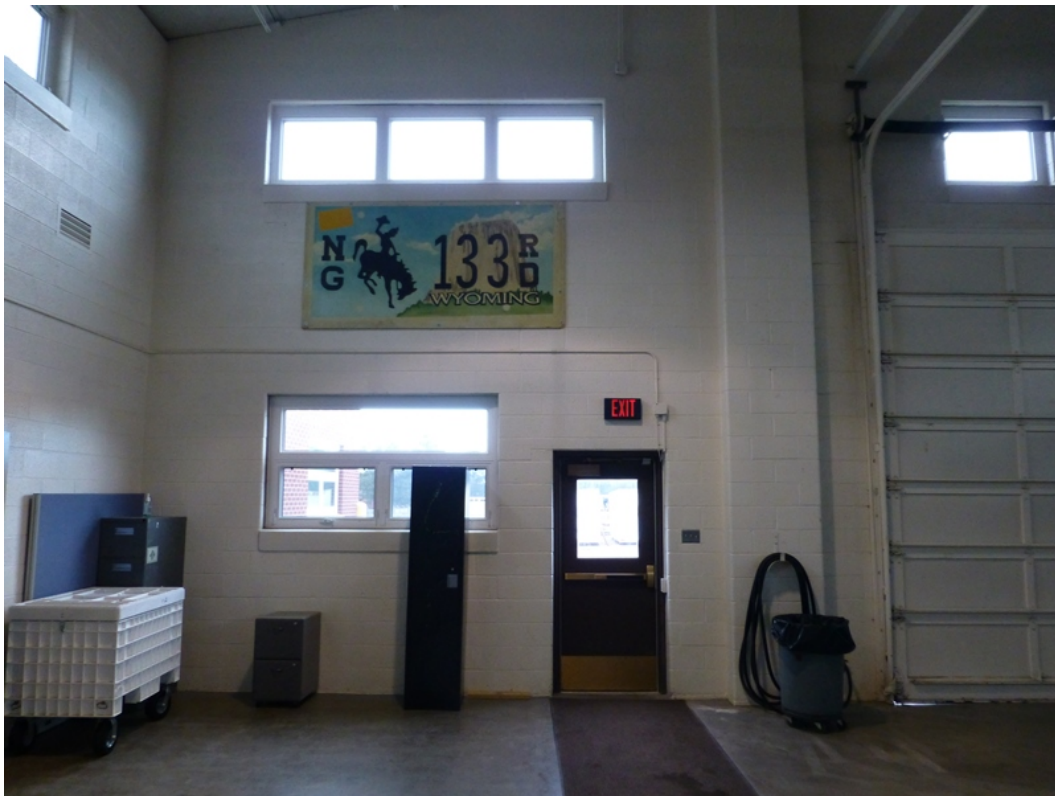
Photo 51. Laramie Armory, replacement door, window, and clerestory window on the left side of the west wall of the drill hall (ERDC-CERL, 2015).

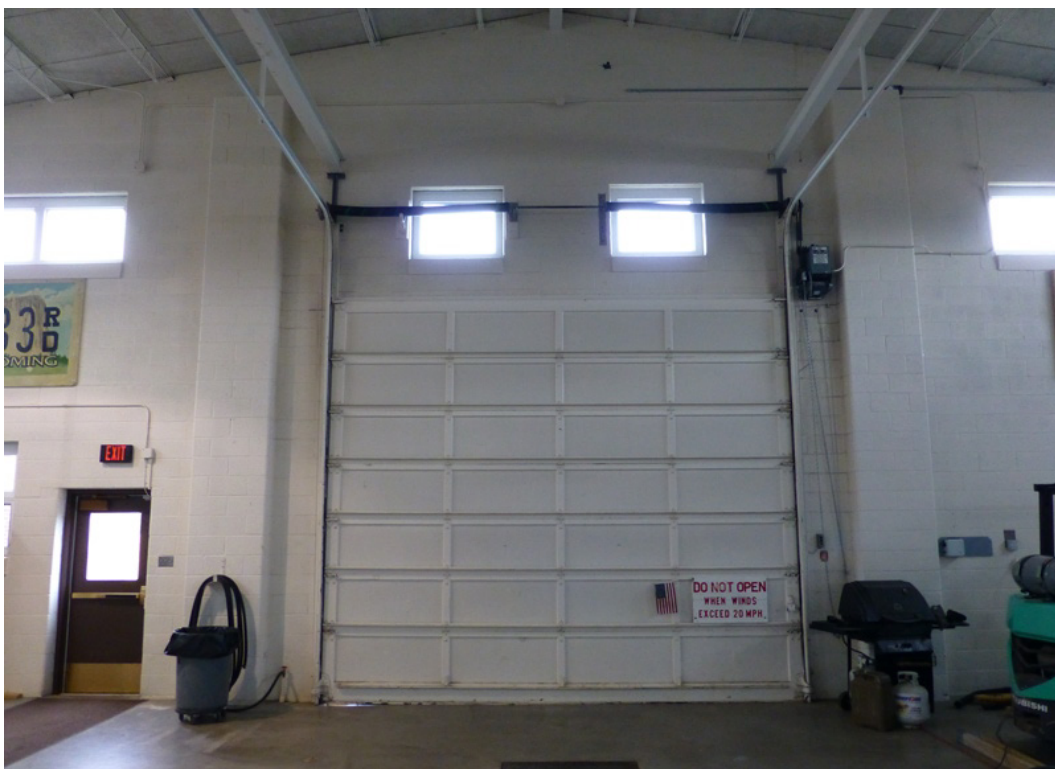
Photo 52. Laramie Armory, replacement metal overhead door on the west wall of the drill hall (ERDC-CERL, 2015).

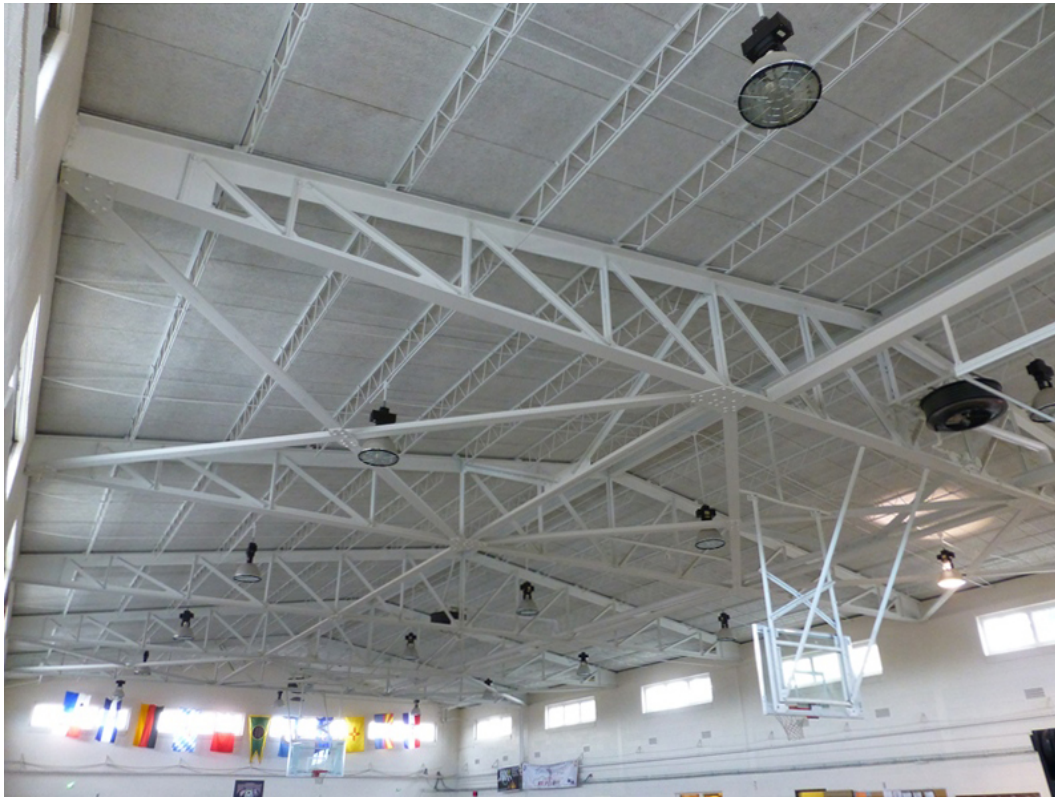
Photo 55. Laramie Armory, exposed metal truss roof system in the drill hall (ERDC-CERL, 2015).

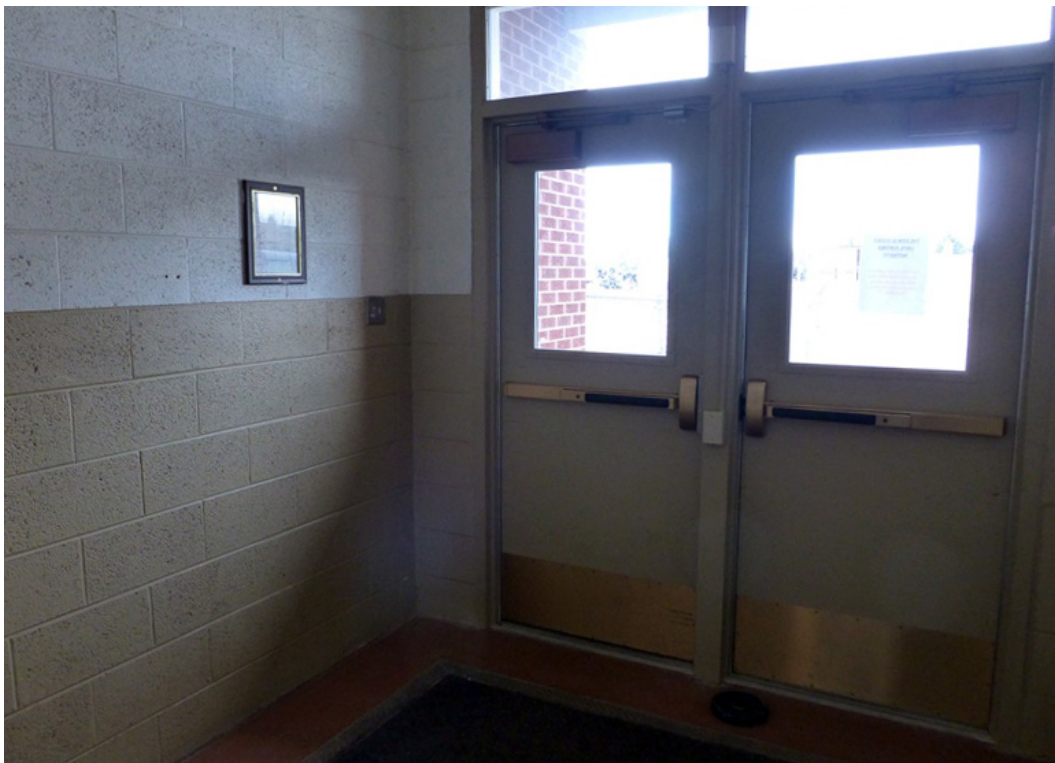
Photo 72. Laramie Armory, replacement metal doors, leading from north vestibule to the exterior (ERDC-CERL, 2015).

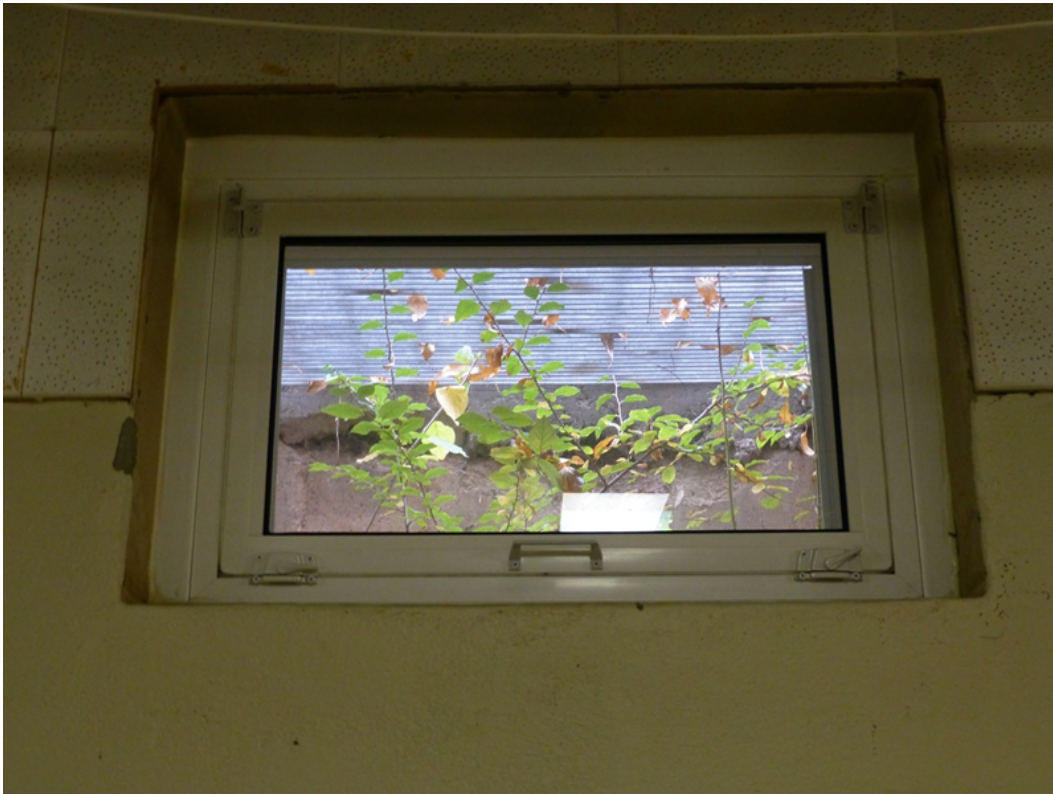
**Photo 83. Laramie Armory, replacement vinyl hopper window in the basement (ERDC-CERL, 2015).**

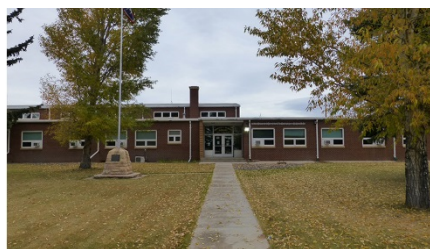
**South (front) elevation: original drawing from 1957 [left], compared to the condition of the elevation with replacement windows in 2015 [right] (ERDC-CERL, 2015).**

There are original stainless steel letters spelling out “Wyoming National Guard” that are placed just to the right of the entry, above two replacement windows. The left side of the elevation consists of six larger replacement windows, three smaller replacement windows, and two narrow replacement windows (latrine windows). The right side of the elevation consists of eight of the larger replacement windows. The background of the south elevation is the double-height wall of the drill hall. There are five evenly spaced replacement windows placed on this part of the wall. A brick chimneystack extends from the one-story shed roof and projects above the double-height gable roof of the drill hall.

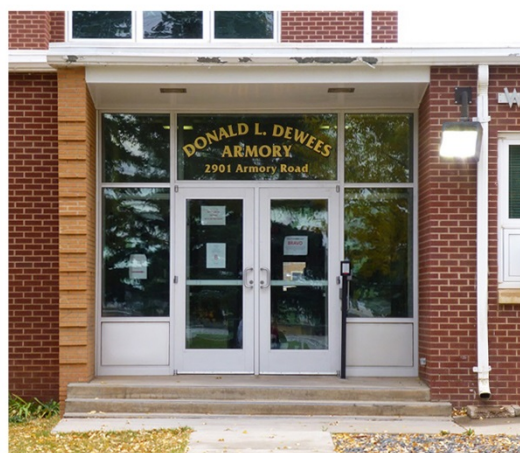
**Main entry on the south (front) elevation: original drawing from 1957 [left], compared to the condition of the elevation with doors, sidelights, and transom in 2015 [right] (ERDC-CERL, 2015).**

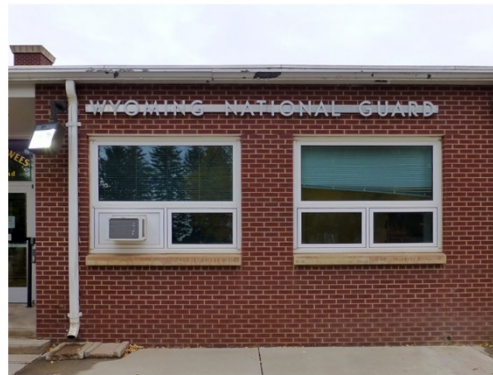
Eight-pane steel-sash windows and stainless-steel lettering on the south (front) elevation: Original drawing from 1957 [left], compared to the condition of the replacement vinyl one-over-two windows and original lettering in 2015 [right] (ERDC-CERL, 2015).

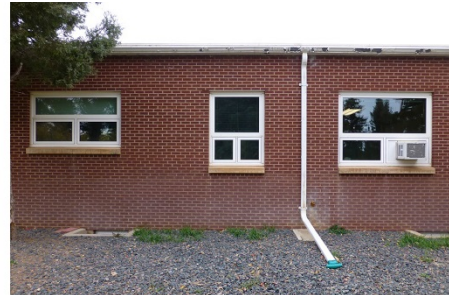
Three different size multipane steel-sash windows: original drawing from 1957 [left], compared to the condition of the different sizes vinyl one-over-two replacement windows in 2015 [right] (ERDC-CERL, 2015).

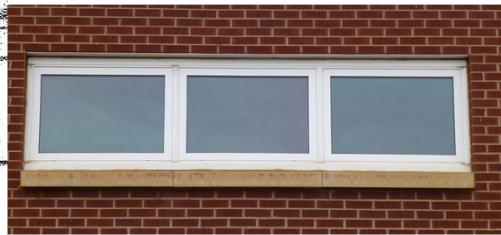
Clerestory windows: original drawing from 1957 [left], compared to the condition of the vinyl-sash single-pane replacement windows in 2015 [right] (ERDC-CERL, 2015).

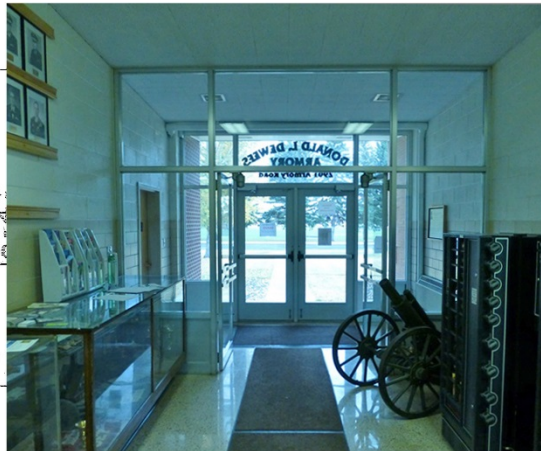
South vestibule doors, sidelights, and transom: original drawing from 1957 [left], compared to the condition of the original bright-aluminum and plate-glass doors, sidelights, and transom in 2015 [right] (ERDC-CERL, 2015).

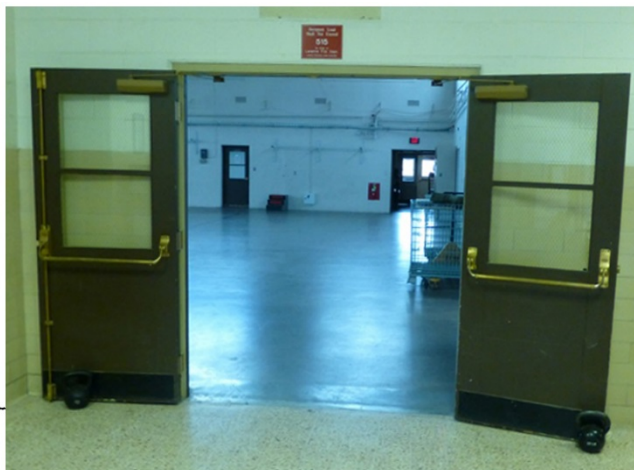
Set of metal doors with divided lights: original drawing from 1957 [left], compared to the condition of the original doors that lead from the lobby into the drill hall in 2015 [right] (ERDC-CERL, 2015).

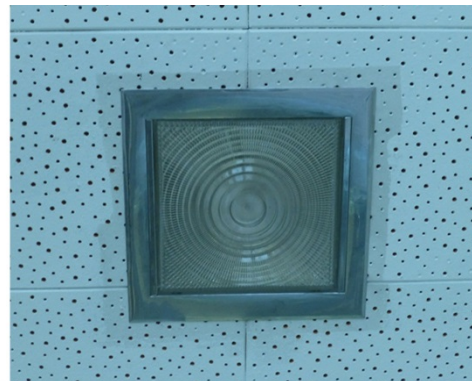
SQUARE  
RECESSED  
LENS UNIT

Square recessed light fixture: original drawing from 1957 [left], compared to the condition of the original light fixture located in the vestibule and lobby in 2015 [right] (ERDC-CERL, 2015).
