## **Comparing Manned Aerial Surveys to Unmanned Aerial Surveys for Cetacean Monitoring in the Arctic: Field Report**

Robyn Angliss<sup>1</sup>, Megan Ferguson<sup>1</sup>, Phil Hall<sup>2</sup>, Van Helker<sup>3</sup>, Amy Kennedy<sup>4</sup>, Todd Sformo<sup>5</sup>

Naval Surface Warfare Center Dahlgren Division

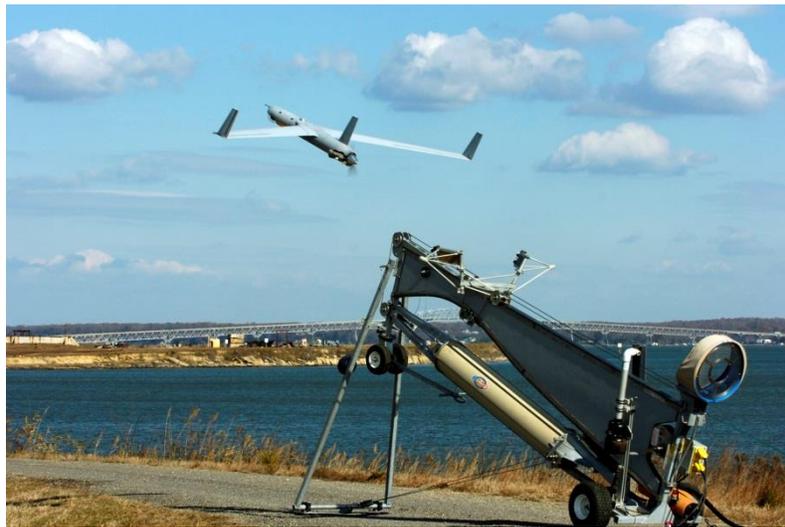
**Figure 2.** ScanEagle® on launch at Naval Surface Warfare Center – Dahlgren Division

The mission used two ScanEagle® UAS manufactured by Insitu, Inc. (Figure 2). All pilots were trained by Insitu and had Letters of Authorization designating them as approved ScanEagle® UAS pilots by a US Navy Squadron. ScanEagle® dimensions and performance characteristics are included in Table 1.

*Launch system.* The SuperWedge® Launcher was used to launch the aircraft (Figure 2). The launcher is charged by an attached air compressor. The UAV is launched by removing the safety pin and then the catapult is manually activated using a pull trigger. On firing, the launcher accelerates the UAV, and at the end of the rail, the UAV is launched at takeoff speed.

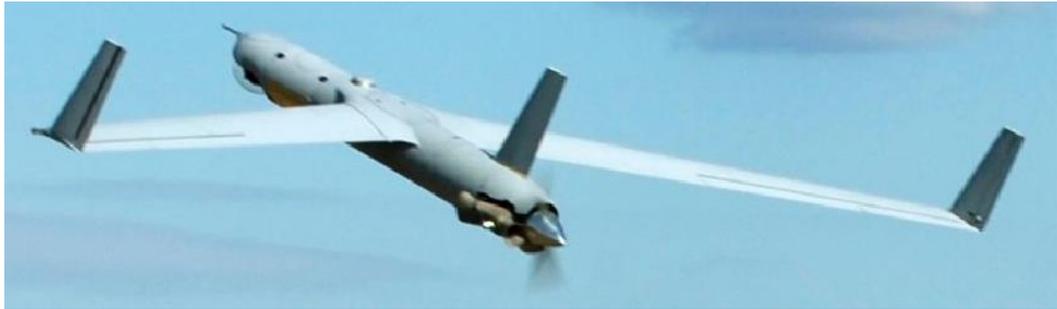
**Figure 3.** ScanEagle® UAV

The ScanEagle® UAV is a long endurance aircraft composed of modules that are replaceable at the field site. The ScanEagle® UAV (Figure 3) is a tailless aircraft that features a high aspect ratio swept wing. It has a rear-mounted engine driving a pusher propeller. Two sets of elevons on the wings provide pitch and roll control, with rudders on the wingtips for directional control.

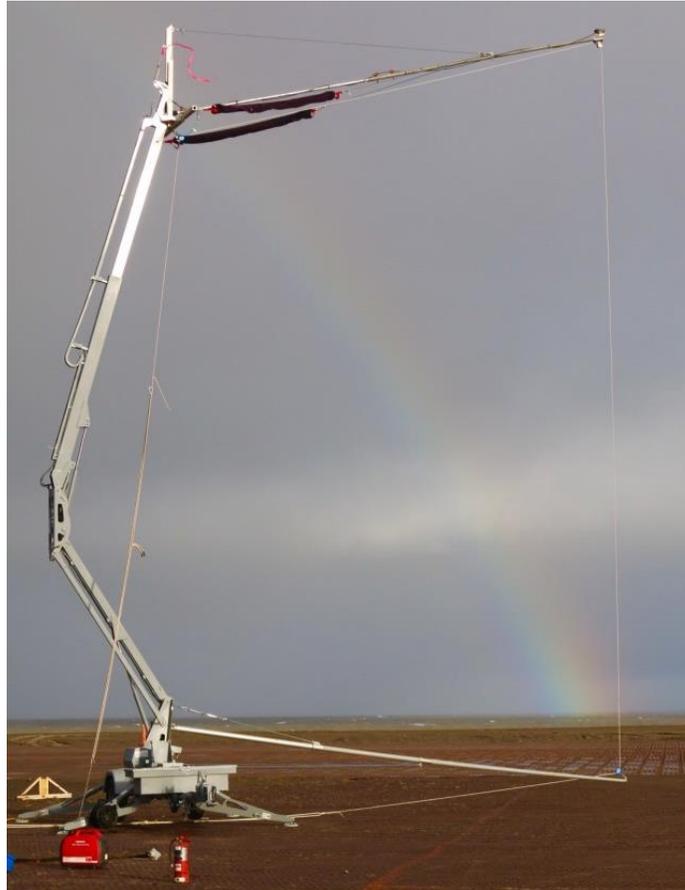
**Figure 4.** Skyhook® retrieval system, Barrow AK.

*Retrieval system.* The SkyHook® retrieval system (Figure 4) captures the UAV. The SkyHook® system uses a GPS receiver and antenna to make an accurate approach via data relayed through the control station. The aircraft is captured by flying into a rope suspended approximately 45 feet above the surface. A hook on the wingtip catches the line and quickly stops the aircraft.

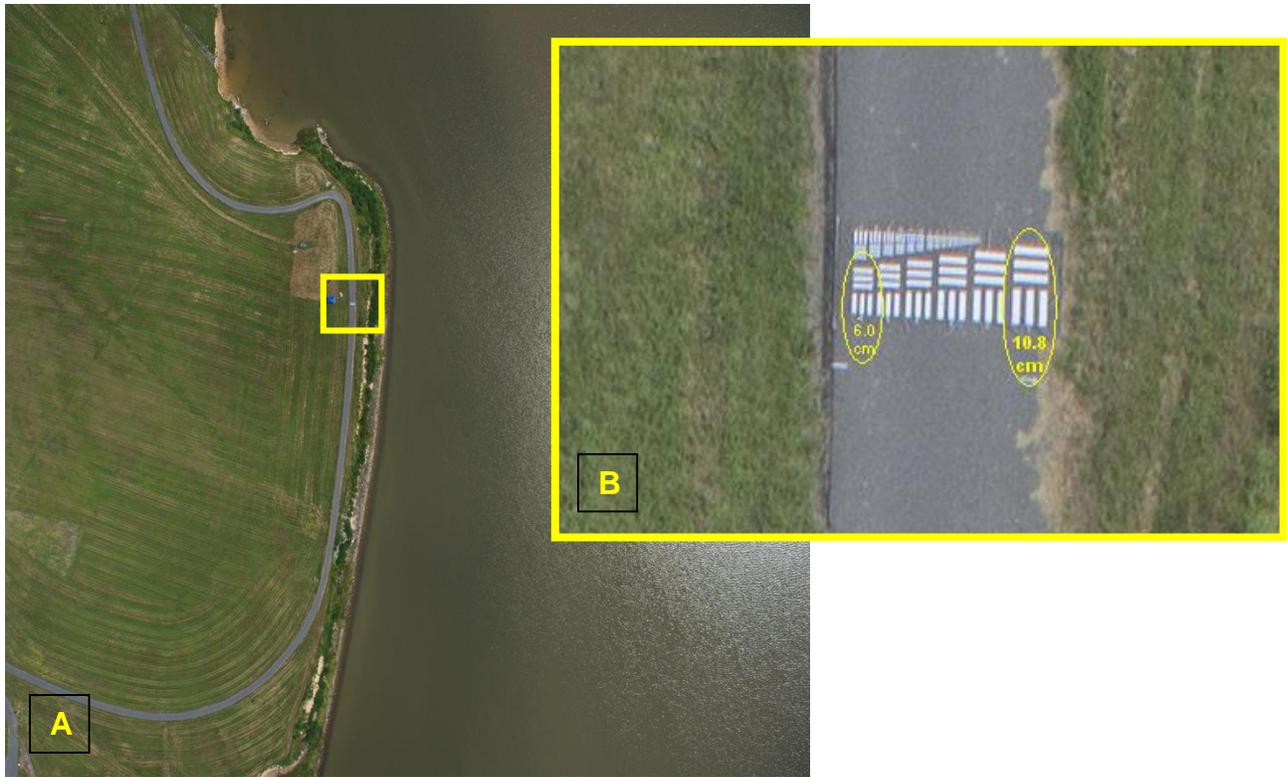
**Figure 5.** Image A was taken from the UAS during the test flight in Dahlgren, VA at 1050 ft AGL and 60 kts ground speed. Image B shows the calibration target at 300% zoom, with circles around the 6 cm wide and 10.8 cm wide calibration tribars.

The Nikon D810 and 20 mm Nikkor lens was flight tested at NWSCDD on 21-22 July 2015. The UAS overflew a tri-bar calibration target at pre-determined altitudes in order to assess the accuracy of the camera system. In addition, the tests were necessary to ensure that the pilots could determine whether the camera was firing. The bars on the calibration target ranged from 0.5 cm wide to 10.8 cm wide. During the test flights, images taken at 1050 ft AGL and 60 kts showed an image resolution of 6 cm (Figure 5).

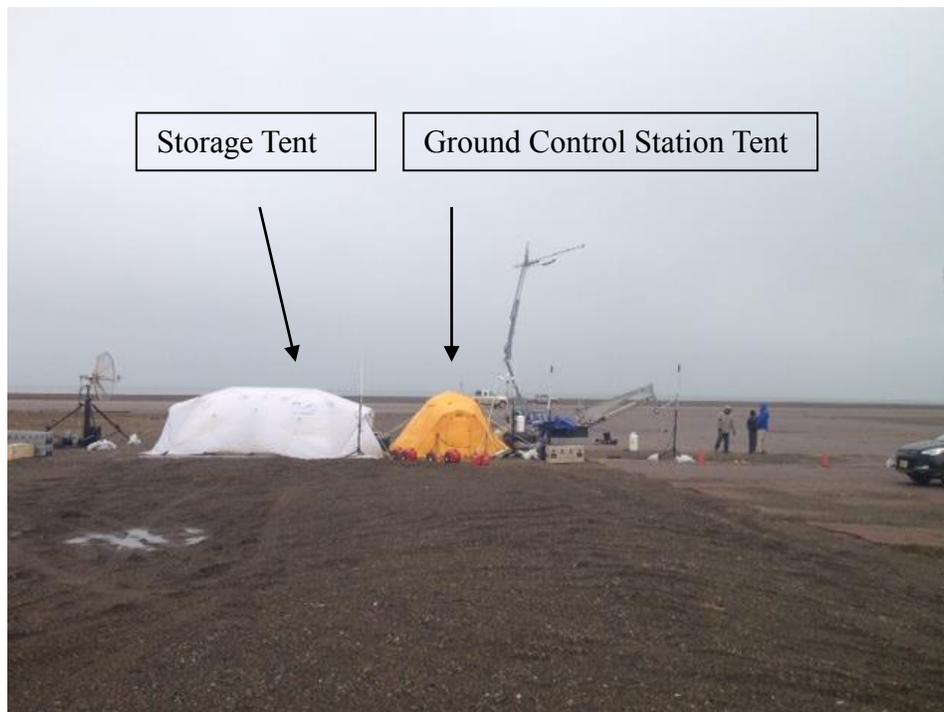
**Figure 7.** ScanEagle® UAS ground equipment

The shore team (5 staff from Dahlgren; 3 staff from the AFSC) was based at the runway north of the Naval Arctic Research Laboratory (NARL), approximately 5 miles north of Barrow, Alaska. Portable Arctic Oven tents were used to shelter the GCS, the UAS, and the survey team. The tents, along with the launch and retrieval equipment, were positioned near the defunct NARL runway in front of the northernmost hanger (Figures 6-8).

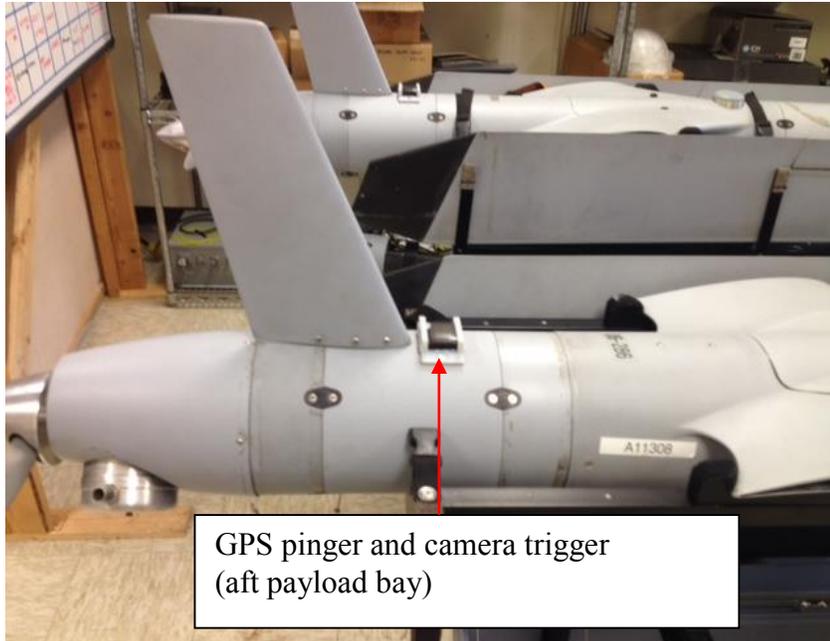
**Figure 15.** Aft payloads in the ScanEagle®

3. EO board camera (14): The EO board camera provided the UAS operator with situational awareness during flight.
4. GPS pinger (15): The GPS pinger was intended to aid in recovery of the UAS in the event of a controlled water landing. The GPS pinger also allowed for GPS metadata to be included with the images taken with the D810 camera.

5. Camera trigger (15): The camera trigger was intended to allow for the D810 camera to have pictures taken based on GPS distance instead of using the camera timer.

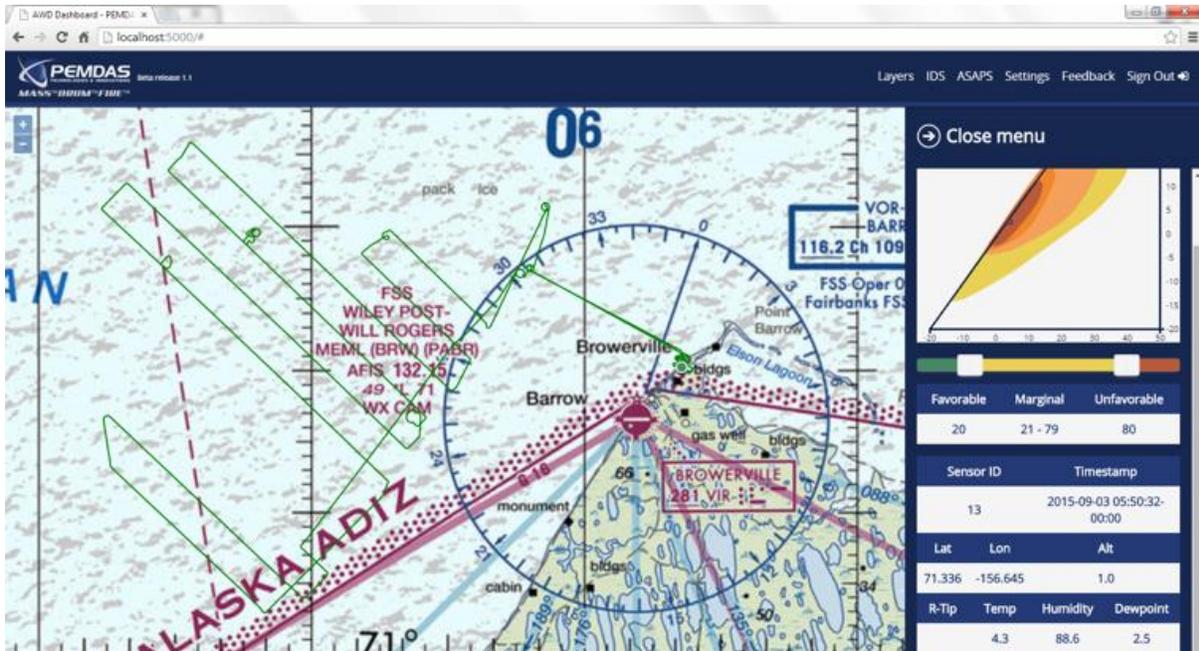
**Figure 16.** Screenshot from nowcasting and ASAP sensor. The display shows the ScanEagle® flight path with live display of carburetor icing threat, altitude, temperature, humidity, and dewpoint.

PEMDAS provided a real-time carburetor icing diagram (Figure 16; upper right hand side of the screenshot). Changes to the way the ScanEagle® was flown were based on this carburetor icing information. For example, the data reflected that the ScanEagle® was almost always in critical carburetor icing. The decision was made to fly at a higher speed/RPM to decrease the likelihood of ice formation. Due to the high risk, additional monitoring of RPM was implemented.
