# Use of Coatings on Hydraulic Steel Structures

## Part 1—Overview and Field Survey

*by Michael K. McInerney, Charles P. Marsh, Vincent F. Hock,  
Alfred D. Beitelman, Allen Skaja, and Thomas A. Carlson*

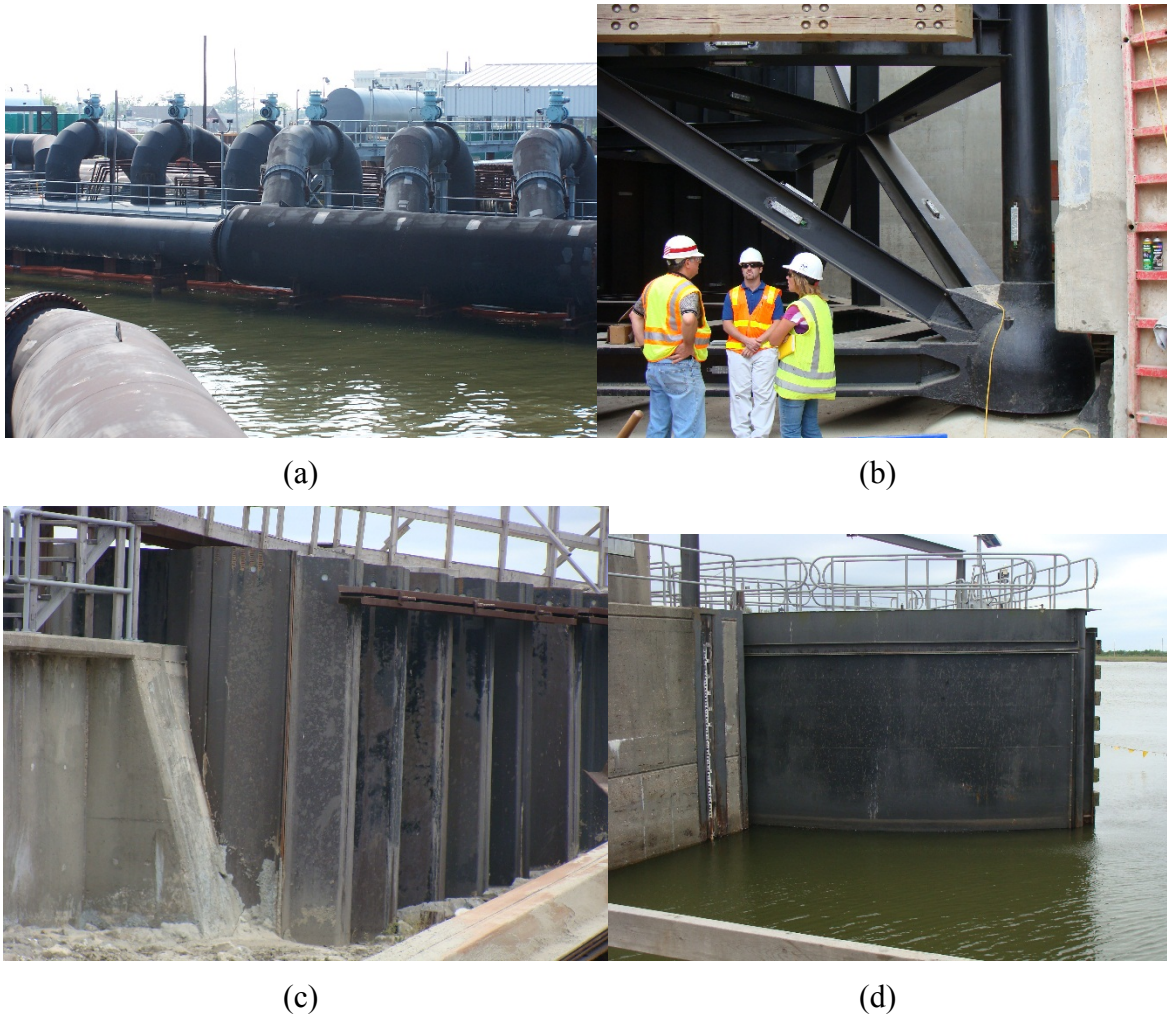
**Coal Tar:** A common coating system is coal tar epoxy. It is made with coal tar pitch and epoxy resin, and therefore it is slightly difficult and hazardous to work with since it contains polynuclear aromatics and small quantities of carcinogens (<1%). Coal tar enamel has high viscosity and is therefore applied hot. Coal tar coatings are heavy duty and create high-build protective coatings. Today, coal tar enamel is only applied in a factory, such as on small-diameter pipe that will be buried. The blend of epoxy resin and coal tar provides an excellent protective barrier coating for steel, iron, and concrete. These systems have the potential to provide a significantly long service life. Pictorial examples of coal tar coatings are provided in Figure 1.

Figure 1. Examples of coal tar coating: (a) pumping station; (b) sector gate; (c) sheet piles; and (d) sector gate in brackish water.

Coal tar enamel coatings are best used for underground applications because exposure to sunlight will cause degradation. It is applied hot but is not used much anymore, especially in the field. Coal tar epoxy is used on buried pipe, sheet pile, and concrete. Coal tar has been used on sheet piles and sector gates in New Orleans.

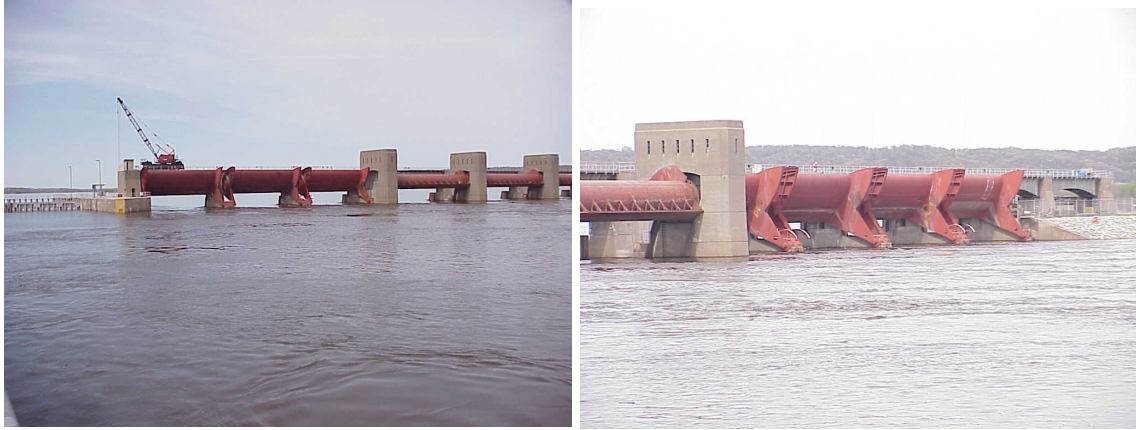
Figure 2. Examples of vinyl coating. (a) Tainter and roller gates on the Mississippi; (b) 50-year-old vinyl on miter gate; and (c) closure gate in New Orleans.

coatings have resulted in both very long and very short service lives. Photo examples of vinyl coatings are provided in Figure 2.

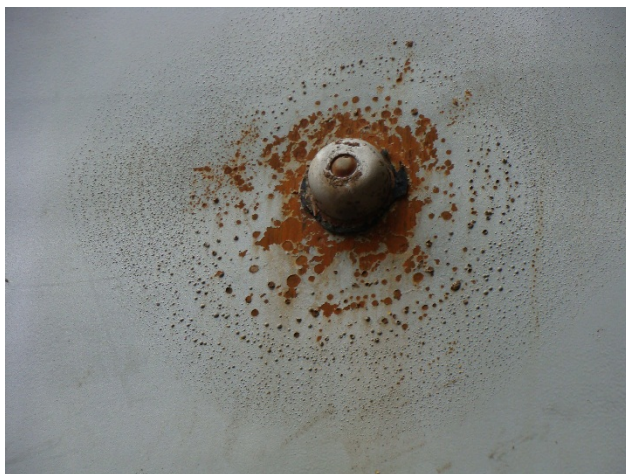
Another cause of coating failure is the improper use of CP. High CP voltages can destroy coatings. An example in Mobile District was discovered when some gates that were in the water for 38 years were removed; the gates had no rust, but the paint was bubbled around anodes and corners where there was elevated potential. It is common for overvoltage to destroy coatings. This is not a problem for sacrificial anodes, only for impressed current systems which can be turned up above the 1.4 volt threshold. This overvoltage condition may exist when the CP voltage is not continuously monitored. An example of coating failure from CP overvoltage is shown in Figure 3

Figure 3. Example of failure from CP overvoltage.  
Sacrificial anode caused blistering of coating.
