U.S. Air Force Airfield Damage Repair (ADR) Modernization Program

Evaluation of Flowable Fill Surface Performance

William D. Carruth and Dr. Isaac L. Howard

November 2016

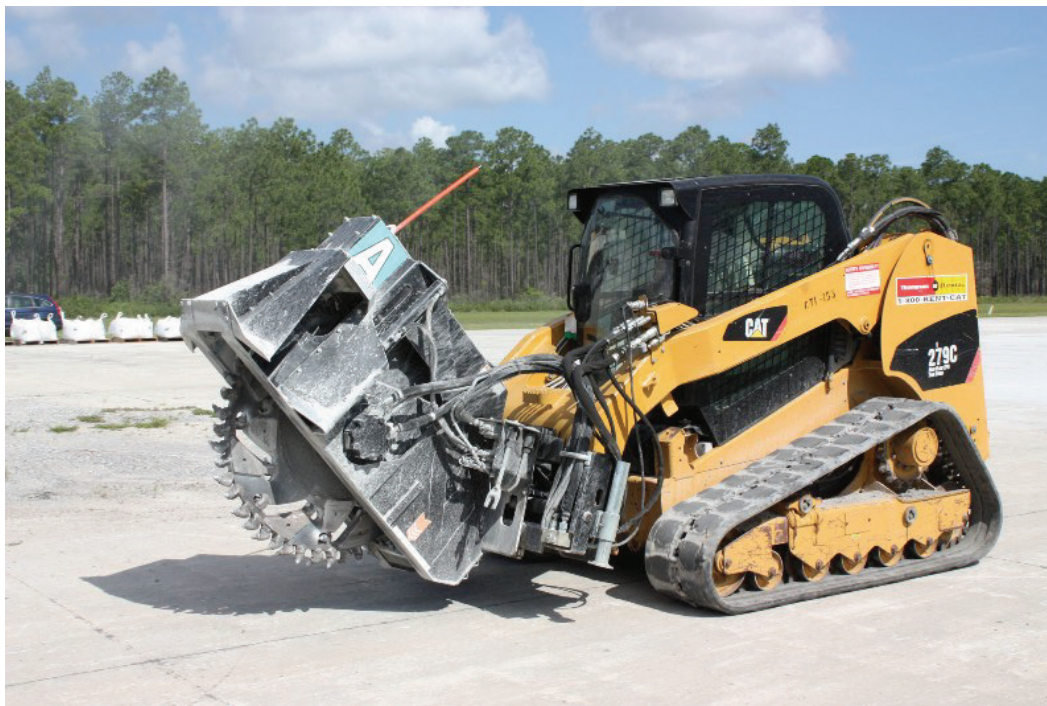
Figure 1. Tracked Caterpillar 279C CTL with SW45 wheel saw attachment.

The CTL used for testing was equipped to operate the Caterpillar SW45 wheel saw attachment as shown in Figure 1. The SW45 produces a 3.5-in.-wide cut with a maximum depth of 18 in. Specifications for the SW45 can be found in Table 2.

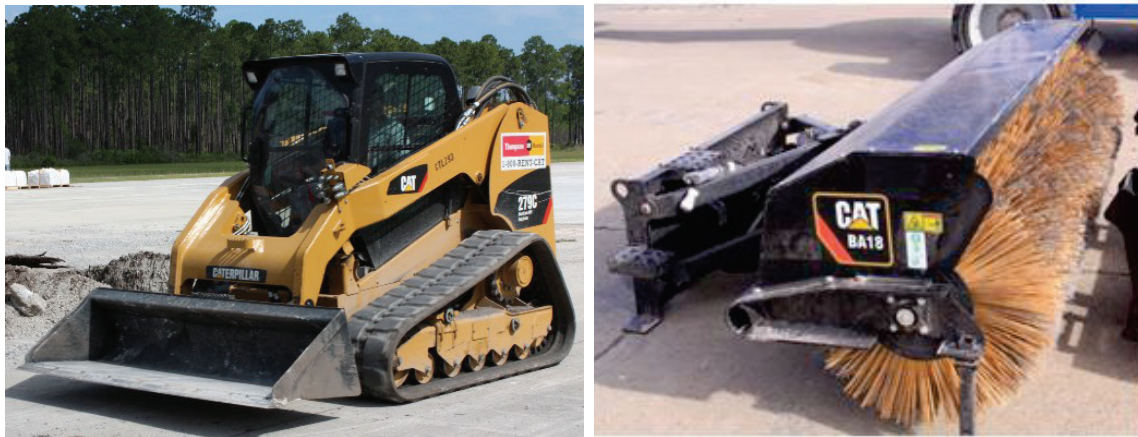
Figure 2. Bucket (left) and broom (right) attachments for Caterpillar 279C terrain loader.

Caterpillar Bucket and BA18 broom attachments (Figure 2) for the Caterpillar 279C CTLs were used for debris removal and cleanup before, during, and/or after each crater repair test.

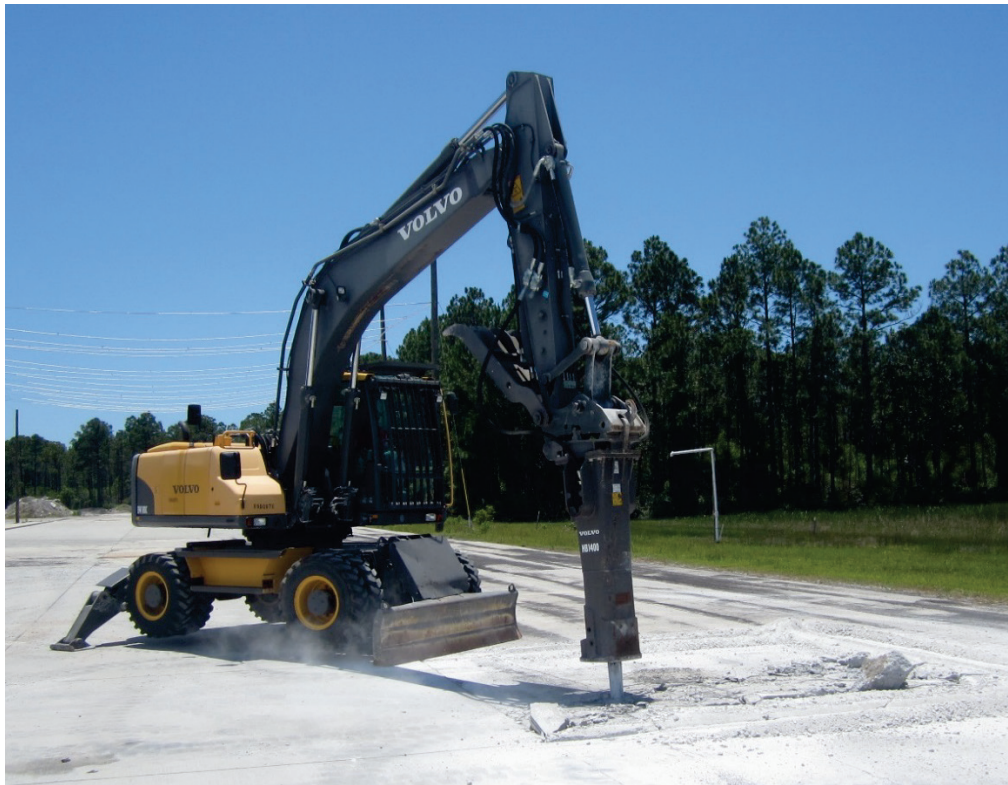
Figure 3. Volvo EW180C excavator with HB1400 hammer.

Wheeled excavators are preferred over tracked excavators for crater repair purposes, because they are more mobile and do not cause damage to the airfield pavement. The Volvo EW180C wheeled excavator was used during testing for breaking and excavation (Figure 3). Specifications for the Volvo EW180C and Volvo HB1400 hammer attachment are listed in Table 3 and Table 4, respectively. The excavator was equipped with quick-disconnect fittings for the hammer and bucket work tool attachments. The bucket used for excavation was 36 in. wide and had 8-in.-long teeth.

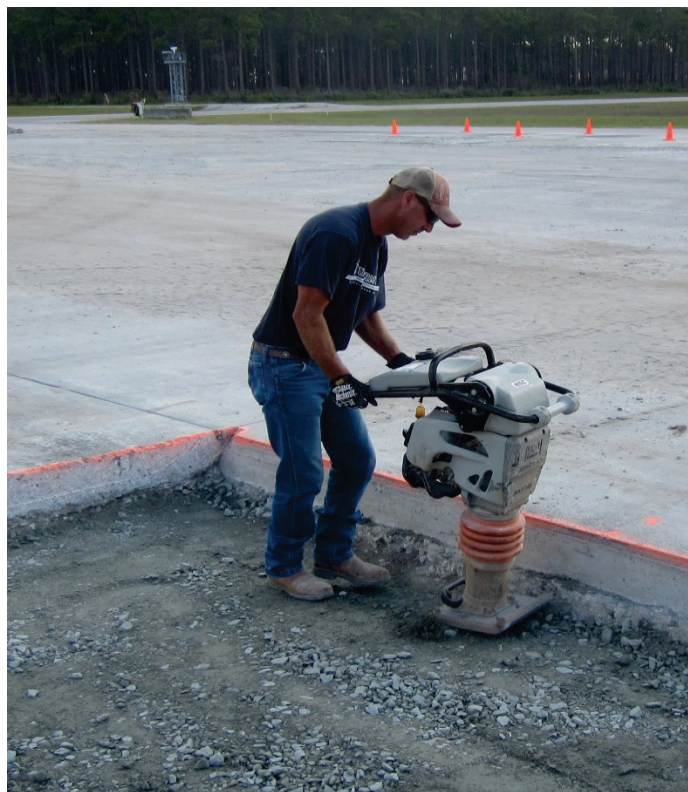
Figure 4. Multiquip Mikasa MTX-70 rammer-style compactor.

A small rammer-style compactor was used to compact the natural subgrade, sand backfill, and crushed stone backfill material during testing. The compactor used was a Multiquip Mikasa MTX-70 (Figure 4), which has a 2.8-hp motor capable of providing 3,350 lbf of impact force. Additional specifications are displayed in Table 5. The small rammer-style compactor was used, since larger compaction equipment would be difficult to maneuver inside small craters. In addition, the smaller rammer-style compactor eliminates the logistical burden of deploying larger compaction equipment.

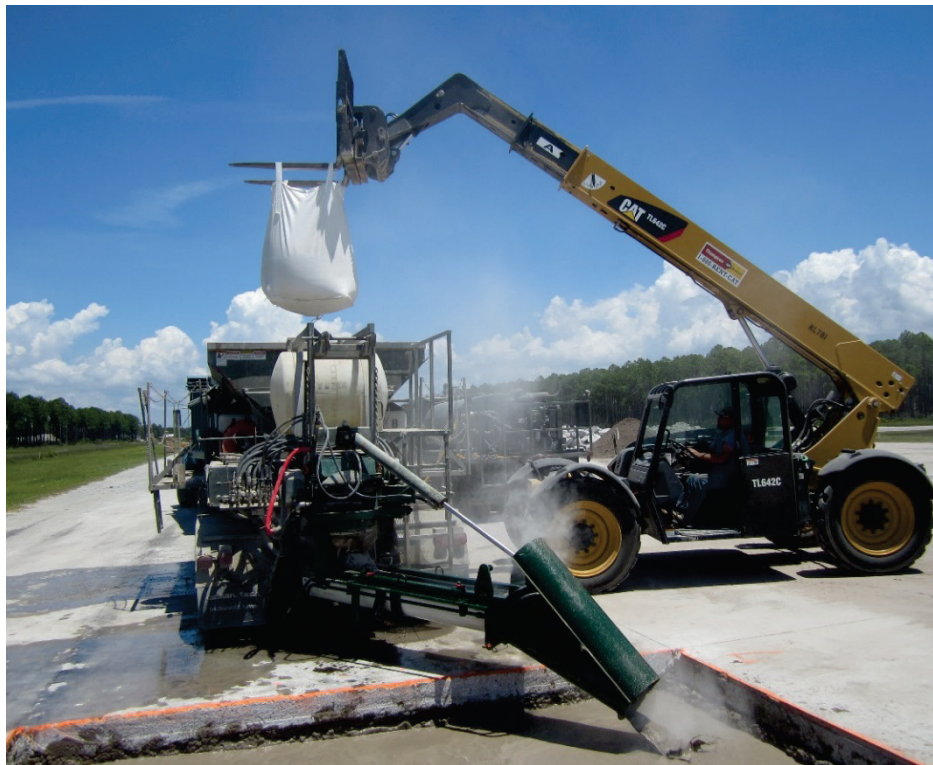
Figure 5. Extendable-boom forklift loading supersack into volumetric mixer.

An extendable-boom forklift was used to move the 3,000-lb supersacks of pre-blended flowable fill materials. The extendable boom was a Caterpillar TL642 telescopic forklift, which was capable of lifting 6,500 lb and extending 30 ft. The extendable boom is needed so that the large supersacks of flowable fill can be loaded into the simplified volumetric concrete mixer, as shown in Figure 5.

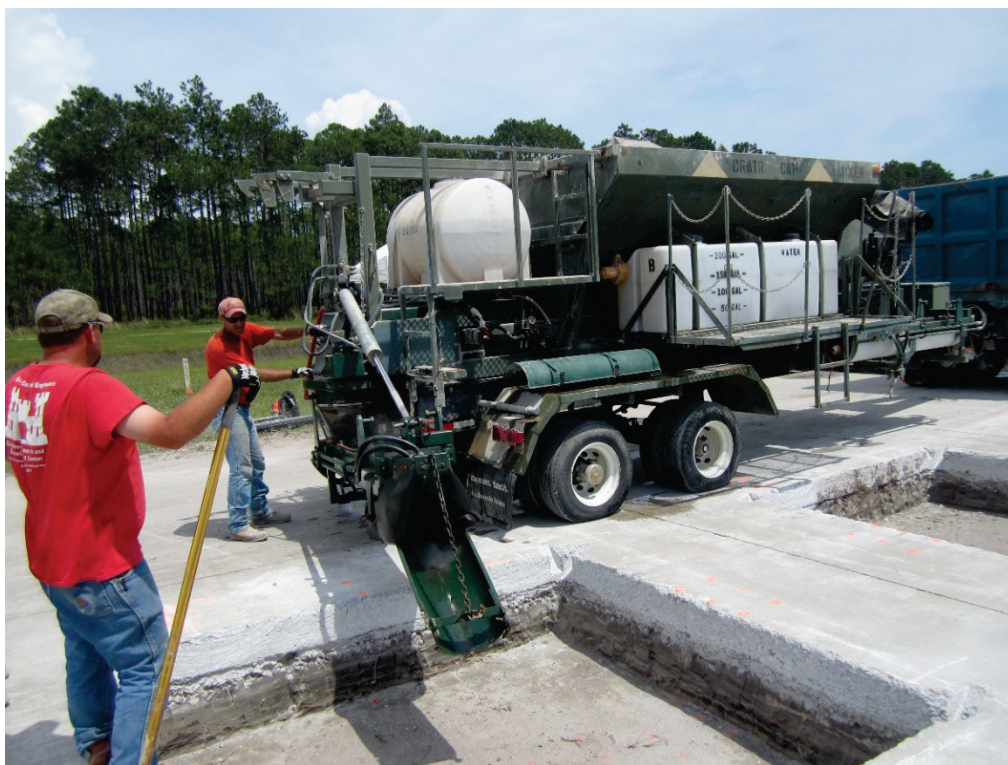
Figure 6. Simplified volumetric mixer.

A specially designed tow-behind simplified volumetric concrete mixer (Figure 6) was previously designed by CemenTech Inc. in consultation with the ERDC for use in the ADR modernization program. The simplified volumetric mixer is pre-calibrated for rapid-setting cementitious repair materials to include flowable fill and concrete capping material.

positive displacement water pump to meter mix water according to a fixed pump speed, two 200-gal water tanks on each side of the mixer, a washout tank with pressure washer, and a replaceable mixing auger mounted in a discharge boom at the rear of the machine. The machine is outfitted with two retractable catwalk platforms, a bin entry platform, a replacement auger, and two super sack piercing points. The only means of controlling the water-cement (w/c) ratio is by adjusting a strike-off gate, which can change the height of the dry material on the conveyor belt feeding the mix auger. Allowing more dry material to enter the mix auger results in a mix with a lower w/c ratio. The wheel for adjusting the gate height has a scale from 1 to 12, where 1 allows the least amount of material to enter the mix auger and 12 allows the most. However, typical strike-off gate settings used during production of rapid-setting flowable fill or rapid-setting concrete range from 4 to 8.

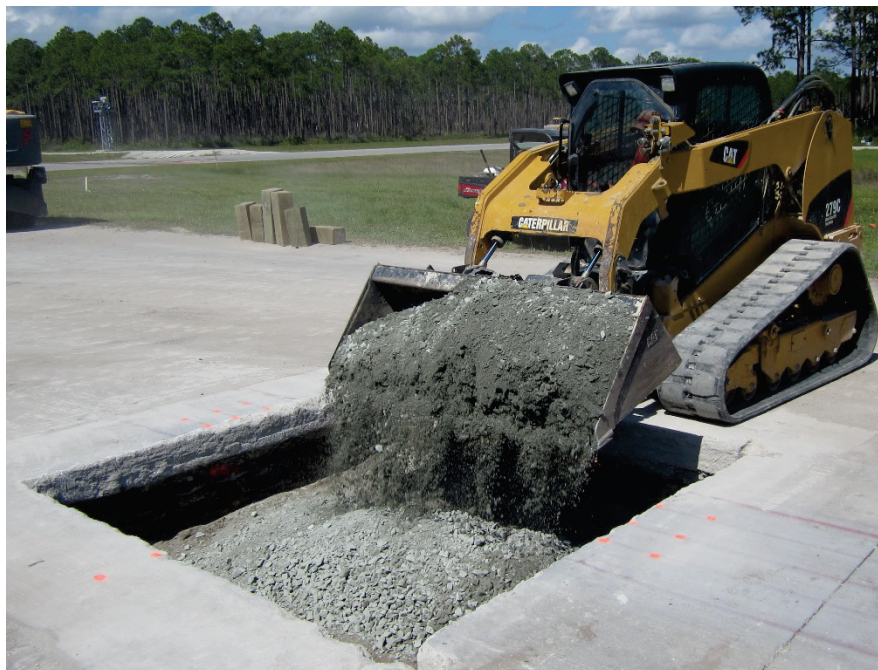
Figure 7. Crushed stone limestone backfill.

Crushed limestone (Figure 7) purchased from a local vendor was used as a backfill material for some test craters. Crushed limestone was selected because it can be available on some U.S. Air Force (USAF) airfields that have access to higher quality materials. The maximum aggregate size of the material was approximately 1 in. The USCS classification of the material was a well-graded gravel with silt and sand (GW-GM). The fines within the crushed limestone were non-plastic.

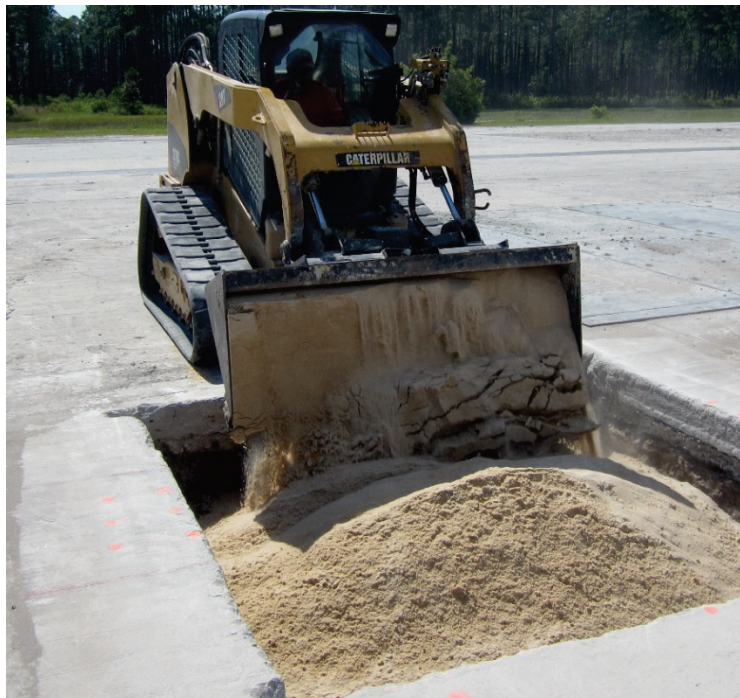
Figure 8. Masonry sand backfill.

Commercial masonry sand (Figure 8) purchased from a local vendor was used to backfill some test craters. This material was selected to use as a backfill because it can be available in remote areas where higher quality materials are unavailable. The USCS classification of the material was a poorly graded sand (SP) with 0.5% fines. The small amount of fines observed were non-plastic.

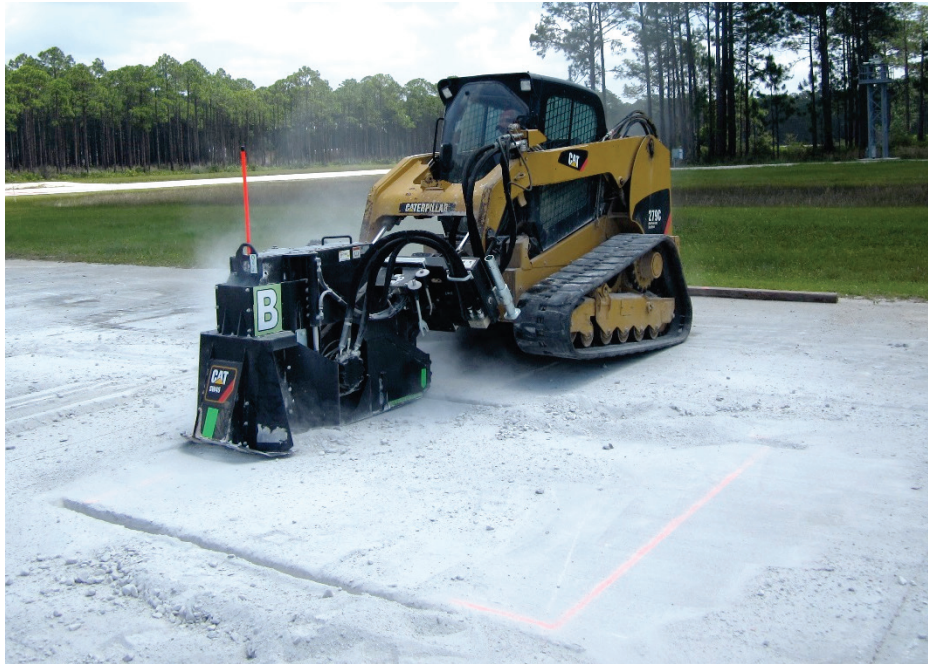
Figure 9. Saw cutting with CTL and wheel saw attachment.

For marking, the target size of the finished crater repair (8.5 ft by 8.5 ft or 15 ft by 15 ft) was measured and marked with a string line and marking paint. Since no upheaval was present, stanchions were not used in the marking process. Saw cutting was conducted using the CTL with a wheel saw attachment. For breaking and excavating, a Volvo EWC-30 wheeled excavator with the appropriate attachment (hammer or bucket) was used. A small mini-excavator was also used in some instances to remove material along the walls of the excavation. In an actual crater repair scenario, this type of fine excavation would not be conducted. However, since the thicknesses of each layer of the crater repair structure was important to the objective of the project, a tolerance of ± 0.5 in. was imposed. Figure 9, Figure 10, and Figure 11 show the saw-cutting, breaking, and excavating processes, respectively. Figure 12 shows an excavated 8.5-ft by 8.5-ft crater, and Figure 13 displays an excavated 15-ft by 15-ft crater.

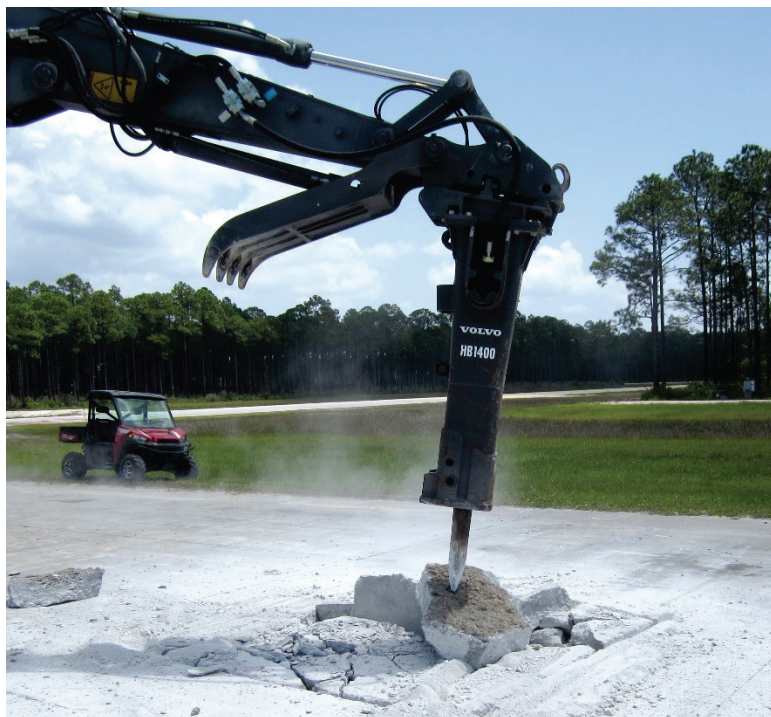
Figure 10. Breaking using Volvo HB 1400 breaker attachment.

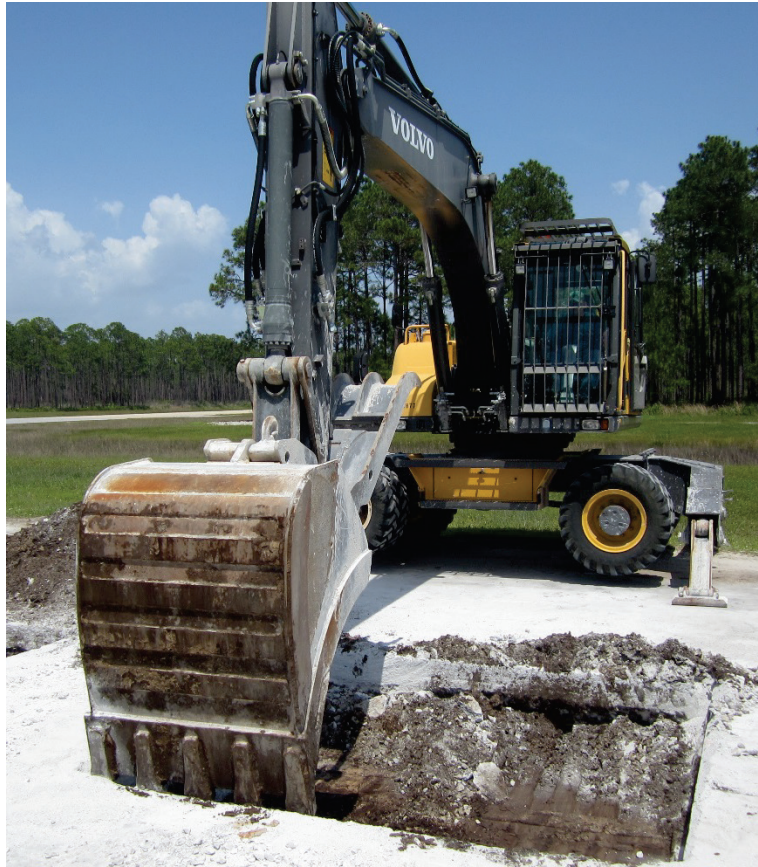
Figure 11. Excavation using the Volvo EW 180C wheeled excavator.

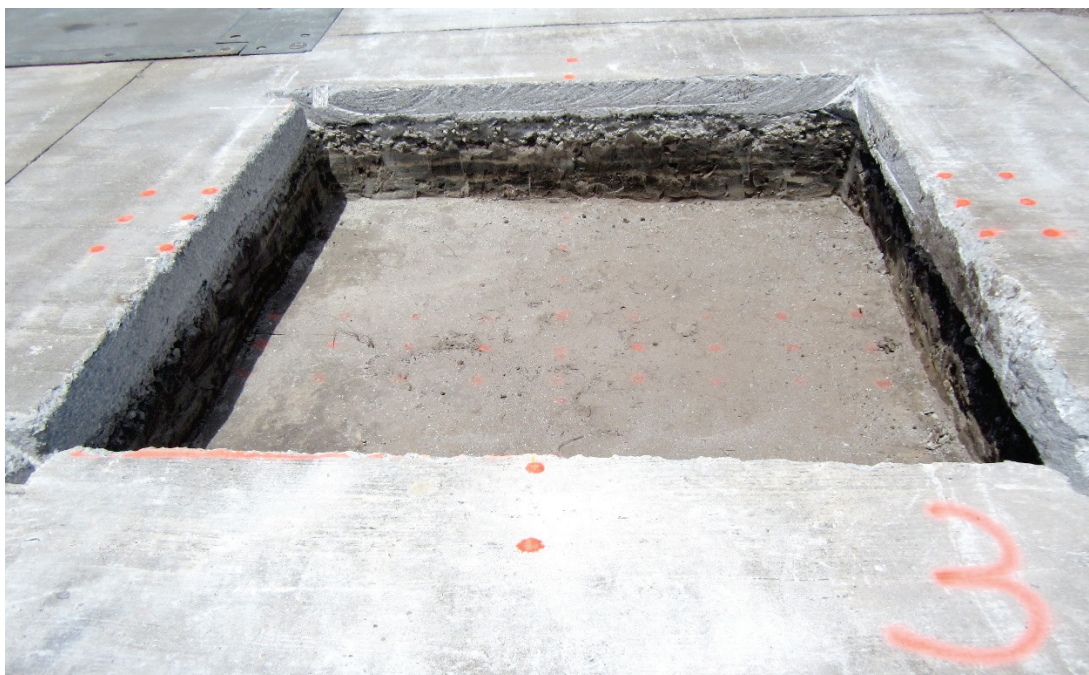
Figure 12. Excavated 8.5-ft by 8.5-ft crater

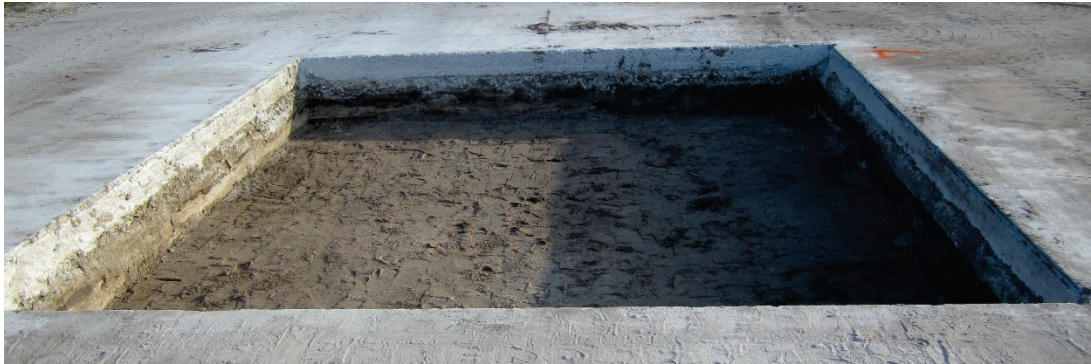
Figure 13. Excavated 15-ft by 15-ft crater.

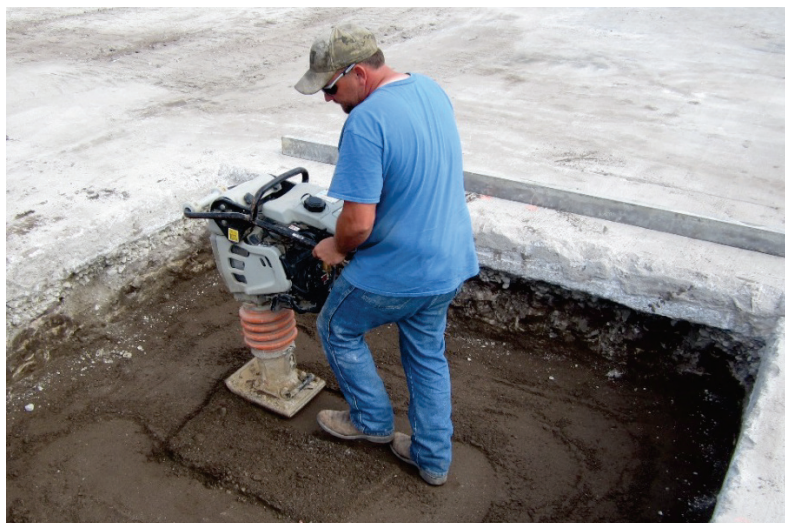
Figure 14. Compaction of natural subgrade.

Once excavation of the crater repairs was complete, the natural subgrade was compacted with a rammer-style compactor as shown in Figure 14. Two coverages were performed during compaction. For some craters, no backfill layer was used, and flowable fill material was placed over the subgrade as described in Section 3.4. Some craters were backfilled with either masonry sand or crushed stone. The sand and crushed stone are described in Section 2.3.

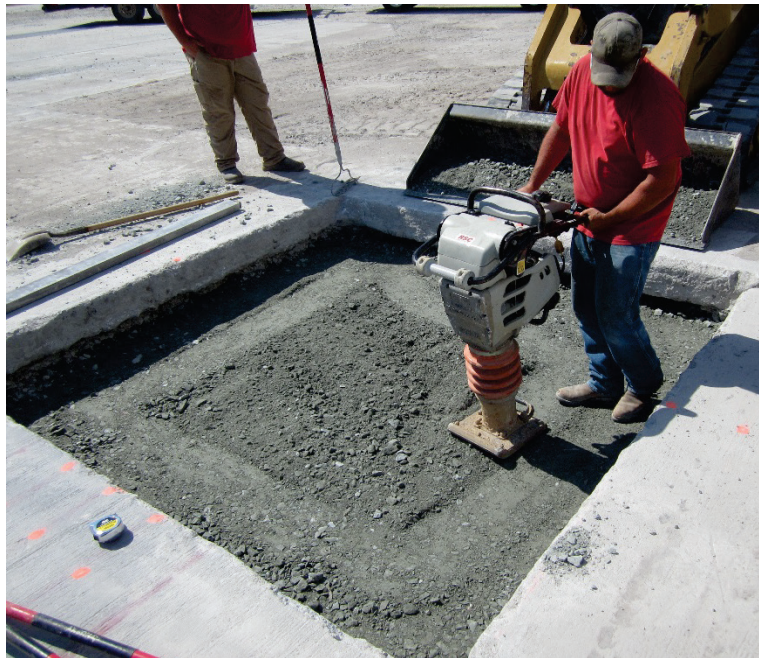
Figure 15. Compaction of crushed stone backfill material.

Backfill materials were placed in two separate lifts, each one approximately half of the total target thickness, with a maximum lift thickness of 6 in. The CTL and hand tools were used to place and level the material. Two coverages of compaction with the rammer-style compactor were applied, and any remaining areas of loose material were also compacted. A small amount of water was added to the masonry sand to aid compaction. Figure 15 shows compaction of the crushed stone backfill material.

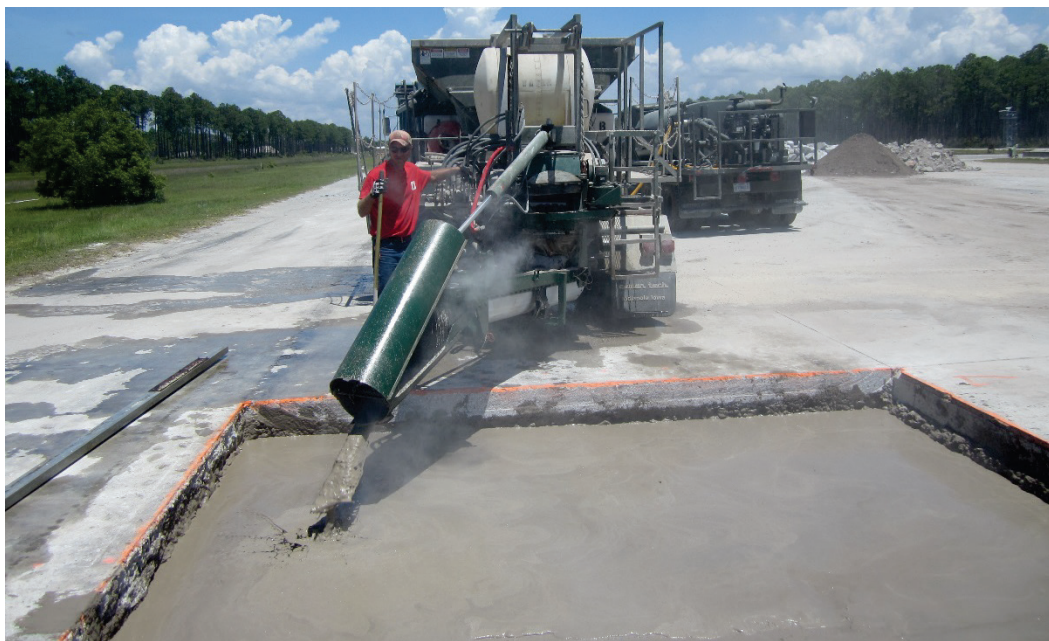
Figure 16. Rapid-setting flowable fill placement during a large crater repair.

During the test, the rapid-setting flowable fill supersacks were continuously loaded into the volumetric mixer, and the mix water tanks were refilled as needed. No chemical additives of any kind were used during testing, since additives are not typically used when rapid-setting flowable fill is used as a backfill in the crater repair process. Figure 16 shows placement of rapid-setting flowable fill during a large crater repair. As shown, one extension chute was used for large crater repairs. Instead of moving the tow vehicle forward and backward to placement material in different areas of the repair, the extension chute was extended or retracted as needed. Once enough material was placed into the excavation, the crater repair cap was struck off with a magnesium screed bar (Figure 17). A 12-ft-long and 20-ft-long screed bar was used for the small and large craters, respectively. While the material was still workable, the surface was screeded multiple times, particularly for

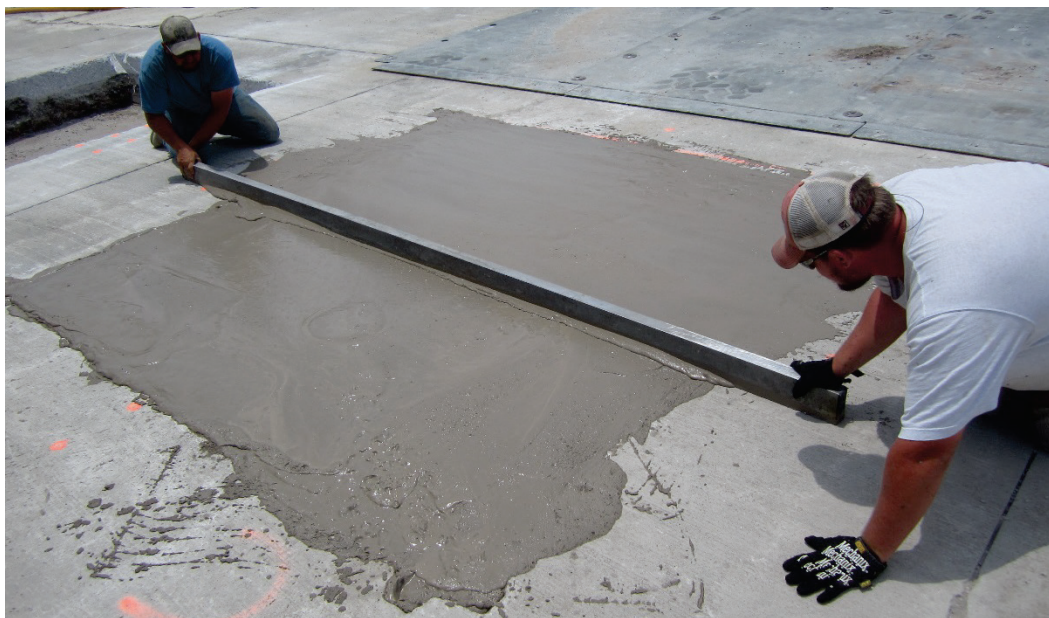
Figure 17. Screeding of rapid-setting flowable fill cap.

the small craters, to ensure the surface was as smooth as possible and matched the elevation of the surrounding pavement. Flat shovels and steel trowels were used to clean the edges of the repair.

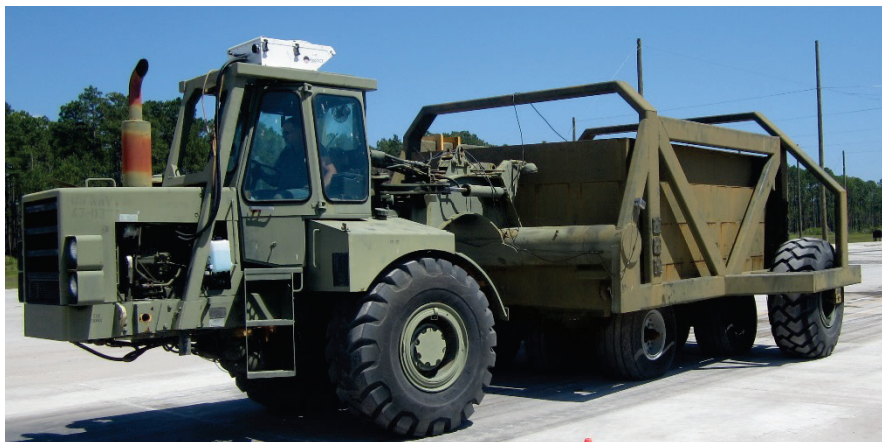
Figure 20 . C-17 load cart.

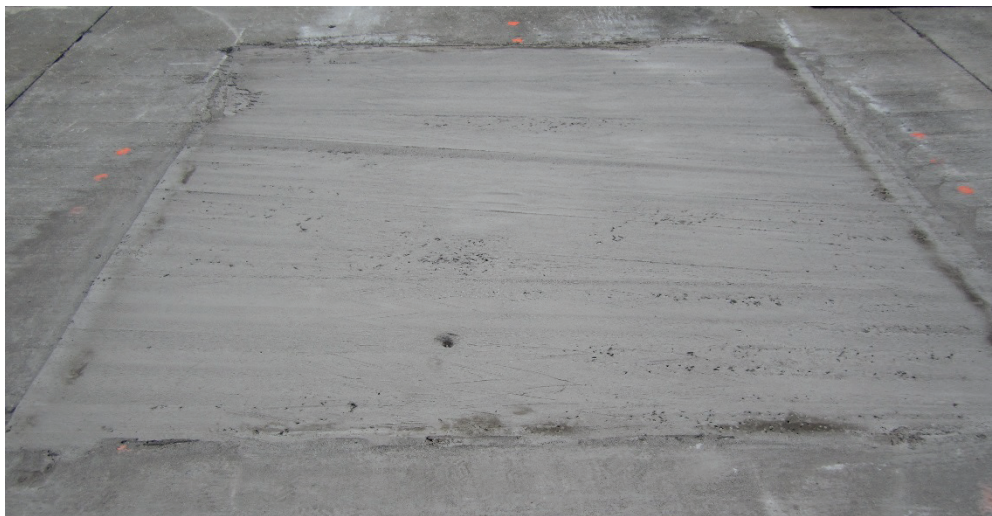
Figure 22. Crater 1 before trafficking.

Before trafficking commenced, each crater was inspected to document any existing distresses. Figure 22 shows Crater 1 before traffic was applied. As

shown, some small deficiencies and a small hole where a DCP test was attempted are visible on the surface. In Figure 23, the surface of Crater 2 shows fewer surface deficiencies but also shows some darker areas around the edge of the crater where the material has likely not reached the same curing level as the center of the crater. These darker areas were no longer visible when trafficking began. Crater 3 exhibited similar characteristics to that of Crater 2, with a much larger area of dark-colored material as shown in Figure 24. However, this dark area was also no longer visible when trafficking began.

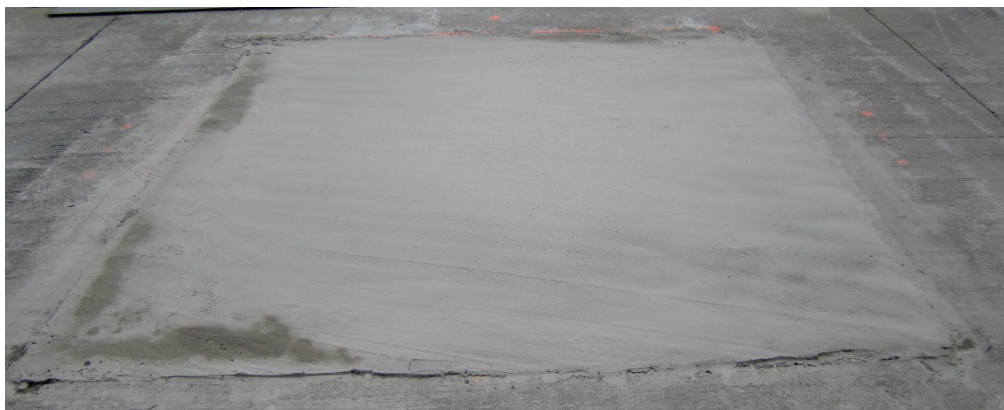
Figure 23. Crater 2 before trafficking.

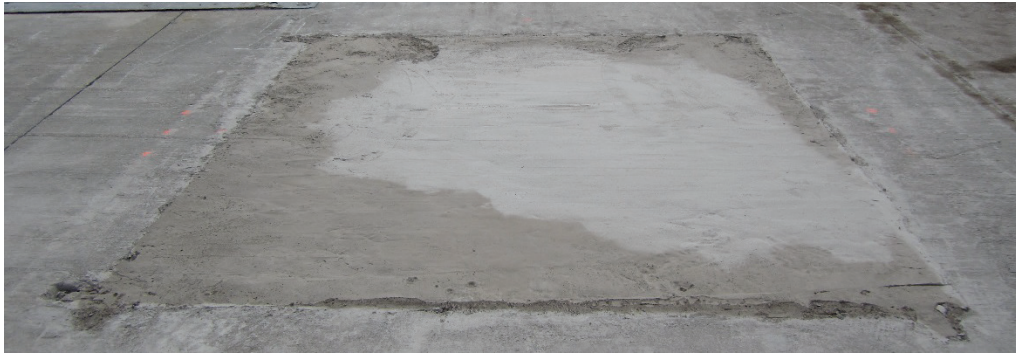
Figure 24. Crater 3 before trafficking.

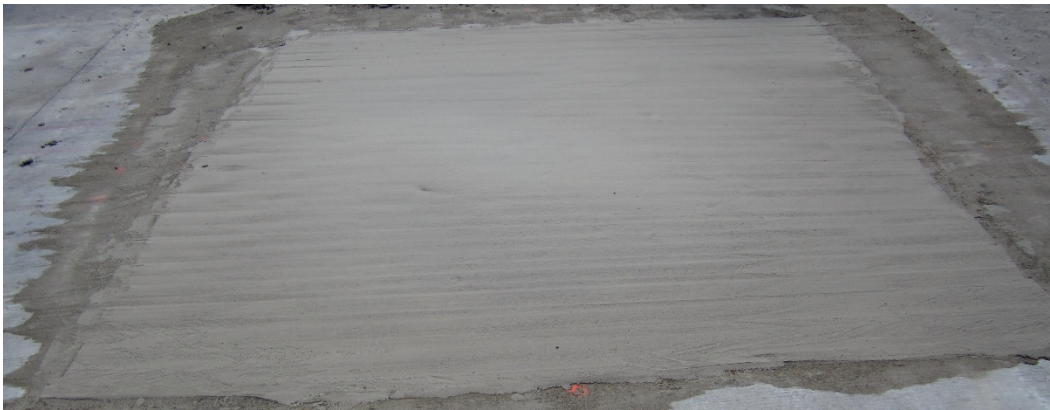
Figure 25. Crater 4 before trafficking.

Figure 25 shows Crater 4 just after screeding and before trafficking. Craters 5 and 6 had a similar appearance. Craters 4, 5, and 6 in general exhibited fewer distresses than Craters 1, 2, and 3. The w/c ratio was decreased by increasing the gate setting on the mixer, resulting in a more viscous and higher strength mix. The w/c ratio changes are discussed further in upcoming paragraphs.

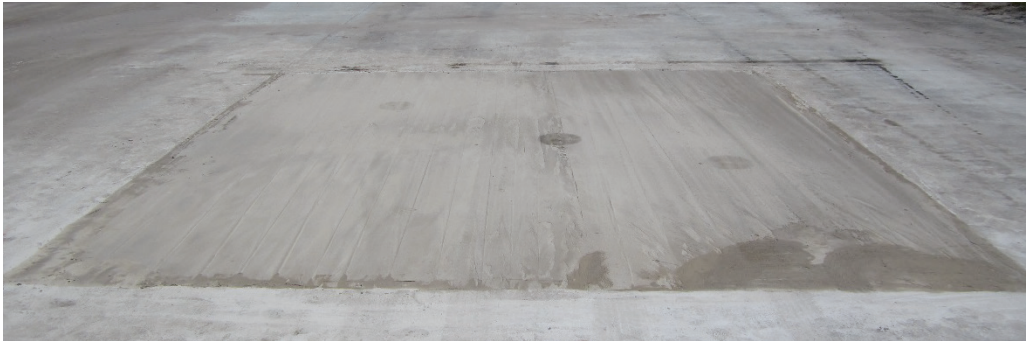
Figure 26. Crater 7 before trafficking.

Figure 26 shows Crater 7 before trafficking. Some minor surface deficiencies were visible near the edge of the crater, but no cracking was observed. A photo of Crater 8 before trafficking is shown in Figure 27. An inset in Figure 27 shows a 0.5-in. deep depression that was created during heavy-weight deflectometer (HWD) testing. Upon further investigation, it was concluded that this test location was a very isolated area of weaker material, since the other two HWD tests on the repair did not result in any depressions. This conclusion was confirmed during trafficking.

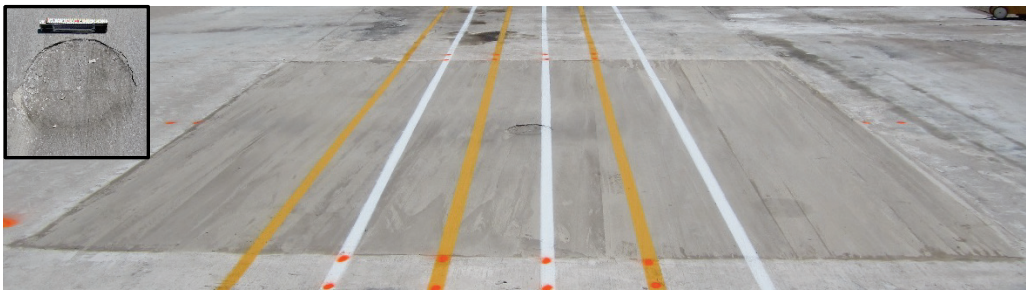
Figure 27. Crater 8 before trafficking.

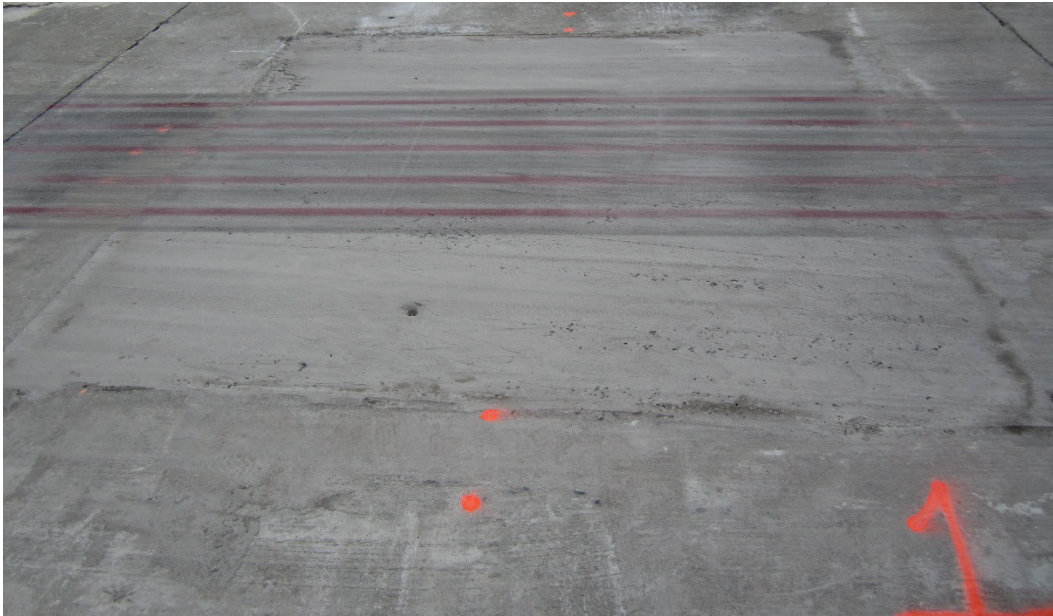
Figure 28. Crater 1, 112 passes, overall.

After the initial 112 passes (7 complete patterns) were applied to Craters 1, 2, and 3, the craters were again visually examined for damage. Figure 28 shows Crater 1 after 112 passes. The only visible distress was a considerable amount of very small debris (Figure 29). The small debris is discussed further in the next section.

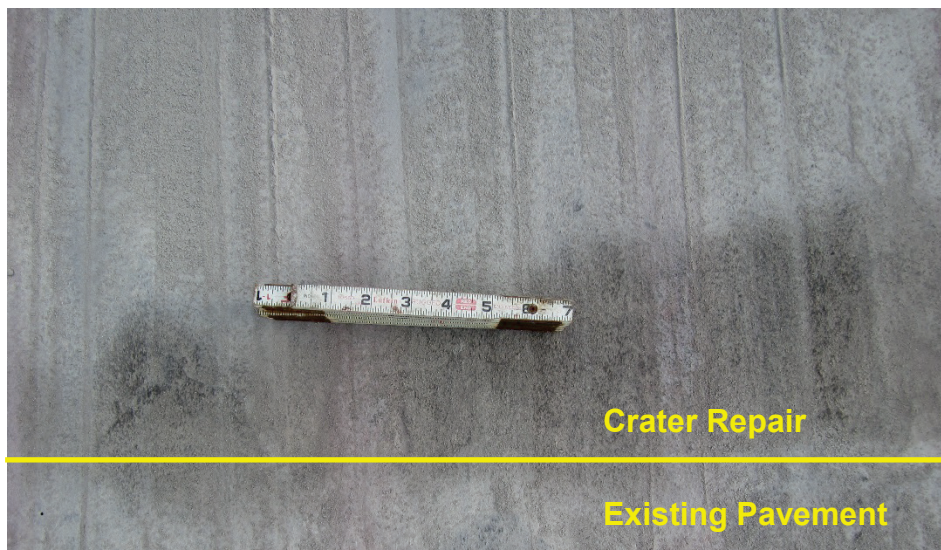
Figure 32. Crater 3, 112 passes, depression.

Figure 30 shows a small depression on Crater 2 after 112 passes, along with the small debris mentioned previously. Figure 31 shows an overall photograph and Figure 32 shows a depression on Crater 3 after 112 passes. Two of these depressions were observed on Crater 3, one on the north edge of the crater and one on the south edge (traffic direction was north to south). As with Crater 1 and 2, the depression and accompanying debris were believed to be caused by the abrasive action of the high pressure F-15E load cart tire. Depressions observed on Craters 1 to 3 were approximately 0.25 in. in depth.

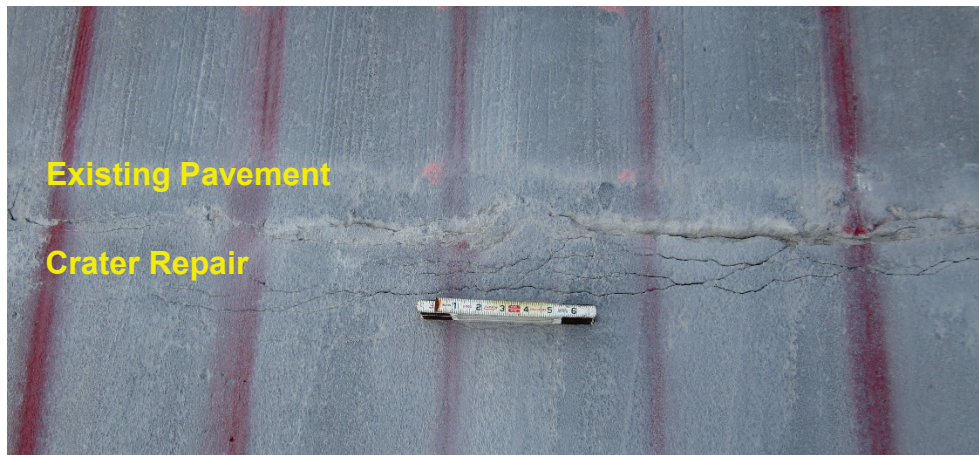
Figure 34. Crater 1, 512 passes, medium-severity joint spalling.

After 512 passes, several notable distresses became apparent. As shown in Figure 34, Crater 1 exhibited medium-severity joint spalling with a high foreign object debris (FOD) potential on the south edge of the repair. Figure 35 shows high-severity joint spalling on the south edge of Crater 2. Some FOD was observed outside the crater and the depth of the spall measured approximately 1 in. The distresses for Crater 3 were less severe; only a depression and medium-severity spalling were observed (Figure 36). Due to the tire hazard created by the high-severity joint spalling, Crater 2 was considered failed. Since Craters 1, 2, and 3 were to be excavated so that Crater repairs 4, 5, and 6 could be constructed, trafficking of Craters 1 and 3 was also ceased.

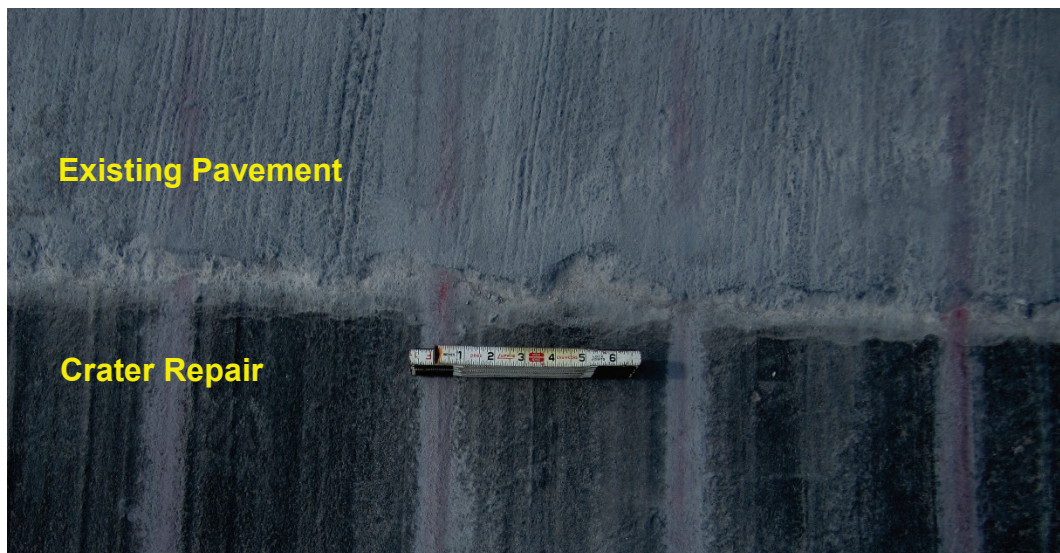
Figure 36. Crater 3, 512 passes, medium joint spalling and depression.

Severe edge spalling is the typical mode of failure exhibited by craters repaired with conventional USAF ADR capping materials (rapid-setting concrete). Since there is no load transfer mechanism (i.e., dowels, rebar), the bond strength between the repair material and the parent slab is the limiting factor when it comes to the failure of the crater repair. Since no distresses that are typically associated with structural failure (faulting, shattered slabs) were observed, it can be reasonably assumed that the thickness of rapid-setting flowable fill was sufficient.

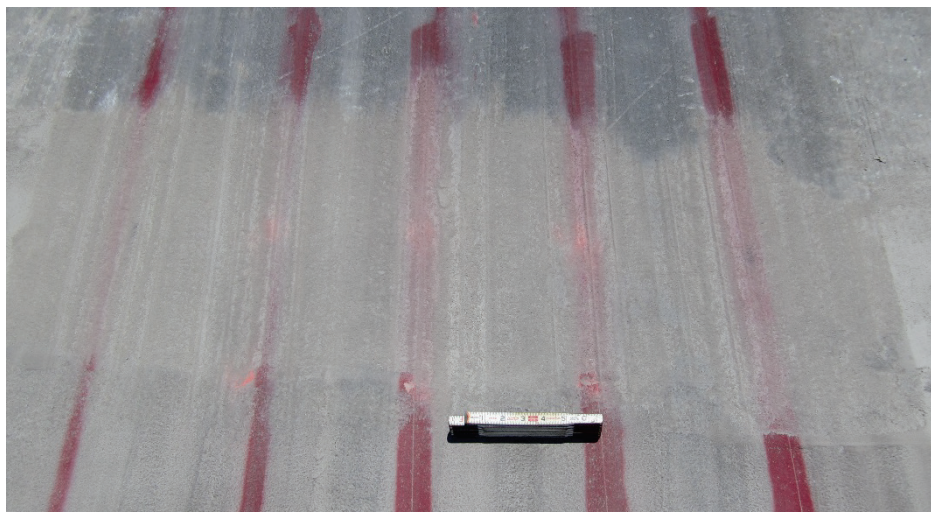
Figure 37. Crater 4, 512 passes, small debris.

After Craters 1, 2, and 3 were excavated and Crater repairs 4, 5, and 6 were constructed, trafficking commenced. Each repair was inspected every 112 passes; however, no distresses were noted, and much less small debris was observed compared to Craters 1, 2, and 3. Figure 37 shows debris accumulating on Crater 4 after 112 passes. Craters 5 and 6 showed a smaller amount of debris compared to Crater 4. Trafficking was ceased at 512 passes due to limited time on the test site, but no notable distresses were observed. Figure 38 shows an overall photograph of Craters 4, 5, and 6 after 512 passes. The reduction in distresses could be due to a slight decrease in the w/c ratio that was implemented for Craters 4, 5, and 6 and discussed previously in Section 3.3.

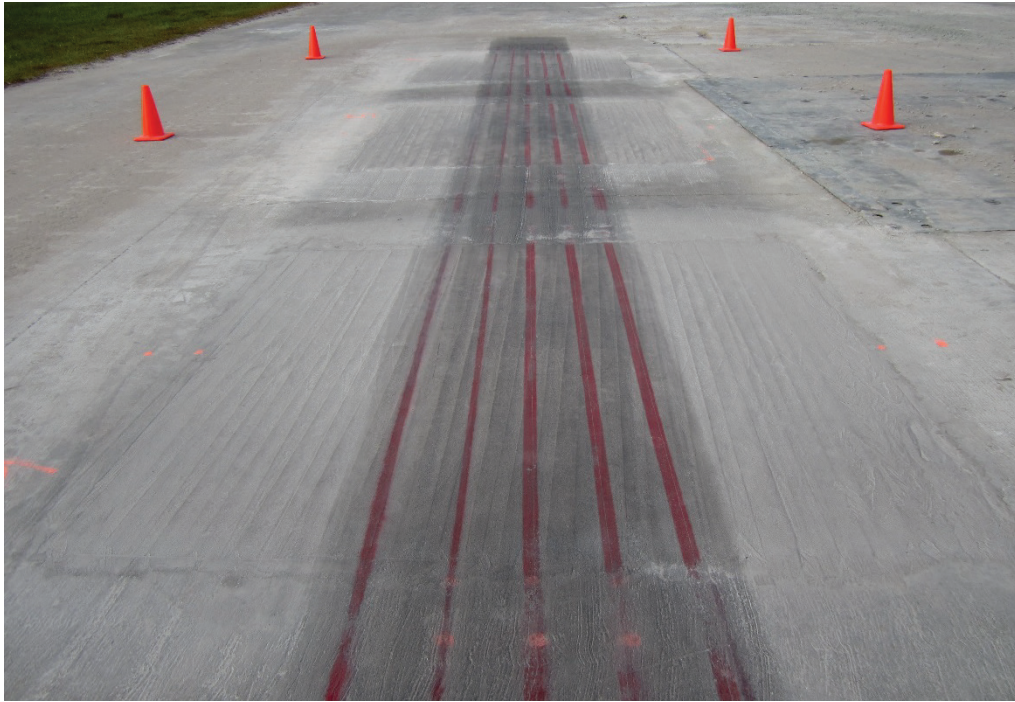
Figure 38. Craters 4, 5, and 6, 512 passes, overall.

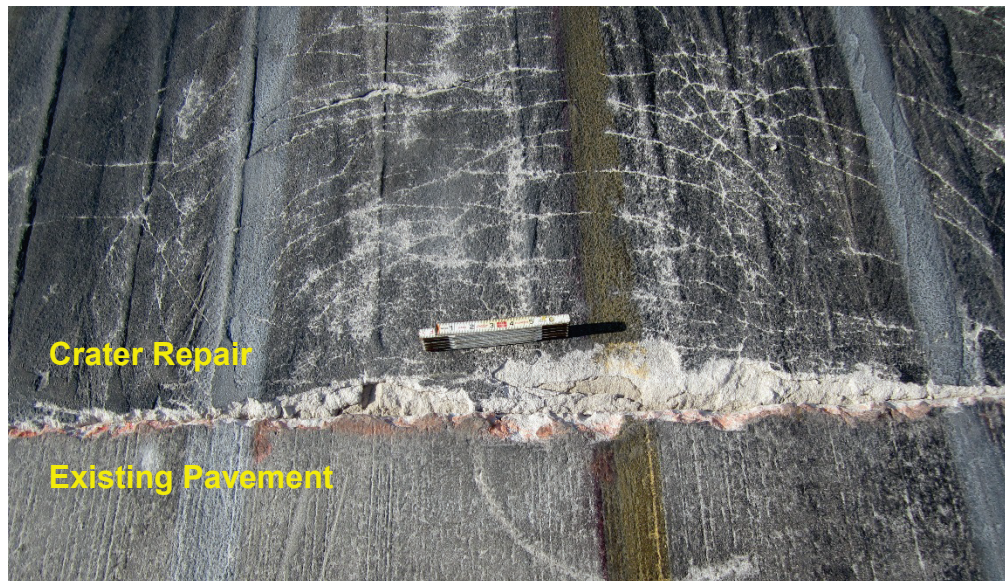
Figure 41. Crater 7, 224 passes, high-severity joint spalling on north edge.

Figure 41 shows the north edge of Crater 7 after 224 passes. The low-severity joint spalling had progressed into high-severity joint spalling, and the network of smaller cracks continued to develop. Figure 42 shows Crater 7 at failure, after 504 passes. On the north edge, the area of low-severity cracking continued to expand, and the spalling along the edge extended to span the entire width of the traffic lanes. The south edge exhibited only a few low-severity transverse cracks as shown in Figure 43, a sharp contrast to the distress observed on the north edge of Crater 7. Trafficking ceased after 504 passes.

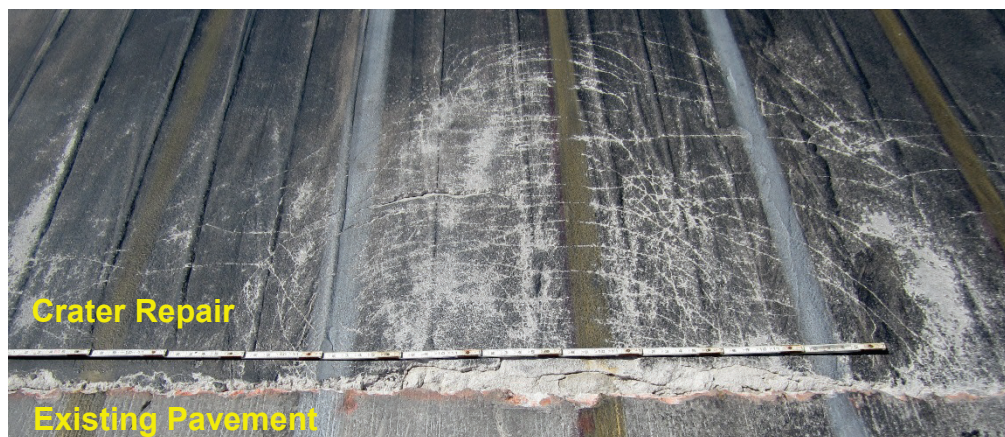
Figure 42. Crater 7, 504 passes, high-severity joint spalling on north edge.

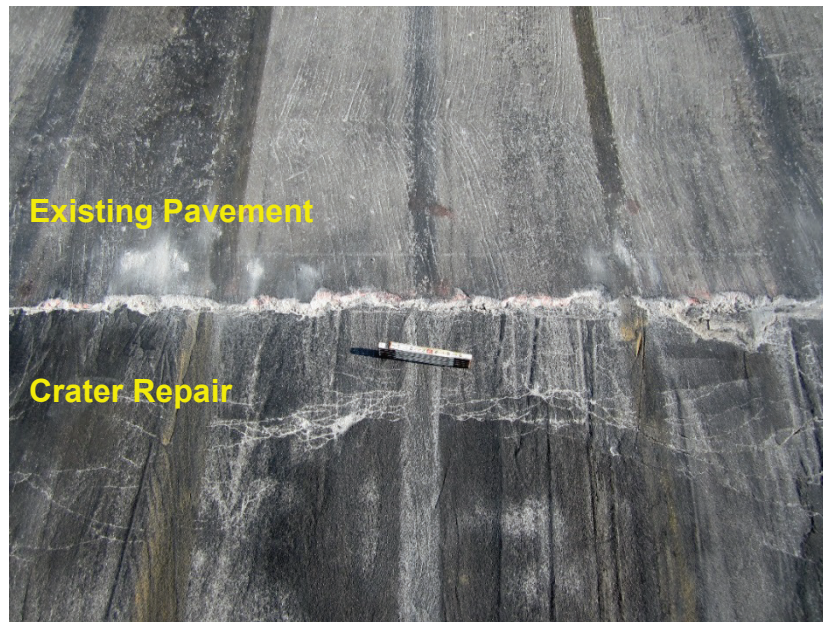
Figure 44. Crater 8, 112 passes, distresses on south edge.

Figure 44 shows the south edge of Crater 8 after 112 passes. Some low-severity transverse cracking and joint spalling was observed. After 224 passes, a low-severity depression with low-severity cracking surrounding the depression was observed (Figure 45). After 224 passes, a larger network of cracks was apparent, and the spall width had increased, as shown in Figure 46. After 504 passes, high-severity joint spalling was observed on both the south edge (Figure 47) and the north edge (Figure 48). On the south edge, some delamination of the surface was observed as shown on the inset of Figure 48. Possible causes of the delamination are discussed in the next section. Trafficking was ceased after 504 passes.
