U.S. Air Force Airfield Damage Repair (ADR) Modernization Program

Evaluation of Flowable Fill Surface Performance

William D. Carruth and Dr. Isaac L. Howard

November 2016

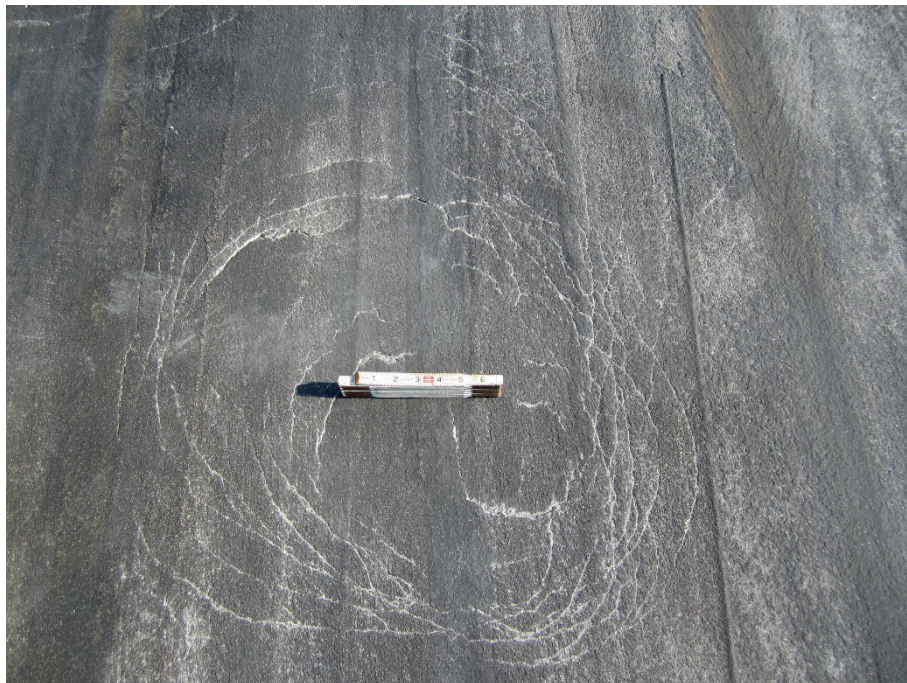
Figure 45. Crater 8, 224 passes, low-severity cracking and depression.

Figure 44 shows the south edge of Crater 8 after 112 passes. Some low-severity transverse cracking and joint spalling was observed. After 224 passes, a low-severity depression with low-severity cracking surrounding the depression was observed (Figure 45). After 224 passes, a larger network of cracks was apparent, and the spall width had increased, as shown in Figure 46. After 504 passes, high-severity joint spalling was observed on both the south edge (Figure 47) and the north edge (Figure 48). On the south edge, some delamination of the surface was observed as shown on the inset of Figure 48. Possible causes of the delamination are discussed in the next section. Trafficking was ceased after 504 passes.

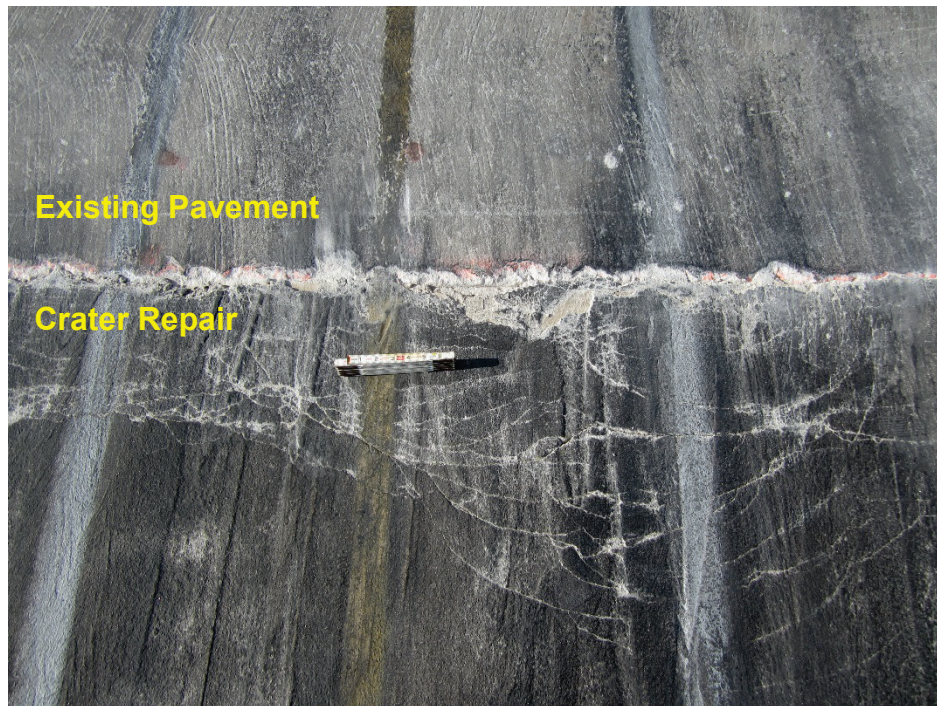
Figure 46. Crater 8, 224 passes, distresses on south edge.

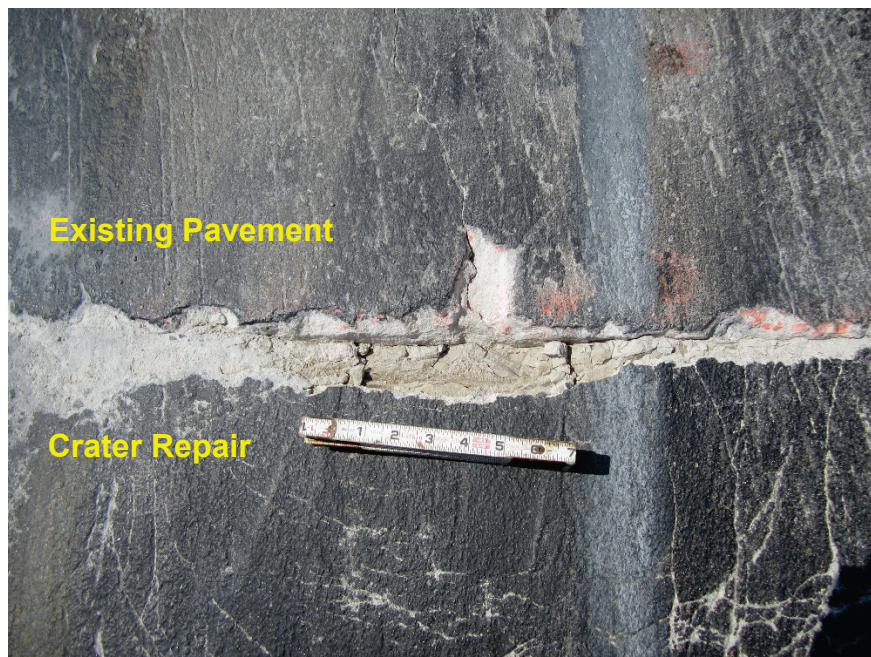
Figure 47. Crater 8, 504 passes, high-severity spalling on south edge.
