**Department of Defence**  
Science and Technology

# Discrimination between Fatigue Cracking and Mechanical Damage in Aircraft Fastener Holes by Eddy-Current Phase Rotation

DST-Group-TR-3289

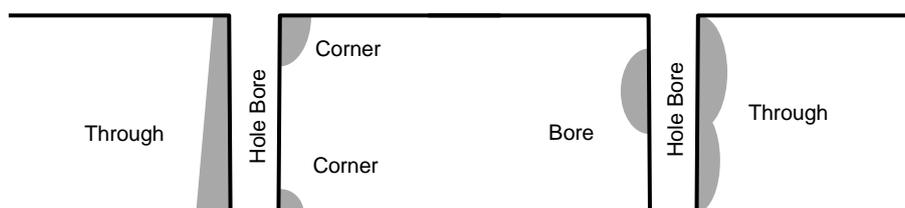
Figure 1. Schematic diagram of fastener holes in a single layer of aircraft structure showing types of cracking that can initiate at the hole surface and grow radially through the structure.

Fatigue cracking can occur at several locations within fastener holes, as shown schematically for a simple single layer aircraft structure in Figure 1, with the fasteners removed. The figure also provides a simplified nomenclature for fatigue cracking at the range of locations possible within a single-layer structure. Figure 1 is somewhat idealised as fastener holes often contain multiple cracks which have joined together to form multi-origin cracks with an irregular shape.

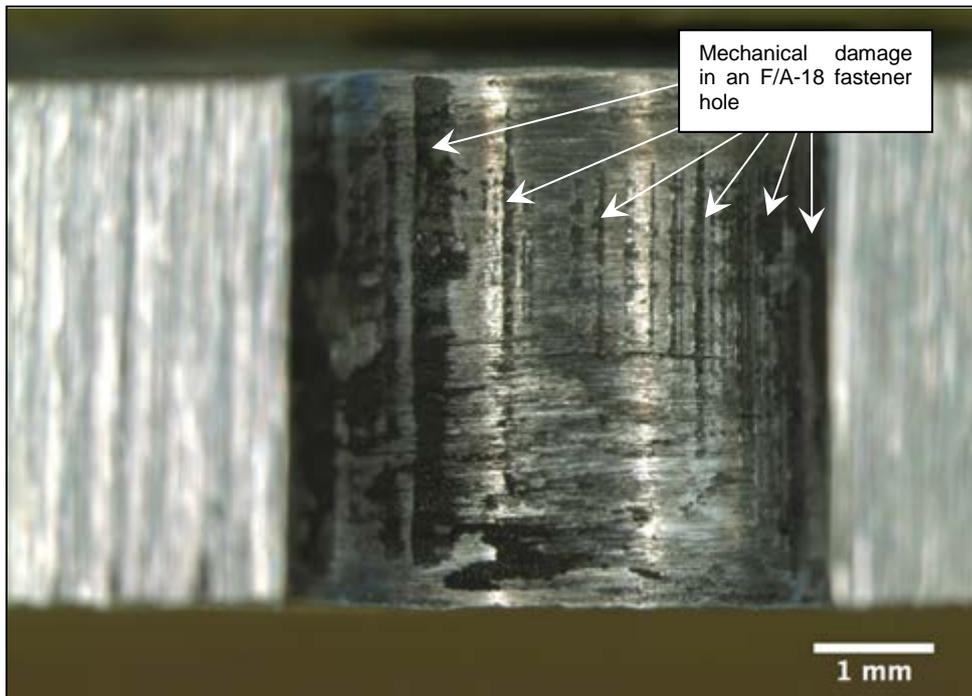
Figure 2. Typical mechanical damage in a 3/16" diameter F/A-18 bulkhead fastener hole following fastener removal. The hole has been broken open for fractographic examination.

Holes can have significant levels of damage present, such as the example shown in Figure 2, from a  $3/16''^1$  (4.76 mm) diameter fastener hole which was broken open as part of this work.

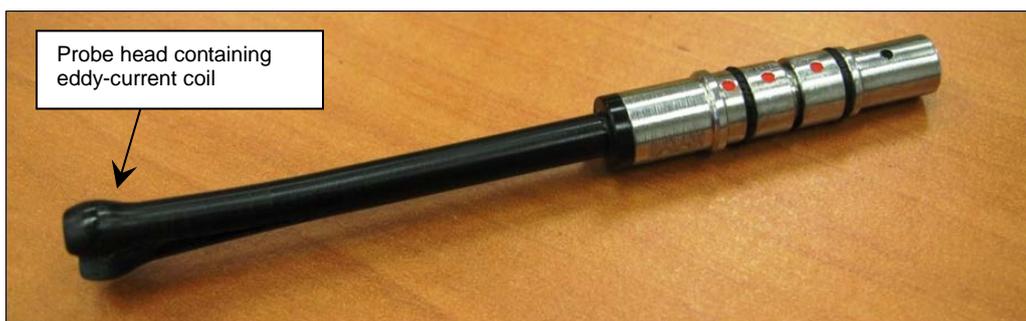
Figure 3. Typical BHEC probe. The coil is located at the end of the polymer spindle, which itself is typically split to provide a light pressure and thus a constant lift-off from the hole surface.

Eddy-current inspection is a well-established NDI method that employs the induced magnetic fields and electrical currents produced by a small probe coil to detect defects in conducting materials [1]. For the inspection of fastener holes using BHEC, the fasteners are removed and a rotating spindle containing the eddy-current coil is inserted into the hole. The eddy-current coil mechanically scans the entire circumference of the hole as the spindle rotates. The operator then moves the probe head through the entire hole bore giving a 100% inspection of the fastener hole within seconds. Figure 3 shows a typical BHEC probe.

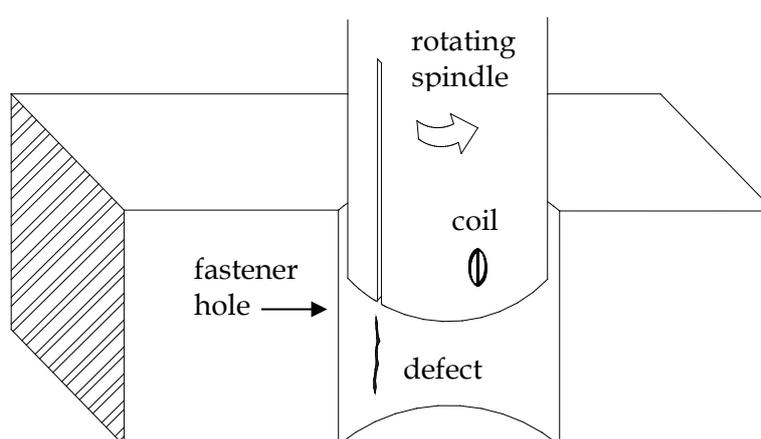
Figure 4. Schematic cut-away diagram for a typical BHEC inspection. The spindle contains a small differential (dual) coil embedded just beneath its surface. As the spindle rotates, the coil scans the bore surface of the hole at a constant lift-off from the surface.

Figure 4 shows a schematic diagram of a typical BHEC inspection. A small (1–2 mm diameter) coil is wound differentially and potted in the polymer spindle. During an inspection, the probe spindle is rotated at a constant speed of up to 3,000 rpm as the inspector moves the probe down the length of the hole. The coil is excited by an alternating current at a selected frequency typically in the range 100 kHz – 2 MHz. When the coil passes over a crack, the eddy currents induced in the alloy around the hole are disrupted, and the resulting change in coil impedance (magnitude and phase) is detected using the associated inspection test-set instrumentation.

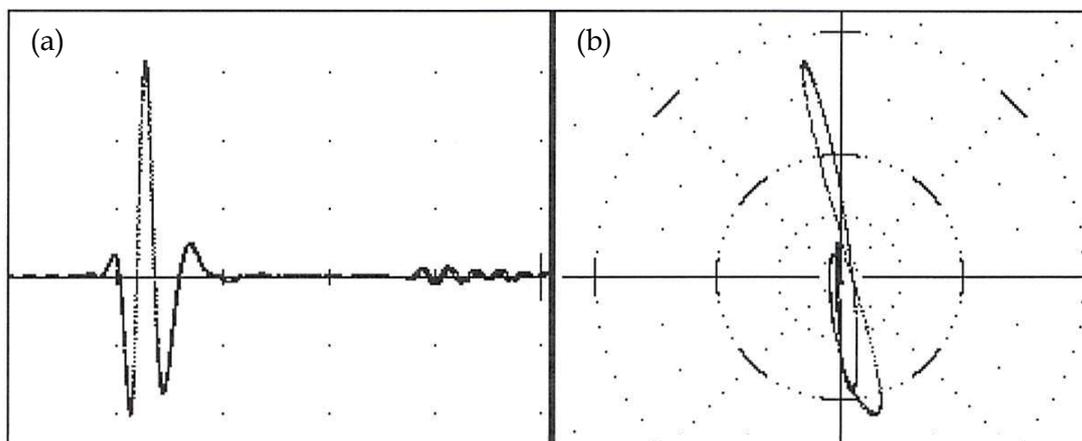
Figure 5. Eddy-current equipment display showing (a) signal vs hole circumference trace and (b) impedance plane (or polar plot) when inspecting a single calibration slot in a test standard.

The distinct peaks appearing to the left in (a) and the distinct loops appearing in the impedance plane display (b) indicate the presence of a defect. Most modern BHEC instruments have a split-screen X-Y (phase plane) & Y-t (voltage/time) to allow the operator to interpret the defect indications more easily.

The BHEC signal arising from a crack in Al alloys is similar in nature to that shown in Figure 5 but with some subtle differences. The amplitude of the signal is somewhat

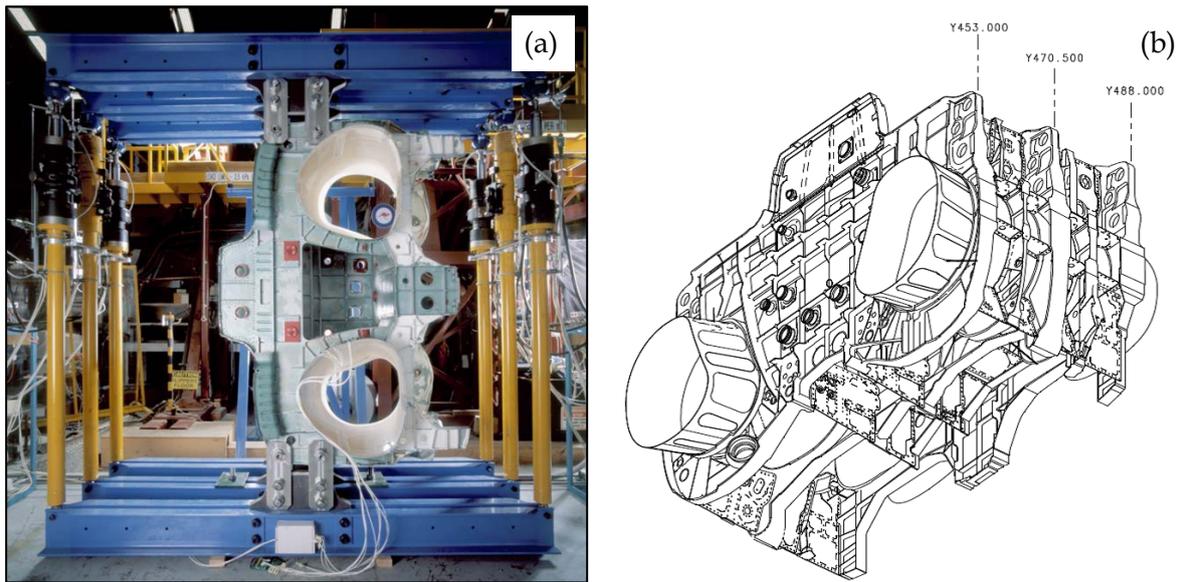
Figure 6. (a) F/A-18 centre barrel undergoing fatigue testing at DST Group test facility. The load on the wings on the centre barrel is provided by the yellow/black actuators attached to blue I-beams located on either side of the bulkheads. (b) Schematic diagram of the centre barrel showing the three bulkheads Y453, Y470.5 and Y488 [9].

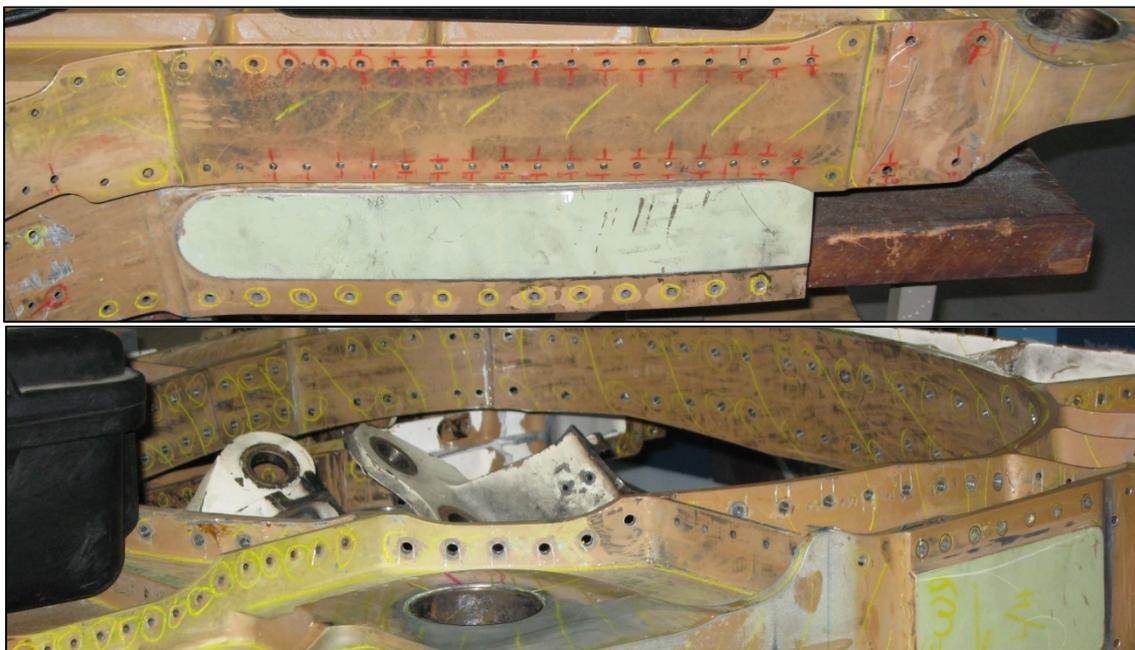
Figure 7. A selection of F/A-18 bulkhead fragments showing a number of holes that were inspected using the BHEC phase-discrimination technique. Yellow markings denote no eddy-current indications found, red markings denote either a crack or damage has been detected.

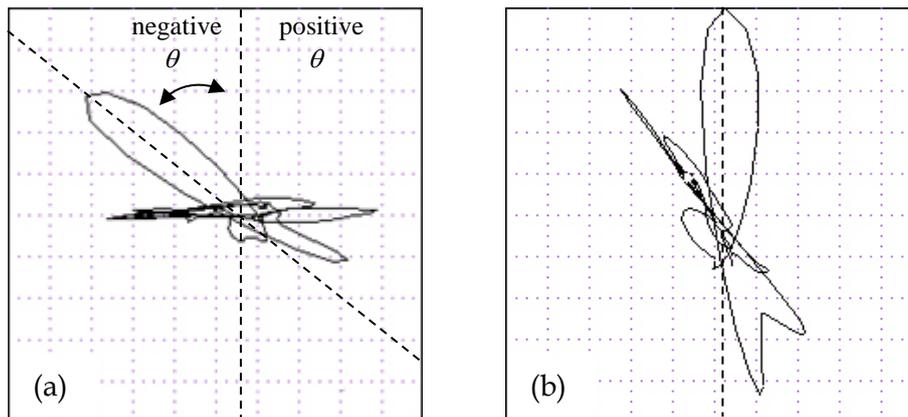
Figure 8. Screen shots of BHEC indications showing (a) the raw impedance plane data with a counter-clockwise rotation from the vertical of about  $45^\circ$ , a negative phase rotation, indicating the presence of likely mechanical damage. (b) The signal rotated to the vertical position to align with the phase orientation of the EDM slot indication.

Figure 8 shows an example of defect impedance signal before and after rotation to the vertical position corresponding to the phase of the EDM slot indication, and application of gain to bring the indication to the appropriate FSH.

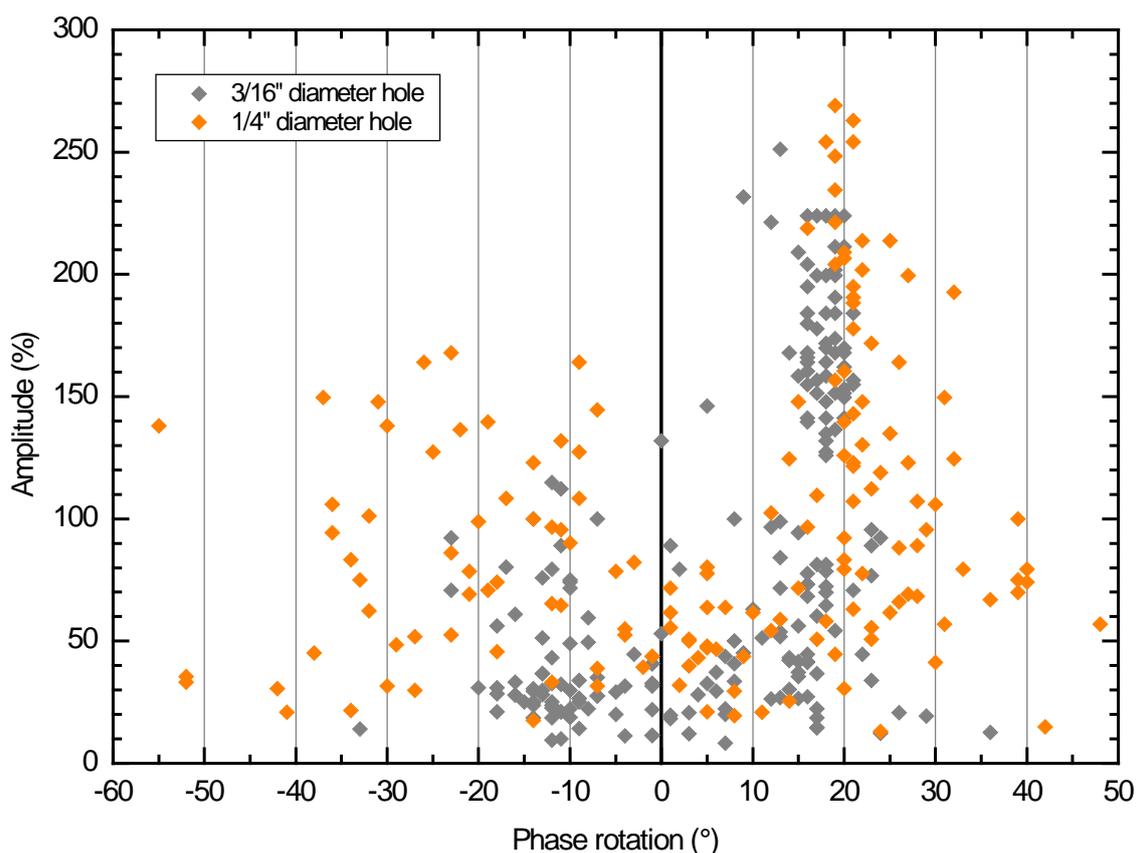
Figure 9. Defect indications detected in 3/16" (◆) and 1/4" (◆) diameter holes via BHEC testing. The amplitude and phase rotation are both measured relative to the setup condition on the EDM slot in the calibration standard.

Several hundred fastener holes were inspected using the method described in Section 4. Fastener holes that did not immediately produce an eddy-current indication were disregarded and played no further role in the study. In total, 365 BHEC indications were recorded by the inspectors, with many fastener holes giving multiple indications. A scatter plot of the normalised amplitude and relative phase of the BHEC defect signals with respect to the EDM slot setup signal is shown in Figure 9.

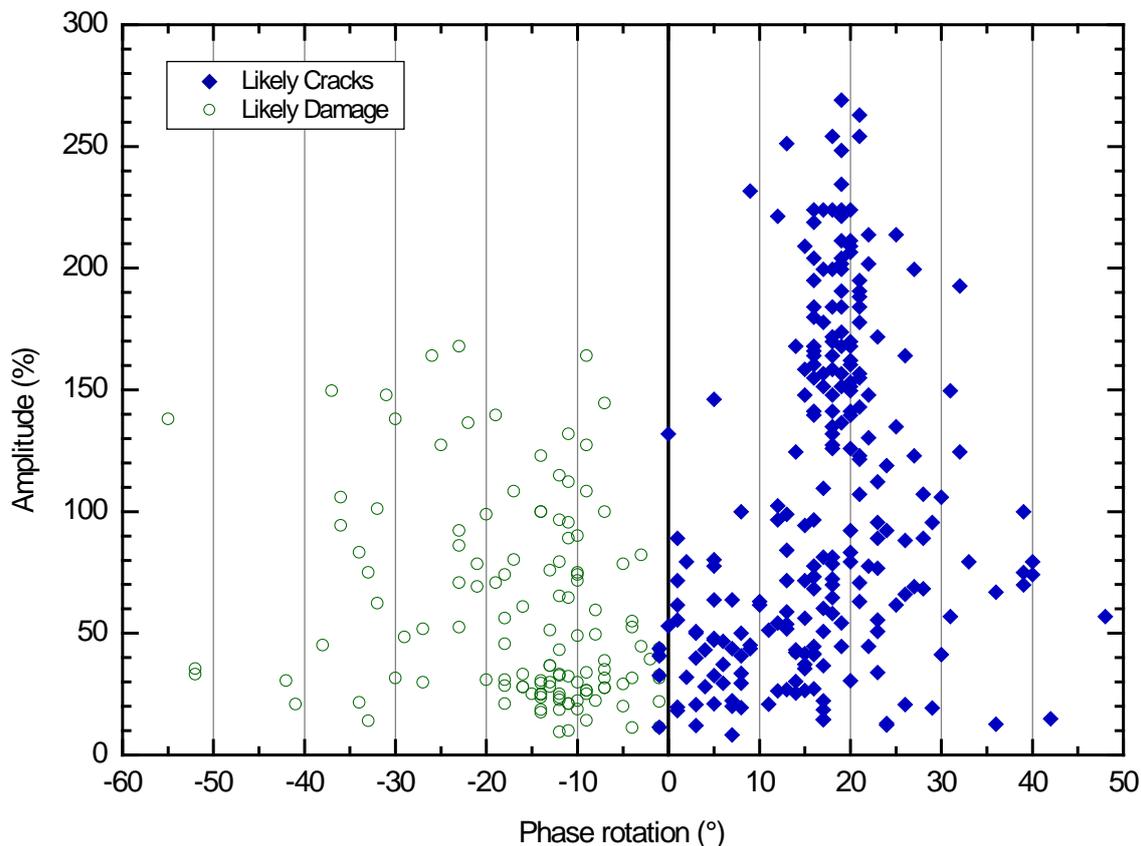
Figure 10. BHEC inspection data with the notional assignment of likely cracks (◆) or likely damage (○) within the holes.

resultant assignments are plotted in Figure 10 and show that 129 of the 365 BHEC indications were considered likely to be due to mechanical damage rather than fatigue cracking.

For the data set presented above, over 1/3 of the BHEC indications would not necessarily require corrective maintenance assuming the phase rotation was able to discriminate accurately between cracks and damage in every case. The number of holes which hypothetically would not require reworking would be somewhat less, as some holes contained both damage indications and crack indications.

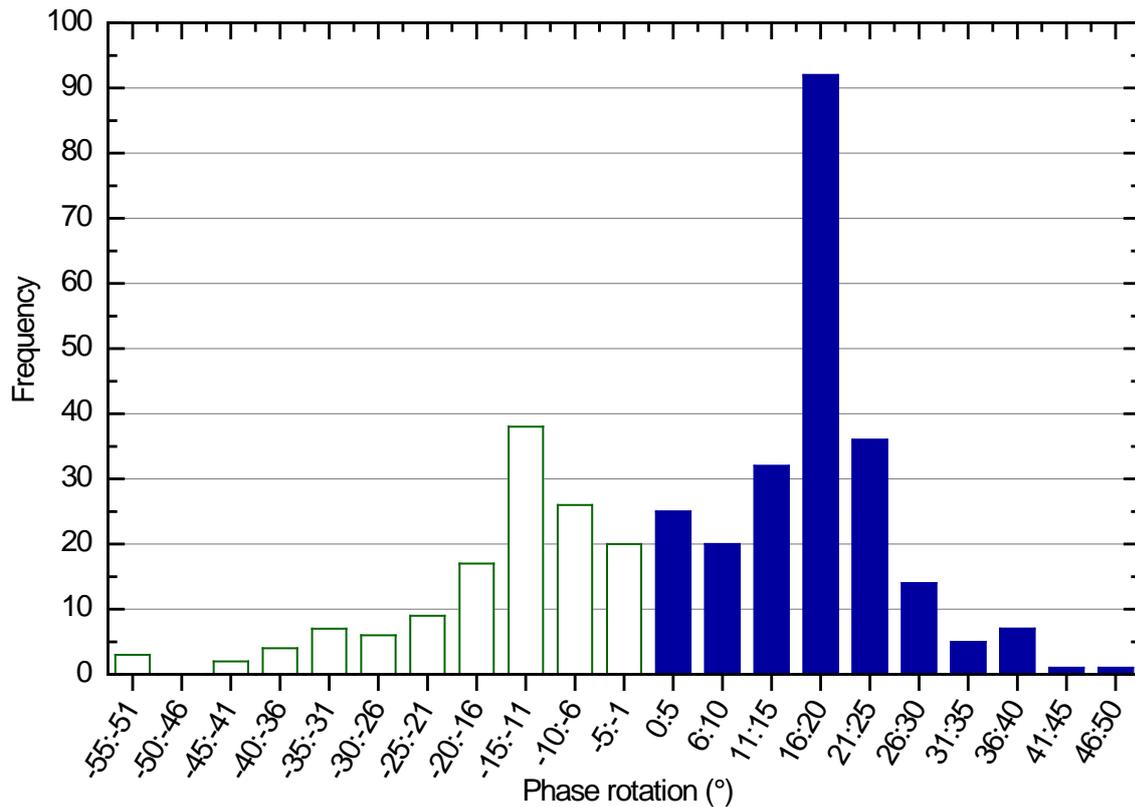
Figure 11. Frequency histogram showing the number of occurrences in five-degree bins. Peaks occur for positive phase rotations around +16° to +20°, and for negative phase rotations at -15° to -11°.

For the negative phase rotation region, a weak maximum occurs in the data for phase rotations in the range  $-15^\circ$  to  $-11^\circ$ . If the two adjacent bins are included, 63% of the negative phase rotation data occur in the range  $-20^\circ$  to  $-6^\circ$ .

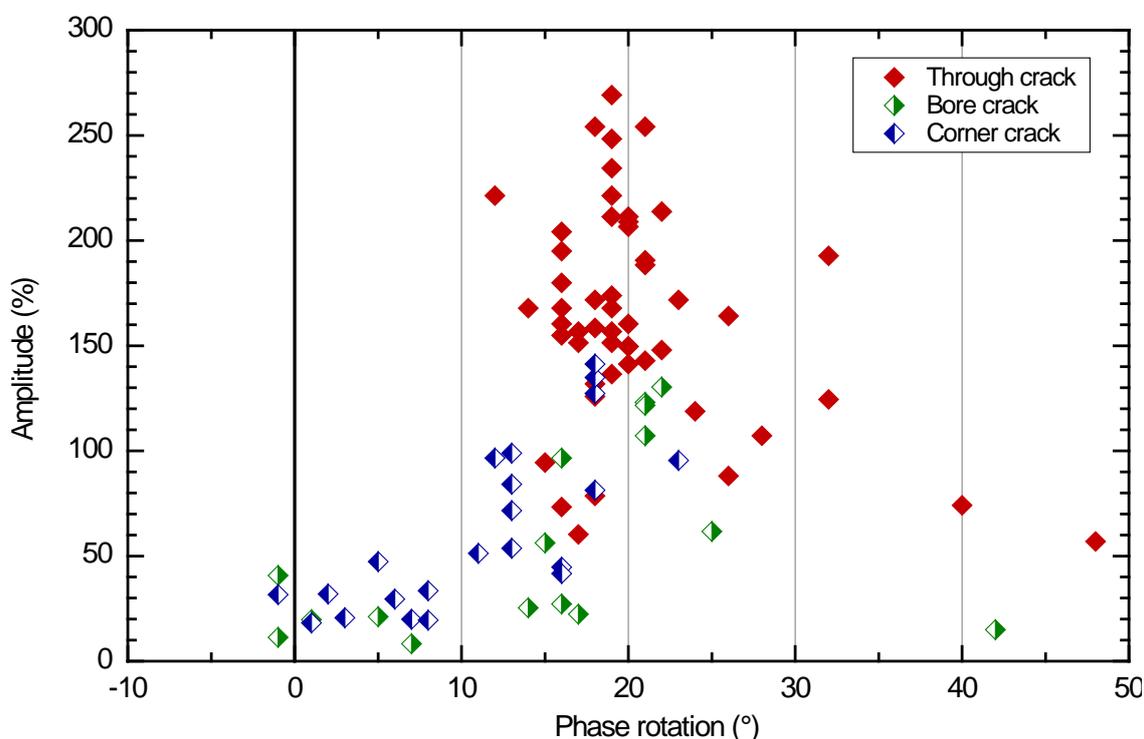
Figure 12. Distribution of through-thickness, corner, and bore cracks as confirmed by fractography. Through-thickness crack are strongly clustered about  $+20^\circ$  phase rotation.

The cracks examined by fractography were further categorised according to crack type to identify trends in the signal amplitude and phase. A scatter plot showing the relative amplitude and phase for through-, corner- and bore cracks for the majority of confirmed cracks is shown in Figure 12. The variation of relative amplitude and phase rotation with crack depth for the three crack types is shown in Figures 13–14. The through-thickness cracks emerge as a distinct population compared with bore- and corner cracks. A tabulated list of the results is also given in the Appendix.

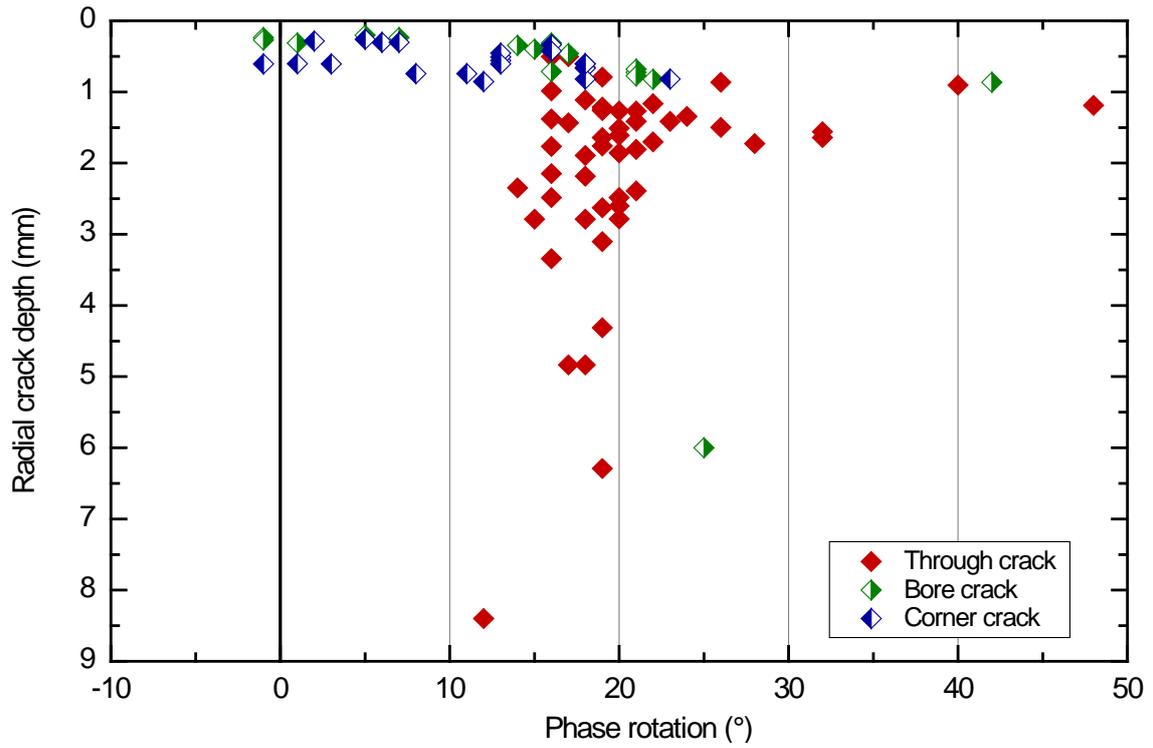
Figure 13. Phase rotation vs crack depth for the confirmed cracks.

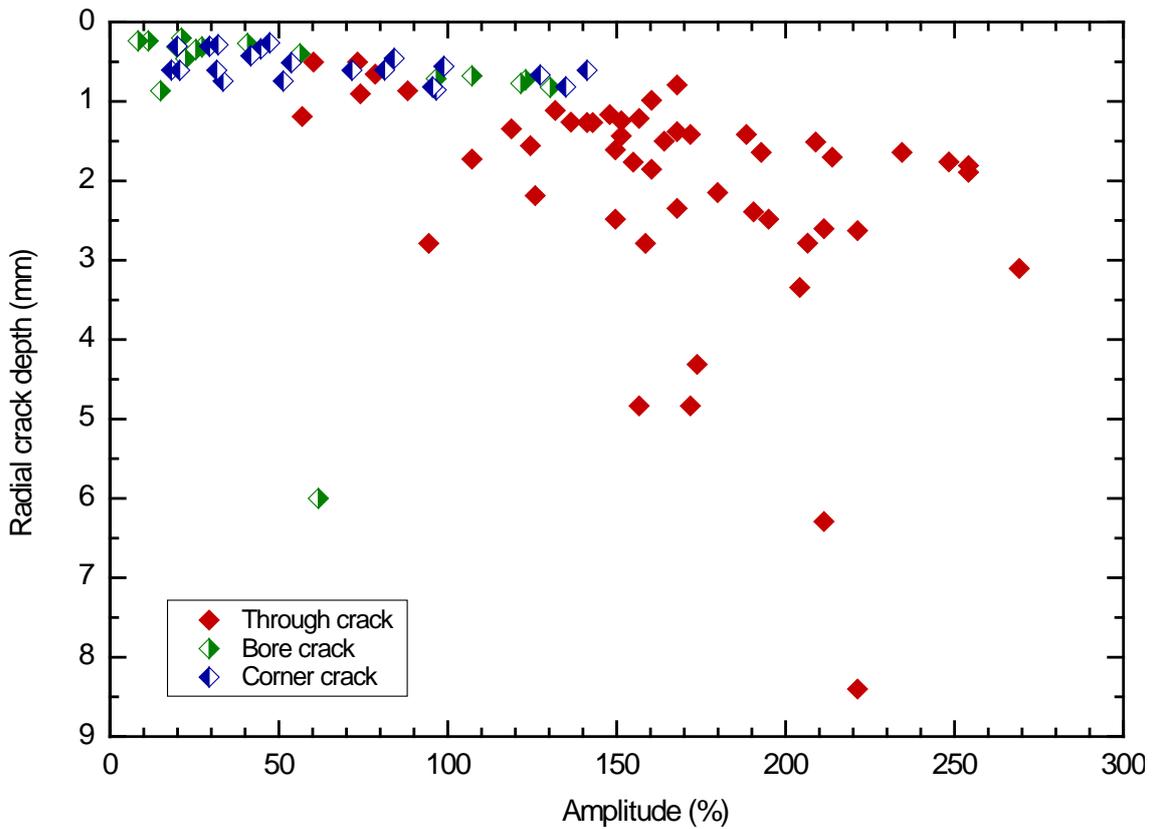
Figure 14. Relative amplitude vs crack depth for the confirmed cracks.

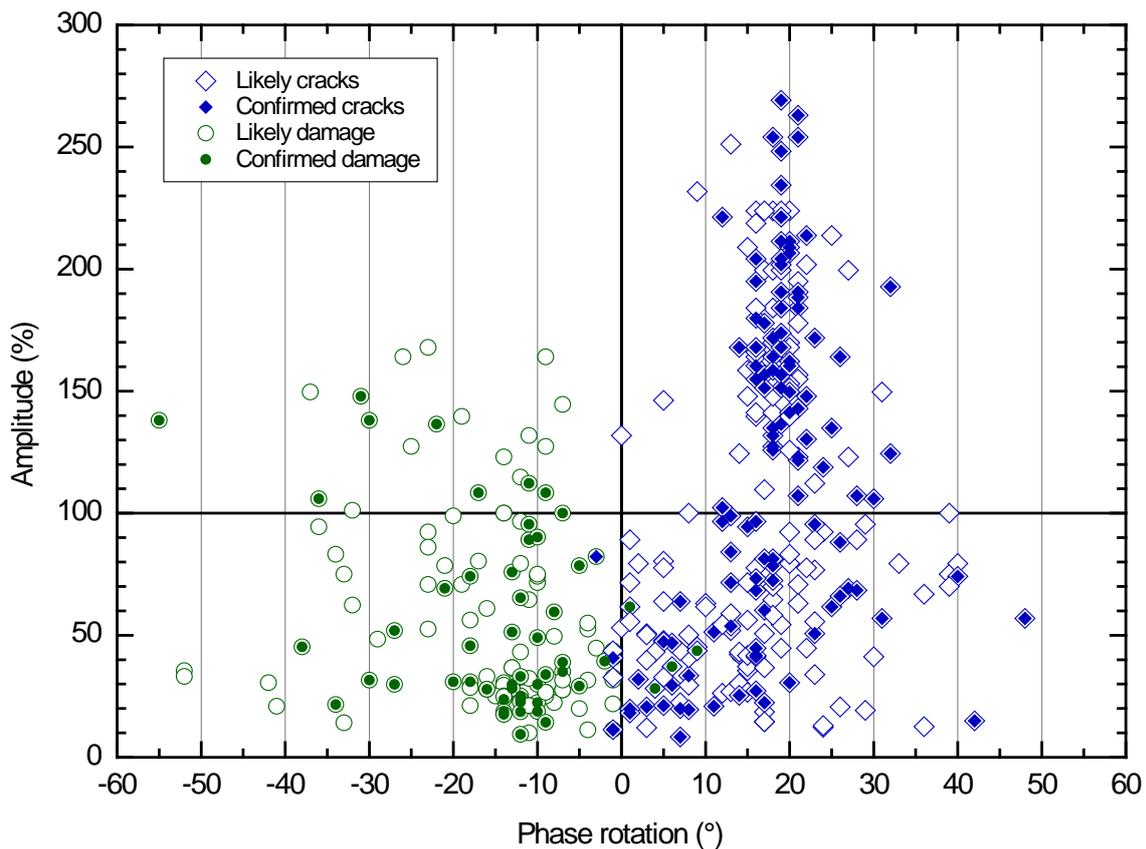
Figure 15. Summary of results from the BHEC phase rotation study. Indication types that have been confirmed using fractography are indicated by a solid marker.

(25°–50°) apparent in Figure 15. The relative amplitude from the modelling tended to be smaller than observed for cracks. These results should be treated as indicative, given the simplifications in the model, the coil geometry and the choice of the reference EDM slot.

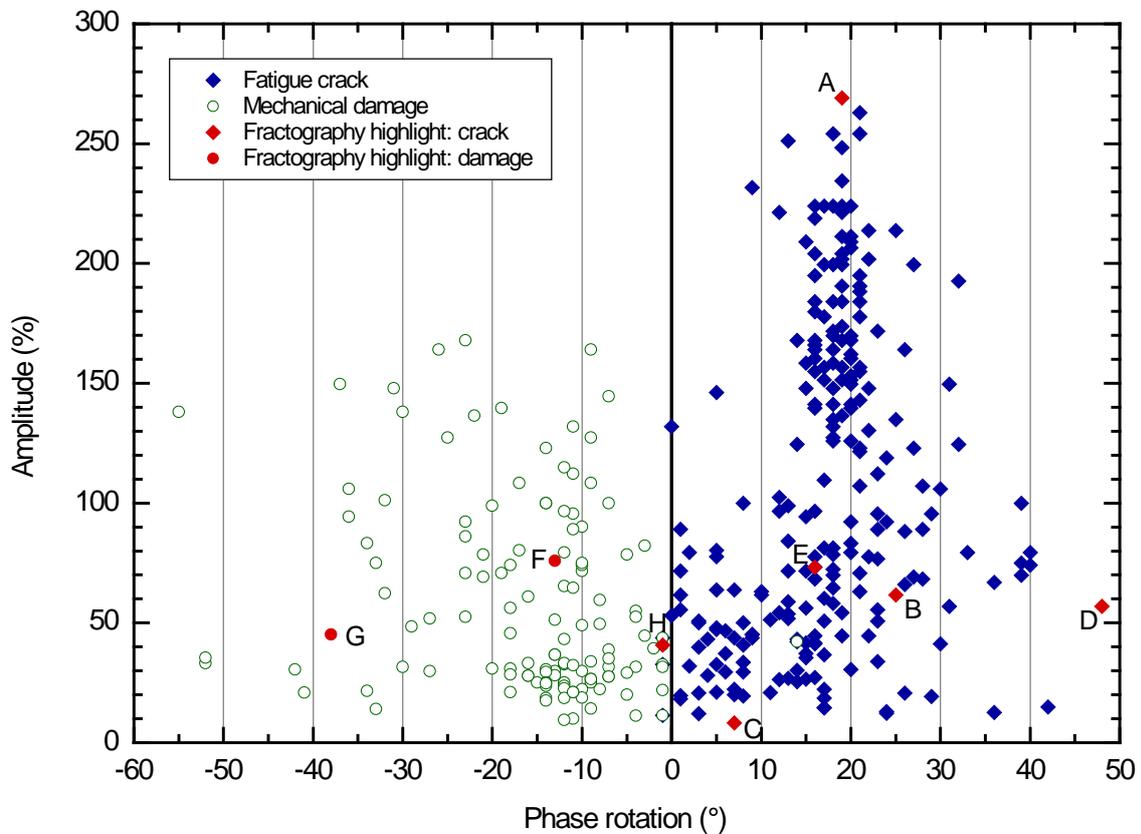
Figure 16. Phase rotation vs amplitude results showing location on the plot of the eight example fractographs presented in this Section.

The fracture surfaces of a number of the fastener holes which were broken open are reproduced in this Section. The results provide a sample of the crack and/or damaged surfaces for a variety of amplitude and phase rotation values. Figure 16 depicts the location of the eight selected fractographs in relation to the relative amplitude - phase rotation scatter plot.

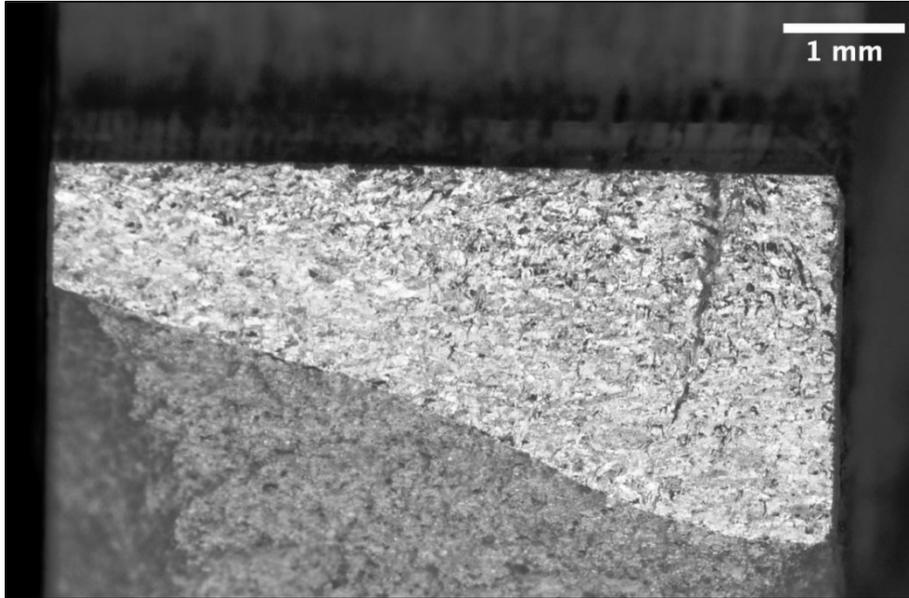
Figure 17. Fragment 14, hole 19C/D (AFT). A large through thickness crack with tapering depth.

- A. Fragment 14, hole 19AFT in the LHS AFT upper flange of bulkhead CB1 453. A large through-thickness crack in a 1/4" diameter hole, having the highest recorded signal amplitude (269%) and a phase rotation of +19° relative to the EDM calibration slot. The fractograph in Figure 17 shows significant tapering of the crack depth from a maximum of 3.104 mm down to approximately 1 mm.

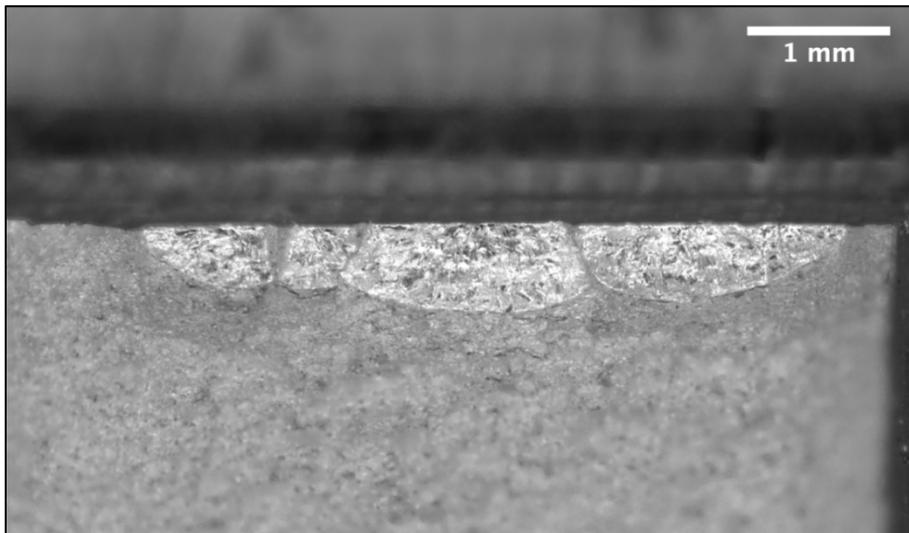
Figure 18. Fragment 12, hole 10A/B (FWD). A multi-origin fatigue crack having a mid-range amplitude and phase rotation response.

- B. Fragment 12, hole 10FWD in the RHS AFT upper flange of bulkhead CB1 453. A near-through crack in a 1/4" diameter hole, having a relative amplitude of 62% and a phase rotation of +25°. Length in the bore was 4.883 mm and radial depth 0.608 mm.

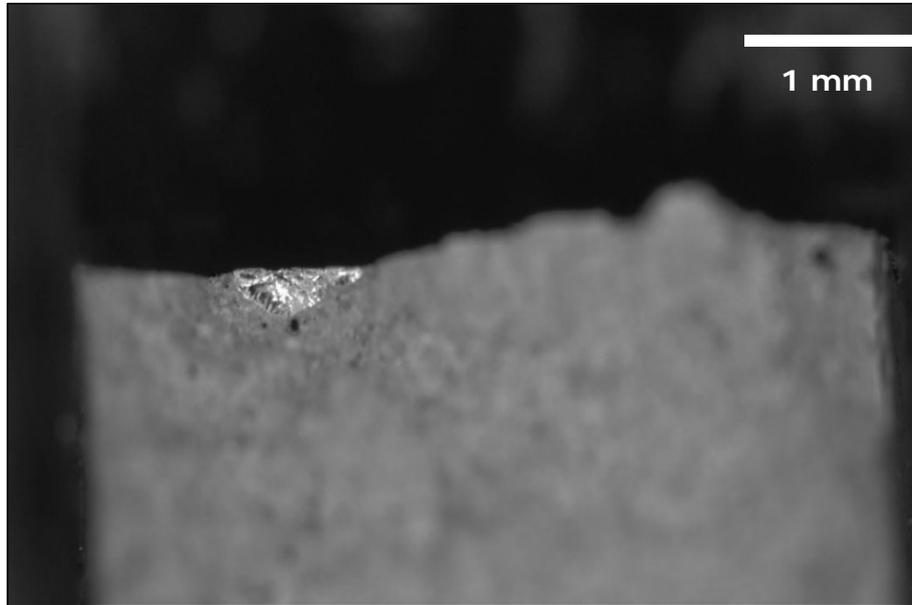
Figure 19. Fragment 1, hole 17C/D (AFT). A very small fatigue crack of depth < 0.25 mm.

- C. Fragment 1, hole 17AFT in the RHS AFT upper flange of bulkhead CB1 470.5. A very small crack in a 3/16" diameter hole, having a relative amplitude of 8% and a phase rotation of +7°. Length in the bore was 0.697 mm with radial depth 0.237 mm, meaning that the original indication was counted as due to damage rather than a crack.

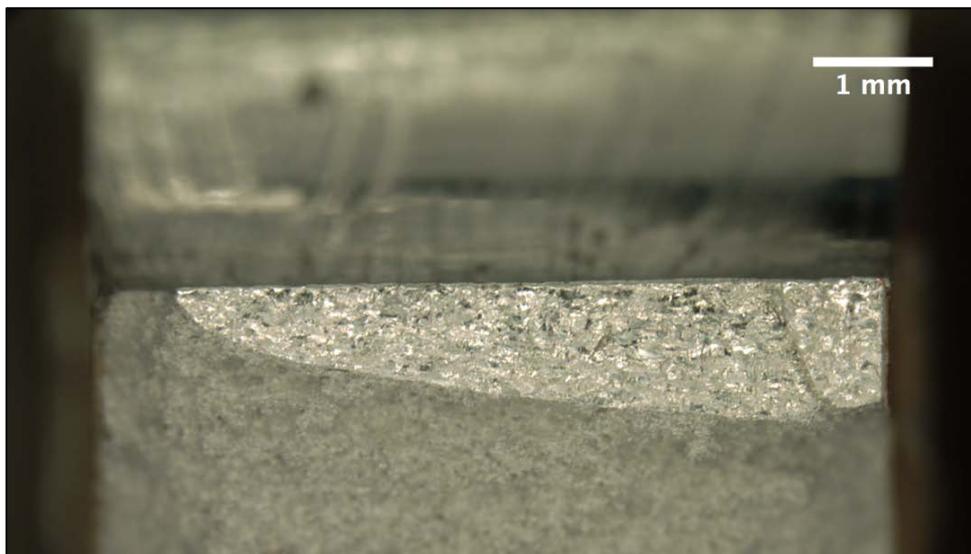
Figure 20. Fragment 12, hole 9C/D (AFT). A near-through crack exhibiting high phase rotation.

- D. Fragment 12, hole 9AFT in the RHS AFT upper flange of bulkhead CB1 453. A large crack in a 1/4" diameter hole, having a relative amplitude of 57% and a very large phase rotation of +48°. Length in the bore was 5.888 mm and radial depth 1.189 mm.

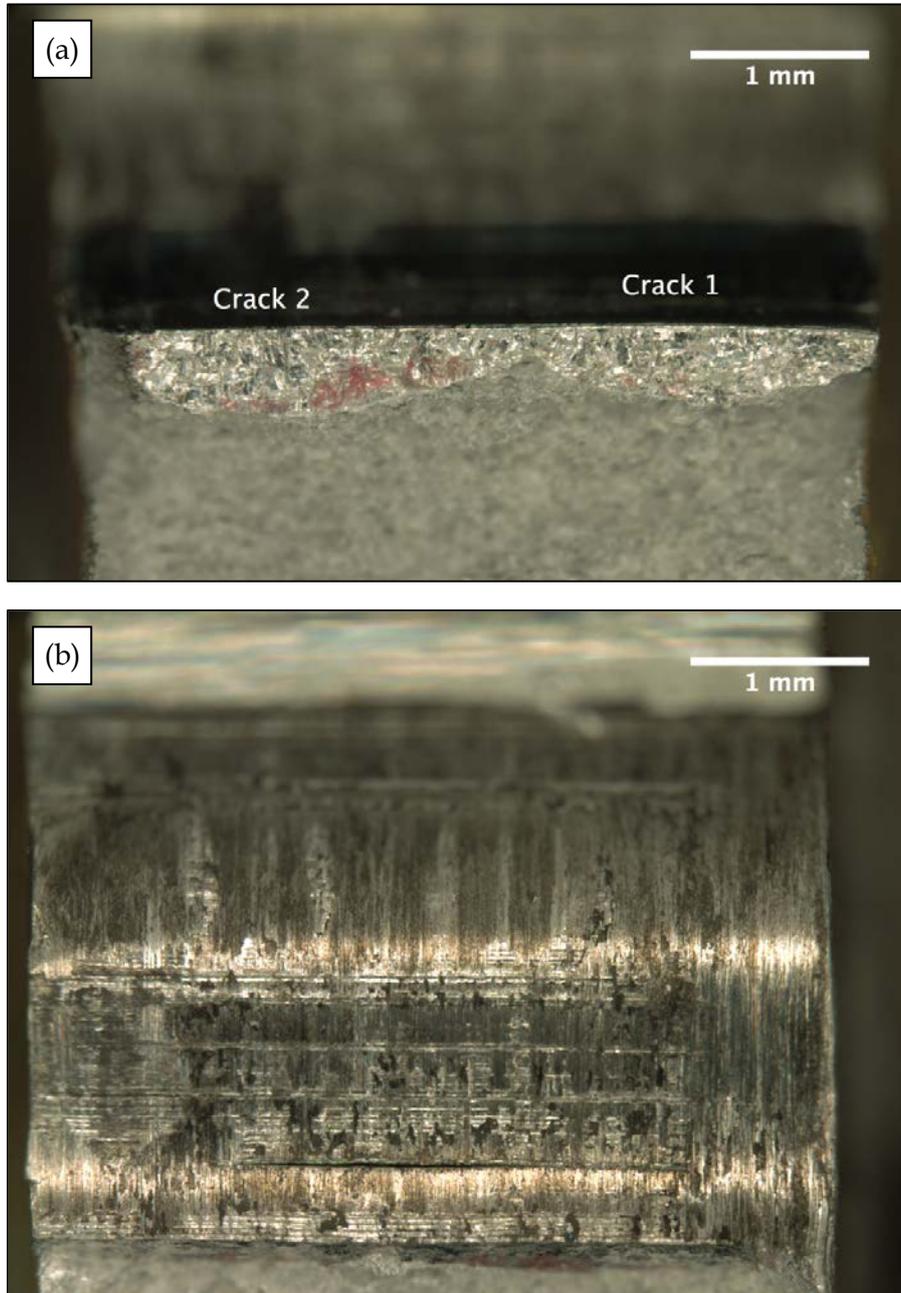
Figure 21. Fragment 1, hole 15C/D (AFT). (a) Two sizeable cracks joining to form a near-through crack in the bore. (b) Overview of the bore, showing large score marks.

- E. Fragment 1, hole 15AFT, in the RHS AFT upper flange of bulkhead CB1 470.5. Two sizeable cracks in a 3/16" diameter hole have joined to form a near-through crack. Relative amplitude 73% and phase rotation of +16°. Length in the bore of the combined crack was 4.196 mm and radial depth 0.504 mm.

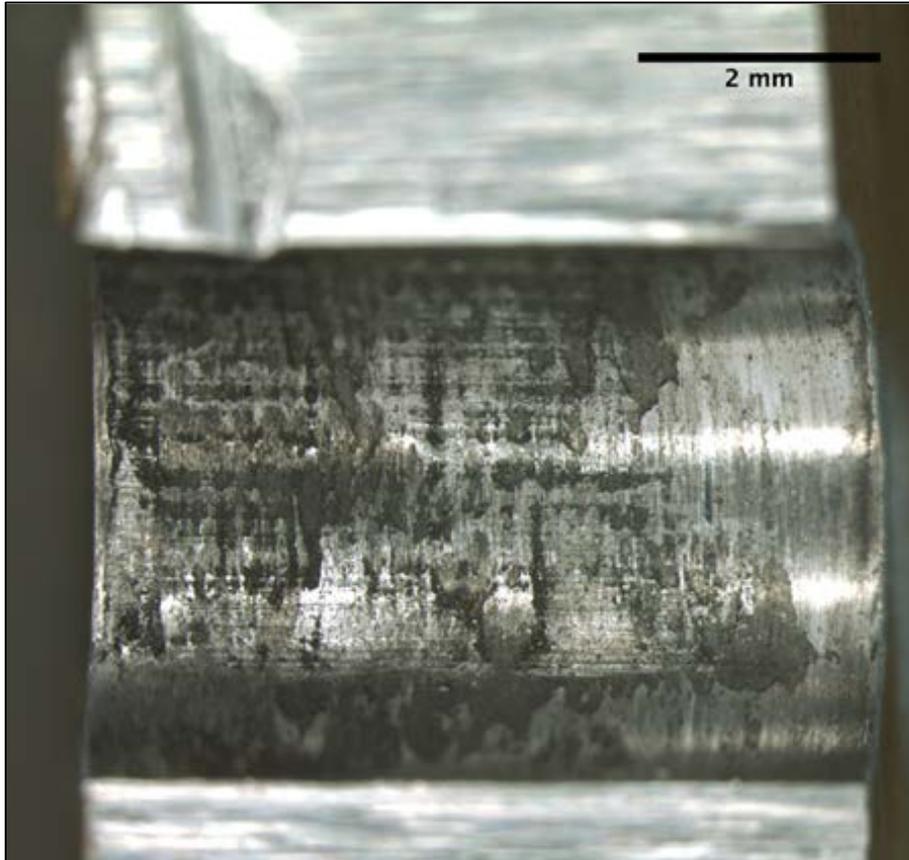
Figure 22. Fragment 1, hole 20. Mechanical damage within the fastener hole resulting in a significant BHEC indication.

- F. Fragment 1, hole 20, in the RHS AFT upper flange of bulkhead CB1 470.5. A damaged 3/16" diameter hole with no fatigue cracking. Relative amplitude 76% and relative phase rotation  $-13^\circ$ .

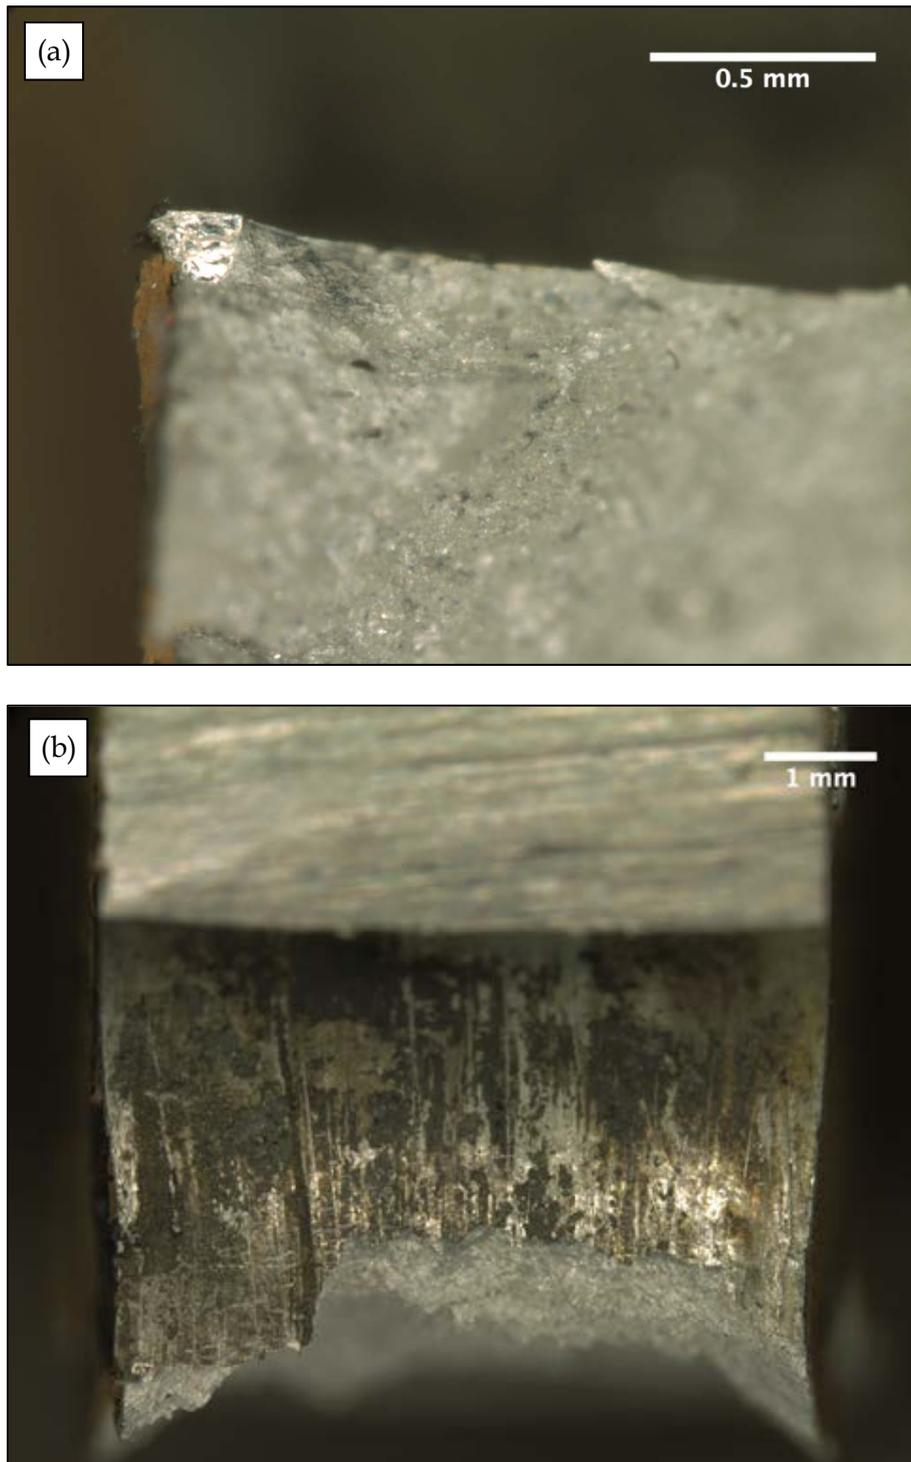
Figure 23. Fragment 15, hole 12A/B (FWD). (a) An extremely small corner crack. (b) The significant amount of damage present in the bore.

- G. Fragment 15, hole 12FWD in the LHS FWD upper flange of bulkhead CB1 453. An extremely small corner crack and significant damage in the bore, resulting in a relative amplitude of 45% and phase rotation of  $-38^\circ$ . Here, the negative phase rotation indicates the damage in the hole far outweighs any signal from the tiny corner crack, which was of length in the bore 0.213 mm and radial depth 0.151 mm.

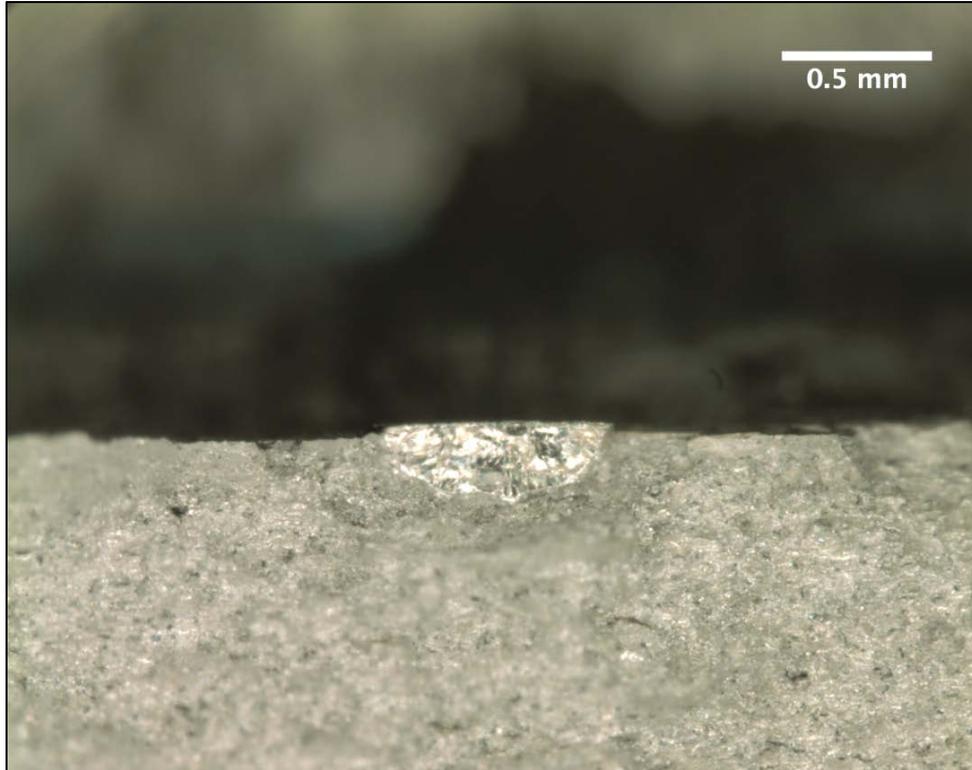
Figure 24. Fragment 13, hole 2A/B (FWD). A small mid-bore crack giving very little phase rotation compared to the EDM calibration slot.

- H. Fragment 13, hole 2FWD in the RHS upper FWD flange of bulkhead CB1 453. A small mid-bore crack of length 0.758 mm and radial depth 0.270 mm in a 3/16" diameter hole. Relative amplitude 41% and a very small relative phase rotation of  $-1^\circ$ .

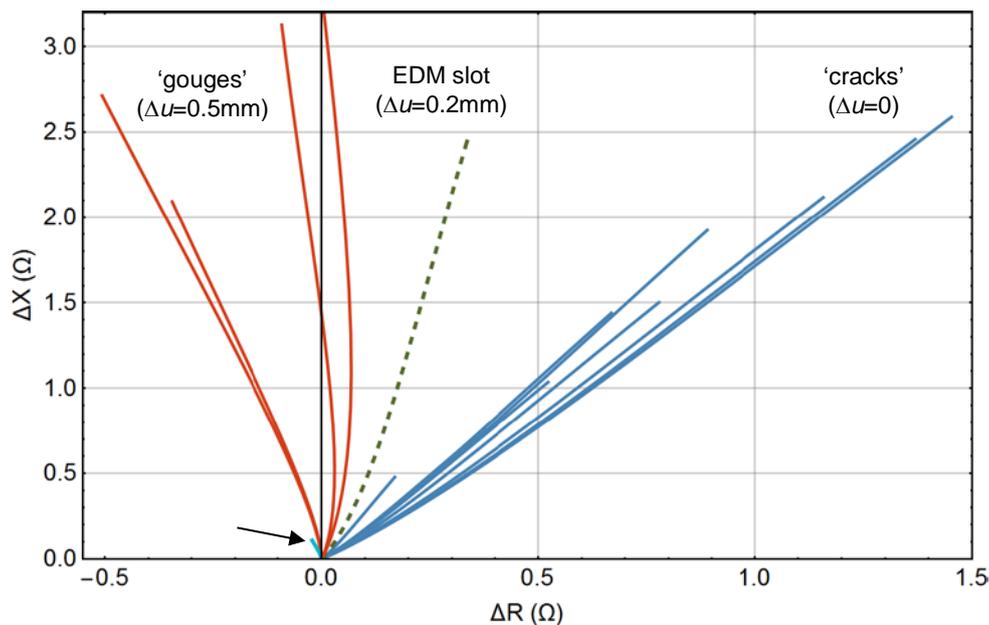
Figure 25. Calculated probe response (Eq.1) in the impedance plane for (i) model cracks, (ii) an EDM slot and (iii) mechanical damage in a flat 2024 Al-alloy plate. The coil was scanned across the defect at the position of maximum signal response,  $f = 500$  kHz. The signal (arrowed) is for a small crack where the scan was not at the position of maximum response.

The corresponding impedance change was computed for scans across the defect at the position of maximum signal. The model results are presented in Figure 25 and show a separation in phase for cracks compared with mechanical damage.

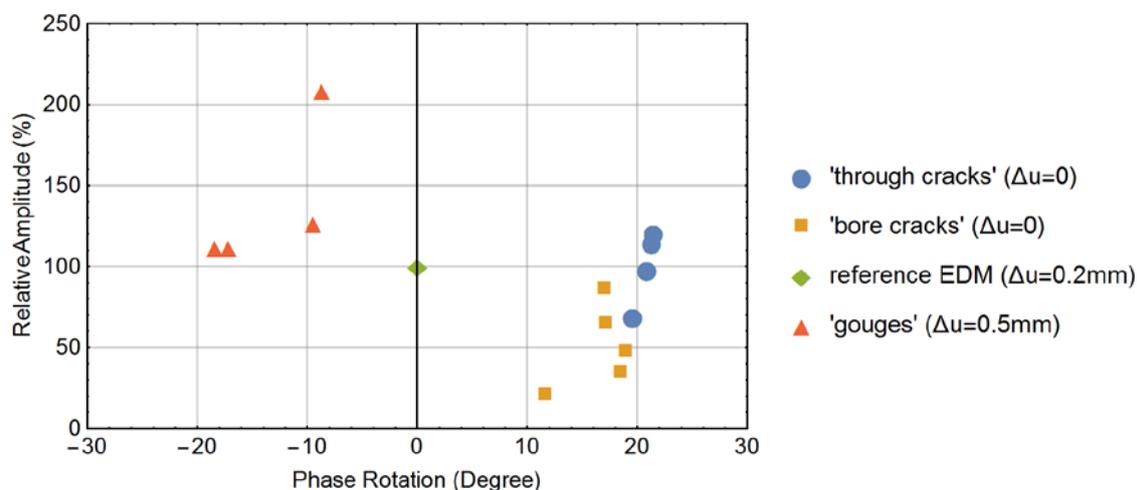
Figure 26. Calculated phase rotation and relative amplitude for model cracks and mechanical damage (gouges) in a flat 2024 Al-alloy plate. The phase and amplitude are calculated relative to a model EDM slot 0.75 mm deep, 0.2 mm wide and with infinite length.

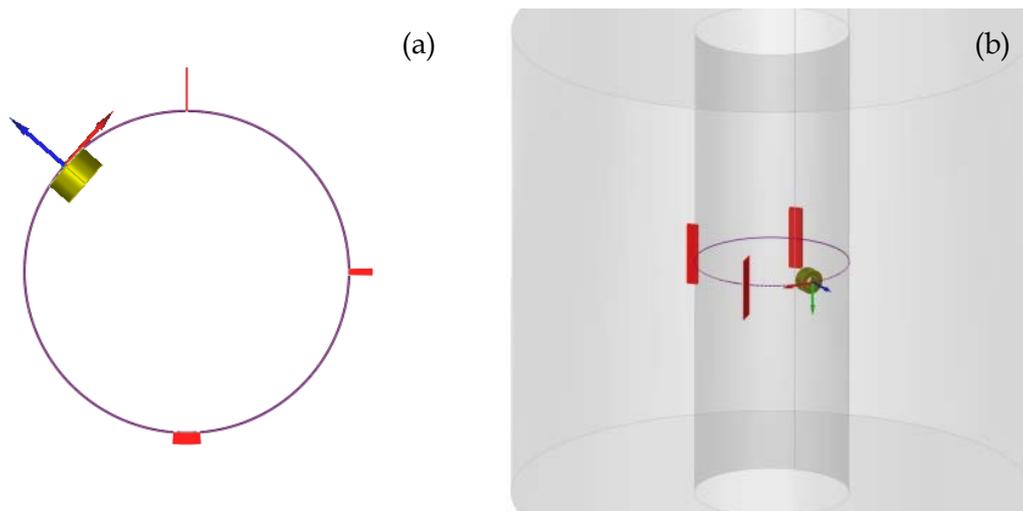
Figure 27. Three-dimensional model of a BHEC inspection, showing a BHEC coil scanning around a fastener hole radius, across two simulated surface-breaking defects. (a) View down the bore, showing the defects, and (b) 3-D view showing the parent material and inspection geometry inside the fastener hole.
