**Department of Defence**  
Science and Technology

# Discrimination between Fatigue Cracking and Mechanical Damage in Aircraft Fastener Holes by Eddy-Current Phase Rotation

DST-Group-TR-3289

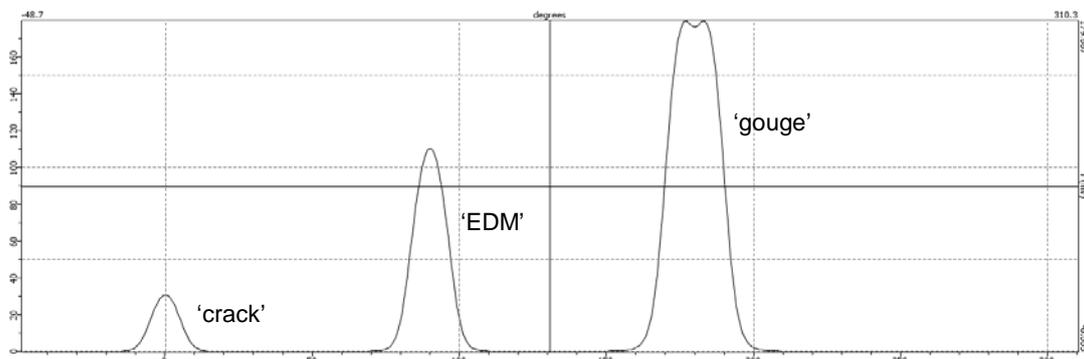
Figure 28. Impedance response for the rotating BHEC coil around the radius of a simulated aluminium fastener hole containing a crack-like defect, and EDM notch, and a gouge-like defect.

The impedance response vs position for the three defects is shown in Figure 28, with the most crack-like defect at left, and the simulated mechanical damage at right.

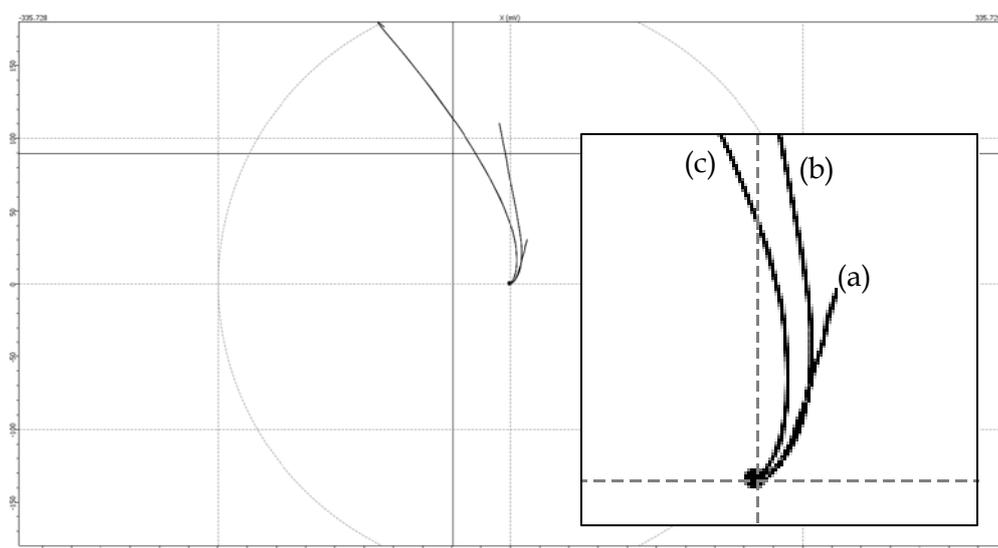
Figure 29. Phase-rotation effect as demonstrated via modelling in CIVA, with detail (inset). (a) Simulated crack, being a slot of width 0.01 mm and depth 0.85 mm, (b) intermediate slot of width 0.10 mm and depth 0.45 mm, and (c) simulated mechanical damage, being a slot of width 0.50 mm and depth 0.22 mm.

Note the curvature of the impedance plane signals in Figure 29, particularly for the defects with larger opening width. This introduces a degree of uncertainty in defining when the tip of the crack has reached the vertical position during a phase rotation.

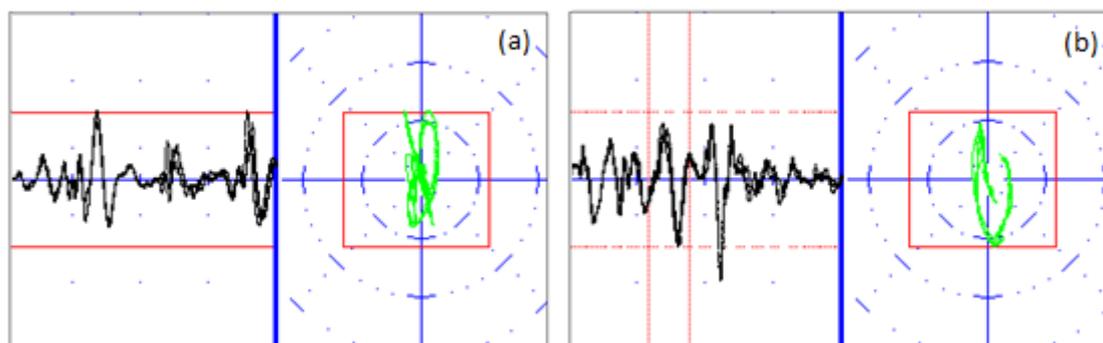
Figure 30. Software filter applied to a BHEC instrument. (a) Y-t or voltage vs hole circumference signal (left), and the corresponding impedance plane (right). (b) A software-filtered trace, where the impedance plane presentation is limited to the signal shown between the red vertical lines. The impedance plane presentation is much less cluttered than for (a).

This enhancement of the usual BHEC software also permits removal of spurious noise signals in holes where both damage and cracking exist, to give an uncluttered impedance plane plot as well as permitting individual phase-discrimination measurements to be made for multiple defects, as is shown in a demonstration version of such software in Figure 31.
