Engineering for Polar Operations, Logistics, and Research (EPOLAR)

Flow-Control Systems Proof of Concept for Snowmelt Runoff at McMurdo Station, Antarctica

Final Report

Under Engineering for Polar Operations, Logistics, and Research (EPOLAR)
EP-ANT-15-04, "Drainage Solutions Implementation"

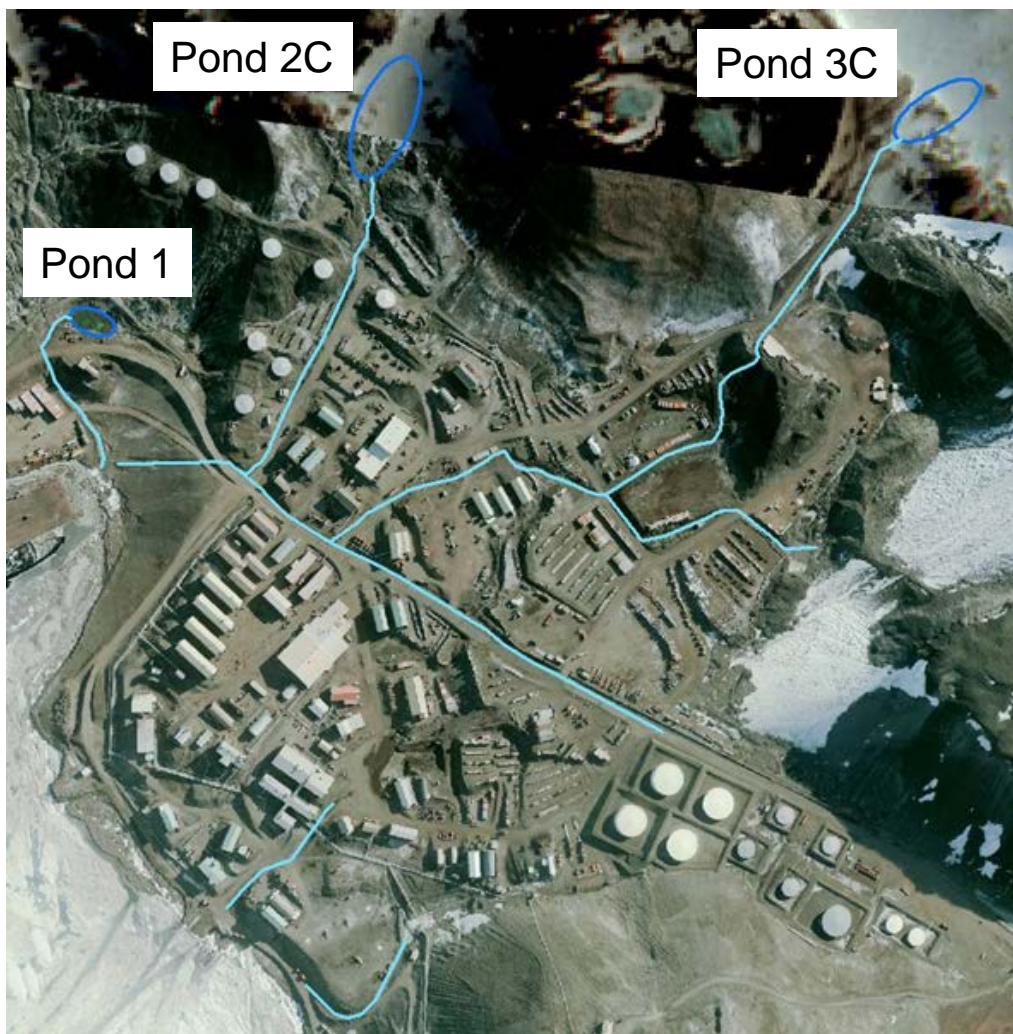
Figure 3. Proposed pond locations from Affleck et al. (2014c).

Ponds detain flow, attenuating the peak and allowing sediment to settle (Ferris 1983). The sediment ponds designed for McMurdo Station were located upstream of drainage paths to capture the snowmelt runoff from subbasins and to control the flow in the channels (Figure 3) (Affleck et al. 2014c). A typical pond would require a riser and outlet pipe; however, the use of a riser and a piped outlet in McMurdo conditions is infeasible due to maintenance requirements from ice accumulation. The design metrics for McMurdo were fully described in Affleck et al (2014c). The sediment ponds were designed to accommodate both water and ice accumulation with the notion that these ponds should be maintained on a regular basis to remove ice and sediment.

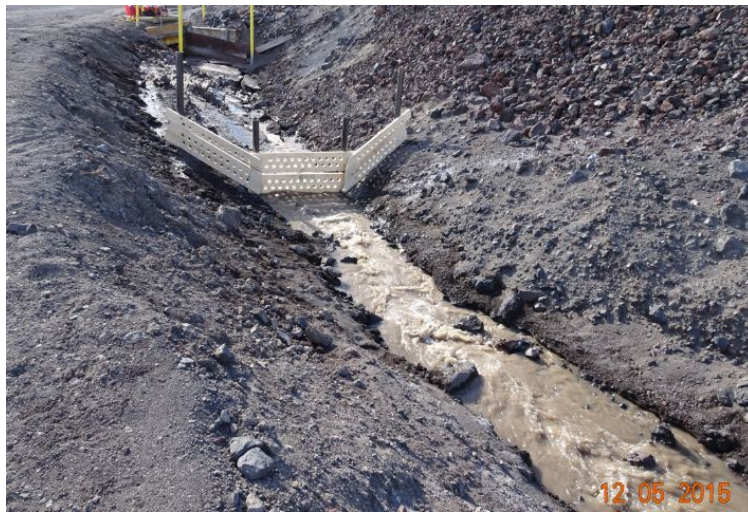
Figure 8. Prototype anchored wooden weir tested along the main channel.

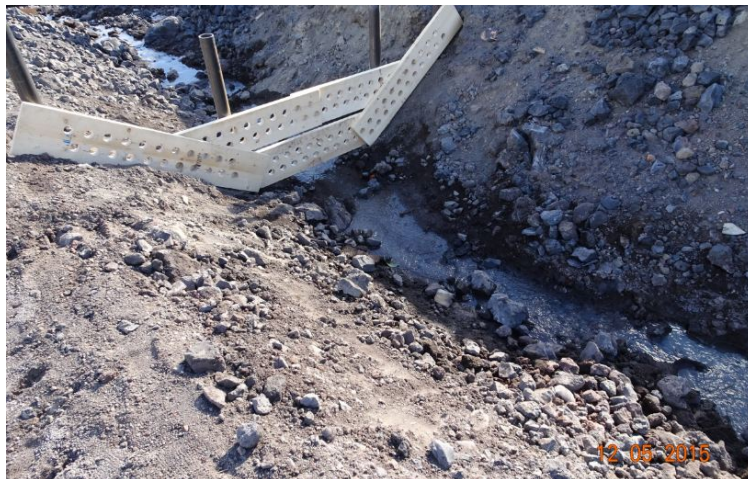
Figure 9. Prototype anchored wooden weir tested along the channel on Gasline Alley.

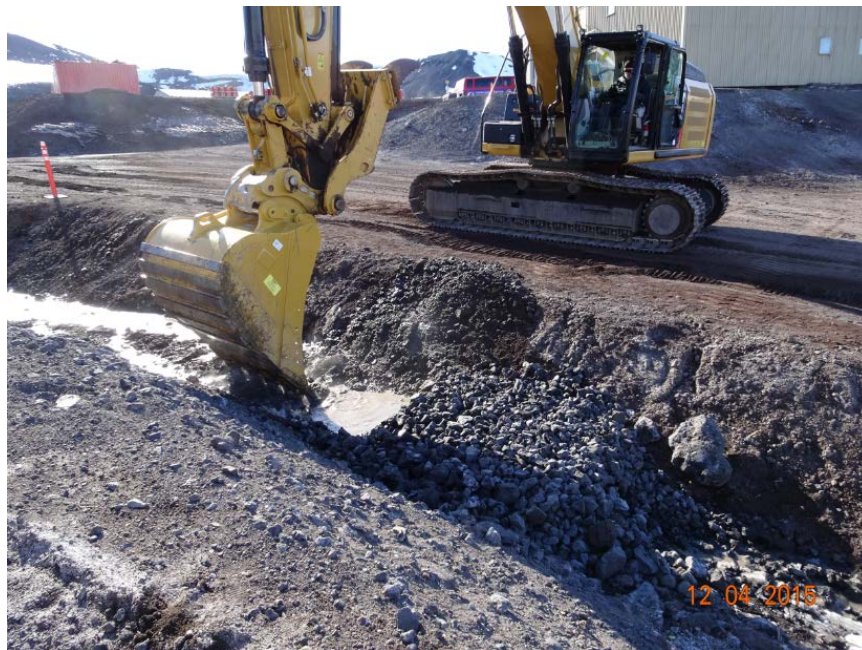
Figure 11. Rock weir using the 2 to 8 in. rocks. The excavator created a sump upstream of the weir.

It took between 3 and 4 hours to build all six rock weirs by using an excavator and a loader at the same time. The loader hauled the rocks and dumped the rocks in the selected location in the channels. The channels were previously shaped and cleared of snow and ice early in the season. The weirs used two rock size ranges: 2 to 8 in. rocks (Figure 11) and 8 to 12 in. rocks (Figure 12). Rock weirs using the 2 to 8 in. rocks were constructed along the channel near Building 175 and upstream along Gasoline Alley (Figure 11). The amount of rocks used depended on the width of the channel and the height of the weir. In upstream channels, rock weirs were built using 8 to 12 in. rocks (Figure 12). The height of the rock weirs (i.e., the height from the middle bottom of the channel to the top of the weir) depended on the channel cross section and ranged from 1.5 to 3 ft. A minimum height of 1.5 ft was used for shallow and wide channel. For narrow channels, a 3 ft rock weir height was used. The excavator was used to shape the weir, to compact the rocks, and to create a sump or depression upstream of the weirs.

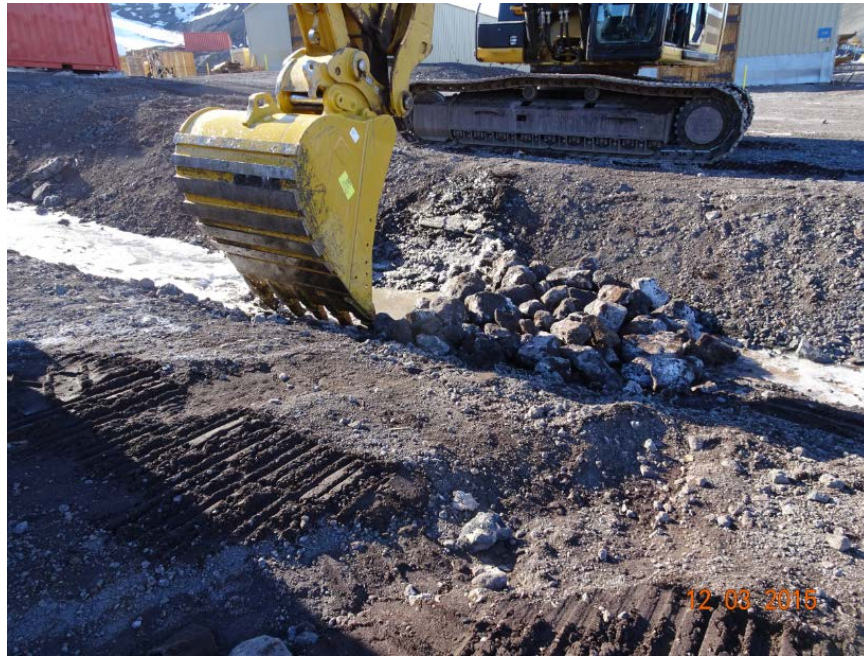
Figure 12. Rock weir using 8 to 12 in. rock sizes with a sump upstream of the weir.

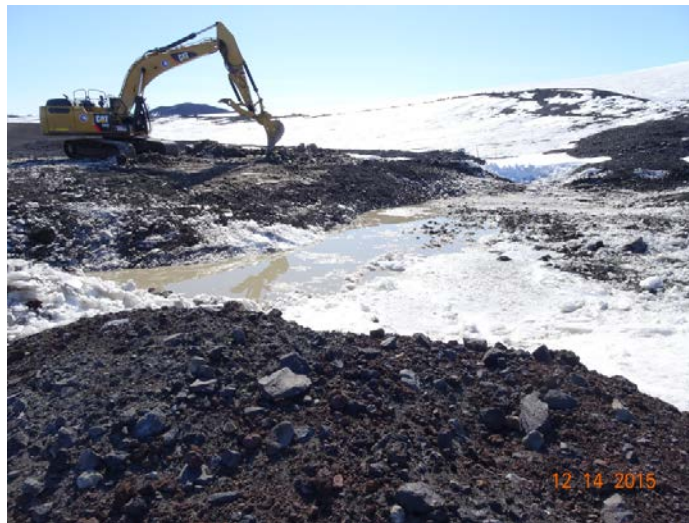
Figure 14. Digging the secondary pond.

An initial survey assessed the topography to determine the best location for Pond 3C. Based on the actual topography, the logical approach was to build adjoining ponds (primary and secondary ponds, Figures 13 and 14). These ponds were built as reservoirs or snowmelt settling ponds. The primary pond is located on a natural depression area. The excavator (with a bucket for digging materials and ripper and hammer, also called a hydraulic hammer or pecker, attachments for breaking the hard layer) was used for digging the pond. Building this pond included digging out a portion of the natural depression (Figure 13). Digging commenced on 12 December 2015 and continued for several days, encountering alternating layers of fractured basaltic boulders and gravelly sand deposits over massive ice layers. The fractured basaltic boulders and gravelly sand materials extracted in the pond area were placed and compacted to build up the top berm. Some boulders and rocks were set aside for building a French drain type of dike in the outlet. Downstream, the outlet is the secondary pond (Figure 14). The secondary settling pond was built to buffer the excess snowmelt from the upper pond. Constructing both the primary and secondary ponds for Pond 3C took 46 equipment hours, including final adjustments (Figure 15).

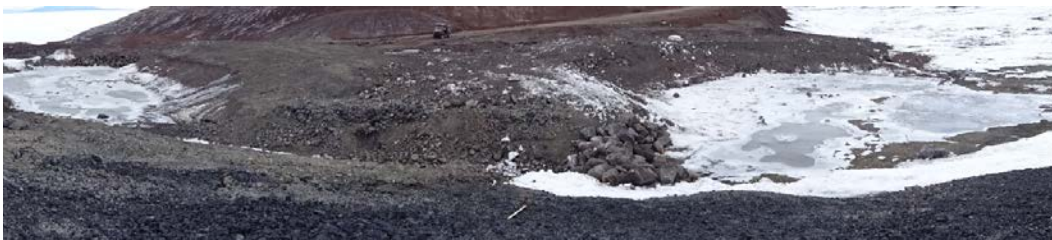
Figure 16. Perspective view of Pond 3C showing the final layout of the primary pond (*right*) and the secondary pond (*left*).

Figures 16 and 17 show the final layout of the ponds. A final survey after fine-tuning the ponds collected information about the final layout to determine the elevations, areas, and volumes. Table 3 summarizes the final sizes of the ponds, which were relatively shallow. The primary pond had a total volume of approximately 21,000 cu ft. The secondary pond covered half the size of the primary pond with a total volume of 11,000 cu ft. The total capacity was approximately 32,000 cu ft, which was significantly smaller than the minimum design for Pond 3C by a factor 15. The rationale for the limitations included that (1) the area had insufficient space to build the designed size; (2) the equipment had other projects to support and so had limited availability for this project; (3) and it was treacherous to dig deeper in ice and hard rock on unstable ground, creating safety concerns for the equipment (sliding and traction) and operator. The ponds built for Pond 3C will serve as experimental settling basins to determine whether the ponds will retain the snowmelt and whether the berm and spillway will hold up and attenuate the flow.

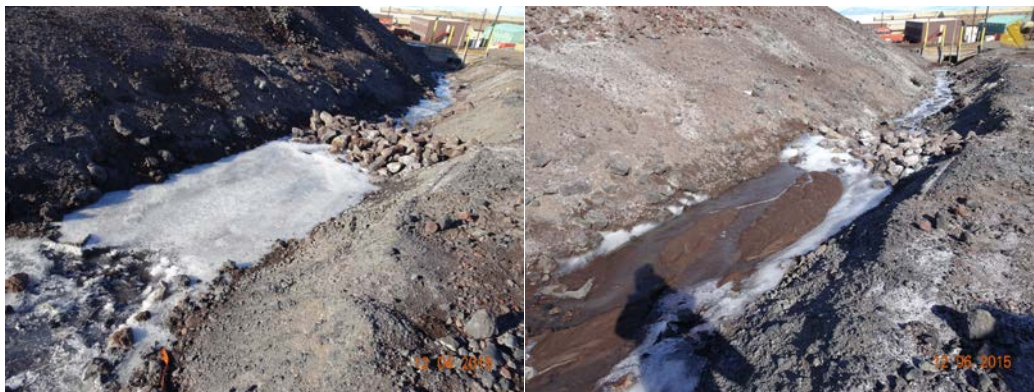
Figure 18. Water stage and sediments upstream of the rock weirs during light flow.

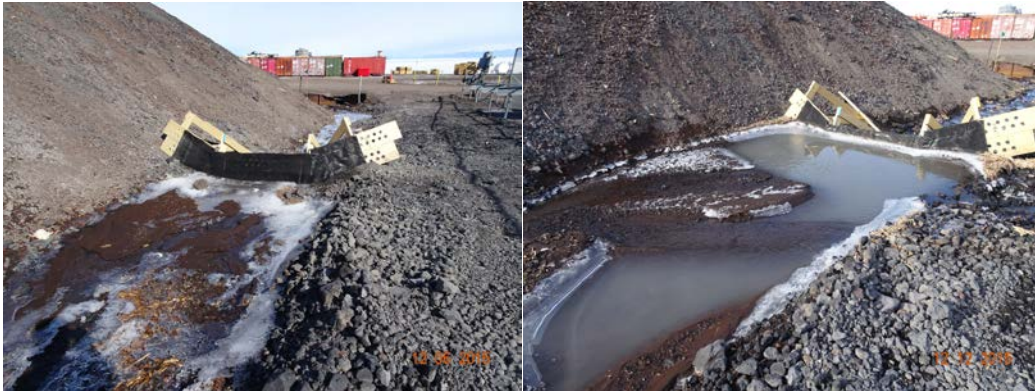
Figure 19. Water stage and sediments upstream of the unanchored wooden weir.

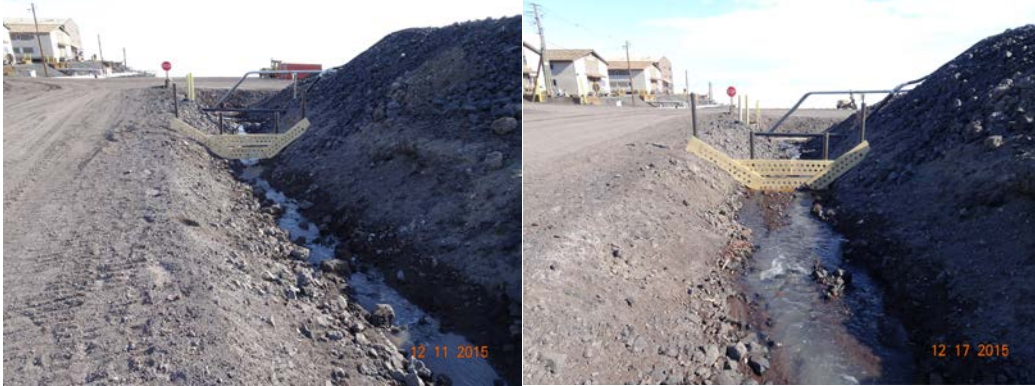
Figure 20. Water stage and sediments upstream of the anchored wooden weir.

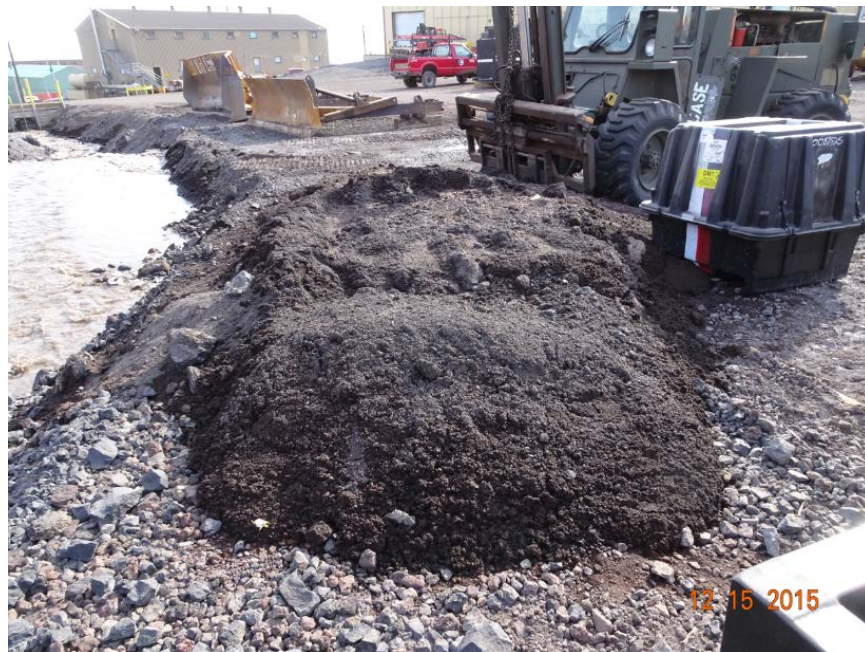
Figure 21. Typical amount of sediments collected from the weirs.

Trapped sediments upstream of the weirs were regularly scooped out with the excavator (Figure 21) and spread on the top side of the banks. Most of the runoff on the drainage channels from the first week of December 2015 to mid-December 2015 came primarily from subbasin 3. Thus, the drainage channels for subbasin 3 runoff flowed continuously at a moderate rate. Runoff from subbasin 2 that flowed in the drainage channel along Gasoline Alley was relatively light from the first week of December 2015 to mid-December 2015 (Figure 20). At that time, the snowmelt for subbasin 2 was accumulating in the existing natural depression/lake at the lower ice field.

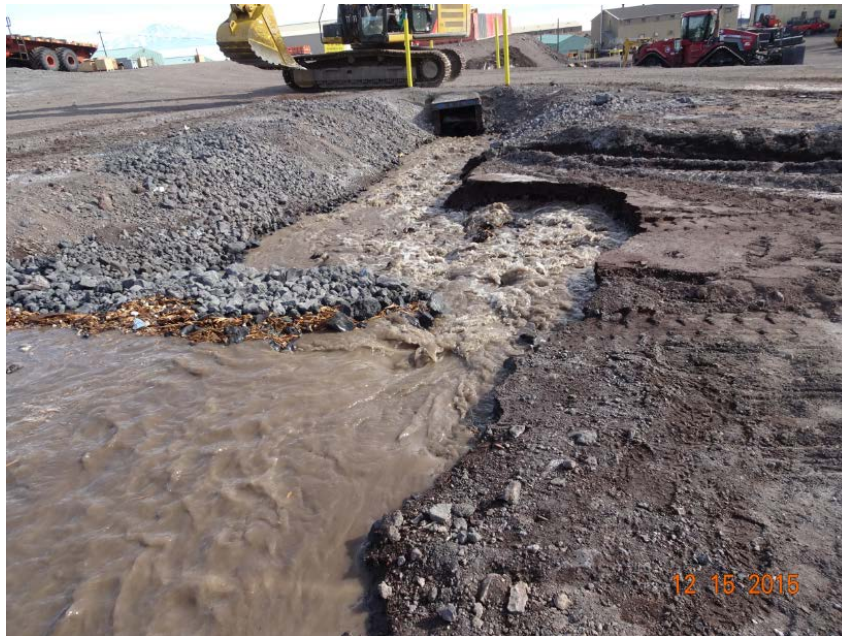
Figure 22. Example of a collapsed bank adjacent to the weir when excessive amounts of runoff occurred.

During peak and heavy runoff periods, failure in the form of erosion occurred along the bank edges next to the weirs, the massive water force eroding the material on the unprotected banks. Another reason for this failure was that the ice in the banks melted, creating space for water to flow. Bank instability was a common occurrence when excessive amounts of runoff passed through the weirs; especially banks with no stone lining or riprap were unprotected and vulnerable to failure (Figure 22).

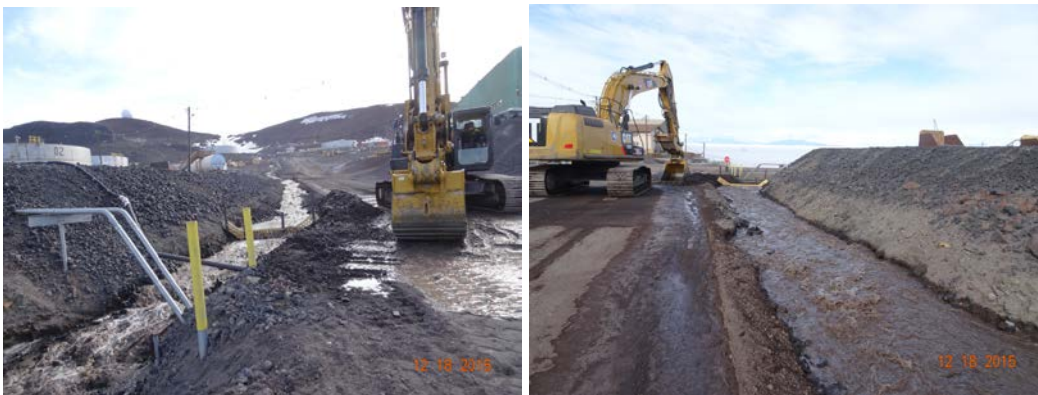
Figure 23. Extreme runoff around 9 a.m. in the drainage channel along Gasoline Alley. The *left* image shows downstream, and the *right* image shows upstream of the weir.

The anchored wooden weirs held up during an excessive runoff period. There was a surge of runoff from subbasin 2 on 18 December 2015, and it overwhelmed the drainage channel along Gasoline Alley (Figure 23). The rock pile shown on the side of the road in Figure 23 was the sediment excavated from the channel upstream of the wooden weir, and the sediments kept building up at this level of flow. By midday, the water had flowed over the weir; and a significant amount of rocks and sediments were trapped in front of it (Figure 24). At this point, the heavy-equipment operators were building a temporary berm by piling stones and rocks along the road to make sure the water stayed in the drainage channel. The excavator continued to remove the stones and rocks trapped in the weirs and deepened the channel.

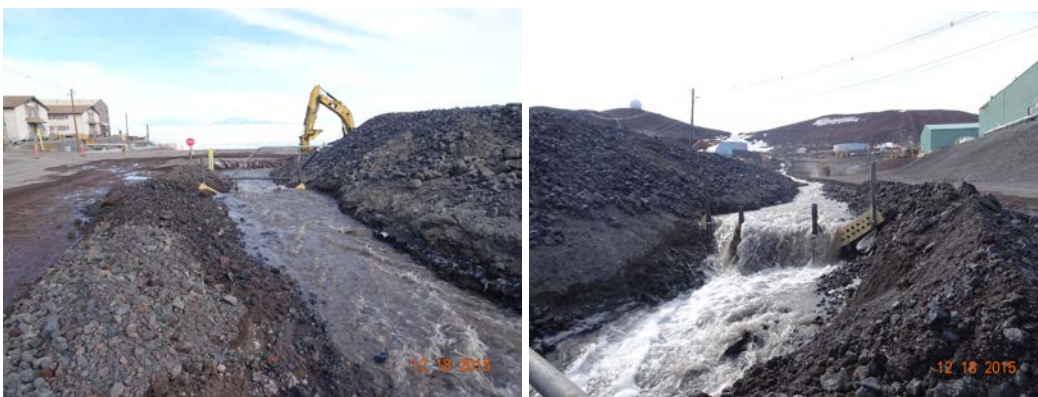
Figure 24. Extreme runoff around 3 p.m. in the drainage channel along Gasoline Alley. The *left* image shows upstream, and the *right* image shows downstream of the weir.

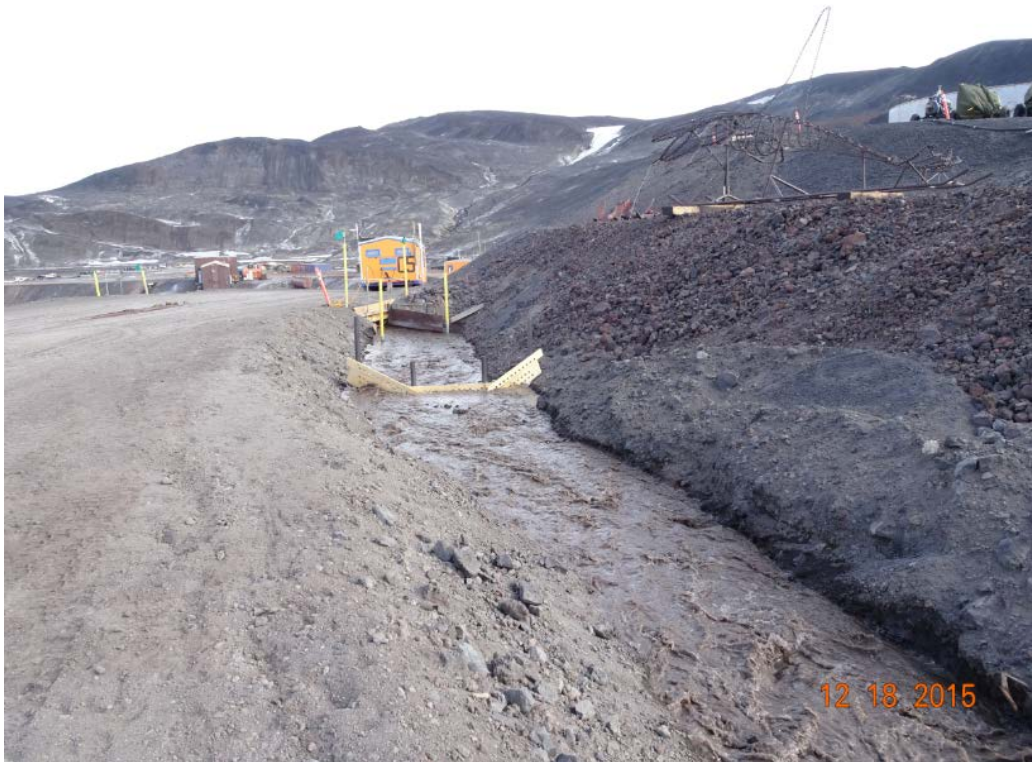
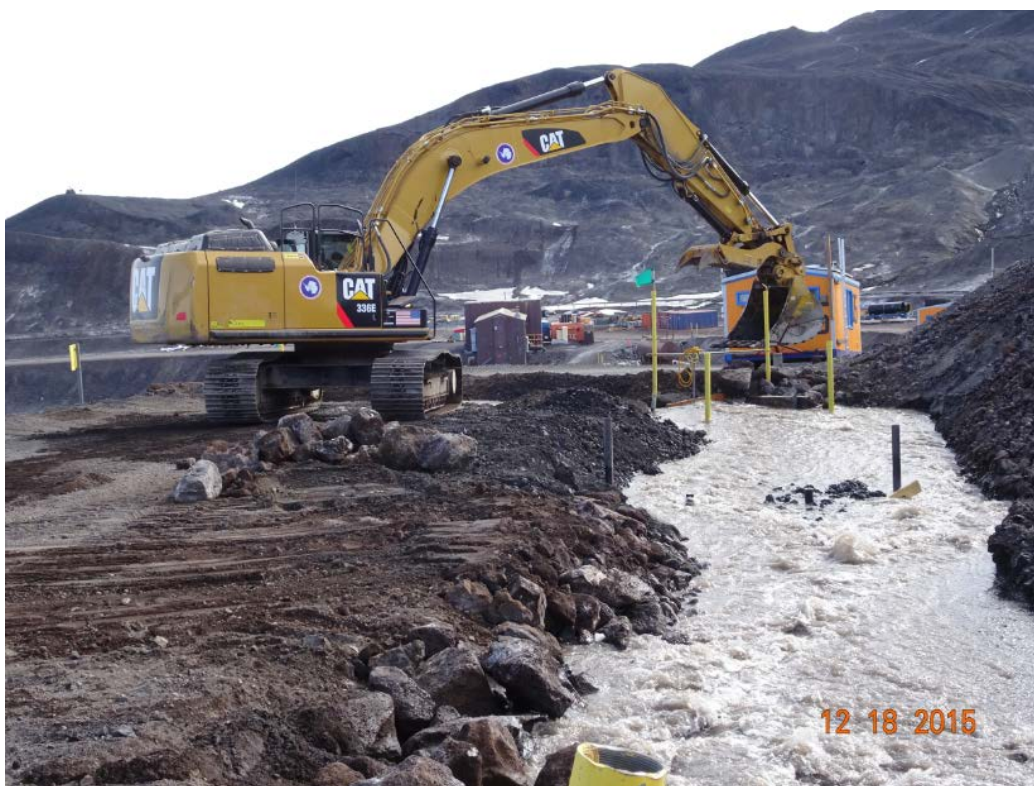
Figure 25. Runoff in the Main Road channel (the *top* picture was taken around 9 a.m., and the *bottom* picture taken around 3 p.m.).

The runoff from subbasin 3 and subbasin 2 (the flow discharged along Gasoline Alley) merged into the main channel along the Main Road, exceeding its capacity (Figure 25). With this extreme level of runoff, the wooden weir was buried in water, sandwiched between sediments and rocks, and considered nonfunctional. The excavator continued placing big rocks along vulnerable banks to minimize significant erosion and scooping sediments out of the channel. The main culvert was full with water and potentially blocked with debris and rocks; the road was purposely dug out, opening a diversion route for excess water. (There was an outburst of so much water that it looked like rapids). The excessive runoff period continued into the following day (19 December 2015) and gradually dwindled within a couple of days.
