ARL-TR-8019 • MAY 2017

Sensing Applied Load and Damage Effects in Composites with Nondestructive Techniques

**by Colleen Rosania, Mulugeta A Haile, Natasha C Bradley,
Asha Hall, Michael Coatney, and Fu-Kuo Chang**

Vehicle Technology Directorate, ARL

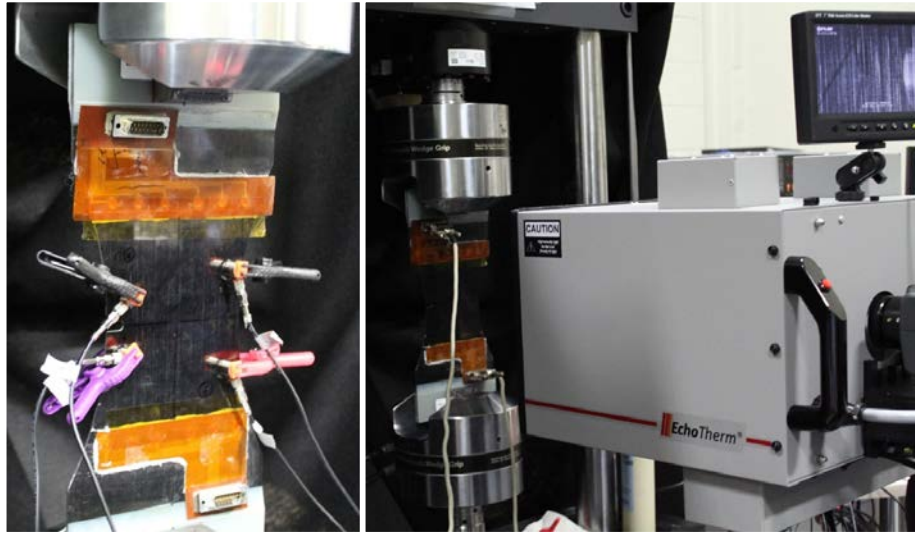
Fig. 6 Photographs showing a composite sample loaded for testing with AE sensors (left) and the thermographic imager and cables attached for ScanSentry data collection (right)

At each data collection point Lamb waves were propagated from each actuator to each sensor, adding up to a total of 36 paths of information to analyze for each actuation frequency at each time point. The actuation signal was a 5-peak Hanning-windowed tone burst signal with a center frequency ranging from 150 to 450 kHz. The average input voltage for each signal was 50 V and the average gain was 20 dB, though actuation parameters were varied for each actuator-sensor event such that the amplitude of the sensed signal was approximately 0.8 V to avoid saturating the sensing system. To choose and verify the wave modes present from these propagation signals, dispersion curves for these composite plates were computed using Disperse software (by Dr Cecilia Wilson). When these actuation frequencies were used, data with distinguishable fundamental symmetric and antisymmetric modes were collected. The testing apparatus is shown in Fig. 6.

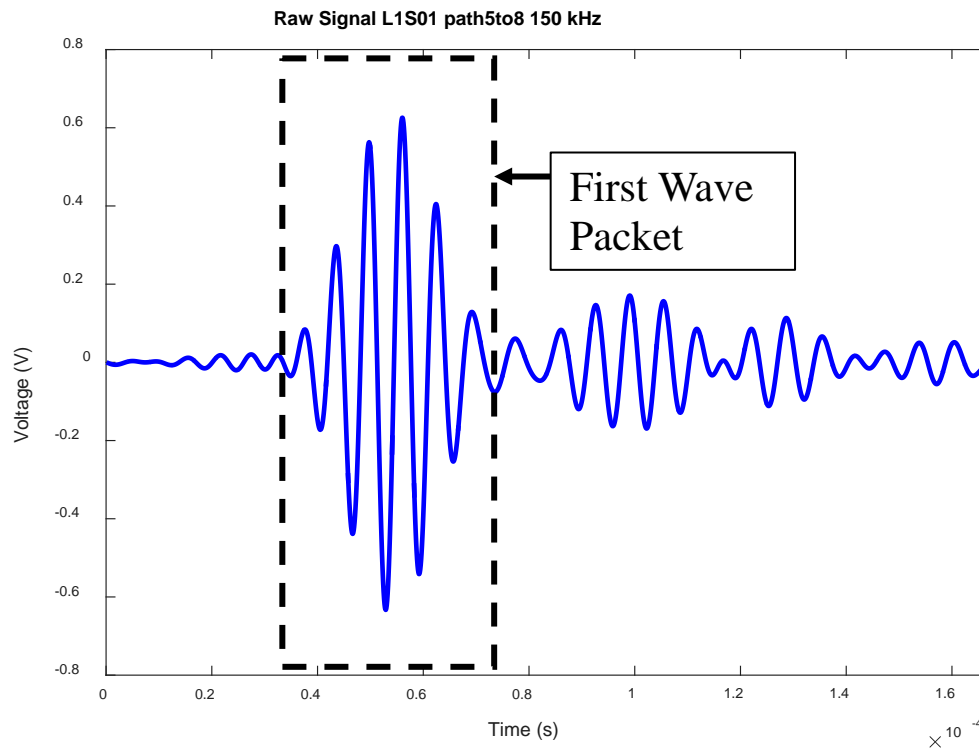
Fig. 11 Example of the raw signal and the windowed first wave packet from L1S01 path 4to9 150-kHz actuation frequency

Based on initial raw data analysis and dispersion curves created pre-experiment, the most consistently clear wave packet was the first arrival, the S_0 mode. Figure 11 shows an example of the sensed signal from an actuator-sensor pair with the actuation frequency of 150 kHz. In each data set, the first arriving wave packet is identified, as shown in Fig. 11, and analyzed for signal parameters in the time and frequency domains. Figure 12 shows the amplitude (A) and time of flight (TOF) were studied in the time domain and are extracted from the window enclosing the first arriving wave packet.

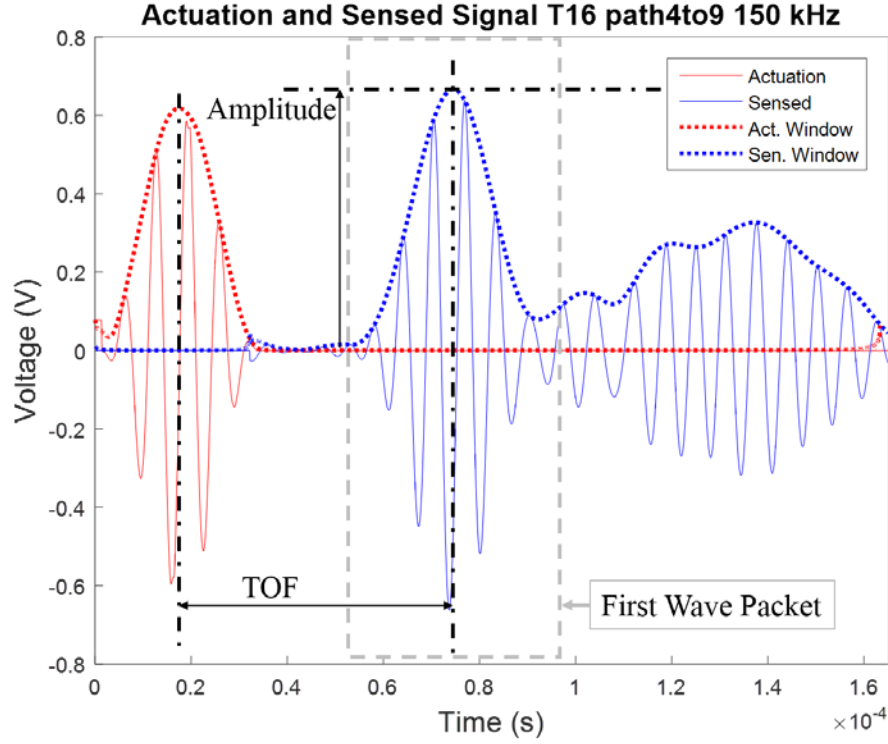
Fig. 12 Example of how the time domain features of TOF and amplitude are calculated from the sensed signal by using the envelopes of the waveforms path 4to9 150-kHz actuation frequency

The amplitude relates to the amount of displacement caused by the propagating Lamb wave and is complexly related to the structural properties and attenuation caused by the material. Signal amplitude changes were extracted using Eq. 1, where s is the sensed signal and H is the Hilbert transform, which finds the envelope of the signal

TOF is the measure of the length of time taken by an actuation signal to reach a sensor. The TOF gives a sense of the Lamb wave velocity, which is related to the material properties of the composite. The TOF calculation is given in Eq. 2 where a is the actuation signal and t is elapsed time.

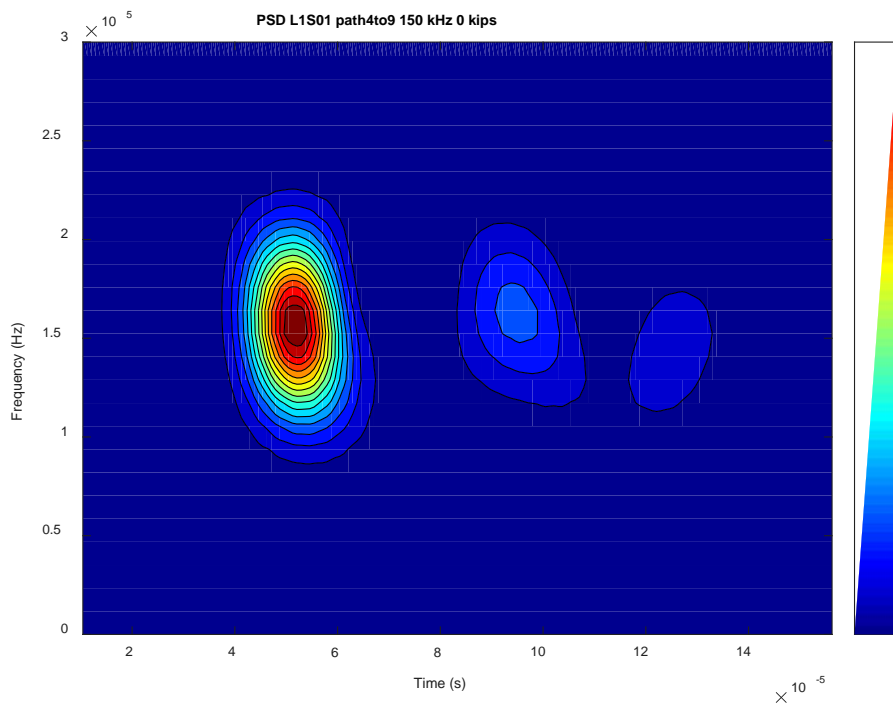
Fig. 13 Example of the PSD of L1S01 path 4to9 150-kHz actuation under a 0-kips load

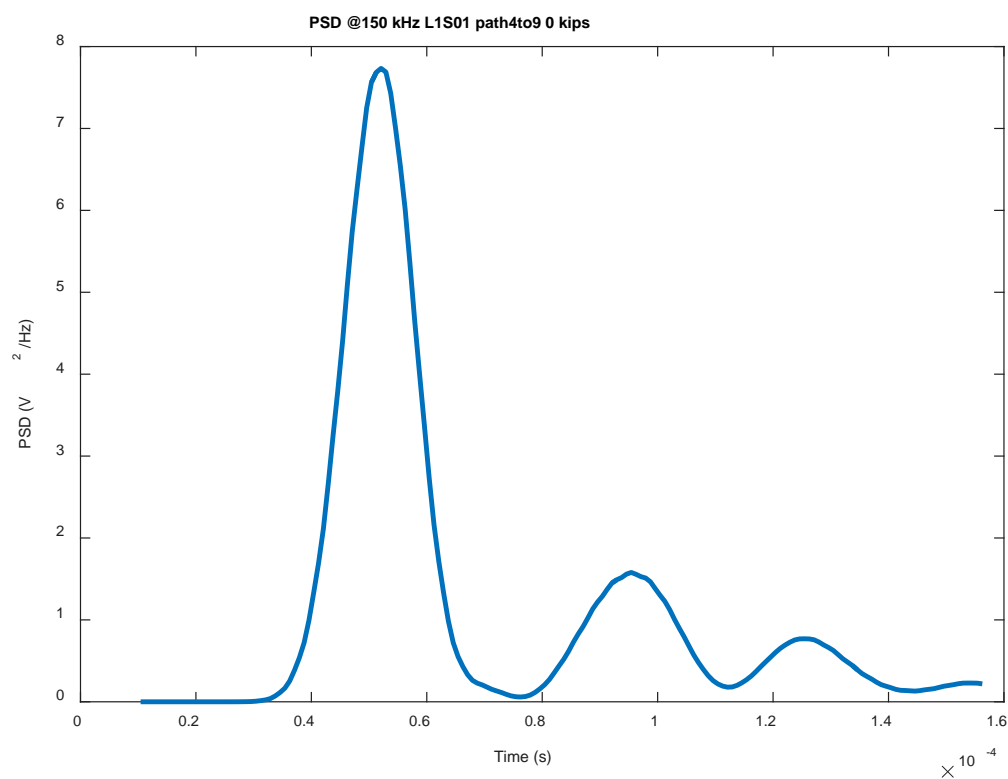
Fig. 14 Extracted PSD of the actuation frequency (150 kHz) of L1S01 path 4to9 at 0 kips (i.e., one slice at 150 kHz extracted from Fig. 13)

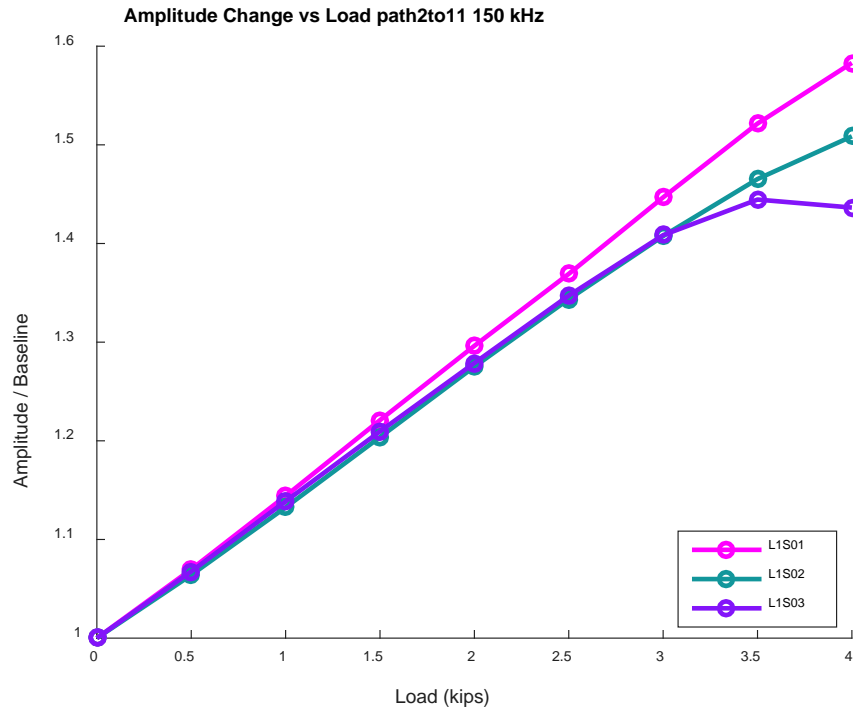
Fig. 17 Normalized amplitude change in the first wave packet of data with actuation frequency 150 kHz from path 2to11 for ARL-tested coupons

Signal features that have been found to be most influenced by applied load are those described in the previous section: amplitude, maximum PSD value, and signal energy. Time of flight is also influenced by applied load, but less consistently than these other signal features. Plots showing the change in these 4 features (normalized to the baseline value for each coupon) as increased load is applied are shown for each straight path: amplitude of path 2to11 in Fig. 17, TOF of path 5to8 in Fig. 18, maximum PSD of path 3to10 in Fig. 19, and energy of path 4to9 in Fig. 20.

Figures 17, 19, and 20 show that above 3 kips load inflection points begin to appear in the data—this is indicative of damage initiation and progression. Based on Figs. 17–20 and similar plots from other paths and actuation frequencies, X-ray images taken after the initial loading cycle, and notes about audible cracking during tests, it can be hypothesized that matrix cracking can begin in a sample between 2.5- and 4-kips load. By filtering out data beyond these inflection points (based on the hypothesis that they are also affected by damage), Lamb wave data influenced only by applied load can be isolated. This will be done when creating modeling strategies to predict applied load from ultrasonic data, as only data with applied load influences and not those from the combined influences of applied load and data should be used for this inverse problem.

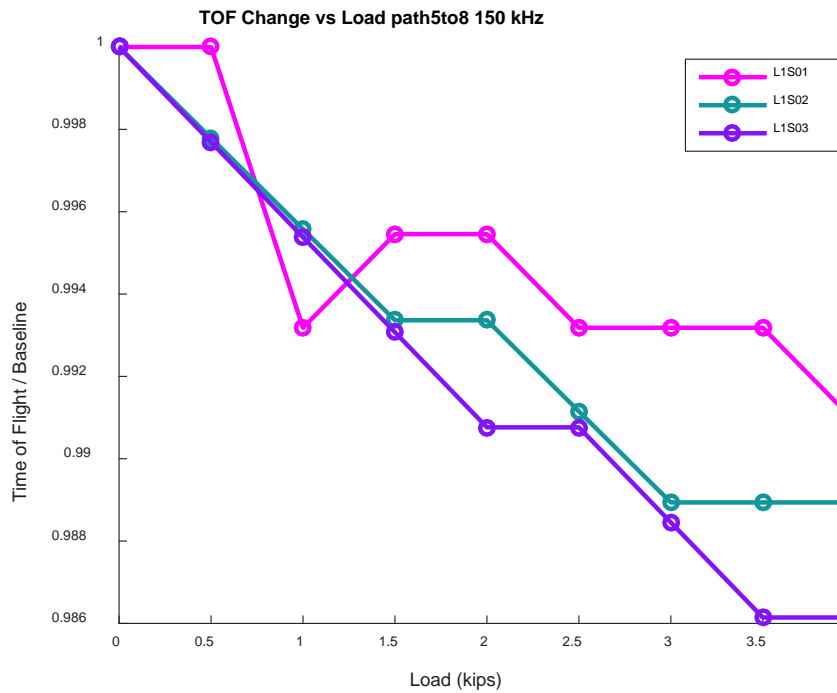
Fig. 18 Normalized TOF change in the first wave packet of data with actuation frequency 150 kHz from path 5to8

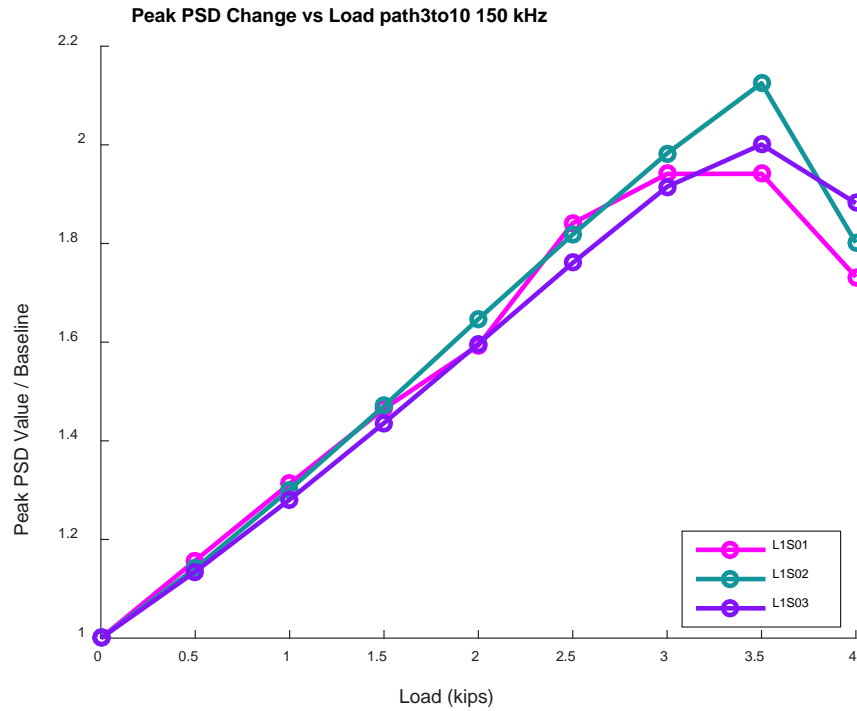
Fig. 19 Normalized maximum PSD value change in the first wave packet of data with actuation frequency 150 kHz from path 3to10

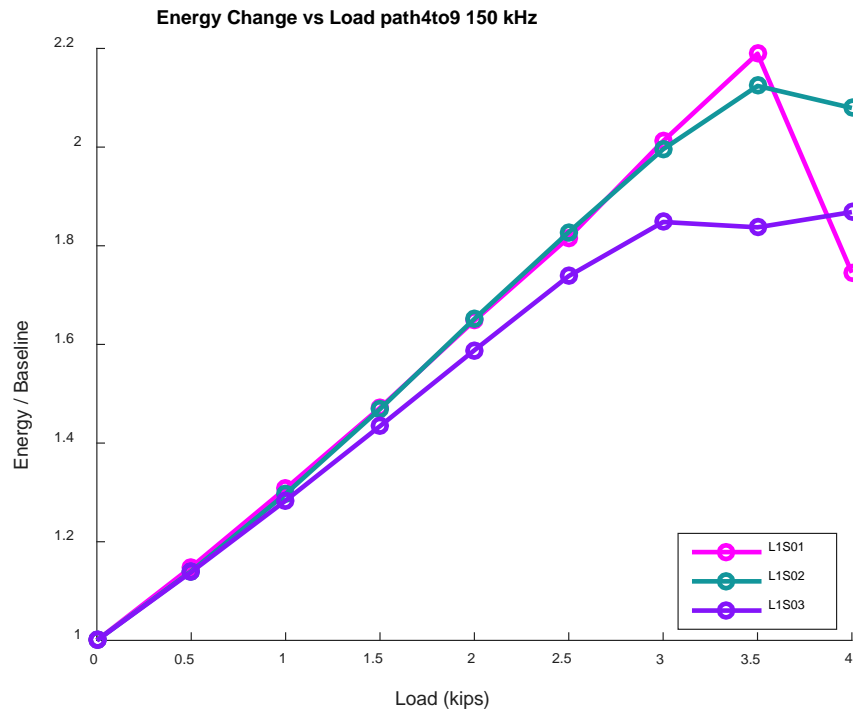
Fig. 20 Normalized energy change in the first wave packet of data with actuation frequency 150 kHz from path 4to9
