Upper and Lower Hamburg Bend 2011 Flood Evaluation on the Missouri River near Hamburg, Iowa

Nathan Clifton, David Abraham, and Dan Pridal

January 2017

Final report

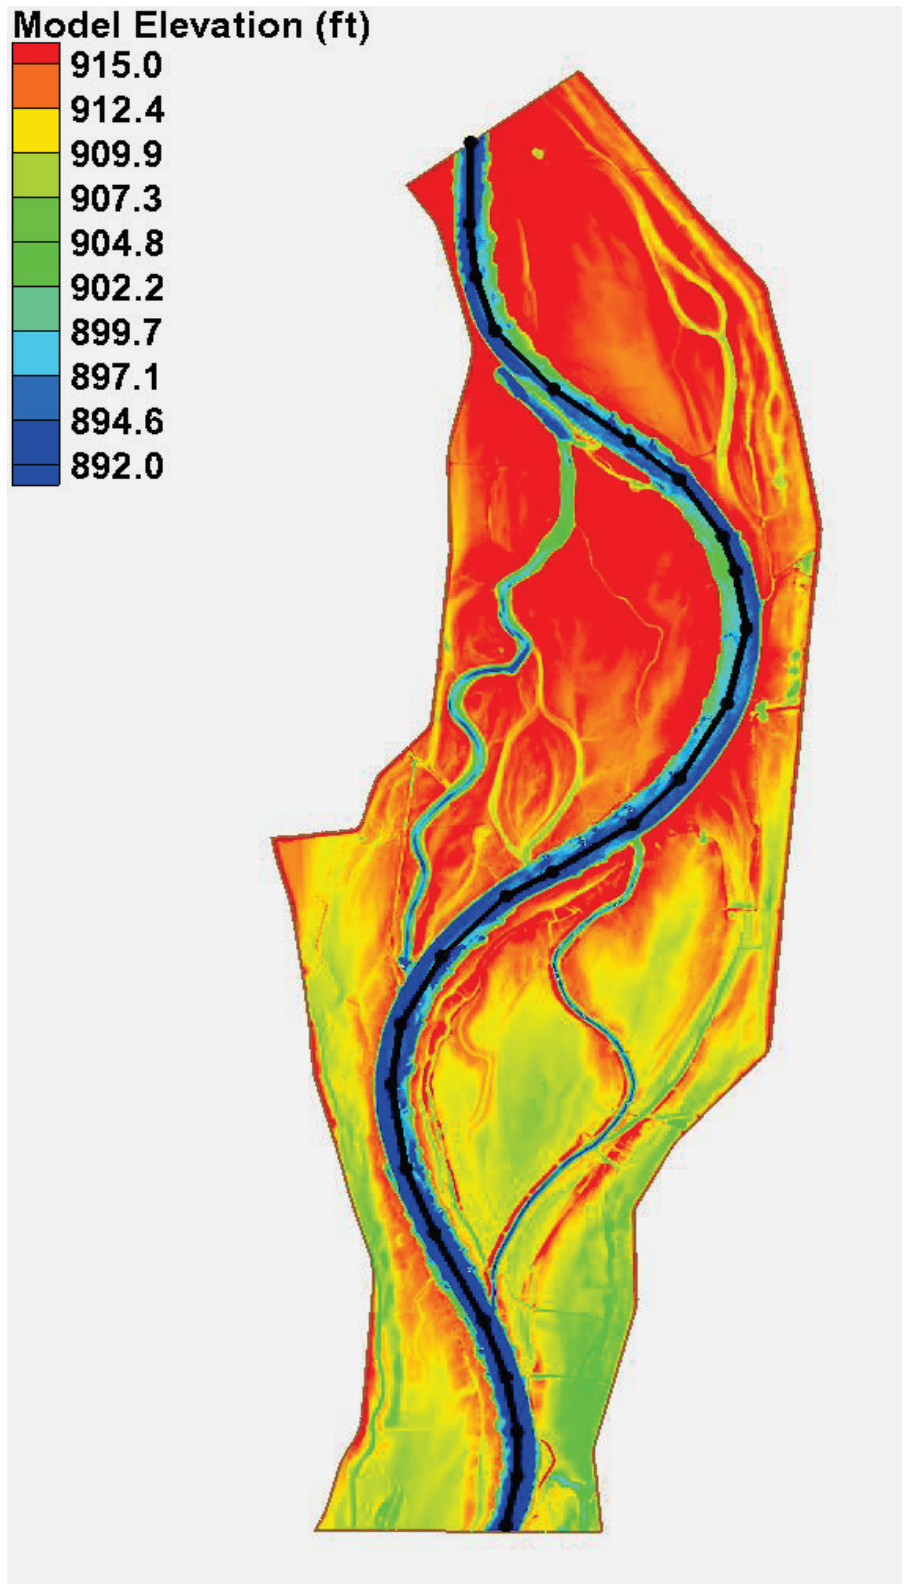
Figure 5. Observation arc overlaid on AdH model elevation data.

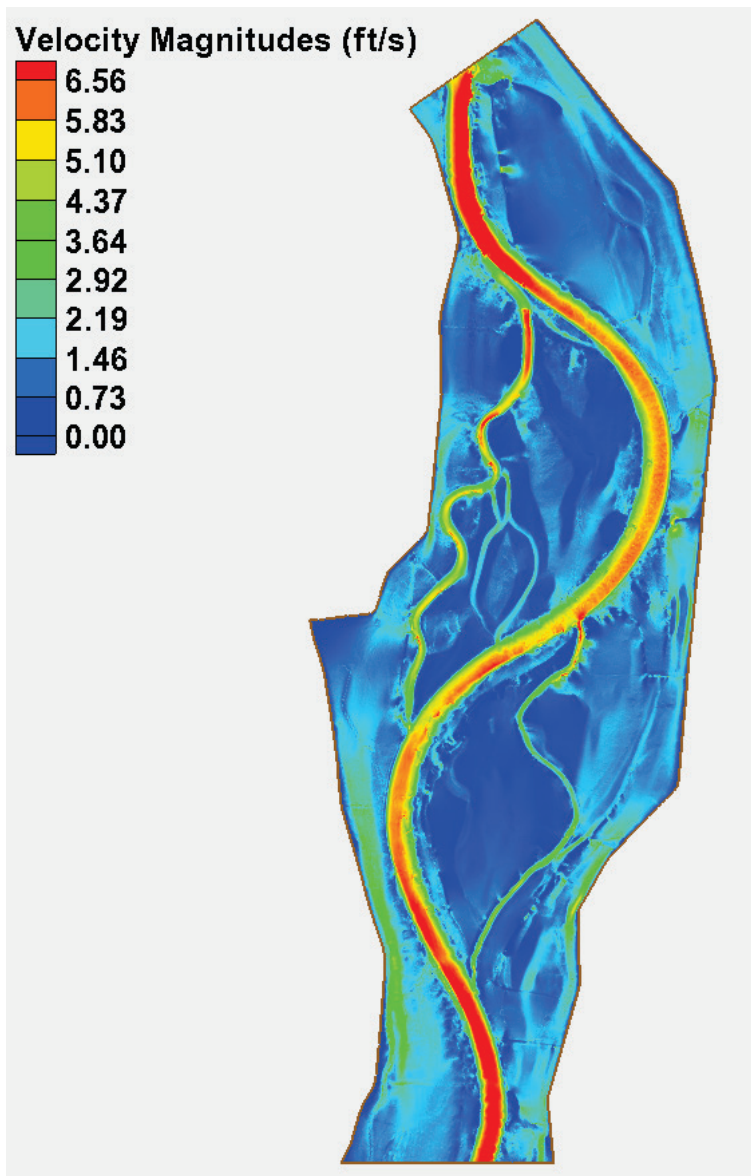
Figure 10. Task 2 velocity magnitudes (ft/sec) for 120,000 cfs (3,398.02 cms) flow.

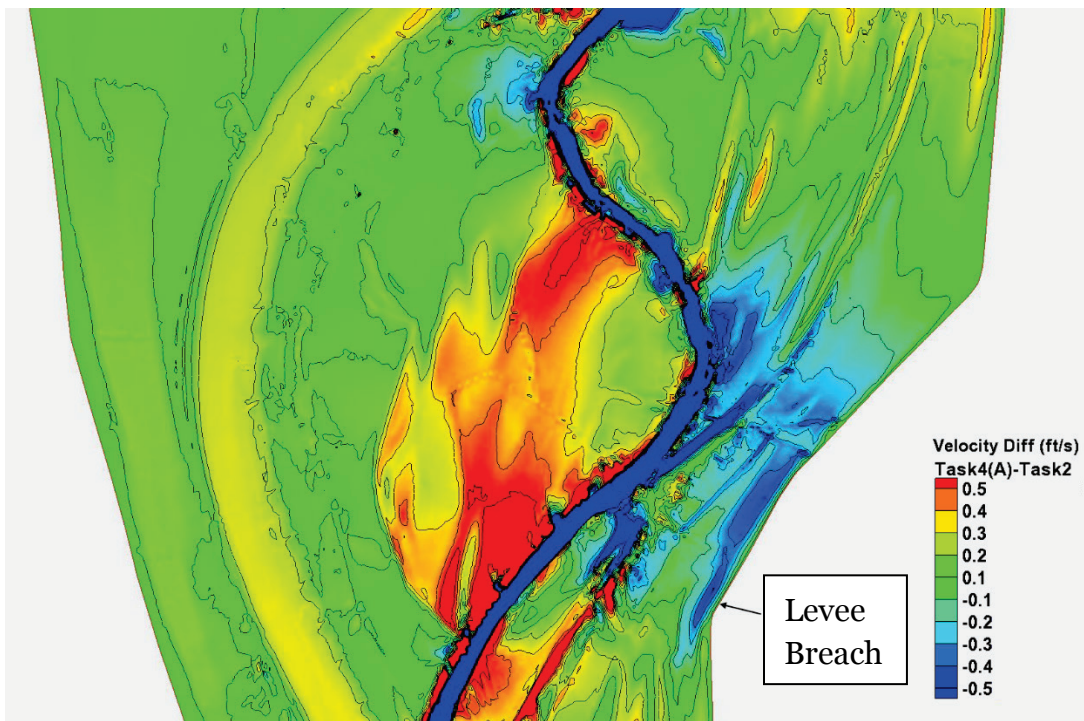
Figure 19. Task 4A - Task 2 velocity magnitude differences (ft/sec) for 160,000 cfs (4,530.7 cms) flow.

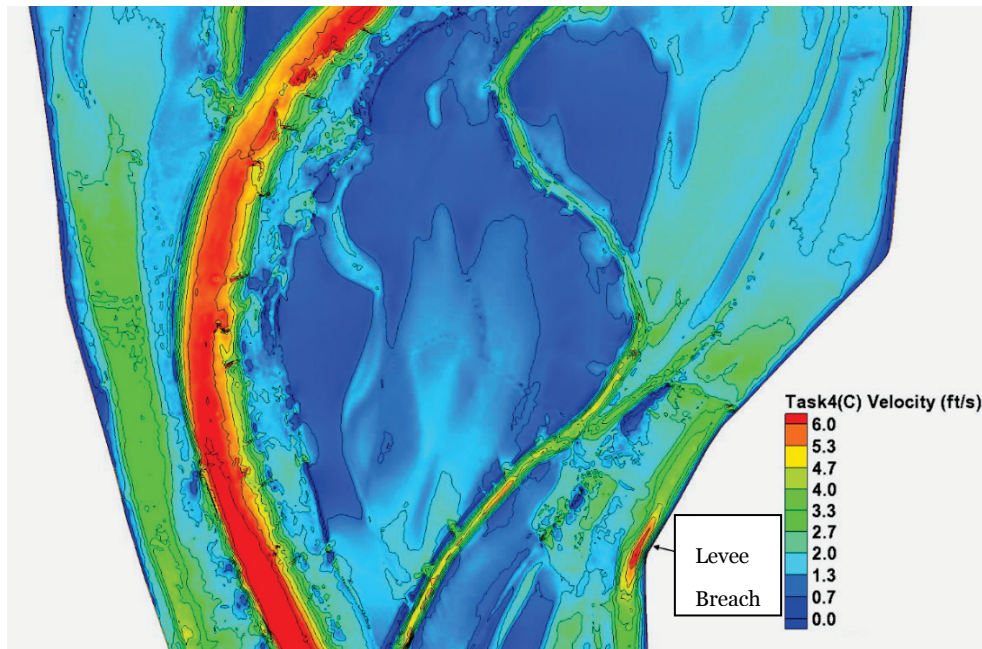
Figure 24. Task 4C velocity magnitudes (ft/sec) for 160,000 cfs (4,530.7 cms) flow.

Figure 24 is the velocity in feet per second at the end the Task 4C simulation.

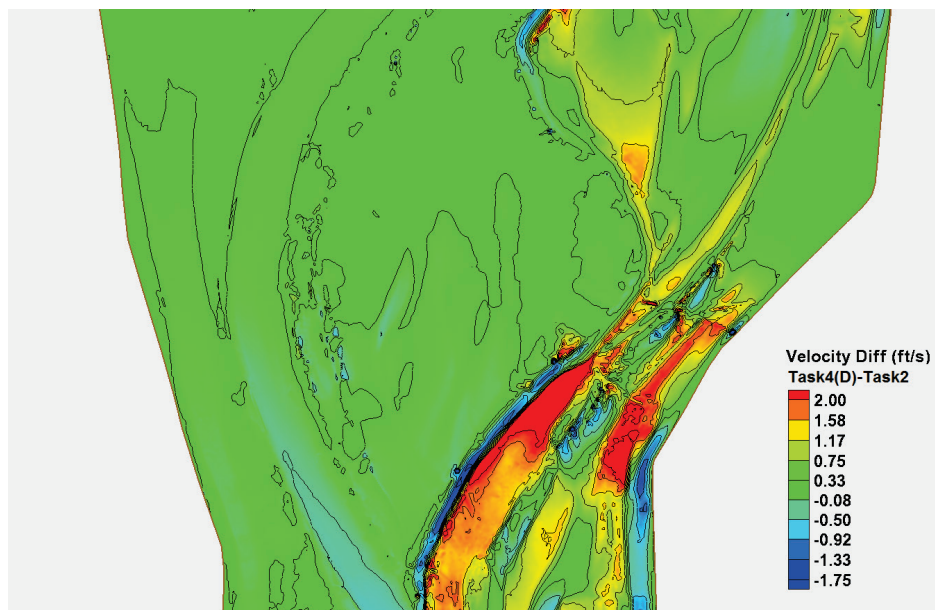
Figure 28. Task 4D - Task 2 velocity magnitude differences (ft/sec) for 160,000 cfs (4,530.7 cms) flow.

These results show that an alternative with all land east of the Lower Chute converted to farmland would have significantly increased nearby floodplain velocities in areas that were dense vegetation but decreased velocities in the near-levee-breach proximity, with a maximum reduction of approximately 1.8 ft/sec, compared to that of the pre-2011 flood conditions. The alternative resulted in much higher conveyance and velocity changes in the area east of the Lower Chute compared to the previous alternatives in both magnitude and area influenced.

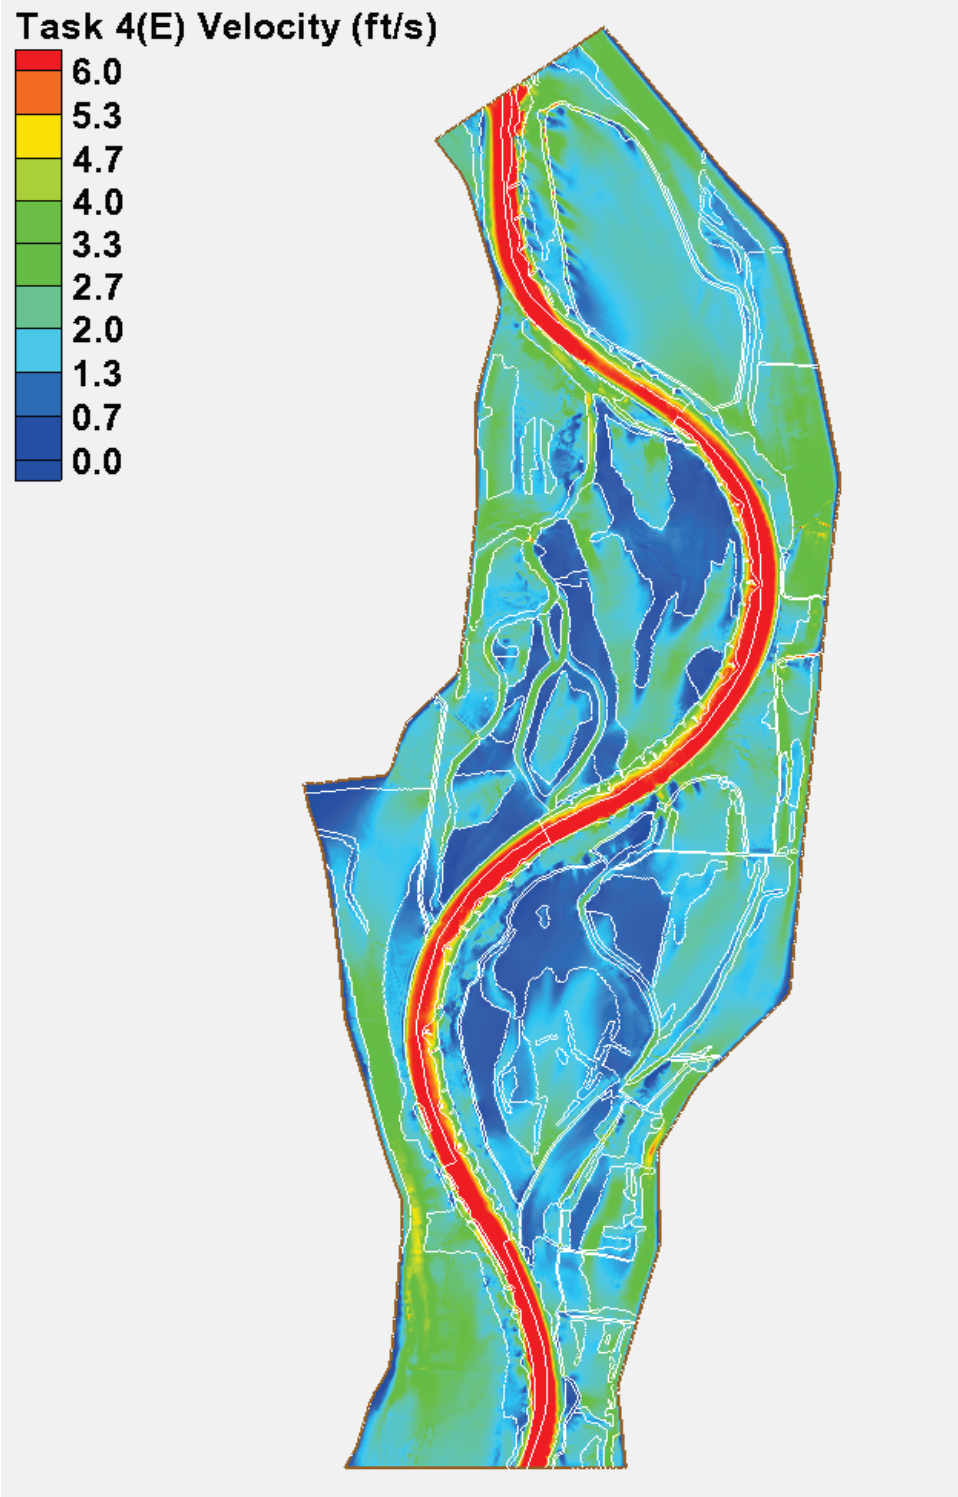
Figure 31. Task 4E velocity magnitudes (ft/sec) for 160,000 cfs (4,530.7 cms) flow.

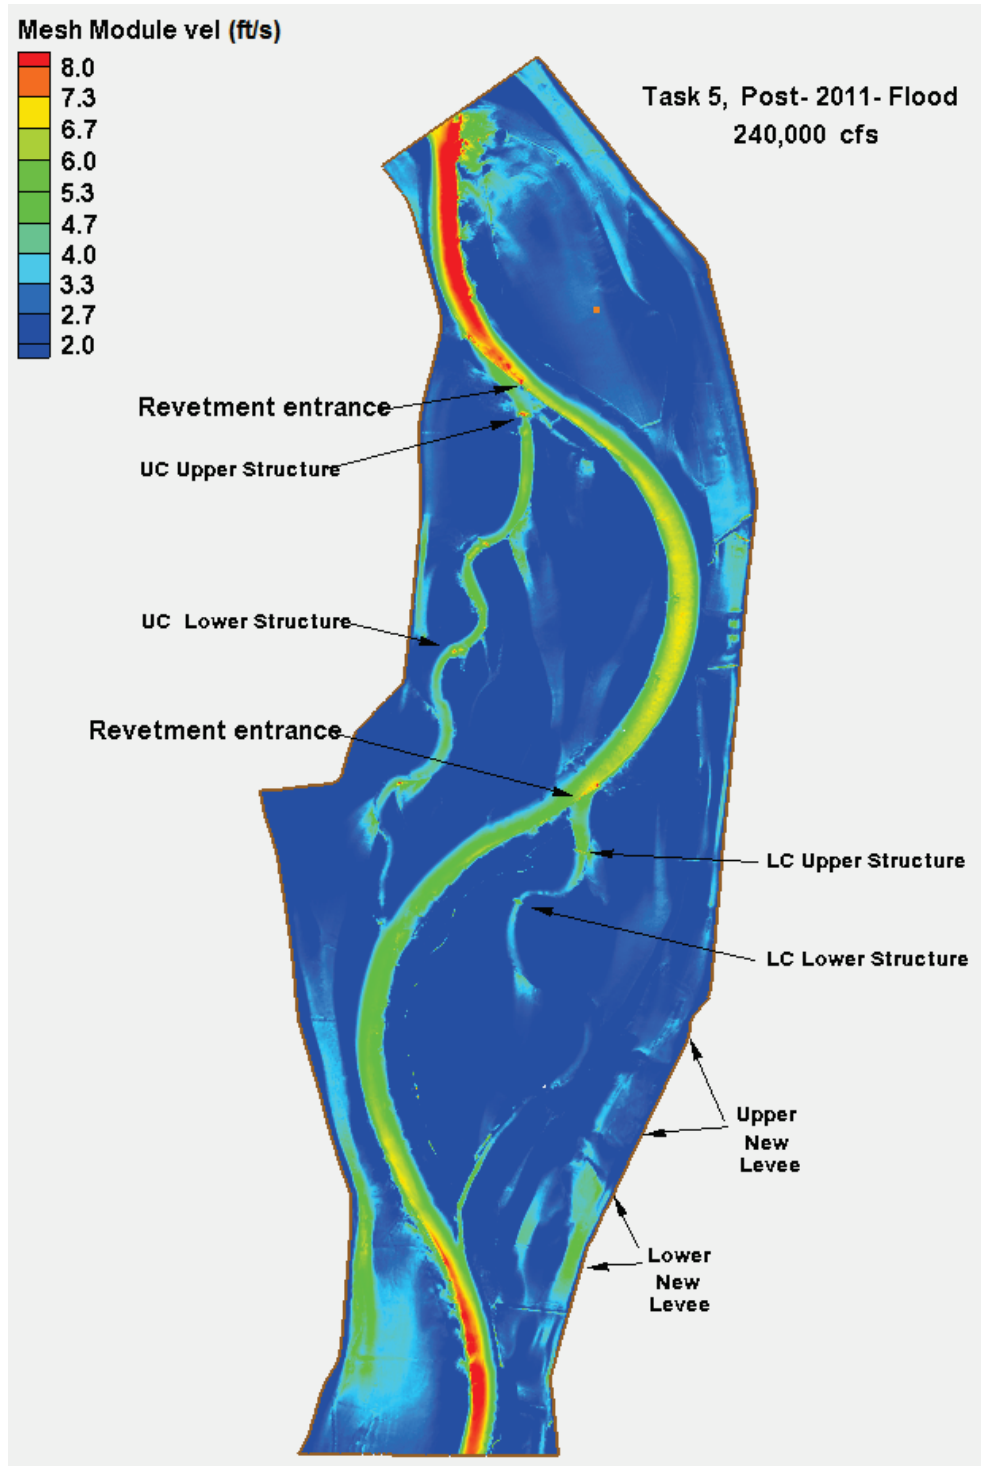
Figure 36. Task 5 velocity magnitudes (ft/sec) for 240,000 cfs (6,796.17 cms) flow.

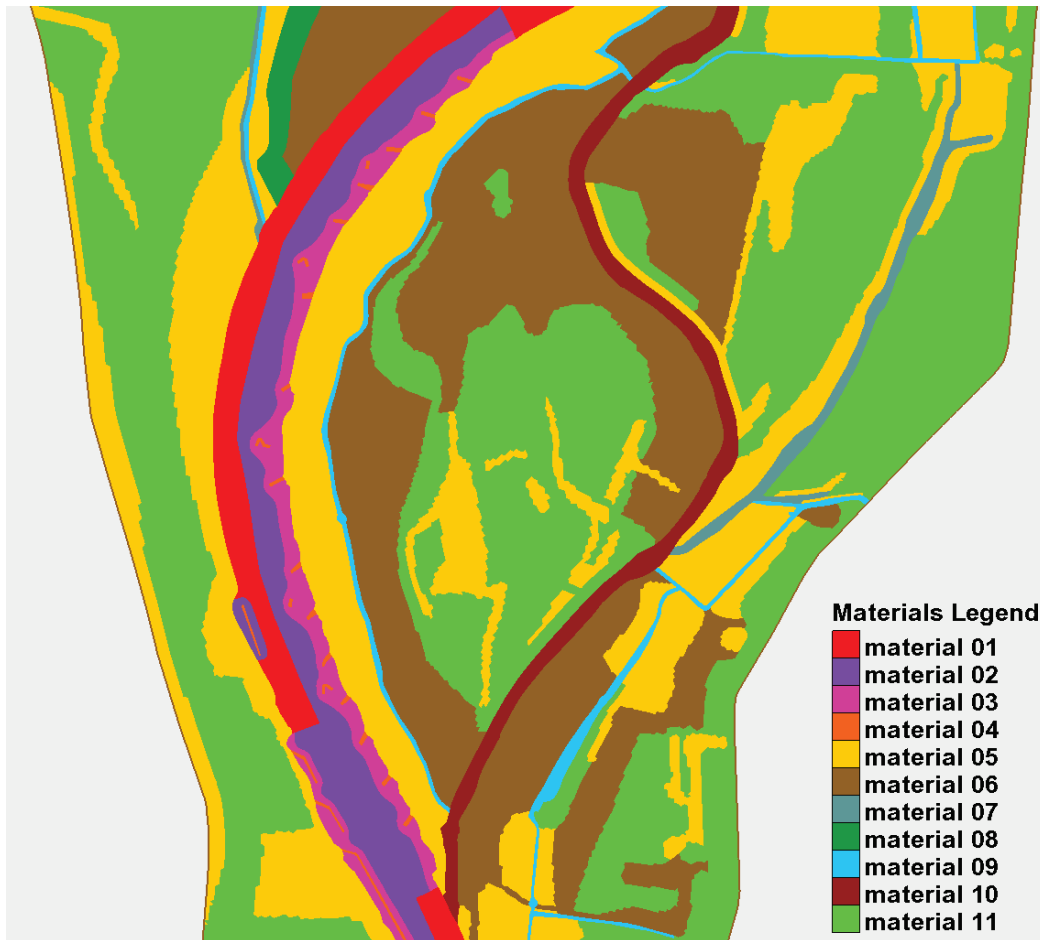
Figure 41. Task 2 (base condition) materials in area of interest.

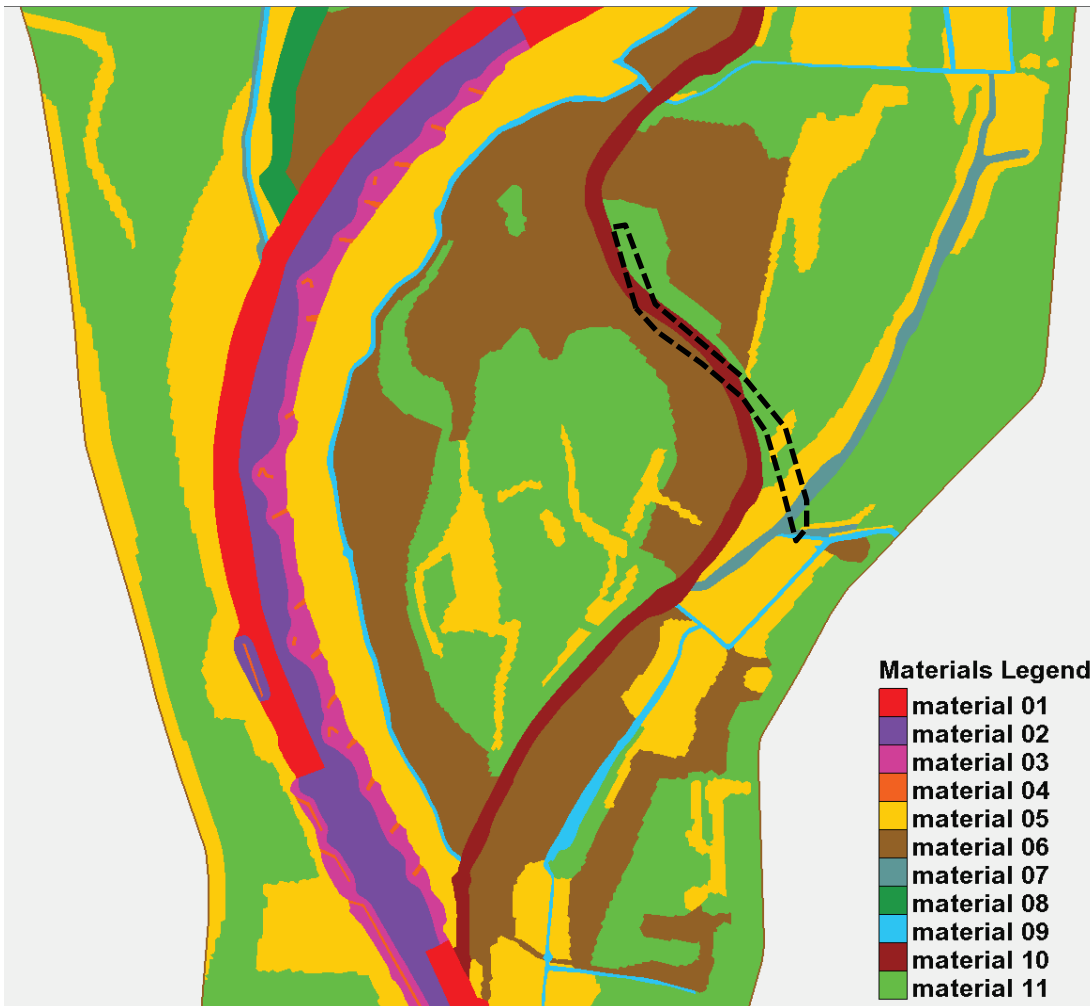
Figure 42. Task 6.2(a) Dotted enclosure indicates trees converted to grass.

Task 6.2(a) required using the base condition Task 2 model (pre-2011 flood with both chutes and all features) to evaluate the benefit of vegetation management in the floodplain by removing trees from the zone along a portion of the east bank of the Lower Hamburg Chute. The area outlined in Figure 42 with a dashed black line shows the previously tree-heavy vegetation area along the Lower Hamburg Chute that was converted to an open, grassy vegetation zone.

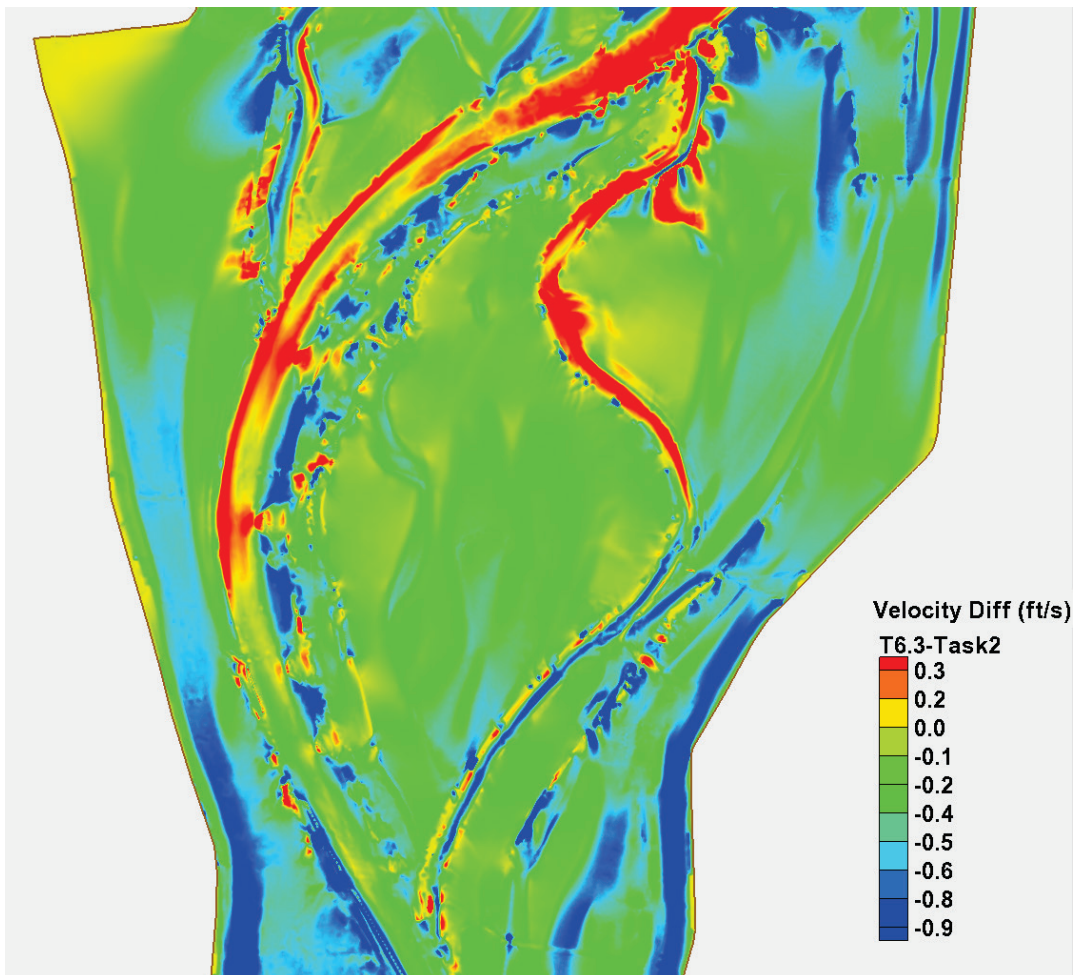
Figure 53. Zoomed view of Task 6.3 – Task 2 velocity differences for a flow of 160,000 cfs (4,530.7 cms) in the Lower Chute.

The velocities in the area surrounding the levee breach were decreased by over 0.9 ft/sec (0.274 m/sec) as the conveyance in the main channel and chutes was greatly increased, therefore lowering the floodplain conveyance and flow velocity. This large velocity decrease provides an indication of dynamic conditions that would have been experienced during the 2011 event.

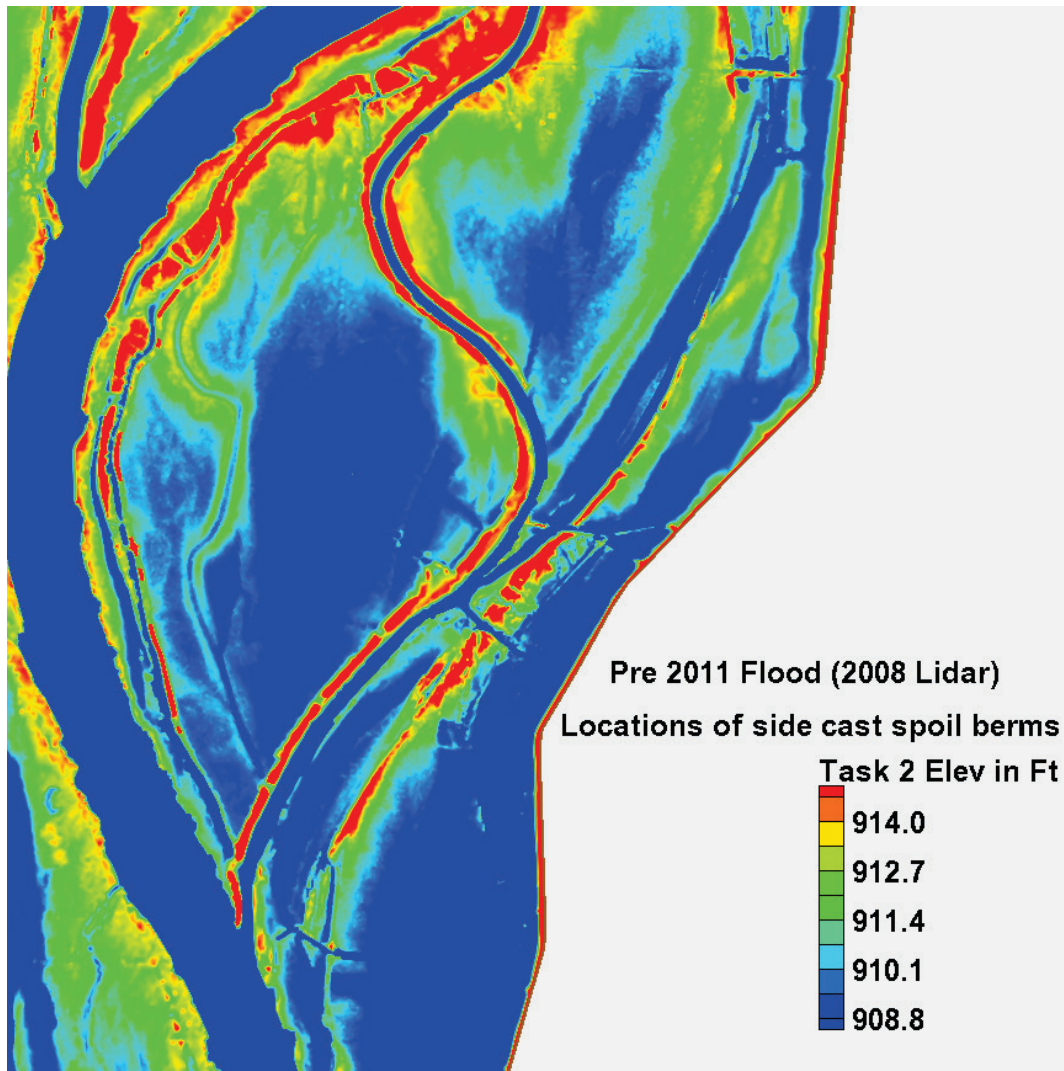
Figure 55. Pre-2011 flood geometry showing original side-cast spoil berms.

Figure 55 shows the pre-2011 flood (2008 lidar) floodplain geometry with the contours set to show the higher elevations. The pre-2011 flood chute is much narrower and the red bands along its banks show clearly the locations of the side-cast spoil berms. By comparing Figure 54 and Figure 55, it is evident that the spoil berms between berm groups 1 and 4 in Figure 54 (which are clearly shown in Figure 55) were completely washed out during the flood. Also, berm group 3 was originally a small group of two to three short berms before the flood (Figure 55), but during the flood (Figure 54), a large bank material was deposited around the entire inside bend. Therefore, most of berm group 3 in Figure 54 did not originate from the original project construction side-cast spoil berms. For purposes of Task 6.4, the post-flood deposited material within this whole bend was left intact within the model.
