**MICROTENSILE BOND STRENGTH COMPARED BETWEEN CAD/CAM
FELDSPATHIC AND RESIN NANO CERAMICS**

A THESIS

Submitted in partial fulfillment of the requirements
For the degree of Master of Science in the
Department of Oral Biology
in the Graduate School of
The Uniformed Services University of the Health Sciences

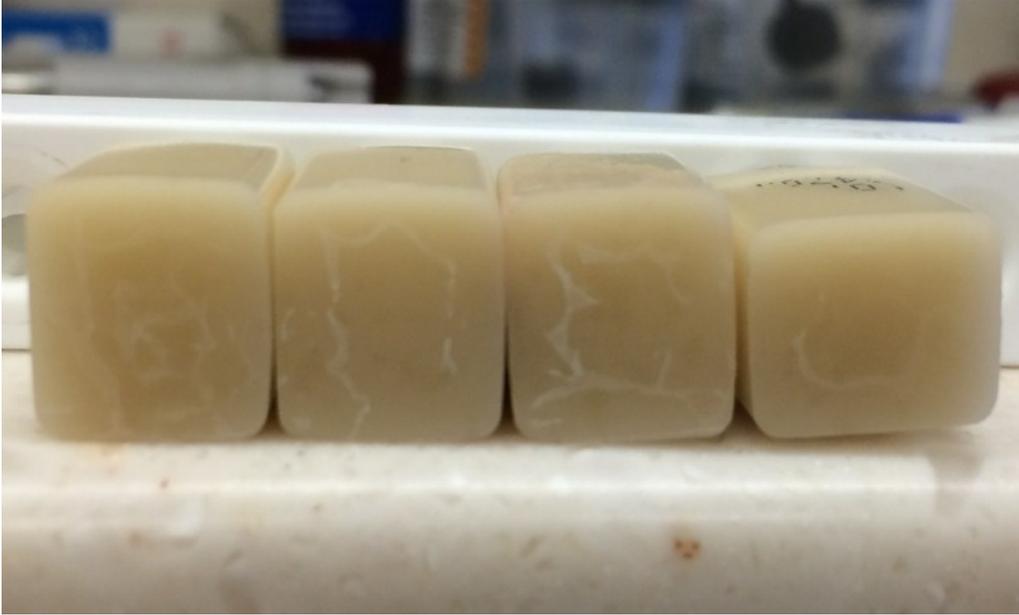
Figure 3. Vitabloc MKII blocks etched with hydrofluoric acid.

This was first major step where differences were seen. Reviewing the figures 3 and 4 of the surface treated blocks, the Vitablocs MKII appear to have similar pattern of etching. On the other hand, the Lava Ultimate blocks are a resin matrix and not glass, and therefore recommended to be sandblasted by manufacturer guidelines. Giving a uniformed surface treatment is difficult when the sandblasting device projects in a stream. Placing the sandblaster too close or for too long in one section will remove more of the block creating an irregular surface. Looking at the figure it is evident that the investigator over-blasted block 'A' and over-corrected by under-blasting block 'D'. Zohairy avoided this problem in their 2002 study by grinding the composite blocks on a polishing machine with 600 grit SiC paper (3).

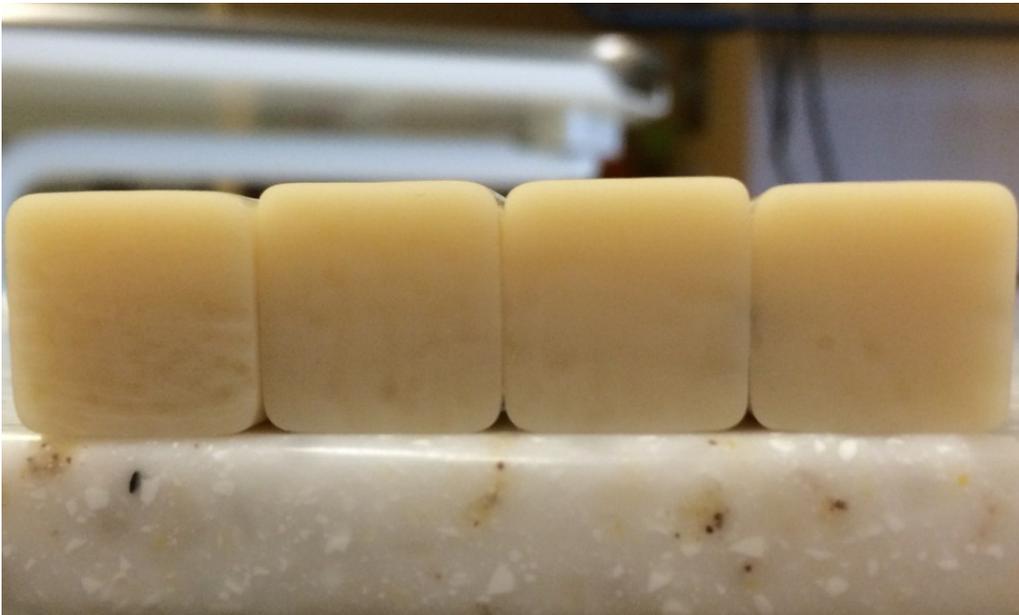
Figure 4. Lava Ultimate blocks air abraded.

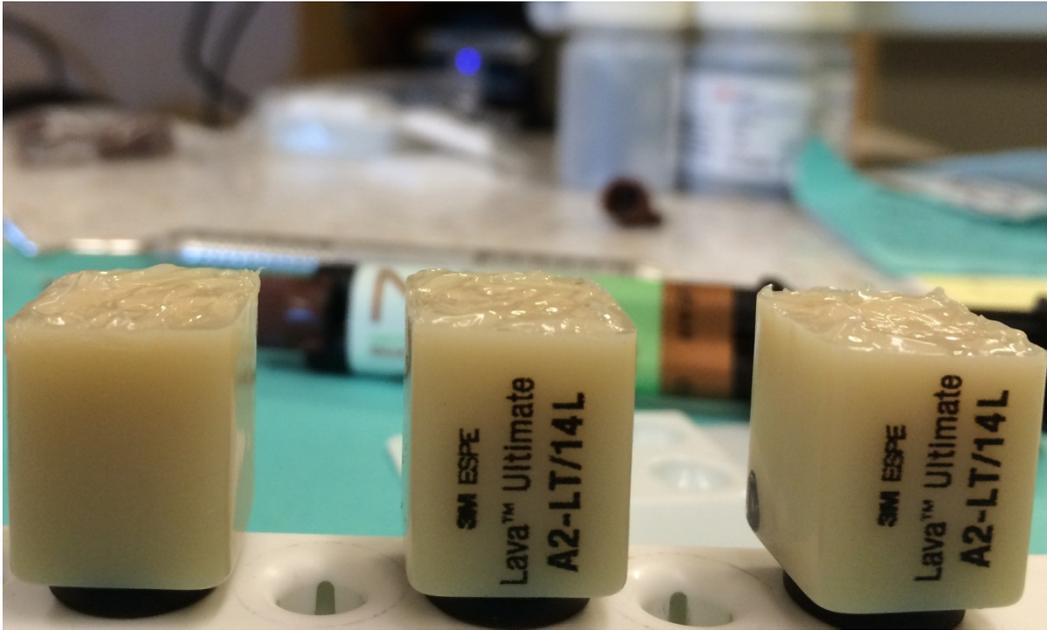
Figure 5. Lava Ultimate with a thin layer of cement.

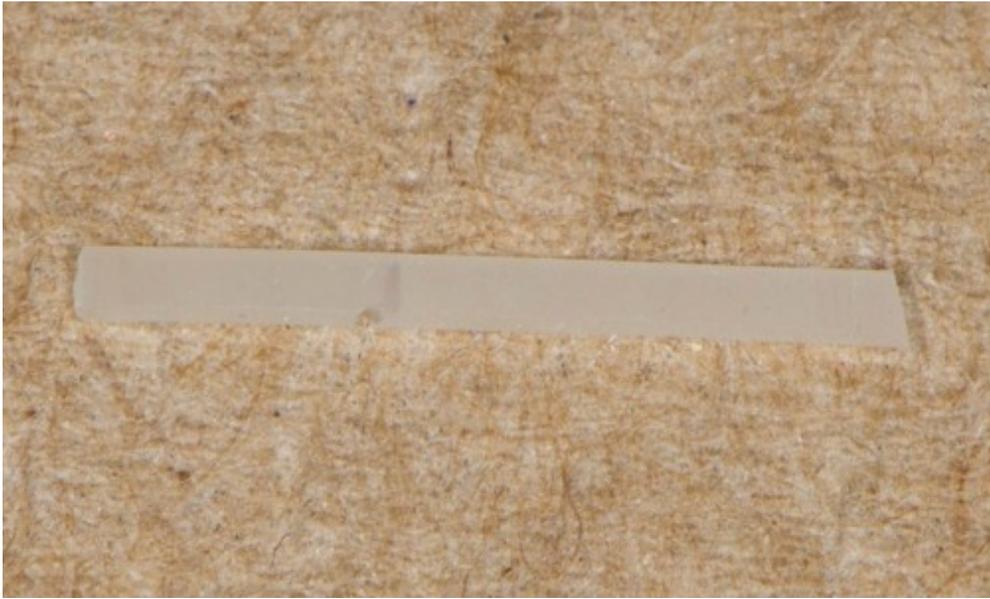
Figure 9. 1mm² Slab with defect from sectioning.

The slabs were viewed under a 30x microscope before and after applying tensile forces, but crack formation may not be detectable at the level and may need more enhanced viewing equipment such as SEM or stereomicroscope, which was not available. Della Bona recommends a thorough SEM examination of the materials and fractured surfaces. He also recommends confirmation of the restorative material's composition through x-ray elemental map analysis. Both of these ensure a more consistent and complete description of the fracture process and mode of failure (51). All slabs with known defects were not used for this experiment.

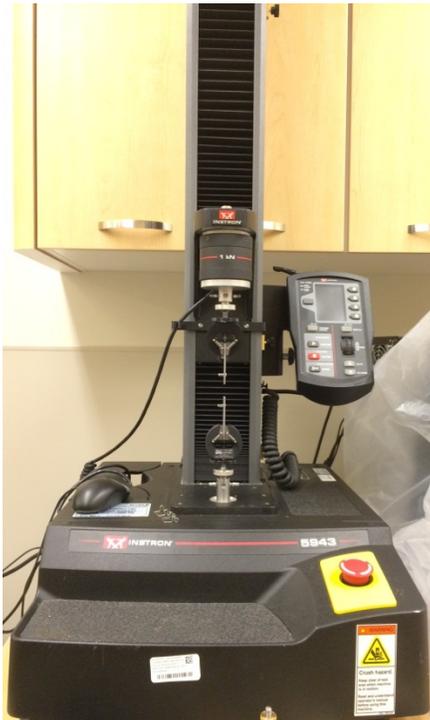
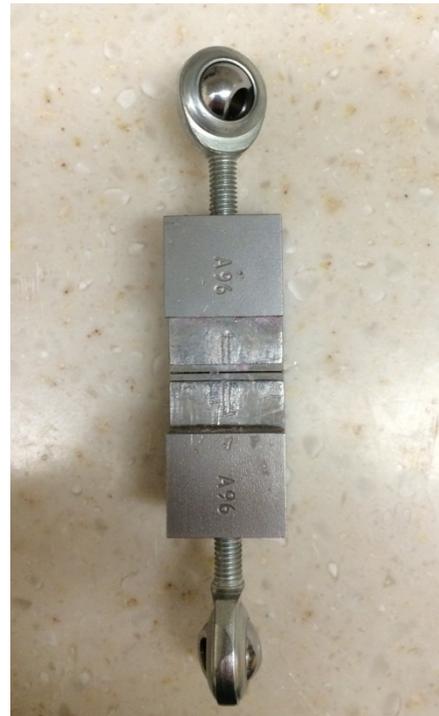
Figure 10 and 11. Instron 5843 Universal Testing Machine and μ TBS jig.

Slabs were bonded in a vertical direction on Instron universal testing plates with cyanoacrylate and placed in a universal testing machine (Model no. 5943 ; Instron; High Wycombe, Bucks, UK) under tensile stress with a crosshead speed of 1mm/min until failure. Micro-tensile bond strength calculations were made using the following equation: $s = L / A$, where “s” is the bond strength
