## **Laboratory Jet Erosion Tests on the Lower American River Soil Samples, Sacramento, CA – Phase 2**

Johannes L. Wibowo and Bryant A. Robbins

May 2017

Final report

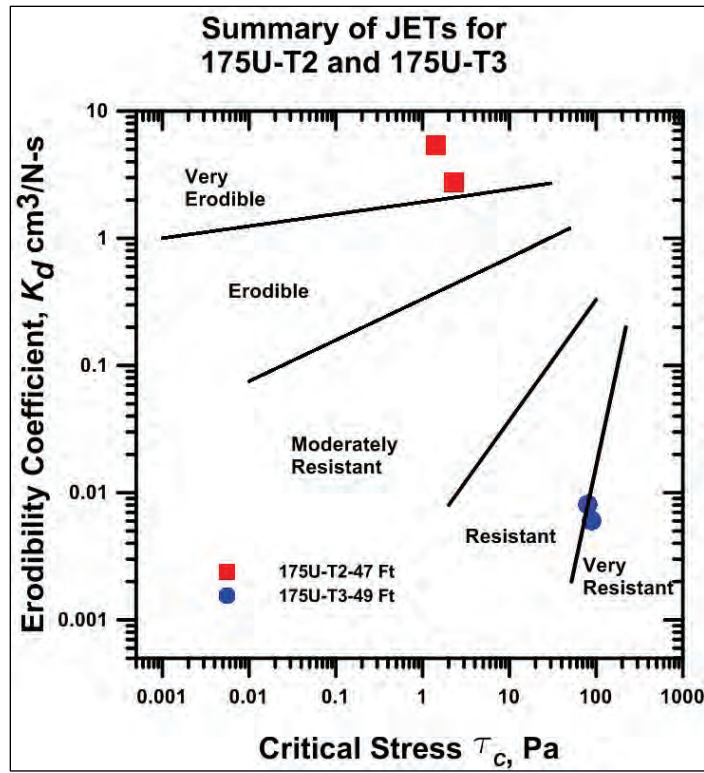
Figure 22. Summary of test data of boring from right bank of the LAR between RM 9.6.

The seventh group of summarized JET results from two sample tubes from two boreholes in the left bank of the LAR at RM 9.6 is shown in Figure 22. The results are for borings 175U-Tube 2 and 175U-Tube 3. The sample depths ranged from 47 to 49 ft below the riverbed. According to the data from Boring 175U-Tube 2, researchers determined that the soil was approximately 20 ft below the suggested ERS, but the specimen was soft, silty, fine-to-medium sand. Both specimens showed no resistance against erosion and were categorized as VE. The other soils from the same boring (Tube 3, located 22 ft below the ERS and 2 ft deeper than the previous sample) exhibited much more resistance to erosion and were categorized as VR. A complete listing of values of erosion resistance of all seven groups is in Table 2 and is also shown in Figure 23 along with the groups' locations. All erosion data, along with photographs of specimens before and after JETs, are in Appendix A. Laboratory soil property data are in Appendix B.

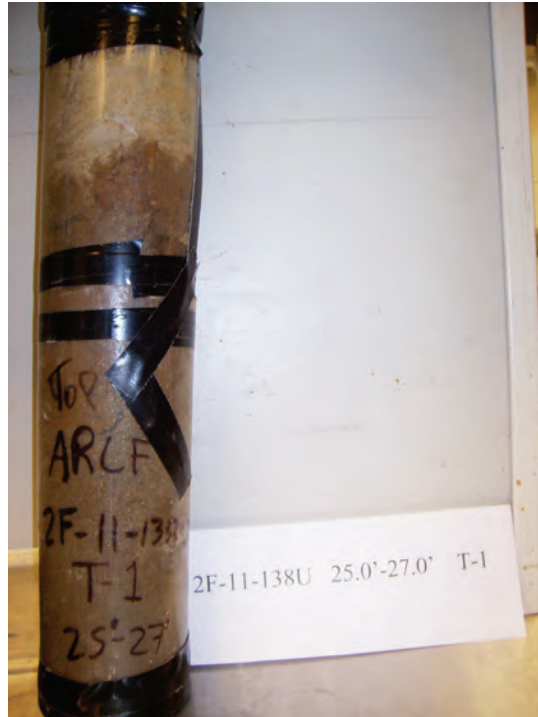
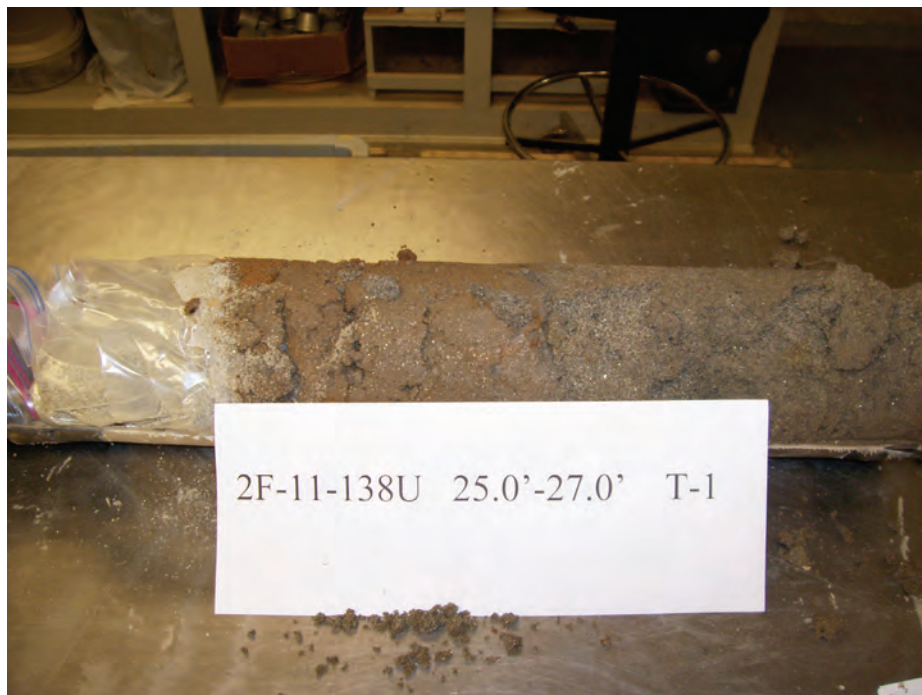
Classification and Condition of Lexan Tube Sample			
		Sheet No.: <u>1</u>	
		Date Extruded: <u>7/23/2012</u>	
Project: <u>Sacramento JET Testing Phase II</u>		Job No.: <u>120320</u>	
Boring No.: <u>2F-11-138U</u>	Sample No.: <u>T1</u>	Depth, ft.: <u>25 - 27</u>	
		Extruded By: <u>EP/JE</u>	
Recovery: <u>20"</u> (As Denoted on Field Log)		Tube Length: <u>20"</u> (As Measured in Lab)	
0		Classification and Condition of Sample	Test Assignments
		Bag of Sand (5")	
6"		Wax (1")	
12"			
		Tan and gray silty fine sand (SM) with mica (14")	
18"			
Remarks: _____			
_____

Figure B1. Sample from Boring 2F-11-138U Tube 1 with depth of 25.0 to 27.0 ft.

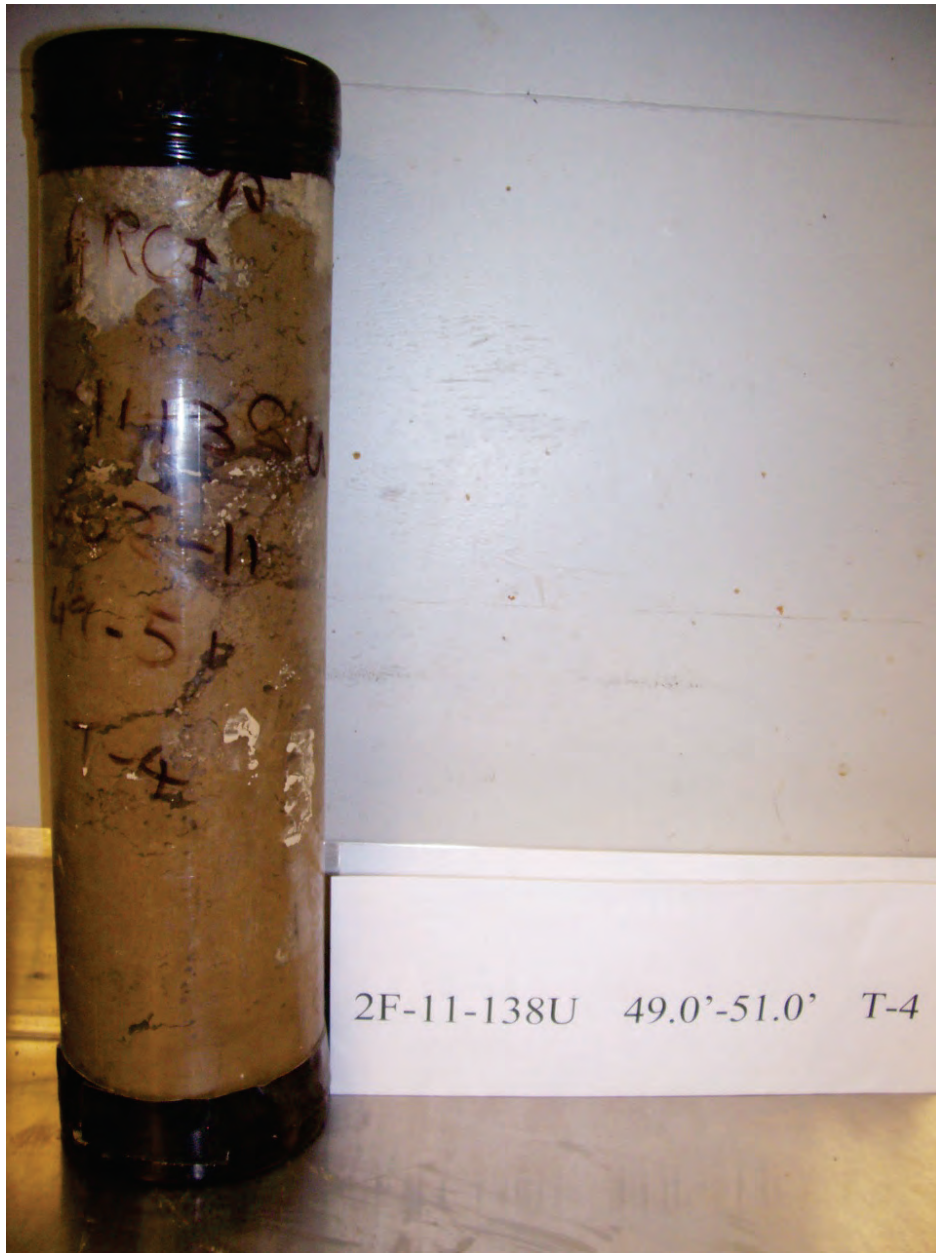
Classification and Condition of Lexan Tube Sample			
		Sheet No.: <u>2</u>	
		Date Extruded: <u>7/23/2012</u>	
Project: <u>Sacramento JET Testing Phase II</u>		Job No.: <u>120320</u>	
Boring No.: <u>2F-11-138U</u>	Sample No.: <u>T4</u>	Depth, ft.: <u>49 - 51</u>	
		Extruded By: <u>EP/JE</u>	
Recovery: <u>20"</u> (As Denoted on Field Log)		Tube Length: <u>16"</u> (As Measured in Lab)	
0		Classification and Condition of Sample	Test Assignments
6"		Bag of Sand (3")	
		Wax (2")	
12"		Tan and light gray silt (ML), slightly sandy (11")	
Remarks:			
<div style="background-color: #cccccc; padding: 2px; display: inline-block; margin-bottom: 5px;"> <b>Burns Cooley Dennis, Inc.</b>  <small>Geotechnical and Materials Engineering Consultants</small> </div>			
Burns Cooley Dennis, Inc.	551 Sunnybrook Road Ridgeland, Mississippi 39157		Phone (601)-856-9911 Fax (601)-856-9774

Figure B2. Sample from Boring 2F-11-138U Tube 4 with depth of 49.0 to 51.0 ft.

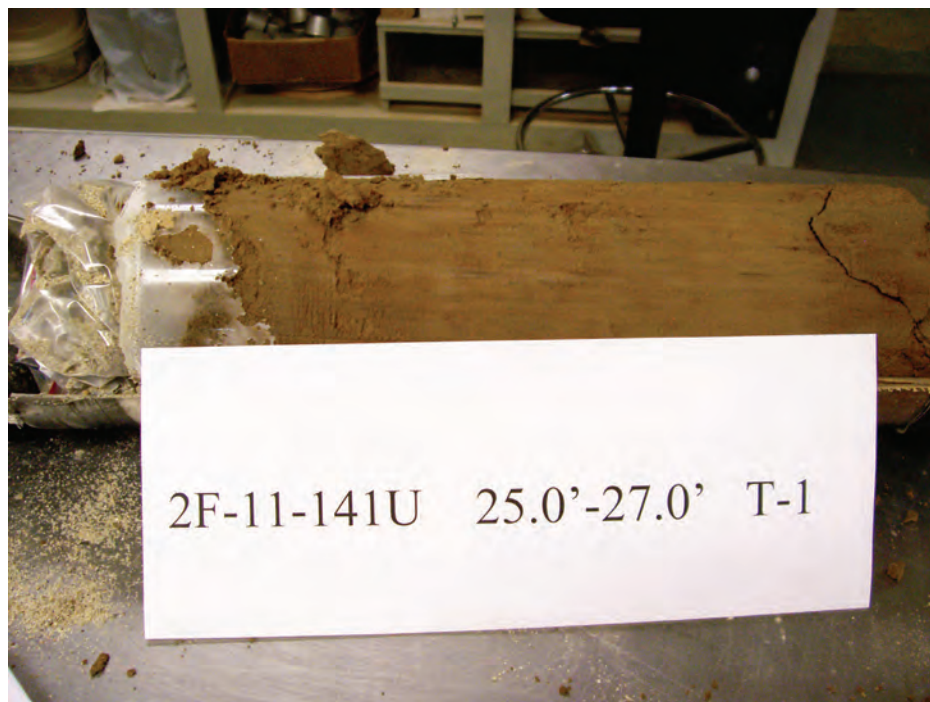
Classification and Condition of Lexan Tube Sample			
		Sheet No.: <u>4</u>	
		Date Extruded: <u>7/23/2012</u>	
Project: <u>Sacramento JET Testing Phase II</u>		Job No.: <u>120320</u>	
Boring No.: <u>2F-11-141U</u>	Sample No.: <u>T1</u>	Depth, ft.: <u>25 - 27</u>	
		Extruded By: <u>EP/JE</u>	
Recovery: <u>21.5"</u> (As Denoted on Field Log)		Tube Length: <u>16"</u> (As Measured in Lab)	
0	Classification and Condition of Sample		Test Assignments
6"	Bag of Sand (2")		
	Wax (1")		
12"	Tan sandy silt (ML) (13")		
Remarks:

Figure B4. Sample from Boring 2F-11-141U Tube 1 with depth of 25.0 to 27.0 ft.

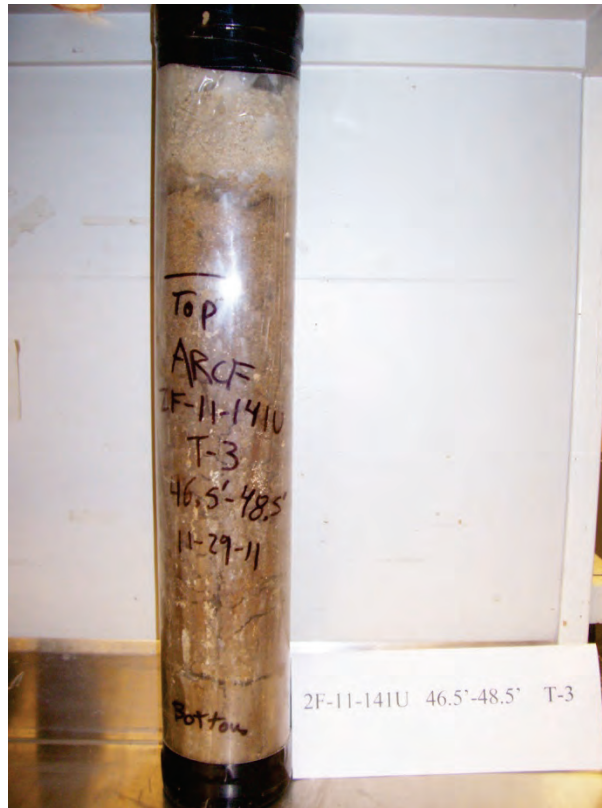
0			Classification and Condition of Sample	Test Assignments
			Bag of Sand (4")	
			Wax (1")	
6"				
12"				
18"			Tan silt (MH) (19")	
24"

Figure B5. Sample from Boring 2F-11-141U Tube 3 with depth of 46.5 to 48.5 ft.

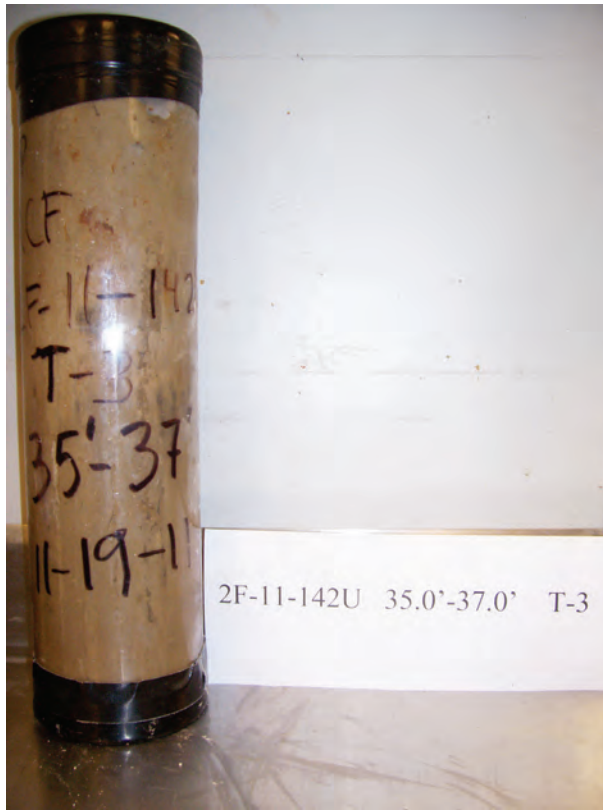
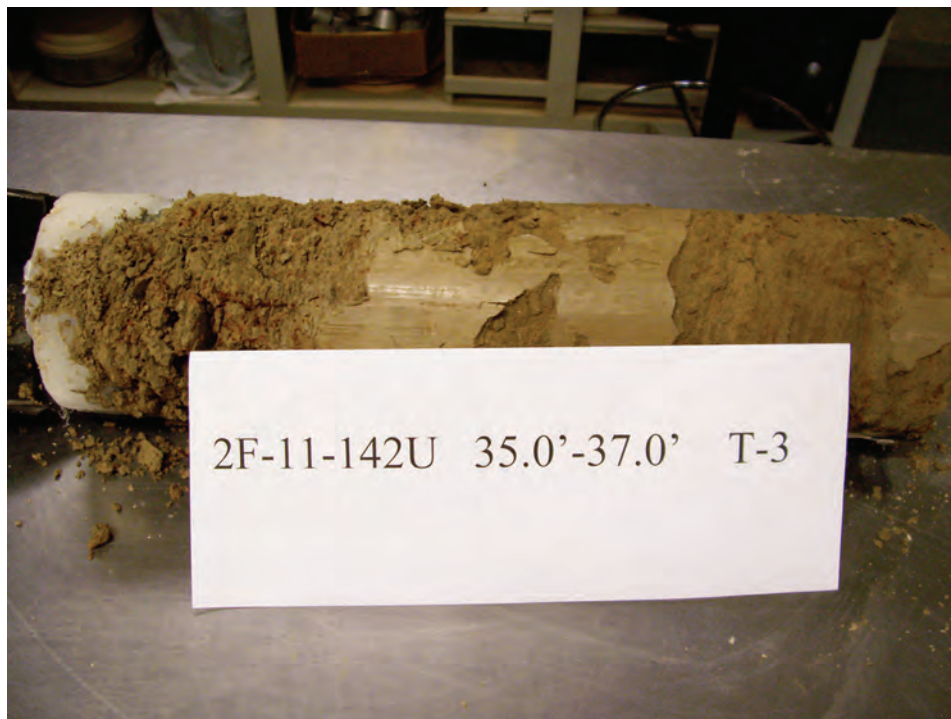
0			Classification and Condition of Sample	Test Assignments
			Wax (2")	
6"				
			Tan and red silt (ML) with sand (14")	
12"

Figure B6. Sample from Boring 2F-11-142U Tube 3 with depth of 35.0 to 37.0 ft.

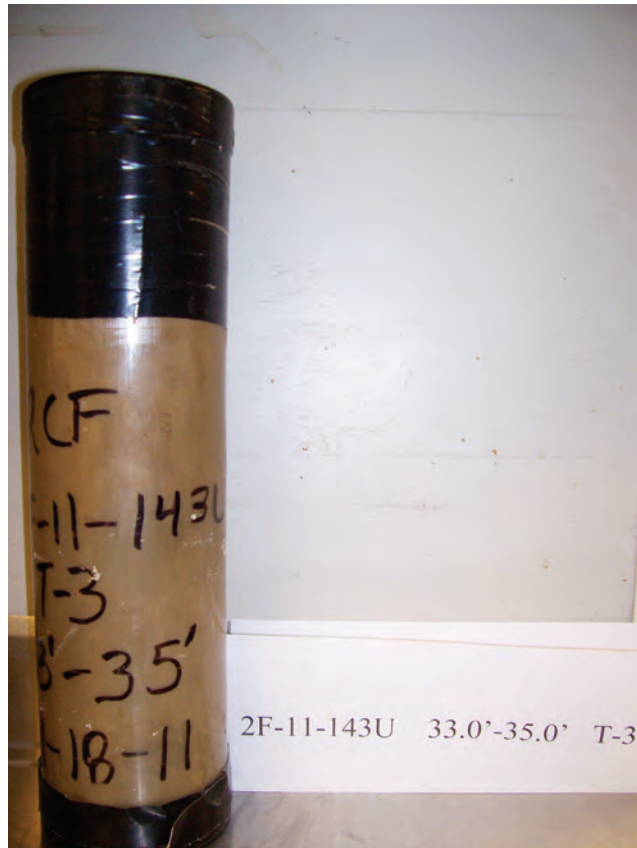
0	Classification and Condition of Sample	Test Assignments
	Wax (1")	
6"	Tan and red silty fine sand (SM) (9")	
12"	Tan and red silt (ML), slightly clayey, with sand (6")

Figure B7. Sample from Boring 2F-11-143U Tube 3 with depth of 33.0 to 35.0 ft.

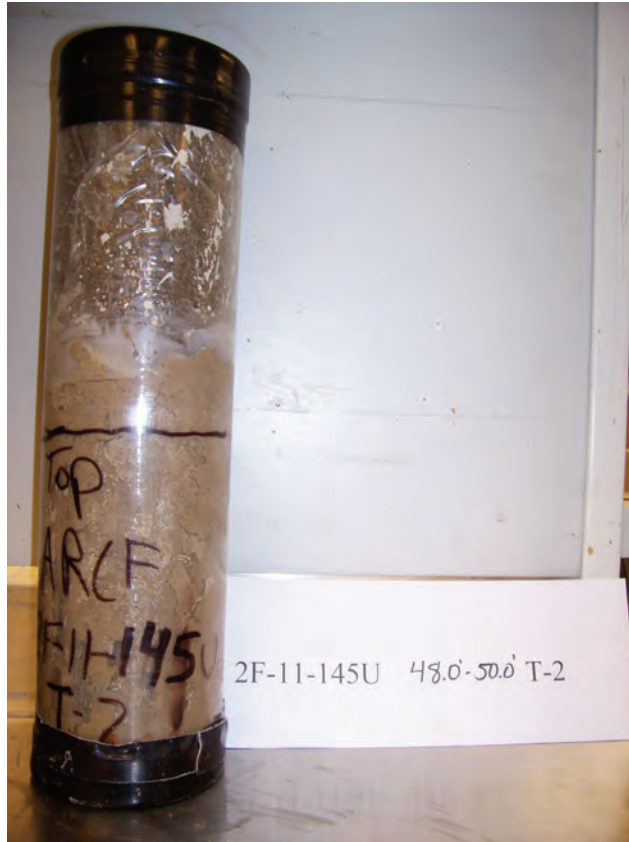
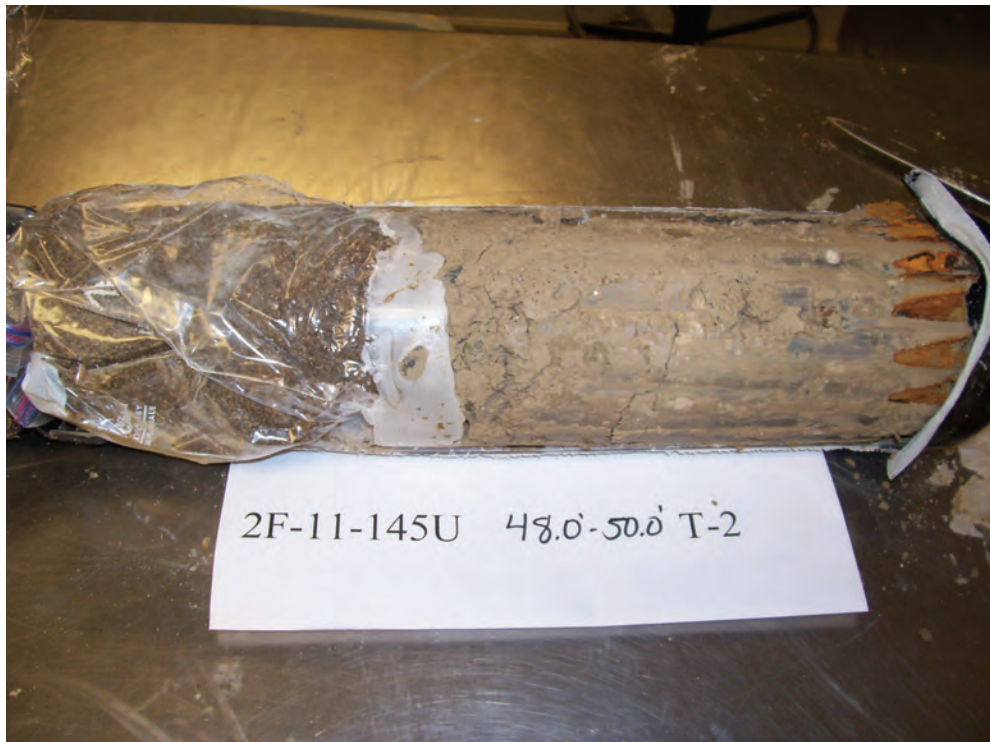
0		Classification and Condition of Sample	Test Assignments
6"		Bag of Sand (6")	
		Wax (1")	
12"		Embedded Cobblestone (2")	
		Tan and light gray clayey silt (ML), with sand (7")

Figure B9. Sample from Boring 2F-11-145U Tube 2 with depth of 48.0 to 50.0 ft.

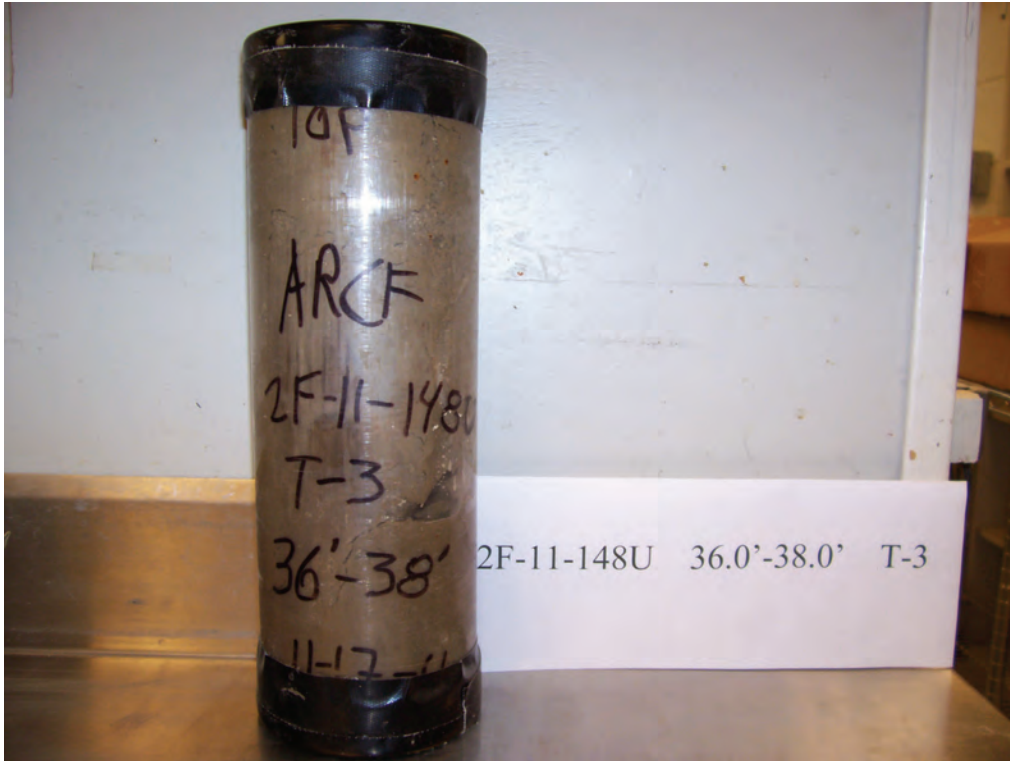
Classification and Condition of Lexan Tube Sample		
		Sheet No.: <u>10</u>
		Date Extruded: <u>7/23/2012</u>
Project: <u>Sacramento JET Testing Phase II</u>		Job No.: <u>120320</u>
Boring No.: <u>2F-11-148U</u>	Sample No.: <u>T2</u>	Depth, ft.: <u>36 - 38</u>
		Extruded By: <u>EP/JE</u>
Recovery: <u>?</u> (As Denoted on Field Log)		Tube Length: <u>11"</u> (As Measured in Lab)
0	Classification and Condition of Sample	Test Assignments
	Hard tan silty clay (CL) slightly sandy, with mica (3")	
6"	Tan sandy silt (ML), with mica (8")	
Remarks:

Figure B10. Sample from Boring 2F-11-148U Tube 3 with depth of 36.0 to 38.0 ft.

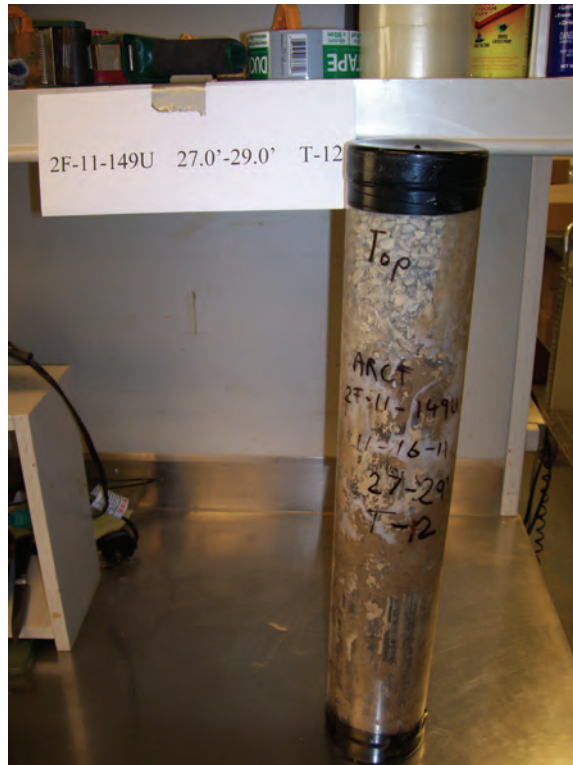
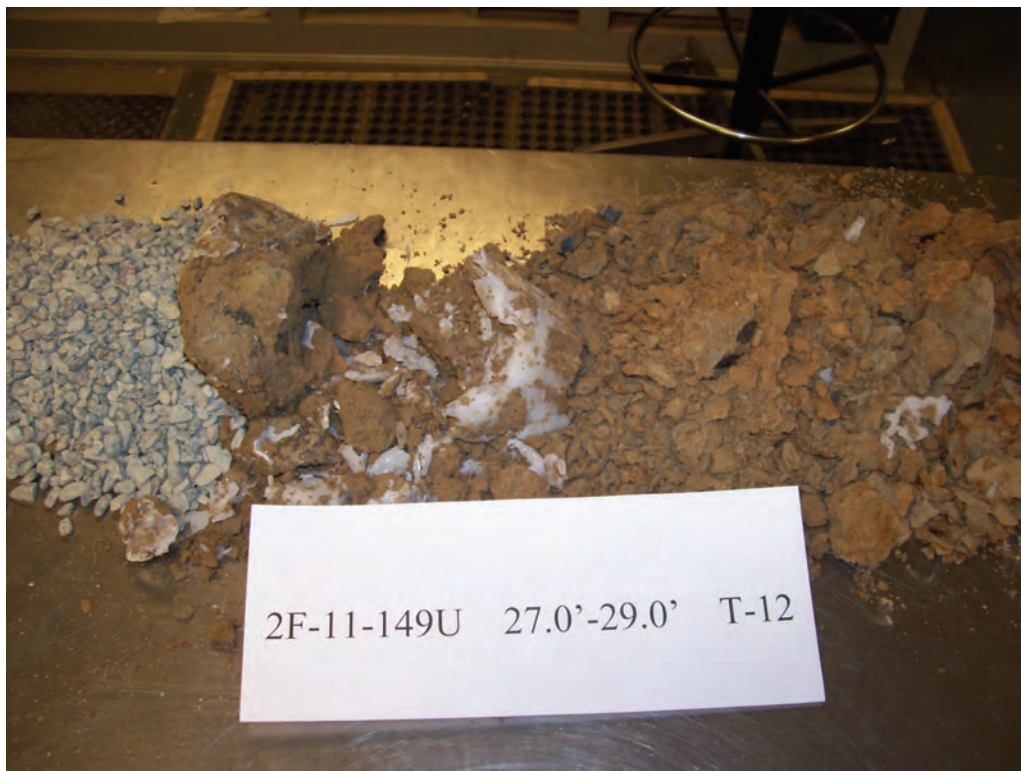
Classification and Condition of Lexan Tube Sample			
		Sheet No.: <u>11</u>	
		Date Extruded: <u>7/23/2012</u>	
Project: <u>Sacramento JET Testing Phase II</u>		Job No.: <u>120320</u>	
Boring No.: <u>2F-11-149U</u>	Sample No.: <u>T2</u>	Depth, ft.: <u>27 - 29</u>	
		Extruded By: <u>EP/JE</u>	
Recovery: <u>15"</u> (As Denoted on Field Log)		Tube Length: <u>24"</u> (As Measured in Lab)	
0		Classification and Condition of Sample	Test Assignments
6"		Gravel (9")	
12"		Wax (3")	
24"		Tan and light gray silt (ML), with sand (11")	
Remarks:

Figure B11. Sample from Boring 2F-11-149U Tube 2 with depth of 27.0 to 29.0 ft.

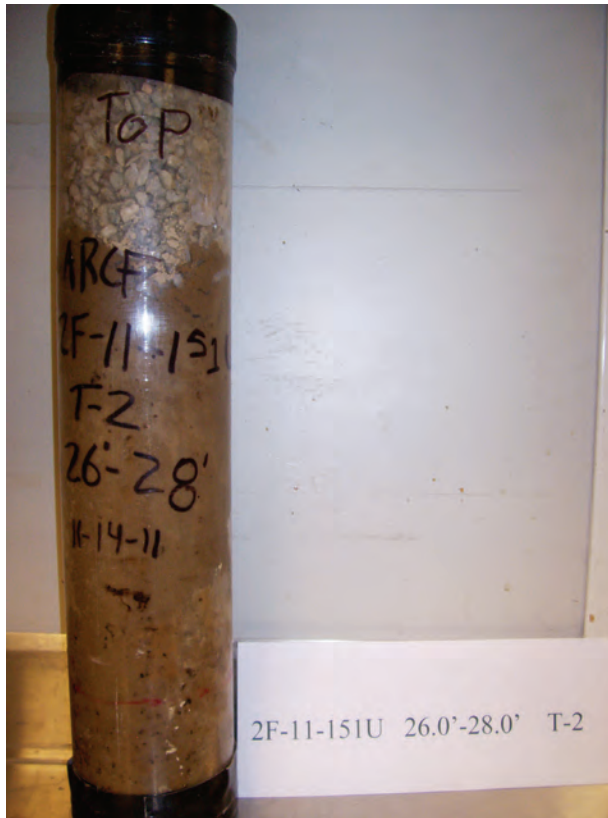
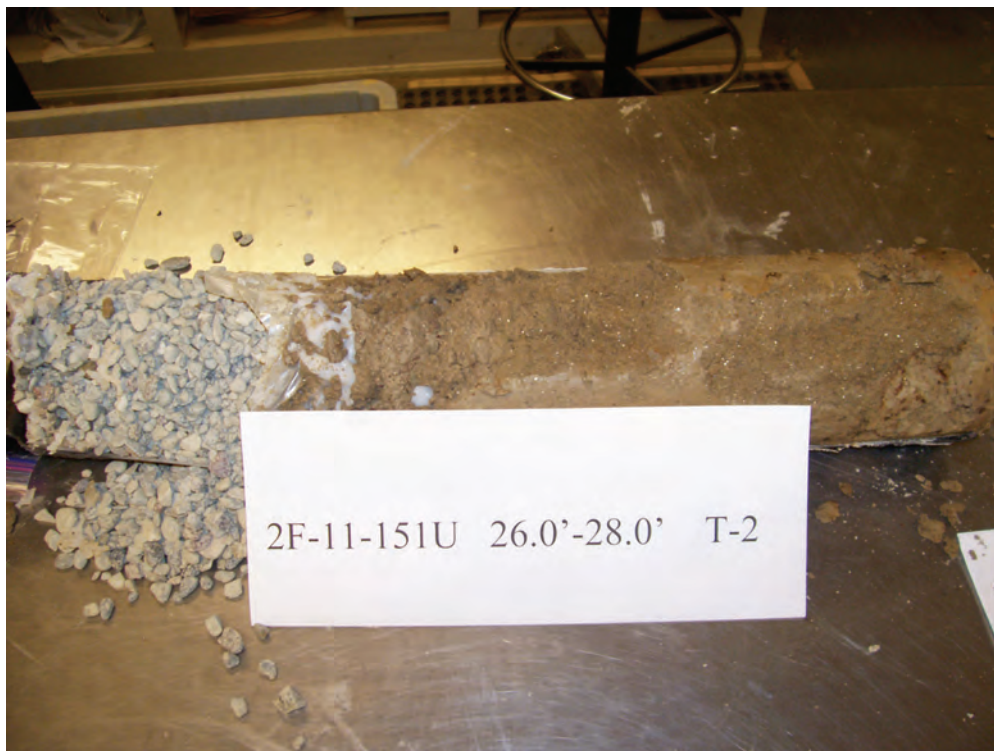
0			Classification and Condition of Sample	Test Assignments
6"			Gravel (6")	
			Wax (1")	
12"				
			Tan silty fine to medium sand (SM) with mica (13")	
18"

Figure B12. Sample from Boring 2F-11-151U Tube 2 with depth of 26.0 to 28.0 ft.

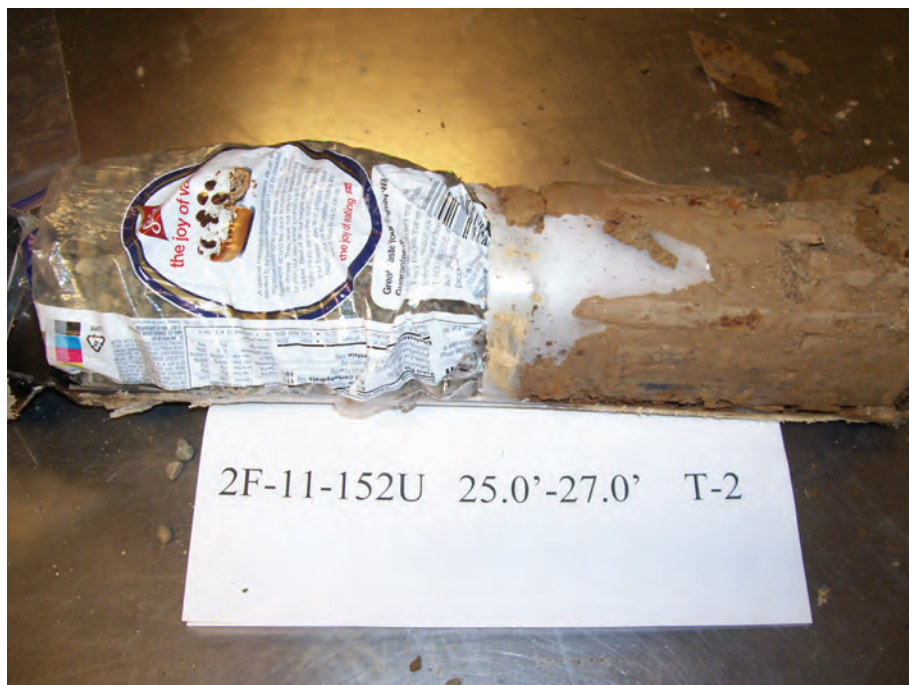
Classification and Condition of Lexan Tube Sample		
		Sheet No.: 13
		Date Extruded: 7/23/2012
Project: <u>Sacramento JET Testing Phase II</u>		Job No.: 120320
Boring No.: <u>2F-11-152U</u>	Sample No.: <u>T2</u>	Depth, ft.: 25 - 27
		Extruded By: EP/JE
Recovery: <u>16"</u> (As Denoted on Field Log)		Tube Length: <u>16"</u> (As Measured in Lab)
0	Classification and Condition of Sample	Test Assignments
6"	Bag of Gravel (8")	
12"	Wax (1")	
	Tan and light gray silt (ML) with sand (7")	
Remarks:

Figure B13. Sample from Boring 2F-11-152U Tube 1 with depth of 25.0 to 27.0 ft.

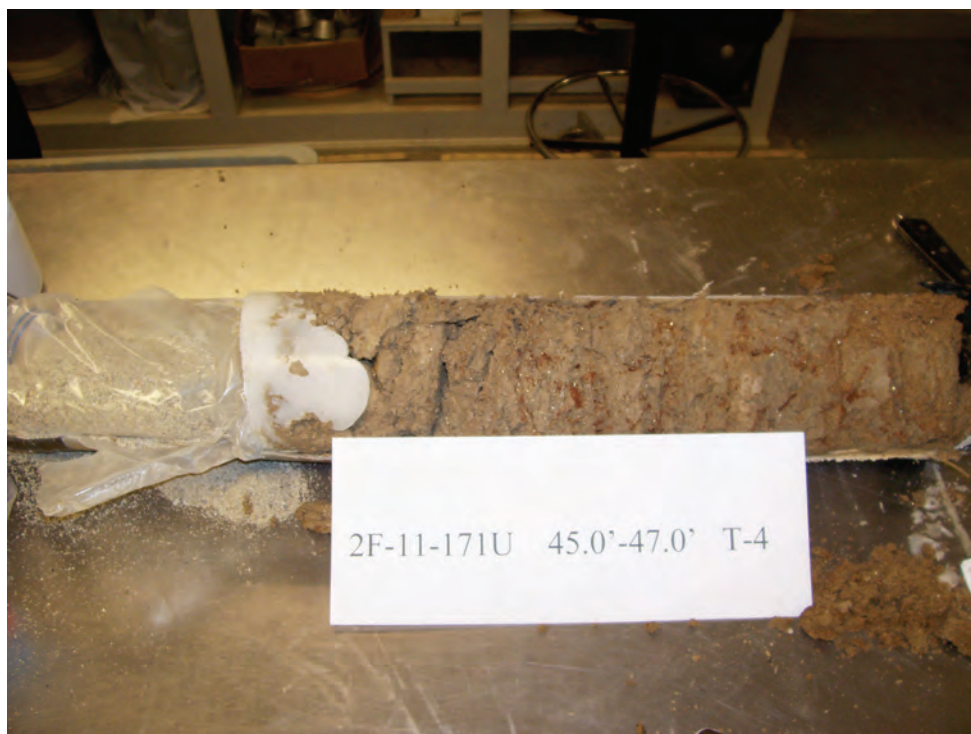
Classification and Condition of Sample	Test Assignments
0				
6"			Bag of Sand (7")	
12"			Wax (1")	
18"			Tan silty clay (CL) with sand and mica (16")	
24"

Figure B14. Sample from Boring 2F-11-171U Tube 4 with depth of 45.0 to 47.0 ft.

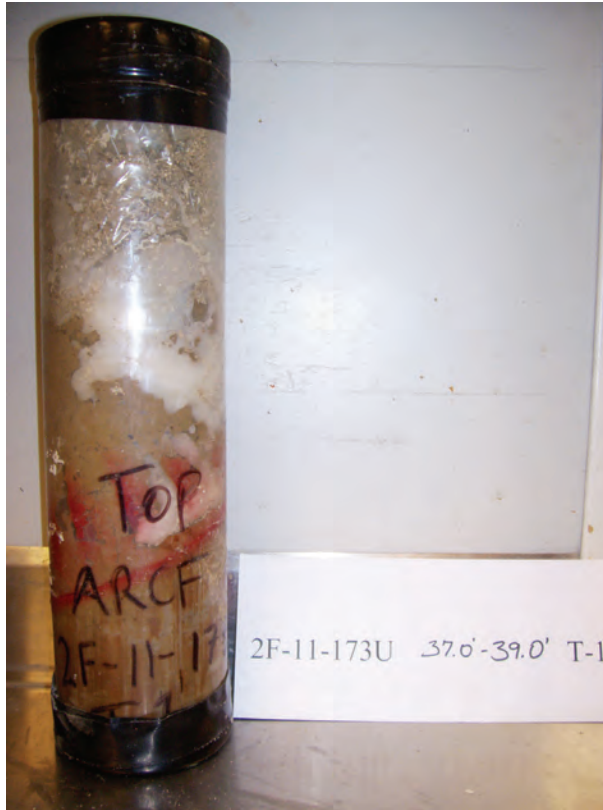
Classification and Condition of Sample	Test Assignments
0				
6"			Bag of Sand (6")	
12"			Wax (3")	
			Tan clayey silt (ML), slightly sandy, with mica (7")

Figure B15. Sample from Boring 2F-11-173U Tube 1 with depth of 37.0 to 39.0 ft.

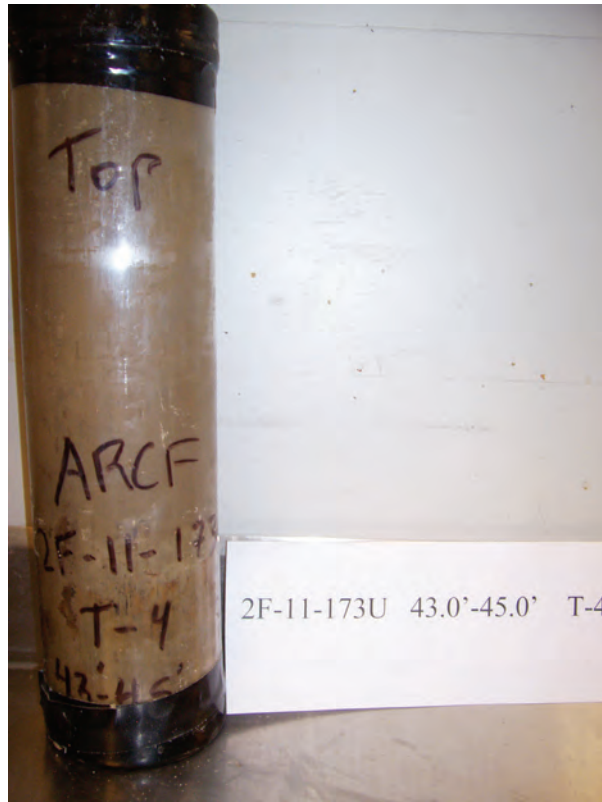
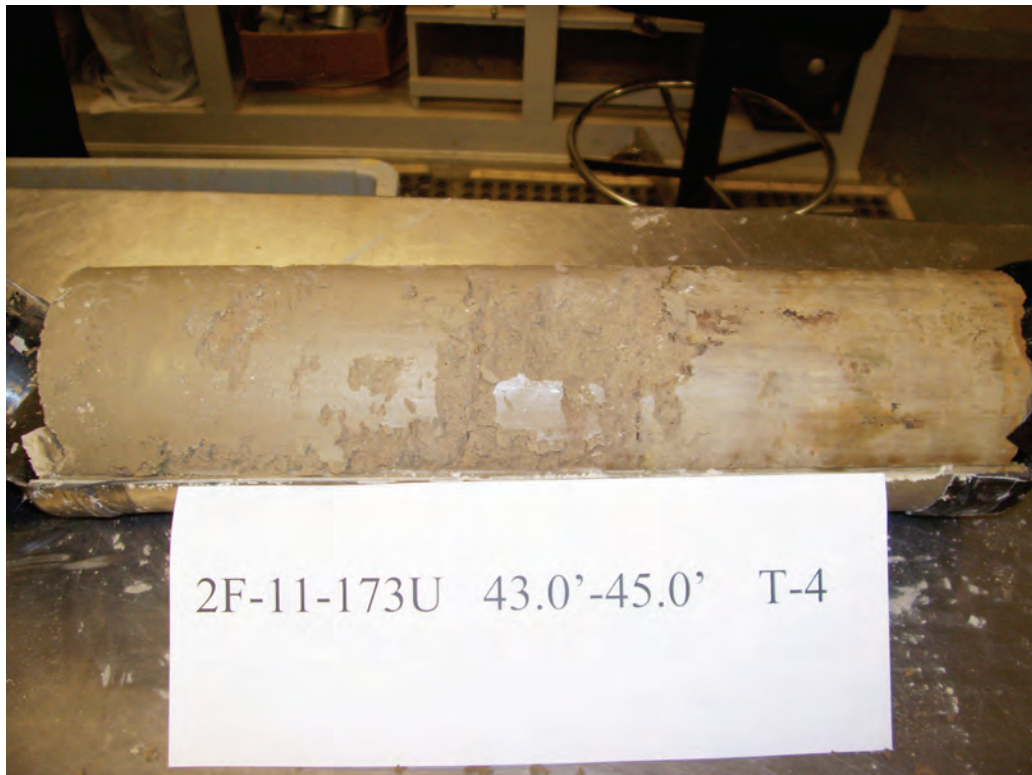
Classification and Condition of Lexan Tube Sample			
		Sheet No.: <u>16</u>	
		Date Extruded: <u>7/23/2012</u>	
Project: <u>Sacramento JET Testing Phase II</u>		Job No.: <u>120320</u>	
Boring No.: <u>2F-11-173U</u>	Sample No.: <u>T4</u>	Depth, ft.: <u>43 - 45</u>	
		Extruded By: <u>EP/JE</u>	
Recovery: <u>23"</u> (As Denoted on Field Log)		Tube Length: <u>16"</u> (As Measured in Lab)	
0		Classification and Condition of Sample	Test Assignments
6"		Tan sandy silt (ML) (16")	
12"			
Remarks:			
<div style="background-color: #cccccc; padding: 2px; display: inline-block;"> <b>Burns Cooley Dennis, Inc.</b>  <small>Geotechnical and Materials Engineering Consultants</small> </div>			
Burns Cooley Dennis, Inc.	551 Sunnybrook Road Ridgeland, Mississippi 39157	Phone (601)-856-9911 Fax (601)-856-9774

Figure B16. Sample from Boring 2F-11-173U Tube 4 with depth of 43.0 to 45.0 ft.

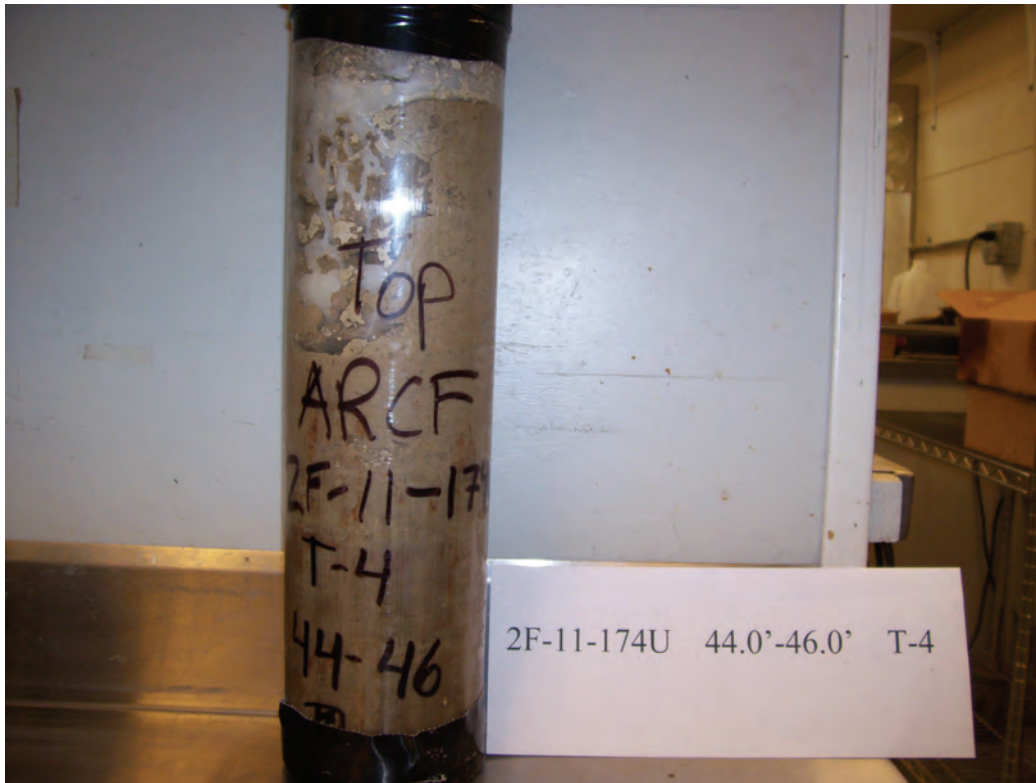
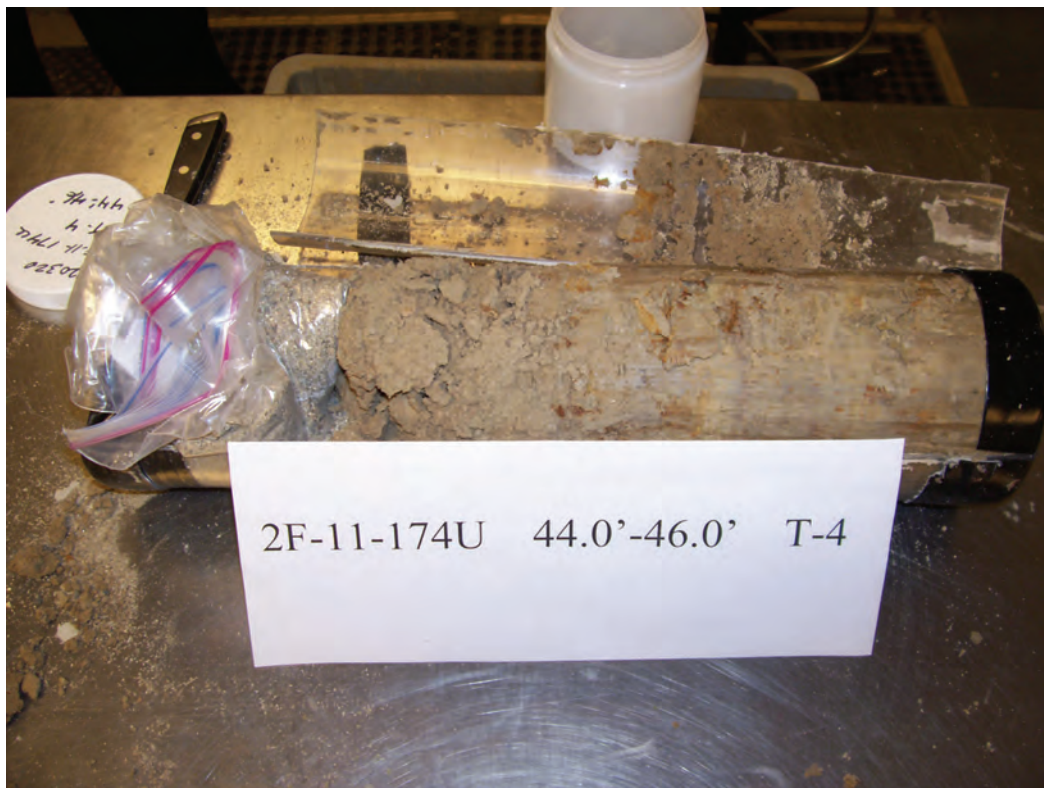
0			Classification and Condition of Sample	Test Assignments
6"			Bag of Sand (2")	
			Wax (1")	
12"			Tan and light gray silt (ML), slightly clayey (13")

Figure B18. Sample from Boring 2F-11-174U Tube 4 with depth of 44.0 to 46.0 ft.

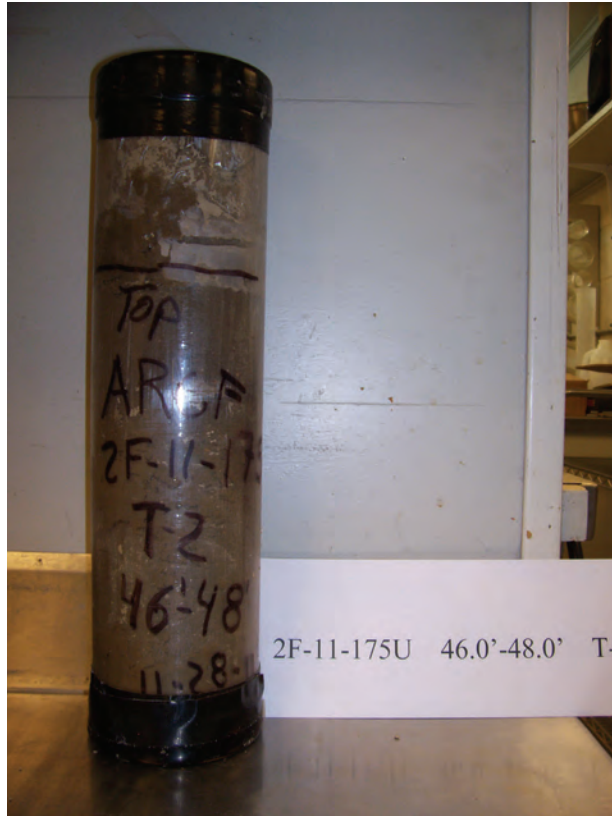
0		Classification and Condition of Sample	Test Assignments
6"		Bag of Sand (4")	
		Wax (1")	
12"		Tan silty fine to medium sand (SM) (11")

Figure B19. Sample from Boring 2F-11-175U Tube-2 with depth of 46.0 to 48.0 ft.

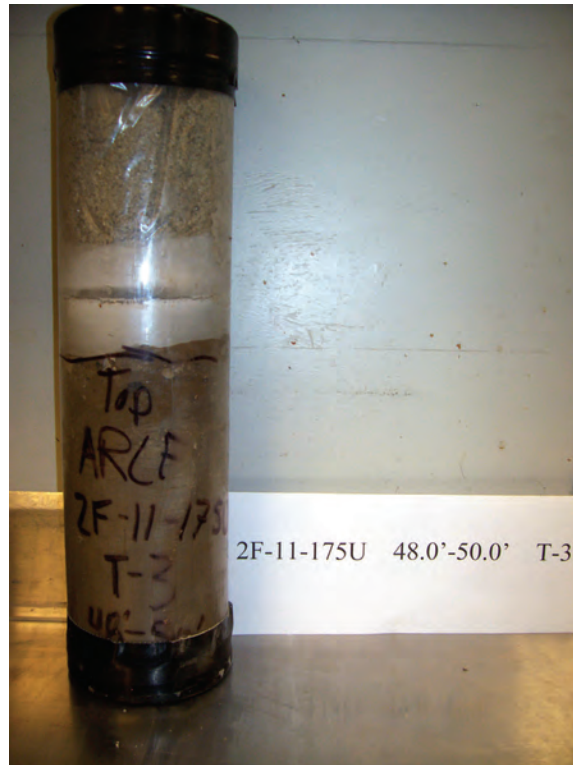
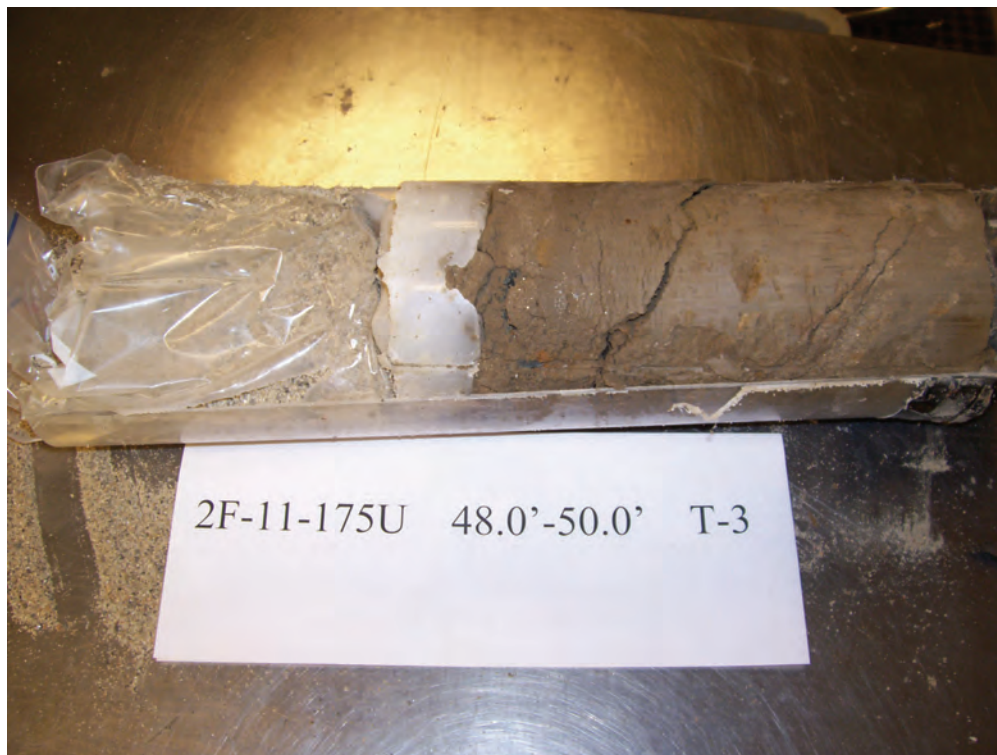
Classification and Condition of Lexan Tube Sample		
		Sheet No.: <u>20</u>
		Date Extruded: <u>7/23/2012</u>
Project: <u>Sacramento JET Testing Phase II</u>		Job No.: <u>120320</u>
Boring No.: <u>2F-11-175U</u>	Sample No.: <u>T3</u>	Depth, ft.: <u>48 - 50</u>
		Extruded By: <u>EP/JE</u>
Recovery: <u>16"</u> (As Denoted on Field Log)		Tube Length: <u>16"</u> (As Measured in Lab)
0	Classification and Condition of Sample	Test Assignments
6"	Bag of Sand (5")	
6"	Wax (1")	
12"	Tan and light gray silt (ML) (10")	
Remarks: _____		
_____

Figure B20. Sample from Boring 2F-11-175U Tube-3 with depth of 48.0 to 50.0 ft.

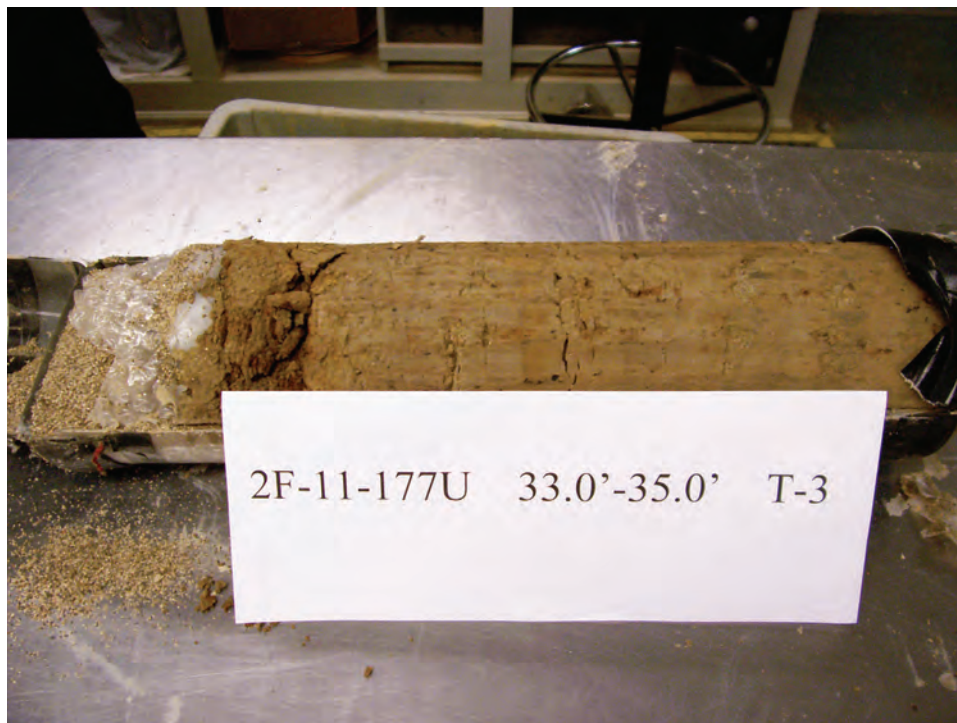
Classification and Condition of Sample	Test Assignments
0				
6"			Bag of Sand (3")	
			Wax (1")	
12"			Tan and light gray clayey silt (ML) with sand and mica (12")

Figure B21. Sample from Boring 2F-11-177U Tube-3 with depth of 33.0 to 35.0 ft.

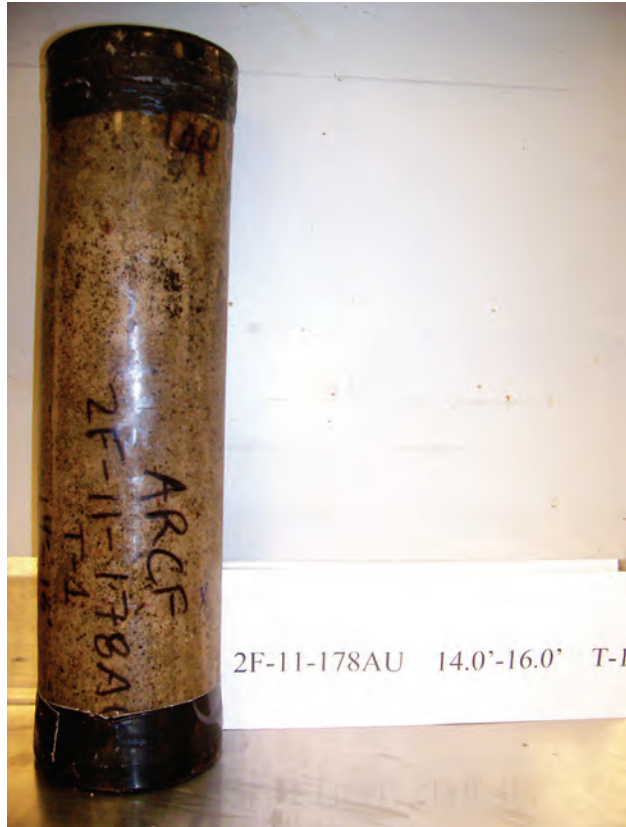
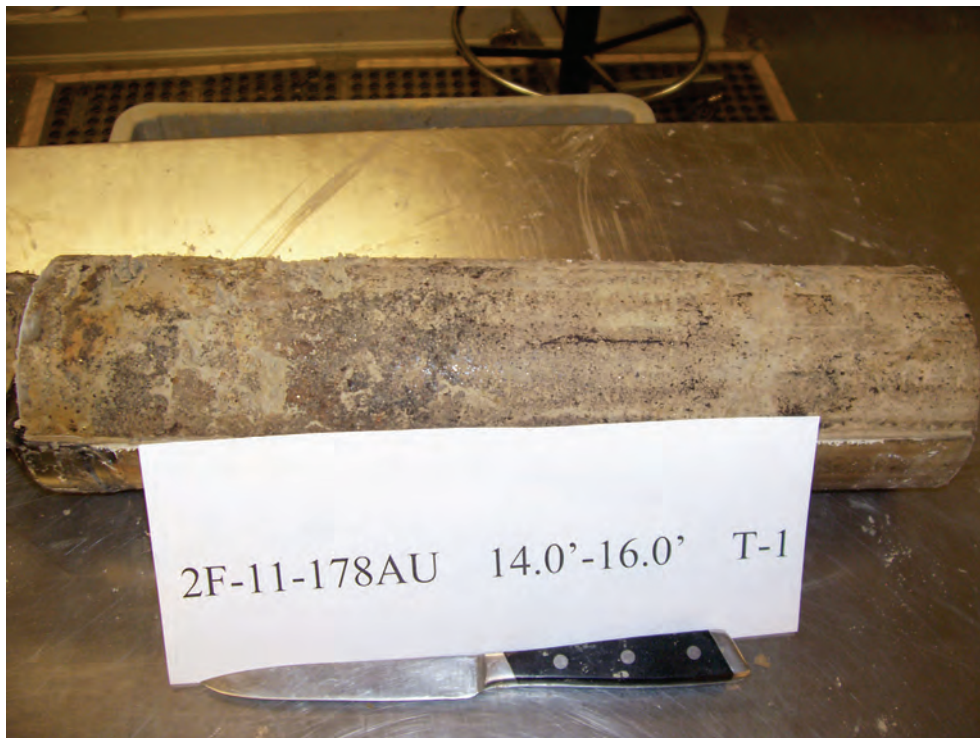
Classification and Condition of Lexan Tube Sample		
		Sheet No.: <u>22</u>
		Date Extruded: <u>7/23/2012</u>
Project: <u>Sacramento JET Testing Phase II</u>		Job No.: <u>120320</u>
Boring No.: <u>2F-11-178AU</u>	Sample No.: <u>T1</u>	Depth, ft.: <u>14 - 16</u>
		Extruded By: <u>EP/JE</u>
Recovery: <u>24"</u> (As Denoted on Field Log)	Tube Length: <u>16"</u> (As Measured in Lab)	
0	Classification and Condition of Sample	Test Assignments
	Wax (1")	
6"		
12"	Tan and light gray silt (ML) with sand and mica (15")	
Remarks:		
<div style="background-color: #cccccc; padding: 2px; display: inline-block;"> <b>Burns Cooley Dennis, Inc.</b>  <small>Geotechnical and Materials Engineering Consultants</small> </div>		
Burns Cooley Dennis, Inc.	551 Sunnybrook Road Ridgeland, Mississippi 39157	Phone (601)-856-9911 Fax (601)-856-9774

Figure B22. Sample from Boring 2F-11-178U Tube-1 with depth of 14.0 to 16.0 ft.

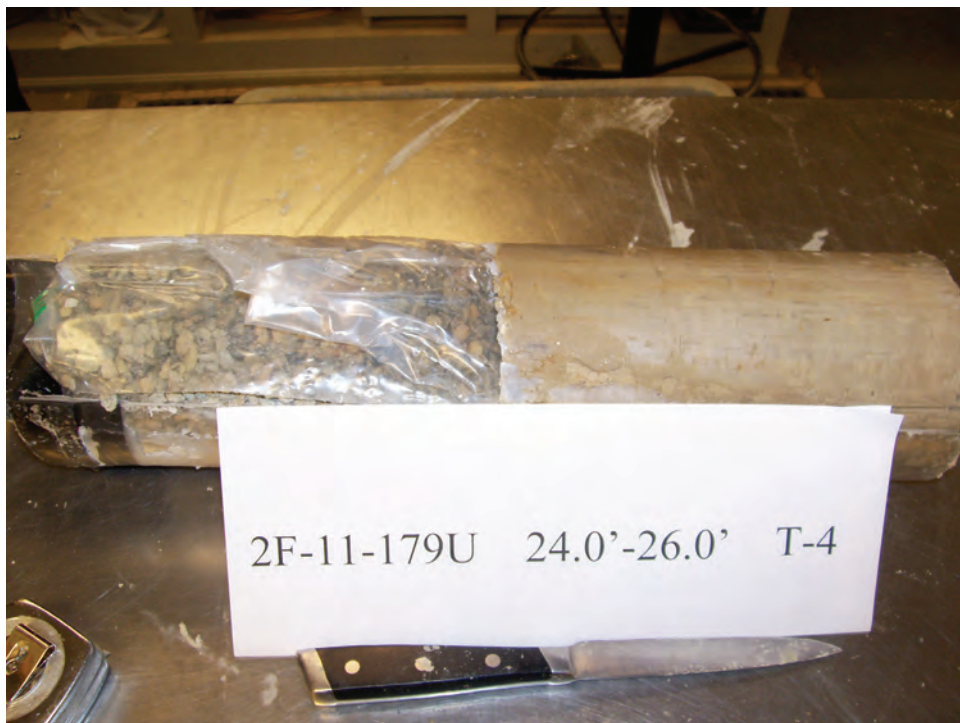
Classification and Condition of Sample	Test Assignments
0				
6"			Bag of Gravel (8")	
			Wax (1")	
12"			Tan and light gray silt (ML)

Figure B24. Sample from Boring 2F-11-179U Tube-4 with depth of 24.0 to 26.0 ft.
