AFCEC-CO-TY-TR-2018-0001

**CONVERTING HANGAR HIGH EXPANSION
FOAM SYSTEMS TO PREVENT COCKPIT
DAMAGE: FULL-SCALE VALIDATION TESTS**

September 2017

**AIR FORCE CIVIL ENGINEER CENTER
OPERATIONS DIRECTORATE**

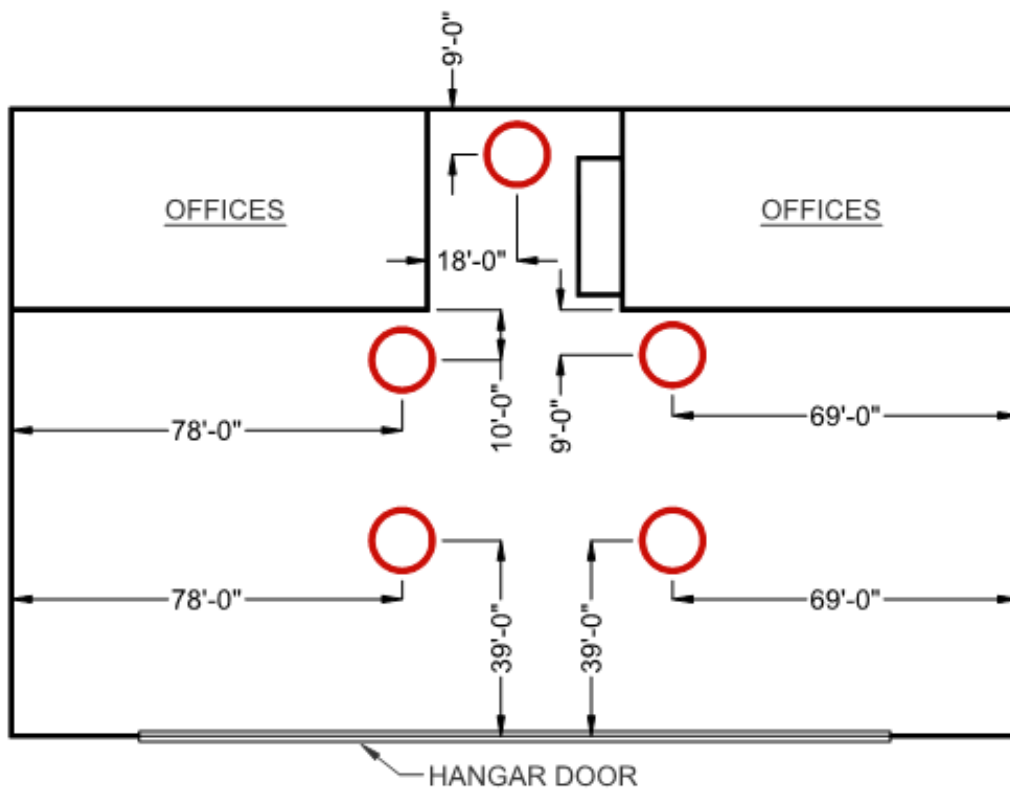
Figure 4. High Expansion Foam Generator Locations

There were five Chemguard 15000WP high expansion foam generators installed in the hangar. The locations are shown in Figure 4. A photograph and schematic of a Chemguard 15000WP generator are provided in Figure 5. The discharge characteristics of the generator are shown in the plot in Figure 6.

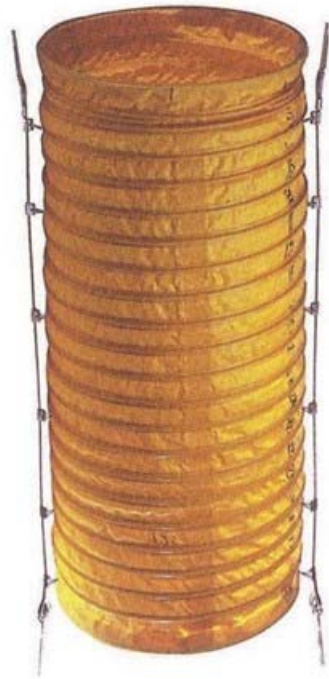
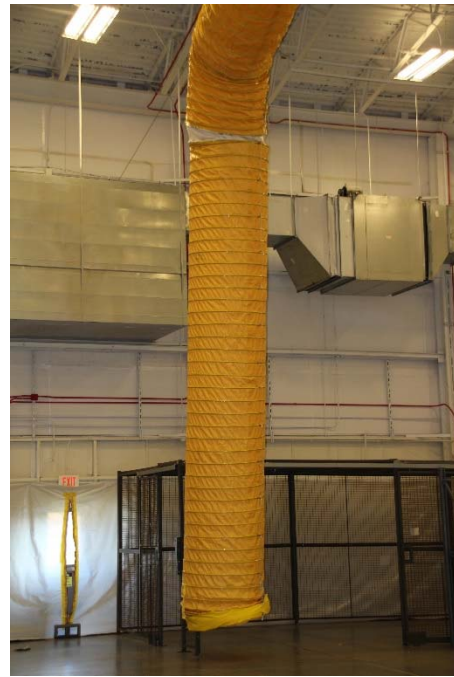
Figure 9. Vertical Duct Configuration

The vertical runs are equipped with a cable support system that runs down opposite sides of the duct as shown in Figure 9. The vertical runs were suspended from the overhead using ½” steel cable connected to the ceiling trusses. The inlets to the vertical ducts were approximately 16 in. above the floor. A typical ductwork run is shown in Figure 10.

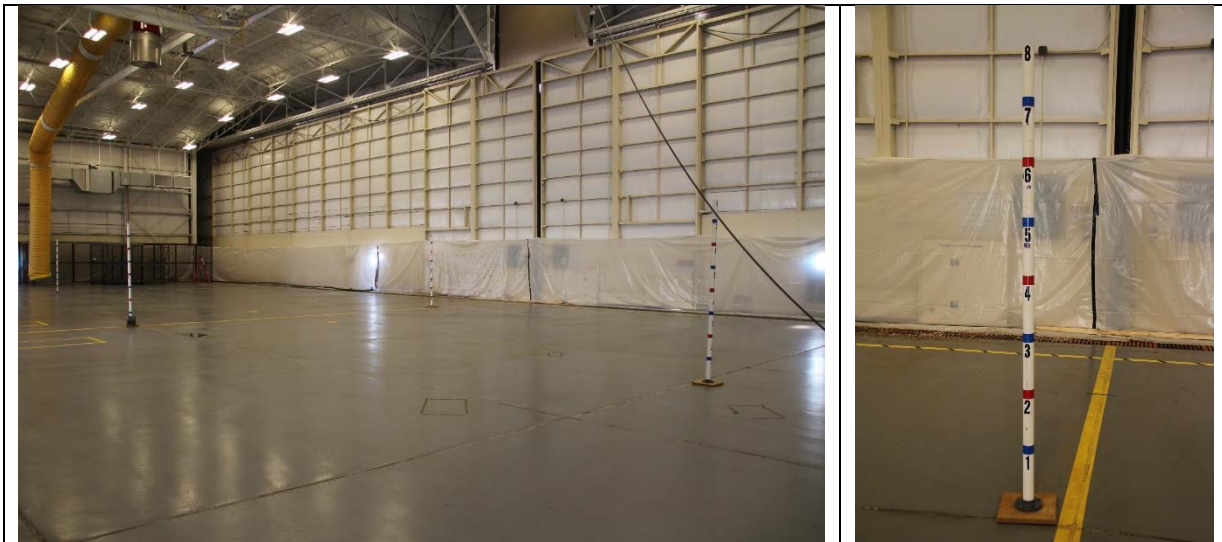
Figure 12. Depth Indicator Locations

To aid in assessing the foam depth as a function of time, five, depth indicators were installed in the hangar during each test. The depth indicators consisted of a 2 in. PVC vertical pipe stand with markings at one foot increments. Three depth indicators were installed equally spaced down the centerline of the hangar (i.e., the location of the fuselage when a plane is parked in the hangar), and the remaining two positioned at the wing tip locations. A close up of a depth indicator and their installed locations are shown in Figure 12.

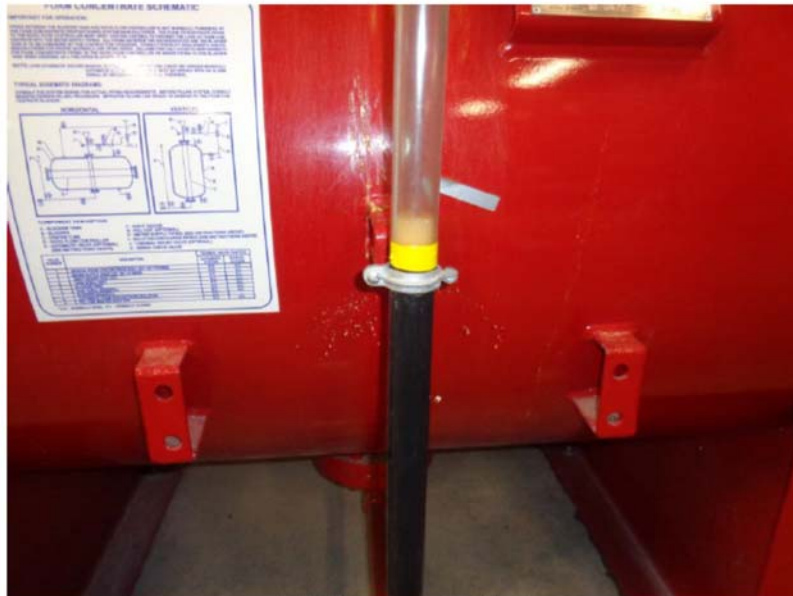
Initial foam concentrate level

Upon following OEM procedures for a foam concentrate level check, the bladder tank was isolated from the riser, the tank shell drain valve opened to drain water from the tank shell; the tank shell vent valve was opened, the bladder vent valve was opened and once all the water had drained from the tank shell, the bladder tank was found to be only half full.

The “black” foam concentrate initially found in the sight glass appeared to be as a result of contact with the carbon steel pipe attached to the sight glass tube.

Base Maintenance Department provided a supply of foam concentrate and the bladder tank was topped-off to the appropriate level.

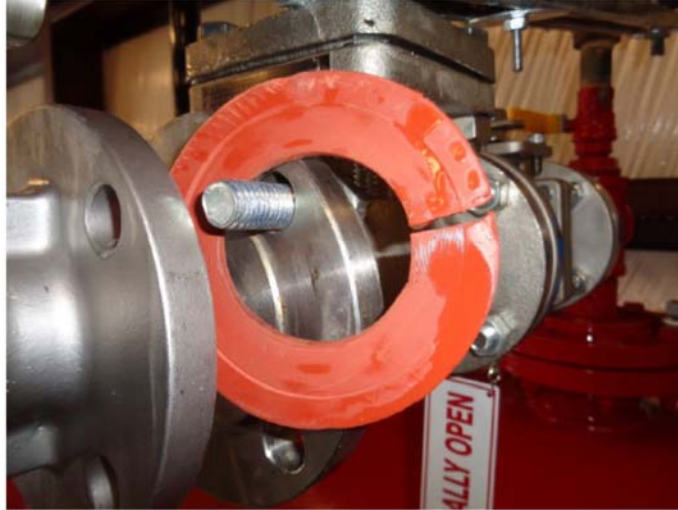
During the re-pressurisation of the bladder tank, one (1) of the gaskets in the foam concentrate line to the ratio controller failed. Subsequently, all four (4) gaskets in the foam concentrate line were replaced by the base Maintenance Department.
