AFRL-RX-WP-TR-2018-0071

BURNER RIG TESTING OF A500[®] C/SiC

17 MARCH 2018
Final Report

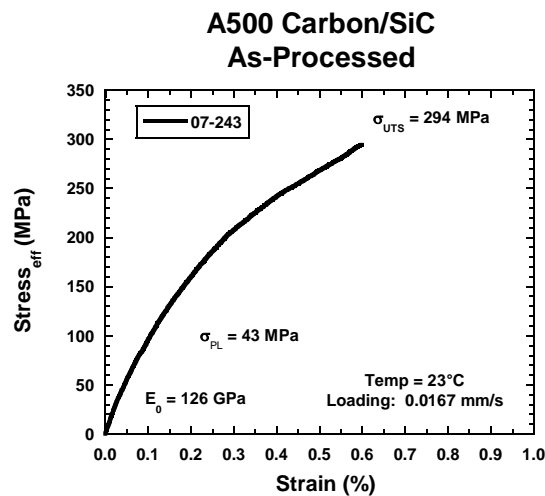
Figure 6. Typical Room-Temperature Tensile Stress-Versus-Strain Trace for As-Manufactured A500 C/SiC

A typical-room temperature tensile stress-versus-strain trace for A500 C/SiC is shown in Figure 6. The calculation of efficient strength will be described in a following section. It is important to note that, since there are carbon fibers in a SiC matrix, the CTE difference between the fibers and matrix results in extensive matrix cracks during processing. Therefore, during a tension test, there is usually only a short initial linear region followed by a gradual transition to non-linear stress-versus-strain behavior. This transition typically occurs between 30 MPa and 70 MPa for as-manufactured material. After the proportional limit is reached, there is extensive non-linear behavior up to approximately 150 MPa, and then the traces appear to be fairly linear up to near the UTS. It is suggested that, in this region, the CMC is completely micro-cracked and most of the load is being carried by the fibers. Stiffness is approximately 125 GPa and UTS is around 300 MPa. The A500 CMC exhibits good composite behavior and strain to failure typically exceeds 0.5%.

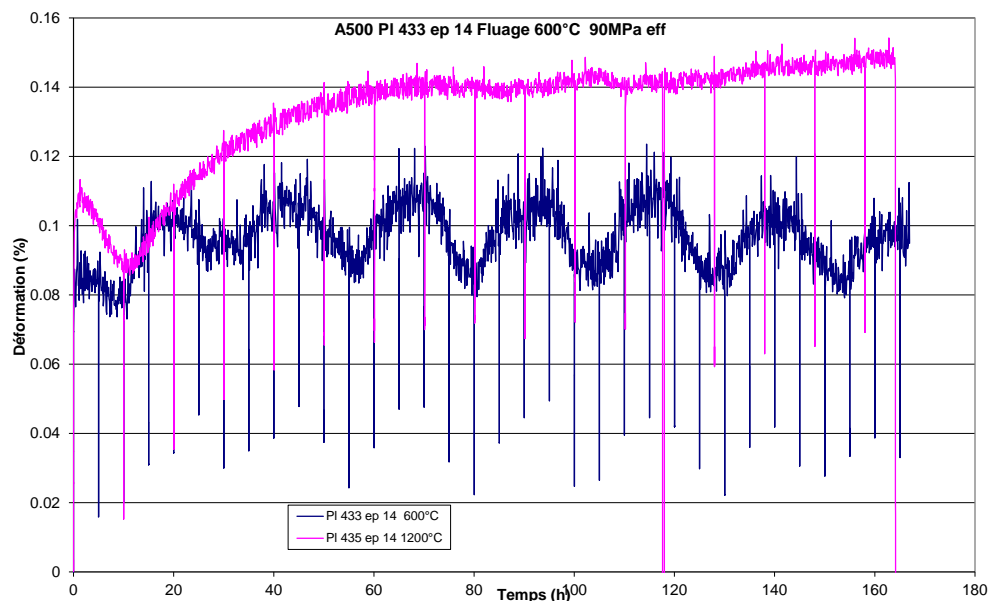
Figure 11. Strain Versus Time for A500 Loaded in Creep at 90 MPa (1200°C) and Fatigue at 90 MPa (600°C) for 160 Hours

SPS demonstrated test parameters in creep at an efficient strength level of 90 MPa and temperatures of 1200°C (acceptance test specimen #435-14), and in fatigue at 90 MPa and 600°C (acceptance test specimen #433-14). Both tests were stopped at 167 hours, without failure, in accordance with a minimum time criteria of 150 hours. The resulting displacement-versus-time traces for both tests are shown in Figure 11. The measured displacements were small and both specimens ran out past the life criterial of 150 hours.

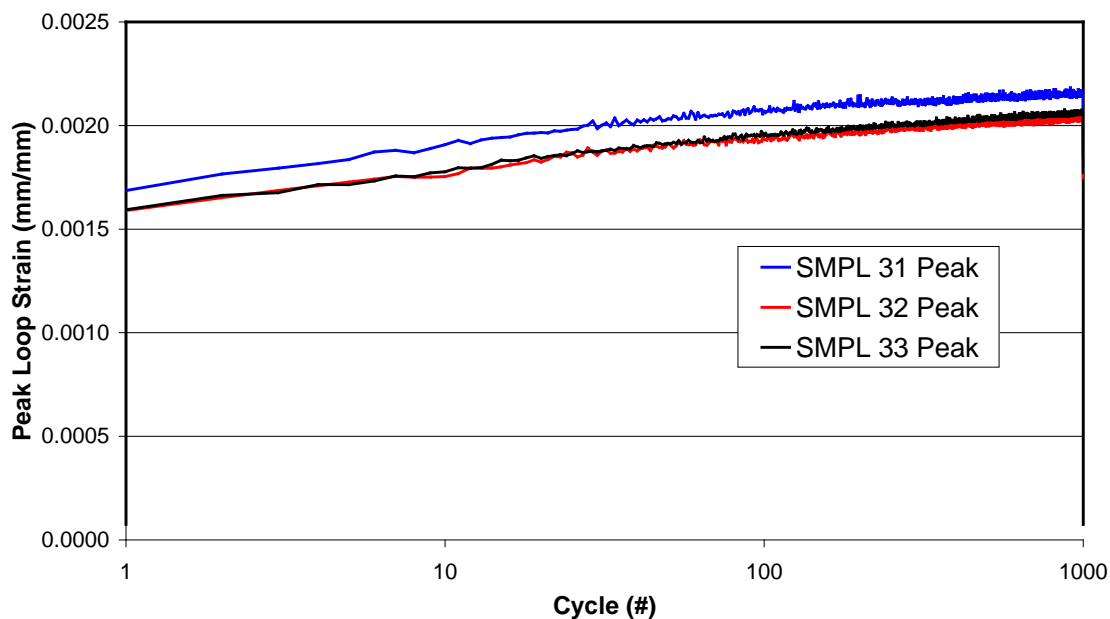
Figure 13. Peak Strain Versus Cycles for Three Specimens

Samples 31, 32 and 33 were fatigued at room temperature, at a maximum effective peak stress of 150 MPa for 1,000 cycles. All samples survived the fatigue tests. Efficient stress-strain curves for several of the fatigue cycles were captured during the tests and the results studied in order to determine the damage incurred. The peak strain for each loop is shown in Figure 13 which shows that all of the test specimens exhibited similar behavior. A plot showing efficient stress-versus-strain cycles for several different cycles for Sample 31 is given in Figure 14. There is a subtle shift in the loop location, indicating strain was accumulating in the sample. However, there is no clear way to visually note the presence of a slope shift that could indicate damage based on a modulus change. Curve fitting was done to a vast majority of the cycles and the damage parameter determined [based on $D = ((1-E_i)/E_o)$ where D is the damage parameter, E_i is the modulus per individual cycle, and E_o is the initial modulus] and is shown in Figure 15. The damage parameter appears to be leveling off starting at 800 cycles and suggests that the test specimens are saturated with micro-cracks.

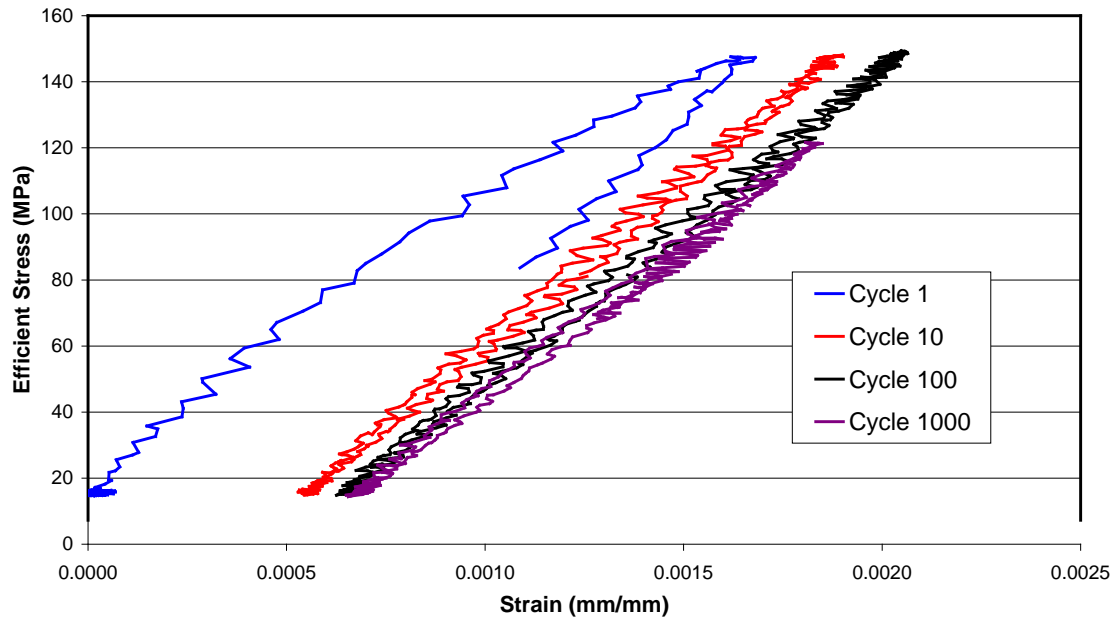
Figure 14. Cyclic Loop Data for Sample 31

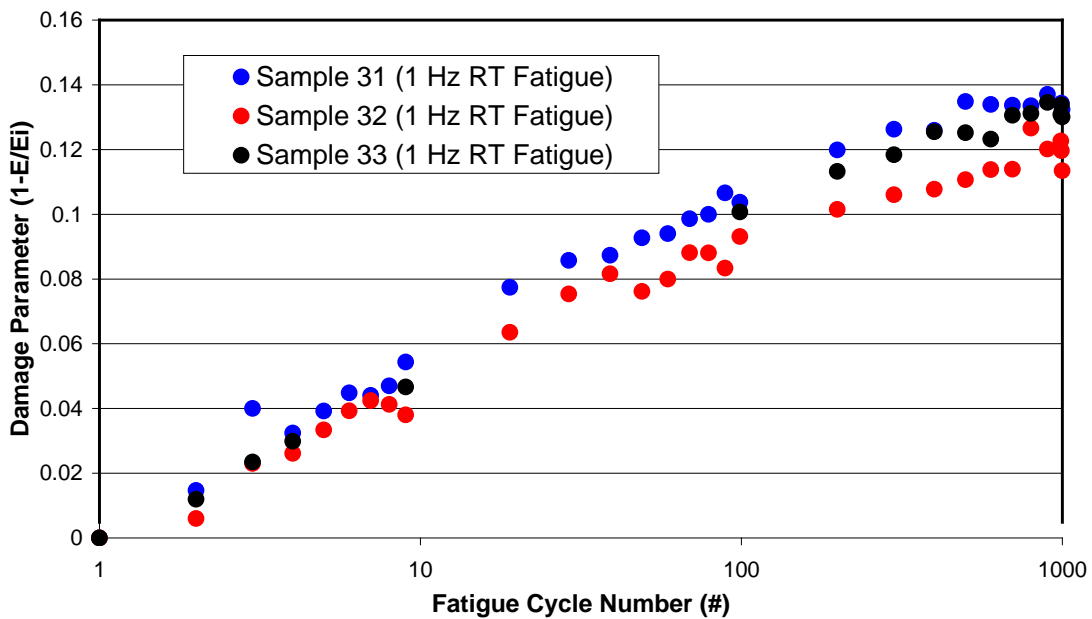
Figure 15. Damage Parameter Versus Cycle for Three Samples Subjected to 1 Hz Testing

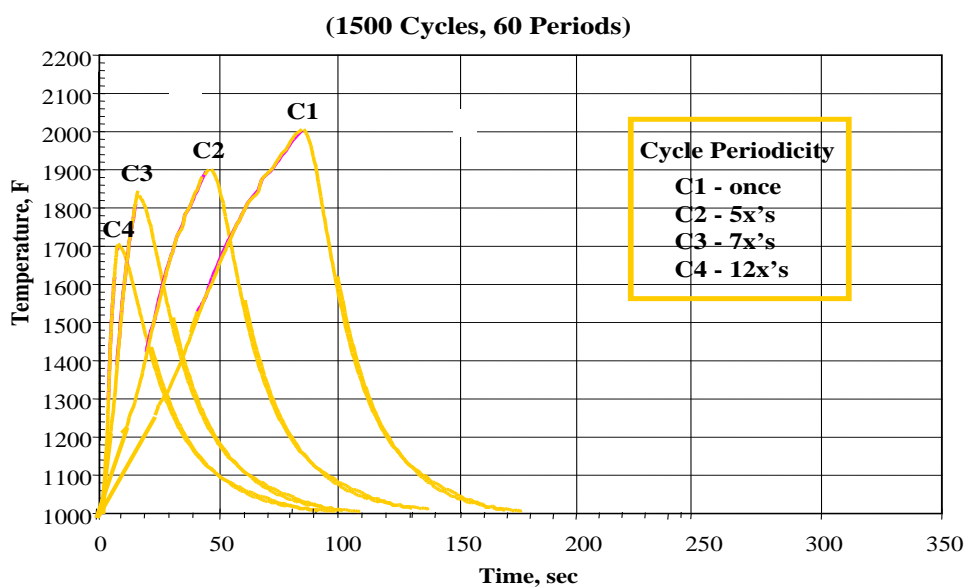
Figure 17. Example of the Burner Rig Temperature Profiles Used

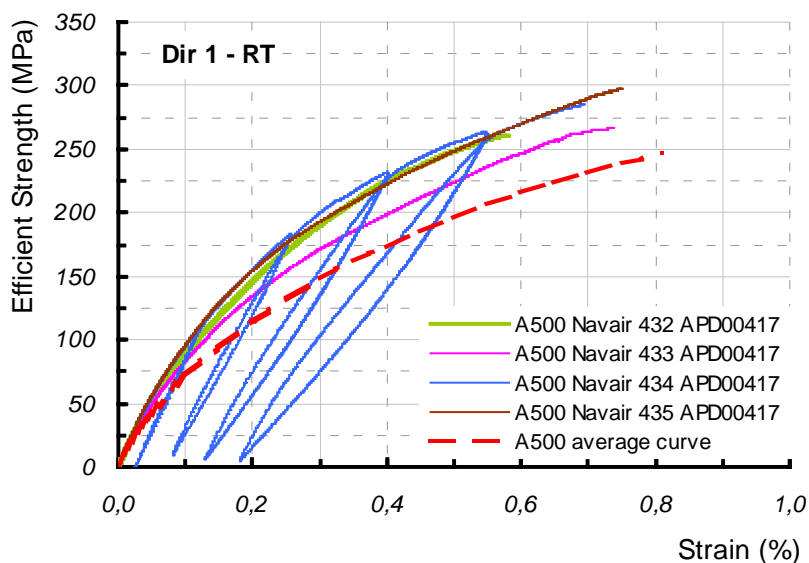
Figure 22. Efficient Stress Versus Strain for As-Manufactured A500 C/SiC Tested by SPS

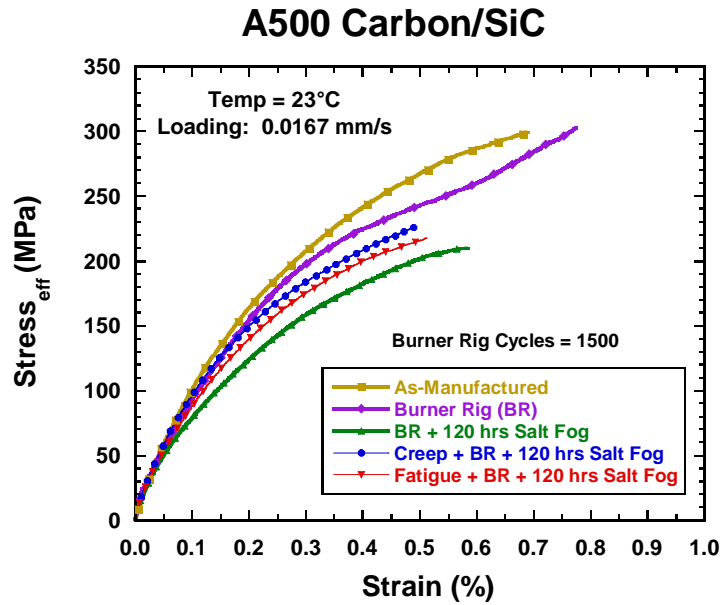
Figure 27. Tensile Stress-Versus-Strain Behavior for A500 Following Various Burner Rig and Salt Fog Exposure Durations

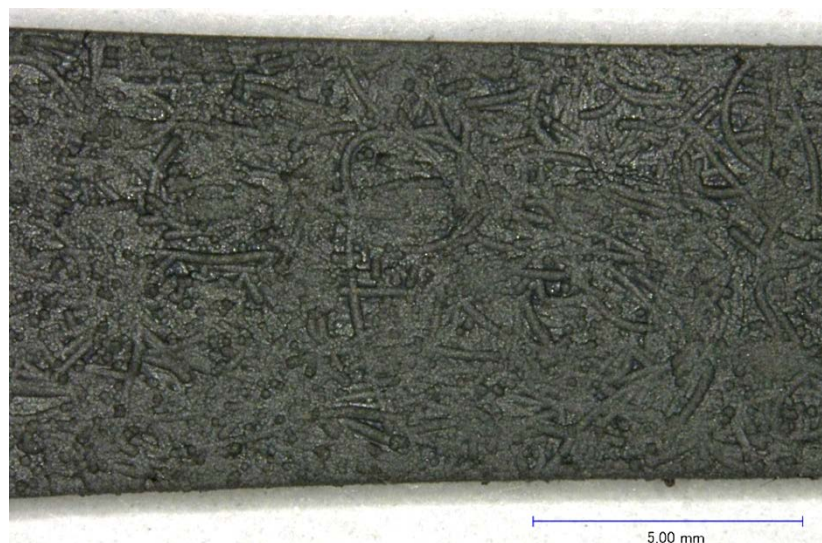
Figure 29. Optical Photograph Surface of Gage Section of As-Manufactured A500 C/SiC Sample – (#07-245)

Figure 28 shows a failed as-manufactured tensile specimen and Figure 29 shows a higher magnification optical photograph of the surface of the gage section of the tensile specimen. There was nothing noteworthy to report about the surface of the test specimen, other than a few stray fibers coated with a thick layer of matrix.

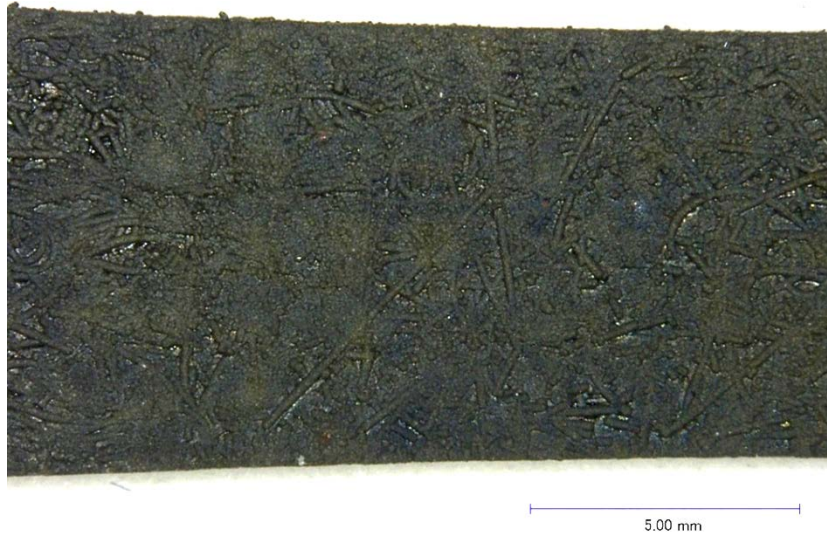
Figure 31. Optical Photograph Of A Tension-Tested A500 C/SiC Sample (#3) After 300 Burner Rig Cycles and 24 Hours Salt Fog Exposure

Figure 30 shows a failed tensile specimen that saw 300 burner rig cycles plus 24 hours of salt fog exposure, and Figure 31 shows a higher magnification of the gage section of the tensile specimen. The only difference between this specimen and the as-manufactured specimen is that it appears to be a bit darker. Other than that no other differences could be observed.

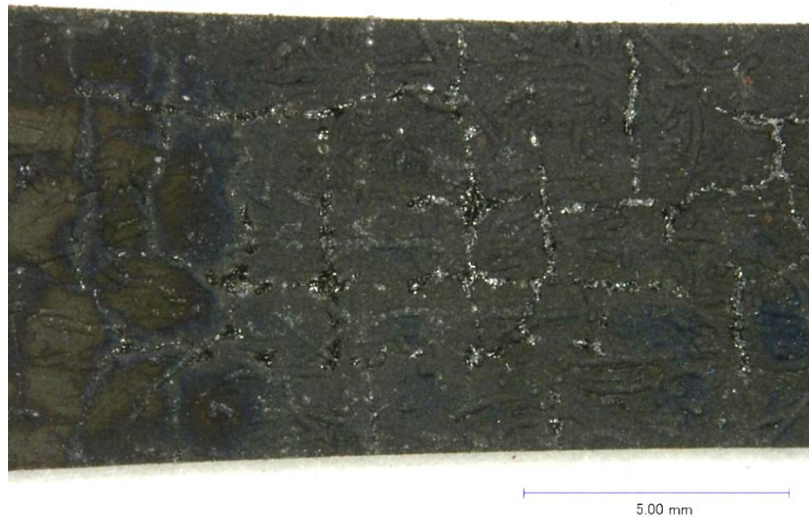
Figure 33. Optical Photograph of a Tension-Tested A500 C/SiC Sample (#13) After 600 Burner Rig Cycles and 48 Hours Salt Fog Exposure

Figure 32 shows a failed tensile specimen that saw 600 burner rig cycles plus a total of 48 hours of salt fog exposure, and Figure 33 shows a higher magnification of the gage section of the tensile specimen. Here, at 600 cycles one can observe a distinct cracking pattern in the higher magnification image and that the cracks appear to be filled in with a thin layer of white material. We know from SEM work that this white material is actually a foamy glass that is a by-product of the sealing phases in the matrix reacting with the moisture and salt during the burner rig exposures.

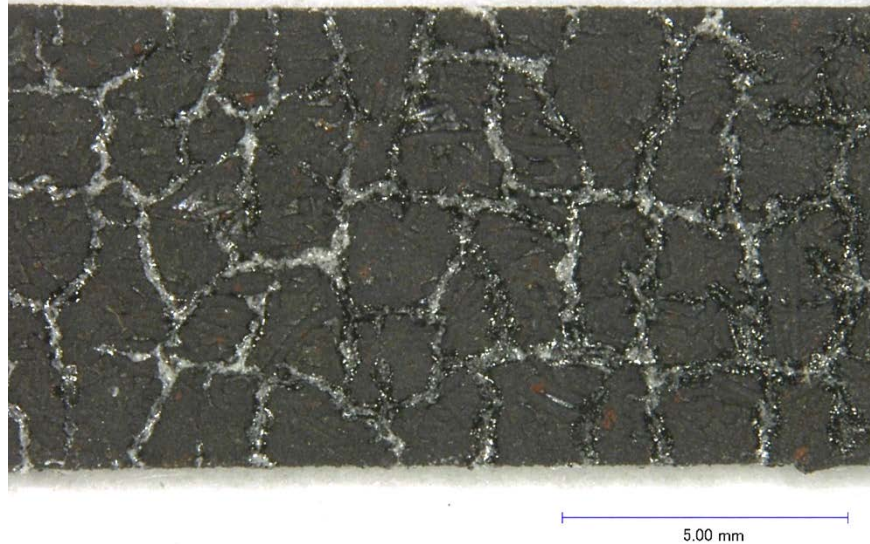
Figure 35. Optical Photograph of a Tension-Tested A500 C/SiC Sample (#4) After 900 Burner Rig Cycles and 72 Hours Salt Fog Exposure

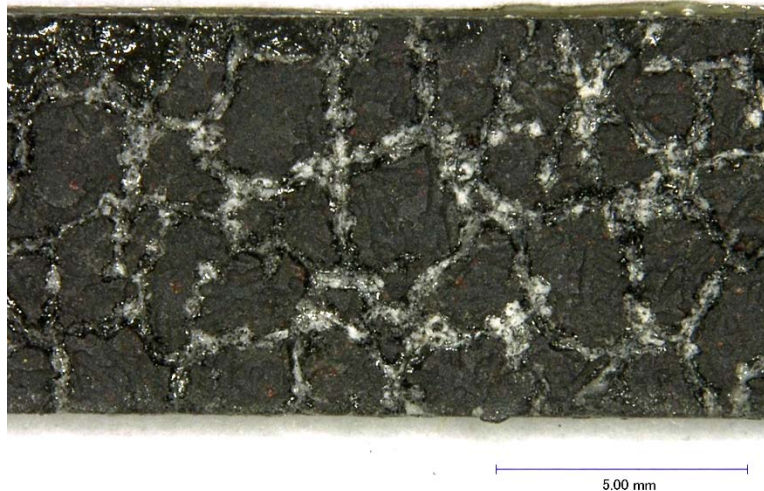
Figure 39. Optical Photograph of a Tension-Tested A500 C/SiC Sample (#8) After 1500 Burner Rig Cycles and 120 Hours Salt Fog Exposure

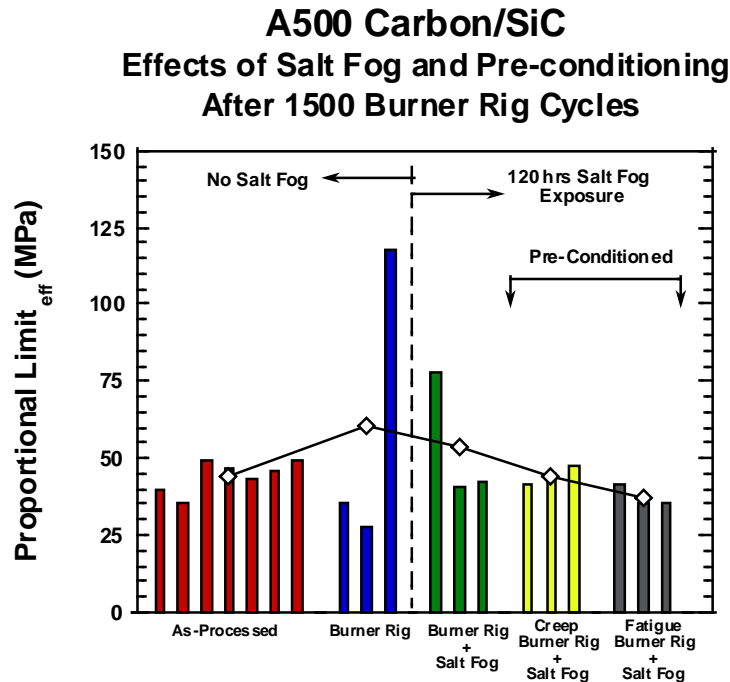
Figure 42. Proportional Limit Versus Test Condition for A500 C/SiC

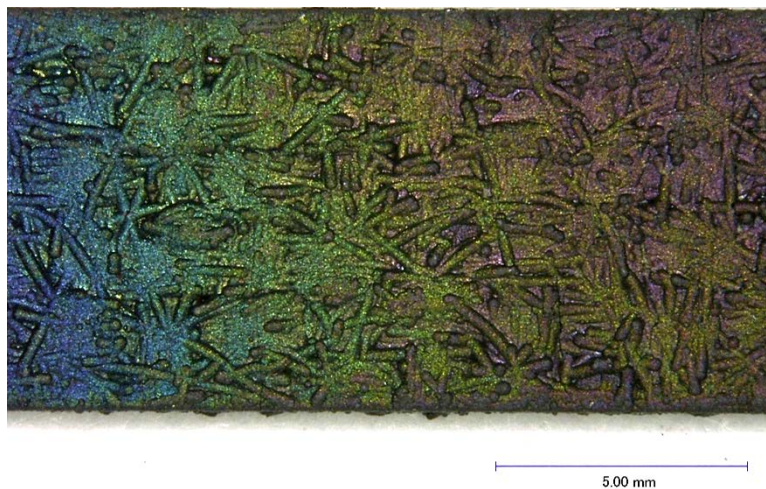
Figure 48. Optical Photograph Of The Surface Of The Gage Section of A500 C/SiC Specimen After 1500 Burner Rig Cycles and No Salt Fog Exposure

Figure 47 shows a failed specimen that saw 1500 burner rig cycles and Figure 48 is a higher magnification of the gage section. This sample does exhibit some discoloration in the gage section due to an extremely thin oxide layer forming on the surface of the specimen during exposure to the open flame. The color pattern was dependent on the location with respect to the flame, and indicates that the oxidized layer thickness varies with location and related maximum temperature.

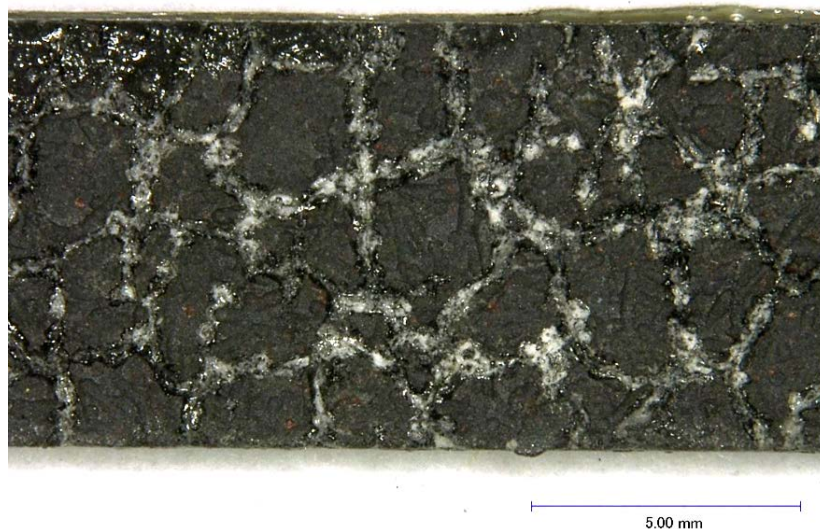
Figure 50. Optical Photograph Of The Surface Of The Gage Section of A500 C/SiC After 1500 Burner Rig Cycles Plus Salt Fog Exposure

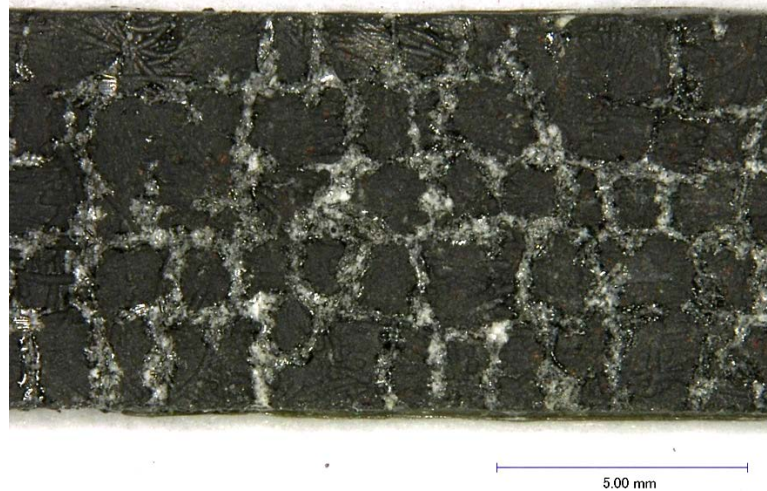
Figure 52. Optical Photograph of the Surface of the Gage Section of a A500 C/SiC Fatigue Specimen Pre-conditioned (1 Hz, 150 MPa, 24°C, 1000 Cycles) After 1500 Burner Rig Cycles Plus Salt Fog Exposure
