Architectural and Landscape Survey of Camp Guernsey, Wyoming

Adam D. Smith, Megan W. Tooker, and Sunny E. Adams

June 2017

Under Project Number 458417, "Camp Guernsey Historic Context and Building
Evaluation"

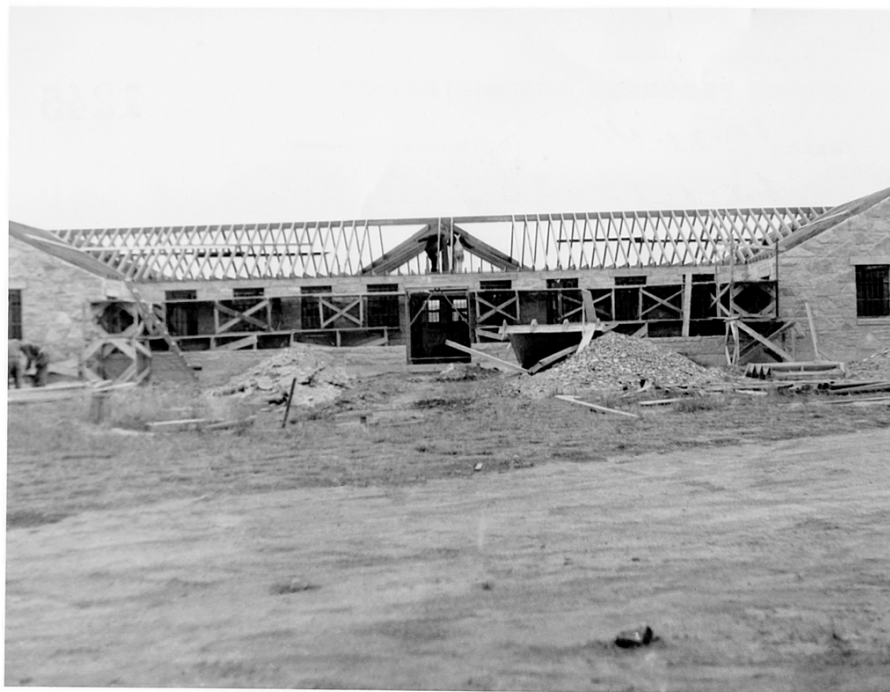
Figure 9. Building 201, officers' mess hall at Camp Guernsey under construction, 1939 (Wyoming State Archives).

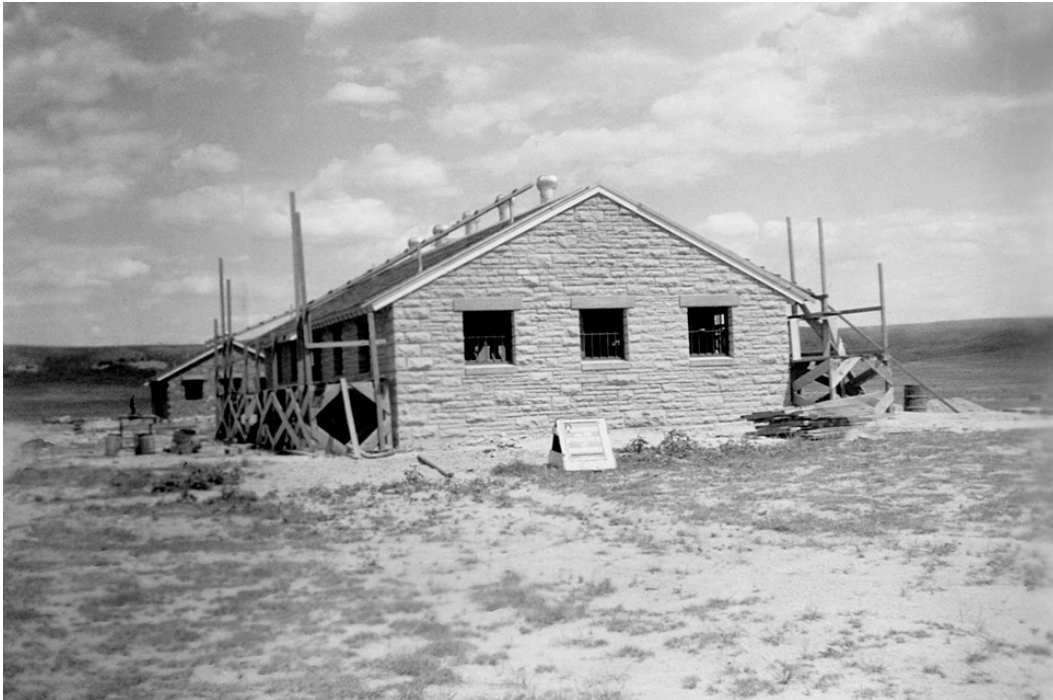
Figure 12. One of the first group of enlisted men's latrines (Buildings 312, 313, 315, 316) at Camp Guernsey under construction, 1939 (Wyoming State Archives).

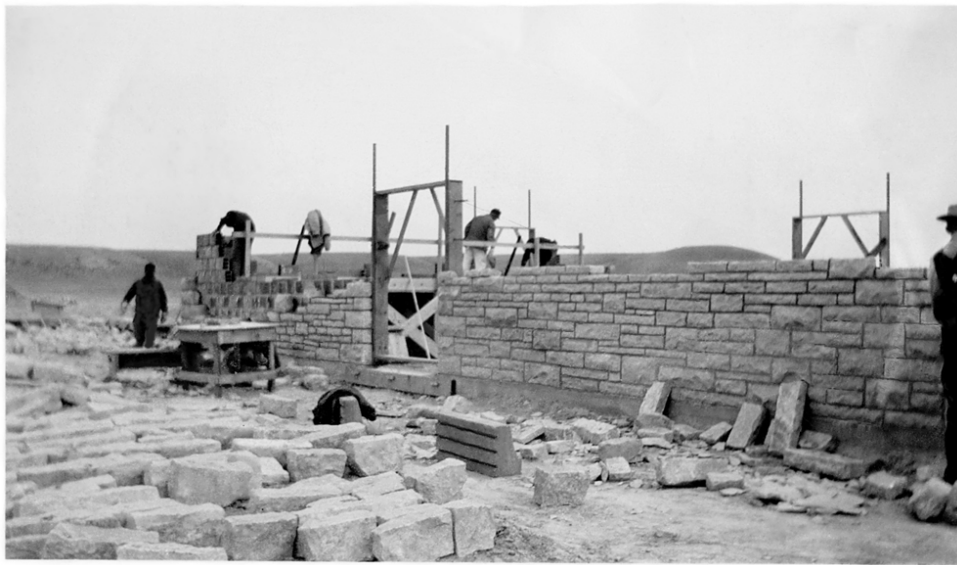
Figure 14. One of the enlisted men's latrines at Camp Guernsey under construction with random-laid, cut ashlar masonry, 1939 (Wyoming State Archives).

altering design plans. One significant change was that the stone masonry veneer used for the building changed from random-laid, cut ashlar masonry (Figure 14) to uncut random rubble masonry (Figure 15). This change decreased construction time by nearly half. As a result, the difference in the first phase of building at Camp Guernsey is visible by the different masonry veneer. The cantonment included 21 buildings built under the first phase of the WPA grant, and eight more built under a second phase. Additionally, the cantonment included more than 169 concrete tent floors for use by troops, officers, and staff. The second phase of construction included the addition of sidewalks, streets, fences and other landscaping, sewers, and other infrastructure.¹⁷

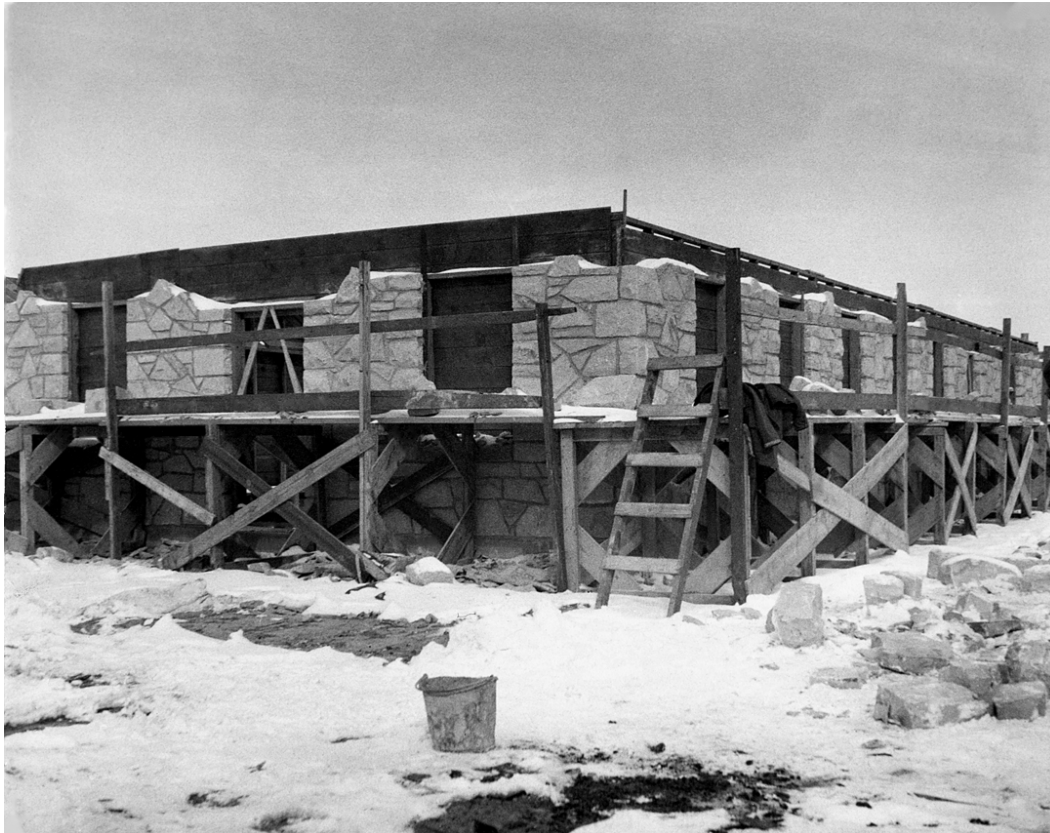
Figure 15. One of the enlisted men's mess halls (Buildings 211–223) at Camp Guernsey under construction with uncut random rubble masonry, 1939 (Wyoming State Archives).

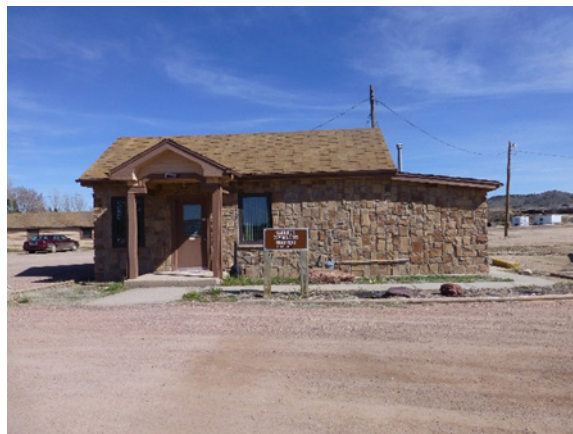
Figure 28. South elevation of Building 010 at Camp Guernsey (ERDC-CERL, 2016).

Building 010 is a small one-story wood-frame building with a concrete foundation, stone veneer exterior walls, a gable roof clad with asphalt shingles, and overhanging eaves (Figure 28). The fascia and soffit are wood. The windows are replacement, single-pane, anodized-bronze aluminum. A lean-to addition is located on the east side of the original structure. The addition has a shed roof clad with asphalt shingles and stone veneer exterior walls.

The south elevation of Building 010 faces Hunton Road and overlooks the parade ground (Figure 28). An open gable roof porch is supported by two wood columns, and it protects a replacement door on the left side of the elevation. A replacement window flanks either side of the entry bay (Figure 28). The right side of the south elevation is part of the lean-to addition. The west elevation faces Buildings 201 and 301. There are two replacement windows on this elevation (Figure 29 and Figure 30). The right side of the elevation is part of the original structure with two replacement windows and the left side is the lean-to addition (Figure 31). The east elevation faces Building 406. The original east elevation is no longer visible due to the construction of a lean-to addition. There is a single-entry replacement door located in the center of the elevation and a narrow replacement window located on the left side of the elevation (Figure 32).

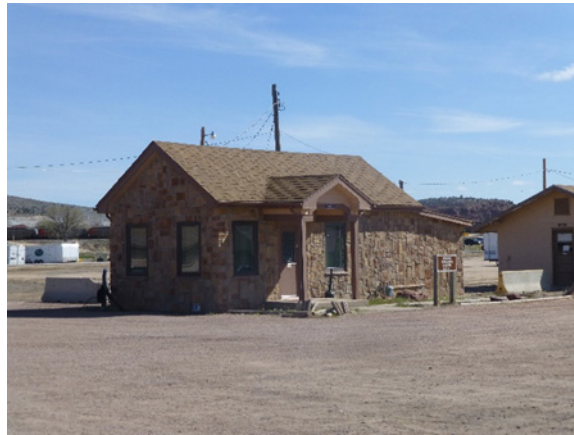
Figure 29. Southwest oblique of Building 010 at Camp Guernsey (ERDC-CERL, 2016).

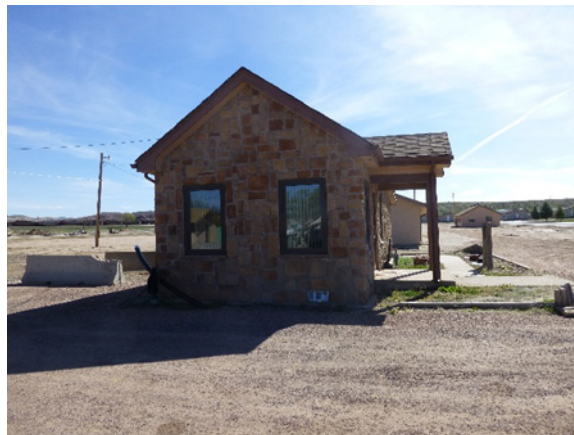
Figure 30. West elevation of Building 010 at Camp Guernsey (ERDC-CERL, 2016).

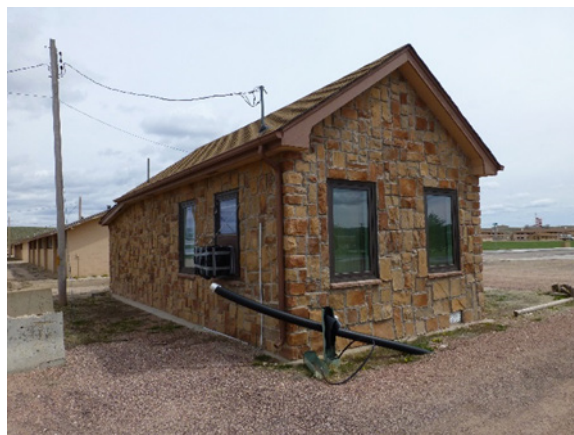
Figure 31. Northwest oblique of Building 010 at Camp Guernsey (ERDC-CERL, 2016).

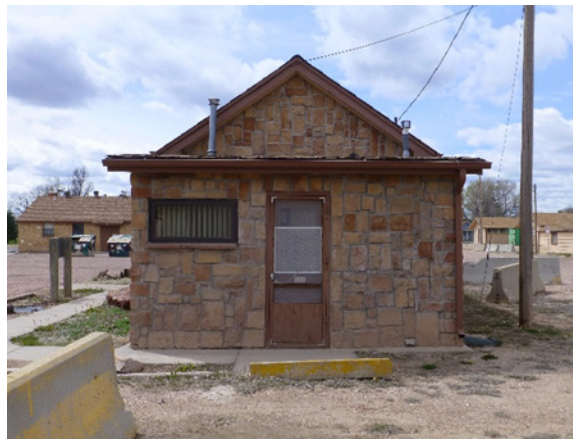
Figure 32. East elevation of Building 010 at Camp Guernsey (ERDC-CERL, 2016).

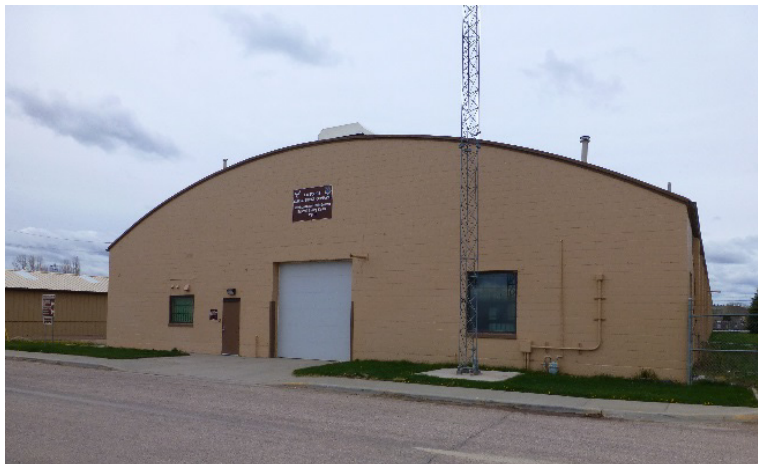
Figure 35. East elevation of Building 011 at Camp Guernsey (ERDC-CERL, 2016).

Building 011 is a large, double-height, rectangular structure with a concrete foundation, concrete block exterior walls, and an arched roof with built-up roofing (Figure 35–Figure 37). The north and south elevations are divided into bays by concrete block pilasters. The majority of the original multipane windows (Figure 37) have been replaced with single-pane anodized-bronze aluminum windows (Figure 38). The windowsills are concrete. The entry doors are replacement metal (Figure 37), and the large metal roll-up doors have been replaced (Figure 35). The building is oriented in an east-west direction. There have been two additions constructed on the south side of the original structure (Figure 39).

The east elevation of Building 011 faces Fremont Avenue and consists of a centrally placed roll-up door, flanked on either side by replacement windows. There is a single-entry replacement door located to the left of the roll-up door. A narrow strip of grassy lawn stretches in front of the elevation with a poured concrete driveway leading to the roll-up door. A detached metal antenna tower is placed on a concrete pad in front of the building (refer to Figure 35).

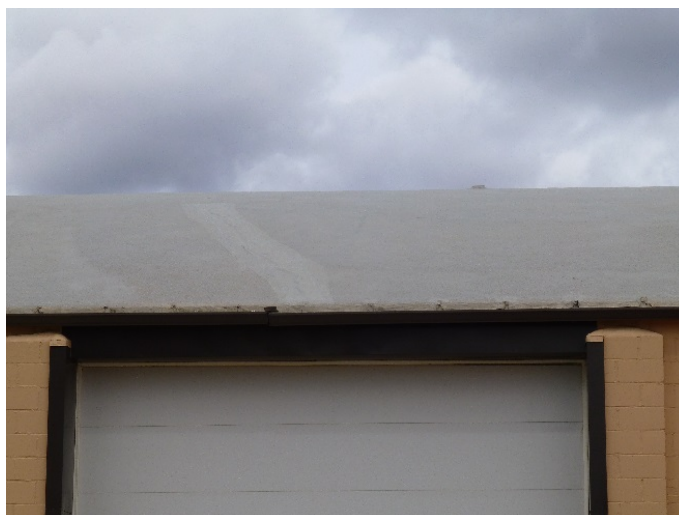
Figure 36. Close-up of the arched roof and built-up roofing on south side of Building 011 at Camp Guernsey (ERDC-CERL, 2016).

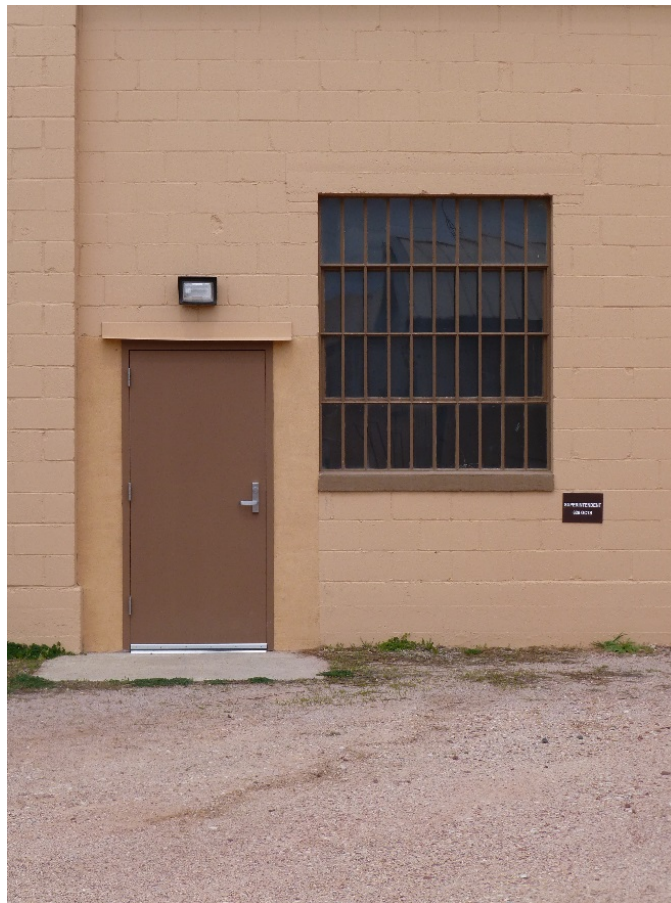
Figure 37. Original multipane steel-sash industrial window and replacement metal door on the south side of Building 011 at Camp Guernsey (ERDC-CERL, 2016).

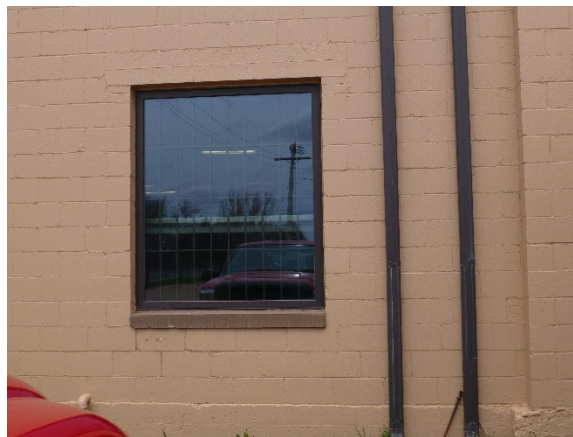
Figure 38. Replacement, single-pane, anodized-bronze aluminum window on the south side of Building 011 at Camp Guernsey (ERDC-CERL, 2016).

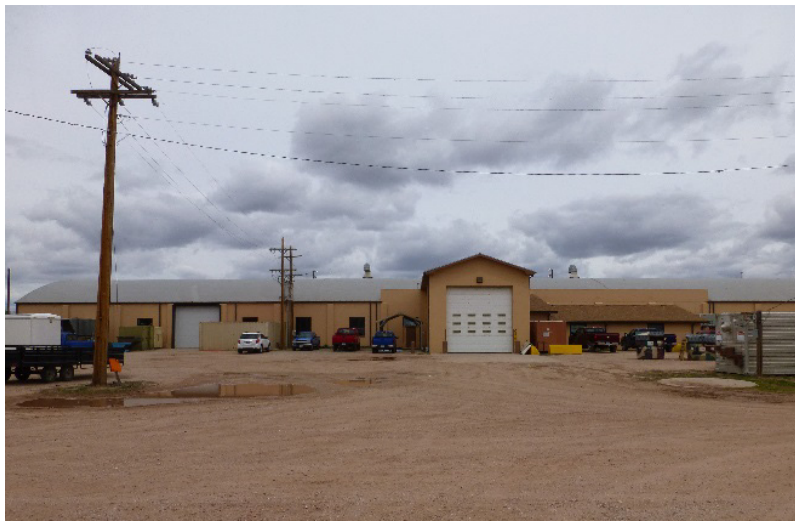
Figure 39. Overall view of the south elevation of Building 011 at Camp Guernsey (ERDC-CERL, 2016).

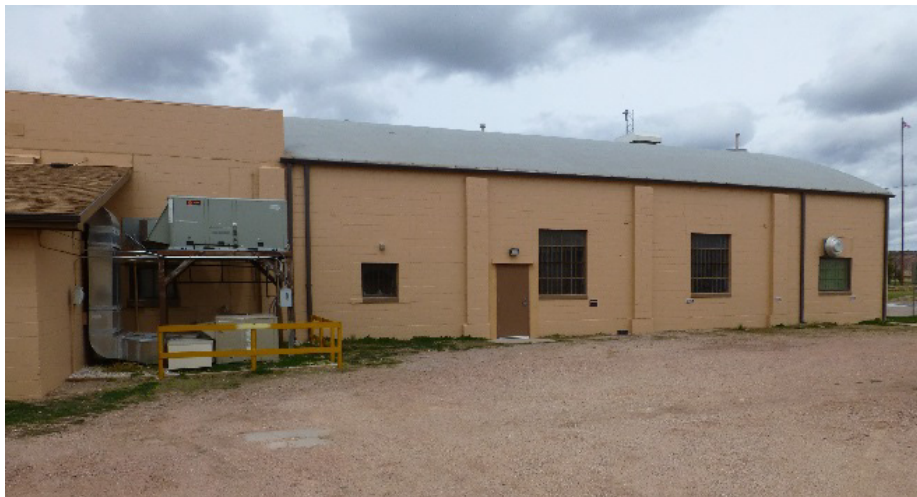
Figure 40. Right side of Building 011 at Camp Guernsey, exemplifying how the south elevation originally looked with concrete block walls and concrete block pilasters (ERDC-CERL, 2016).

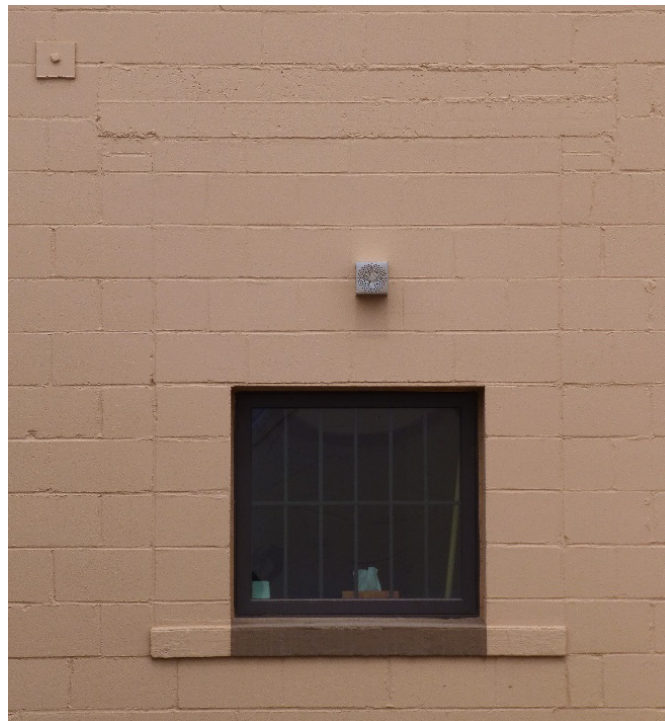
Figure 41. Modified window opening on the right side of the original south elevation of Building 011 at Camp Guernsey (ERDC-CERL, 2016).

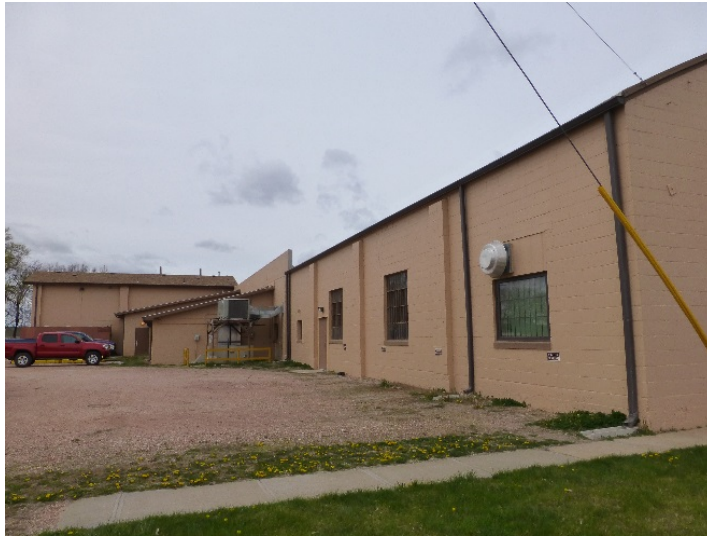
Figure 42. Looking west toward the right side of the original south elevation and at the east elevation of the one-story shed roof addition and double-height addition of Building 011 at Camp Guernsey (ERDC-CERL, 2016).

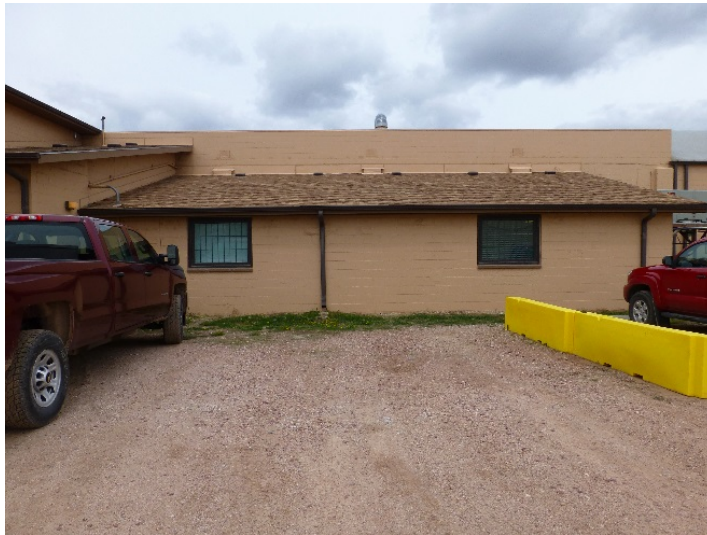
Figure 43. South elevation of the one-story, shed roof addition on the south side of Building 011 at Camp Guernsey (ERDC-CERL, 2016).

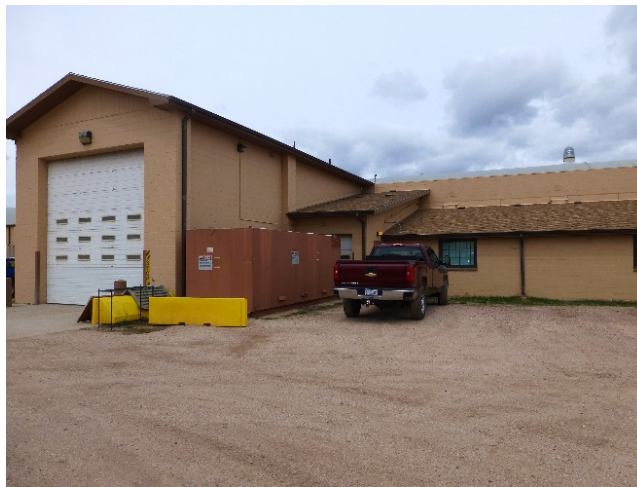
Figure 44. Southeast oblique of the double-height bay addition on the south side of Building 011 at Camp Guernsey (ERDC-CERL, 2016).

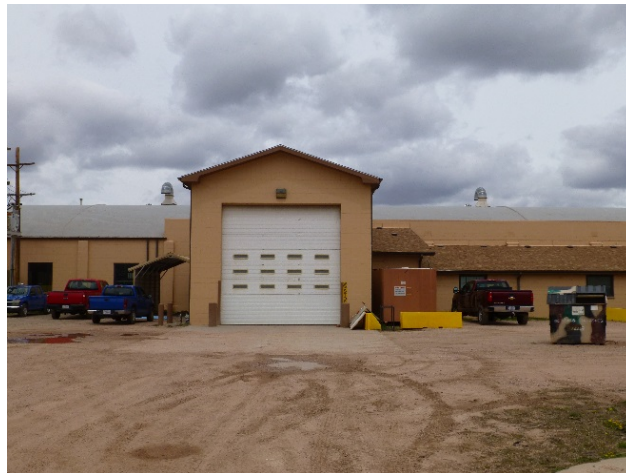
Figure 46. West elevation of the double-height bay addition on the south side of Building 011 at Camp Guernsey (ERDC-CERL, 2016).

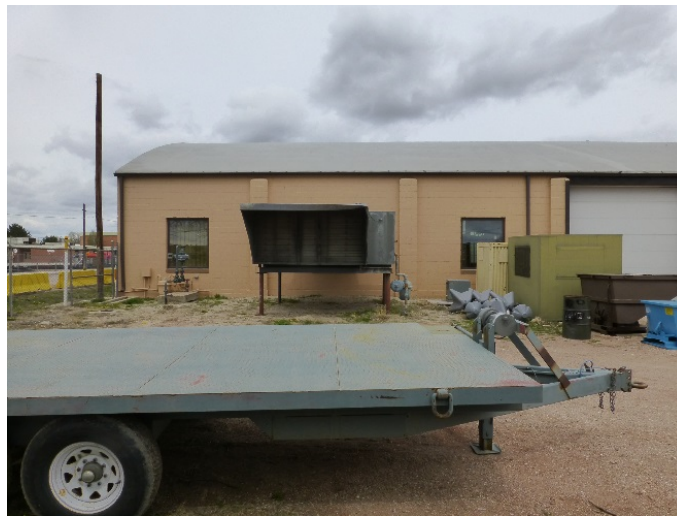
The north elevation of Building 011 overlooks a grassy area toward the high school athletic field that is outside the installation boundary. The north elevation is divided into 18 bays by concrete block pilasters (Figure 50). Each bay has a single-pane replacement window, with the exception of one bay that has a replacement entry door (Figure 51).

Figure 50. Looking southwest from the lawn in front of the headquarters (Building 101) toward the overall view of the north elevation of Building 011 at Camp Guernsey (ERDC-CERL, 2016).

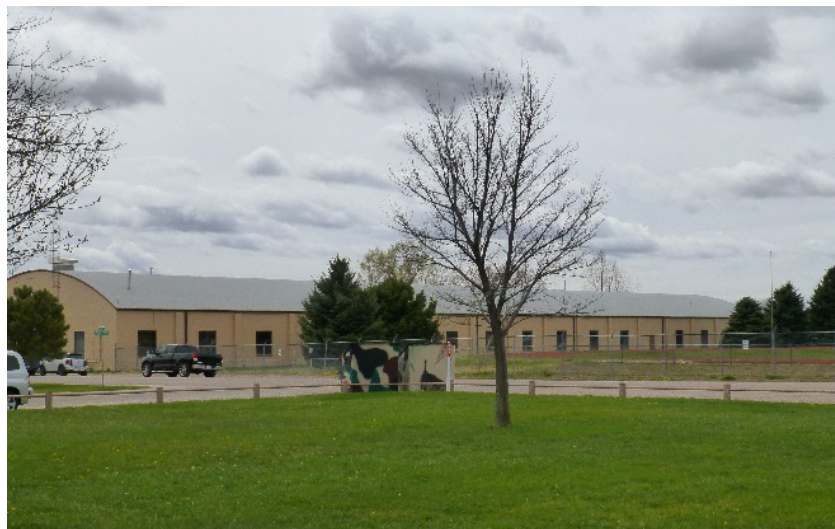
Figure 51. North elevation of Building 011 at Camp Guernsey (ERDC-CERL, 2016).

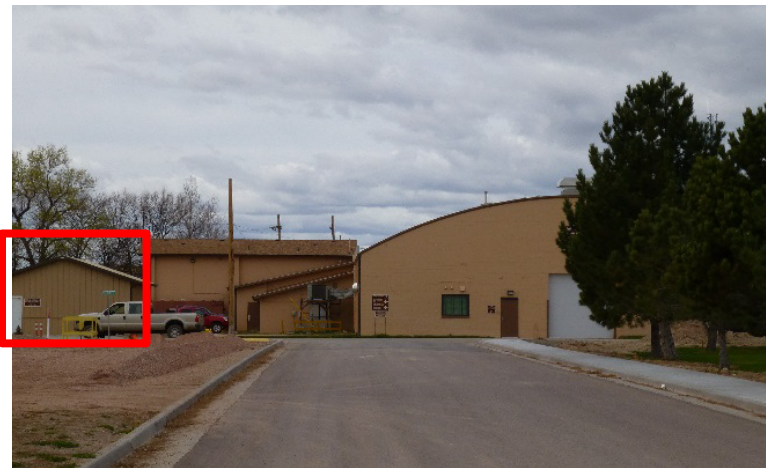
Building 011A is a one-story, prefabricated, metal structure with a rectangular footprint, a concrete foundation, and metal gable roof with overhanging eaves (Figure 54 and Figure 55). The building is oriented in the east-west direction. The east elevation faces Fremont Avenue and overlooks a large gravel lot. This elevation has one metal entry placed on the left side (Figure 54). A poured concrete pad is located in front of this elevation. The west elevation faces a gravel lot and consists a metal roll-up door on the left side of the elevation (Figure 55). A poured concrete pad is located in front of this door. There are no window or door openings on the north and south elevations.

Figure 54. Northeast oblique of Building 011A (ERDC-CERL, 2016).

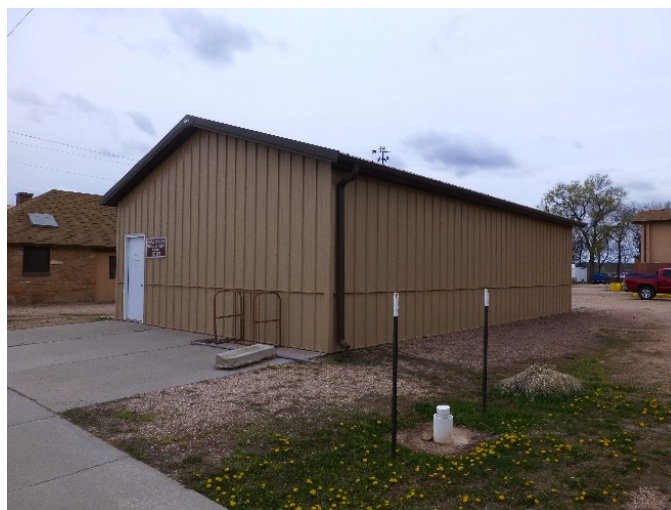
Figure 55. Southwest oblique of Building 011A (ERDC-CERL, 2016).

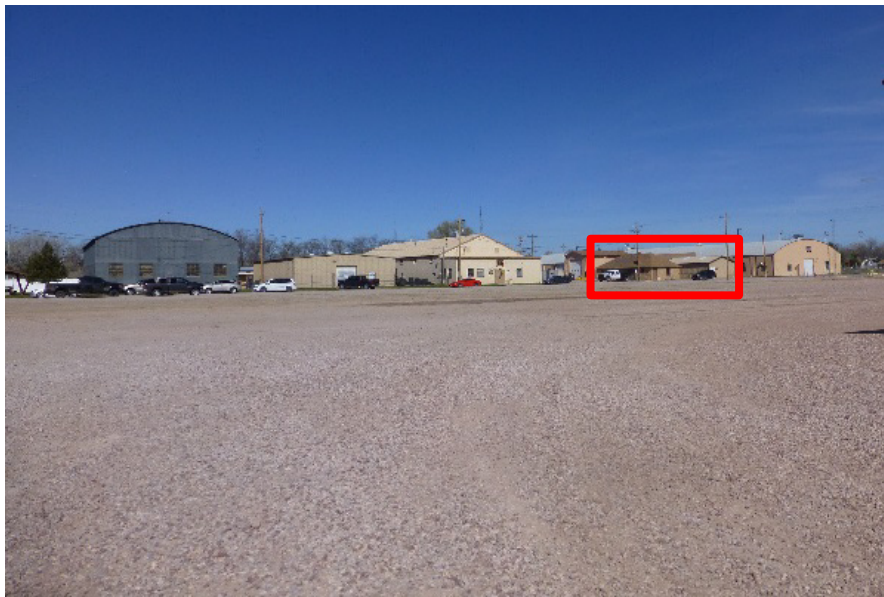
The east elevation faces Fremont Street (Figure 58). The exterior is clad with sandstone. There is a replacement door on the left side, and a replacement window on the right side of the east elevation. The south elevation faces Building 013. The right side of the south elevation is the original portion of the building and is clad with stone, and the left side is the addition that is clad with synthetic stucco material (Figure 64). There is a replacement window and an original set of wood doors on the right side, and window and single-entry door on the left side of the south

Figure 58. East elevation, part of the original Building 012 at Camp Guernsey (ERDC-CERL, 2016).

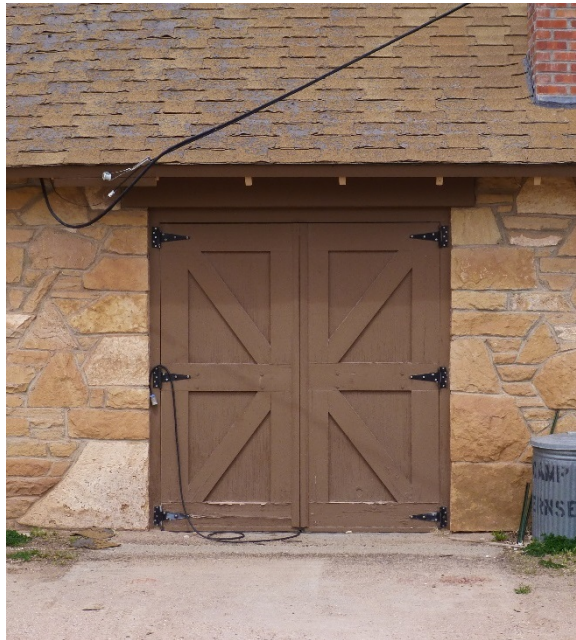
elevation. The west elevation faces a gravel lot and is void of any fenestration (Figure 65). The north elevation faces Building 011A. The left side of the west elevation is the original portion, and the right side is the modified addition. The left side has a modified door opening. The original doors have been removed, the concrete lintel above is intact, and the opening has been filled in and clad with synthetic stucco material. A window is placed in the modified opening (Figure 62).

Figure 62. Modified door opening on the left side of the north elevation of Building 012 at Camp Guernsey, with the intact concrete lintel above (ERDC-CERL, 2016).

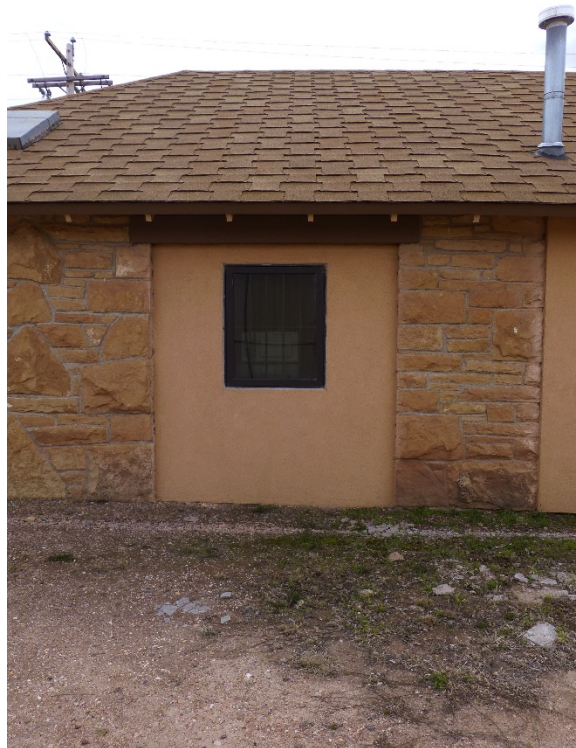
Building 012 is small rectangular structure with a concrete foundation. The building was built in two phases (Figure 64). The east end of the building is the original portion of the structure and has cut sandstone exterior walls, and the west end is a later addition that is clad with a synthetic stucco material (Figure 66). The addition retains the same proportions and roofline of the original. The hipped roof is clad with asphalt shingles and has overhanging eaves with exposed rafter tails on the original portion of the building (Figure 59). The windows are single-pane replacement windows (Figure 60). The windowsills are concrete (Figure 60). The entry door is replacement. There is a set of original wood doors on the south elevation (Figure 61). A modified door opening is on the north elevation (Figure 62). An internal brick chimney with a concrete cap is located on the southeast corner of the roof (Figure 63).

Figure 63. Brick chimney on the southeast corner of the roof of Building 012 at Camp Guernsey (ERDC-CERL, 2016).

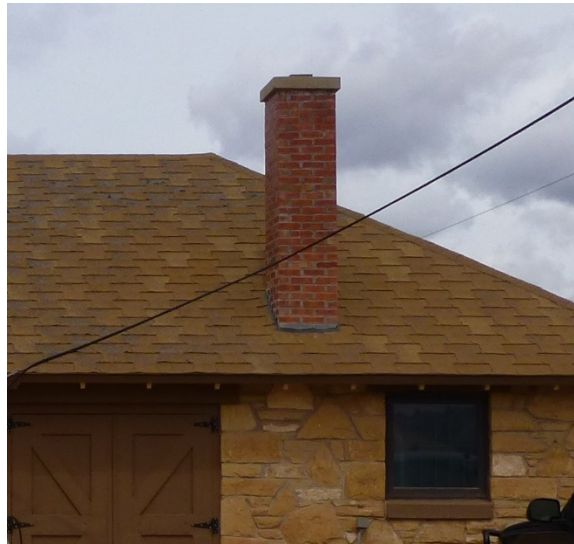
Figure 64. South elevation with original building [right] and addition [left] of Building 012 at Camp Guernsey (ERDC-CERL, 2016).

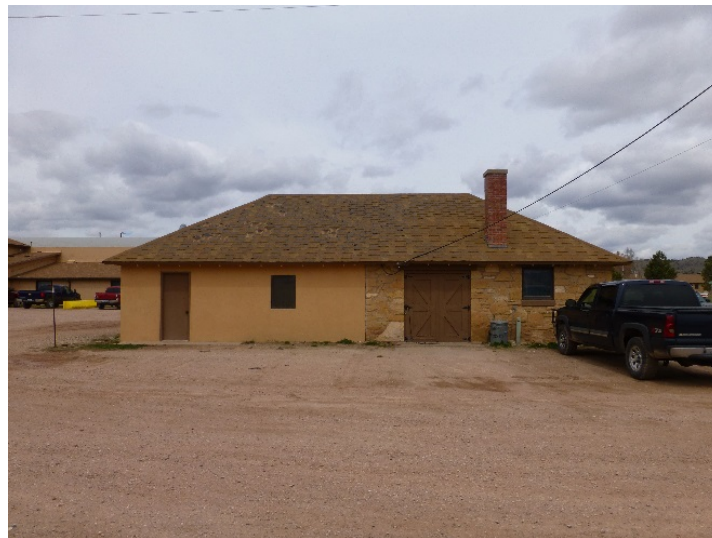
Figure 65. Northwest oblique of the addition of Building 012 at Camp Guernsey (ERDC-CERL, 2016).

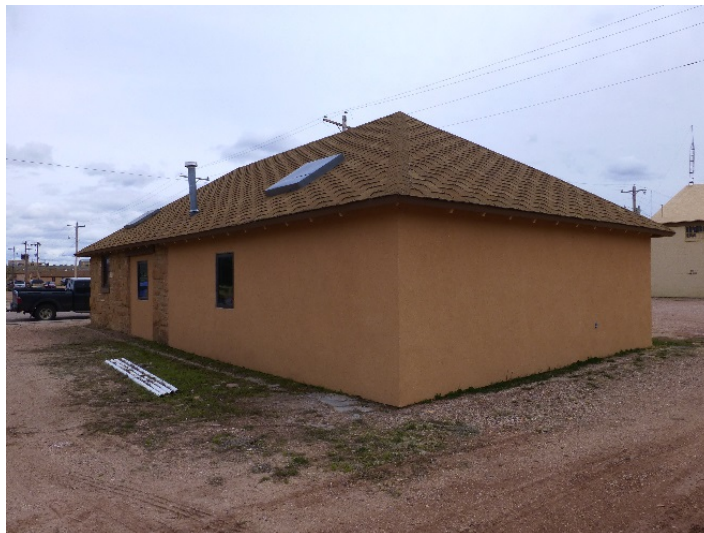
Figure 66. Close-up of the connection between the original stone exterior wall and overhanging eave with rafter [left] and the modified addition now clad with synthetic stucco material [right] on Building 012 at Camp Guernsey (ERDC-CERL, 2016).

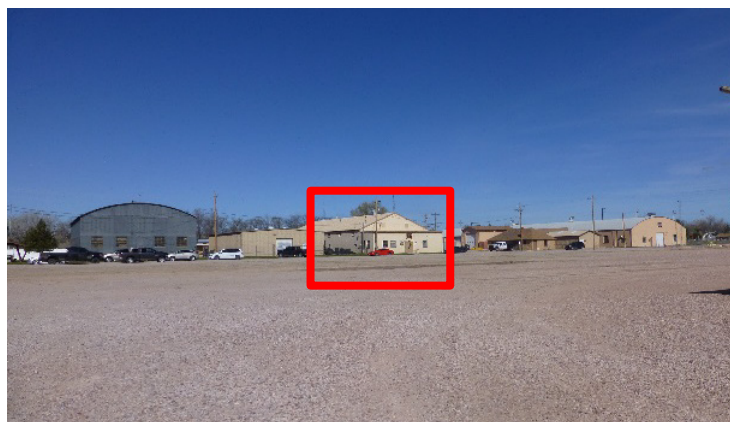
The east elevation of Building 013 faces Fremont Avenue. The foreground is the one-story portion, with a centrally placed set of metal doors flanked on the left by two replacement windows and on the right with one replacement window and one modified window opening (Figure 69). A narrow strip of grassy lawn stretches in front of the east elevation, and a poured concrete sidewalk with concrete steps and concrete ramp lead to the entry doors.

Figure 69. East elevation of Building 013 at Camp Guernsey (ERDC-CERL, 2016).

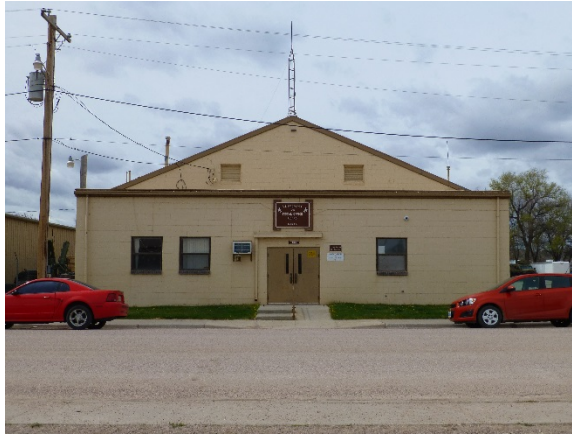
Building 013 is a long rectangular structure with a concrete foundation, concrete block walls, and a gable roof (Figure 69). The original roof was corrugated metal, and the built-up roofing material was added at a later date (Figure 70 and Figure 71). The majority of the building is double-height, with a one-story concrete block appendage on the east side (Figure 69). The one-story portion has a shallow shed roof. Original multipane steel-sash windows with brick windowsills are nestled under the roof line on the north and south elevations (Figure 72). Replacement one-over-one anodized-bronze aluminum windows with brick windowsills are on the east side of the one-story portion (Figure 73). The entry doors are metal with a narrow pane, and the overhead door is metal (Figure 74 and Figure 76).

Figure 70. Close-up of the modified metal roof with the addition of spray foam material on Building 013 at Camp Guernsey (ERDC-CERL, 2016).

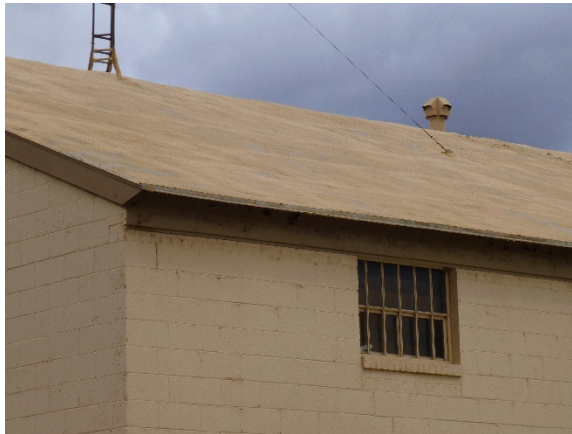
Figure 71. Close-up of the overhanging eave on the north and south elevations of Building 013 at Camp Guernsey, with the original, exposed, corrugated roofing material and metal fascia system (ERDC-CERL, 2016).

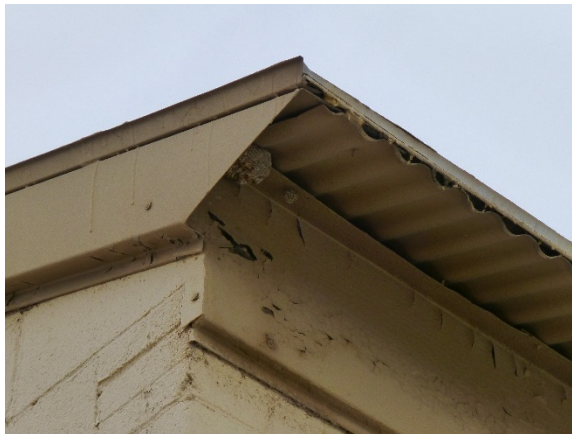
Figure 72. Original multipane steel-sash industrial-style window on the north and south elevations of Building 013 at Camp Guernsey (ERDC-CERL, 2016).

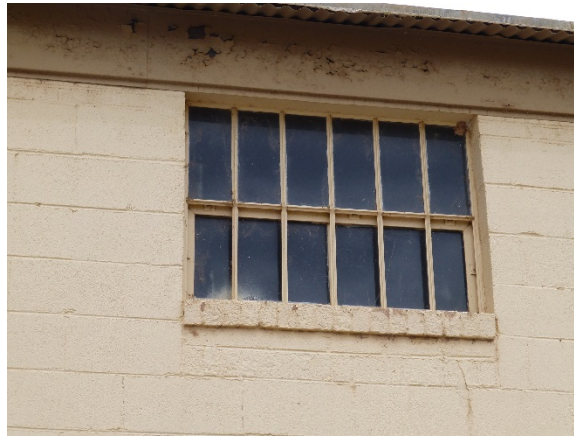
Figure 73. Replacement one-over-one windows on the east elevation of Building 013 at Camp Guernsey (ERDC-CERL, 2016).

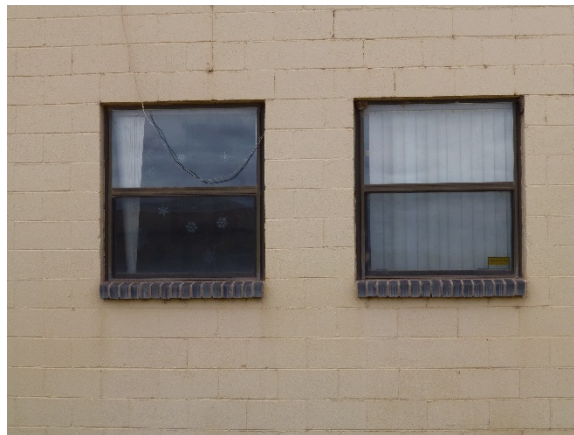
Figure 74. Metal entry doors with narrow pane on the east elevation of Building 013 at Camp Guernsey (ERDC-CERL, 2016).

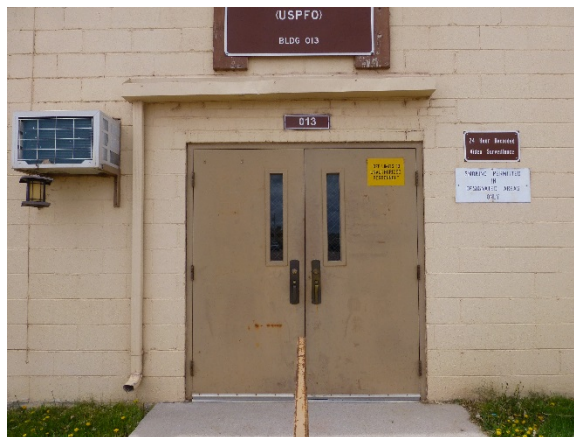
The south elevation of Building 013 faces Building 13A. There are seven, evenly spaced, original windows that are placed at the top of the concrete block wall underneath the roof line (Figure 75).

Figure 75. Southwest oblique of Building 013 at Camp Guernsey (ERDC-CERL, 2016).

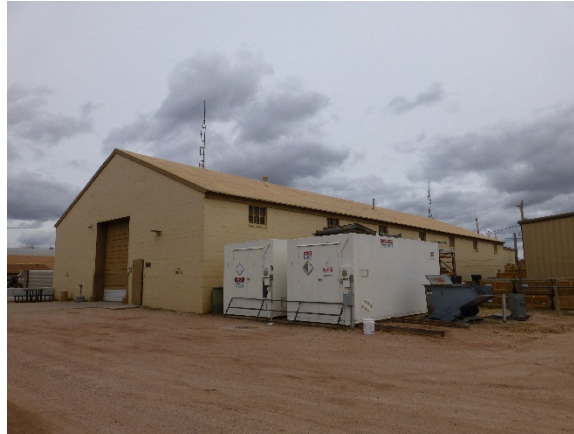
The west elevation of Building 013 faces a gravel lot. There is a centrally placed, large, metal overhead door that is flanked on the right side by a single-entry replacement metal door (Figure 75 and Figure 76).

Figure 76. West elevation of Building 013 at Camp Guernsey (ERDC-CERL, 2016).

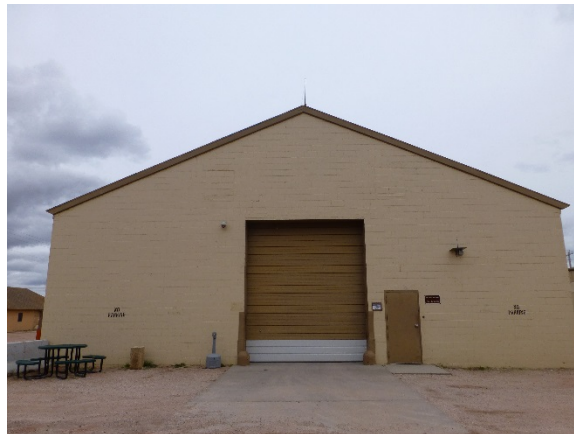
The north elevation of Building 013 faces a gravel lot and Buildings 011 and 012. It is similar to the south elevation, with seven evenly spaced, original windows that are placed at the top of the concrete block wall underneath the roof line (Figure 77).

Figure 77. North elevation of Building 013 at Camp Guernsey (ERDC-CERL, 2016).

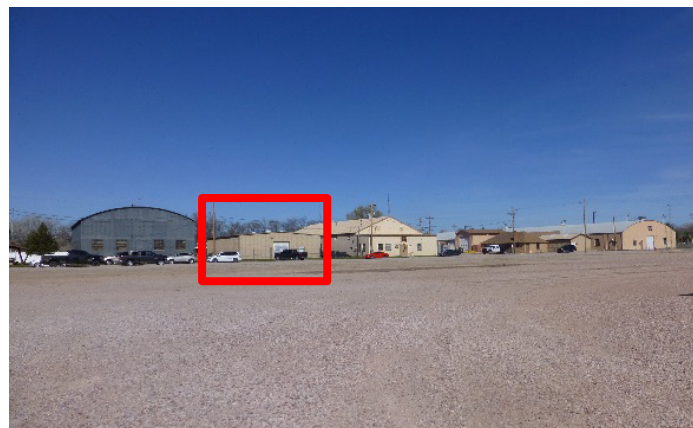
Building 013A is a one-story building with a rectangular footprint, a concrete foundation, metal-clad exterior walls, and a gable roof clad with metal roofing material with overhanging eaves on the north and south sides (Figure 80). The east elevation faces Fremont Avenue and overlooks a large gravel lot. There is a centrally placed metal overhead door flanked on the right side by a metal single-entry door (Figure 80). The west elevation faces a gravel lot and consists of a centrally placed metal overhead door flanked on the left side by metal single-entry door (Figure 81). There are no window or door openings on the north and south elevations.

Figure 80. Northeast oblique of Building 013A at Camp Guernsey (ERDC-CERL, 2016).

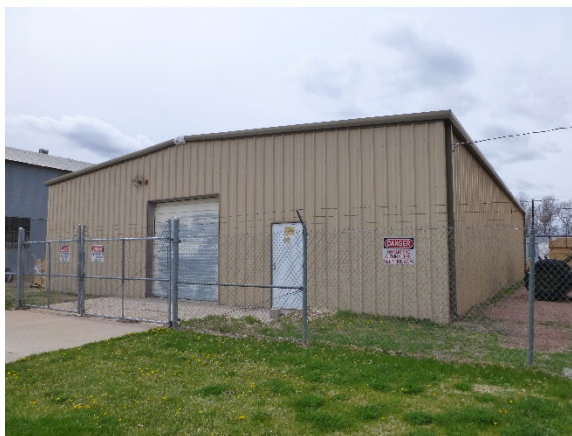
Figure 81. West elevation of Building 013A at Camp Guernsey (ERDC-CERL, 2016).

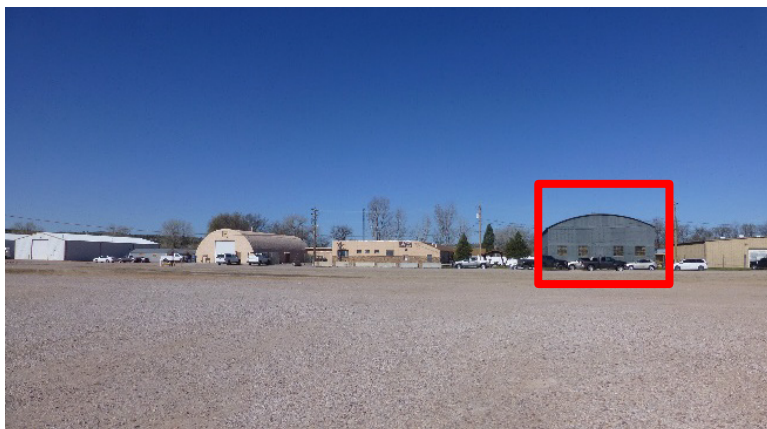
Building 014 is a large double-height metal-framed structure with a rectangular footprint (Figure 84). The building is oriented in an east-west direction. It has a concrete foundation, metal frame and trusses, exterior walls clad with galvanized corrugated-metal sheets, and a corrugated-metal arched roof (Figure 85). The windows are original multipane steel-sash awning industrial-style (Figure 86). The entry door is an original, metal, panel door (Figure 87), and the overhead door is a replacement (Figure 88). A small, star-shaped shield reading “Starbilt” is placed near the top center of the east and west elevations (Figure 89).

The east elevation faces Fremont Avenue and overlooks a large gravel lot. A small grassy area with a concrete sidewalk stretches along this elevation (Figure 84). An original metal door is placed in the center of the elevation flanked on either side by two original windows (Figure 84). The south elevation faces a grassy area between Building 014 and 015 (Figure 90). There are eight evenly spaced original windows (Figure 90). The west elevation faces a gravel lot and consists of a central replacement metal overhead door flanked on either side by two original windows (Figure 91). The north elevation faces a 013A building and consists of eight evenly spaced original windows (Figure 92).

Figure 84. Southeast oblique of Building 014 at Camp Guernsey (ERDC-CERL, 2016).

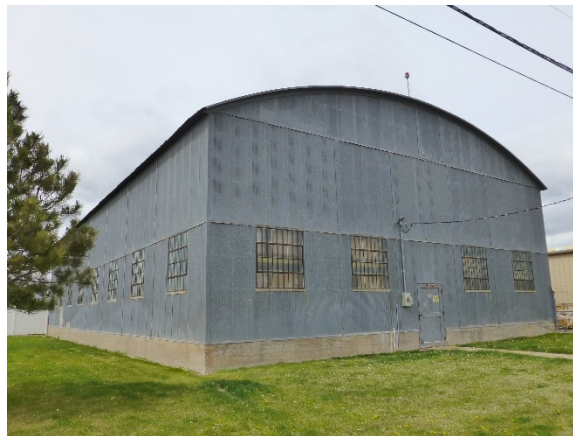
Figure 85. Close-up of the corrugated metal roof on Building 014 at Camp Guernsey (ERDC-CERL, 2016).

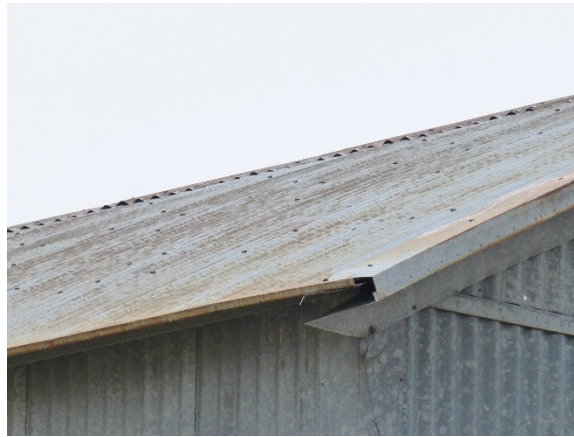
Figure 86. Original multipane steel-sash awning industrial-style window on Building 014 at Camp Guernsey (ERDC-CERL, 2016).

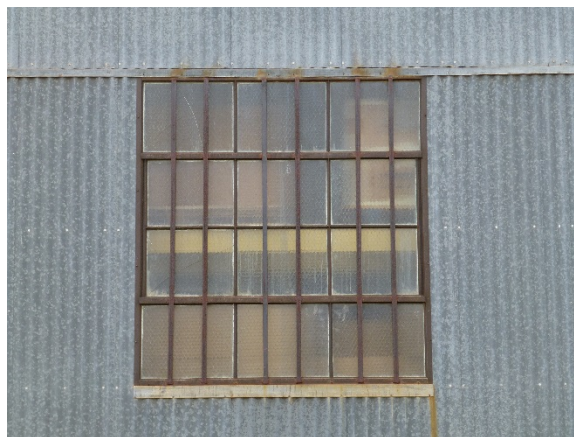
Figure 87. Original metal panel entry door on the east elevation of Building 014 at Camp Guernsey (ERDC-CERL, 2016).

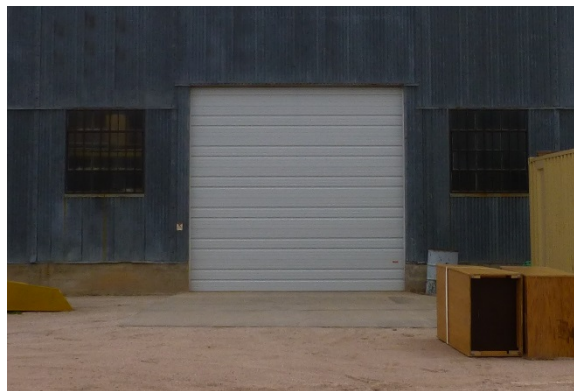
Figure 89. “Starbilt” star-shaped shield on the east and west elevations of Building 014 at Camp Guernsey (ERDC-CERL, 2016).

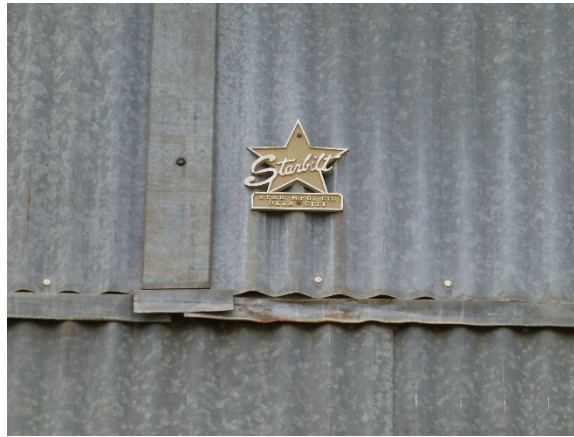
Figure 90. South elevation of Building 014 at Camp Guernsey (ERDC-CERL, 2016).

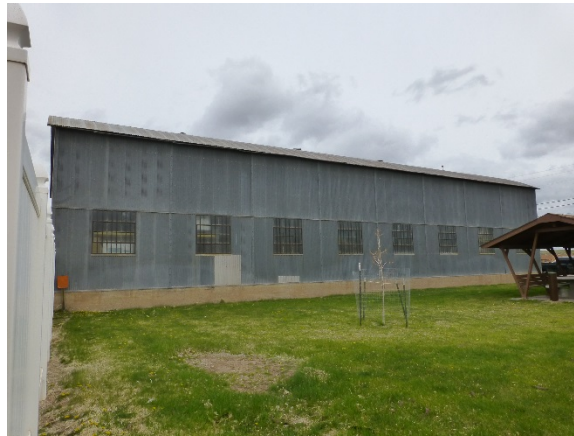
Figure 91. West elevation of Building 014 at Camp Guernsey (ERDC-CERL, 2016).

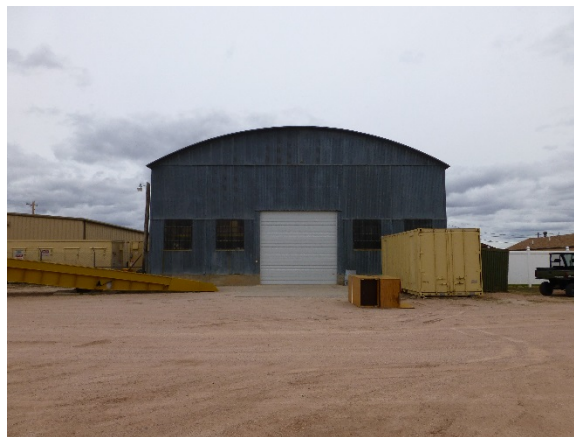
Figure 92. North elevation of Building 014 at Camp Guernsey (ERDC-CERL, 2016).

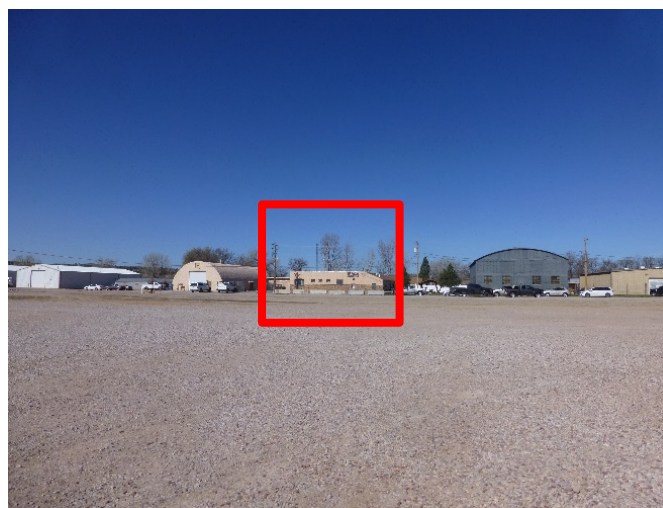
Figure 95. East elevation of Building 015 at Camp Guernsey (ERDC-CERL, 2016).

The east elevation of Building 015 faces Fremont Avenue and is characterized by a half wall constructed of cut stone veneer with a concrete cap on the bottom and synthetic stucco clad exterior wall on the top (Figure 95 and Figure 96). The right side of the elevation with the gable roof is part of the original structure and consists of single-entry metal door and a window (Figure 95). The middle and left section of the elevation are part of the later concrete block addition. There is a three-pane metal-sash slider window, three small single-pane fixed windows, and a two-pane slider window on this part of the elevation (Figure 95 and Figure 96).

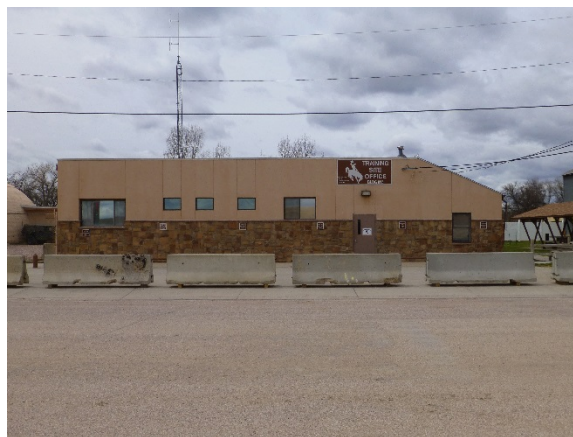
Figure 96. Southeast oblique of the later concrete block southeast addition on Building 015 at Camp Guernsey (ERDC-CERL, 2016).
