Architectural and Landscape Survey of Camp Guernsey, Wyoming

Adam D. Smith, Megan W. Tooker, and Sunny E. Adams

June 2017

Under Project Number 458417, "Camp Guernsey Historic Context and Building
Evaluation"

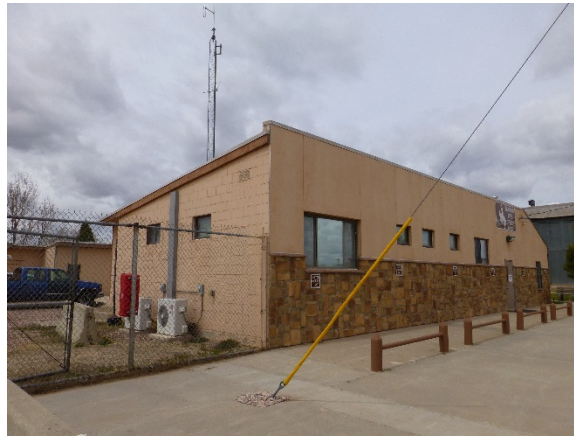
Figure 97. South elevation of the later concrete block southeast addition on Building 015 at Camp Guernsey (ERDC-CERL, 2016).

The south elevation of Building 015 faces Building 016 and overlooks an enclosed gravel lot (Figure 98). The right side of the elevation is the later concrete block addition with a shed roof and wood fascia (Figure 97). The south elevation has one small single-pane fixed window, one small two-pane fixed window, and a recessed entry with a metal door and metal frame screen door (Figure 97). A set of poured concrete steps provide access to this entry. The middle section of the south elevation is part of the original structure (Figure 98). The south exterior wall is clad with wood-grain Masonite siding, and there are five one-over-one replacement windows on this part of the south elevation (Figure 98). The left side of the south elevation is another later, concrete block addition with a shed roof; however, the majority of this part of the building is covered with an even later concrete block addition that connects Building 015 to Building 016 (Figure 98).

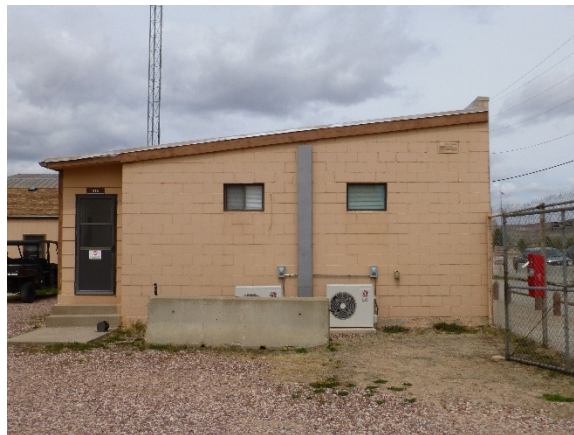
Figure 98. Overall south elevation of Building 015 at Camp Guernsey: concrete block addition [left], original [middle], and concrete block addition [right] (ERDC-CERL, 2016).

The inside of the U-shape; the west elevation of the southeast concrete block addition consists of two small windows. The east elevation of the southwest concrete block addition has an overhanging eave and three one-over-one windows (Figure 98).

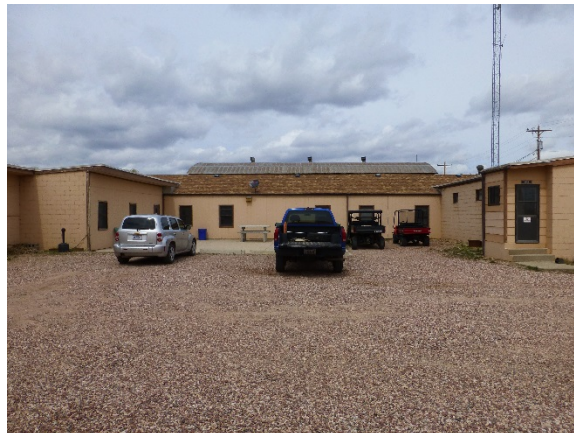
Figure 99. West elevation of the original Building 015 at Camp Guernsey (ERDC-CERL, 2016).

The west elevation faces Buildings 527G and 527H. The left side of the elevation is part of the original structure with a gable roof, is clad with wood-grain Masonite siding, and consists of a metal entry door with an adjacent one-over-one window (Figure 99). The right side of the elevation is the later concrete block addition and consists of two one-over-one windows (Figure 100). The right side is connected to the even later concrete block addition that connects Building 015 to Building 016 (Figure 100).

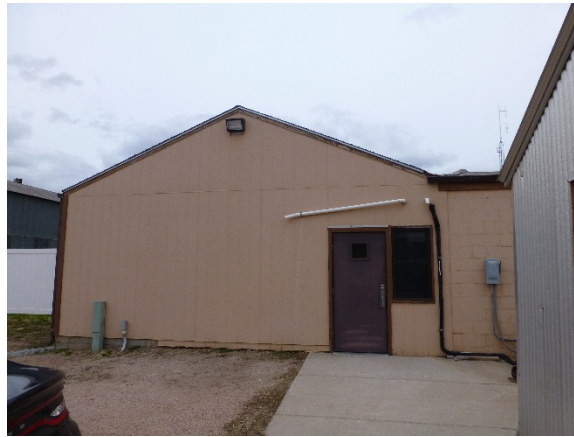
Figure 100. West elevation of the later concrete block addition and the even later concrete block addition connecting Building 015 to Building 016 at Camp Guernsey (ERDC-CERL, 2016).

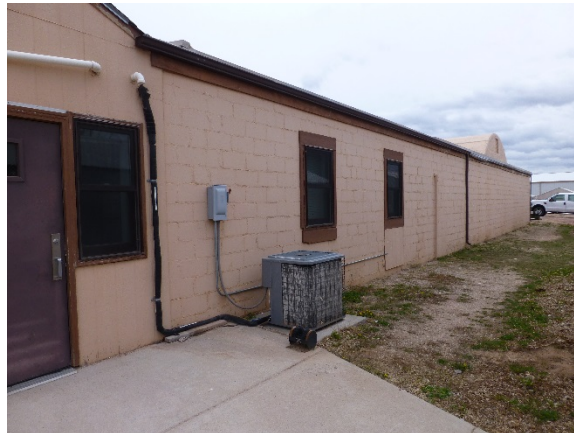
Figure 101. Right side of the north elevation part of the original Building 015 at Camp Guernsey (ERDC-CERL, 2016).

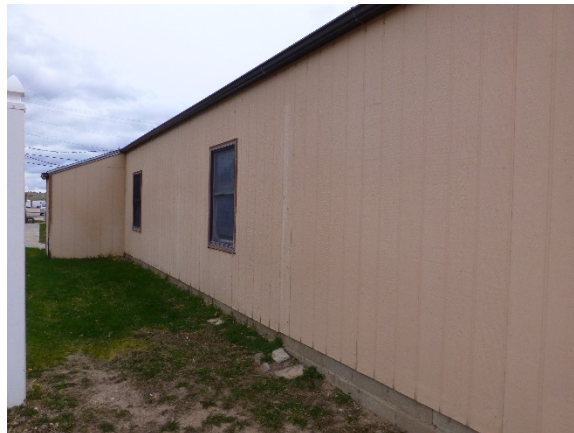
Figure 102. North elevation part of the original Building 015 at Camp Guernsey (ERDC-CERL, 2016).

The north elevation faces the grassy area between Building 015 and Building 014. This elevation is part of the original structure with a gable roof. It is clad with wood-grain Masonite siding. There are two one-over-one windows on the right side of the elevation. A projecting enclosed vestibule is clad with the same wood-grain Masonite siding and has a shed roof (Figure 101). A single metal entry door is located on the east side of the vestibule with a poured concrete sidewalk leading to the east side of the building (Figure 102). There are five one-over-one windows and two smaller slider windows are located on the east side of the elevation (Figure 102).

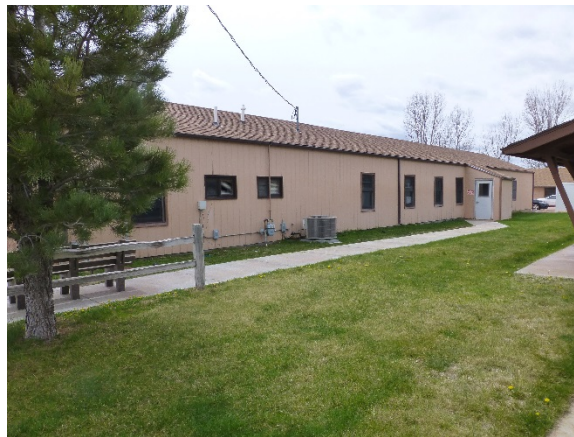
Figure 103. Looking west at the later concrete block addition connecting Building 016 [left] and Building 015 [right] at Camp Guernsey (ERDC-CERL, 2016).

A concrete block addition with a metal shed roof was added at a later date off the south side of the southwest concrete block addition connecting Building 015 to Building 016 (Figure 103). Wood sliding doors are located on the east side of this addition (Figure 104).

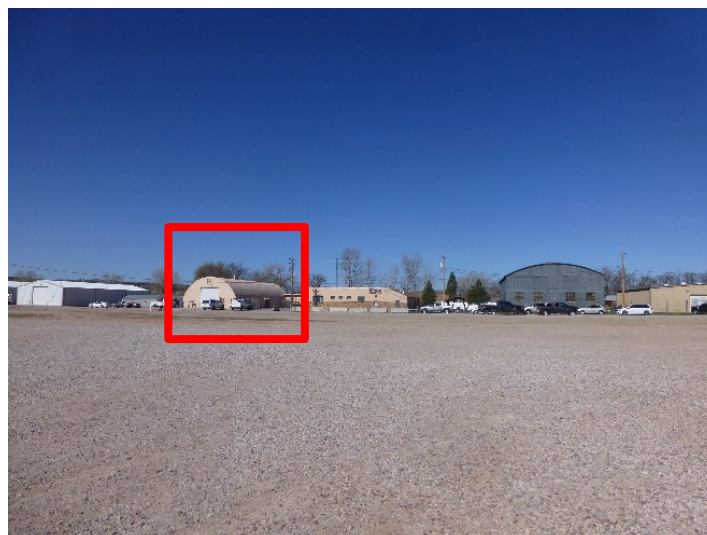
Figure 107. East elevation of Building 016 at Camp Guernsey (ERDC-CERL, 2016).

Building 016 is a one-story, rectangular building with a concrete foundation and a semicylindrical roof shape (Figure 107). Corrugated metal covers the arched steel truss system; however, the metal has been covered with polyurethane foam (Figure 108). A rectangular concrete block addition has been added to the west side of the north elevation of the original structure, connecting it to Building 015.

The east and west elevations of Building 016 are similar, with a central metal roll-up door and a metal louvered vent directly above (Figure 107–Figure 110). There is a metal entry door on the right side of the east overhead door and one on the left side of the west overhead door. The south elevation has one wood-framed window on the right side of the elevation (Figure 108). The north elevation has a projecting entry bay located in the middle of the elevation that consists of a metal door (Figure 110 and Figure 111).

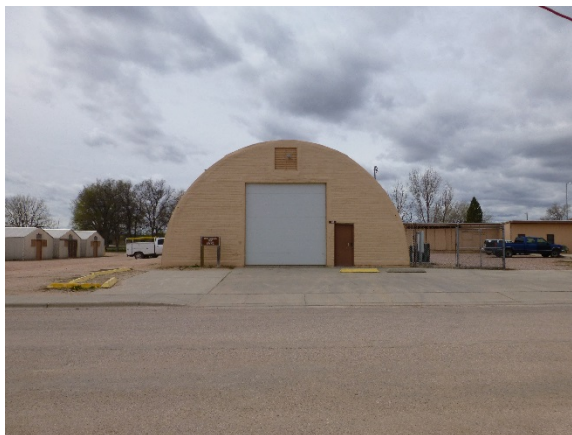
Figure 108. South elevation of Building 016 at Camp Guernsey (ERDC-CERL, 2016).

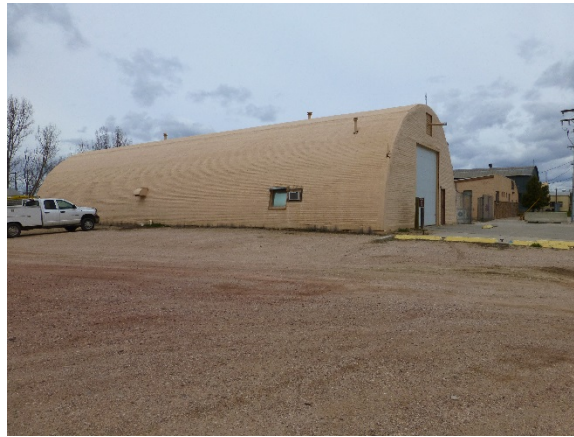
Figure 109. West elevation of Building 016 at Camp Guernsey (ERDC-CERL, 2016).

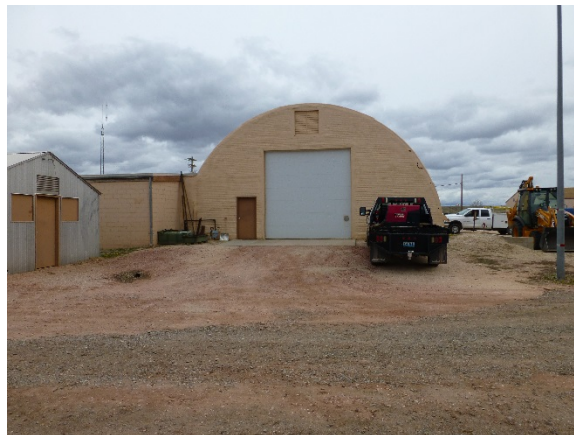
Figure 110. Northeast oblique of Building 016 at Camp Guernsey (ERDC-CERL, 2016).

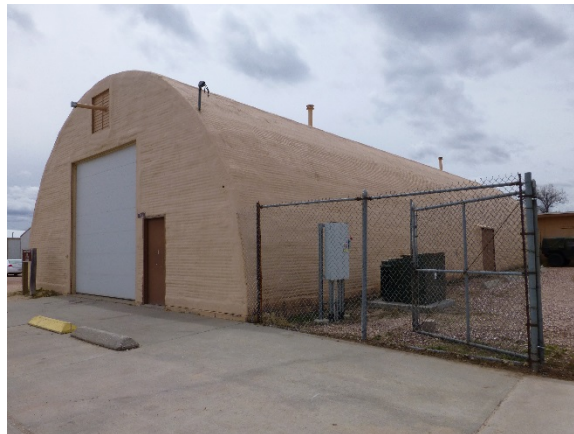
Figure 111. Looking west at the concrete block addition between Building 016 [left] and Building 015 at Camp Guernsey [right] (ERDC-CERL, 2016).

An addition extends from the west side of the north elevation of Building 016 and runs in a north-south direction to connect with Building 015 (Figure 111). The addition has a shed roof clad with corrugated metal with an overhanging eave on the east side. The east side of this addition consists of two wood sliding doors, one on the far left side and one on the far right side of the elevation, with the central portion having six staggered, wood, sliding doors. The tracks are fastened below the roofline and the eave, leaving an opening just above the doors (Figure 112). The west elevation faces Buildings 527G and 527H, with no windows or doors (Figure 113).

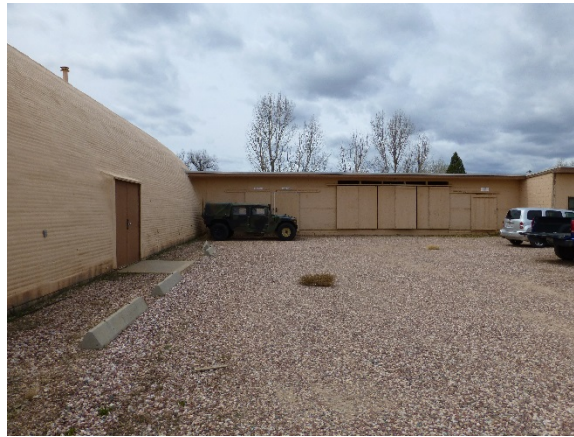
Figure 112. Close-up of the sliding wood doors on the east side of Building 016's concrete block addition at Camp Guernsey (ERDC-CERL, 2016).

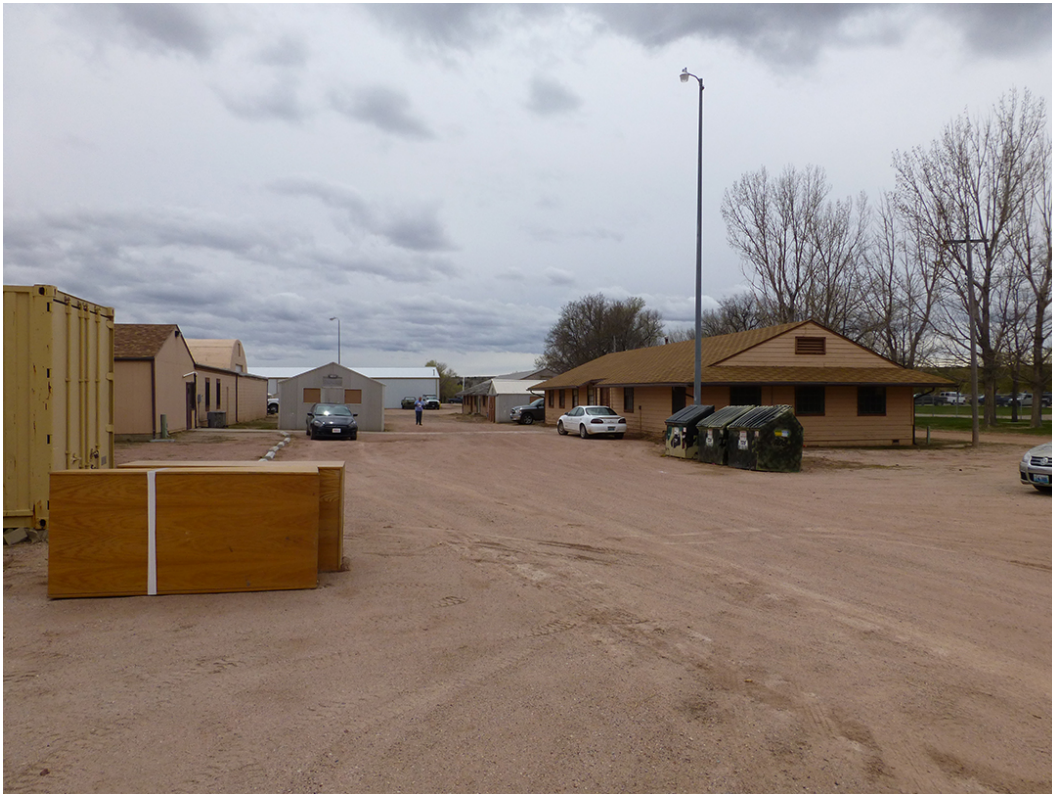
Figure 116. Southeast oblique of Building 017 at Camp Guernsey (ERDC-CERL, 2016).

Building 017 is a one-story, rectangular building with a concrete block foundation, exterior walls clad with wood shiplap siding, and a gable roof clad with asphalt shingles (Figure 116). The roof has a large overhanging eave with exposed wood rafter details, and it wraps around the building and forms pent roofs at the gable ends on the north and south sides (Figure 117). The eave is cut back over the entries (Figure 119 and Figure 120). Wood, louvered vents are placed in the gable ends on the north and south elevations (Figure 120 and Figure 121). The windows are original eight-over-eight wood-sash double-hung windows (Figure 118). The doors are a combination of original wood panel and replacement metal doors (Figure 119 and Figure 120).

The east elevation of Building 107 faces a gravel lot and Building 015. The elevation consists of a set of wood panel doors. This set of doors is placed slightly to the right of center of the elevation (Figure 116), and a poured concrete ramp provides access to this entry. There are six original wood windows on this elevation (Figure 116). The south elevation faces Building

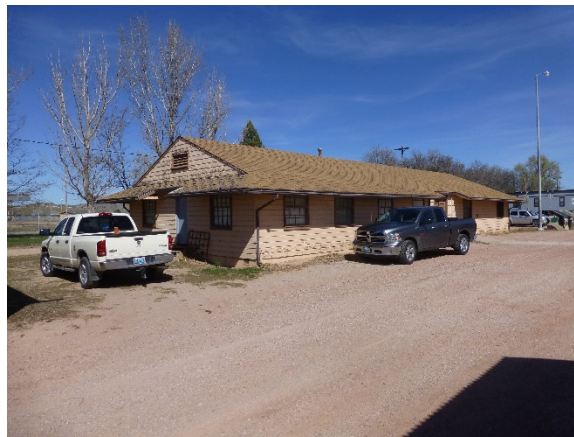
Figure 117. Close-up of the large overhanging eave with exposed wood rafter details of Building 017 at Camp Guernsey (ERDC-CERL, 2016).

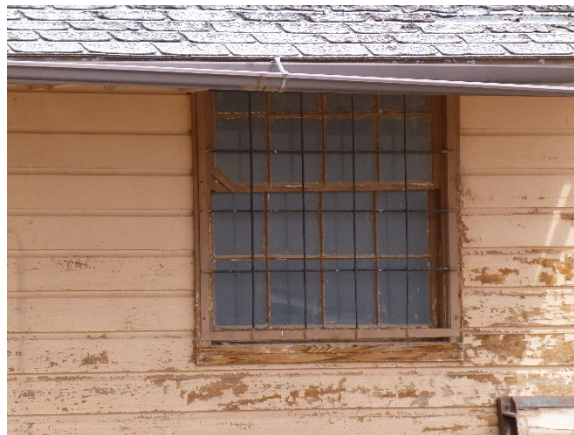
Figure 127. Replacement metal doors on the east elevation of Building 018 at Camp Guernsey (ERDC-CERL, 2016).

Building 018 is a one-story, rectangular building with a concrete block foundation, exterior walls clad with wood shiplap siding, and a gable roof clad with asphalt shingles (Figure 124). The roof has a large overhanging eave with exposed wood rafter details that wraps around the building and forms pent roofs at the gable ends on the north and south sides (Figure 125). The eave is cut back over the entries (Figure 127 and Figure 128). Wood, louvered vents are placed in the gable ends on the north and south elevations (Figure 128 and Figure 129). The windows are original eight-over-eight wood-sash double-hung windows with metal security bars over them (Figure 126). The doors are replacement metal and wood (Figure 127).

The east elevation faces a gravel lot and Building 016. The elevation consists of a set of metal doors, one with a large light. This set of doors is placed slightly to the right of center of the elevation (Figure 127). An original wood window flanks either side of these doors and a concrete stop is placed in front of the entry. There is a single-entry replacement wood door on the far right side of the elevation, and another single-entry replacement wood door is located just left of the center of the east elevation. There are two original wood windows on the left side of the east elevation (Figure 124). The south elevation is symmetrical, with a centrally placed, wood, panel door that is accessed by a concrete block stoop. An original wood window flanks either side of the door (Figure 128). The west elevation faces a row of trees and the boundary fence. There are eight evenly spaced, original, wood windows on this west elevation (Figure 129). The north elevation faces Building 527F and consists of three evenly spaced original wood windows (Figure 129).

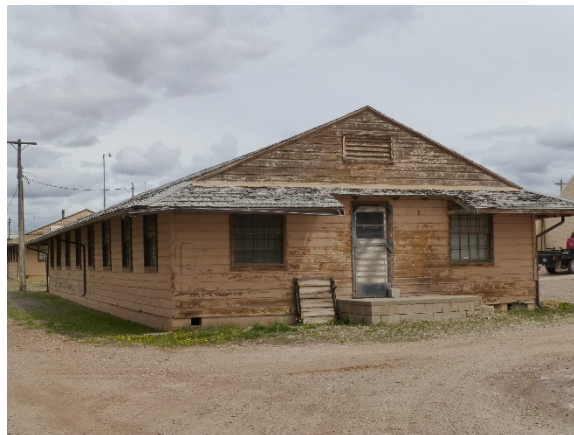
Figure 129. Northwest oblique of Building 018 at Camp Guernsey (ERDC-CERL, 2016).

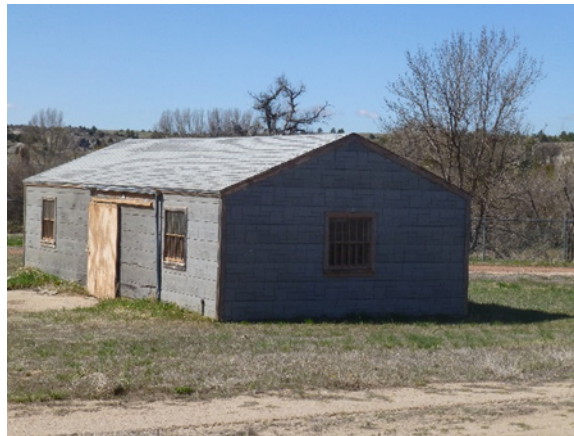
Building 021 is a small one-story structure with a rectangular footprint, a concrete foundation, a gable roof clad with asphalt shingles, and exterior walls clad with rolled asphalt siding (Figure 131). The building is oriented in the north-south direction. The east elevation consists of a centrally placed wood sliding door. This is not an original door. An original window flanks either side of the door. The north elevation has a centrally placed

original window. A wood sliding door is located on the south elevation, and there are no window or door openings on the west elevation.

Figure 131. Northeast oblique of Building 021 at Camp Guernsey (ERDC-CERL, 2016).

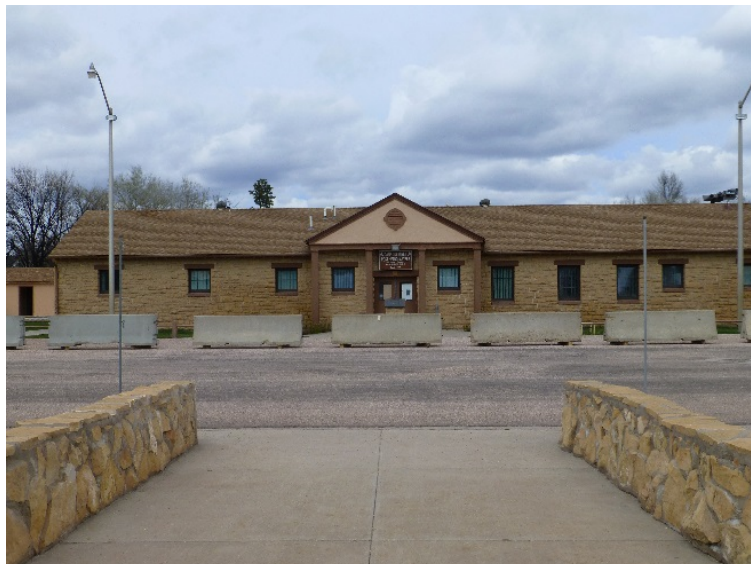
**Figure 135. South elevation of Building 101
at Camp Guernsey (ERDC-CERL, 2016).**

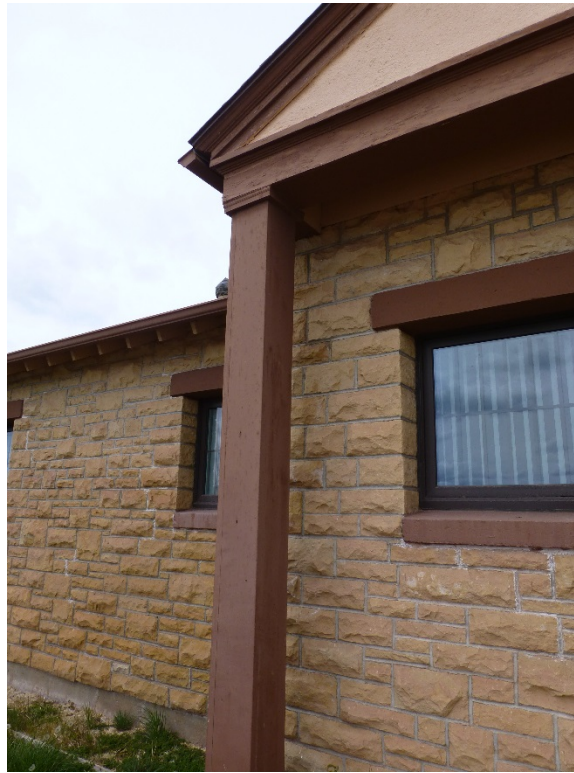
right side of the elevation has three larger replacement windows and two smaller replacement windows (Figure 135 and Figure 142). The left side of the elevation consists of three smaller replacement windows (Figure 135).

Figure 142. Right side of the south elevation with the landscaped lawn of Building 101 at Camp Guernsey (ERDC-CERL, 2016).

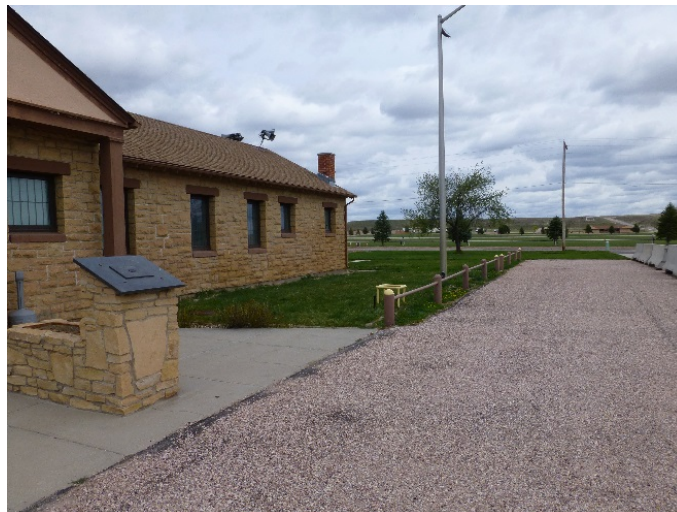
The north elevation of Building 101 overlooks a wide gravel road. There is a centrally placed entry bay that consists of a set of replacement doors (). There are three smaller replacement windows on the right side of the elevation, and two larger replacement windows on the left side of the elevation (Figure 143).

Figure 143. Northwest oblique of Building 101 at Camp Guernsey (ERDC-CERL, 2016).

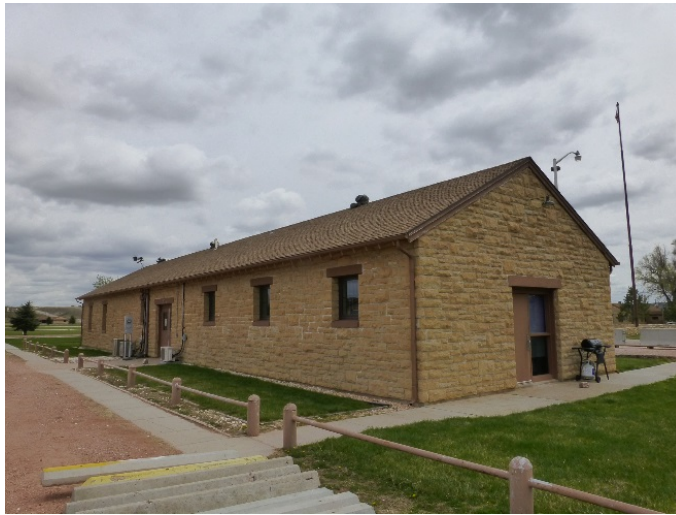
The west elevation of Building 101 faces Fremont Avenue and consists of a centrally placed door. The original set of doors has been removed, and the large opening has been filled with a single-entry metal door flanked on the right side by a two-pane sidelight (Figure 144).

Figure 144. Replacement metal door with two-pane side light on the west elevation of Building 101 at Camp Guernsey (ERDC-CERL, 2016).

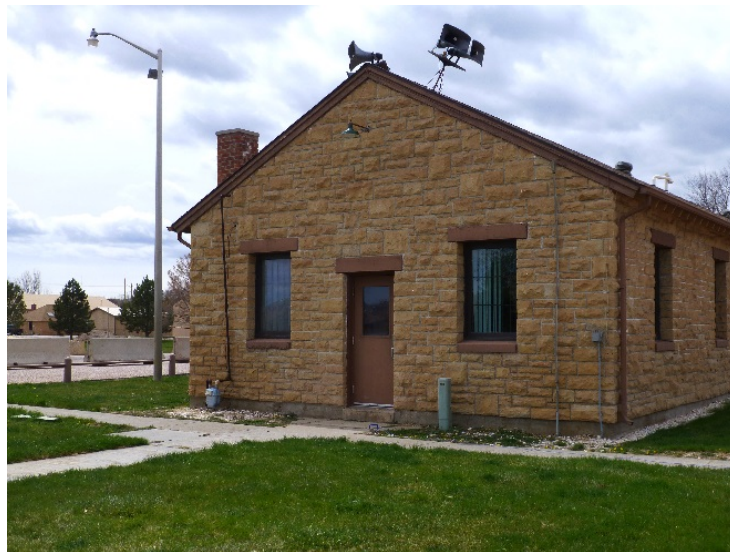
The east elevation faces Hunton Road and overlooks the parade ground (refer to Figure 132). The east elevation has a centrally located replacement door, flanked on either side by a large replacement window (Figure 145).

Figure 145. East elevation of Building 101 at Camp Guernsey (ERDC-CERL, 2016).

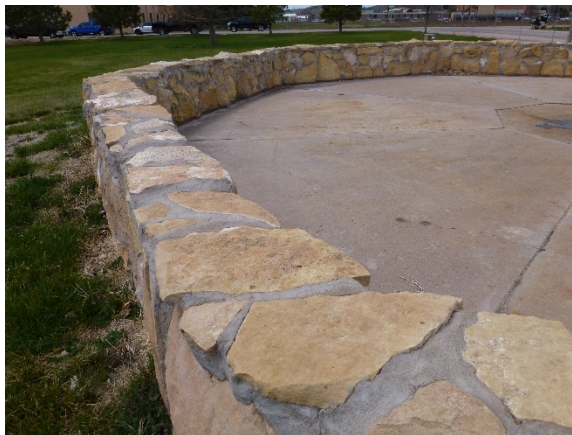
Figure 150. Cut stone wall constructed by the 197th Engineering Company for Building 101 at Camp Guernsey (ERDC-CERL, 2016).

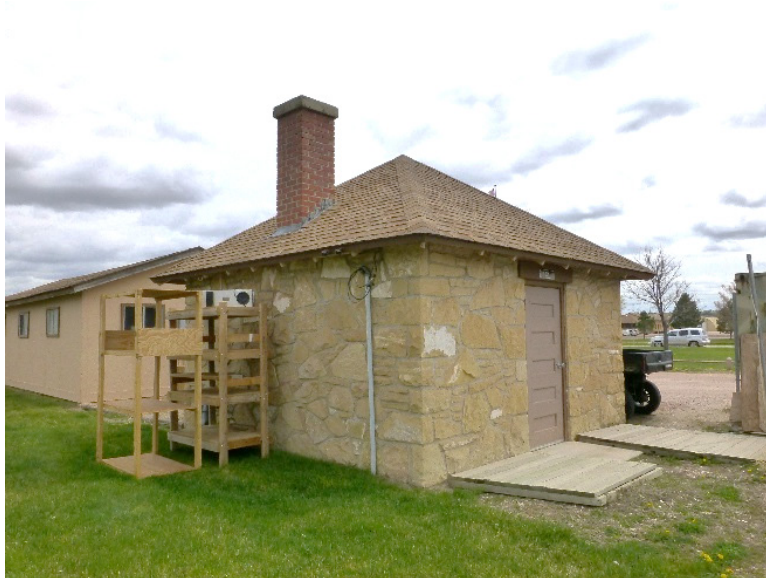
Building 102 is a small square structure with a concrete foundation, cut sandstone exterior walls, a pyramidal roof clad with asphalt shingles and overhanging eaves with exposed wood rafter tails (Figure 153, Figure 154, and Figure 156). The exterior walls are constructed of roughly coursed locally quarried buff-color sandstone with cement mortar. The windows are replacement single-pane with a concrete windowsill and lintel (Figure 154). The door is an original wood panel with a concrete lintel. There is a brick chimney that projects from the north side of the roof (Figure 153).

The west elevation faces the fenced property boundary of the cantonment and overlooks Fremont Avenue. There is a single-entry original wood door placed in the center of the elevation (Figure 153). The east and south elevations each have a single replacement window (Figure 154 and Figure 155).

Figure 153. Northwest oblique of Building 102 (ERDC-CERL, 2016).

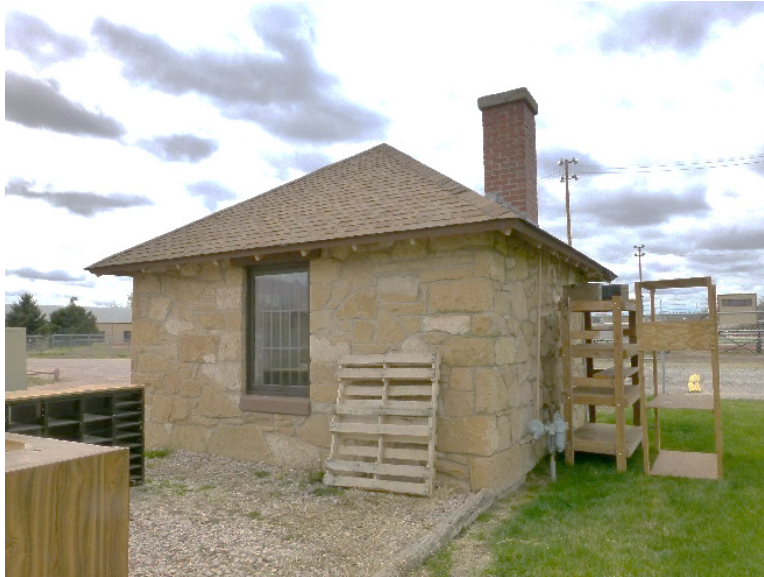
Figure 154. East elevation with replacement window (ERDC-CERL, 2016).

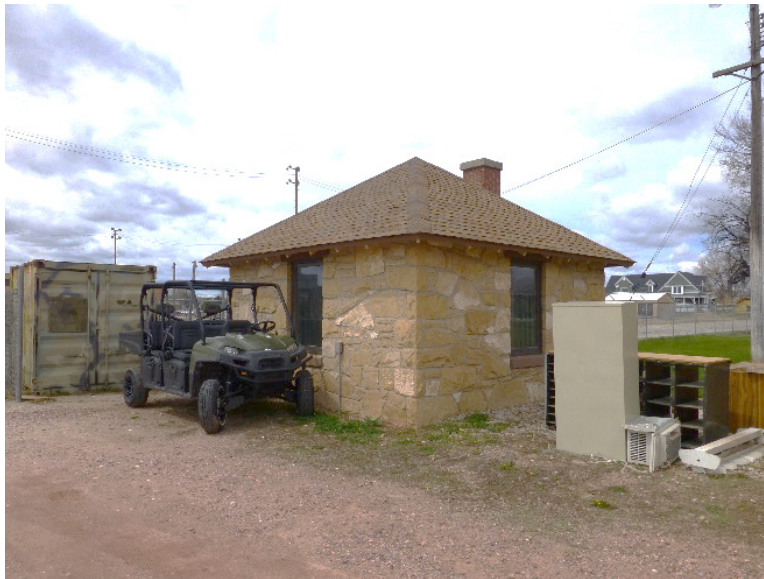
Figure 155. Southeast oblique of Building 102 (ERDC-CERL, 2016).

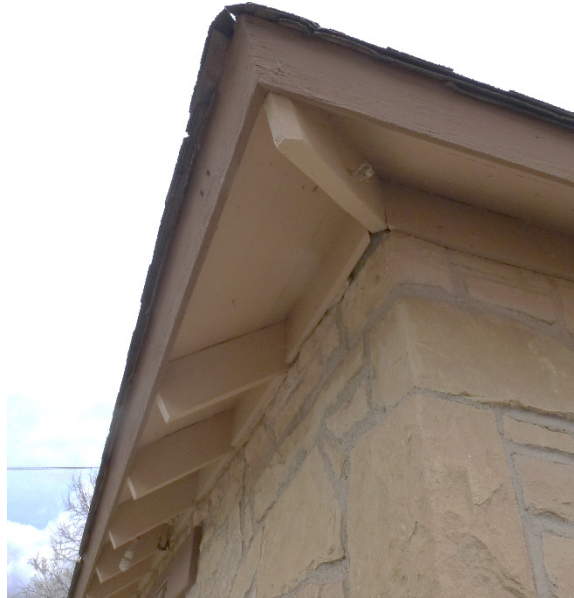
Figure 156. Close-up of the overhanging eave with exposed wood rafter tails and the cut sandstone walls (ERDC-CERL, 2016).

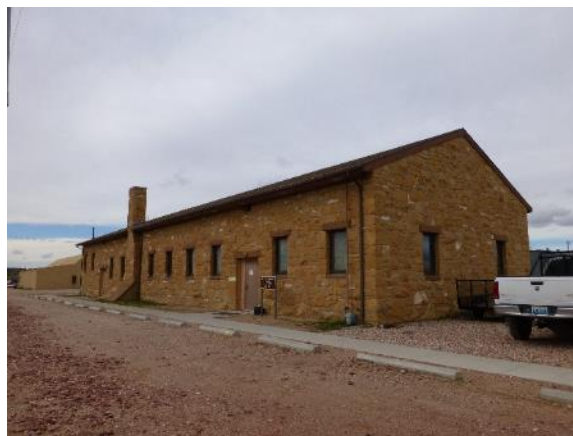
Building 106 is a one-story building with a concrete foundation, cut-stone exterior walls, and a gable roof clad with architectural asphalt shingles with overhanging eaves (Figure 160 and Figure 161). The walls are constructed of locally quarried, buff-colored sandstone laid in irregular patterns with cement mortar (Figure 161). The windows are replacement, single-pane, anodized-bronze aluminum windows (Figure 162). The doors are replacement metal doors; however, they do not fill the original large door openings, so some infill was used around the newer doors (Figure 163). The windowsills and lintels are concrete (Figure 162 and Figure 163). There are two stone-clad chimneys, each with a concrete cap (Figure 164). A “1944” inscription is located on the north gable end (Figure 165). The fascia is wood (Figure 165). A small, wood, shed-style vestibule has been added to the south elevation (Figure 166).

Figure 160. Northeast oblique of Building 106 at Camp Guernsey (ERDC-CERL, 2016).

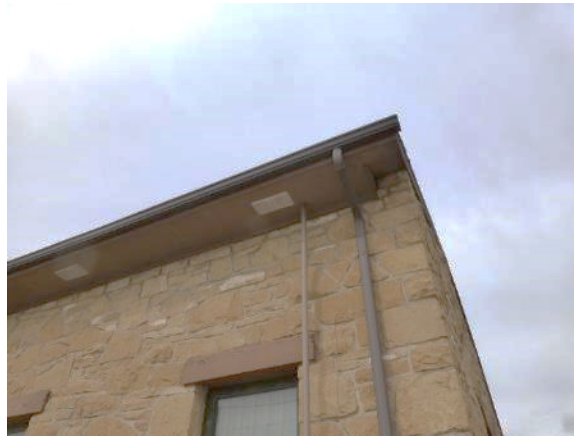
Figure 161. Close-up of the overhanging eave and stone exterior walls of Building 106 at Camp Guernsey (ERDC-CERL, 2016).

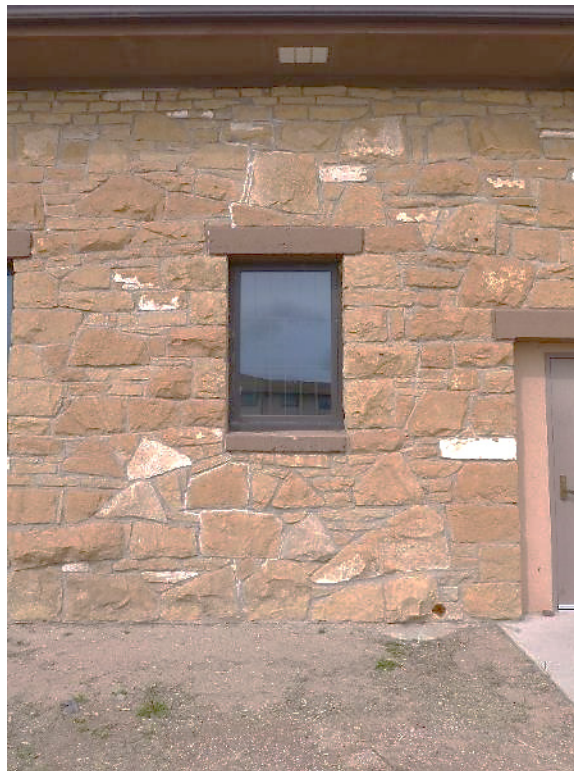
Figure 162. Replacement, single-pane, anodized-bronze aluminum window on Building 106 at Camp Guernsey (ERDC-CERL, 2016).

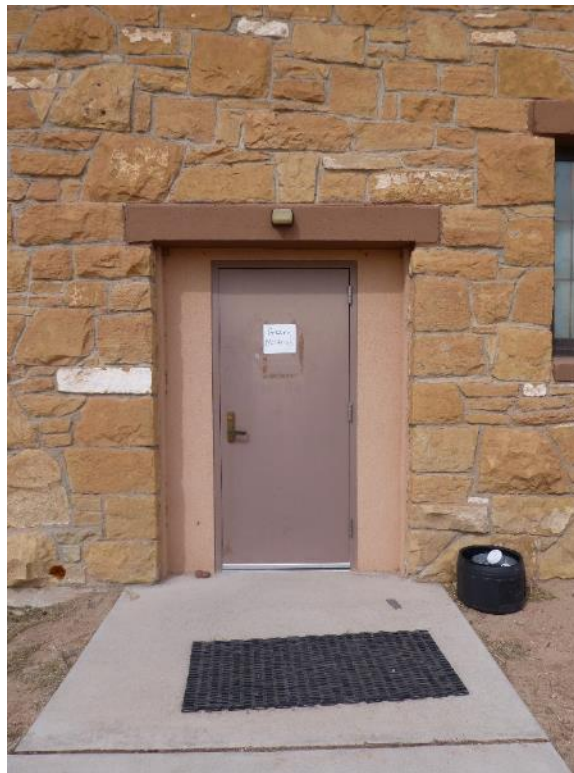
Figure 163. Replacement metal entry door with some infill on Building 106 at Camp Guernsey (ERDC-CERL, 2016).

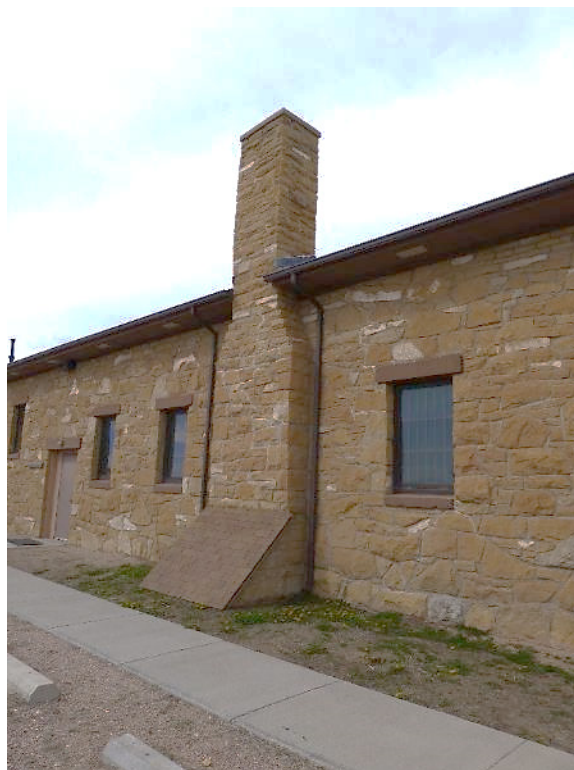
Figure 164. Stone chimney with concrete cap on Building 106 at Camp Guernsey (ERDC-CERL, 2016)

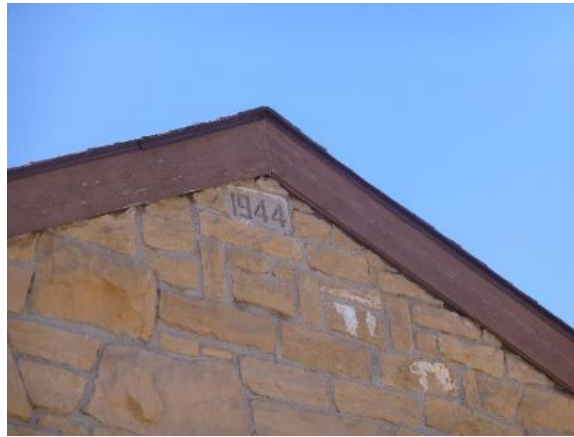
The north elevation faces Building 602 and has two replacement windows (Figure 167). The “1944” inscription is located in the gable end (Figure 165).

Figure 165. Close-up of the “1944” inscription placed in the north gable end of Building 106 at Camp Guernsey (ERDC-CERL, 2016).

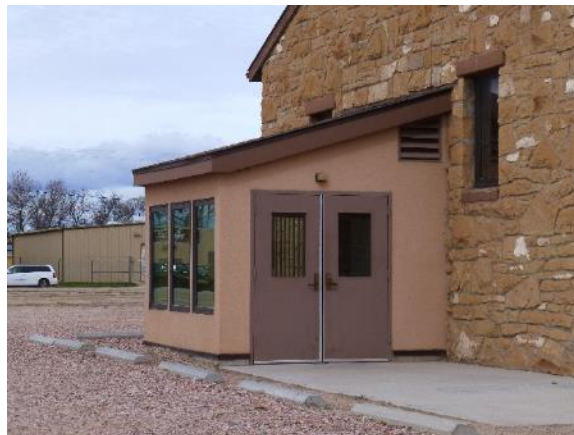
Figure 166. Wood shed vestibule addition located on the south elevation of Building 106 at Camp Guernsey (ERDC-CERL, 2016).

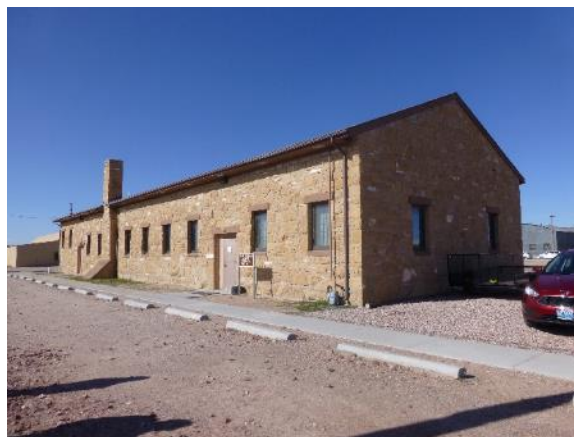
Figure 167. Northeast oblique of Building 106 at Camp Guernsey (ERDC-CERL, 2016).

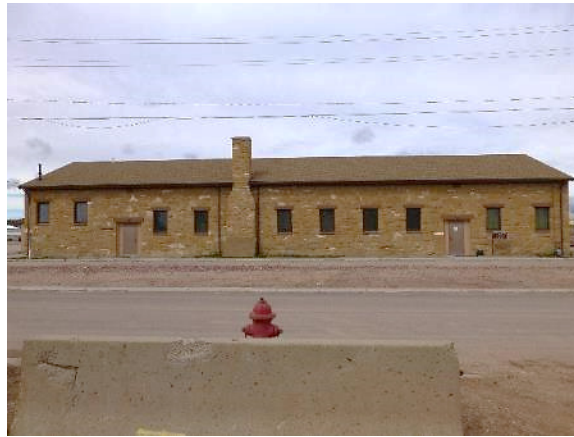
The east elevation faces Hunton Road (Figure 167–Figure 169), overlooking the former concrete pad tent area. The east elevation consists of evenly spaced window openings. The far-left two windows are placed slightly higher in the stone wall than the eight other windows on this elevation. A chimney is located just to the left of center on the elevation. There are two replacement doors. A poured concrete sidewalk stretches in front of the east side of the building.

Figure 168. East elevation of Building 106 at Camp Guernsey (ERDC-CERL, 2016).

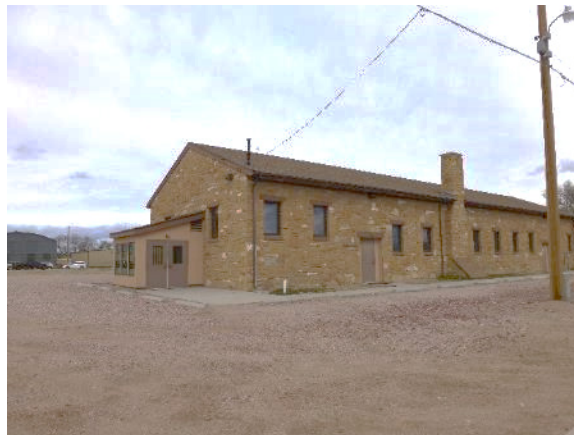
The south elevation faces Building 603. The south elevation has a newly constructed, wood, shed vestibule addition that is located in the center of the elevation (Figure 169 and Figure 170). The south and west side of the addition have windows, and a set of metal doors is located on the east side of the addition. There are two windows placed in the stone wall on either side of the addition.

Figure 169. Southeast oblique of Building 106 at Camp Guernsey (ERDC-CERL, 2016).

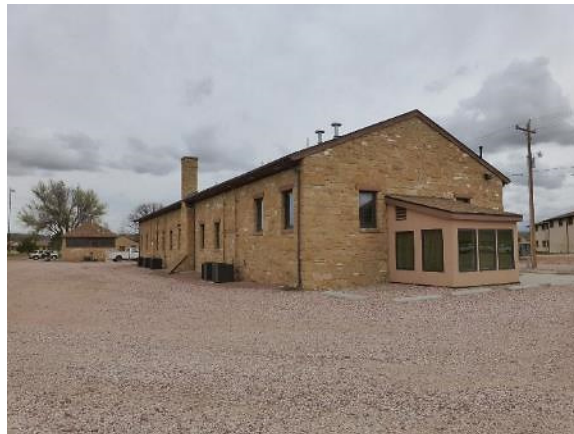
Figure 170. Southwest oblique of Building 106 at Camp Guernsey (ERDC-CERL, 2016).

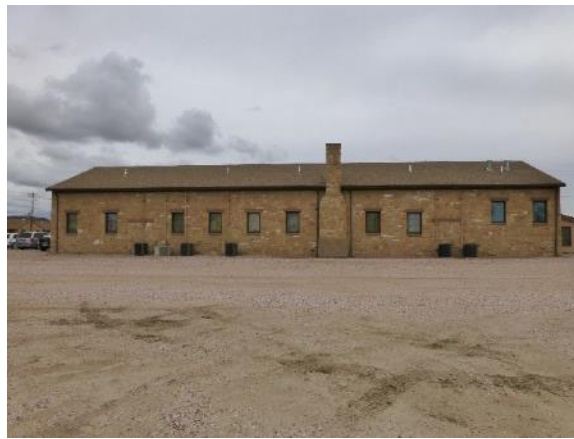
The west elevation faces a large gravel lot overlooking the row of DPW buildings. The west elevation mirrors the east elevation with the exception of the two doors (Figure 171). The original doors have been removed, and the openings have been filled with stone, but the lintels remain intact (Figure 172).

Figure 171. West elevation of Building 106 at Camp Guernsey (ERDC-CERL, 2016).

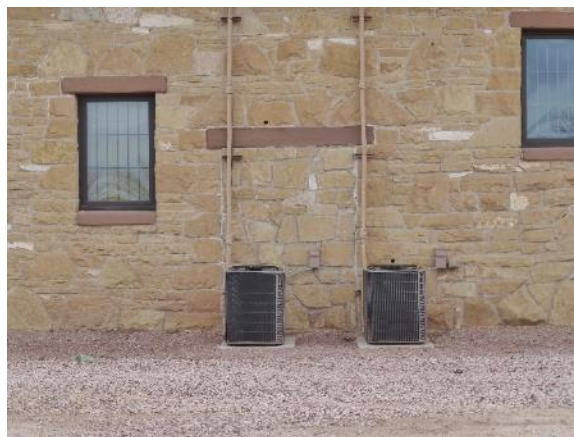
The interior of Building 106 is divided into entrance vestibules on the north and south, a long corridor on the east (Figure 173), and a large classroom on the west (Figure 175). The fireplaces on the east and west walls have been encased in drywall (Figure 174 and Figure 176). Partition walls constructed of drywall, vinyl tile flooring, carpet, drop-ceilings, new light fixtures, and new interior doors were all installed at an unknown recent date. Building 106 interior does not have any elements from the period of significance (although it is unknown what is underneath the fireplace drywall).

Figure 173. Interior view looking north down the newly renovated interior with new partition walls, flooring, and ceiling in Building 106 at Camp Guernsey (ERDC-CERL, 2016).

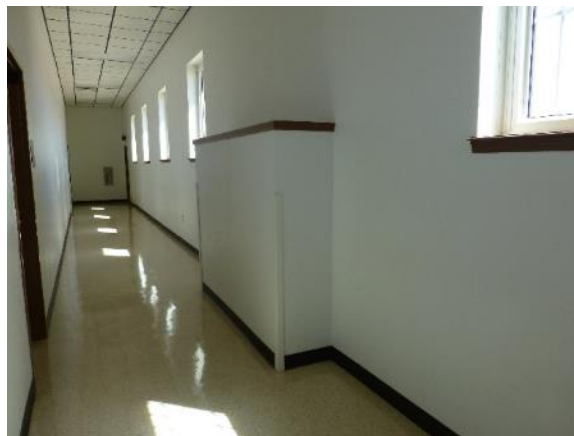
Figure 175. Interior view of the newly renovated classroom space on the west side of Building 106 at Camp Guernsey (ERDC-CERL, 2016).

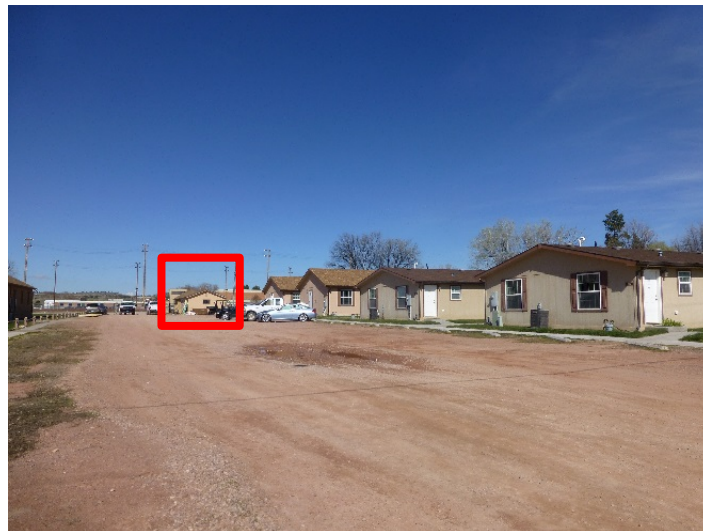
Building 109 is a small, one-story, rectangular structure with a concrete foundation, plywood-clad exterior walls, and a gable roof with overhanging eaves (Figure 180). The windows are small, two-pane, aluminum-sash sliding windows, and the door is wood. The west elevation faces Building 102 and consists of a single-entry door on the right side and a window on the left side (Figure 180). There is a small, wood, louvered vent located in the gable end of the west elevation. The north elevation consists of three evenly spaced windows (Figure 180). The east elevation has one window and a small louvered vent in the gable end. The south elevation faces a gravel road and consists of three evenly spaced windows.

Figure 180. Northwest oblique of Building 109 (ERDC-CERL, 2016).

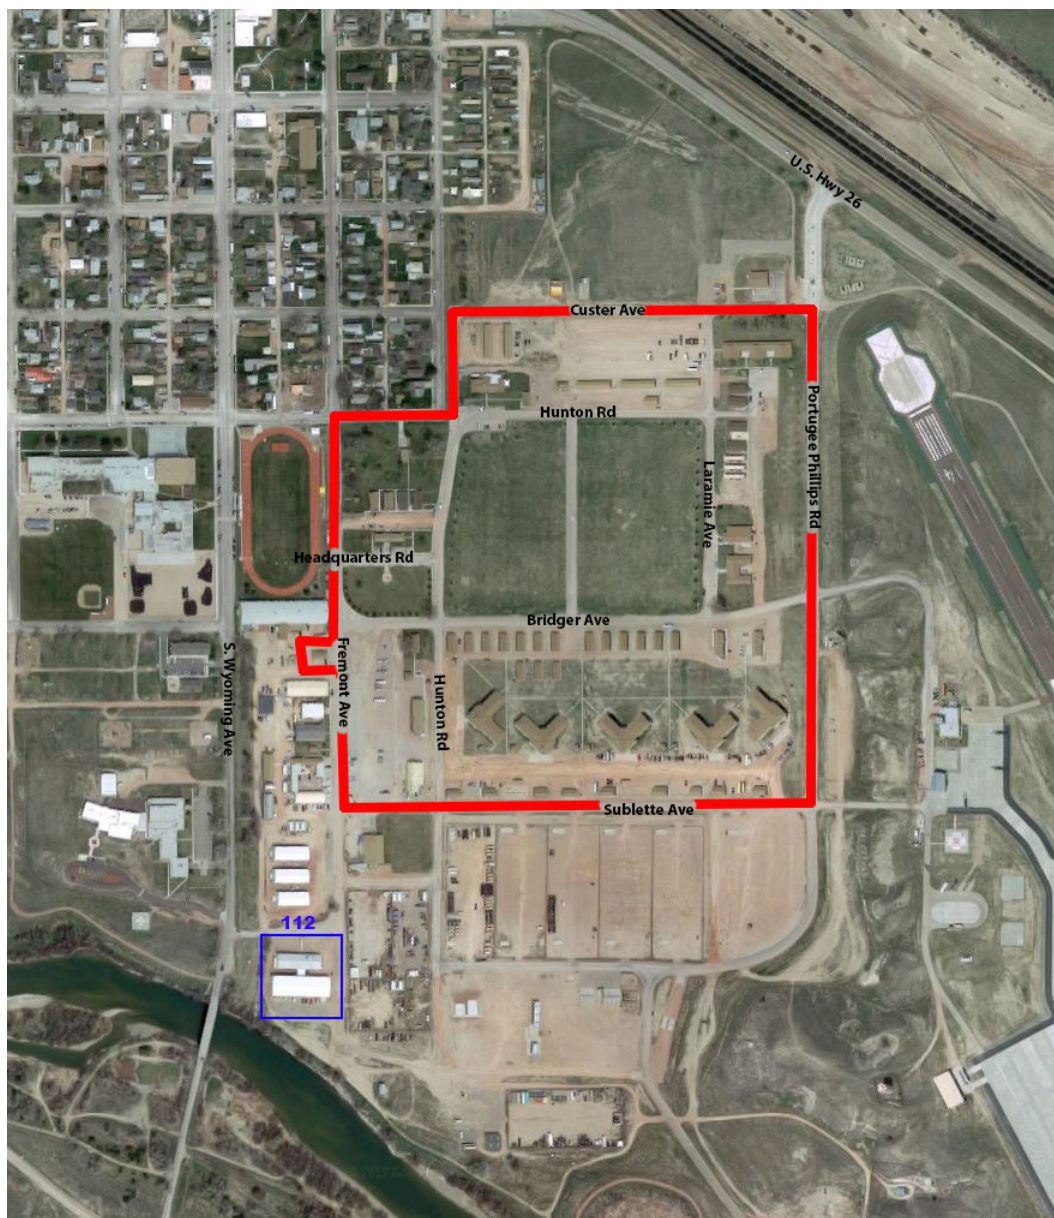
Building 112 is a large, metal, prefabricated structure with an overall H-shaped footprint. The north wing of the building is the original portion of the building, and the south wing is a later addition (Figure 182). The north portion of the building is a long rectangular structure with a concrete foundation, metal walls, and a shallow gable metal roof (Figure 183). The doors are metal. There are several doors on the north elevation, and one metal door on the south elevation of the north wing. A narrow one-story

Figure 182. South elevation of Building 112 at Camp Guernsey, with original building on the right and the later addition on the left connected by a one-story metal hyphen (ERDC-CERL, 2016).

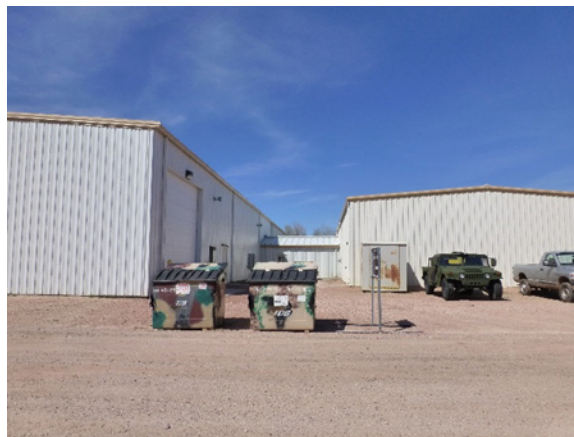
Figure 183. North elevation of Building 112 at Camp Guernsey, with original building in the foreground, and the taller metal addition in the background (ERDC-CERL, 2016).

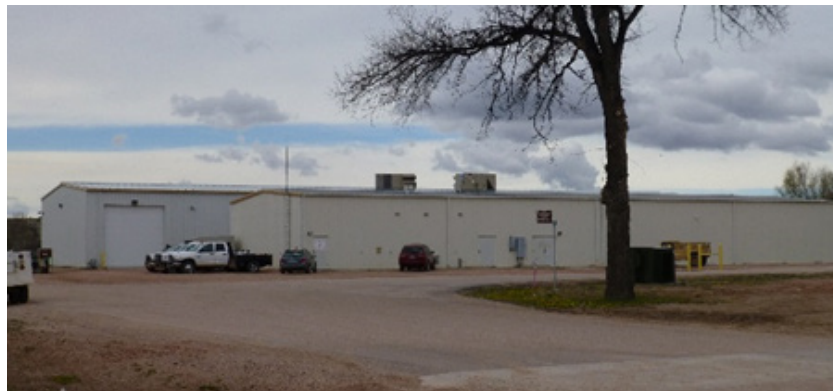
metal hyphen, located on the south side of the north wing, connects the north wing to the south wing (Figure 184). The hyphen has a metal gable roof and a metal door. The south wing is also a long rectangular structure; however, it is longer in length and taller in height than the north wing (Figure 184). The south wing has a concrete foundation, metal walls, and a shallow gable metal roof. There are large metal overhead doors on the north and south elevations of the wing.

Figure 184. Southeast oblique of the south wing [addition] of Building 112 at Camp Guernsey (ERDC-CERL, 2016).

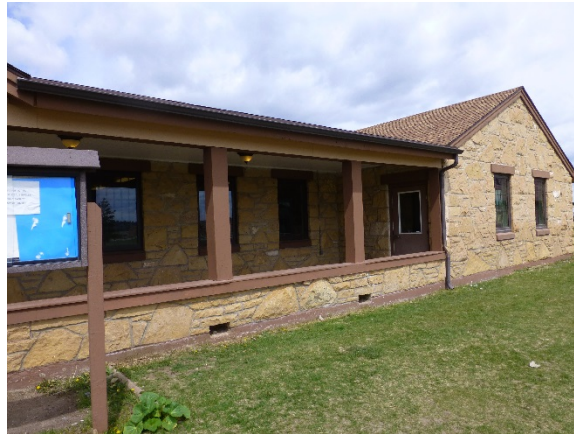
Figure 196. View of the portico of Building 201 at Camp Guernsey, with a concrete floor and wood beadboard ceiling (ERDC-CERL, 2016).

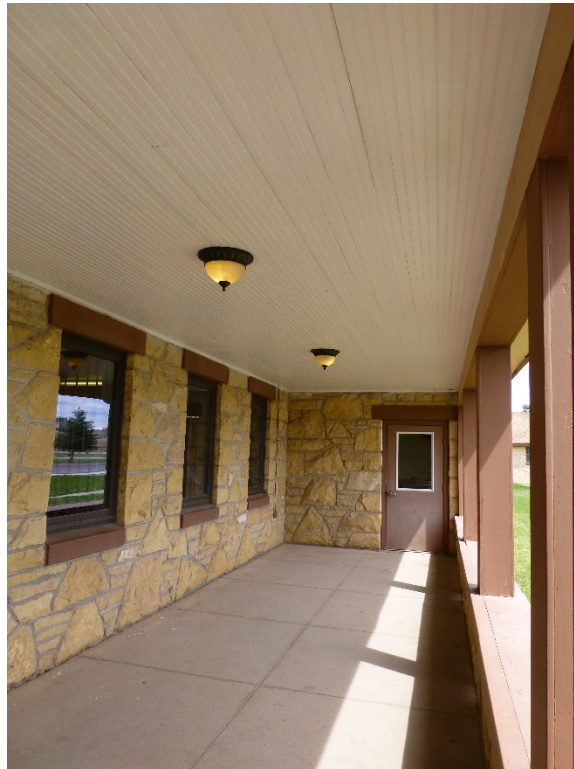
Figure 197. Southwest oblique of Building 201 at Camp Guernsey (ERDC-CERL, 2016).

The west elevation faces the newly paved road and consists of a large exterior chimney that is located in the center of the elevation (Figure 197). A small replacement window and a larger replacement window flank either side of the chimney (Figure 197).

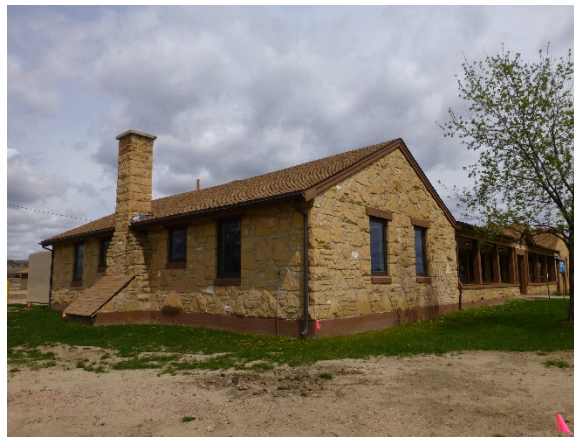
The right side of the north elevation consists of three replacement window (Figure 198). The middle section of the north elevation projects outward and has a hipped roof. The west side of the projecting wall has replacement windows. The majority of the north elevation is no longer visible due to the construction of a long, rectangular, concrete block addition (Figure 199–Figure 202). The addition has a shed roof clad with asphalt shingles. The windows on this addition are anodized-bronze aluminum. A small part of the original stone on the north elevation can be seen on the left side, where the addition is connected to the wall (Figure 202).

Figure 198. Northwest corner of Building 201 (ERDC-CERL, 2016).

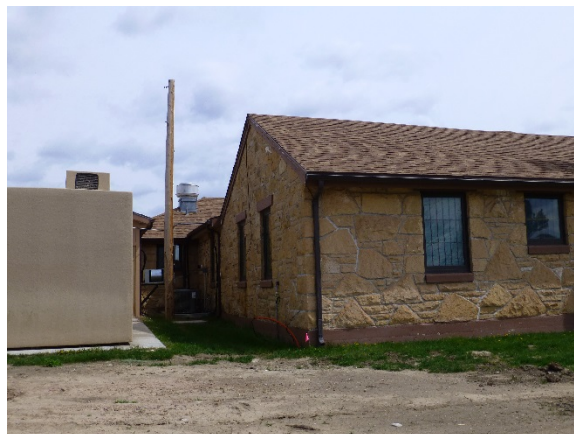
Figure 199. Wood and concrete block addition on the northwest side of Building 201 at Camp Guernsey (ERDC-CERL, 2016).

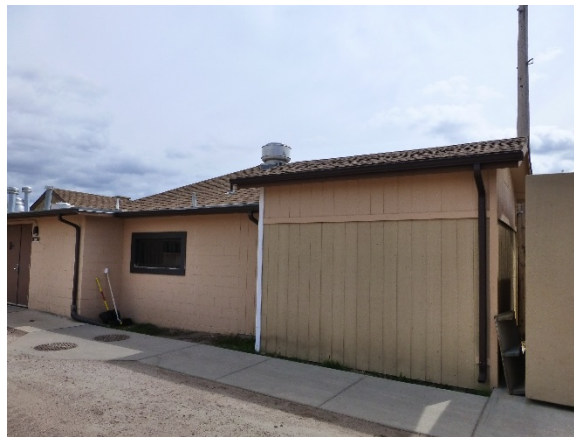
Figure 200. Concrete block addition on the middle of the north elevation of Building 201 at Camp Guernsey (ERDC-CERL, 2016).
