Architectural and Landscape Survey of Camp Guernsey, Wyoming

Adam D. Smith, Megan W. Tooker, and Sunny E. Adams

June 2017

Under Project Number 458417, "Camp Guernsey Historic Context and Building
Evaluation"

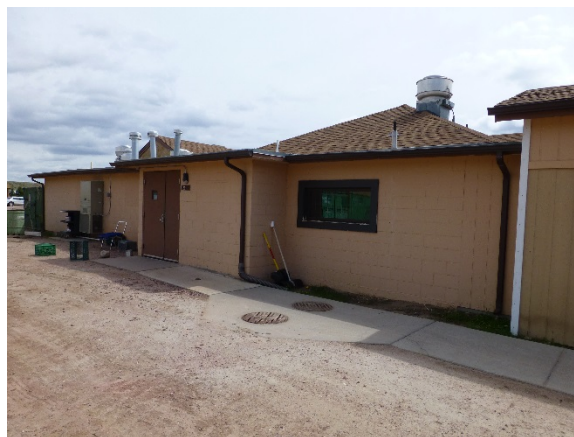
Figure 201. Left side of the concrete block addition on the north side of the original portion of Building 201 at Camp Guernsey (ERDC-CERL, 2016).

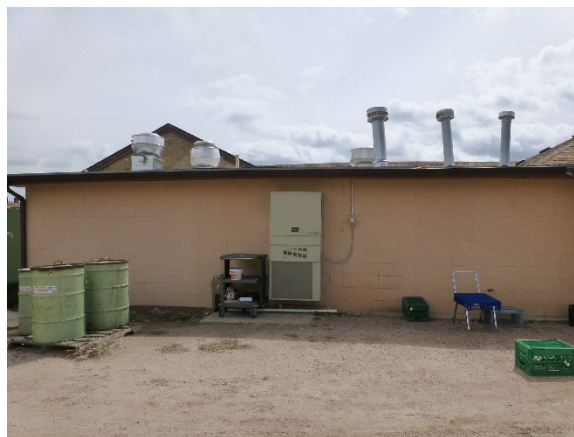
Figure 202. Close-up of the connection between the original stone wall and the concrete block addition on the north side of Building 201 at Camp Guernsey (ERDC-CERL, 2016).

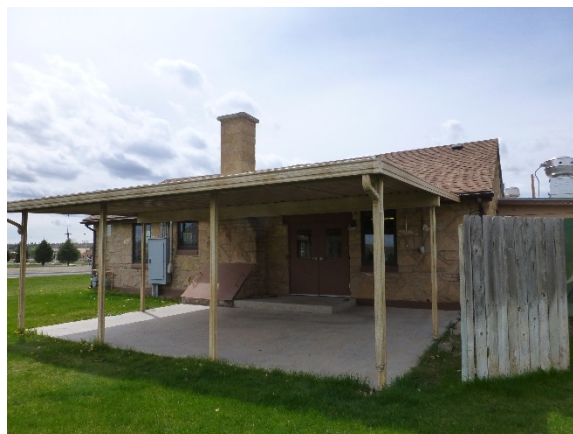
Building 201's interior is divided into three large, public spaces toward the front of the building and a series of kitchen and service rooms toward the rear of the building. The middle public space is primarily for serving food (Figure 204), the west and east rooms are both utilized for dining and their stone fireplace surrounds are intact (Figure 205 and Figure 206).

Figure 204. Interior view of the central public space utilized for serving food in Building 201 at Camp Guernsey (ERDC-CERL, 2016).

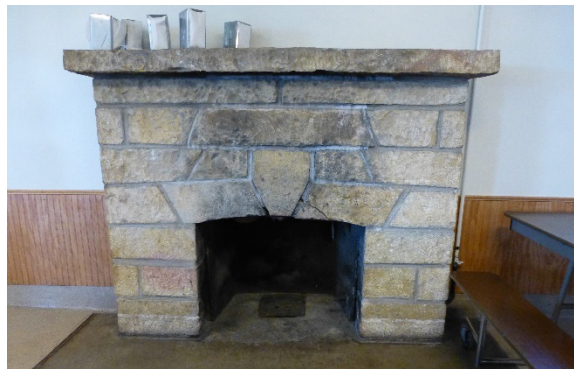
Figure 206. Original stone fireplace on the east wall in the east dining room of Building 201 at Camp Guernsey (ERDC-CERL, 2016).

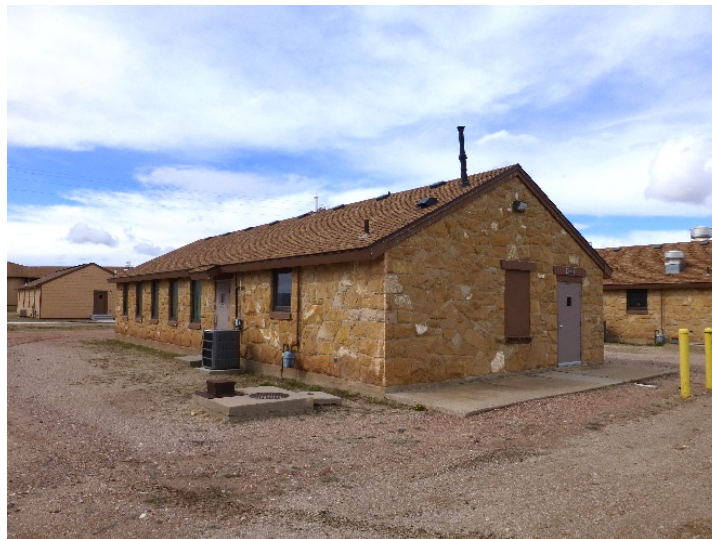
Figure 211. Overhanging eave modified with wood fascia and soffit covering the original exposed wood rafter tails on Building 216 at Camp Guernsey (ERDC-CERL, 2016).

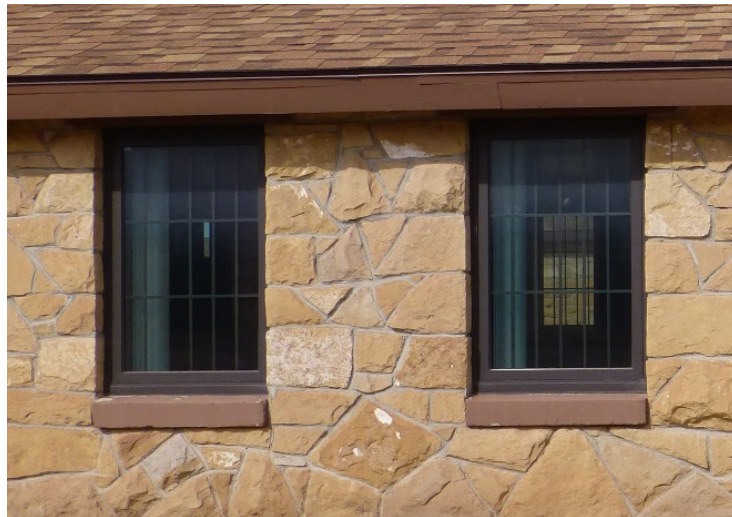
Figure 212. Replacement, single-pane, anodized-bronze aluminum windows on Building 216 at Camp Guernsey (ERDC-CERL, 2016).

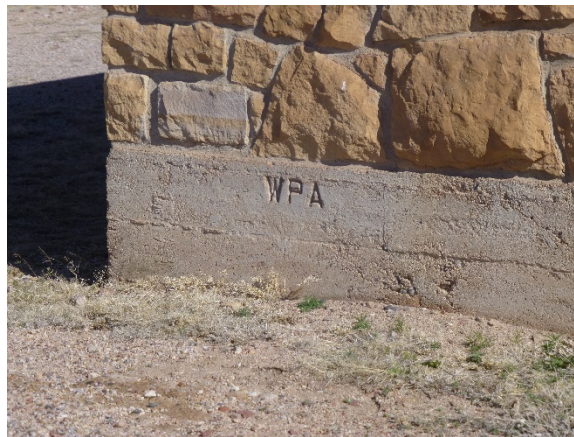
Figure 215. Close-up of “W.P.A.” inscribed in the southwest corner of the concrete foundation of Buildings 216 at Camp Guernsey (ERDC-CERL, 2016).

The WPA enlisted men's mess halls (Buildings 211–223) are one-story buildings with raised concrete foundations, cut-stone exterior walls, and gable roofs clad with architectural asphalt shingles and featuring overhanging eaves (Figure 210). Wood fascias and wood soffits have been added to the overhanging eaves on the east and west sides, covering the original exposed wood rafter tails (Figure 211). The walls are constructed of locally quarried, buff-colored sandstone laid in irregular patterns with cement mortar. The windows are replacement, single-pane, anodized-bronze aluminum windows (Figure 212). Smaller replacement, single-pane, anodized-bronze aluminum windows are located on the east and west elevations (Figure 213). The doors are replacement metal doors (Figure 214). The windowsills and lintels are poured concrete (Figure 212 and Figure 213). The "W.P.A" is inscribed into the southwest corner of the raised concrete foundations on several of the buildings (Figure 215) and the "W.P.A 1940" shield is placed on the lintel above several of the south doors (Figure 216). The buildings measures approximately 25'-9" x 62'.

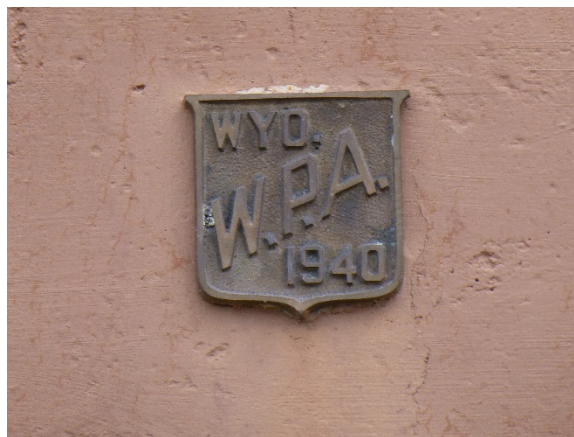
The south elevation faces the former tent pad area (Figure 219—Figure 221). Central replacement metal doors are flanked on either side by replacement windows. A building number plaque and a “W.P.A 1940” shield are placed on the lintel of several of the doors. A concrete stoop is located in front of the door.

Figure 216. Close-up of “W.P.A.” 1940 shield, placed on the lintel of several of the south doors of Buildings 211–223 at Camp Guernsey (ERDC-CERL, 2016).

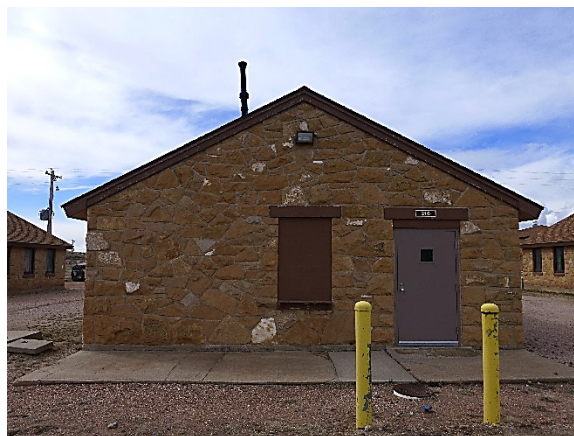
The north elevations face Bridger Avenue and overlook the parade ground (Figure 217 and Figure 223). There are modified window openings located in the middle of some of the north elevations that have been filled with concrete block, and replacement metal doors are located on the right side of the elevations. A building number plaque is placed on the lintel above the door. Replacement light fixtures are attached to the stone walls at the gable end. A poured concrete pad stretches in front on the elevation.

Figure 217. North elevation of Building 216 at Camp Guernsey (ERDC-CERL, 2016).

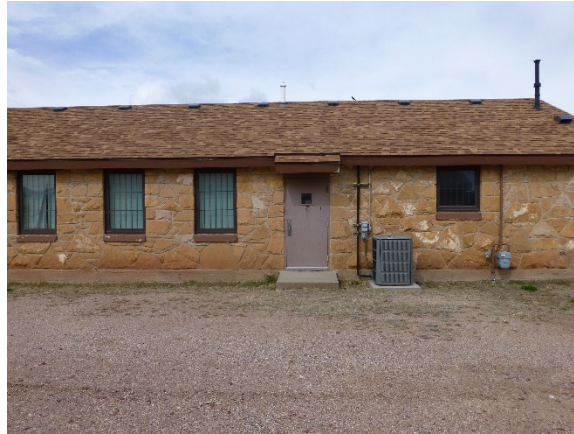
The east elevations consist of five larger replacement windows, a smaller replacement window, and a replacement metal door (Figure 218). A small extension of the roof projects out over the door forming a shallow canopy to protect the doors.

Figure 218. East elevation of Building 216 at Camp Guernsey (ERDC-CERL, 2016).

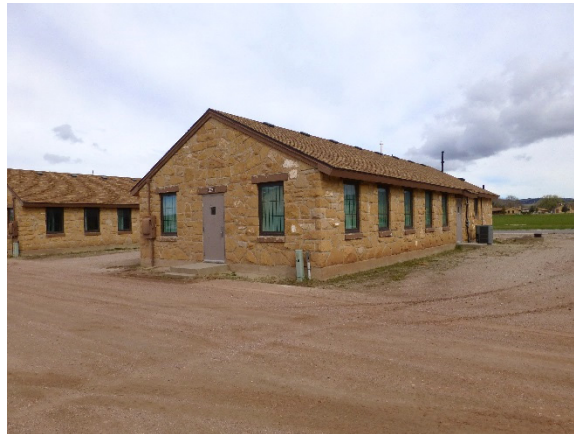
Figure 219. Southeast oblique of Building 216 at Camp Guernsey (ERDC-CERL, 2016).

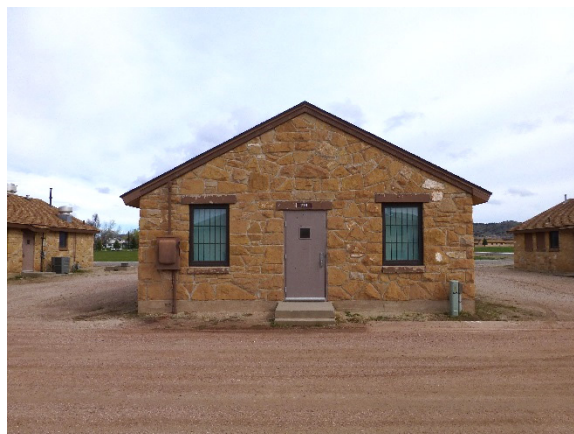
Figure 220. South elevation of Building 216 at Camp Guernsey (ERDC-CERL, 2016).

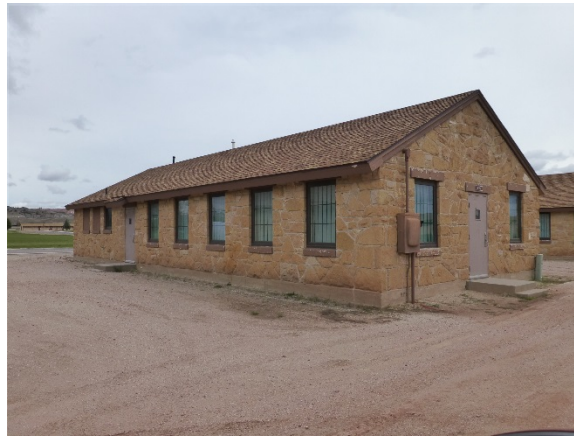
Figure 221. Southwest oblique of Building 216 at Camp Guernsey (ERDC-CERL, 2016).

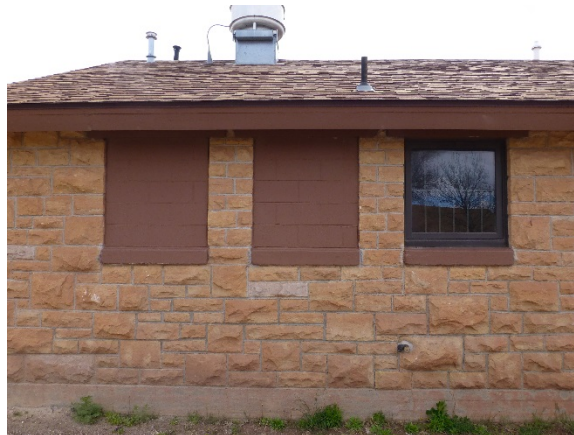
The west elevations consist of five large replacement windows on the right side of the elevations and three smaller window openings on the left sides (Figure 222). Typically, two of the smaller window openings on this elevation have been filled with concrete block, and one has been replaced with an anodized-bronze aluminum window. Replacement metal doors separate the two groups of windows. Concrete stoops are placed in front of the doors.

Figure 222. Modified window openings and replacement window on the left side of the west elevation of Building 216 at Camp Guernsey (ERDC-CERL, 2016).

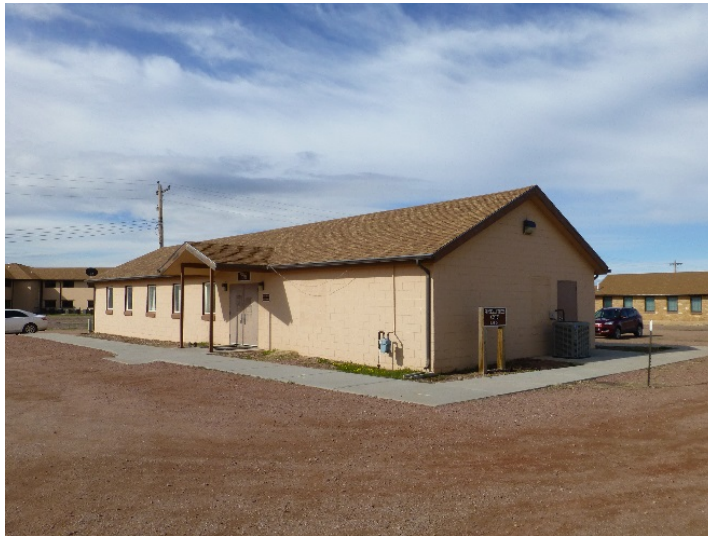
Figure 225. Northeast oblique of Building 224 at Camp Guernsey (ERDC-CERL, 2016).

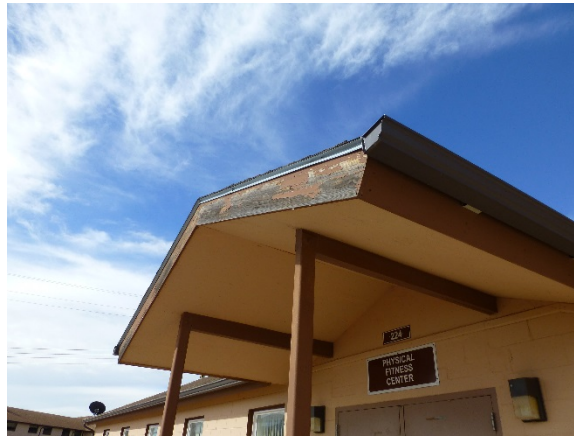
The east elevation of Building 224 faces Building 225 and has five evenly spaced windows on the left side of the elevation (Figure 225). A gable wood porch canopy is supported by two wood posts, and it protects a set of metal doors with narrow vertical lights just to the right of the windows (Figure 227). A poured concrete pad is placed in front of the entry doors where the wood posts rests. A replacement light fixtures has been added to either side of the doors (Figure 228). A building number plate and a “Physical Fitness Center” sign is placed above the door (Figure 227). A single window opening just to the right of the doors has been modified with concrete block infill.

Figure 227. Wood gable porch canopy added to the east elevation of Building 224 at Camp Guernsey (ERDC-CERL, 2016).

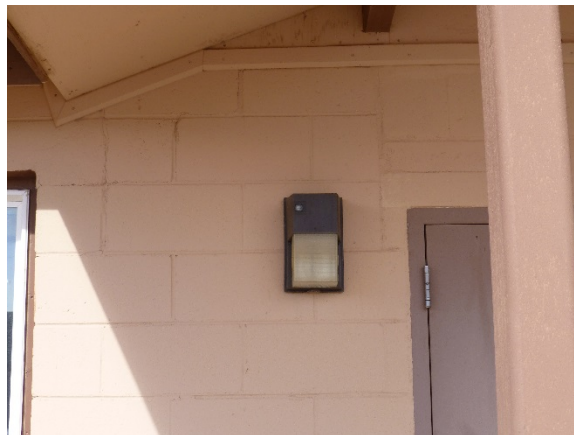
Figure 228. Replacement light fixture on the east elevation of Building 224 at Camp Guernsey (ERDC-CERL, 2016).

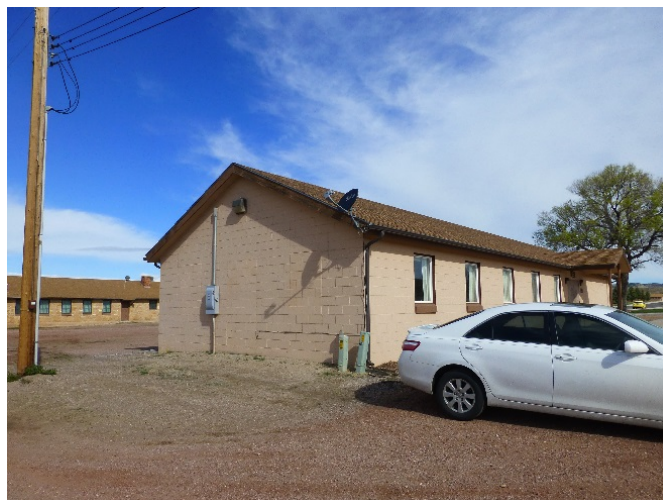
The south elevation of Building 224 faces the former tent area and Building 504. A single-entry door and two windows have been removed, and the openings have been filled with concrete block (Figure 229).

Figure 229. Southeast oblique of Building 224 at Camp Guernsey (ERDC-CERL, 2016).

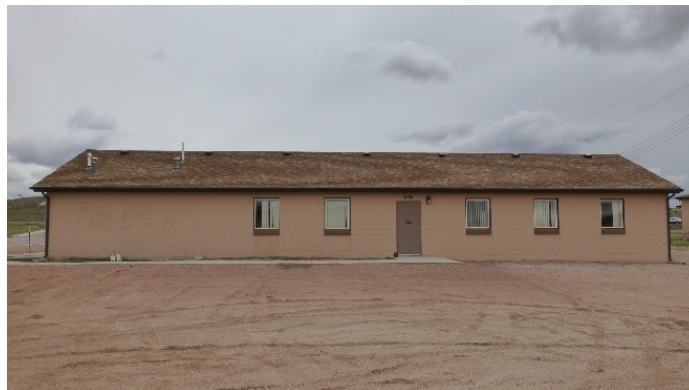
The left side of the west elevation of Building 224 has three small window openings filled with concrete block (Figure 230). The windowsills have been removed on these modified window openings. The west elevation consists of five replacement windows and a single replacement metal door. A poured concrete pad is placed in front of the door.

Figure 230. West elevation of Building 224 at Camp Guernsey (ERDC-CERL, 2016).

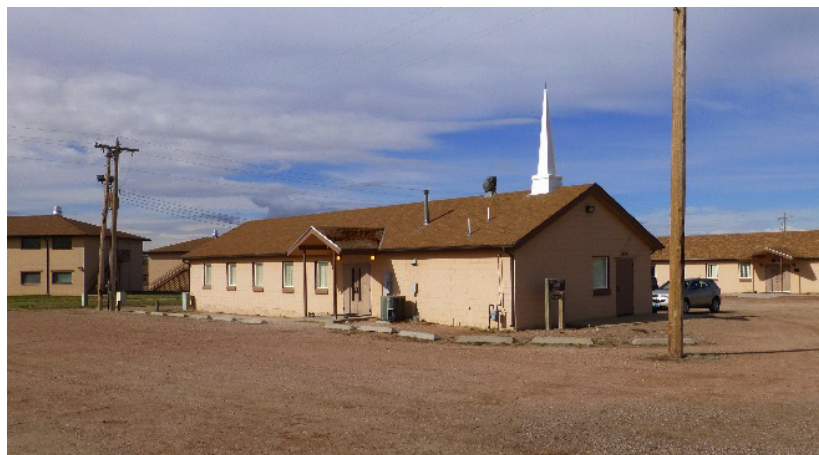
Building 225 is a one-story rectangular building with a raised concrete foundation, concrete block exterior walls, and a gable roof clad with asphalt shingles that measures 27' x 84' (Figure 232). The building has replacement single-pane, vinyl-sash, fixed-pane windows with original concrete windowsills (Figure 233) and replacement metal entry doors. An intersecting gable forms a porch at the main entry on the east elevation. The fascia and soffit are painted wood. A white steeple is located on the north end of the gable roof (Figure 234).

The north elevation of Building 225 faces Bridger Avenue and consists of a metal entry door and a single window (Figure 232). A building number

Figure 232. Northeast oblique of Building 225 at Camp Guernsey (ERDC-CERL, 2016).

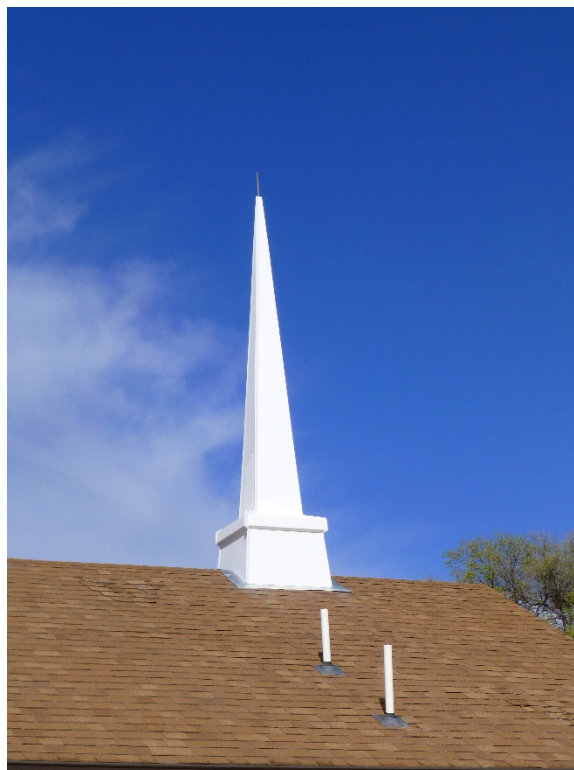
Figure 234. Close-up of the white steeple located on the north end of the gable roof of Building 225 at Camp Guernsey (ERDC-CERL, 2016).

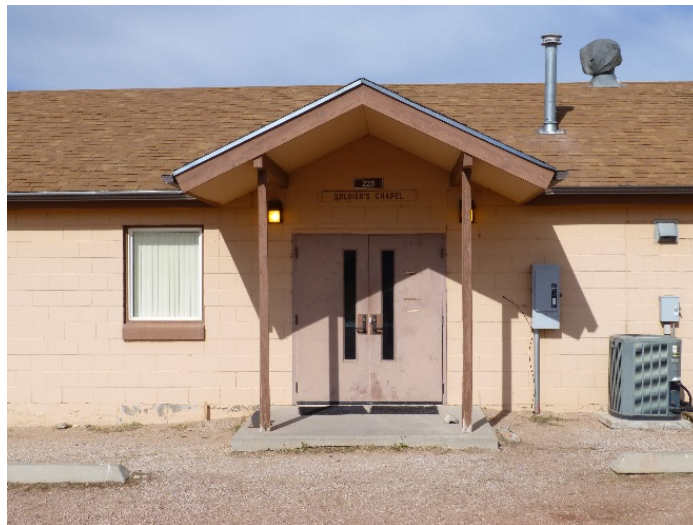
The east elevation of Building 225 faces P. Phillips Road and has five evenly spaced windows on the left side of the elevation (Figure 232 and Figure 235). A gable wood porch canopy is supported by two wood posts and protects a set of metal doors with narrow vertical lights just to the right of the windows. A poured concrete pad is placed in front of the entry doors where the wood posts rests. A building number plate and a “Soldiers Chapel” sign is placed above the door (Figure 233). A single window opening just to the right of the doors has been modified with concrete block infill.

Figure 235. Metal entry doors on the east side with gable canopy cover of Building 225 at Camp Guernsey (ERDC-CERL, 2016).

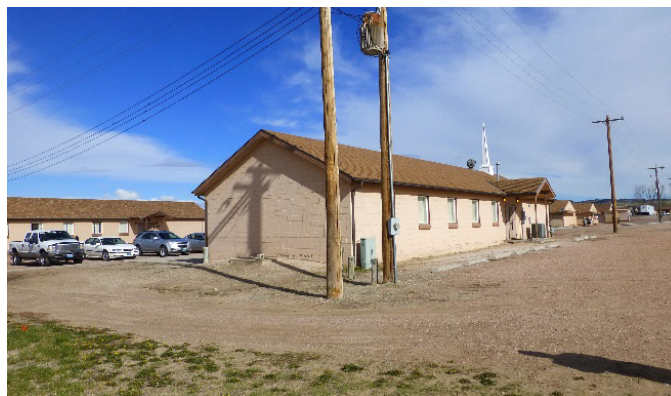
The south elevation of Building 225 faces Building 507. A single-entry door and two windows have been removed, and the openings have been filled with concrete block. A poured concrete pad is located in front of the filled door opening (Figure 236).

Figure 236. Southeast oblique of Building 225 at Camp Guernsey (ERDC-CERL, 2016).

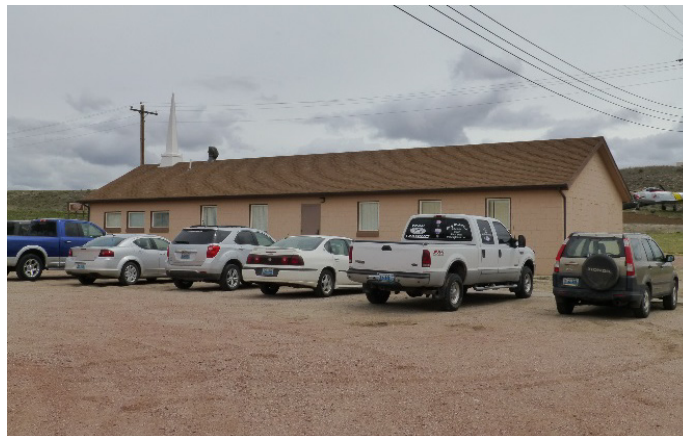
The west elevation of Building 225 faces Building 224. The left side of the elevation has three small, replacement, single-pane windows (Figure 237). There is a single-entry metal door flanked on the left side by two larger replacement windows and on the right side by three larger replacement windows (Figure 237).

Figure 237. West elevation of Building 225 (ERDC-CERL, 2016).

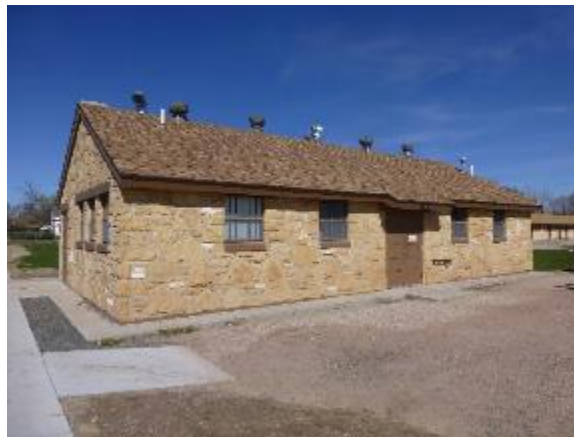
Building 301 is a one-story, rectangular building with a concrete foundation, cut-stone exterior walls, and a gable roof clad with architectural asphalt shingles with modified overhanging eaves (Figure 240 and Figure 241). The original, exposed, wood rafter tails have been enclosed by plywood, creating a boxed eave. The walls are constructed of locally quarried, buff-colored sandstone laid in irregular patterns with cement mortar. While many of the WPA-era buildings exhibit this motif, the triangular-shaped stones are particularly prominent and numerous on this building (Figure 242).

Figure 240. East elevation of Building 301 at Camp Guernsey (ERDC-CERL, 2016).

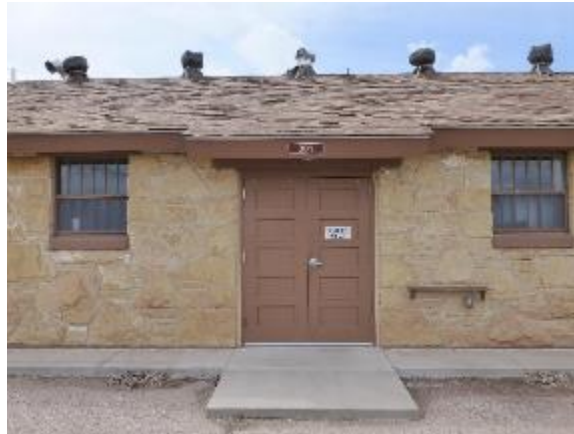
The windows are original multipane steel-sash with concrete windowsills and lintels (Figure 242). The doors are original wood panel with a concrete lintel (Figure 243 and Figure 244). A brick chimney with concrete cap projects from the west side of the roof. Several metal ventilators are placed along the ridge of the roof (Figure 247). An original, steel, mop-drying rack is located near the east doors (Figure 247).

Figure 243. Original wood panel doors with concrete lintel and the original, steel, mop-drying rack on the right side of the doors of Building 301 at Camp Guernsey (ERDC-CERL, 2016).

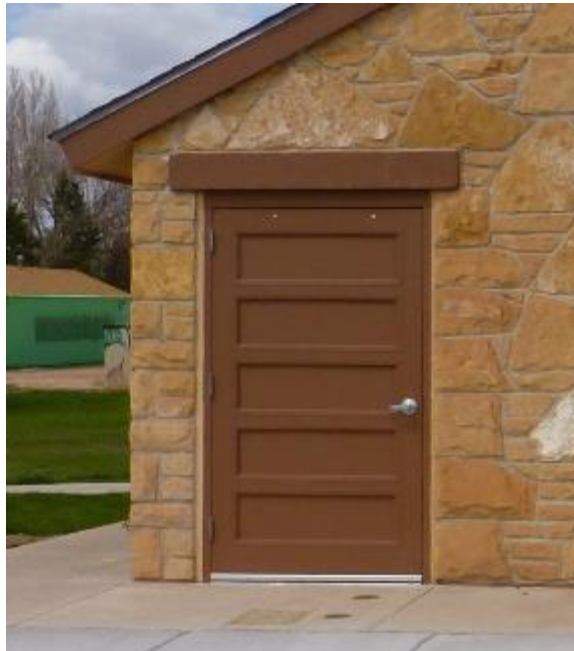
Figure 244. Replacement wood door on the south side of Building 301 at Camp Guernsey (ERDC-CERL, 2016).

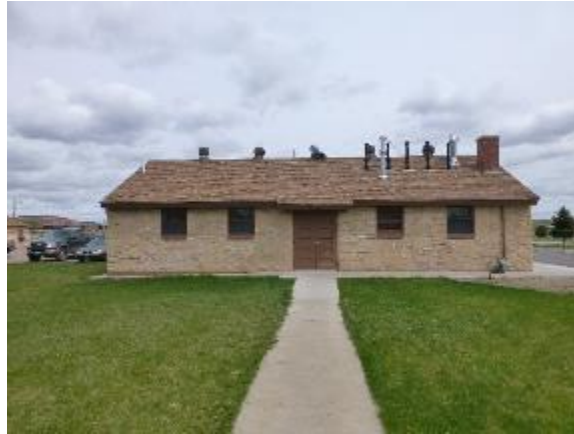
The west elevation faces Building 201. The elevation is symmetrical, with a centrally placed entry. The entry consists of a set of original wood doors that are protected by an overhanging canopy that extends from the roof. Two original windows flank either side of the entry (Figure 245). The south elevation faces Hunton Road and overlooks the parade ground. There is an original wood door on the left side of the elevation and three original windows on the right side (Figure 246). The east elevation faces the gravel lot/hardstand for the 1974 one-story concrete block barracks. The east elevation is symmetrical, with a centrally placed entry. The entry consists of a set of original wood doors that are protected by an overhanging canopy that extends from the roof. Two original windows flank either side of the entry (Figure 247). The north elevation faces Building 405 and consists of three windows and a wood door.

Figure 245. West elevation of Building 301 at Camp Guernsey (ERDC-CERL, 2016).

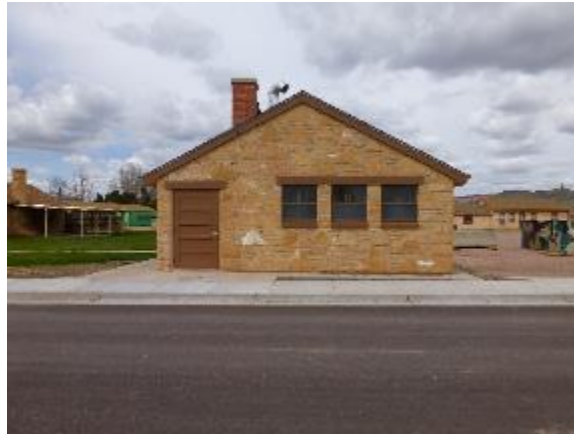
Figure 246. South elevation of Building 301 at Camp Guernsey (ERDC-CERL, 2016).

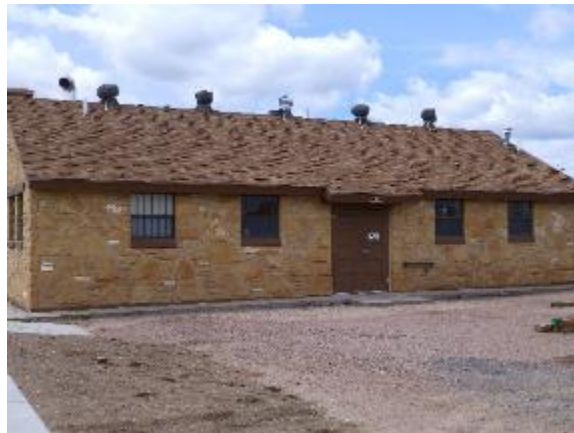
Figure 247. East elevation of Building 301 at Camp Guernsey (ERDC-CERL, 2016).

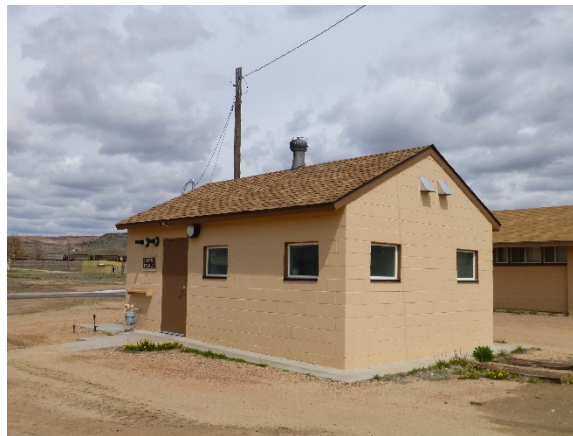
Building 302 is a small, one-story, rectangular structure with a concrete foundation, concrete block exterior walls, and a gable roof clad with asphalt shingles and overhanging eaves on the east and west sides (Figure 249–Figure 251). The windows are replacement single-pane vinyl windows, and the doors are replacement metal doors.

The west elevation of Building 302 has a replacement door and two small windows (Figure 249 and Figure 250). A steel mop-drying rack is placed on the left side of the door. The south elevation faces Building 201 and consists of two windows (Figure 249). The north elevation of Building 302 has a replacement entry door on the right side of the elevation and a metal louvered vent above the door (Figure 250). There is a modified window opening on the left side of the elevation that is filled with concrete block. The east elevation faces Building 404 and consists of three evenly spaced windows (Figure 251).

Figure 249. Southwest oblique of Building 302 at Camp Guernsey (ERDC-CERL, 2016).

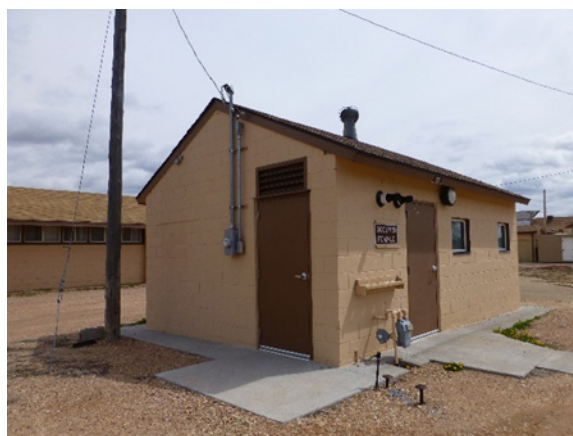
Figure 250. Northwest oblique of Building 302 at Camp Guernsey (ERDC-CERL, 2016).

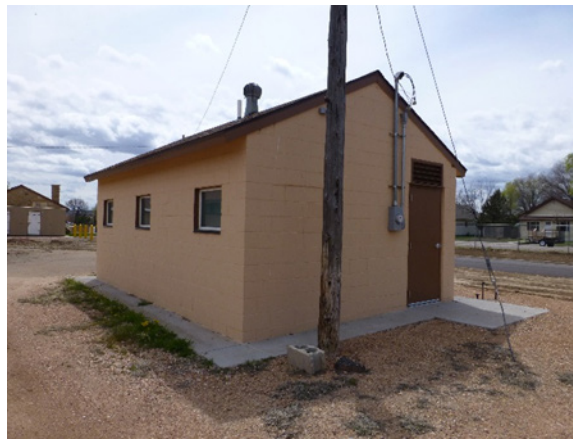
Figure 251. Northeast oblique of Building 302 at Camp Guernsey (ERDC-CERL, 2016).

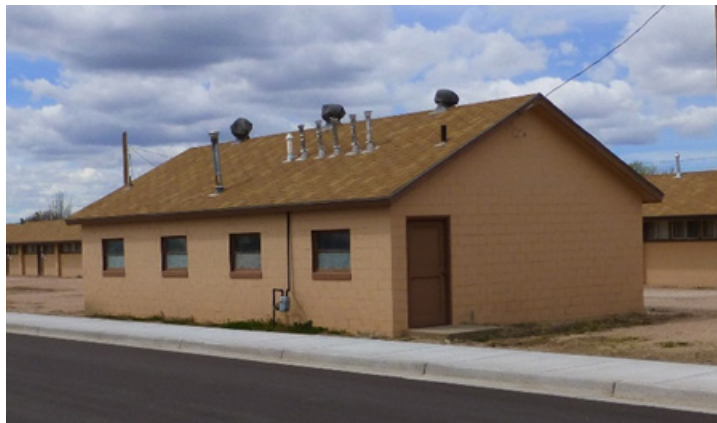
Building 303 is a one-story rectangular structure with a concrete foundation, concrete block exterior walls, and a gable roof clad with asphalt shingles and overhanging eaves (Figure 254). The fascia and soffit are wood. The original windows are one-over-one steel-sash awning-style with concrete windowsills (Figure 255). The doors are metal; one solid metal door and two metal doors with a large pane in the top half (Figure 256). There is an original, steel, mop-drying rack left of the north doors (Figure 256). There are several roof ventilators placed along the ridgeline (Figure 254).

The south elevation of Building 303 faces Hunton Road and overlooks the parade ground. There are four, evenly spaced windows (Figure 254) on the south elevation. The west elevation has two windows (Figure 257). The north elevation faces Building 407. A set of original doors with large panes is placed just to the left of center on the north elevation, with one window to the left of the doors and two windows to the right of the doors (Figure 258). The east elevation faces Laramie Avenue and has one wood door located on the left side of the elevation (Figure 259).

Figure 254. Southeast oblique of Building 303 (ERDC-CERL, 2016).

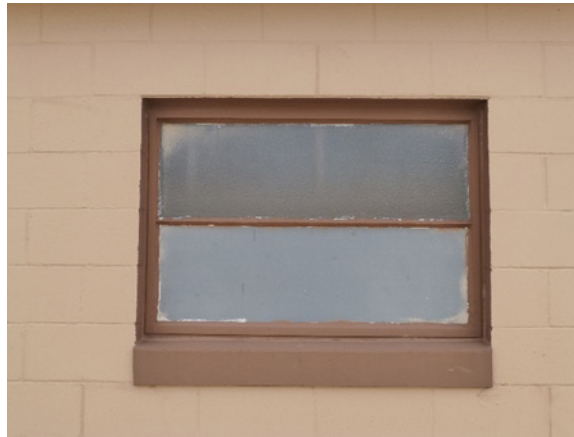
Figure 255. Close-up of an original, one-over-one, steel-sash, awning-style window on Building 303 at Camp Guernsey (ERDC-CERL, 2016).

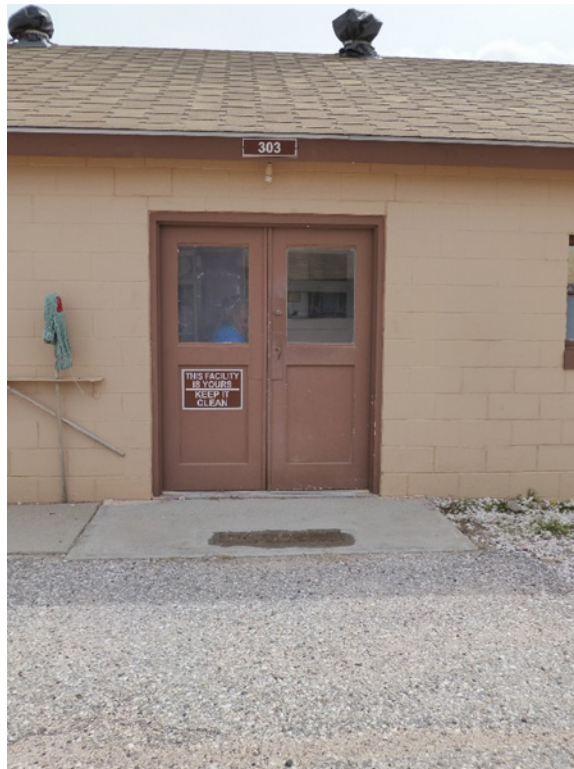
Figure 256. Original wood doors with one large pane and an original, steel, mop-drying rack located on the left side of the doors of Building 303 at Camp Guernsey (ERDC-CERL, 2016).

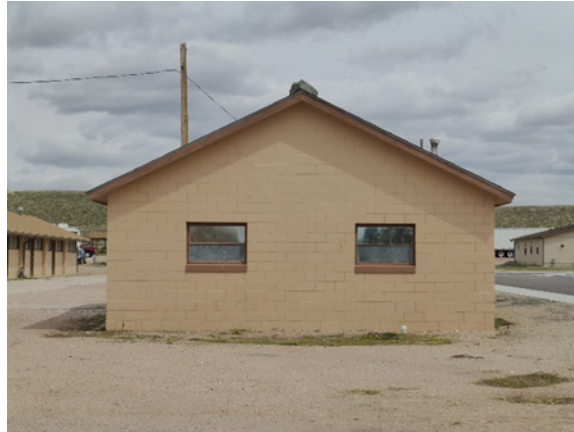
Figure 257. West elevation of Building 303 at Camp Guernsey (ERDC-CERL, 2016).

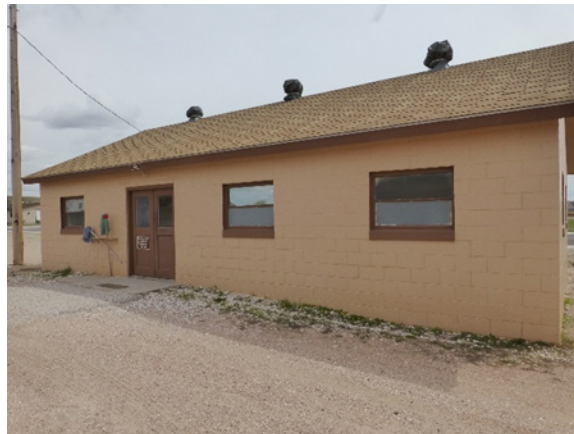
Figure 258. North elevation of Building 303 at Camp Guernsey (ERDC-CERL, 2016).

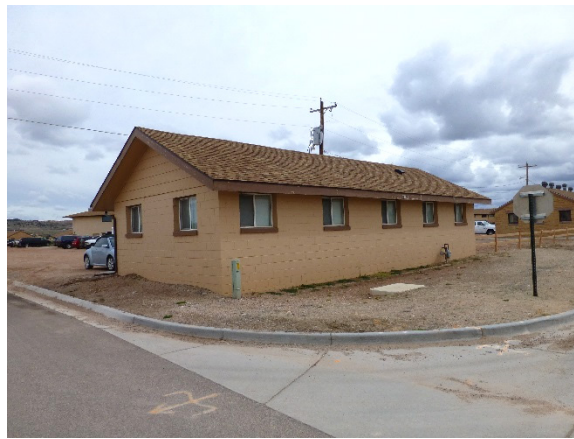
Figure 266. Northeast oblique of Building 311 at Camp Guernsey (ERDC-CERL, 2016).

The north elevation faces Building 501 and overlooks a gravel lot. There are two windows and a single-entry door (Figure 262 and Figure 266). The door is placed on the right side of the elevation. A bronze plaque is placed to the left of the door and a building number plate is placed above the door on the wood fascia. A concrete sidewalk stretches along the front of the building on the north side. The west elevation has two windows (Figure 265). The south elevation faces Sublette Avenue and has five evenly spaced windows (Figure 265). The east elevation is void of any fenestration (Figure 266).

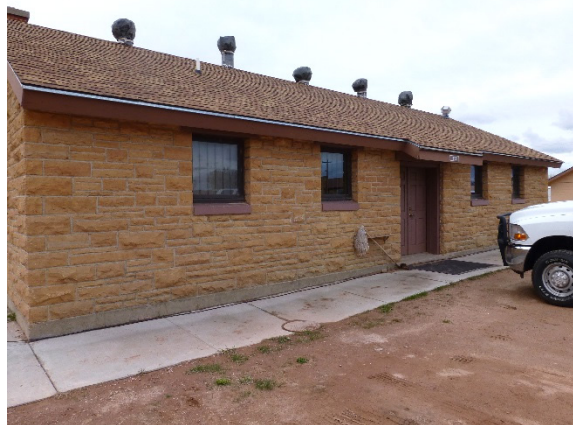
Figure 270. Close-up of the modified overhanging eave where the original wood rafter tails have been enclosed with plywood on Building 312 at Camp Guernsey (ERDC-CERL, 2016).

Building 312 is a one-story rectangular building with a concrete foundation, cut-stone exterior walls, and a gable roof clad with architectural asphalt shingles with overhanging eaves (Figure 269 and Figure 270). The walls are constructed of locally quarried, buff-colored sandstone laid in irregular patterns with cement mortar. The windows are replacement, single-pane, anodized-bronze aluminum (Figure 271), and the doors are replacement wood panel (Figure 272 and Figure 273). The windowsills and lintels are poured concrete (Figure 271). A brick chimney stack projects from the east end of the roof, and several metal ventilators are placed along the ridge of the roof (Figure 276). An original, steel, mop-drying rack is located near the set of north doors (Figure 274). A concrete sidewalk encompasses the building.

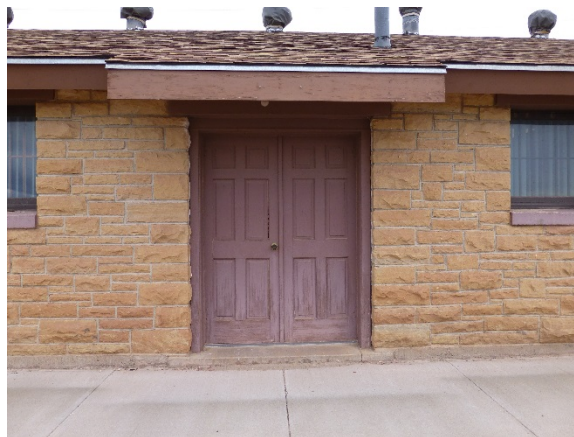
Figure 273. Original wood panel door on the east elevation of Building 312 at Camp Guernsey (ERDC-CERL, 2016).

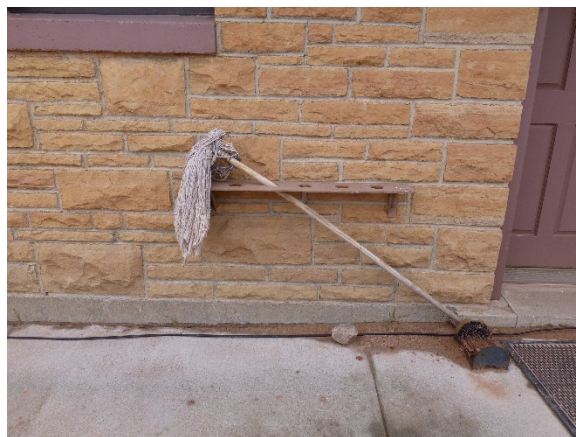
Figure 275. West elevation of Building 312 at Camp Guernsey (ERDC-CERL, 2016).

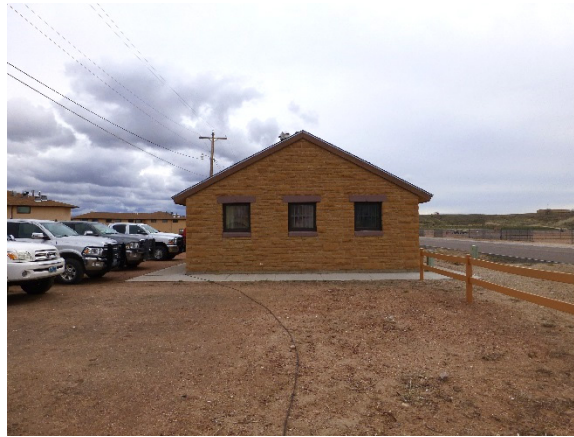
Figure 276. Southwest oblique of Building 312 at Camp Guernsey (ERDC-CERL, 2016).

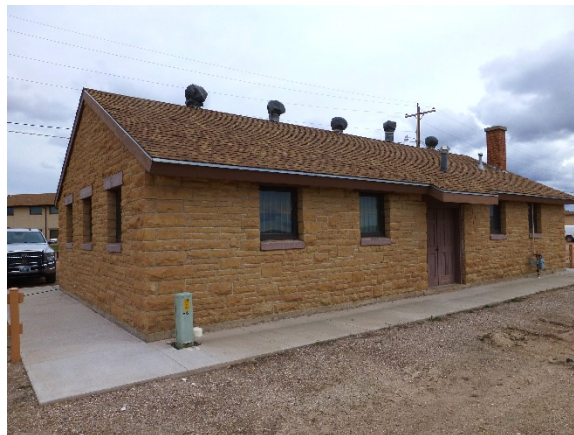
Figure 277. Southeast oblique of Building 312 at Camp Guernsey (ERDC-CERL, 2016).

The north elevation of Building 312 faces a gravel lot and the former concrete pad tent area (where the 1990s barracks currently are located). The elevation is symmetrical, with a centrally placed entry. The entry consists of a set of replacement wood doors that are protected by an overhanging canopy that extends from the roof. Two replacement windows flank either side of the entry (Figure 269). The west elevation of Building 312 faces Building 311 and consists of three, evenly spaced replacement windows (Figure 275). The south elevation faces Sublette Avenue and mirrors the north elevation (Figure 276 and Figure 277). The east elevation faces Building 313 and consists of an original wood panel door (Figure 277). The door is placed on the left side of the elevation.

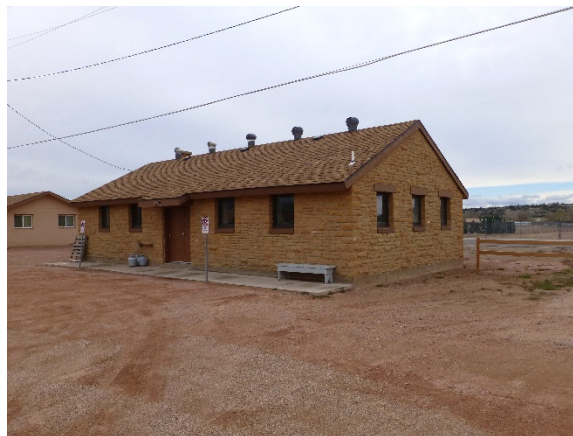
Figure 281. Close-up of the modified overhanging eave where the original wood rafter tails have been enclosed with plywood on Building 313 at Camp Guernsey (ERDC-CERL, 2016).

Building 313 is a one-story rectangular building with a concrete foundation, cut-stone exterior walls, and a gable roof clad with architectural asphalt shingles with overhanging eaves (Figure 280 and Figure 281). The walls are constructed of locally quarried, buff-colored sandstone with cement mortar. The windows are replacement, single-pane, anodized-bronze aluminum (Figure 282) and the doors mixture of original and replacement wood panel (Figure 283 through Figure 285). The windowsills and lintels are poured concrete (Figure 282). A brick chimney stack projects from the east end of the roof and several metal ventilators are placed along the ridge of the roof (Figure 287). An original, steel, mop-drying rack is located near the north doors (Figure 286). A concrete sidewalk is on the north and east sides of the building.

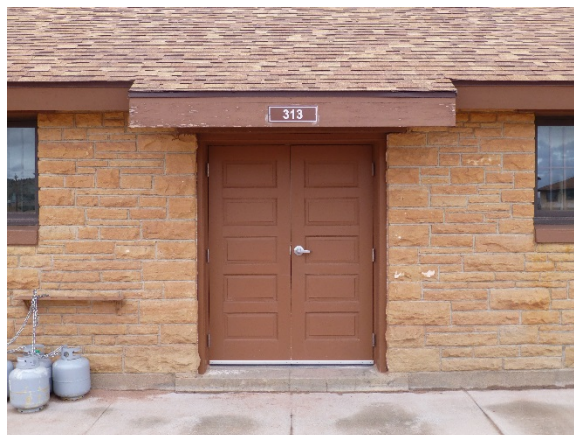
Figure 284. Original wood panel doors on the south elevation of Building 313 at Camp Guernsey (ERDC-CERL, 2016).

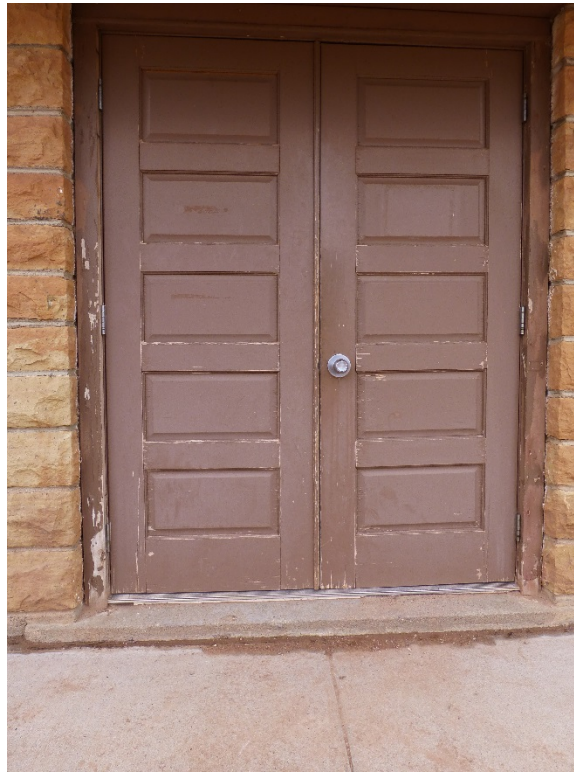
Figure 285. An example of an original wood panel door on an east elevation (ERDC-CERL, 2016).

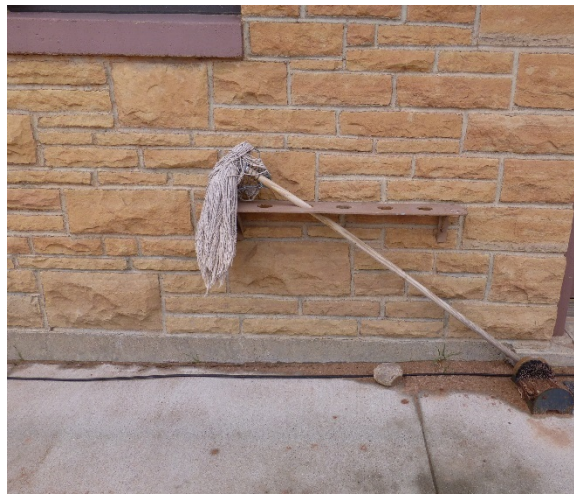
Figure 287. Southeast oblique of Building 313 at Camp Guernsey (ERDC-CERL, 2016).

The north elevation faces a gravel lot and overlooks the former concrete pad tent area (where the 1990s barracks currently are located). The elevation is symmetrical, with a centrally placed entry. The entry consists of a set of original wood doors that are protected by an overhanging canopy that extends from the roof. Two replacement windows flank either side of the entry (Figure 280). The west elevation faces Building 312 and consists of three evenly spaced replacement windows (Figure 280). The south elevation faces Sublette Avenue and mirrors the north elevation (Figure 287). The east elevation faces Building 314 and consists of an original wood panel door (Figure 287). The door is placed on the left side of the elevation.

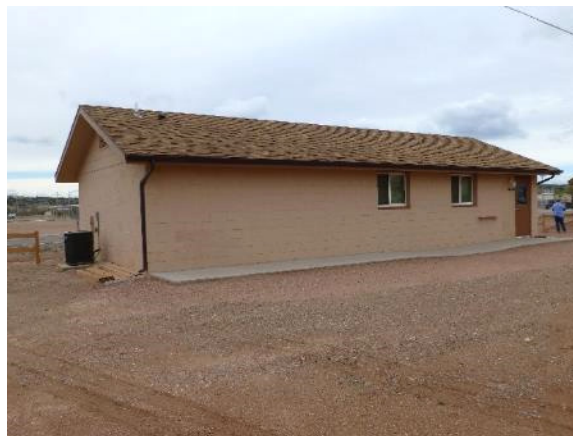
Figure 291. Example of the modified overhanging eave with wood fascia and wood soffit on Building 314 at Camp Guernsey (ERDC-CERL, 2016).

Building 314 is a one-story rectangular building with a concrete foundation, concrete block exterior walls, and a gable roof clad with asphalt shingle with overhanging eaves (Figure 290 and Figure 291). The windows are original two-pane metal-sash slider windows with concrete windowsills (Figure 292). The windows on the north and south elevations are placed high within the wall, nestled under the overhanging eaves. The door is metal with a large pane. The fascia and soffit are constructed of wood and wood siding is covering the gable ends on the east and west ends.

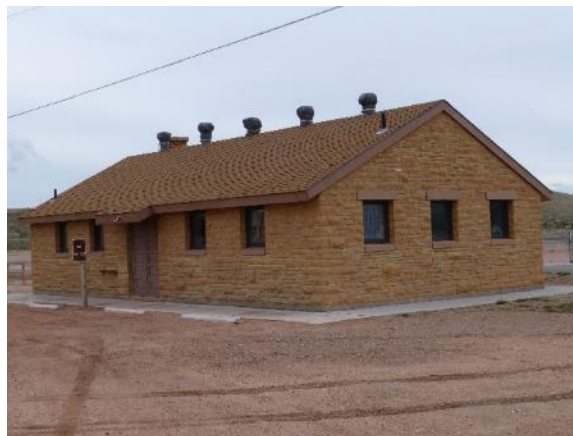
Figure 296. Example of the modified overhanging eave where the original wood rafter tails have been enclosed with plywood on Building 315 at Camp Guernsey (ERDC-CERL, 2016).

Building 315 is a one-story, rectangular building with a concrete foundation, cut-stone exterior walls, and a gable roof clad with architectural asphalt shingles with overhanging eaves (Figure 295 and Figure 296). The walls are constructed of locally quarried, buff-colored sandstone with cement mortar. The windows are replacement, single-pane, anodized-bronze aluminum (Figure 297), and the doors are a mixture of original and replacement wood panel doors (Figure 298 and Figure 299). The windowsills and lintels are poured concrete (Figure 297 and Figure 301). A brick chimney stack projects from the east end of the roof, and several metal ventilators are placed along the ridge of the roof (Figure 295). An original, steel, mop-drying rack is located near the north doors (Figure 300). A concrete sidewalk encompasses the building.

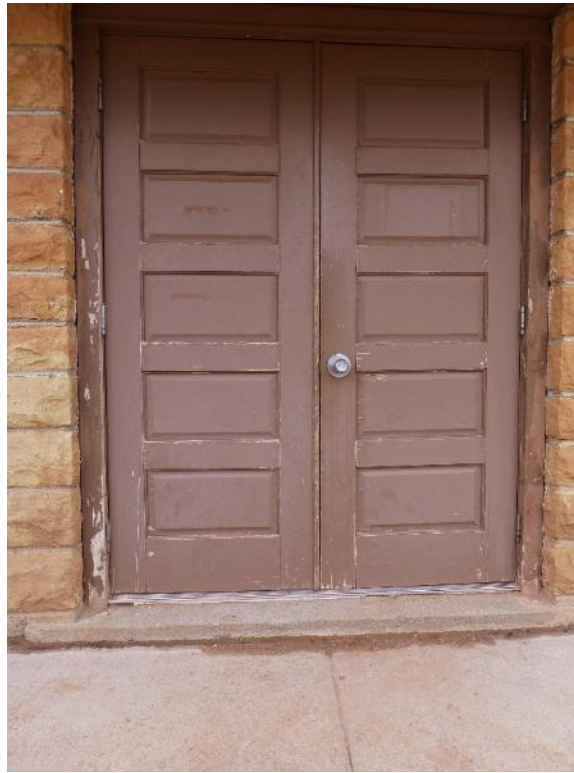
Figure 299. Original wood panel door on the east elevation of Building 315 at Camp Guernsey (ERDC-CERL, 2016).

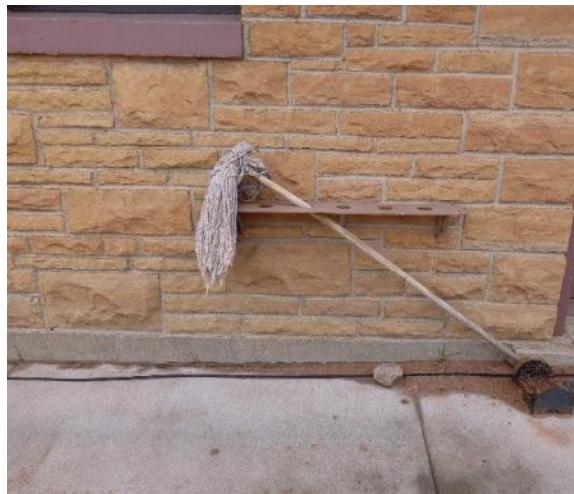
Figure 301. Southeast oblique of Building 315 at Camp Guernsey (ERDC-CERL, 2016).

The north elevation of Building 315 faces a gravel lot and overlooks the former concrete pad tent area (where the 1990s barracks currently are located). The elevation is symmetrical, with a centrally placed entry (Figure 295). The entry consists of a set of replacement wood doors (in-kind) that are protected by an overhanging canopy that extends from the roof. Two replacement windows flank either side of the entry (Figure 295). The west elevation faces Building 314 and consists of three evenly spaced replacement windows (Figure 295). The south elevation faces Sublette Avenue and mirrors the north elevation (Figure 301). The east elevation faces Building 316 and consists of an original wood panel door (Figure 301). The door is placed on the left side of the east elevation.

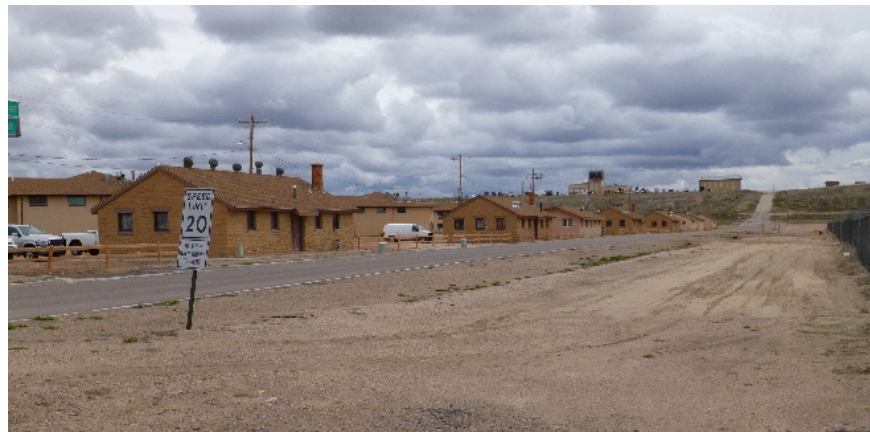
Figure 304. Northwest oblique of Building 316 at Camp Guernsey (ERDC-CERL, 2016).

Building 316 is a one-story, rectangular building with a concrete foundation, cut-stone exterior walls, and a gable roof clad with architectural asphalt shingles with overhanging eaves (Figure 304 and Figure 305). The walls are constructed of locally quarried, buff-colored sandstone with cement mortar. The windows are replacement, single-pane, anodized-bronze aluminum (Figure 306) and the doors are original wood panel (Figure 307–Figure 309). The windowsills and lintels are poured concrete (Figure 306). A brick chimney stack projects from the east end of the roof and several metal ventilators are placed along the ridge of the roof (Figure 310).

The north elevation faces a gravel lot and overlooks the former concrete pad tent area (where the 1990s barracks currently are located). The elevation is symmetrical, with a centrally placed entry (Figure 304). The entry consists of a set of wood panel doors (one original and one modified with plywood) that are protected by an overhanging canopy that extends from the roof (Figure 307). Two replacement windows flank either side of the entry (Figure 304). The west elevation faces Building 315 and consists of three evenly spaced replacement windows (Figure 304). The south elevation faces Sublette Avenue and mirrors the north elevation (Figure 310). The east elevation faces Building 317 and consists of an original wood panel door. The door is placed on the left side of the elevation.

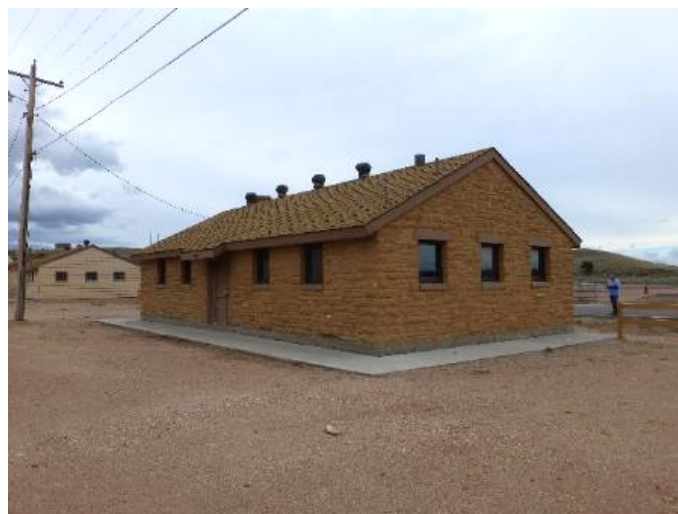
Figure 305. Example of the modified overhanging eave where the original wood rafter tails have been enclosed with plywood on Building 316 at Camp Guernsey (ERDC-CERL, 2016).
