Architectural and Landscape Survey of Camp Guernsey, Wyoming

Adam D. Smith, Megan W. Tooker, and Sunny E. Adams

June 2017

Under Project Number 458417, "Camp Guernsey Historic Context and Building
Evaluation"

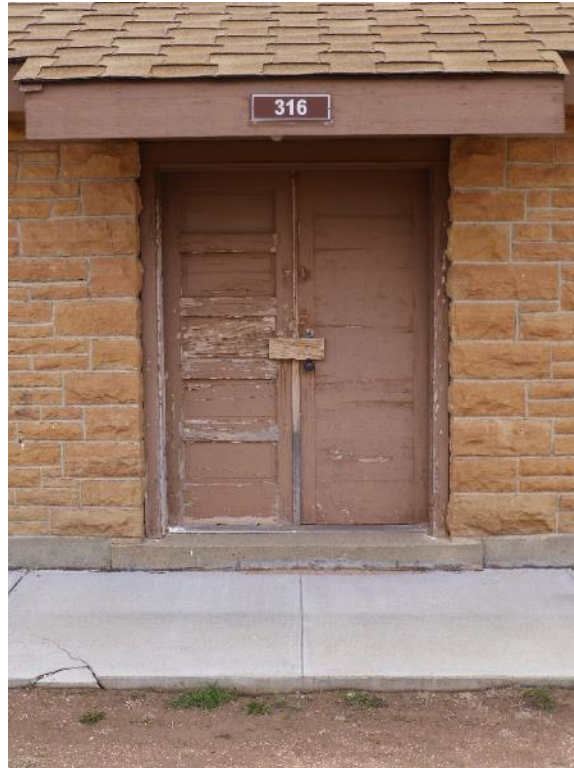
The north elevation faces a gravel lot and overlooks the former concrete pad tent area (where the 1990s barracks currently are located). The elevation is symmetrical, with a centrally placed entry (Figure 304). The entry consists of a set of wood panel doors (one original and one modified with plywood) that are protected by an overhanging canopy that extends from the roof (Figure 307). Two replacement windows flank either side of the entry (Figure 304). The west elevation faces Building 315 and consists of three evenly spaced replacement windows (Figure 304). The south elevation faces Sublette Avenue and mirrors the north elevation (Figure 310). The east elevation faces Building 317 and consists of an original wood panel door. The door is placed on the left side of the elevation.

Figure 307. Entry on the north elevation, with original wood panel door on the left and modified wood door on the right on Building 316 at Camp Guernsey (ERDC-CERL, 2016).

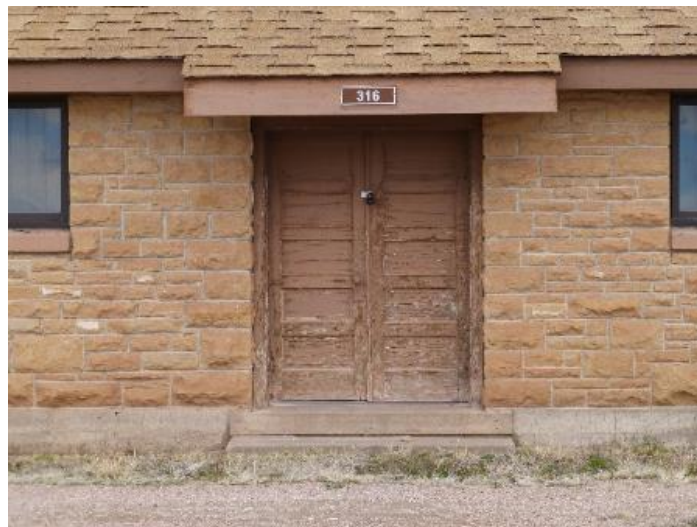
Figure 308. Original wood panel doors on the south elevation of Building 316 at Camp Guernsey (ERDC-CERL, 2016).

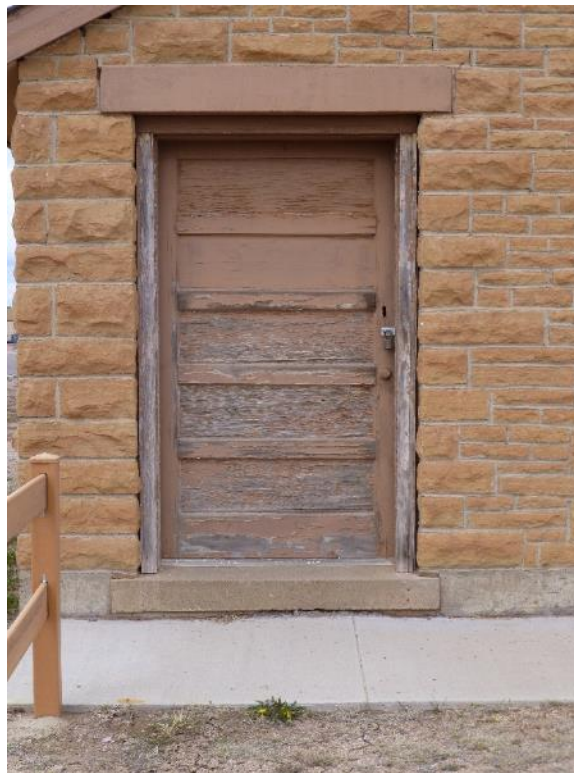
Figure 309. Original wood panel door on the east elevation of Building 316 at Camp Guernsey (ERDC-CERL, 2016).

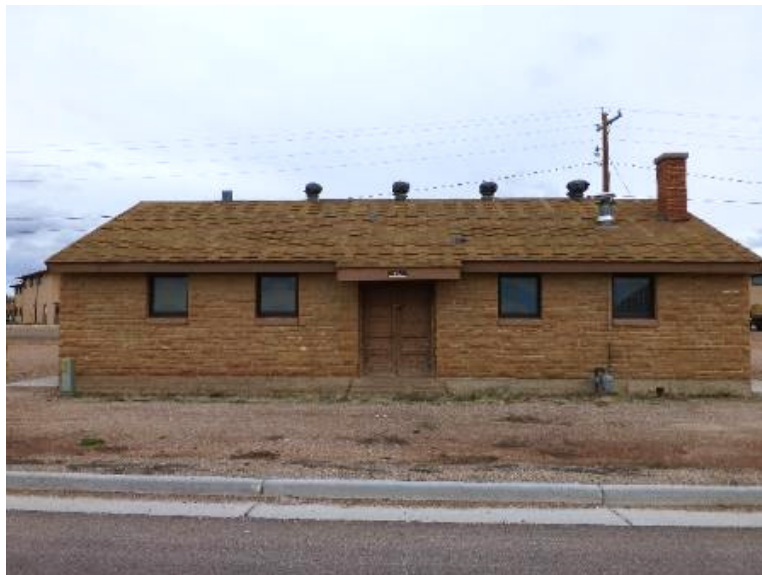
Building 316 is a one-story, rectangular building with a concrete foundation, cut-stone exterior walls, and a gable roof clad with architectural asphalt shingles with overhanging eaves (Figure 304 and Figure 305). The walls are constructed of locally quarried, buff-colored sandstone with cement mortar. The windows are replacement, single-pane, anodized-bronze aluminum (Figure 306) and the doors are original wood panel (Figure 307–Figure 309). The windowsills and lintels are poured concrete (Figure 306). A brick chimney stack projects from the east end of the roof and several metal ventilators are placed along the ridge of the roof (Figure 310).

Figure 310. South elevation of Building 316 at Camp Guernsey (ERDC-CERL, 2016).

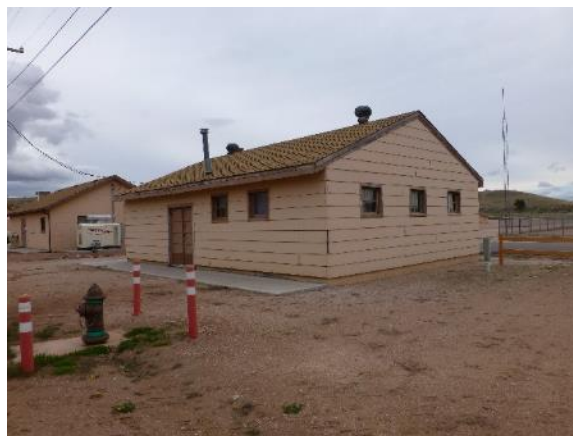
Building 317 is a one-story, rectangular building with a concrete block foundation, exterior walls clad with Masonite siding, and a gable roof clad with asphalt shingle with overhanging eaves (Figure 313 and Figure 314). The windows are a mixture of original six-pane wood-sash slider windows, single-pane wood-sash windows, and two-pane wood-sash windows with wood windowsills (Figure 315). The windows on the north and south elevations are placed high within the wall, nestled under the overhanging eaves. The doors are wood panel (Figure 316). The fascia and soffit are constructed of wood (Figure 317). A brick chimney stack is located on the south side of the east end of the roof (Figure 318).

The north elevation of Building 317 overlooks a gravel lot. There are two windows (one six-pane and one single-pane) and a set of entry doors (Figure 313). A concrete sidewalk stretches along the front of the building on the north side. The west elevation has three windows: two six-pane and one two-pane (Figure 313). The south elevation faces Sublette Avenue and has five windows; two six-pane and three single-pane (Figure 318). The east elevation faces Building 318 and has an original wood panel door located on the left side of the elevation (Figure 318).

Figure 313. Northwest oblique of Building 317 at Camp Guernsey (ERDC-CERL, 2016).

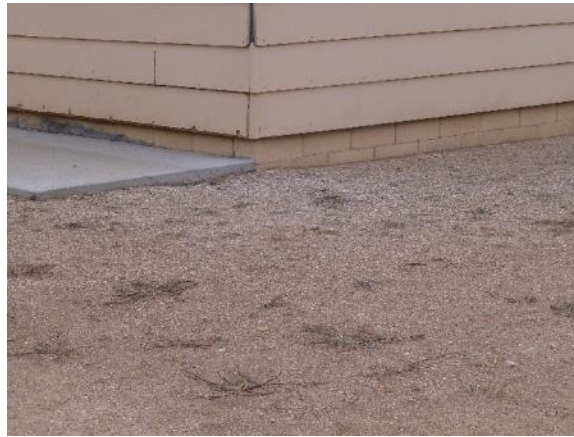
Figure 314. Close-up of the concrete block foundation and Masonite siding on Building 317 at Camp Guernsey (ERDC-CERL, 2016).

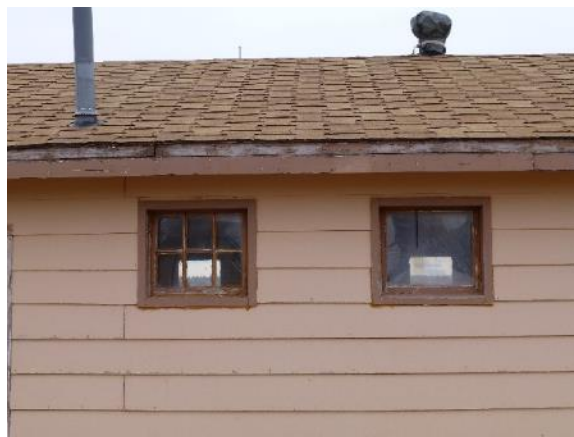
Figure 315. Original six-pane wood sash window [left] and single-pane wood-sash window [right] on Building 317 at Camp Guernsey (ERDC-CERL, 2016).

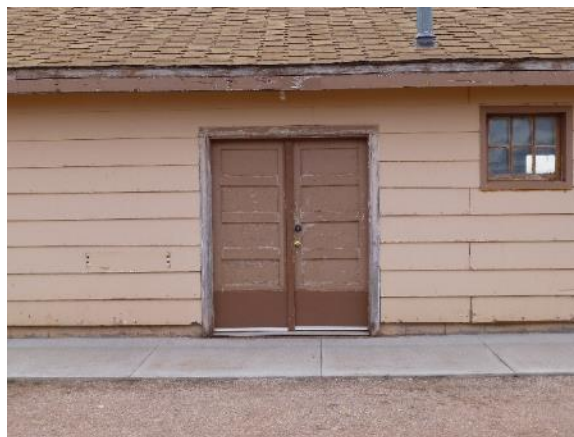
Figure 316. Original wood panel doors on the north elevation of Building 317 at Camp Guernsey (ERDC-CERL, 2016).

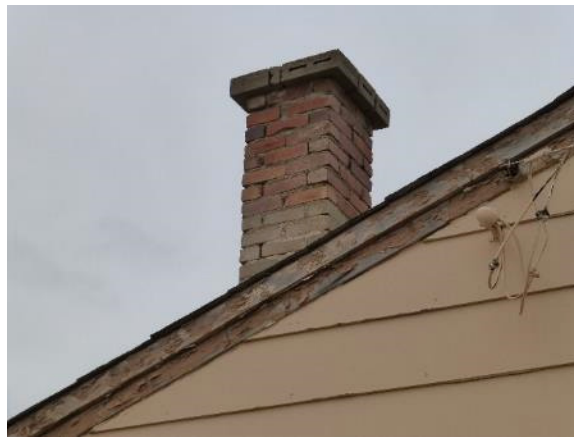
Figure 317. Brick chimney stack on the east end of the roof and wood fascia detail of Building 317 at Camp Guernsey (ERDC-CERL, 2016).

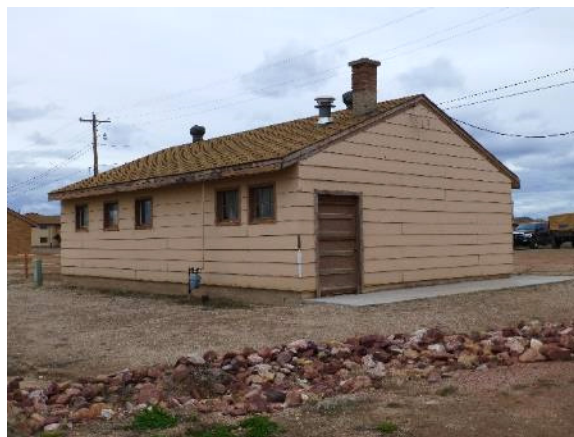
Figure 318. Southeast oblique of Building 317 at Camp Guernsey (ERDC-CERL, 2016).

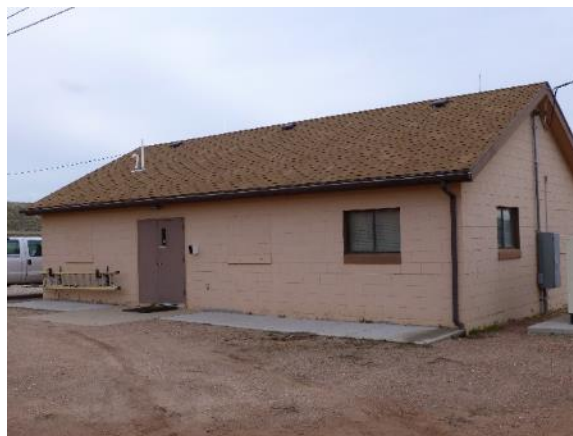
Building 318 is a one-story, rectangular building with a concrete foundation, concrete block exterior walls, and a gable roof clad with asphalt shingles with overhanging eaves (Figure 321). The original windows are two-pane, metal-sash, slider windows with concrete windowsills (Figure 322). The majority of the original windows have been removed, and the openings filled with concrete block. The doors are replacement metal doors. The fascia and soffit are constructed of wood (Figure 321).

The north elevation overlooks a gravel lot. A set of replacement doors is located just to the left of center. There is a modified window opening on the left side of the doors and a modified window opening and an original window on the right side of the elevation (Figure 321). The east elevation faces Building 317 and consists of an original window [left] and a modified window [right] (Figure 323). The south elevation faces Sublette Avenue and consists of four evenly spaced modified window openings (Figure 324). The west elevation of Building 318 faces Building 319, and a replacement metal door is located on the left side of the elevation (Figure 325).

Figure 321. Northwest oblique of Building 318 at Camp Guernsey (ERDC-CERL, 2016).

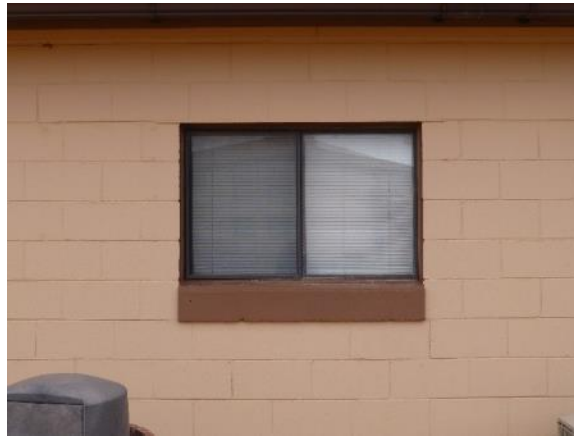
Figure 322. Close-up of the original two-pane metal-sash slider window with concrete windowsill (ERDC-CERL, 2016).

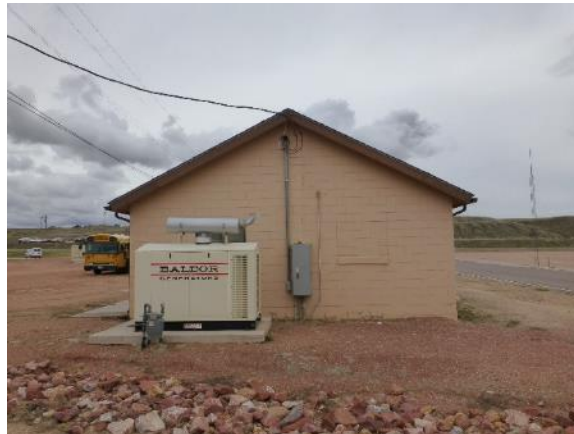
Figure 323. East elevation of Building 318 (ERDC-CERL, 2016).

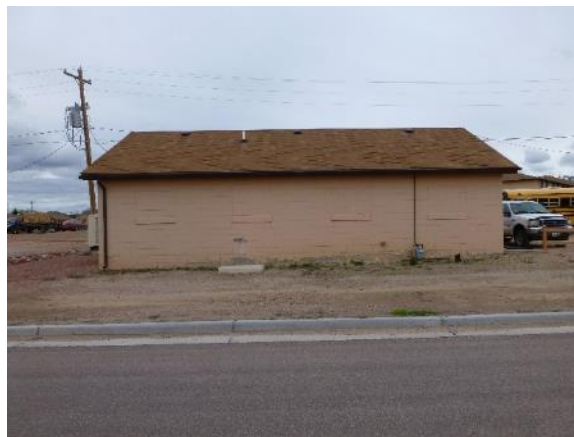
Figure 324. South elevation of Building 318 (ERDC-CERL, 2016).

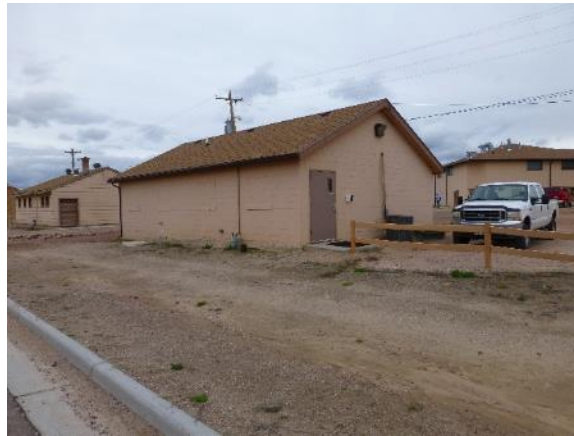
Figure 325. Southeast oblique of Building 318 (ERDC-CERL, 2016).

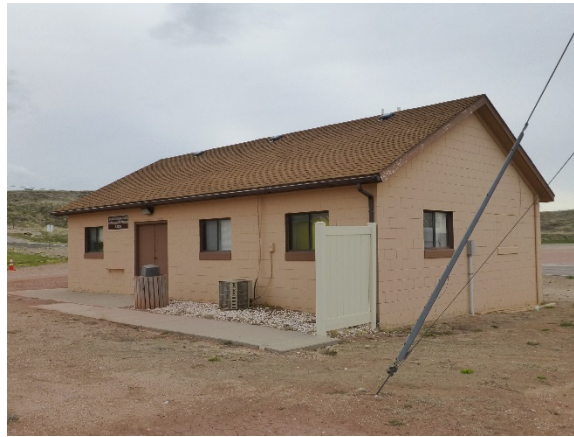
Building 319 is a one-story, rectangular building with a concrete foundation, concrete block exterior walls, and a gable roof clad with asphalt shingle with overhanging eaves (Figure 328). The original windows are two-pane, metal-sash, slider windows with concrete windowsills (Figure 329). The doors are metal (Figure 330 and Figure 331). The fascia and soffit are constructed of wood. A poured concrete sidewalk wraps around the north and east sides of the building.

The north elevation of Building 319 overlooks a gravel lot and faces Building 505. A set of original metal doors is located just to the left of center. There is one window on the left side of the doors and two windows on the right side of the elevation (Figure 328). There is an original, metal, mop-drying rack located just to the left of the door and a replacement light fixture above the door (Figure 330). The west elevation faces Building 318 and consists of an original window [left] and a modified window [right] (Figure 328). The south elevation faces Sublette Avenue and consists of four evenly spaced openings; the far left one has been modified with concrete block infill, and the other three are original two-pane, metal-sash windows (Figure 332). The east elevation faces Portugee Phillips Road and consists of an original metal door with divided lights (Figure 331 and Figure 332). A replacement light fixture is placed above the door.

Figure 328. Northwest oblique of Building 319 at Camp Guernsey (ERDC-CERL, 2016).

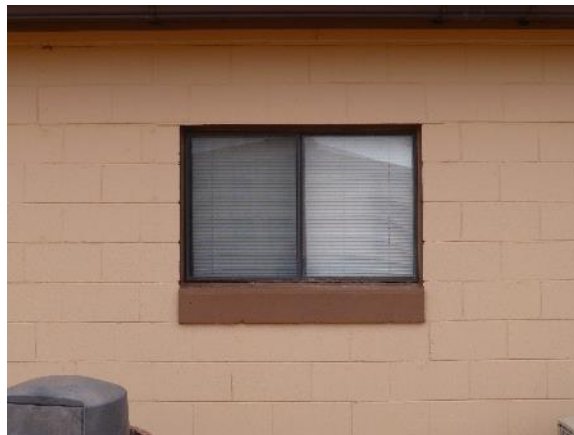
Figure 329. Close-up of the original, two-pane, metal-sash, slider windows with a concrete windowsill on Building 319 at Camp Guernsey (ERDC-CERL, 2016).

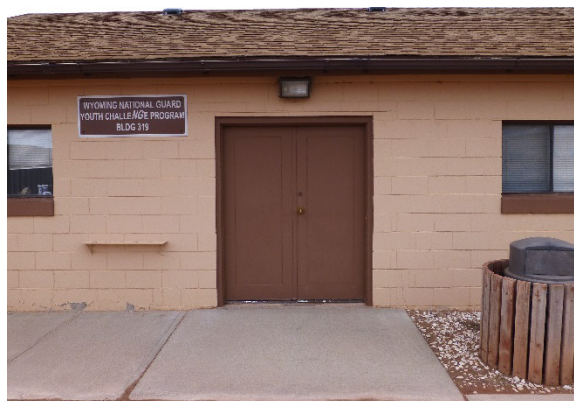
Figure 330. Original metal doors on the north elevation of Building 319 at Camp Guernsey (ERDC-CERL, 2016).

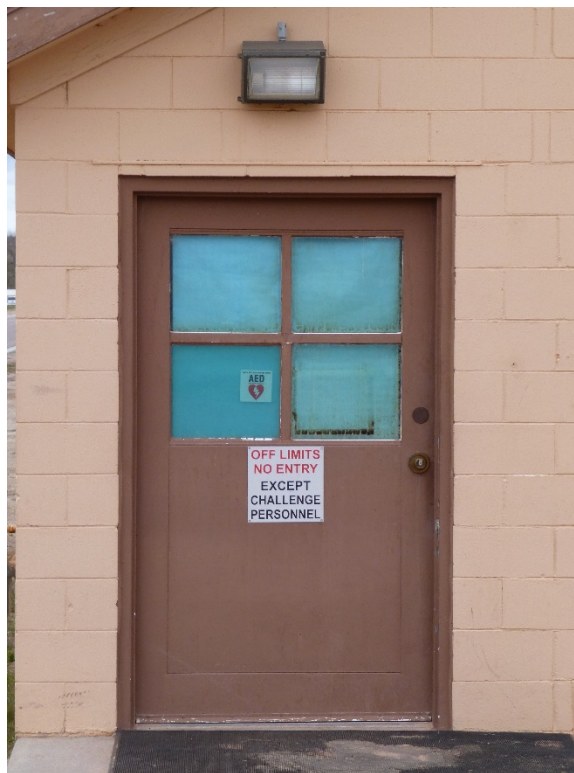
Figure 331. Original metal door with divided lights on the east elevation of Building 319 at Camp Guernsey (ERDC-CERL, 2016).

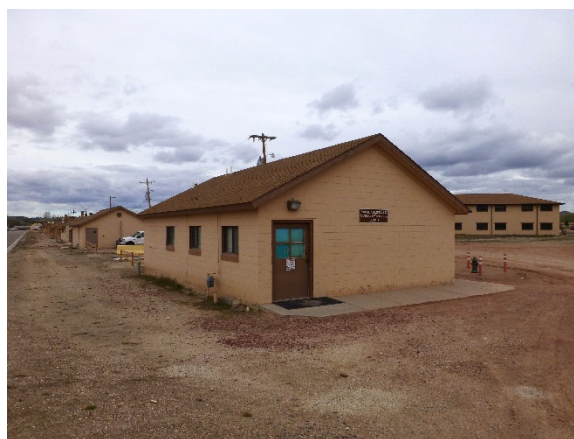
Figure 332. Southeast oblique of Building 319 at Camp Guernsey (ERDC-CERL, 2016).

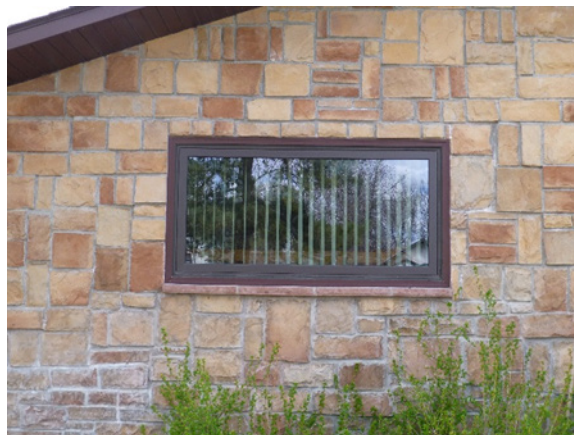
Building 400 is a small one-story structure with a concrete block foundation, square cut stone-clad exterior walls, and a gable roof clad with asphalt shingles with overhanging eaves and wood soffits (Figure 335 and Figure 336). The windows are replacement anodized-bronze aluminum (Figure 337 and Figure 338). The doors are replacement metal entry doors. The east elevation faces a large landscaped lawn overlooking Hunton Road. The elevation is symmetrical, with a central entry bay that consists of a set of replacement metal and plate-glass doors flanked on either side by a large replacement window (Figure 335). A wood deck is located in front of the entry doors. The south elevation has one large, single-pane, replacement window located on the right side of the elevation, and a louvered vent is placed in the gable end (Figure 338). The west elevation has a single-entry metal replacement door and three smaller replacement windows (Figure 339). The north elevation overlooks a concrete driveway and consists of a large replacement window that is located on the left side of the elevation (Figure 339).

Figure 337. Replacement, single-pane, anodized-bronze aluminum window on Building 400 at Camp Guernsey (ERDC-CERL, 2016).

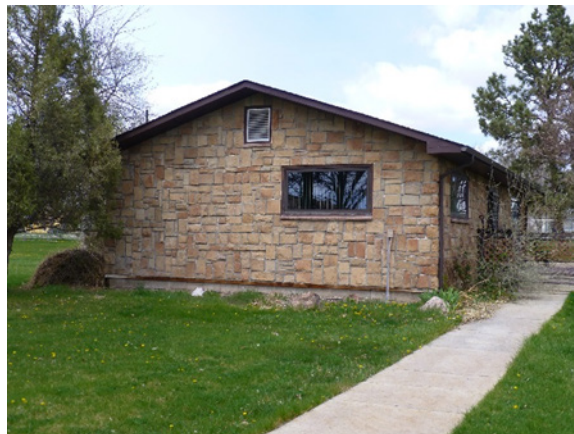
Figure 338. South elevation of Building 400 at Camp Guernsey (ERDC-CERL, 2016).

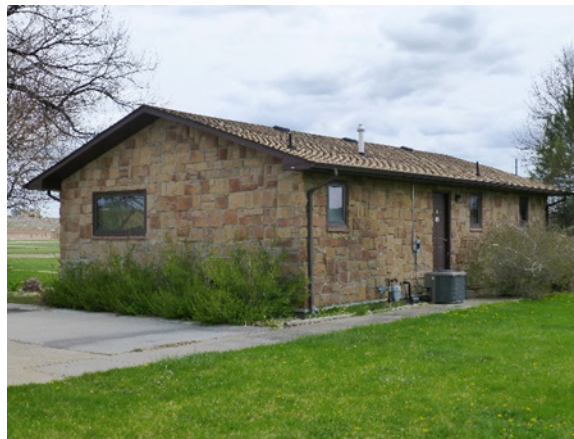
Figure 339. Northwest oblique of Building 400 at Camp Guernsey (ERDC-CERL, 2016).

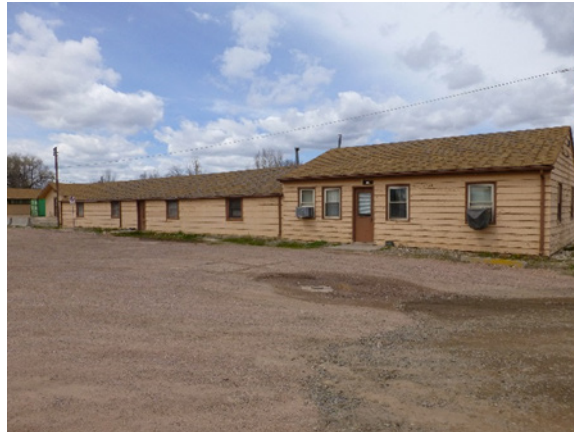
Building 402 is a one-story wood-frame structure with a T-shaped footprint, a concrete foundation, pressed-wood lap siding covering the exterior walls, and a cross-gable roof clad with asphalt shingles (Figure 342 and Figure 346). The eastern end of the building is a later, one-story, wood-frame addition and is slightly taller in roofline than the original (Figure 342). The windows are a combination of wood-frame, double-hung, and aluminum-sash (Figure 343–Figure 345). There is one original, multipane wood window located on the north elevation of the original T-shaped building (Figure 344).

The south elevation of Building 402 overlooks a gravel lot and faces Hunton Road (Figure 342 and Figure 346). The left and middle portions of the elevation are the original building. It is symmetrical, with a central door flanked on either side with two modified door openings that are currently filled with a replacement wood windows, and the remainder of the opening is clad with pressed-wood siding (Figure 343). The right side of the elevation is the later addition. There are four one-over-one aluminum-frame windows and a single-entry door (Figure 342).

Figure 342. South elevation with the original T-shaped portion [left] and the later addition [right] of Building 402 at Camp Guernsey (ERDC-CERL, 2016).

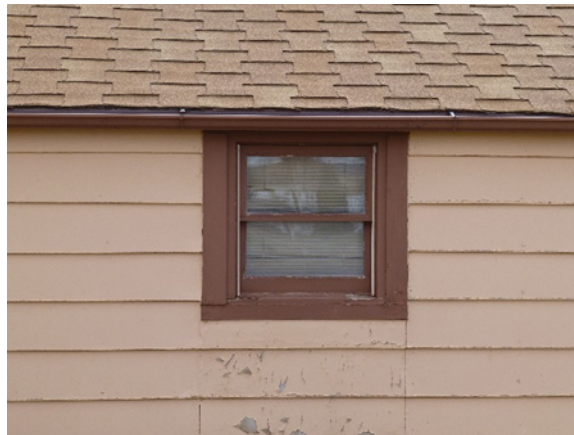
Figure 343. Modified door opening with window and siding infill on the original T-shaped portion of Building 402 at Camp Guernsey (ERDC-CERL, 2016).

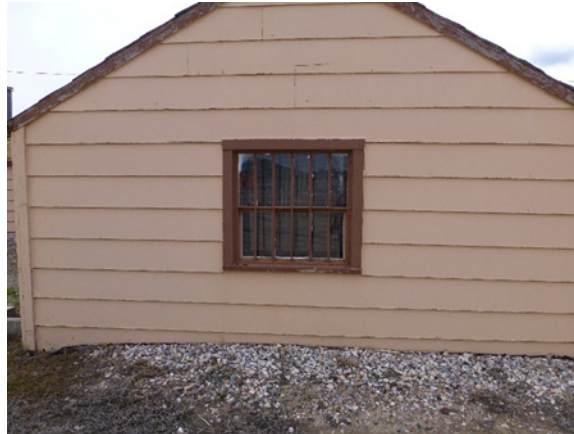
The north elevation of Building 402 overlooks a gravel lot. The right side of the elevation is the original T-shaped building and the left side is the later addition (Figure 348 and Figure 349). The middle portion of the right side projects out and has an original, multipane, wood-frame window (Figure 344). The left and right sides of the right portion of the elevation each have a modified door opening filled with a replacement wood window, and the remainder of the opening is clad with pressed-wood siding (Figure 343). The left side of the north elevation is the 1967 addition, and it consists of three one-over-one, aluminum-framed windows (Figure 349).

Figure 344. Original wood, double-hung window on the north elevation of the north wing of the original T-shaped portion of Building 402 at Camp Guernsey (ERDC-CERL, 2016).

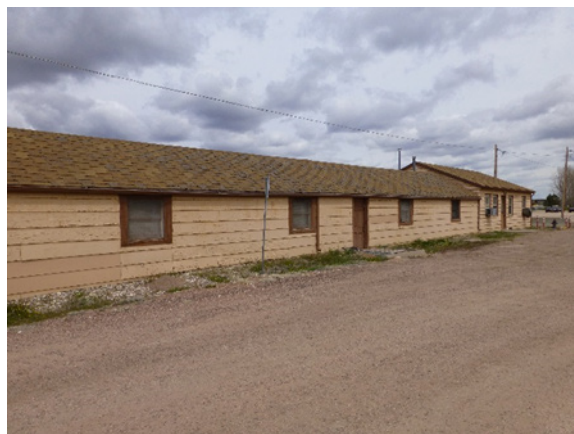
Figure 347. West elevation of the original T-shaped portion of Building 402 at Camp Guernsey (ERDC-CERL, 2016).

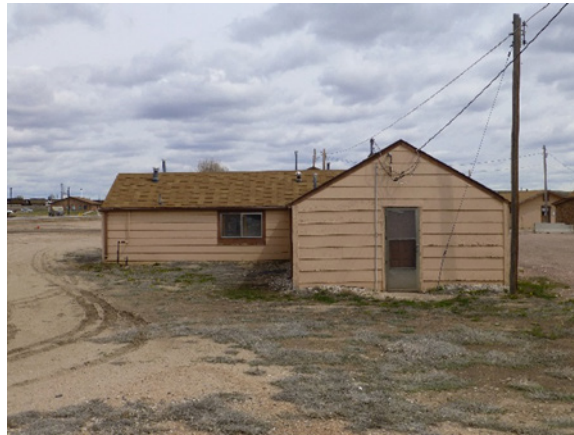
Figure 348. Northwest oblique of the original T-shaped portion of Building 402 at Camp Guernsey (ERDC-CERL, 2016).

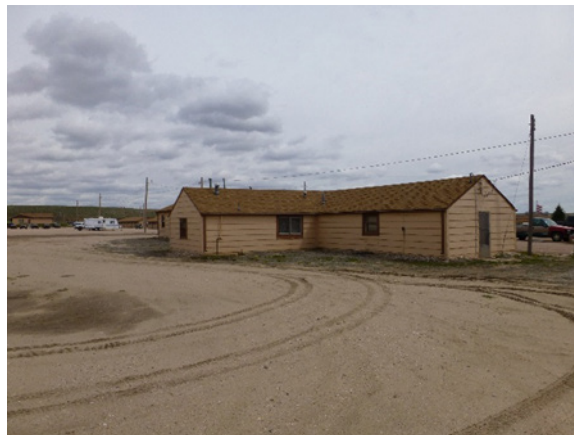
Figure 349. North elevation with the original T-shaped portion [right] and the later addition [left] for Building 402 at Camp Guernsey (ERDC-CERL, 2016).

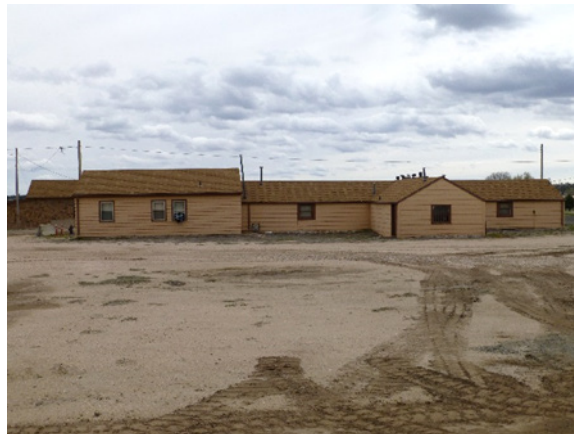
Figure 350. East elevation of the addition to Building 402 at Camp Guernsey (ERDC-CERL, 2016).

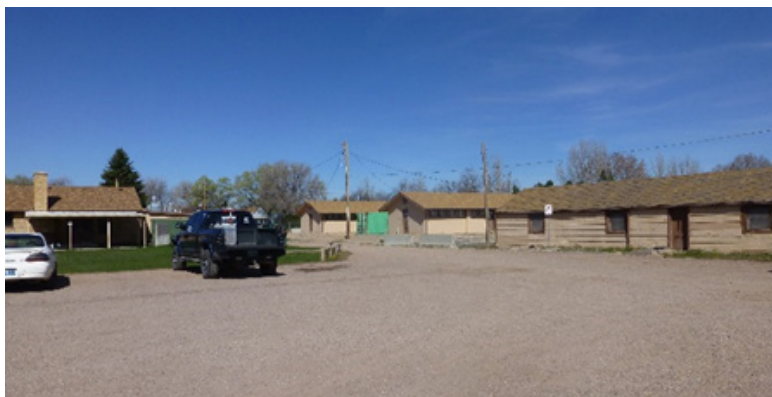
Figure 353. Northwest oblique of Building 404 (ERDC-CERL, 2016).

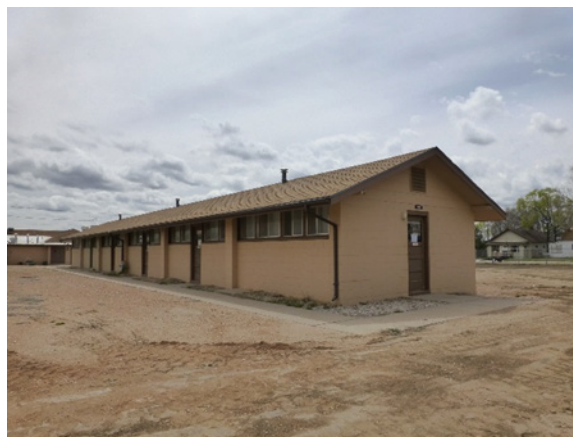
Figure 358. South elevation of Building 404 at Camp Guernsey (ERDC-CERL, 2016).

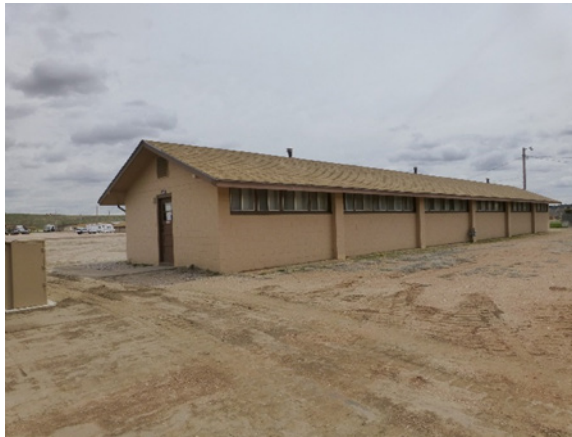
Figure 361. Close-up of the overhanging eave and the gable end clad with pressed-wood siding of Building 405 at Camp Guernsey (ERDC-CERL, 2016).

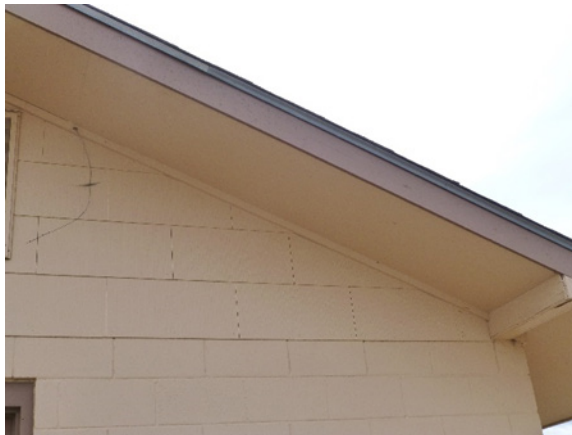
Figure 362. Band of replacement, aluminum-sash, slider windows on the east and west elevations of Building 405 at Camp Guernsey (ERDC-CERL, 2016).

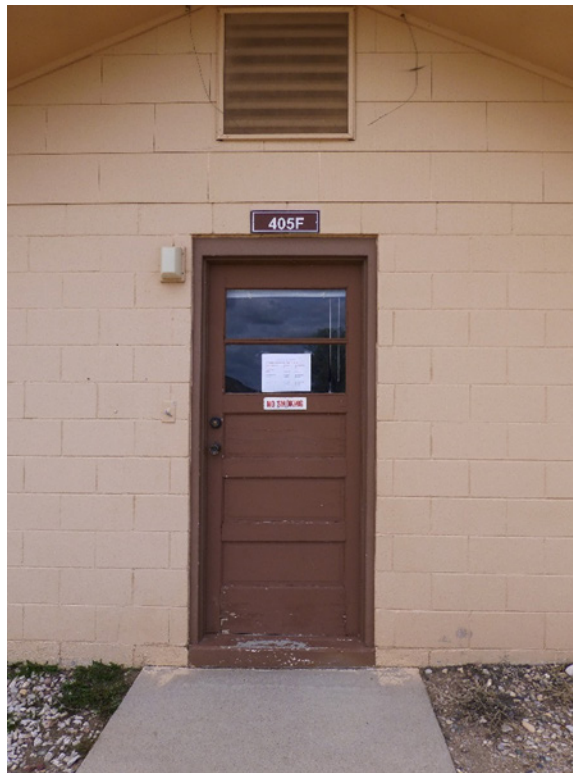
Figure 364. East elevation of Building 405 at Camp Guernsey (ERDC-CERL, 2016).

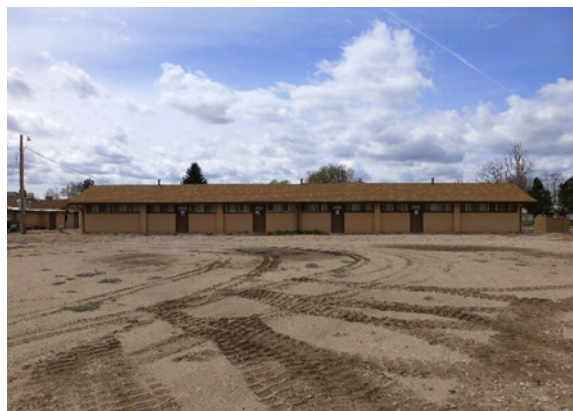
Figure 365. South elevation of Building 405 at Camp Guernsey (ERDC-CERL, 2016).

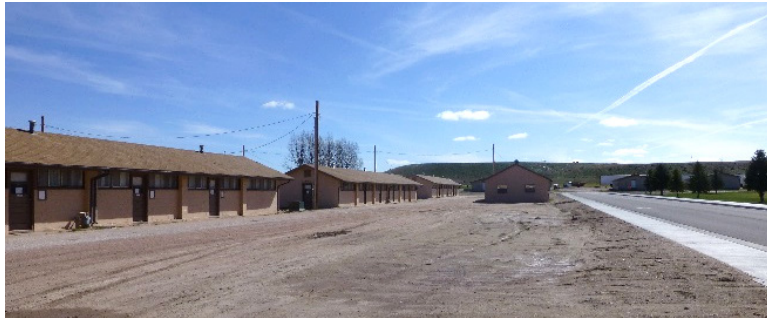
Figure 368. South side of Building 406 at Camp Guernsey (ERDC-CERL, 2016).

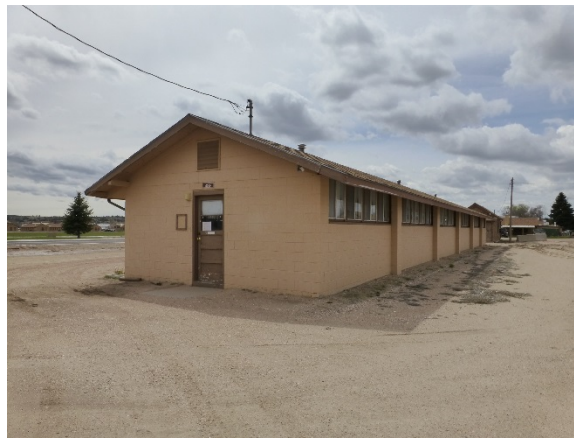
Figure 373. West elevation of Building 406 at Camp Guernsey (ERDC-CERL, 2016).

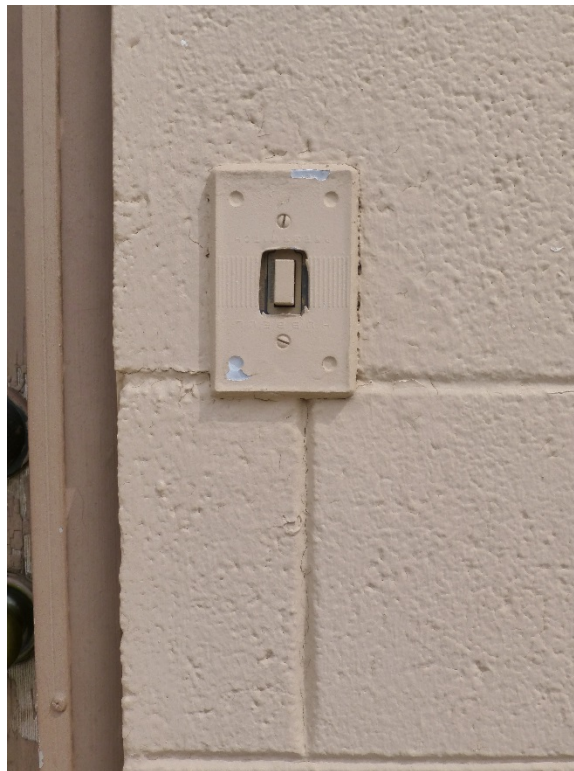
Building 408 is a long, one-story rectangular structure that is oriented in the east-west direction. It has a concrete foundation, concrete block exterior walls, and a gable roof clad with asphalt shingle with overhanging eaves (Figure 384 and Figure 385). The east and west gable ends are clad with pressed-wood siding (Figure 385). The long north and south elevations are divided into bays by concrete block pilasters (Figure 384 and Figure 389). The bands of windows on the east and west elevations are replacement, aluminum-sash, slider windows (Figure 386). The doors are original, wood panel with two-panes in the top half (Figure 388). There are individual doorbells placed at each entry on the south elevation (Figure 387).

Figure 388. Close-up of the door and window detail on the four middle bays of the south elevation on Building 408 (ERDC-CERL, 2016).

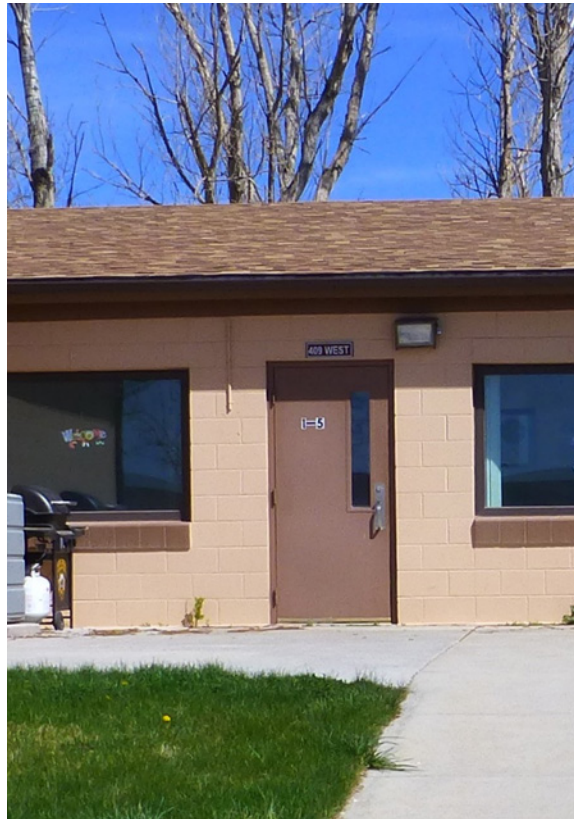
spaced paired replacement windows on this side of the building. The east elevation faces Portugee Phillips Road and consists of a single-entry door and one replacement window (Figure 391 and Figure 394). The south elevation faces a paved parking lot. There are three projecting wings and two recessed entry sections on this elevation (Figure 395–Figure 397). There are two pairs of replacement windows on each end of the projecting wings (Figure 394 and Figure 395), and two single-entry doors and three windows on each recessed section (Figure 396 and Figure 397). The west elevation faces Laramie Avenue and overlooks the parade ground (Figure 398). A poured concrete sidewalk leads from the parking lot to a poured concrete pad that fills the space between each projecting wing. There is a single-entry door and one window on this elevation (Figure 399).

Figure 394. Southeast oblique of Building 409 at Camp Guernsey (ERDC-CERL, 2016).

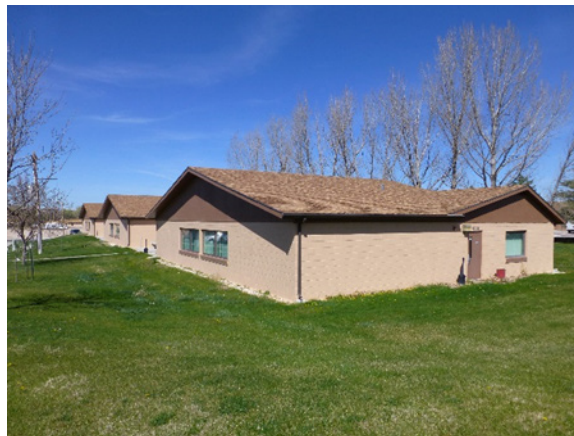
Building 409 is a large, one-story structure with an E-shaped footprint, a concrete foundation, concrete block exterior walls, and an east-west gable roof with three projecting cross-gables off the south side (Figure 391, Figure 395, and Figure 398). The roof is clad with asphalt shingles and the gable ends are clad with vertically ribbed Masonite siding. The windows are replacement, single-pane, anodized-bronze aluminum with concrete block windowsills (Figure 392). The doors are metal with a narrow glass pane (Figure 393).

Figure 395. South elevation of Building 409 at Camp Guernsey (ERDC-CERL, 2016).

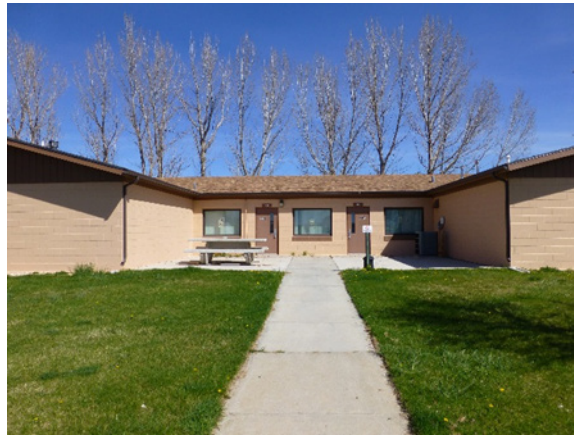
Figure 397. Left-side recessed entry on the south elevation of Building 409 at Camp Guernsey (ERDC-CERL, 2016).

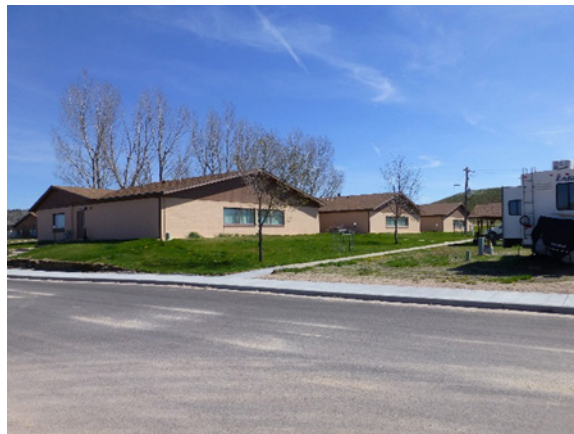
Figure 399. West elevation of Building 409 at Camp Guernsey (ERDC-CERL, 2016).

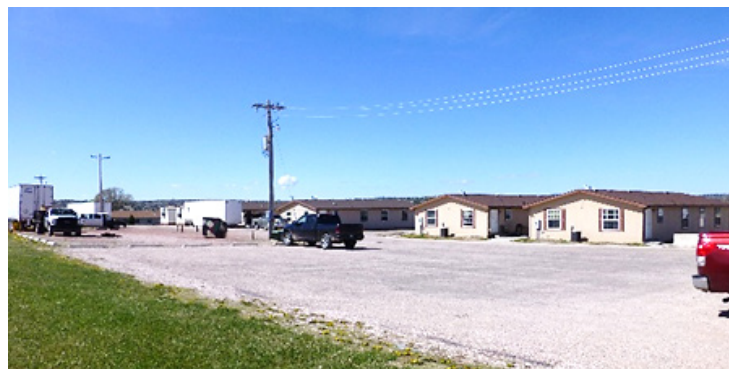
Buildings 410, 411, 412, and 413 are simple, one-story, rectangular structures. Each building has a raised concrete foundation, “wood-like” board exterior walls, and a gable roof clad with asphalt shingles and overhanging eaves (Figure 402–Figure 406). The windows are one-over-one vinyl-sash and the doors are metal. The west elevations face Laramie Avenue and overlook the parade ground. Each west elevation has a single-entry metal door that is slightly left of center (Figure 403). Metal steps provide access to the elevated doors. The south elevations each consist of four windows and a single-entry door (Figure 402 through Figure 404). The door is located on the right side of the elevation. The north elevations each consist of three windows, one small window, and a single-entry metal door (Figure 405). The door is located on the left side of the north elevations, with a concrete stoop. The east elevations face a paved parking lot and consist of two windows (Figure 407).

Figure 402. Southwest oblique of Buildings 413 [right] and 412 [left] at Camp Guernsey (ERDC-CERL, 2016).

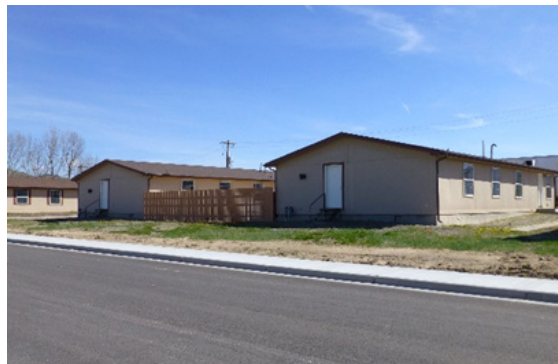
Figure 403. Southwest oblique of Building 413 at Camp Guernsey (ERDC-CERL, 2016).

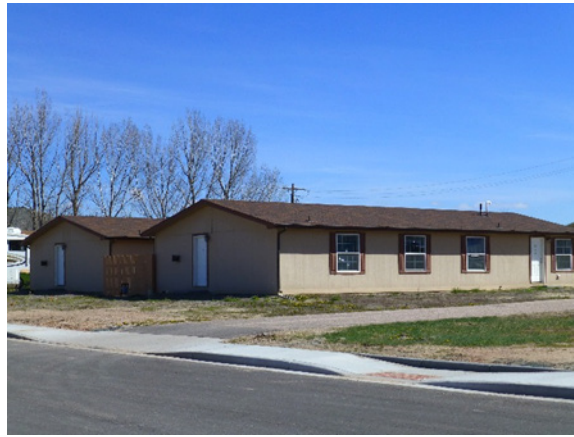
Figure 405. Northwest oblique of Building 412 at Camp Guernsey (ERDC-CERL, 2016).

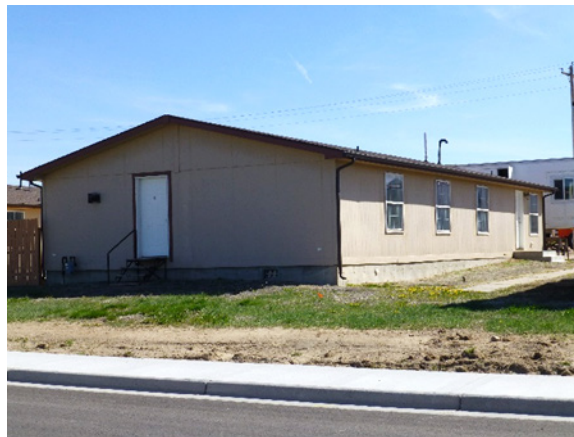
Figure 406. West elevation of Buildings 410 [left] and 411 [right] at Camp Guernsey (ERDC-CERL, 2016).

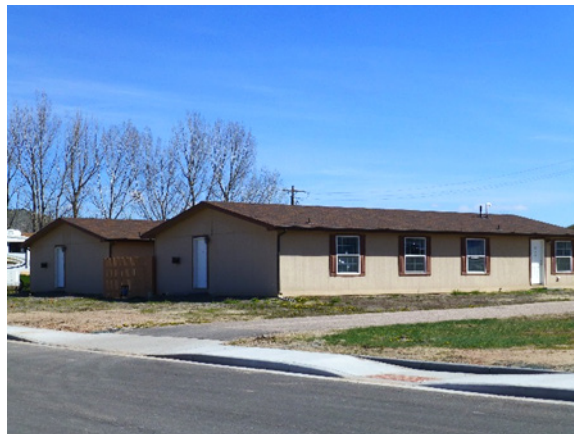
Figure 407. Northwest oblique of Building 412 at Camp Guernsey (ERDC-CERL, 2016).

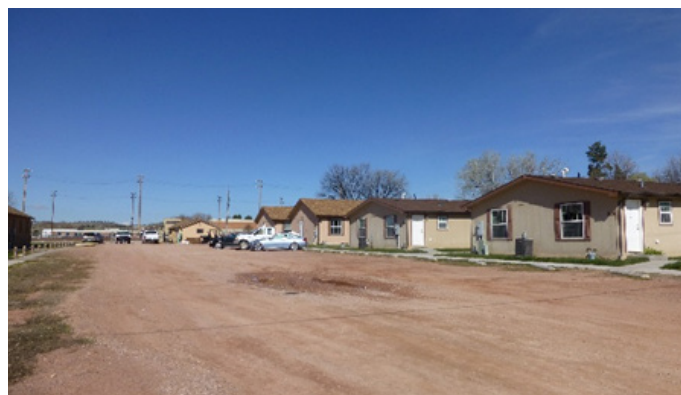
Buildings 414 and 415 are one-story, long, rectangular buildings with concrete foundations, exterior walls clad with wood sheets (plywood), and gable roofs with asphalt shingles with overhanging eaves (Figure 410 and Figure 411). The windows are double-hung vinyl windows, and the doors are metal. The south elevations overlook the wide gravel road and consist of single-entry doors placed in the center of the elevations (Figure 410). The west elevations consist of three windows (Figure 411). The north elevations of Buildings 416 and 417 overlook the large landscaped lawn and consist of paired windows placed on the left side of the elevations, whereas Buildings 414 and 415 have only an entry door (Figure 413). The east elevations have single-entry doors on the right side. The roofs above the doors are a cross gable. There are two windows with vinyl shutters on the left side of the east elevations (Figure 412).

Buildings 416 and 417 are one-story, rectangular buildings with concrete foundations, exterior walls clad with wood sheet (plywood), and gable roofs with asphalt shingles and overhanging eaves (Figure 410). The windows are double-hung vinyl, and the doors are metal. The south elevations overlook the wide gravel road and consist of two windows with vinyl shutters (Figure 410 and Figure 412). The west elevations have four windows and a door (Figure 411). The north elevations overlook the large landscaped lawn and consist of a single-entry metal door, placed just to the left of center on the elevation (Figure 413). The east elevations have three windows on the right side, and a door with a smaller window on the left side (Figure 412).

Figure 410. South elevations of (left to right): Buildings 415–417 at Camp Guernsey (ERDC-CERL, 2016).

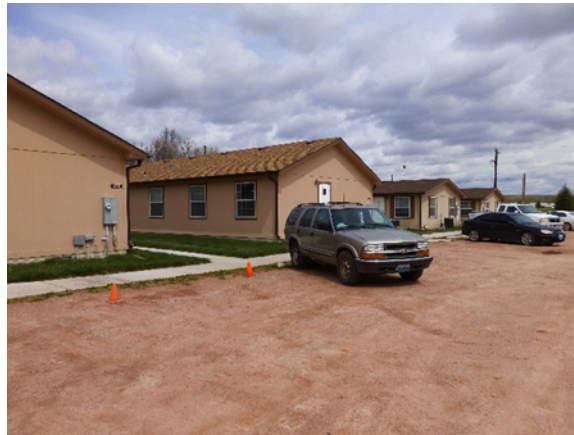
Figure 411. West elevation of Building 414 at Camp Guernsey (ERDC-CERL, 2016).

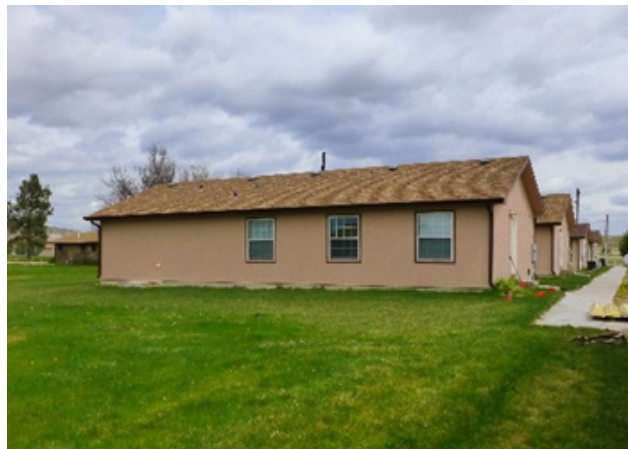
Figure 412. Southeast oblique of (left to right): Buildings 414–417 at Camp Guernsey (ERDC-CERL, 2016).

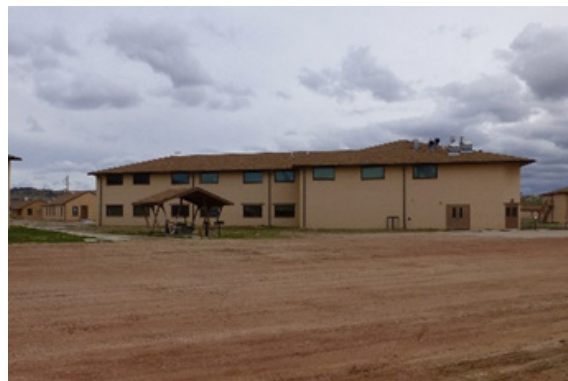
The right-side, long elevations of the wings have six windows per floor on the recessed part of the elevations, and three windows per floor and a single-entry metal door on the projecting portion of the elevations (Figure 415, Figure 421, and Figure 426). The left-side, long elevations of the wings have six windows per floor on the recessed portions, three windows on the second floors, and a set of metal doors on the first floors on the projecting portion (Figure 415 and Figure 419). The long elevations facing each other in the “L” each consist of six windows per floor per elevation (Figure 420, Figure 422, and Figure 423).

Figure 420. View toward the southwest of Building 503 at Camp Guernsey (ERDC-CERL, 2016).

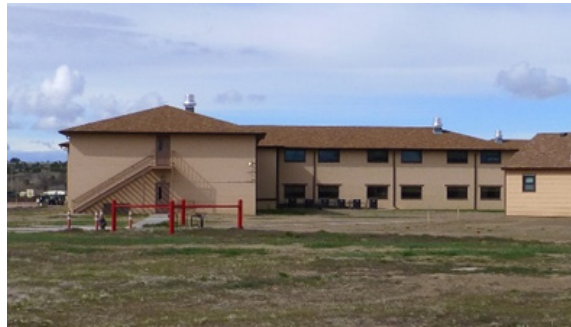
Figure 421. View toward the northwest of Building 503 at Camp Guernsey (ERDC-CERL, 2016).

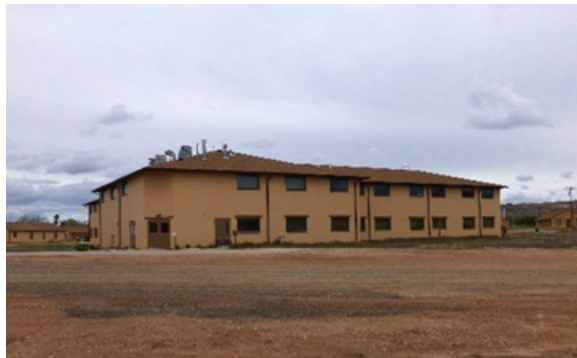
Buildings 501, 502, 503, 504, and 505 are large, two-story, concrete structures (Figure 415). These buildings have an L-shaped footprint, concrete block exterior walls, and a hipped roof clad with asphalt shingles with overhanging eaves (Figure 415 and Figure 422). The windows are large, single-pane, anodize bronze aluminum with a concrete windowsills and lintels, and they form a repetitive pattern on the long elevations (Figure 416 and Figure 422). The doors are metal with a large pane in the top half and metal with a narrow pane (Figure 417 and Figure 418). There is a set of exterior metal stairs located at the end elevations of the legs of the L-shapes (Figure 418). The point of each “L” is chamfered, and there is

Figure 422. View toward the south of Building 504 at Camp Guernsey (ERDC-CERL, 2016).

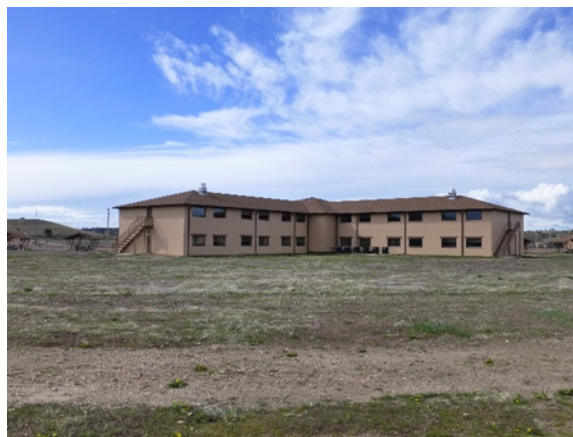
Figure 423. View toward the northeast of Building 505 at Camp Guernsey (ERDC-CERL, 2016).

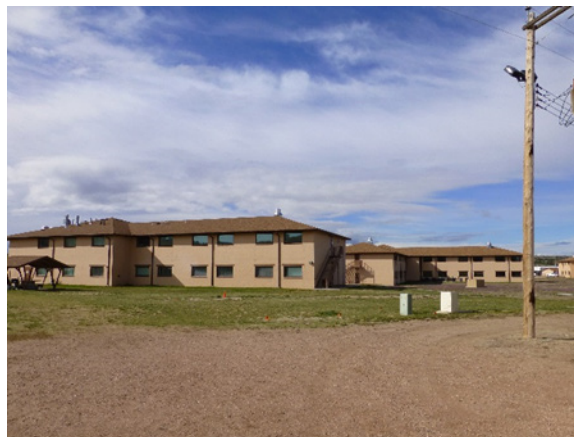
a set of two entry doors at the point (Figure 417). Building 501 is oriented with the inside of the “L” facing east, Buildings 502, 503, and 504 are oriented with the inside of the “L” facing north, and Building 505 is oriented with the inside of the “L” facing west (Figure 425).

Figure 425. View toward the south of Building 505 at Camp Guernsey (ERDC-CERL, 2016).

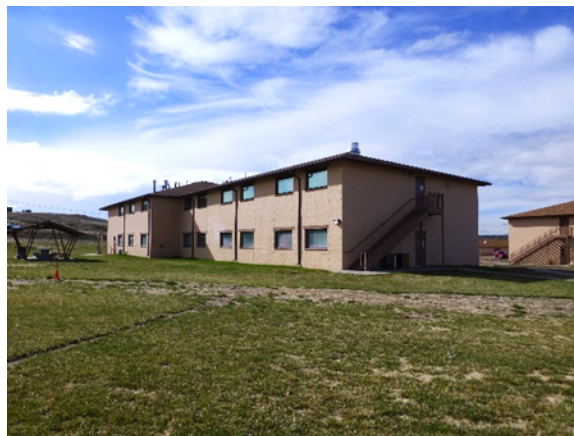
Figure 426. View toward the west of Buildings 505, 504, 503, 502, and 501 [left to right] at Camp Guernsey (ERDC-CERL, 2016).

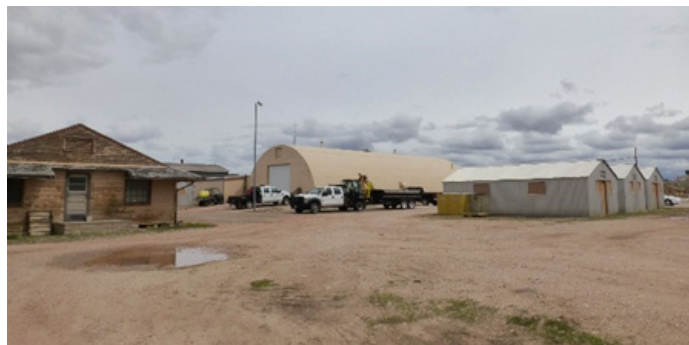
Figure 428. Looking northeast across the gravel lot toward Building 018 [left, Building 016 [middle], and Buildings 527E, 527D, and 526H [right] at Camp Guernsey (ERDC-CERL, 2016).

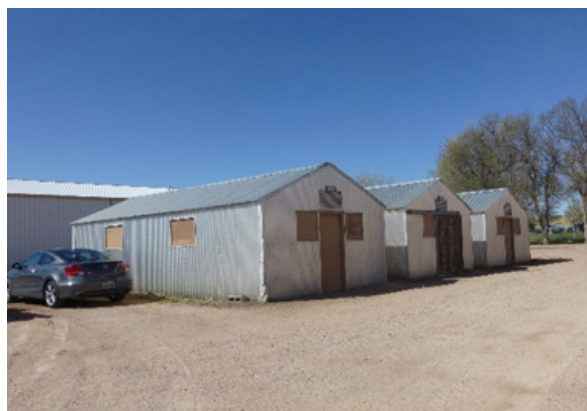
Buildings 526H, 527D, and 527E are prefabricated metal, one-story, rectangular buildings with a concrete foundation, exterior walls clad with corrugated metal siding, and a gable roof clad with corrugated metal panels (Figure 428 and Figure 430). The buildings are oriented in a north-south direction with a metal louvered vent in the north and south gable ends of the buildings. The original metal windows have been removed, the window openings have been filled with plywood, and the doors have been replaced (Figure 429 and Figure 430).

Figure 429. Northeast oblique of Buildings 526H, 527D, and 527E [left to right] at Camp Guernsey (ERDC-CERL, 2016).

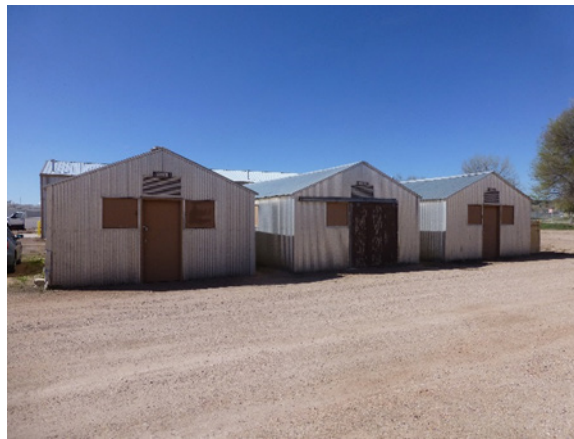
The north elevations of Buildings 526H, 527D, and 527E are symmetrical, with a centrally placed replacement door flanked on either side by modified window openings, with the exception of the north elevation of Building 527D, where a wood sliding door has been added (Figure 430). The west elevations have two modified window openings (Figure 431). The east elevations have two modified window openings (Figure 428). The south elevations are symmetrical with a centrally placed replacement door flanked on either side by modified window openings, with the exception of the modified door opening on Building 527D (Figure 431).

Figure 430. North elevation of Buildings 526H, 527D, and 527E [left to right] at Camp Guernsey (ERDC-CERL, 2016).
