Architectural and Landscape Survey of Camp Guernsey, Wyoming

Adam D. Smith, Megan W. Tooker, and Sunny E. Adams

June 2017

Under Project Number 458417, "Camp Guernsey Historic Context and Building
Evaluation"

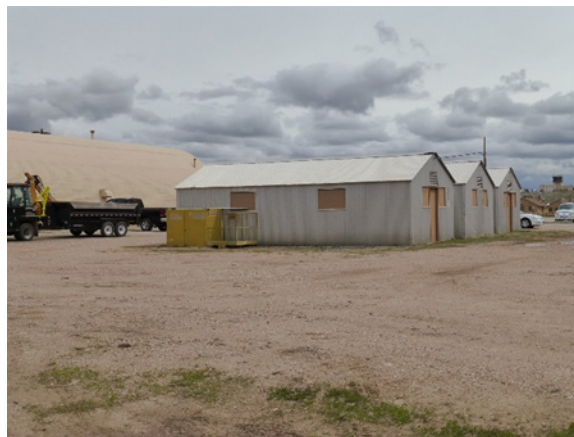
The north elevations of Buildings 526H, 527D, and 527E are symmetrical, with a centrally placed replacement door flanked on either side by modified window openings, with the exception of the north elevation of Building 527D, where a wood sliding door has been added (Figure 430). The west elevations have two modified window openings (Figure 431). The east elevations have two modified window openings (Figure 428). The south elevations are symmetrical with a centrally placed replacement door flanked on either side by modified window openings, with the exception of the modified door opening on Building 527D (Figure 431).

Figure 431. Southwest oblique of Buildings 526H, 527D, and 527E [left to right] at Camp Guernsey (ERDC-CERL, 2016).

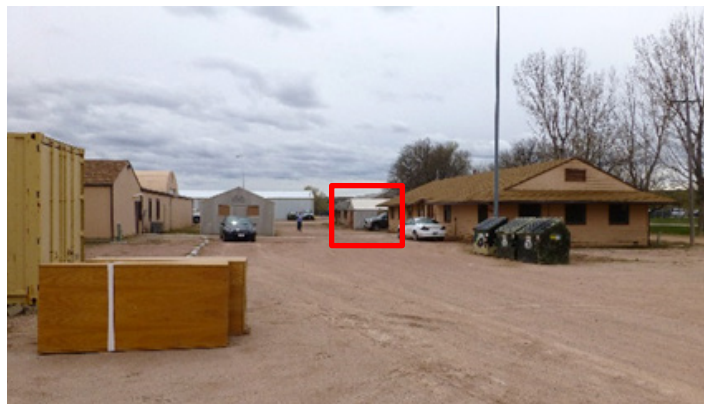
Figure 433. Looking south down the gravel lot toward Building 527F [outlined in red] at Camp Guernsey (ERDC-CERL, 2016)

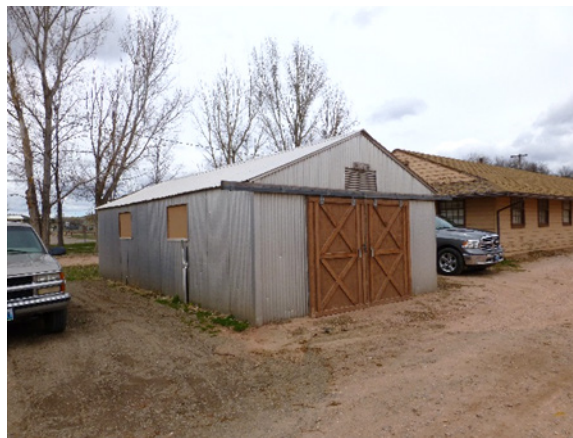
Building 527F is a prefabricated metal, one-story, rectangular building with a concrete foundation, exterior walls clad with corrugated metal siding, and a gable roof clad with corrugated metal panels (Figure 434). The building is oriented in an east-west direction, with a metal louvered vent in the east and west gable ends of the buildings.

The east elevation overlooks a gravel lot and faces Building 016. The elevation has been modified; the original door has been removed along with the two windows that flank either side of the door opening and replaced with sliding barn-style doors (Figure 434). The window openings and original door opening is covered with an added wood sliding door (Figure 435). The north elevation faces Building 017, and the south elevation faces Building 018. Each elevation has two modified window openings (Figure 434 and Figure 435). The west elevation faces the property fence and west boundary line of trees. The west elevation is symmetrical, with a centrally placed replacement door flanked on either side by a modified window (Figure 436).

Figure 434. Southeast oblique of Building 527F at Camp Guernsey (ERDC-CERL, 2016).

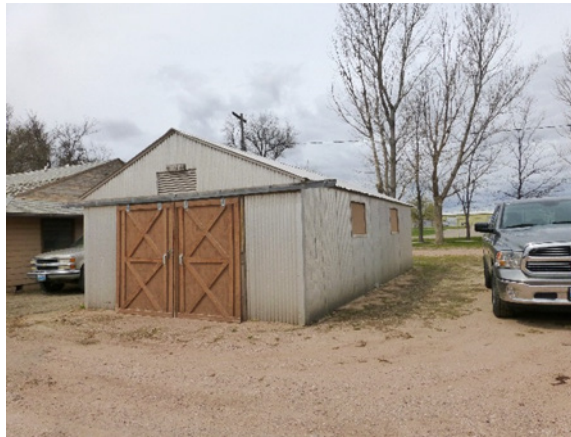
Figure 435. Northeast oblique of Building 527F at Camp Guernsey (ERDC-CERL, 2016).

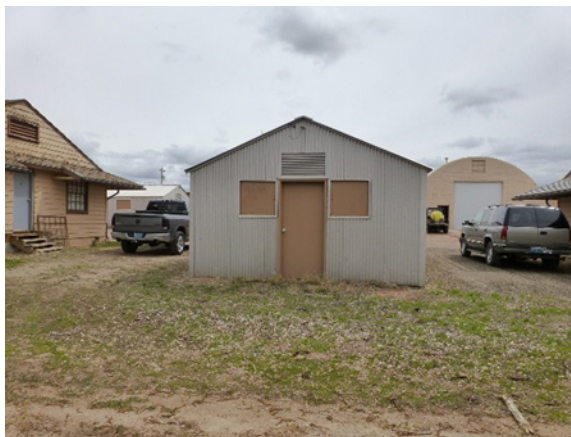
Figure 436. West elevation of Building 527F at Camp Guernsey (ERDC-CERL, 2016).

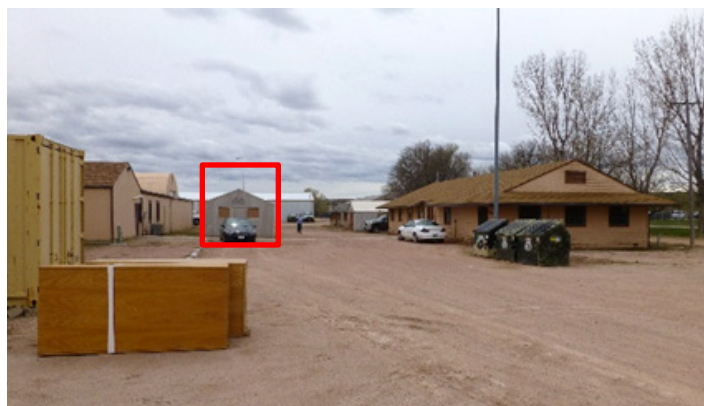
Figure 438. Looking south down the gravel lot toward Buildings 527G (red box) and 527H [directly behind 527G] at Camp Guernsey (ERDC-CERL, 2016).

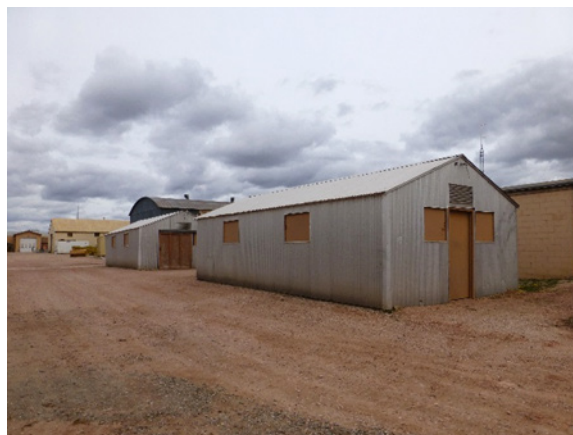
Buildings 527G and 527H are prefabricated metal, one-story, rectangular buildings with a concrete foundation, exterior walls clad with corrugated metal siding, and a gable roof clad with corrugated metal panels (Figure 439). The buildings are oriented in a north-south direction with a metal louvered vent in the north and south gable ends of the buildings. The original metal windows have been removed, the openings have been filled with plywood, and the doors have been replaced (Figure 439 and Figure 440).

The north elevations are symmetrical, with a centrally placed door openings flanked on either side by a modified window opening (Figure 440). The east and west elevations each have two modified window openings (Figure 439). The south elevation of Building 527H has a centrally placed door flanked on either side by modified window openings, and the south elevation of Building 527G has had a wood sliding door added to it (Figure 439).

Figure 439. Southwest oblique of Building 527H [foreground] and Building 527G [background] (ERDC-CERL, 2016).

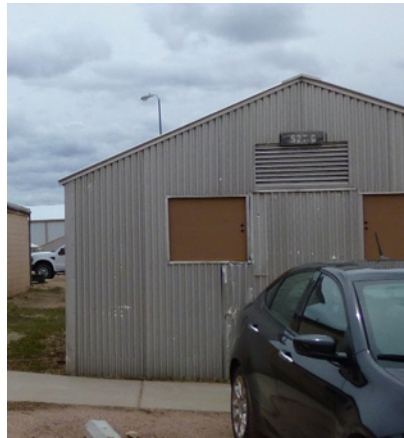
Figure 440. North side of Building 527G (ERDC-CERL, 2016).

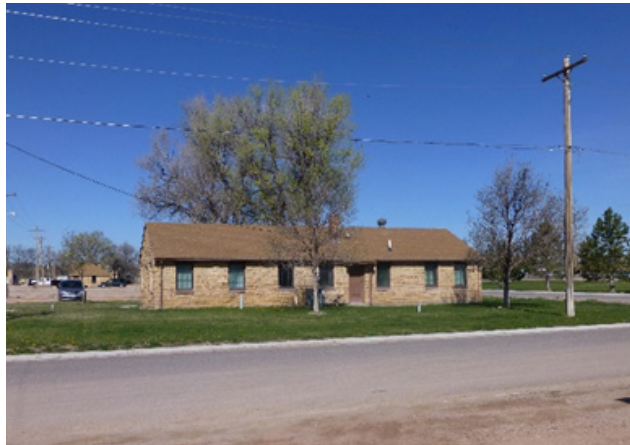
Building 601 is a one-story building with a concrete foundation, cut-stone exterior walls, and a gable roof clad with architectural asphalt shingles with overhanging eaves and exposed wood rafter tails on the east and west sides of the building (Figure 442 and Figure 443). The walls are constructed of locally quarried, buff-colored sandstone that is laid in irregular patterns with cement mortar. The windows are replacement, single-pane, anodized-bronze aluminum windows (Figure 444) but without changing the size of the original window bay openings. The doors are combination of replacement metal doors and original five-panel wood door (Figure 445 and Figure 446). The sills and lintels are poured concrete (Figure 450 and Figure 451). A “W.P.A 1940” shield is placed on the lintel

The east elevation of Building 601 faces Hunton Road (Figure 442 and Figure 449 and Figure 450). The elevation consists of seven window bays with replacement windows and an original wood panel door. The roof overhangs further above the door creating a small canopy cover (Figure 442).

Figure 442. Looking west across Hunton Road at the east elevation of Building 601 (ERDC-CERL, 2016).

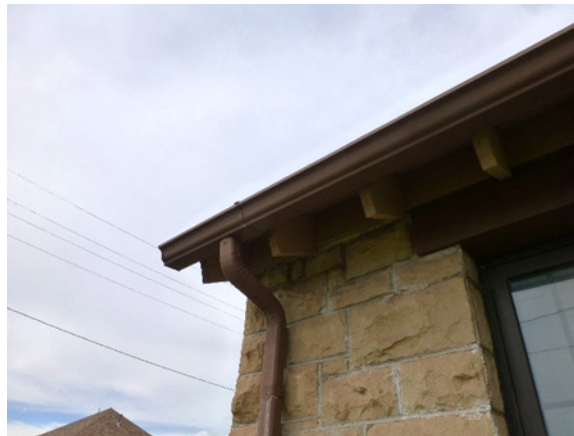
Figure 443. Close-up of the overhanging eave with exposed wood rafter tails (ERDC-CERL, 2016).

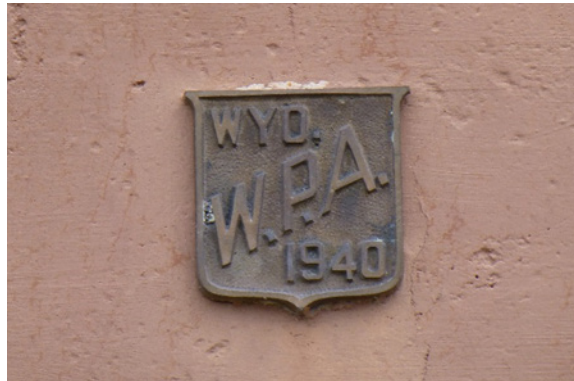
above the south door (Figure 447). A brick chimney with a concrete cap projects from the central part of the east side of the gable roof (Figure 448 and Figure 449). A small vestibule addition has been constructed on the west side of the building. The building measures approximately 26'5" x 66'8."

Figure 447. Close-up of “W.P.A.” 1940 shield placed on the lintel of the south door of Building 601 at Camp Guernsey (ERDC-CERL, 2016).

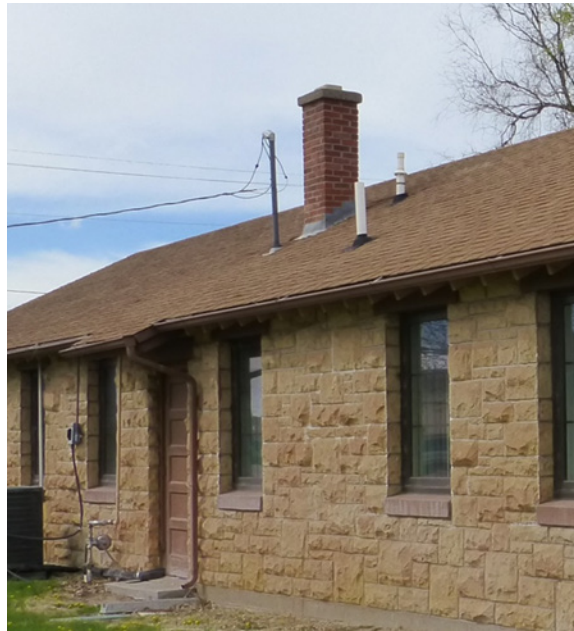
Figure 448. Brick chimney with concrete cap on Building 601 at Camp Guernsey (ERDC-CERL, 2016).

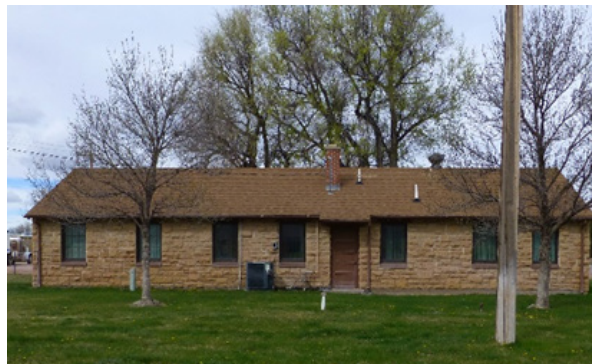
Figure 449. East elevation of Building 601 at Camp Guernsey (ERDC-CERL, 2016).

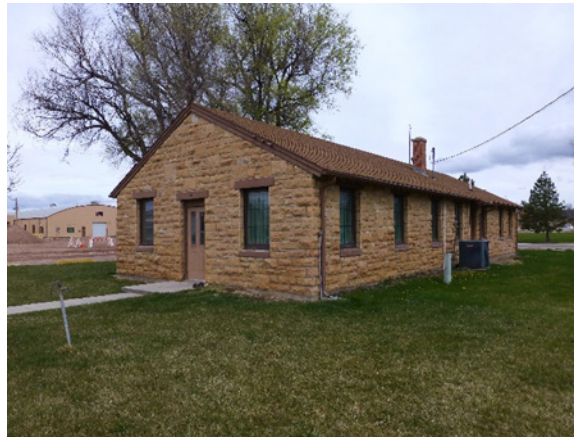
Figure 450. Southeast oblique of Building 601 at Camp Guernsey (ERDC-CERL, 2016).

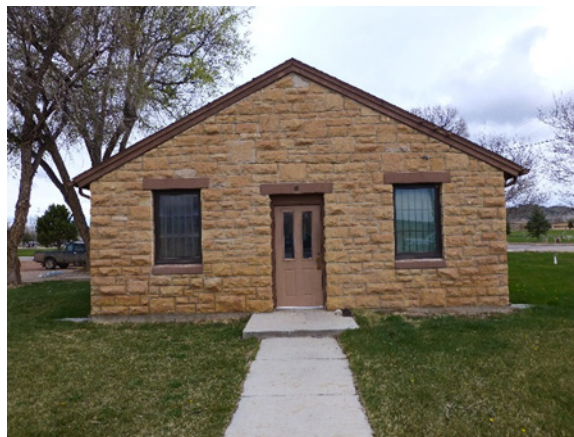
The south elevation of Building 601 faces Building 602 and is symmetrical with a central door flanked on either side by a replacement window (Figure 451 and Figure 452). The door is a replacement metal door with a "W.P.A" shield placed on the lintel above the door (Figure 447). A concrete stoop with a poured concrete sidewalk that leads to Building 602 is placed in front of the door (Figure 445).

Figure 451. South elevation of Building 601 at Camp Guernsey (ERDC-CERL, 2016).

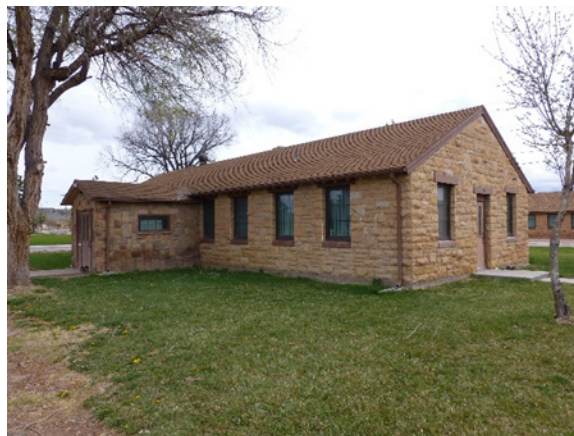
Figure 452. Southwest oblique of Building 601 at Camp Guernsey (ERDC-CERL, 2016).

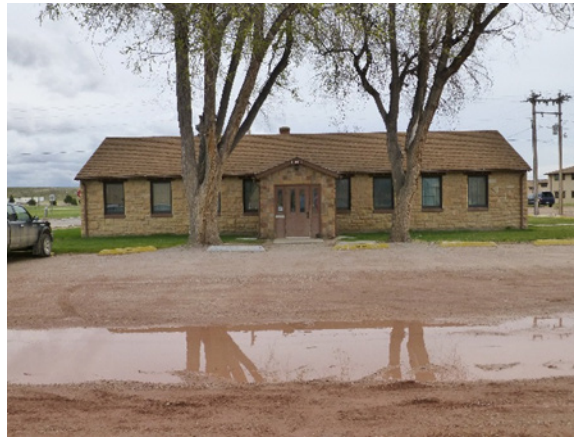
The west elevation of Building 601 faces a gravel parking lot. Two large trees frame the vestibule addition located in the center of the elevation (Figure 453). The addition has a gable roof and stone-clad exterior walls. However, the stone on the addition is different in color, texture, and arrangement than is found on the original building's exterior walls (Figure 454). A metal door with sidelights is located on the west side of the addition, and small horizontal windows are located on the north and south sides of the addition. The west elevation of the original structure has eight bays filled with replacement windows, four on each side of the vestibule addition.

Figure 453. West elevation of Building 601 at Camp Guernsey (ERDC-CERL, 2016).

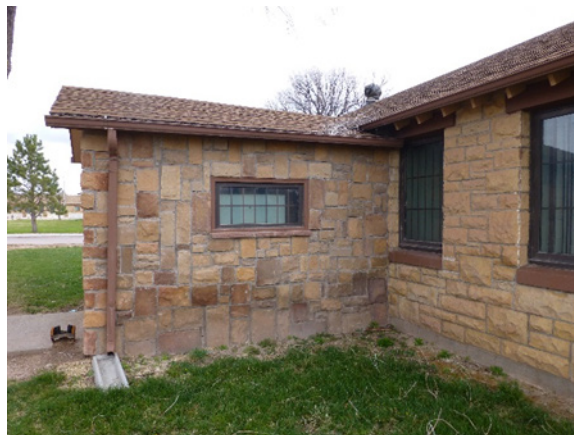
Figure 454. Close-up of the vestibule addition using different stone on the west side of Building 601 at Camp Guernsey (ERDC-CERL, 2016).

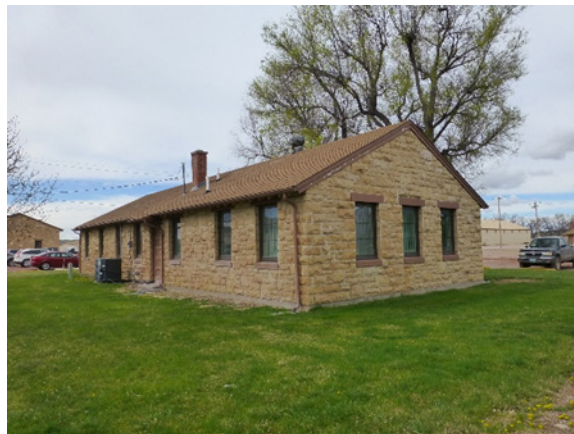
The north elevation of Building 601 faces Bridger Avenue and overlooks the landscaped lawn in front of the headquarters, Building 101. The elevation is symmetrical, with three evenly spaced replacement windows (Figure 455).

Figure 455. Northeast oblique of Building 601 at Camp Guernsey (ERDC-CERL, 2016).

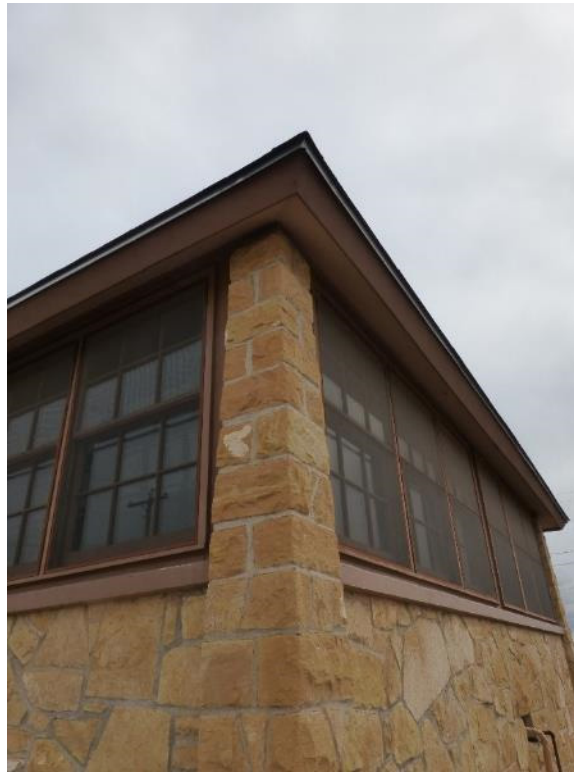
Building 601 is a one-story building with a concrete foundation, cut-stone exterior walls, and a pyramidal hipped roof clad with architectural asphalt shingles with overhanging eaves (Figure 457 and Figure 458). The walls are constructed of locally quarried, buff-colored sandstone laid in irregular patterns with cement mortar. The stonework clads only the bottom half of the walls and the four corner columns that support the roof (Figure 458). The upper half of the building has infill additions that consist of wood

Figure 458. Close-up of the overhanging eave and stone exterior walls on Building 602 at Camp Guernsey (ERDC-CERL, 2016).

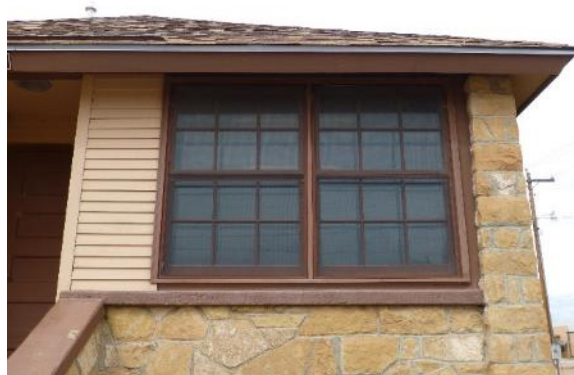
siding and wood double-hung windows (Figure 458 and Figure 459). Mesh screens are placed over all of the windows. A wood panel entry door is located on the east elevation (Figure 460), along with a set of concrete stairs with cut-stone side walls with concrete caps. A “W.P.A” stamp is located on the south wall cap (Figure 461).

Figure 459. Example of paired infill windows on Building 602 at Camp Guernsey (ERDC-CERL, 2016).

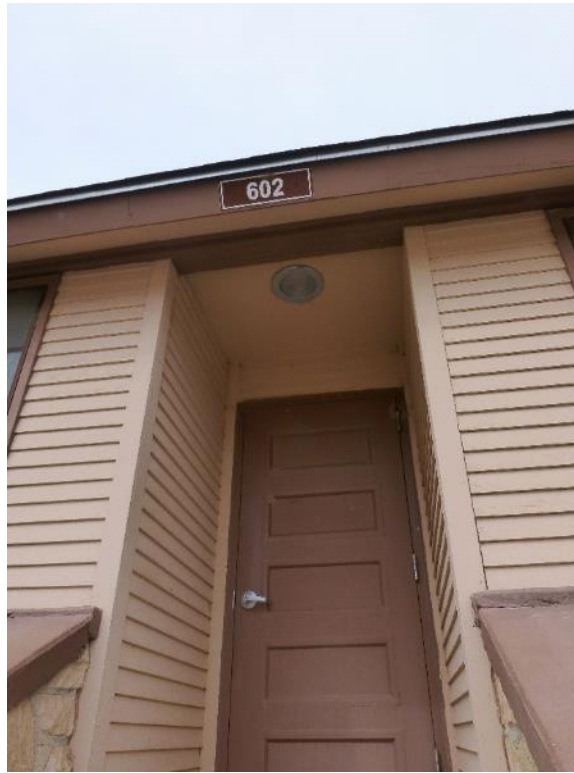
Figure 460. Wood panel entry door on Building 602 at Camp Guernsey (ERDC-CERL, 2016).

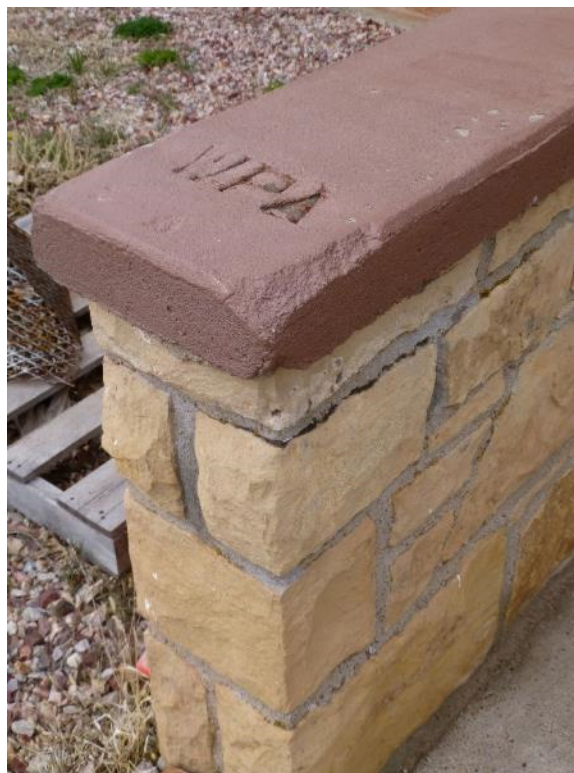
Figure 461. "W.P.A" stamped on the left handrail of the east elevation of Building 602 at Camp Guernsey (ERDC-CERL, 2016).

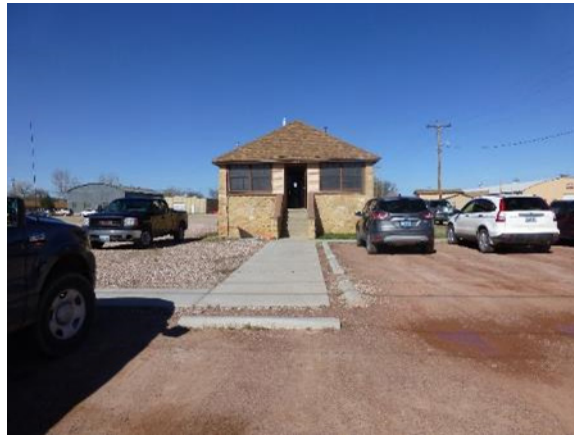
The east elevation faces Hunton Road (Figure 462–Figure 464) and overlooks the former concrete pad tent area. The elevation is symmetrical, with a centrally placed metal panel door that is recessed under the overhanging eaves. Concrete stairs provide access to the elevated entry and stone-clad side walls/handrails that frame the walkway up to the stairs. Paired wood windows are located on either side of the door.

Figure 462. East elevation with gravel parking lots and paved sidewalk of Building 602, leading to Building 106 at Camp Guernsey (ERDC-CERL, 2016).

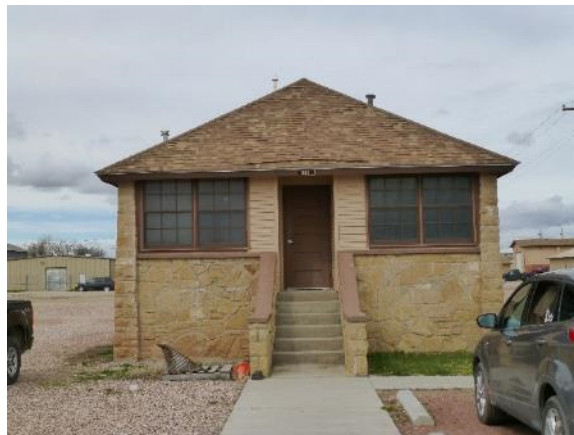
Figure 463. East elevation close-up of Building 602 at Camp Guernsey (ERDC-CERL, 2016).

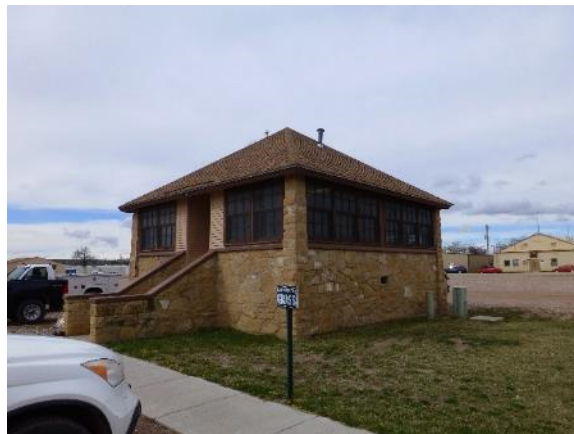
The north, south, and west elevations are similar, with each consisting of six wood windows placed in the upper half of the wall (Figure 464 and Figure 465).

Figure 464. Northeast oblique with a small, sparse, grass-covered lawn on the north side of Building 602 at Camp Guernsey (ERDC-CERL, 2016).

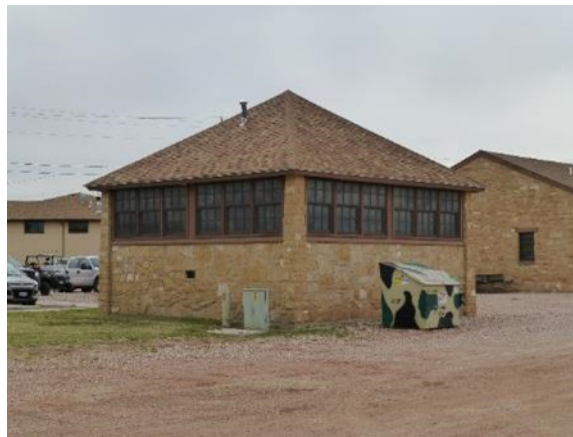
Figure 465. Southwest oblique of Building 602 at Camp Guernsey (ERDC-CERL, 2016).

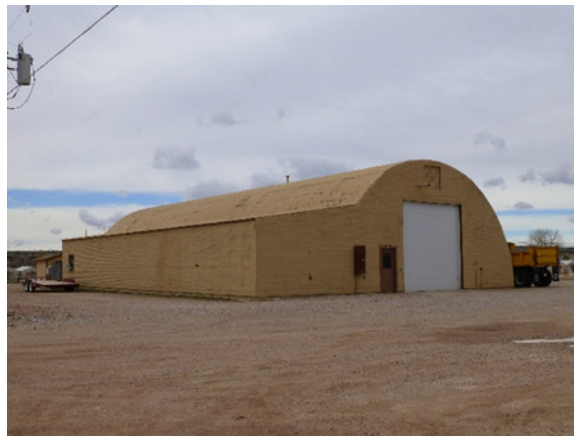
Building 603 is a one-story, rectangular building with a concrete foundation and a semicylindrical roof shape. Corrugated metal covers the arched-steel truss system; however, the corrugated metal has been covered with polyurethane foam (Figure 468). A long, rectangular, metal addition with a shed roof has been added to the east side of the original structure.

Figure 468. Close-up of the polyurethane foam covering the original corrugated metal exterior (ERDC-CERL, 2016).

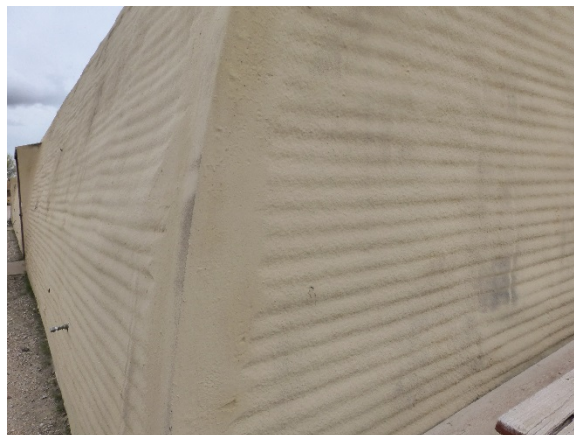
Figure 469. South elevation of Building 603 (ERDC-CERL, 2016).

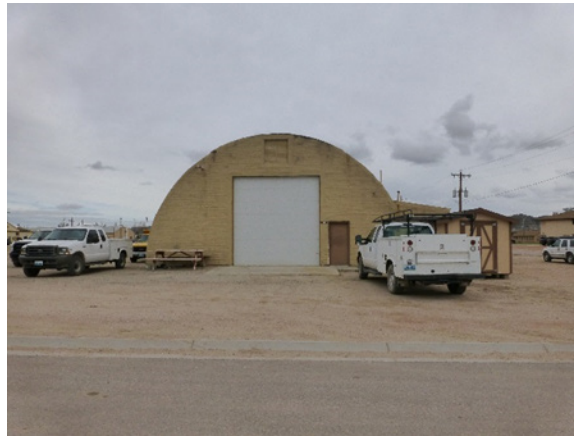
Figure 470. Northwest oblique of Building 603 (ERDC-CERL, 2016).

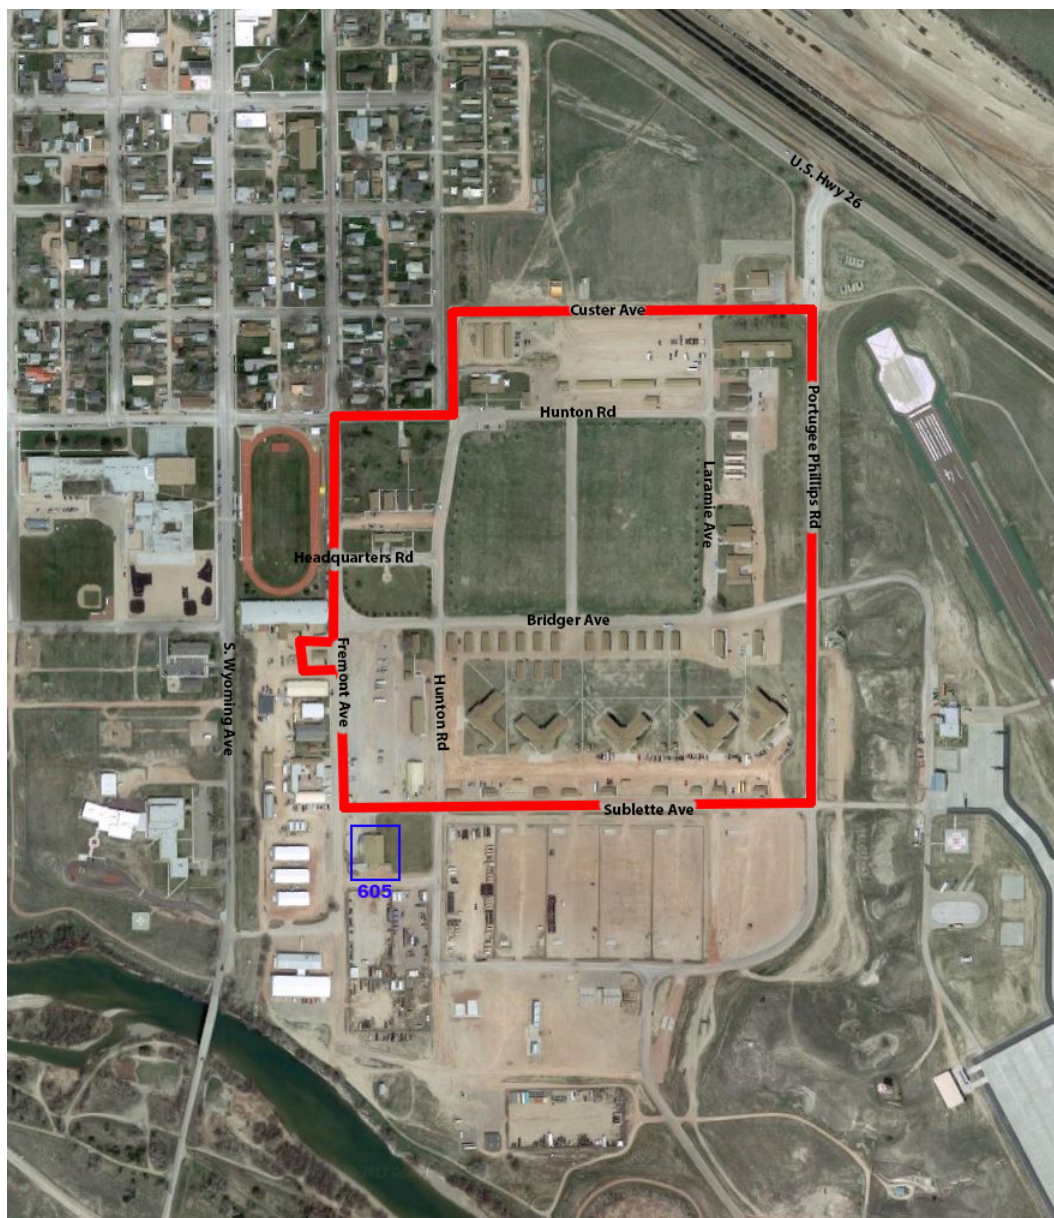
The north elevation of Building 605 consists of an offset metal roll-up door flanked on the right by a single-entry metal door. There also are two, small, metal, louvered vents and a large, metal, louvered vent with a concrete lintel (Figure 474 and Figure 475) on the north elevation. The west elevation consists of a single-entry metal door, two small windows, and a large, metal, louvered vent (Figure 476). The south elevation faces the motor pool area. The loading dock is on this elevation is defined by a raised concrete platform, a concrete ramp with metal pipe handrails, and a gable roof canopy structure that projects over the loading dock (Figure 477). There is a metal roll-up door and a single-entry metal door under the canopy, and two windows flank either side of the canopy (Figure 477). The east elevation is void of any fenestration.

Figure 474. Northeast oblique of Building 605 at Camp Guernsey (ERDC-CERL, 2016).

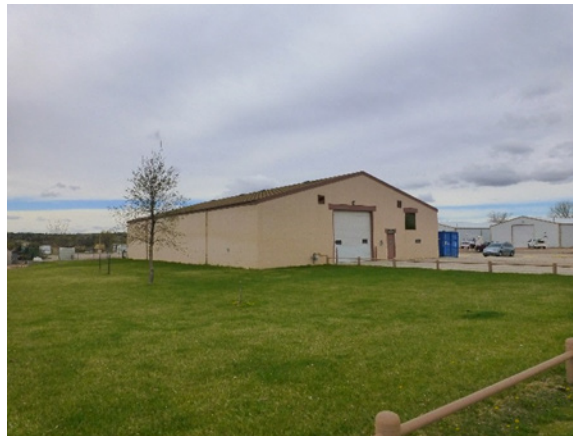
Figure 475. North elevation of Building 605 at Camp Guernsey (ERDC-CERL, 2016).

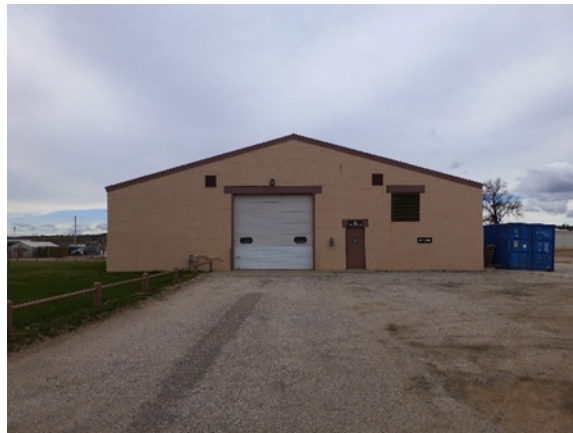
Figure 476. West elevation of Building 605 at Camp Guernsey (ERDC-CERL, 2016).

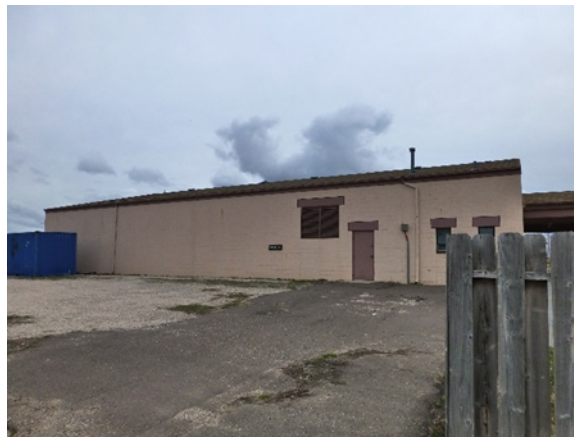
Figure 477. South elevation of Building 605 at Camp Guernsey (ERDC-CERL, 2016).

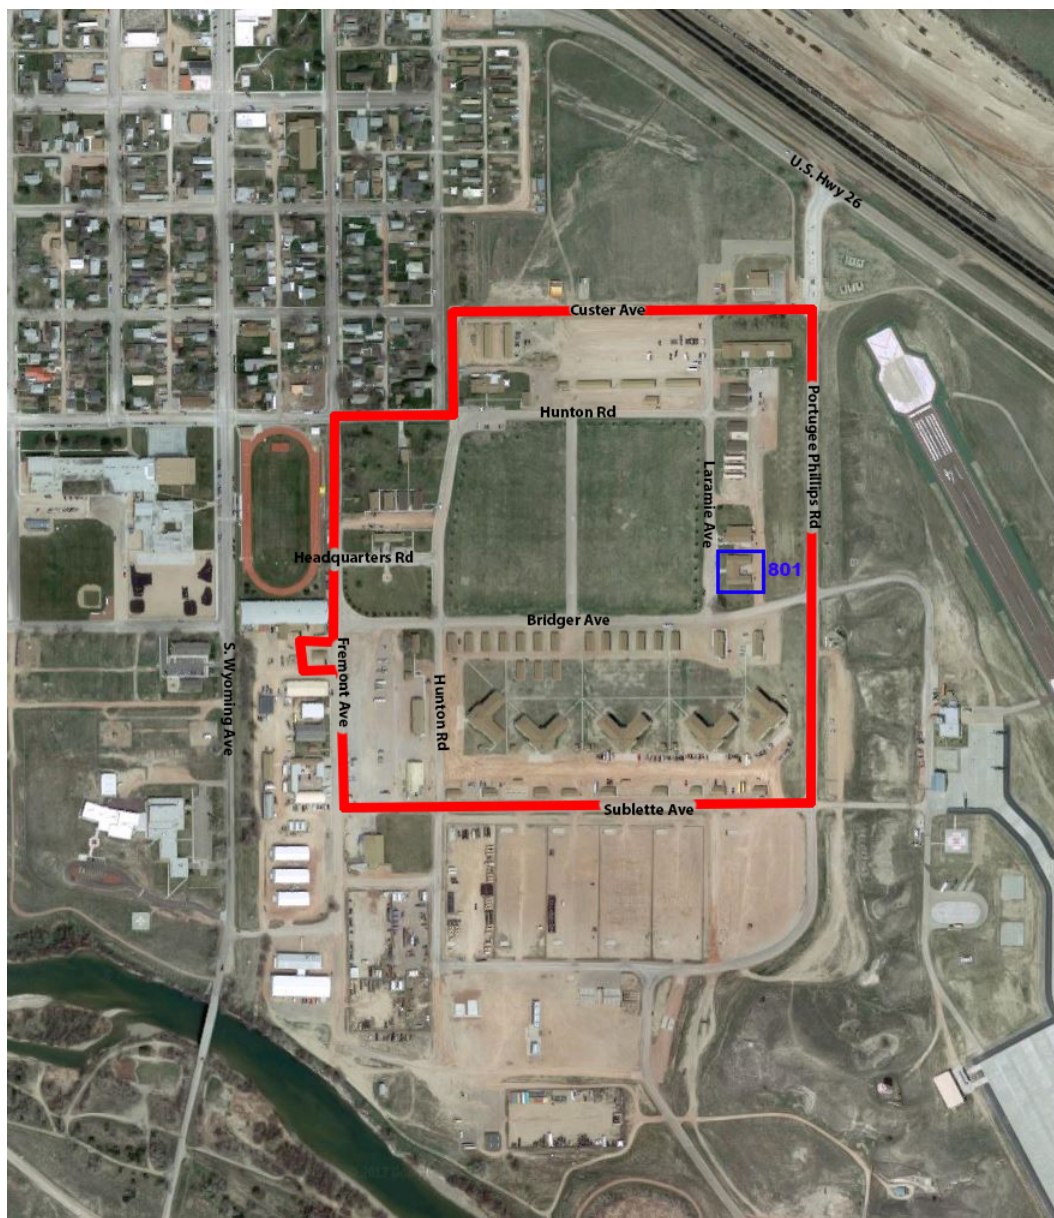
Building 801 is a one-story structure with a U-shaped footprint, a concrete foundation, cross gable pent roofs clad with asphalt shingles and overhanging eaves, and exterior walls clad with Masonite siding (Figure 479 and Figure 480). All of the original windows have been removed, and the openings covered with the Masonite siding.

Figure 479. Southwest oblique of Building 801 at Camp Guernsey (ERDC-CERL, 2016).

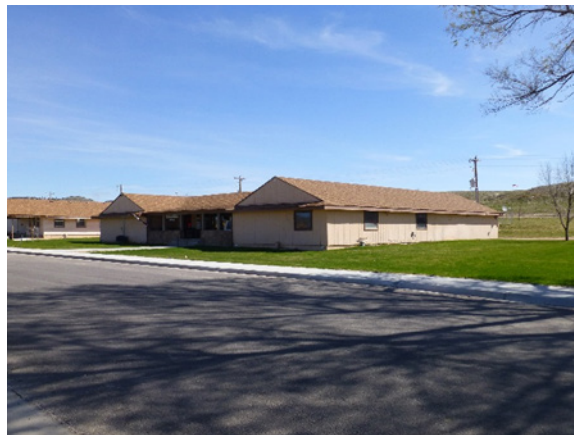
Figure 480. Close-up of the modified overhanging eaves on Building 801 at Camp Guernsey (ERDC-CERL, 2016).

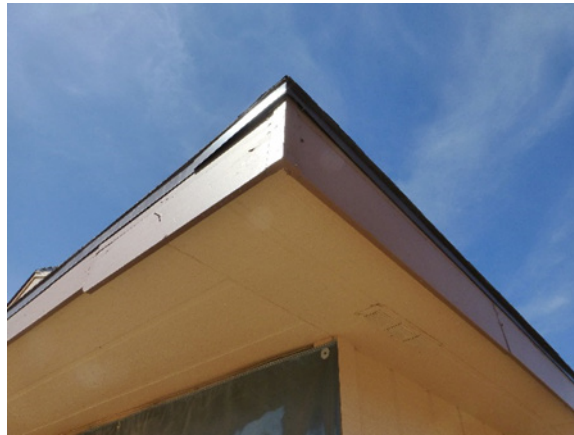
The west elevation of Building 801 faces Laramie Avenue (Figure 481) and overlooks the parade ground. The west elevation has front-facing gables (pent roofs) at either end of the elevation. The central connecting wing has a recessed porch. The porch roof is supported by wood columns that rest on a stone wall. The porch is elevated and accessed by a set of concrete steps that lead to a poured concrete sidewalk. The entry doors under the porch roof are replacement anodized-bronze aluminum and plate glass with sidelights. Two, large, single-pane anodized-bronze aluminum windows are on the left side of the doors and one large window is on the right side. There is one large single-pane window on the right side of the elevation.

Figure 481. West elevation of Building 801 at Camp Guernsey (ERDC-CERL, 2016).

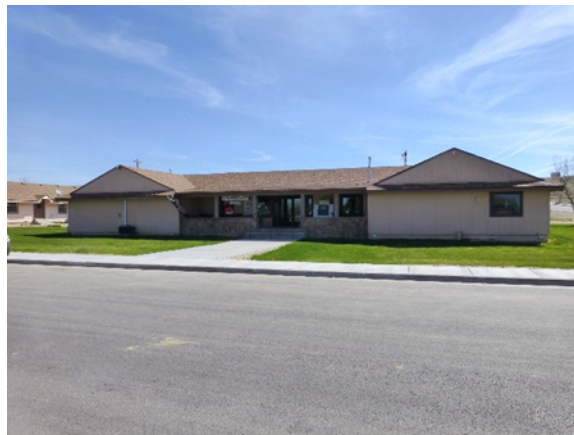
The north elevation of Building 801 faces Building 802. There are no window or door openings on this elevation (Figure 482 and Figure 483).

Figure 482. Northwest oblique of Building 801 at Camp Guernsey (ERDC-CERL, 2016).

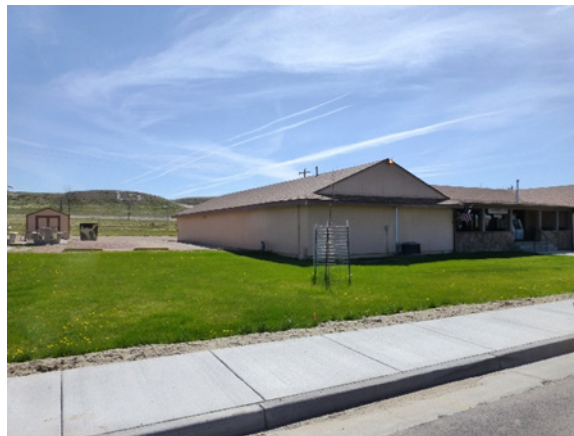
Figure 483. North elevation of Building 801 at Camp Guernsey (ERDC-CERL, 2016).

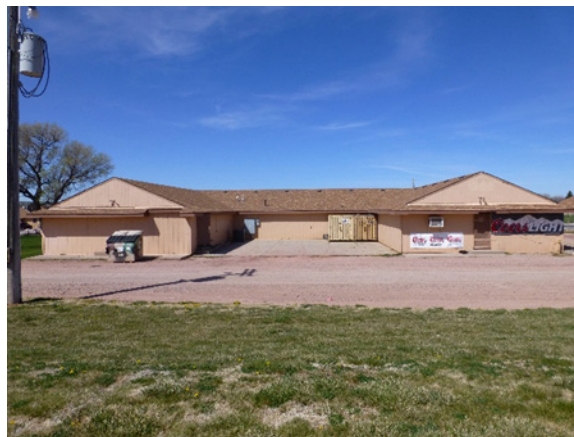
There are two, large, single-pane windows located on the left side of the south elevation of Building 801 (Figure 485 and Figure 486).

Figure 485. Southeast oblique of Building 801 at Camp Guernsey (ERDC-CERL, 2016).

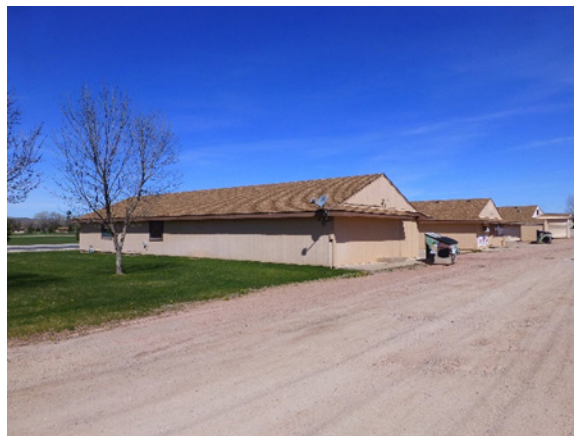
Figure 486. Southwest oblique of Building 801 (ERDC-CERL, 2016).

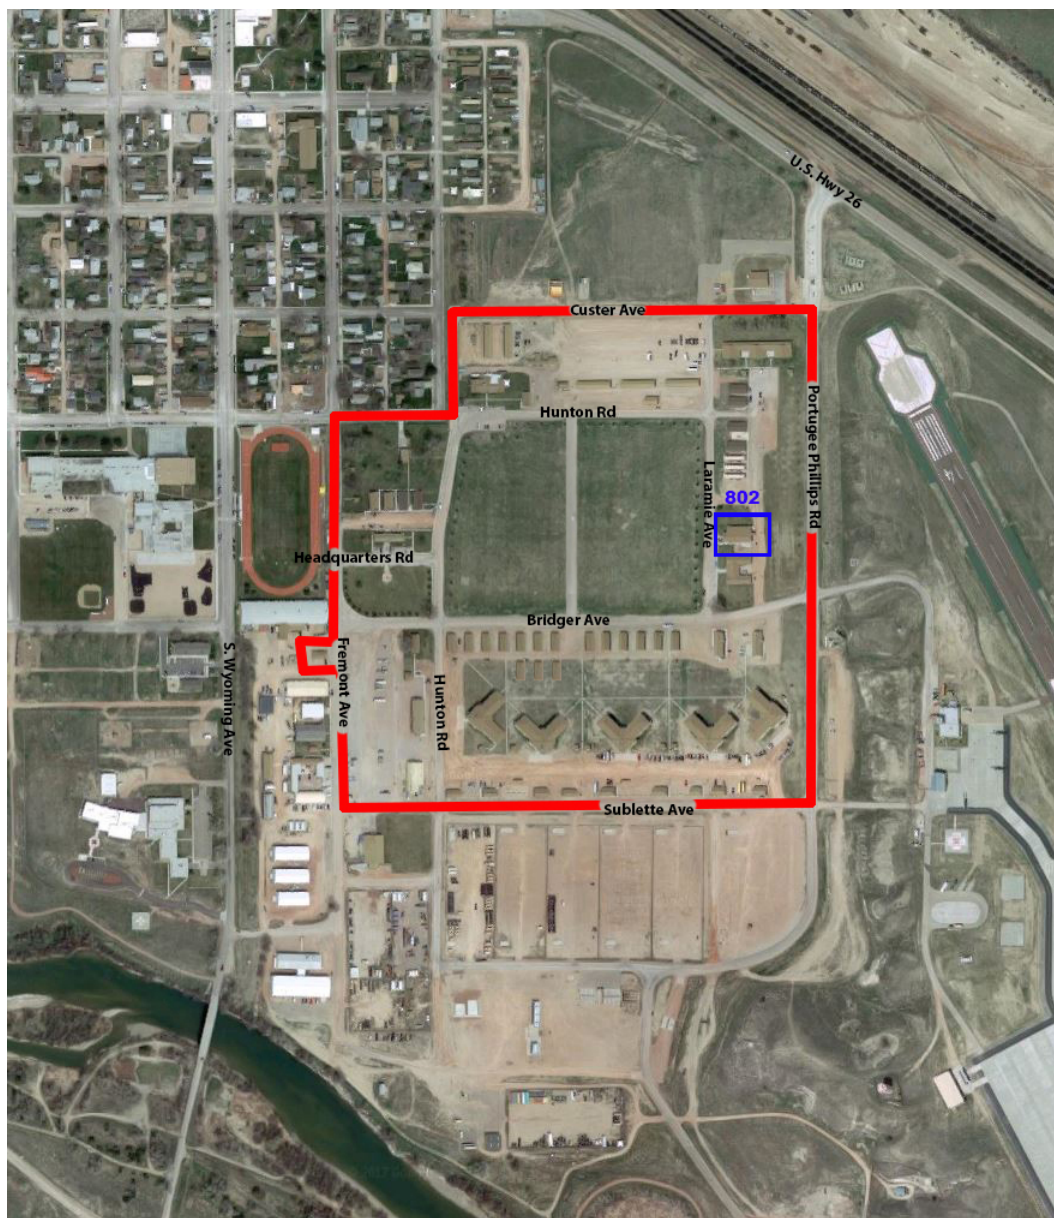
Building 802 is a one-story wood frame structure with a rectangular footprint, a concrete block foundation, vinyl clad exterior walls, and a gable roof with overhanging eaves (Figure 488). The gable extends further to the north creating an asymmetrical façade from the west side (Figure 488). Metal sheet pieces have been added to enclose the original exposed wood rafter tails; however, some of these pieces have fallen off and once again expose the original roof detail (Figure 489). The windows are

Figure 488. South elevation of Building 802 at Camp Guernsey (ERDC-CERL, 2016).

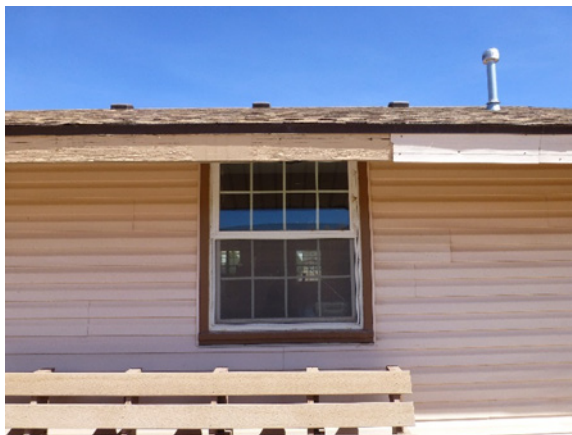
The west elevation of Building 802 faces Laramie Avenue and overlooks the parade ground. The gable end extends over a concrete porch (Figure 491). Metal posts support the gable roof. Metal handrails enclose the porch area. A set of concrete steps provide access to a single-entry door. Two replacement windows are located on the right side of the door.

The south elevation of Building 802 faces Building 801. The ground slopes away from the building on the left side exposing more of the concrete block foundation (Figure 491). There is a centrally placed metal door that has a set of concrete steps. A small gable roof is placed above the door. The door is flanked on the left side by three replacement windows and the right side by two replacement windows and a sliding aluminum door (Figure 491). The sliding door has replaced an original window opening. A poured concrete patio is located in front of the sliding door.

Figure 491. Southwest oblique of Building 802 at Camp Guernsey (ERDC-CERL, 2016).

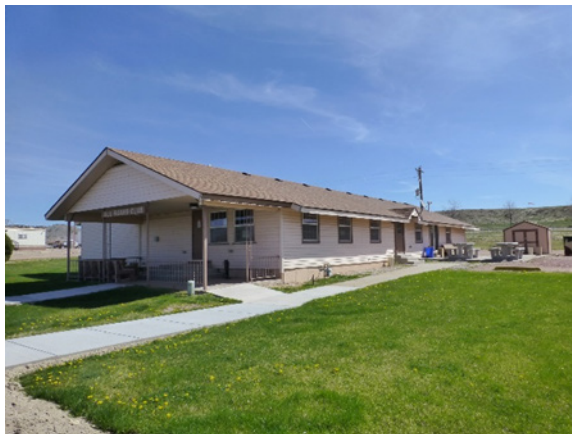
The north elevation of Building 802 has six, evenly spaced, replacement windows (Figure 492 and Figure 493).

Figure 492. North elevation of Building 802 at Camp Guernsey (ERDC-CERL, 2016).

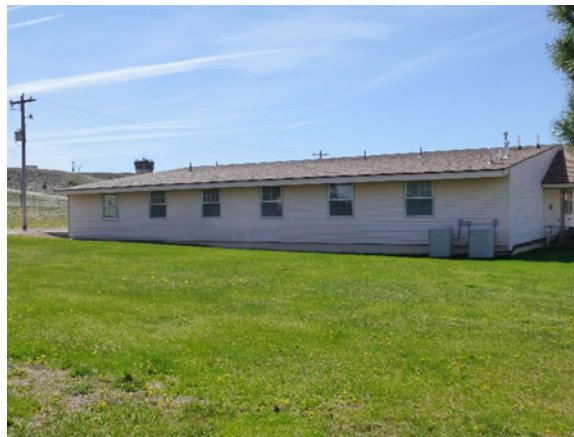
The east elevation of Building 802 faces a gravel road. There is a small gable addition located in the middle of the elevation. There is a metal door and a single replacement window on the right side of the elevation. There is a single metal door located on the left side of the elevation. The overhanging eave above this door has been cut out (Figure 493).

Figure 493. Northeast oblique of Building 802 at Camp Guernsey (ERDC-CERL, 2016).

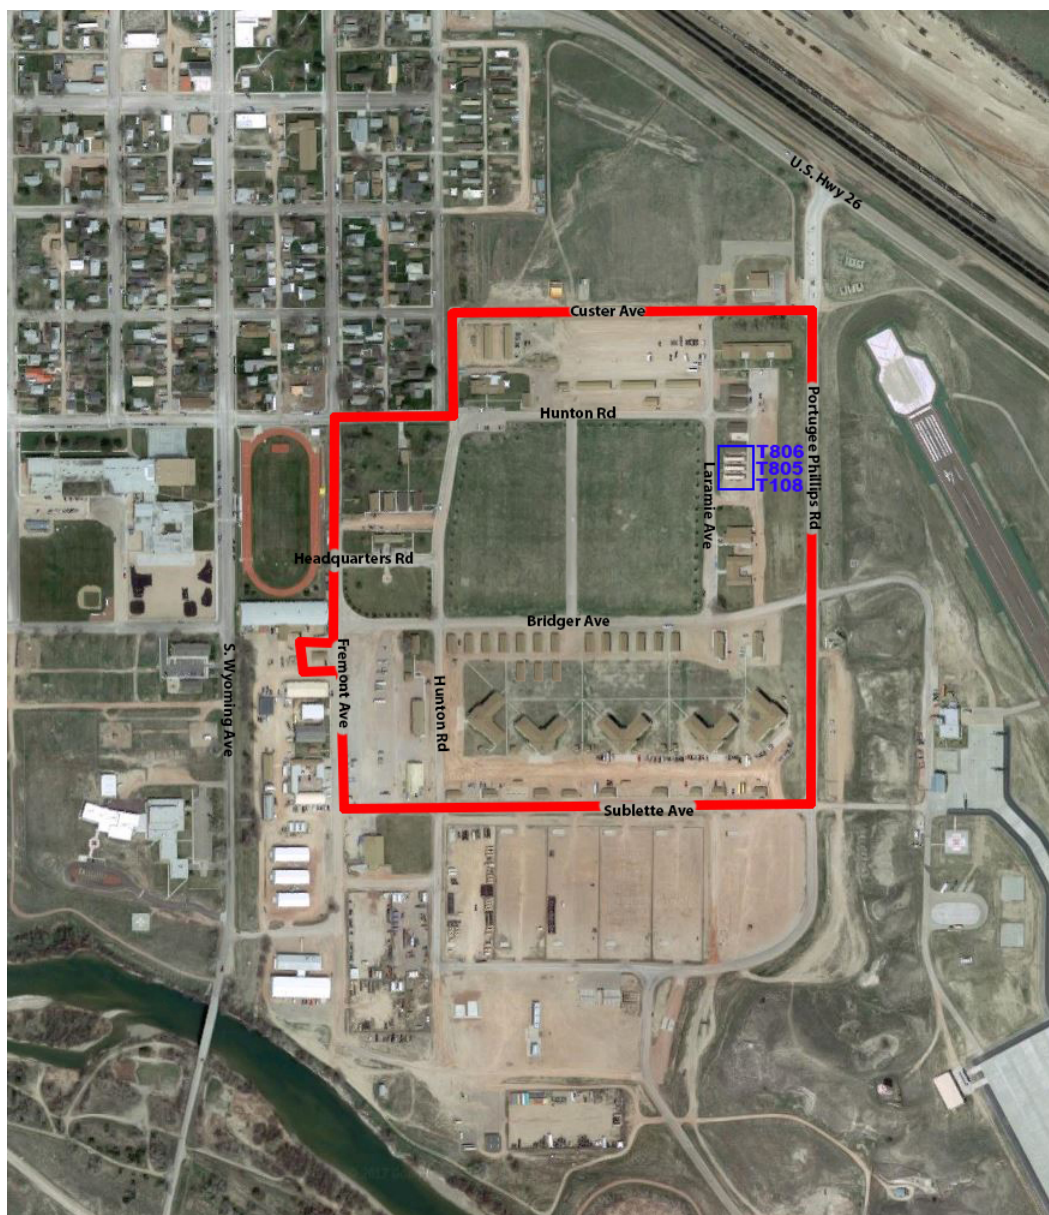
Buildings T108, T805, and T806 are simple, one-story, rectangular, prefabricated metal trailer buildings. The buildings rest on a concrete block pier foundation, with a metal skirt surrounding the elevated base of each building (Figure 495). The exteriors are clad with metal panels, and the roofs are slightly arched and sheathed with metal panels. The windows are two-pane sliders, and the doors are metal. The buildings are oriented in an east-west direction, with Building T108 at the south end, T805 in the

The west elevations of Buildings T106, T805, and T806 face Laramie Avenue (Figure 495 and Figure 496) and overlook the parade ground. There is one window located slightly right of center on the west elevations (Figure 496). The south elevations consist of four windows and two entry doors. The elevated doors are accessible via two sets of wood steps (Figure 495). The north elevations consists of five windows (Figure 497). The east elevations have a piece of large mechanical equipment attached to the exterior wall (Figure 497 and Figure 498).

Figure 495. View toward the northeast of Buildings T106, T805, and T806 (right to left) at Camp Guernsey (ERDC-CERL, 2016).

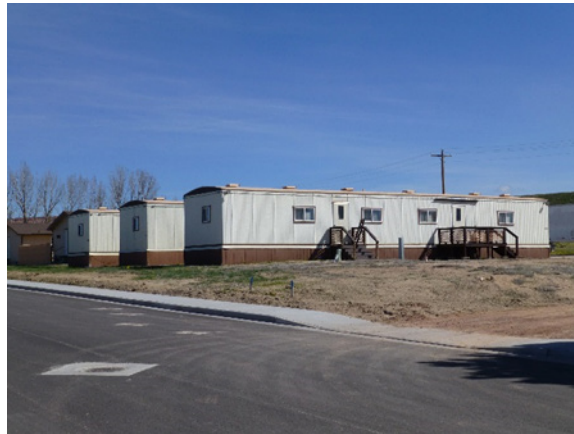
Figure 496. West elevations of Buildings T805 (right) and T806 (left) at Camp Guernsey (ERDC-CERL, 2016).

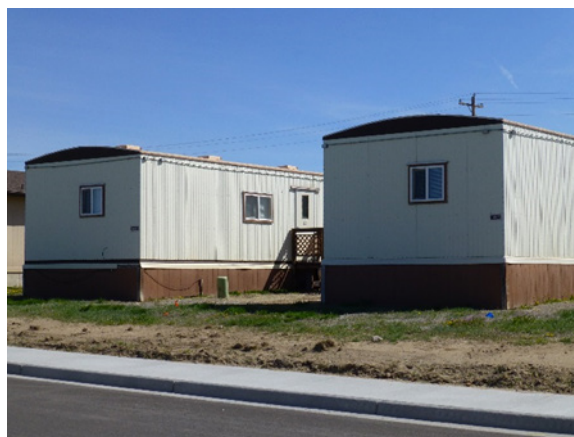
Figure 497. Northeast oblique of Building T106 at Camp Guernsey (ERDC-CERL, 2016).

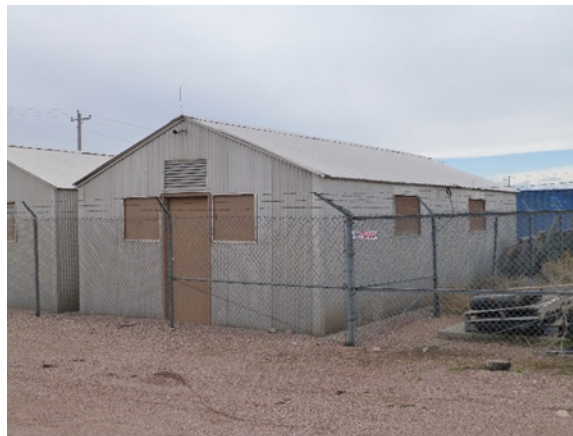
Figure 502 Oblique of a typical metal building at Camp Guernsey (ERDC-CERL, 2016).

No-number Buildings A, B, C, D, and E are prefabricated, metal, one-story, rectangular buildings with concrete foundations, exterior walls clad with corrugated metal siding, and gable roofs clad with corrugated metal panels (Figure 502 and Figure 503). The buildings are all oriented in a north-south direction, with metal louvered vents in the north and south gable ends. The original metal windows have been removed, the openings have

been filled with plywood, and the doors have been replaced (Figure 502 and Figure 503).

The north elevations are symmetrical, with centrally placed replacement doors flanked on either side by modified window openings (Figure 502). The west elevations have two modified window openings (Figure 502). The east elevations have two modified window openings (Figure 503). The south elevations are symmetrical with centrally placed replacement doors flanked on either side by modified window openings (Figure 503).

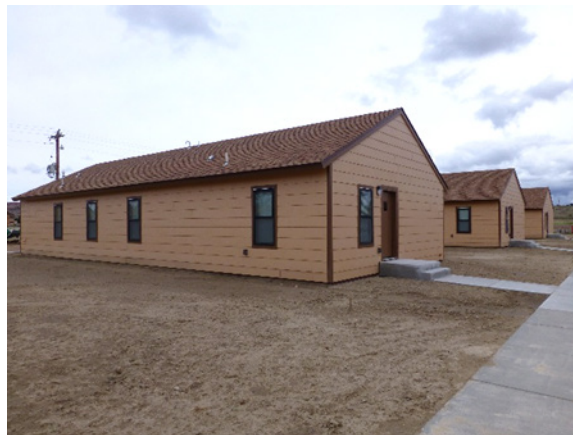
Figure 505. View toward the northeast of Buildings F, G, and H [left to right] at Camp Guernsey (ERDC-CERL, 2016).

walls clad with hardy-plank boards (Figure 505 and Figure 508). The foundations are concrete slabs and a light-weight steel-frame structural systems. The exposed concrete slabs have been covered with metal flashing (Figure 507). The windows are metal-sash, one-over-one. The doors are metal. Concrete sidewalks connect each building on the north and south sides.

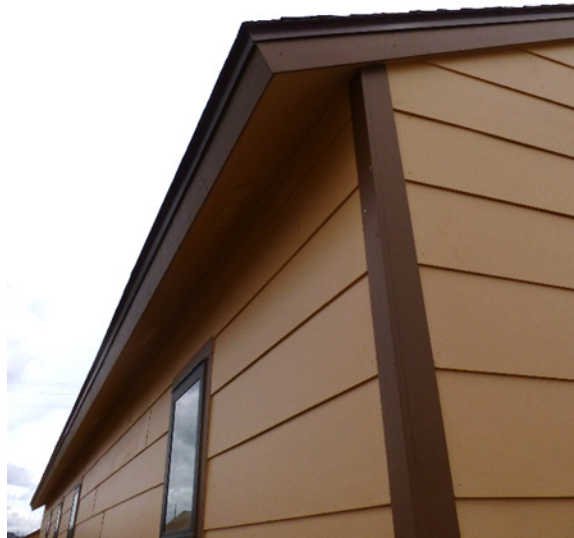
Figure 506. Close-up of the overhanging eave on Buildings F, G, and H at Camp Guernsey (ERDC-CERL, 2016).

No-number Buildings F, G, and H are one-story structures with rectangular footprints, gable roofs clad with asphalt shingles with overhanging eaves on the east and west sides (Figure 506), and exterior
