Architectural and Landscape Survey of Camp Guernsey, Wyoming

Adam D. Smith, Megan W. Tooker, and Sunny E. Adams

June 2017

Under Project Number 458417, "Camp Guernsey Historic Context and Building
Evaluation"

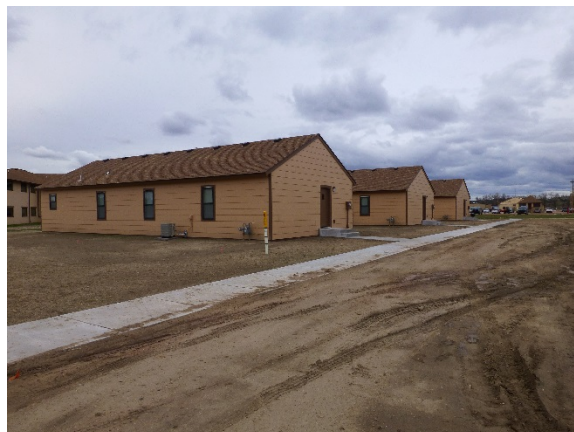
Figure 508. View toward the southwest of Buildings H, G, and F [left to right] at Camp Guernsey (ERDC-CERL, 2016).

The south elevations of Buildings F, G, and H face Building 502. There is a single, metal, entry door placed just to the left of center. Poured concrete stoop with steps provides access to the door. One window is located on the left side of the door (Figure 508). The west elevations consist of four windows—three on the left side and one on the right side (Figure 508). The east elevations also consist of four windows—three on the right and one smaller one on the left (Figure 508). The north elevations face Buildings 215, 216, and 217. There are single-entry metal doors placed just to the right of center. A poured concrete stoop with steps provides access to the doors.

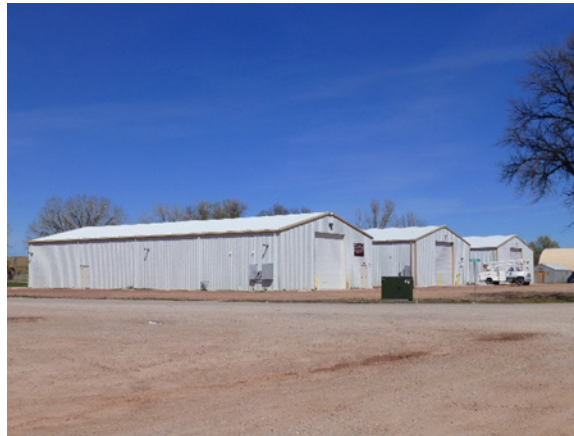
Figure 510. Southeast oblique of no-number Building I [background], Building J [middle], and Building K [foreground] at Camp Guernsey (ERDC-CERL, 2016).

No-number Buildings I, J, and K are large, prefabricated, metal structures, each with a concrete foundation, metal walls, and a shallow metal gable

roof (Figure 510). The buildings are built in a north-south row and are oriented in the east-west direction with Building I at the north end, Building J in the middle, and Building K at the south end (Figure 511). The southernmost structure, Building K is slightly shorter in length than the other two structures.

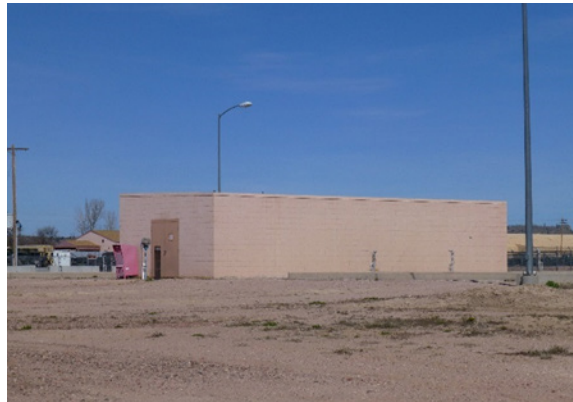
Figure 513. Southeast oblique of Wash rack #1 (ERDC-CERL, 2016).

Wash rack #1 is a simple, one-story building with a rectangular footprint, a concrete foundation, concrete block exterior walls, and a shed roof. It is surrounded by a large gravel lot (Figure 513). There is a set of metal doors on the north and south elevations. There are eight concrete wash pads located per each of the west and east sides of the building.

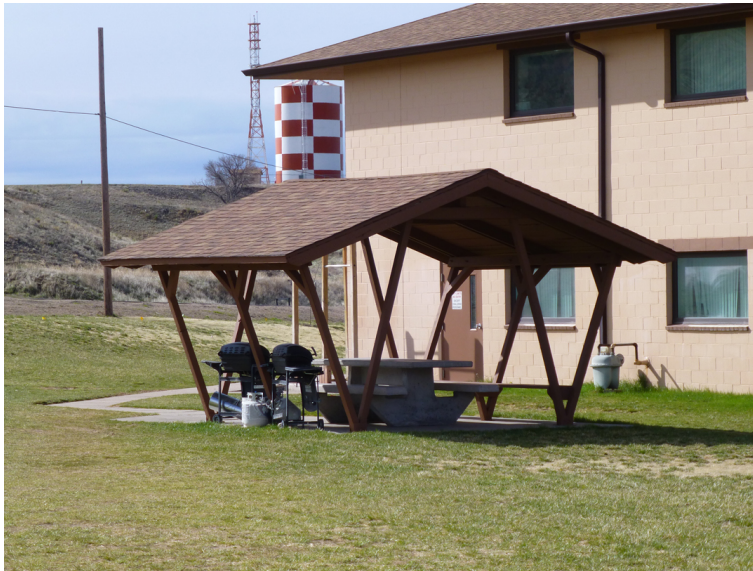
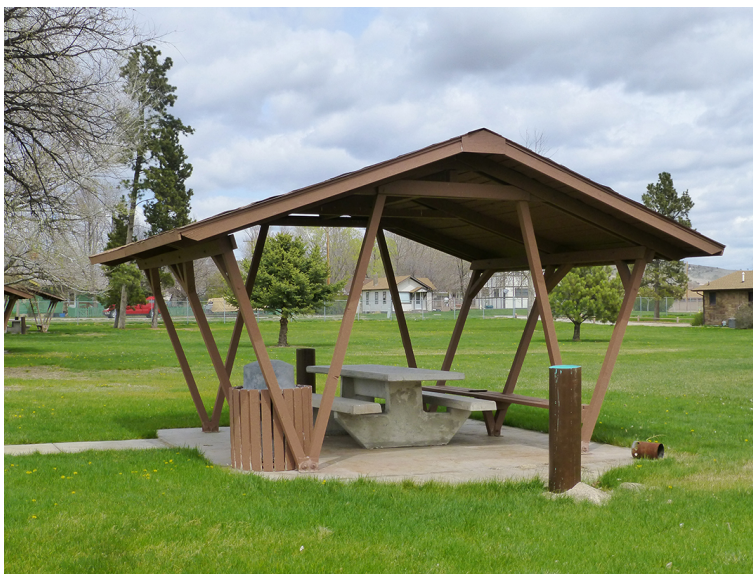
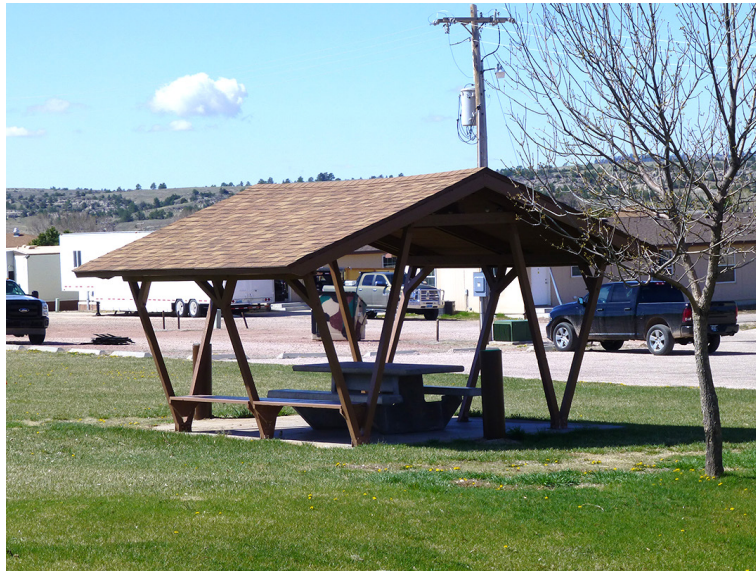
The pavilions are constructed of steel supports and a wood roof that covers a concrete slab (Figure 515–Figure 517).
