USMMA Historic District Property Maintenance and Repair Manual

Volume 7 – Stucco Elements

Final report

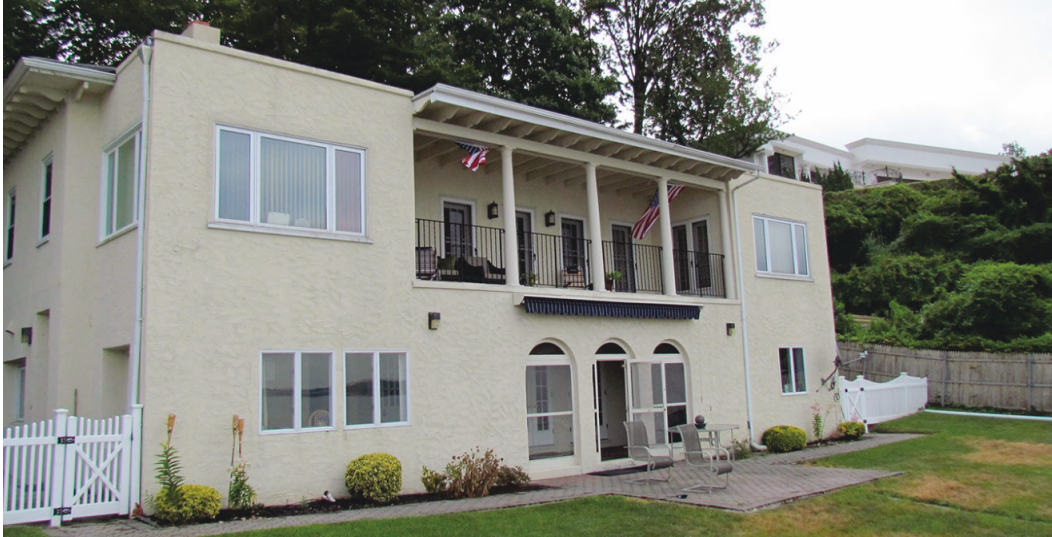
Figure 1. Stucco-clad exterior wall, west facade of Quarters D (Grenwolde Casino) (USMMA, 2013).

- Stucco applied to an exterior wall (Figure 1, Figure 4–Figure 7) is intended to function as a watertight surface. Unless maintained, rainwater will penetrate the open joints and cracks that may appear over time.
- Stucco is particularly susceptible to water damage, which in turn will cause the stucco to lose its bond and pull away from its substrate (Figure 8 and Figure 9).
- Crazeing and hairline cracks are to be expected with historic stucco, but if they appear on a large amount of wall areas or cover the entire surface, inspections should be done on the underlying substrate.

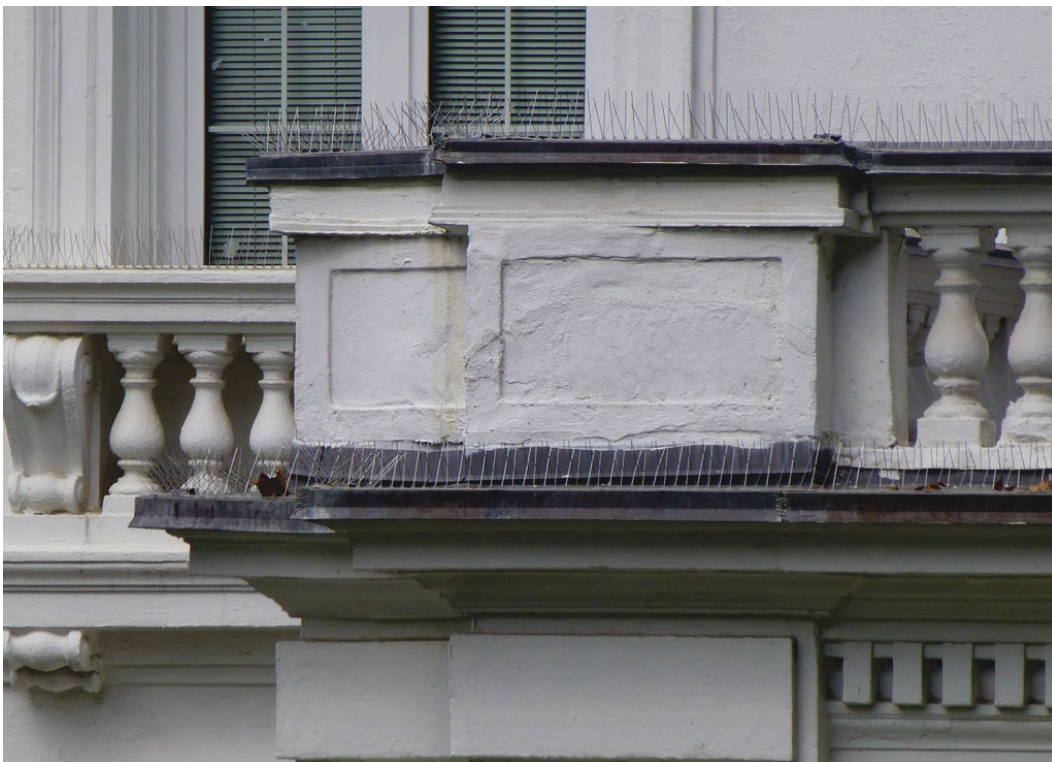
Figure 2. Flashing and pigeon control placed on top of architectural elements covered with stucco material; replacement stucco needs to be finished with color, appearance, and texture of original stucco (ERDC-CERL, 2015).

- The USMMA needs to develop a periodic inspection process for all of its buildings that have stucco finishes to ensure deterioration and degradation is mitigated and/or fixed as quickly as possible (Figure 2 and Figure 3).

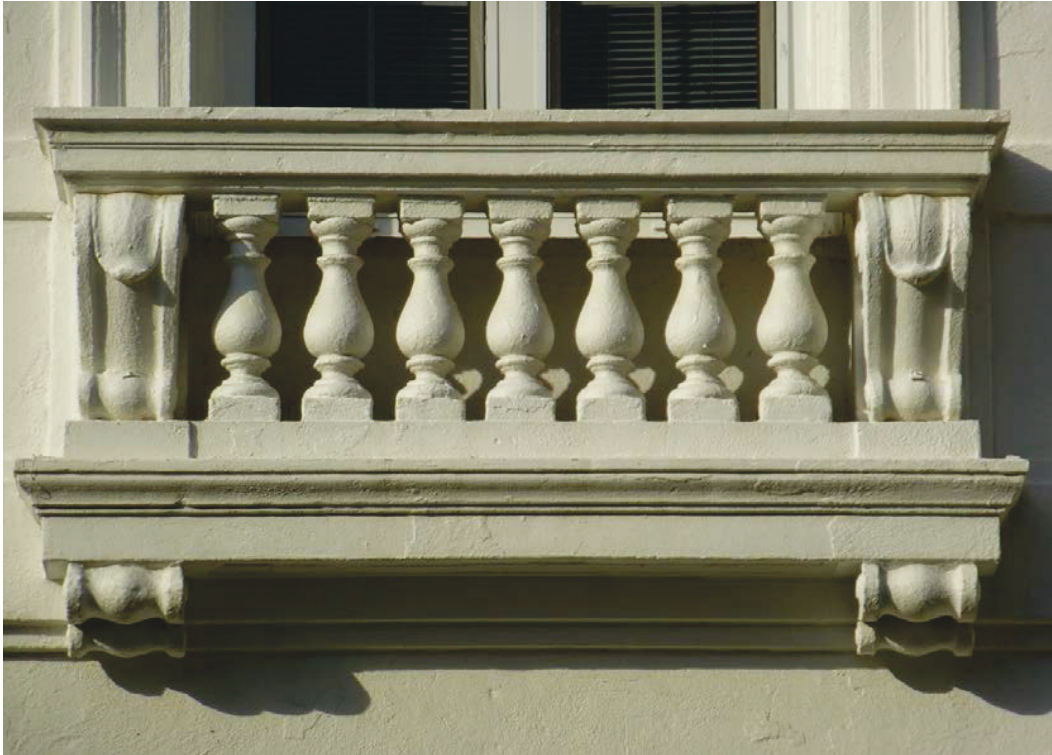
Figure 3. Stucco-clad balustrade that has been painted (ERDC-CERL, 2013).

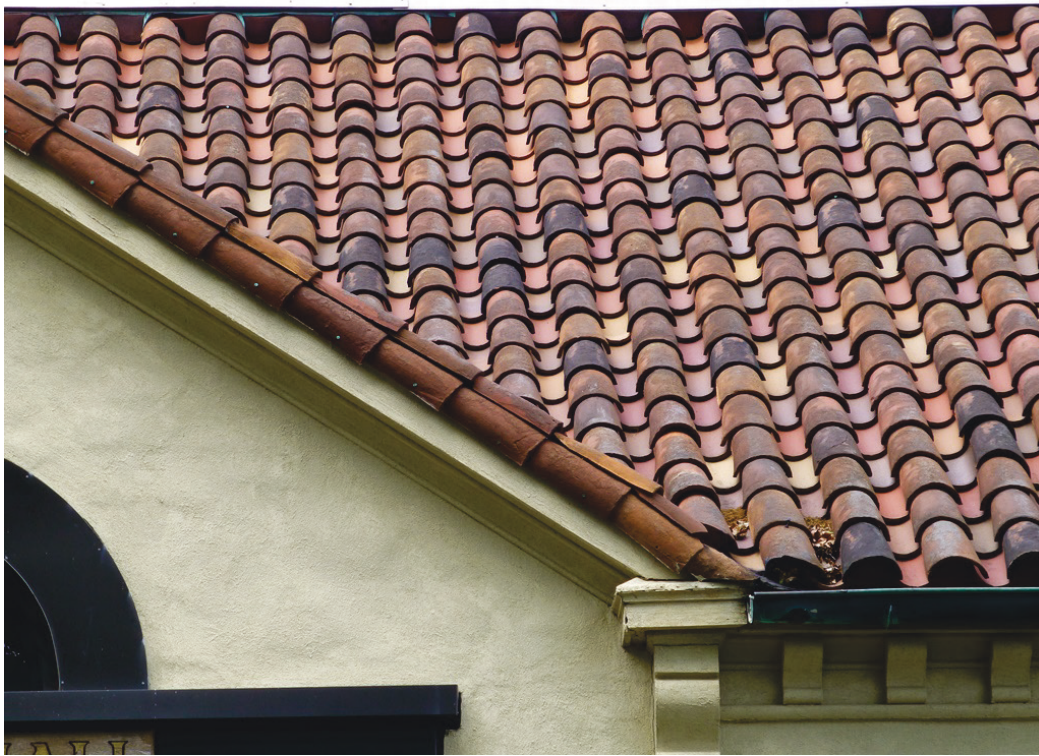
Figure 5. Stucco details, corbel and dentils, on Melville Hall (ERDC-CERL, 2013).

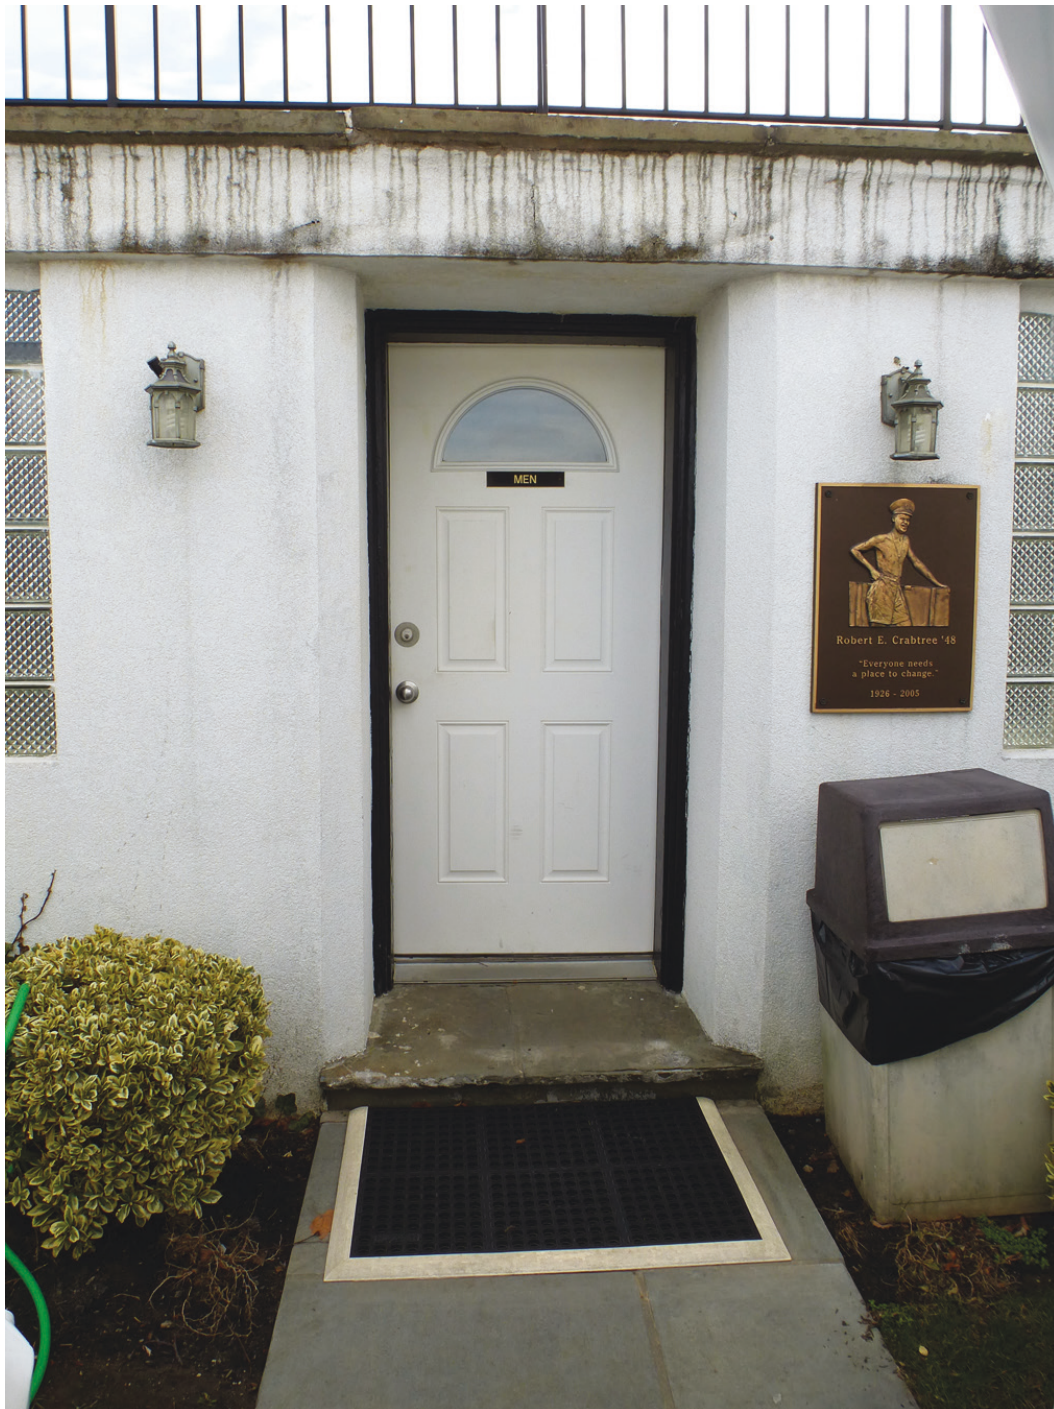
Figure 7. Stucco on concrete at the Eldridge Pool bathhouses (ERDC-CERL, 2013).

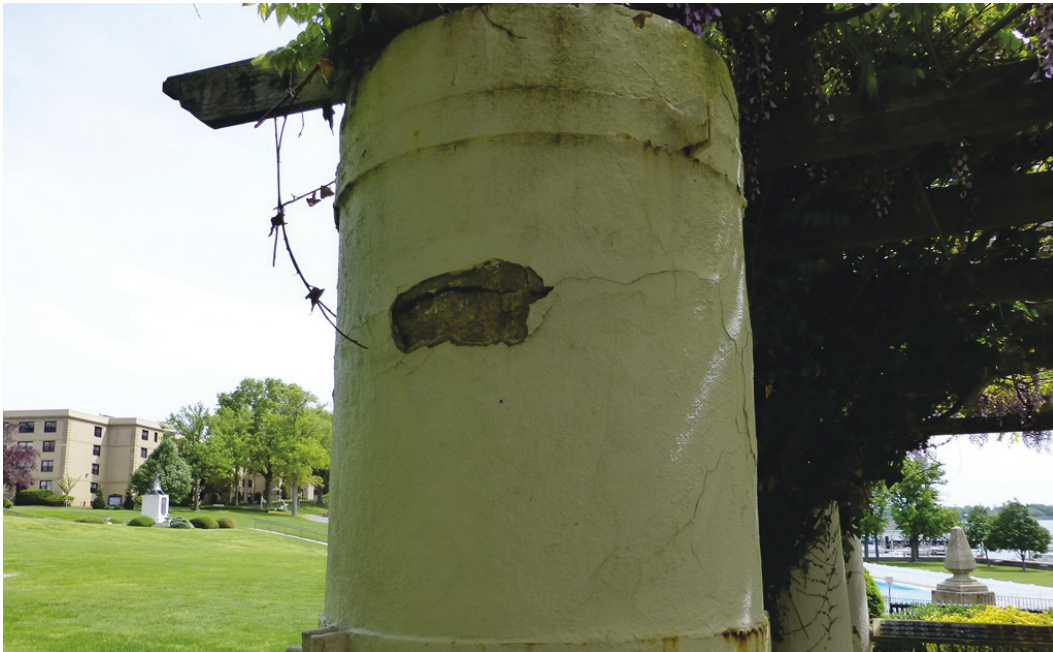
Figure 8. A concrete pergola column with a parge of stucco that is failing (ERDC-CERL, 2015).

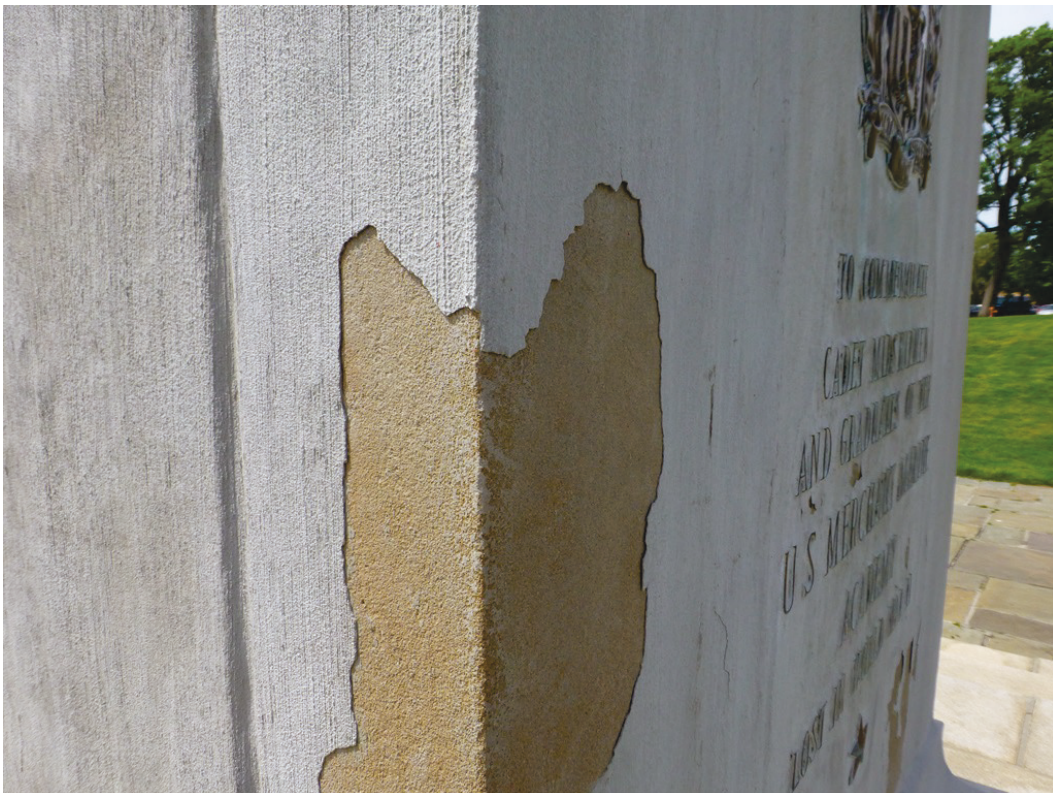
Figure 9. A stucco parge that is failing on this monument (ERDC-CERL, 2015).
