Material Selection for Bumpers and Fenders for Lock Gates and Guidewalls

Stuart D. Foltz and Richard G. Lampo

November 2017

Final Report

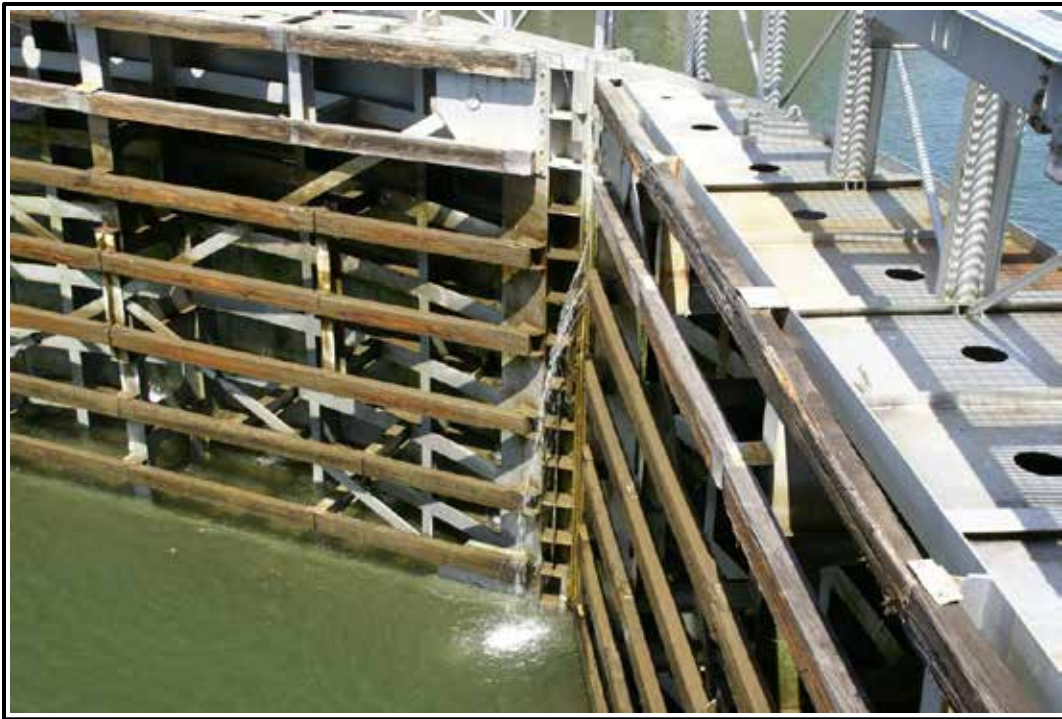
Figure 2-1. Typical wooden fender installation.

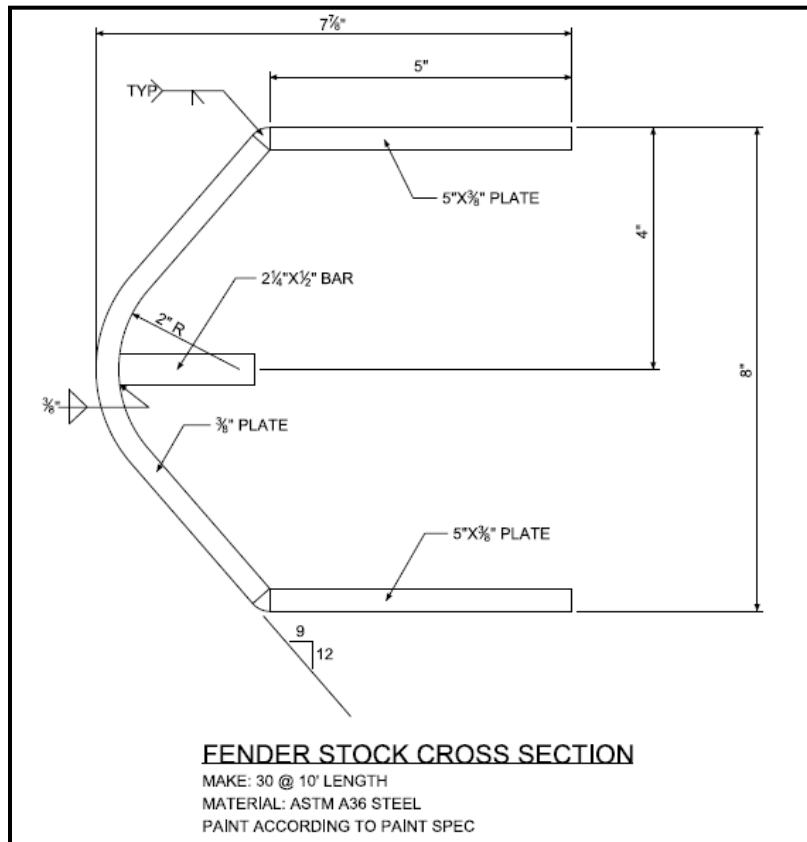
Figure 2-2. Fabricated steel fender.

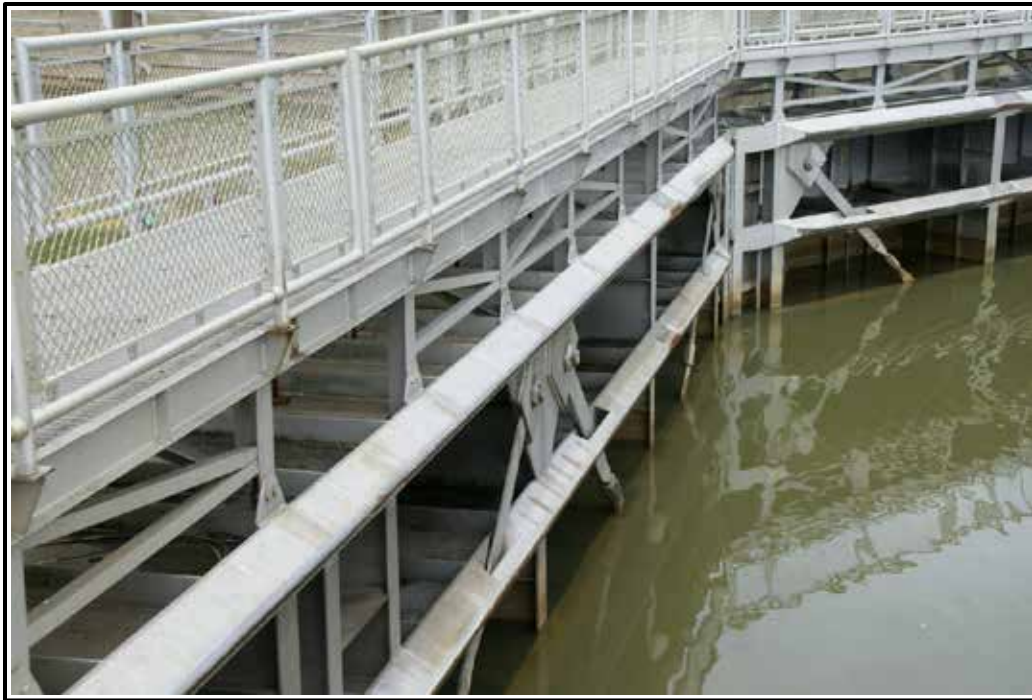
Figure 2-3. Triangular steel fenders.

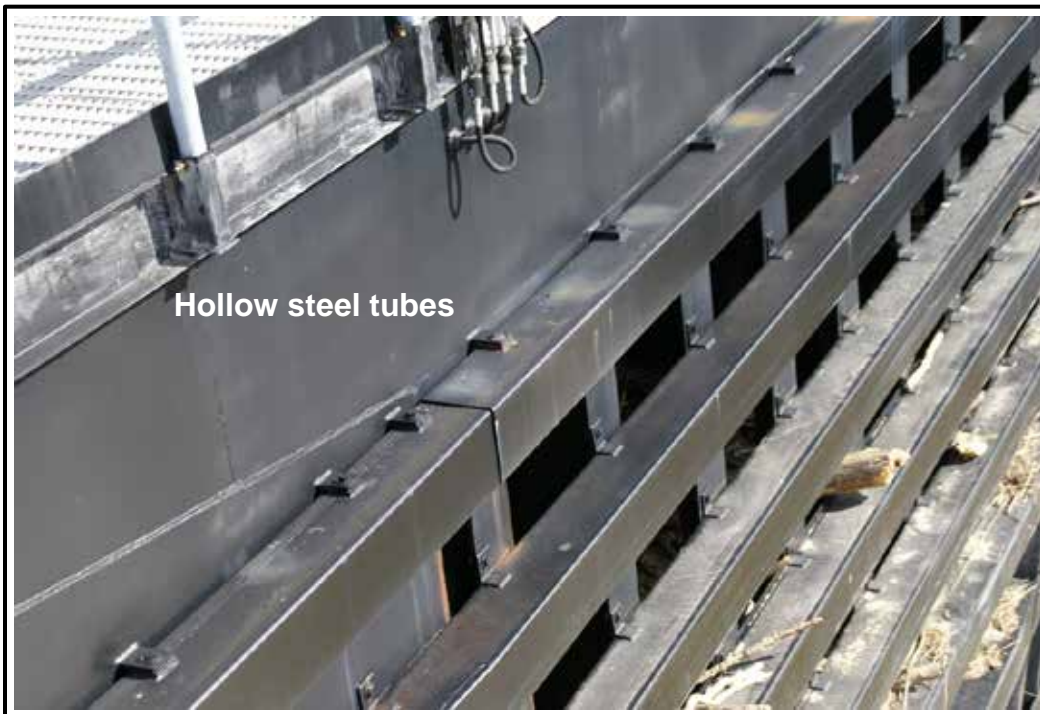
Figure 2-4. Square tubular steel fenders (Winfield L&D).

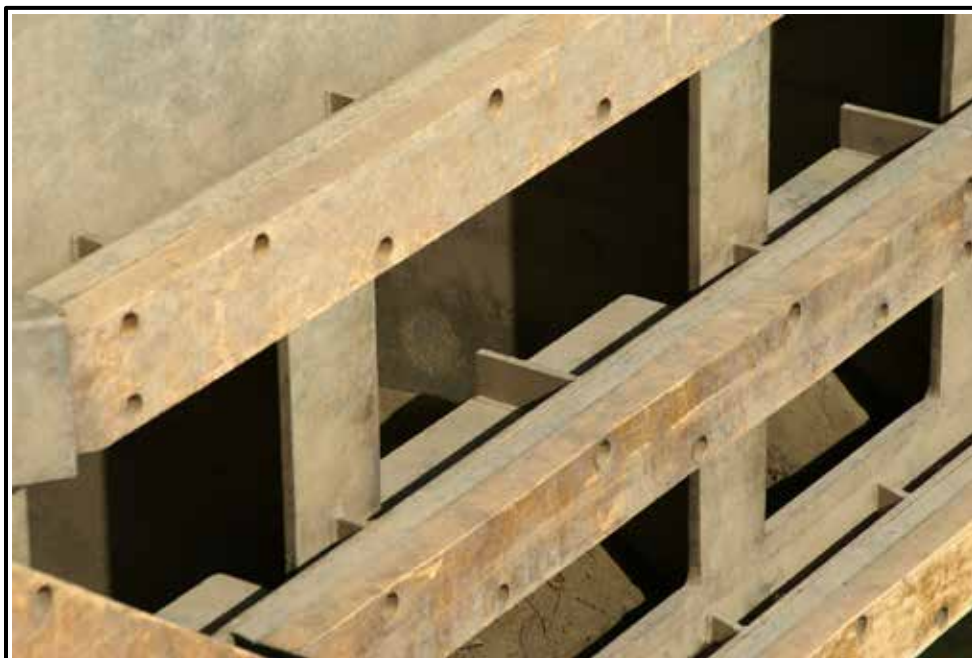
Figure 2-6. Layered UHMWPE and elastomeric fenders (Olmsted L&D).

The most recent trend is a growth in the use of multi-layered fenders, typically consisting of a UHMWPE exterior with an elastomeric rubber backing (Figures 2-5 and 2-6). This design may also include a steel shape (Figures 2-7 and 2-8). The polyethylene provides a rubbing surface that is resistant to damage from scraping and minor impacts; the rubber layer is supposed to help absorb shocks; and for larger impacts, the steel shape will deform, further minimizing the energy transferred into the gate.

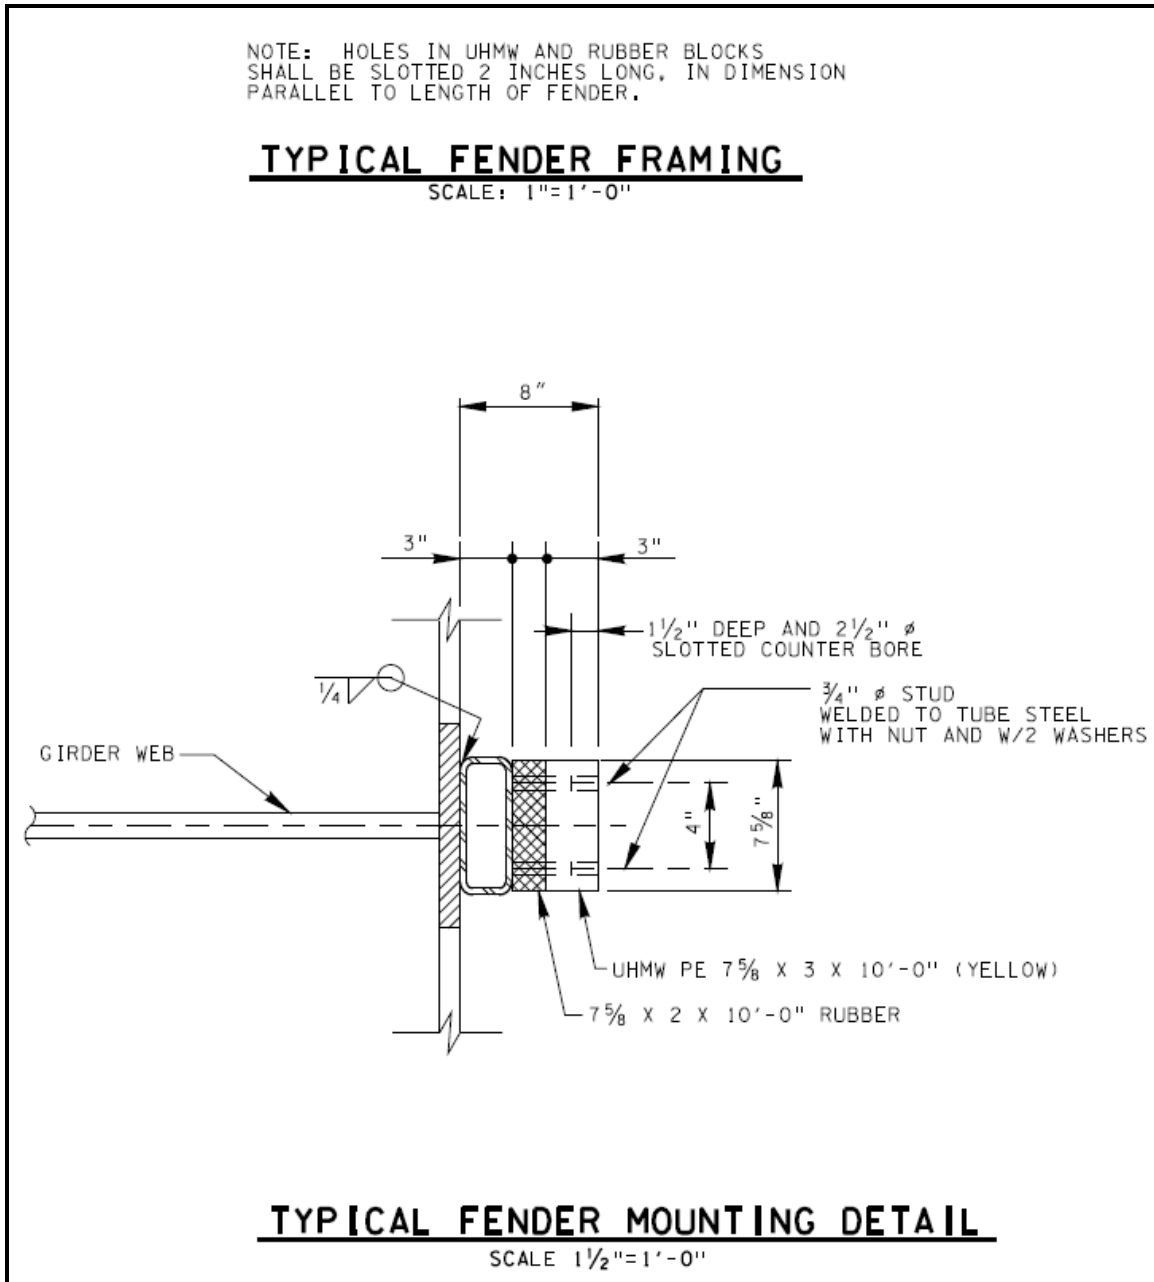
Figure 2-7. Layered fender design with steel tube (McAlpine L&D).

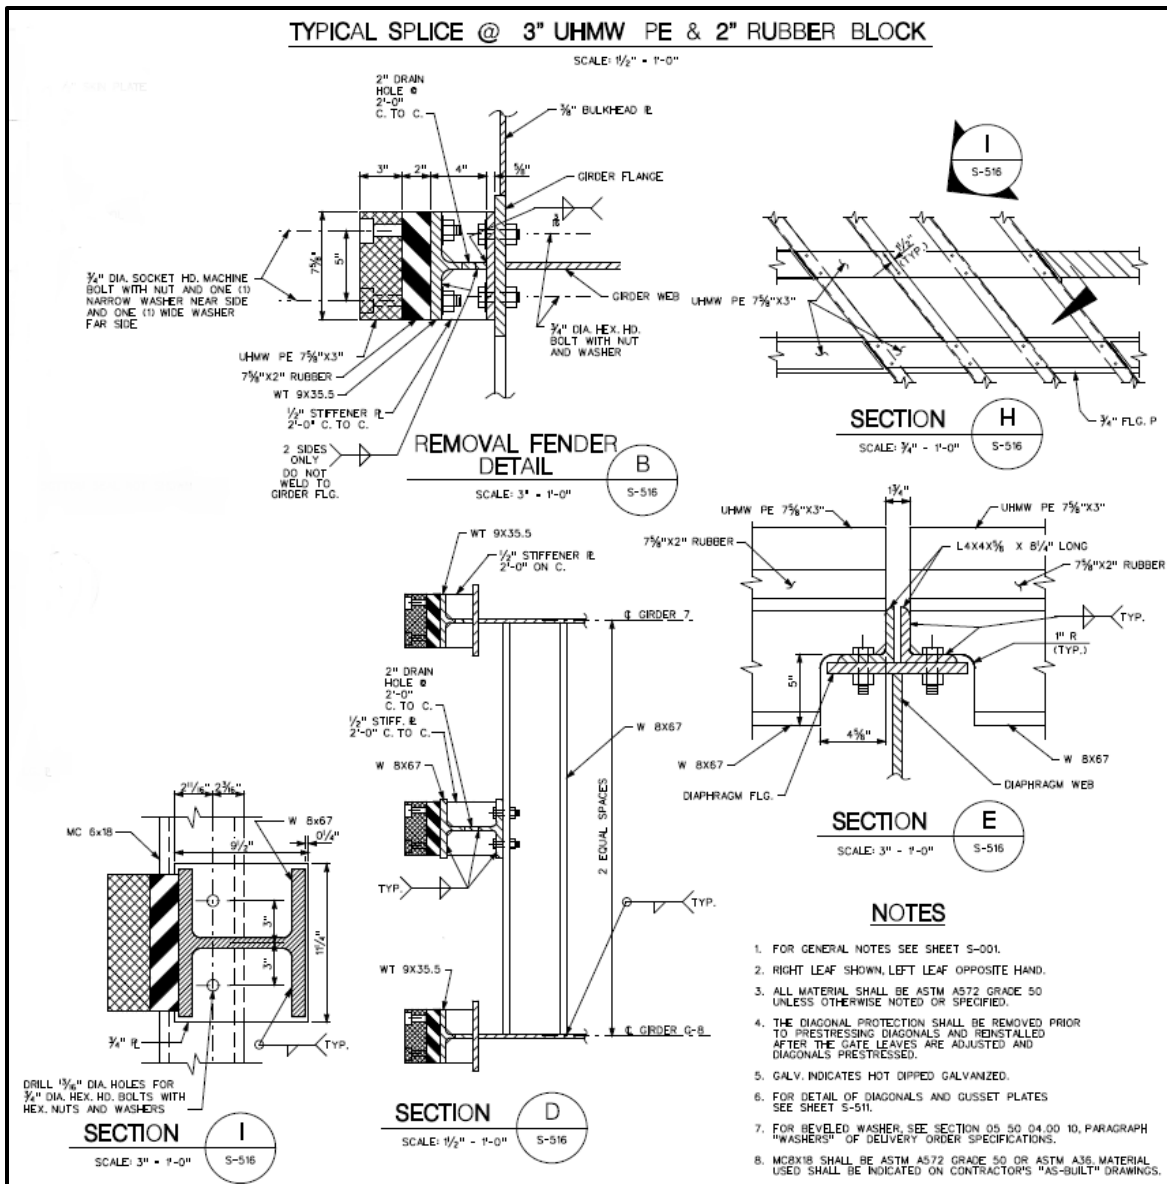
Figure 2-8. Layered fender design with steel I and T sections (Greenup L&D).

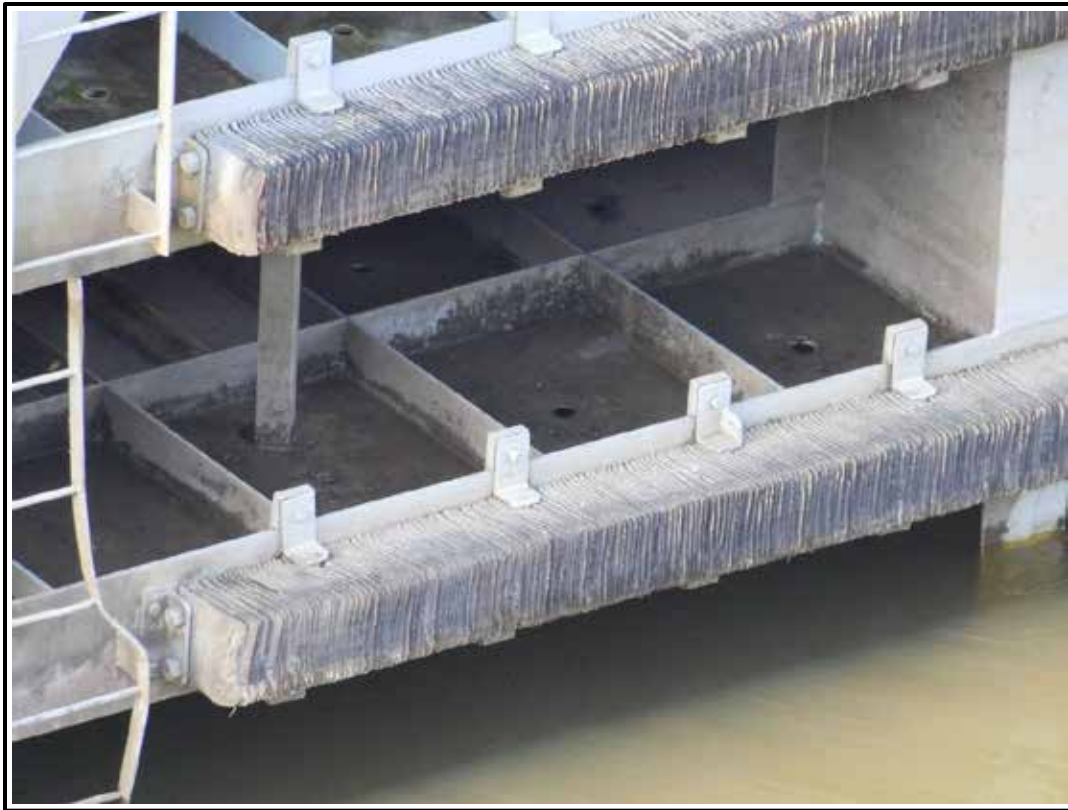
Figure 2-9. Recycled rubber fenders (Holt L&D).

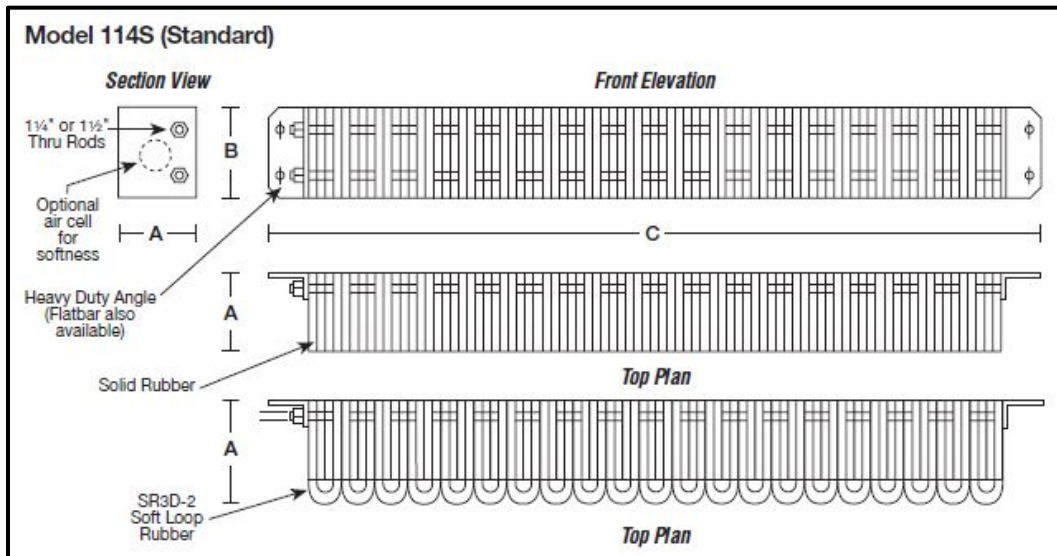
Figure 2-10. Rectangular and loop side fenders.

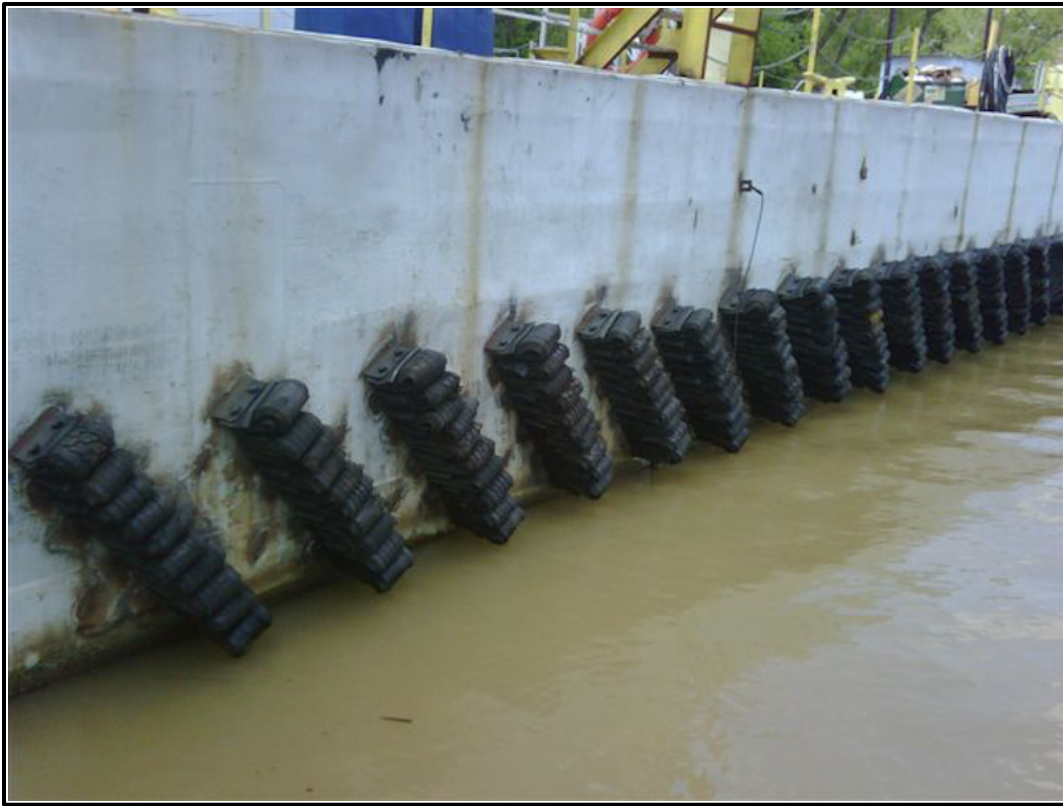
Figure 2-11. Loop fenders.

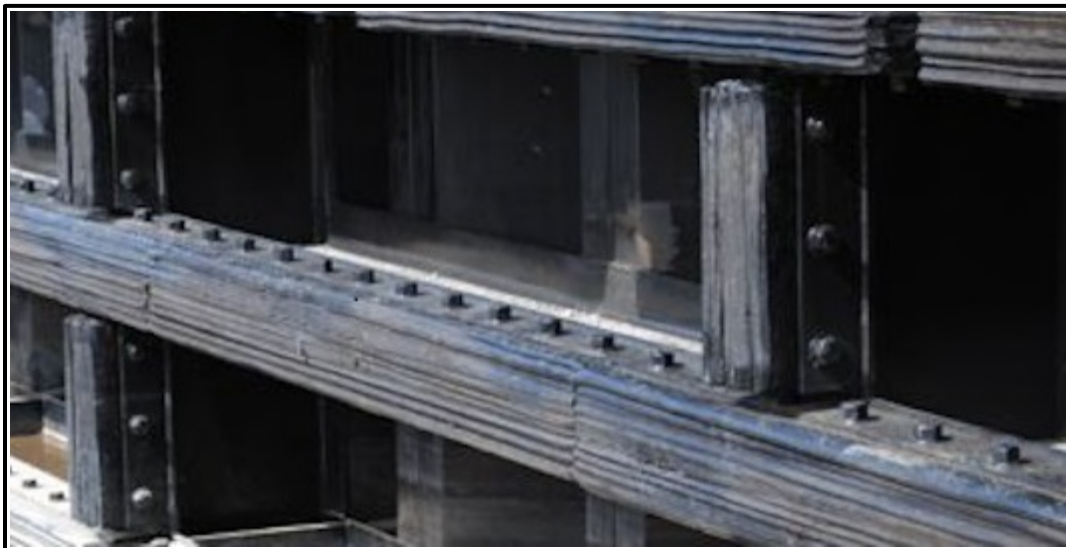
Figure 2-12. I-beam fender.

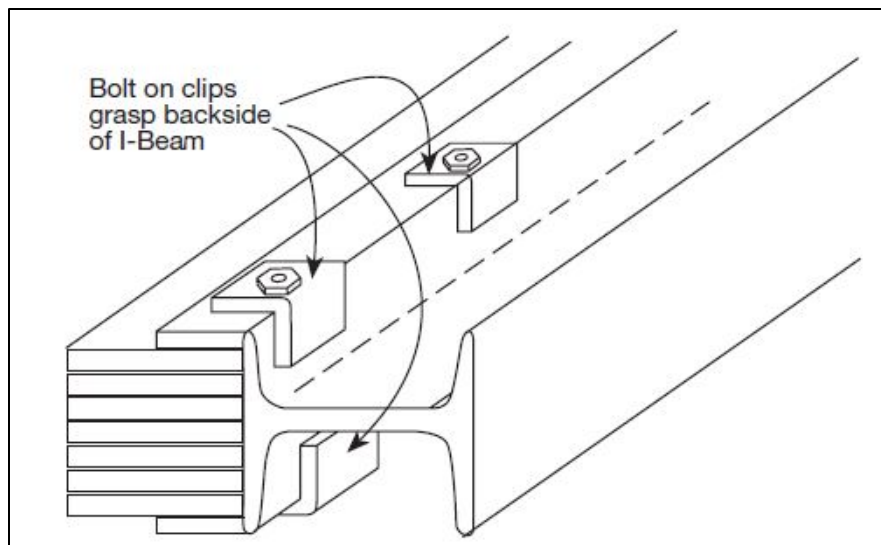
Figure 2-13. I-beam fender design.

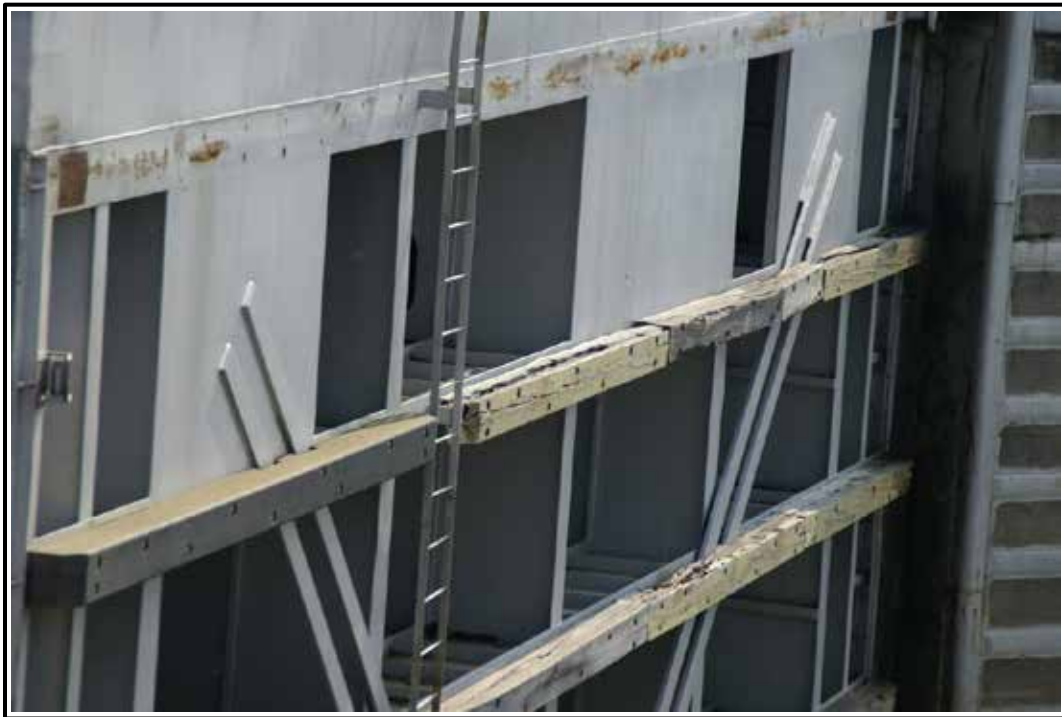
Figure 2-14. Deteriorated wood fenders and one replacement HDPE fender.

Wood is very susceptible to environment related degradation, especially in the wet but un-submerged applications typical for fenders (Figure 2-14). The various preservatives that are used to slow the degradation also have disadvantages and tend to lose effectiveness with age. Moreover, the chemicals used to treat wood such as TreCreosote and chromated copper arsenate can leach from the wood into the water, and can harm the environment. Depending on local regulations, wood treated with these chemicals may need to be discarded as hazardous waste.

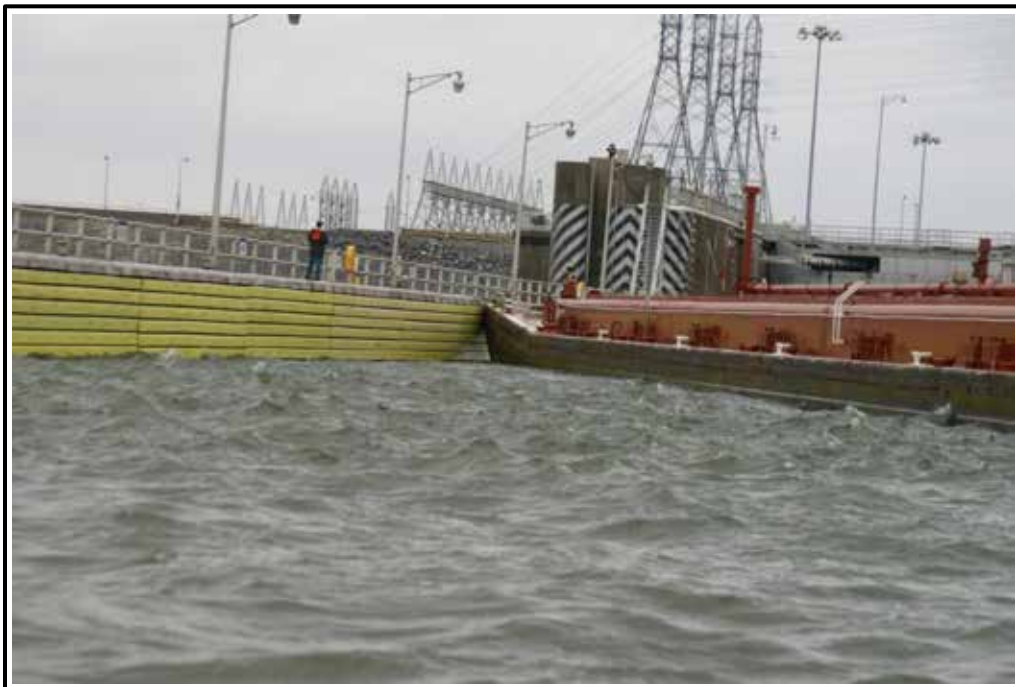
Figure 2-15. Kentucky Lock upstream approach wall with yellow fenders for better visibility.

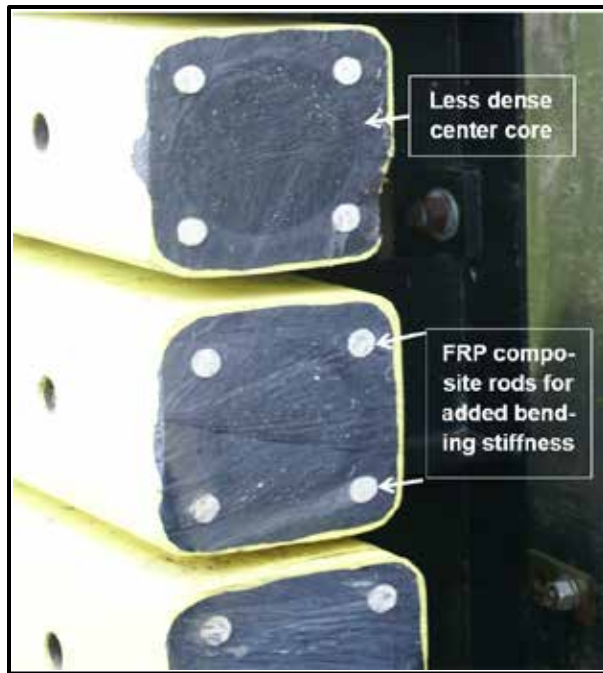
Figure 2-16. HDPE timbers with circular less dense and softer core.

Many USACE districts reported problems with the attachment of polyethylene timbers due to bolt pull-out and breakage. Countersunk bolts increase this risk, especially for HDPE, which has a relatively less dense core (Figure 2-16). The bolt breakage issue may be similar for wood except that, since polyethylene can otherwise survive greater forces, pulled through or broken bolts are more likely to appear as the sole failure mode.

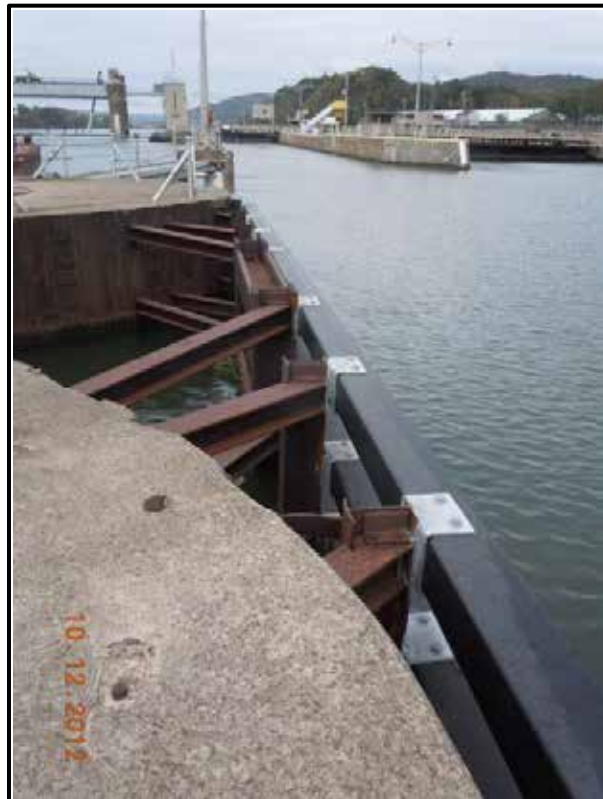
Figure 2-17. Approach walls at the Emsworth Locks & Dams, Pittsburgh, PA.

A different attachment method has been successfully used on the approach walls at the Emsworth Locks & Dams, Pittsburgh, PA (Figure 2-17). More recently, it was learned that a similar attachment was used for fenders on the miter gates at Lockport Lock and Dam, Lockport, IL (Figure 2-18). The vertical through-bolts used in these two applications should eliminate most problems with weak attachment while also allowing expansion slots as large as necessary. The Lockport application also addresses creep by fully supporting the member with a steel channel. Soo Locks use a similar attachment with oak fenders.

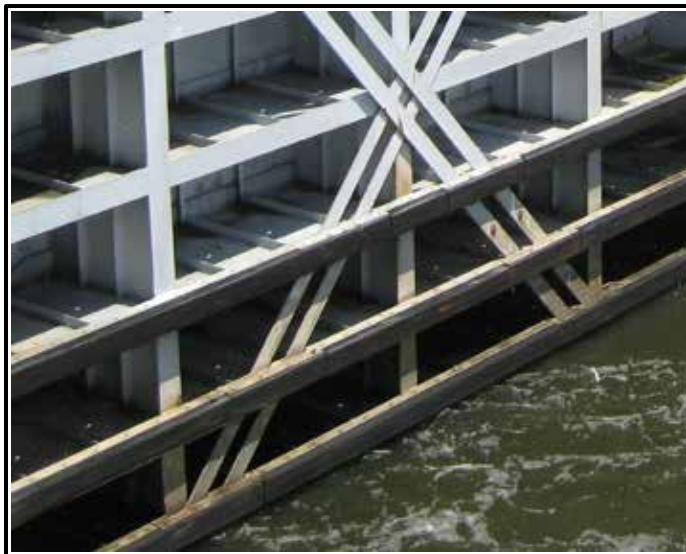
Figure 2-18. Fenders at Lockport Lock and Dam, Lockport, IL.

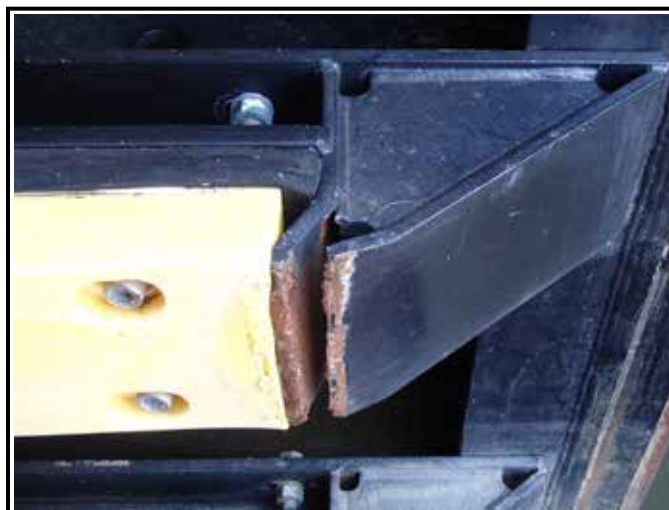
Figure 2-19. View of typical plate deformation and broken weld at the fender guard transition (Greenup L&D).

Fenders separate the barge from the gate, thereby limiting the potential for hang-ups on corners that might transfer more load as the barge passes. While a hang-up on a fender will cause far less damage than a hang-up on a gate structural member, the ends of the fenders are a common point of damage. If a barge hits just before the fender, it may not slide past the start of the fender; or as it slides by something, the barge may get snagged as it passes the endpoint of the fender (see Figure 2-19). Some fenders are tapered to reduce the likelihood of hang-ups but a tapered fender also provides less protection to the underlying gate.

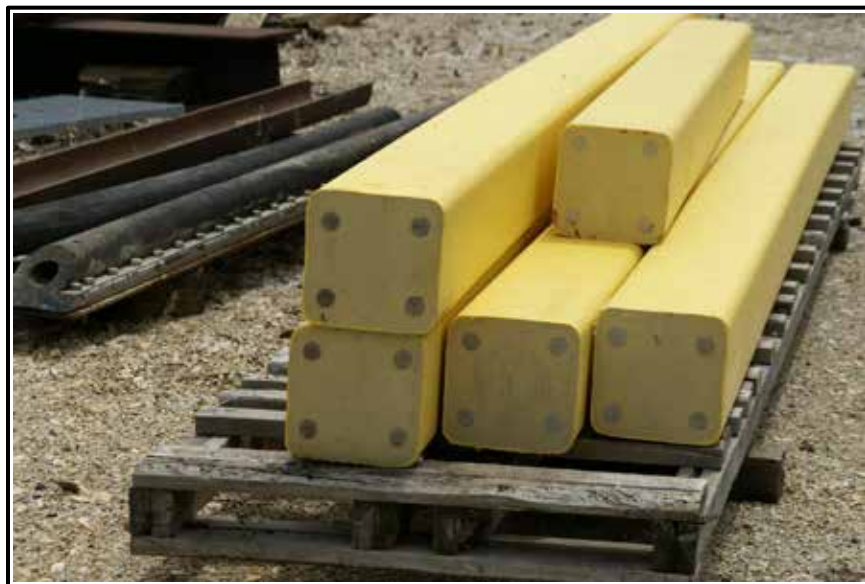
Figure 2-20. Composite rebar reinforced HDPE timbers. Note yellow color throughout the cross-section.

Polyethylene has a tendency to creep and sag over time. The longer the unsupported length and higher the service temperature, the more this becomes an issue. The use of glass fiber reinforcement or fiberglass composite rods (Figure 2-20) adds stiffness and provides added resistance to creep by reducing the strain in the HDPE. The added cost needs to be weighed against the cost of alternatives such as the use of additional supports for the fenders.

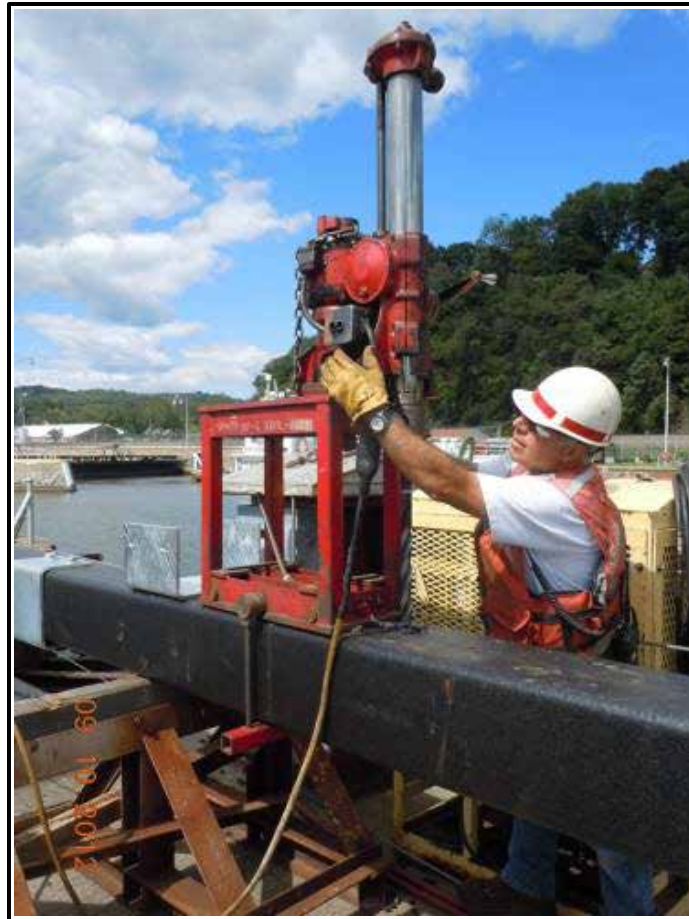
Figure 2-21. Pre-drilling the attachment points.

- It is recommended to pre-drill holes (see Figure 2-21).
- Carbide-tipped blades and bits are recommended.
- Do not drill holes near any embedded rebar material as the load capacity will be altered if the rebar is damaged.

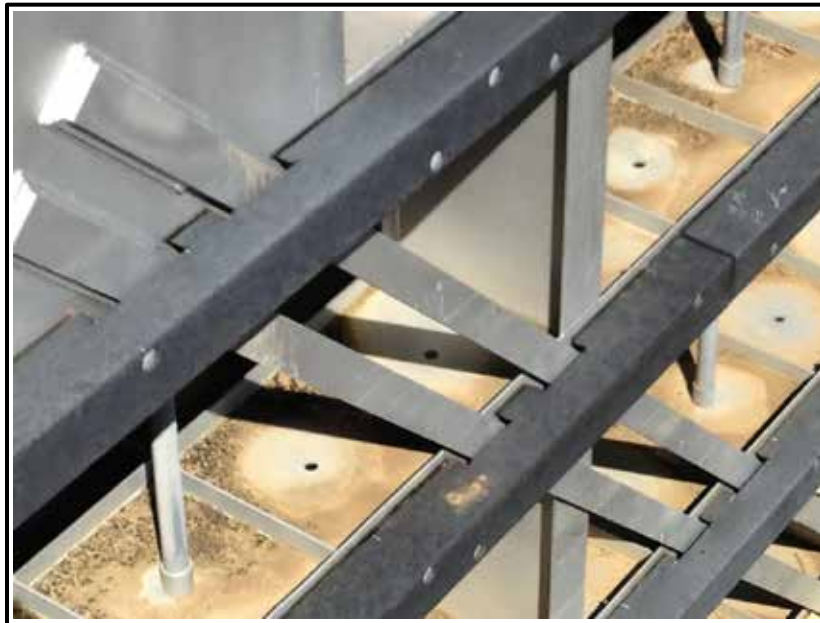
Figure A-1. HDPE fenders.

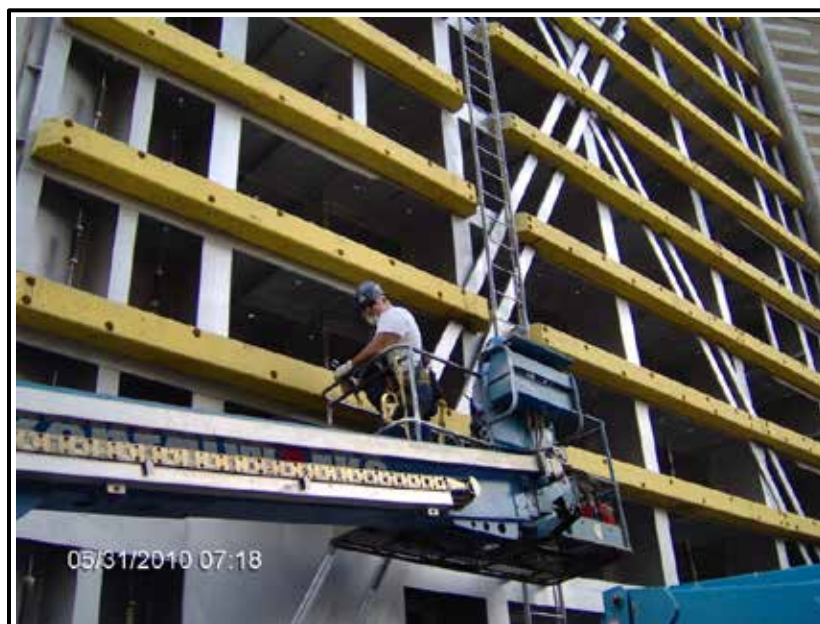
Figure A-2. Installation of HDPE fenders colored yellow for visibility.

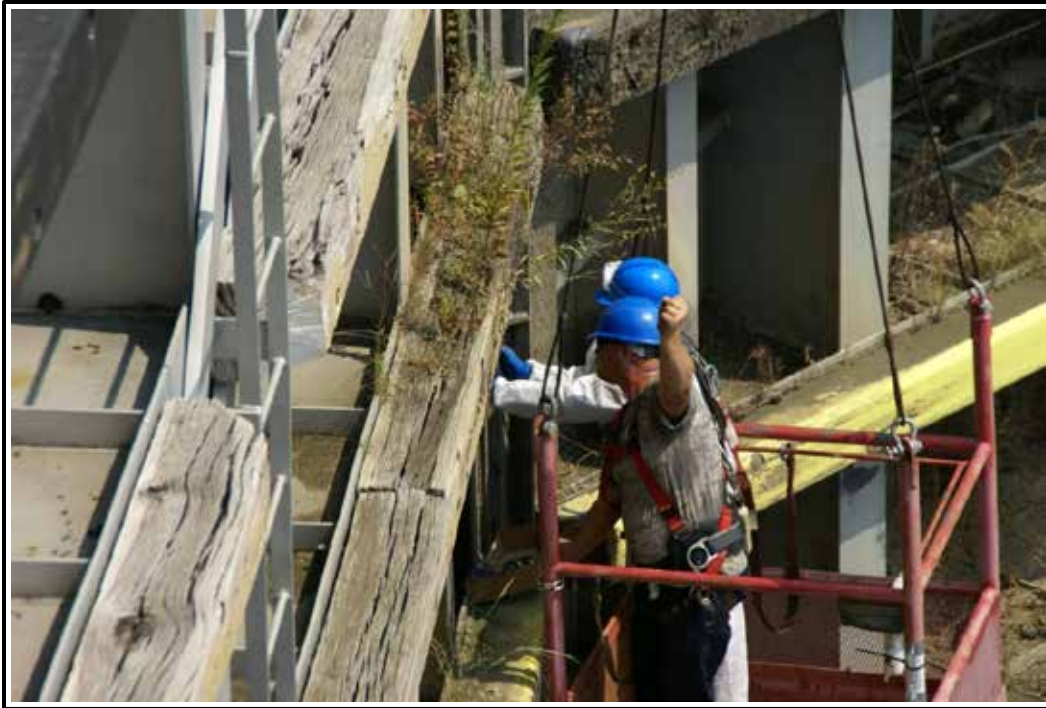
Figure A-3. Fender repairs. Notice vegetation growing out of the timber.

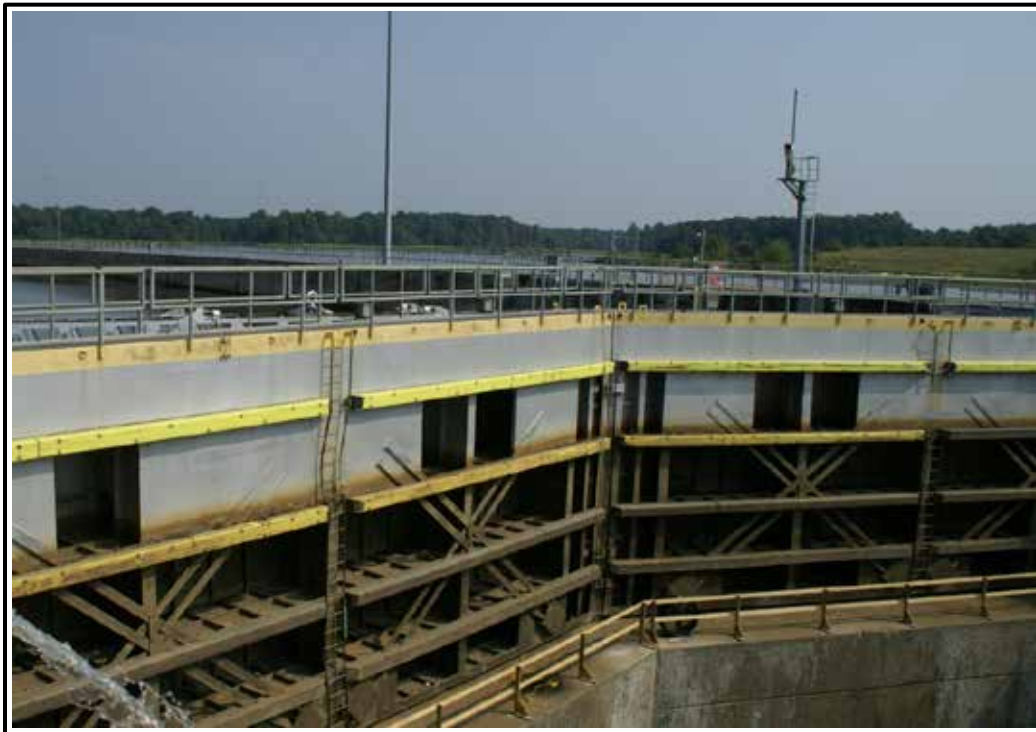
Figure A-4. Various fender types and damaged ladders.

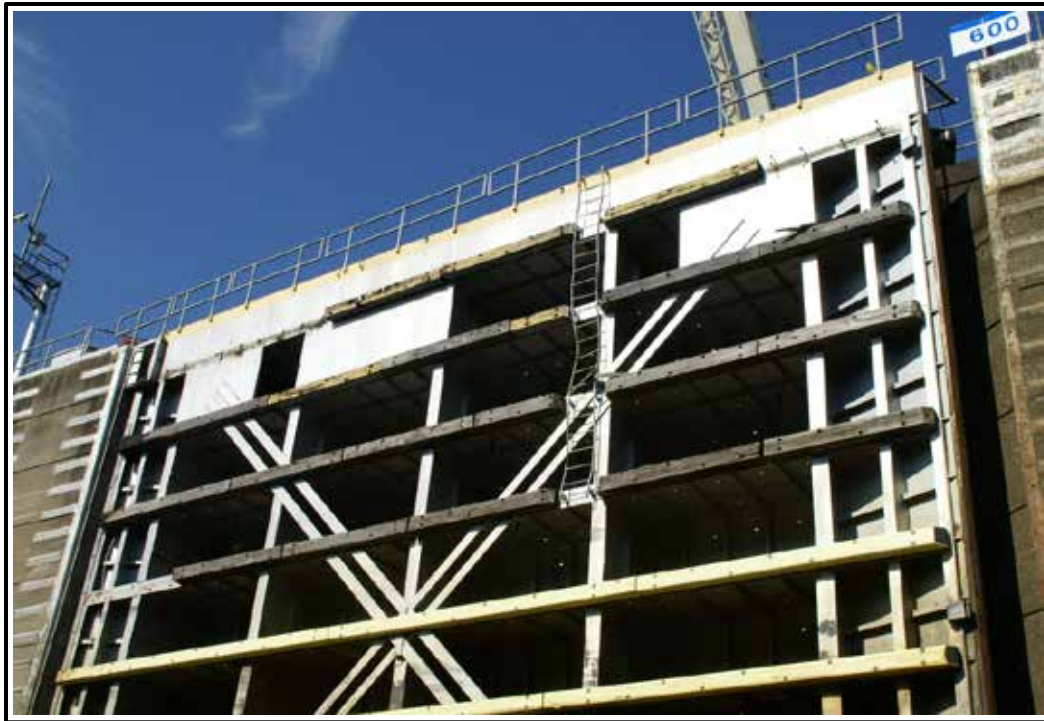
Figure A-5. Various fender types and damaged ladder.

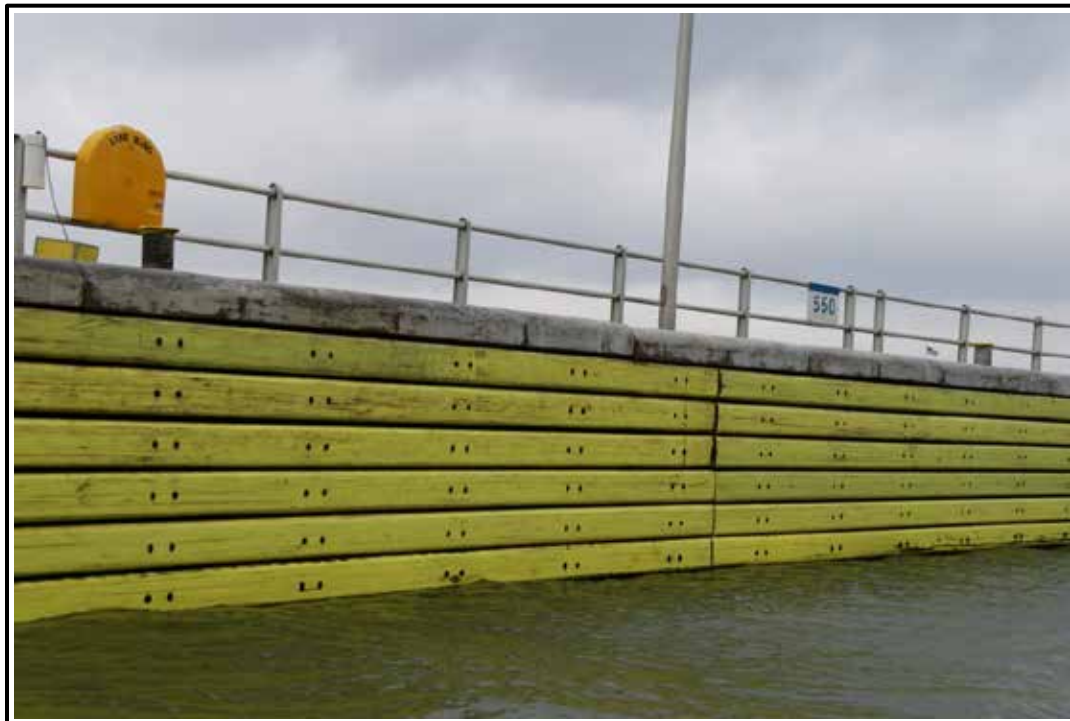
Figure A-6. Approach wall with yellow HDPE fenders (Kentucky Lock).

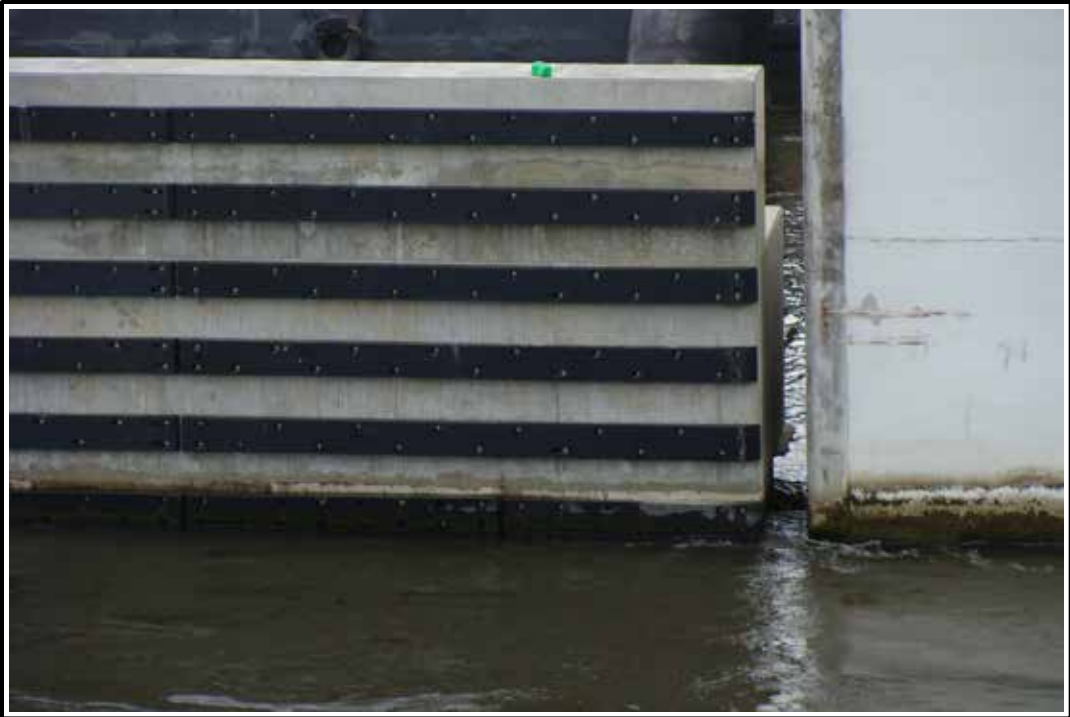
Figure A-7. Approach wall with HDPE fenders (Lake Borgne Surge Barrier).

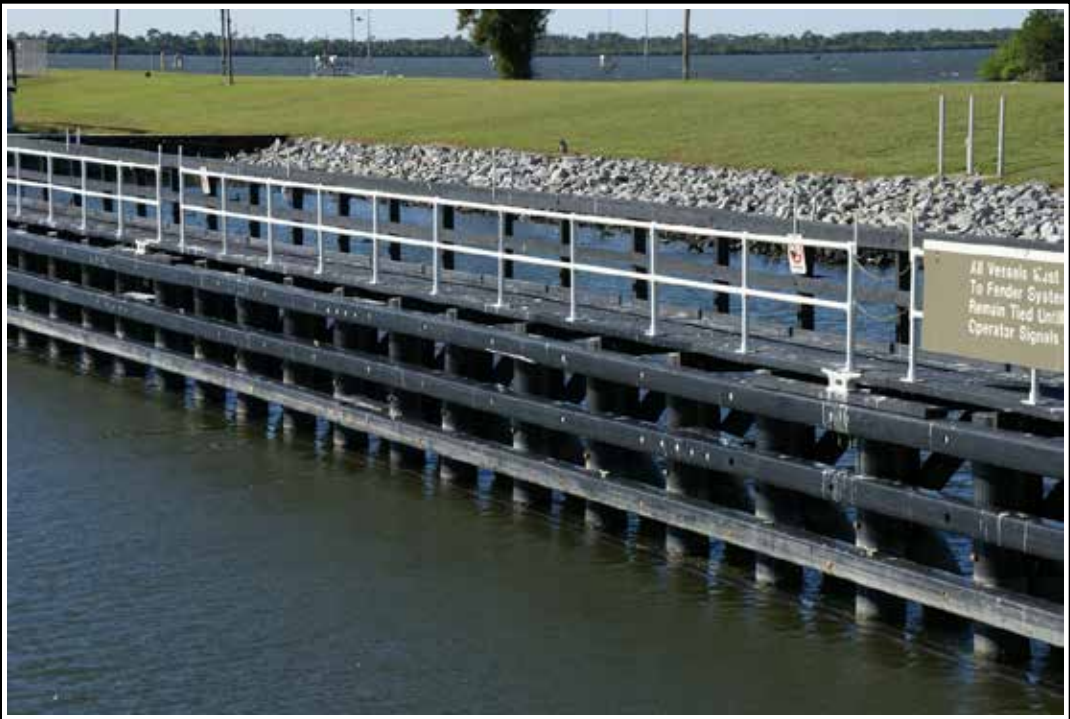
Figure A-8. Guidewall with HDPE fenders (Port Canaveral Locks).

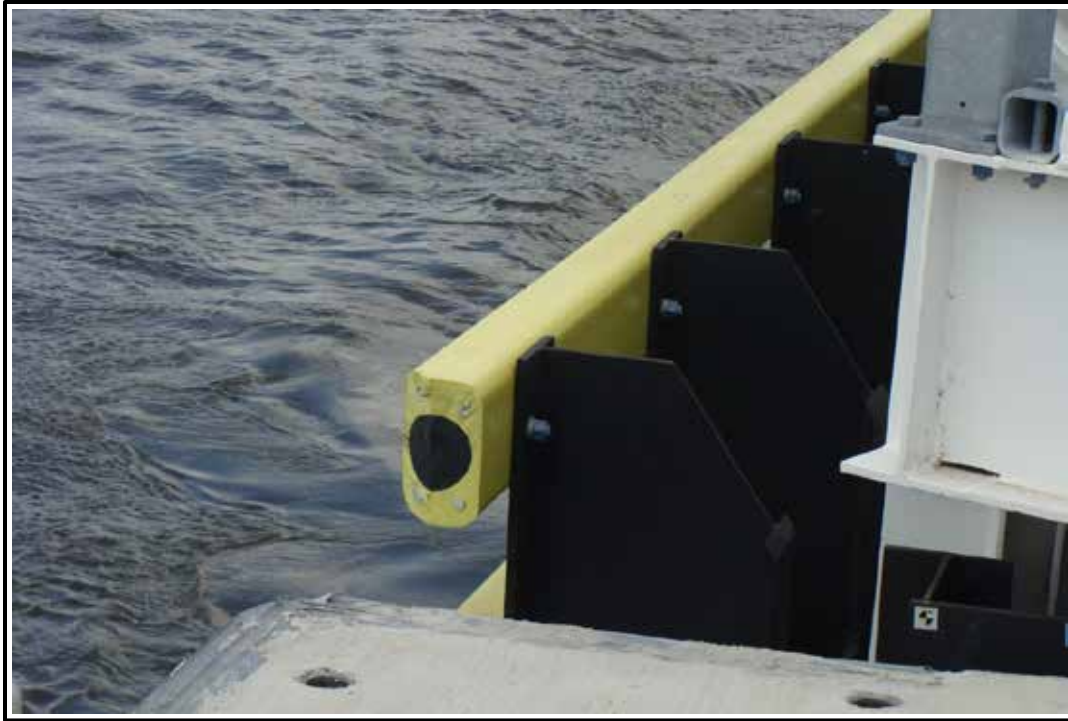
Figure A-9. Composite plastic bumper with polyethylene core and FRP reinforcement.

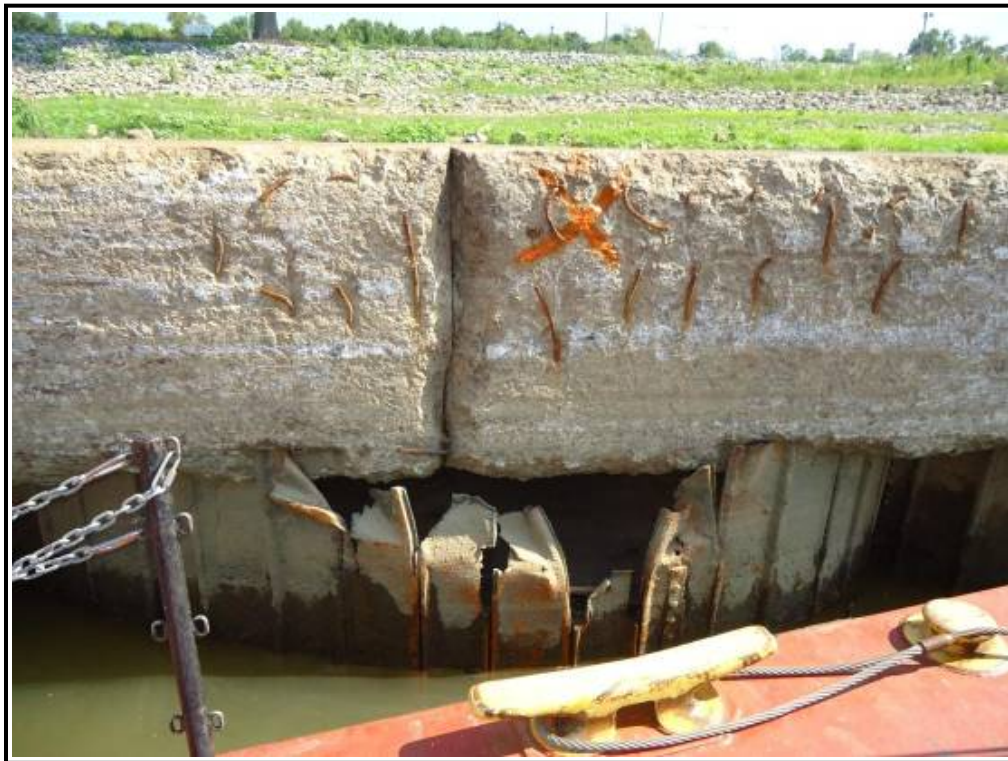
Figure A-10. Deteriorated wall due to barge rubbing (Ohio River Lock #52).
