Material Selection for Bumpers and Fenders for Lock Gates and Guidewalls

Stuart D. Foltz and Richard G. Lampo

November 2017

Final Report

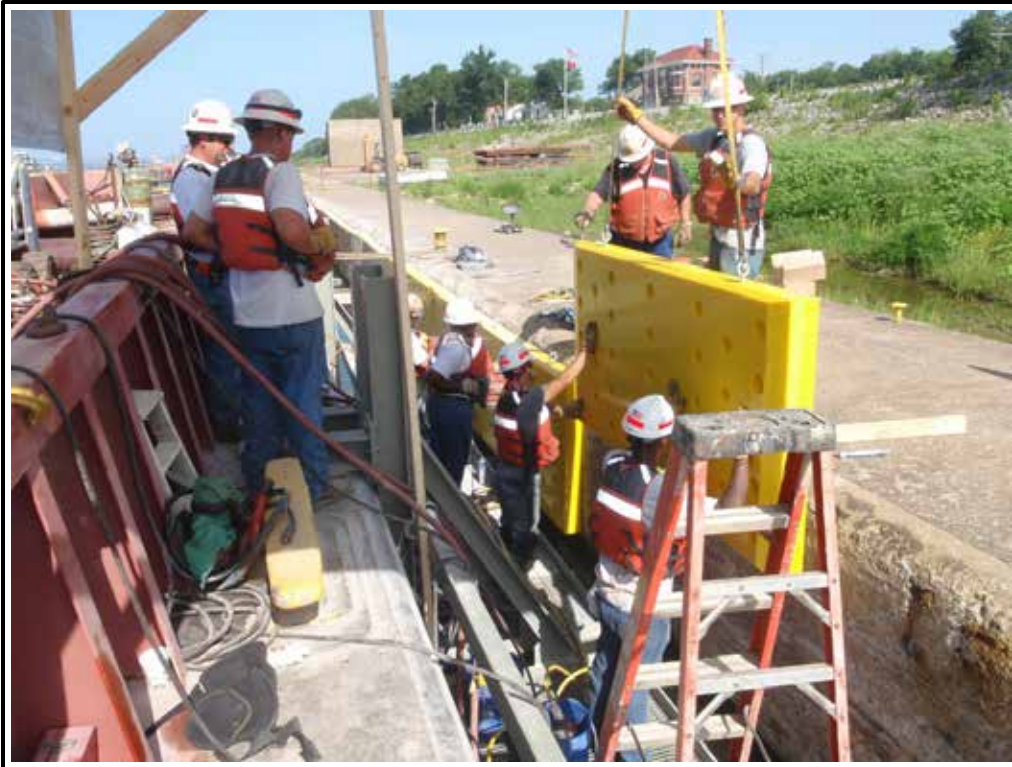
Figure A-11. UHMWPE panel on deteriorated armor wall (Ohio River Lock #52).

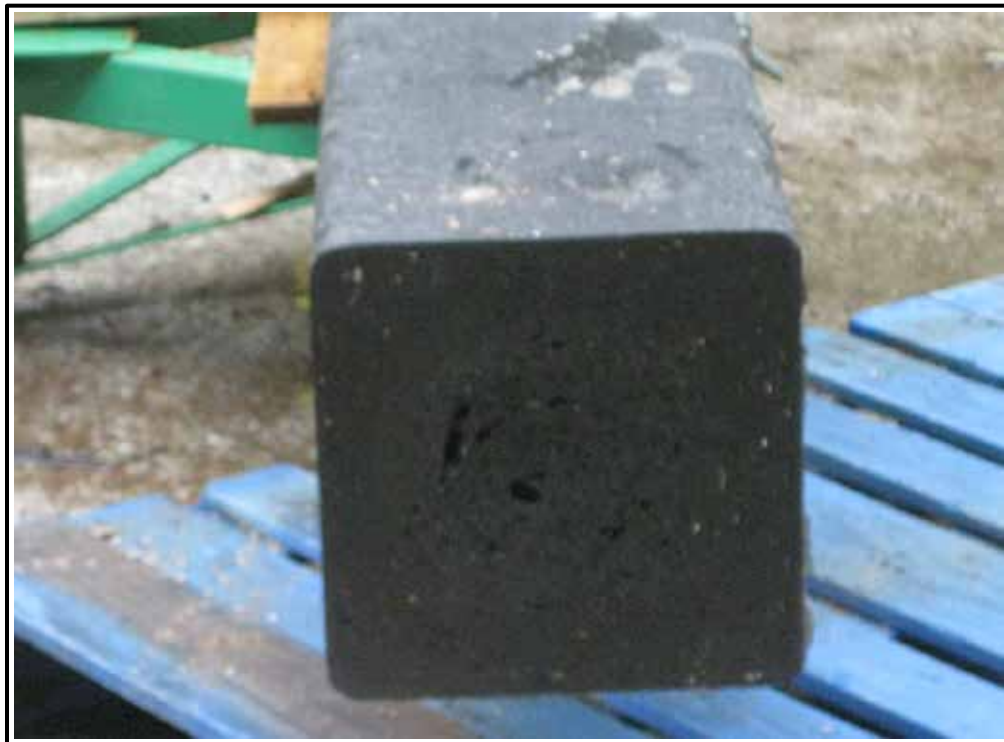
Figure A-12. HDPE timber with typical void formations in the center core.

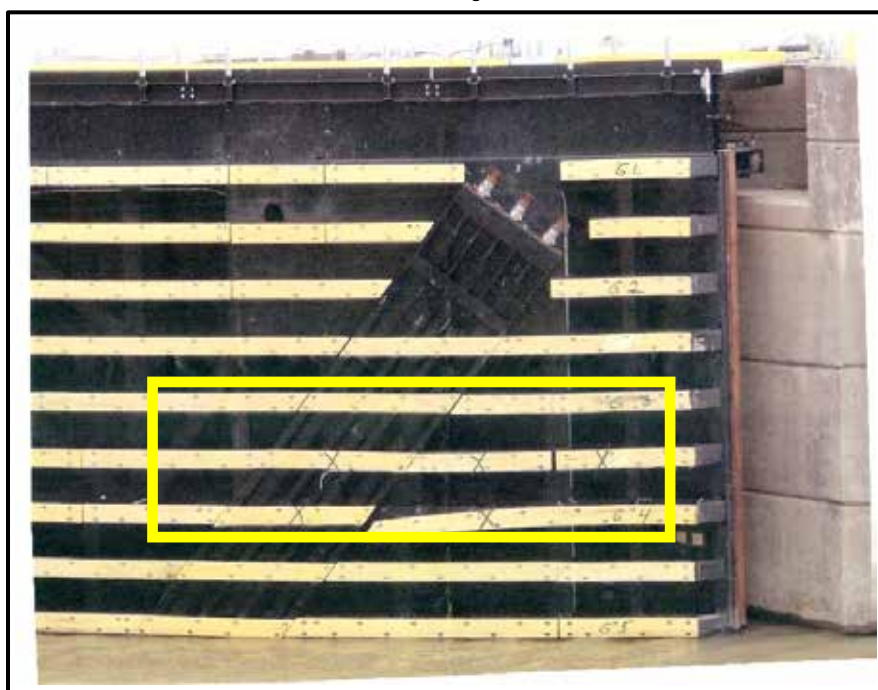
In early June 2014, a barge impacted the upstream miter gate in the main chamber at Greenup Locks and Dam (Figure B-1). It appeared that an approaching barge impacted the end fender guard transition pieces of the fender protection causing the plate to deform and welds to break (Figure 2-19 in Chapter 2 of this report). As the barge continued to rub down the side of the gate leaf, it caused the UHMWPE fender material to compress and severely damage or shear off the $\frac{3}{4}$ -in. machine bolts used to attach the fender material to the gate (Figure B-2). The yellow UHMW fender protection material was severely gouged in several areas and has splintered and flaked due to being compressed (Figure B-3). The $\frac{5}{8}$ -in. steel diagonal protection plate was bowed in three locations that span the steel channel sections (Figure B-4). The rubber backing to the yellow fender protection appeared to have performed appropriately and was intact.

Figure B-1. Greenup Lock and Dam, main chamber upstream river wall leaf, view of damaged area.

Huntington District structural engineers determined that the gate was not compromised due to the impact and recommended replacing the damaged fender material with the same yellow UHMWPE fender material as originally installed.

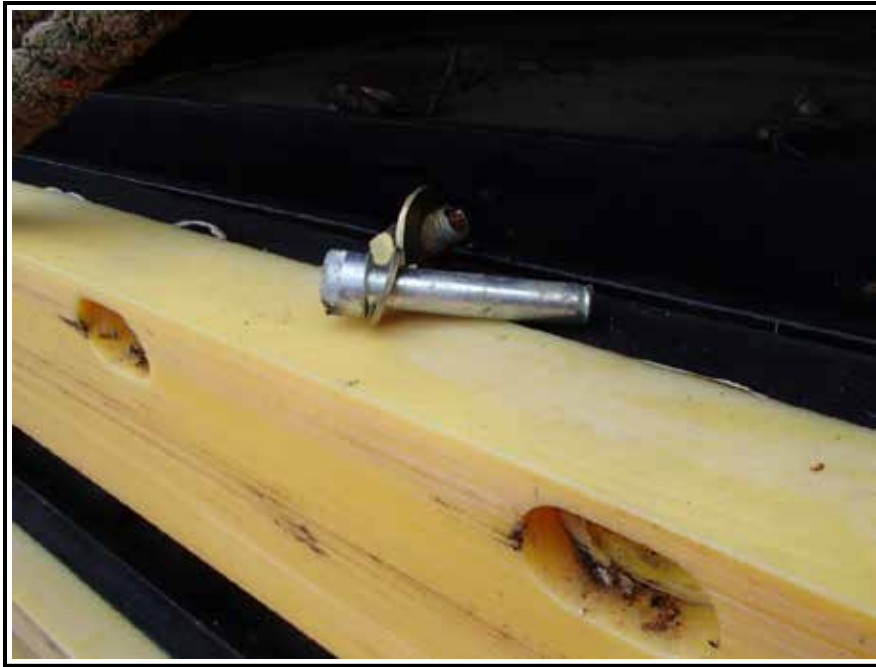
Figure B-2. Greenup Lock and Dam, main chamber upstream river wall leaf, view of sheared off machine bolt. Most bolts are bent or sheared off, but stayed in place.

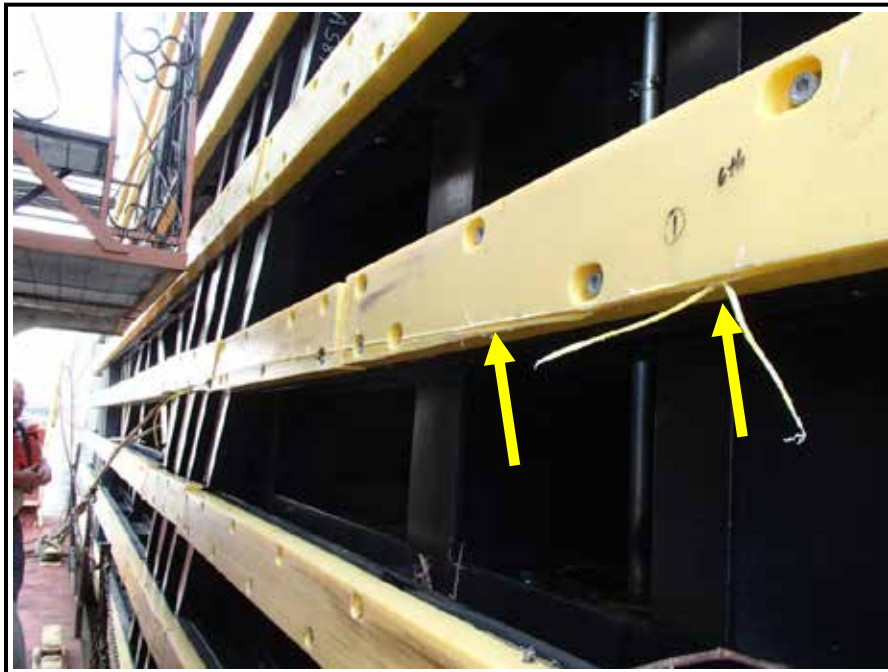
Figure B-3. View of gouges in UHMW fender.

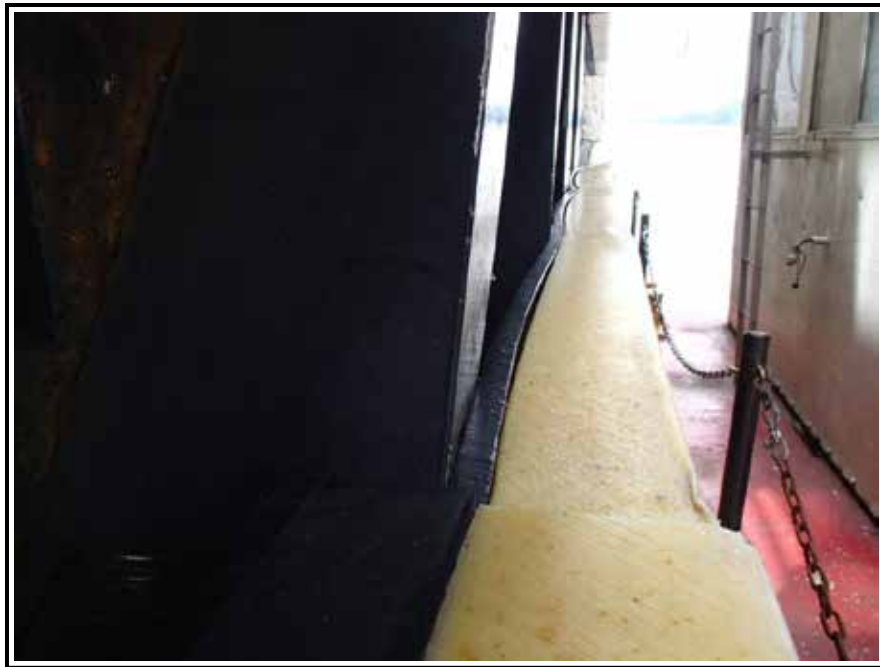
Figure B-4. Greenup Lock and Dam, main chamber upstream river wall leaf, view of bent protection plate over the diagonals.

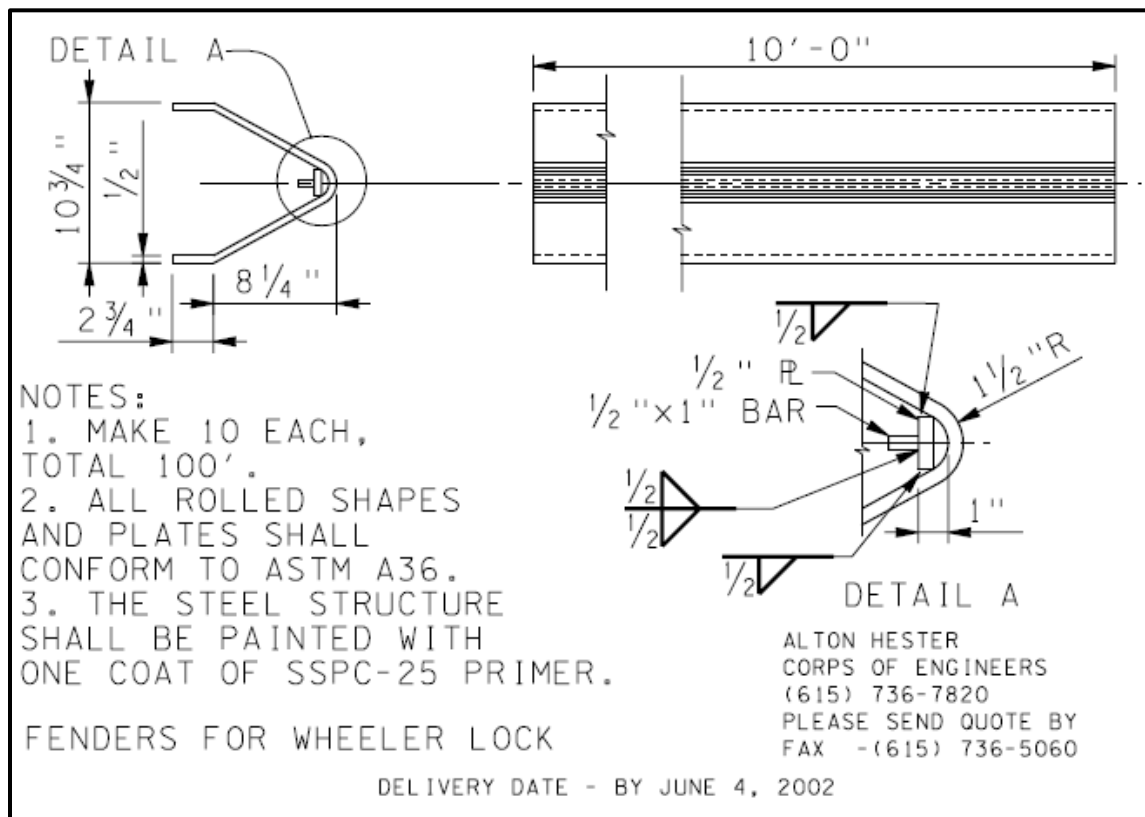
Figure C-1. Wilson L&D fender design.

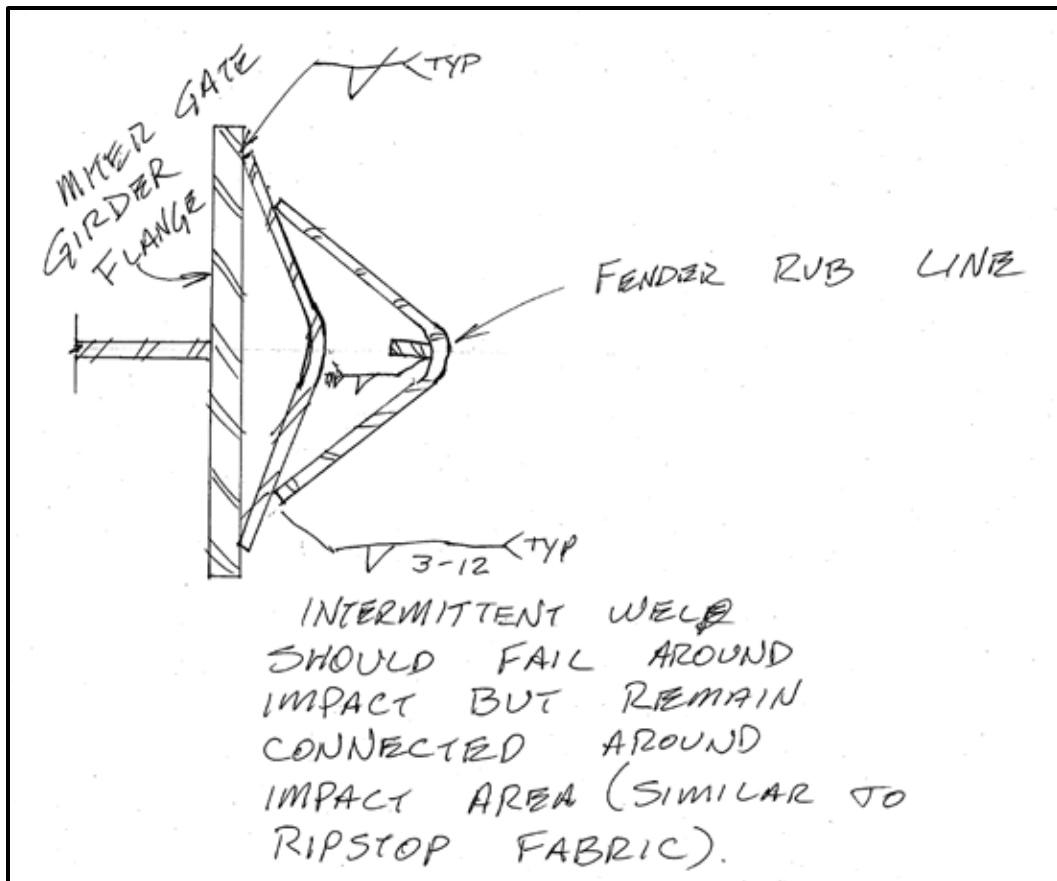
Figure C-2. Proposed CELRN fender design.
