Creating Nesting Habitat for the Common Tern (*Sterna hirundo*) on the Repaired Ashtabula Breakwater: Lessons Learned 2014 – 2016

By Michael P. Guilfoyle, Richard J. Ruby, Burton C. Suedel,
Thomas J. Fredette, Paul Bijhouwer, Andrew Hannes, Karen Adair,
Cynthia J. Banks, and Anthony M. Friona

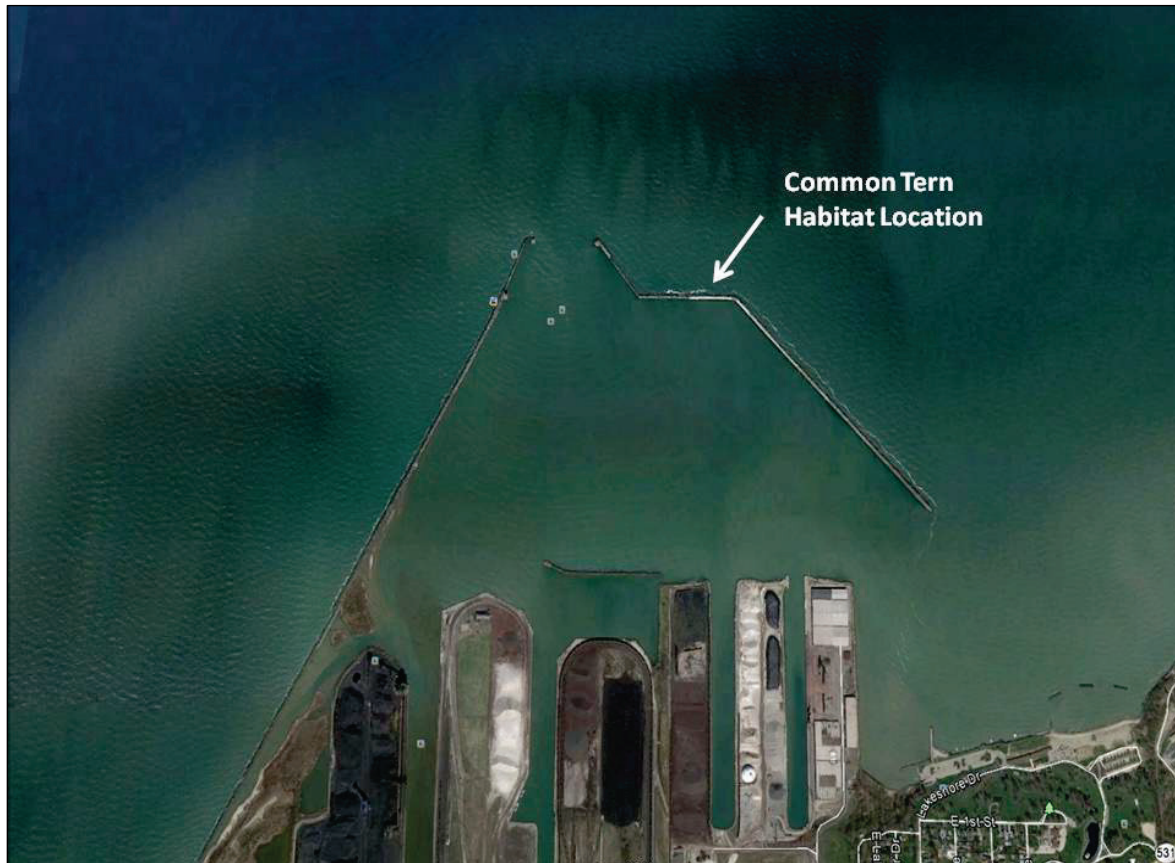
Figure 1. Location of the repaired breakwater in the Ashtabula Harbor, OH.

NESTING SITE DESIGN: Specific details on the breakwater nesting habitat design can be found in Fredette et al. (2016). Briefly, a major feature of the breakwater is that it is not connected to land (Figure 1), which greatly reduces access to the site by mammalian predators. The breakwater crest was repaired with a double row of pre-cast cement blocks laid end-to-end. There are two types of blocks: (1) a toe block (8 ft x 8 ft x 4 ft) used to anchor the base of the structure, and (2) modified blocks on top that have a 6 in. deep recess filled with gravel to serve as a suitable substrate for tern nesting (Figures 2 and 3). When completed, the blocks were placed end-to-end and side-to-side on the breakwater. Each eight-block section provides approximately 250 ft² of nesting area (Figure 3). Once the blocks were in place, fence posts were erected in pre-cast holes in the blocks. Cabling was attached to the posts along the sides and over the top of the nesting substrate to protect the habitat from avian predators. Metal-mesh side fencing was also placed around the bottom edge of the nesting structure to prevent mammals from accessing the site while also preventing young Common Terns from potentially falling (Figure 3).

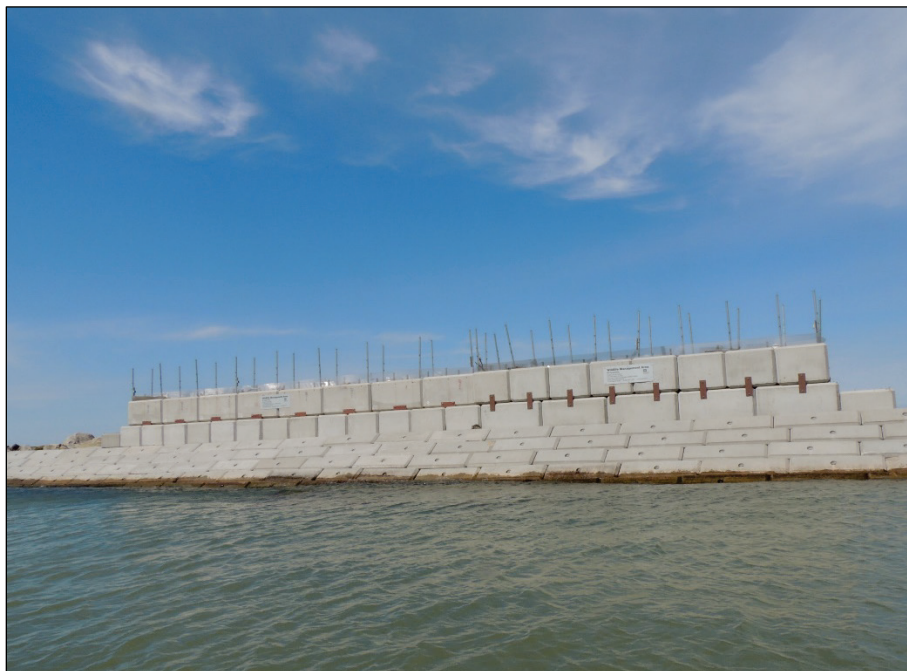
Figure 2. Blocks established on the Ashtabula breakwater were designed to create nesting habitat for the state-listed (Ohio) Common Tern (Photo Credit: Michael Guilfoyle, ERDC-EL).

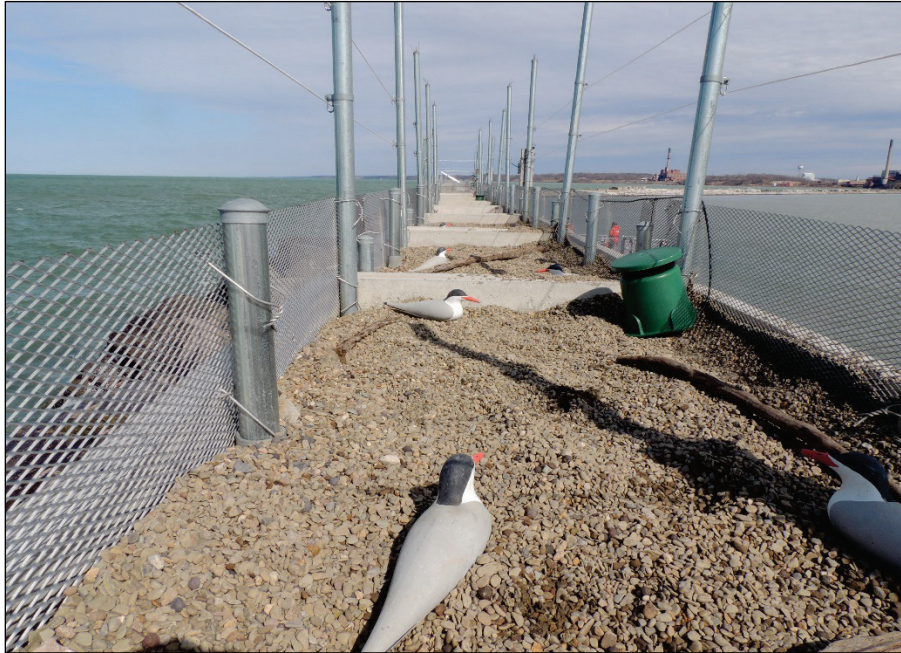
Figure 3. Nesting habitat created for the Common Tern on the repair breakwater in the Ashtabula Harbor (Photo Credit: Michael Guilfoyle, ERDC-EL).

FEATURES USED TO ATTRACT/PROTECT TERNS: Six to twelve wooden decoys were placed on the gravel substrate to attract birds (Figure 3), and two solar powered Murremaid® call boxes were used to broadcast calls during the day (Figure 4). Wooden covers and driftwood were added to provide cover and shield young Common Terns from exposure. Three to six motion-activated cameras were placed on the structure to visually capture use of the site by terns or other birds not detected during regularly scheduled manned surveys. In addition, cabling (5/32 in. PVC clothesline) along the sides and over the top of the nesting structure was used to deter avian predators, particularly gulls, from preying on eggs and chicks (Fredette et al. 2016). The cabling was spaced about 1.5 ft to 2.0 ft to provide access to the nesting substrate by terns; however, it was narrow enough to discourage or prevent gull access. In the initial construction of the site, ¼ in. to ½ in. #9 pea stone gravel was used as nesting substrate. However, these stones were washed away during winter months in 2014 and 2015. In April 2016, 2.5 in. to 3.0 in. of #3 gravel was used as a base layer and covered with ½ in. to ¾ in. #67 pea sized gravel. It is expected that the #3 gravel will remain in place during the winter months and that the #67 gravel will be more efficiently replaced, if needed.

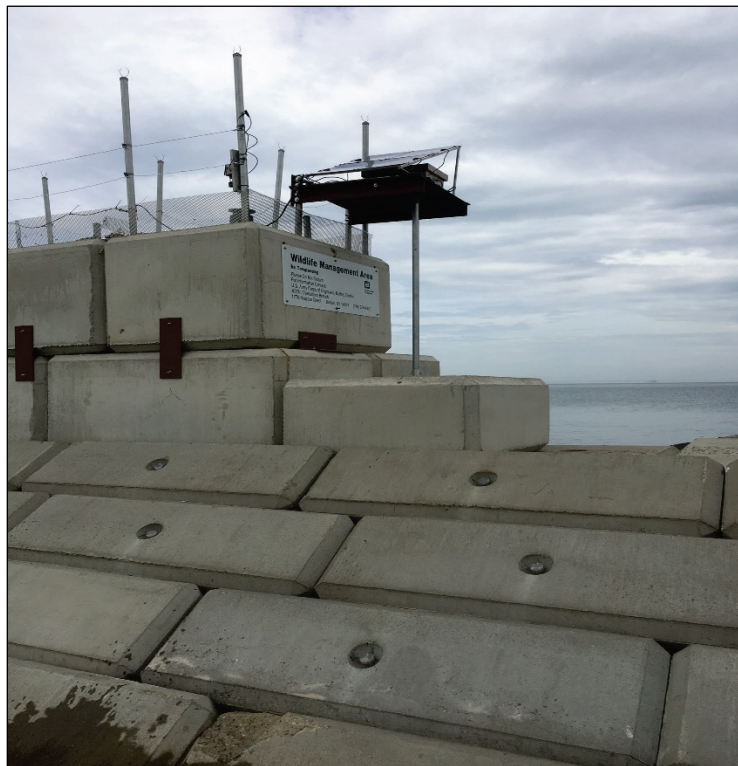
Figure 4. Murremaid® call boxes were placed on both ends of the repaired Ashtabula breakwater. In 2016, the call boxes were elevated above the structure to protect them from over washes during storms (Photo Credit: Michael Guilfoyle, ERDC-EL).

recharge the enclosed battery, the system was unable to restart the MP3 player once the battery power had been drained (e.g., during the night or during overcast periods). During the 2015 season, a newly purchased call box performed as designed until a storm in late May damaged both call boxes via wave action. As a result, for the remainder of the breeding season in 2015, no broadcast calls occurred. In late 2015, USACE Buffalo District purchased a new Murremaid® call box, and a second functioning call box was constructed by utilizing the parts from the two flooded call boxes. Therefore, two functioning call boxes were in operation in 2016. Moreover, the two call boxes were elevated above the nesting site (see Figure 4) to protect them from high water during any spring storms.

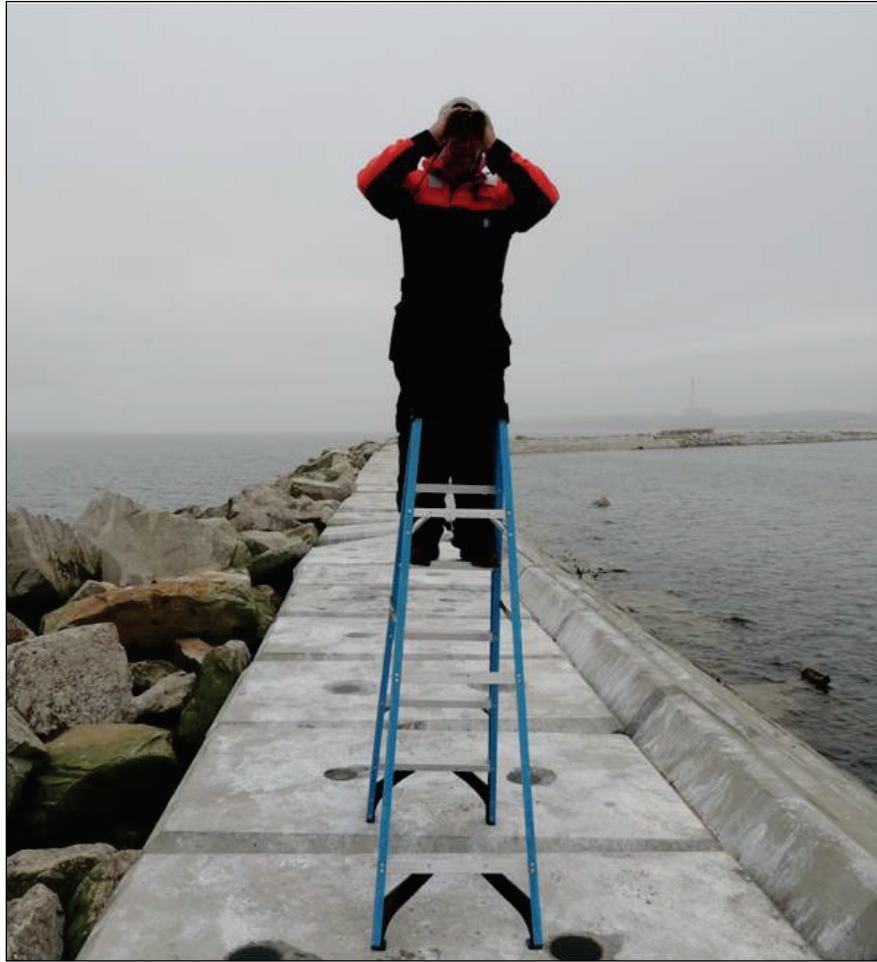
Figure 5. A 6-ft stepladder was used to observe any nesting terns at the created habitat on the Ashtabula repaired breakwater (Photo Credit: Michael Guilfoyle, ERDC-EL).

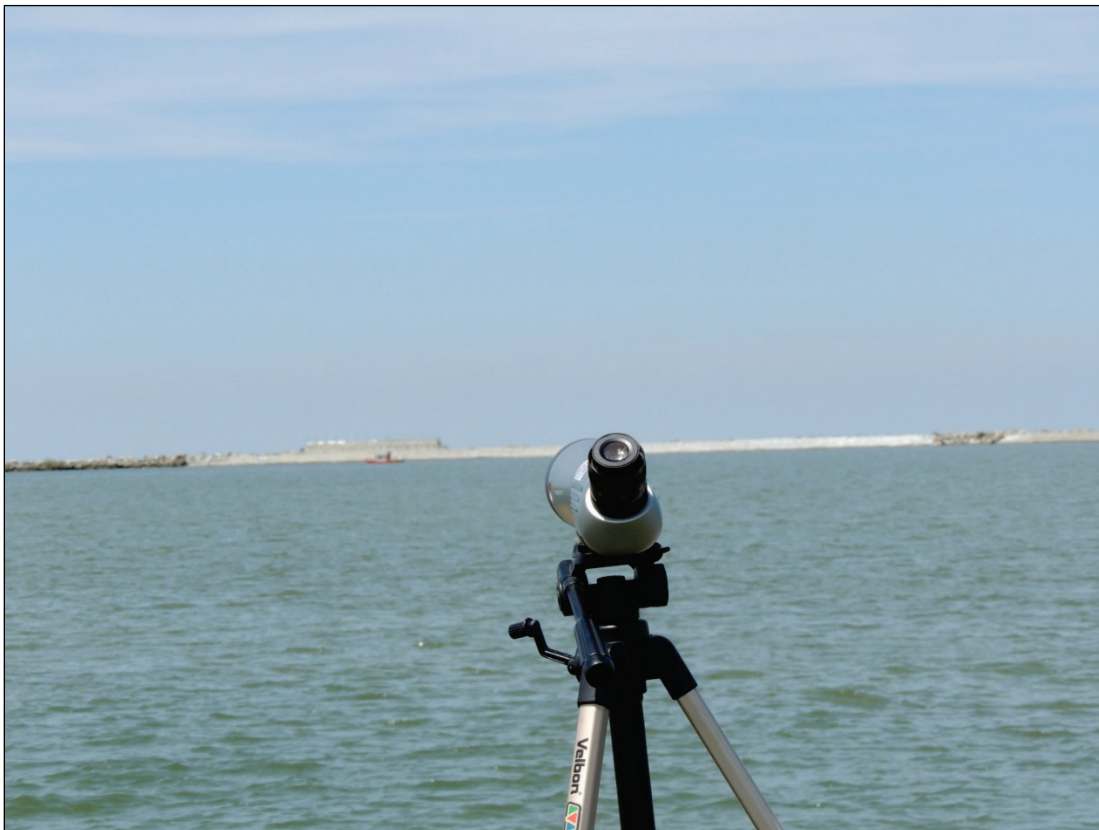
Figure 6. Placement of spotting scope on the Kinder-Morgan property with view of the restored Ashtabula breakwater for weekly spotting scope surveys and biweekly surveys on the breakwater (Photo Credit: Michael Guilfoyle, ERDC-EL).

Beginning in 2015, access to the property of Kinder-Morgan, Inc., a mining and energy infrastructure company with a base along the Ashtabula Harbor shoreline, provided a location with an excellent vantage point of the breakwater via a spotting scope (Leica® Televid 65 mm angled spotting scope) (Figure 6). From this vantage point, 30-minute counts were conducted in May and June of 2015 and 2016. The survey focused on the upper portion of the nesting area and any birds flying or landing within the scope's view were counted. The nesting area was also visually surveyed without a spotting scope to detect birds in the area that were not specifically in the scope's view. As with the 10-minute surveys on the breakwater, the spotting scope surveys would also record all birds utilizing the adjacent breakwaters, open water habitat, and any flyovers in the vicinity of the breakwater.

At the Ashtabula nesting site, several factors may have prevented documenting the presence of terns. During the 2014 and 2015 seasons, repeated boat repairs reduced the monitoring conducted. Several opportunities to conduct surveys in 2014 were lost because of adverse lake conditions. This problem was remedied in 2015 when access to the Kinder-Morgan, Inc. property was obtained, which created a vantage point to observe the Ashtabula breakwater (see Figure 6). The procurement of a more reliable boat during the 2016 season aided monitoring efforts that year.

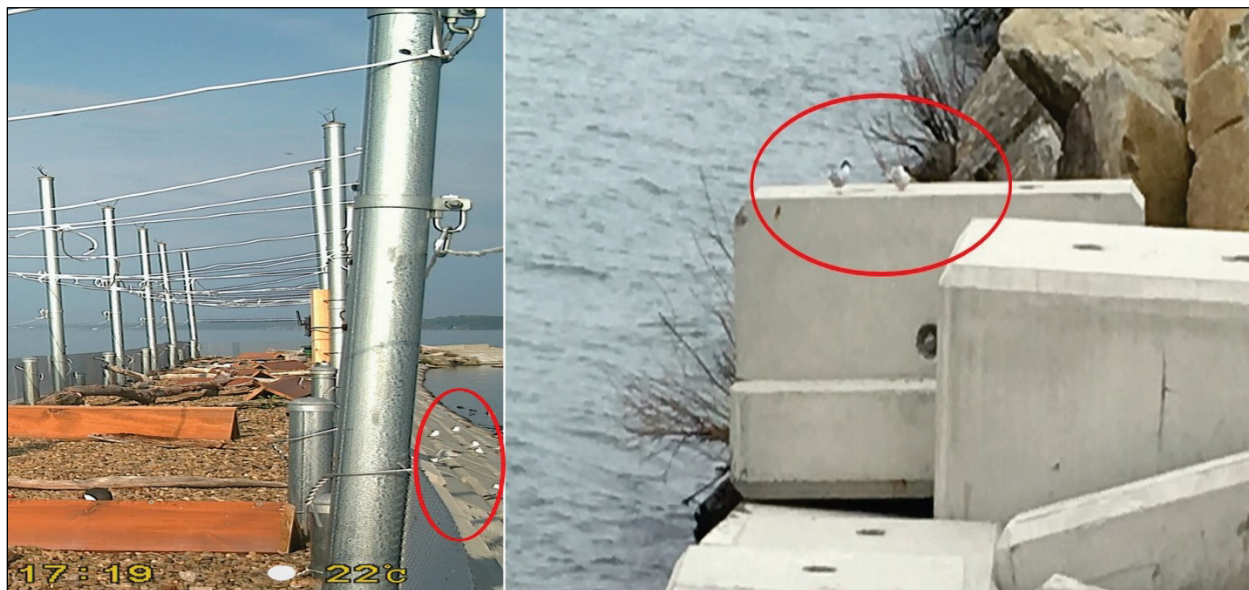
Figure 8. Common Terns were observed visiting the Ashtabula breakwater in June 2014 (left: picture from motion-activated camera) and in April 2016 (right: Photo Credit: Richard Ruby, USACE).
