## **Physical Model Analysis of the Foster Joseph Sayers Dam**

Ben Burnham, Marshall Thomas, and Jane Vaughan

December 2018

Under Project no. 122098, "Stilling Basin—Stilling Basin Study/Repair"

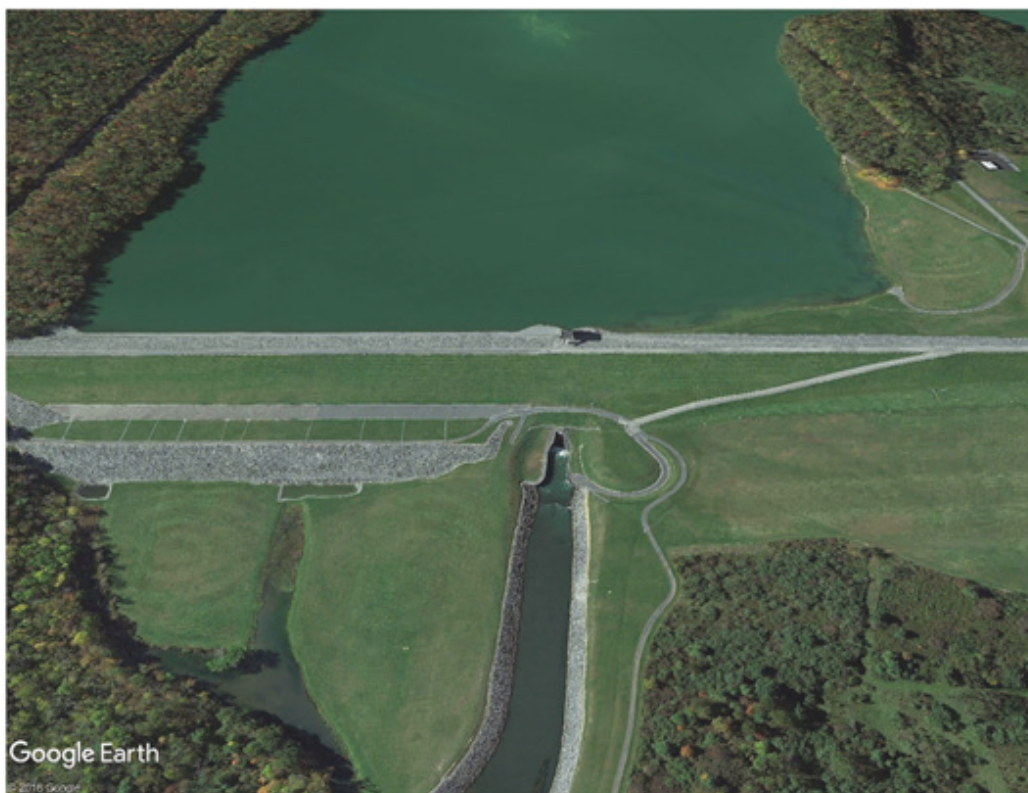
Figure 1. Photograph of Foster Joseph Sayers Dam and Outlet Works (Google Earth).

Foster Joseph Sayers Dam (Figure 1) is located on Bald Eagle Creek approximately 1 mile downstream of Blanchard, PA, and 3.5 miles upstream of Howard, PA, as can be viewed in Figure 2. Forming Foster Joseph Sayers Reservoir, the dam has a storage capacity of 99,000 acre-feet at spillway crest, a reservoir surface area of 1,730 acres at summer conservation pool elevation, a length of approximately 6,835 feet (ft), a height of approximately 93 ft, and a normal summer and winter pool elevation of 630 ft and 610 ft, respectively. The dam has a crest elevation of 683.0 ft and a maximum pool elevation at design surcharge of 677.8 ft<sup>1</sup>. Sayers Dam is owned and operated by the U.S. Army Corps of Engineers (USACE), Baltimore District (NAB).

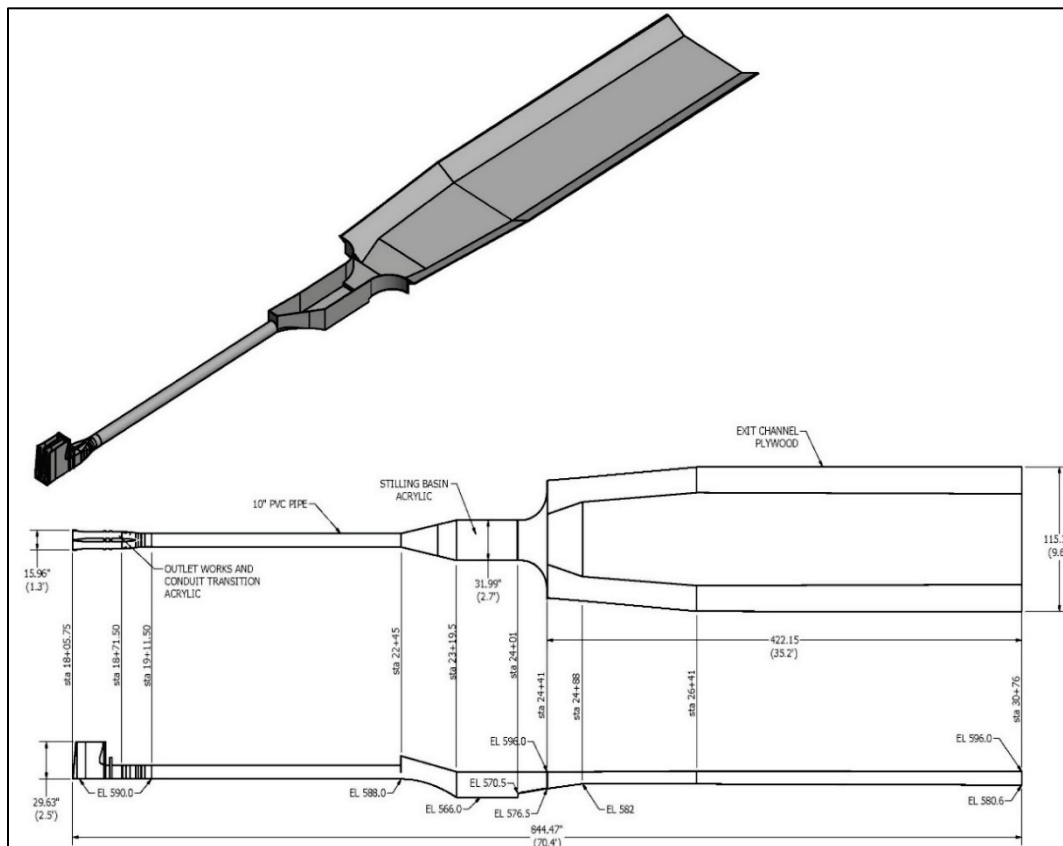
Figure 3. Schematic of model outlet works.

The physical model contains all the projects' hydraulic features affecting flow in the stilling basin. This consists of the upper reservoir with the upper approach channel, the gate structure with two independently operated lift gates, 15 ft diameter culvert, the stilling basin, and an exit channel. Upstream of the upper reservoir, the model connects to existing pipe, which supplies water to the model. Downstream of the exit channel, the model connects to a flume that directs the flow to a drain. Schematics of the physical model are shown in Figure 3 and Figure 4. Photographs of the physical model are shown in Figure 5 to Figure 9.

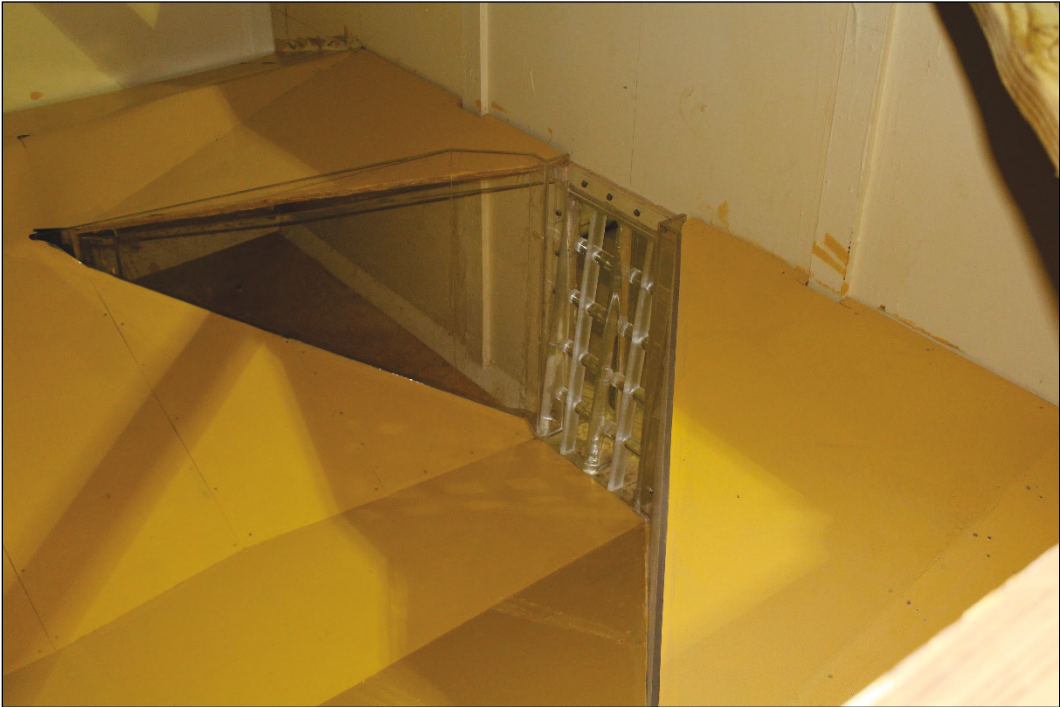
Figure 8. View looking upstream of exit of culvert and trajectory fillets.

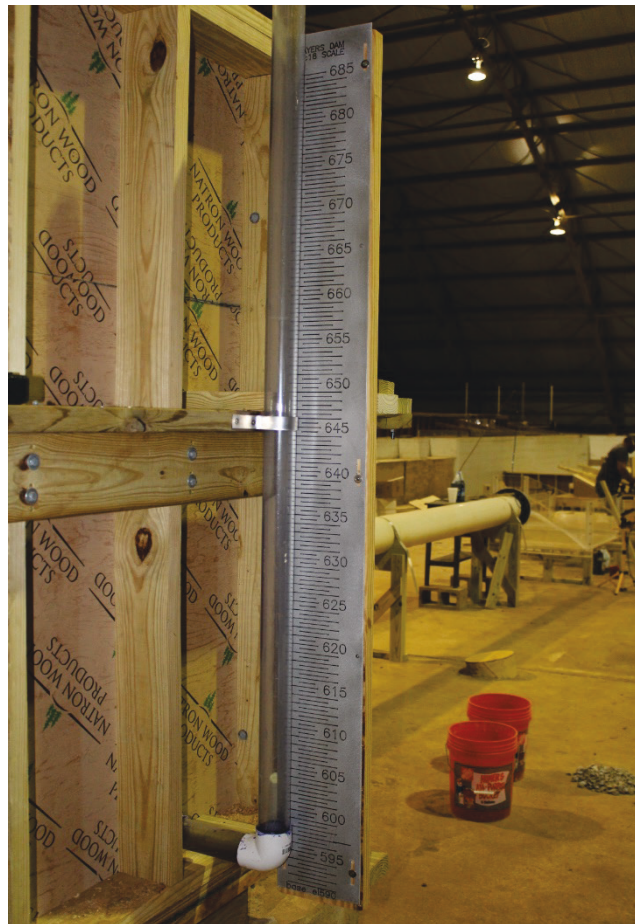
Figure 10. Elevation marker – head bay.

Elevation markers on the head bay and exit channel of the model were used to identify water-surface elevations. The elevation markers used can be seen in Figure 10 and Figure 11. A point gage was also used on the exit channel and can be seen in Figure 12 and Figure 13.

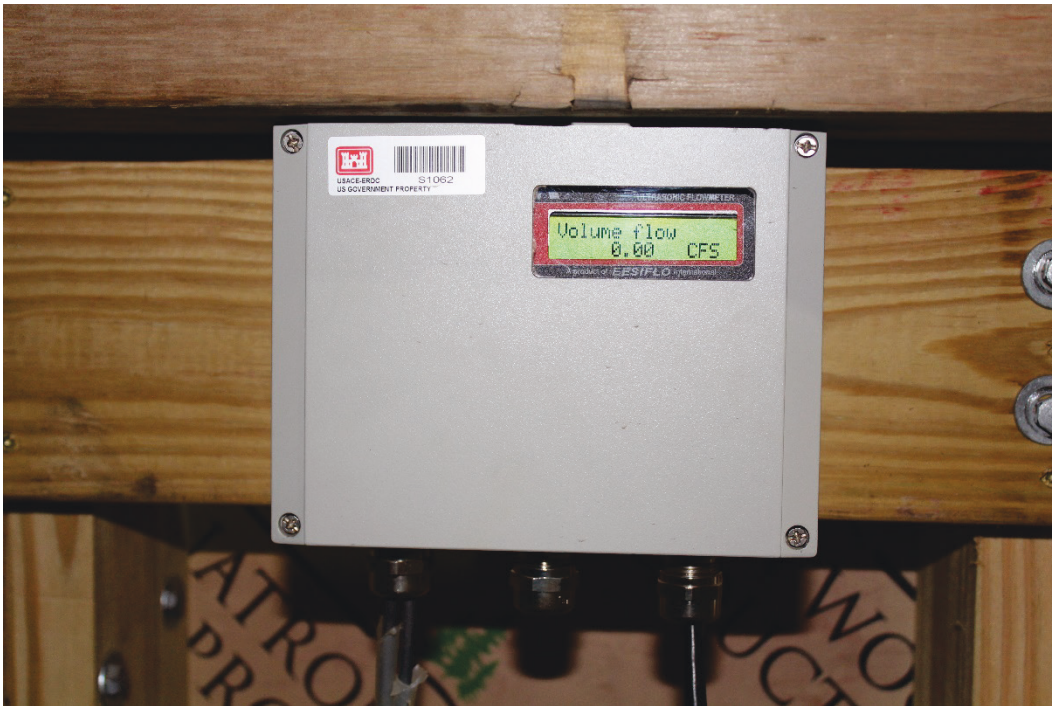
Figure 14. Ultrasonic flowmeter.

The flow rate through the model was measured by an ultrasonic flowmeter as shown in Figure 14. This flowmeter measures the flow rate using ultrasonic transducers to measure the transit time of ultrasonic pulses into and against the direction of flow. This time difference is directly related to the average velocity of the flow. The analog output of the flowmeter was sampled at 50 hertz to align with the other time-dependent measurements recorded during all experiments.

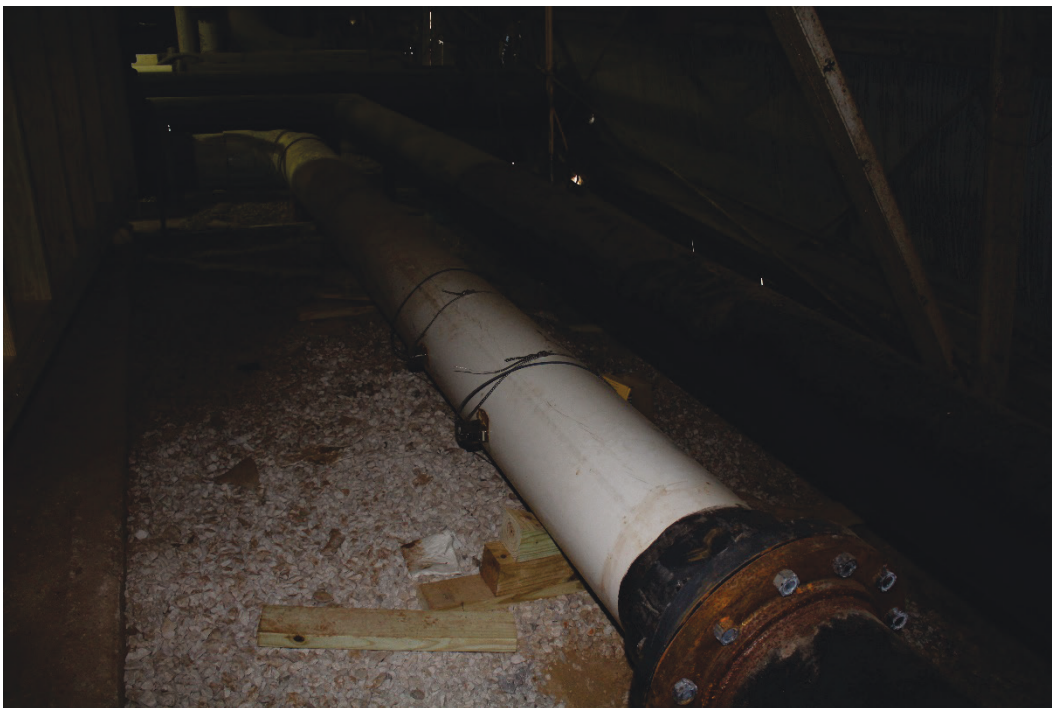
Figure 15. Ultrasonic flowmeter sensors location.

The flow rate sensors were located on the supply pipe to the physical model behind the head bay. Per the manual of the flowmeter, the sensors had to be at least 10 ft from a 90-degree elbow of the supply pipe and located in a straight section of the supply pipe. Sensors for the flowmeter are shown in Figure 15.

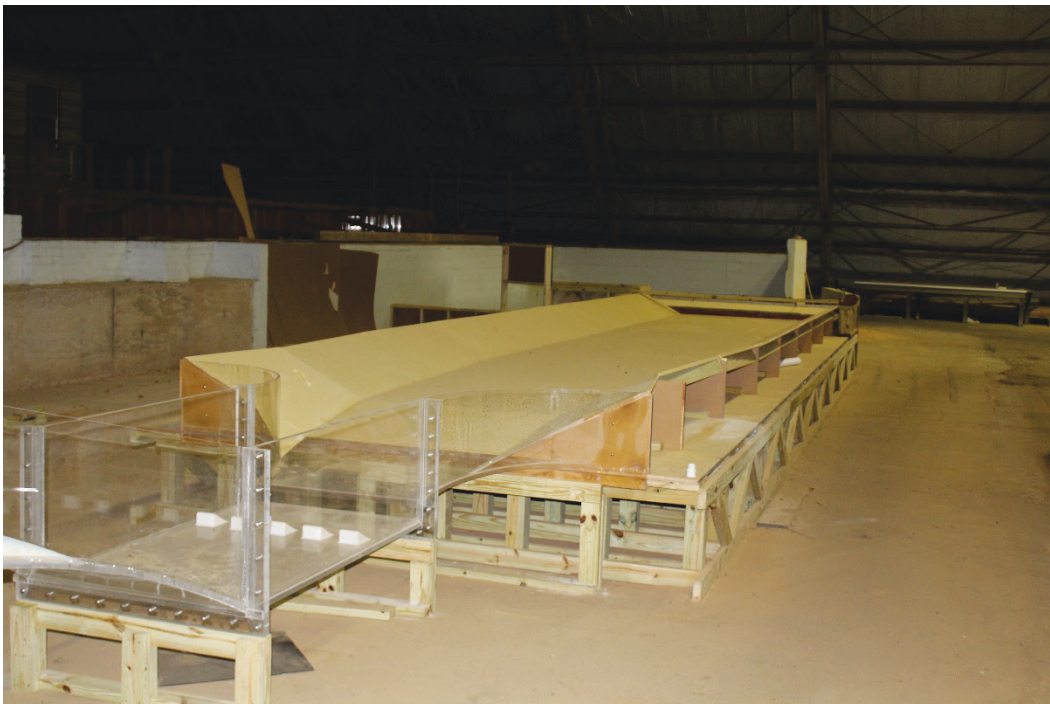
Figure 16. View looking downstream of exit channel constructed of marine grade plywood.

The first set of tests was completed with the exit channel reproduced with marine grade plywood to represent a fixed bed. An example of the exit channel conditions described can be seen in Figure 16.

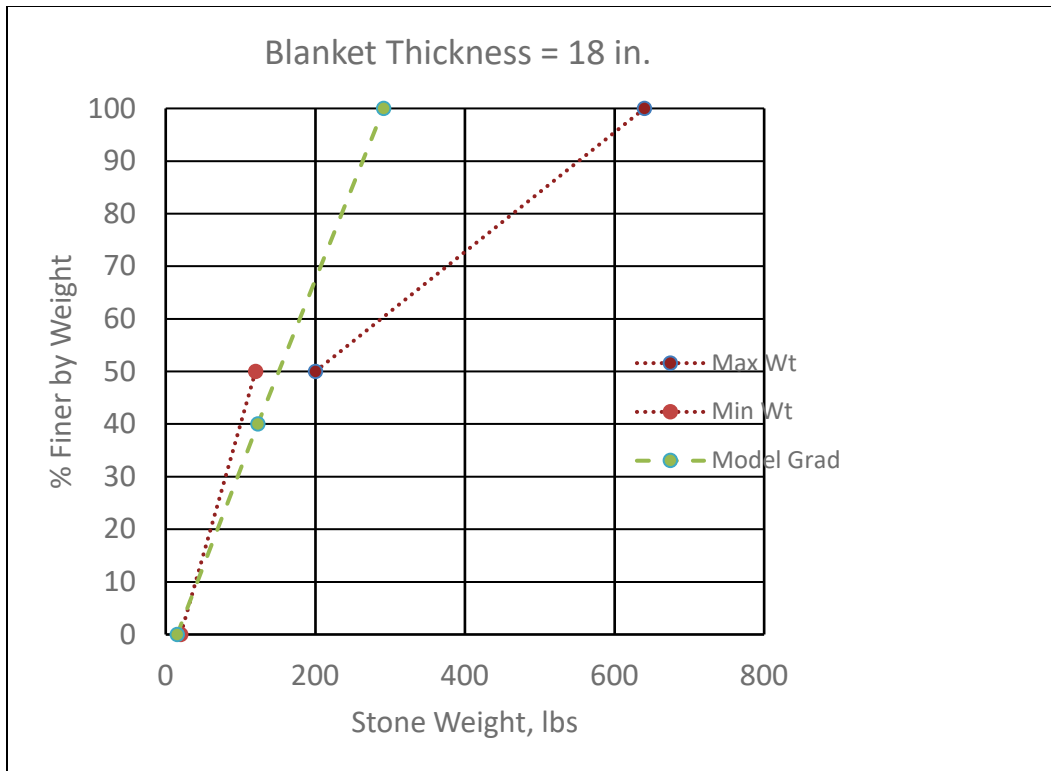
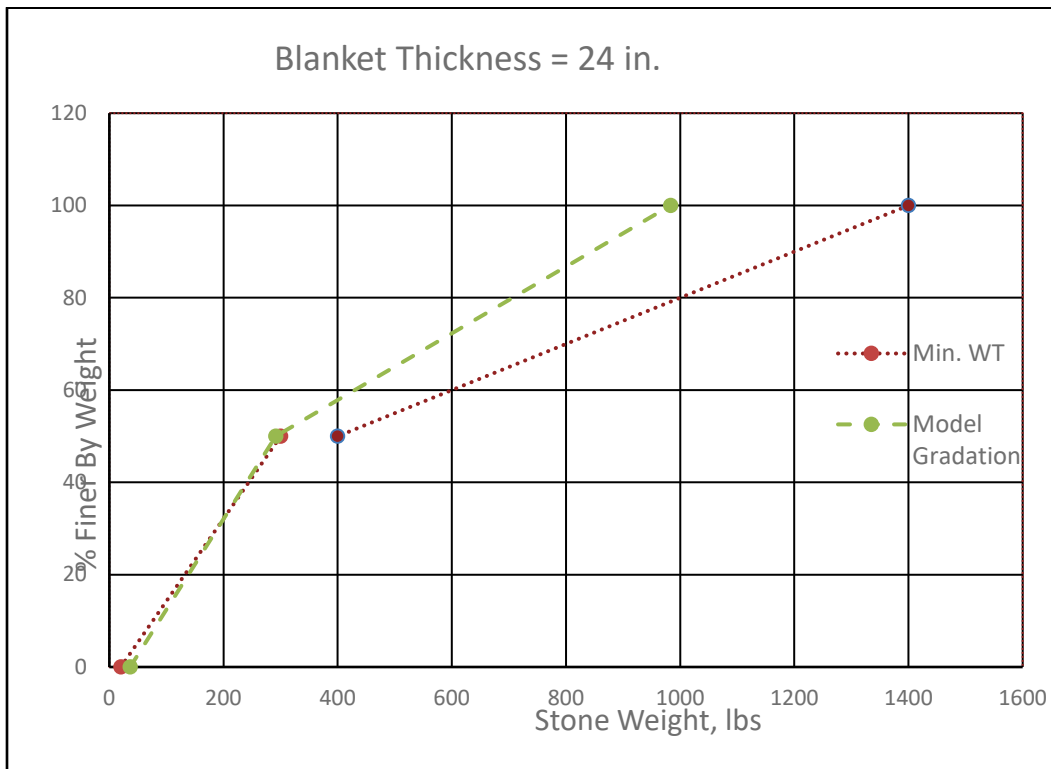
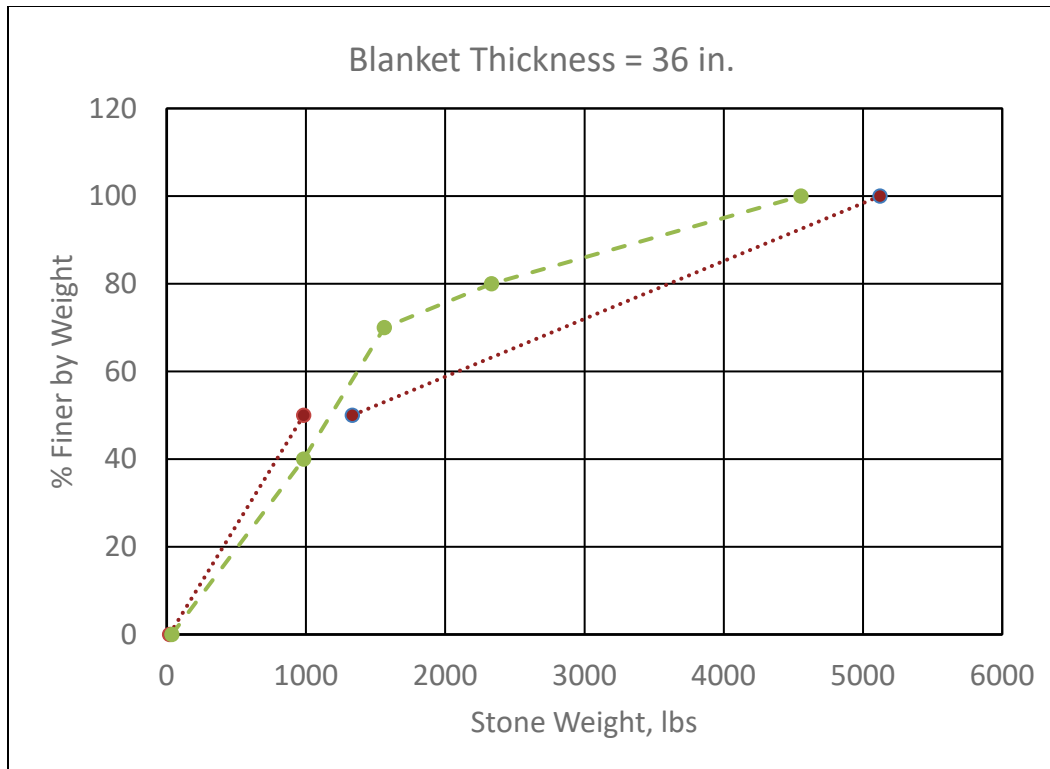
Figure 17. 18 in. blanket thickness gradation.

The gradations used for the initial tests are shown in Figure 17 to Figure 19. The gradation for the 18 in. blanket thickness consisted of a mixture containing 40% stones weighing 15.4 to 123 lb (7.4 to 13.5 in.) and 60% stones weighing 123 to 291 lb (13.5 to 18 in.). The gradation for the 36 in. blanket thickness consisted of a mixture containing 40% stones weighing 36.4 to 983 lb (9 to 27 in.), 30% stones weighing 983 to 1,562 lb (27 to 31.5 in.), 10% stones weighing 1,562 to 2,331 lb (31.5 to 36 in.), and 20% stones weighing 2,331 to 4,553 lb (36 to 45 in.).

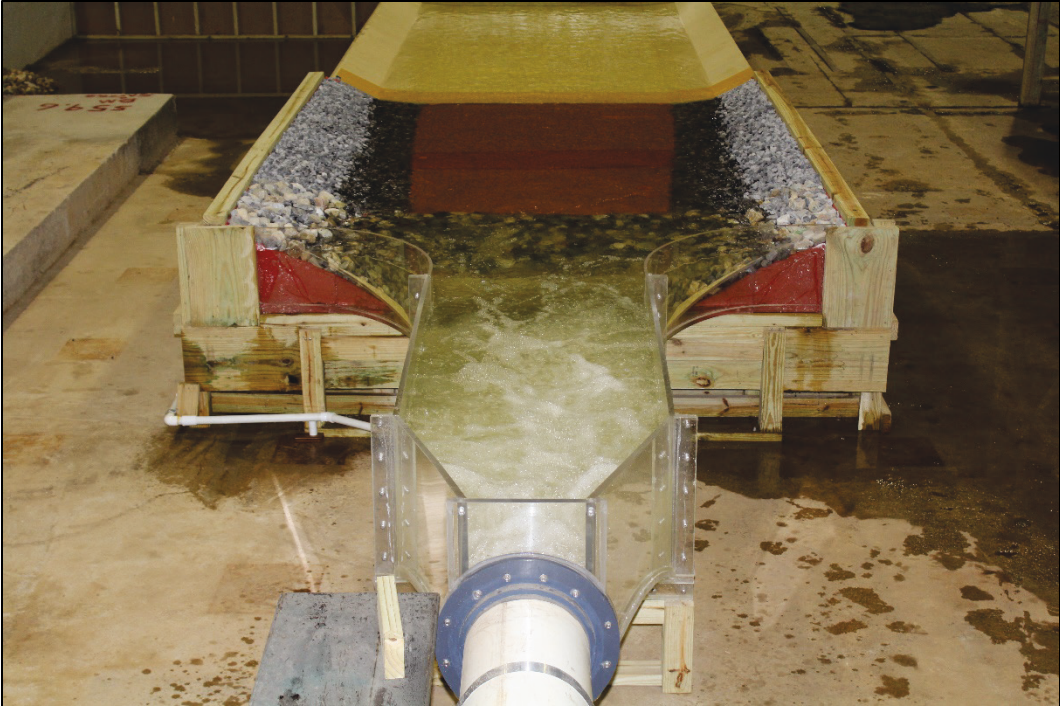
Figure 20. Movable bed exit channel with a discharge of 2,000 cfs.

Tests resumed once the 36 in. riprap blanket thickness and 18 in. riprap blanket thickness were installed in the exit channel. A 200 ft length of the exit channel was converted to a movable bed configuration. This configuration can be seen in Figure 20 and Figure 21. The 36 in. riprap blanket thickness was installed in the model for 60 ft down from the stilling basin on the side and bottom of the exit channel as the construction drawings portray. Downstream of this section, the 18 in. riprap blanket thickness was installed only on the sides, again following the construction drawings. Table 5 lists the tests that were completed using the 36 in. riprap blanket thickness. For all tests, the water was never turbulent enough for riprap to be entrained and moved upstream into the stilling basin.

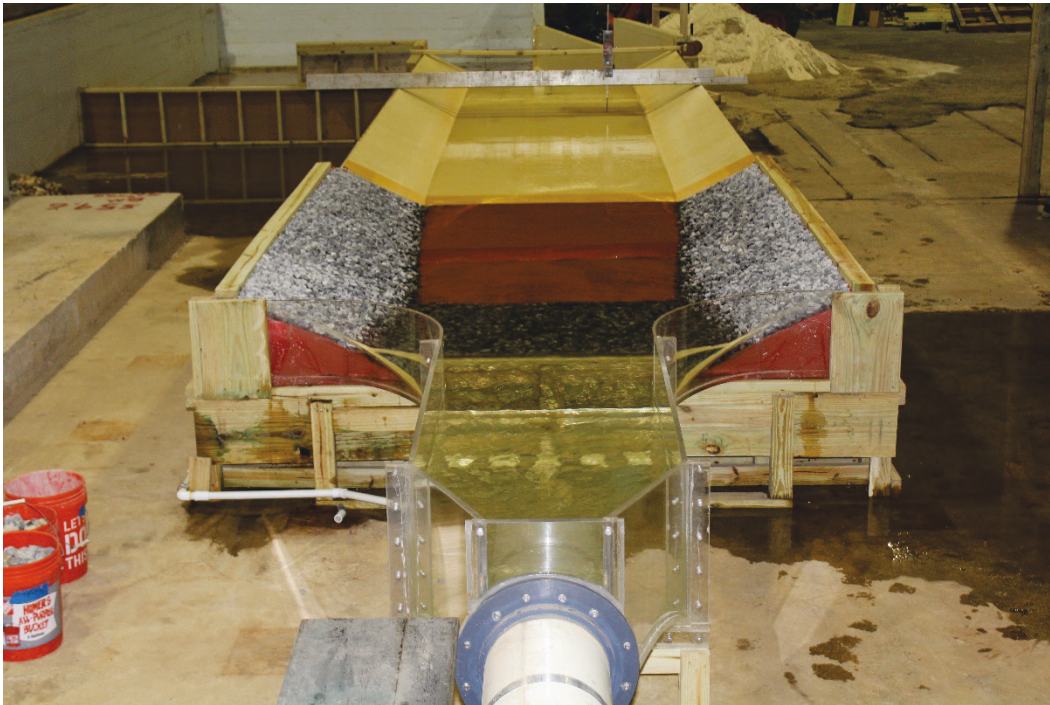
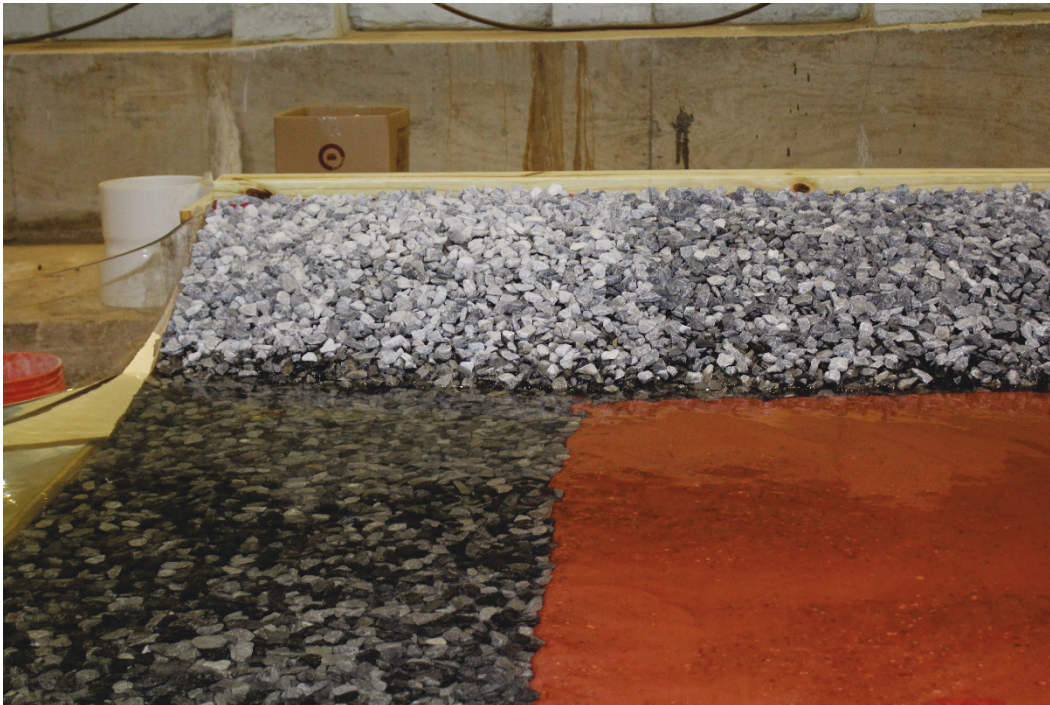
Figure 22. 36 in. blanket thickness replaced with 18 in. blanket thickness looking downstream.

A  $W_{50}$  minimum of 96 lb was computed. Using the tables (HQUSACE 1994), a 21 in. to 24 in. riprap blanket thickness could be used. Since this thickness was close to the gradation used for the 18 in. blanket thickness, the 36 in. blanket thickness was replaced with the 18 in. riprap blanket thickness. The premise being if this riprap did not move during the tests, the existing 36 in. blanket thickness at the project would not move. Also, the specifications for the 18 in. blanket thickness riprap was provided by NAB. Figure 22 and Figure 23 show where the 36 in. blanket thickness zone was replaced with 18 in. blanket thickness.

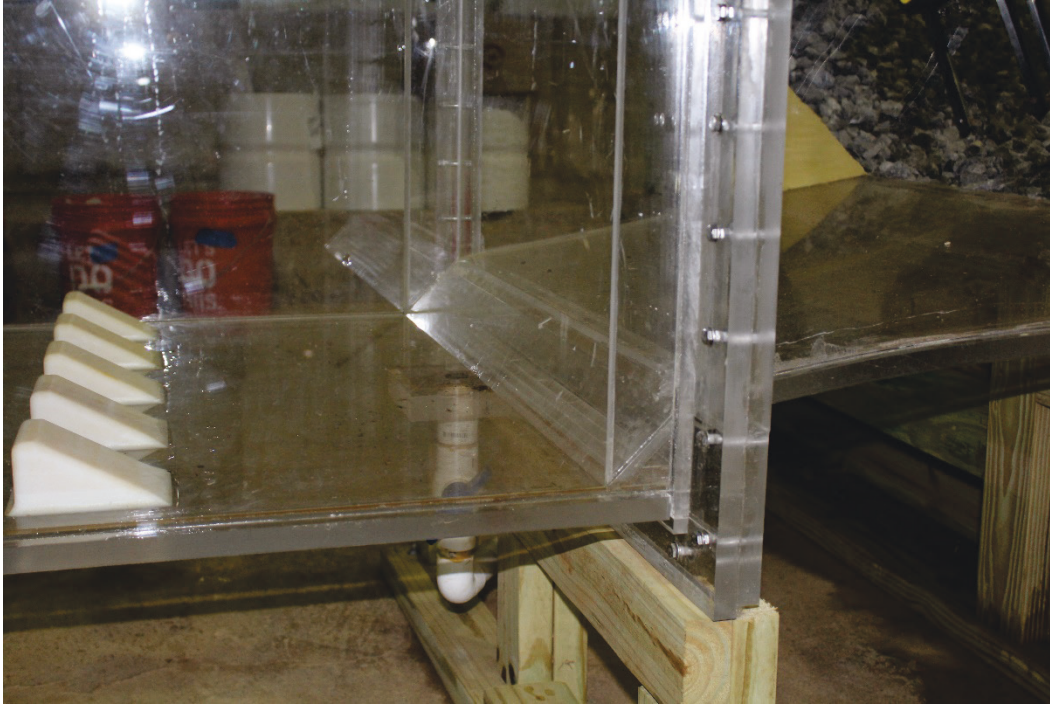
Figure 24. High-slope 45-degree fillet added at the end sill in the stilling basin.

A 45-degree fillet made of acrylic was added to the front of the end sill shown in Figure 24 to determine if rock could be flushed from the stilling basin with a lower flow (<2,000 cfs). Rocks ranging from three-eighths in. to 1.0 in. in diameter were added in the bottom of the stilling basin. A few small rocks were flushed out of the basin with a discharge of 3,000 cfs. After the small rocks were replaced in the basin, the small rocks would again be flushed out. However, larger rock would remain in the stilling basin with a 3,000 cfs flow.

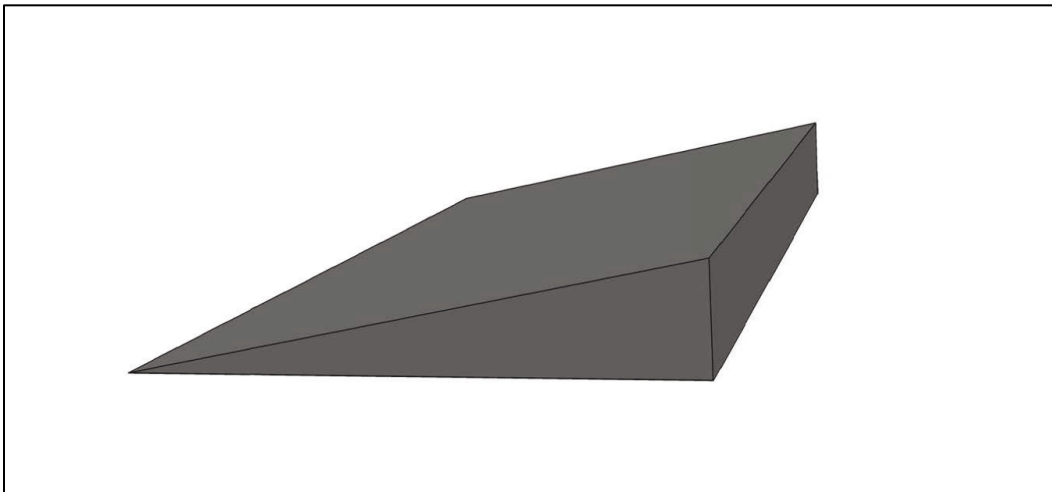
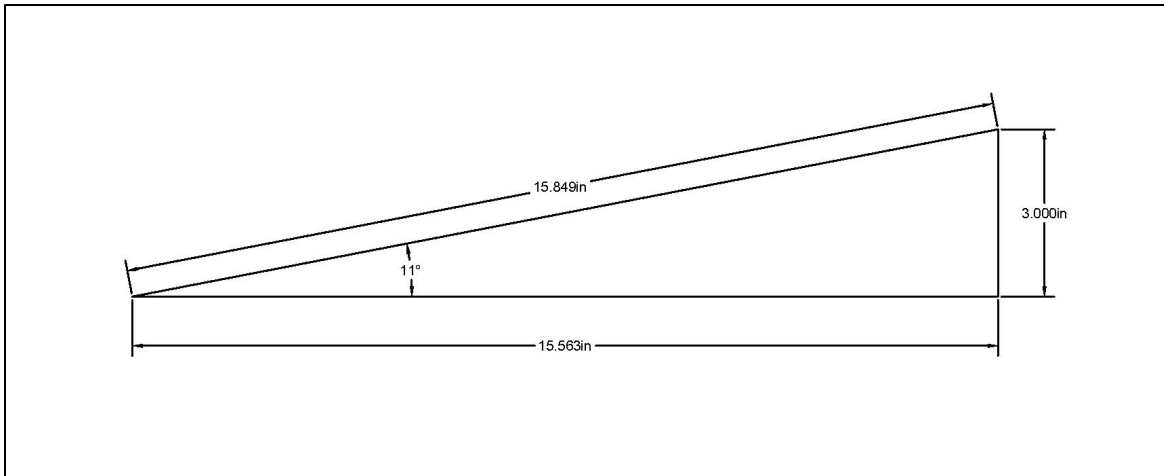
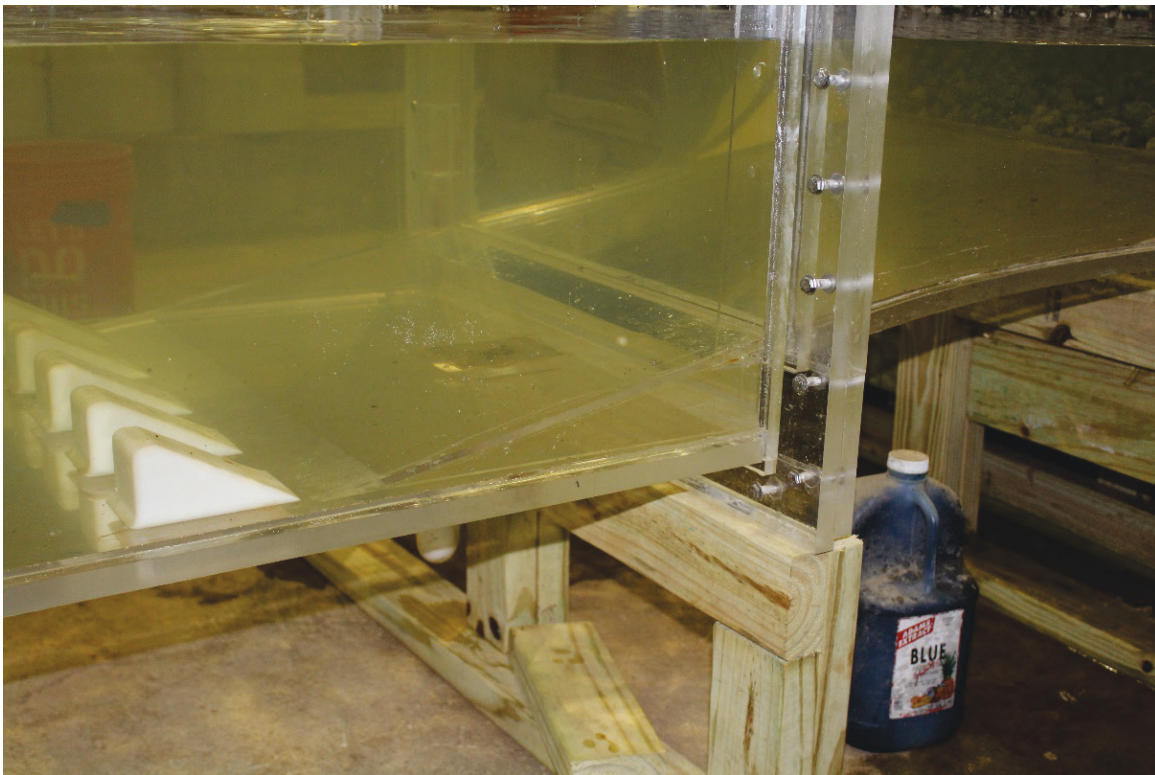
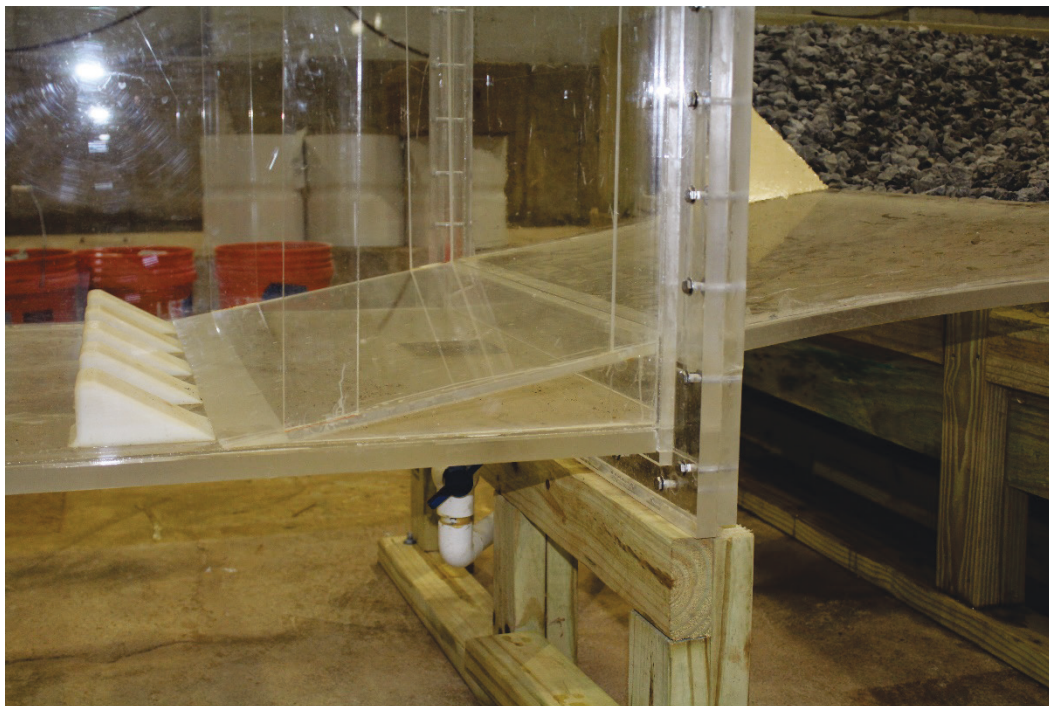
Figure 25. 3D CAD drawing of fillet added in stilling basin.

Another fillet design with a slope similar to the slope of the apron was installed in front of the end sill in the stilling basin and can be seen in Figure 25 to Figure 28. This particular design was approached since the 45-degree fillet previously tested did help to flush out small rock, but the larger rock did not flush out at a flow that was acceptable for the project to do on a periodic basis. The upstream toe of this fillet began at the downstream edge of the baffle blocks and terminated at the top of the end sill.

This particular fillet insert flushes rock out of the stilling basin at lower flows well. The rocks placed in the basin were three-eighths in. to 1.0 in. diameter, which were equivalent to 6.75 in. to 18 in. stone at the project. For Test 127, with a 1,500 cfs flow, rock moved downstream onto the concrete apron, indicating with a flow of 1,500 cfs, rocks would be able to flush out of the basin. Therefore, a sizable rock would be flushed with a flow as low as 1,500 cfs. With a flow of 2,000 cfs in Test 128, all of the rocks placed in the basin were flushed out of the basin and downstream to the end of the concrete apron. Test 130 with a flow of 3,000 cfs flushed all rocks out of the basin. Also during Test 130, very large rock of 2 in. in diameter placed in the stilling basin was flushed to the concrete apron area, and it slowly moved up the apron toward the riprap exit channel. For reference, 2 in. rock in the model would equate to 36 in. rock at the project.

Another observation made during the test with the low-slope fillet installed was the turbulence with low flows in the stilling basin was noticeably less than without the fillet piece. This concludes that with the low-slope fillet in, if rock were placed or pulled into the basin, it would not swirl around on the bottom of the basin causing concrete degradation at a

Of all the design changes tested, the best design change to add into the stilling basin is the low-slope fillet in front of the end sill. This provided the best results for riprap that is entrapped in the basin to be flushed at flows that the project releases annually. Since a design to repair the stilling basin exists, incorporating the design of the low-slope fillet into that design would be advantageous to reduce design and construction costs.

- The primary recommendation by ERDC is to design and construct a low-slope fillet to be placed immediately upstream of the end sill while repairing the remainder of the stilling basin. This would allow riprap that is entrapped within the stilling basin to be flushed at flows

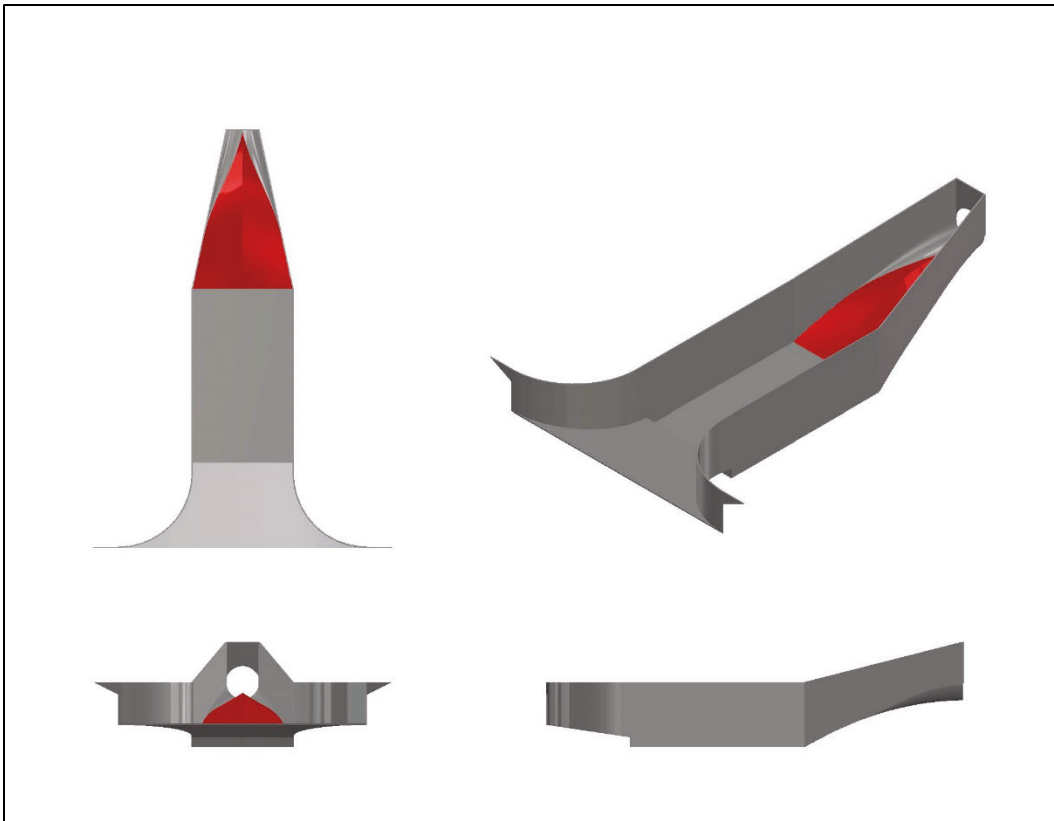
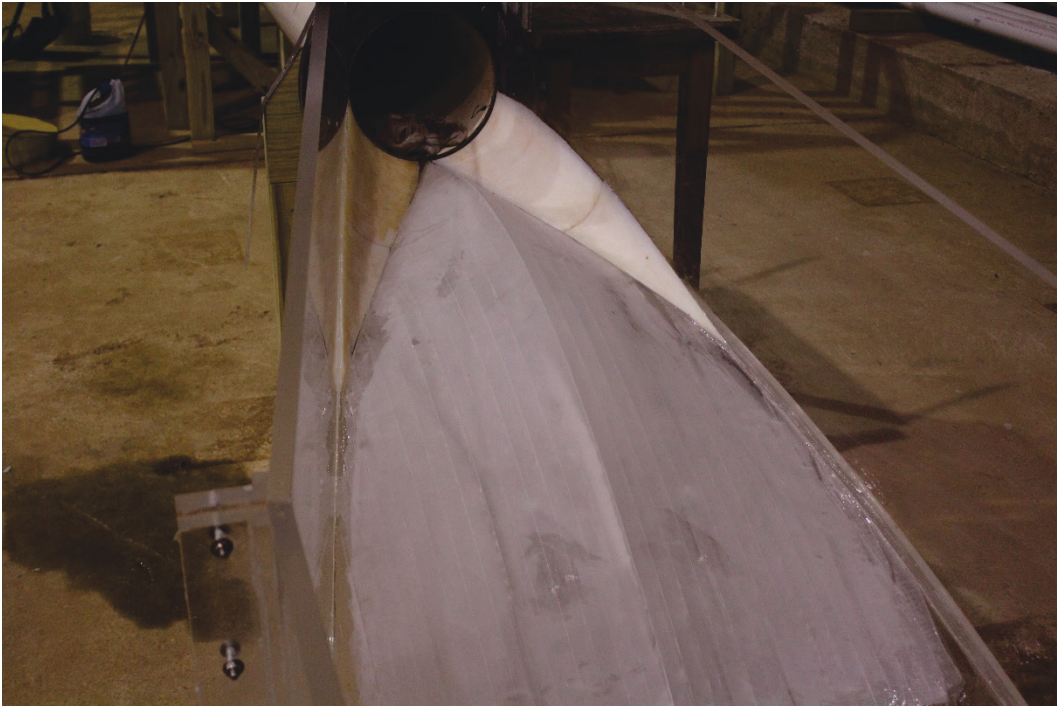
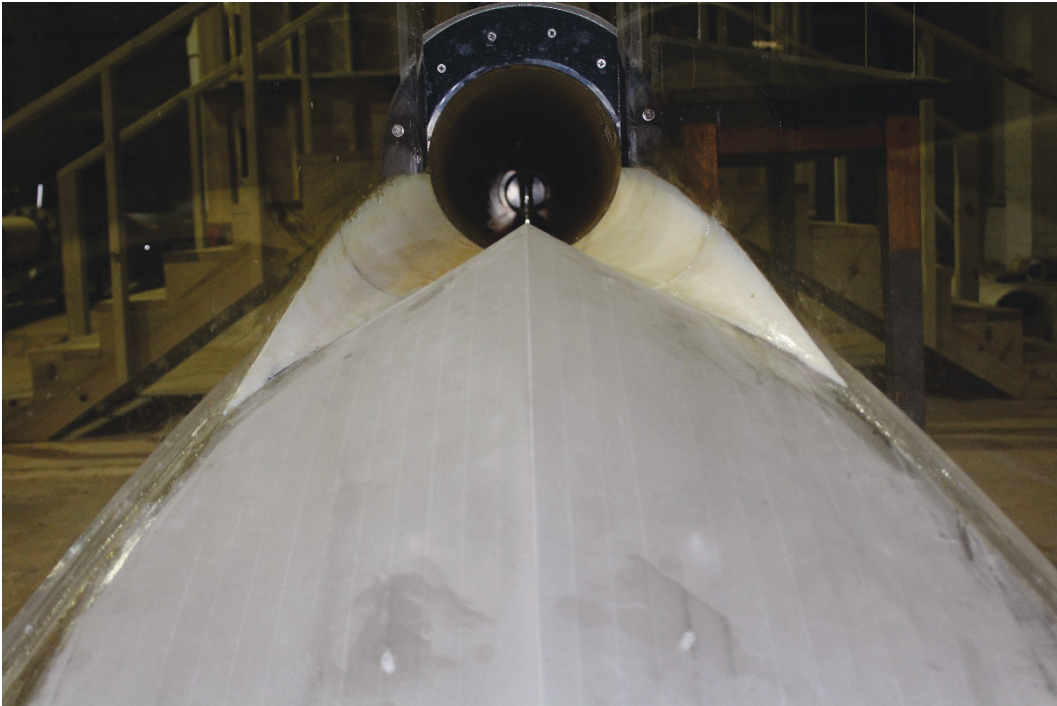
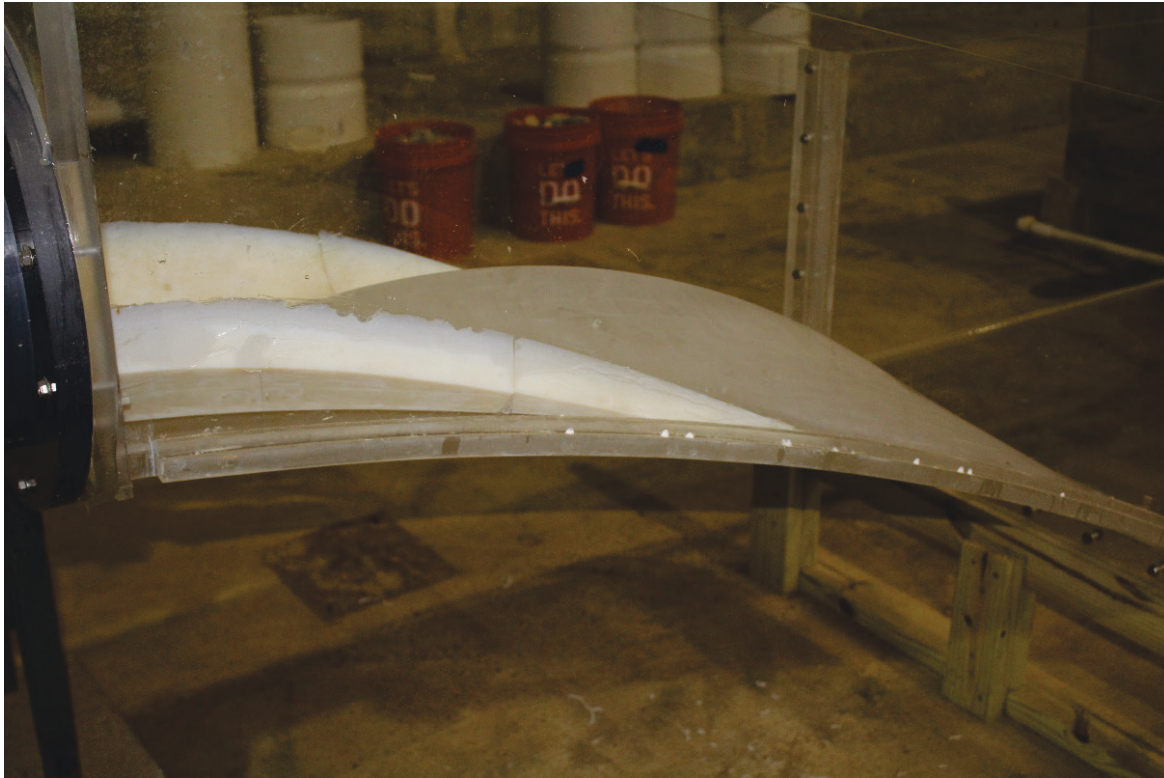
Figure 29. CAD drawings of the inverted V added to the parabolic trajectory.

A condition described in Section 3.1.2, the flow in previous tests indicated the flow exiting the culvert would oscillate from one side of the stilling basin to the other, which causes large horizontal eddies with flows at or below 2,000 cfs. The inverted V is designed to divide the flow exiting the culvert evenly and direct it down both sides of the stilling basin. The intent is to prevent horizontal eddies from forming and ensure the flow is uniform within the stilling basin. Dry bed views of the inverted V installed in the basin are shown in Figure 29 to Figure 32.

An inverted V was installed on the parabolic drop to distribute the flow exiting the conduit in a manner that eliminates an eddy on one side of the stilling basin. Tests with and without the low-slope fillet insert were performed, and the inverted V provided satisfactory results for flow conditions below 2000 cfs. However, at higher cubic feet per second flows, the inverted V produced more turbulent conditions, and riprap moved downstream from the 36 in. riprap zone.

The inverted V design is primarily intended for projects where the culvert outlet is low for the tailwater that is present. The high tailwater causes the flow exiting the culvert to move to one wall rather than distribute uniformly down the parabolic drop. This results in a horizontal eddy in the stilling basin with low flows, which in most cases is not desirable. The stilling basin design at Sayers works well for the design flow but also results in a horizontal eddy forming in the basin for the lower flows. This eddy results from the basin being oversized for the low flows. Although the eddy is present for the low flows, it would not be a big concern if rock were not in the stilling basin. The flow exiting the stilling basin for the low flows is not turbulent and does not appear to cause any problems in the exit channel.

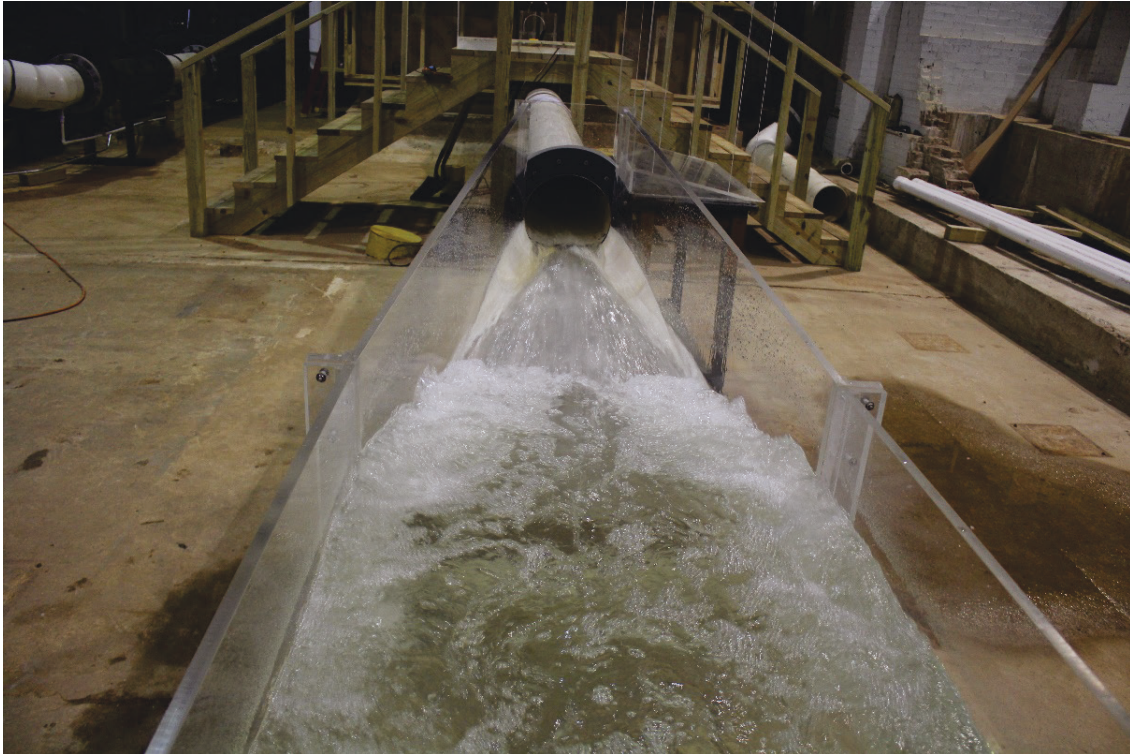
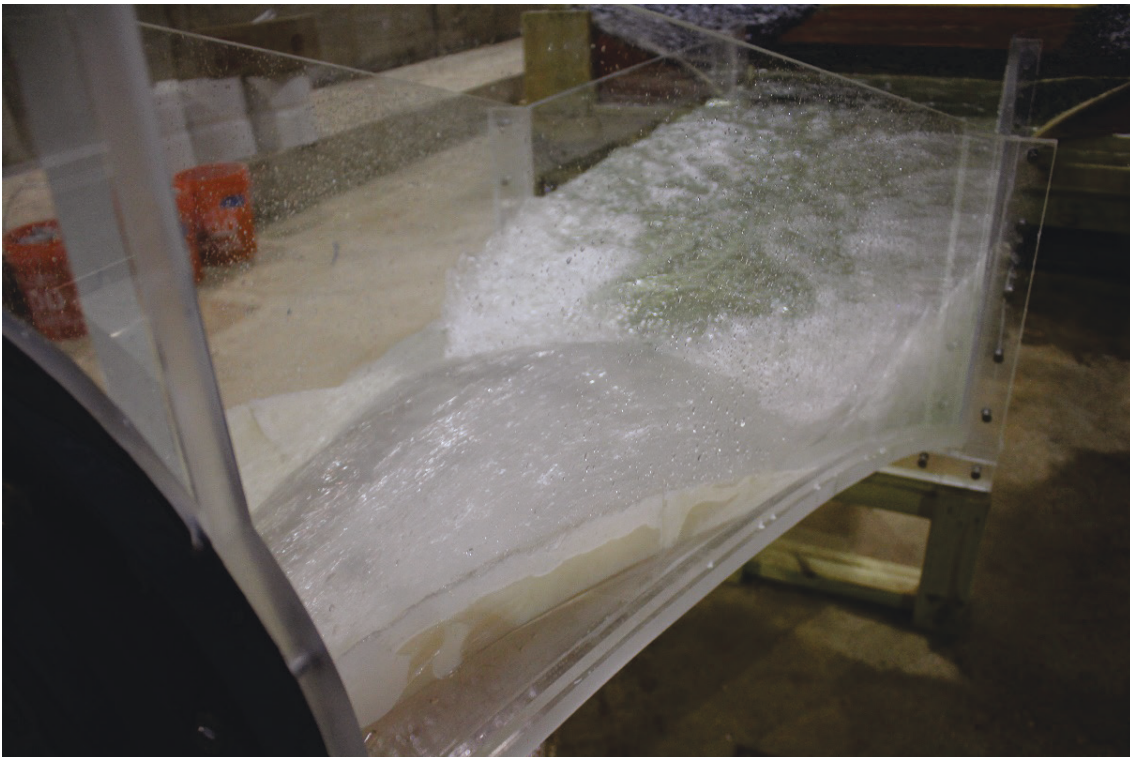
Figure 33. View looking upstream with a discharge of 1,000 cfs and the inverted V installed.

The inverted V divided the flow equally to each side of the stilling basin for flows at or below 2,000 cfs. Also, rocks that were placed in the basin did not move around as much indicating less turbulence in the bottom of the basin for flows up to 1,500 cfs. In previous low-flow tests without the inverted V insert, rocks were observed to swirl around on the bottom of the basin much more. This would be ideal for the Sayers project since a large majority of the flows experienced at the project annually are in the 150 to 500 cfs range. Figure 33 and Figure 34 show the inverted V with a 1,000 cfs flow.

During the tests, the flow inside the stilling basin became more turbulent as the discharge increased compared to previous tests without the inverted V insert installed. With the inverted V dividing the flow to each side of the stilling basin, the effect of a higher current was evident on each side above the concrete and riprap apron. It was also observed that once the tests were completed, some riprap in the exit channel was displaced and moved downstream. Movement was observed on the channel invert as well as the side slopes of the exit channel.

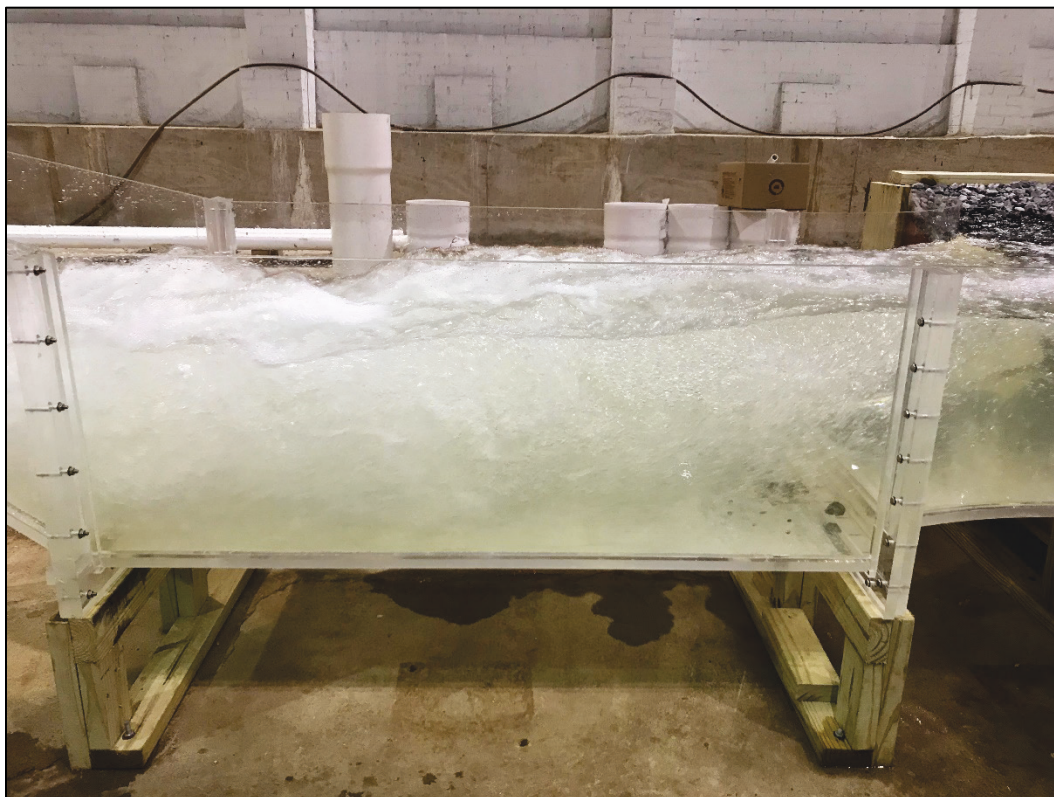
Figure 35. Flow conditions in the stilling basin with a discharge of 5,000 cfs and the baffle blocks removed.

The last tests (Tests 170 – 176) were conducted with the baffle blocks removed from the stilling basin. The existing baffle blocks are badly damaged; therefore, NAB wanted to explore the possibility of removing the baffle blocks altogether. Figure 35 shows the stilling basin with the baffle blocks removed. The test conditions are summarized in Table 9.

For Tests 170 and 171, with 615 cfs and 1,000 cfs, respectively, the flow conditions in the stilling basin were similar to the tests with the baffle blocks present. However, for Test 172, with a 1,500 cfs flow, rocks that were placed within the stilling basin were violently moved around on the bottom of the stilling basin. Also, the horizontal eddy formed on the left side was noticeably larger than the horizontal eddy observed with baffle blocks present. This larger horizontal eddy attributed to the rocks moving violently around on the bottom of the stilling basin. Since Sayers Dam releases 1,500 cfs flow annually, removal of the blocks would be detrimental to the project.

The baffle blocks in the prototype have been damaged and need repairs; therefore, the baffle blocks were removed in the stilling basin physical model and tested at the request of NAB. Since the current condition of the baffle blocks is badly deteriorated, removing them altogether is practical. Testing revealed that the removal of the baffle blocks causes greatly increased turbulence in the bottom of the stilling basin. The baffle blocks were considered necessary to adequately dissipate the energy of the flow in the stilling basin.
