*U.S. Air Force Rapid Airfield Damage Recovery (RADR) Modernization Program*

## **Evaluation of Commercially Available Screeds for Finishing of Rapid-Setting Concrete**

# **Evaluation of Commercially Available Screeds for Finishing of Rapid-Setting Concrete**

Final report

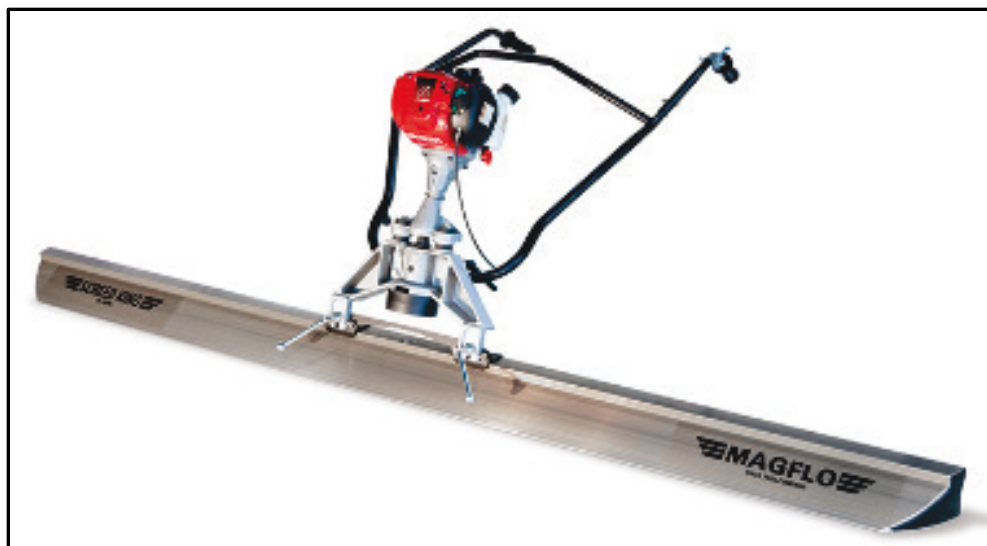
Figure 1. Vibratory screed.

Figure 1 shows the manual vibratory screed used in previous RADR testing and demonstrations including the Operational Utility Assessment (OUA) (Priddy et al. 2013b), ADR Cold Weather Demonstration (Edwards et al. 2013), ADR Wet Weather Demonstration (Bell et al. 2013), and ADR Large Crater Demonstration (Carruth et al. 2015). Several manufacturers make a product similar to the one shown in Figure 1. Table 1 lists manufacturers discovered during a market survey, along with estimated costs for the power head and a 10-ft screed board. Each of these models functions in a similar manner. The screed bar is designed to strike off and float the concrete simultaneously, and the small attached power head provides vibration to remove pockets of air that may exist in the concrete. Several different screed bar lengths are available, from 5 ft to 16 ft. The Wyco Screed King was used for the testing described herein.

Using the vibratory screed is somewhat cumbersome, since the main operator must step into the repair and drag the screed across to strike off the material. The operator must wear protective gear and rubber boots during operation. Also, the edges of the screed bar must often be held down manually by two other personnel in order to ensure the repair is struck off evenly. The advantages of this screed include ease of transport, relatively low cost, and satisfactory performance in troop demonstrations. The vibratory screed is currently included in the USAF Sustainment Pavement Repair (SuPR) kit and ADR Tool Trailer.

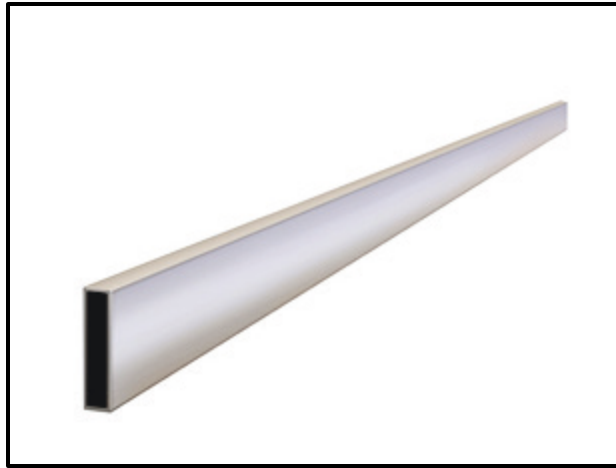
Figure 2. Magnesium bar screed.

Another type of screed that has been used successfully in previous ADR demonstrations is a simple magnesium bar screed (Figure 2). The cross-section dimensions of the bar screed are 1.5 in. by 3.5 in., and many different lengths are available. The weight of the 10-ft version used during testing is approximately 12 lb, and the estimated cost is \$200. The advantages of the magnesium bar screed are that it is durable enough to resist warping after repeated use and can easily be moved between repairs since it is lighter than similar screeds made of other materials (e.g., wood or steel). However, the magnesium bar screed does not provide any vibration and is difficult to maneuver if the concrete material has a thick consistency. The magnesium bar screed is also included in the USAF SuPR kit.

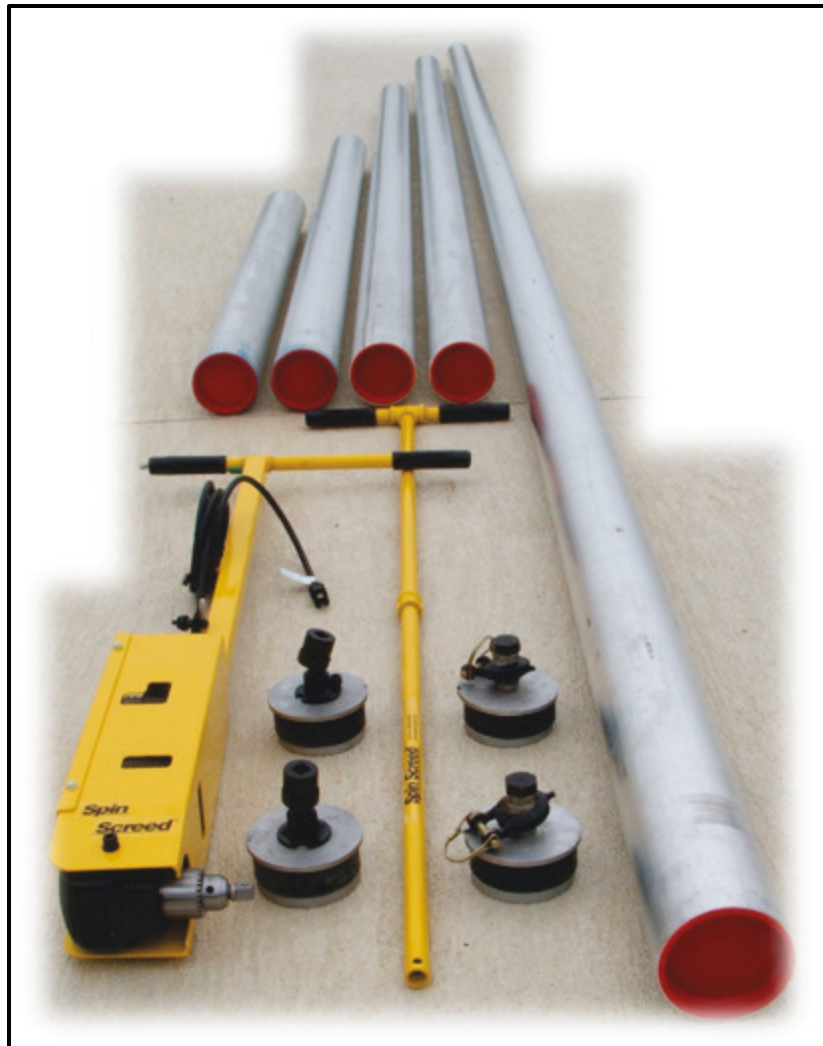
Figure 3. Spin screed.

A roller screed (Figure 3) was also evaluated. A number of roller screeds were identified during an initial market survey conducted before testing, and some details are provided in Table 2. The Spin Screed® is lightweight, is easily maneuverable between craters, and utilizes spinning aluminum pipes of varying lengths to strike off the concrete. Lengths are available in 1-ft increments from 1 ft to 20 ft. The power to spin the pipes is provided by a standard angle drill on one end and a non-powered receiver on the other end. Both ends have handles so the screed can be guided across the repair during the screeding process. A 120V power source with a standard grounded outlet is required to operate the angle drill. According to the manufacturer, the spin screed is capable of screeding concrete that exhibits a slump of 3 in. or greater. The spin screed works by floating on the surface of the concrete and moving the material surcharge in the direction of screeding, thus leveling the material behind the screed.

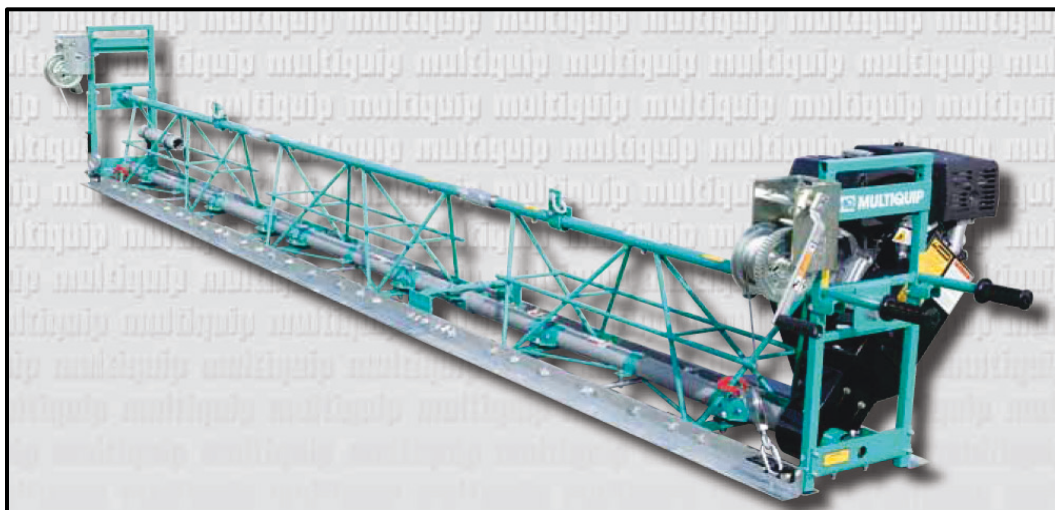
Figure 4. Vibratory truss screed.

A standard vibratory truss screed (Figure 4) was included in the testing program. The model used was the Multiquip® WSHE50KIT11H, which is included in the USAF SuPR kit, but models are available from other manufacturers, as shown in Table 3. The screed has a modular design to enable the length to be adjusted very easily. The base screed includes a 7.5-ft-long section with an 11-HP engine to provide vibration and one of the automatic winches. Five-ft sections of truss screed can be added only to the base screed, and then a 2.5-ft section that includes the other powered winch is installed on the opposite end. Manual cranks for the winches are also included for redundancy. The sections included in the SUPR kit can be assembled to produce a 25-ft-long screed. An assembled 10-ft screed was used for the testing described in this report. This

configuration weighs 241 lb, and each additional 5-ft section weighs 95 lb. The weight of the screed is designed to prevent the screed from riding up over stiffer concrete mixes, but a forklift is required to move the screed between repairs. Another option is to use the screed dolly accessory (included in the SuPR kit) to move the screed shorter distances. According to the manufacturer, the product is designed to screed concrete with a slump of 3 in. or greater.

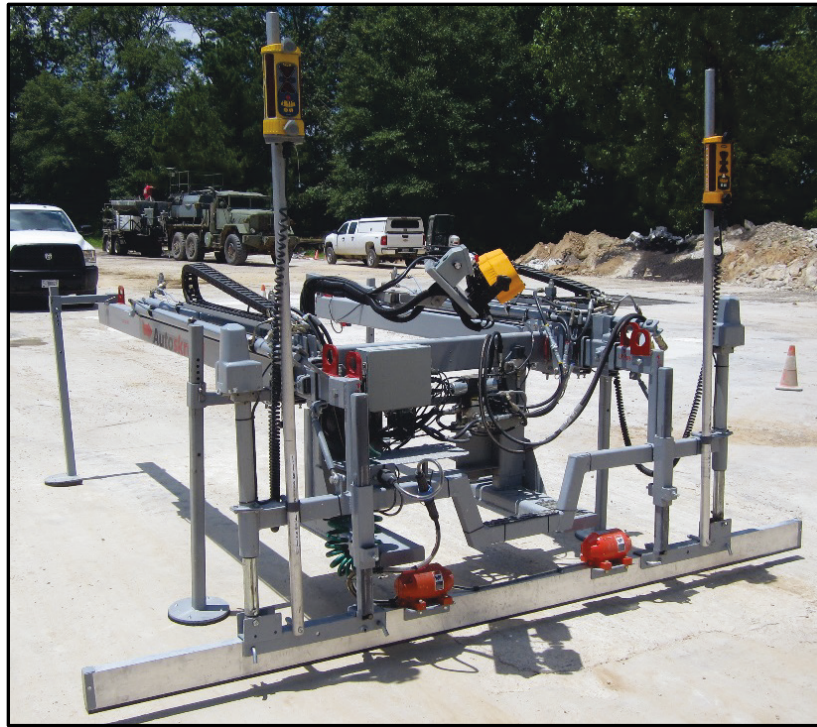
Figure 5. Autoskreed®.

The Autoskreed® is a screed attachment for a skid steer loader that utilizes a hydraulically powered reach system to extend over the repair, lower the screed bar, and then retract to strike off the placed concrete. The Autoskreed® is capable of being operated by one person. The bar used for testing was 12 ft long, but the bar can be replaced with shorter or longer bars as needed. The bar is also equipped with two hydraulically powered motors that provide vibration. Power for the hydraulic motors was provided by the battery on the skid steer loader during testing. Estimated cost for the commercially available version of the Autoskreed® is over \$75,000. However, pricing could change depending on quantity and any future reductive modifications.

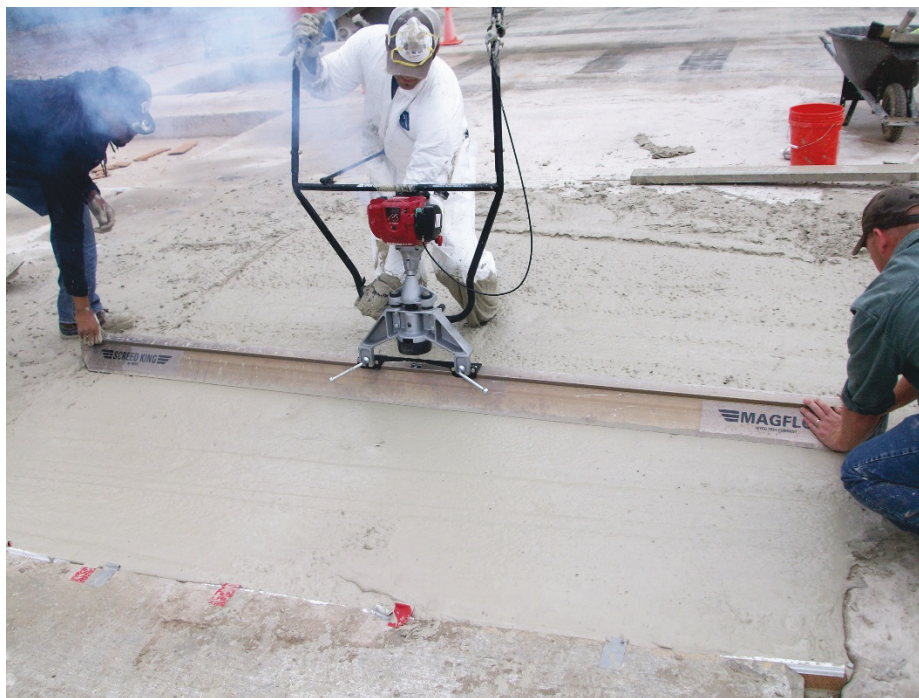
Figure 6. Vibratory manual screed testing.

Figure 6 shows the manual vibratory screed during testing. The screed was easy to set up and operate. Due to its lighter weight relative to some of the other screeds, it is also easily transported between repairs. However, as shown in Figure 6, one of the major disadvantages of this screed is the requirement for one person to actually step into the repair during screeding, which can be cumbersome and requires extra safety protection (plastic suit and rubber boots). Also, two other personnel are typically required to hold down the ends of the screed to ensure a flush repair, particularly for rapid-setting concrete mixtures with a thicker consistency (lower slump). The shape of the screed bar and vibration did provide a quality finished surface, as shown in Figure 6. Using this screed was moderately strenuous, which could lead to fatigue after multiple repairs are conducted consecutively.

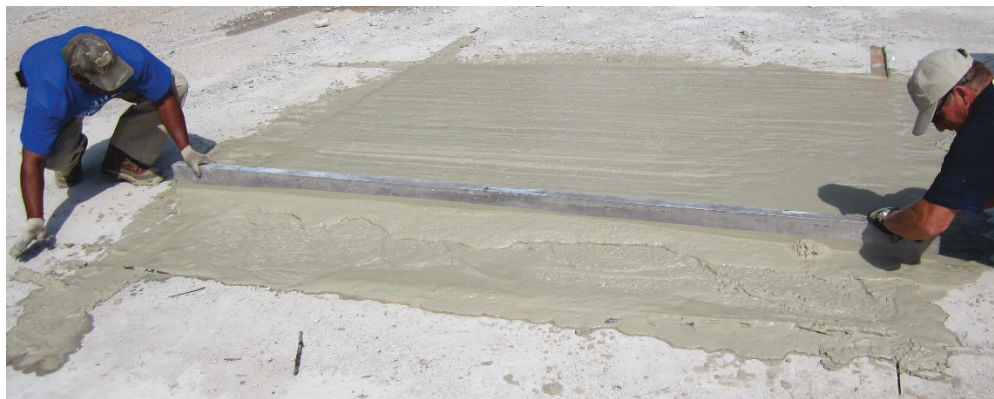
Figure 7. Magnesium bar screed testing.

Testing of the magnesium bar screed is shown in Figure 7. The bar screed was the easiest screed to transport, and no set-up time is needed. Only two personnel were required to operate the screed. As shown in Figure 7, some small ridges of material were observed where the screed was placed at different points across the repair during multiple passes. If these ridges

are not smoothed out quickly, the material reaches initial set and the small ridges become permanent. The lack of vibration also likely contributed to this observation. Overall, the screed provided an adequate finish during testing. For rapid-setting concrete mixtures with a more fluid consistency (higher slump), the magnesium bar screed worked well. However, mixtures with a thicker consistency were much more difficult to strike off. Moving the screed back and forth across the repair while applying sufficient pressure to strike off thicker material is strenuous and could lead to fatigue after multiple crater repairs are conducted.

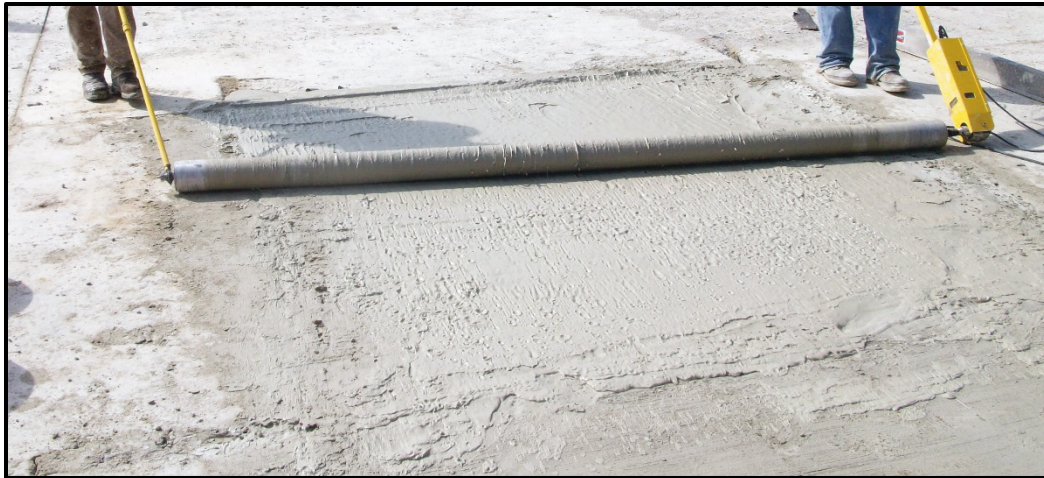
Figure 8. Roller screed testing.

The roller screed during operation is shown in Figure 8. The roller screed did require some set-up time since an external power source (i.e., a generator) must first be moved into position, which also made the screed assembly relatively cumbersome to transport without a vehicle. While the roller screed required only two personnel to operate, the finish did not appear as smooth as those of the other screeds. Also, the power cord for the drive end of the screed could become an obstruction during operation. The screed required minimal exertion to operate and did exhibit the fastest screed times, as noted in Table 4.

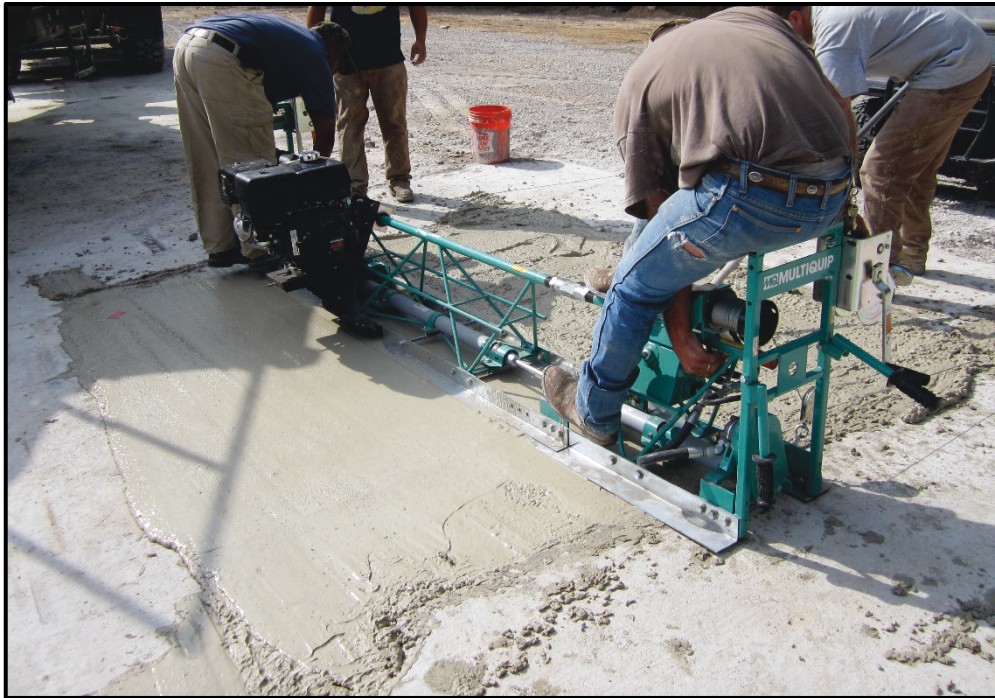
Figure 9. Vibratory truss screed testing.

The vibratory truss screed (Figure 9) was tested using the included automatic winches to pull the screed across the repair. Setting up the screed was somewhat time consuming, since anchors had to be installed to attach the cable used by the winches and the screed had to be moved into the proper position with equipment. Two pieces of rebar were driven into the ground adjacent to the concrete test area to be used as anchors. For the RADR crater repair process, the winches would likely need to be anchored to the volumetric concrete mixer or mixer prime mover, since drilling anchors would be time consuming in the middle of a surfaced runway, apron, or taxiway. Two personnel were required for screeding, one on each end of the screed to make any necessary adjustments to the winch speed as the screed moved across the repair. These two personnel are shown standing on the screed during operation in Figure 9, but this is not required. Since the winches physically pull the screed across the repair, very little physical exertion was required by the operators. For transporting the screed between repairs, a piece of equipment is required due to the weight of the screed, as discussed in Section 2.1.4. Transporting the screed on a pallet is preferred, since the screed does not have fork pockets and lifting the screed under the top of the truss can cause damage. The additional weight does enable the screed to easily strike off mixtures with a thicker consistency (lower slump) and provide a very smooth finish, as shown in Figure 10.

- The vibratory truss screed provided the best finish with only a small amount of exertion by the operators but was difficult to transport, set up, and operate. Two personnel, along with a vehicle, were required to move the screed. Anchor points were also required to attach the winches that pull the screed across the repair. Overall, the truss screed finished last in the screed rankings shown in Table 6.

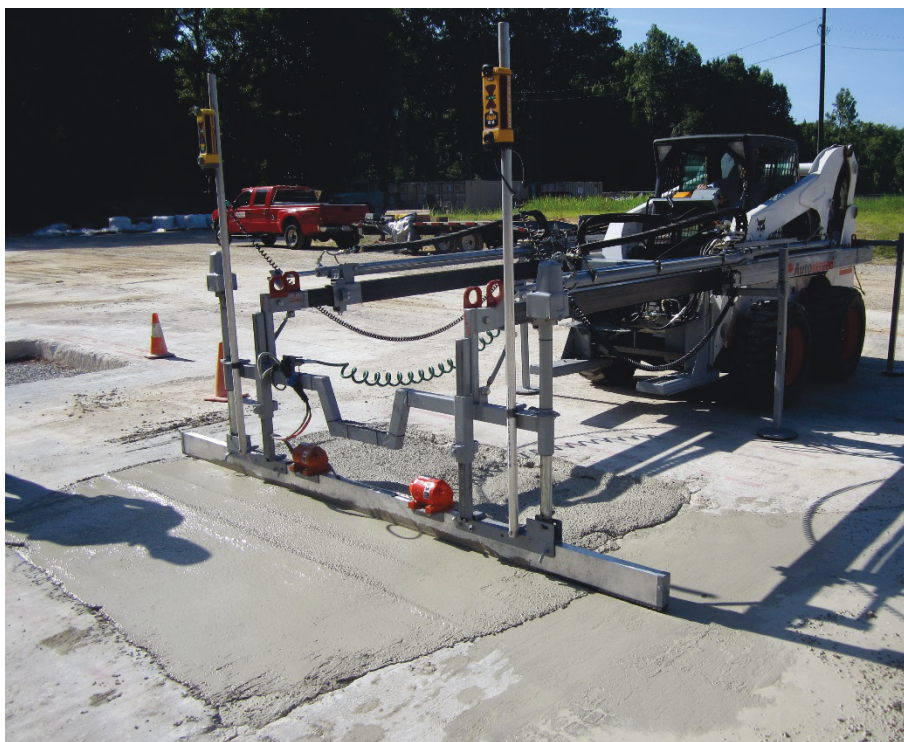
Figure 11. Autoskreed® testing.

The Autoskreed® was used to screed three repairs, one of which is shown in Figure 11. Some initial setup was required to ensure the Autoskreed® was properly attached to the skid steer, and the electrical cords for the vibrators were connected to the skid steer battery. No additional setup was required between repairs (other than alignment), and the screed was easily transported since it was used as a skid steer attachment. Two to three passes of the Autoskreed® were required to create a flush repair for each

One improvement that is suggested is to increase the speed of reach, as each extension across the crater before screeding took approximately 1 min. Modifications must also be made to enable the Autoskreed® to be compatible with an extendable boom forklift, since that vehicle is projected as the preferred prime mover for the screed within the ADR crater repair process. Recommended changes to the Autoskreed® are detailed in section 4.2 of this report.
