**AFRL-RX-WP-TR-2019-0163**

**INFLUENCE OF TEST METODOLOGY AND  
ENVIRONMENT ON STRESS RUPTURE LIFE OF  
NEXTEL720/AS**

**30 APRIL 2019  
Final Report**

**AIR FORCE RESEARCH LABORATORY  
MATERIALS AND MANUFACTURING DIRECTORATE  
WRIGHT-PATTERSON AIR FORCE BASE, OH 45433-7750  
AIR FORCE MATERIEL COMMAND  
UNITED STATES AIR FORCE**

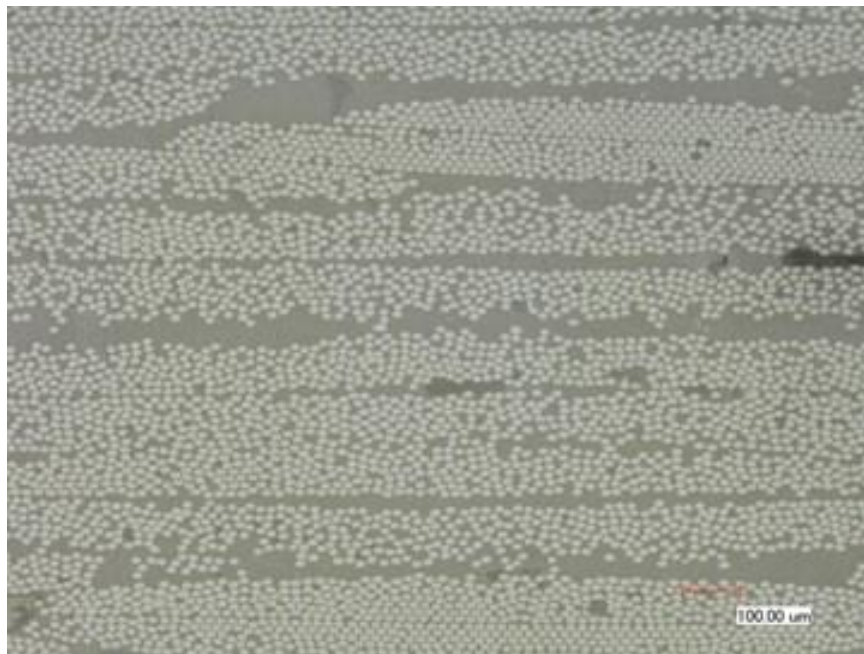
**Figure 12. Representative  $\pm 45$  Micrograph of N720/AS Microstructure (200 $\times$ , C)**

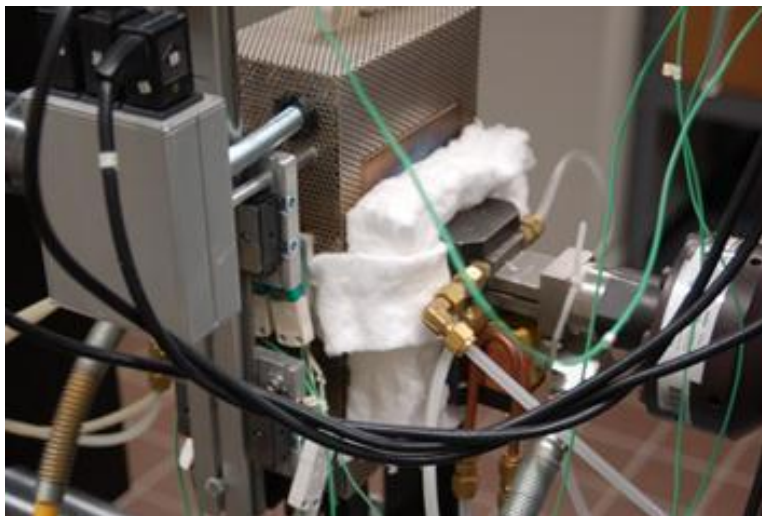
**Figure 25. Photograph of Furnace Packed with Custom-Cut Insulation**

A schematic of the furnace showing the three control and five thermal mapping/profiling TCs is shown as Figure 21. Photographs of a N720/AS test specimen being instrumented for temperature profile measurements are shown in Figure 22 and Figure 23. The TCCs used for the temperature mapping were bonded directly to a N720/AS test specimen and labeled as “Specimen TC.” For this study, it was decided that an extremely detailed thermal profile mapping of the test specimen was required. Therefore, a total of eleven TCs were bonded to the test specimen – five to record the gage section and the remaining six recorded the temperature beyond the gage section. The three furnace zones are controlled by TCs that enter the furnace several millimeters below the test specimen and the tips are sealed with ceramic adhesive – referred to as “Furnace TC.” In addition, three TCs are inserted between the two halves of the furnace and brought very close (~3 mm) to the gage section edge of the test specimen to represent the furnace air temperature at that location. They are labeled “Witness TC”, and the ends are sealed with adhesive to avoid reactions with the test specimen (Figure 24). The calibration procedure involves adjusting the temperature set-point of the Furnace TC until the Specimen TC reaches both the desired maximum temperature and temperature profile along the length – the Witness TCs only being used for additional reference. For each thermal profile run, adjustments were made until the temperatures along the entire 28 mm of the machined gage length of the test specimen were within  $\pm 1\%$  of the target test temperature, which for this study, was 1100°C. Once all TCs were in place, the top furnace half was lowered into place and additional insulation added between the furnace and grips, as shown in Figure 25.
