Beneficial Use of Dredged Material with Increased Fine Sediment Content: A Case Study at Egmont Key, Florida

Katherine E. Brutsché, Coraggio K. Maglio, Zachary J. Tyler,
Jase D. Ousley, and Ping Wang

June 2019

Final report

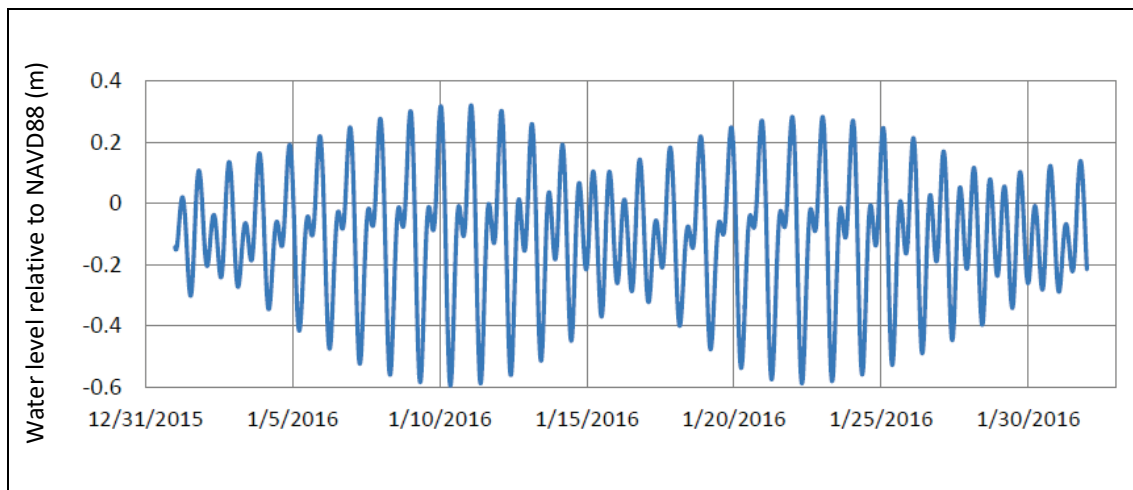
Figure 4. Study area tidal regime as predicted for NOAA station 8726520 St. Petersburg, FL, for January 2016.

The study area experiences a mixed tide regime in that it has diurnal and semidiurnal components of unequal magnitudes. Spring tides are diurnal and have an approximate range of 0.8 to 1.2 m. Neap tides are semidiurnal with an approximate range of 0.4 to 0.5 m (Wang et al. 2011). An example tidal record as observed from St. Petersburg, FL (NOAA Station 8726520) for January 2016 (Figure 4) illustrates this spring/neap tidal cycle. Tidal range in the study area is less than 2 m and classified as micro-tidal. Although the tidal range is relatively small, tides play an important role in the nearshore morphodynamics of the study area. This is mainly due to the large water body area (1,030 km²) and tidal prism (6.466×10^9 m³) of Tampa Bay (Galperin et al. 1991; Goodwin 1984; Lewis and Estevez 1988). The large tidal prism drives strong tidal flows through the two inlets, Egmont Channel and Southwest Passage, at both ends of Egmont Key. These tidal flows can potentially have significant influence on the morphodynamics of Egmont Key.

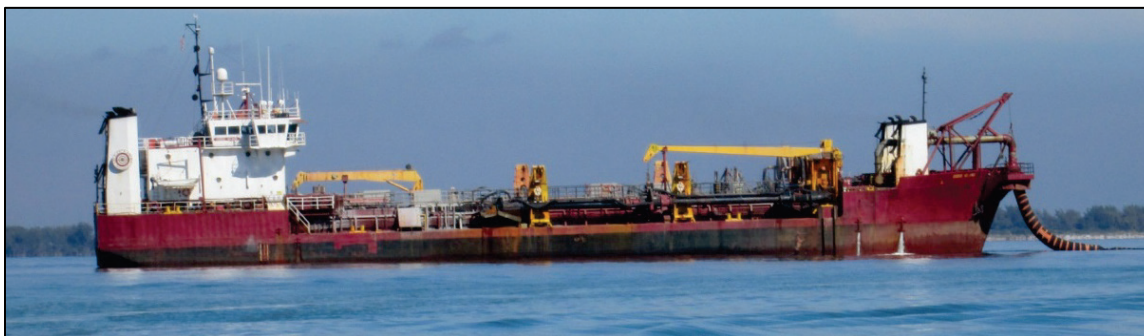
Figure 5. The *Dodge Island*, a GLDD hopper dredge, pumping out material to Egmont Key on 16 December 2014.

The 2014–2015 Tampa Harbor dredging project was conducted by the GLDD hopper dredges the *Dodge Island* (November and December 2014) and the *Padre Island* (January through March 2015). Both dredges used bow pump-out capabilities to send material to the placement areas using a pipeline (see Figure 5). Material was dredged from Tampa Harbor Entrance Channel and placed in two portions of Egmont Key, with two different types of nourishment styles. A traditional beach nourishment was constructed at the north end of the island, while a CSSZ nourishment was constructed just south of the midpoint of the island (Figure 1).

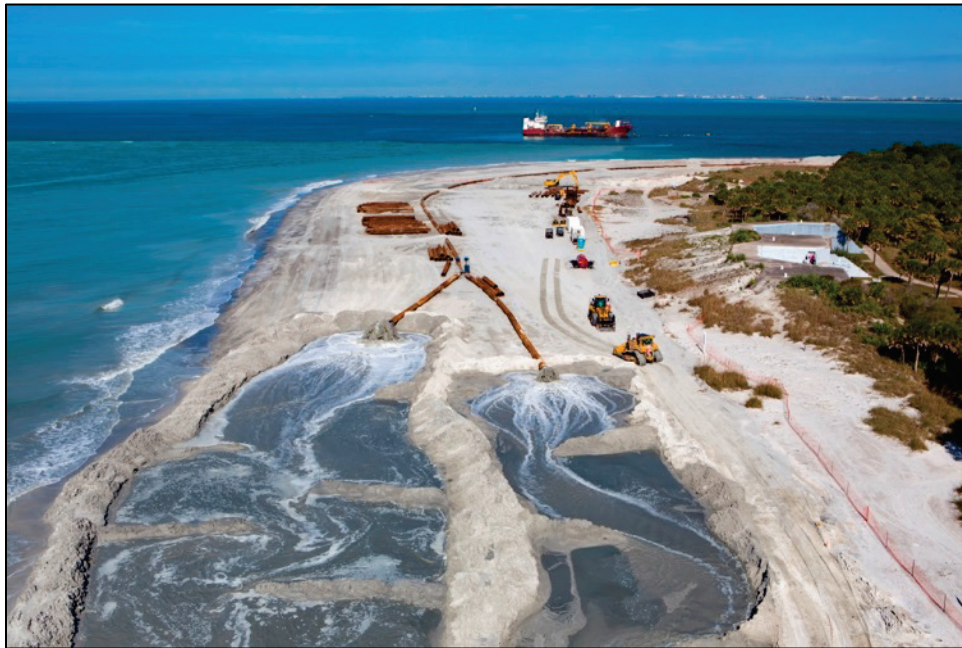
Figure 6. Traditional beach placement at northern end of Egmont Key, Florida, 26 December 2014. (Photo courtesy of GLDD.)

The traditional trapezoidal fill template at the northern end of Egmont Key used a Y-valve and two placement cells with longitudinal dikes with intermediate spurs to increase settlement and minimize material lost to the active swash zone, see Figure 6. The use of this placement design with a Y-valve with two cells allows for one side to be closed down for extending outfall pipes without having to stop discharge. Placement of dredged material occurred at the north end of the island from 19 November to 28 December 2014 and then from 21 January to 5 February 2015. Total volume of this placement was approximately 244,000 m³.

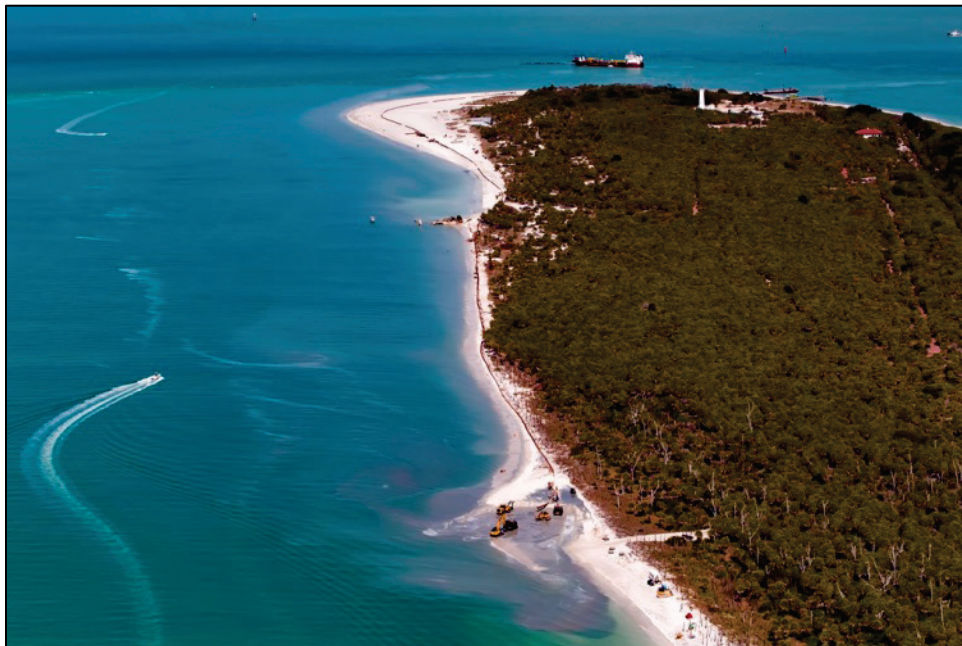
Figure 7. Shore based pipeline and CSSZ placement in center of Egmont Key, Florida, 21 February 2015. (Photo courtesy of GLDD.)

Approximately 0.8 km south of the traditional beach nourishment, the CSSZ placement was constructed. Geomorphic features created by the CSSZ placement method were designed to function as a feeder beach to areas adjacent to the nourishment. The CSSZ placement occurred from 8 February to 6 March 2015, with a total volume of approximately 82,000 m³. Figure 7 shows the completed northern beach placement as well as the CSSZ placement being constructed.

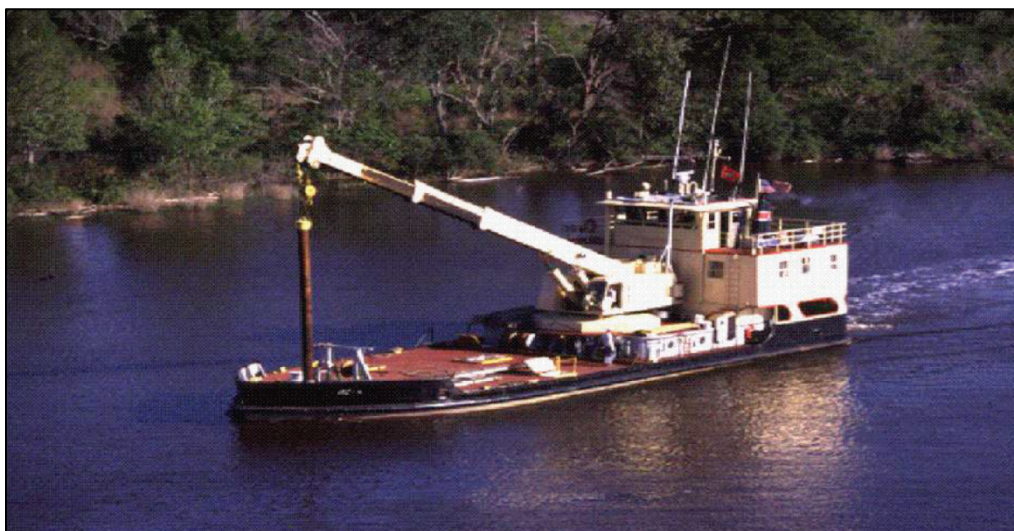
Figure 8. USACE Wilmington District M/V *SNELL*.

Vibracoring was conducted by the USACE multi-purpose vessel (M/V) *SNELL* (Figure 8). The *SNELL* is approximately 32 m × 10 m with a draft of ~2 m. The vessel carries a 35-ton crane that deploys the vibracoring apparatus. During the period of 2–3 April 2014, the *SNELL* obtained 39 cores: 34 cores from Egmont Channel Cut 1, 1 core from Egmont Channel Cut 2, and 4 cores from Mullet Key Channel (Figure 9).

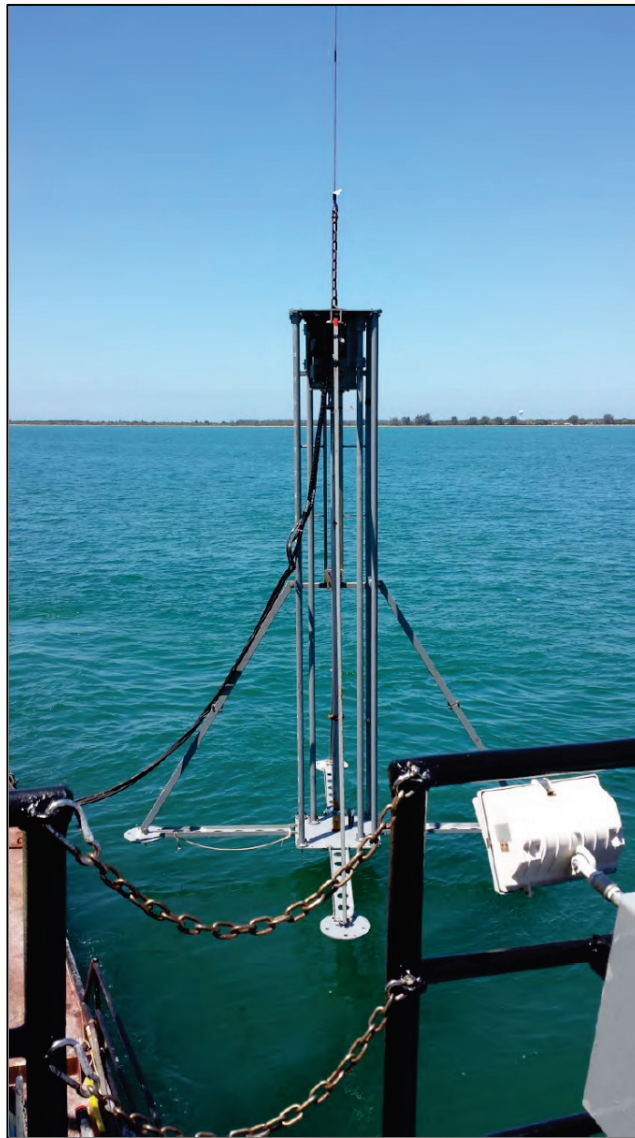
Figure 10. Vibracoring apparatus deployment, Egmont Channel.

All borings were drilled using an International Construction Equipment Model 2 hydraulic vibratory driver fitted with a 4-inch outer diameter drill stem, clear plastic liner, sediment retainer, drilling shoe, and a model 50 power unit (Figure 10). Borings were sited using a Furuno NavNet 3D global positioning system located on the crane and linked to HYPACK® with DREDGEPAK®. Elevations of the borings were determined using the horizontal position of the boring(s) projected onto the Lower Tampa Bay Examination Survey FY13. The vibracore apparatus was modified to limit the maximum depth of penetration to 1.5 m. Sample depth was constrained so that samples captured the shoaled material within the dredging prism along with the upper portion of the channel substrate while reducing sampling below the needed strata. All borings were measured to ensure a minimum of 80% recovery. The average penetration for the borings was 1.4 m.

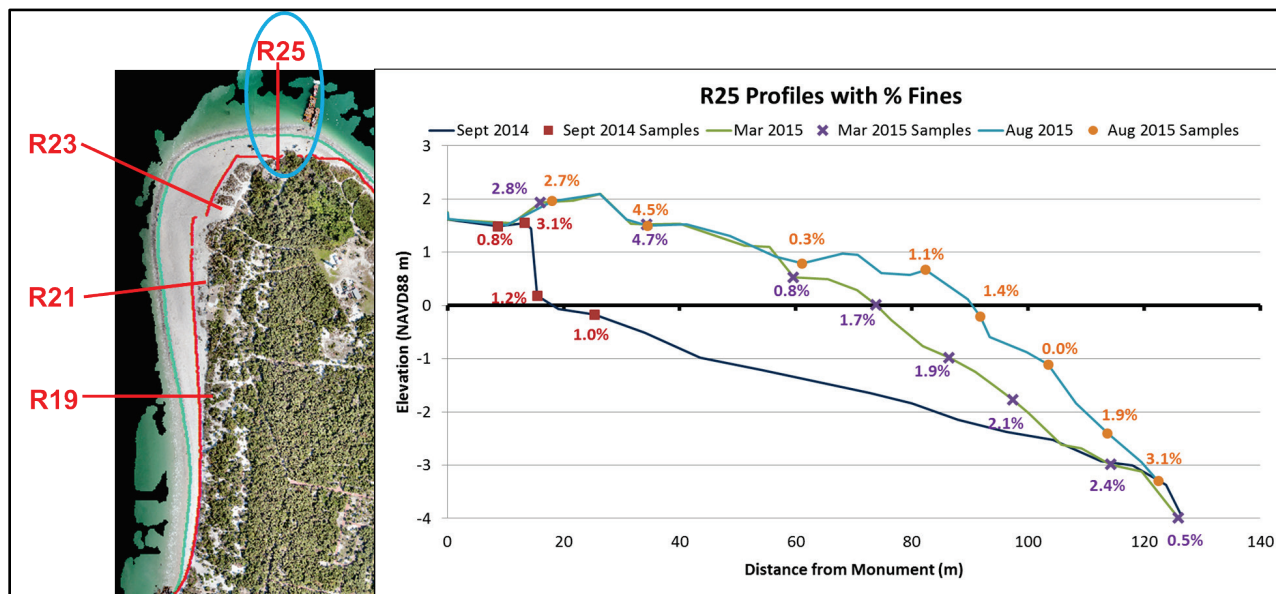
Figure 12. Profile line R-25 across the northern tip of Egmont Key in the traditional placement area.

The USF CRL collected cross-shore profile surveys along Egmont Key prior to construction in September 2014 and following construction in March and August 2015 (Figure 12–Figure 18). Surface sediment samples were taken along the cross shore profile lines.

Figure 12–Figure 18 indicate the percentage of fines for each of the surface sediment samples taken along the profiles. The pre-construction profiles in the traditional nourishment template contained less than 2% fines on the subaerial beach. Higher percentages of fines were typically found with distance offshore. A maximum fines content of 17.9% was measured at the toe of the foreshore along R21; however, generally the sediment samples contained less than approximately 5% fines. Immediately post-construction in March 2015, samples on the subaerial beach contained 5% or less of fine material. Again, the highest percentage of fines was found at the toe of the foreshore with up to 34.3% at R19 (Figure 15). This is also at the edge of the fill, which may have had an impact on the anomalous concentration of fines seen here.

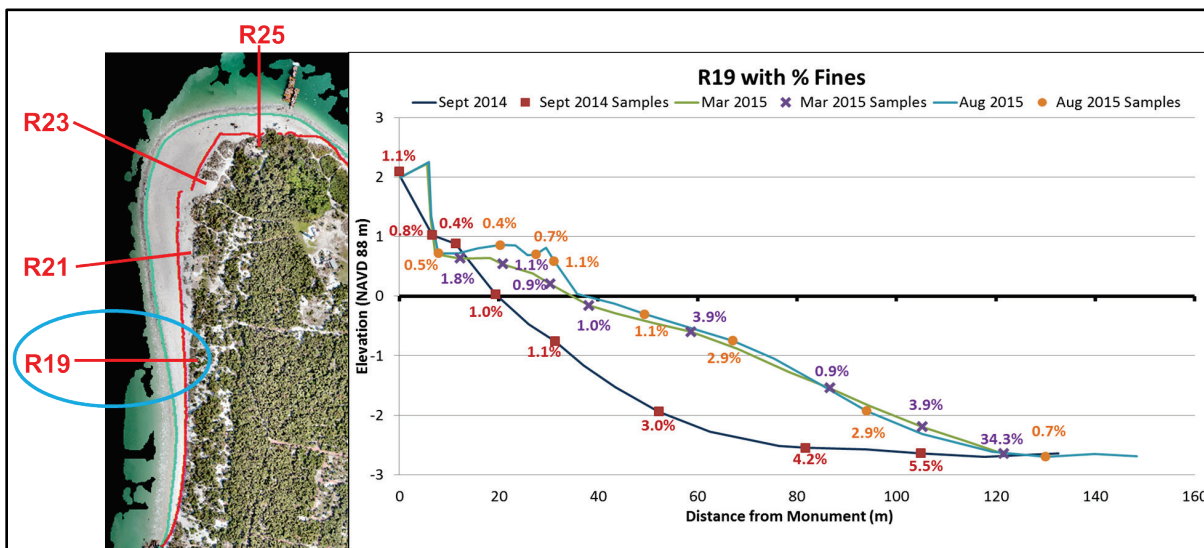
Figure 15. Profile line R-19 across the southern taper area of the traditional fill area on Egmont Key.

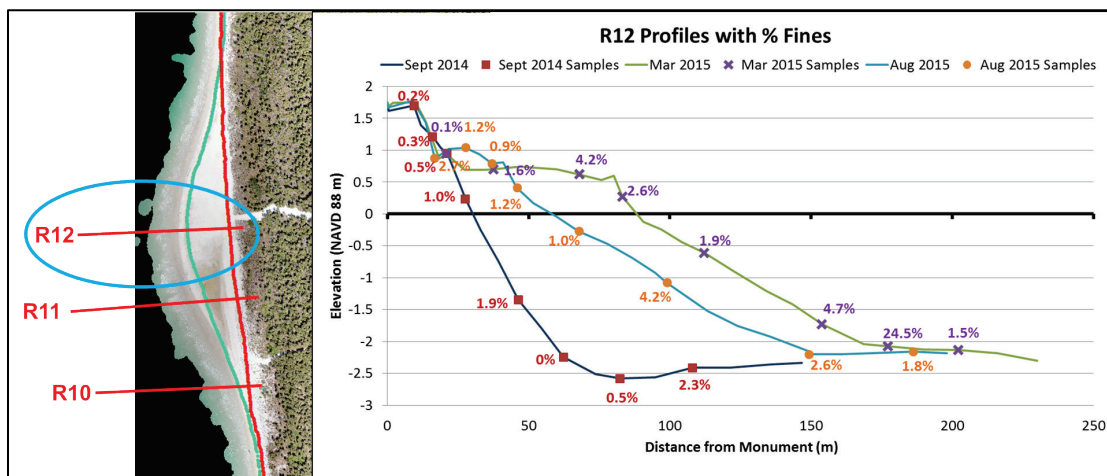
Figure 16. Profile line R-12 across the point of the CSSZ placement on Egmont Key.

Similar to the traditional nourishment site, the highest concentration of fines at the CSSZ placement was found at the farthest offshore extent of the fill (toe of fill). The toe of fill showed higher fines content at the CSSZ transects (24.5%–83.8%) compared to the traditional placement. However, by the next sampling event (5 months later), the fine sediment content had dropped below 5% in these areas. In fact, the August 2015 sampling period showed that all surface samples across the dry beach transect contained less than 5% fine material.

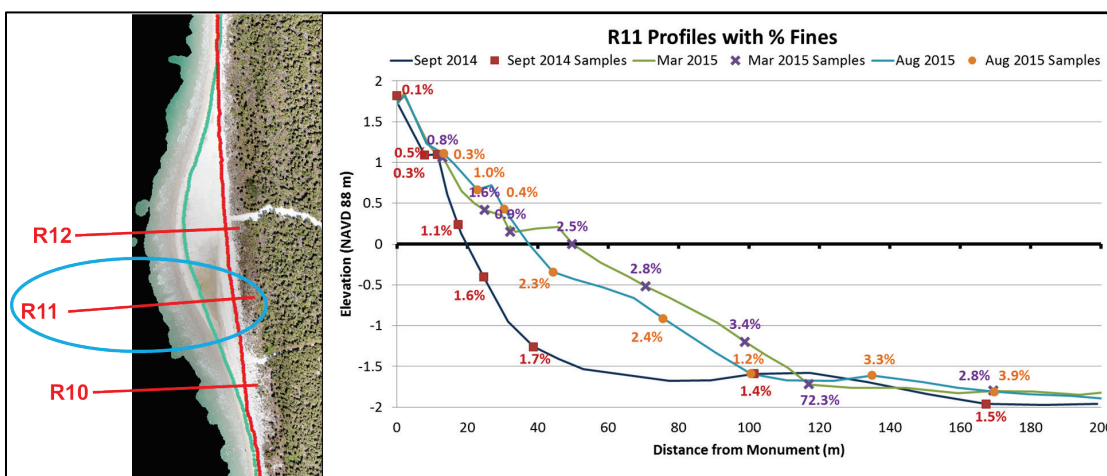
Figure 17. Profile line R-11 moving south along the CSSZ placement area taper on Egmont Key.

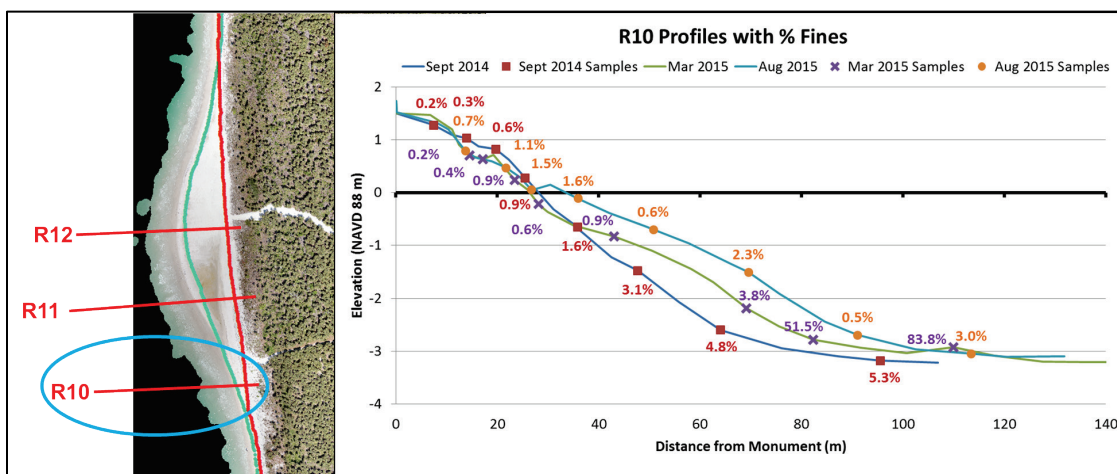
Figure 18. Profile line R10 across the southern most portion of the CSSZ area on Egmont Key.

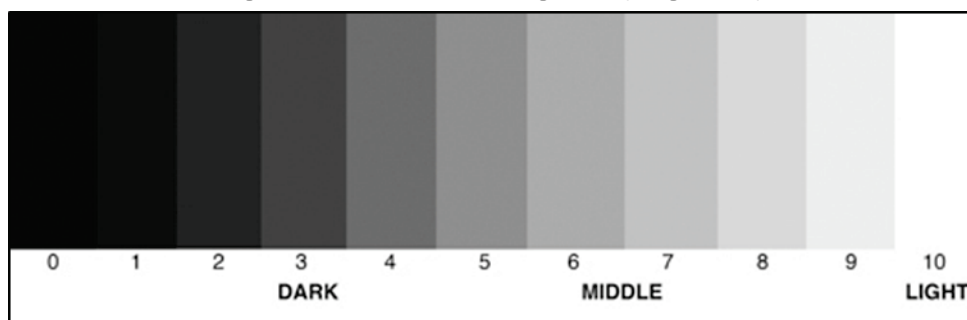
Figure 19. Example Munsell Color chart for reference (image from <http://blog.stephens.edu/arh101glossary/?glossary=value>).

The in situ channel material was darker (Munsell Value [MV]=4.36) than the existing native beach (MV=5.9), likely due to higher content of darker color fines and organic material. Due to fines and organics loss during dredging and placement, composite samples of the post-construction beach was lighter in color value than the parent channel material (MV=5.3). The CSSZ Munsell value was identical to the pre-construction beach while the traditional placement site had a darker value of 5.0. An image referencing the different color values is found in Figure 19.
