## Predicting Service Life Utilizing Freeze-Thaw Modeling of Aging Navigation Structures

# **Predicting Service Life Utilizing Freeze-Thaw Modeling of Aging Navigation Structures**

Final report

Under 6.1 Predictive Service Life Modeling of Concrete Deterioration Processes in  
Navigation Structures  
Project Number 476923

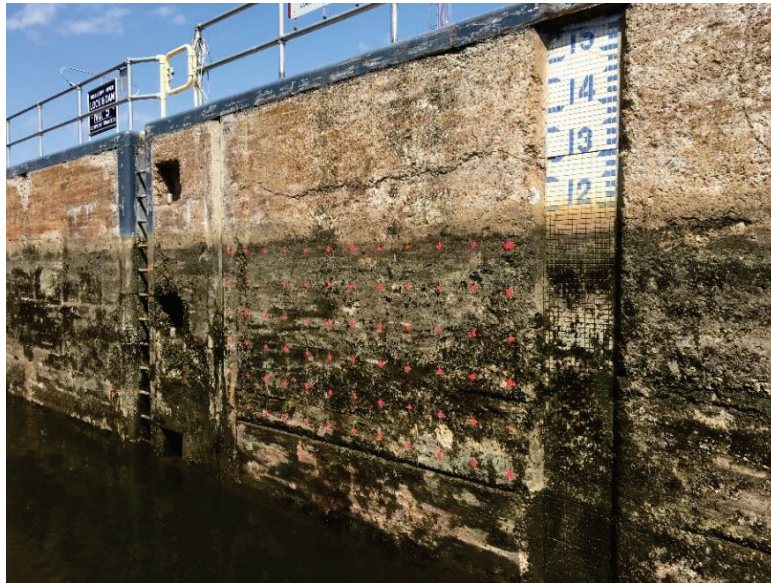
Figure 5. L5V section.

The L5 vertical section (L5V) was chosen on the I-Wall of the chamber at Panel 13. This section is located in what is considered the “splash zone,” the area of the vertical lock wall in which the concrete is submerged at the high water level and unsubmerged at the low water level for normal lock operations. The location of section L5V is shown in Figures 4, 5, and 6. Each section was marked with spray paint and given a grid system for labeling of cores and marking deterioration. Each point on the grid system is 1 ft from adjacent points.

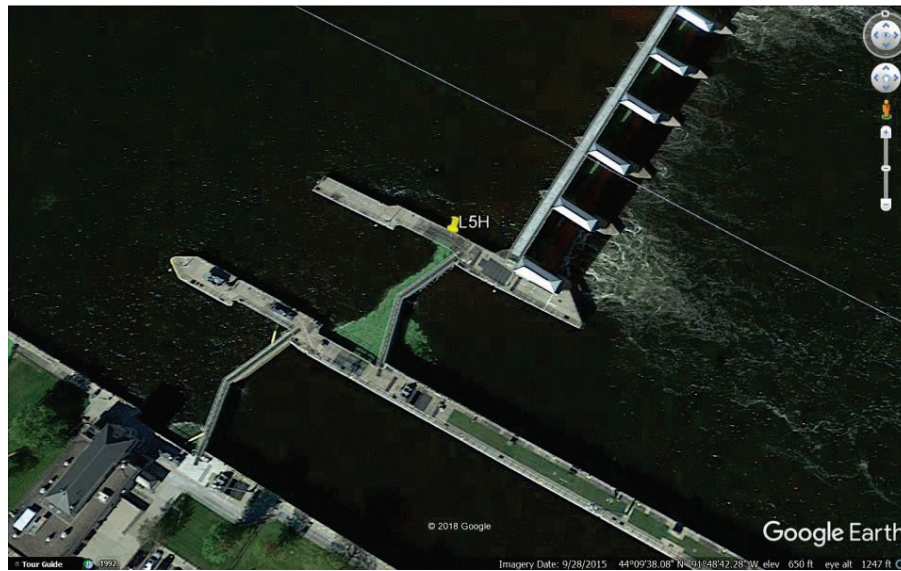
Figure 7. L5H location ( $44^{\circ} 9'38.55''\text{N}$ ,  $91^{\circ} 48'42.37''\text{W}$ ).

The L5 horizontal section (L5H) was chosen on the deck of the river wall, monolith 5. This section contained several patches, joints, and visible spalls. Figures 7, 8, and 9 serve to illustrate this section.

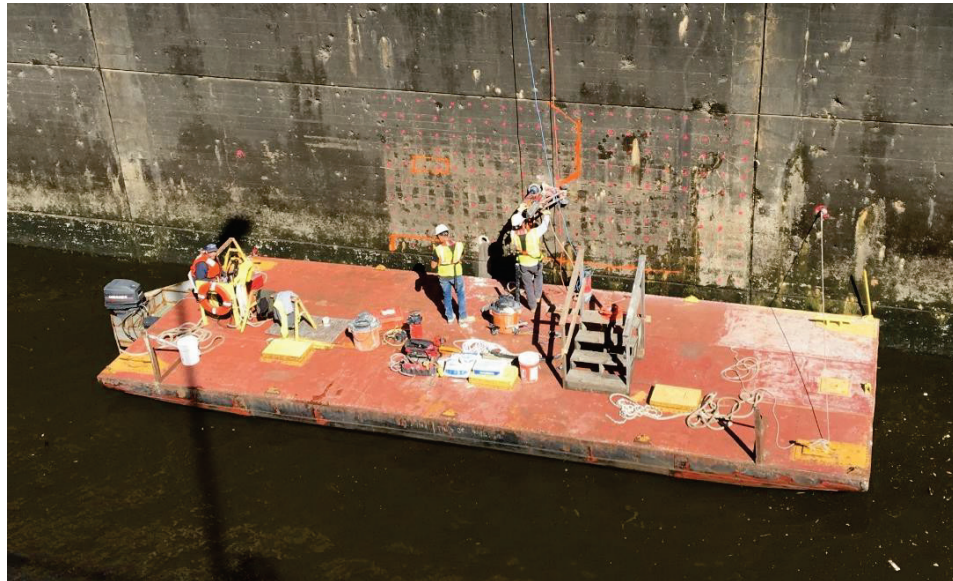
Figure 11. LSAFV section.

The LSAF vertical section (LSAFV) was chosen on the I-Wall at Panel I10. Similar to the L5V section, this section is also located in the splash zone. The location was observed to have portions of visible deterioration. Figures 10, 11, and 12 show the LSAFV section.

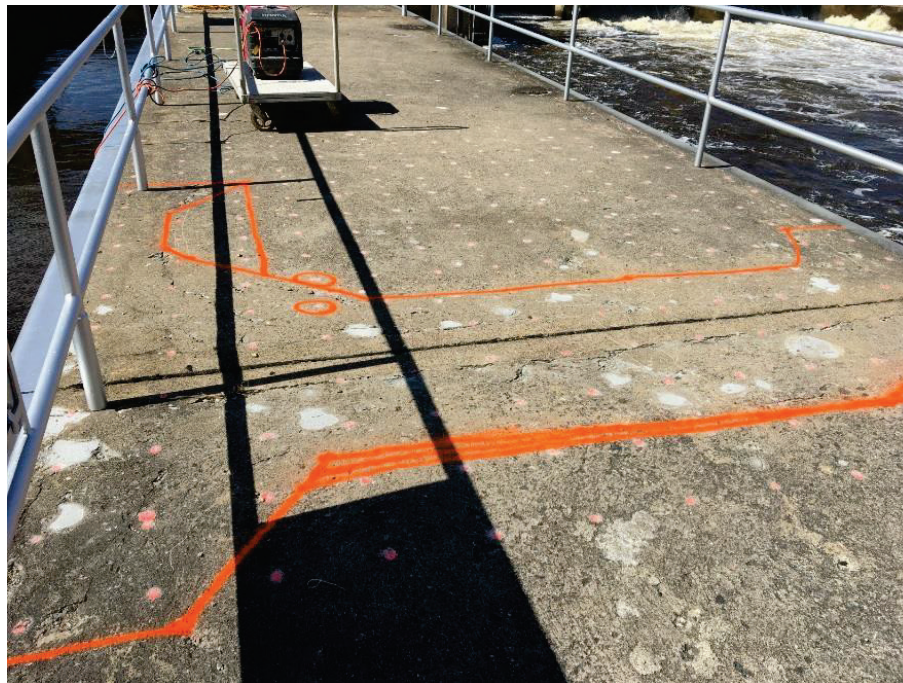
Figure 14. LSAFH section.

The LSAF horizontal section (LSAFH) was chosen from the deck of the I-Wall at Panels I10 and I11. This section included a monolith joint associated with a large amount of perceived deterioration. LSAFH is shown in Figures 13, 14, and 15.

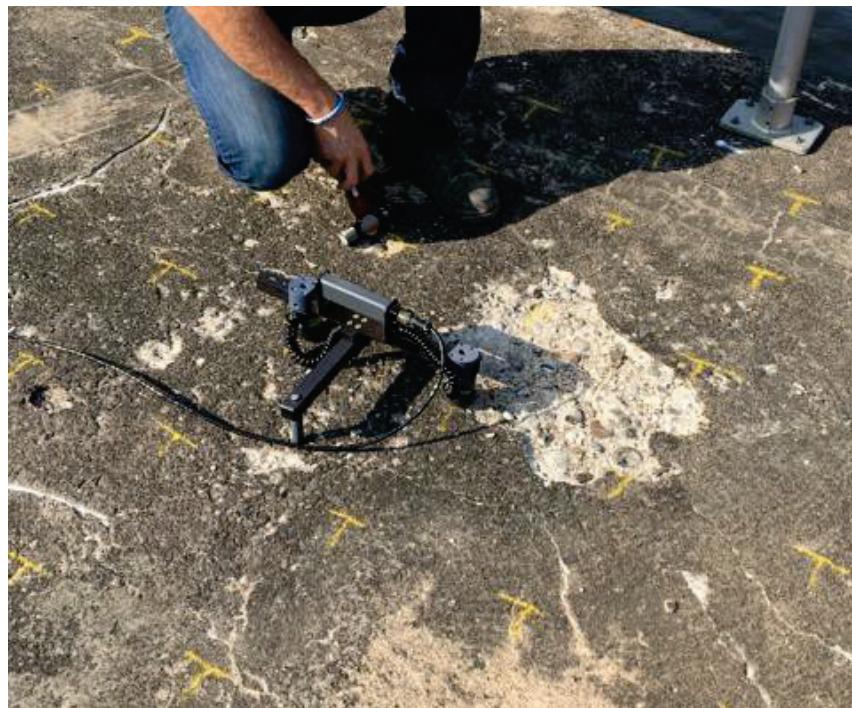
Figure 18. SASW equipment.

SASW testing consisted of a surface impact device and a collection device at a certain distance to measure wave velocities through the media. For this project, an Olson Instruments SASW-S system was used at a sensor

spacing distance of 12 in. Data were collected in a left-to-right orientation so that when the impact was tested at point 1, the collection sensor would be at point 2 as per the grid layout. The final point in each line would naturally cause the data collected to be located outside of the grid. Three “strikes” of the impactor were measured at each location. Over 2,100 SASW data points were collected. SASW equipment is shown in Figure 18.

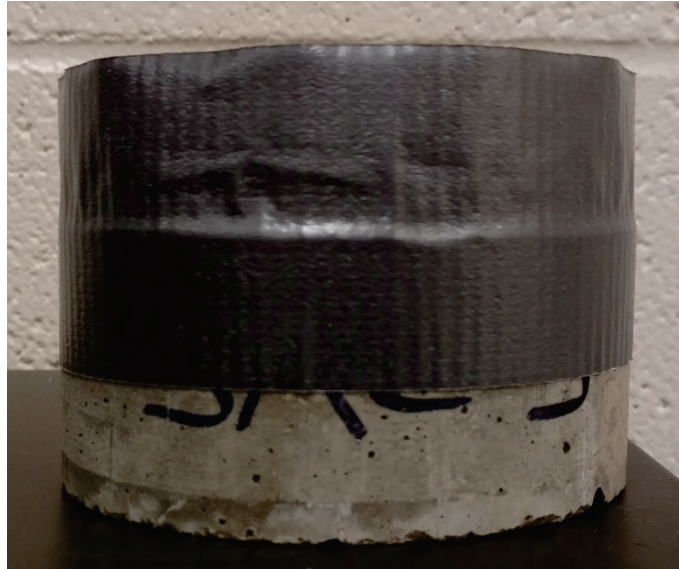
Figure 20. Puck with tape reservoir.

To test the reservoir, water was first filled, then emptied, and the surface patted dry to achieve a saturated surface dry condition. An initial mass measurement was then taken. The reservoir was refilled and the specimens allowed to sit at room temperature on a laboratory bench until the next measurement at which time the technique was repeated. Specimens were monitored and measurements recorded for a minimum of five consecutive days.
