U.S. Air Force Rapid Airfield Damage Repair (RADR) Program

Development of an Integrated Pavement Screed for Screeding Asphalt or Concrete Crater Repairs

Ben C. Cox and Nolan R. Hoffman

August 2019

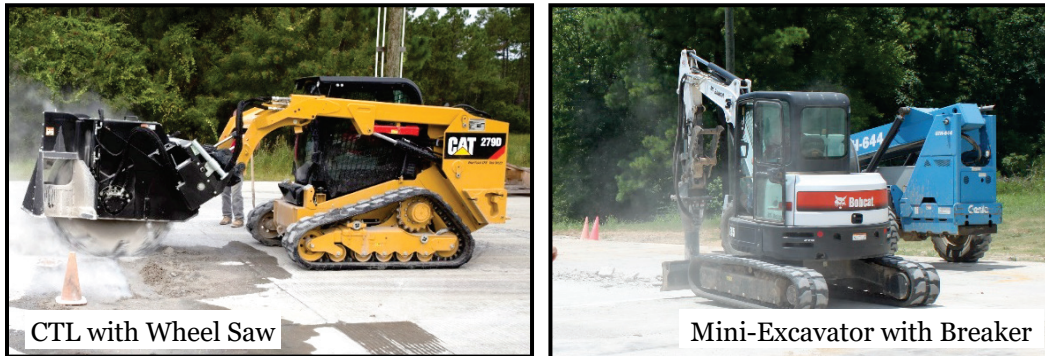
Figure 2.3. Producing test craters.

The test craters were produced from intact slabs as illustrated in Figure 2.3. Markings either 8.5- or 15-ft square were painted on the slabs and then saw-cut using a compact track loader (CTL) and CTL wheel saw. Concrete within the cuts was then broken and removed using a mini-excavator with breaker head and bucket attachments. Each crater was then excavated to a depth of 24 in. prior to backfilling.

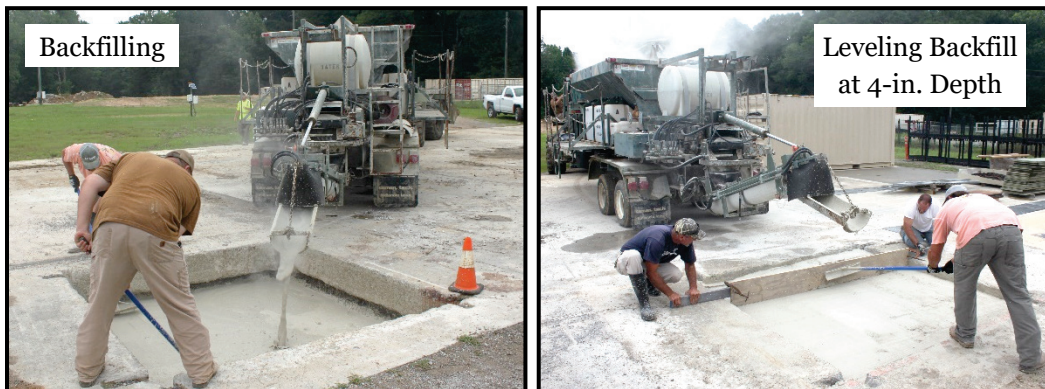
Figure 2.4. Placing FF-CTS-2 backfill in test craters.

As shown in Figure 2.4, each crater was backfilled with 20 in. of FF-CTS-2 using the SVM so that the remaining depth of each crater was 4 in. Strips of 0.75-in. plywood were clamped to a magnesium straight bar such that the straight bar could be dragged across the concrete surface and the plywood would strike off the FF-CTS-2 at the 4-in. depth.

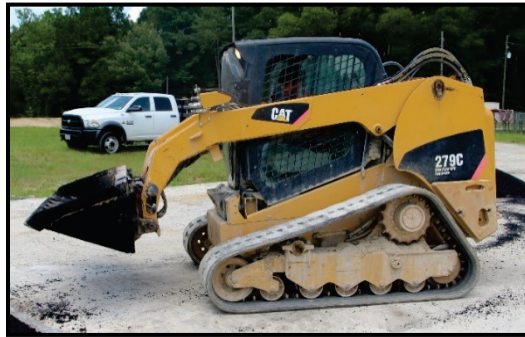
Figure 2.6. Caterpillar 279C compact track loader.

Figure 2.6 shows a Caterpillar 279C CTL, or skid steer, which was used primarily during AC repairs to charge the crater with AC from the stockpile. It was also frequently used for cleanup tasks. These CTLs are rubber-tracked machines with high-flow hydraulics and quick-connect fittings that are used extensively in modernized ADR processes because they are versatile and efficient for many purposes. While there are many CTL attachments that may be used during RADR operations, the only attachment used in this project was a bucket attachment.

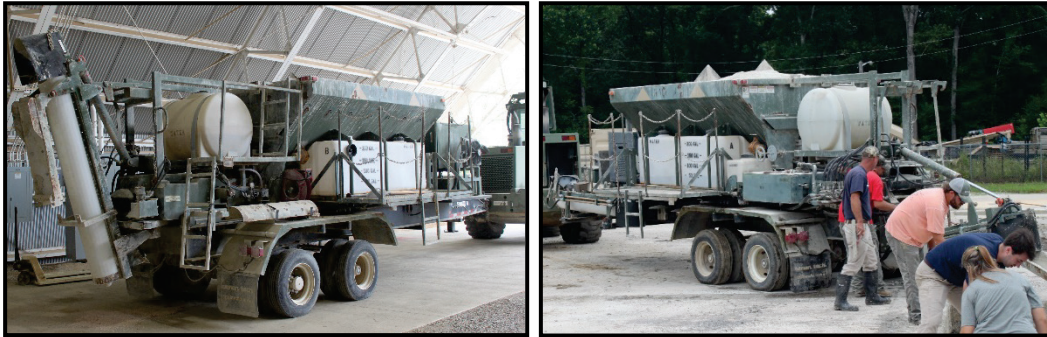
Figure 2.8. Simplified volumetric mixer (7 yd³).

The SVM₇ is towed with a vehicle capable of pulling at least 20 tons (typically a dump truck). Key components of the SVM₇ are a single dry material hopper (approximately 7-yd³ capacity), a conveyor belt feed system, a water pump to meter mix water at a fixed pump speed, two 200-gal water tanks, a washout tank, and a replaceable mixing auger mounted in a discharge boom at the rear of the mixer. The SVM₇ is also equipped with two retractable catwalk platforms, a bin entry platform, a replacement auger, and two supersack piercing points.

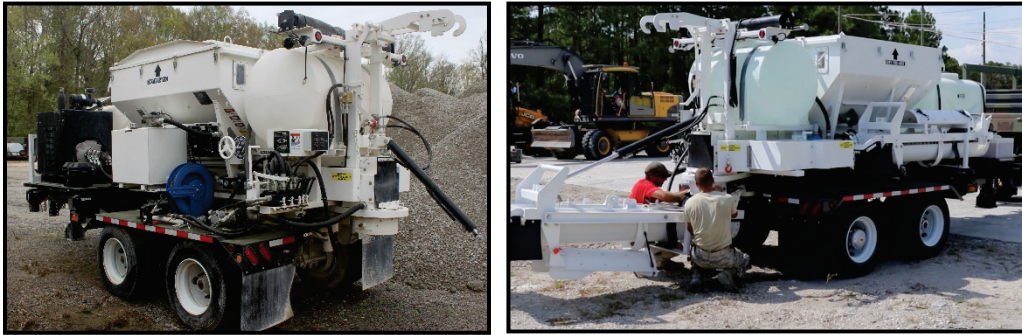
Figure 2.9. Simplified volumetric mixer (2 yd³).

Figure 2.9 shows the 2-yd³ simplified volumetric mixer (denoted SVM₂) that was designed as a lighter, leaner SVM₇ alternative for the RADR program. Operationally, it is nearly identical to the SVM₇ with the exception that its dry material hopper is approximately 2 yd³.

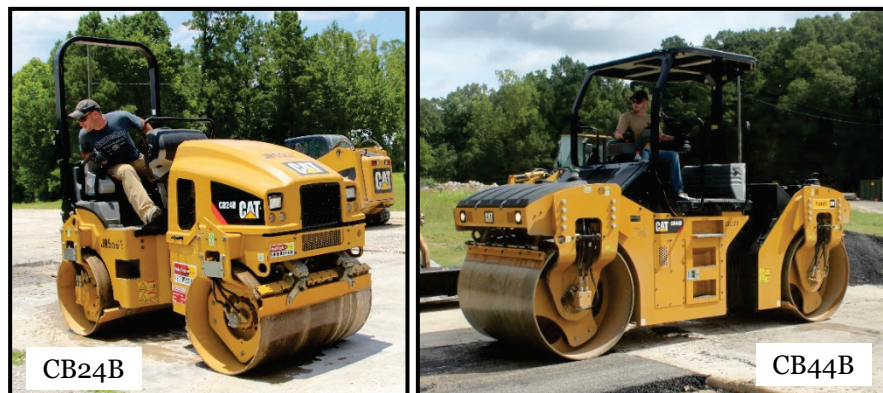
Figure 2.10. Steel wheel roller compactors.

Figure 2.10 shows two steel wheel rollers that were used in this project for compacting AC repairs; Table 2.5 provides roller specifications. A smaller 47-in. roller was rented for most of the work in this project as it is relatively similar to the roller supplied in the Sustainment Pavement Repair (SuPR) kit. A larger 59-in. roller was rented for one repair series as it was closer in size to that used in the original asphalt screed study.¹ It was used to compare any differences in compacted AC density and, consequently, roll-down factors necessary for AC.

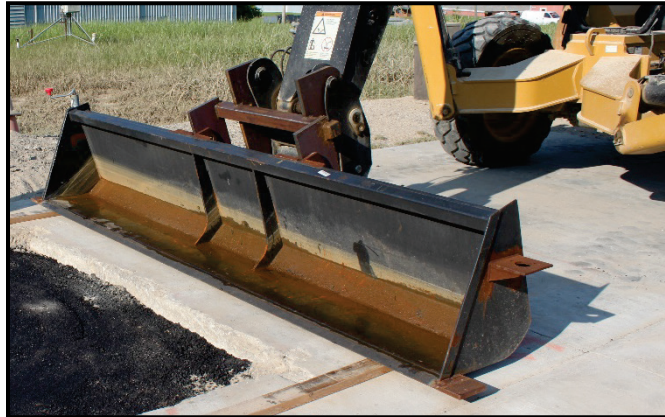
Figure 2.12. Bucket Strike Off.

The BSO (Figure 2.12) is another asphalt screed also designed by ARA in cooperation with an external fabrication shop.¹ It consists of a custom long, shallow bucket that was modified to directly couple to a telehandler in place of the fork attachment. For this reason, a vertical float mechanism was incorporated that allows approximately 3 in. of vertical travel between the bucket and the telehandler boom. This was intended to provide some forgiveness to the operator and prevent the need for constant boom angle adjustments while extending the boom across the repair. The bucket was made as wide as possible while trying to minimize the volume of material it would hold, reducing the load on the telehandler. The bucket was nominally 11 ft wide by 1 ft-6 in. deep by 2 ft tall.

Grade control skis on jacks were originally incorporated on each side of the BSO; however, they were insufficiently braced, bent during repair trials,¹ and removed. Adjustable end gates separate from the grade control skis were fabricated and clamped onto the leading edge of the BSO bucket. Like the BSO itself, these incorporated a vertical float feature. Being adjustable, the screeding width was variable from 0 to 11 ft.

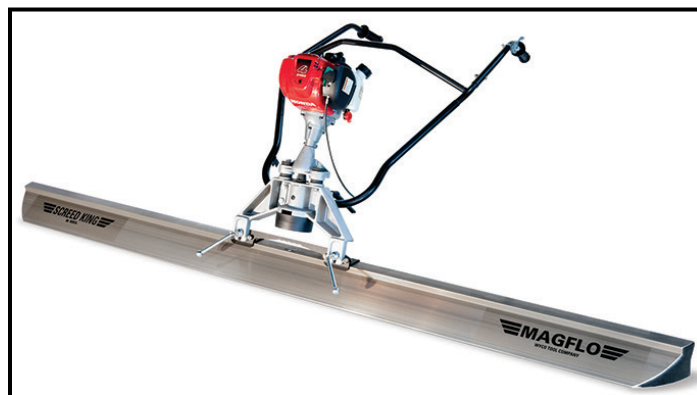
Figure 2.14. Wyco Screed King.

The Screed King requires the operator to walk through the repair to drag the screed across it. This can be somewhat cumbersome. The screed is relatively lightweight as well, which lends to its tendency to ride up over the repair material rather than striking it off. As a result, two additional operators are required to apply pressure to the ends of the screed bar in order to keep it in contact with the ground and maintain a flat repair. Otherwise, it is an economical screed that can be easily transported and has had satisfactory results in previous troop demonstrations.

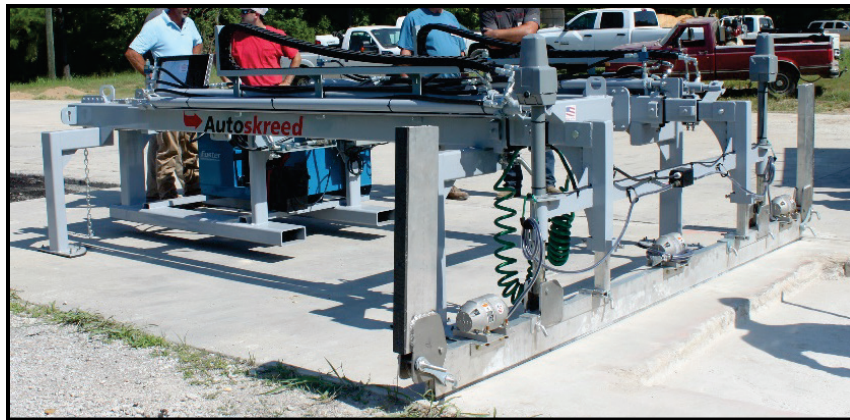
Figure 2.15. Hydraulic Autoskreed (ASHyd).

Nasby Fabrication developed two new Autoskreed models based on ERDC recommendations. The ASHyd discussed in this section is moved and positioned near a crater by a telehandler. Once positioned, the ASHyd operates independently using an onboard hydraulic power supply to extend the screed boom over the repair and electric jacks to raise or lower the screed board to the desired elevation. The hydraulic boom and the electric jacks are operated by a handheld remote, allowing the operator to act as his own spotter. It also has two 12 V electric vibrator motors to aid in consolidating and finishing the repair surface. Table 2.6 provides pertinent specifications of the ASHyd.

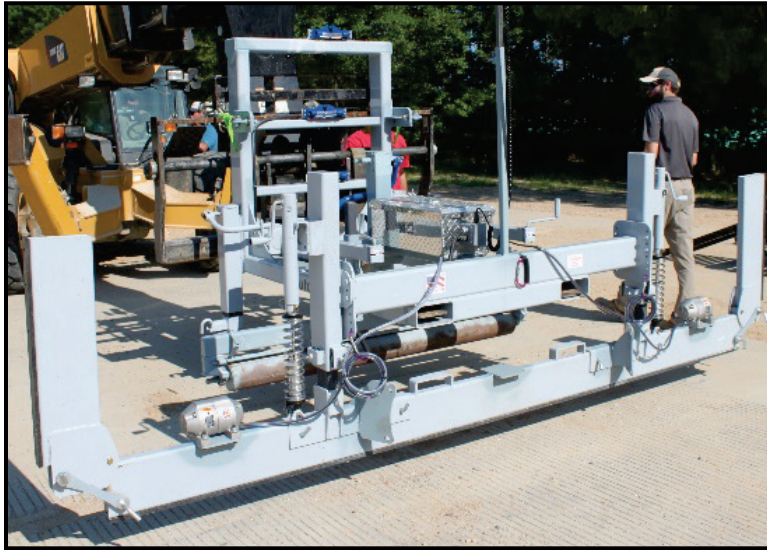
Figure 2.16. Telehandler Autoskreed (ASTH).

The telehandler-powered Autoskreed (ASTH) (Figure 2.16) is the second model developed by Nasby Fabrication based on ERDC recommendations and is a simpler concrete screed relative to the ASHyd. Unlike the ASHyd that has its own hydraulics and boom, the ASTH utilizes the boom on a telehandler to extend over and screed a repair. The ASTH has no separate, onboard engines or hydraulics, which results in a lower maintenance screed solution. Table 2.7 provides pertinent ASTH specifications.

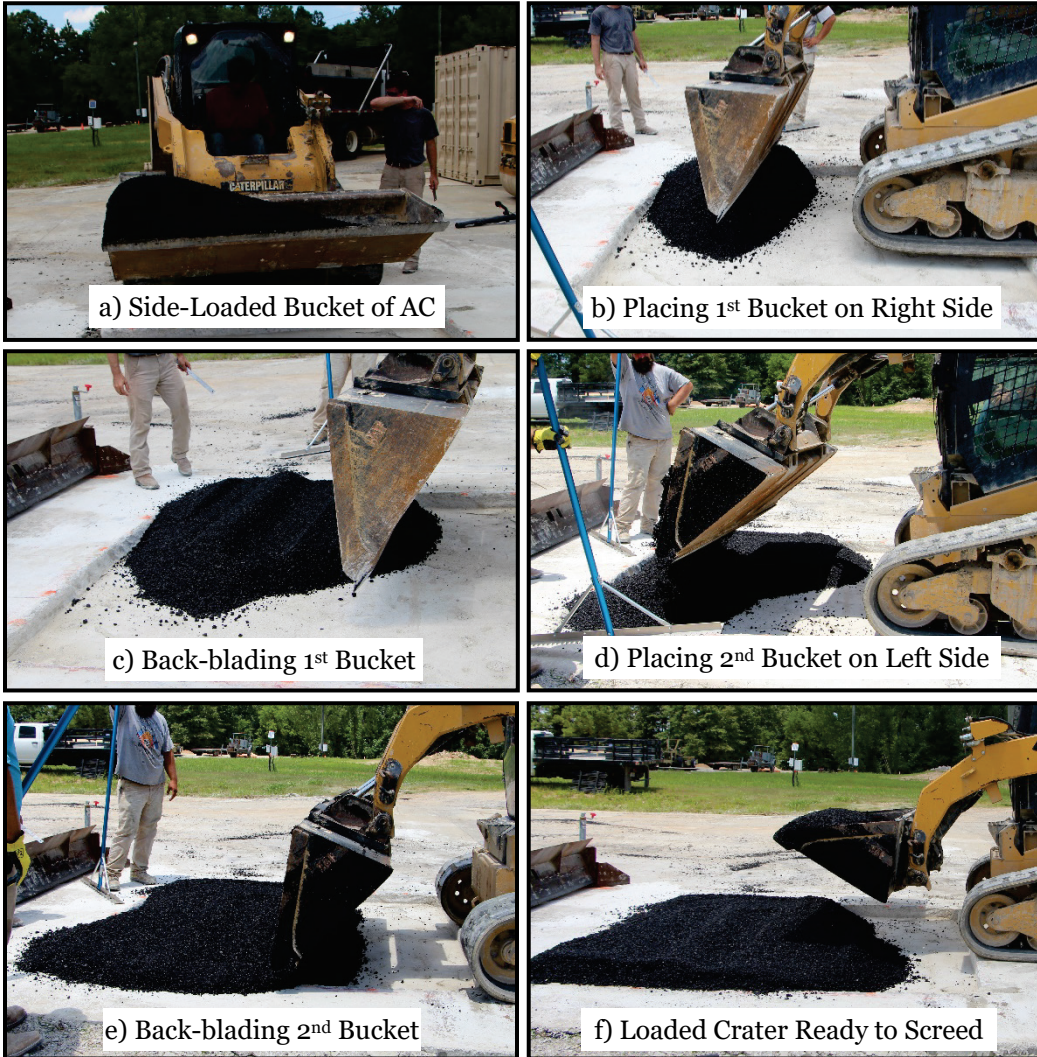
Figure 2.19. Photos of loading AC and performing pre-strike-off.

During AC placement, the screed was positioned near the crater with the screed set 1.5 in. above the parent slab surface so that the compacted AC surface would be flush with the parent slab. This 1.5-in. roll-down factor was found to be sufficient for a 4-in.-deep repair.¹ The CTL operator placed the first load of material near the screed, working away from the screed. Once the crater was approximately 60-70% filled with AC, screeding began. As with concrete repairs, asphalt repairs required a screed operator and a spotter. In many cases, one screed pass was sufficient; in some cases, multiple screed passes were needed. The following subsections describe any procedural details specific to each screed. Note these procedures were the initial operating procedures used or those prescribed by the manufacturer – any procedural improvements are discussed in Chapter 3 results.

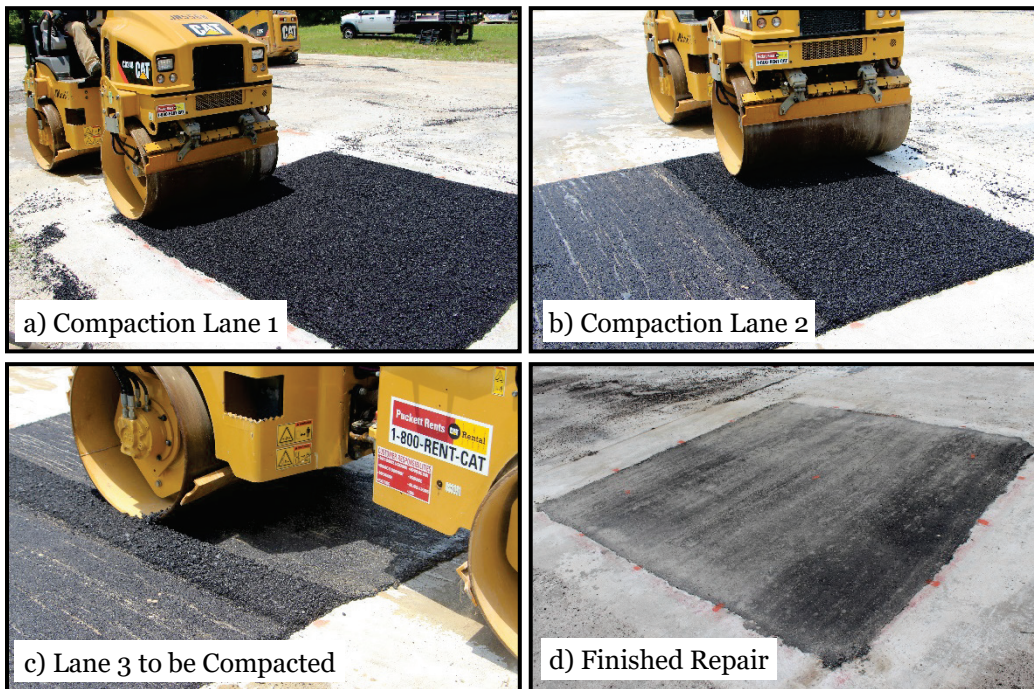
Figure 2.21. Photos of AC compaction with CAT CB24B.

Compaction began as soon as other equipment cleared the area and excess AC was removed. The roller pattern used¹ was used herein with minor modifications to accommodate the 47-in.-wide CAT CB24B roller (Figure 2.20). A small crater (8.5 ft wide) or one lane of a large crater (approximately 7.5 ft wide) was compacted in three compaction lanes. In each compaction lane, seven total passes were applied with a pass being defined as a pair of forward and backward passes. The first pass (initial) was half static and half vibratory; the next two (intermediate) were vibratory; and the final four (finish) were static. However, the initial pass was applied in all three compaction lanes before applying intermediate passes in compaction lane #1 as illustrated in Figure 2.20. Likewise, all intermediate passes were applied before any finish passes. When the CAT CB44B was used, only two compaction lanes were necessary, but compaction was otherwise identical. Figure 2.21 shows typical photos of compaction following the Figure 2.20 roller pattern.

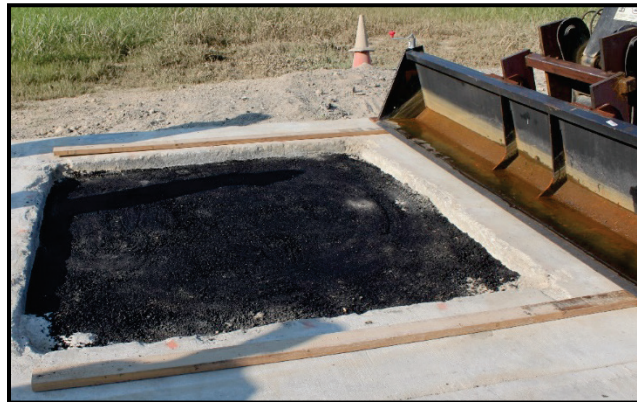
Figure 2.22. Grade blocks.

The BSO, which did not have grade control skis, was set to the 1.5-in. grade height by laying 2x4 lumber on each side of the crater (Figure 2.22) and placing the BSO on top of the 2x4s. These 2x4s are further referred to as the grade blocks. The bucket was angled so that the blade of the bucket was parallel with the parent slab. Like the SSO, the telehandler boom had to be angled downward to place the BSO on the grade blocks, so the operator occasionally had to raise the boom angle based on the spotter's guidance. For the large crater, additional 2x4s were placed inside the crater to support the grade blocks.

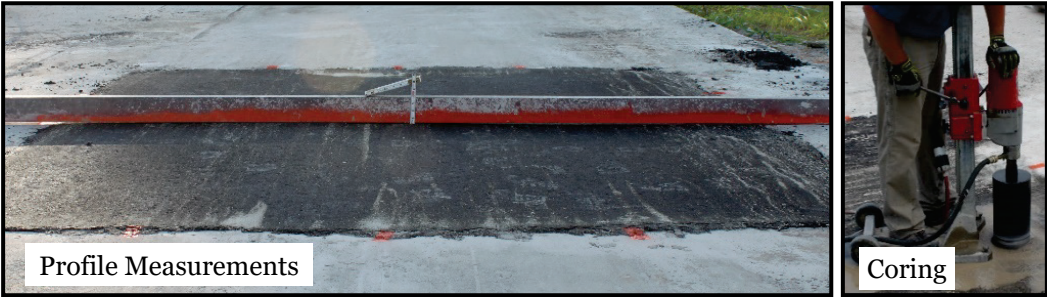
Figure 2.23. Repair evaluations.

Finished repair quality was evaluated by visual inspection, surface profile measurements, and, in several cases with AC repairs, core samples (Figure 2.23). Key items of interest during visual inspection were extreme roughness issues, cracking for RSC repairs, evidence of segregation or tearing for AC repairs, and any other notable distress. Surface profiles were measured using a straightedge on a 2-ft grid for small craters or a 3-ft grid for large craters and were reported as deviation (in.) relative to the existing grade of the surrounding parent slab. Cores cut from AC repairs were dried in the lab for air void (V_a) determination following ASTM D6752 (ASTM 2017c) and D2041 (ASTM 2011) for bulk and maximum specific gravities, respectively. This was to verify that reasonable compaction was being achieved using the set roller pattern.

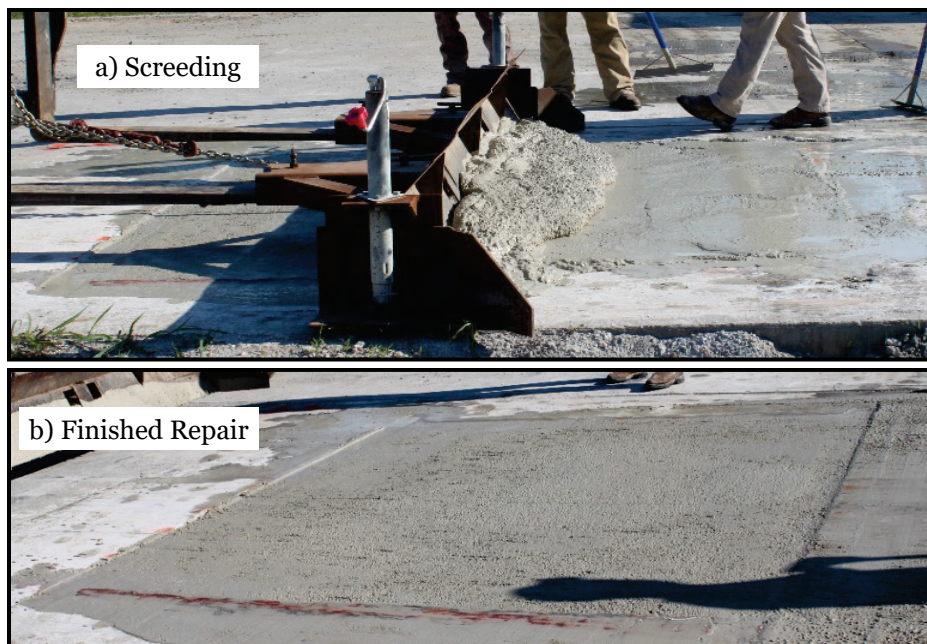
Figure 3.2. Small crater RSC repair with the SSO.

Overall, the simplicity of the SSO made it easy to operate, and it worked very well for small repairs. Figure 3.2 shows the SSO in use on a small repair where the recessed characteristic of the finished surface is visible in Figure 3.2b. Otherwise, there were no issues of note.

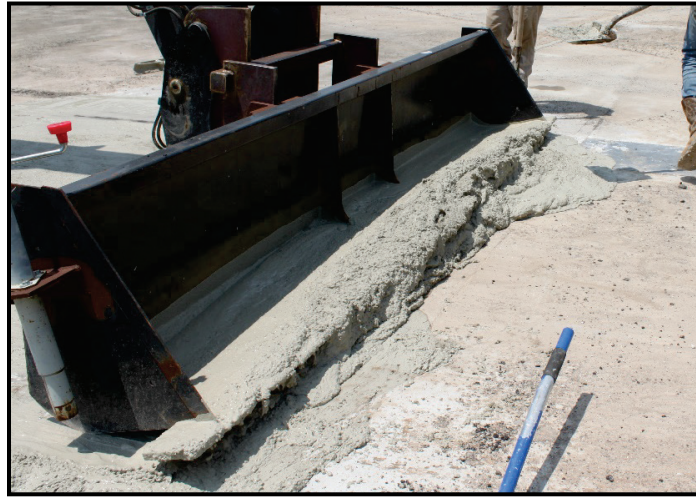
Figure 3.5. Excess RSC retained in BSO bucket requiring more cleaning.

Overall, the BSO was also simple and easy to operate and performed similarly to the SSO for small repairs. Figure 3.4 shows a small repair with the BSO. In general, the BSO worked well, but the bucket retained a considerable amount of RSC (Figure 3.5) which increased cleanup efforts.

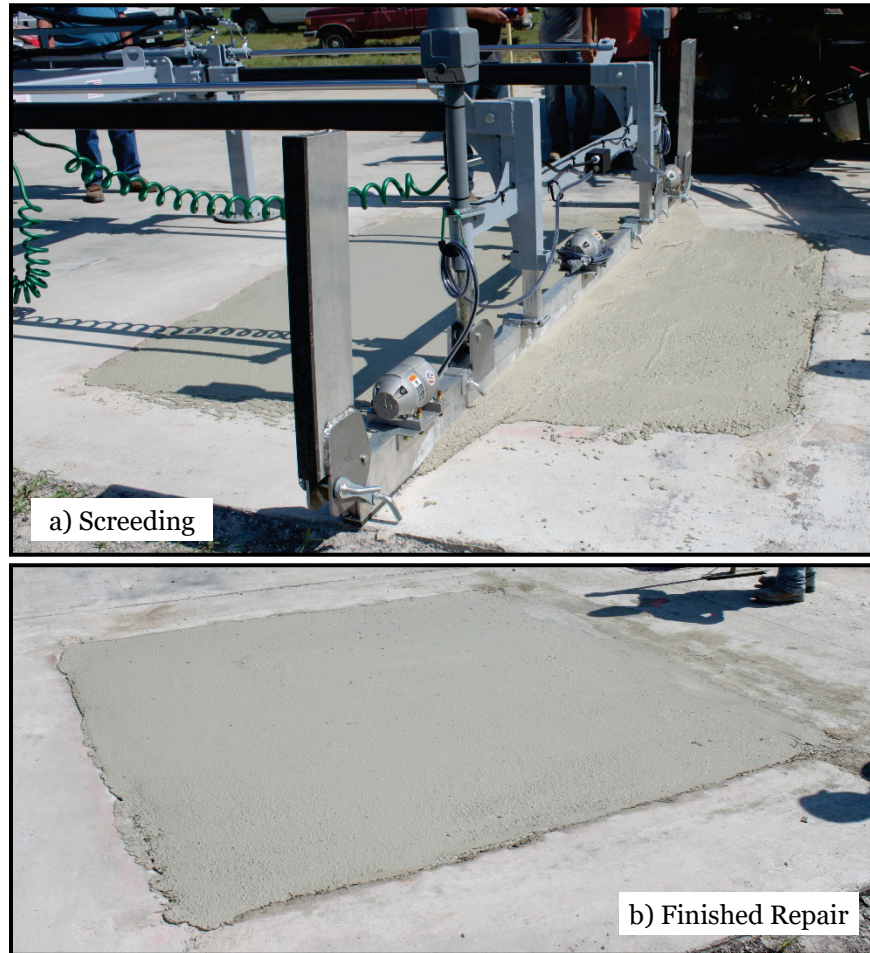
Figure 3.7. Small crater RSC repair with the ASHyd.

The ASHyd worked well for small repairs. Figure 3.7 shows the ASHyd in use. The ASHyd was easy to operate as all functions could be controlled from the user's remote. For crater C2, the crater was overfilled with an excess of RSC to test the ability of the hydraulics to push a large amount of material, in which case it had no issue.

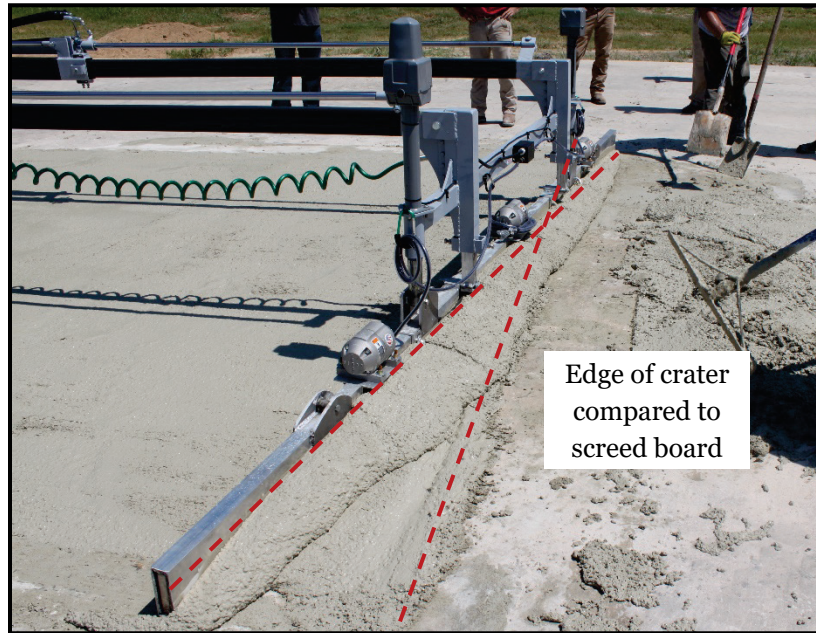
Figure 3.8. Angled ASHyd screed board.

One detracting, though not prohibitive, aspect of the ASHyd is that the left and right hydraulic cylinders are connected via a hydraulic flow divider. As a result, if resistance on the two cylinders is unbalanced (e.g., more concrete is built up on one side of the screed than the other), flow will be diverted to the cylinder with less resistance. This causes the screed board to advance faster on one side (Figure 3.8). If it becomes too angled, the hydraulic booms can bind. The only solution once this began was to fully extend or retract the screed to realign both cylinders.

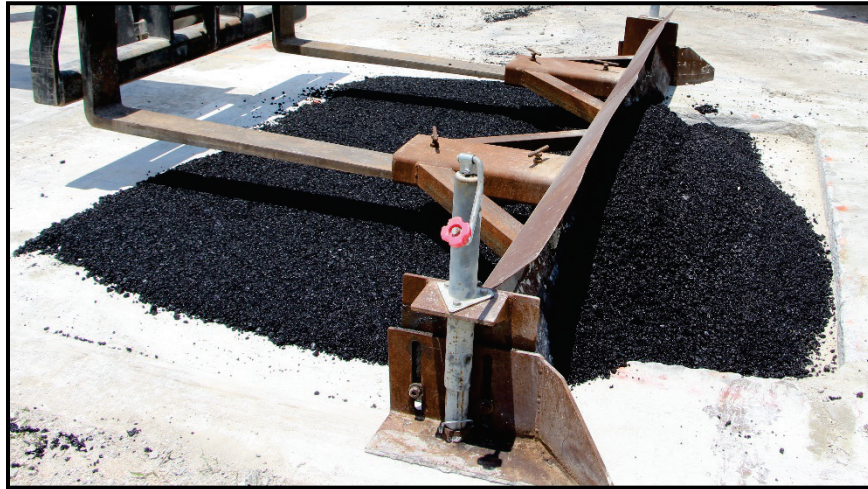
Figure 3.12. Screeding small crater AC repair with the SSO.

The SSO worked well overall for small repairs, providing a well-screeded surface. Figure 3.12 shows the SSO in use. Because the end gates are incorporated into the grade control skis and cannot be relocated to match the width of the crater, excess AC spilled to the outside of the repair during screeding as shown in Figure 3.13 and had to be removed with shovels and rakes before compaction. This could have been alleviated by decoupling the end gates and grade skis so that the end gates were adjustable. However, if the end gates were set at the edges of the crater, the telehandler would have to be perfectly aligned with the crater. Otherwise, the end gates would drift into or away from the crater edges as the screed was advanced. This scenario was also discussed in Pullen et al. (2016) where an emphasis was placed on aligning the telehandler with the crater.¹ For the 30-ft repairs in particular, this was not necessarily easy because a slight misalignment, that may not be visually apparent at first, would be magnified as the screed was extended. While it required more handwork to clean up the edges between screeding and rolling, it was felt in this project that this method may be an overall better solution than trying to exactly trim AC along the crater edges with end gates.

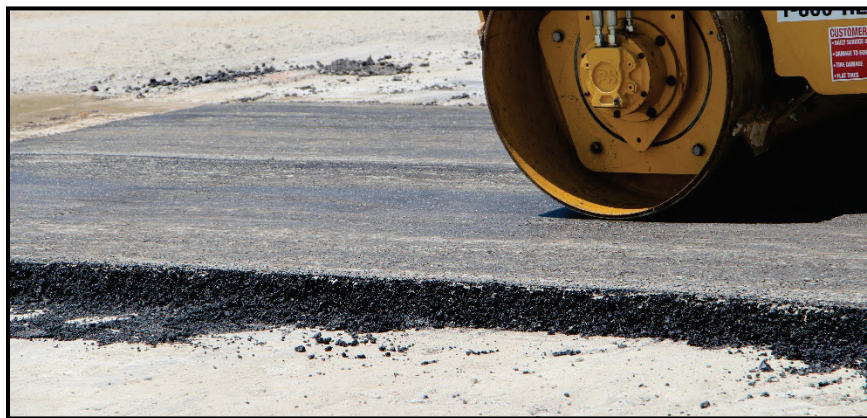
Figure 3.17a shows the second large repair paving lane between screeding and compaction. Figure 3.17b shows the same lane after the first roller pass where waviness from improper loading with the CTL is noticeable. This waviness was not rolled out during compaction and likely led to the worsened profile measurements in Table 3.2.

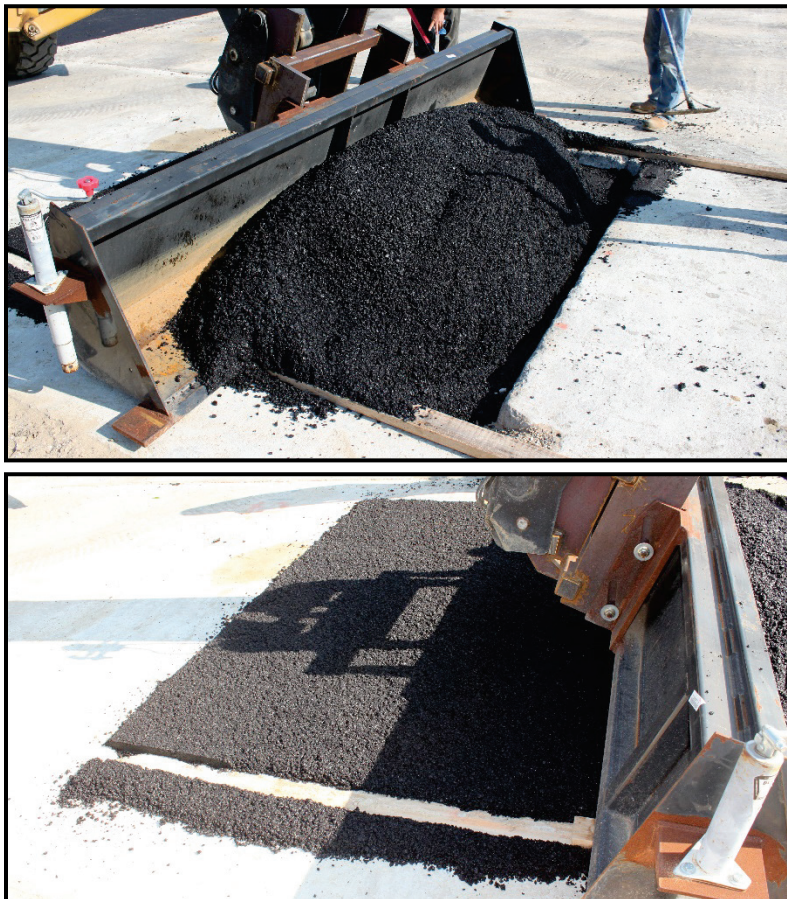
Figure 3.19. Screeding small crater AC repair with the BSO.

The BSO worked well overall for small repairs, providing a well-screeded surface. Figure 3.19 shows the BSO in use. The biggest issue with the BSO was its lack of a grade control system, requiring the use of 2x4s to provide the roll-down factor. If placed directly at the crater edges, the 2x4s helped to some extent in the amount of AC cleanup required between screeding and compaction. It did not completely eliminate cleanup though. Another notable difference with the BSO is that it requires more AC be loaded into the crater to accommodate the amount that will fill the bucket. Cleanup of excess AC was required using shovels and rakes as with the SSO in Figure 3.13. Figure 3.20 shows a completed small crater AC repair.

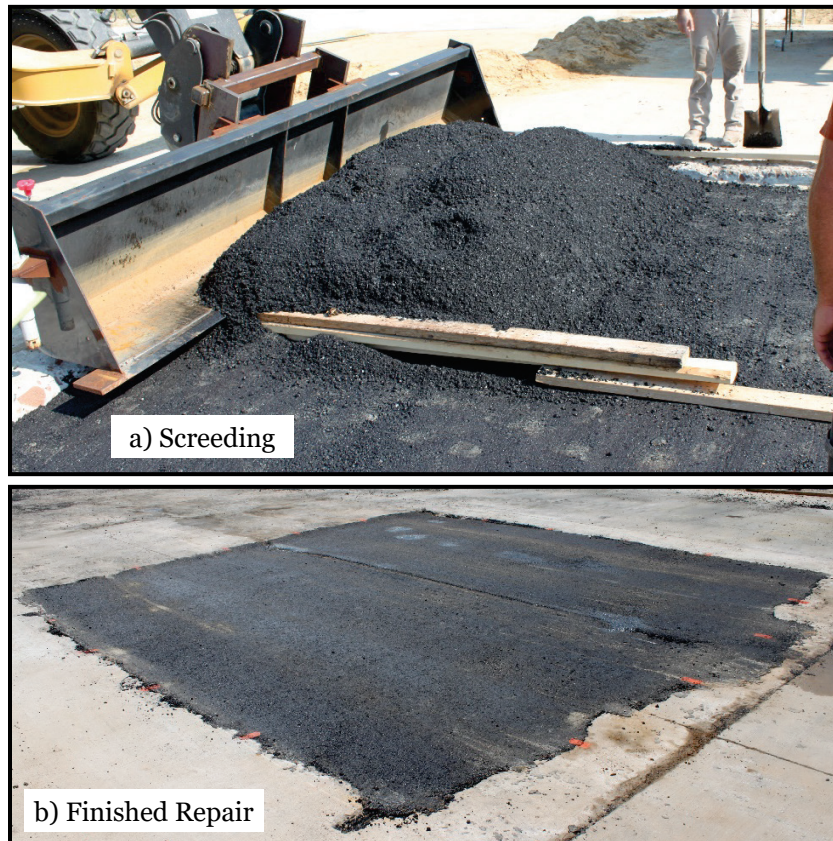
Figure 3.21. Large crater AC repair with the BSO.

For the large repair, the BSO provided a final surface almost equivalent to the SSO; however, the entire screeding process was much clumsier as multiple 2x4 grade blocks were required (Figure 3.21). Also, excess AC remained in the bucket, meaning the BSO did not fill in low spots as well as other screeds. Overall, the large BSO repair did not satisfy RQC requirements based on *MD* (i.e., within-repair roughness).

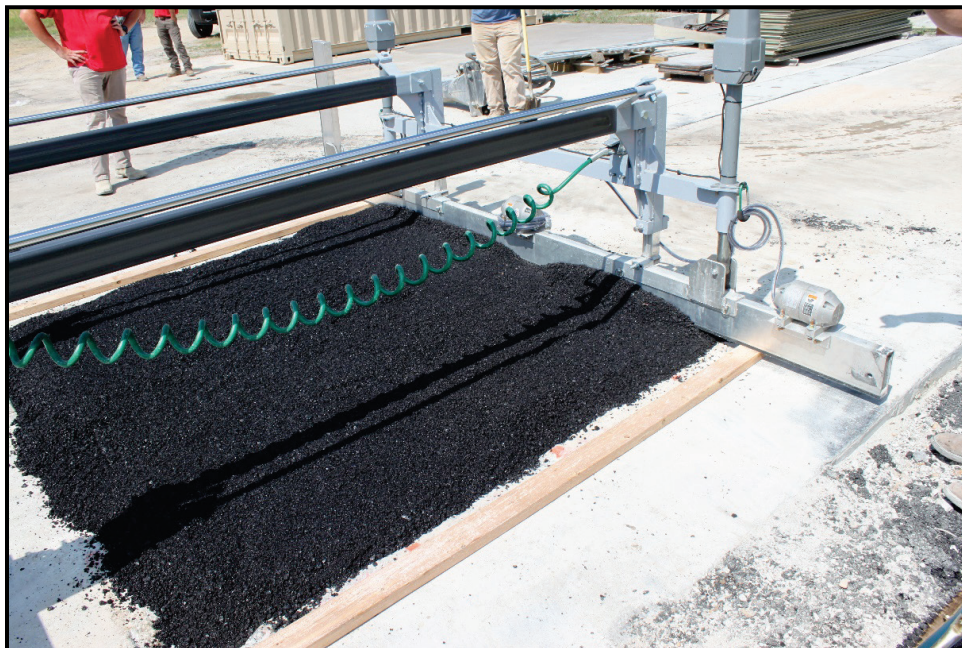
Figure 3.22. Small crater AC repair with the ASHyd.

Figure 3.22 shows the ASHyd screeding a small repair. Once positioned, the screed worked quickly but struggled to move large amounts of AC. Instead, the ASHyd would begin riding up on the AC. To work around this issue, the repairs were screeded in multiple passes, incrementally lowering the screed board to the 1.5 in. height. As with the BSO, 2x4 grade blocks were used to provide the 1.5 in. reference. The incremental passes caused some waviness in the screeded surface as shown in Figure 3.23, but this was mostly rolled out during compaction. In contrast to all other screed testing in this project that pushed material away from the telehandler or ASHyd, AC was pulled towards the ASHyd as a precaution to prevent any potential bending of the hydraulic cylinders. Figure 3.24 shows a completed small crater repair.

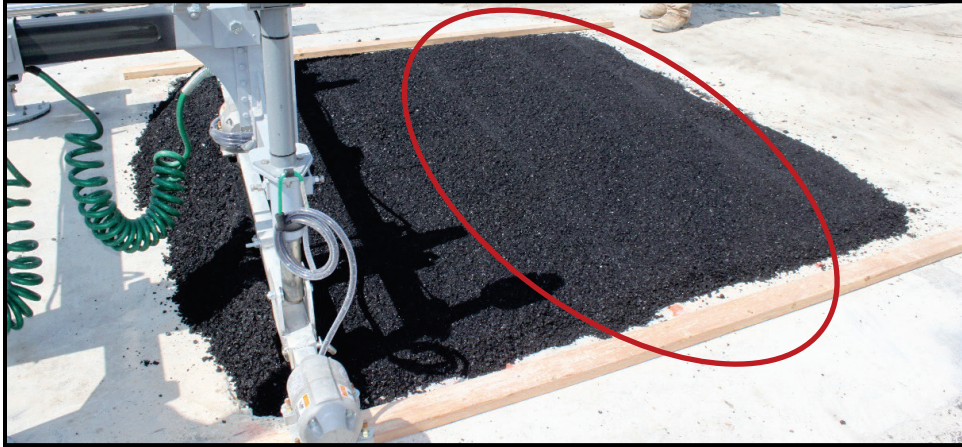
Figure 3.23. Waviness in screeded surface of ASHyd small crater AC repair.

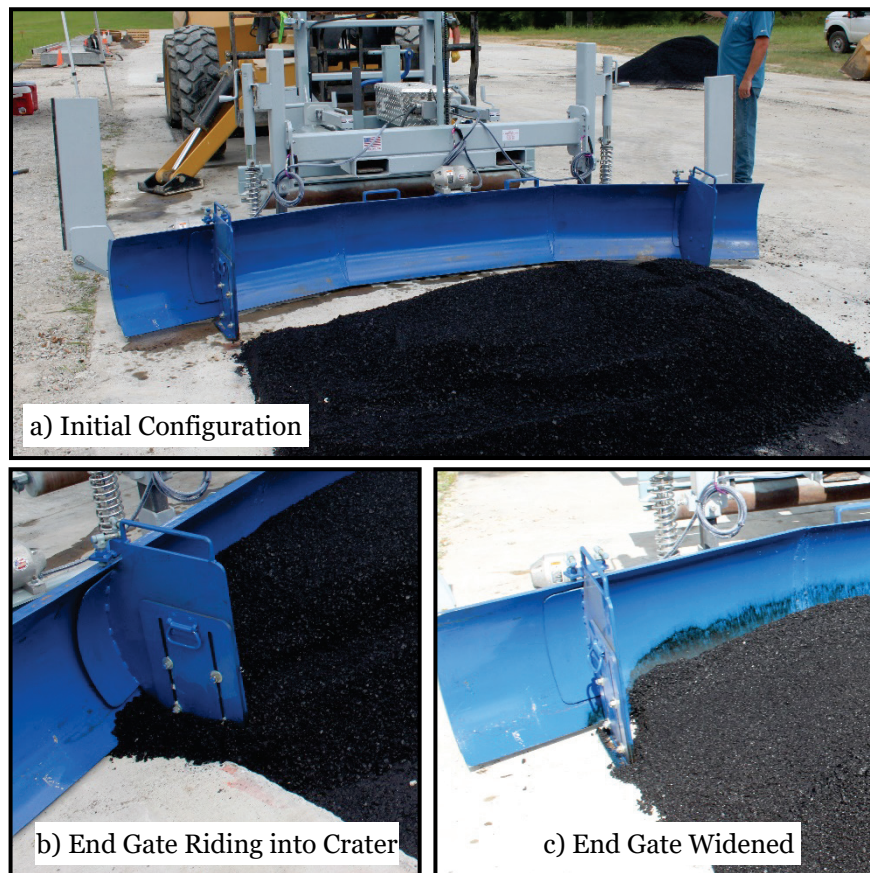
Figure 3.25. Small crater C1 AC repair with the ASTH.

For small crater C1, the ASTH used the pin-on U-blade and end gates that doubled as grade control skis. Figure 3.25a shows the screed in position with the end gates set to match the crater width. Because of the inward angle of the end gates, they both drifted into the crater while screeding as shown in Figure 3.25b. This cut off part of the asphalt material but also caused the ASTH to snag and begin chattering across the repair. Ultimately, the end gates were widened as shown in Figure 3.25c, acting

solely as grade control skis. Because the U-blade was pinned to the ASTH at its center section and the grade control skis were located on the outer sections, the middle of the U-blade sagged when any downward force was put on the ASTH. Thus, while there was about 1.5 in. of roll-down at the outside edges of the repair, the middle of the repair had essentially no roll-down factor. This is evidenced by the Table 3.2 average elevation of approximately 0.5 in. below the surrounding pavement, the lowest elevation of all asphalt repairs.

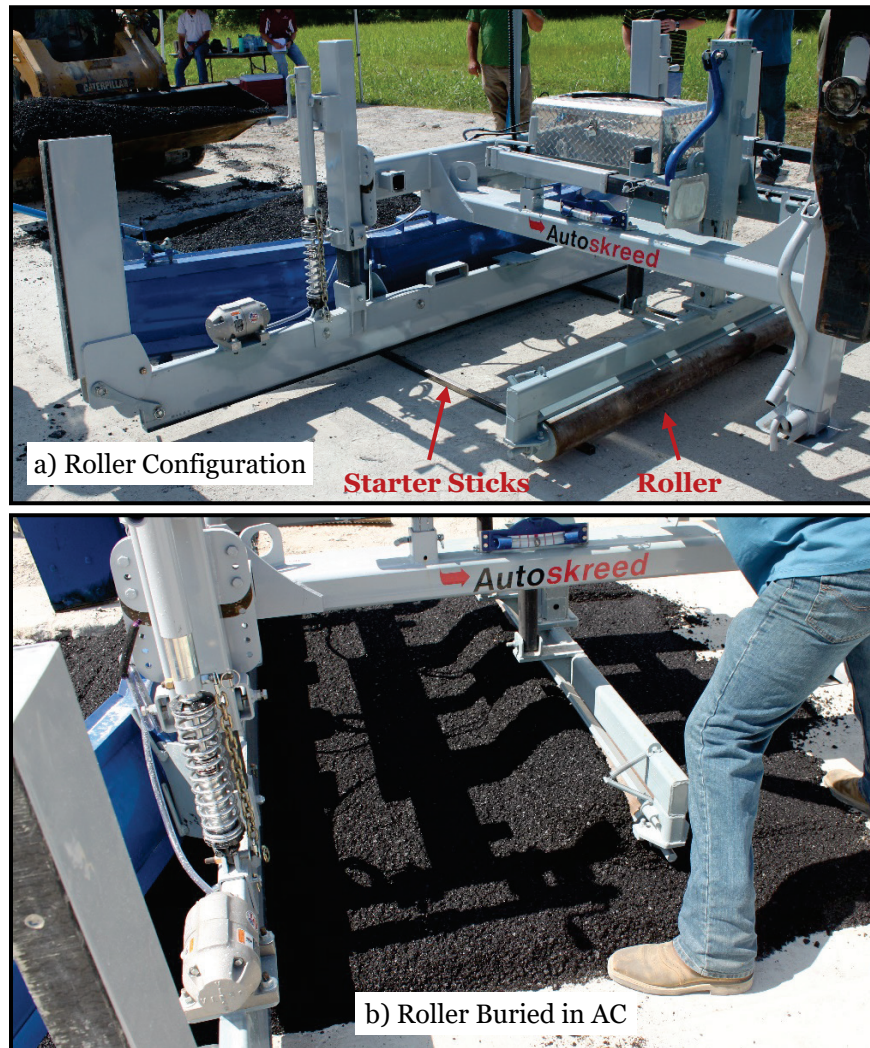
Figure 3.26. Small crater C2 AC repair with the ASTH.

For small crater C2, a slightly different approach was tried since crater C1 was not fully successful. The end gates were set wide and used essentially for grade control only. To prevent the middle of the U-blade from sagging again, the roller system designed for use with large repairs was also used. Figure 3.26a shows the roller system resting on the 1.5-in. square starter sticks with the idea being that the roller would transition seamlessly from the starter sticks to the AC and simply roll across it at a consistent grade. Figure 3.26b shows that the roller plowed through the AC rather than rolling across it. Screeding was finished with handwork.

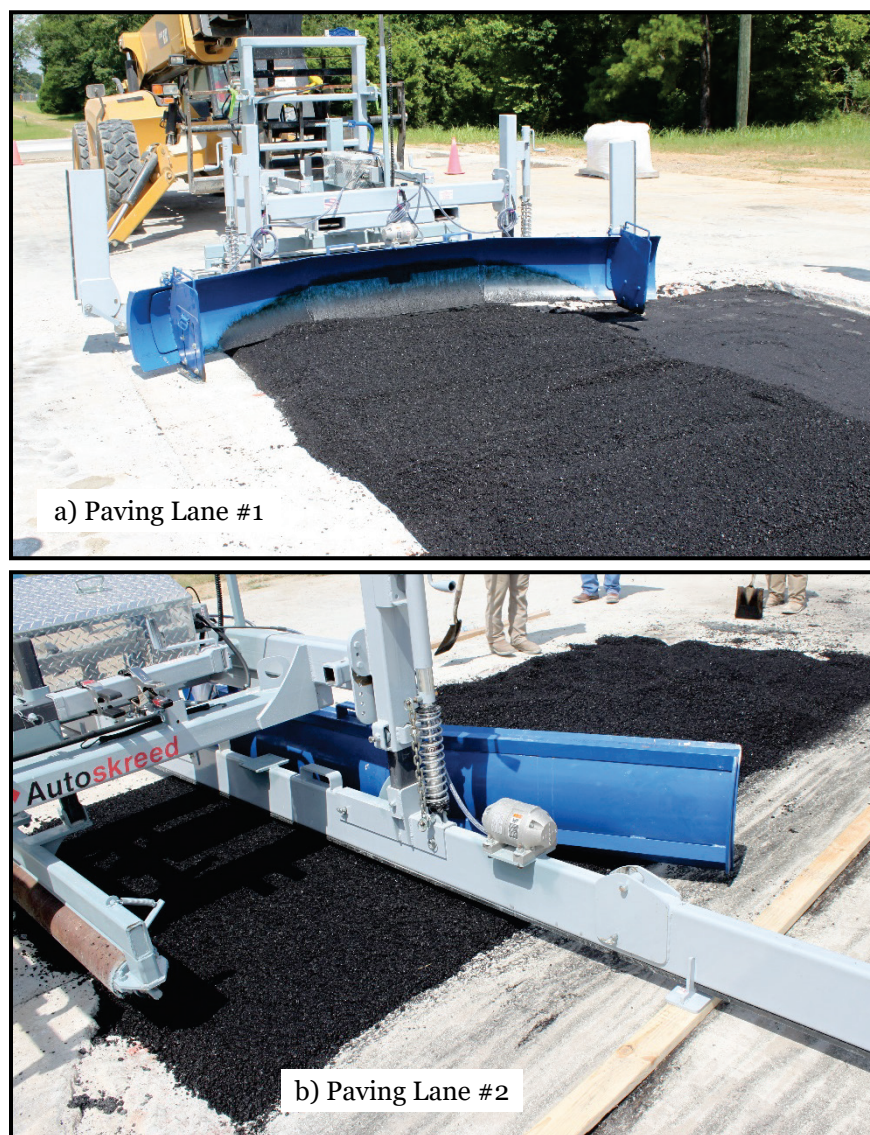
Figure 3.27. Large crater AC repair with the ASTH.

For the large crater repair, neither the roller nor the end gates were used to any meaningful degree. For the first paving lane, the telehandler boom was constantly adjusted to try to, first, keep the outside end gate in contact with the parent slab and, second, keep the U-blade level from left to right as the inside end gate was unsupported (Figure 3.27a). For the second paving lane, small steel brackets designed as stands for the screed board were placed under the screed board to ride on 2x4 grade blocks as shown in Figure 3.27b. Overall, this process was one that would not be easily repeatable because it relied too much on the operator. Ultimately, the large ASTH repair did not satisfy RQC requirements based on *MD* (i.e., within-repair roughness).

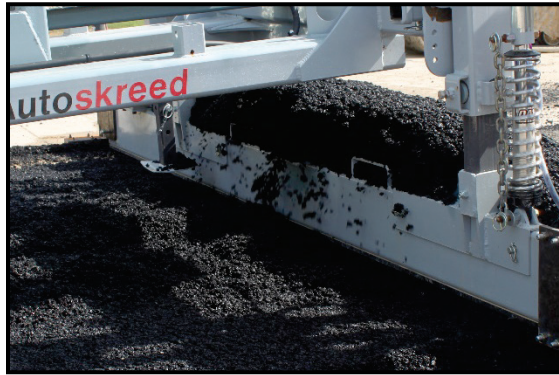
Figure 4.8. AC overtopping ASTH-Mod screed board.

Testing the ASTH-Mod on the small crater revealed two issues. First, AC easily overtopped the 8-in.-tall screed board if the AC in the crater was not sufficiently leveled during pre-strikeoff or if, though leveled, there was too much AC in the crater. Figure 4.8 illustrates this problem. This problem was already anticipated based on Chapter 3 testing; however, no effort was made to address this during the screed integration work because the resources required to build a new screed board were not justified given the simplicity of the issue. The problem could be relatively easily addressed if

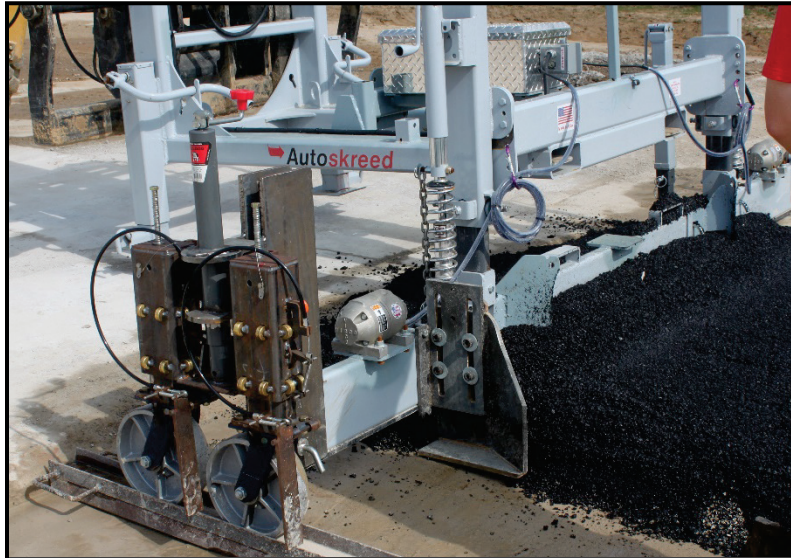
On the large crater, the AGCS and floating end gate demonstrated the potential to work; however, preloading the travel springs on the ASTH caused minor issues. Recall that the travel spring stiffnesses were 140 lb/in. Typically, the springs were preloaded 3 in. to the midpoint of their total 6 in. travel distance. This would result in 840 lb of downward force being applied to the screed. Because the screed board was located at the end of the telehandler forks, creating a 6-ft moment arm, it was difficult to apply this preload while keeping the ASTH-Mod level. Instead, the ASTH-Mod tended to roll backwards as illustrated in Figure 4.9.

With the ASTH-Mod angled, the floating end gate also sat at an angle with the nose up as can be seen in Figure 4.9. This allowed the end gate to ride on top of any AC in its path rather than directing it into the width of the placement and creating a clean vertical face. As the screed extended across the repair, the end gate gradually climbed creating a tapered edge as shown in Figure 4.10.

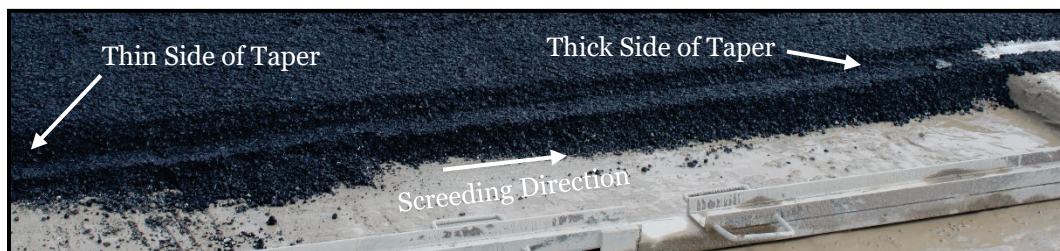
Figure 4.10. Tapered AC edge due to upward angle of end gate nose.

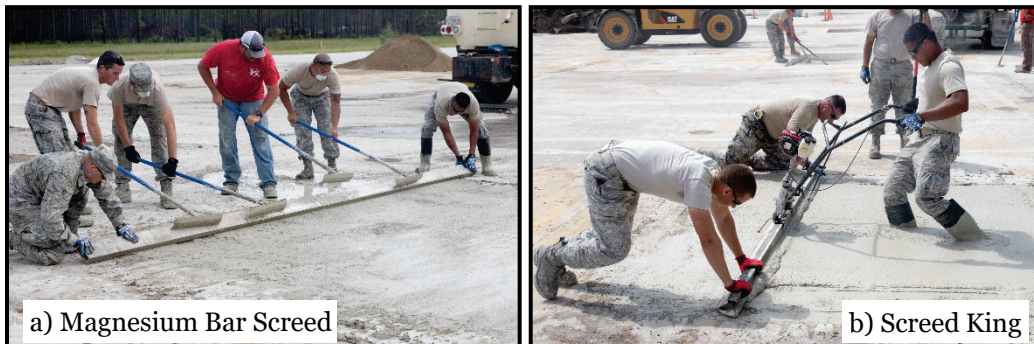
Figure 5.3. Bar screed and Screed King in use at the RADR demonstration.

With respect to manpower, the ASTH required one operator and one spotter, while the bar screed or Screed King required at least three airmen or more in some cases. For example, Figure 5.3a shows a case where six men (one ERDC technician had to assist the airmen) were required to drag the bar screed. This was at least partly because of the width of the repair

and the amount of excess concrete, creating a significant weight of concrete that must be moved. Figure 5.3b also shows that one person must wade through the fresh concrete when using the Screed King, which can be cumbersome. In addition to requiring one less airman, the physical effort involved with use of the ASTH was significantly less than that of the bar screed or Screed King, which has some benefit. Note that final finishing and cleanup of excess concrete still required more than two airmen in most cases, regardless of which screed was used.
