TECHNICAL REPORT 3163

August 2019

**Eelgrass and Macroalgae in Vicinity
of the Proposed Service Pier Extension
at Naval Base Kitsap Bangor**

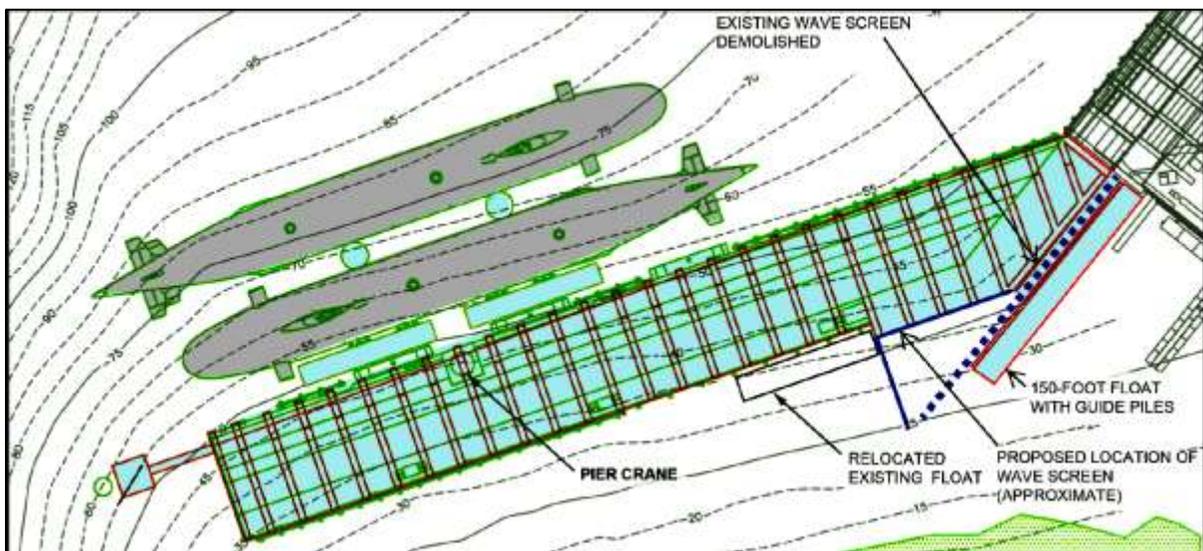
Figure 3: Proposed Project (Source: Modified from Naval Facilities Engineering Command).

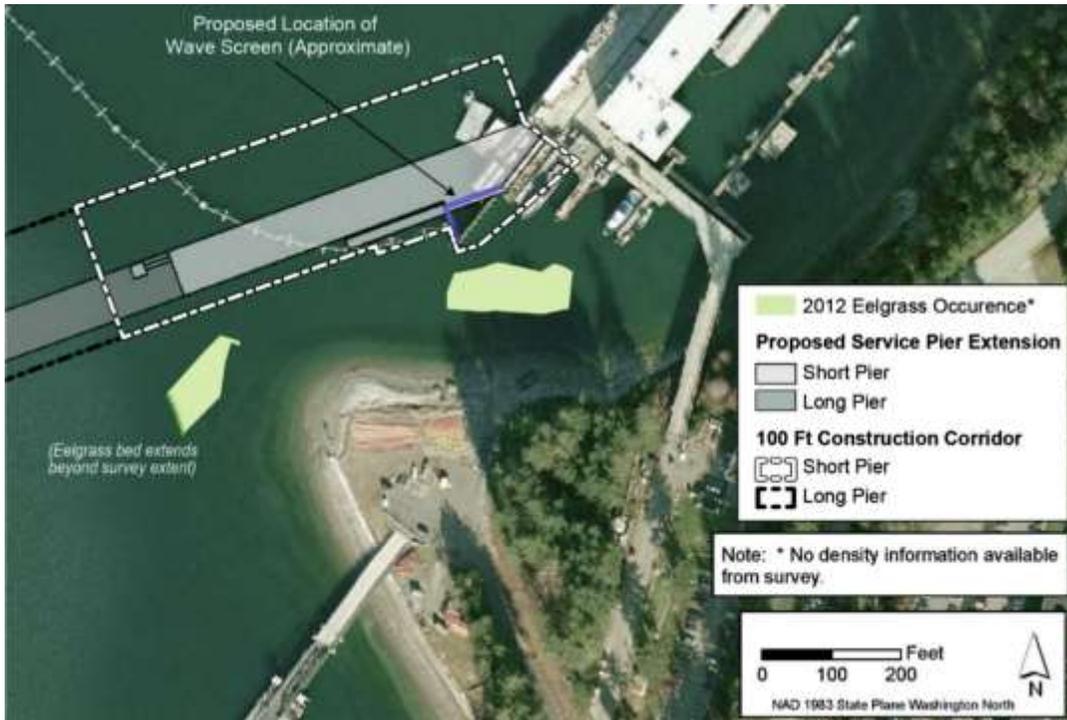
Figure 4: 2012 Detected eelgrass beds. (Source: Anchor QEA, 2012).

Prior underwater video surveys detected two eelgrass beds shoreward of the project area: one near the end of Carlson Spit, and one to the northeast, mostly inshore of the existing pier and wave screen structure (Anchor QEA, 2012; Figure 4). In addition, extensive macroalgae beds were detected using underwater video in the nearshore area (SAIC, 2009; Figure 5).

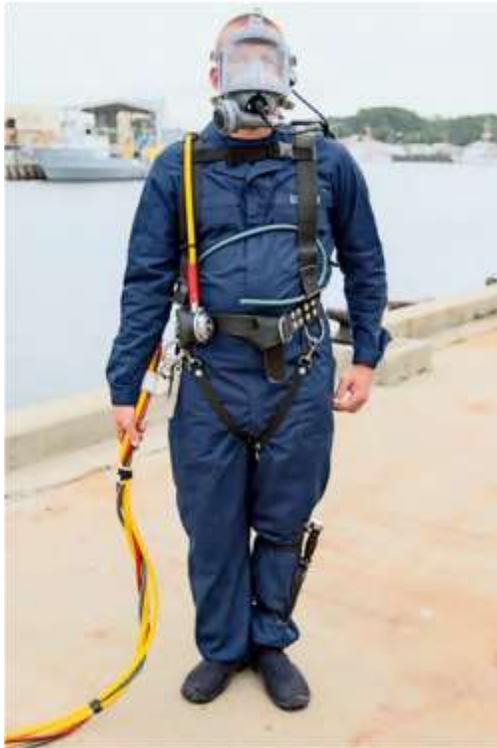
Figure 8: MK 20 MOD O full face mask (Source: U.S. Navy Diving Manual, 2016).

Only macroalgae within the permanent project footprint and temporary work area was assessed for percent cover by divers, as stated in the USACE-approved survey plan (NAVFAC NW, 2018). Both scuba and surface-supplied diving modes were used to conduct the macroalgae surveys. Scuba was conducted using conventional regulators and MK-20 full face masks with communication cables to facilitate communication between the SSC Pacific scientific diver and the scientist topside (Figure 8).

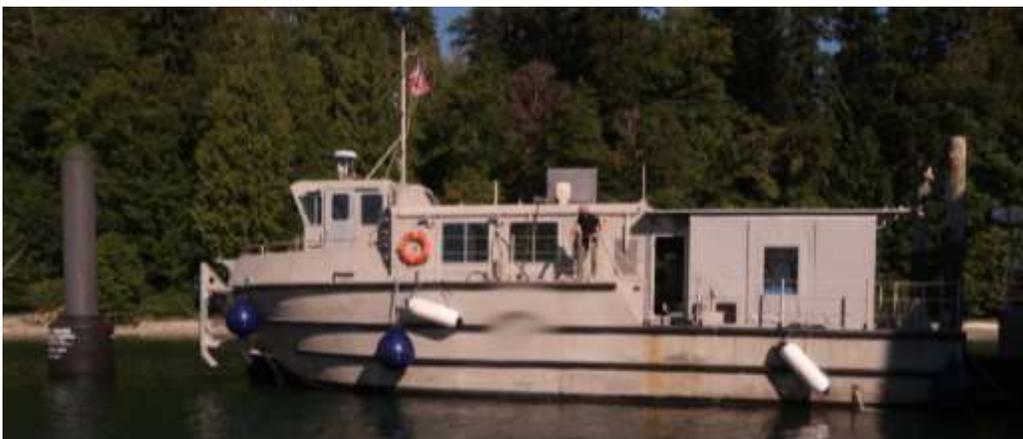
Figure 10: Delta boat used for the surface-supplied diving platform.

Two diving vessels were utilized for this survey. A larger vessel known as the Delta dive boat was the diving platform for the surface-supplied medium (Figure 10). A smaller boat was used for SCUBA and to access areas where the larger vessel was not capable of staying on site to cover the areas required for ground truthing.

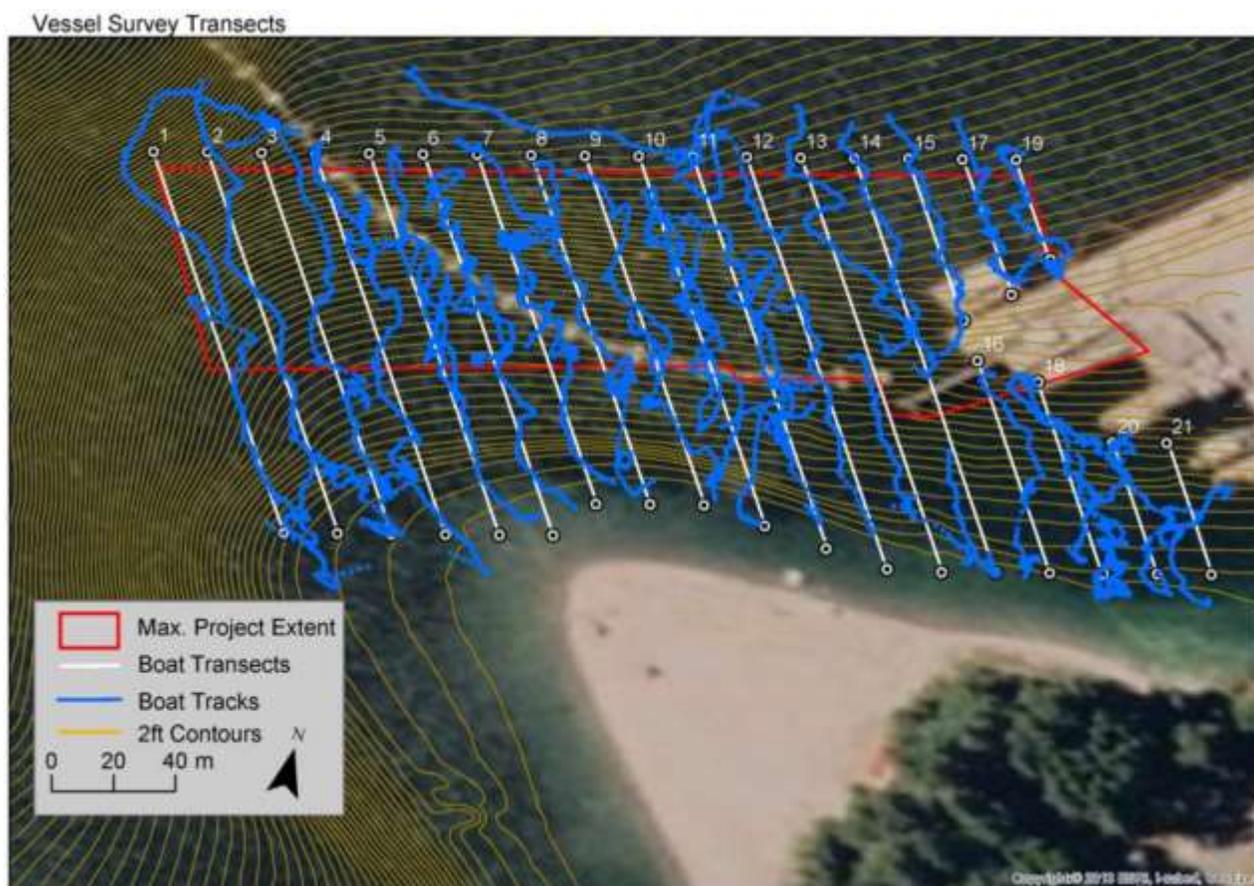
Figure 11: Target and Actual Vessel Survey Transects.

Figure 11 shows the boat tracks completed, as recorded by the Garmin Montana GPS unit. Transects 4-14 had to be completed in at least 2 sections because of the floating US Navy security barrier at the project location that the boat could not pass through, as well as ongoing vessel traffic. Transects 20 and 21, as well as the shoreward portions of transects 10 and 14 were completed twice, because post-survey inspection of the GPS tracks indicated that the boat had drifted unacceptably far from the planned survey line.

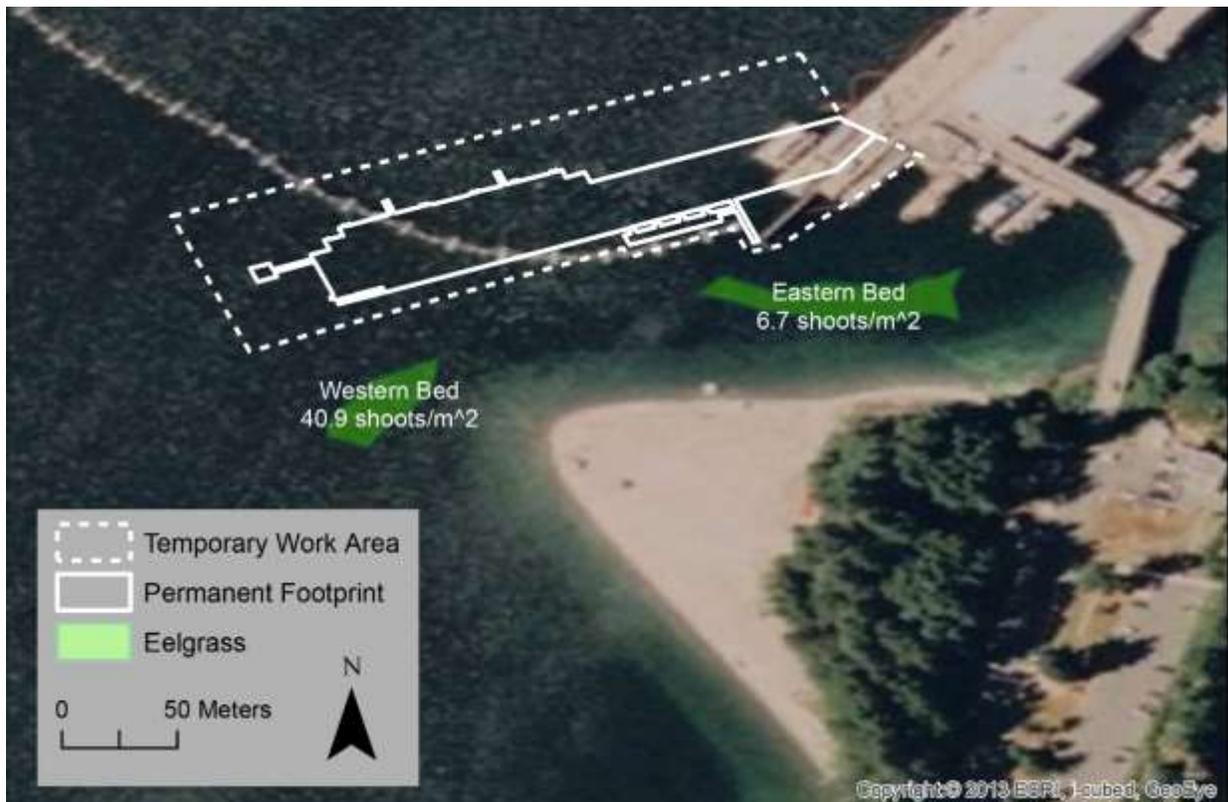
Figure 12: Diver-delineated eelgrass bed extents, with average shoot density.

The western eelgrass bed was delineated at 0.15 acres (609 m²), while the eastern bed was delineated at 0.26 acres (1,036 m²; Figure 12). The minimum distance between the closest portion of each eelgrass bed and the temporary work zone is 23 m and 12 m for the western and eastern beds, respectively. The minimum distance between the closest portion of the permanent project footprint and each eelgrass bed is 31 m and 16 m, respectively.

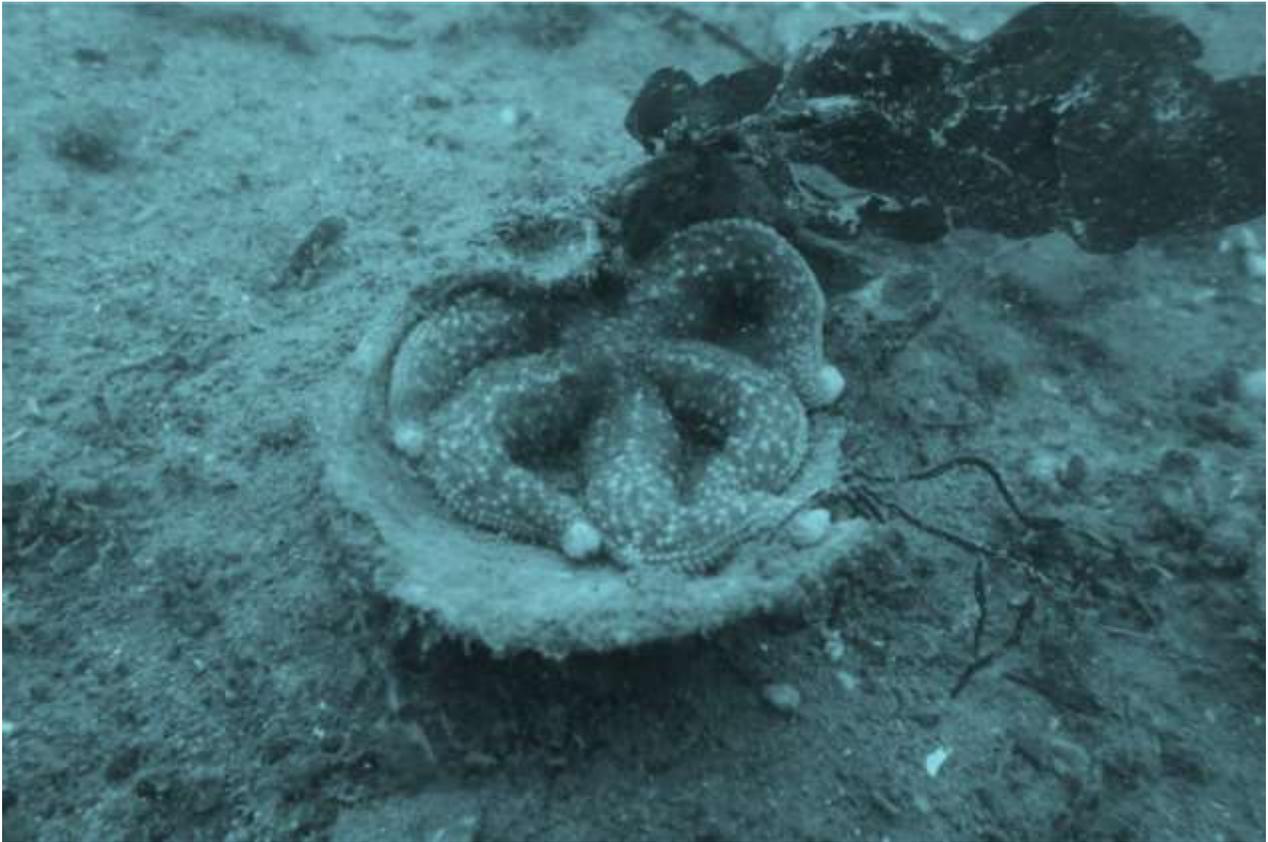
Figure 16: Example of macroalgae attached to shell; not rooted in substrate.

Some video transects indicated preliminary detections of macroalgae in deeper portions of the permanent project footprint and temporary work area, but groundtruthing dives showed that most of the areas had no presence of macroalgae. There are several possible reasons why this apparent discrepancy occurred. During diving surveys, some macroalgae were observed attached to small hard substrate items such as bivalve shells; the macroalgae on these items could appear to be part of an actual rooted macroalgae bed on the video, but in reality they are not rooted and may move with the current (Figure 16). In other situations, a large blade of macroalgae (for example, *Laminaria* sp.) may have appeared to comprise more than 5% algae in a quadrat, but in reality covered less area as only single, widely spaced blades of kelp were observed in some areas. Further, some decomposing macroalgae may have settled on the bottom of the seafloor in drifts, which may have appeared to be beds of macroalgae during video acquisition, but were actually not attached to the substrate.

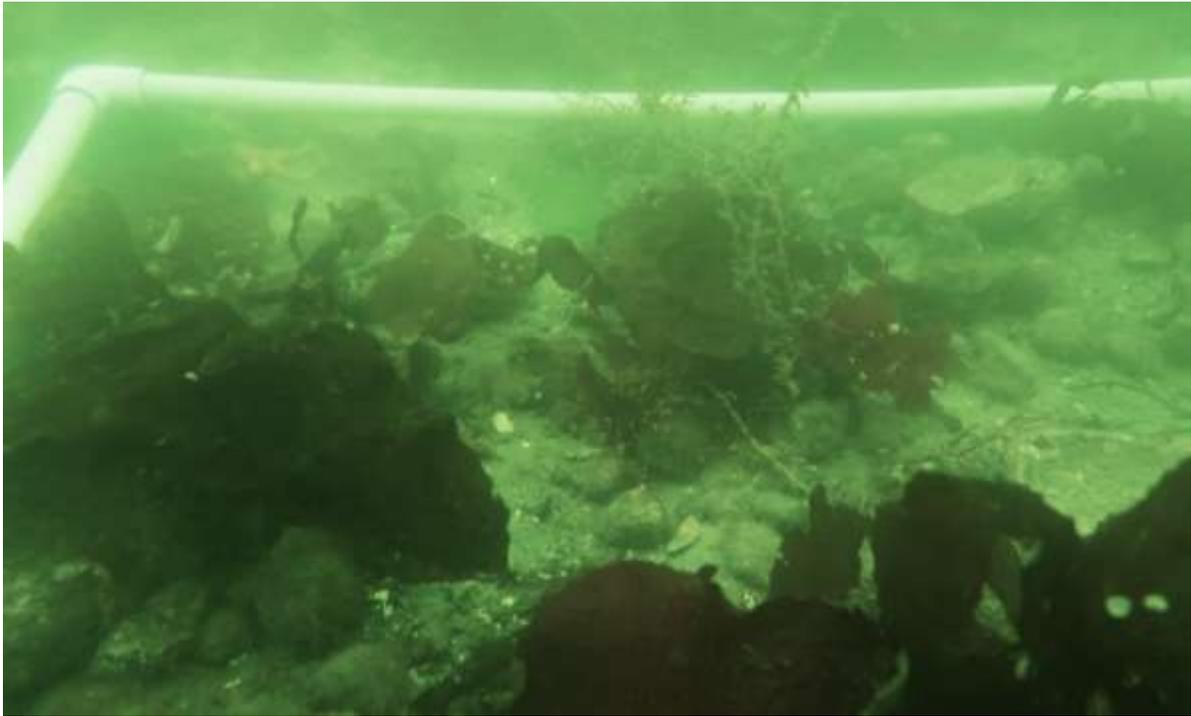
Figure 18: Representative macroalgae quadrat near the shoreward edge of the temporary work area.

Quadrats were placed on perpendicular-to-shore transects to quantify macroalgae within the maximum project extent. Quadrats closer to the shoreward edge of the temporary work area had denser macroalgae (Figure 18), which became sparser in the offshore direction towards and into the permanent project footprint (Figure 19).

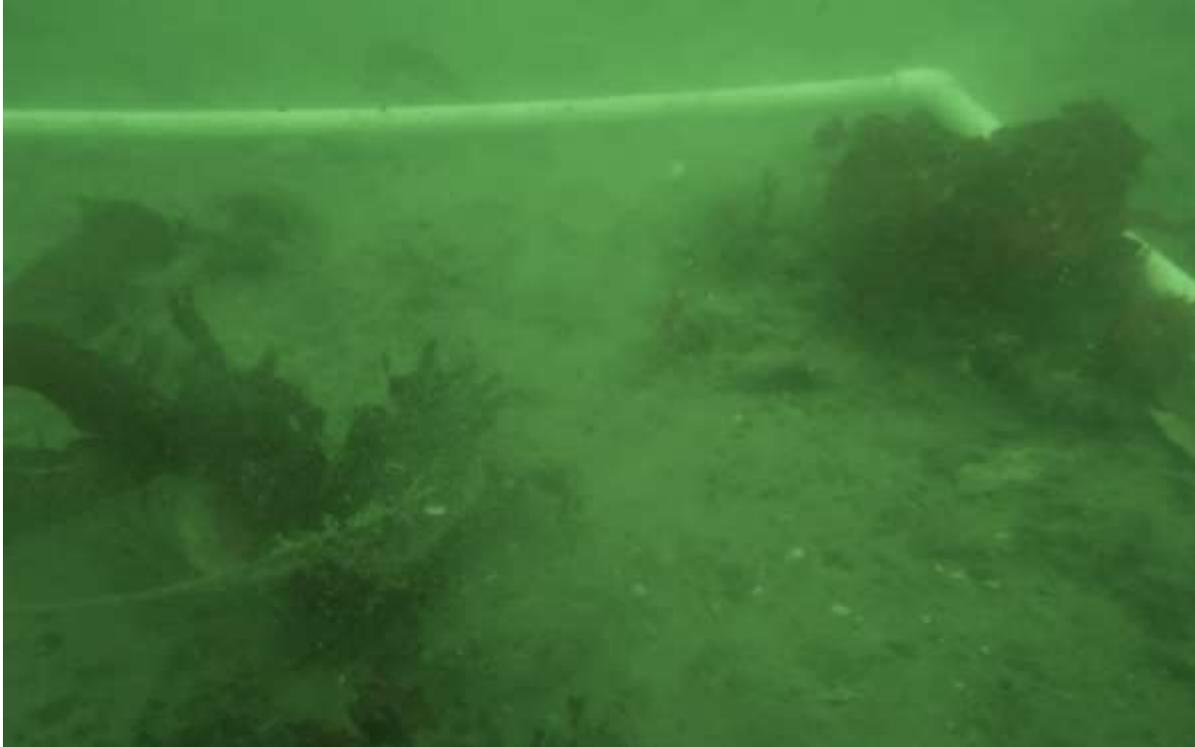
Figure 19: Representative macroalgae quadrat near the seaward boundary of the main macroalgae bed inside the maximum project extent.

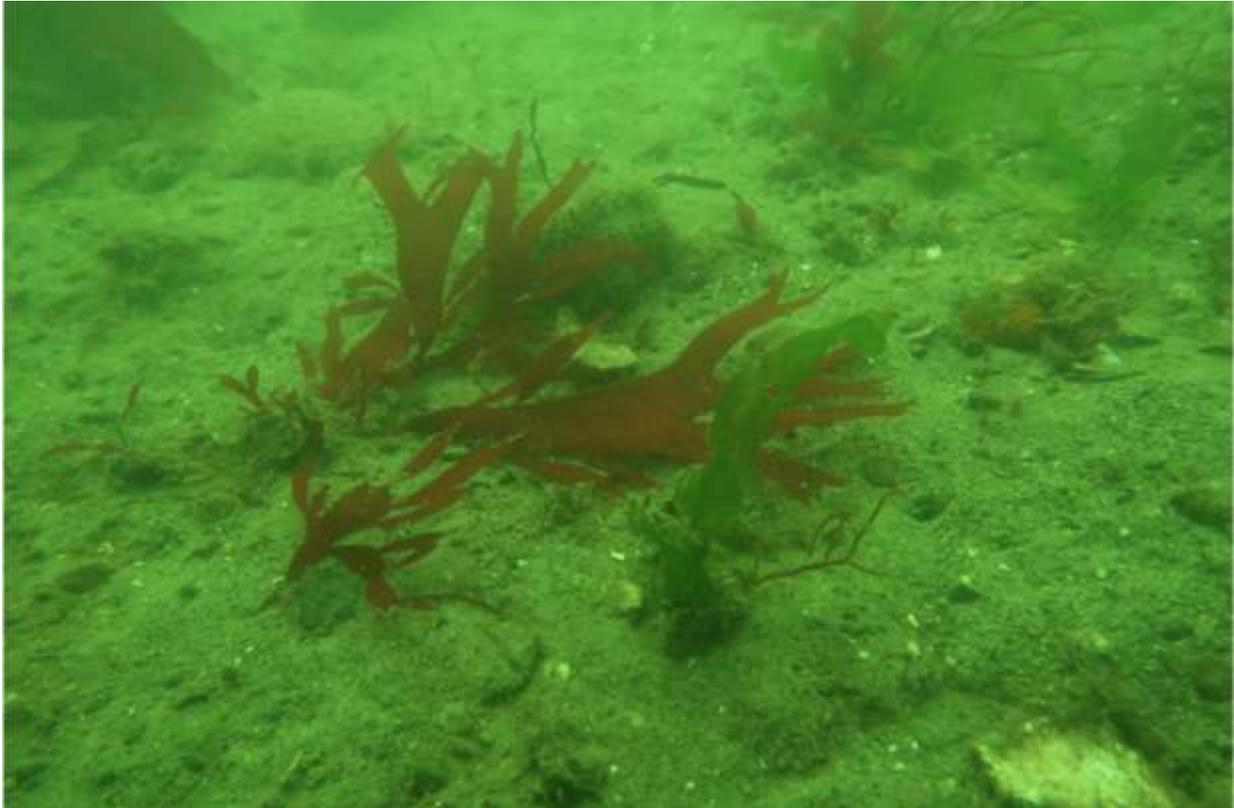
Figure 20: Unknown (possibly red) alga that covered < 0.05% of area in the main macroalgae bed within the maximum project extent.

A total of 41 quadrats were placed inside the main macroalgae bed delineated within the maximum project extent. This bed contains overall macroalgae densities that fall within Braun-Blanquet cover class #2. On average, the macroalgae bed surveyed contains 16.7% macroalgae, with minimum and maximum cover within individual quadrats ranging from 6-75%. Most of this was understory kelp (notably *Laminaria sp.*) at an average of 12.9% cover, followed by *Sarcodiotheca gaudichaudii* and *Ulva sp.* at 1.7 and 1.6%, respectively, and *Sargassum muticum* at 0.5%. There was also an unknown small alga, likely a red, that covered an average of 0.05% of the bed (Figure 20, Figure 21).

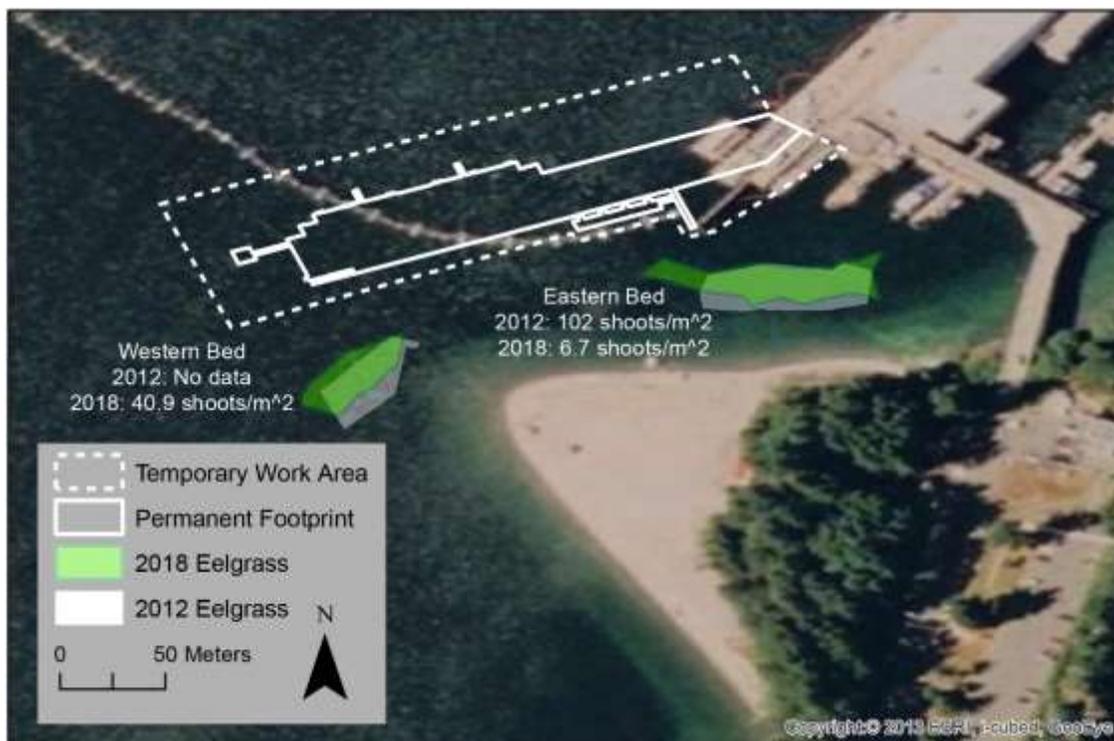
Figure 24: Comparison of eelgrass bed extents from surveys in 2012 surveys in 2018.

The 2012 eelgrass survey report states that shoot density was “high” and showed “good coverage within the [eastern] bed” (Anchor QEA, 2012). This contrasts strongly with the results from the 2018 survey, which found that the eastern bed was very sparse and patchy.

The size and shape of the western bed appears to have remained relatively stable, although the bed location as a whole seems to have shifted. This could represent a change in the location of this eelgrass bed in response to dynamic environmental conditions, or could represent differences in survey methods. The 2012 survey did not include a diver component for the western bed.

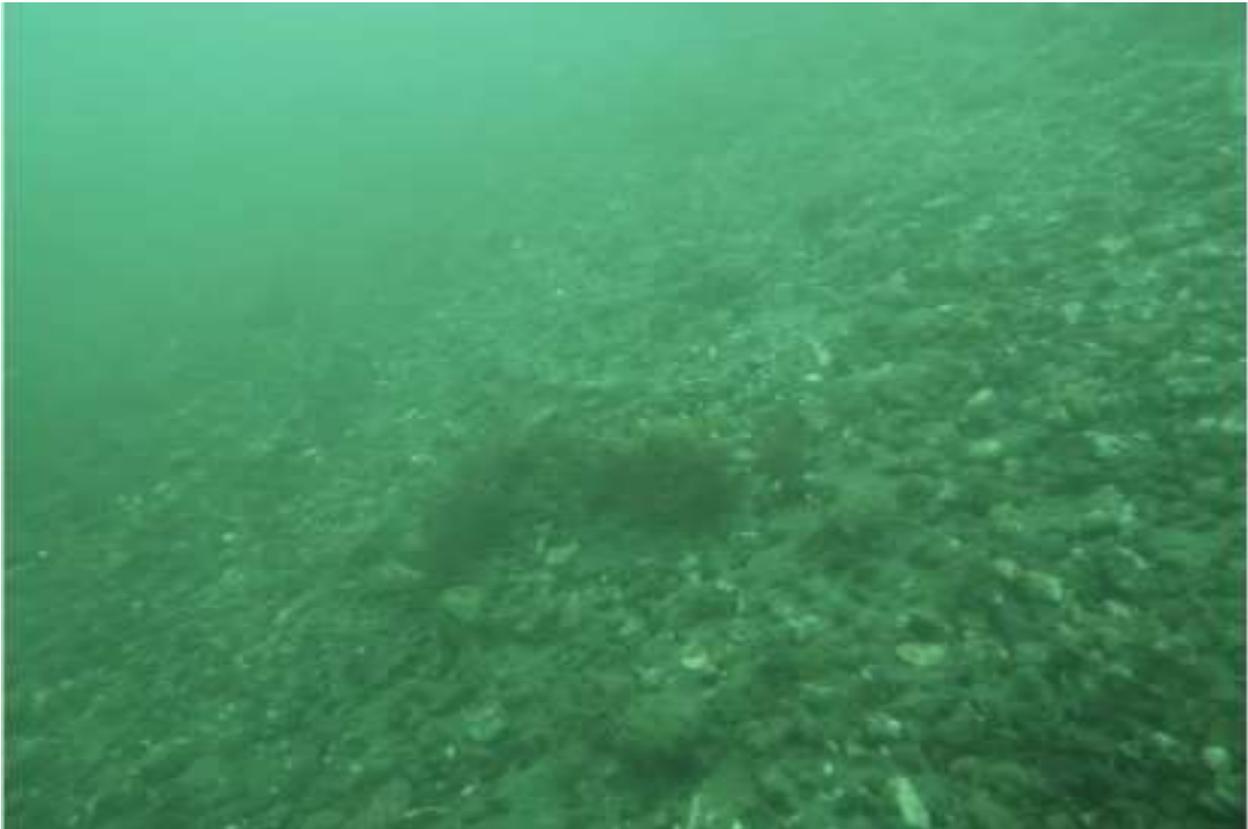
Figure C-1. Image representative of some of the surveyed project footprint, showing unconsolidated sediment, shell hash, and < 5% macroalgae coverage.

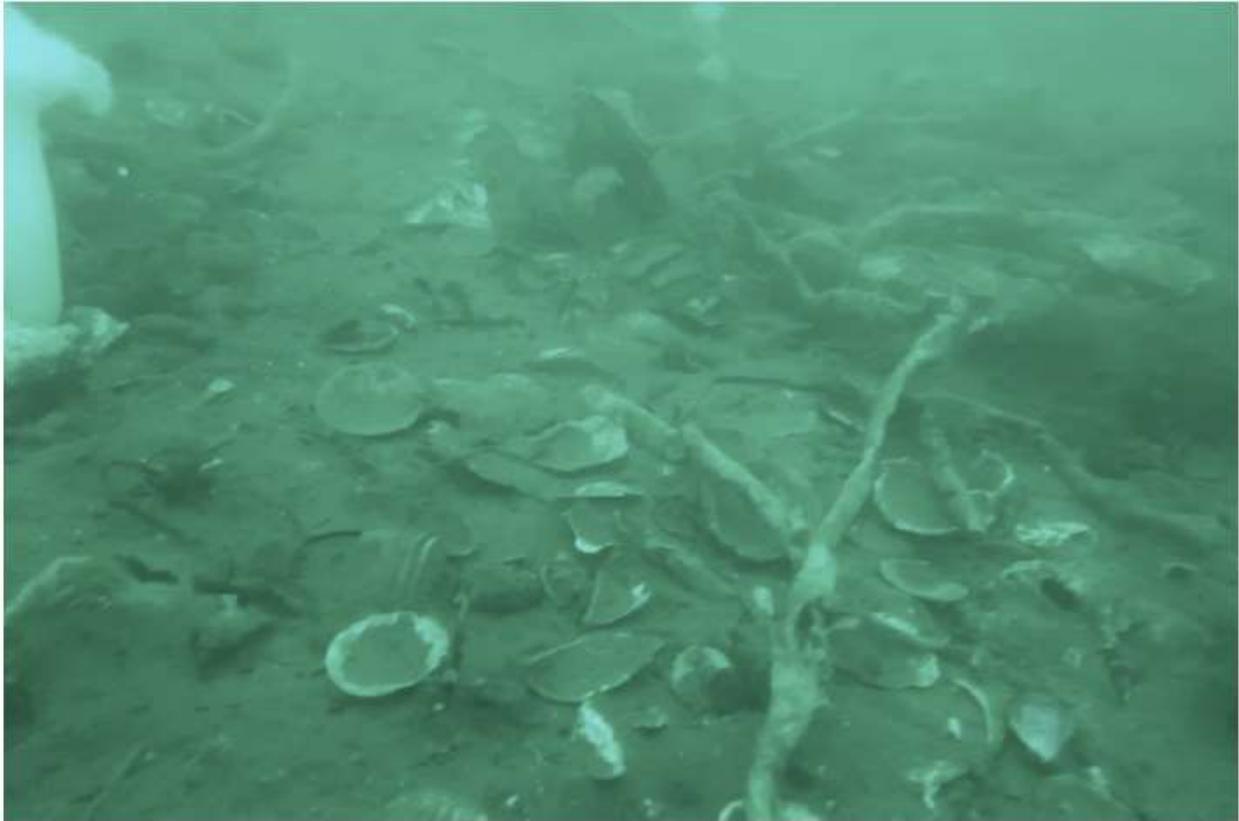
Figure C-2. Representative image of bottom type in deeper survey areas closer to the Service pier.
