title: AIRFIELD PAVEMENT CONDITION SURVEY, USNAS LOS ALAMITOS, CA

author: R. B. BROWNIE

date: APRIL 1976

CIVIL ENGINEERING LABORATORY

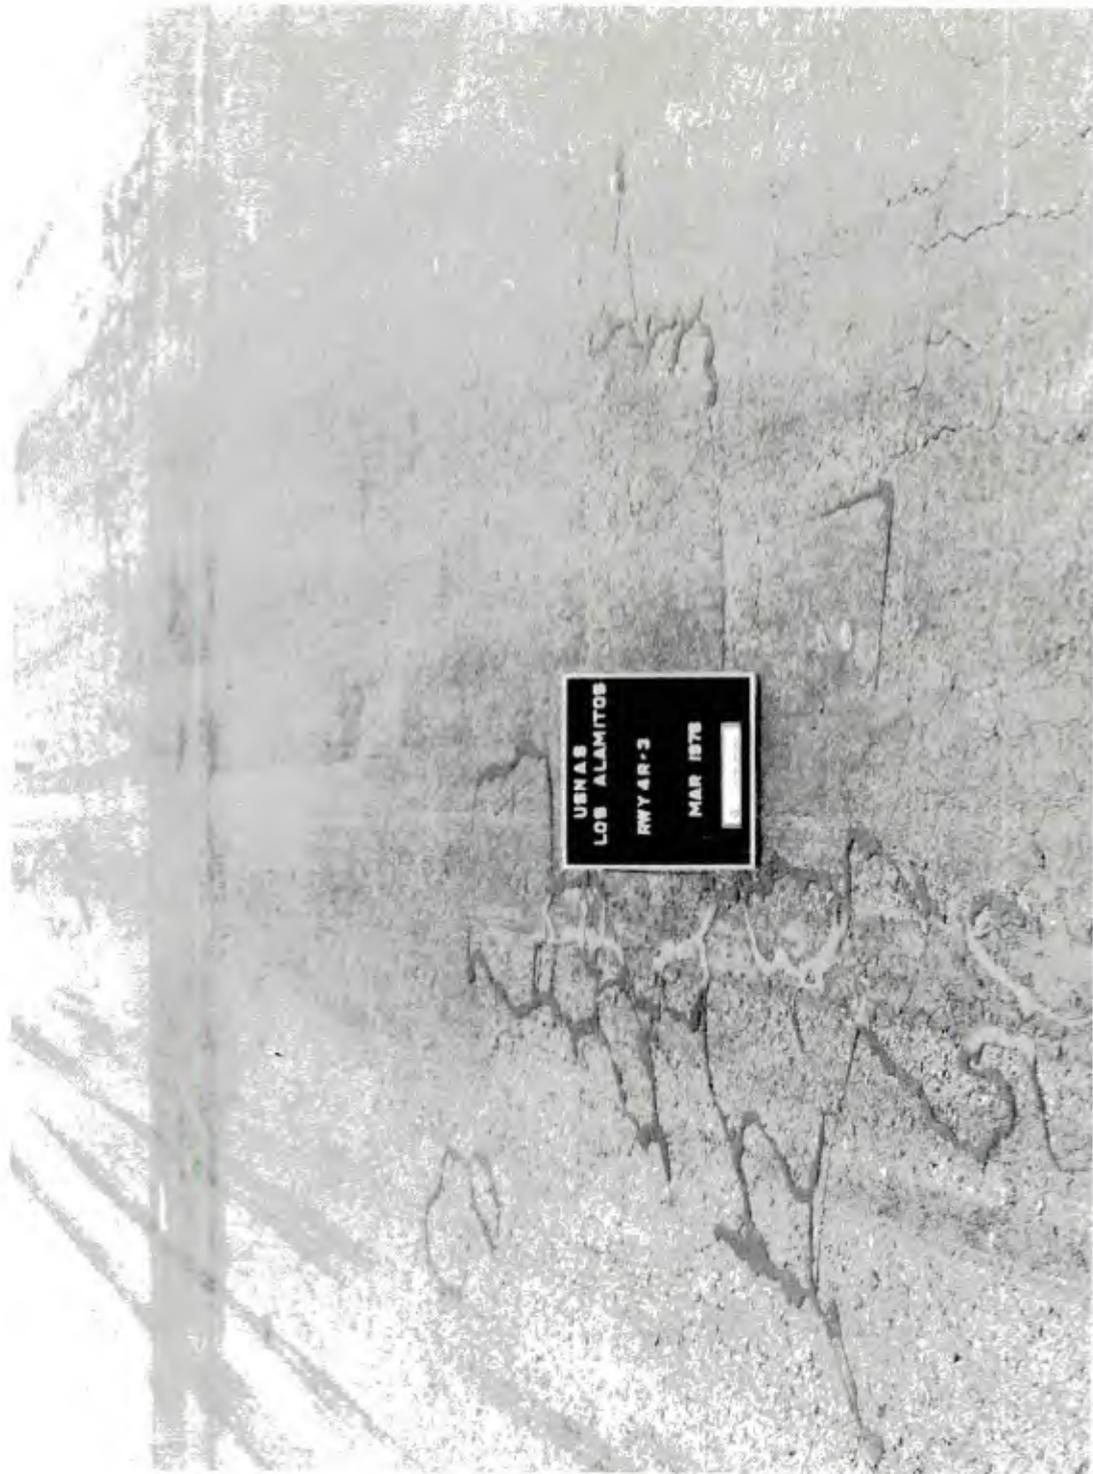
Figure 4. Pattern cracking, Discrete Area R4R-3.

Total weighted defect densities for asphaltic concrete pavements range from 1.72A (0.00A being no visible defects) for discrete area R4R-3, to 22.33A for discrete area R4L-1. For portland cement concrete areas, total weighted defect densities ranged from 0.00C for discrete area R4R-4, to 0.94C for discrete area R4R-1.

| Defect Type | Length or Area of Sampled Defects | Total Length or Area of All Defects (c) x Ratio | Defect Density (per 10 sq. ft.) 10 d/a | Defect Severity Weight | Weighted Defect Density: (e) x (f) |
|---|---|---|--|---|---|
| Surface is completely devoid of bitumen. Surface texture is rough, caused by loss of fines. See Figure 4. | | | | | |
