## **Wave-Speed-Based Performance Indicators for Portugues Dam**

Ziyad H. Duron, Peter Orme, Spenser Anderson,  
Henry Diaz-Alvarez, Vincent P. Chiarito,  
and Mihan H. McKenna

October 2018

Final Report

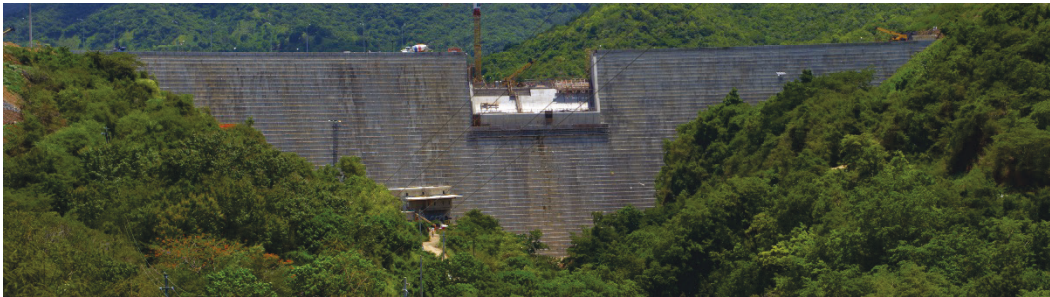
Figure 1. Portugues Dam; photograph taken August 2013 at the conclusion of PBT and prior to completion of the ogee spillway.

Portugues Dam is a thick-arch, roller compacted concrete (RCC) dam built in Puerto Rico by the U.S. Army Corps of Engineers and is one of only about 10 such dams in the world. The dam is 220 ft tall and 1230 ft long and has an ogee spillway 140 ft long. Base and crest thicknesses are 111 ft and 30 ft, respectively; and more than 355,000 cubic yards of concrete was used in its construction. The dam was designed as a three-dimensional structure with closed contraction joints and underwent an extensive RCC design and testing program. The tensile strength of the horizontal lift joints plays an important role in the dam's ability to perform under seismic loading, which leads to the focus of the current study.

Portugues Dam is located on the Portugues River three miles northwest of the city of Ponce in Puerto Rico. The dam was completed in early 2014 and provides flood control for a region of more than 40,000 inhabitants and over 13,000 residential structures. Figure 1 is a photograph of the dam at the time of testing during the summer of 2013.

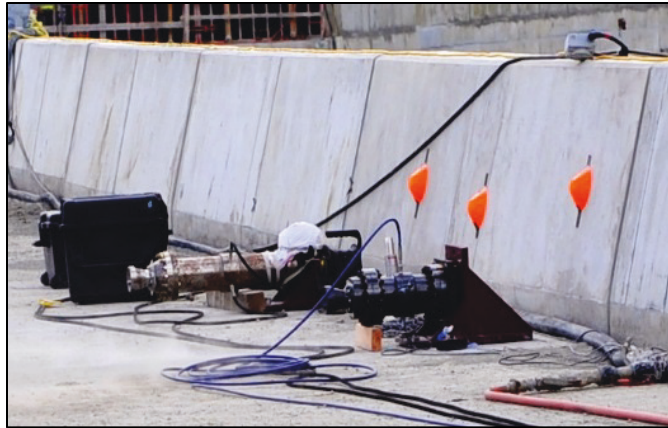
Figure 2. Cold Gas Thrusters mounted onto Portugues Dam.

The development of the PBT technique is described in Duron et al. (2013) and its adaptation to a large, concrete multiple-arch dam is described in Goldkamp et al. (2014) and Edelman et al. (2014). Found in the references are specifics regarding instrumentation, particularly those associated with the excitation device that is referred to as a Cold Gas Thruster (CGT); motion sensors; and acquisition systems and parameters. Primary testing at Portugues Dam was conducted using one CGT, but a second CGT was used to investigate potential advantages of multiple (two) devices. A photograph of the CGTs mounted on the crest of the dam is shown in Figure 2.

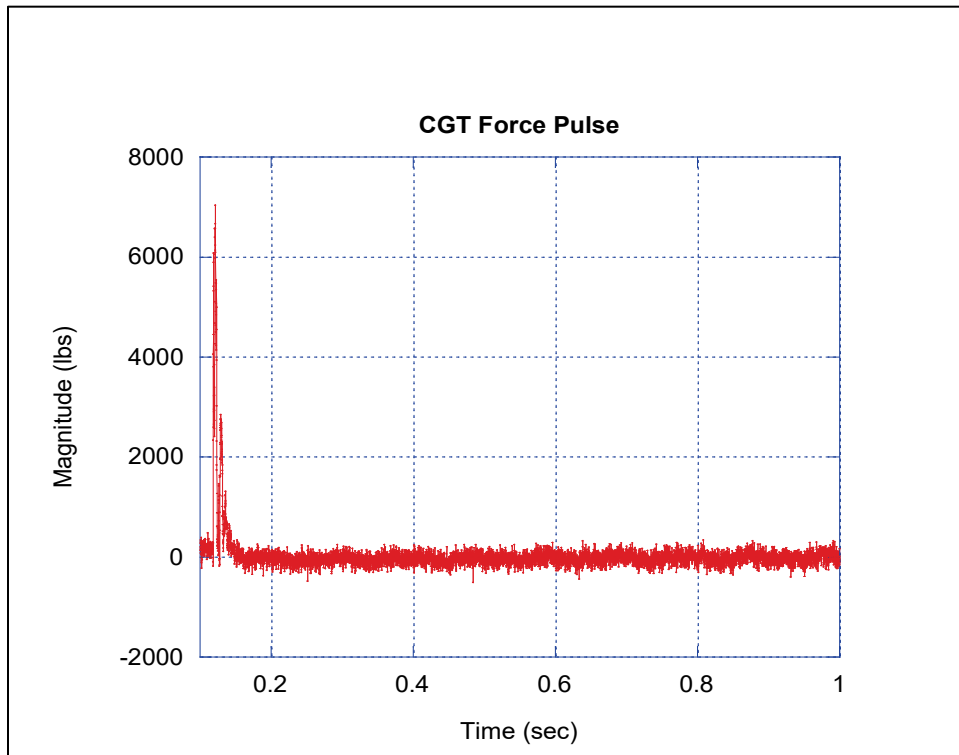
Figure 3. Typical force pulse delivered by the CGT to the dam.

A typical force pulse delivered to the dam from the CGT is shown in Figure 3.

Peak force levels ranged between 6,000 and 8,000 lb, and repeatability in terms of the pulse width (10 msec) and dissipation was very good for the tests at Portugues Dam. Additional CGT instrumentation included a shock accelerometer that monitored the acceleration induced in the dam at the CGT attachment location; a typical response is shown in Figure 4.

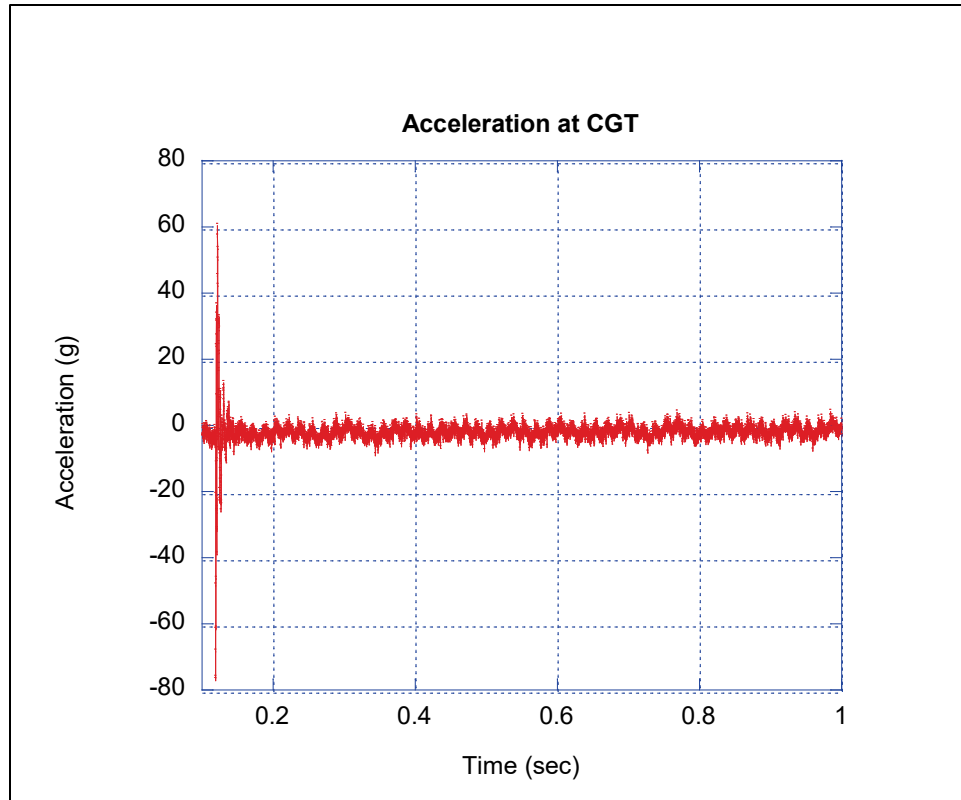
Figure 4. Induced acceleration response at CGT attachment location.

Peak acceleration levels approach 80 g's and are associated with the acceleration of the CGT at load delivery. These levels have been observed in previous PBTs of dams, and the ratio of the peak force and the peak acceleration levels in the measured responses correspond to the mass (or weight) of the CGT itself (approximately 150 lb as configured at Portugues Dam). As a result and based on previous experience with the testing technique and instrumentation, the acceleration levels and overall character of the shock acceleration response are consistent with expected behavior and are indicative of satisfactory CGT performance.

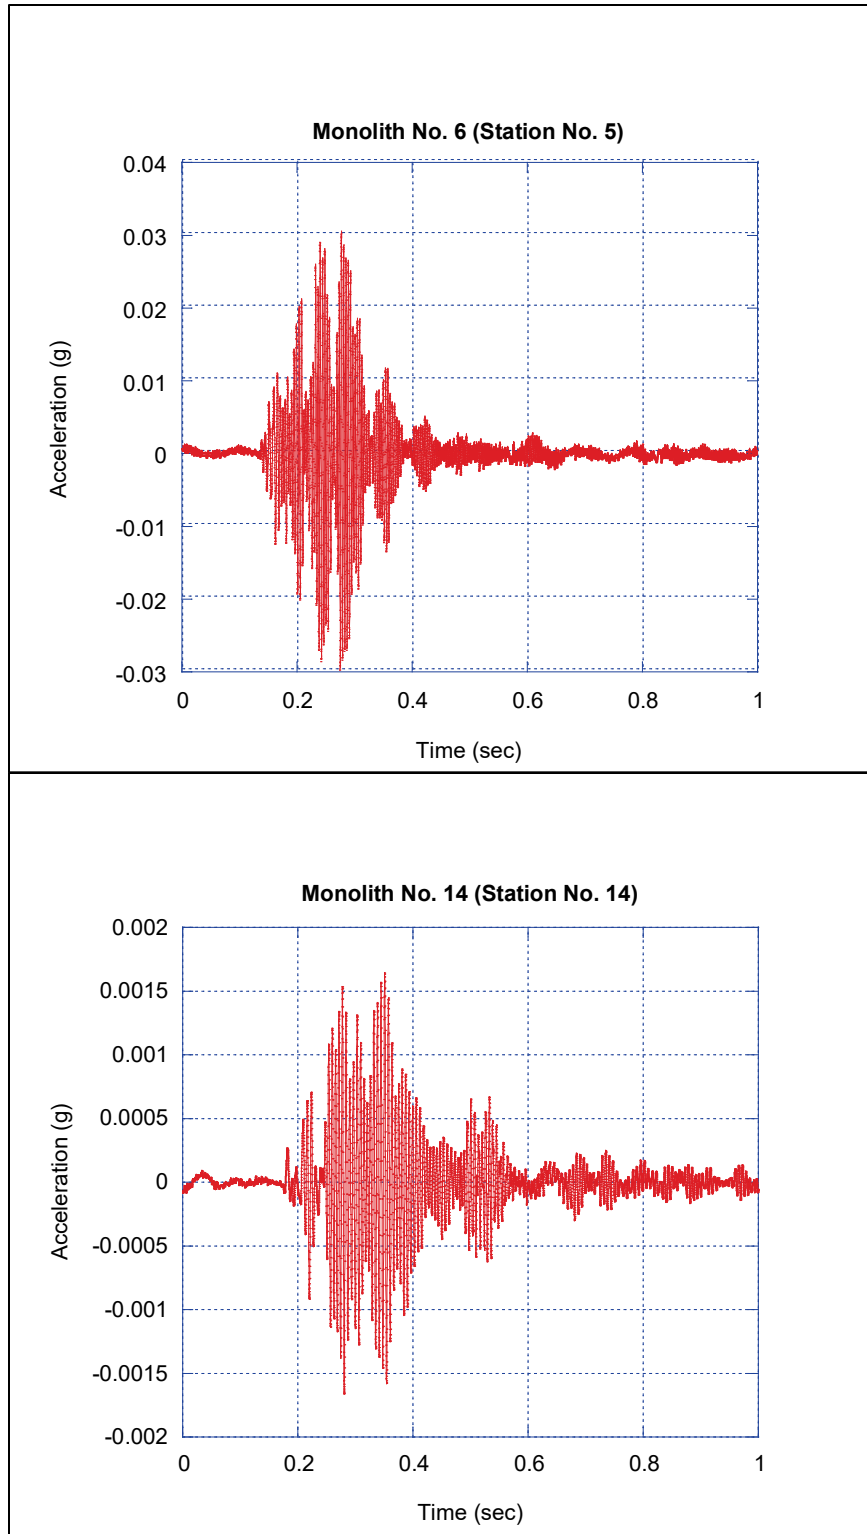
Figure 6. Sample acceleration responses to CGT force pulse.

Accelerometers were oriented radially along the crest in the stream direction, and the CGT remained anchored to the crest at monolith No. 8 throughout the test. Sample responses on each side of the spillway are shown in Figure 6.

The transient characteristics indicated in these responses are consistent with previous PBTs of dams and illustrate the broad frequency content induced by the CGT. The overall nature of these responses is also consistent with that expected during seismic loading, which highlights a significant advantage of PBT over traditional testing techniques.

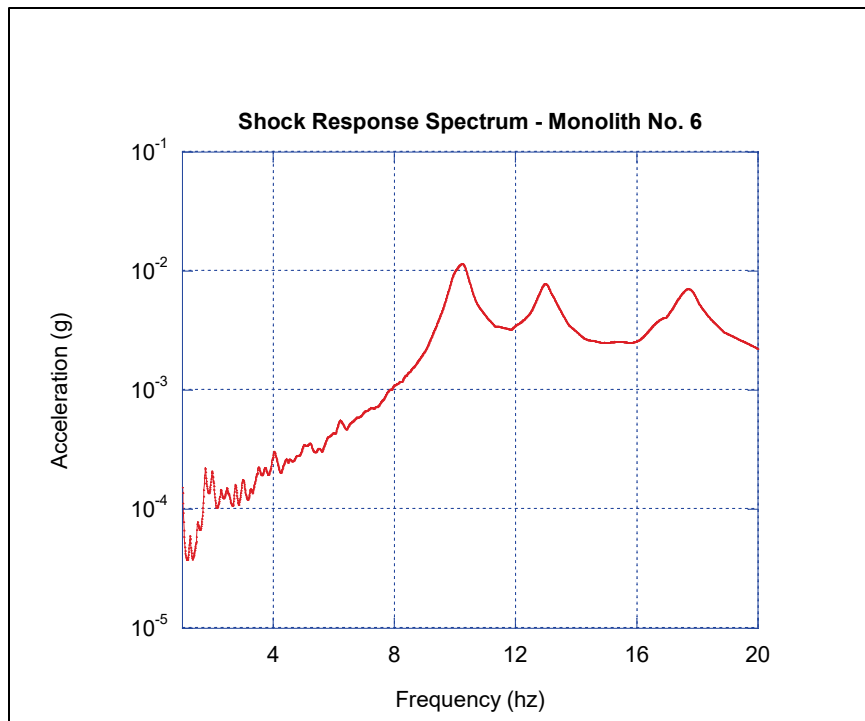
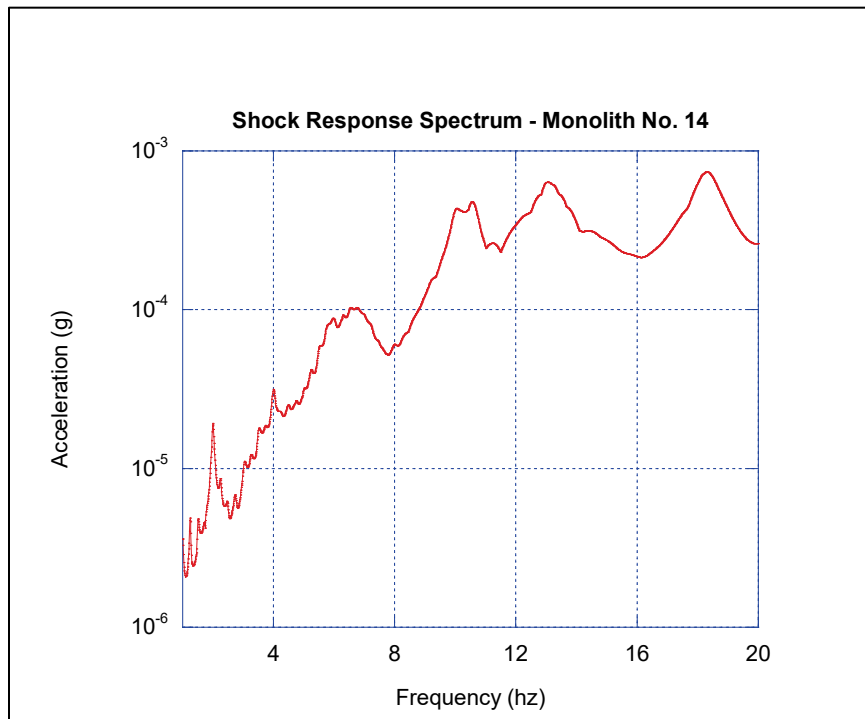
Figure 7. Sample shock response spectra associated with PBT responses at monoliths 6 and 14.

The SRS analysis technique was used to confirm resonances in the dam and to develop an estimate of the response shape associated with the fundamental resonance. Sample SRS responses for monoliths 6 and 14 are shown in Figure 7.

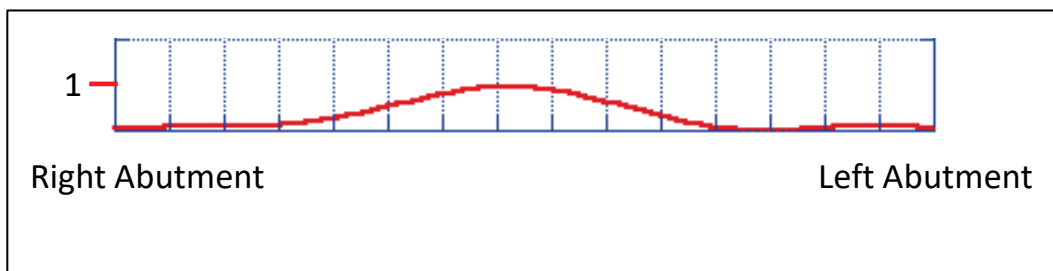
Figure 8. Response shape at 4.8 Hz; modal amplitude is normalized to 1 as indicated.

A simplified analysis procedure was developed based on SRS responses to obtain an estimate for the response shape associated with the fundamental resonance at 4.8 Hz. The approach takes advantage of the fact that the unique aspect of any response shape lies in the relative amplitudes across the structure and not in the absolute magnitudes of the response. As a result, ratios of SRS response levels can be used to arrive at a response shape defined by relative magnitudes based on a reference location in the dam. Using the SRS response at monolith No. 8 as the reference, an estimate for the response shape at 4.8 Hz was determined, as shown in Figure 8.

Since the ogee spillway was still under construction during PBT at Portugues Dam, no responses were acquired between monoliths 10 and 13. Nonetheless, the response shape is consistent with expected behavior and illustrates the ability of PBT to extract eigen properties of the dam in a manner consistent with traditional techniques, including the Fourier analysis of forced vibrations in a dam.

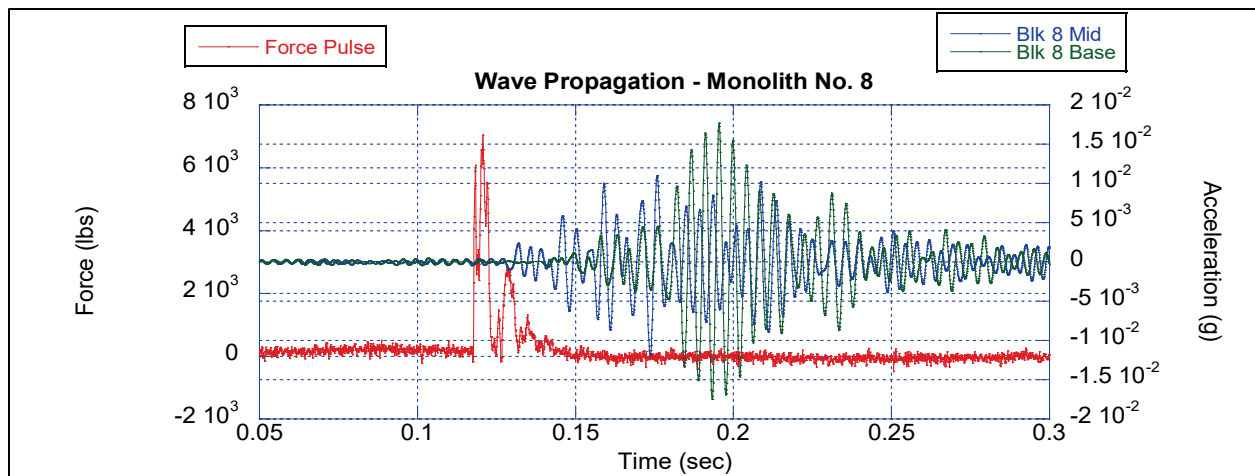
Figure 9. Wave propagation in monolith No. 8.

To illustrate the ability of PBT to excite wave propagation in the dam, a timing comparison within monolith No. 8 is shown in Figure 9.

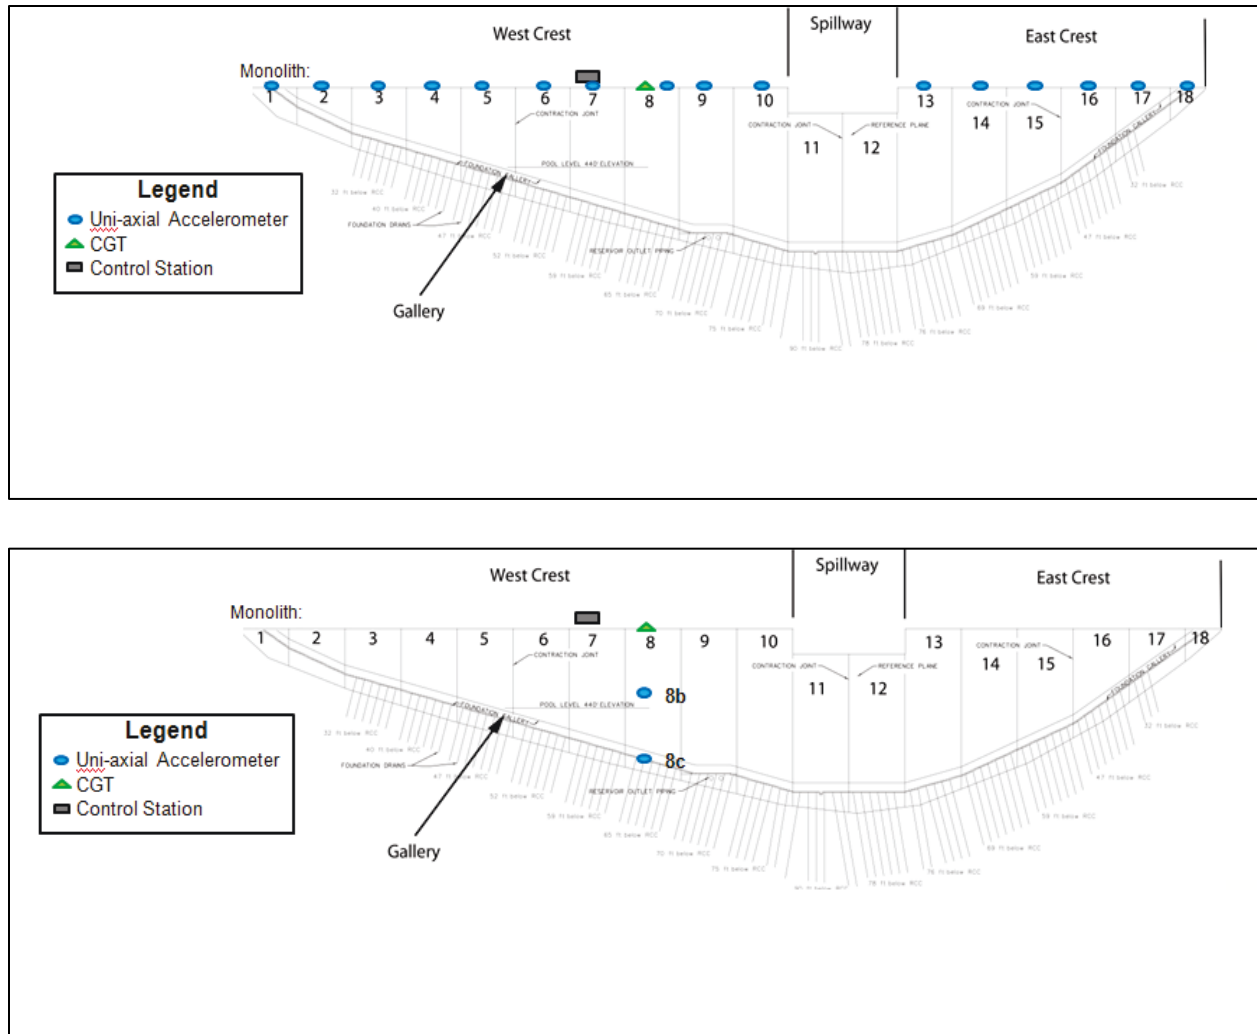
Figure 10. Measurement layouts for determining wave speed estimates along the crest (top) and in monolith No. 8 (bottom) at Portugues Dam; locations 8b and 8c correspond to the mid-height and the base of the monolith, respectively.

The key to developing wave speed estimates in the dam is identifying accurate and reliable wave arrival times at each measurement location either along the crest or along a single monolith. At Portugues Dam, wave speed estimates were obtained along the crest and in monolith No. 8 by using the measurement layouts shown in Figure 10.
