Use of Liquid Metal Embrittlement (LME) for Controlled Fracture

ARL-TR-4976

September 2009

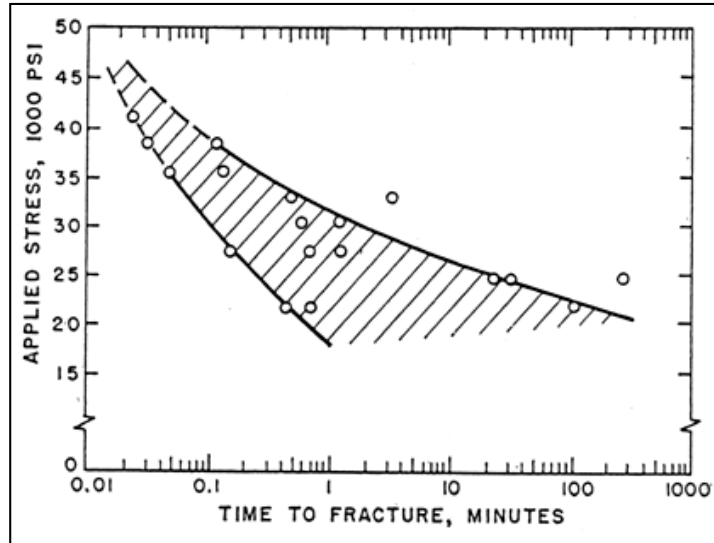
How fast materials fail due to LME depends on many factors. An indication of the role that applied stress plays is shown in figure 2 (6). As shown in the figure, fracture could possibly take place in under a second, given a high tensile stress. The material in question is AISI 4130 steel with a hardness value of HRC 44. The embrittling agent is molten lithium.

Figure 2. Effect of applied stress on time to failure using LM embrittlement.

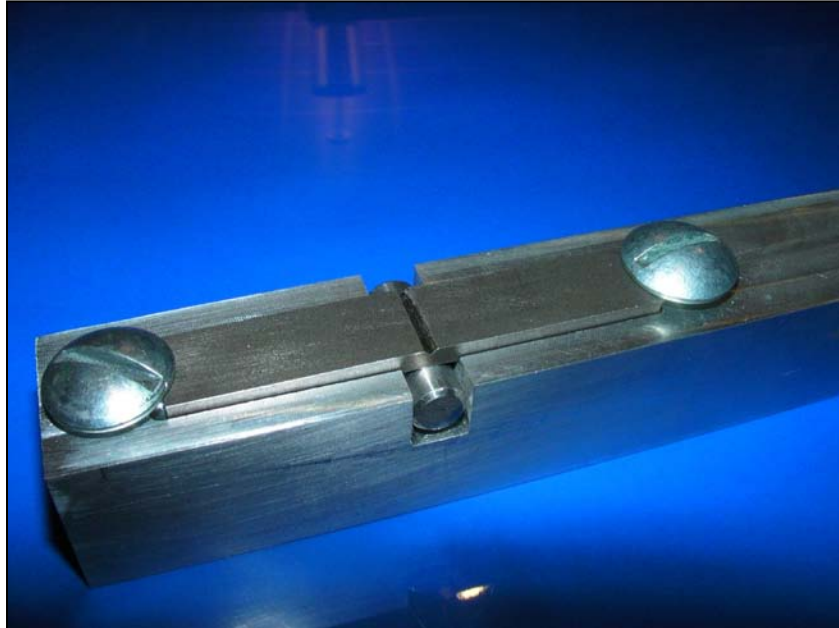
The literature clearly states that LME will only occur when the sample is under tensile stress (6). The drop tower provides a tensile stress at the crack tip, but it occurs very rapidly. In order to induce a tensile stress state in the Charpy bar at a slower rate, a special jig was made by which the modified Charpy bar could be put under a tensile load. A picture of this jig is shown in figure 7. The Charpy bar is held down at its ends by two screws. Another screw (not shown in the picture) can be advanced against a hardened pin in contact with the back of the sample so as to cause a deflection in the bar. The amount of deflection is measured with a dial indicator. The

jig is positioned so that the LM can be applied to the notch while the sample is under tension. The idea was to induce the start of embrittlement before the sample is tested in the drop tower.

Figure 7. Picture of jig used to deflect the Charpy bar.

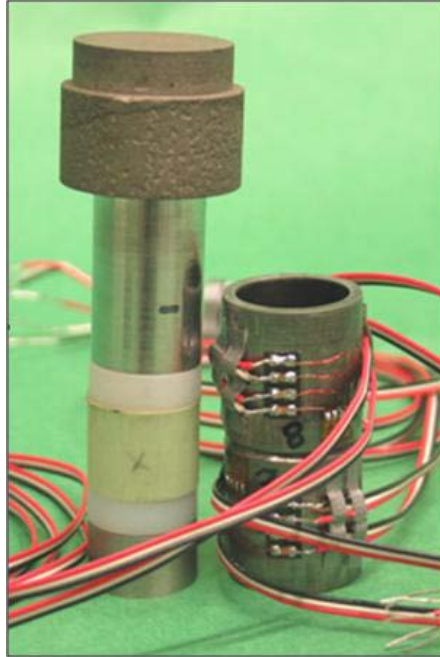
Pressure was applied to the center of the cylinder by filling the cylinder with an elastomeric material and applying pressure to that material. Figure 9 shows a picture of the test pieces. The green elastomeric material was shaped to fit the inside of the cylinder. After it was inserted into the cylinder, two nylon caps were used to seal the elastomeric material inside the cylinder. This figure shows the elastomeric material and the end caps outside the cylinder. Sitting on top of this arrangement is the steel piston used to push on the elastomeric material. Also shown is the cylinder with strain gages attached. After all the parts were assembled, the cylinder was put into a load frame and the pressurization took place. For this particular test, two 90° quadrants of the circumferential groove (on opposite sides of the cylinder) were coated with the LM mixture. The expectation was that these locations were where the fracture would initiate.

Figure 9. Experimental arrangement for pressurized cylinder test.

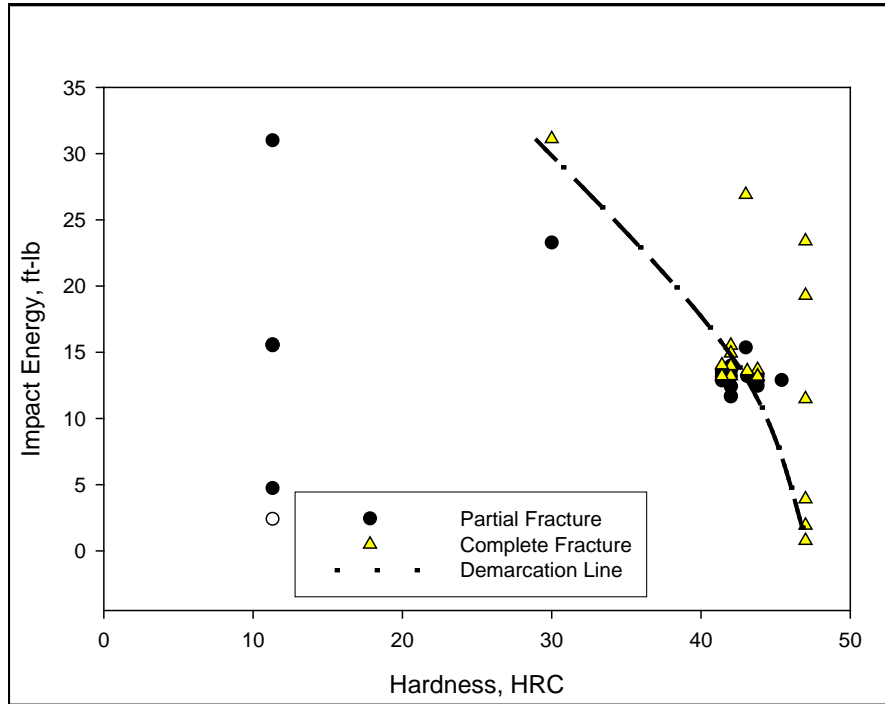
Data from the preliminary drop tower tests are plotted in figure 11. Figure 11 shows the impact energy versus sample hardness and whether the sample broke into two parts (complete fracture) or was intact (partial fracture). For high hardness values (~47 HRC) the samples broke at all impact energies, whereas at low hardness values (~11 HRC) the samples did not completely fracture over the entire range of impact energy applied to the sample. The dashed line in figure 11 separates, approximately, the partial and complete fractures.

Figure 11. Drop tower test results for all modified Charpy bars not treated with LM; dashed line tends to separate complete and partial fractures.

It should be pointed out that if the strain rate is an important parameter, then it might be more appropriate to plot the hardness versus the impact velocity. However, the mass of the tup remains constant, so the impact energy is proportional to the square of the impact velocity. Thus, any major trends should be the same either way the data are presented.

By replotting the data in figure 11, ARL can focus on the region of hardness values between HRC 40 and 50. This range of hardness values was considered appropriate, based on data for another type of steel shown in figure 1. Figure 12 plots these data and shows that between hardness values of HRC 41 to 45 and above 14 ft-lb of impact energy, the Charpy bar will most likely completely fracture (note the one outlier at a hardness value of HRC 43.6). Below impact energy of 13 ft-lb, it is highly likely that the Charpy bar will not completely fracture. Between 13 and 14 ft-lb, there appears to be a zone of mixed results. (One might sense that there is a higher probability that fracture will occur in this region as the hardness value increases. However, the data are not convincing.) Expressed in different terms, if the sample has a low hardness value and the strain rate is low, then it is highly likely that the fracture will be arrested

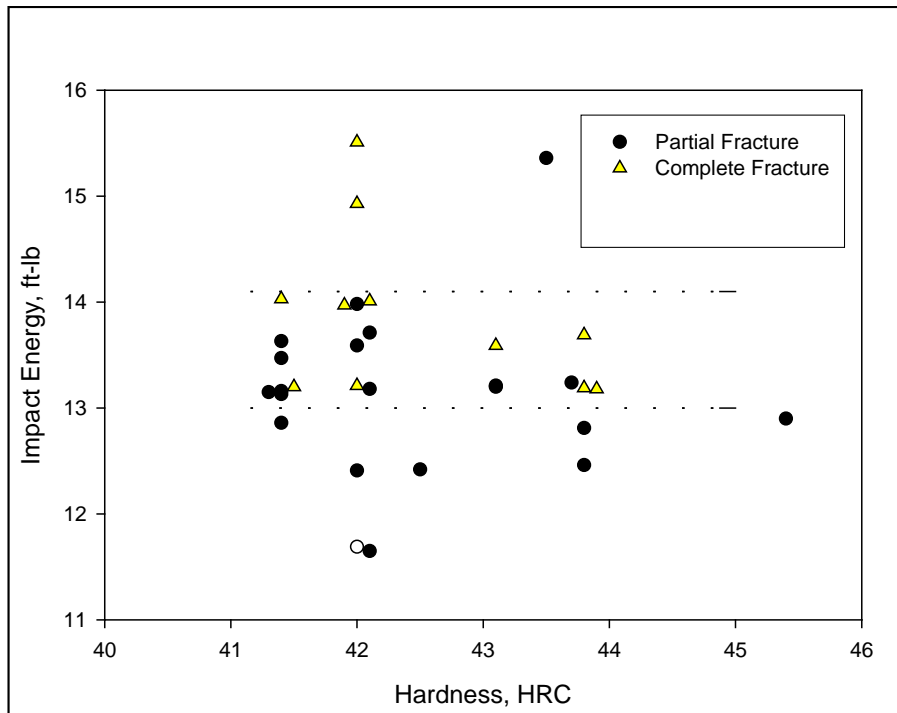
within the sample. If the sample has a high hardness value and the strain rate is high, it is likely to fracture completely.

Figure 12. Enlarged region of drop tower test data from figure 10 (untreated samples); dashed lines enclose region of mixed results.

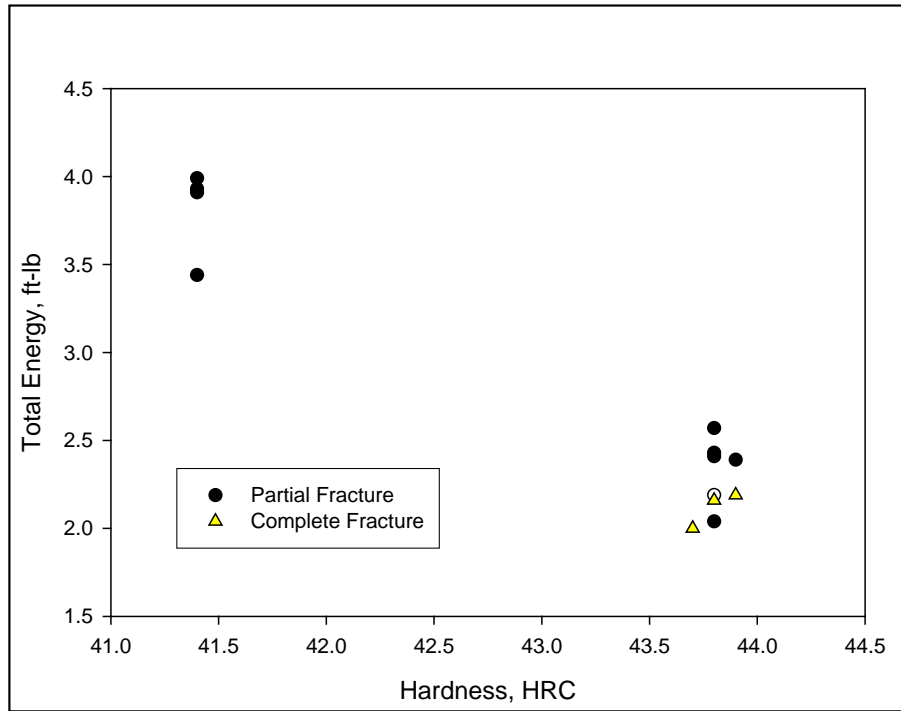
Until now, there was concern with whether the sample completely fractured or not. For those samples that completely fractured, ARL would like to know if they would have completely fractured at a much lower impact energy (i.e., was the fracture brittle in nature). One indicator that is available from the drop tower test machine is the total energy expended on the sample, either to fracture or deform it. If the sample fractures with a low value of this energy, then it may be that it fractured in a brittle manner and that lower impact energy might have fractured it also. Figure 14 shows the total energy expended for the samples shown in figure 13. The figure shows that there is no gap between the energies required either to partially or completely fracture the sample. The fact that a sample separates in some cases and not in others for samples with similar hardness values is taken as experimental variation. For the untreated samples with a hardness value of HRC 47 (see figure 12), the absorbed energy ranged from 0.73 to 1.48 ft-lb. Thus, the absorbed energy appears to be more a function of sample hardness than prior treatment.

Figure 14. Total energy expended on the sample during the drop test for LM-treated samples.

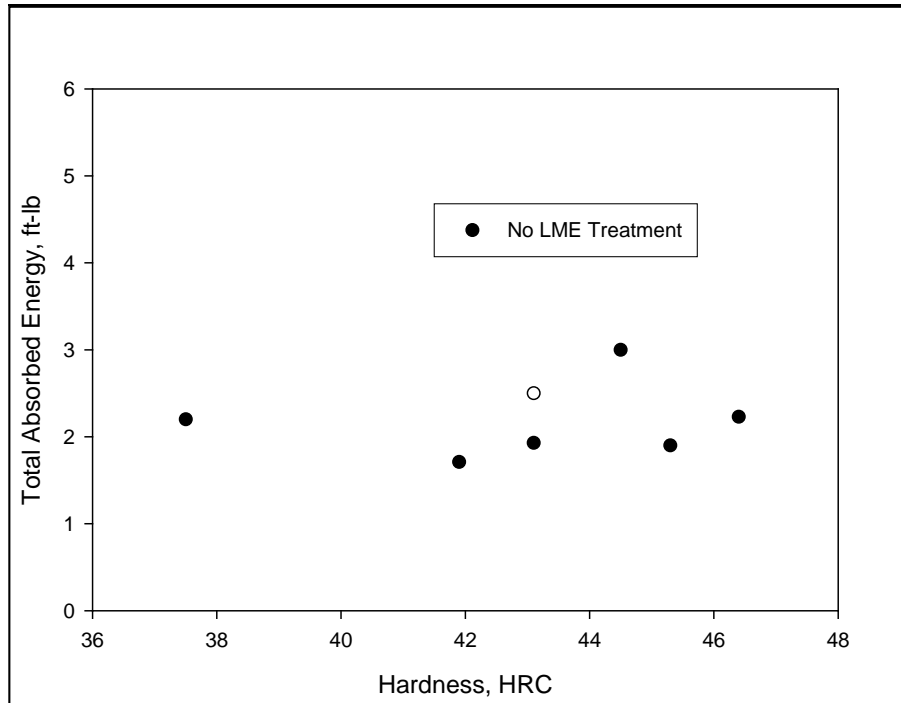
Baseline drop tower tests were conducted on the pre-stressed (but not treated with LM) Charpy bars. The drop tower was configured to provide an impact energy of 12.8 ft-lb in all cases. Some of the bars completely fractured and some did not. Two of the samples were filled with a riffler file. One of them completely fractured and one did not. Various degrees of deflection were used, up to and including a deflection of 0.060 in. The total energy to deform or fracture the samples as a function of sample hardness is shown in figure 15. These values are not a great deal different from those shown in figure 14. The most important point taken from this figure is that there is still no appreciable difference in total energy needed to partially or completely fracture these samples.

Figure 15. Drop tower test results for pre-stressed samples not treated with LM.

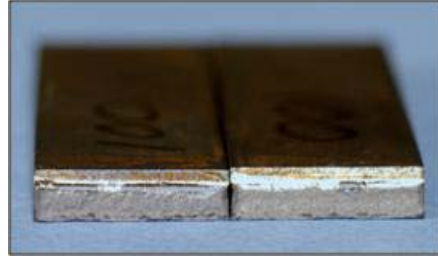
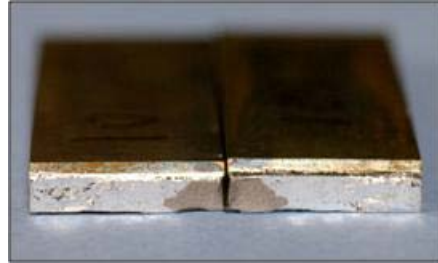
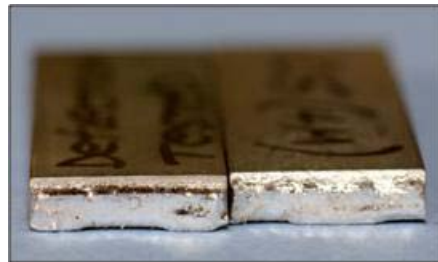
The drop tower test results are now examined for those samples that were both pre-stressed and treated with LM. Photographs of the fracture surfaces of the first three samples tested in this manner (100-PN, 101-PN, and 102-PN) are shown in figures 16a, 16b, and 16c, respectively. Sample 100-PN fractured completely, but the other two did not. However, the degree of fracture for the latter two samples was so great that the two ends of these samples were easily separated after the tests. The deflection of these particular samples prior to the impact tests were not measured as carefully as in subsequent tests. The deflection is estimated to have been approximately 0.050 in for each sample. (Note that without a precise measurement of the deflection, these samples were not included in any of the described procedures.) There was a varying degree of wetting by the LM on each of the samples' fracture surfaces. Sample number 100-PN was not wetted, sample number 101-PN was partially wetted, and sample number 102-PN was completely wetted. The absorbed energy appears to correlate with the degree of wetting. That is, sample number 100-PN had the greatest absorbed energy, sample number 101-PN had less absorbed energy, and sample number 101-PN had the least absorbed energy (see section A-3, tables A-2a through A-2c in the appendix).

Figure 16a. Non-wetted fracture surfaces (sample number 100-PN).

Figure 16b. Partially wetted fracture surfaces (sample number 101-PN).

Figure 16c. Completely wetted fracture surfaces (sample number 102-PN).

Initial work began with 1038 steel samples. Variations in the test results were observed. Part of these variations might be ascribed to small differences in the treatments given the samples. For instance, figures 16a through 16c show quite different results in terms of the amount of surface wetting by the LM. These differences might be ascribed to small differences in the deflections given each sample, leading to large differences in the degree of fracture for the samples. These differences might also be ascribed to the inherent variable nature of the fracture process. Another possible source of variation was the difficulty in achieving uniform sample hardness, both within a given sample and from sample to sample. This variation was mitigated, to some extent, by switching to 4340 steel.

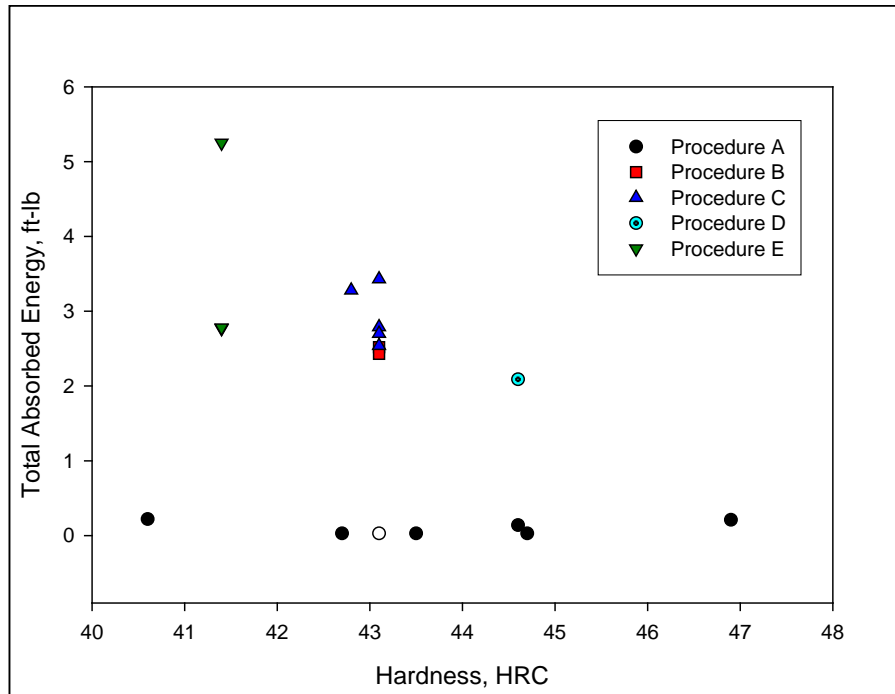
These results can be grouped according to the procedures that were used to treat the samples. These test results are shown in figure 17. In this figure, there is no distinction between partial and complete fractures.

Figure 17. Drop tower test results for pre-stressed, LM-treated samples.

There is a clear gap in absorbed energy between results for samples treated by Procedure A and results for the other samples. The total absorbed energy for the Group A samples is effectively zero.

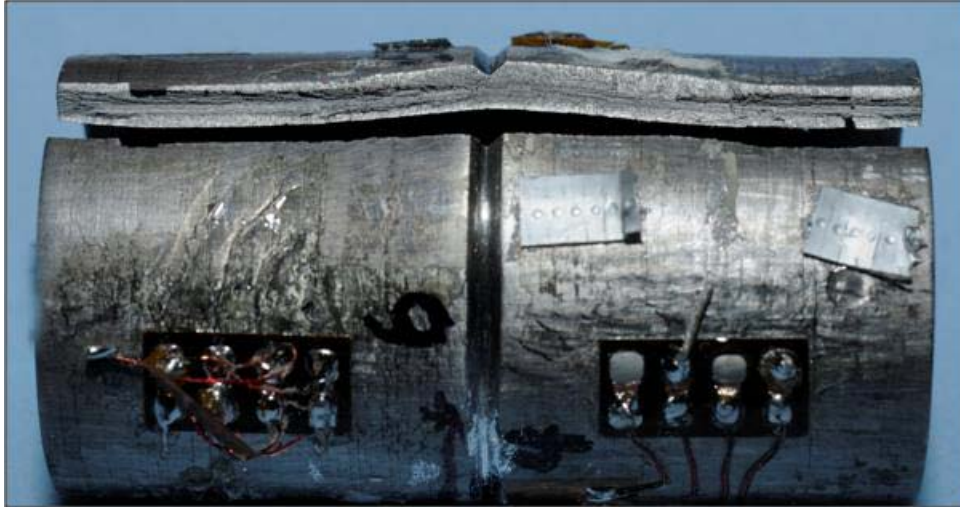
Two steel cylinders were tested. The first one was pressurized at a cross-head displacement rate of 0.1 in/min, and the second was tested at a higher rate, 1.0 in/min. Both cylinders split in the longitudinal direction at loads over 20,000 lb. The first cylinder is shown in figure 18. A large amount of permanent deformation has occurred in the middle of the cylinder. The local deflection at the center of the cylinder is on the order of that generally achieved in the flat modified Charpy bar samples. However, it was not sufficient to fracture the cylinder at the circumferential groove location. The fracture along a longitudinal direction is due to the very high hoop stresses generated by the internal pressure. There is a similar tendency for fracture seen along the longitudinal direction in the explosive experiments (14–16).

Figure 18. Cylindrical steel cylinder after pressurization test showing longitudinal fracture.

The nature of the fracture in the longitudinal direction is quite different for the static and dynamic cases. Figure 18 shows a longitudinal fracture caused by a static internal pressure. It can be characterized primarily as a tensile failure. The failure mechanism of the cylinder due to explosive loading is more complex. At the early stages of the cylinder expansion, tensile cracks are formed in the longitudinal direction on the outer surface of the cylinder. As the cylinder expands further, these external tensile cracks link up to the inner surface of the cylinder by means of compressive shear failures. How LM would promote or enhance this process is unknown.

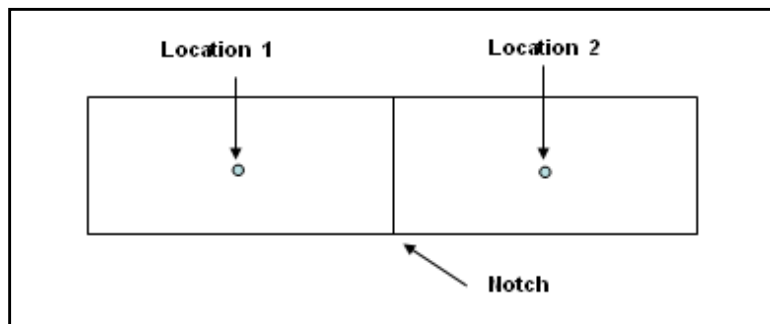
One source of possible test variation was sample hardness. Small variations in this parameter might prove to be critical, especially in the range of HRC 40 to 50, based on the data presented in figure 11. An initial examination of the variation in hardness value from sample to sample was conducted to quantify the variation. Two measurements were made on each sample, taken from locations on the sample as shown in figure A-3. Hardness data for 19 samples are shown in figure A-4. All samples shown in this figure were made from 1038 steel. Individual measurements spanned a hardness value range from HRC 32 to HRC 48. There was almost a 10-point span of hardness for sample number 10 (127).

Figure A-3. Hardness measurement locations on the modified Charpy bar.
