**SERDP-WP-2144 • SEPTEMBER 2016**

# **Understanding Corrosion Protection Requirements for Adhesive Bond Primers WP-2144**

**Diane Kleinschmidt  
Naval Air Warfare Center, Aircraft Division  
Patuxent River, MD 20670**

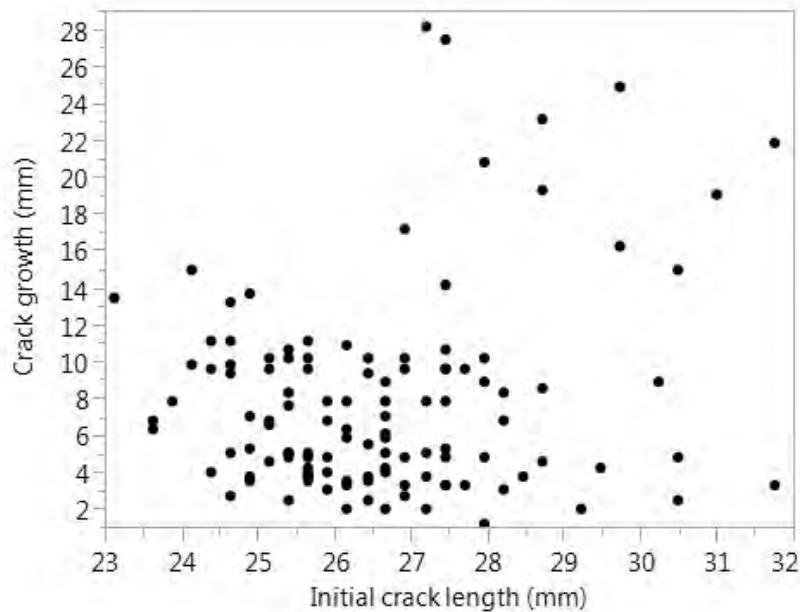
**Figure 11: Indoor WCET specimens, initial Cytec primer screening (BR 6700-1, BR 6747-1, and BR 6747-1NC), all surface treatments, all environmental conditioning factors**

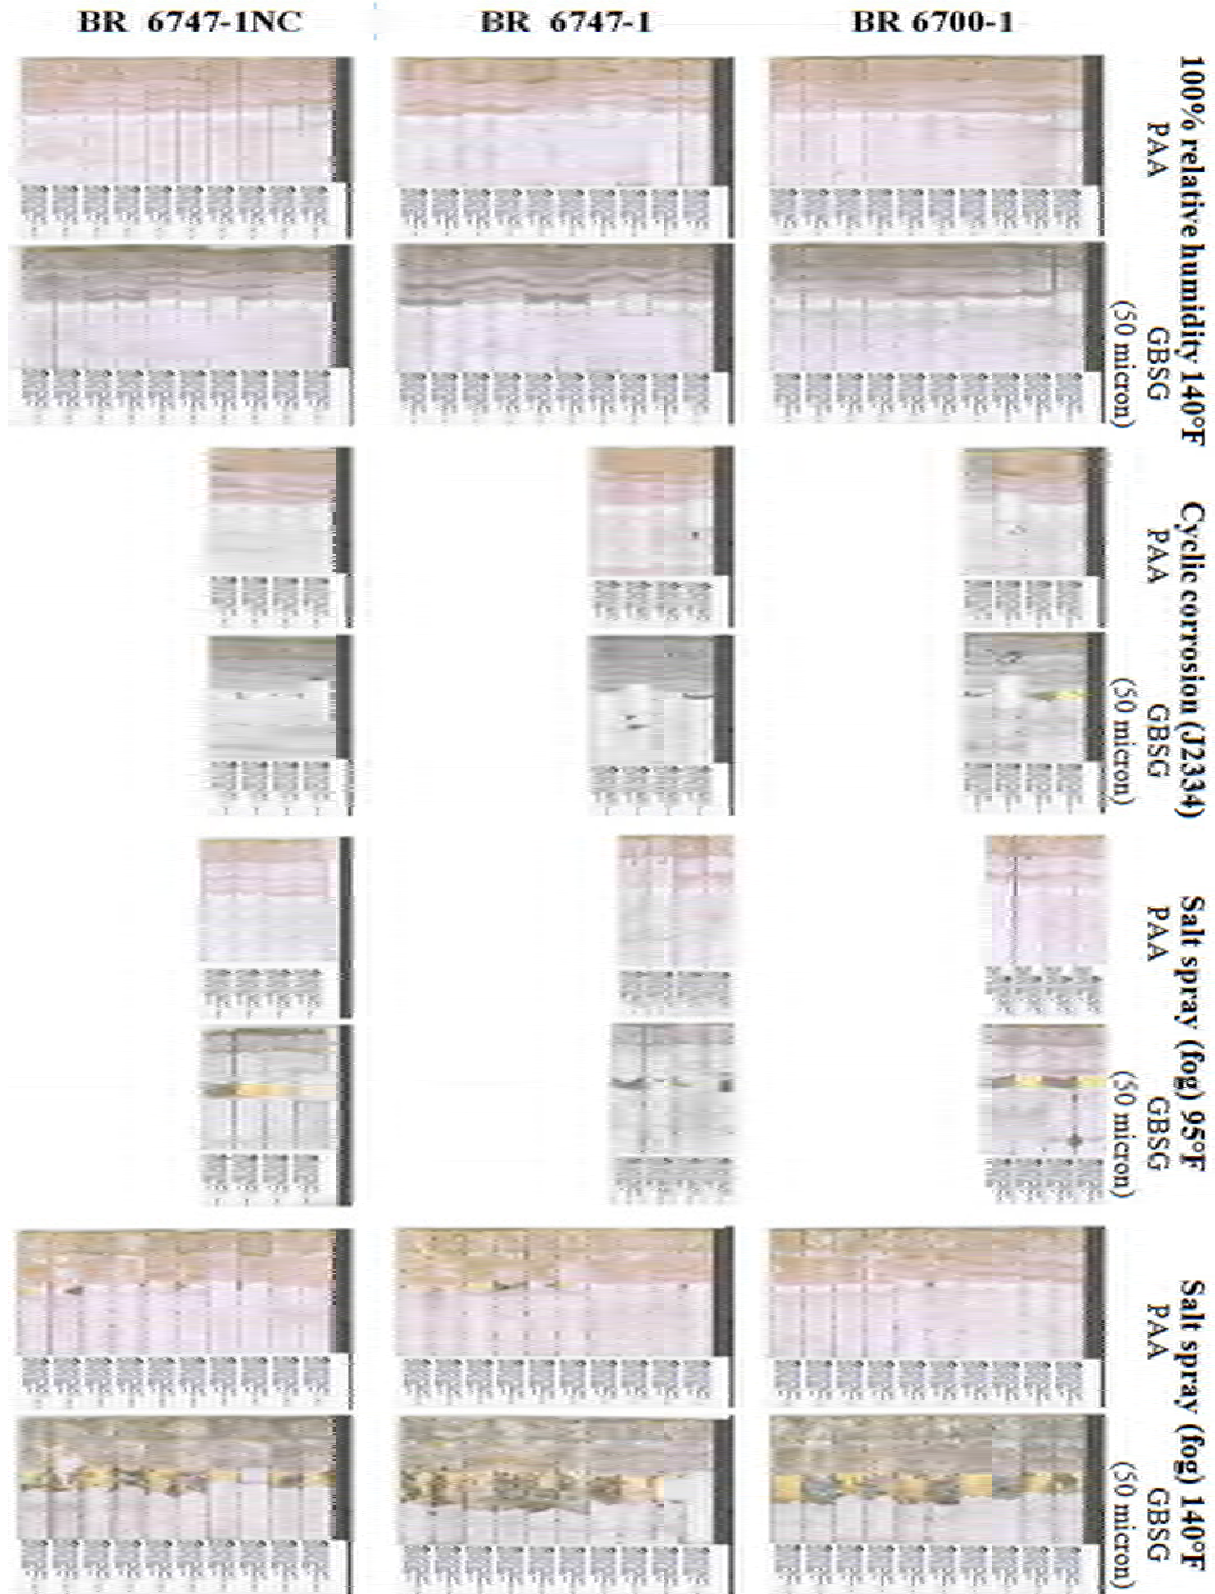
Figure 16 WCET failure surfaces for initial indoor Cytec primer samples (BR 6700-1, BR 6747-1, and BR 6747-INC), all surface treatments, all environmental conditioning factors. Legibility of identification tags is not critical; figure provides relative condition/failure mode for primer/condition set.

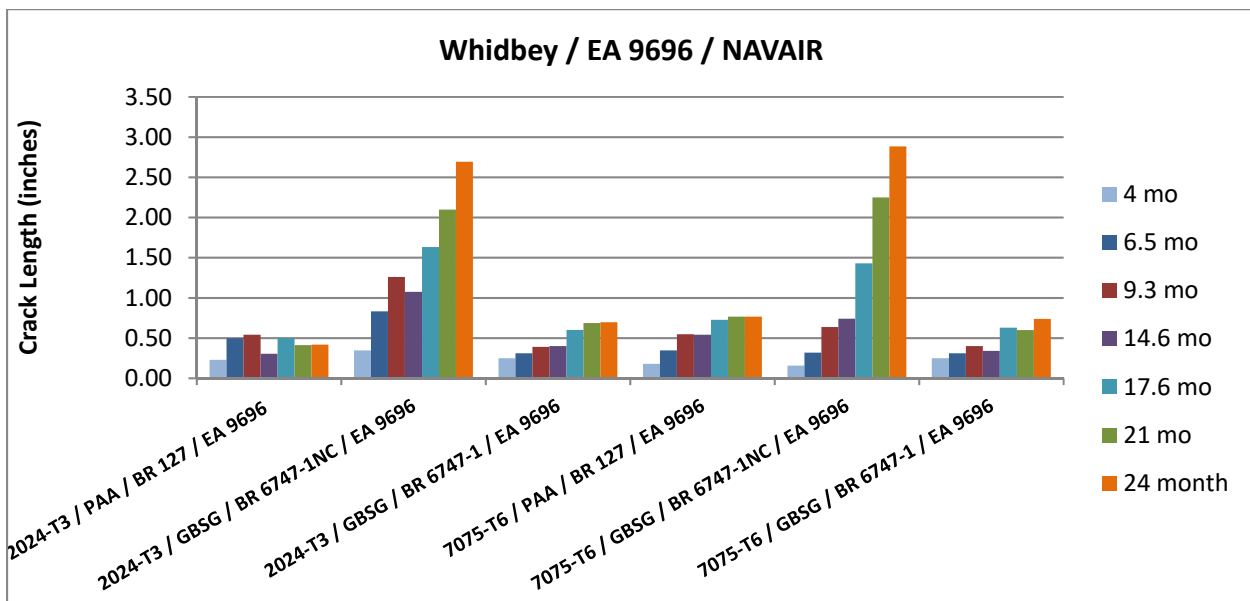
Figure 21. Total crack length data over exposure time at Whidbey for EA 9696 samples fabricated at NAVAIR  
 Table 12. Average Crack Growth Results for Marine Atmospheric Environment DCBs Bonded with FM 73

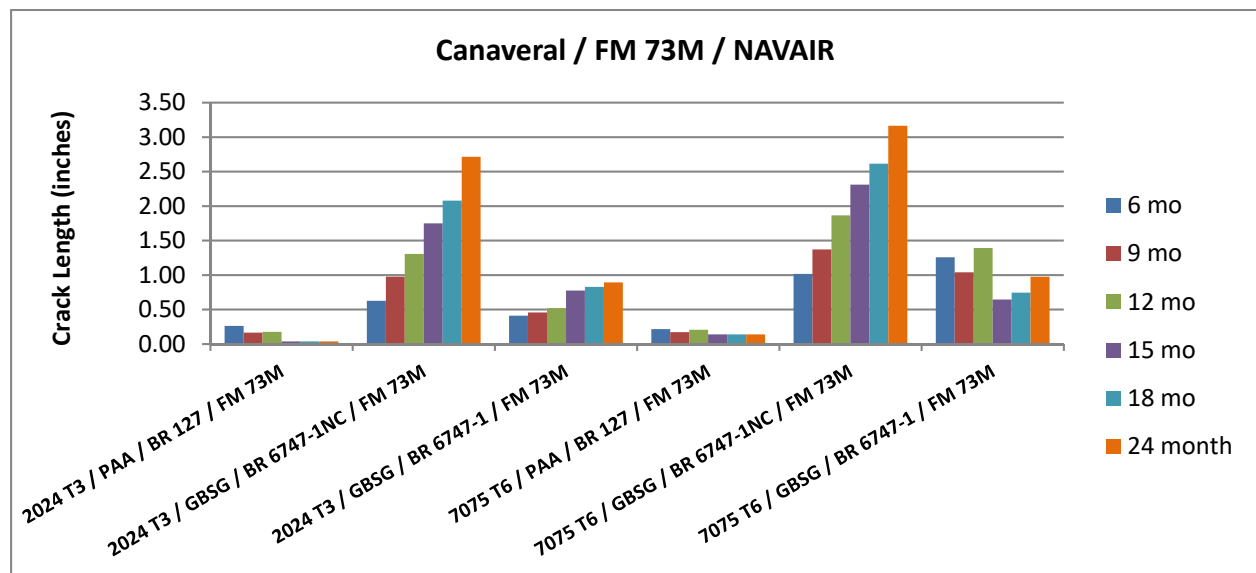
Figure 22: Total crack length data over exposure time at Canaveral for FM 73M samples fabricated at NAVAIR

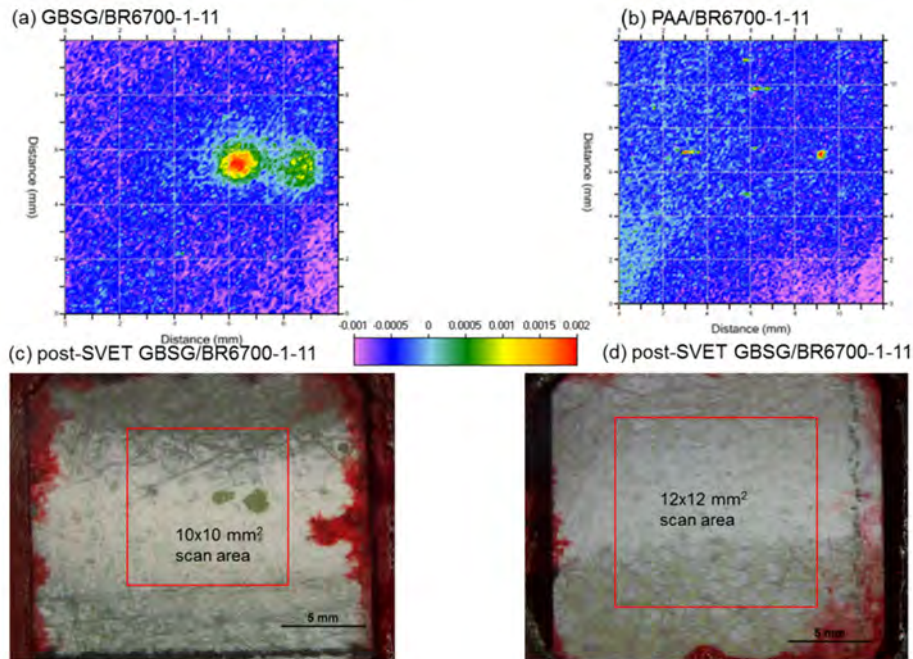
Figure 68: Effect of surface prep on SVET maps GBSG/BR 6700 (left) and (b) PAA/BR 6700 (right) in 100ppm NaCl

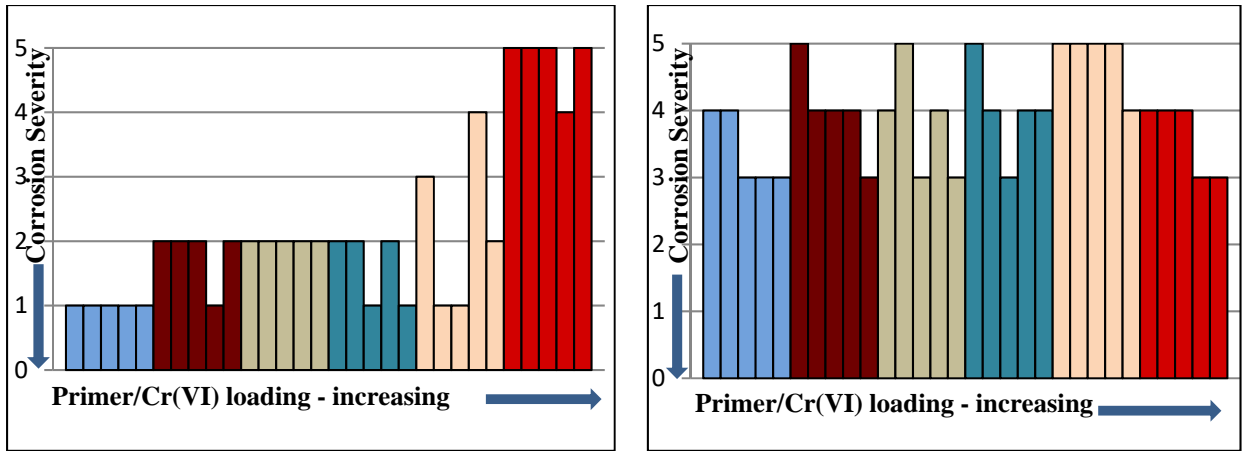
Figure 81: Scribe corrosion response: primer chromate loading in *primer-only* Al7075/GBSG panels after 48 hours in NSF (left); primer chromate loading in *primer-only* Al7075/PAA panels after 48 hours in NSF (right)

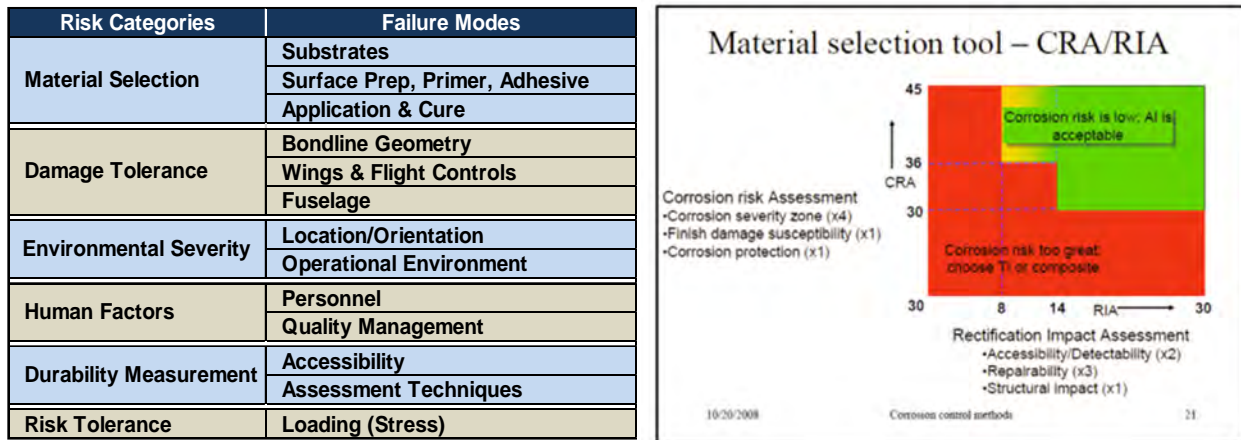
Figure 147 B-CRAT Risk Categories and material selection tool.
