## TECHNICAL MEMORANDUM TM-2328-SHR

### INVESTIGATION INTO ACRYLIC PAINT CRACKING (APC) ON ASPHALTIC PAVEMENTS

January 2000

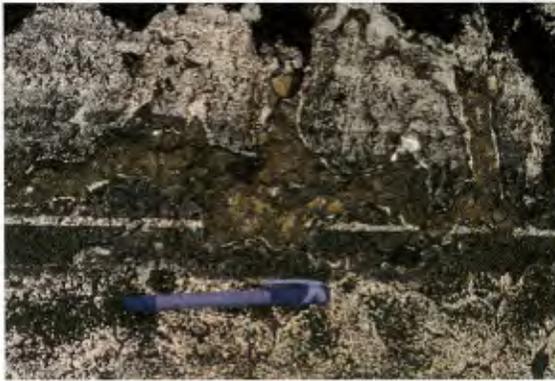
APC, NAS North Island.

Runway 29 – 11 contains a Slurry Seal (SS) applied to 4” of Asphaltic Concrete (AC) over 8” of Portland Cement Concrete (PCC)<sup>11</sup>. In FY 97, the runway received 129,000 combined take-offs and landings<sup>12</sup>. Extreme annual temperatures range from 30°F to 108°F with daily averages between 56°F to 71°F<sup>13</sup>. In 1987, the runway received a new SS and was subsequently coated<sup>14</sup>. Since 1987, the runway has received two or more overcoats for a total Dry Film Thickness (DFT) ranging from 55 mils to 120 mils (1 mils = 0.001”). White markings displayed 3” to 6” diameter sections of paint outlined by cracks whereas yellow taxi lines displayed smaller 2” to 3” diameter sections of paint

outlined by cracks. In general, APC penetrated the full 3/8" SS depth and, in some cases, cracking was observed to a depth greater than 1".

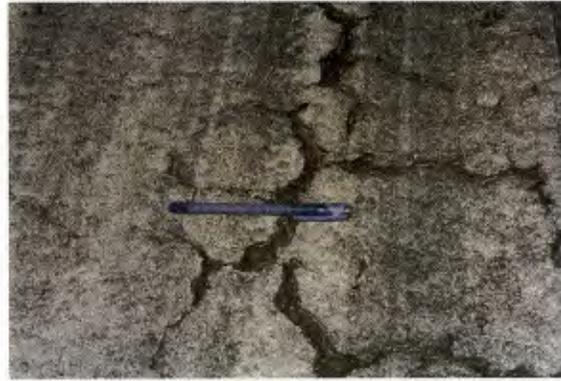
APC, NAS North Island.

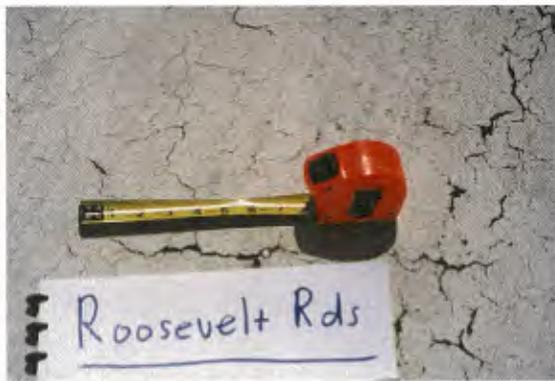
APC, NS Roosevelt Rds.

Forty-five percent of Runway 7 – 25 contains 3.5" of AC applied to a paving fabric over 11" of PCC<sup>20</sup>. In FY 95, the runway received approximately 10,300 combined take-offs and landings<sup>21</sup>. Rainfall averages 58 inches per year and mean annual temperatures range from 74°F to 82°F with summer highs reaching the middle 90s<sup>22</sup>. In 1993, the runway received its' AC overlay and was subsequently coated<sup>23</sup>. The overlaid AC contains two coats of marking paint<sup>24</sup>. Overall, painted surfaces displayed moderate APC with paint crack depths  $\leq 1/2$ " and paint crack widths  $\leq 3/8$ ". However, dime to quarter sized sections of paint have begun to spot fail and may contribute to an increase in FOD (Foreign Object Damage).

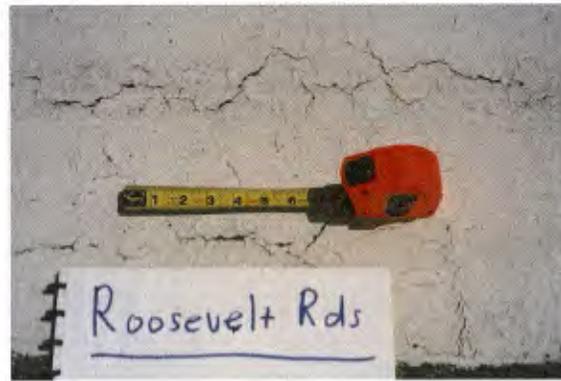
APC, NS Roosevelt Rds.

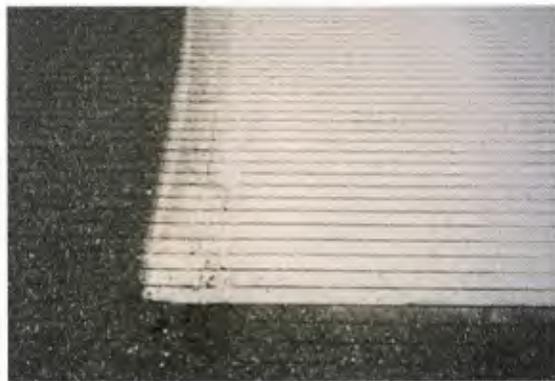
Grooved, friction course  
Shreveport Regional.

Shreveport Regional's AC runway contains a grooved, friction course. Grooves are 1/4" wide by 3/8" deep and have been placed transverse at 1.75" intervals. Airfield markings contain a 3.5 year-old coating base and, built-up by overcoating, display an approximate thickness of 50 mils<sup>25</sup>. The centerline marking was free of APC whereas threshold markings contained microchecked paint (small, hairline mudcracks). Although combinations of waterborne and water-based acrylics are used, APC, as identified on the above three runways, was absent. It appears that the grooved, friction course may have relieved the stresses which generally produce APC.

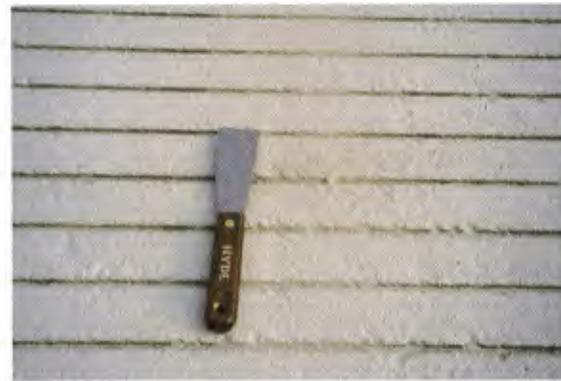
Threshold marking, Shreveport Regional.

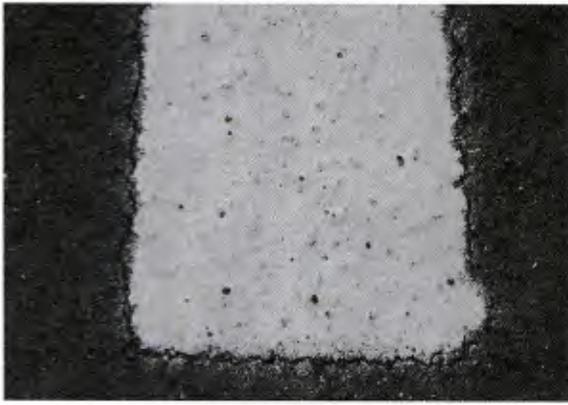
Early stage of edge cracking.

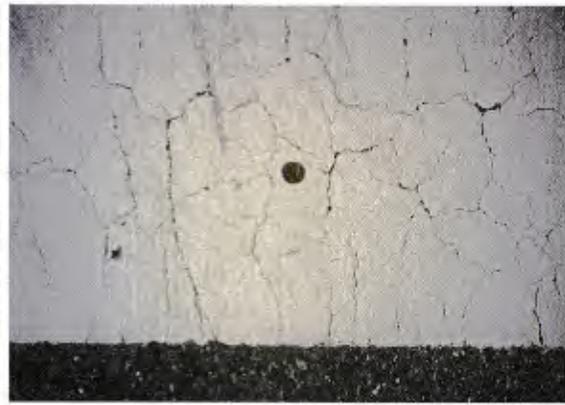
Early stage of APC.

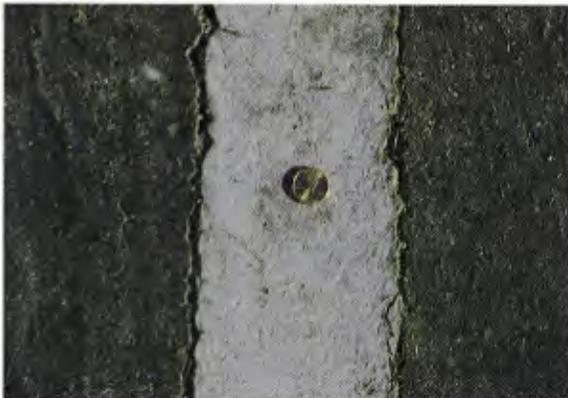
Advanced stage of edge cracking.

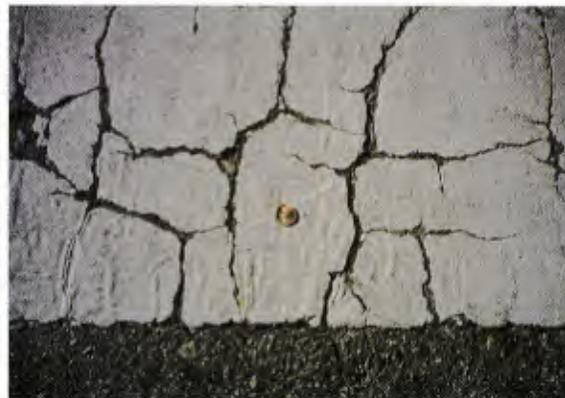
Advanced stage of APC.

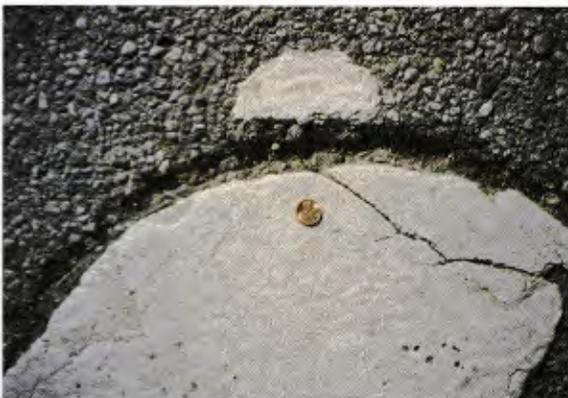
Severe edge cracking.

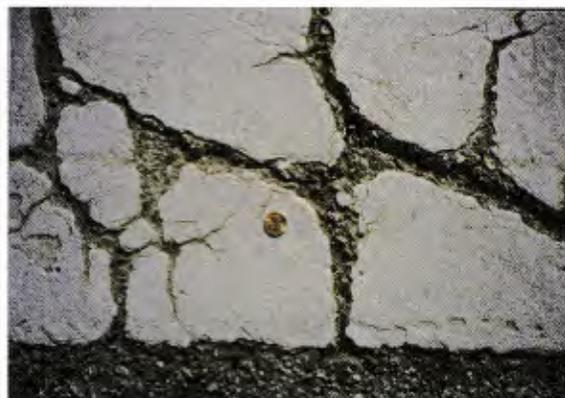
Severe APC.

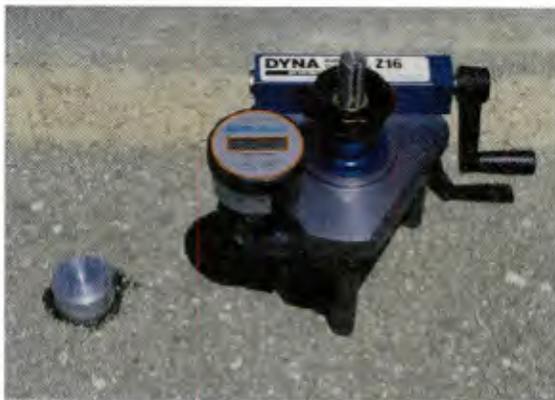
Proceq Dyna Tester and 2" pull-off puck.

The cohesive strength of four Southern California asphaltic wearing surfaces was quantified using a Proceq Dyna Tester and 2" diameter pull-off pucks. Cohesive strength testing was conducted in the field and performed on the following wearing surfaces: A) 4 year-old, 3" thick AC pavement with up to 1/2" coarse aggregate, B) 5+ year-old road SS, C) 1 year-old parking lot SS, and D) 1 year-old parking lot Seal Coat (SC). Asphaltic wearing surfaces are thermoplastic whereby cohesive strength decreases with increasing temperature. Table 1 lists cohesive strengths for the above wearing surfaces tested at various surface temperatures.

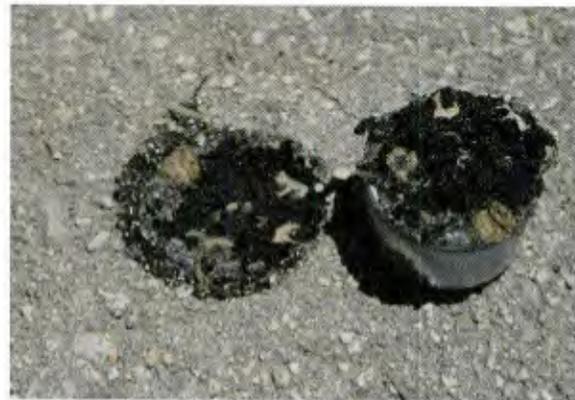
AC cohesive failure: 1/4" of AC attached to pull-off puck.

Cohesive strength values represent the wearing surfaces' maximum tensile strength and, in general, limits marking paint adhesion to asphaltic surfaces. For example, if a marking paint was applied to the above AC surface and tested for adhesion at 108°F: maximum paint adhesion is displayed when the marking paint produces an AC cohesive failure at 106 psi.

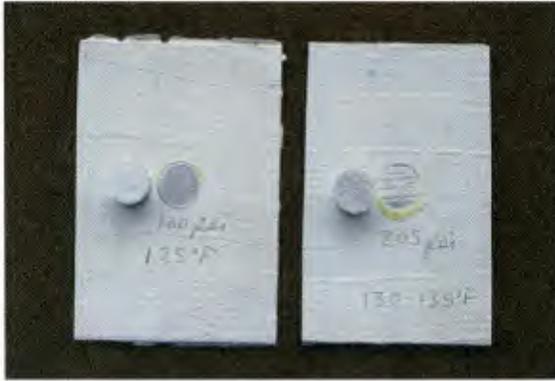
Pull-off pucks and samples with resulting paint cohesive failures.

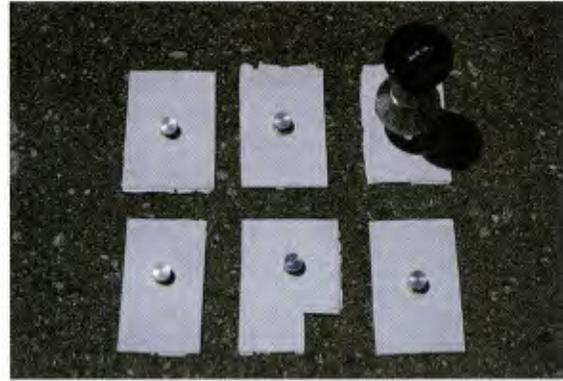
Elcometer adhesion tester and 3/4" pull-off pucks attached to paint samples.

An Elcometer adhesion tester with 3/4" diameter pull-off pucks was used to quantify the cohesive strength of paints. Paints were applied to either grit blasted aluminum or grit blasted steel. Table 2 lists the cohesive strength of paints at room temperature whereas Table 3 lists the cohesive strength of Paints I, II at elevated temperatures.

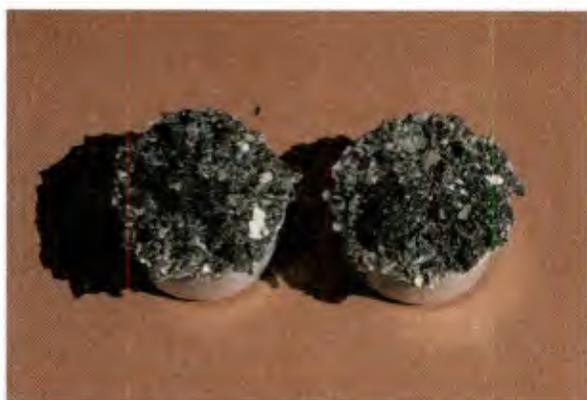
Paint with attached chunks of AC indicate paint adhesion > AC cohesive strength.

Paints were applied to clean AC in one coat at an approximate Dry Film Thickness (DFT) of 10 mils. Paint adhesion was quantified using a Proceq Dyna Tester and 2" diameter pull-off pucks. Table 4 lists adhesion values at a specific AC surface temperature and represents the average of two tests per paint. Each pull-off test produced an AC cohesive failure and results signify maximum paint adhesion to AC. Table 5 lists overcoat adhesion values of Paint I applied over each of the six paints. Results from overcoat adhesion suggest waterborne acrylics develop excellent bonds to previously applied acrylics.

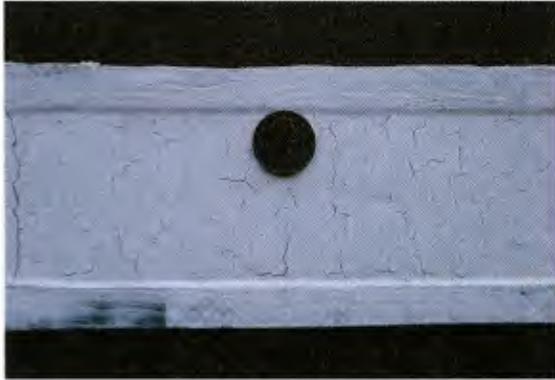
Paint I cracking at > 30 mils DFT.

Paints were applied in one coat at several DFTs to either a Teflon sheet or a metal substrate (aluminum, steel) and observed for the presence of cracks. Paint cracking occurs when the paint's internal stress exceeds the paint's cohesive strength. Table 12 identifies the presence of cracked paint at several DFTs.

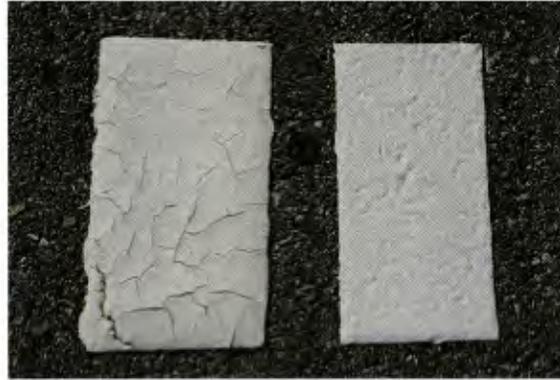
Paint I (left), Paint HB (right).

Paint I and batch two of Paint HB displayed slight cracking at DFTs as low as 22 mils whereas batch one of Paint HB and Paint EA were crack free at DFTs up to 50 mils. As anticipated, the elastomeric modified acrylics (EA/I, EA/II) displayed less cracking at higher DFTs when compared to the unmodified formulations. It was disappointing to observe the high degree of variation between the two commercial batches of Paint HB. The first batch of Paint HB displayed excellent crack resistance whereas the second batch displayed cracking at approximately 1/3 the DFT of batch one.

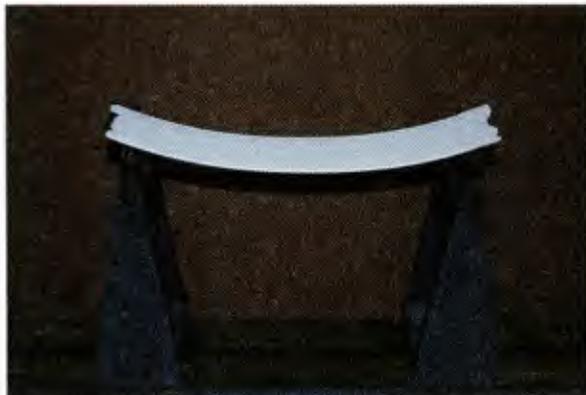
Shim bending technique.

Residual Cure Stress (RCS) was quantified using the freely supported beam method (shim bending technique)<sup>33,34,35,36</sup>. Paints were applied to stainless steel shims (0.012" x 10" x 2": SS 302) at DFTs ≥ 38 mils. The initial shim deflection, prior to coating, was used as the zero point. Equations (1) and (2) are presented in Reference 35 and were used to calculate RCS. Table 13 lists RCS per mil of cured paint.

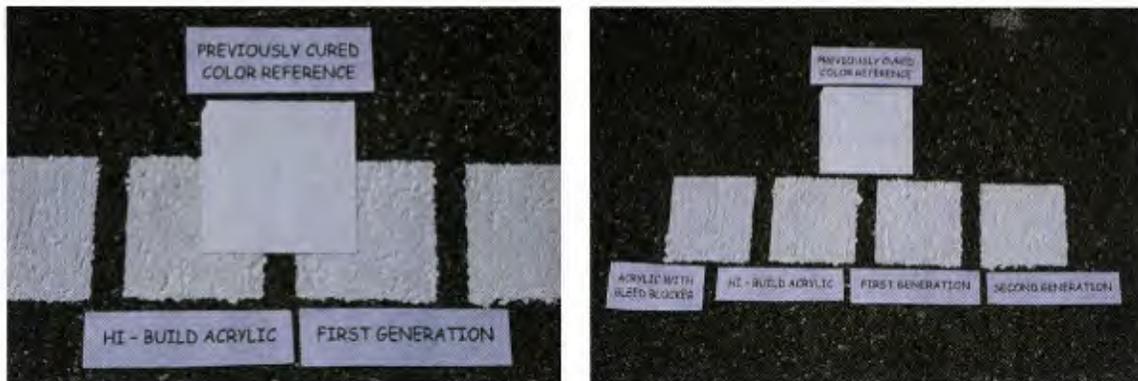
Paints HB, I displayed poor asphaltic bleed resistance. Testing for asphaltic bleed resistance.

Paints were applied to a clean, four-year old AC surface at approximately 10 mils DFT by brush. Table 15 lists qualitative visual results for asphaltic bleed resistance whereby paint EA, doped with an asphaltic bleed-blocking agent, outperformed the acrylic marking paints.

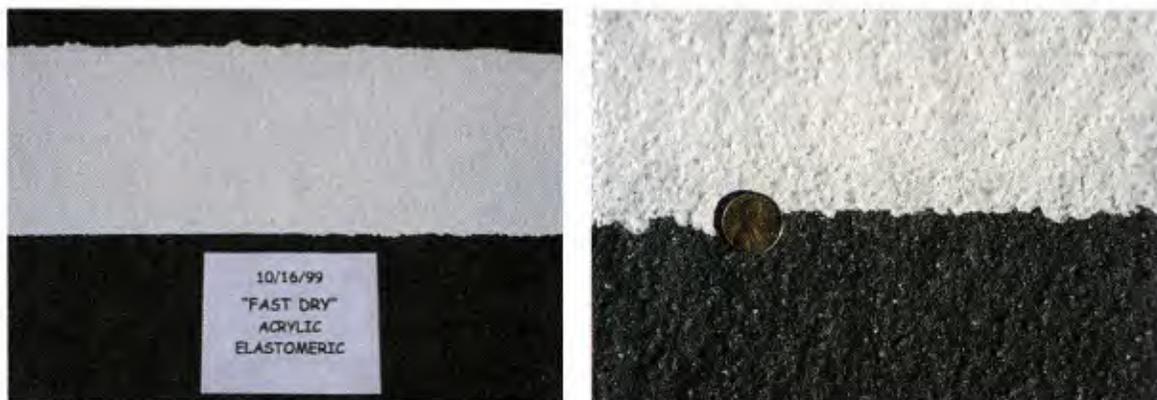
Patch applied to parking lot SS.

Crack free at 2 months: Parking lot SS patch.

Two Paint EA patch tests were applied to the following areas located in Southern California at approximately 10 mils DFT: A) Stop sign stripe over AC, and B) One-year old parking lot SS. Patch A was used to evaluate abrasion resistance whereas Patch B was used to evaluate the effects of both RCS and short-term thermal cycling. Adjacent Patch B, the parking lot SS displayed a cohesive strength of 18.5 psi at 103°F and previously applied marking paints contained significant edge cracking. At two months service, patches were evaluated for performance. After approximately 20,000 car passes, Patch A displayed poor abrasion resistance whereby previously coated high spots had failed. Patch B, however, was not subjected to automotive traffic and remained crack free (0 % edge and internal cracking). Results validate the following Paint EA properties: 1) Poor abrasion resistance, 2) Low transfer of RCS to substrates, and 3) Flexibility sufficient to combat thermally induced SS movement.

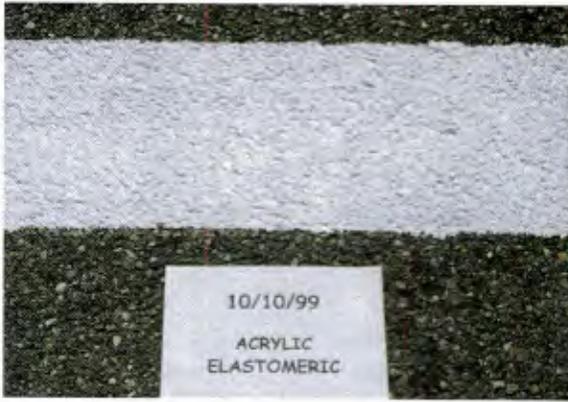
Patch applied as stripe for stop sign.

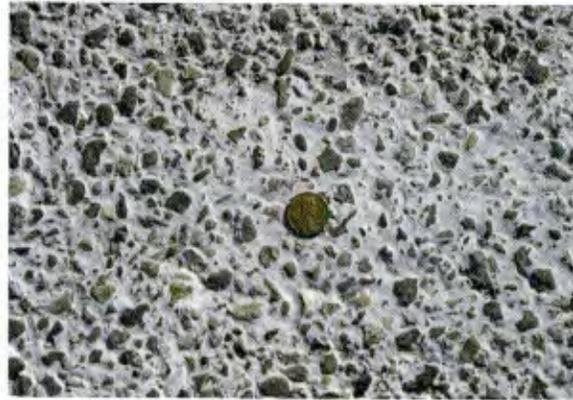
Poor abrasion resistance at 2 months service: Stop sign stripe.

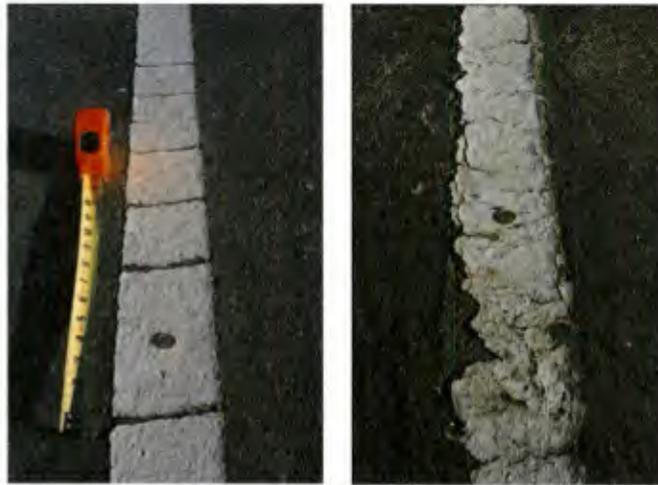
Stripes were applied at the same time: right stripe receives sprinkler runoff.

Moisture induced stress occurs when coatings absorb moisture from rainfall, high humidity, dew, and pavement moisture vapor emission. Cycling between water absorption (volume increase) and drying (volume contraction) increases cohesive and adhesive paint stress. As previously noted, the tested paints displayed water absorption weight increases ranging from 5.5 % to 12.6 %. In general, a 10 % increase in weight represents approximately a 13 % increase in volume<sup>50</sup>. Paints I, II displayed approximately a 10 % weight increase from water absorption and, since they also displayed poor flexibility, should weather poorly when subjected to high levels of moisture. As evident in the above photographs, high levels of moisture accelerate acrylic marking paint failures.

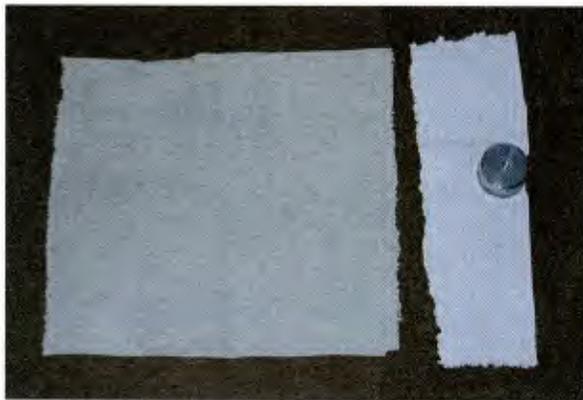
The above flexible acrylic was lifted in sheets, using hand pressure, from a concrete substrate.

Flexible acrylic marking paints designed for asphaltic pavements must contain the appropriate level of tensile strength, adhesive strength, and percent elongation. If coating/substrate adhesion is well below the coating's tensile strength and the paint contains a high percent elongation, the marking paint may fail in sheets when subjected to various stresses. The above photograph shows a flexible coating which developed an adhesive strength of 70 psi to concrete and, as a result of a high percent elongation ( $\geq 300\%$ ) and a high tensile strength ( $\geq 300$  psi), was pulled off the concrete in sheets. Ideal properties for semi-flexible marking paints are presented in Table 18 below.
