Technical Note N-1124

ANIMAL UNDERMINING OF NAVAL SEAFLOOR
INSTALLATIONS

NAVAL CIVIL ENGINEERING LABORATORY
Port Hueneme, California 93041

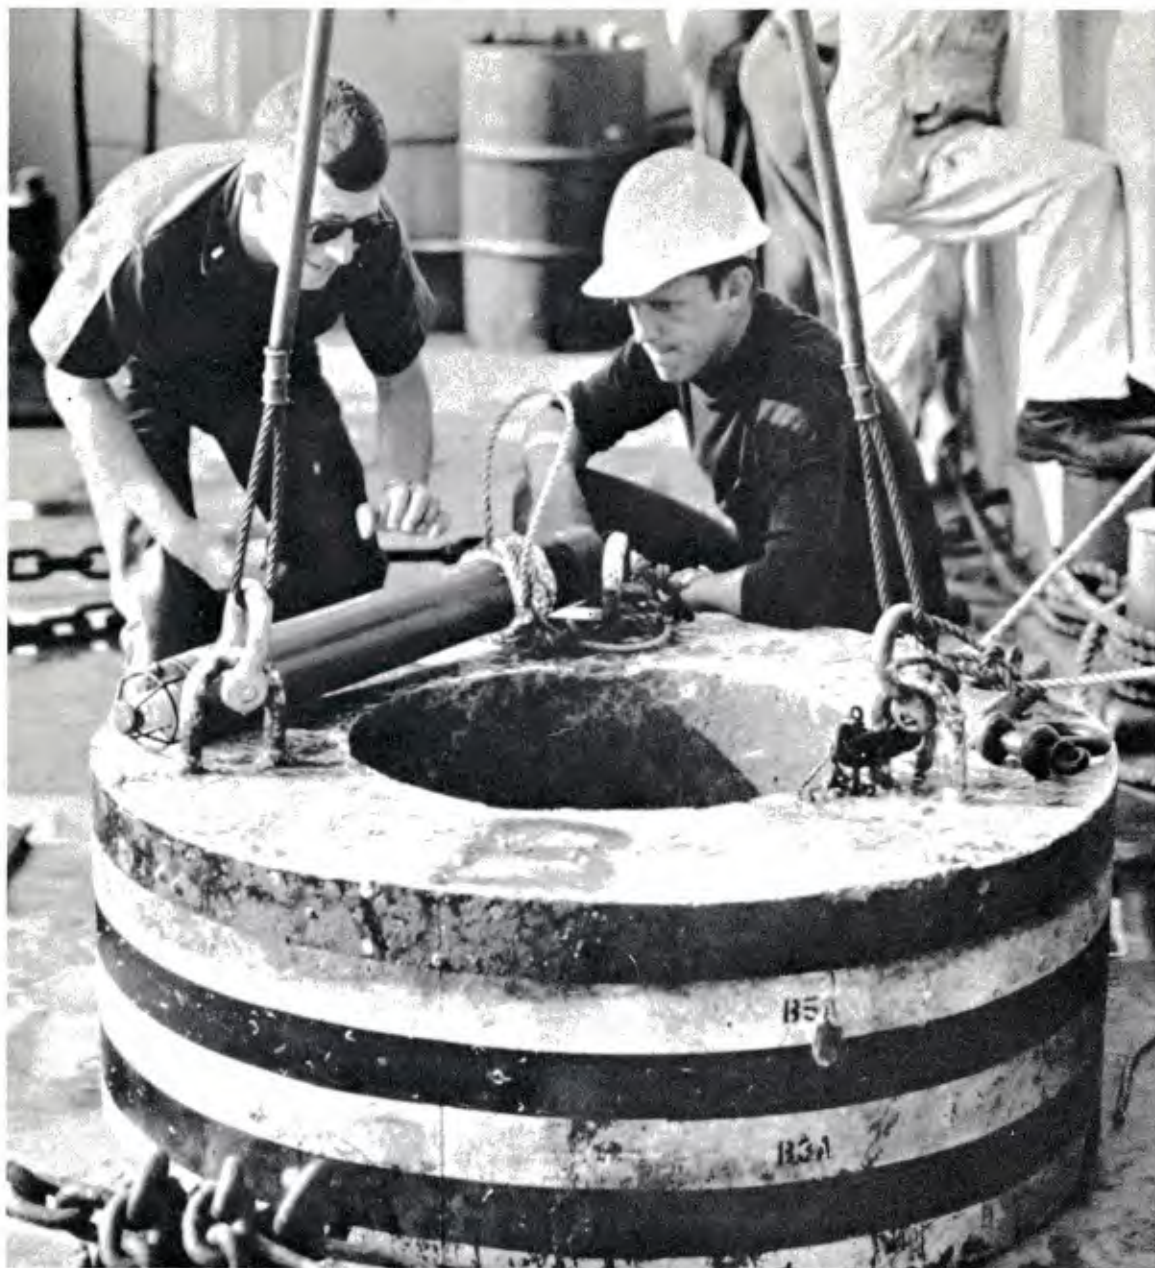
Figure 1. A 4-foot diameter by 2-foot high cylindrical concrete footing.

Information on engineering properties of bottom sediments is essential for (1) determining their effects on proposed foundations for undersea structures, (2) selection of suitable sites, and (3) designing a foundation (footings) for underwater Navy structures. To obtain such information, an in-situ footing foundation performance experiment was initiated by Naval Civil Engineering Laboratory (NCEL) engineers by placing several 4-foot diameter by 2-foot high cylindrical concrete footings (Figure 1) on the seafloor in 120 feet of water at Pitas Point, located about 12 miles north of Port Hueneme, California.^{1,2} The seafloor at this test site consists of fine clayey-silty sediment. The inspection of the emplaced concrete footings was conducted regularly by Navy Seabee divers.³ After several weeks of exposure on the seafloor, divers, prompted by observations of unusually large settlements, discovered several individual tunnel-like openings of animal burrows measuring 2 to 3 inches in diameter located around the perimeter of the footings. This finding was of great concern to ocean engineers because such animal burrows may undermine the stability of the concrete footings placed on the seafloor.

An average of about one inspection dive per month was conducted to inspect and evaluate the various footings placed on the seafloor at Pitas Point. Divers have discovered deep scoured areas underneath one side of the 4-foot diameter concrete spread-footings. Because of poor visibility encountered on the seafloor, animals which could have been inhabiting the scoured area under the footings were not detected. Animals actually tunneling or scouring the sediment under the footings were also not detected nor observed by divers. An NCEL engineer-diver who inspected the 4-foot diameter footings observed that the scouring effects were found on one side of each of the three footings and that one of these footings had fallen into the scoured depressions. As a result of this observation, it was tentatively concluded that surge action caused by large swells may have been responsible for the scouring effect produced under the footings rather than by marine animals. However, there are marine animals which do scour or excavate a depression under rocks or other objects placed on the seafloor. The California spiny lobsters have been observed by divers to scour a deep hole under rocks as a place to hide from predators.⁴ Hartman⁵ mentions that there is a burrowing fish, *Otophidium* sp. which inhabits the ocean floor. It is an eel-like fish commonly known as a spotted cusk-eel⁶ which ranges from Oregon to Baja California living on the seafloor in depths of 60 to 800 feet or more. The adult cusk-eel is about 14 inches long and burrows rapidly into the sediment tail first when startled or disturbed. The adults are usually found hidden beneath rubbles and crevices and holes on the sea floor.

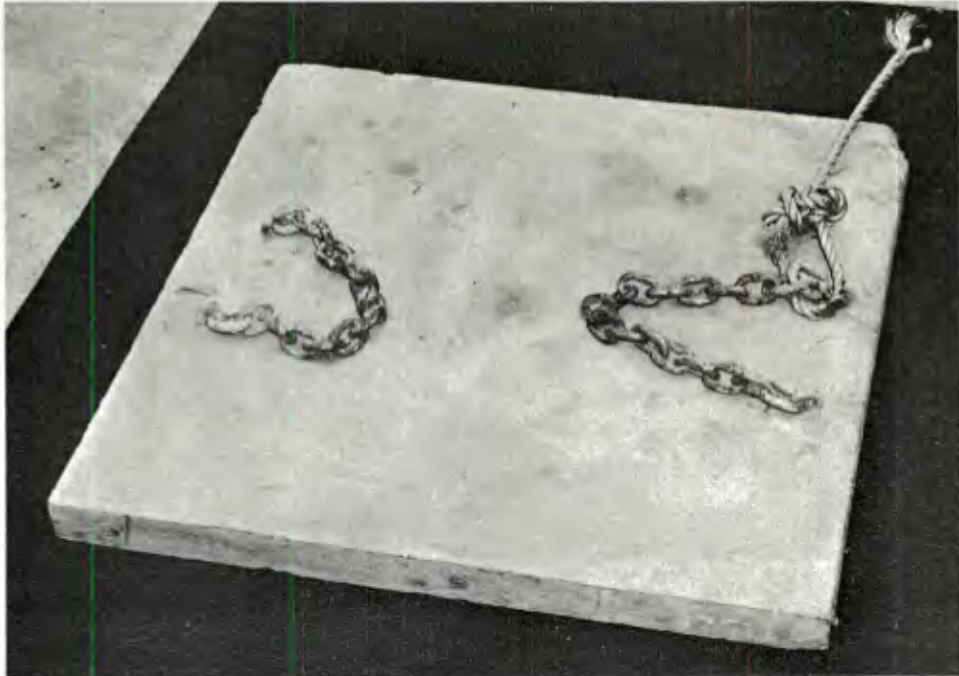
1. Concrete Footing (Figure 6). There were 10 *Listriolobus pelodes* and over 25 *Sternaspis* sp, an annelid worm, in approximately one

cubic foot of sediment collected from under the footing (Figures 7 and 8). Barnacles were not found attached to the surface of this concrete footing probably because it was buried and covered with about 2 inches of bottom sediment when located.

Figure 6. Recovered 2-foot square concrete footing.

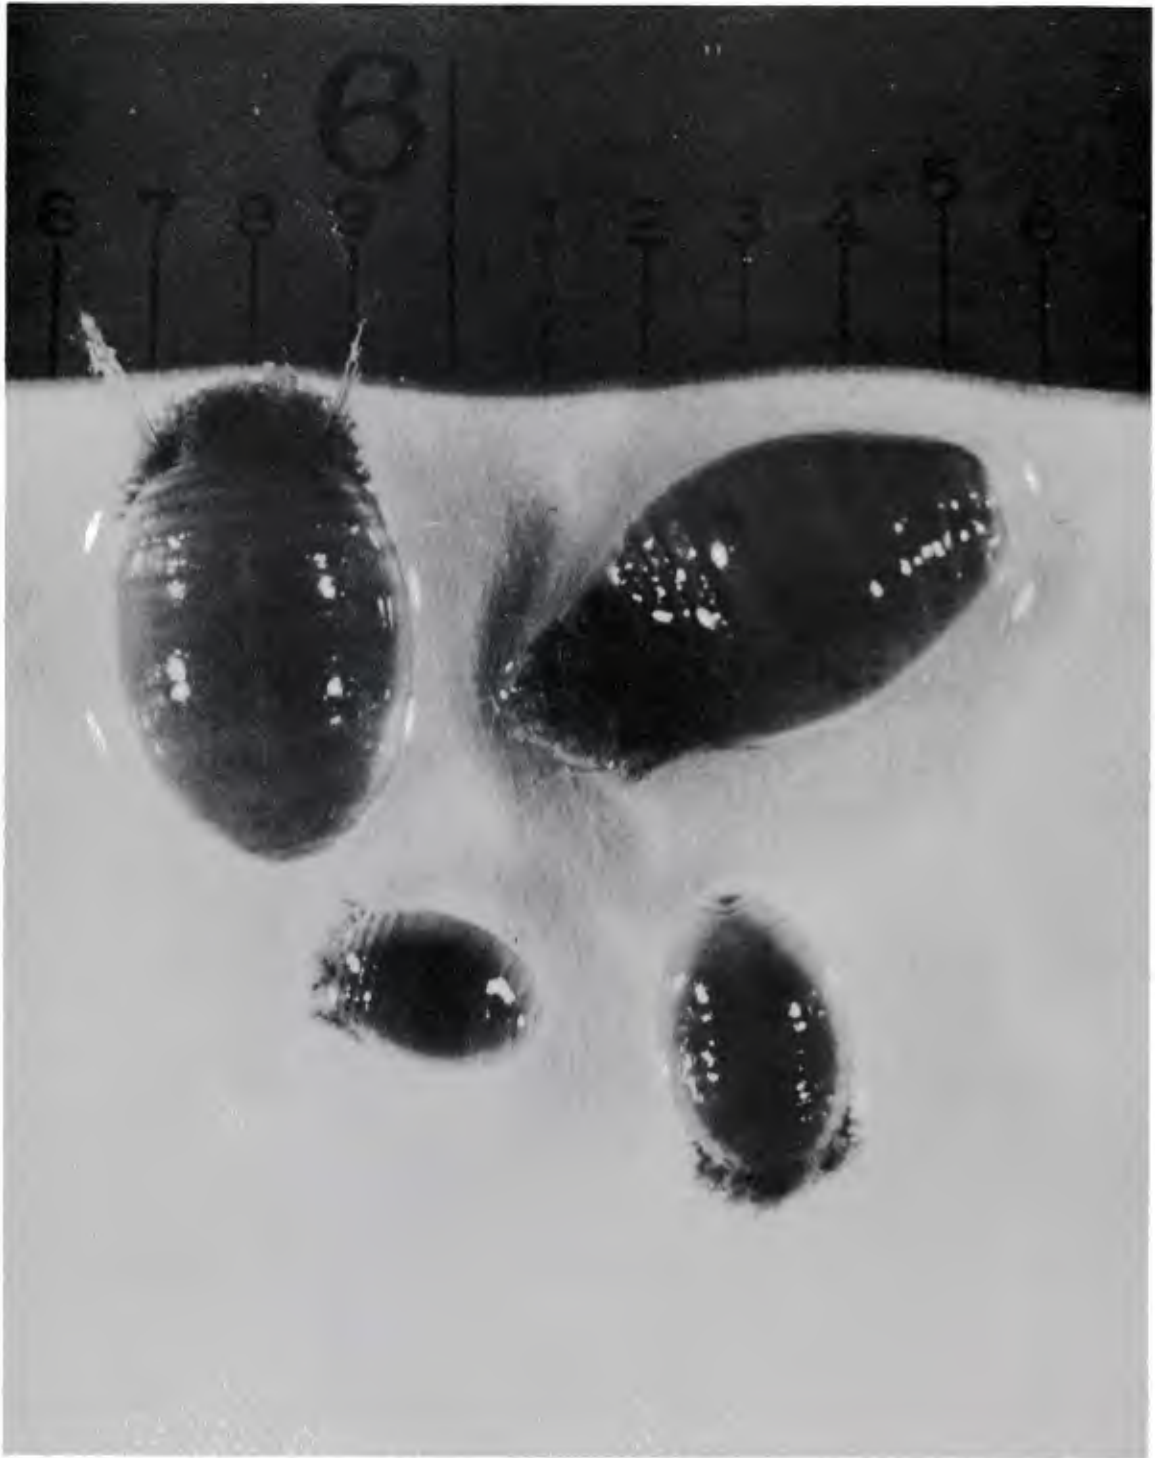
Figure 7. *Listriolobus pelodes*, an echiuroid worm, which forms a U-shaped burrow in the sediment.

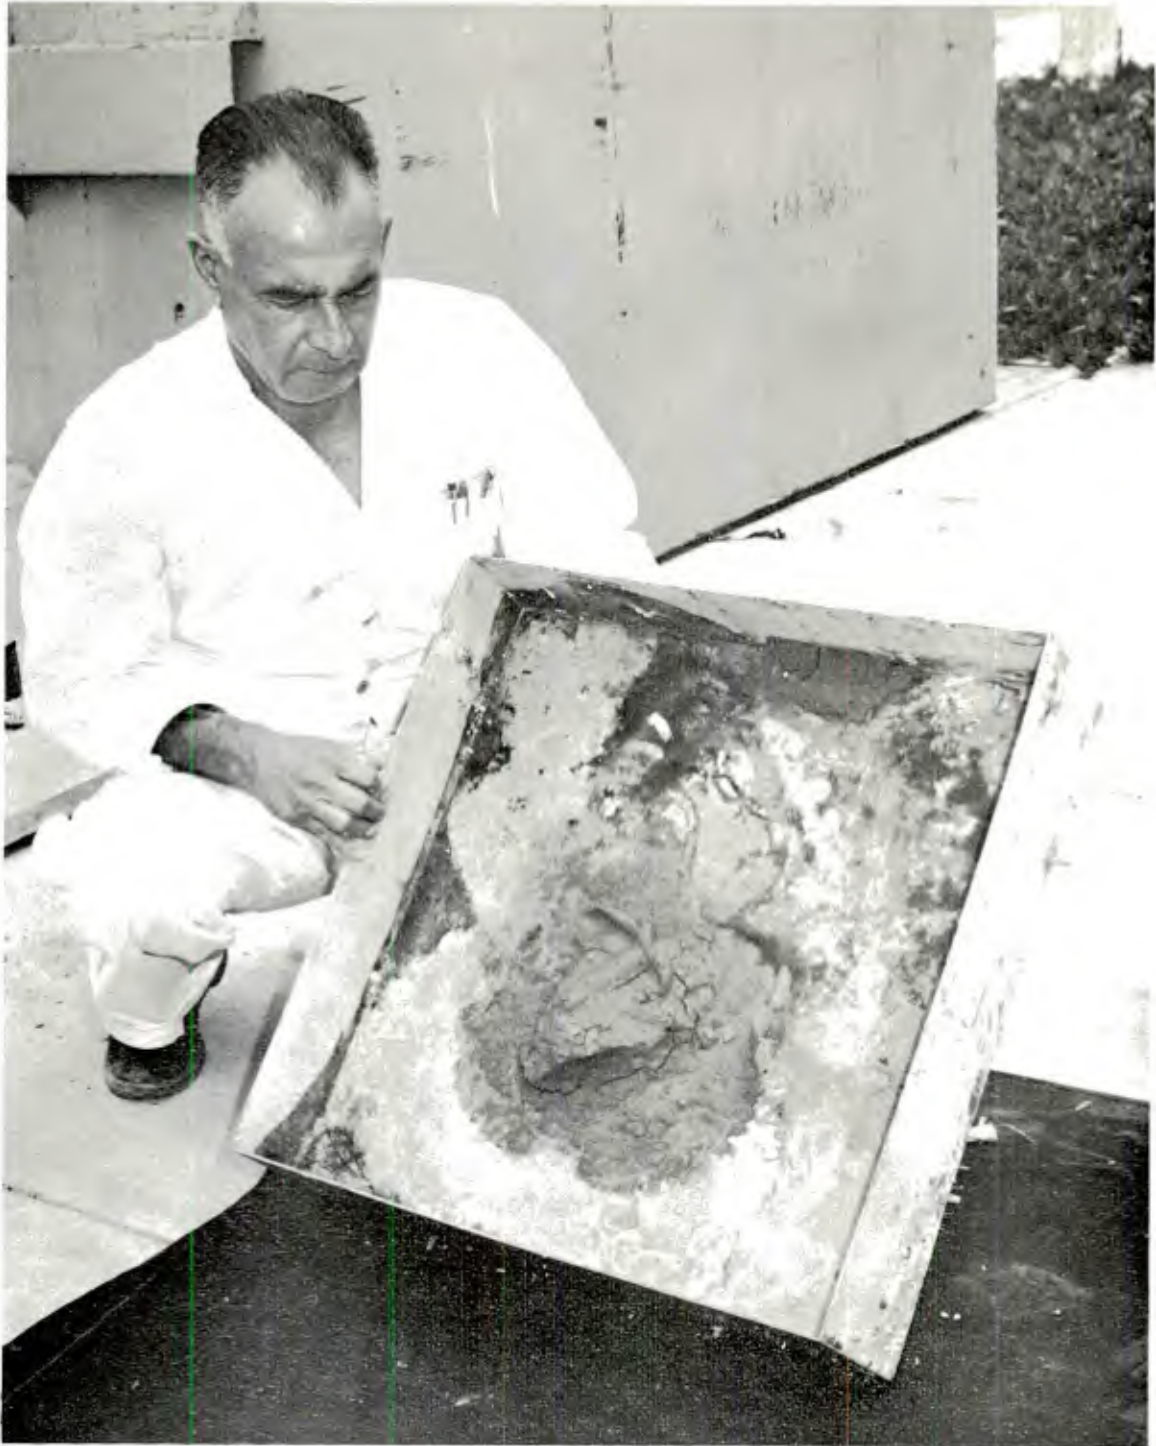
2. Concrete Footing (broken). There were 5 small *Listriolobus pelodes* and about 10 *Sternaspis sp.* in the sediment sample.
3. Concrete Footing with Aluminum Skirt (Figure 9). Burrowing animals were not found in the sediment sample. The mud sample collected by divers from underneath the inverted box-like structure was black and a strong odor of hydrogen sulfide (produced by sulfate-reducing bacteria) was being given off from the sediment. This indicates that an anaerobic environment was formed in the sediment under the footing and that such environment prevented burrowing organisms from undermining the footing. Numerous barnacles (*Balanus concavus pacificus*) were attached to the surface of the concrete and paint but upon closer examination all the animals were found to be dead (Figure 10). There were numerous large blisters formed under the vinyl paint where the painted section had been exposed in mud containing black sulfides.

Figure 9. Interior view of recovered concrete footing with aluminum skirt.

From all indications, the 6-inch wide mechanical barrier placed around the footings produced an anaerobic environment in the sediment by preventing fresh seawater from entering the protected area. Such an environment will prevent most marine animals from undermining the footing. Copper sulfate crystals placed under flat footings may rout animals living in the sediment but they may return after the copper sulfate has been depleted and washed away.

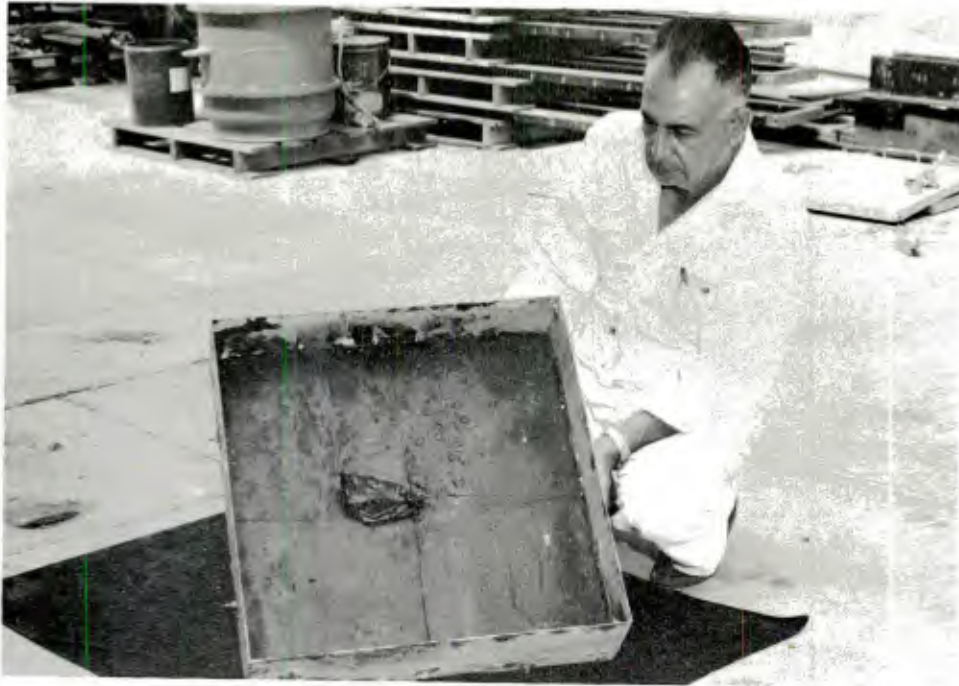
4. Copper Sulfate Placed Under Concrete Footing with Aluminum Skirt (Figures 11 and 12). Only 3 *Sternaspis sp.*, an annelid worm, were found in the sediment sample. Specimens of *Listriolobus pelodes* were absent. A small sample of sediment found inside the protected footing was slightly discolored and produced a trace of hydrogen sulfide odor. For this reason, the environment under the footing was slightly anaerobic.

Figure 11. Exterior view of recovered 2-foot square concrete footing with an aluminum skirt.

Figure 12. Interior view of Figure 11 showing plastic bag which contained copper sulfate crystals.

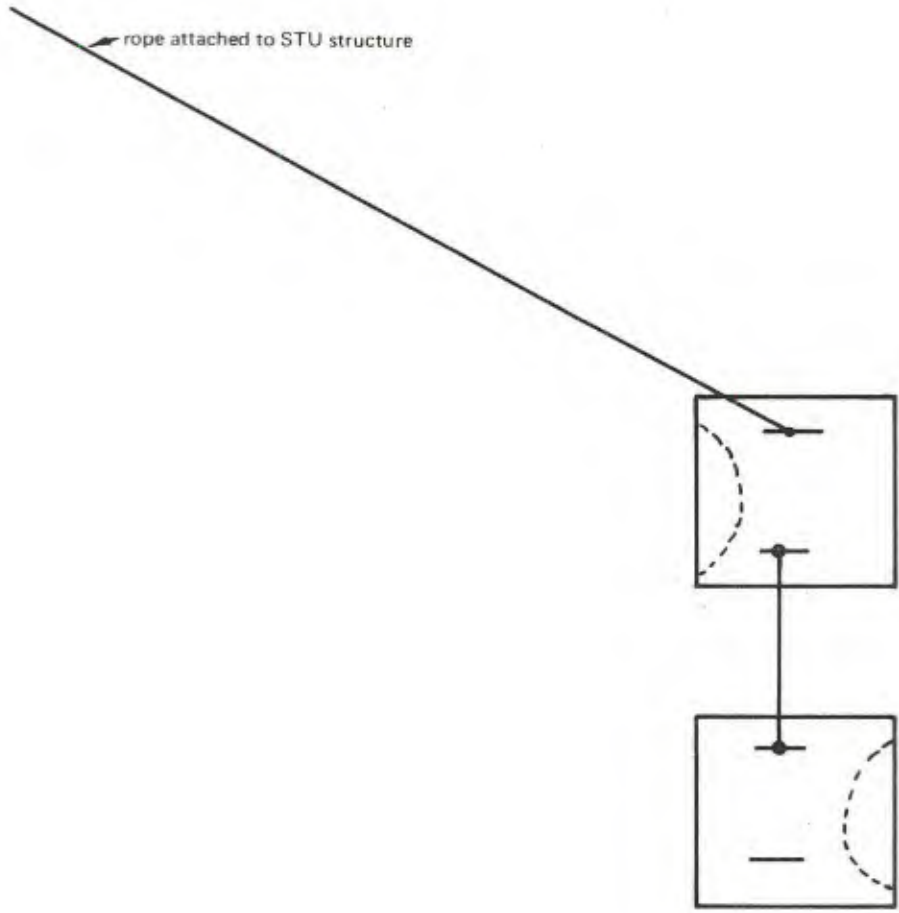
After about two months of exposure on the ocean floor the two 2-foot square concrete footings, separated about three feet from each other, were inspected for animal undermining. Divers reported that the visibility on the seafloor was excellent and that they found deeply scoured areas underneath both footings. The scoured area measured about four inches deep into the sediment below the footings and about six inches wide from the edge toward the center of the footing. The scouring effect was present on different sides of the two footings (Figure 16), so that it appeared doubtful that bottom currents would have caused it; animals may well have been responsible. At the time of the inspection, however, animals were not found close to nor detected inside the scoured area under the footings.

Figure 16. Scouring found under the 2-foot square concrete footings exposed on the seafloor at STU test site in 120 feet of water.
