NAVAL FACILITIES ENGINEERING SERVICE CENTER
Port Hueneme, California 93043-4370

TECHNICAL MEMORANDUM

TM-2103-AMP

FLEXOR MARRIAGE BRIDLE TESTS

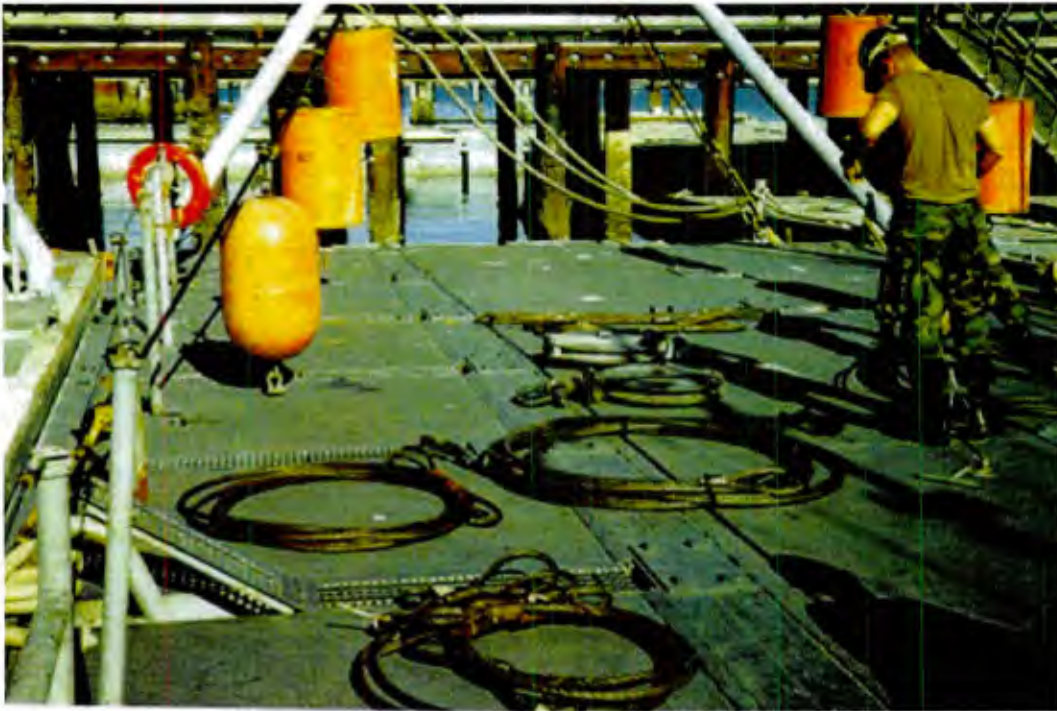
Figure 1
SLWT deck with wires and snatch blocks.

The tests were conducted on 13-14 January 1994. Figure 1 shows typical hardware laid out and prepared for use. The hardware list included the equipment cited in the test plan (Appendix A) as well as PH-11 padeyes, wire straps, and anchors (for ballast weights). Figure 2 presents the wire bridle legs, consisting of 1-inch wire straps 55 feet long, with swaged soft eyes approximately 18 inches long. The pendants in Figure 3 were also made of 1-inch wire, swaged eye construction, and measured approximately 5 feet in length. The snatch blocks were 18 inches in size and are produced by two different manufacturers: Crosby-Laughlin (Figure 4) and McKissick (Figure 5). The PH-11 padeyes were drawn from the onboard inventory that is typically carried on a side loadable warping tug (SLWT) used in Maritime Prepositioned Force (MPF) onload operations. Three SLWTs and three intermediate roll-on/roll-off (RO/RO) causeway sections were provided with a pair of Flexors installed in one end of each of the intermediate sections. The crew members were briefed on the purpose and sequence of each test, and were encouraged to contribute any suggestions that they felt might be helpful. A log of test operations and execution times is included as Appendix B.

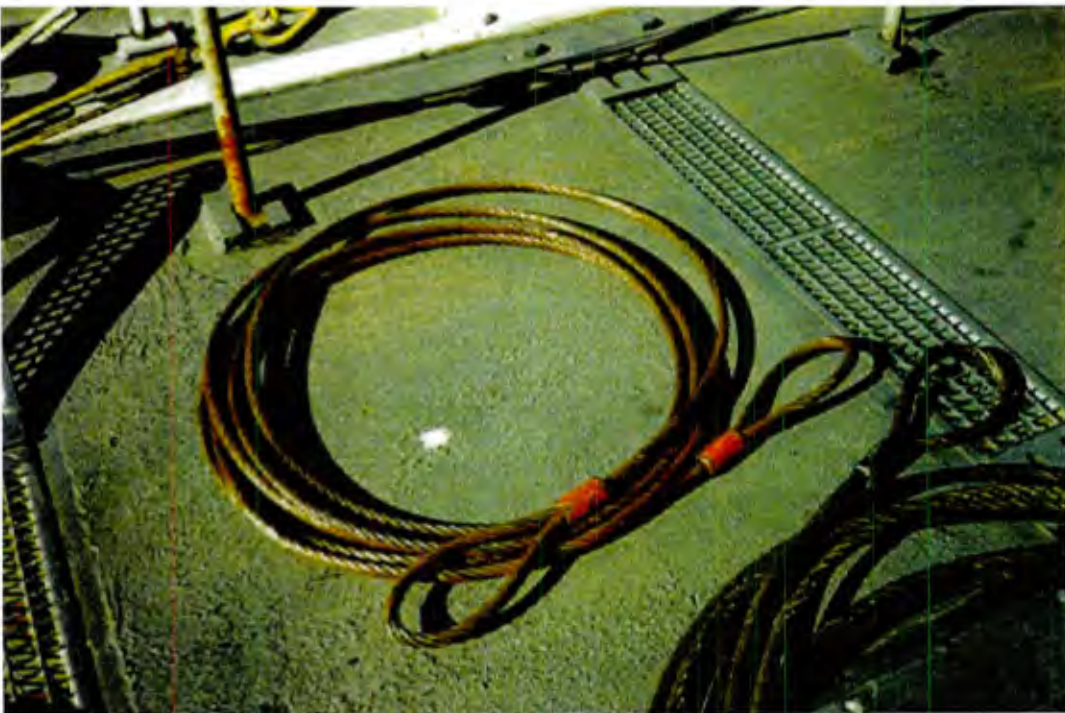
Figure 2
55-foot long bridle legs are formed from 1-inch wire rope.

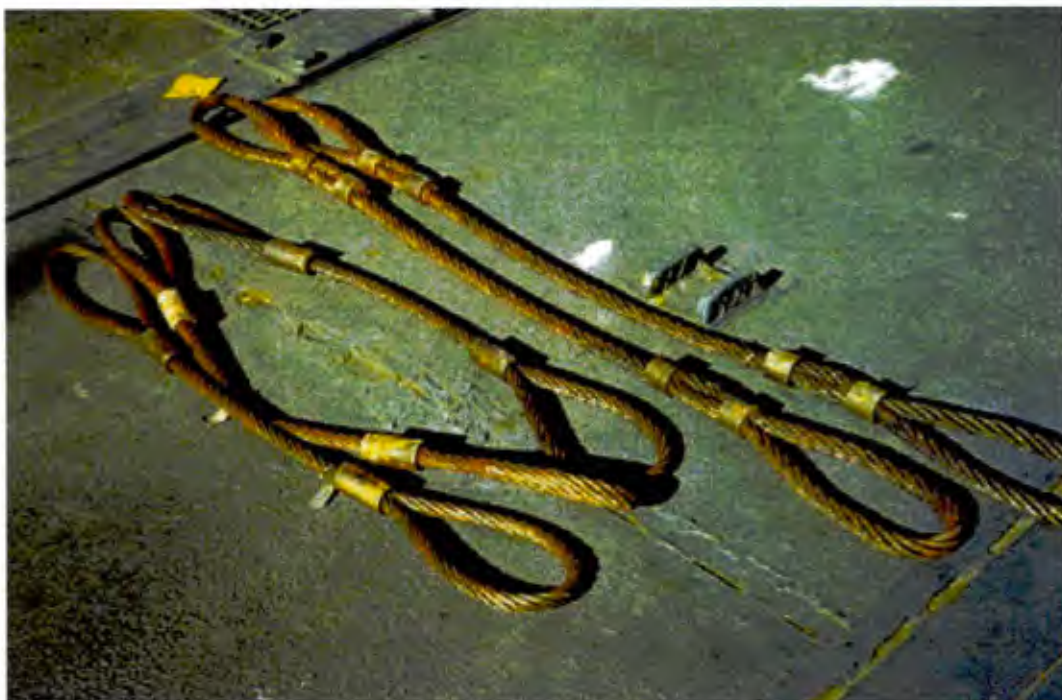
Figure 3
5- to 7-foot long wire pendants.

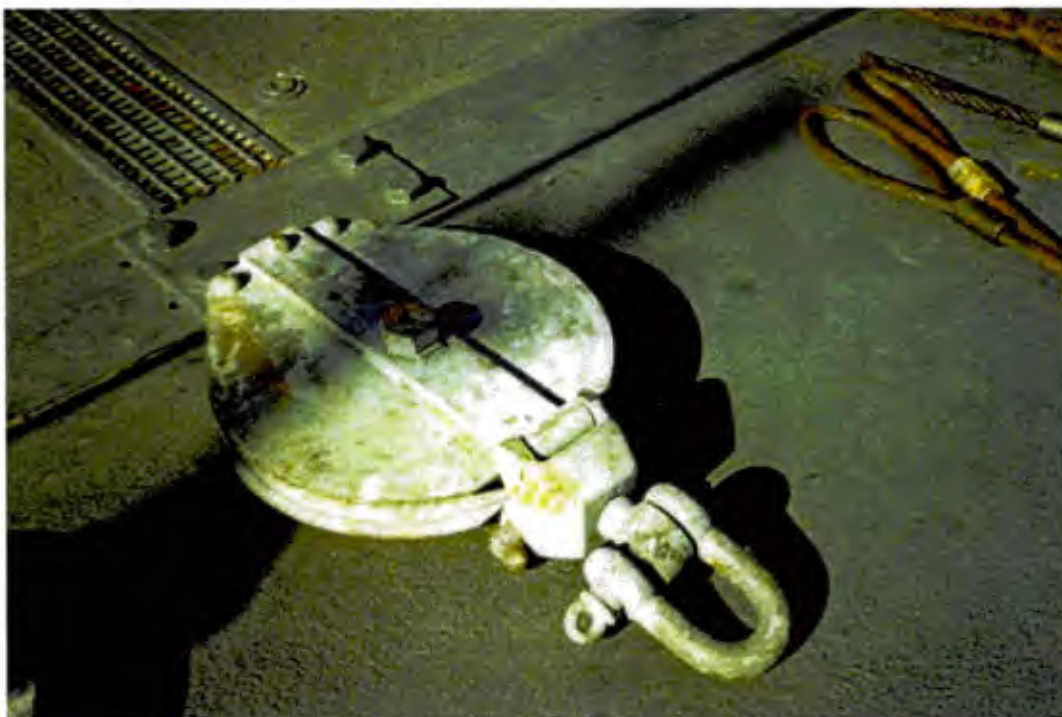
Figure 4
18-inch Crosby-Laughlin snatch blocks.

- The 18-inch snatch blocks are cumbersome and difficult to transfer between sections. The weight of the blocks, especially the Crosby-Laughlin, are more than two men can safely handle on the deck of a causeway in an elevated sea state. The lighter weight McKissick 18-inch snatch blocks were easier to transfer between sections, but were significantly more difficult to reeve when rigging time was a factor. The size of the blocks can be reduced if dedicated 12- to 14-inch blocks are used (currently, the blocks used on marriage bridle operations are drawn from available stores of the lift/launch inventory).

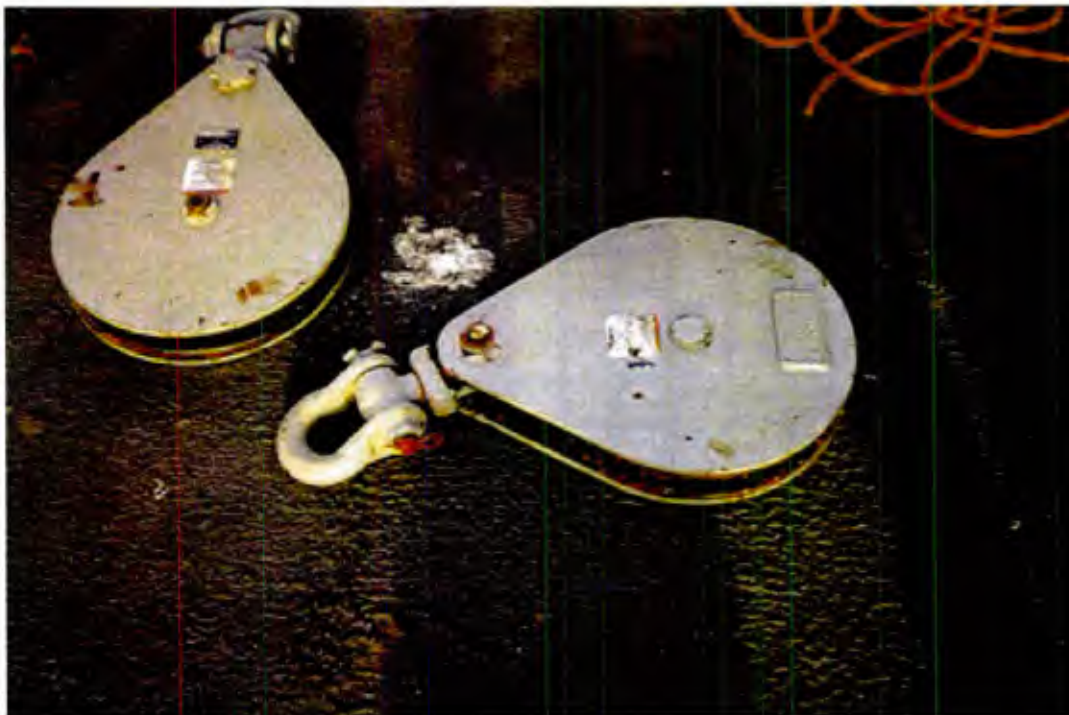
Figure 5
18-inch McKissick snatch blocks.

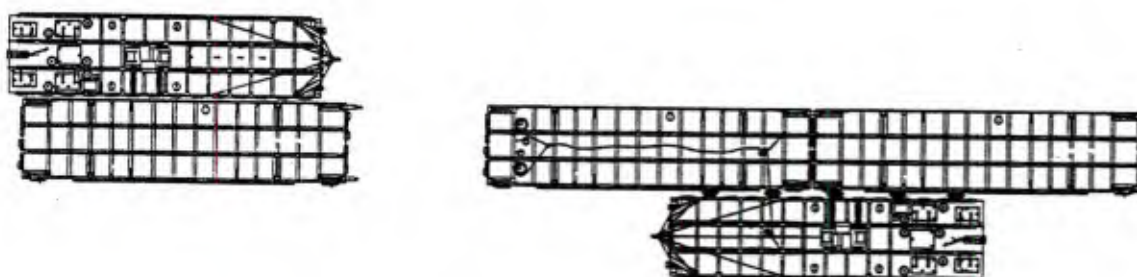
Figure 6
Current method of rigging for bridle-assisted Flexor marriages
(as per NAVFAC P-401).

The first demonstration of a bridle marriage used textbook techniques as documented in NAVFAC P-401 Pontoon System Manual, and taught to prospective craftmasters undergoing SLWT training at the PHIBCB school, Coronado. A schematic of craft and gear is presented in Figure 6. In brief, the sequence requires that all bridle gear be staged on board the causeway section (CW #1) tied alongside SLWT #1, and that a second SLWT approach with the section to be connected in tow. The oncoming section (CW #2) approaches with Flexors extended and crew ready to receive the messenger lines from the first platform.

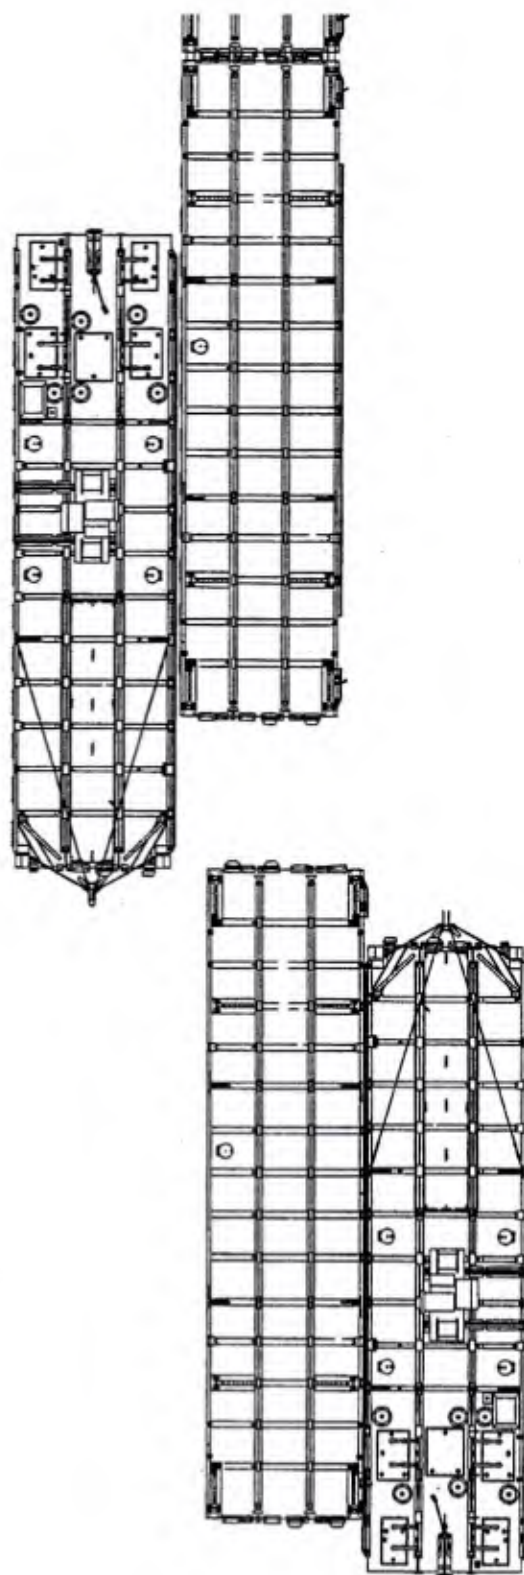
Figure 7
Unassisted method of marrying causeway sections.

In the "frostily" type of marriage, bridles are not used. Rather, the two sections are brought into close proximity by the SLWT operators until the "timing is right." The bow of one of the tugs overlaps the end of the adjacent causeway section and forms a pocket to help guide the incoming section. The SLWTs push the causeways together as the shear connectors engage, and the tugs then hold the sections in place until the Flexors are fully engaged. Although the union is made unassisted, it takes skill and coordination to orient Flexor with Flexor housing as the final push is made. In the actual test sequence, SLWT #2 was brought back into position and reconnected alongside CW #2 to control it while bridle legs and Flexors from the first demonstration were disconnected, thus again freeing the two sections. With the sections still floating in close proximity, a "frostily" marriage was completed by the operators, with only their own handling skills and signals from the deck Petty Officer to guide them. Figure 7 shows the configuration of craft and causeway used in this "frostily" marriage. It took three attempts within a 4-minute period before success was realized, a number considered normal for the prevailing weather and sea conditions.

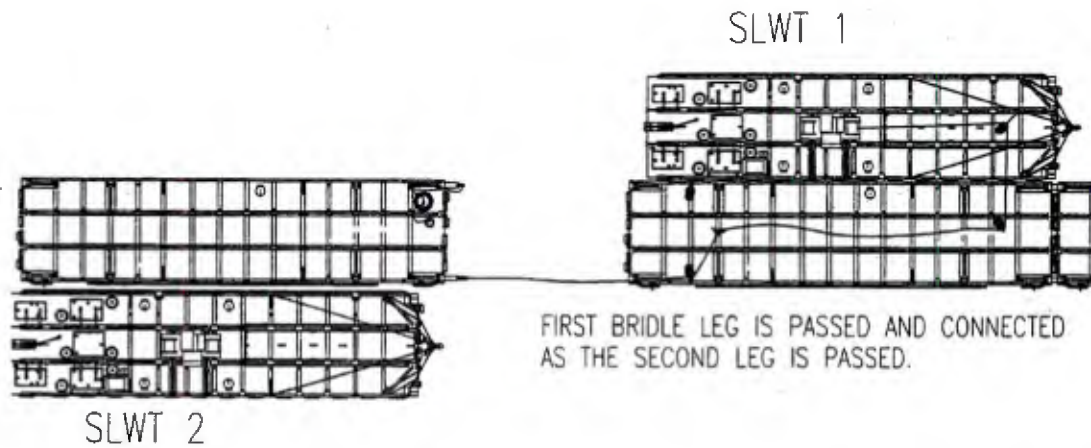
Figure 8
SLWTs maintain heading and relative positions as the
bridle legs are passed (Phase 2 tests).

Phase 2 tests were conducted to demonstrate an alternative approach to those procedures presented in NAVFAC P-401. Figures 8 and 9 show the relative marriage positions of warping tugs and causeway sections as employed during most of the Phase 2 tests. The rationale behind this configuration of warping tugs has to do with improved safety and maneuverability. With both SLWTs heading into the prevailing seaway, maneuverability and seaworthiness aboard

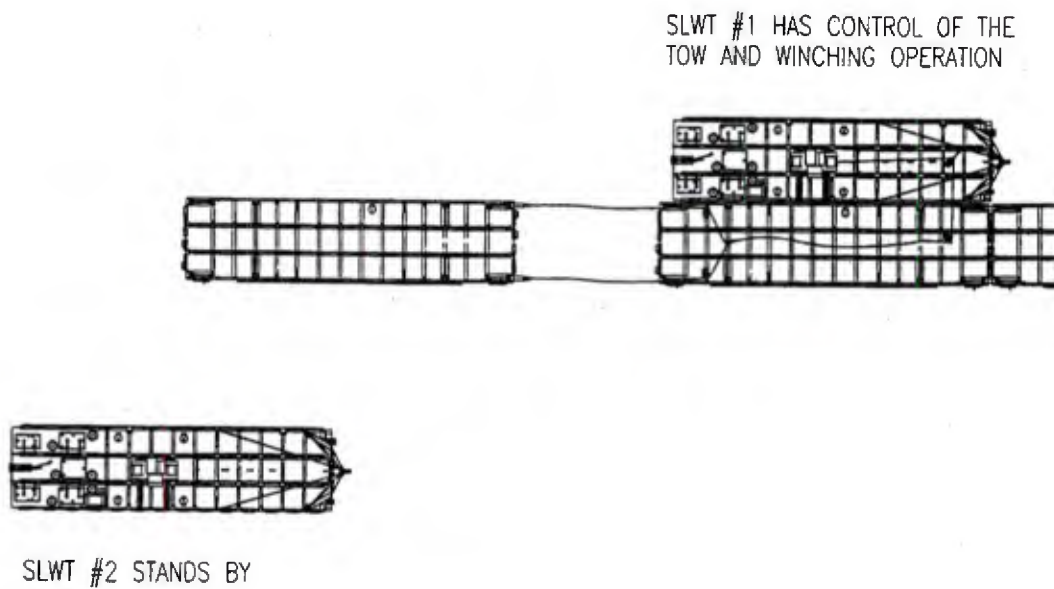
Figure 9
SLWT 1 ready to begin winching operations (Phase 2 tests).

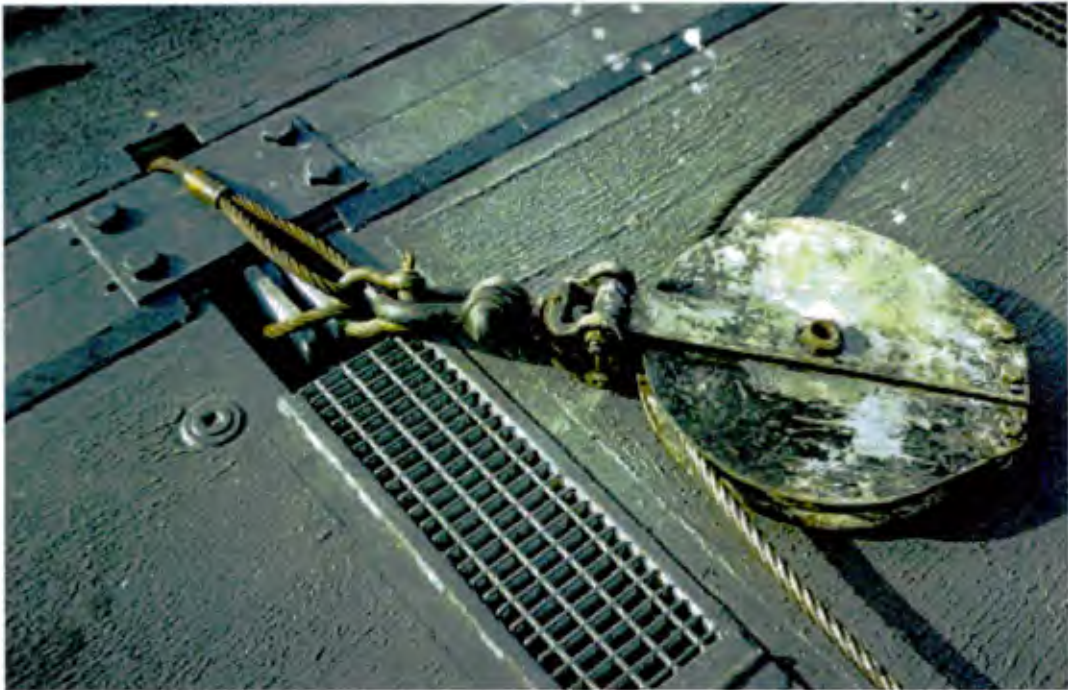
Figure 10
Wire strap around angle and PH-6 padeye rigged to place
18-inch snatch block on the centerline of the causeway.

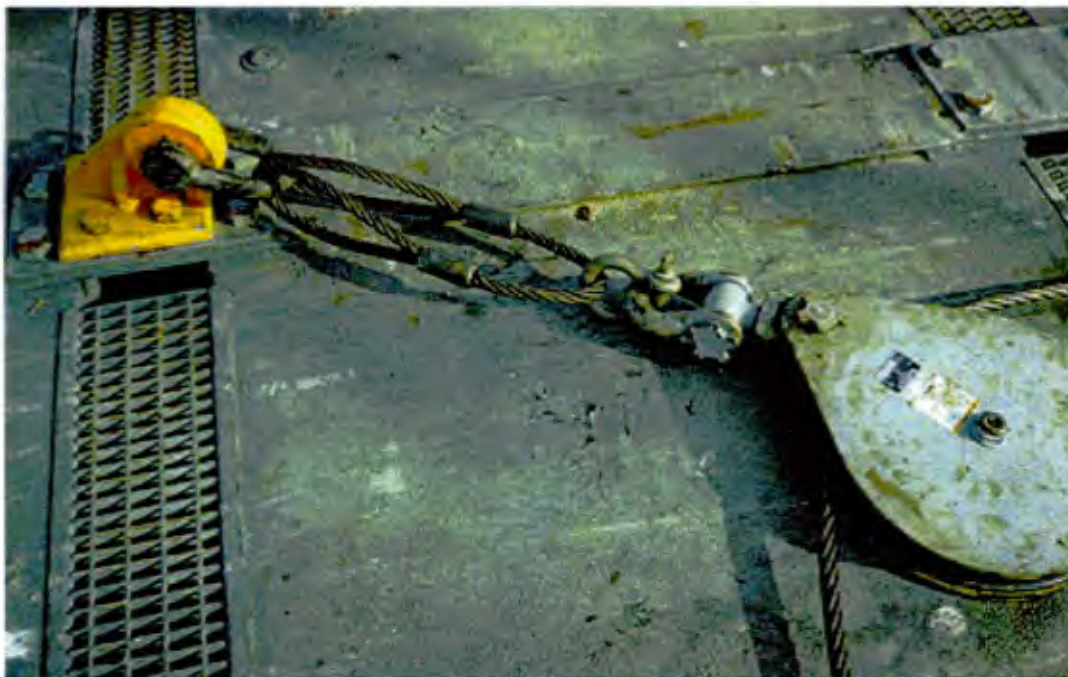
Figure 11
PH-11 padeye rigged to place 18-inch snatch
block on the centerline of the causeway.

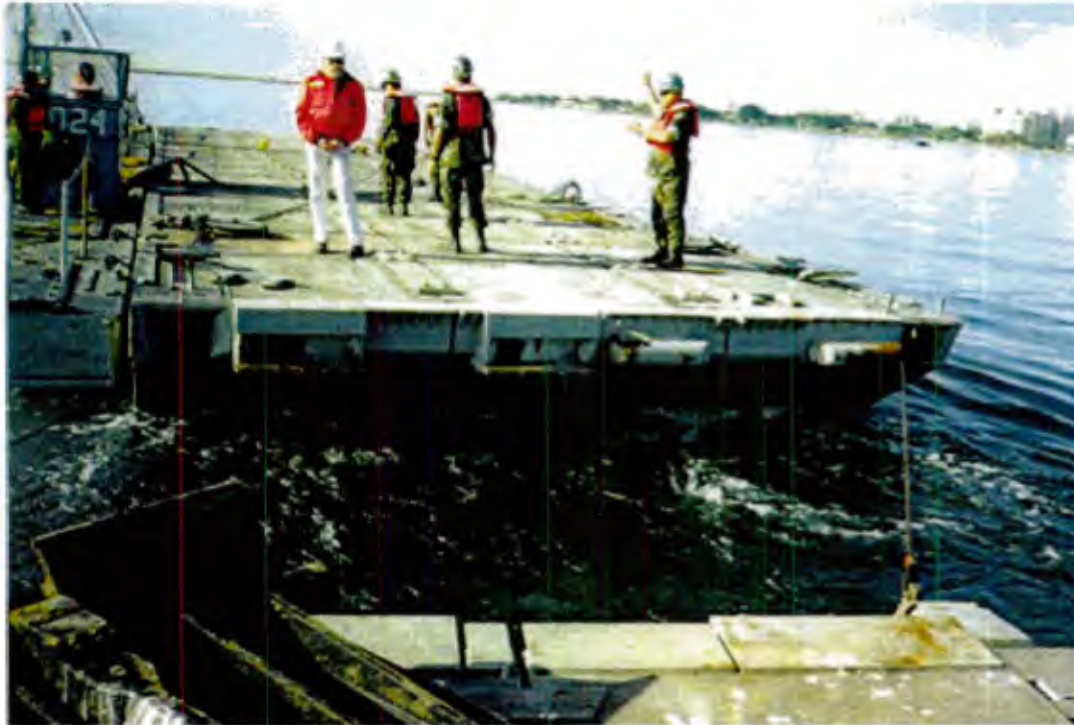
Figure 12
Misalignment of sections during bridle inhaul.

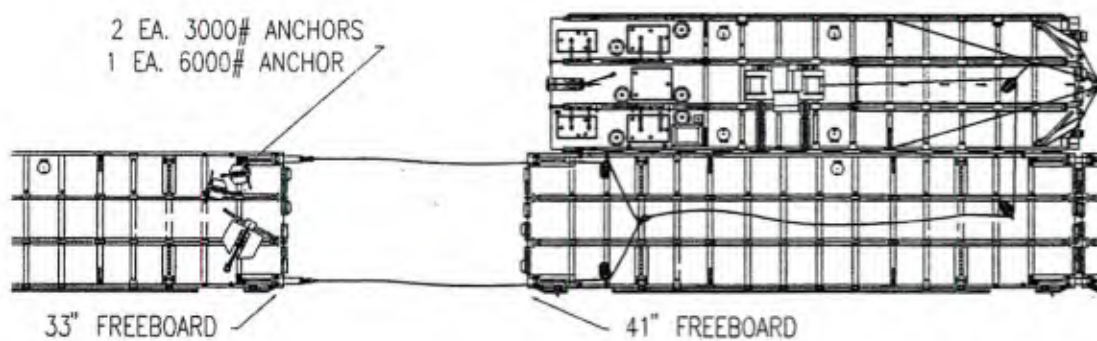
Figure 13
Connection of causeways with 8-inch trim differential.

To accomplish this demonstration, CW #2 was deck loaded with two 3,000-pound anchors and one 6,000-pound anchor as depicted in Figure 13. The anchors were placed so that the loaded end had a freeboard of 33 inches, whereas CW #1 remained empty with a freeboard of 41 inches. The 8-inch trim differential was too great to attempt a "freestyle" marriage, especially given the prevailing weather and sea conditions of dead calm, but the sections were successfully connected while steaming ahead in the same configuration used during the Phase 2 tests.

- The bridles can be used to connect sections that are out of trim by as much as 8 inches in calm water. With the existing connector design, the self-aligning capability of the marriage bridle system can be used to force the out-of-trim ends of two sections together. If the "big mouth" connector (as installed on the stern adaptor unit) is used on the female sides, another 4 inches of trim differential can be accommodated. Operations in rougher water would (to a point) enhance the connectability of these out-of-trim sections with either style of shear connector.

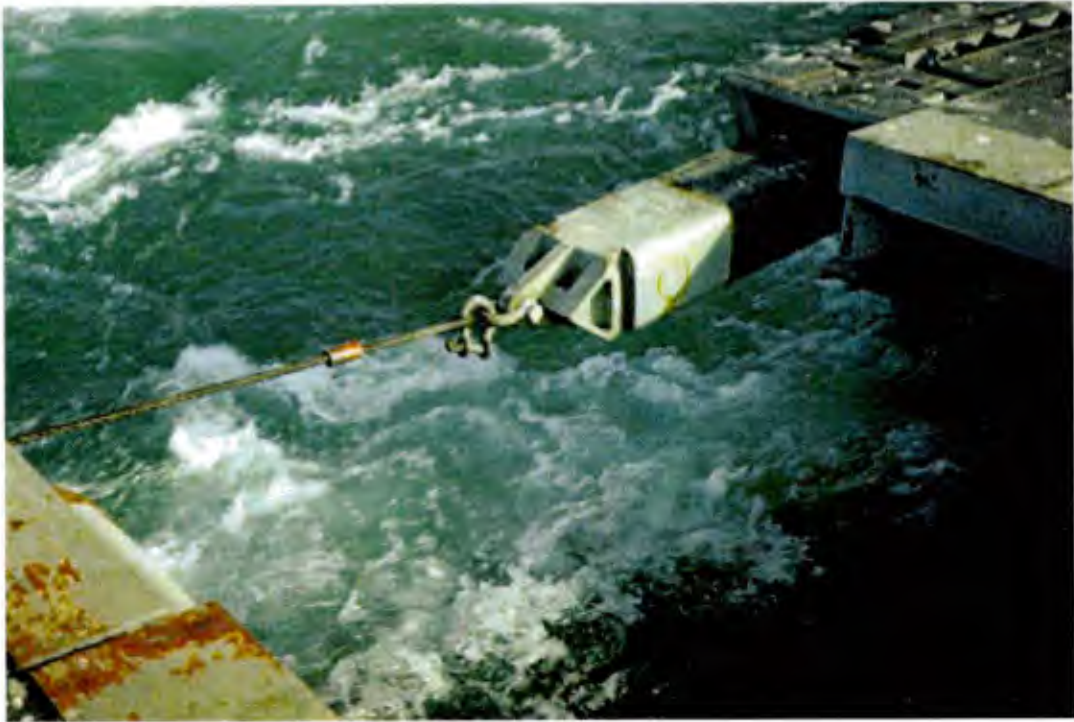
Figure 14
Upset anchor shackles poses a potential jamming problem.

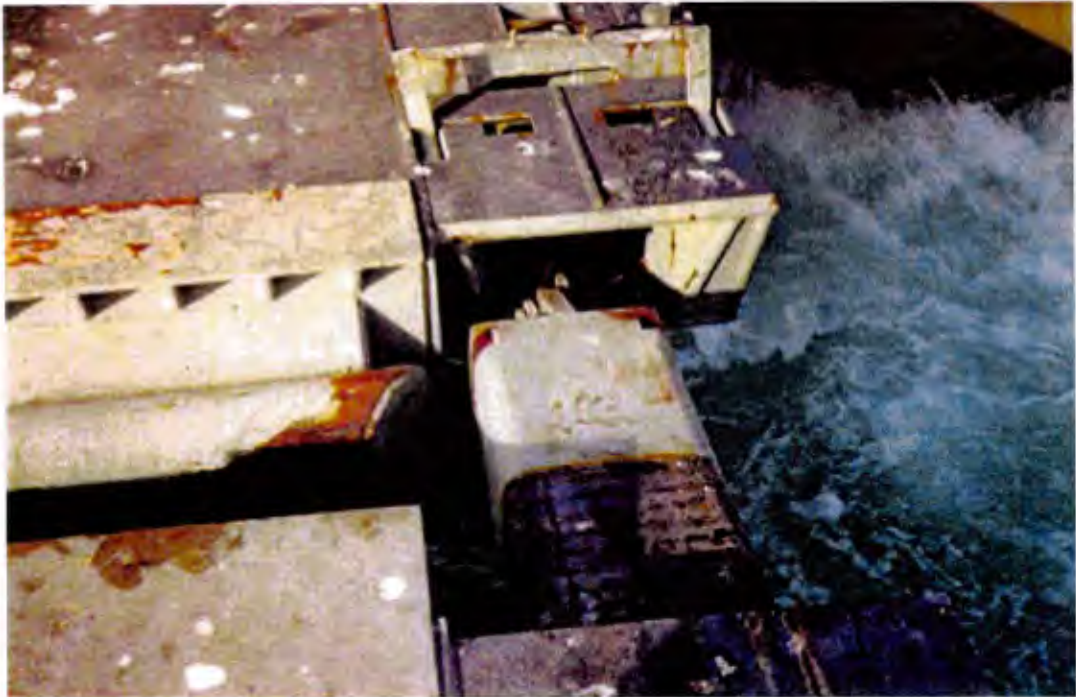
Figure 15
Misalignment of Flexor head and receiver
opening causes momentary binding.

- The Flexors often jam against the entrance to the receiver unless they are well aligned. The design of the Flexor head results in an edge that can "two block" on the edge of the receiver entrance (Figure 15). This could be improved with a redesign of the head.

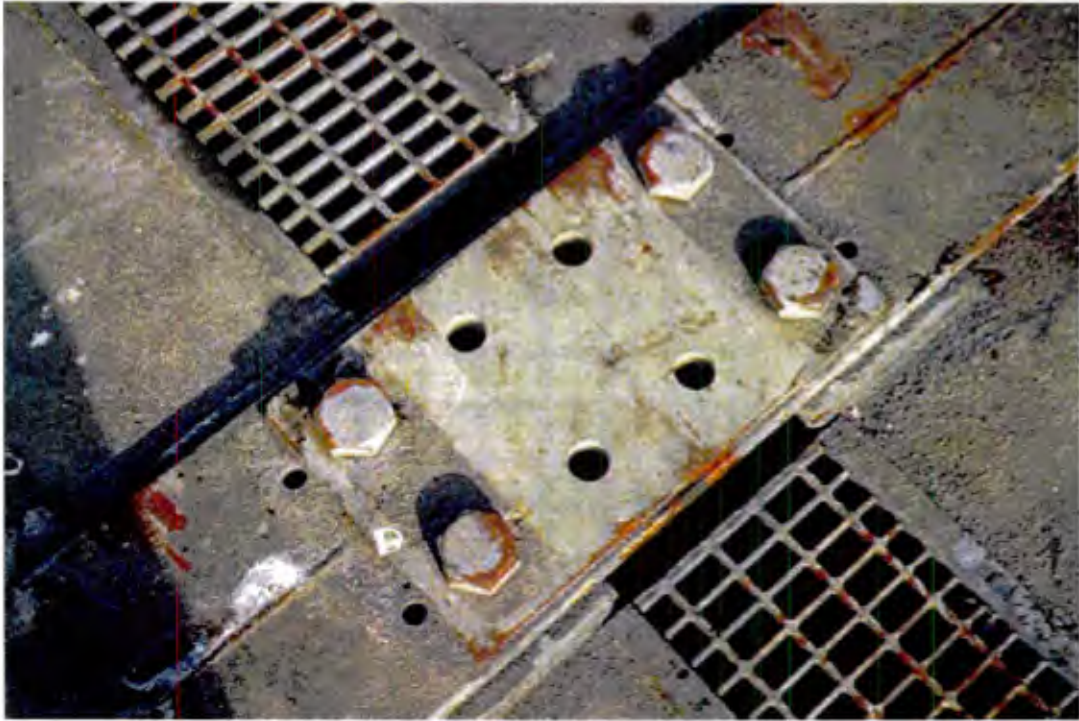
Figure 16
PH-11 mounting position on double angle.

- Modify the deck of the SLWT to accept a padeye on a PH-11 (Figure 16) type of base plate. The padeye should be capable of securing two snatch blocks under the full load of the winch (20,000 pounds). Modify a pontoon haul-back ring to use instead of a PH-11 (Figure 17) if the allowable loads permit. The haul-back ring is more easily stowed, can be dedicated to the marriage bridle rig, and prevents misuse of the PH-11.

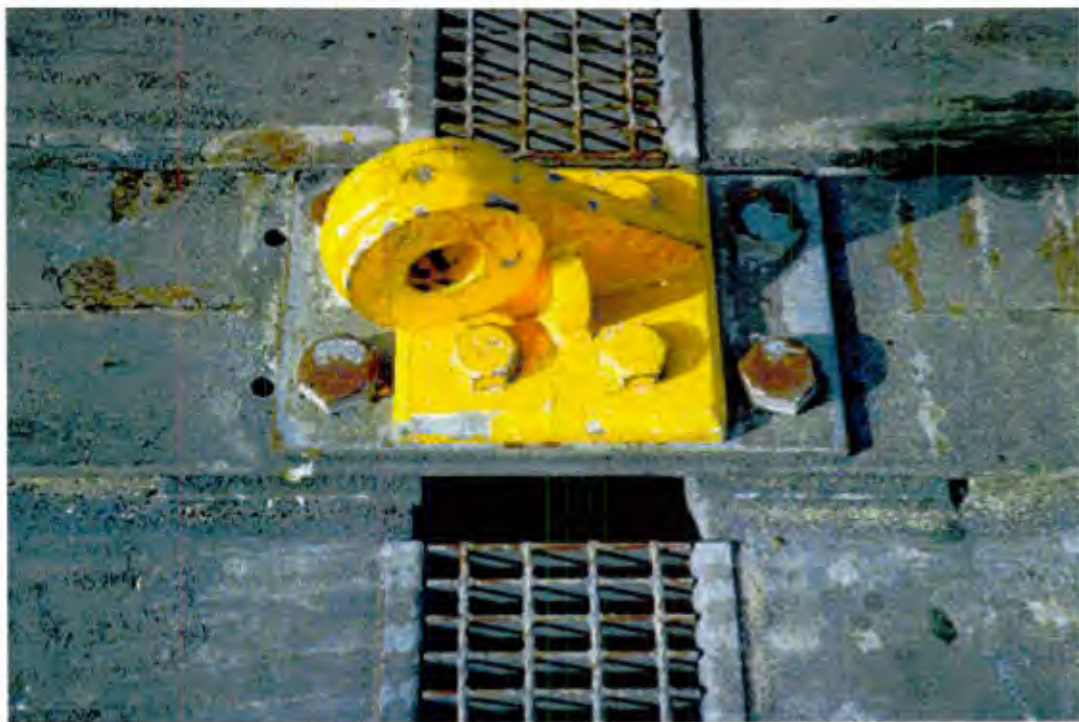
Figure 17
PH-11 padeye bolted to double angle.

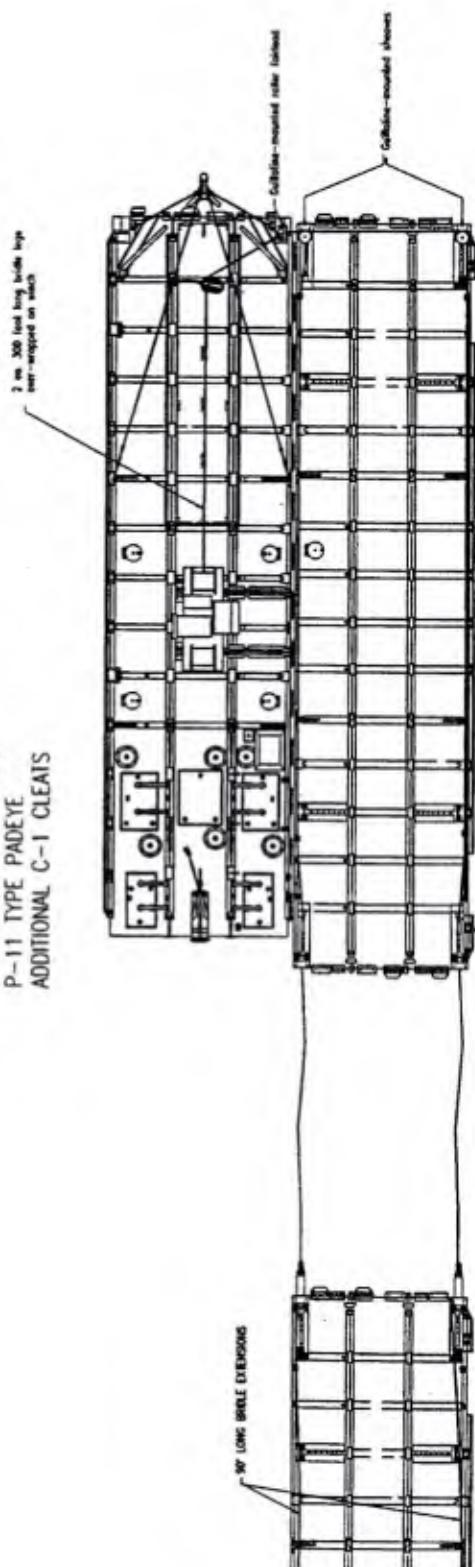
ELIMINATES "Y" BRIDLE CONFIGURATION
 P-8 MOUNTED SHEAVES
 P-11 TYPE PADEYE
 ADDITIONAL C-1 CLEATS

Figure 18
 Bridle marriage with deck loaded cargo.

Although the current application of bridle-assist hardware requires a clear deck, and as such is not compatible with operations that stage deck-loaded cargo, it is nonetheless informative to document the trim differential that may be accommodated by the wire rope bridle legs as the lower section is pulled up and into its counterpart.
