AFRL-AFOSR-UK-TR-2019-0050

Corrosion Resistance of High-Temperature SMAs Under Extreme Environments

09/12/2019
Final Report

Corrosion resistance of High-Temperature Shape Memory Alloys (HTSMAs) under extreme environments

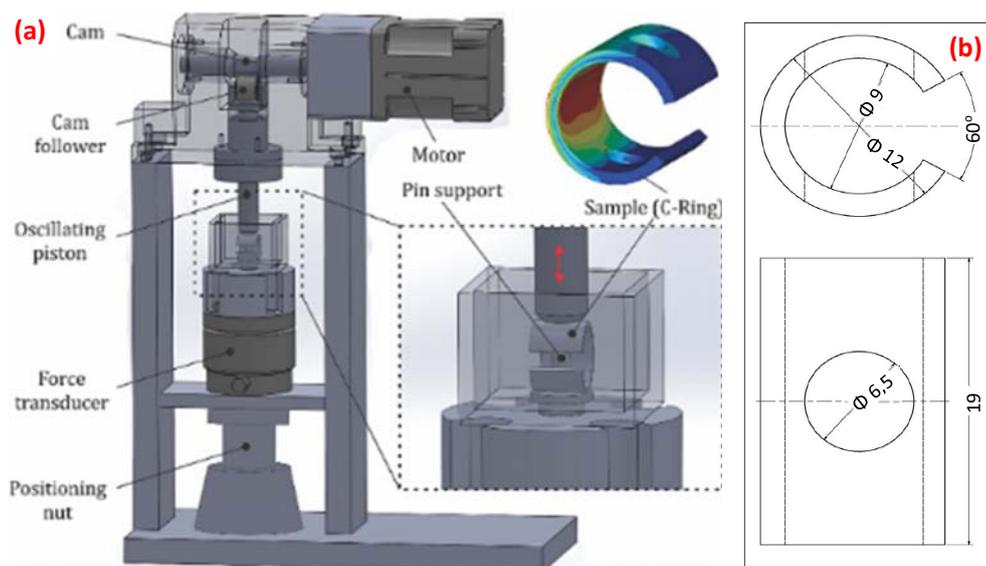
Figure 1: (a) Experimental set-up for testing corrosion-fatigue, employing C-ring samples [3], (b) sample dimensions.

The initial experimental set-up developed for testing the corrosion-fatigue performance of materials is presented in the 3D sketch of Figure 1 [3].

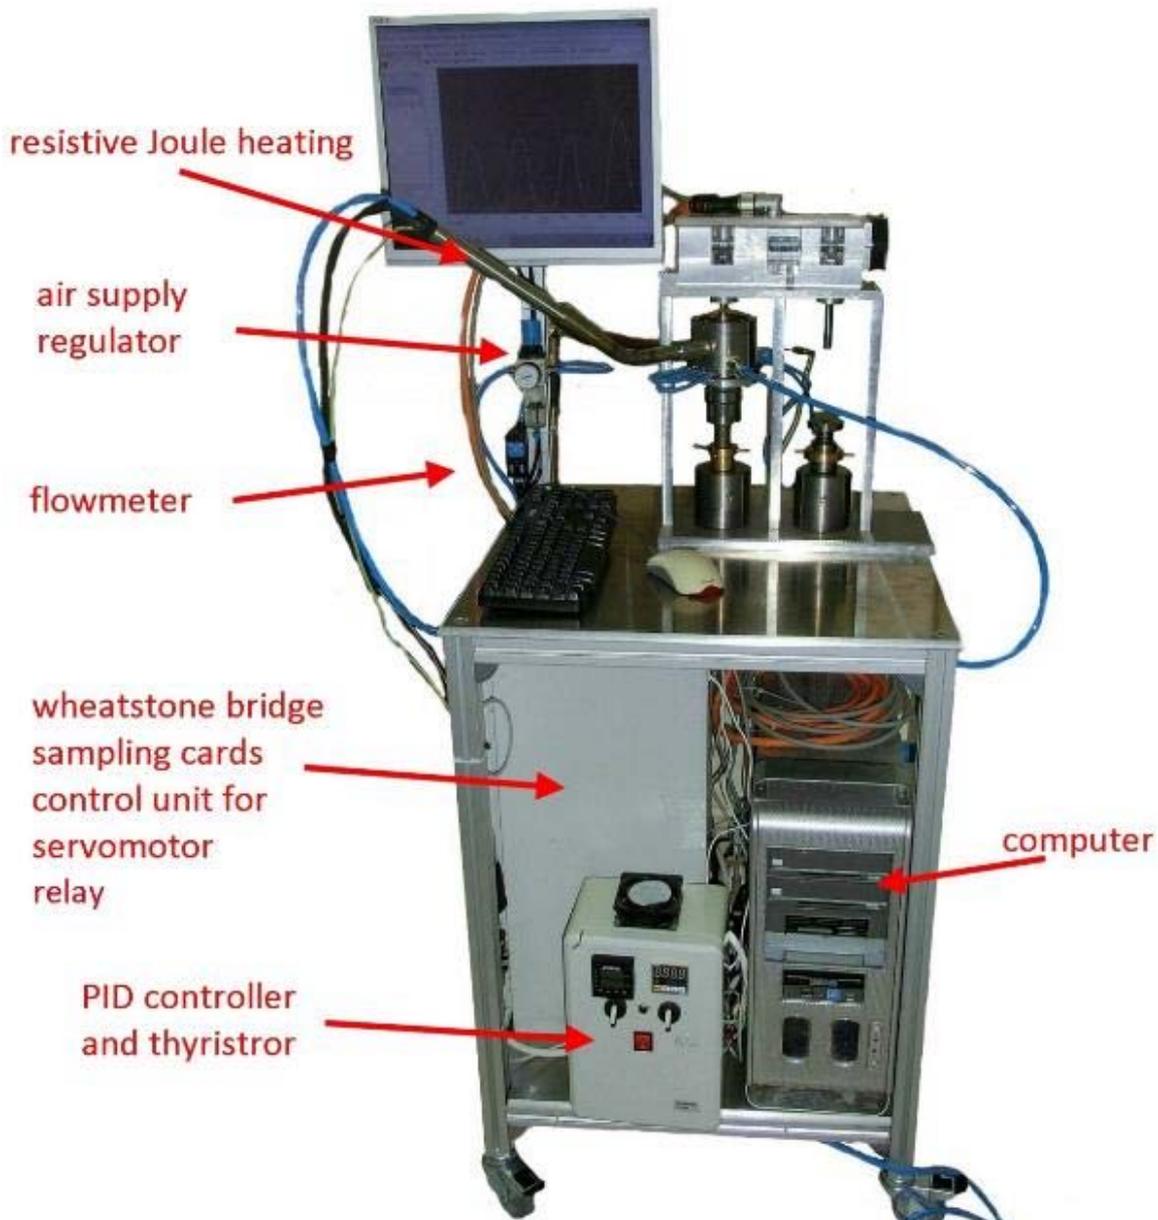
Figure 2: Experimental set-up developed for thermomechanical corrosion fatigue testing, employing C-ring samples.

Figures 2 and 4 present the new version of the experimental set-up developed for the needs of the project. It consists of a stiff frame, a force transducer, a cam-driven piston, a cam machined on a shaft and a servomotor attached at the upper part of the device, rotating the shaft through a gear unit. The servomotor rotating speed is controlled by a control unit software package. The oscillation frequency was regulated at 40Hz for all the tested samples. A custom-made software has been developed to control and monitor the temperature and the applied force signal (see Figure 3), assisting to track the exact time of the specimen's failure.

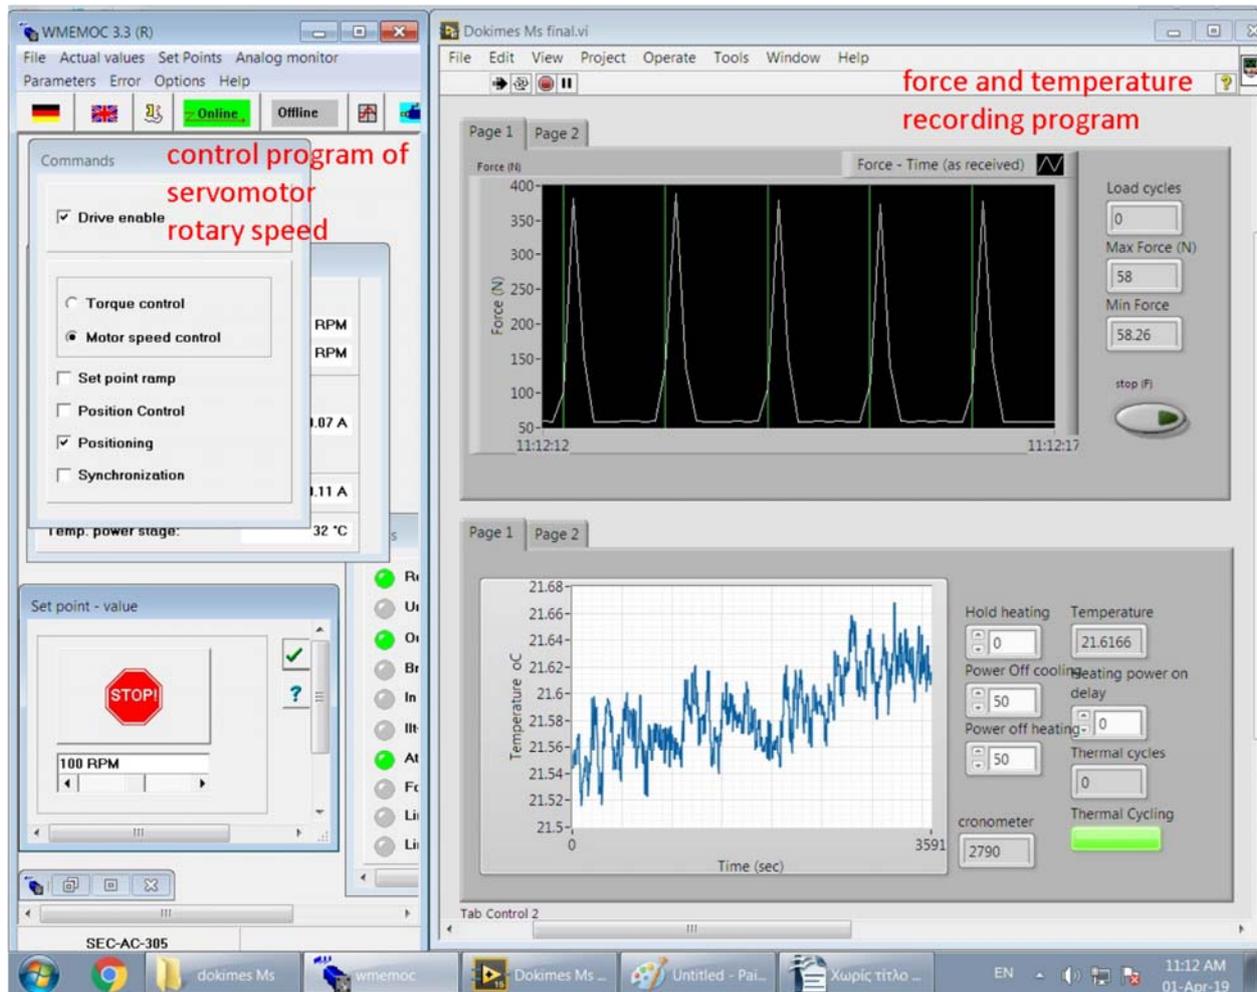
Figure 3: Software packages for guiding the experimental set-up.

The signal from the force transducer is reinforced by a Wheatstone bridge and then guided to a sampling card for reading and storing it, employing the application running on the computer. The signal from the temperature sensor is driven to a separate sampling card that reads the temperature and then processing and storing are handled by the same application on the computer.

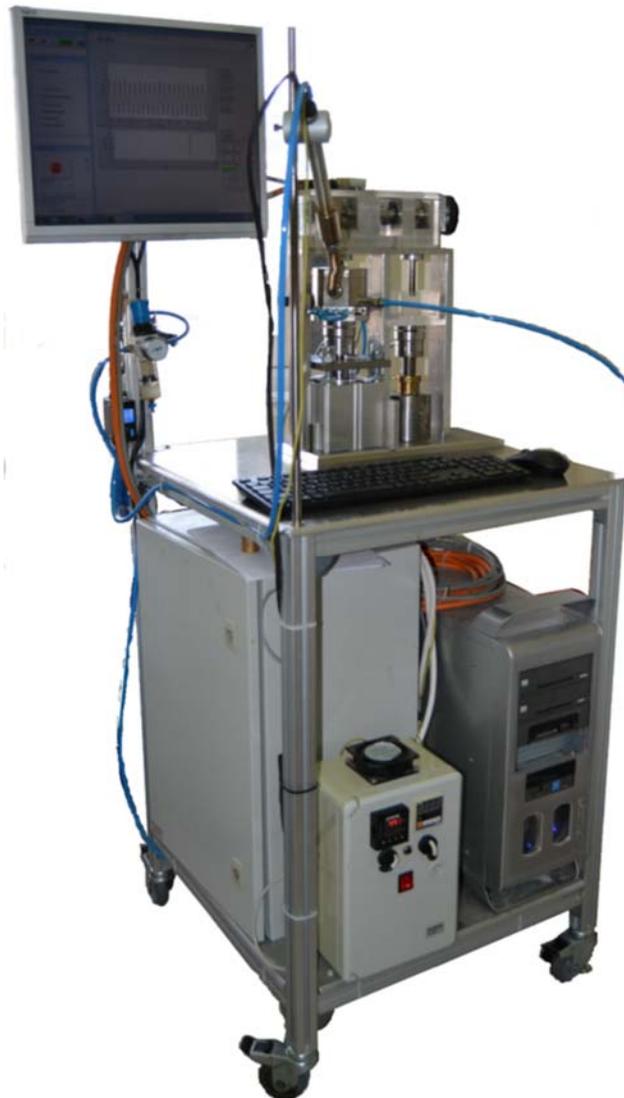
Figure 4: Experimental set-up for thermal fatigue tests at constant force through a pneumatic piston.

achieved by using a PID controller and a thyristor. The flow of the heating air is continuously measured with a flowmeter. In order to control the applied loading force in the specimens, two different methods have been developed that offer different loading modes. The first method uses a robust base in which a drive bolt is mounted which can be driven to the desired position with a positioning nut designed to raise the container and compress the sample between the force sensor and the piston. Once the desired test force is attained, the bolt is locked by a retainer. This option offers a displacement-constrained loading of the sample (see Figures 2 and 5). The second method employs a pneumatic piston at the base of the frame to raise the container and the force is controlled by adjusting the air pressure within a 50-liter inert vessel (see Figures 4 and 5). This method is suitable for performing isobaric thermal (actuation) fatigue tests at a constant force.

- Figure 3:** Software packages for guiding the experimental set-up. (page 6)
- Figure 4:** Experimental set-up for thermal fatigue tests at constant force through a pneumatic piston. (page 7)

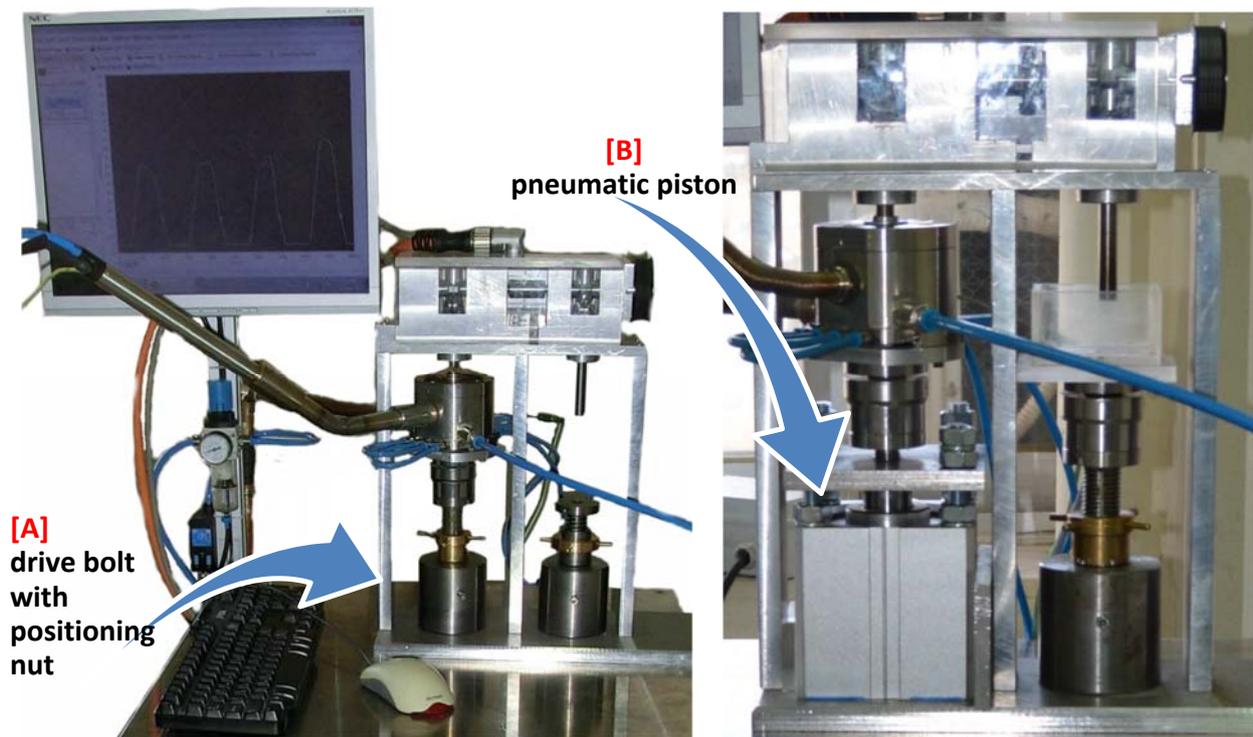
Figure 5: Different control methods of the applied force. The first method in picture [A] uses a drive bolt with a positioning nut. The second method in picture [b] uses a pneumatic piston.

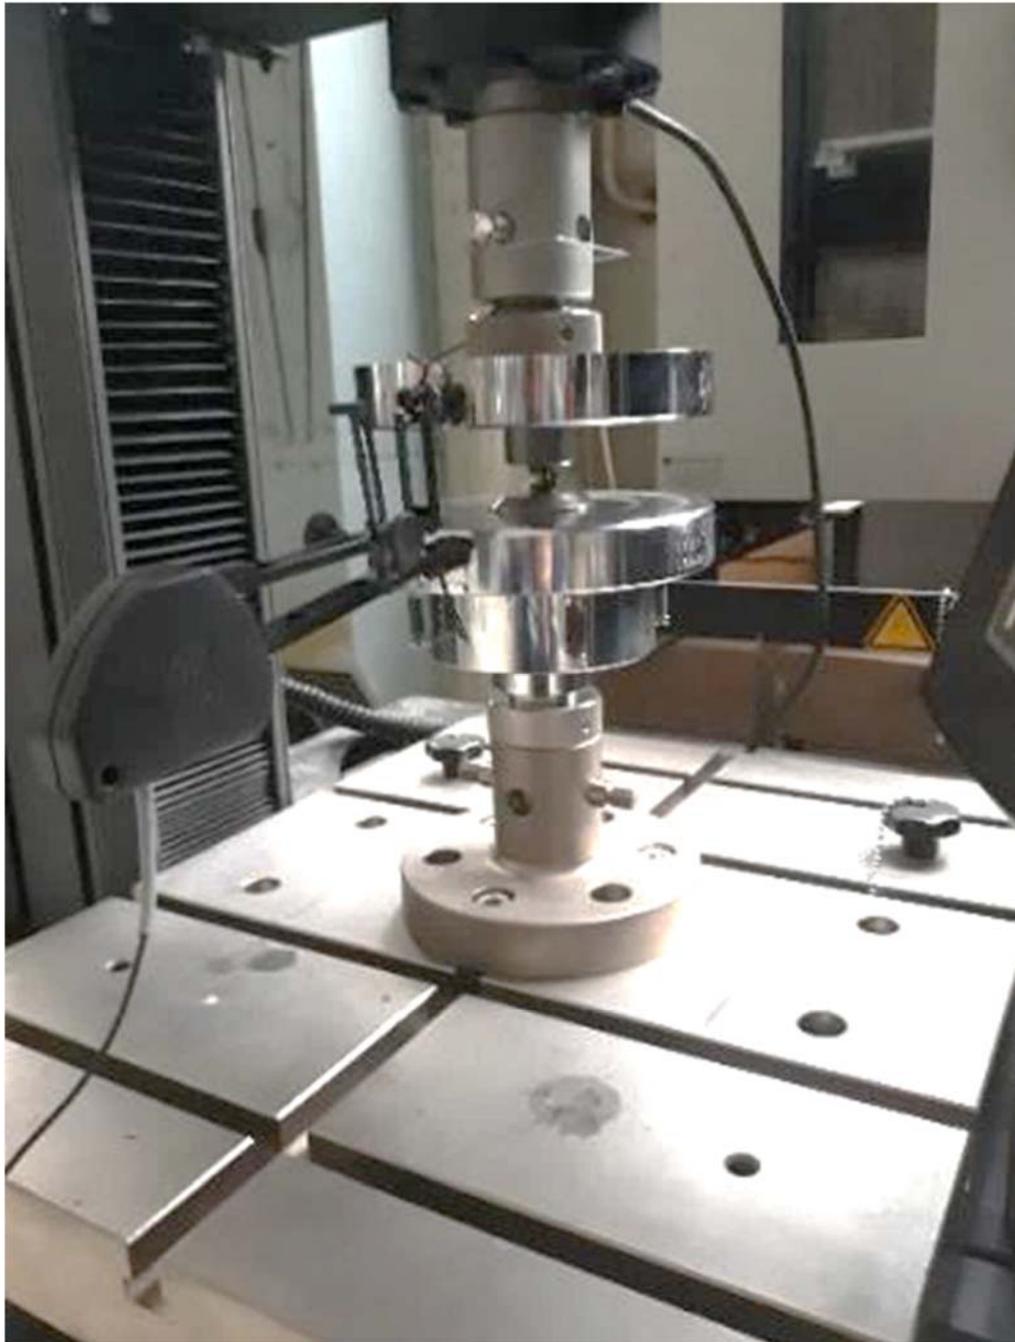
Figure 7: Setup for testing the compression behavior of the c-rings.

mounted on a stainless steel base (sampler) with a guide pin inserted through its holes to maintain a constant position of the samples throughout the experiment. Figure 7 shows the experimental setup employing an Instron tension-compression device. An overview of the experimental testing performed is shown in Diagrams 1, 2 and 3 in the form of load-displacement.

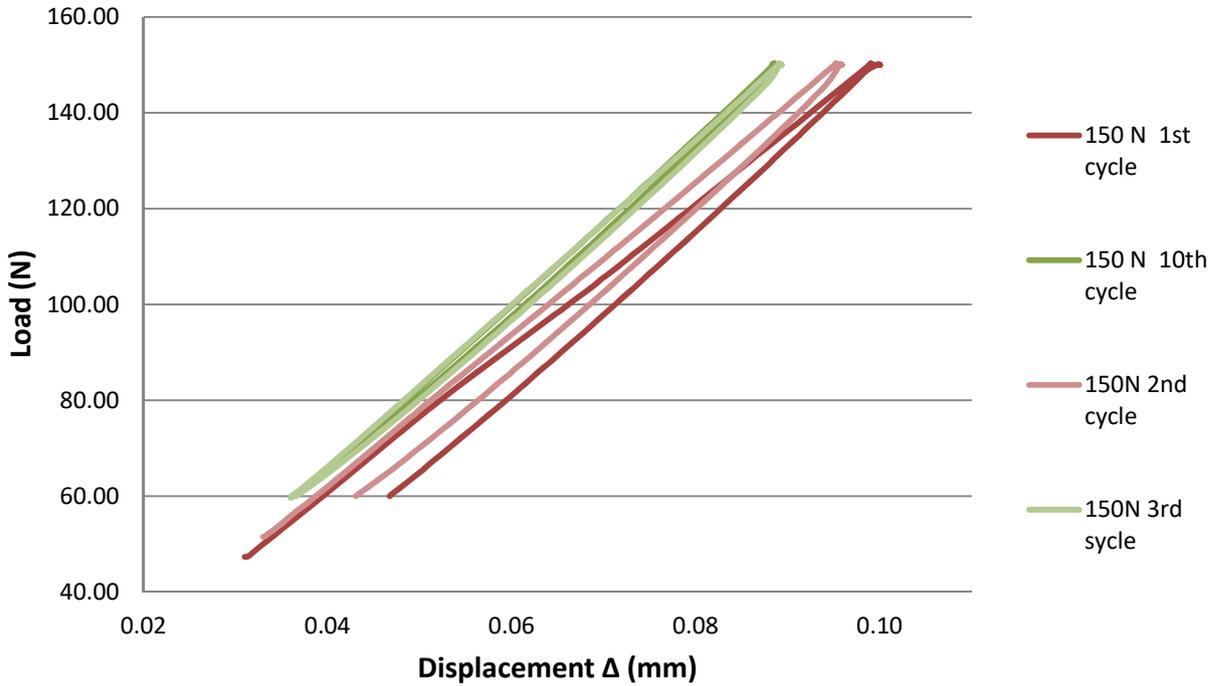
Diagram 1: Load - displacement curves in compression of sma c-ring at 150 N.

The observation of the diagrams shows the presence of hysteresis at unloading, when the specimen was compressed for the first time at 150, 300 and 600N. This is attributed to the stress-dependent detwinning caused to the material when it is in the martensitic phase. At 300 and 600N, after the first loading, the specimen appears completely detwinned each of these loads. It is worth noting that at the lower load of 150N, one cycle is not enough to complete detwinning and therefore an additional one is required. The modulus of elasticity during this 1st cycle (twinned material) at 150N was measured at 55 GPa (see Diagram 5). The stress distribution in the c-ring specimen volume, as illustrated in Figure 8, depends on the geometrical characteristics and the magnitude of the load. Thus, when the specimen shows the behavior of detwinned material, for a given load, this behavior is inverted if the load is increased and a detwinning stress develops in a new area of the specimen. This case can be observed in Diagram 5 between successive experiments from the 10th compression at 150N to the 1st compression at 300N and then from the 10th compression at 300N to the 1st compression at 600N, where the slope of the elasticity modulus changes rapidly downwards. For example, Figure 8 shows the stress distribution for a 600N load on the outer surface of the specimen, as we move angularly from the load direction to the maximum tensile area which is at 0°. If the load value is enough for the development of a stress higher than that of the yield point, the specimen shows first on 0° plastic deformation that grows angularly on the surface and to the inside of the specimen.

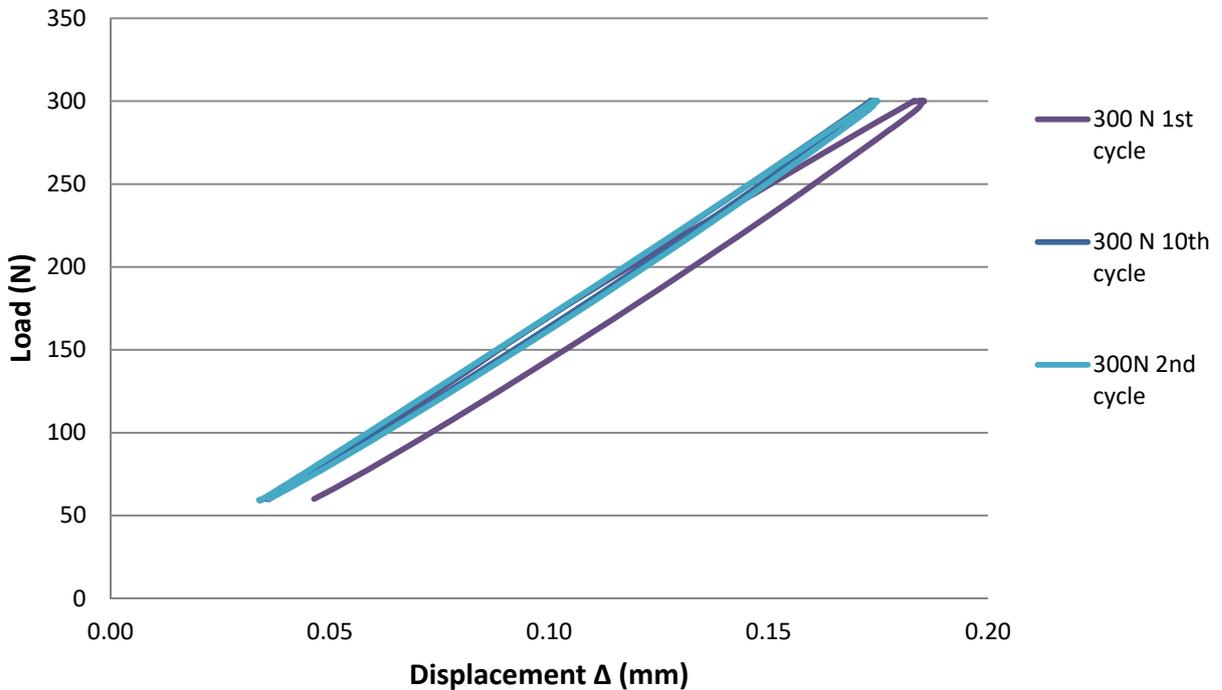
Diagram 2: Load - displacement curves in compression of sma c-ring at 300 N.

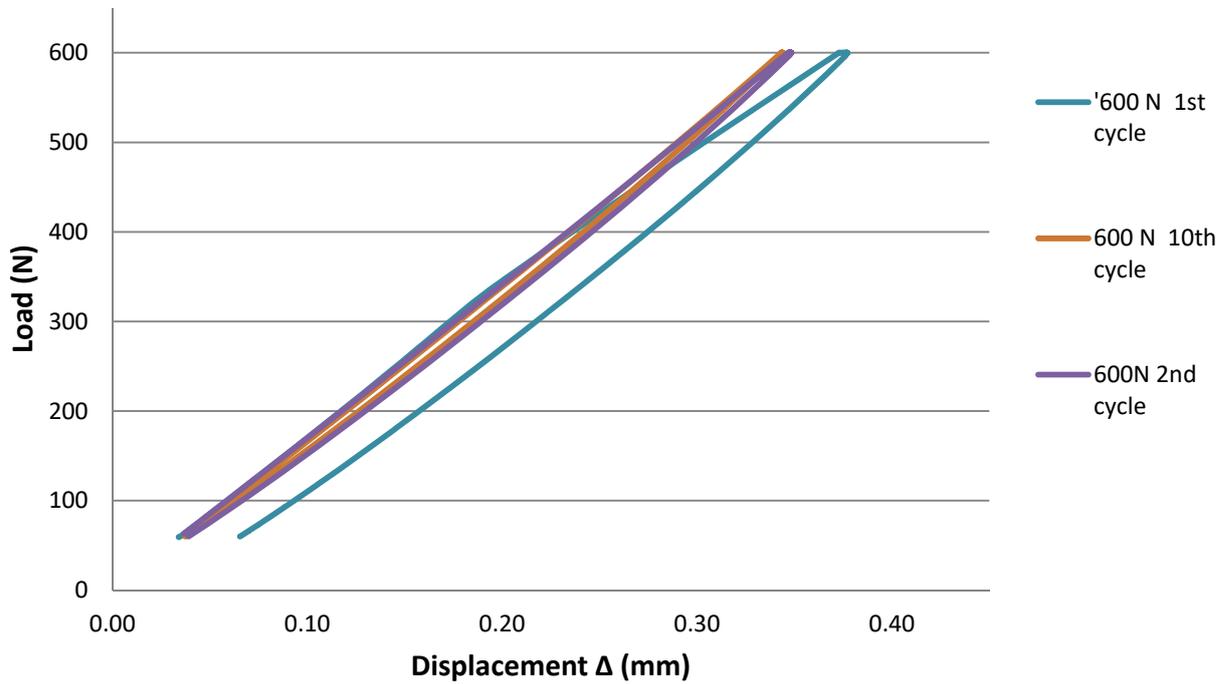
Diagram 3: Load - displacement curves in compression of sma c-ring at 600 newtons.

By applying a load of 600 N and once detwinning has been completed, the specimen presents a fully elastic behavior up to 600 N, without any further deformation between the loading cycles. This allows the selection of this load as the maximum applied in the fatigue investigations. After the first loading of the specimen, the device is adjusted to a new position, as the load changes due to the deformation caused by the detwinning. Adjustments are also made as the experiment progresses. The accumulation of imperfections mainly in the area of maximum stress lead to hardening of the area and changing of the stress field, thus forcing new areas to detwin.

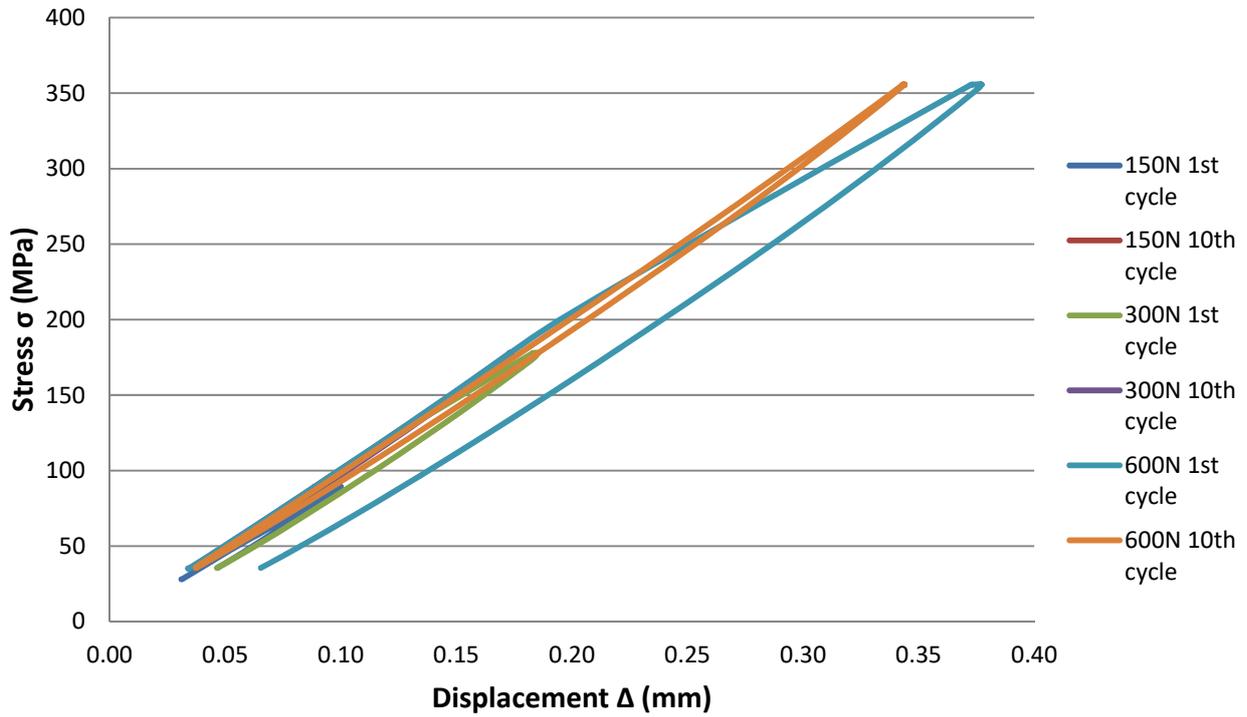
Diagram 4: Stress - displacement curves of first and tenth cycle in various stresses at the martensitic phase in twinned and detwinned specimen.

The loading rate in all experiments was 10 N/sec. Stress - displacement diagram and the modulus of elasticity of the material of the first and tenth loading cycle were derived from load – displacement curves (Diagrams 1, 2 and 3). For these calculations the analytical method of [4] was used, tailored to the c-ring geometry.

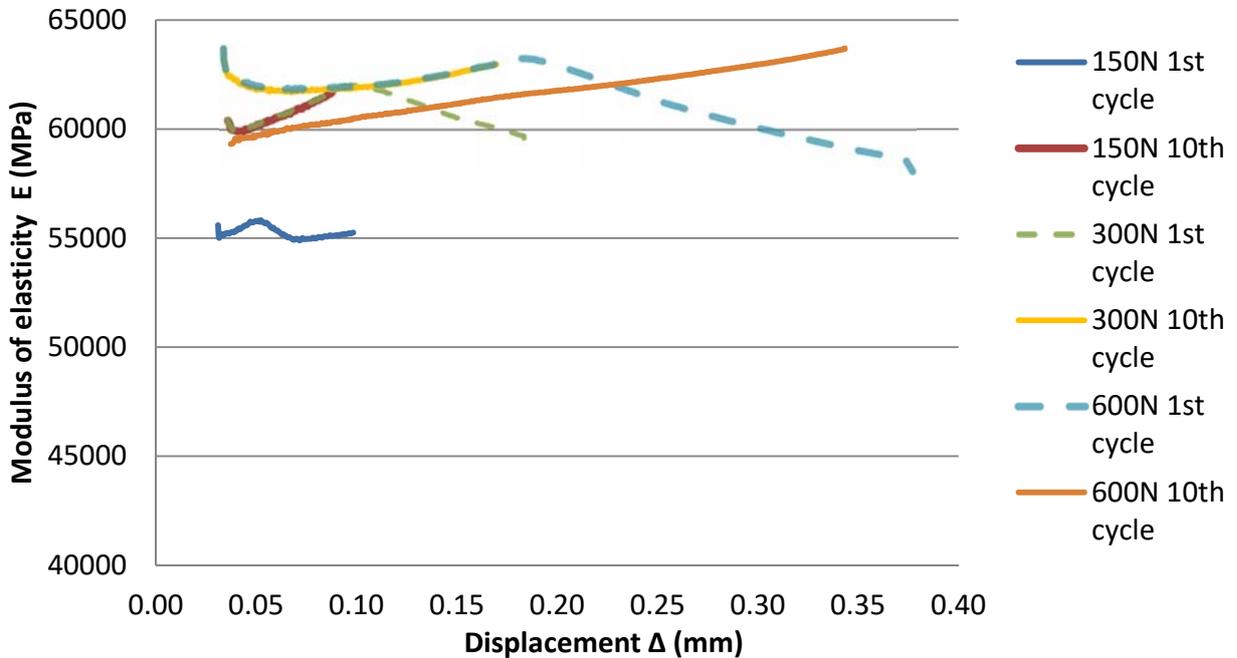
Diagram 5: Modulus of elasticity - displacement of first and tenth cycle in various stresses at the martensitic phase in twinned and detwinned specimen.

The elastic behavior of the material allows to calculate its elastic modulus. Although the sample contains both detwinned and twinned areas, some of the twinned areas are not subject to stresses higher than the detwin limit. From the calculations and as shown in Diagram 5, the modulus of elasticity of the detwinned material reaches the value of 63 GPa.

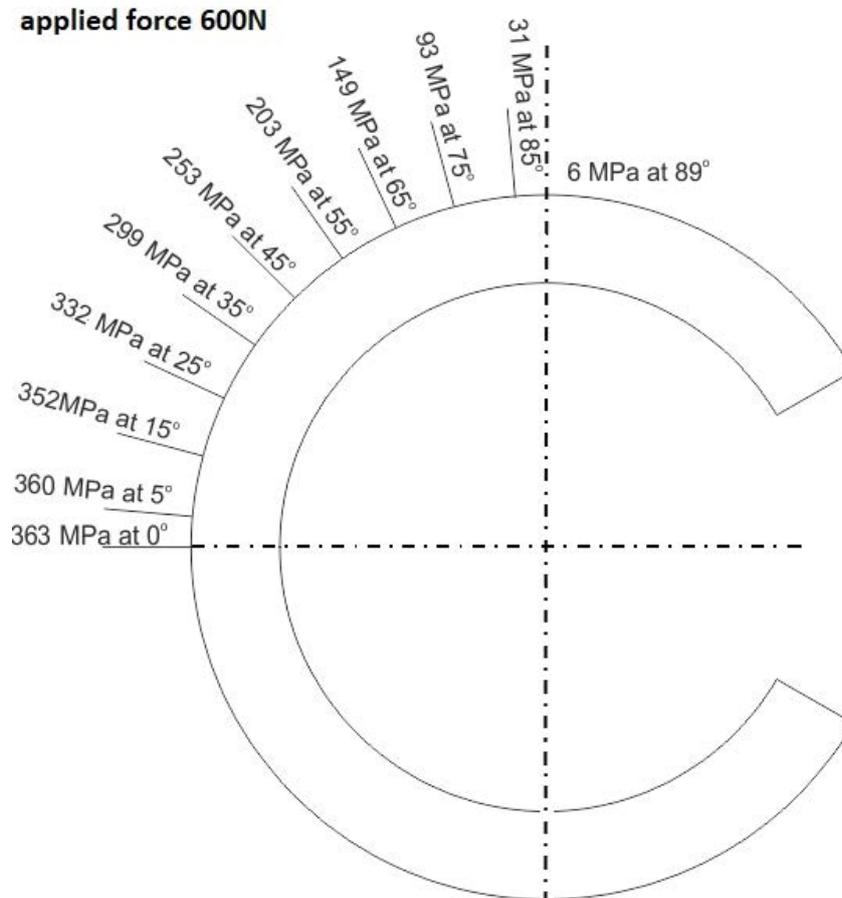
Figure 8: Stress distribution on the c-ring surface.

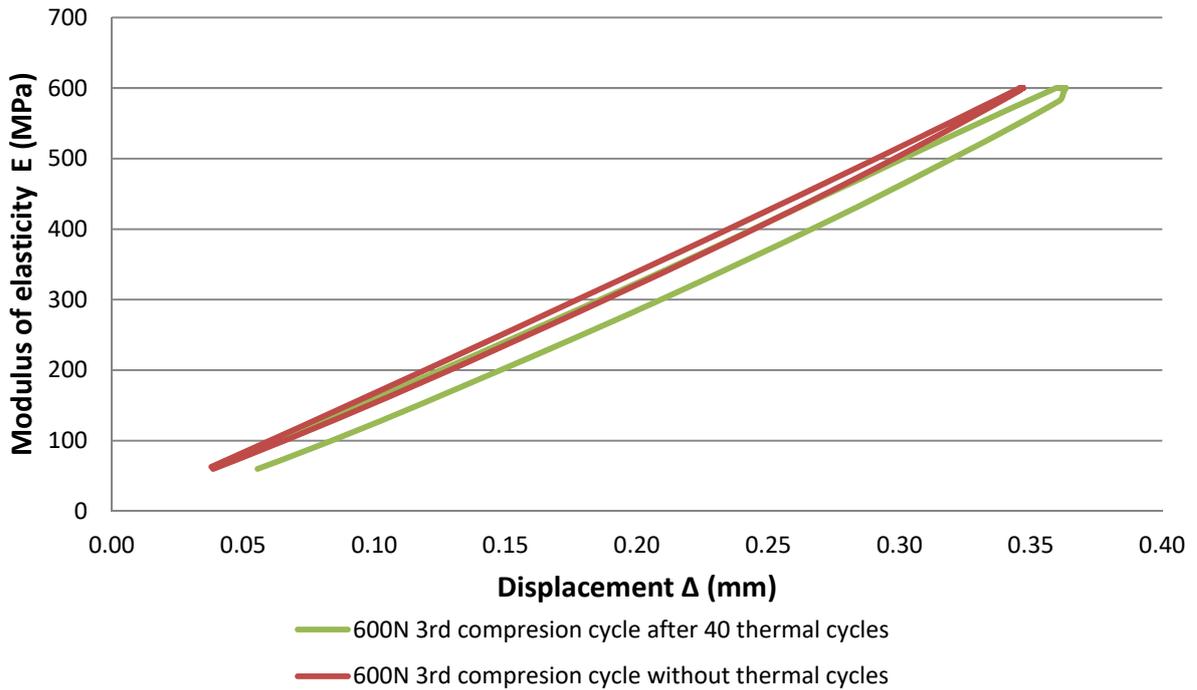
Diagram 6: Stress - displacement curve for NiTiHf c-ring after 40 thermal cycles compared with that of no thermal cycling.

After three mechanical cycles the specimen still presents a small hysteresis. This is attributed to the detwinning of the material during its cooling with simultaneous stress application, but also to the accumulation of imperfections, like dislocations, micro-cracks and other defects [6] that prevent the movement of the martensitic variants boundaries and as a result the residual deformation decreases per cycle, but is maintained for a larger number of cycles [11].

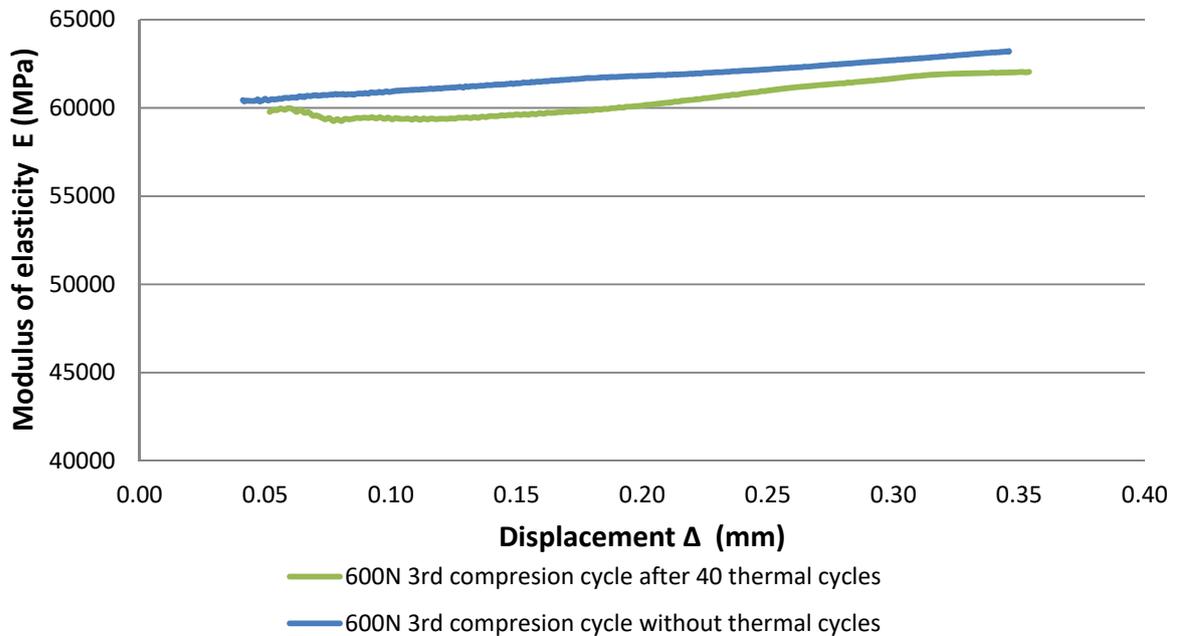
Diagram 7: Modulus of elasticity - displacement curve for NiTiHf c-ring after 40 thermal cycles compared with that of no thermal cycling.

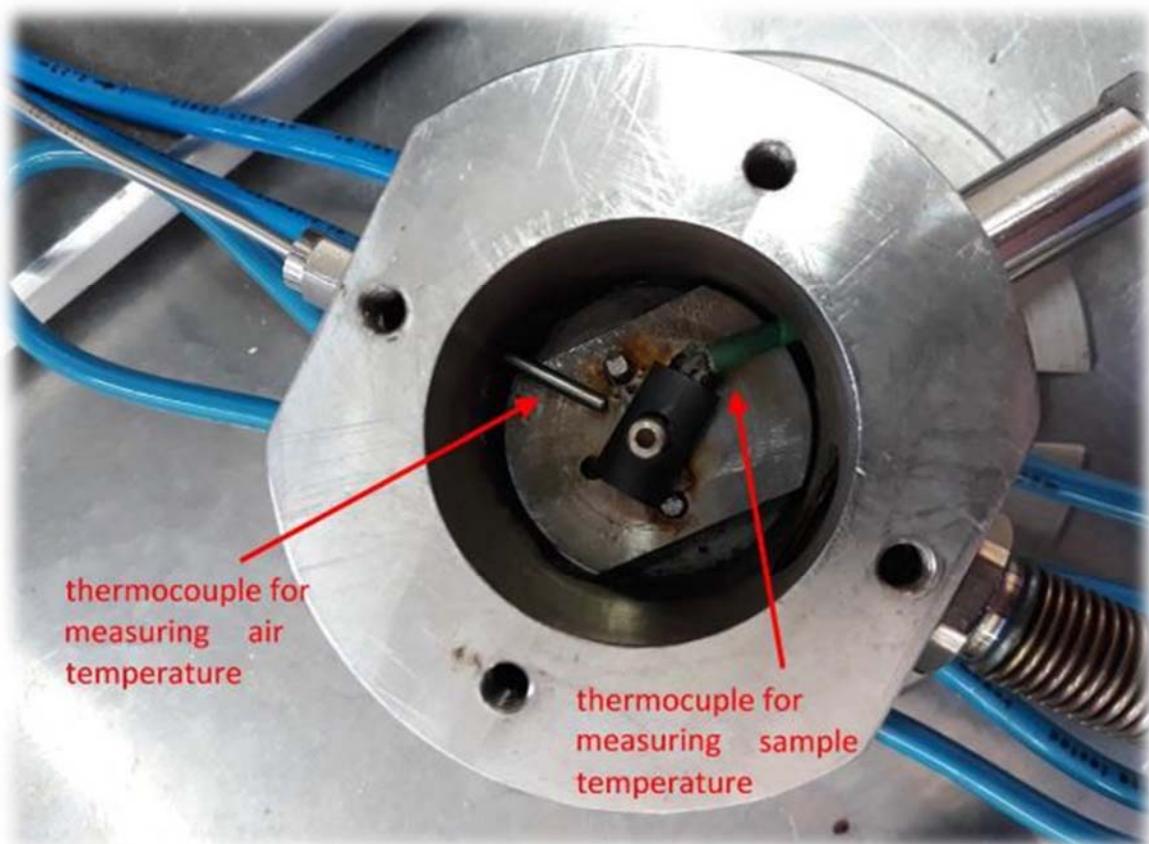
Figure 9: Container with two thermocouples for measure the temperature of the c-ring.

To measure the experimental temperatures, two thermocouples were initially placed inside the container, one being in contact with the c-ring sample while thermally insulated on its free surfaces, and the second served for recording the air temperature (see Figures 9 and 10).

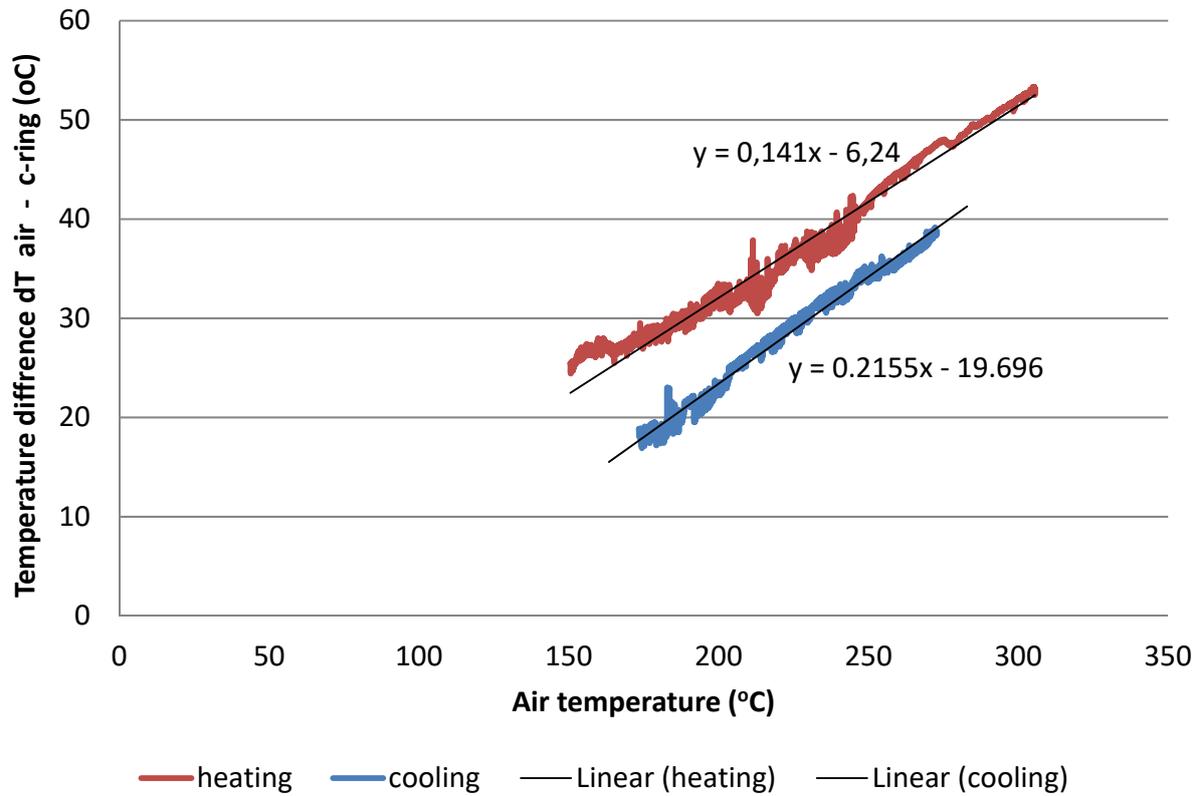
Diagram 8: Temperature difference between the c-ring and the air during heating and cooling.

The heating and cooling rates of the air in the vessel, in the temperature range of interest between 150°C and 300°C, were kept constant at 5°C/min in all experiments conducted. By capturing the difference between the temperatures measured at the air and at the sample during heating and cooling, two trendlines were derived with corresponding equations, one for heating and one for cooling (see Diagram 8). The reason for obtaining such a relationship of the temperature difference measured at the air and at the sample during heating and cooling was to have contactless estimation of the sample temperature by just measuring the air temperature throughout the temperature range of interest. In this way, the distortion of stress distribution and the creation of galvanic conditions during corrosion can be avoided.

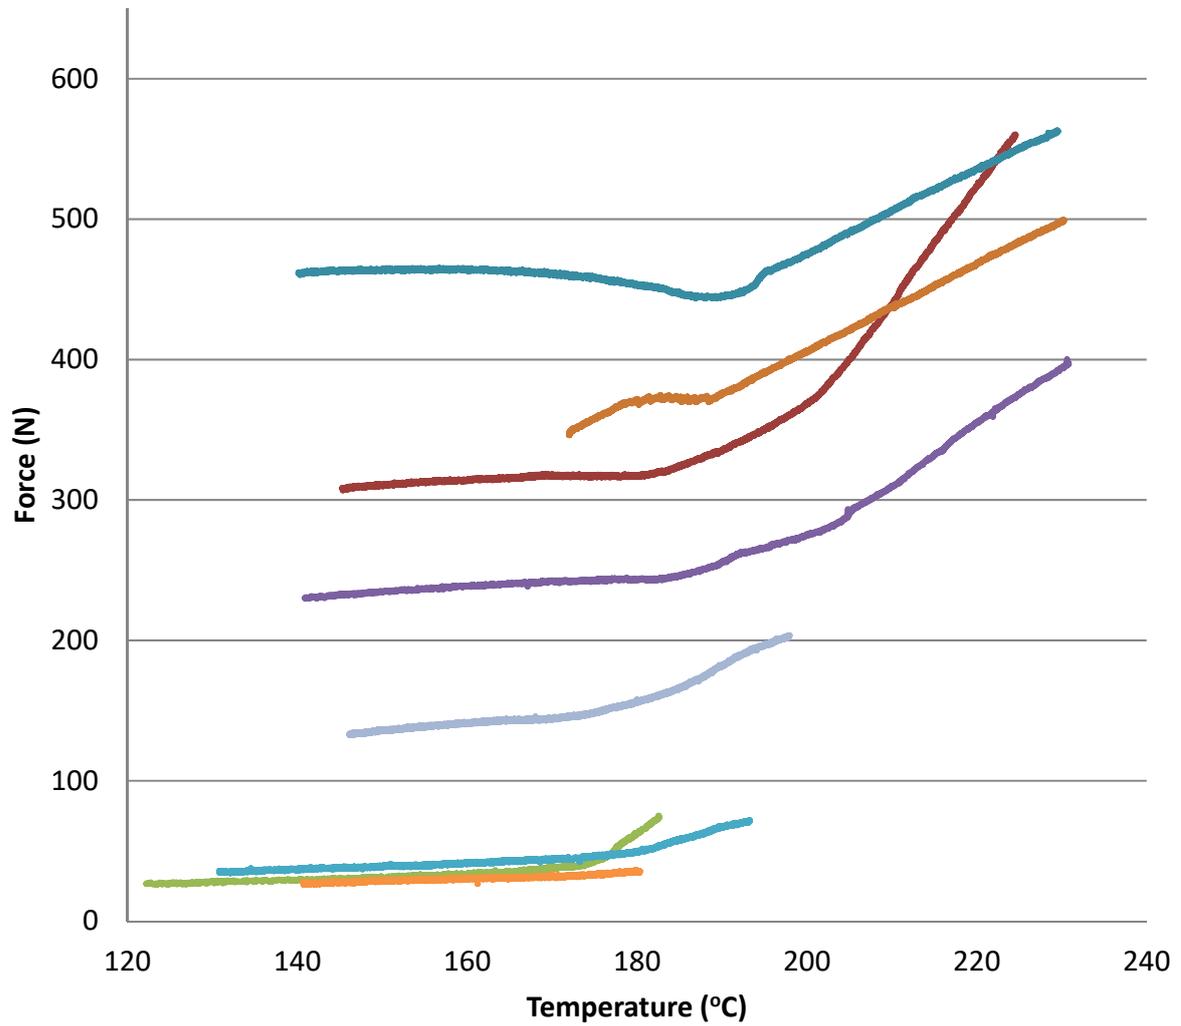
Diagram 9: Temperatures of austenitic transformation start (As) during heating, at various force values.

The following Diagrams (9, 10, 11, 12) show the force-temperature curves for different starting force values. When a change in the slope of the curve is experienced, a phase transformation from martensite to austenite is initiated or completed during heating, and vice versa during cooling.

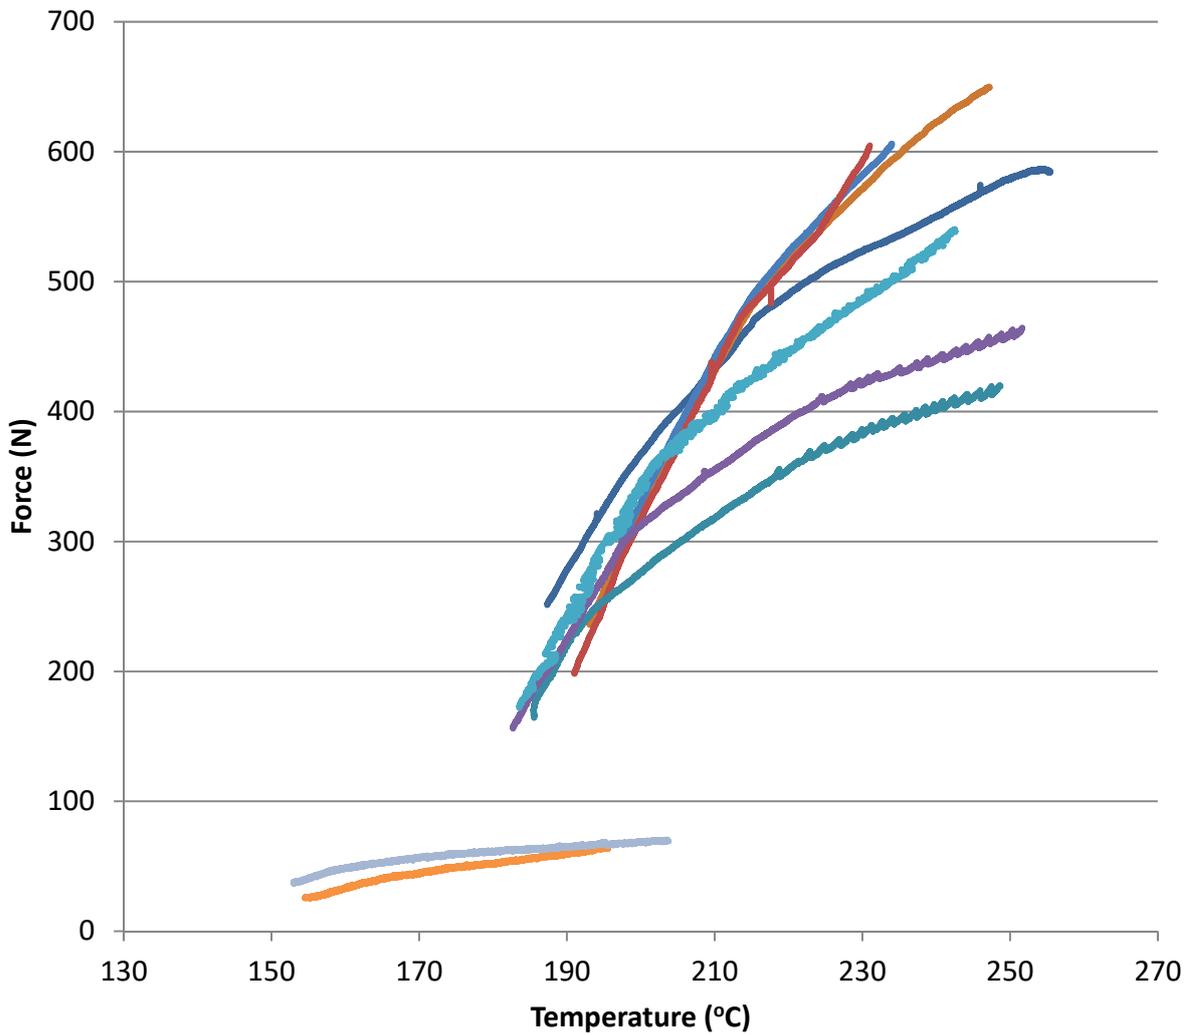
Diagram 10: Temperatures of martensitic transformation start (Ms) during cooling, at various load levels.

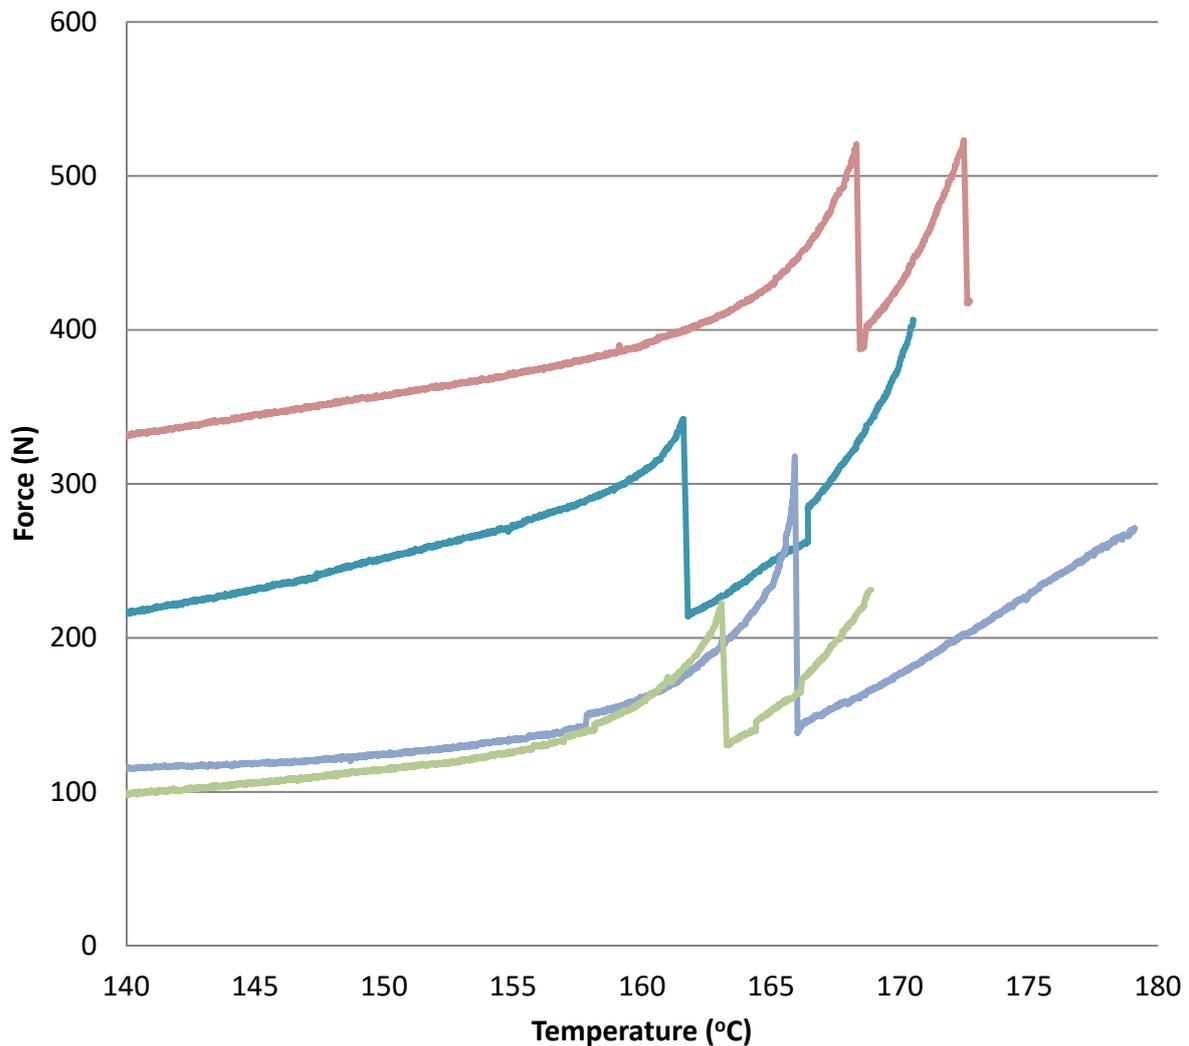
Diagram 11: Temperatures of martensitic transformation finish (Mf) during cooling, at various load levels.

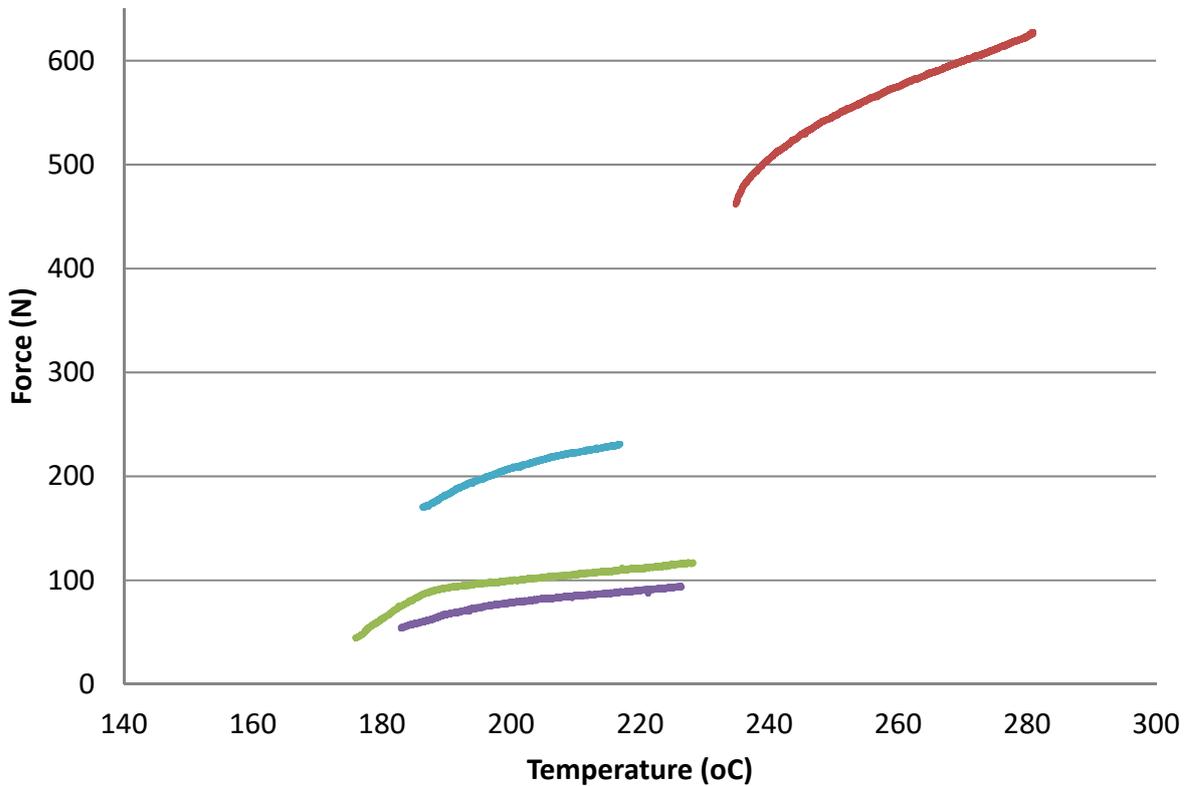
Diagram 12: Temperatures of austenitic transformation finish (Af) during heating, at various load levels.

From the phase transformation diagrams, the critical transformation start and finish temperatures at various load levels were extracted and plotted, as summarized in Diagrams 13 and 14. With the help of trendlines, the force - transformation temperature equations are obtained.
