AFRL-AFOSR-UK-TR-2019-0050

Corrosion Resistance of High-Temperature SMAs Under Extreme Environments

09/12/2019
Final Report

Corrosion resistance of High-Temperature Shape Memory Alloys (HTSMAs) under extreme environments

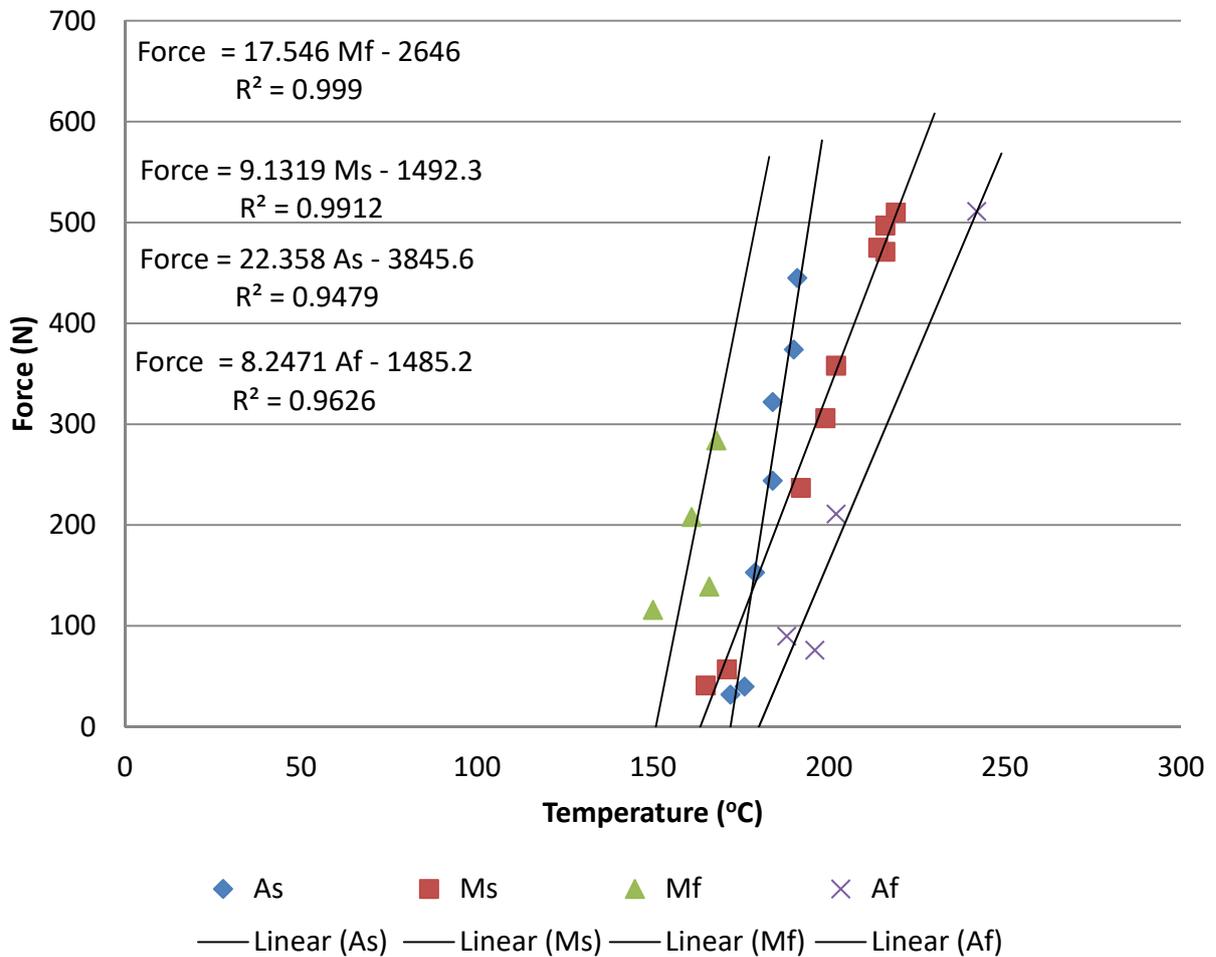
Diagram 13: Force vs. transformation temperature diagram.

$$M_f: 185 \text{ }^\circ\text{C}, M_s: 229 \text{ }^\circ\text{C}, A_s: 199 \text{ }^\circ\text{C}, A_f: 253 \text{ }^\circ\text{C}$$

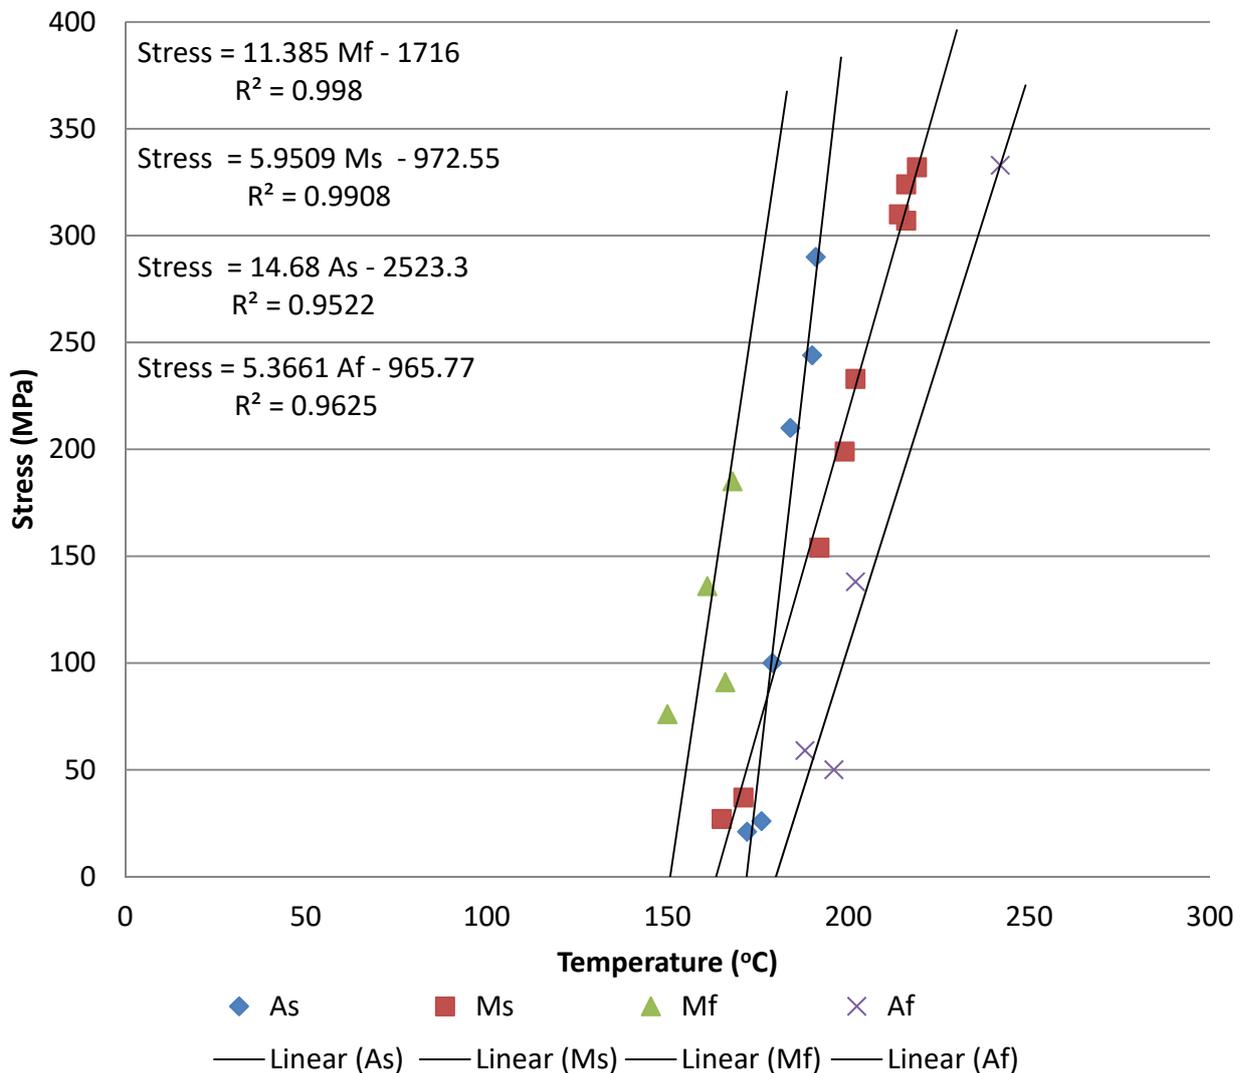
Diagram 14: Stress vs. transformation temperature diagram.

The previous diagram can be transformed into a stress- transformation temperature diagram, by which the corresponding trendline equations may result.

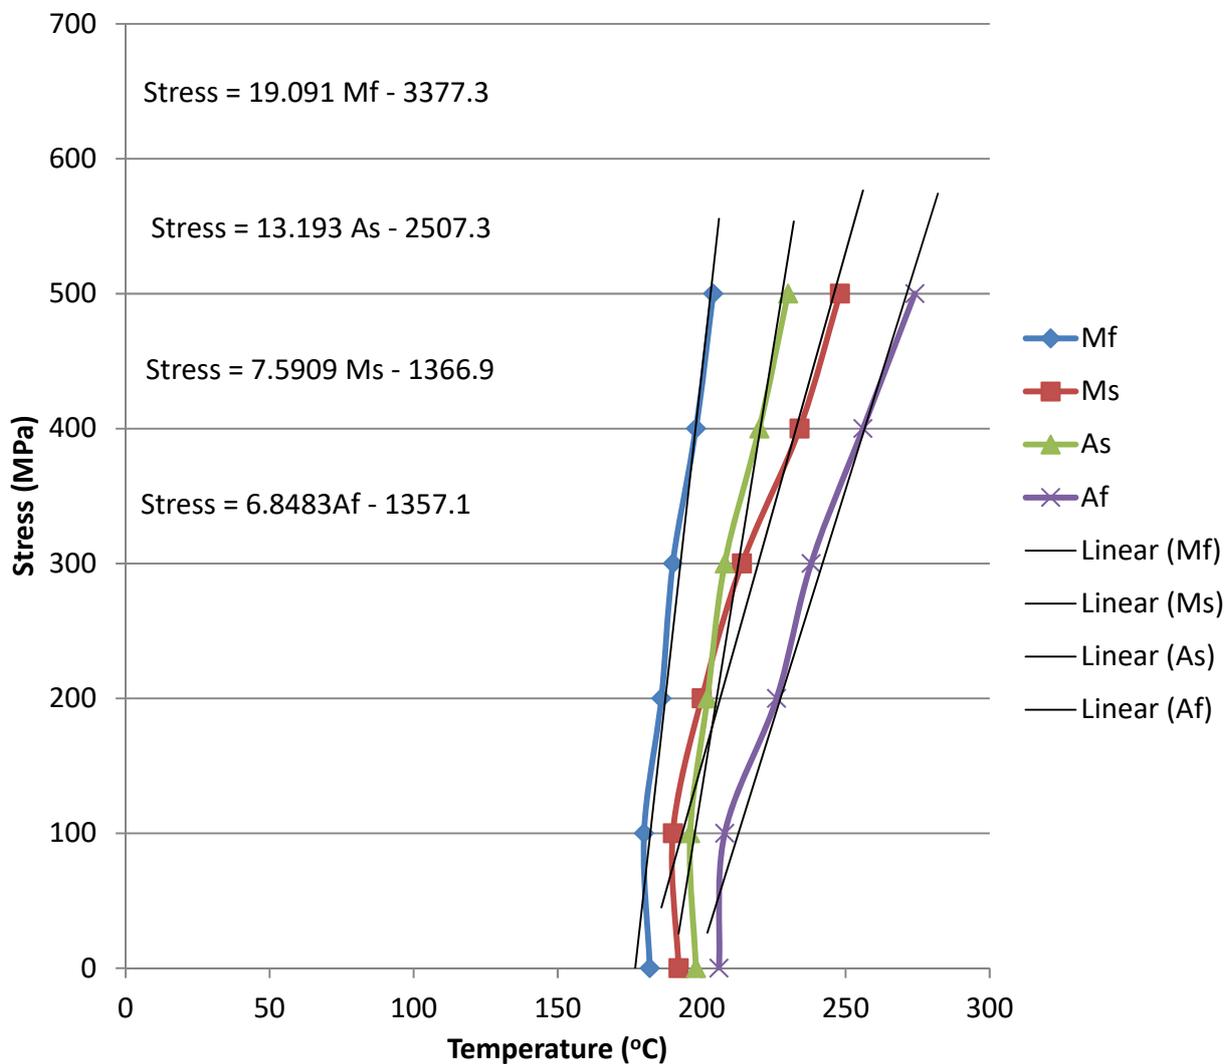
Diagram 15: Phase transformation values from isobaric tension tests at different stress values and temperatures. The calculation equations are exported using the trendlines.

Mf: 197 °C, Ms: 232 °C, As: 220 °C, Af: 255 °C

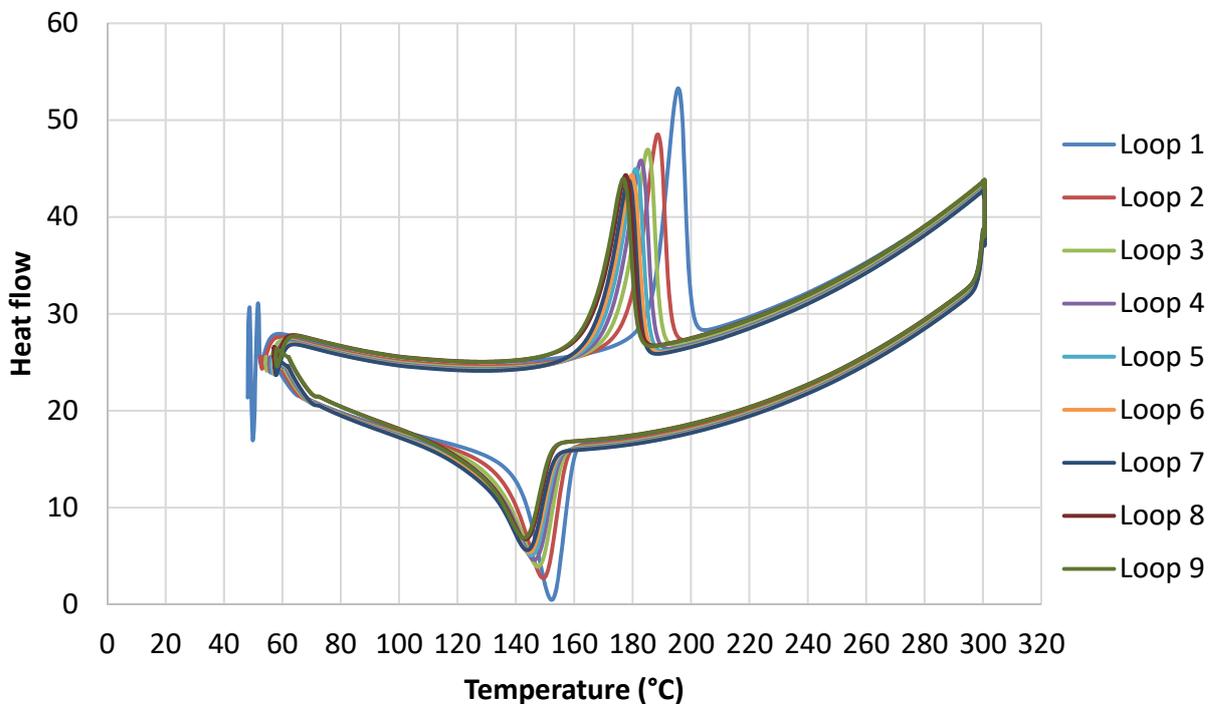
Diagram 16: DSC of the “heat-treated” material.

There is a clear tendency of the material to stabilize, as most of the measurements are accumulated when the number of cycles is increasing. At the 9th thermal cycle, the transformation temperatures are slightly smaller compared to the 1st.

Comparing the two charts (Diagrams 16 and 17) for the “heat-treated” specimen and the “as received” samples, one can easily yield that the transformation temperatures did not change significantly by the heat treatment.

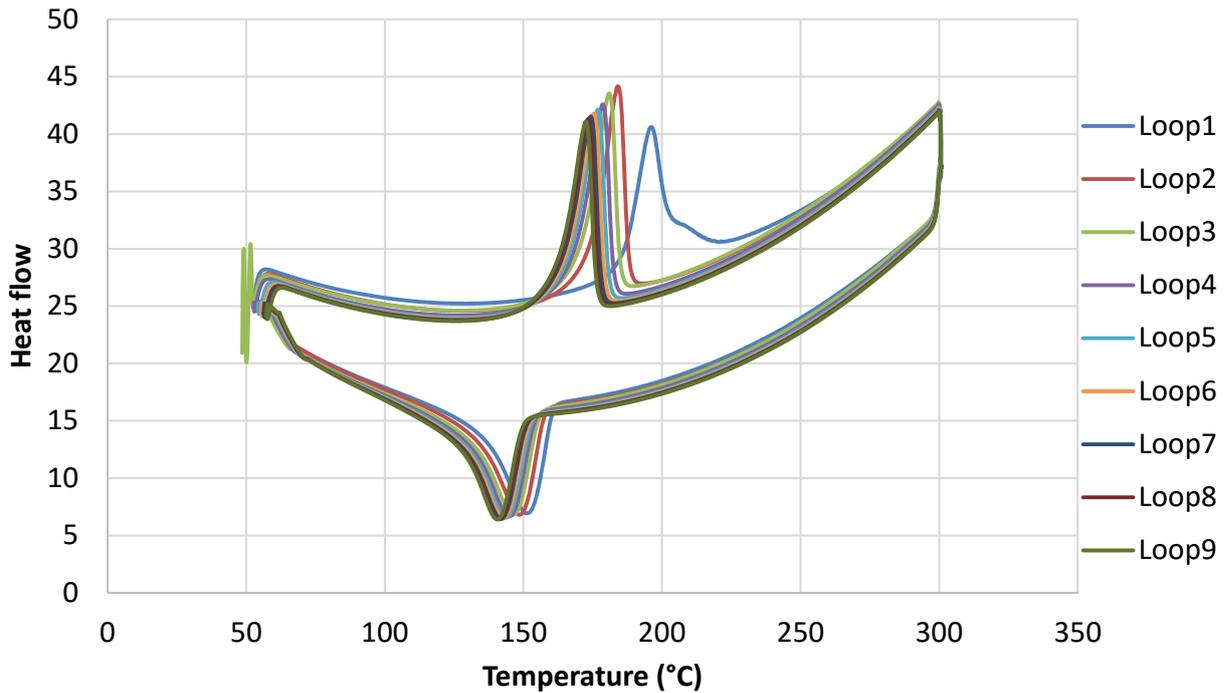
Diagram 17: DSC of the “as received” material,

As it can be observed again, the corresponding values of the 9th thermal cycle are smaller compared to the 1st and tend to stabilize.

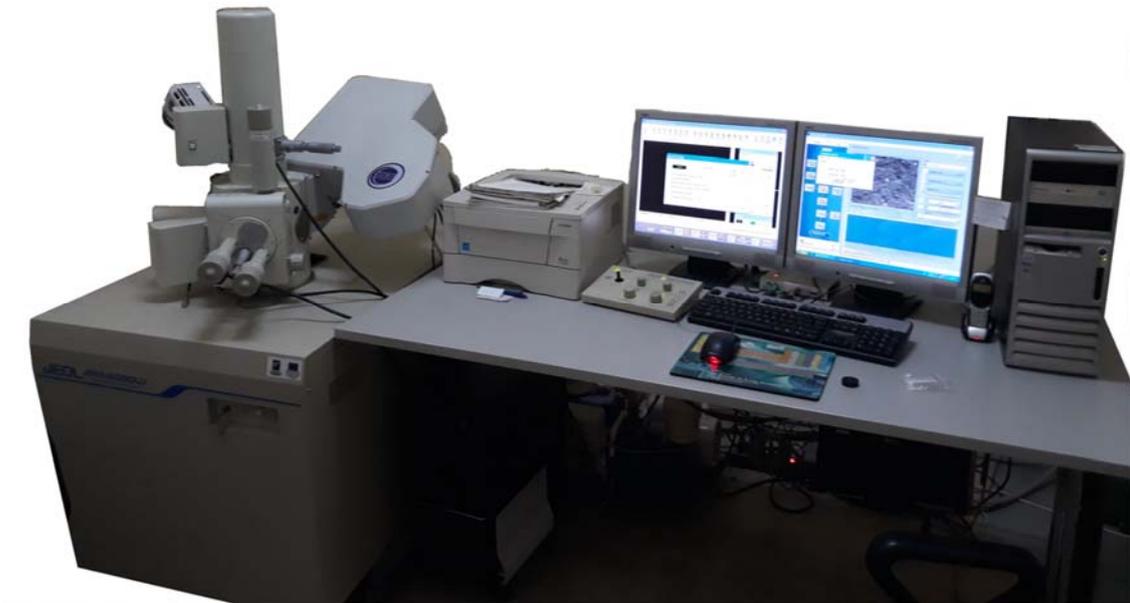
Figure 11: Scanning electron microscope (Jeol JSM – 6390LV) employed in the microstructure investigation.

The samples were examined for their microstructure at room temperature employing by a Jeol JSM – 6390LV scanning electron microscope (SEM) see Figure 11. For this purpose, two sections 1.5 mm thick were cut from two different c-ring samples, one “as received” and one subjected to heat treatment at 550 °C for 3 hours. Figures 12 and 13 present the corresponding SEM images, where in both Martensitic structures can be observed at different orientations (variants) [7].

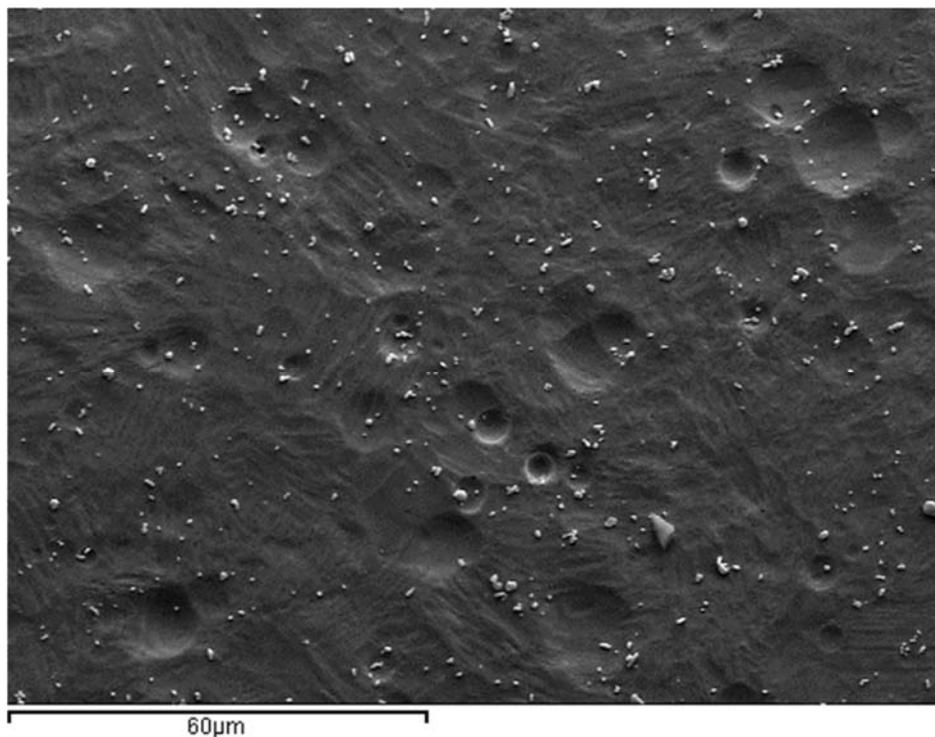
Figure 12: SEM image of the “as received” specimen, where the Martensitic structures can be observed in different orientations (variants).

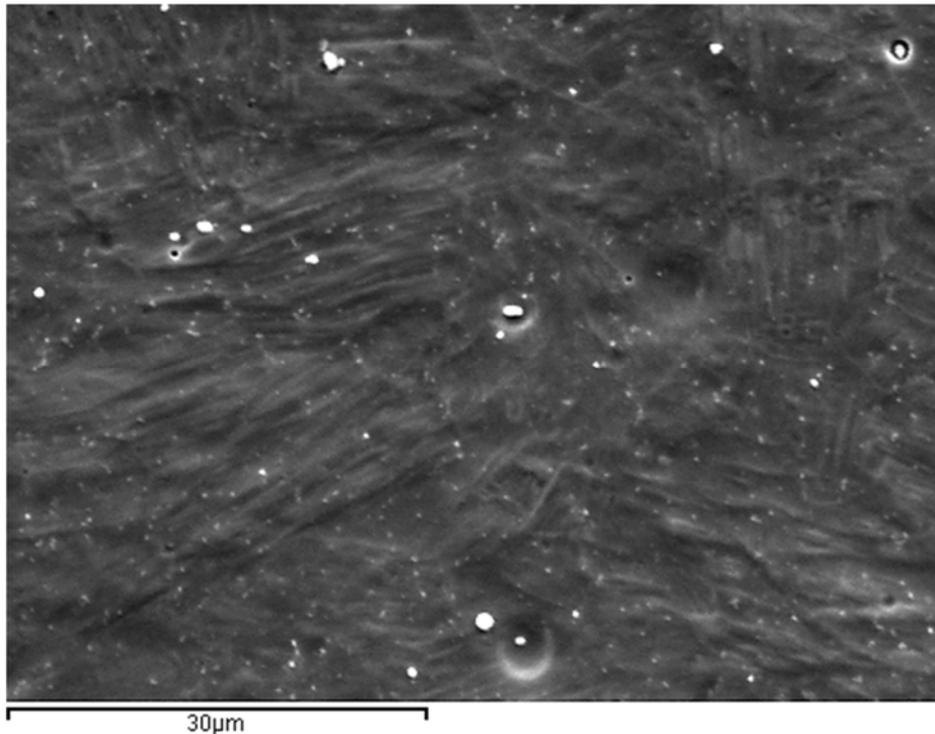
Figure 13: SEM image of the “heat-treated” specimen where the Martensitic structures can be observed in different orientations (variants).

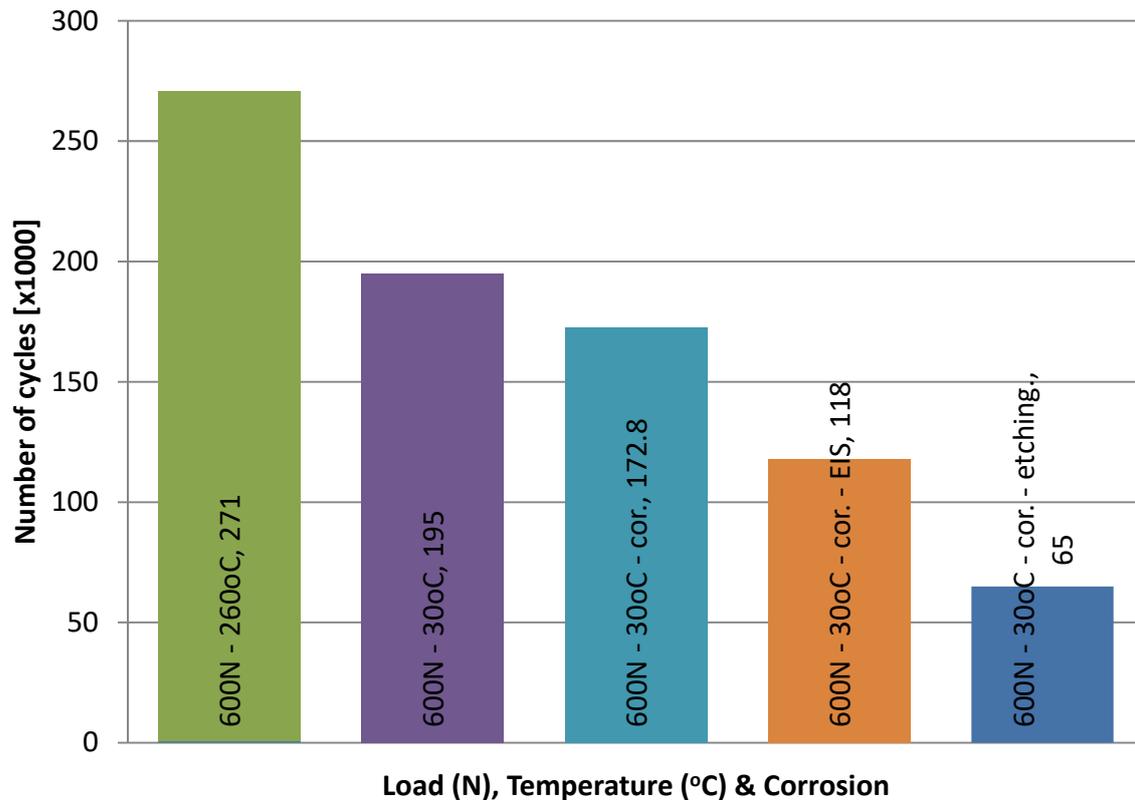
Diagram 18: Fatigue results of NiTiHf in martensitic and austenitic phase, as well as in various corrosion conditions. Loading frequency: 40Hz, loading amplitude: 0 N - 600N (R=0).

Fatigue experiments were carried out with the sample in the martensitic phase at room temperature and in the austenitic phase at a temperature of 260°C. Furthermore, in the martensitic phase, three combined corrosion and fatigue experiments were performed in a 3.5 wt % NaCl aqueous solution. In the second combined corrosion and fatigue experiment, the sample was first subjected to electrochemical cleaning to remove the external oxides and measure the open circuit potential. In all experiments the applied force exerted on the c-ring cyclically varied between $F_{\min} = 0 \text{ N}$ και $F_{\max} = 600 \text{ N}$ ($R=0$) at a frequency of 40Hz. Based on the analytical calculation of the stress for the force of 600 N the maximum stress developed on the surface of the sample raises to 363 MPa. All samples were heat treated at 550 °C for 3 hours prior to testing. Below is a bar chart (Diagram 18) with the results of the experiments, as well as the number of load cycles.

From the fatigue experiments it was observed that the specimen in the austenite phase exhibits longer life span than in the martensite phase (271.000 cycles versus 195.000 cycles). The specimens subjected to fatigue in a corrosive environment showed a shorter life span with variations depending on the corrosion technique used and the sample pre-etching. These results will be further discussed in Chapter 7.

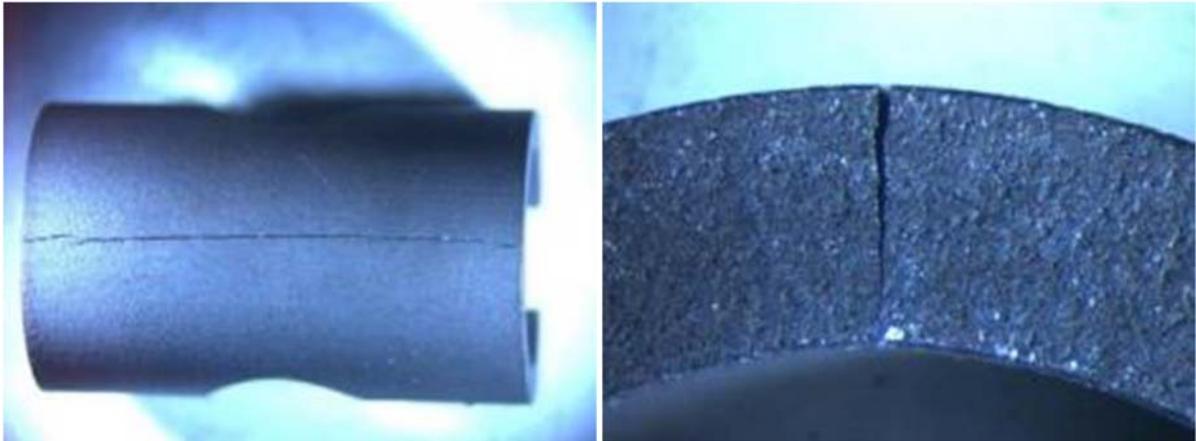
Figure 14: Sample with fatigue crack in martensitic phase after 195.000 cycles. The crack starts at the right-hand side of the specimen at the outer surface where the maximum tensile stress develops.

The different surface-initiated fracture modes of the samples during pure fatigue and corrosion-fatigue can be visualized from the selection of characteristic fractographs taken by stereo microscope (Leica MS5 equipped with Leica DFC490 digital camera). The images of Figures 14, 15 and 16 illustrate the fractured surface of the specimen, resulting from corrosion-free fatigue at ambient temperature (martensitic phase).

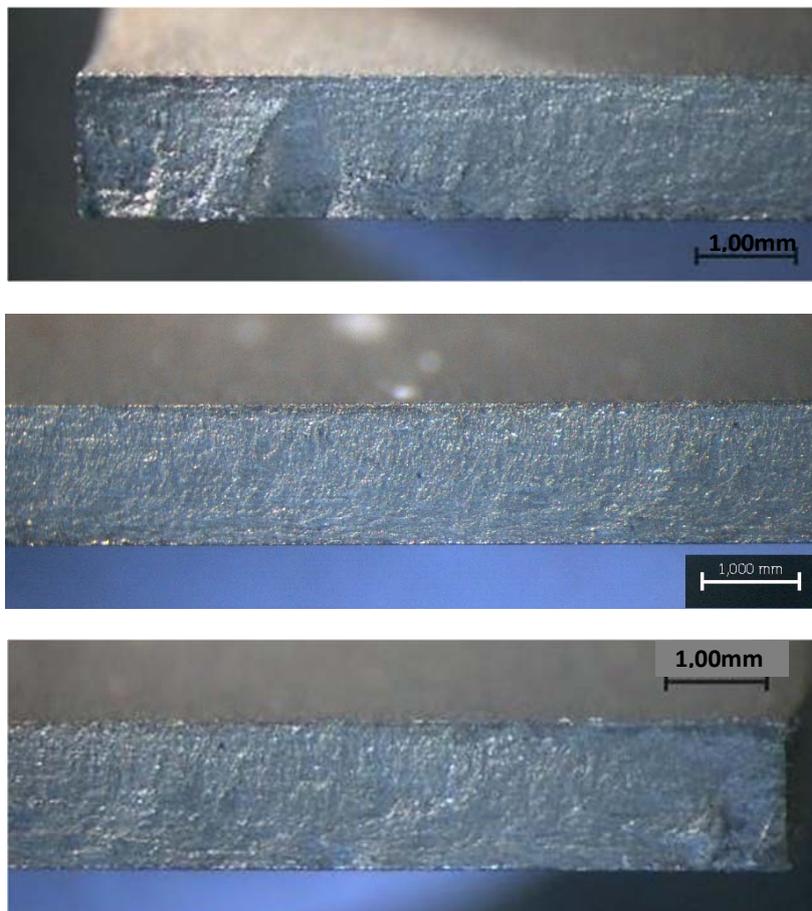
Figure 15: Fractography (16x) of the specimen with fatigue at martensitic phase. The top image shows the end of the crack, the second image shows the middle and the bottom image the crack initiation site.

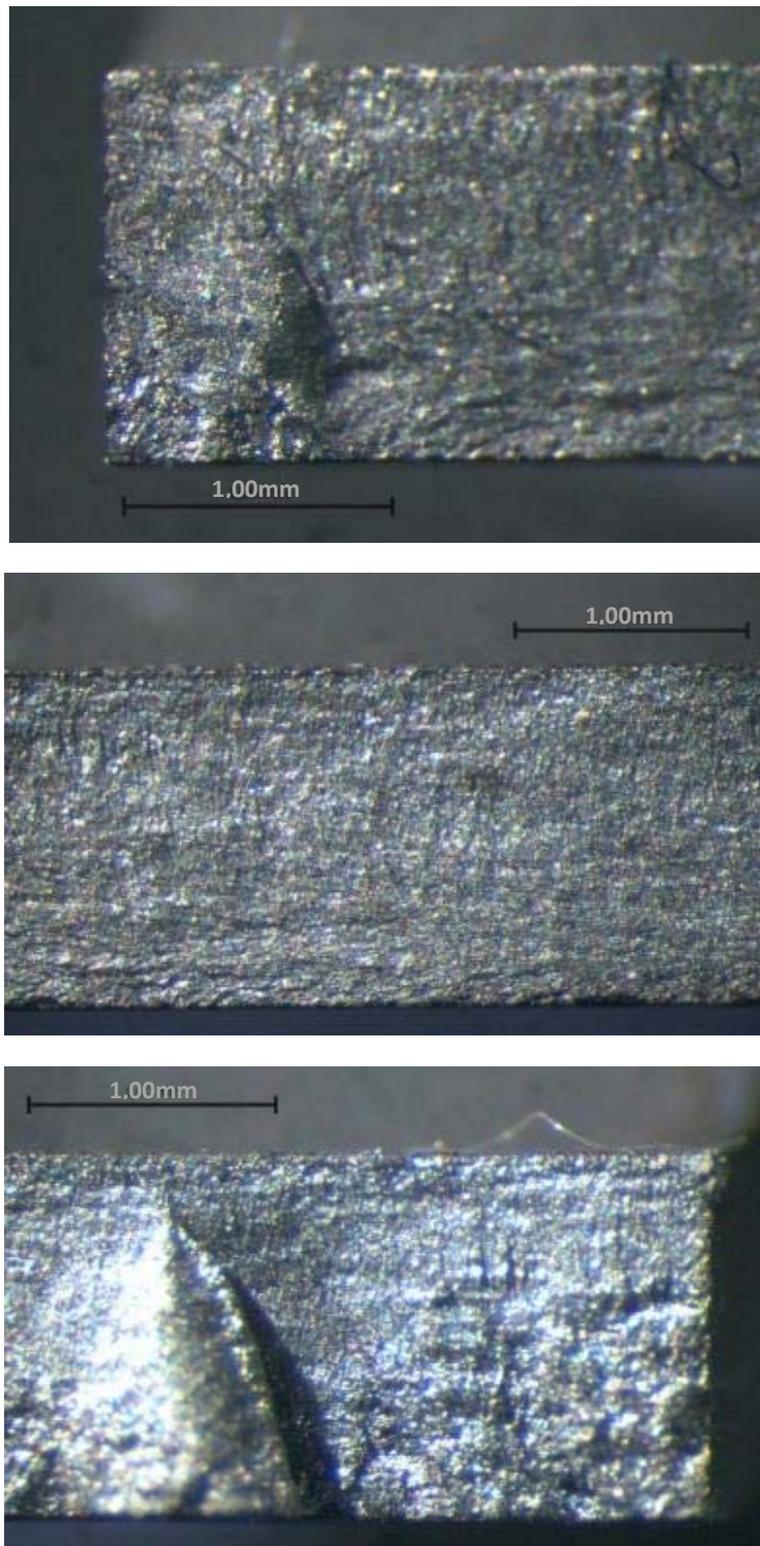
Figure 16: Fractography (40x) of the fractured surface of the other c-ring segment, where the top image shows the end of the crack the second image the middle and the bottom image the crack initiation site.

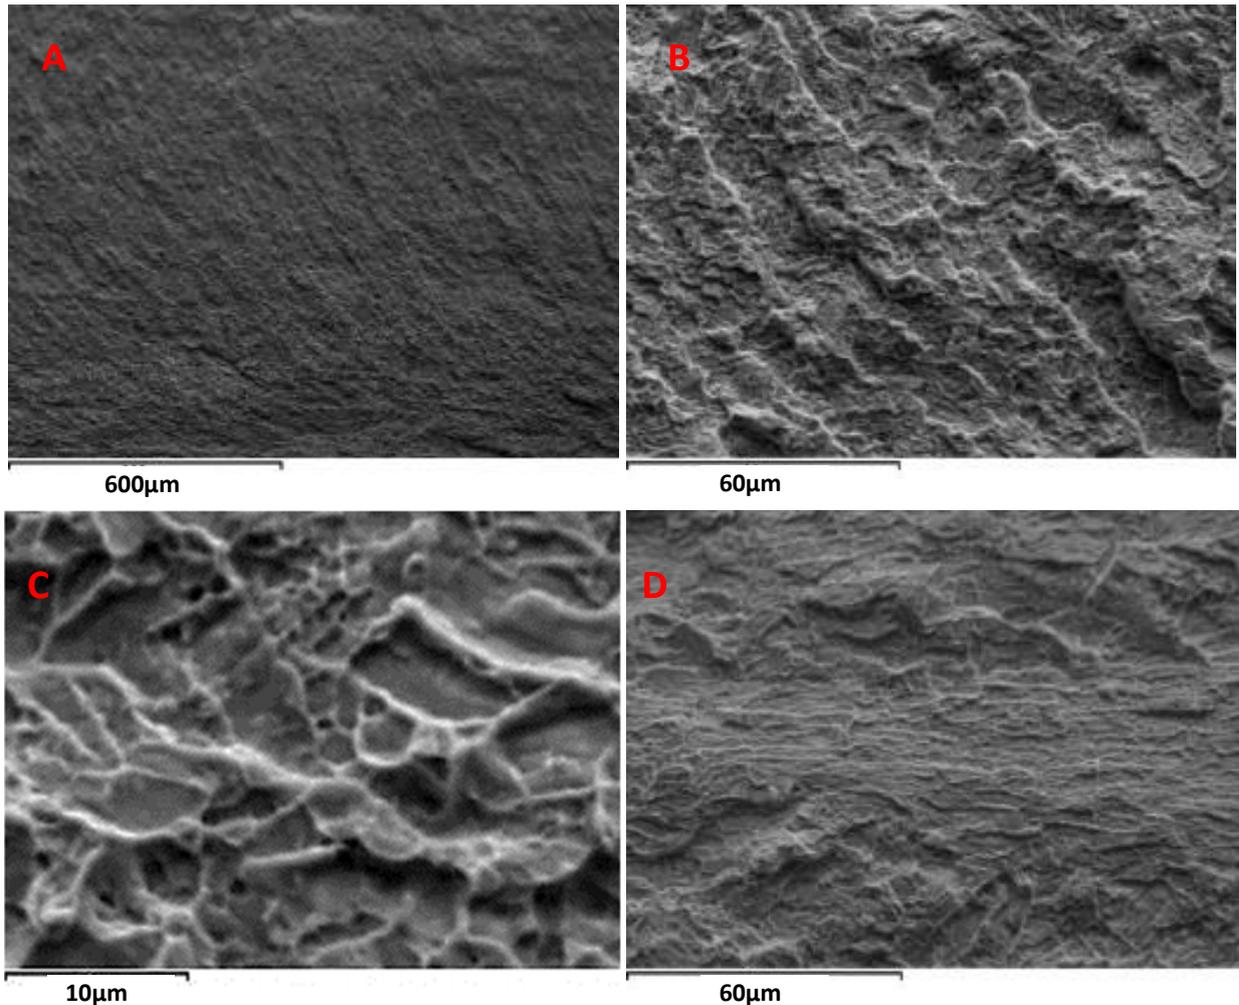
Figure 17: Scanning electron microscopy images of the NiTiHf SMA c-ring fractured surface in the martensitic phase.

In the images (a) and (b) the macroscopic waveform striations of fatigue in the radial direction of the c-ring are visible. In image (c), a morphology matching transgranular cracking appears, while in image (d) the waveform striations change orientation due to the transition from the compressive stresses at the inner surface to the tensile stresses at the outer surface.

The images of Figure 17 were taken by scanning electron microscopy and illustrate the fractured surface of the specimen, resulting from a fatigue experiment at ambient temperature (martensitic phase) after 195,000 cycles.

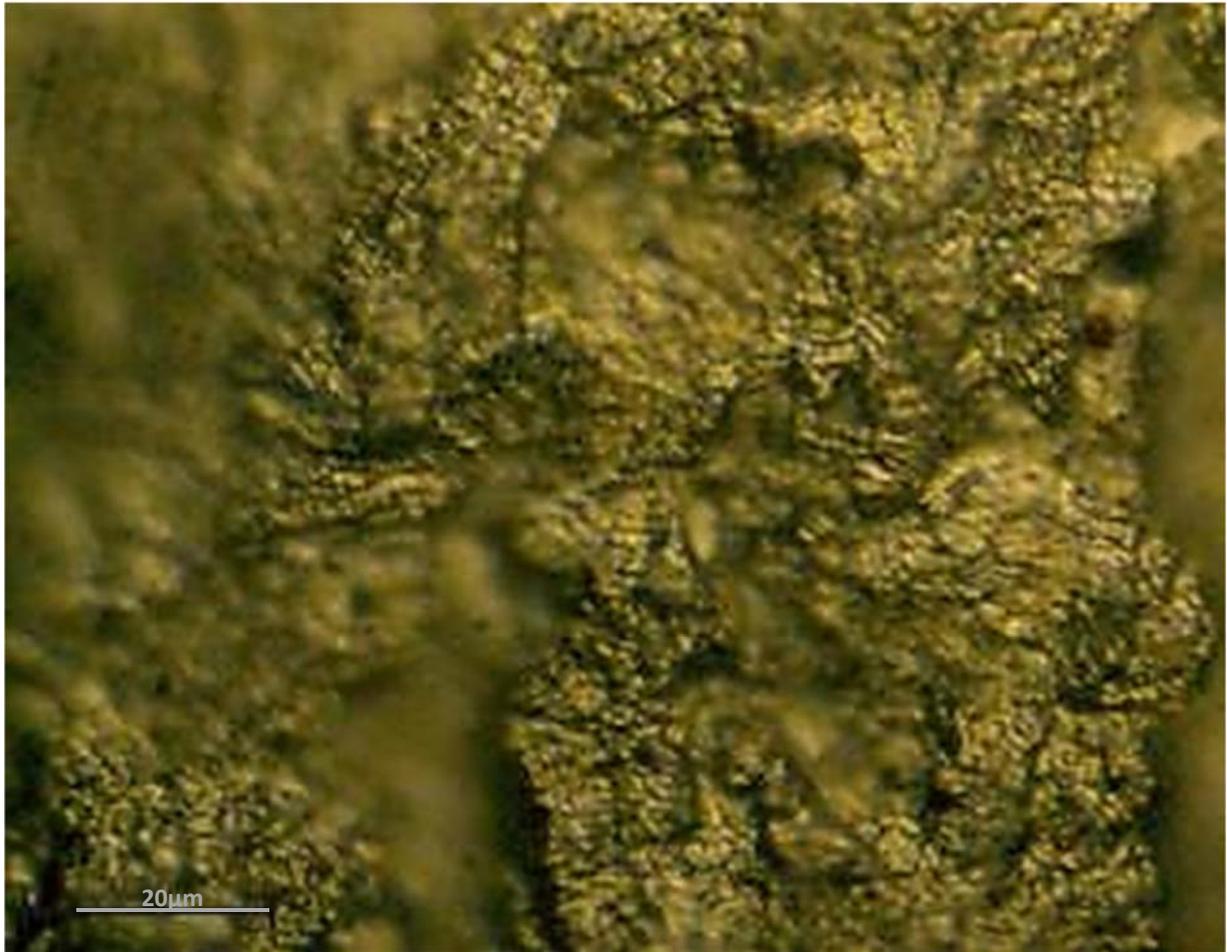
Figure 18: Granular microstructure of the sample in the fractured region.

The image Figure 18 was taken through a Leica DM4000M optical microscope, illustrating the granular microstructure of the sample in the fractured region. The surface texturing does not allow the capturing of a focused image all over the picture.

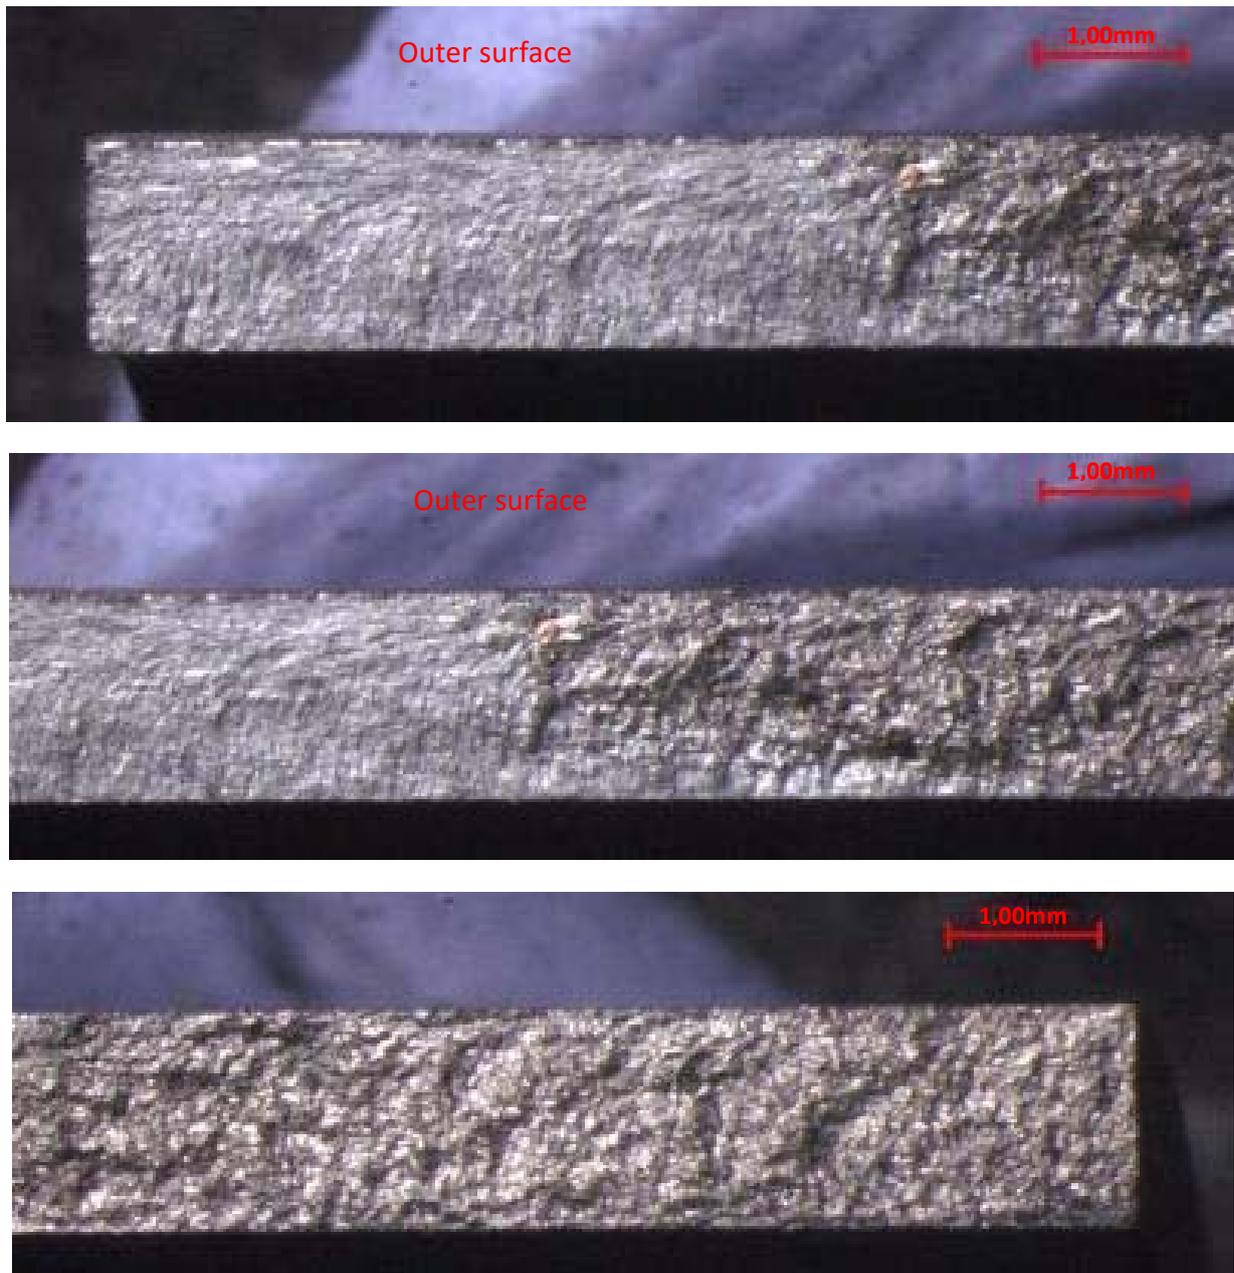
Figure 20: Fractured area of the specimen with fatigue at austenitic phase. The top image focuses on the area of the fatigue crack propagation. In the middle and bottom images, the change in morphology is observed due to brittle fracture.

The images of Figures 19, 20 and 21 illustrate the fractured surface of the NiTiHf sma c-ring specimen, resulting from a fatigue experiment at 260°C (austenitic phase) after 271.000 cycles.

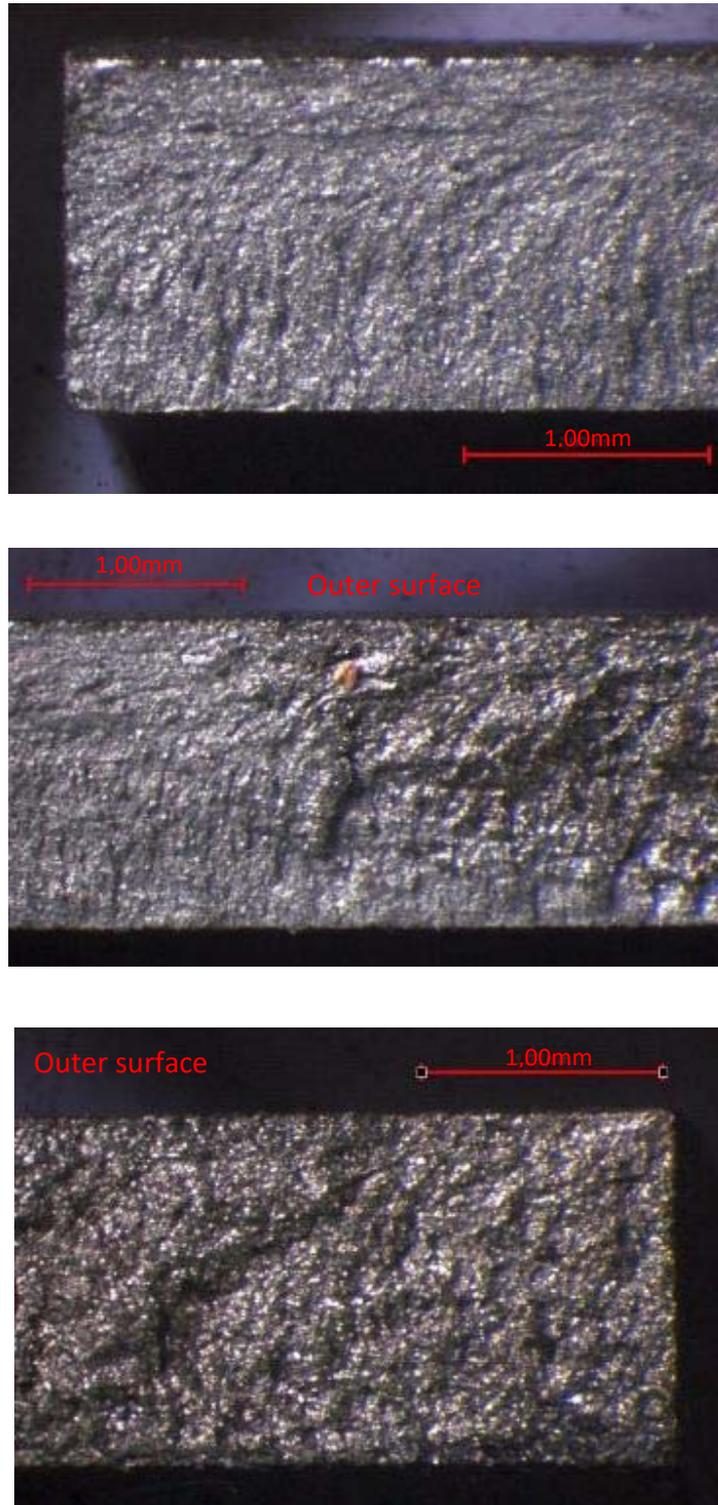
Figure 21: Fractured area of the specimen with fatigue at austenitic phase. Higher magnification images focusing on areas of interest.

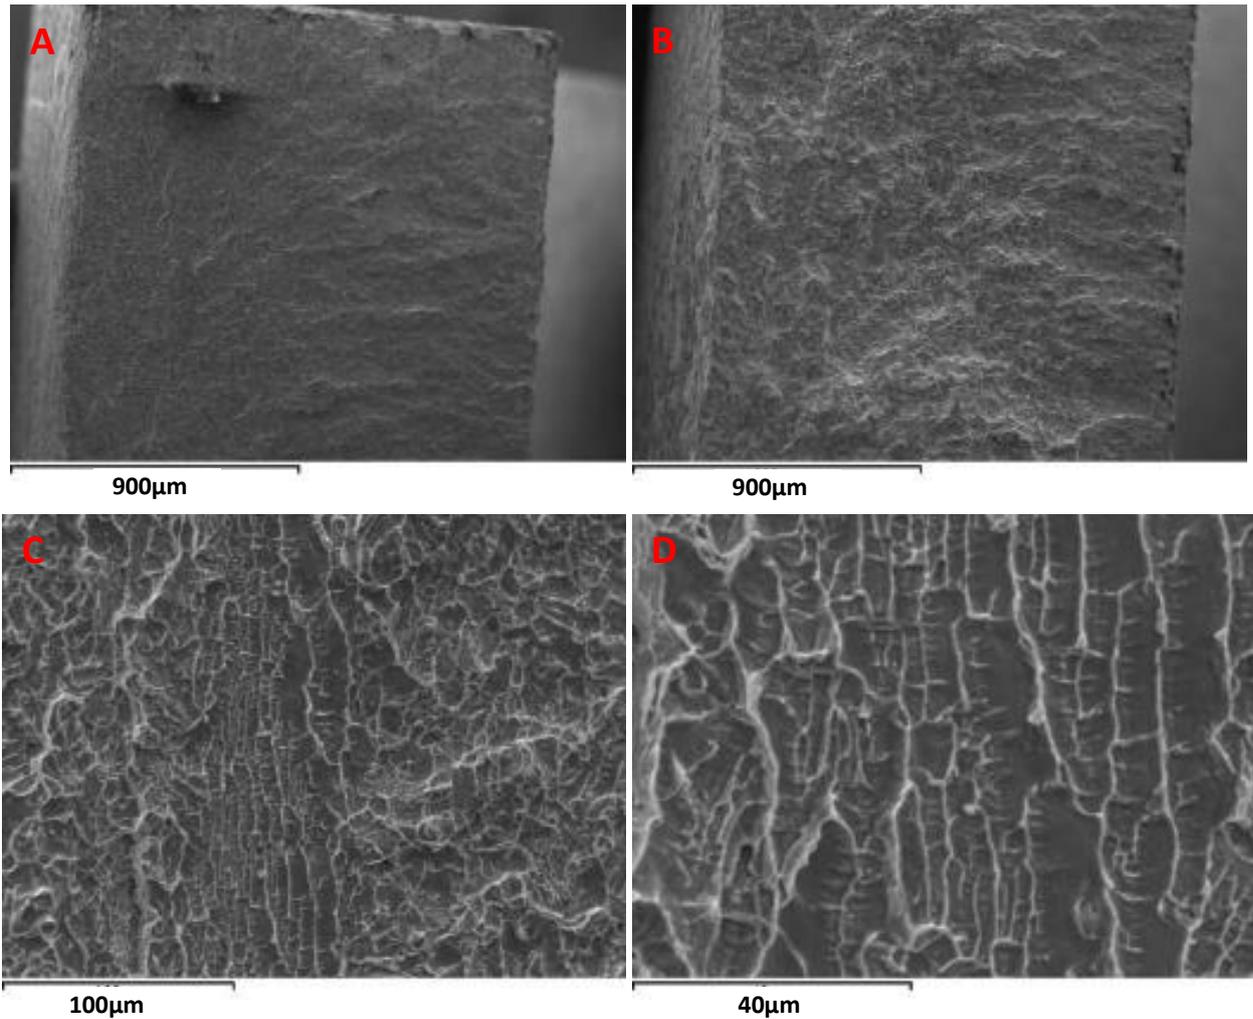
Figure 22: Scanning electron images of the NiTiHf c-ring fractured surface in the austenite phase.

In the image (B) the macroscopic waveform striations of fatigue can be observed. In the image (A), the other side of the fractured surface can be observed in which signs of brittle fracture appear. In the fractographs (C) and (D), evidence of transgranular cracking appear.

The images of Figure 22 were taken through Scanning electron microscopy and illustrate the fractured surface of the sample, resulting from a fatigue experiment at 260 °C (austenitic phase) after 271.000 cycles.

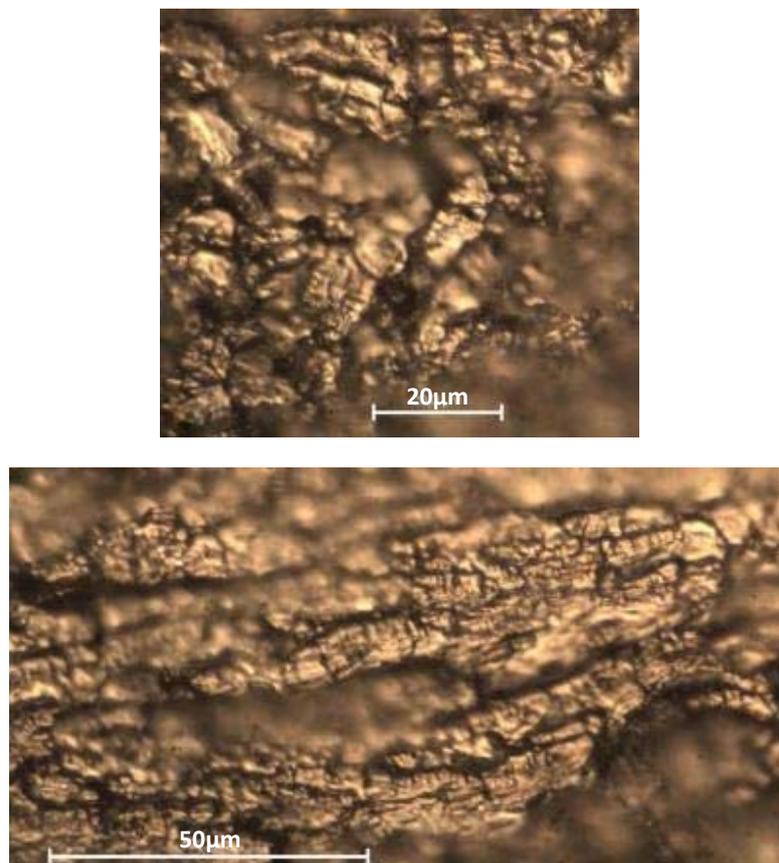
Figure 23: Microstructure of the material on the fractured surface.

The images of Figure 23 were taken through optical microscopy and illustrate the granular microstructure of the sample on the fractured surface.

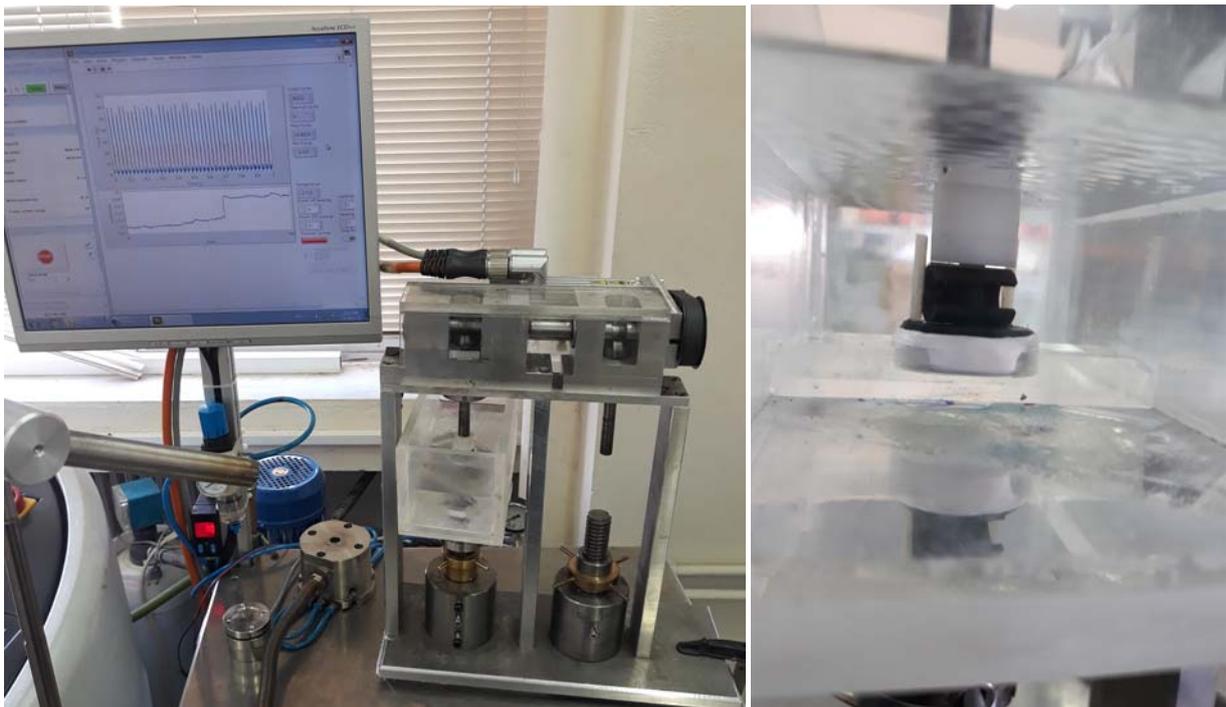
Figure 24: Corrosion – fatigue experiment in 3.5 wt % NaCl aqueous solution.

In the experiments that follow, the effect of corrosion on the fatigue performance was examined. For this purpose, three experiments were performed. In its basic form the experiment repeats the fatigue test with 600N applied force (at 363 MPa) at ambient temperature and a frequency of 40Hz, with the only difference that the sample is placed in 3.5 wt % NaCl aqueous solution. The adjustment made in the experimental setup to facilitate this kind of test is shown in Figure 24.

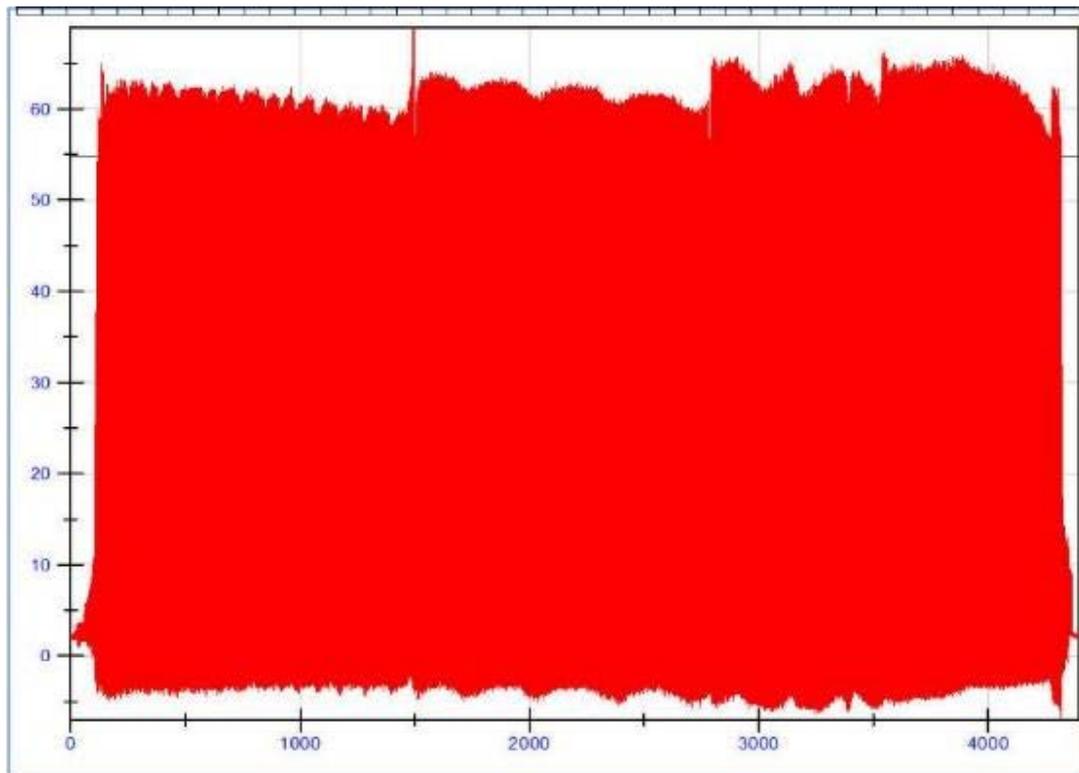
Diagram 19: Observation of individual loading cycles of combined corrosion and fatigue experiment.

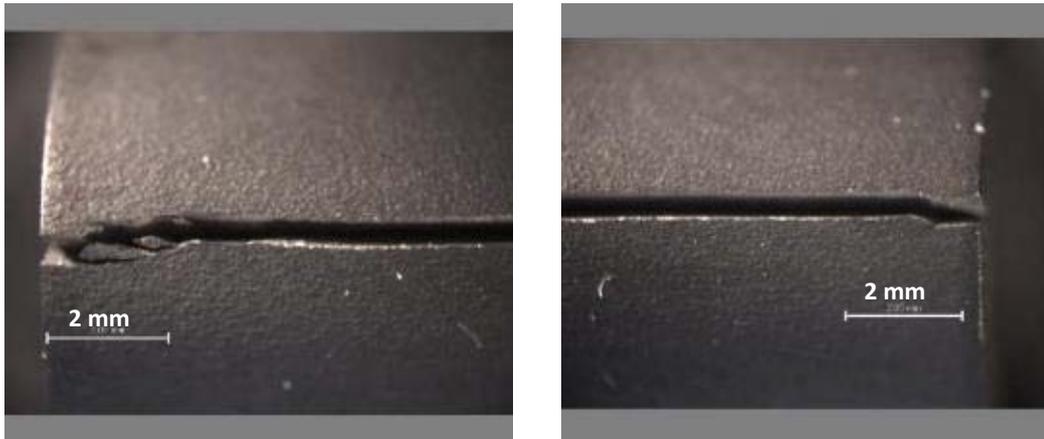
Figure 25: Fractured surface of the specimen of the 1st combined corrosion and fatigue experiment. Right image: beginning of the crack. Left image: end of the crack.

The fractured surfaces are illustrated in Figures 25 and 26.
