AFRL-AFOSR-UK-TR-2019-0050

Corrosion Resistance of High-Temperature SMAs Under Extreme Environments

09/12/2019
Final Report

Corrosion resistance of High-Temperature Shape Memory Alloys (HTSMAs) under extreme environments

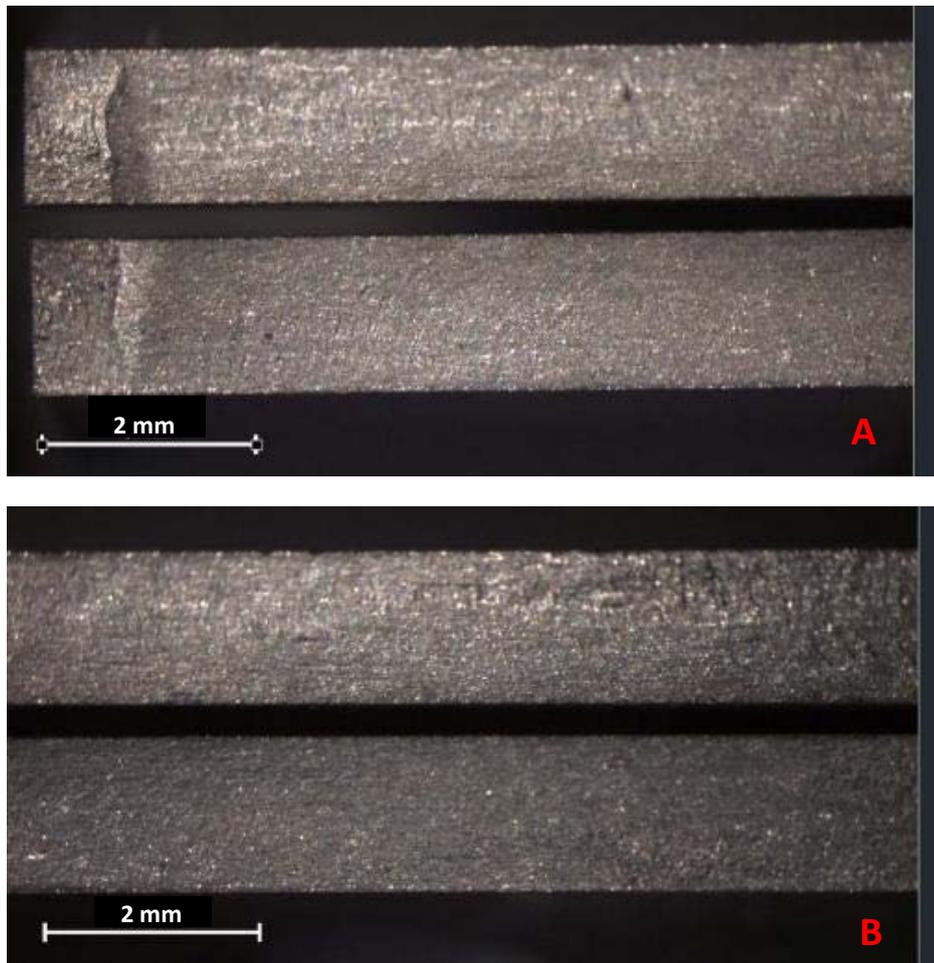
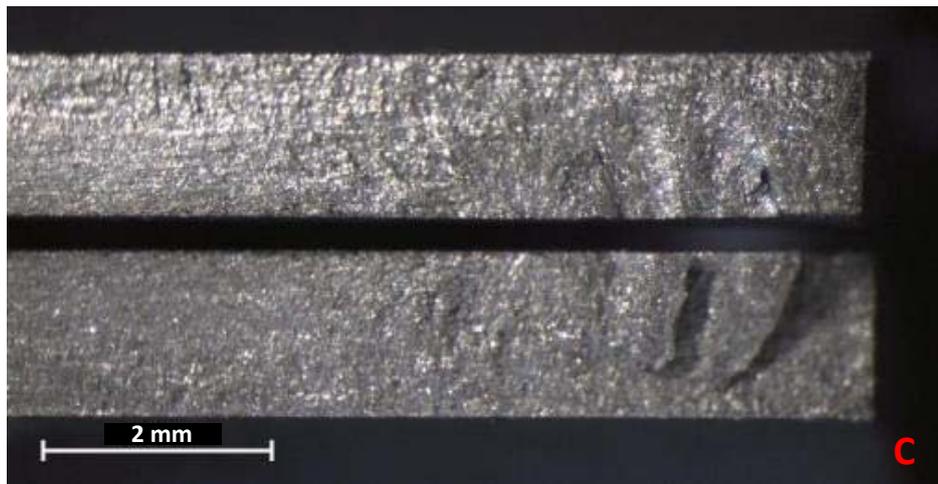
Figure 26: Fracture surface of the specimen of the 1st combined corrosion and fatigue experiment.

Image (A) of Figure 26 shows the beginning of the crack in the two segments resulting from the fracture of the sample. The waveform striations of fatigue are also visible. Image (B) shows the crack propagation, while image (C) shows the final brittle fracture. Figure 27 shows higher magnification images focusing on areas of interest.

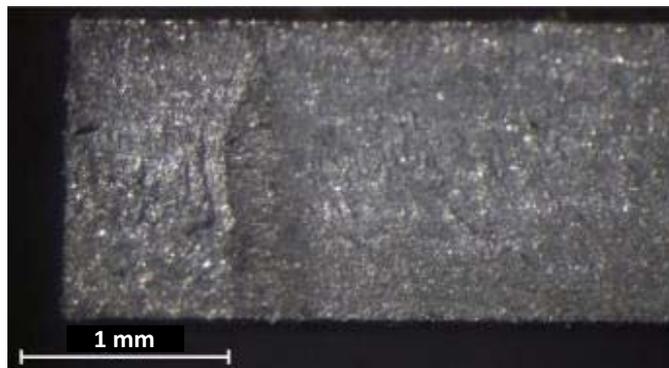
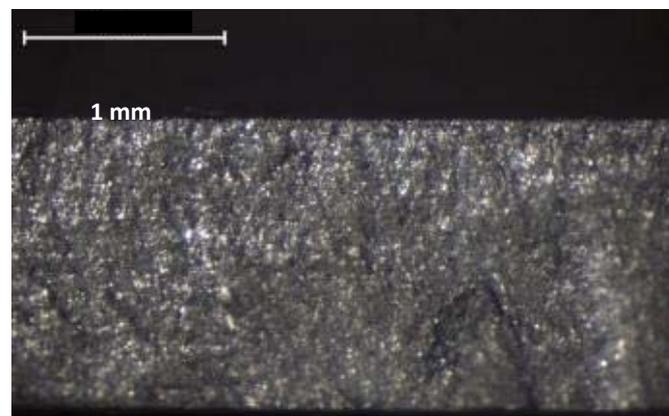
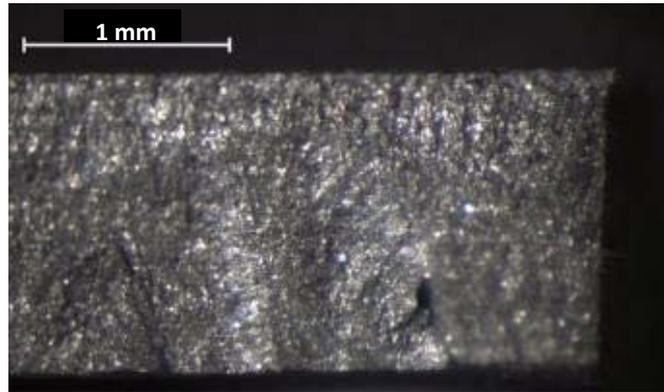
Figure 27: Fractured area of the specimen at higher magnification.

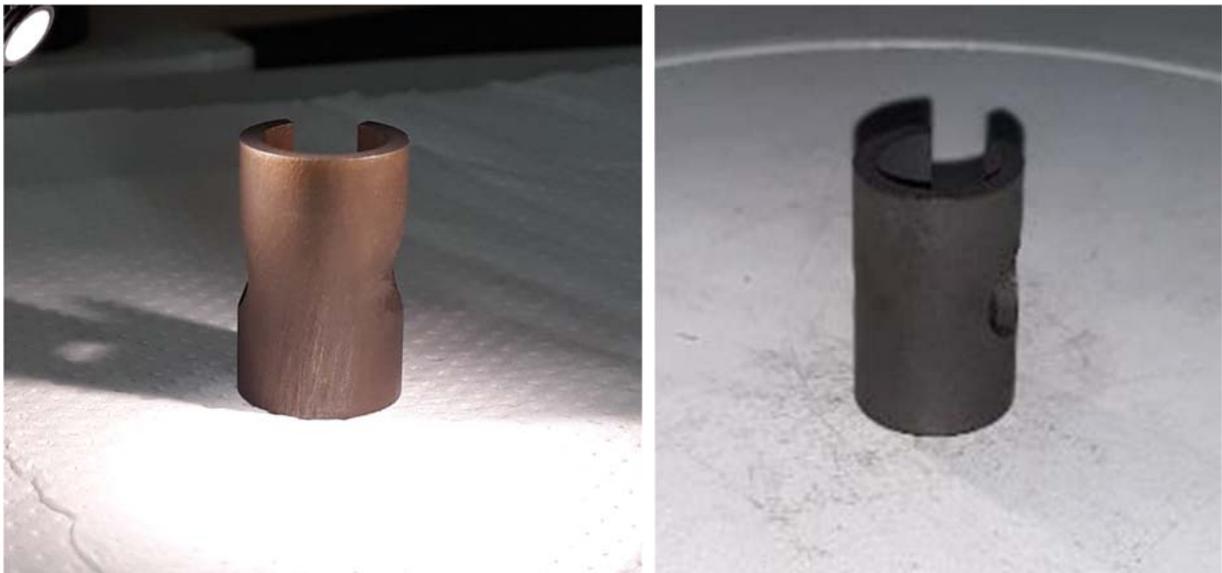
Figure 28: Change of the sample color after heat treatment (right) attributed to surface oxidation.

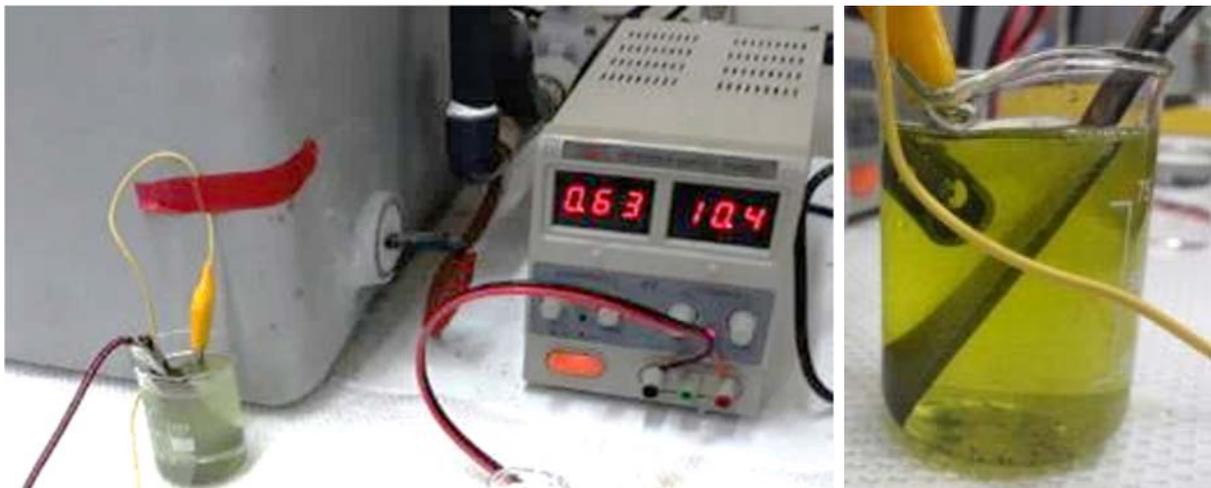
Figure 29: Electrochemical cleaning of NiTiHf specimen.

The removal of the outer oxide layer was performed by electrochemical cleaning to avoid the introduction of mechanical stresses which could lead to the formation of residual stresses,

microcracks and phase transformation. The electrochemical cleaning, as shown in Figure 29, was performed at a voltage of 10 V for 30 minutes with solution 80 v/v % acetic acid and 20 v/v % perchloric acid.

- Figure 28:** Change of the sample color after heat treatment (right) attributed to surface oxidation. (page 46)
- Figure 29:** Electrochemical cleaning of NiTiHf specimen. (page 47)

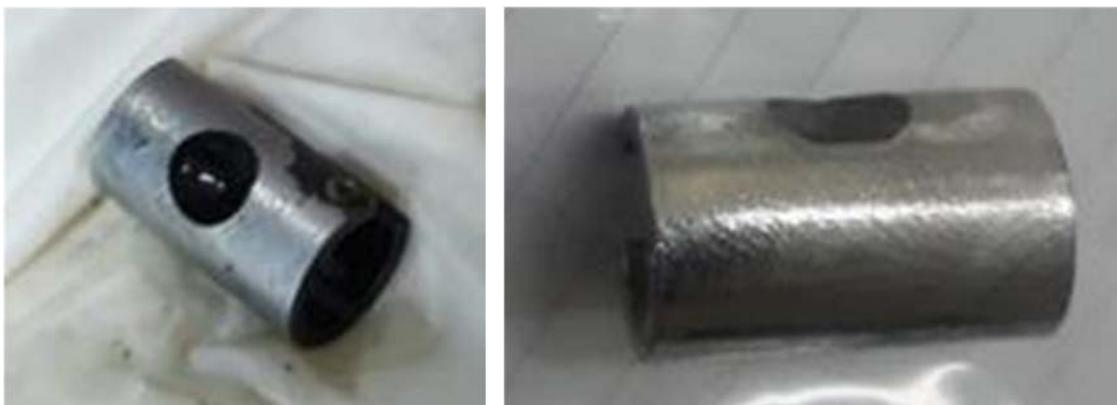
Figure 30: The specimen parent alloy which was revealed from electrochemical cleaning.

However, based on the reduced fatigue life of this specimen, there is a high possibility that the electrochemical cleaning may cause aggressive corrosion that degrades the mechanical strength. This assumption is confirmed by the fractographies that follow.

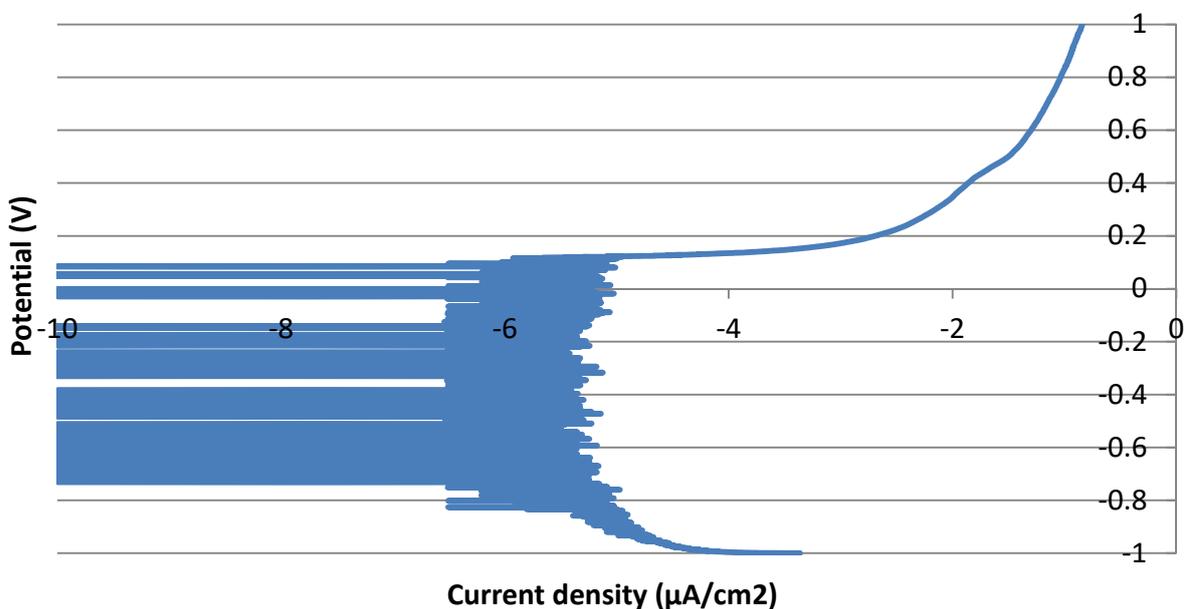
Diagram 20: Potentiodynamic curve in the unloaded state for the cleaned specimen.

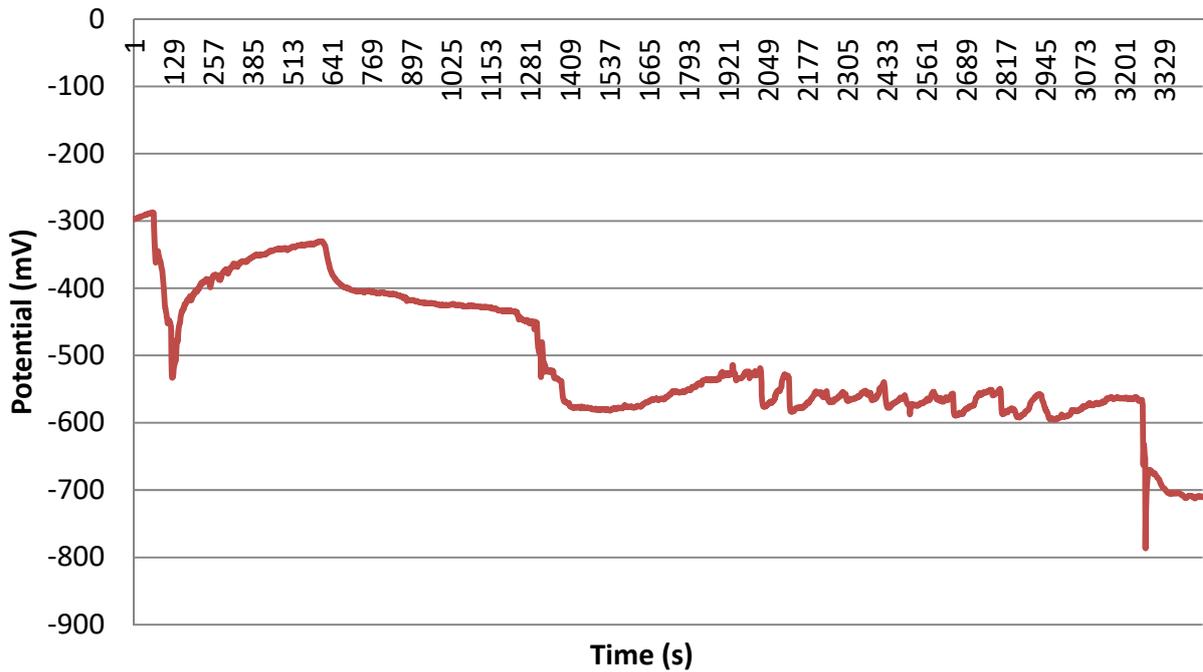
Diagram 21: Detection of open circuit potential and combined corrosion and fatigue test of the cleaned specimen.

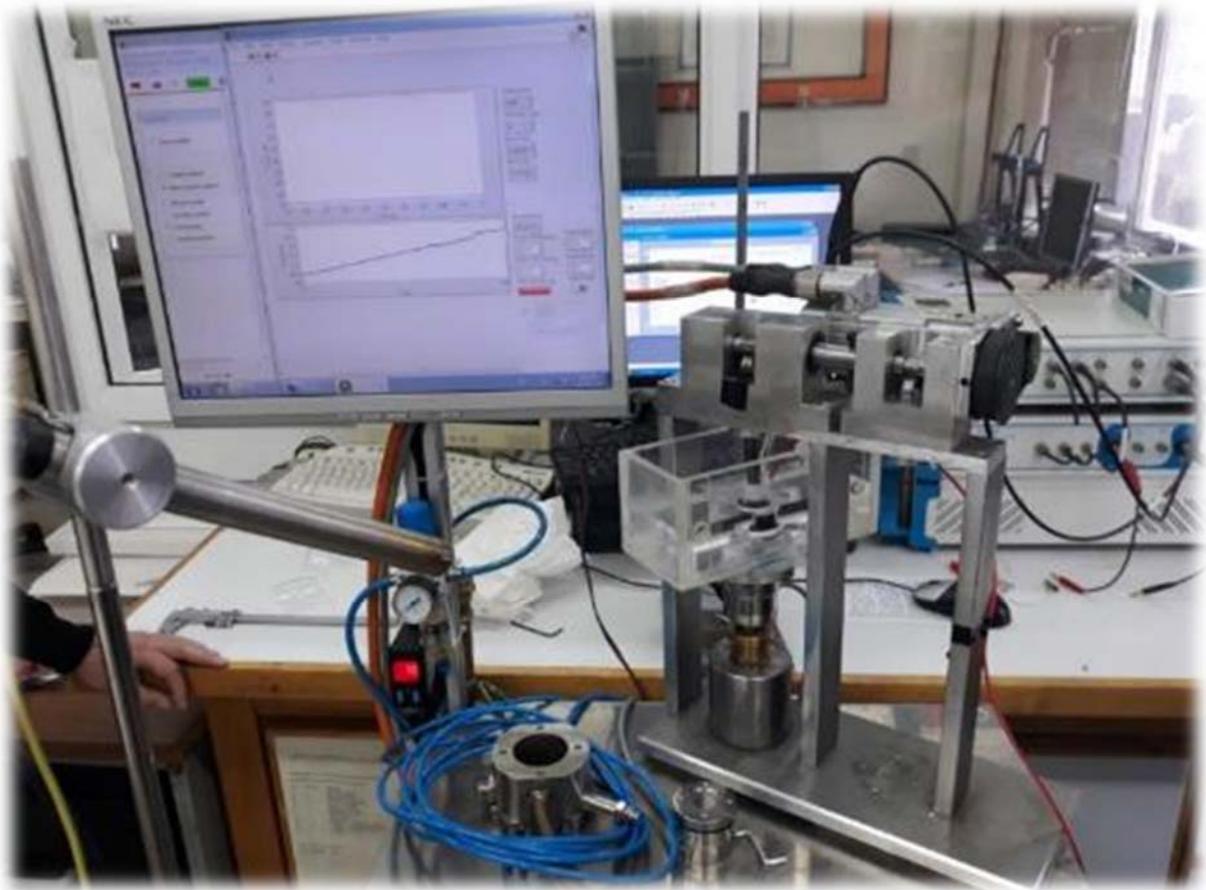
Figure 31: Experimental setup for the investigation of the corrosion-fatigue.

The combination of fatigue and corrosion devices for the next experiment is shown in the Figure 31.

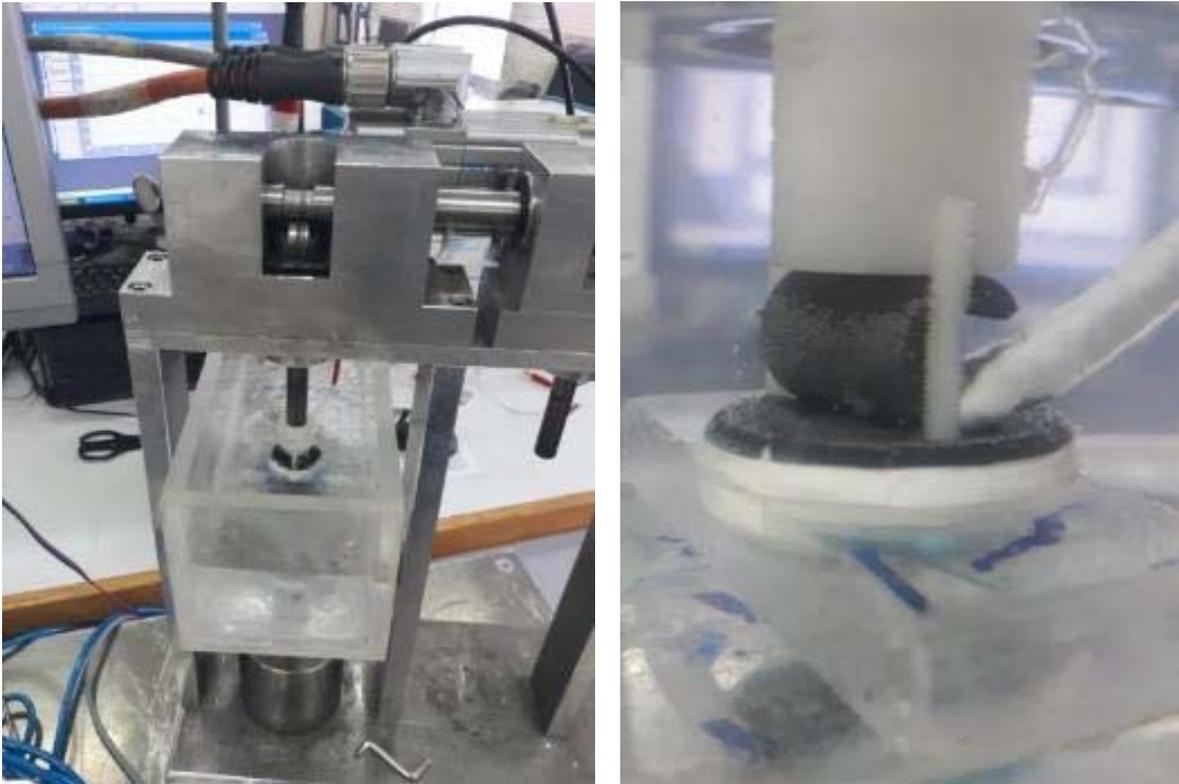
Figure 32: Electrical connection of the specimen and its holder in the fatigue device.

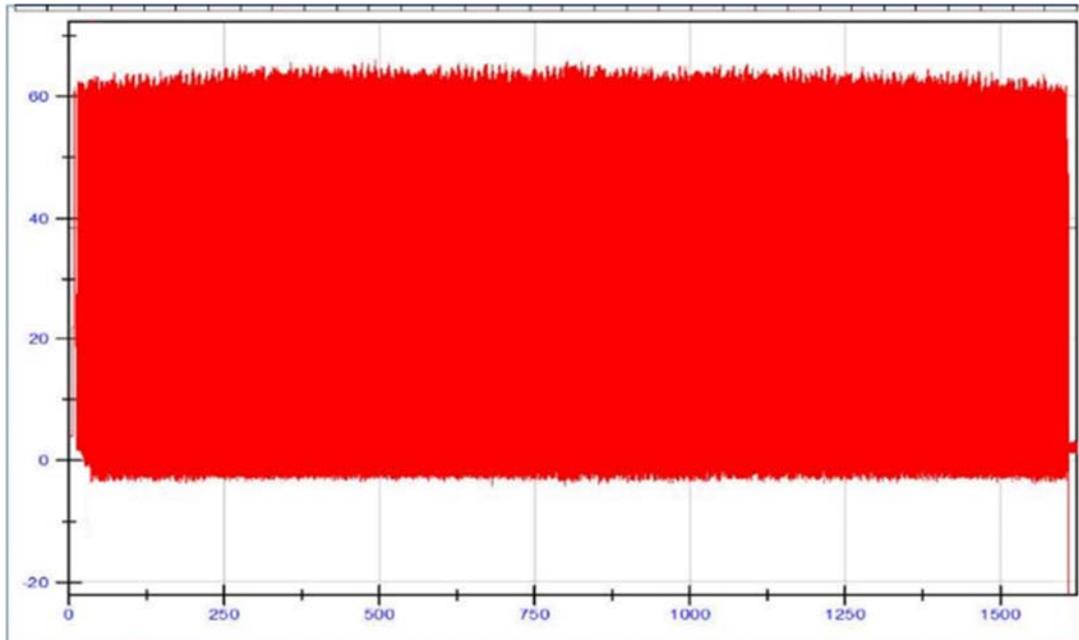
Diagram 22: Waveform of loading cycles for the cleaned specimen until fracture.

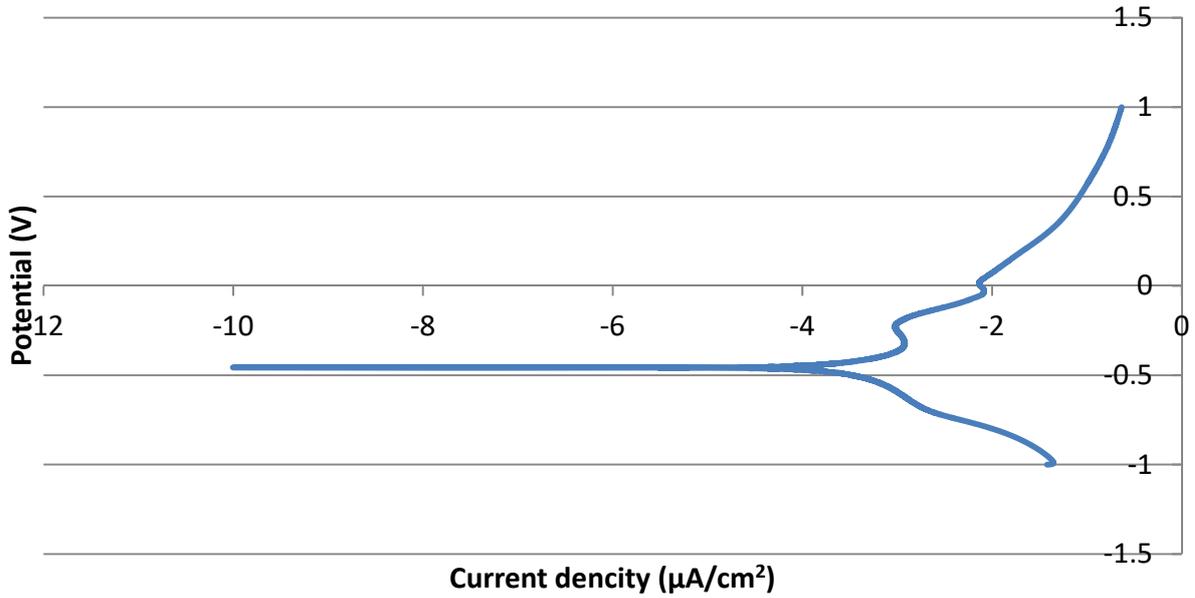
Diagram 23: Potentiodynamic curve in the unloaded state for the uncleaned specimen.

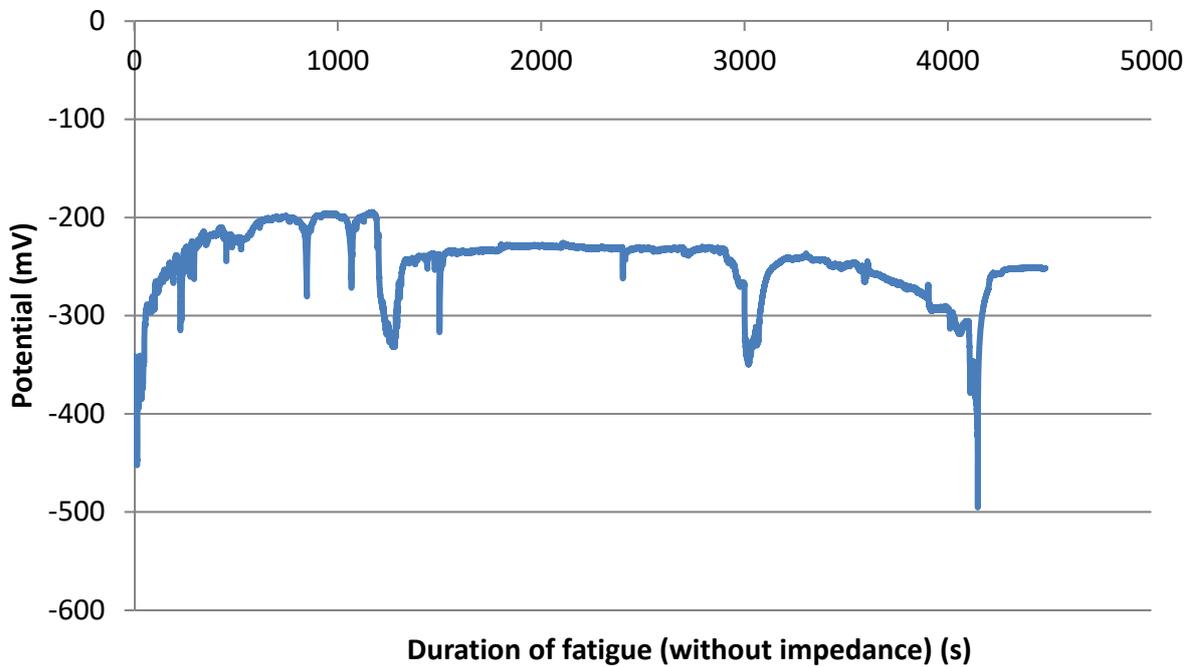
Diagram 24: Detection of open circuit potential and combined corrosion and fatigue test of uncleaned specimen.

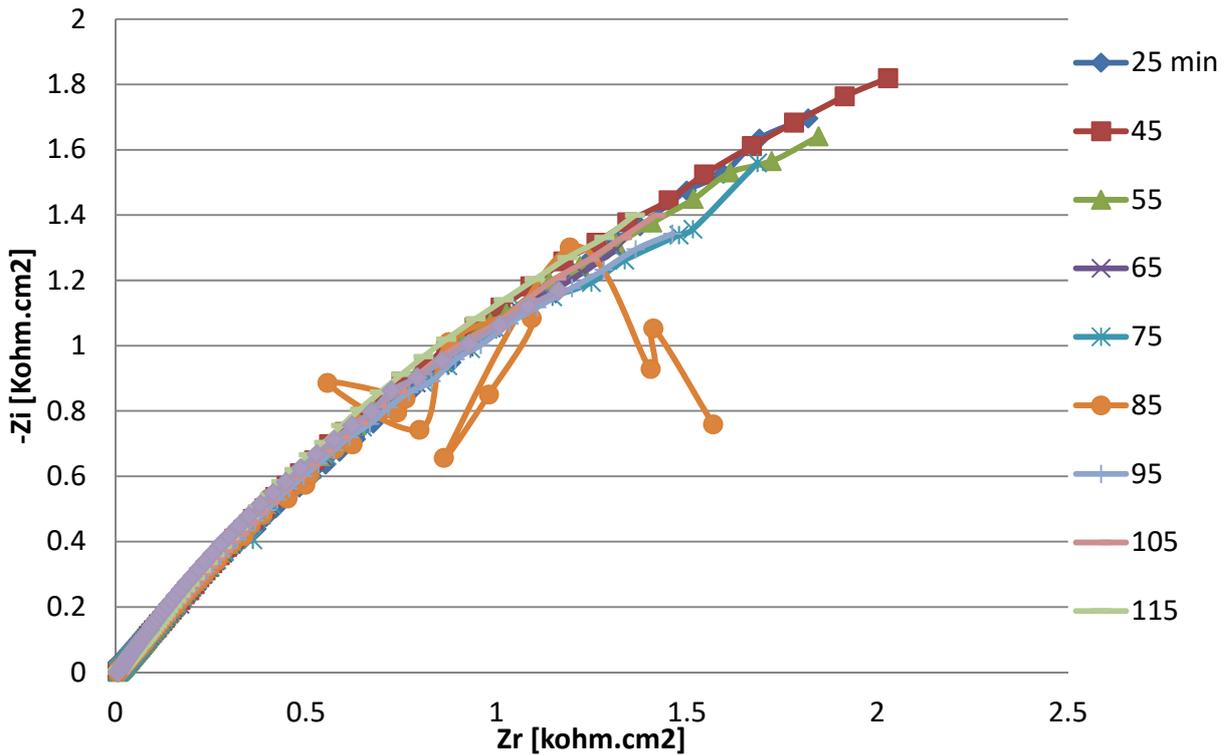
Diagram 25: Electrochemical impedance spectroscopy for the uncleaned specimen in unload state during fatigue experiment.

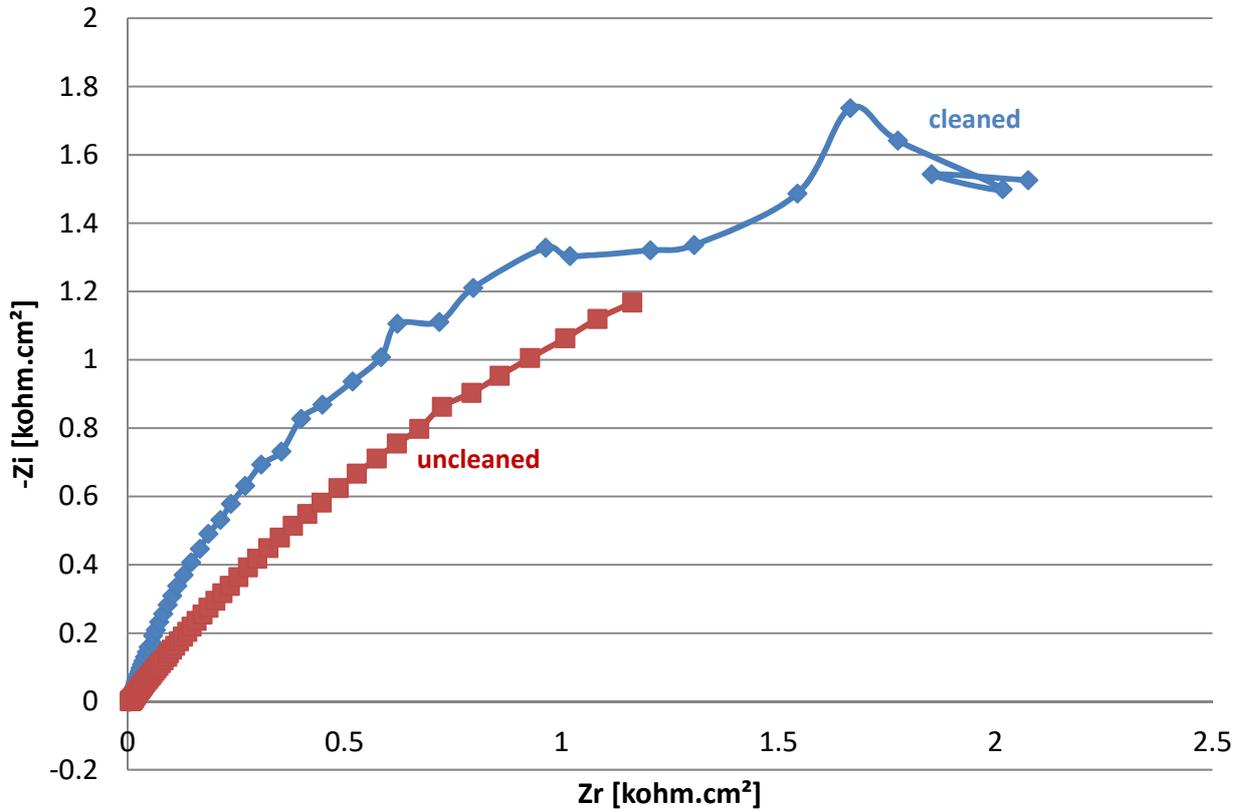
Diagram 26: Impedance comparison of the specimens after fracture.

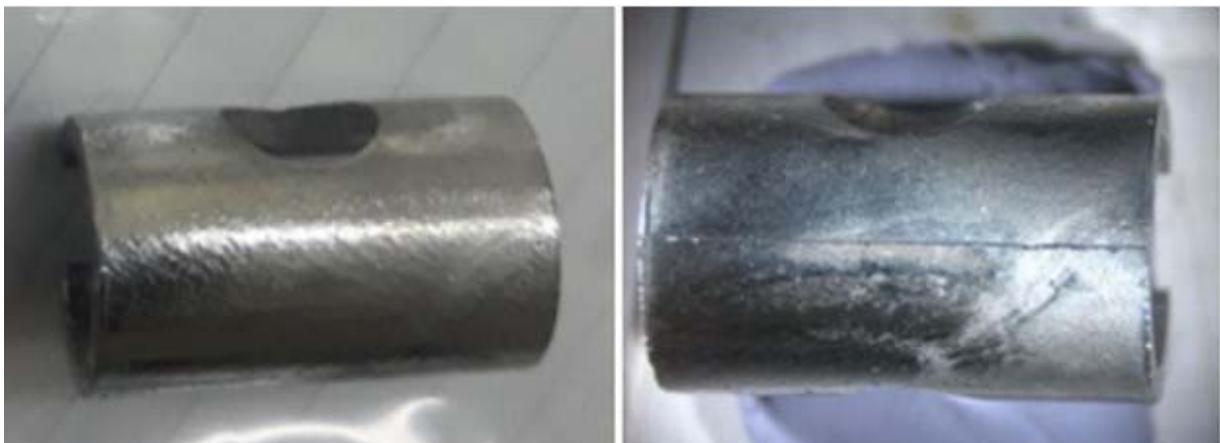
Figure 33: Outer surface of the cleaned specimen before and after the corrosion-fatigue experiment.

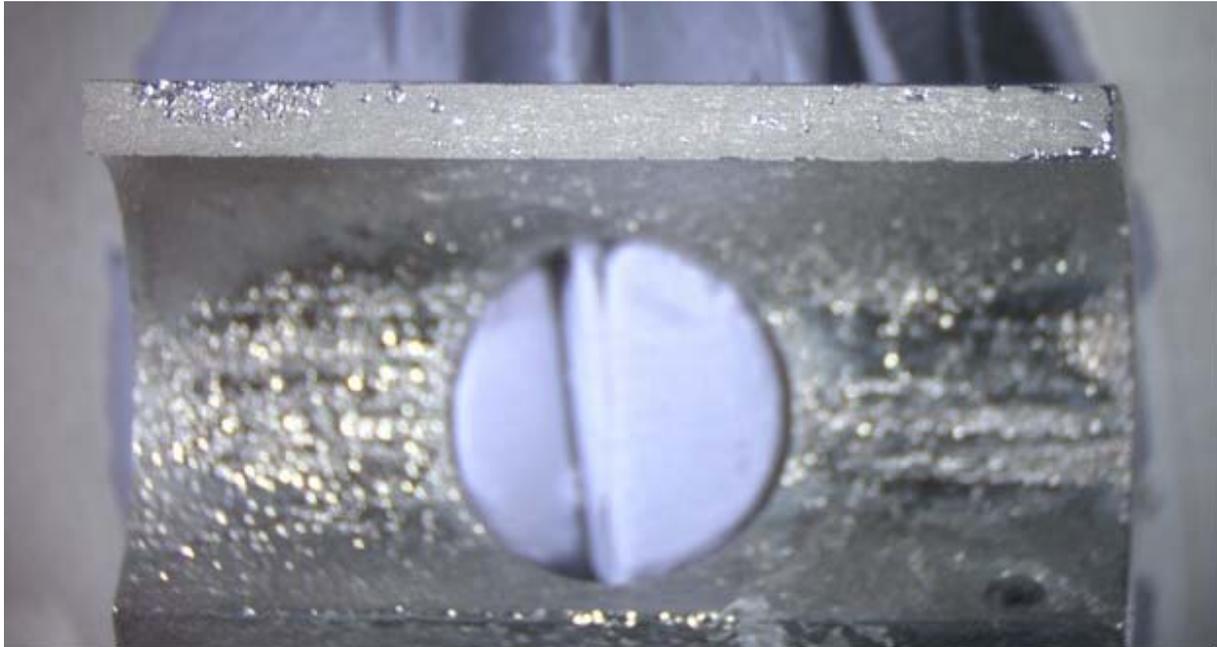
Figure 34: Fractured surface of the electrochemically cleaned specimen after the combined corrosion-fatigue and potentiodynamic polarization test.

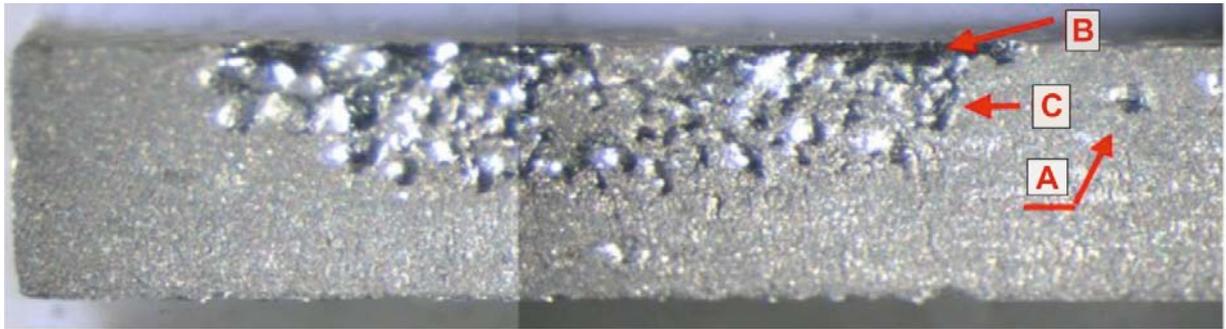
Figure 35: Crack start area where intense pitting corrosion can be observed in two directions.

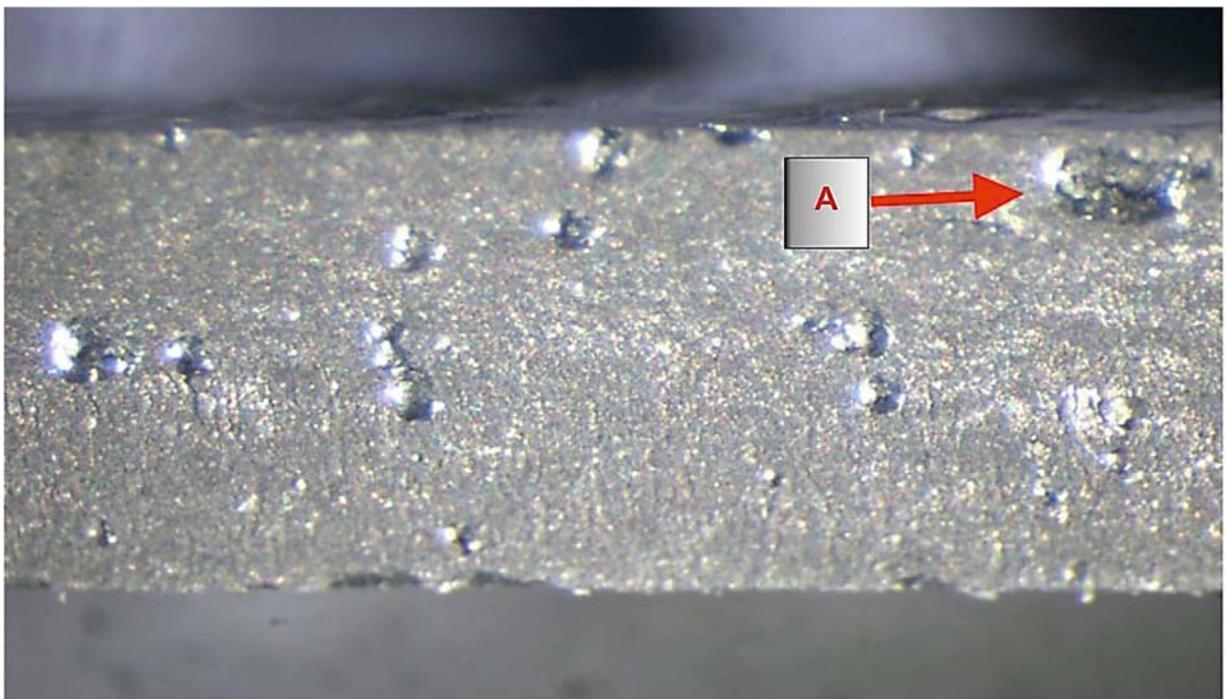
Figure 36: Surface of brittle fracture of electrochemically cleaned specimen, where pitting corrosion is evident.

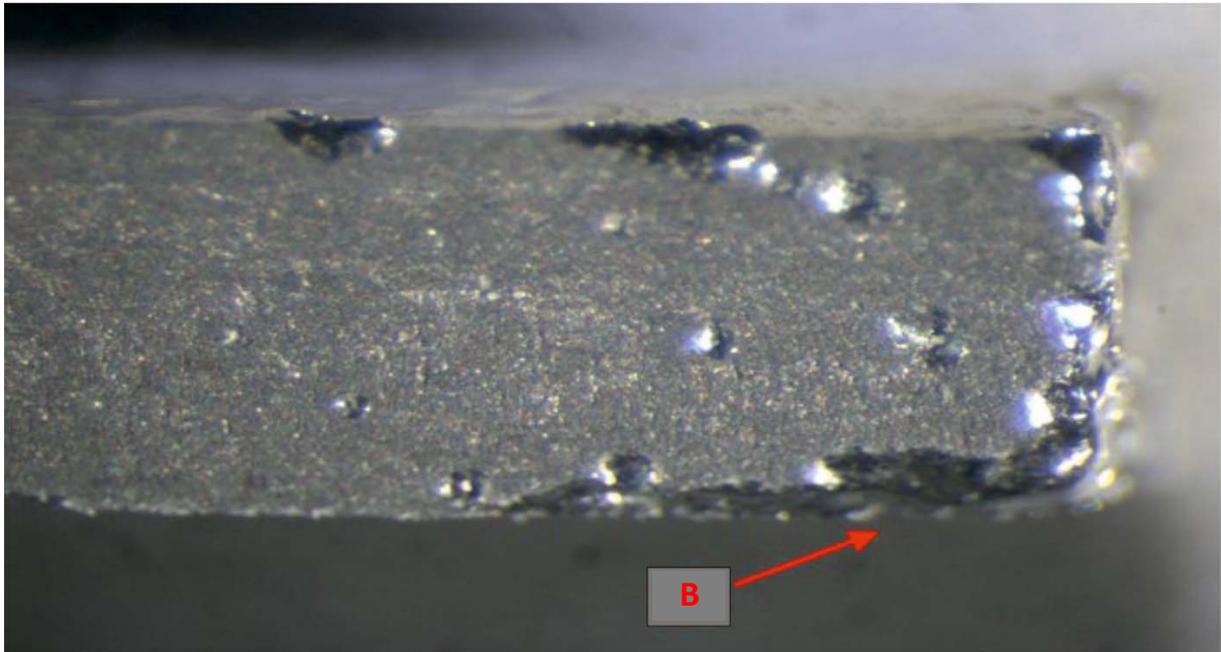
Figure 37: Area of extended surface corrosion of the electrochemically cleaned specimen.

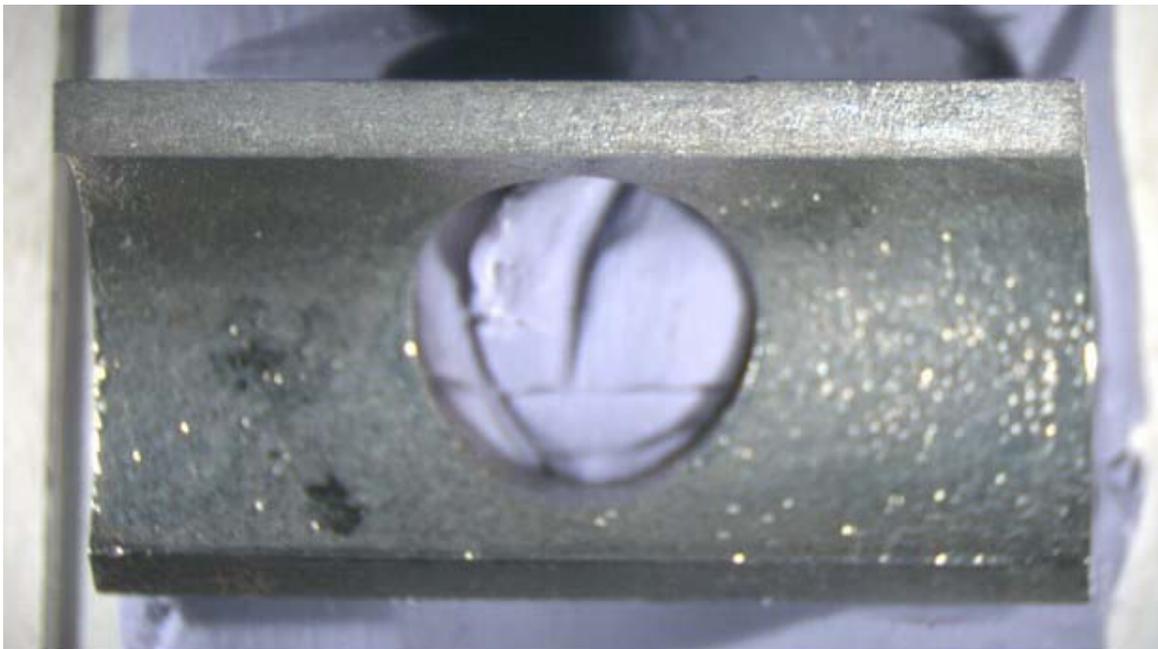
Figure 38: Fracture surface of electrochemically cleaned specimen after fatigue.

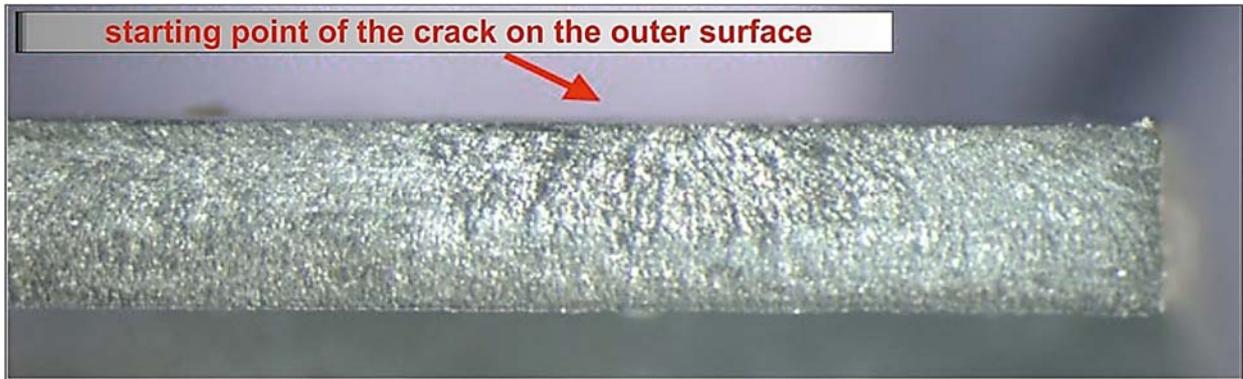
Figure 39: Starting point of the crack in the electrochemically cleaned specimen during combined corrosion-fatigue.

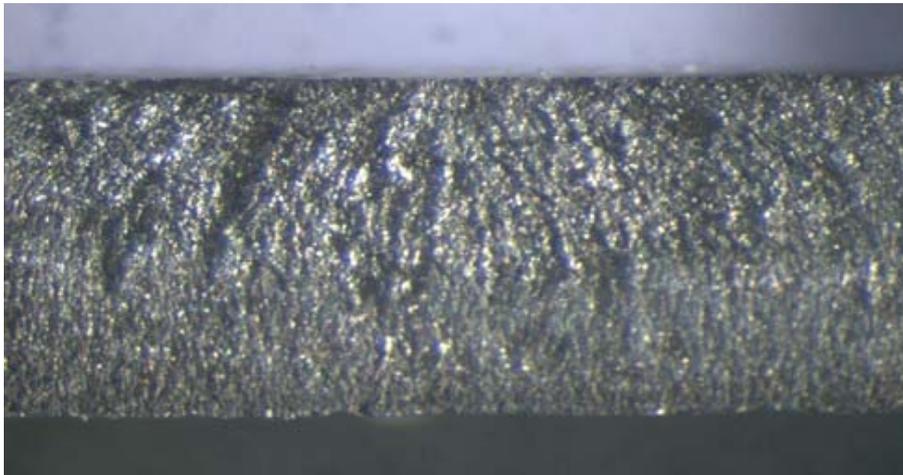
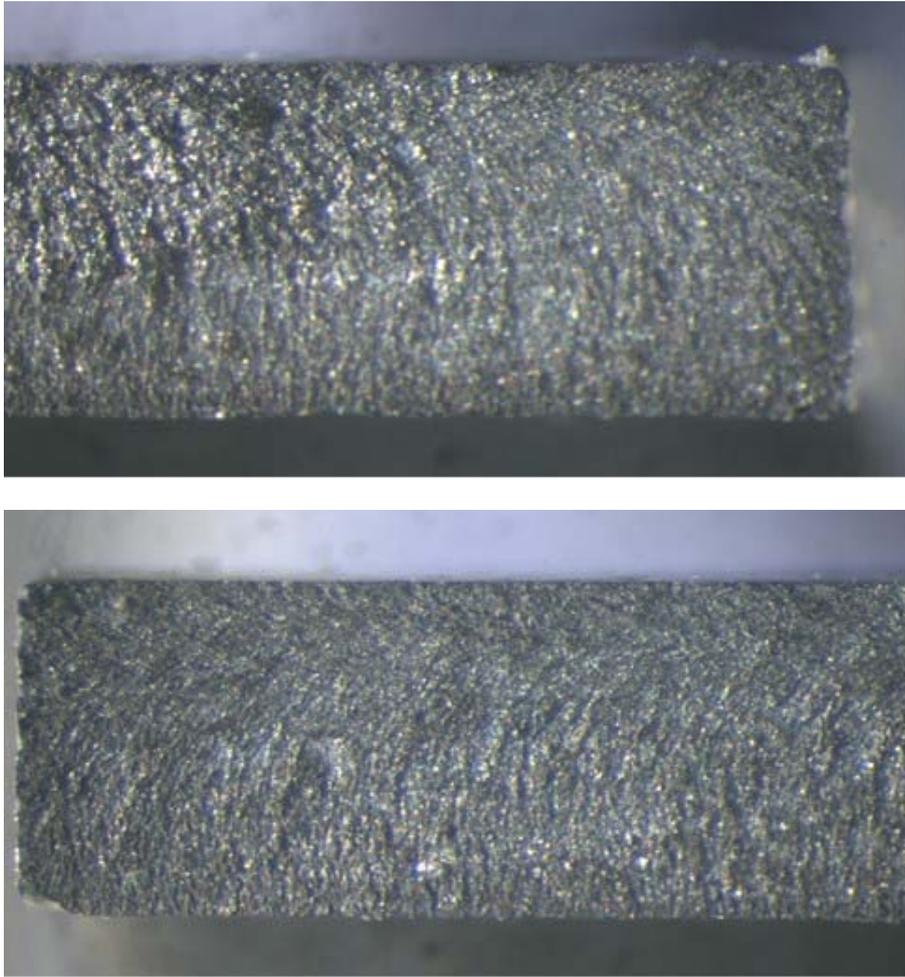
Figure 40: More detailed images of the crack starting point and propagation.

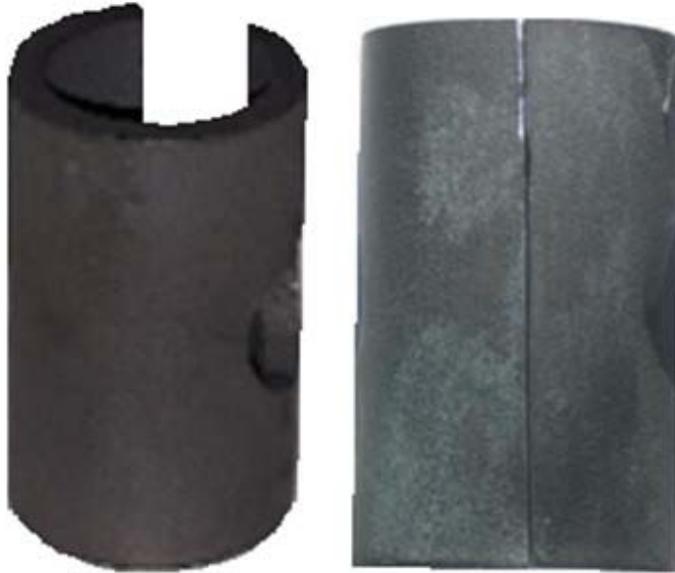
Figure 41: Outer surface of the uncleaned specimen before and after the combined corrosion and fatigue experiment.

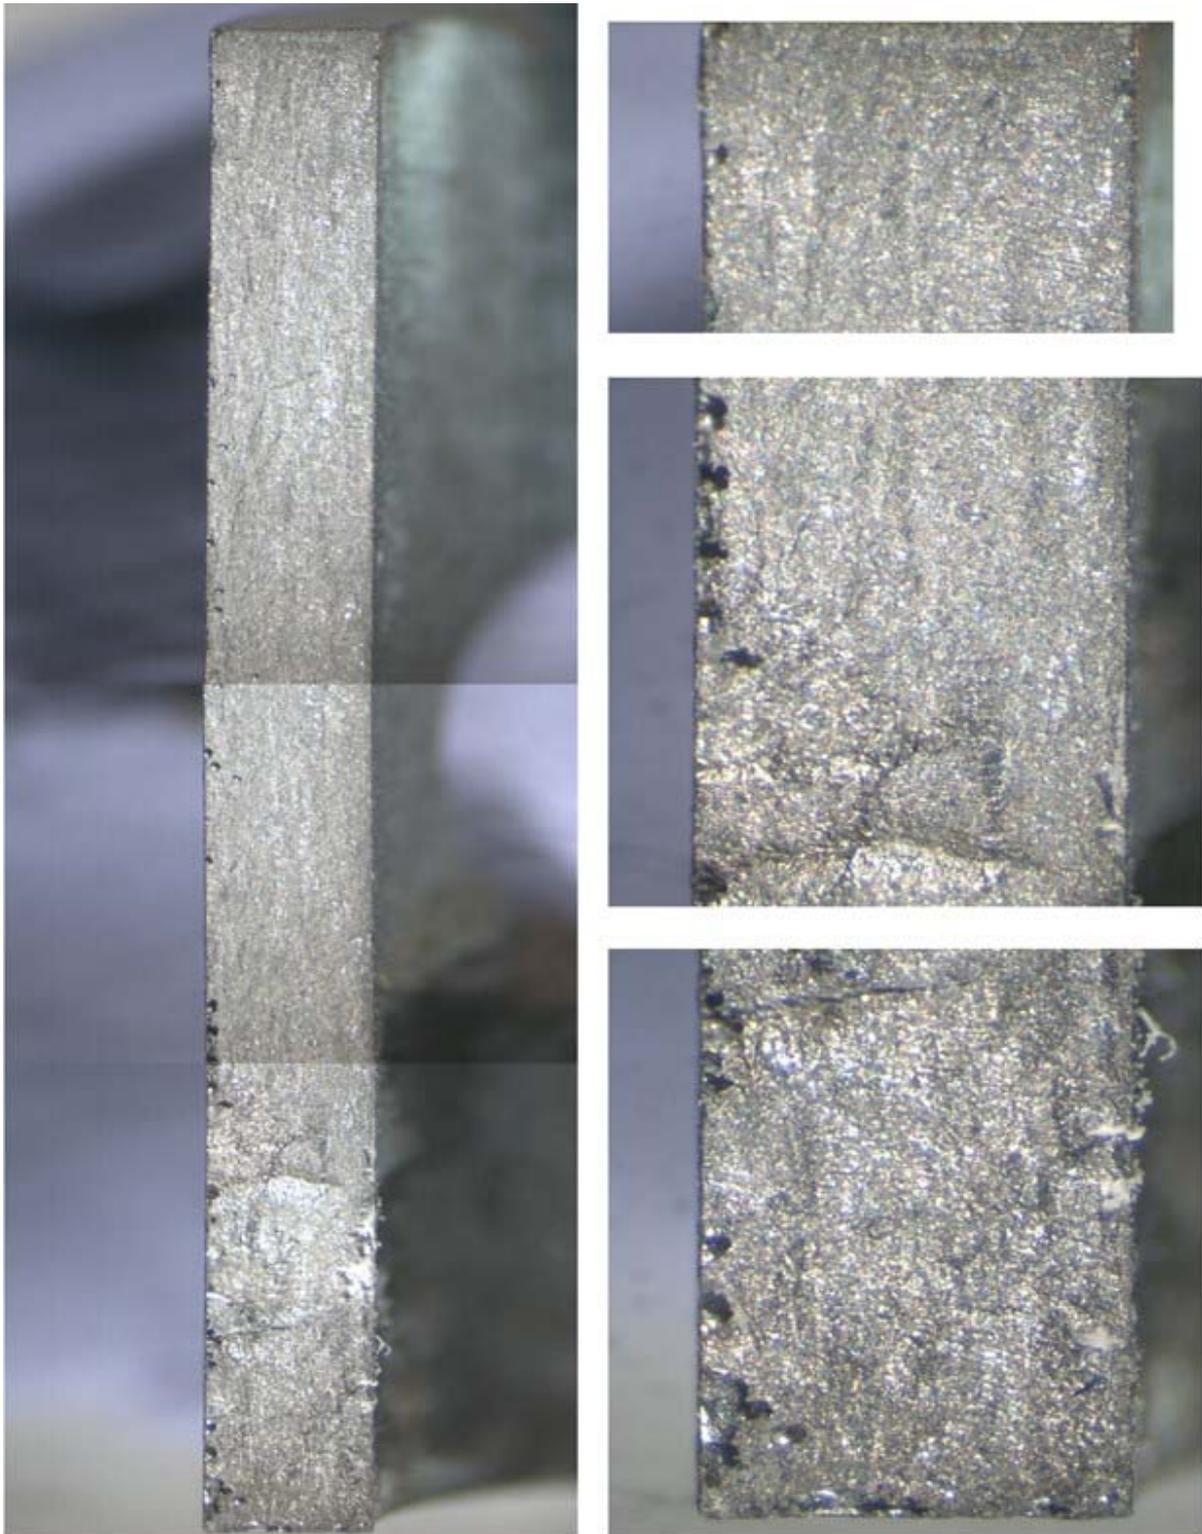
Figure 42: Fractured surface of the uncleaned specimen after the end of the potentiodynamic polarization.

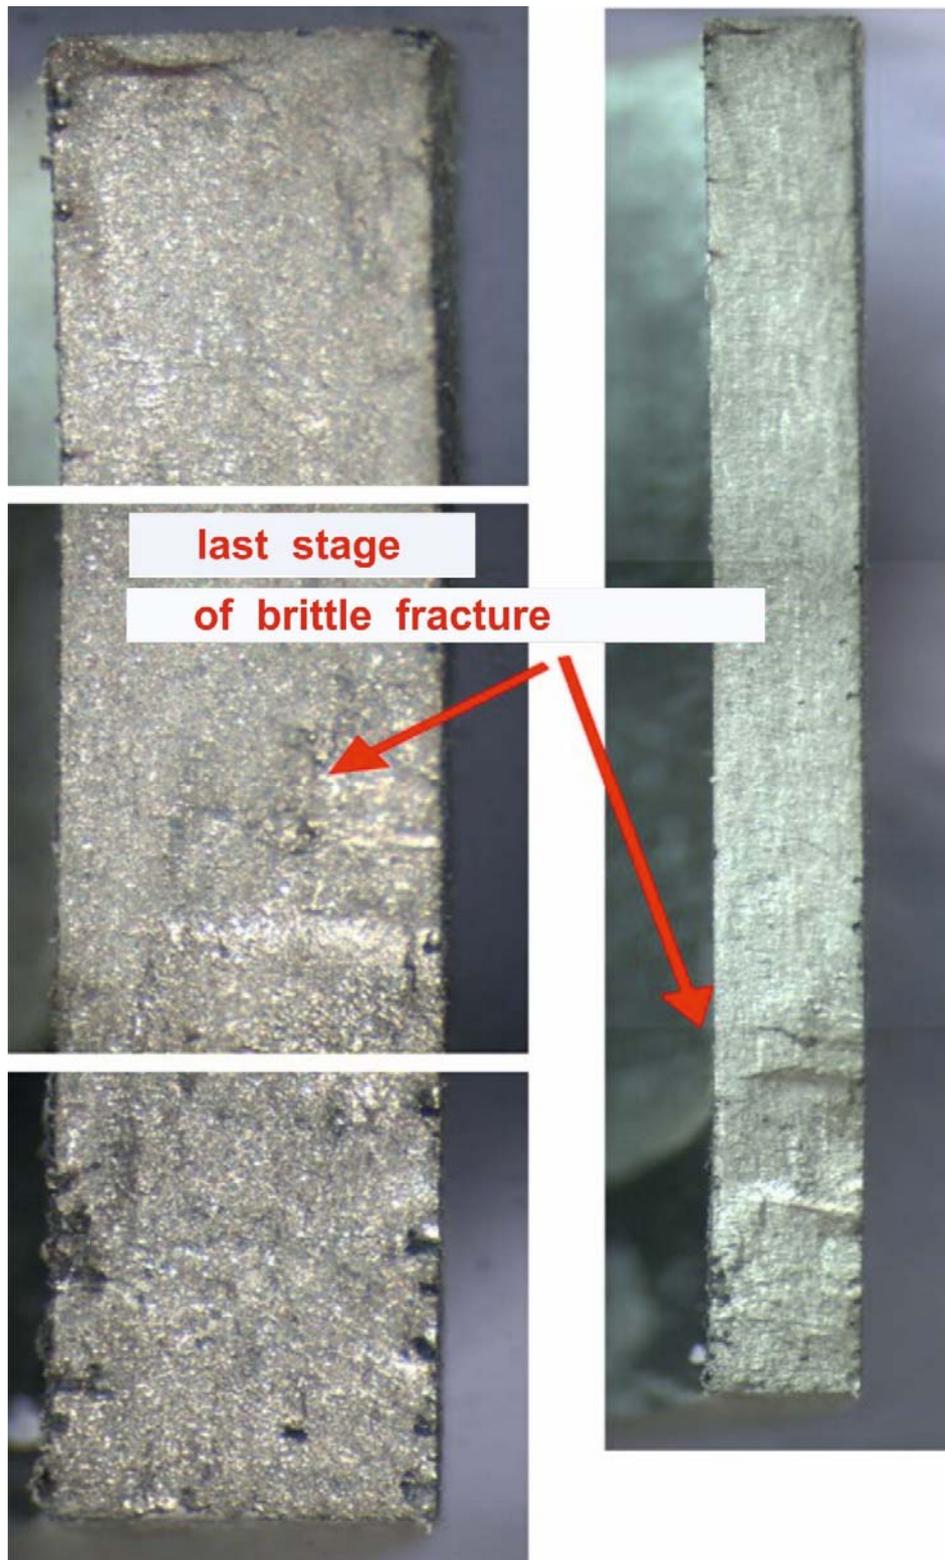
Figure 43: Fractures surface of the uncleaned specimen that which is not subjected to potentiodynamic polarization.
