NAVAL AIR WARFARE CENTER AIRCRAFT DIVISION  
PATUXENT RIVER, MARYLAND

# TECHNICAL INFORMATION MEMORANDUM

REPORT NO: NAWCADPAX/TR-2018/169

## EVALUATION OF AIRCRAFT PROTECTION EQUIPMENT

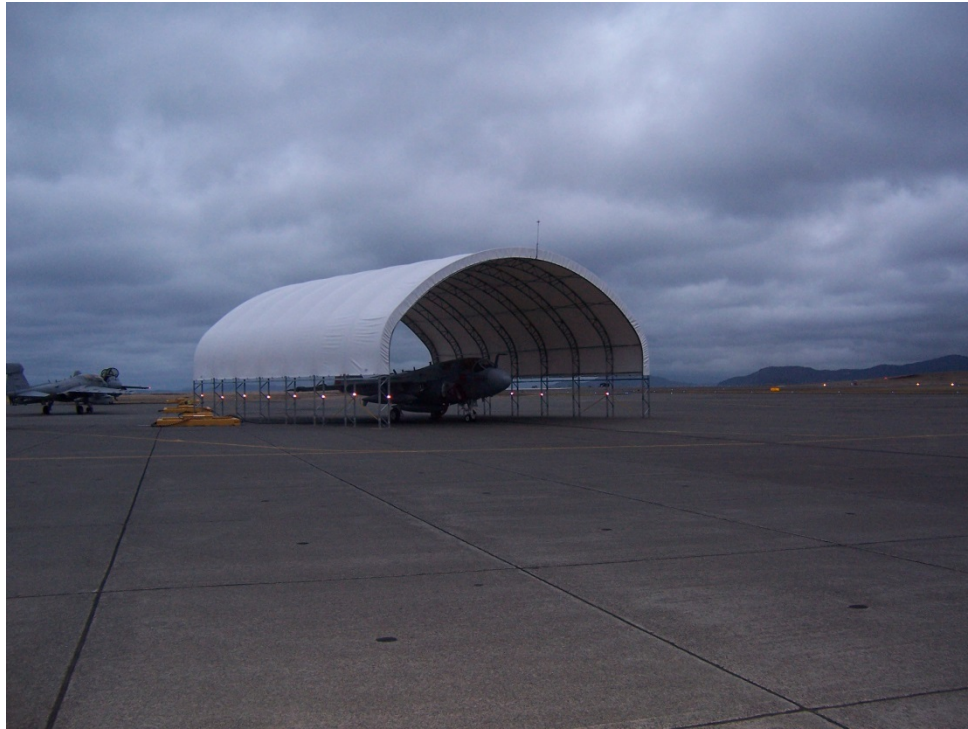
Figure 1: An EA-6B “Prowler” under a sunshade at NAS Whidbey Island, WA

WA. This is critical for the widespread authorization and implementation of these technologies for the fleet of aircraft in the Navy and Marine Corps. Some examples of APE used within the enterprise are shown in Figures 1, 2, and 3. Note that Figures 1 and 2 are of sites and aircraft studied under the program, while Figure 3 is included to demonstrate the minor variability in the appearance of the sunshades.

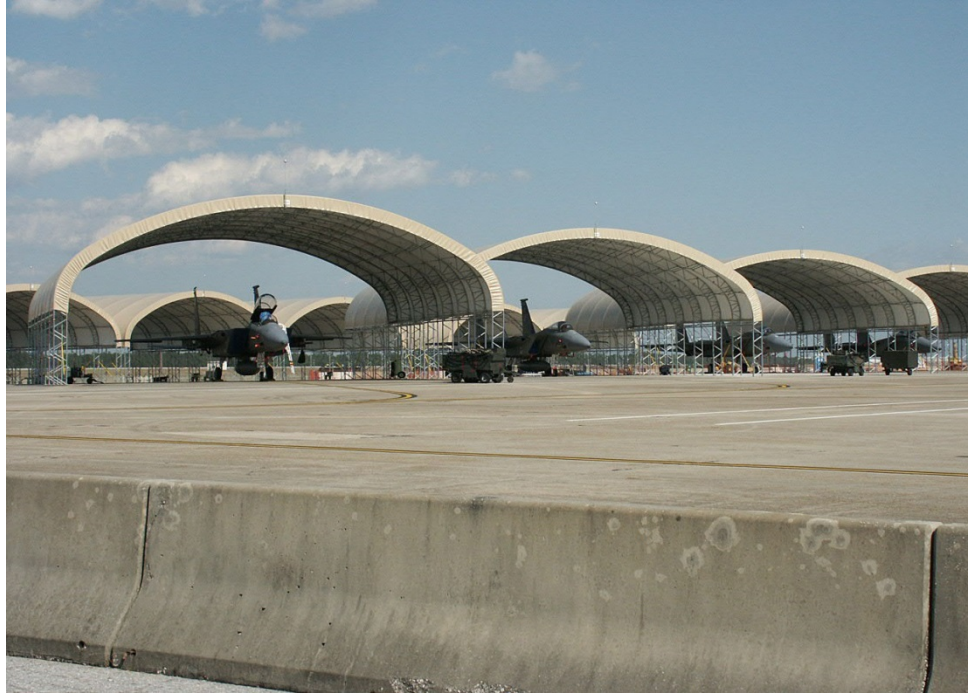
Figure 2: Four side-by-side FA-18 “Super Hornets” under sunshades at NAS Oceana, VA.

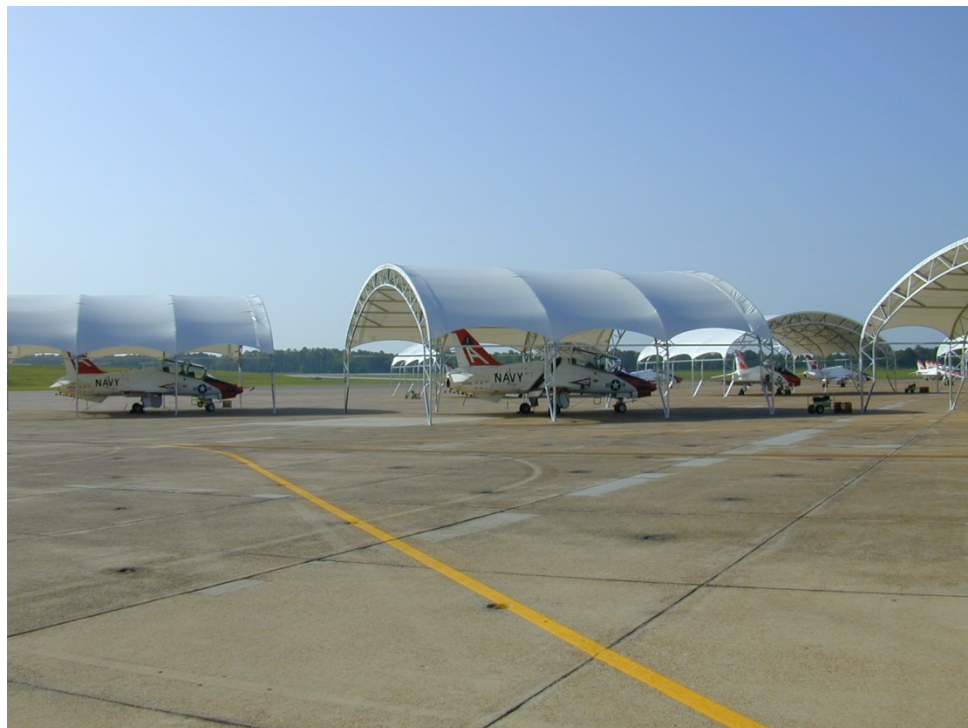
Figure 3: Multiple T-45 “Goshawks” at NAS Meridian, MS. Note. The T-45 was not studied under the program; images are presented here to show the variation in APE construction.

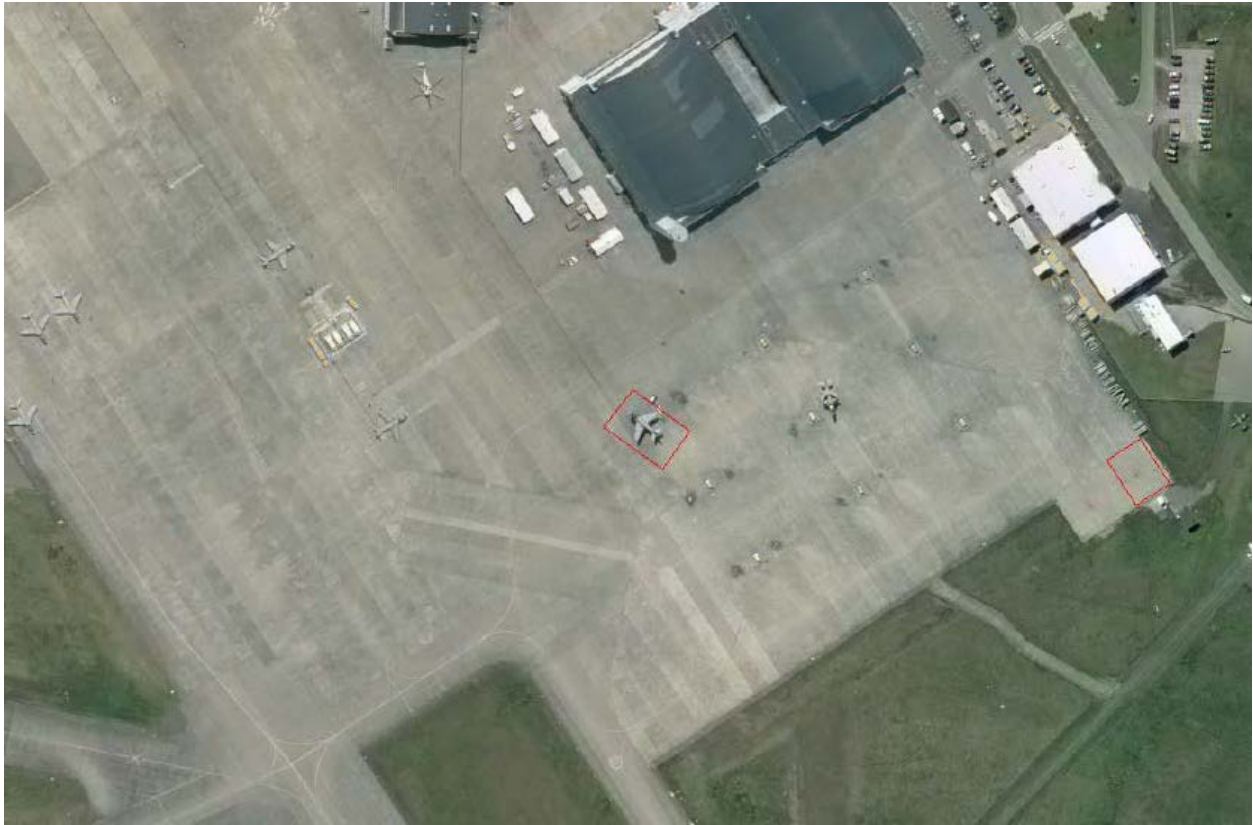
Figure A2: NAS Whidbey Island Site View (Aerial View of Shelter Locations, Enclosed in Red)

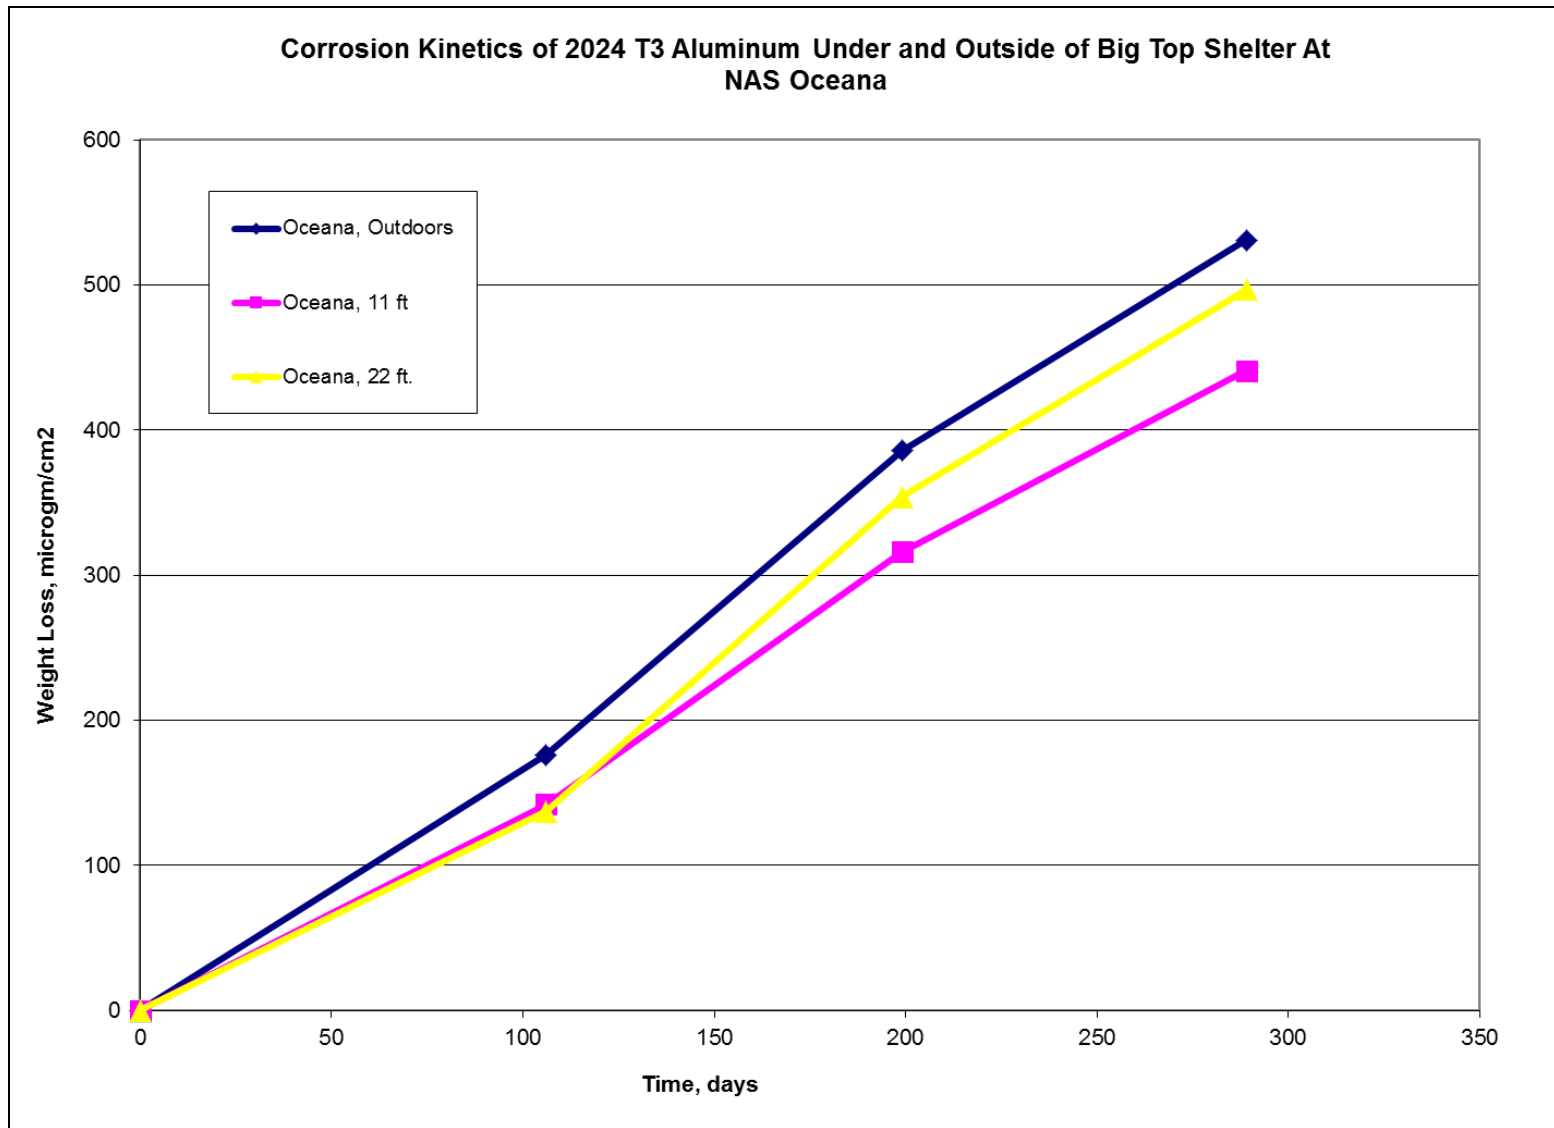
Figure B1: NAS Oceana Corrosion of 2024 T3 Aluminum.

Comparing the Absolute mass loss data from NAS Oceana for different storage conditions, there appears to be a minor reduction in corrosion rate due to storage under the sunshade. Some seasonal effects were noted when analyzing the incremental mass loss data. During the 93-day

period between data collection points 1 and 2, conditions actually contributed to slightly higher corrosion rates at the 22-foot height under the shelter relative to the exposed condition, and the specimens at the 11-foot height condition exhibited the least corrosion.

Knowledge of weather patterns at NAS Oceana is useful in predicting how the sunshade is affecting the corrosion rate. NAS Oceana is located within a “humid subtropical” weather zone, characterized by mild winters and hot, humid summers. Thus, we speculate that there are intermittent periods of rain and thunderstorms in the summer, followed by extensive sunny periods. Further, the condition of wetting caused by thunderstorms and salt spray followed by drying due to sun and wind exposure contributes to higher corrosion rates for exposed coupons. This is due to a combination of the increase of the salt concentration as the surface dries and the localization of the wet film as the surface area decreases due to drying. Thus, one should expect high rates of corrosion during seasons that are rainy, followed by conditions amenable to drying. A specimen that is under a sunshade, and, thus, never exposed to the rain may not experience a high wetness condition, and, thus, the rapid rate of corrosion is not witnessed.

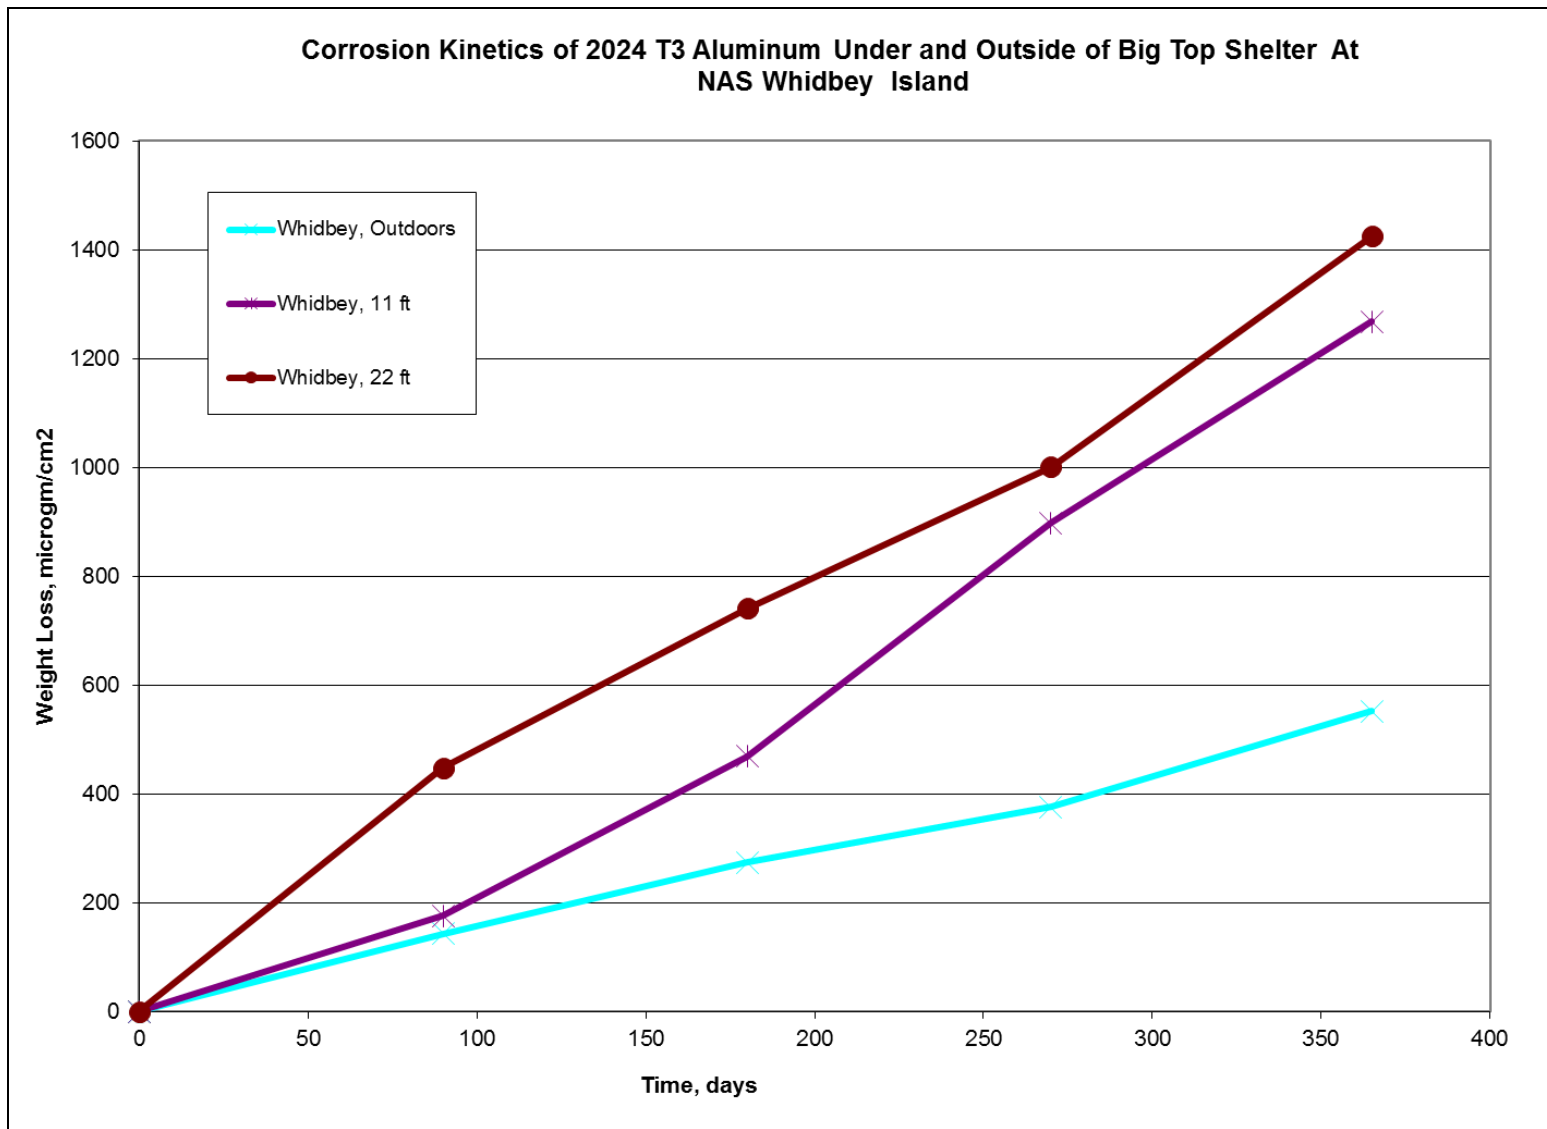
Figure B2: NAS Whidbey Island Corrosion of 2024 T3 Aluminum.

For data from NAS Whidbey Island, the specimens exposed to the elements outside of the sunshade actually exhibited less corrosion than the specimens under the sunshade both when analyzed absolutely and incrementally. Mass loss during the initial 90 day period for specimens exposed and 11-feet under the sunshade were relatively similar (143 ug/cm<sup>2</sup> versus 176 ug/cm<sup>2</sup>); however, for the 90 days between the 180-day and 270-day sampling points, the difference was more pronounced (102 ug/cm<sup>2</sup> compared to 429 ug/cm<sup>2</sup>). This demonstrates the effect that seasonal variation may have on corrosion rates and the role of the shelters.

Likewise, the climate at NAS Whidbey Island is classified as “oceanic” or “temperate marine”, which is exhibited through weather patterns of cool, wet winters and mild, relatively dry summers. In this case, our speculation is that high rates of rainfall keeps the surface of an exposed specimen “wet”, but that it also reduces the concentration of the electrolyte, which reduces the rate of corrosion. In a protected condition, such as under a sunshade, there is no precipitation of diluting salt deposits, and, instead, the most important factor is the humidity of the air. Thus, if the humidity in the air stabilizes around the humidity at which a salt converts from non-hygroscopic to hygroscopic, the surface is constantly in a wetting and drying phase. When the surface is in the drying phase as the electrolyte film is concentrating and localizing, as discussed earlier, it is expected that the corrosion rate will increase. For these reasons, the conditions under the sunshade may be more corrosive at NAS Whidbey Island.

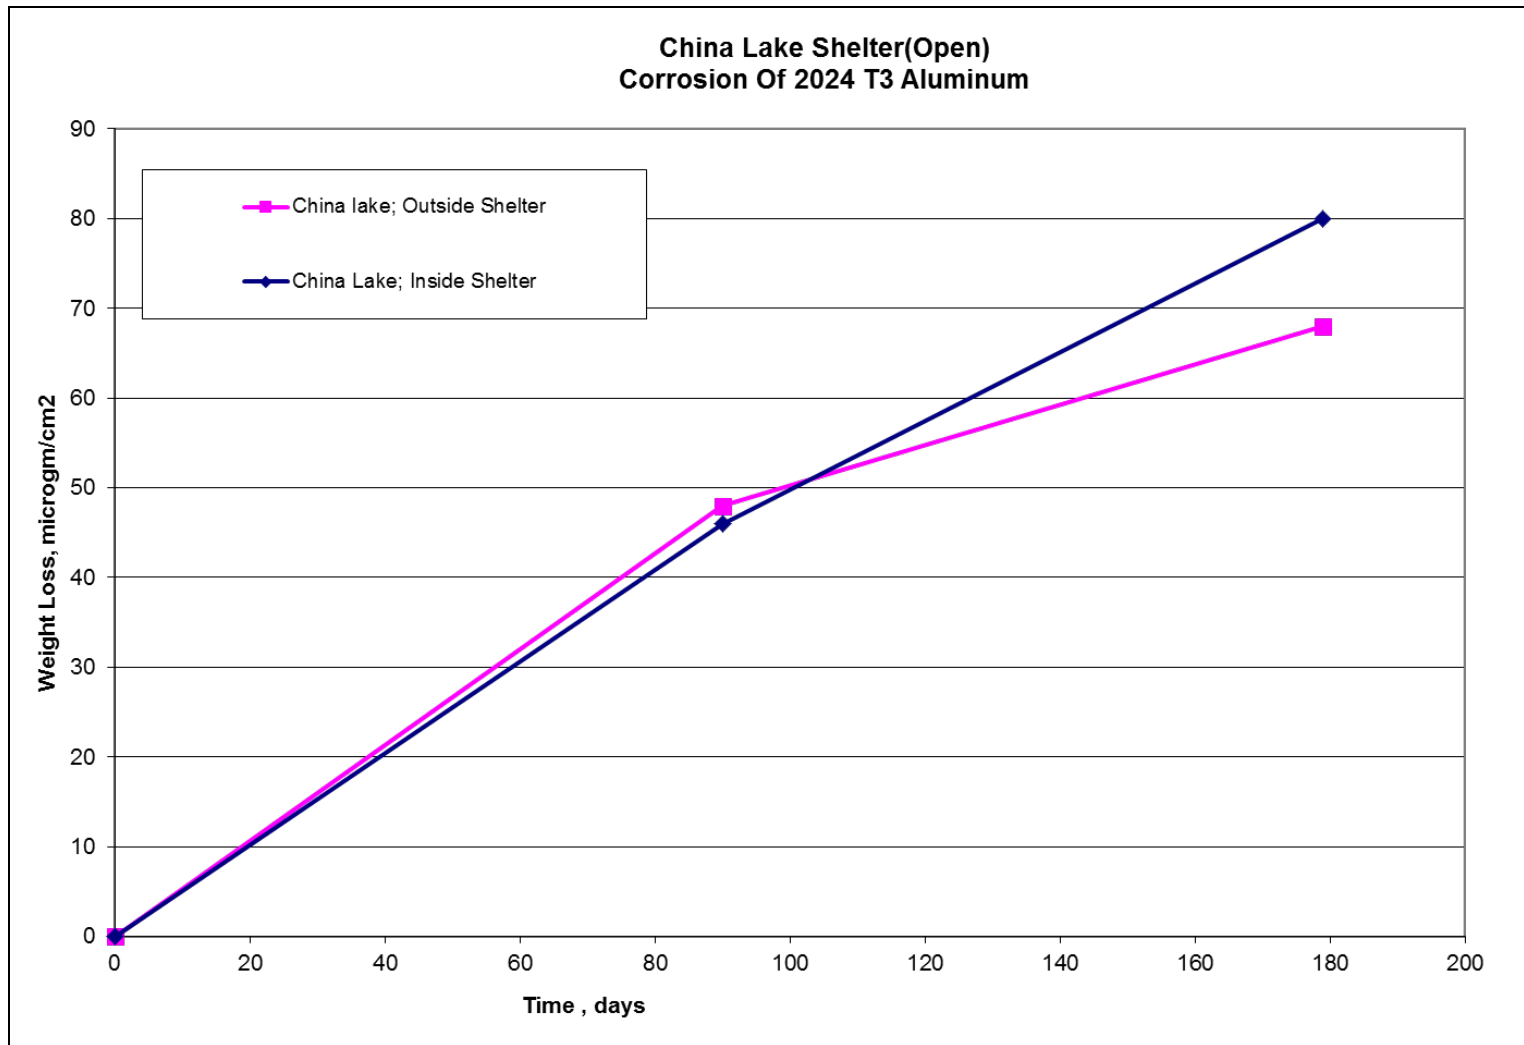
Figure B3: NAS China Lake Corrosion of 2024 T3 Aluminum.

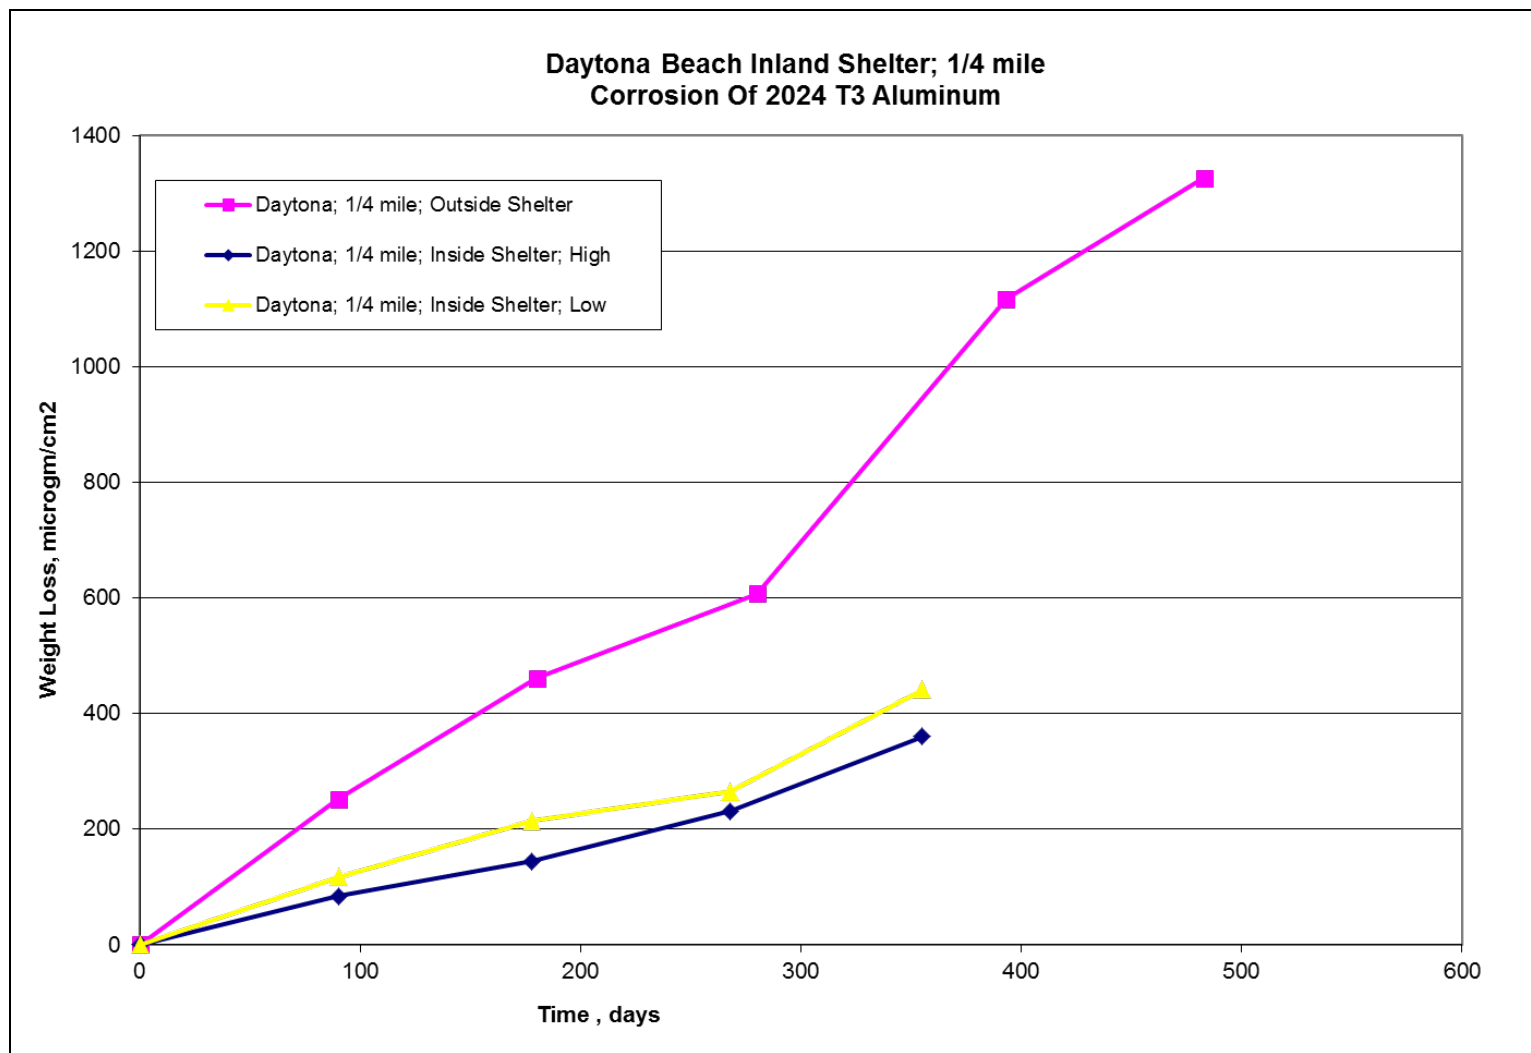
Figure B4: Daytona Beach Corrosion of 2024 T3 Aluminum.

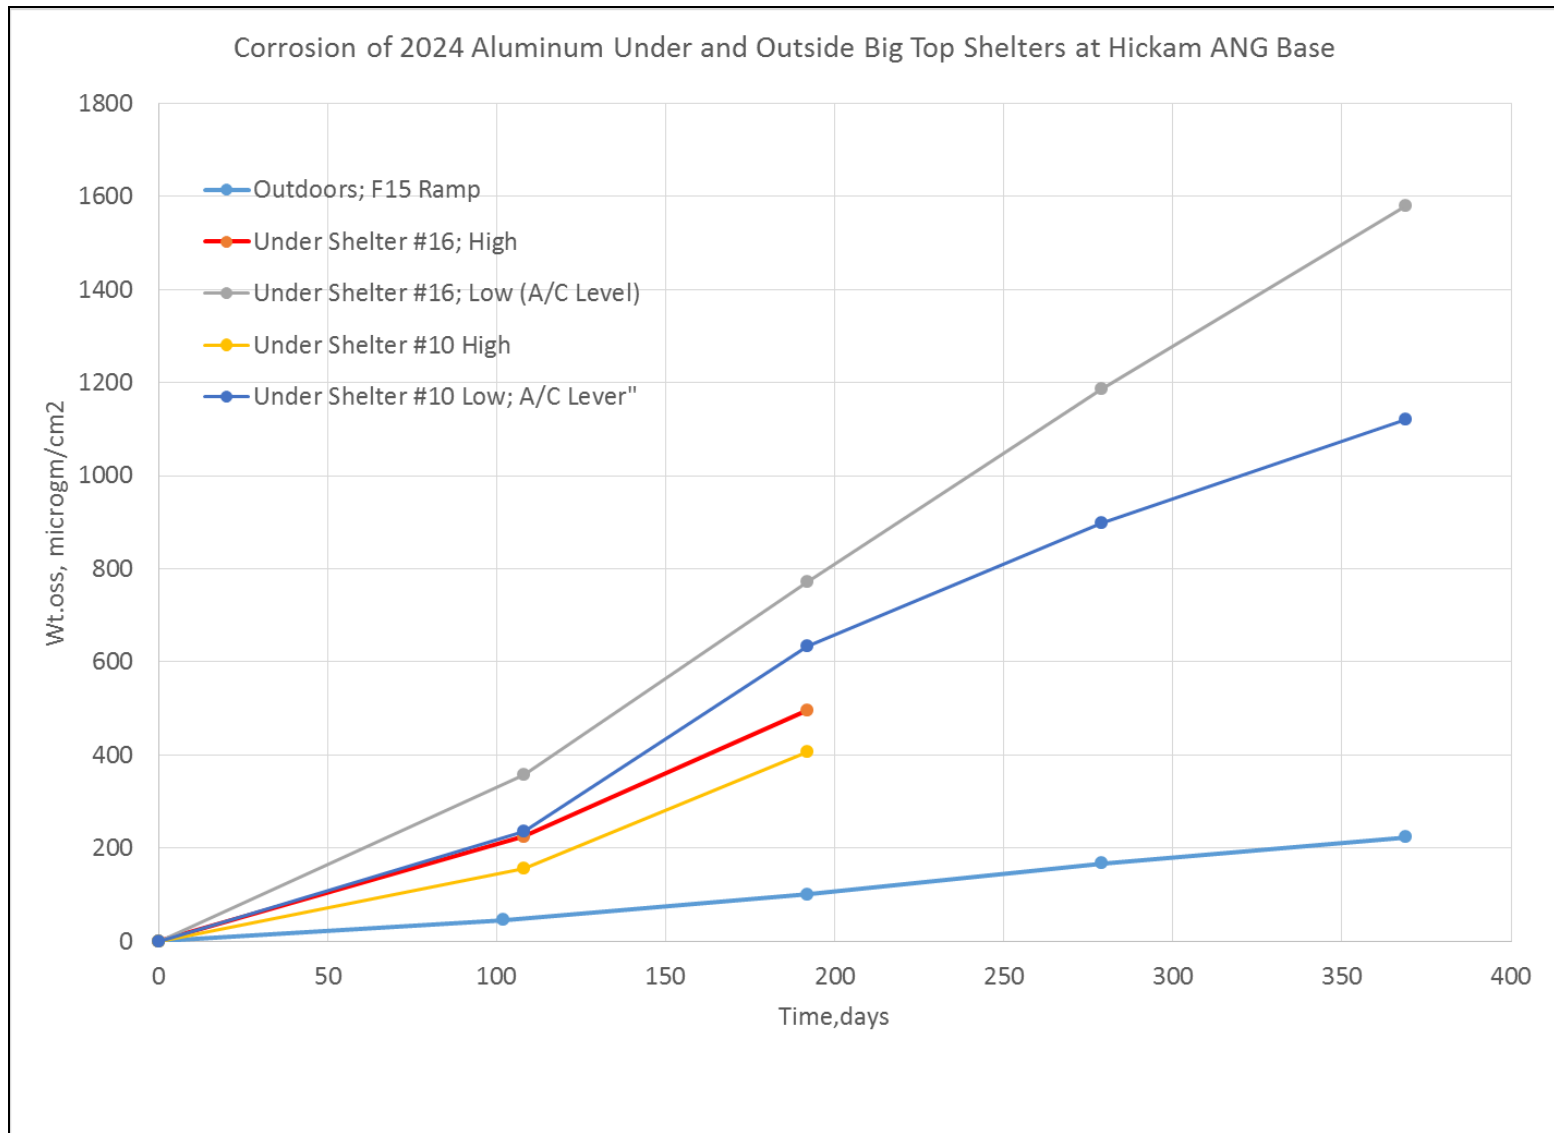
Figure B5: Hickam ANG Base Corrosion of 2024 T3 Aluminum

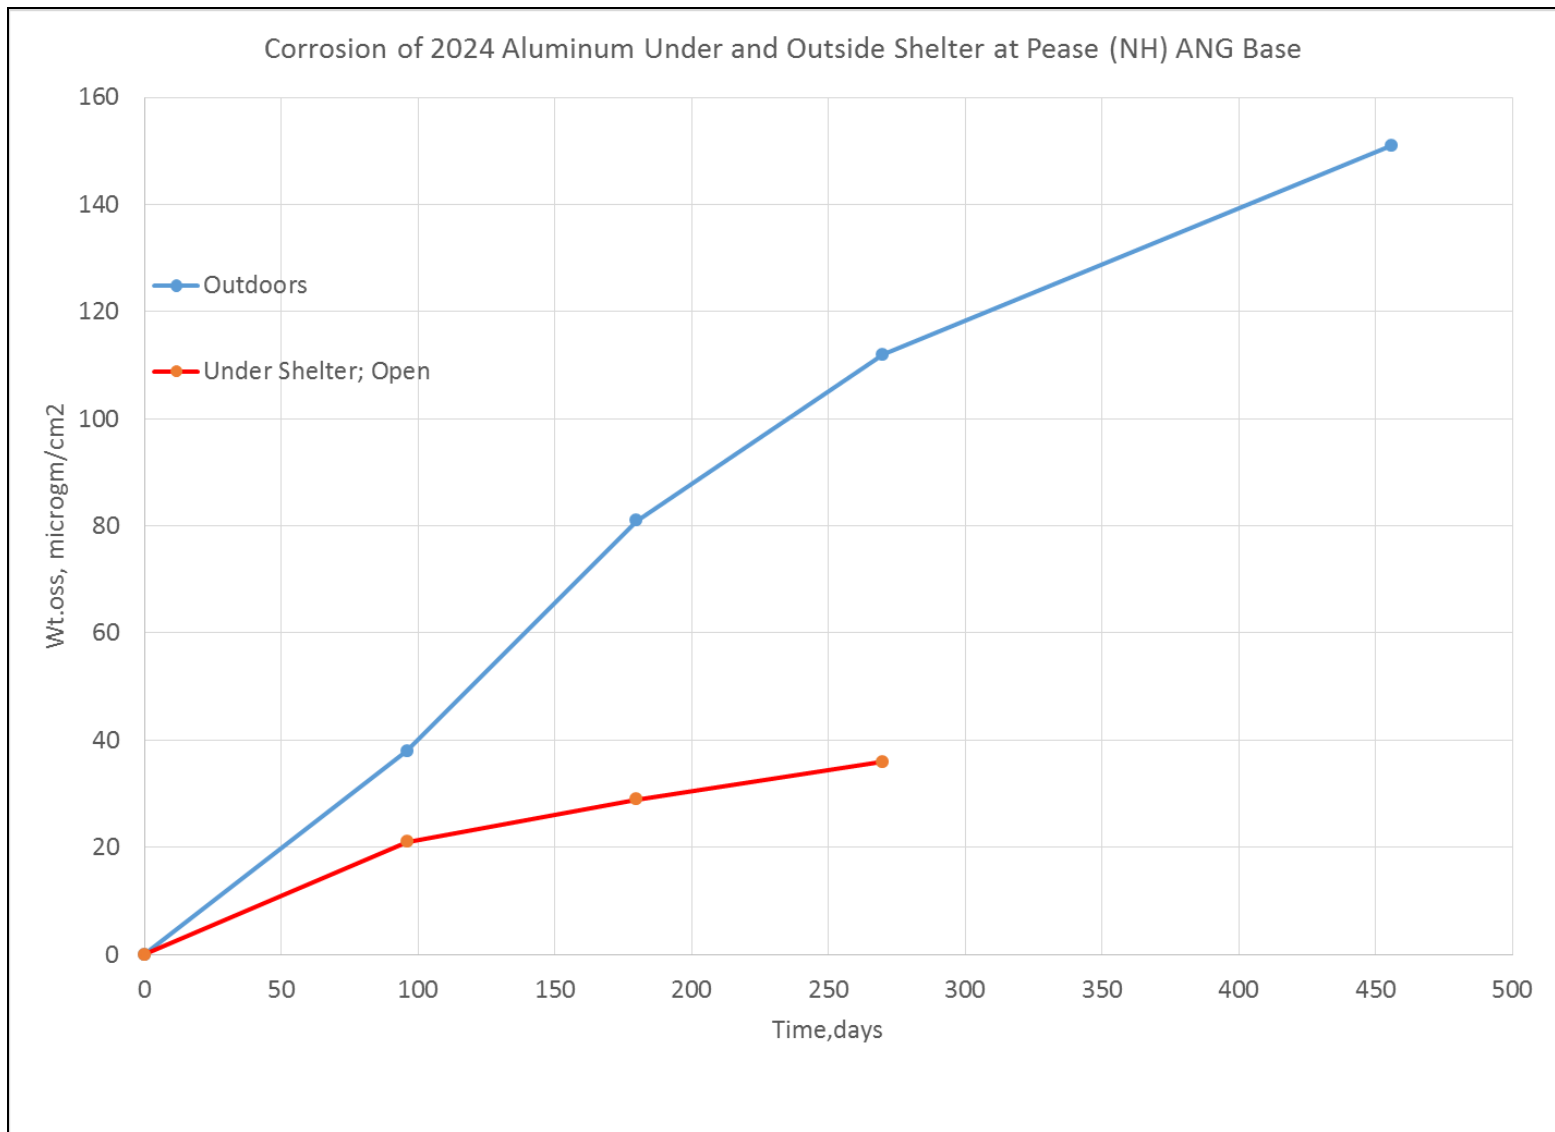
Figure B6: Pease ANG Base Corrosion of 2024 T3 Aluminum

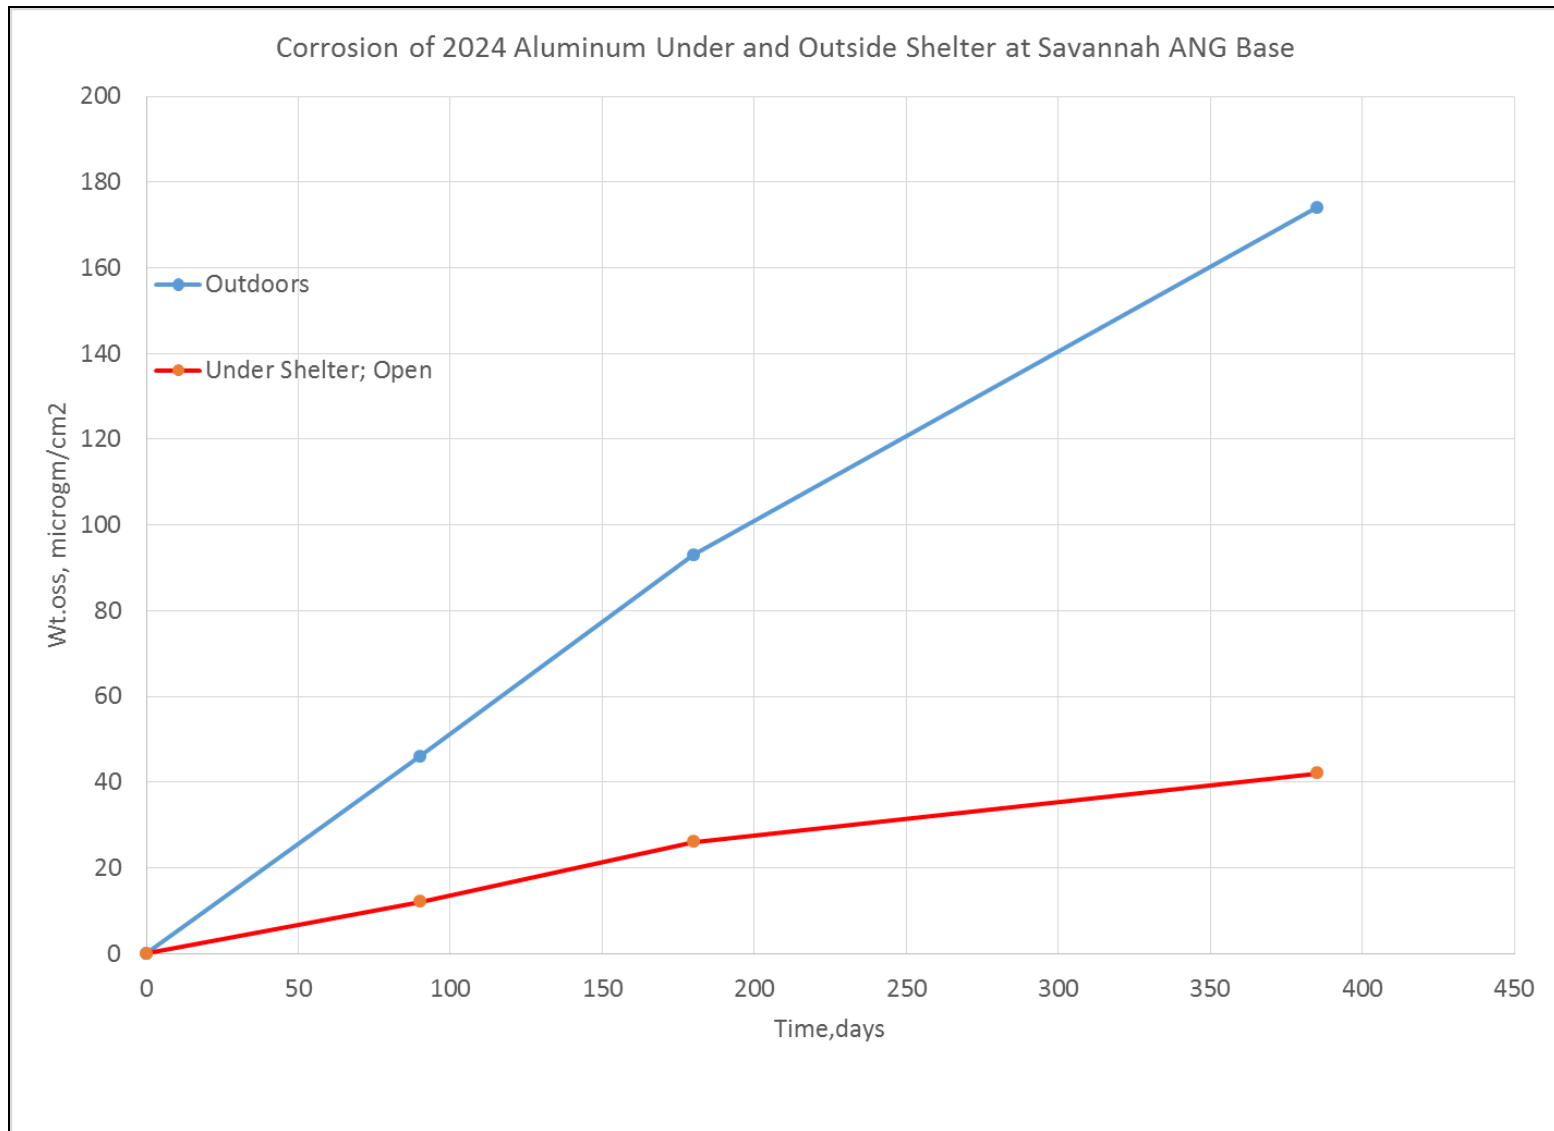
Figure B7. Savannah ANG Base Corrosion of 2024 T3 Aluminum

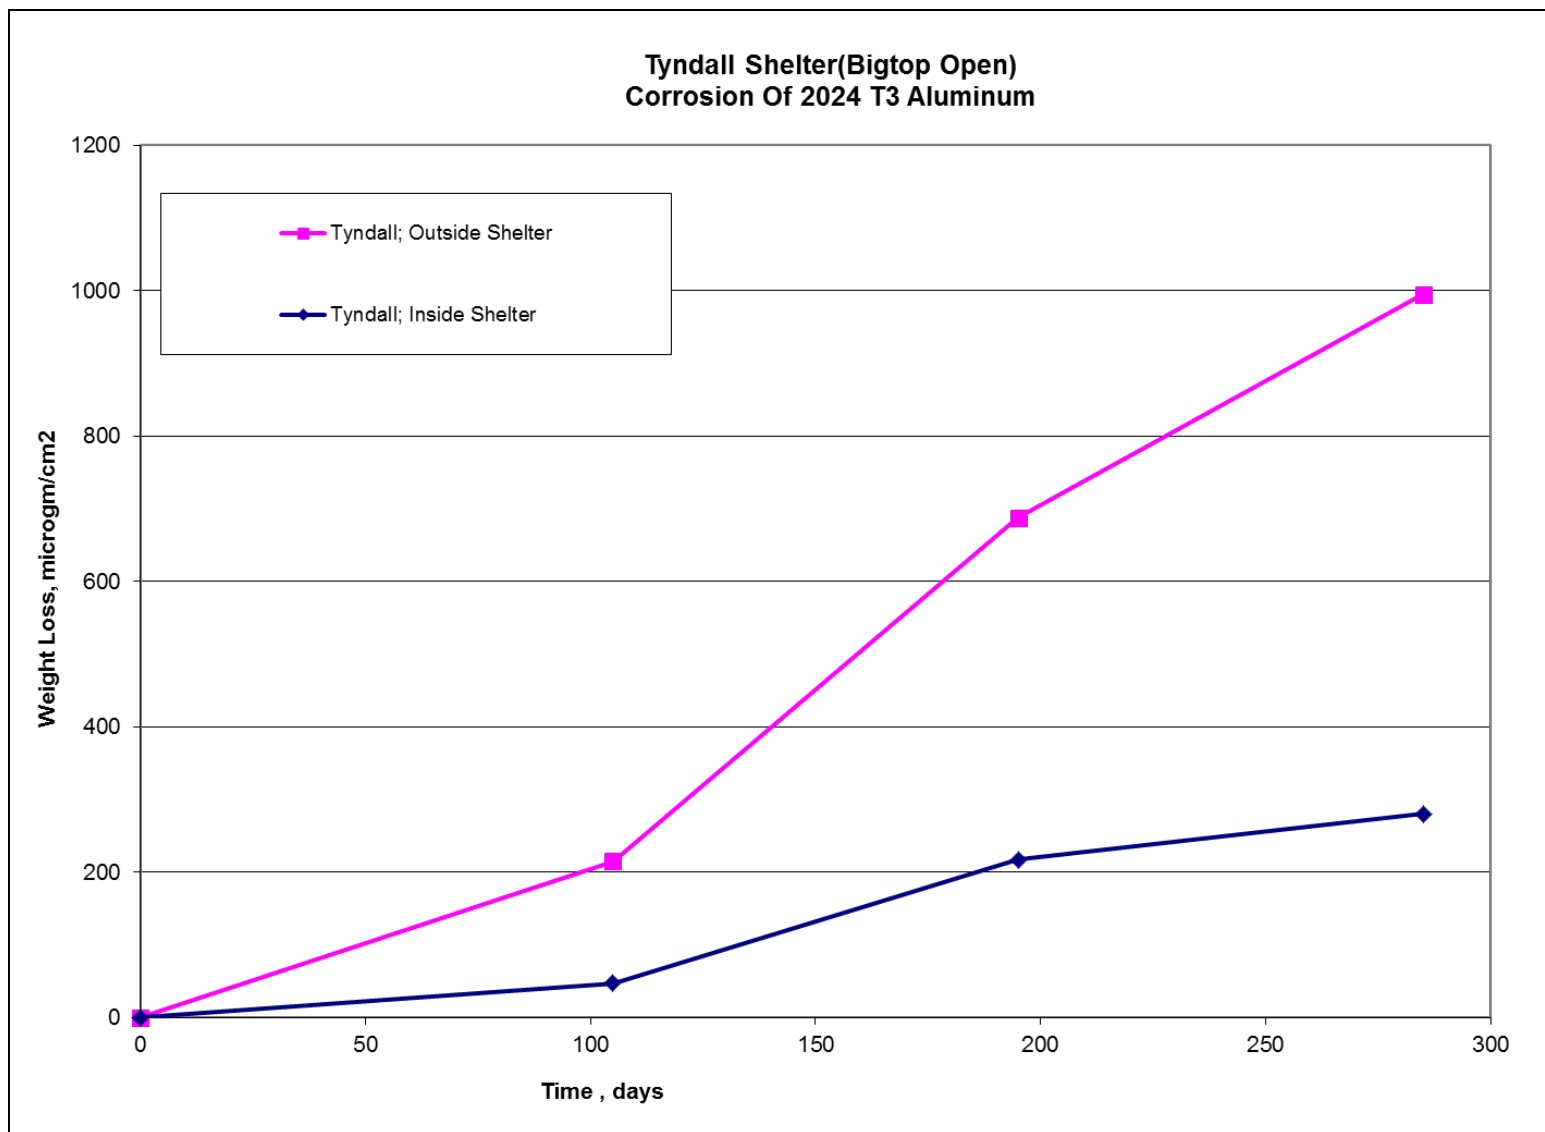
Figure B8: Tyndall AFB Corrosion of 2024 T3 Aluminum
