**US Army Corps
of Engineers®**
Engineer Research and
Development Center

Study of Sand Boil Development at Kaskaskia Island, IL, Middle Mississippi River Valley

September 2020

Final report

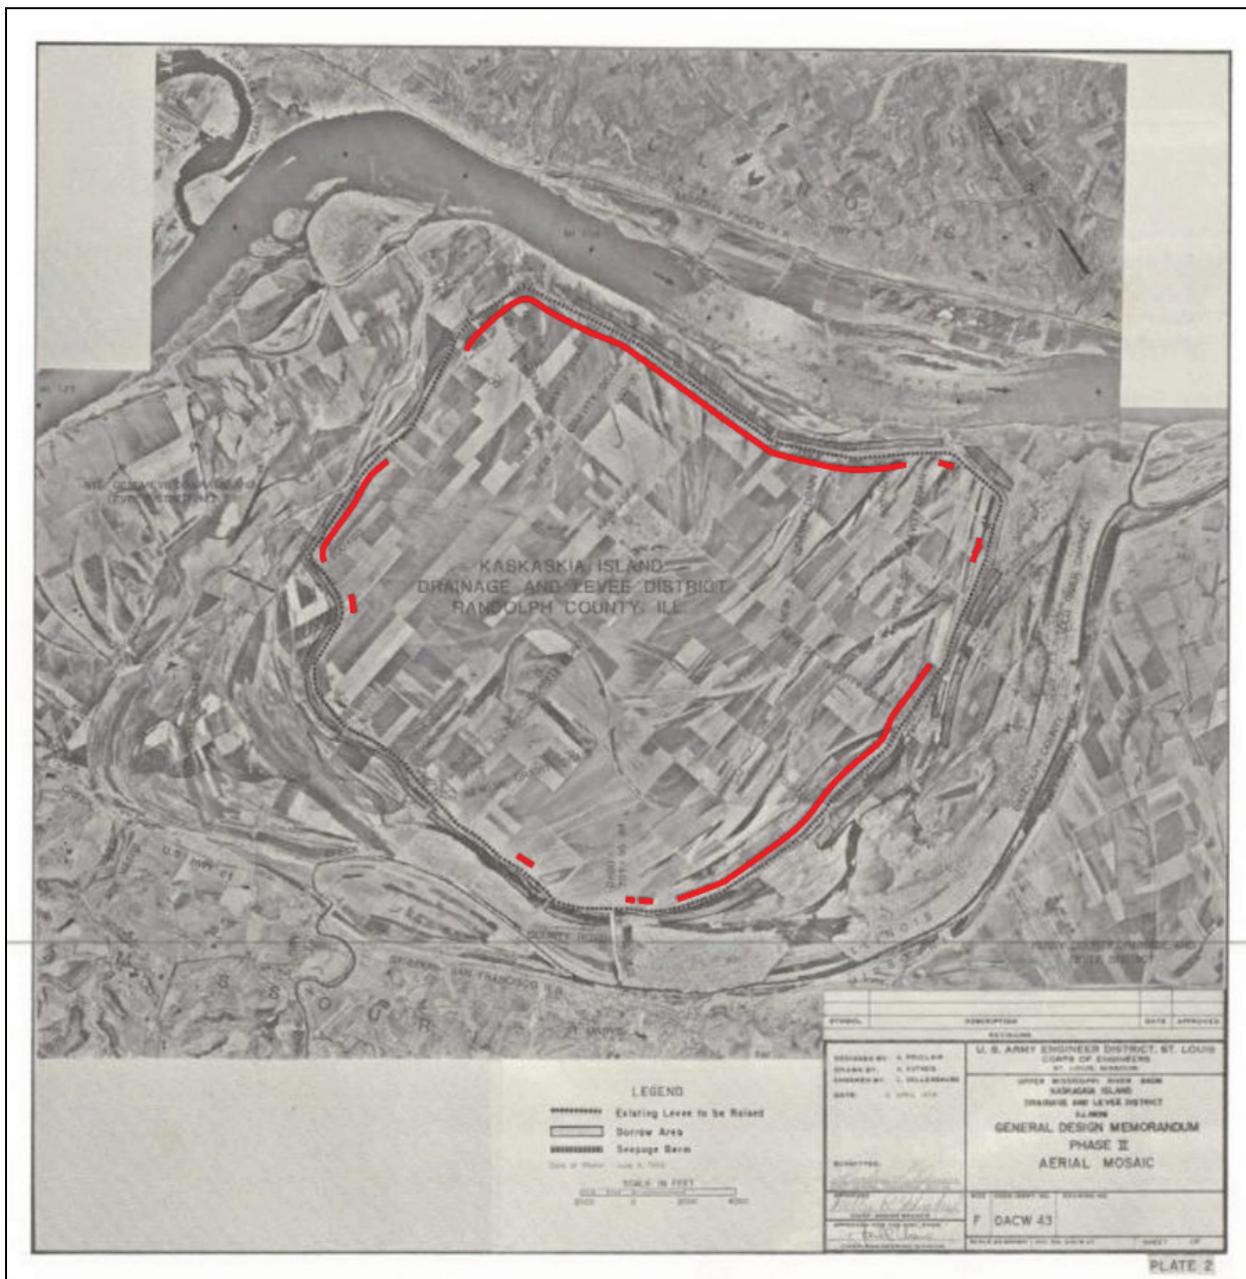
Figure 7. Locations (in red) where seepage berms were constructed during the 1977 levee rehabilitation at Kaskaskia Island.

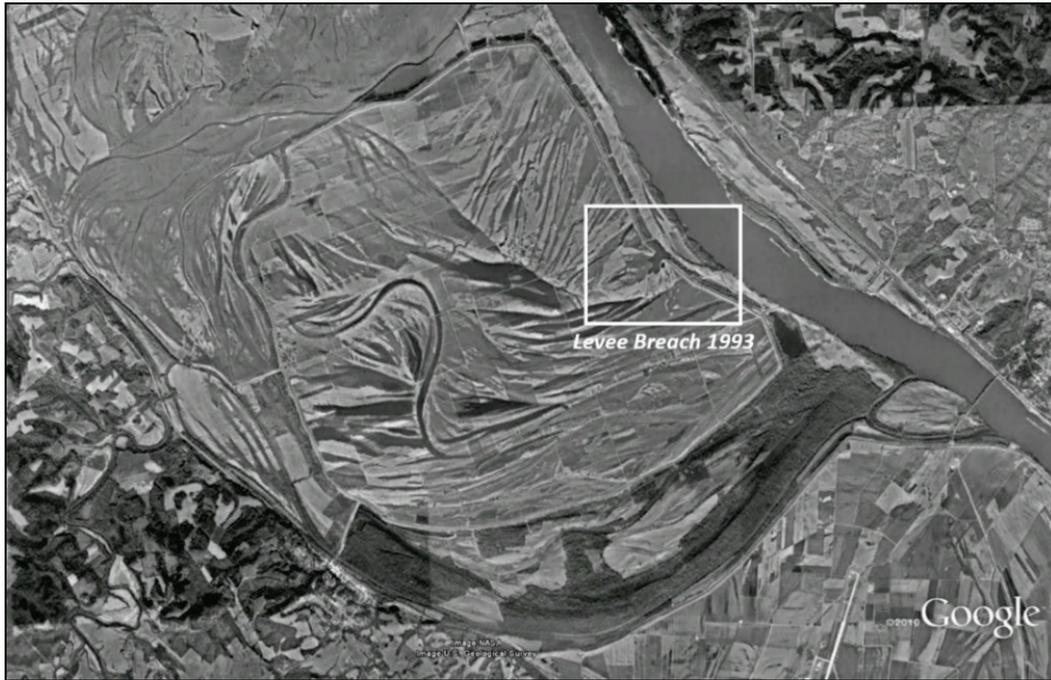
Figure 8. Location of breach at Kaskaskia levee in 1993.

The maximum depth of the scour hole at Kaskaskia reached 50 ft. About 1 million cubic yards of soil were removed over a period of several days during flooding (Chrzastowski et al. 1994). Figure 10 shows the levee breach during the flood. The Great Flood of 1993 was a flood of record and a 100-yr event on the nearby Chester staff gage (RM 109.9). The levee system was again rebuilt following this flood. Numerous engineering borings and laboratory soil test data are available to characterize the stratigraphy at the breach site and from around the island. Failure of the levee at this location was due to loss of pervious foundation soils by seepage and piping and a large sand boil activity.

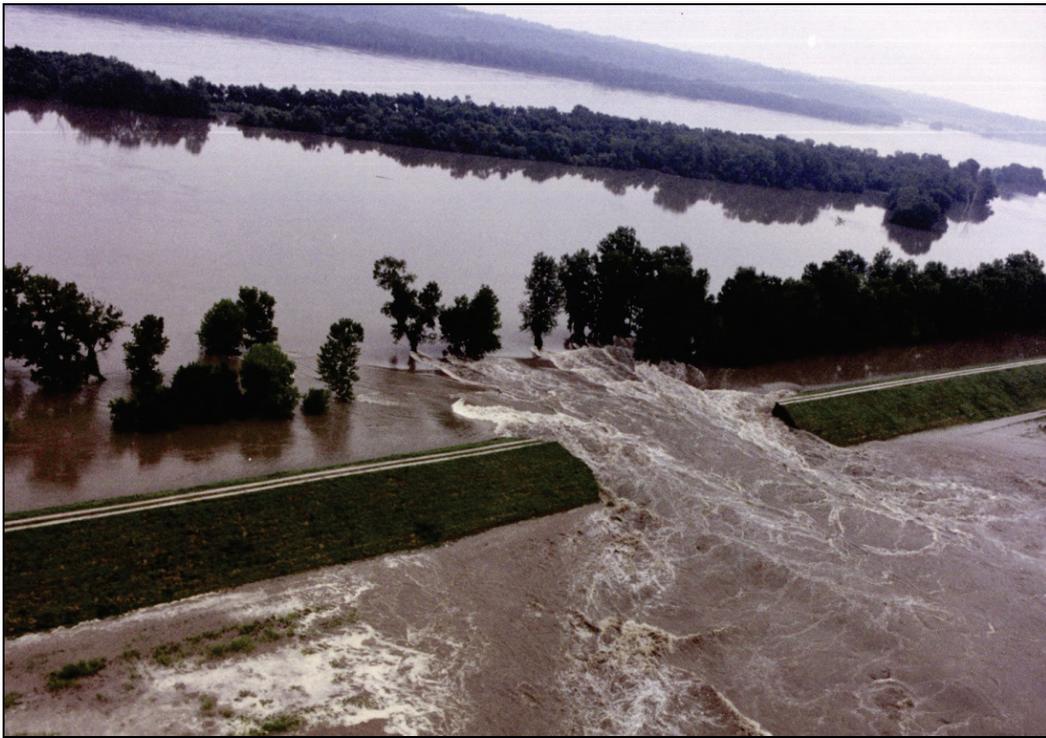
■
Figure 10. Levee breach at Kaskaskia in 1993 during flooding.
(Photo courtesy of St. Louis District.)

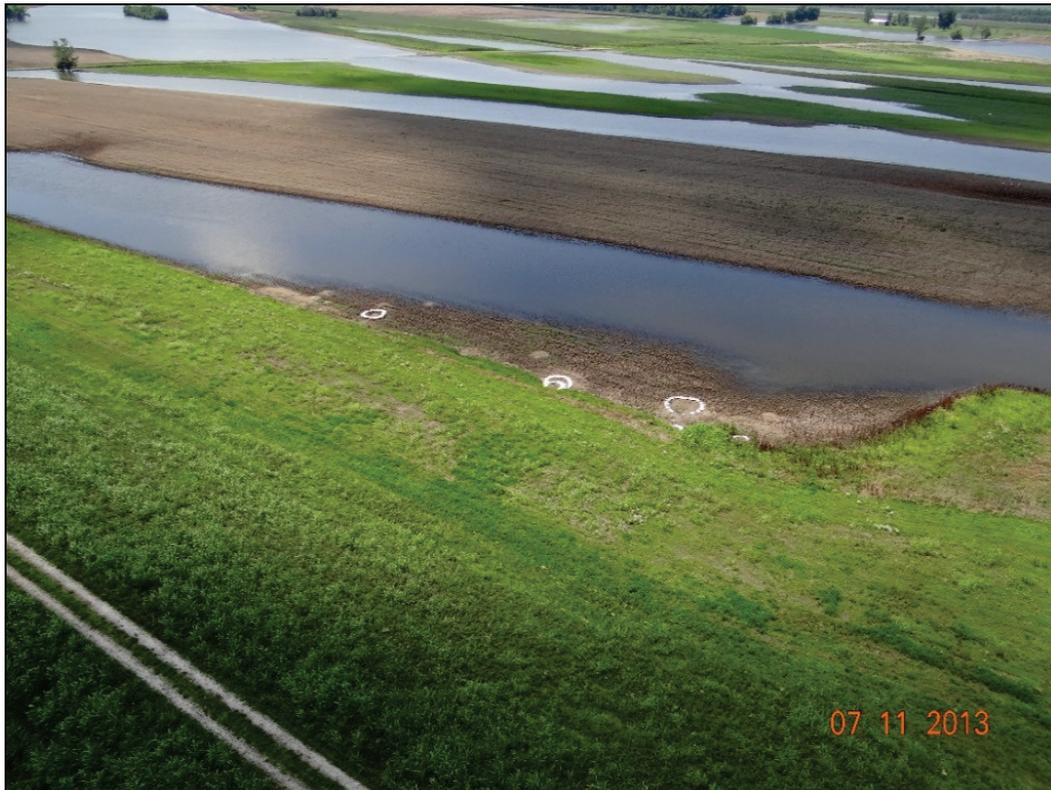
Figure 11. Active sand boils at Kaskaskia Island at the levee toe during the 2013 Flood.

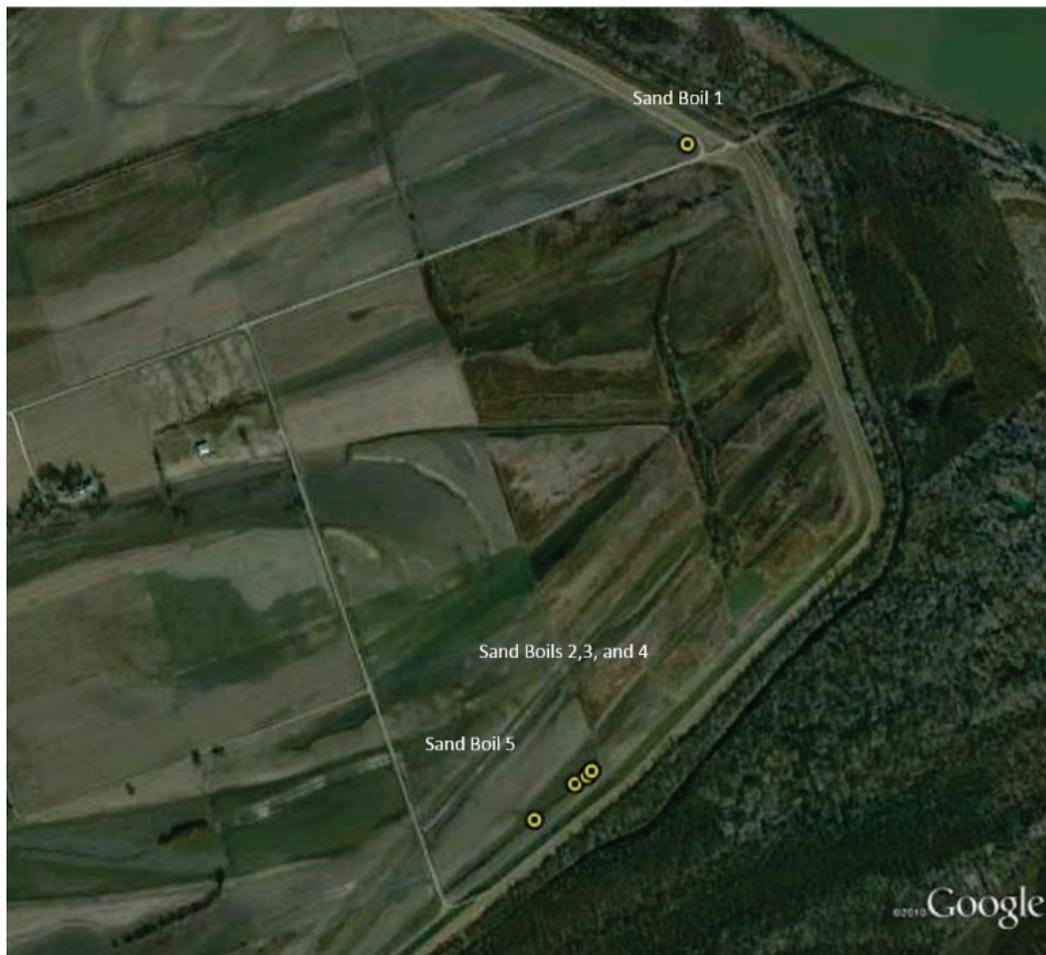
During the initial site visit, a total of five sand boils was identified around both the eastern and southern sides of the island for further study (Figure 17). Most of the recent sand boil activity was located on the southeastern side of the island at the edge of a seepage berm (Figure 17).

Figure 17. Locations of recent sand boils from 2013 and 2014.

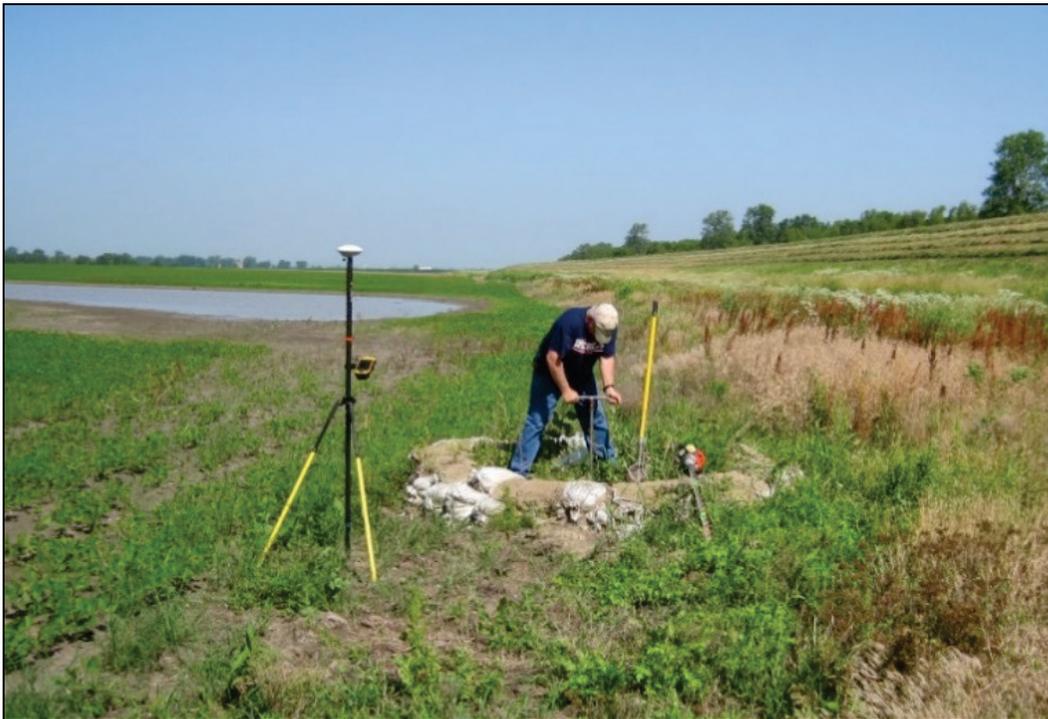
Soil samples of the ejecta material were collected during the first visit. Approximately 1 gal-sized soil samples of the ejecta material were taken from the center of each sand boil with a hand auger (Figure 18).

Figure 18. Soil samples taken with a hand auger from Sand Boil No. 1 for laboratory soil analysis.

A second gal-sized soil sample was taken from the blanket material nearby. Both samples were wrapped in plastic and sealed for transport to ERDC for particle-size analysis and mineralogy. Results of the laboratory testing of the ejecta and blanket samples are presented in Table 1. Curves of the grain-size data from laboratory testing of these samples are presented in Appendix A.

Laboratory classification of sand boil ejecta identifies a silt to fine sand (ML to SM). The upper blanket material corresponds to a clay (CL and CH). The mineralogy of the ejecta from examination of field samples is estimated to be more than 96 percent quartz sand, with minor amounts of mica, feldspars, and less than 1 percent unidentified heavy minerals.

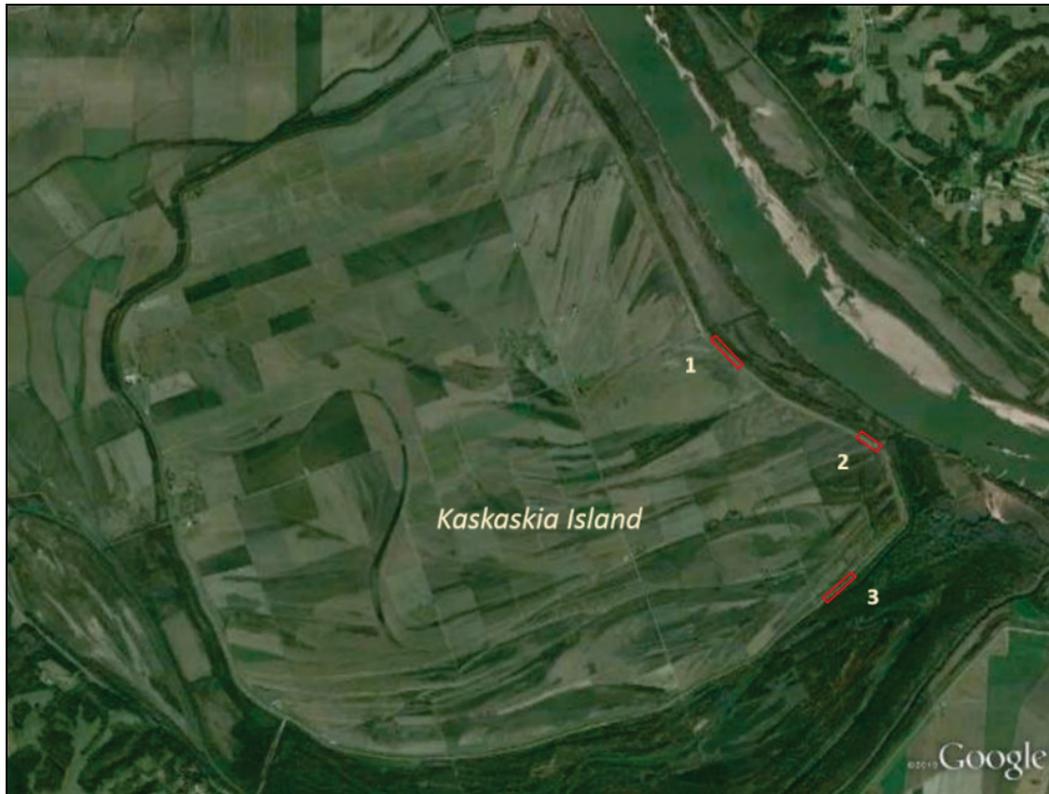
Figure 19. Three study sites were selected along the levee on Kaskaskia Island.

Three locations were targeted for follow-up study with CPT borings for site characterization. The first area (No. 1 on Figure 19) was where the breach had occurred in 1993. Site No. 2 was located at an existing sand boil area (Sand Boil No. 1). Site No. 3 on the southeastern part of the island was referred to as the “Sand boil study area.” Several sand boils were concentrated at this location (sand boils Nos. 2, 3, and 4; Figures 11 and 17). Also present at this location was an area of minor subsidence, referred to as the “slump” area. This slump indicates ground settlements might have occurred at this location due to loss of foundation material.

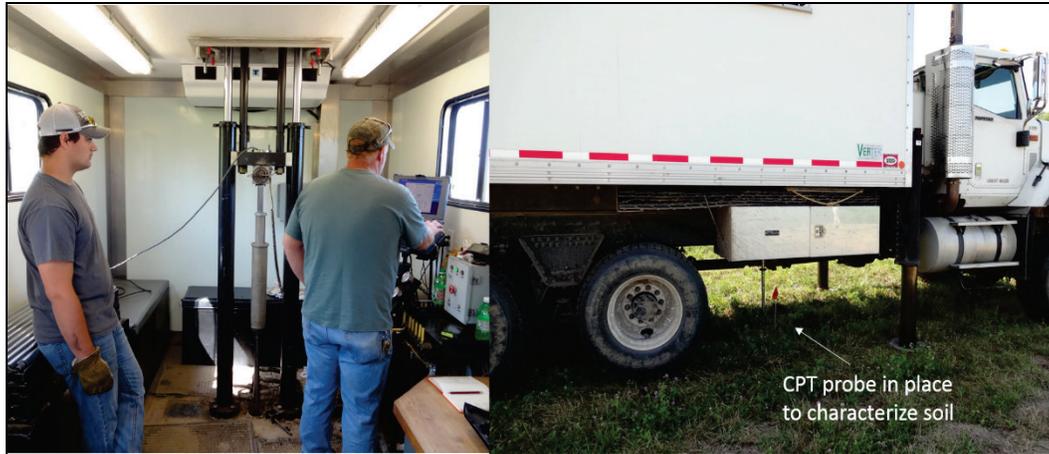
Figure 20. Operators Rusty Penley and James Cumberland prepare the probe to collect CPT data (left). The probe is lowered through the truck floor and pushed into the soil at a constant rate (right).

A Vicksburg District CPT truck and crew (Operators Rusty Penley and James Cumberland) were used for obtaining CPT data from Kaskaskia Island (Figure 20). A total of 71 CPT pushes were completed during the second phase of this study. Individual CPT logs are presented in Appendix B. Most of the CPT pushes were made within the sand boil and slump area identified as area 3 in Figure 19.

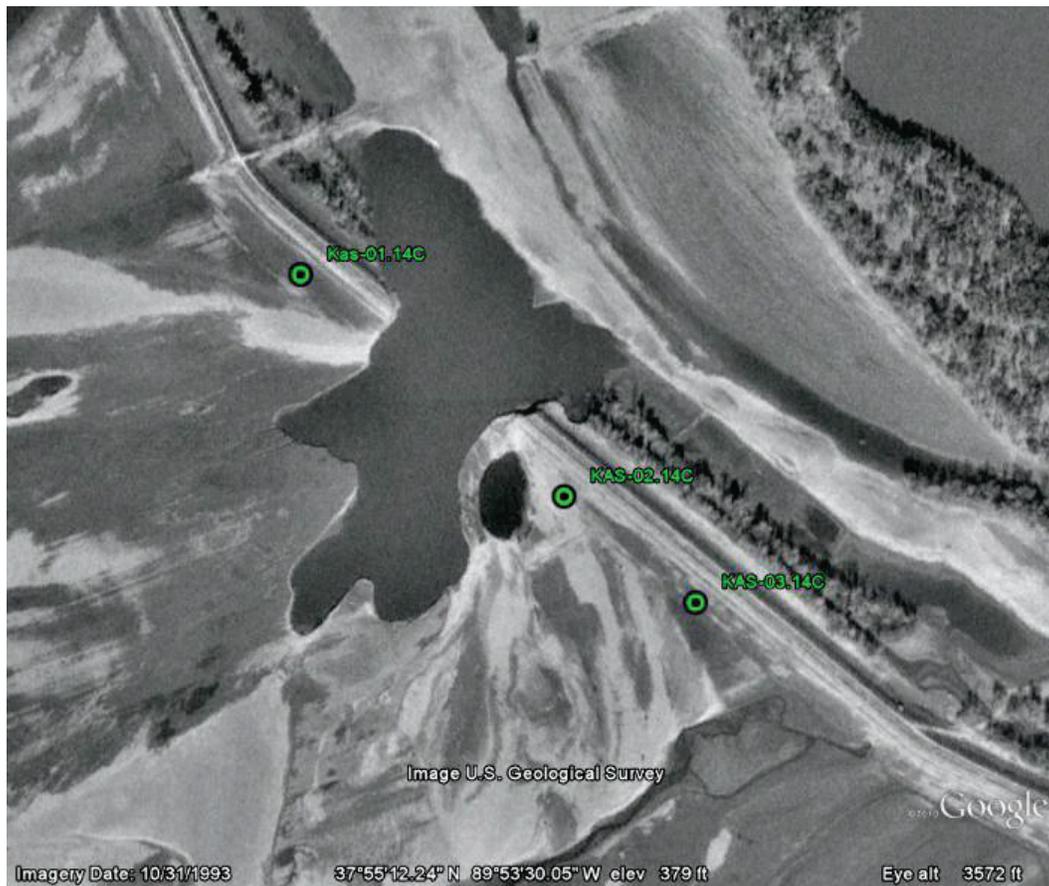
Figure 21. Locations of CPT soundings within study area No. 1. Soundings are overlaid on 1993 imagery of the levee breach.

Three CPT soundings were placed around the repaired 1993 breach area for direct comparison to subsurface conditions and soil layers in the other active sand boil areas studied (Figure 21). The scour hole created during the 1993 breach was filled with hydraulic-placed materials. Figure 22 shows the sounding locations made on a current day image as they relate to the area affected by the breach in 1993.

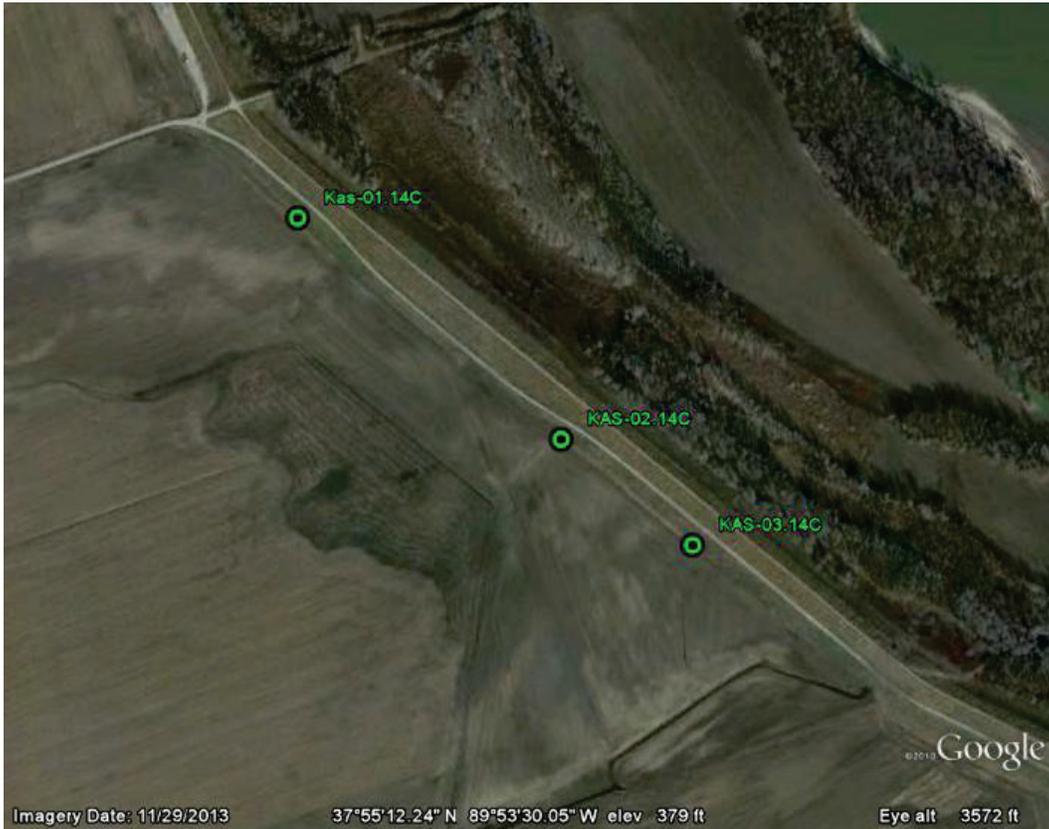
Figure 22. CPT soundings in old, repaired breach location on current image of area.

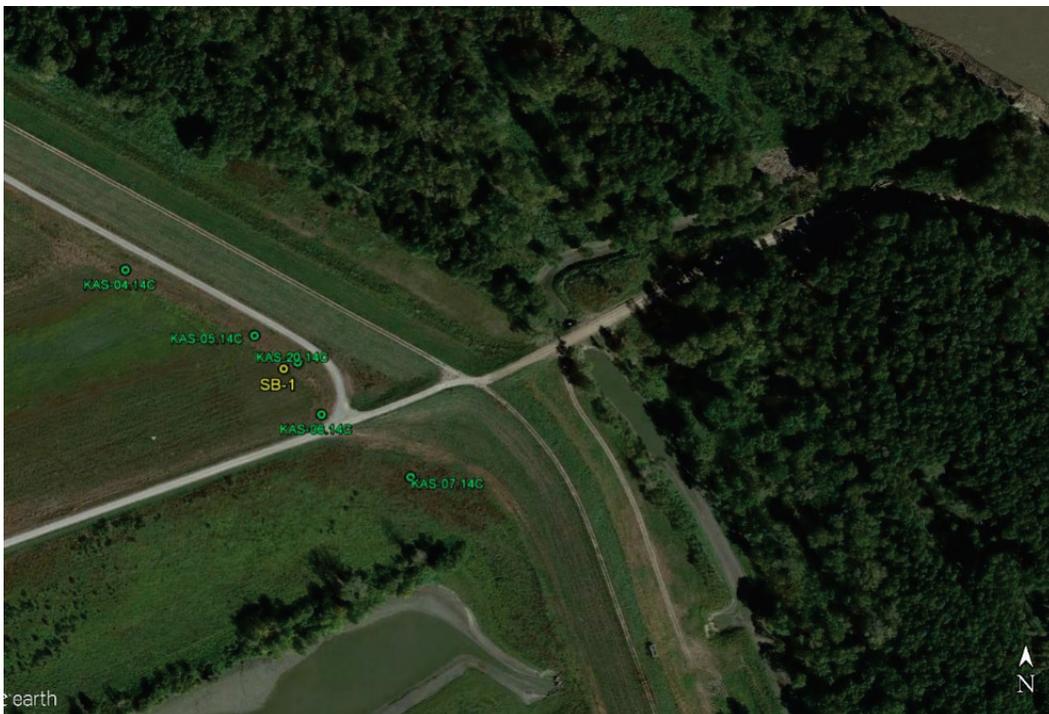
Figure 23. CPT sounding locations near Sand Boil (SB) No. 1 (yellow) and within designated study area No. 2.

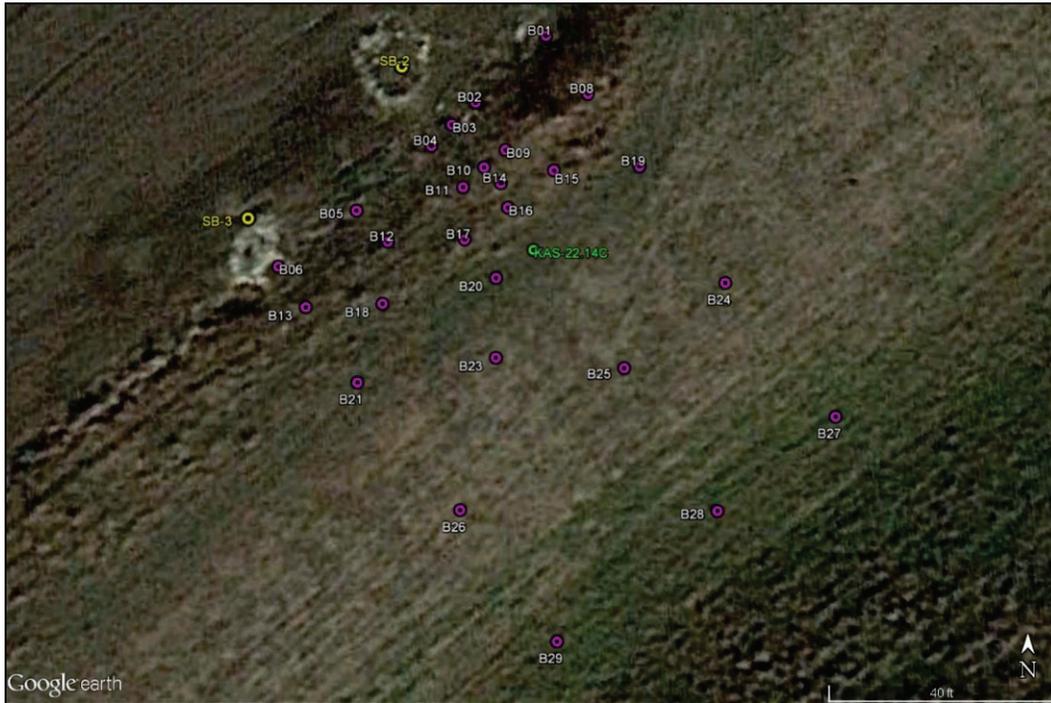
Figure 25. Close-up view of CPT locations at the sand boil area.

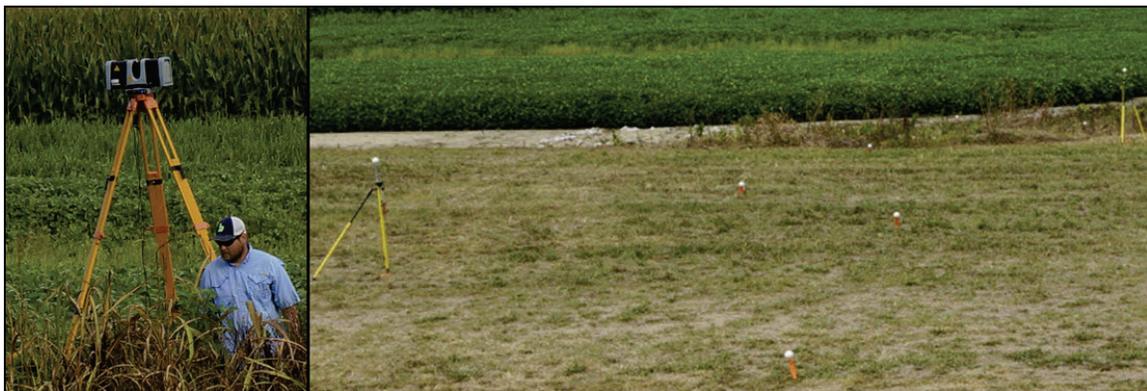
The instrument was mounted on a tripod (station), and small white reflective spheres were placed in and around the scanners FOV. These registration spheres were used later to join the scans together once all of the scans were completed (Figure 28).

Figure 28. The LiDAR station on the edge of a sand boil; Figure 28b shows the registration spheres distributed along the site.

The laser was initialized and a small mirror within the instrument began to spin, which in turn pulsed the laser beam as far as it can “see,” capturing up to 200,000 data points per second. The collection was complete for that station once the instrument had completed the full 360 deg rotation. A data gap or shadow occurred underneath the

instrument. The location of the next scan station was chosen to be close enough to fill in the shadow from this station and have enough common registration targets in order to stitch the scans together.

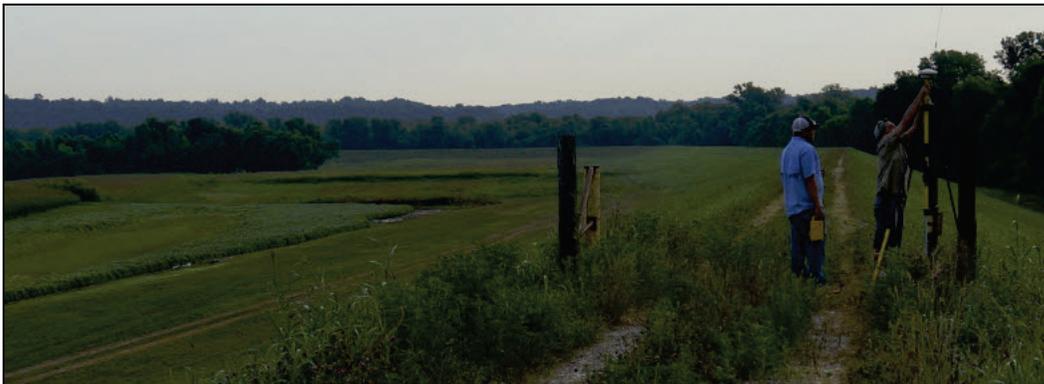
One GPS receiver served as the Base Station and was mounted on a stationary tripod on the top of the levee near a gate (Figure 29). This GPS unit was storing raw GPS signals while, at the same time, transmitting pseudo-corrected positional data to the mobile GPS mounted on the S-Tracker. The stored raw signals were later submitted to the National Geodetic Survey (NGS) via the Online Positioning User Service (OPUS) to obtain accurate positions for the entire survey. After the accurate position of the stationary GPS unit was established by NGS OPUS, the pseudo-corrected mobile GPS positions were adjusted to determine the final X, Y, and Z of every topo point collected.

Figure 29. GPS Base Station near the levee gate at Kaskaskia.

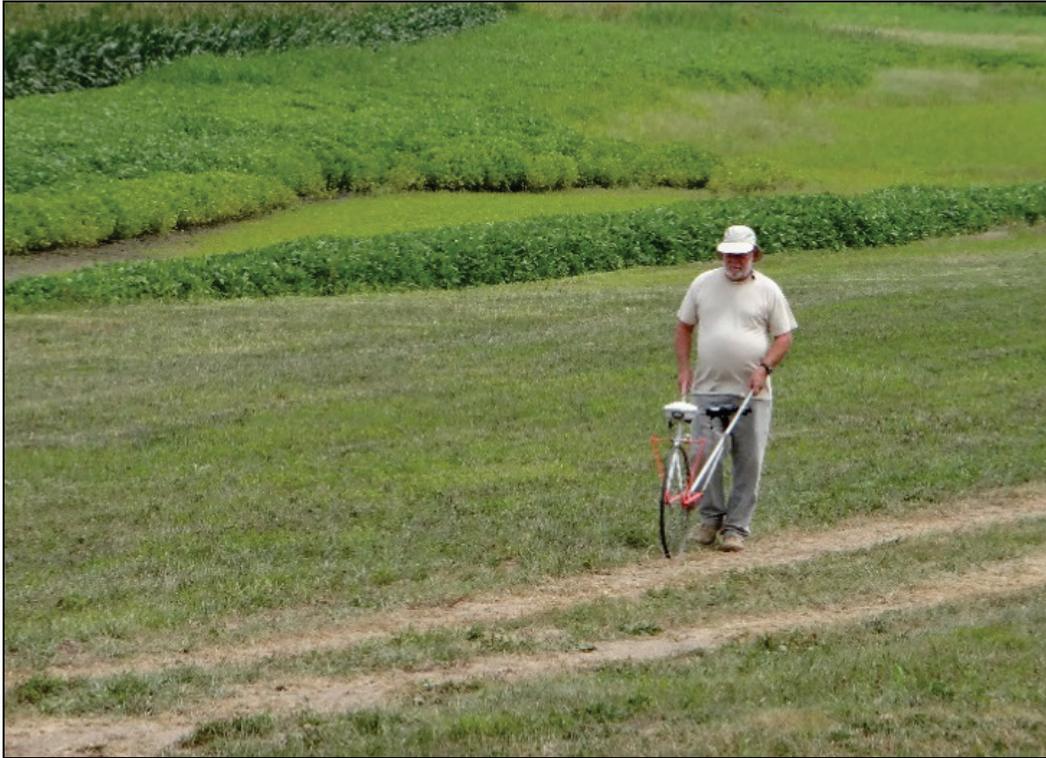
The mobile GPS on the S-Tracker (Figure 30) was configured to store the pseudo-corrected positions at 1-m intervals along a line. Profile lines were visually established approximately 25 m apart along the levee and berm. A portion of these profiles coincided with an area where High Accuracy/High Resolution LiDAR measurements were collected.

Figure 30. Mobile GPS unit mounted on the S-Tracker.

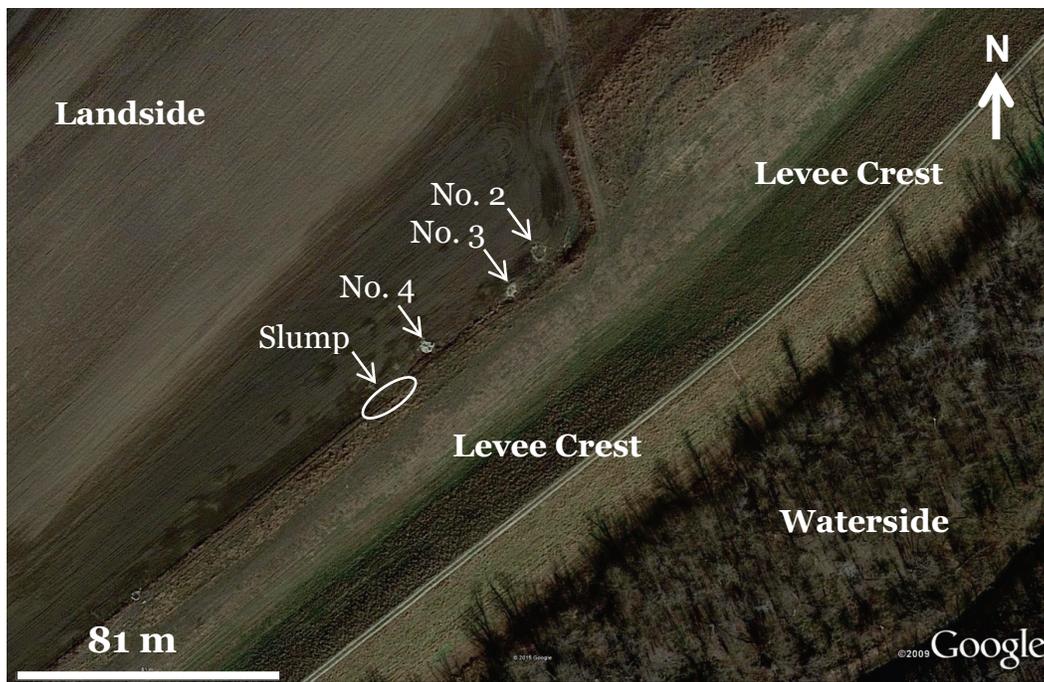
ERT surveys were made in conjunction with CPT borings. Minor site disturbance resulted from vehicles and foot traffic where wet soils were present. Figure 32 presents a close-up image of the site with the primary features of interest identified.

Figure 32. Three sand boils (labeled 2, 3, and 4) and area of slumping at Kaskaskia.

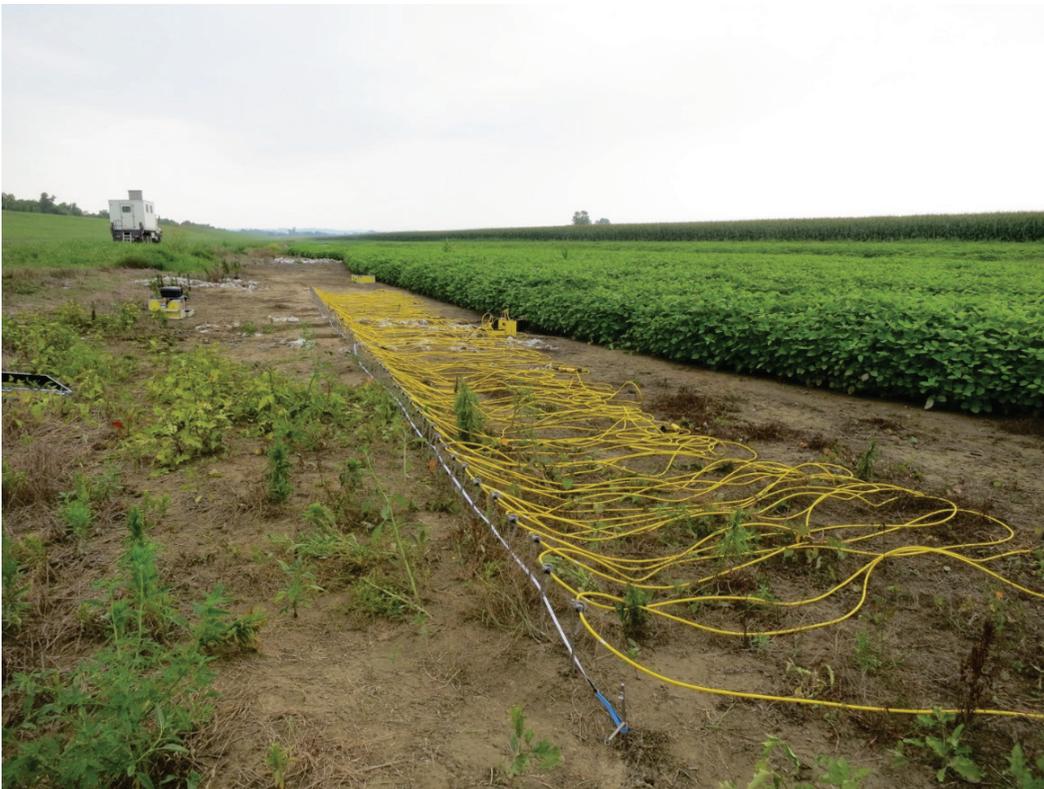
A total of 14 ERT surveys were conducted at the Kaskaskia Island site. All surveys were collected using a SuperSting R8 electrical resistivity imaging system manufactured by American Geosciences Inc. Equipment used is shown in Figures 33 and 34. All 14 surveys were performed using a dipole-dipole array, using 84 electrodes (Figure 35). These electrodes were spaced at one of three electrode spacings (0.25 m, 0.3 m, or 0.5 m, or approximately 10 in., 12 in., and 20 in.)

Figure 33. AGI SuperSting in operation over Sand Boil No. 2 at Kaskaskia, looking southwest.

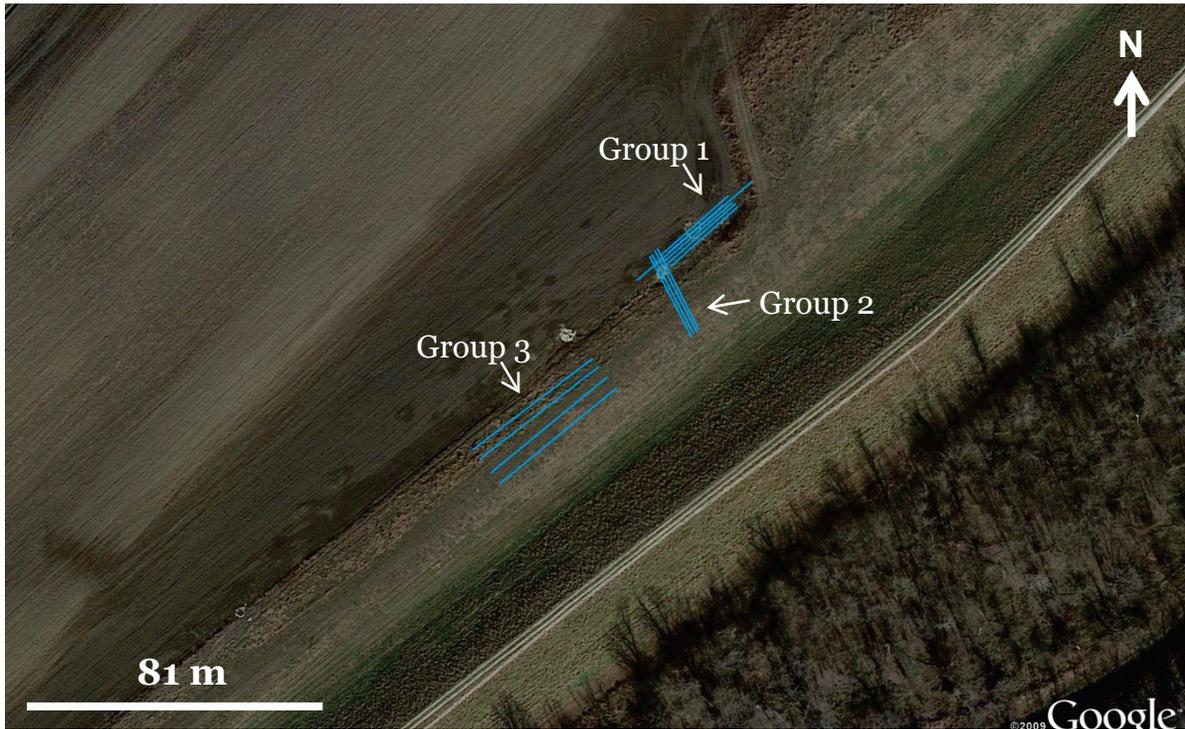
The 14 ERT surveys were conducted in three groupings (Figures 36 and 37) within a larger area (approximately 125×30 m, or approximately 410×100 ft) that had most recently experienced sand boil activity during the summer of 2013. All ERT surveys were collected on the landside of the Kaskaskia levees.

Figure 36. Location of the 14 ERT surveys conducted at Kaskaskia, July 2014. Surveys are grouped based on the features being studied.

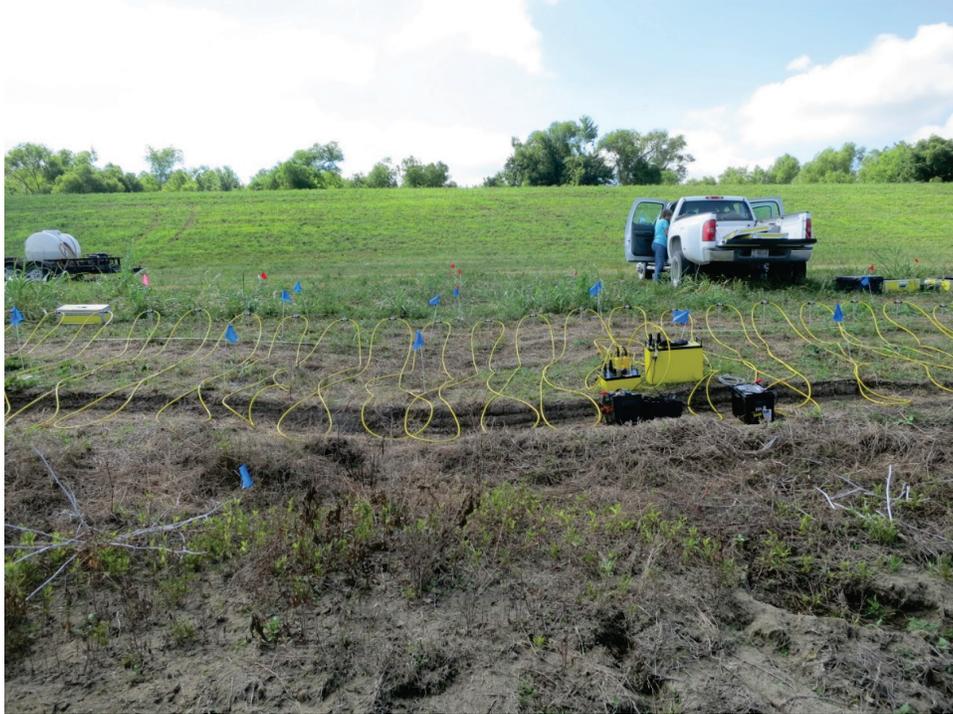
Figure 38. A dip in topography along the edge of the berm. ERT survey line K1407291 is shown. This is the ERT survey line closest to the edge of the berm. The other three slump area ERT lines were located progressively closer to the levee in the background (note pin flags in the background).

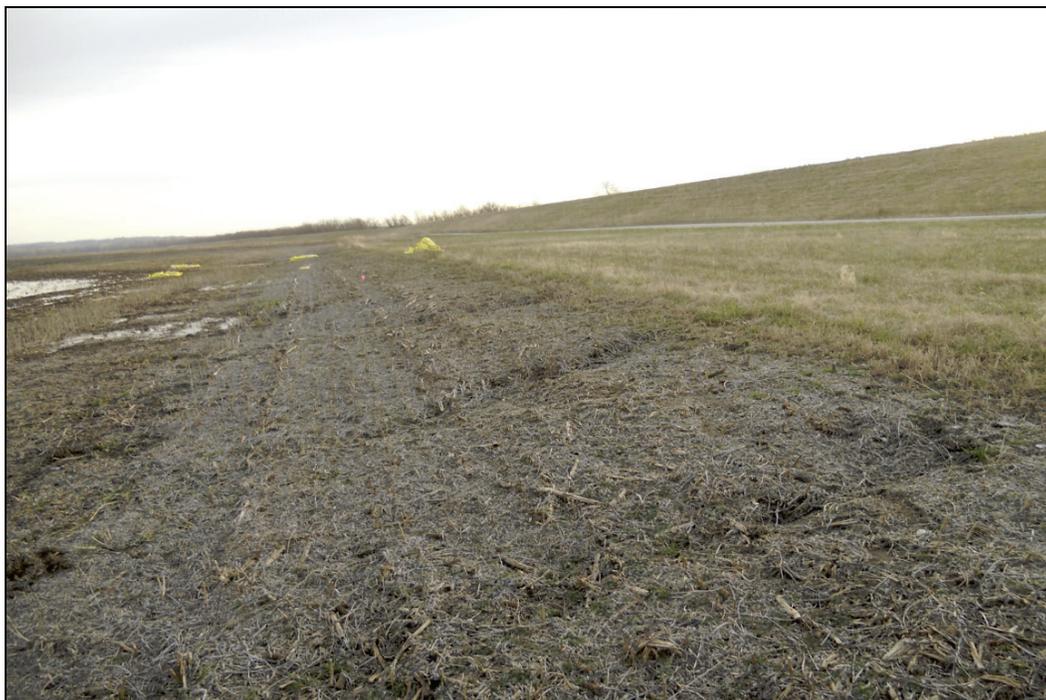
Figure 50. Almost evenly spaced drainage rills at edge of seepage berm. Photograph during January 2016 Flood.

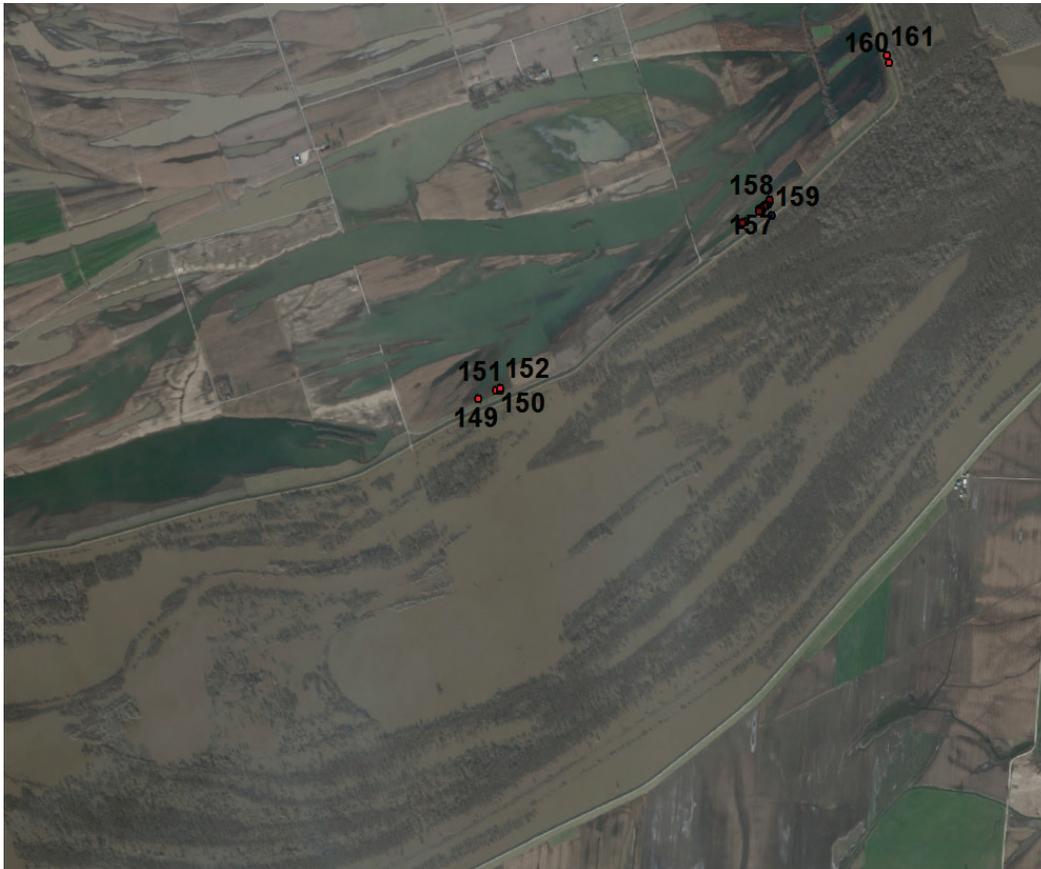
Several new sand boils are shown by the image in Figure 70. Yellow-colored sand bags were used to flood fight the new boils during the 2016 Flood, while white-colored sand bags were used in previous year flood-fight activities.

Figure 69. Digital Globe image of sand boil locations 149 to 161 taken during the 2016 Flood on 5 January 2016. Note extensive flooding in the old river channel and large seepage extent behind the levee.

The different-colored sand bags permit easy identification of any new sand boils from those that had occurred in previous years.

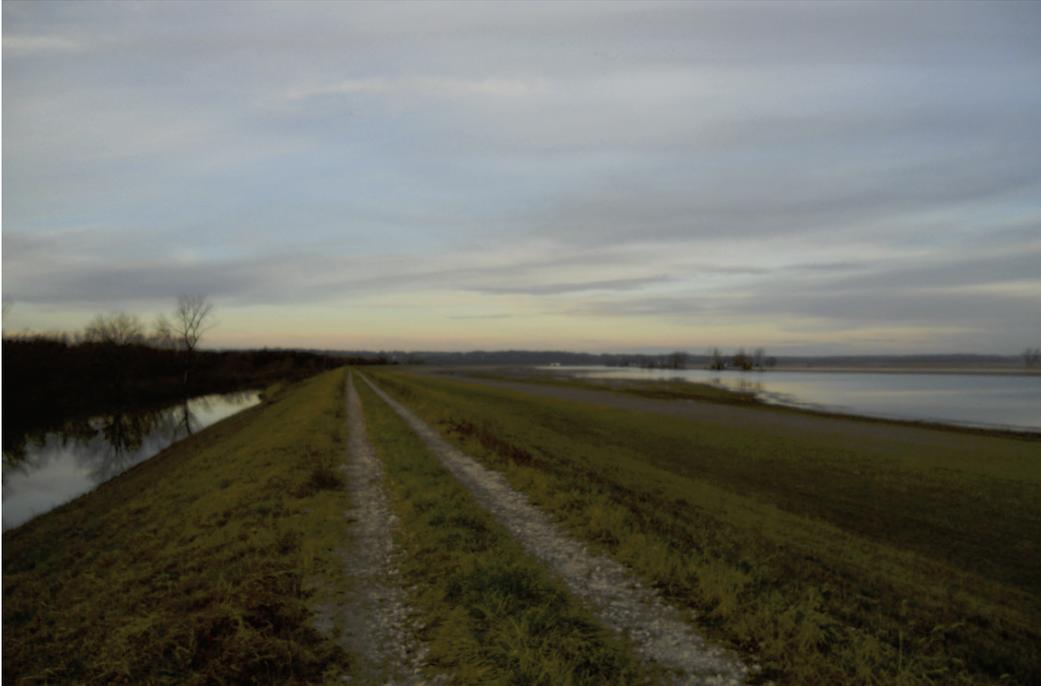
Figure 70 is a view of the large water-filled swale west of sand boil locations 149 to 152. Figure 71 is a westerly view near sand boil locations 149 to 152. Piezometer (marked by blue circle) described in text is located in the cluster of sand boils numbered 157 to 159 at the southeast corner of the island.

Figure 70. View looking west from levee crest toward town of St. Mary. Photograph taken on the morning of 5 January 2016 as flood waters were receding. Interior seepage has collected in the large swale on the right side of the photograph forming extensive lakes across much of the island.

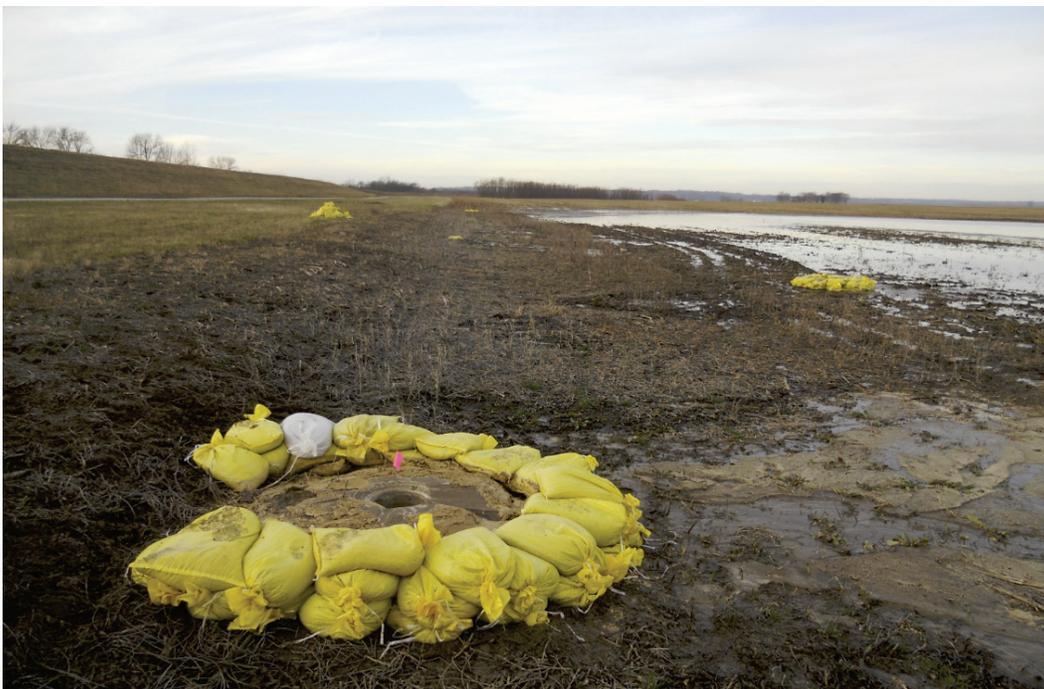
Close-up views of sand boil 151 (see Figures 68 and 69 for location) are shown in Figure 71 and 72. This boil has a 4.3-ft-diam fine sand cone with a 12-in.-diam throat. A dried foam crust is present on the boil surface. The boil was no longer actively flowing at the time as the river stage had dropped below a critical threshold.

Figure 71. View looking due west from base of berm in vicinity of boil No. 151. Several sacked sand boils visible in background. Note the dry brown foam crust present on the surface of the sand boil.

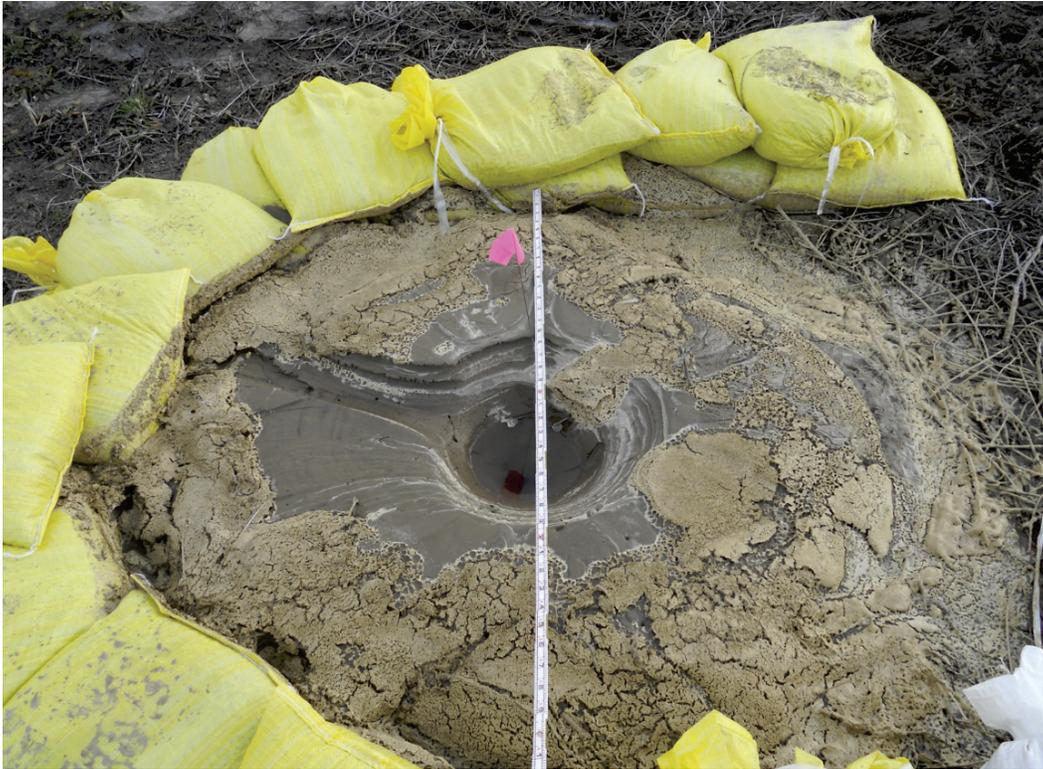
Figure 72. Close-up view of the 4.3-ft-diam sand boil cone at sand boil No. 151, with nearly a 12-in.-diam throat. Boil was no longer active as the river fell below a critical threshold on 5 Jan 2016 visit.

This location did not display sand boil activity during the 2013 Flood as evidenced by the record of sand boil locations recorded by the District (field notes from Curtis Moore and Caroline Williams.) Additionally, the boil was sacked with yellow-colored sand bags, another indication of new boil activity.

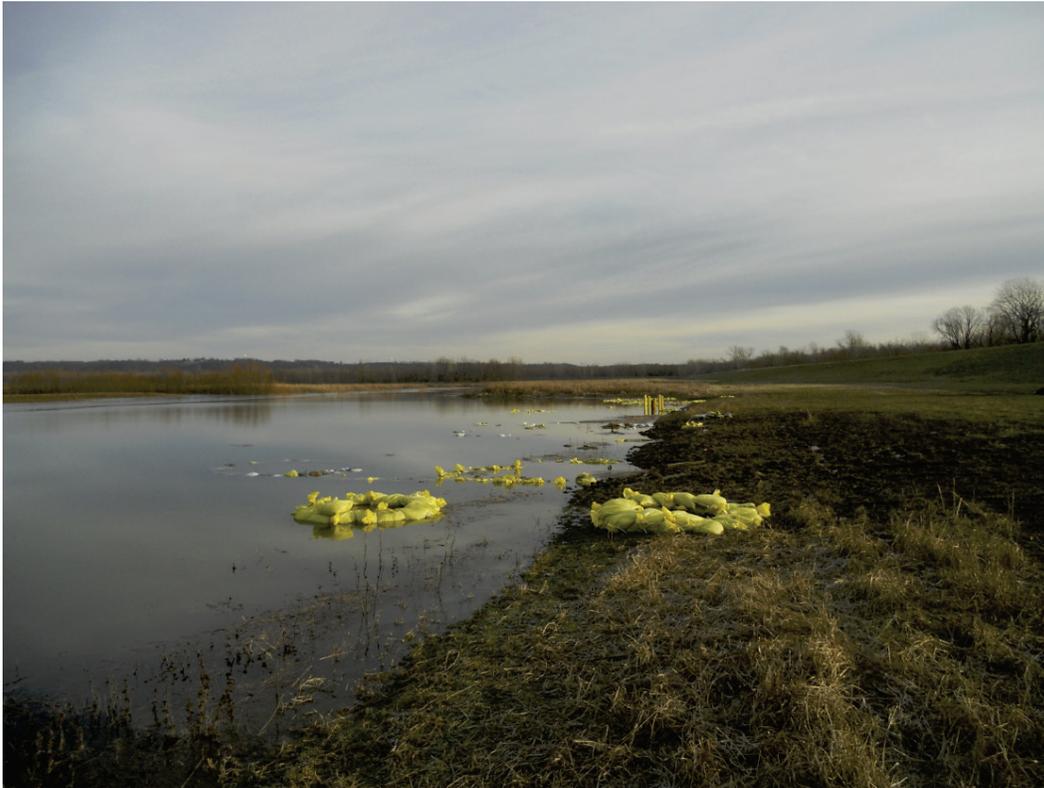
Figure 73. View looking due east at new sacked sand boils (locations 154 to 158) near edge of the enlarged seepage berm in background of photograph. Landside piezometer is visible in center of photograph, where bollards are present to protect the piezometer from vehicle damage. These boils occur at the edge of the 150-wide landside berm and 50 to 75 ft past the edge of the berm. Note the extensive seepage volume that has collected in the large swale, which is nearly parallel to the levee orientation.
