**US Army Corps
of Engineers®**
Engineer Research and
Development Center

Study of Sand Boil Development at Kaskaskia Island, IL, Middle Mississippi River Valley

September 2020

Final report

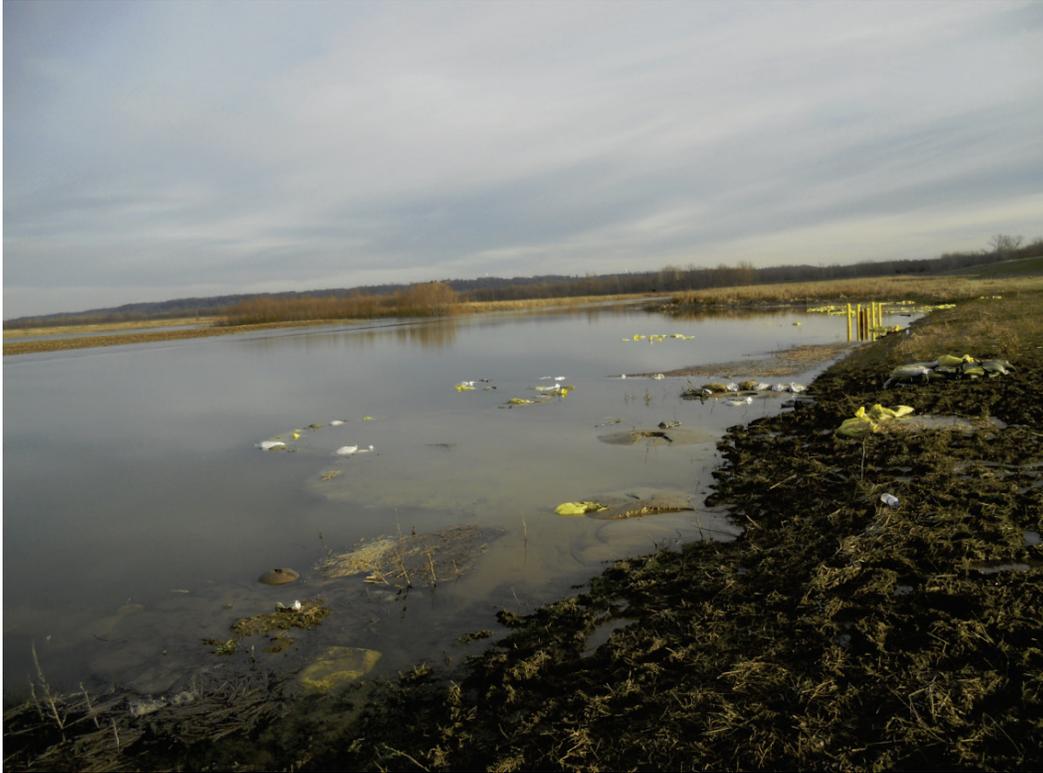
Figure 74. Close-up view of the sacked sand boils (locations 154 to 158) near the landside toe piezometer. Note the different colored bags and the small sand cone that was not sacked in center of image. This location corresponds approximately to the site of the 2013 sand boils (white sand bags were used to ring these boils). This area is the focus of this study. Note extensive seepage at this location.

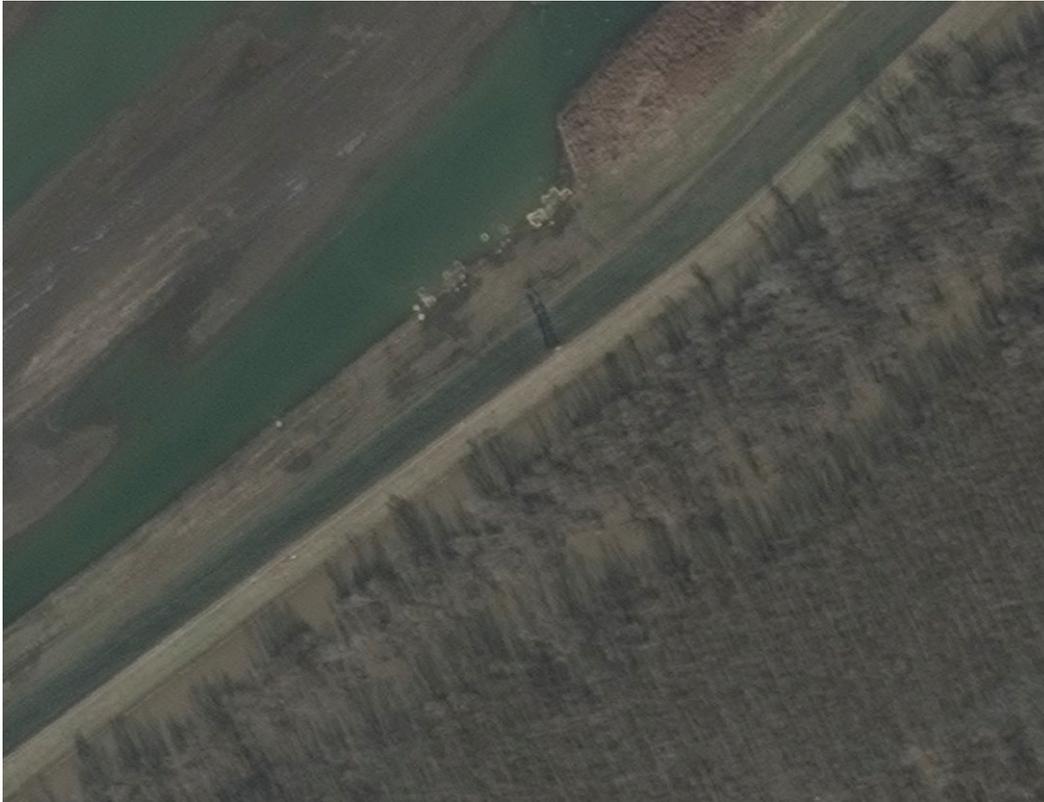
Figure 75. Close-up Digital Globe aerial image of flood conditions and sacked sand boils in Figures 72 through 76. Boils are concentrated at the western end of the wide berm extension (northwest corner) following the 1993 Flood. Image was taken 5 January 2016 at time of the ERDC site visit to Kaskaskia Island. Standing water is near its maximum height.

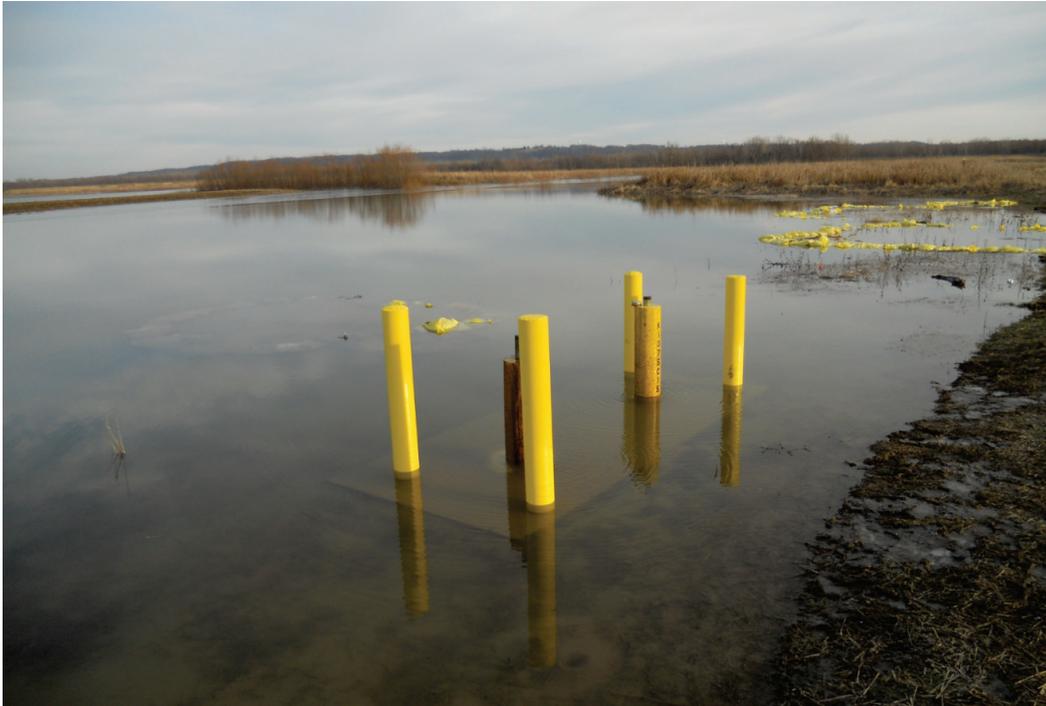
Figure 76. View of landside seepage at piezometer KI-375C15 on 5 Jan 2016. View is looking northeast with large sand boils in background of image and underwater. View shows location of 2013 sand boils.

The 2016 Flood permitted inspection of the levee system during a major flood event to observe seepage extent and new sand boil activity behind the ring levee system protecting Kaskaskia Island. New sand boils were present in the three study areas that are the focus of this investigation. Widespread seepage and flooding were fairly extensive in the vicinity of sand boils No. 2 and 3 as shown by Figures 72 through 76. In addition, several large, new sand boils were present at these locations.

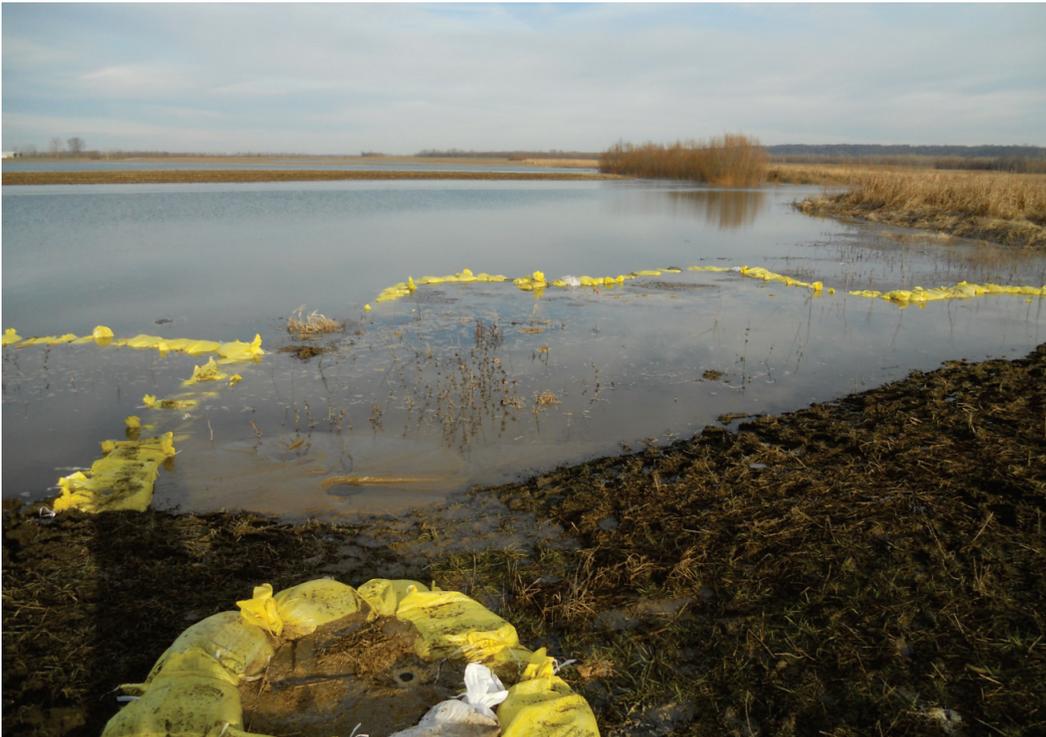
Closer to the Mississippi River, sand boil activity was observed at locations 160 through 164 (see location map in Figure 67). Figures 77 and 78 show sand boils at the toe of the levee near the turn in the ring levee. These boils are located in a reach containing a 100-ft-wide seepage berm. The berm was added as part of the 1978 levee improvements. Figure 78 is closer to study area 2 where Sand Boil No. 1 (Figure 18) is visible in the background in the center part of the image.

Figure 77. Extent of sand boil range near edge of the seepage berm constructed following 1993 Flood (right edge of photo).

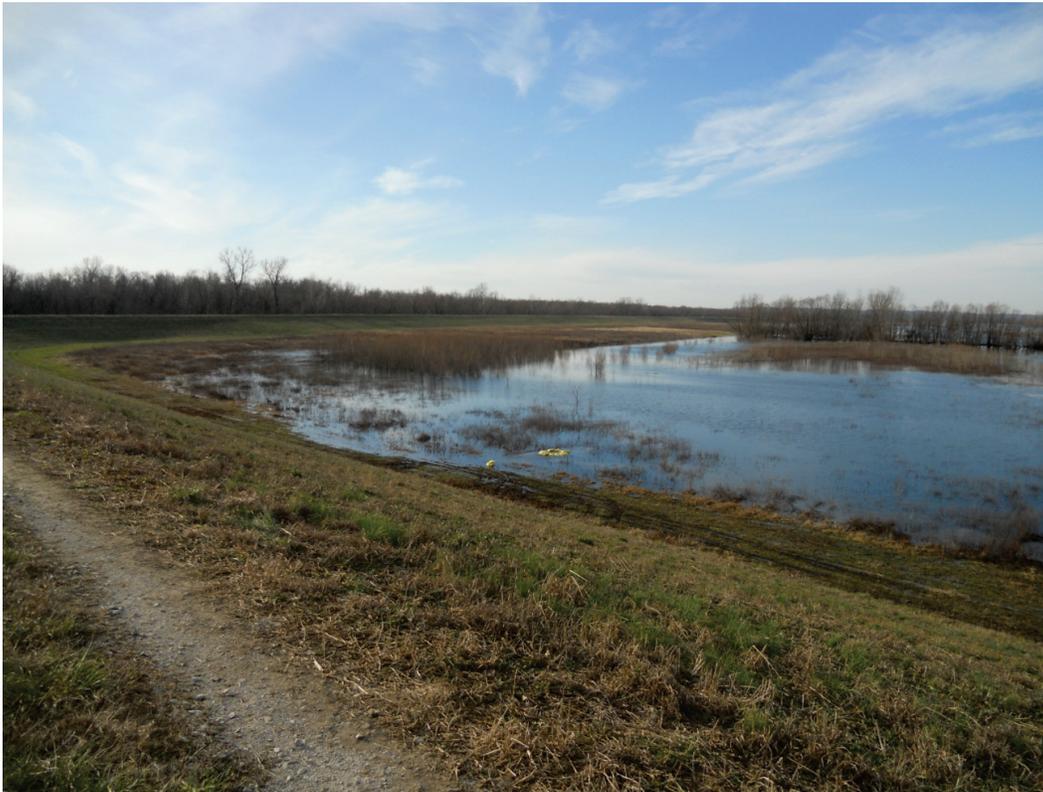
Figure 78. Small bagged boil (number 160) near turn in levee.
Note seepage behind levee.

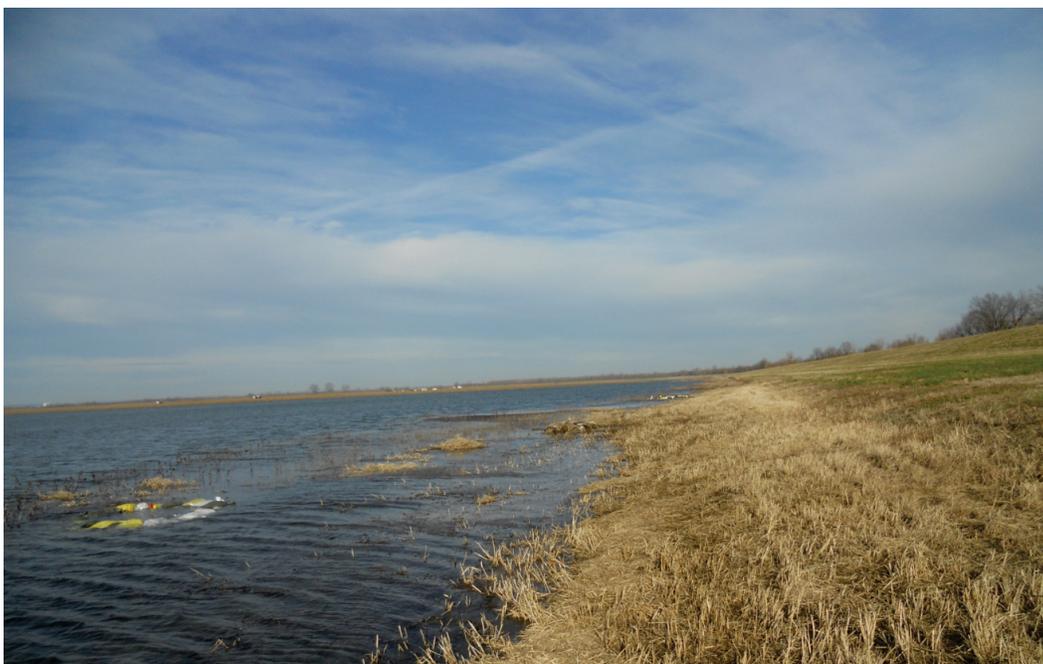
Figure 79. Two moderate-sized bagged sand boils (number 163 and 164) visible in the seepage lake (swale filled with seepage). View is in vicinity of study area 2 corresponding to location of sand boil 1 in Figure 18, which is visible in center of image.

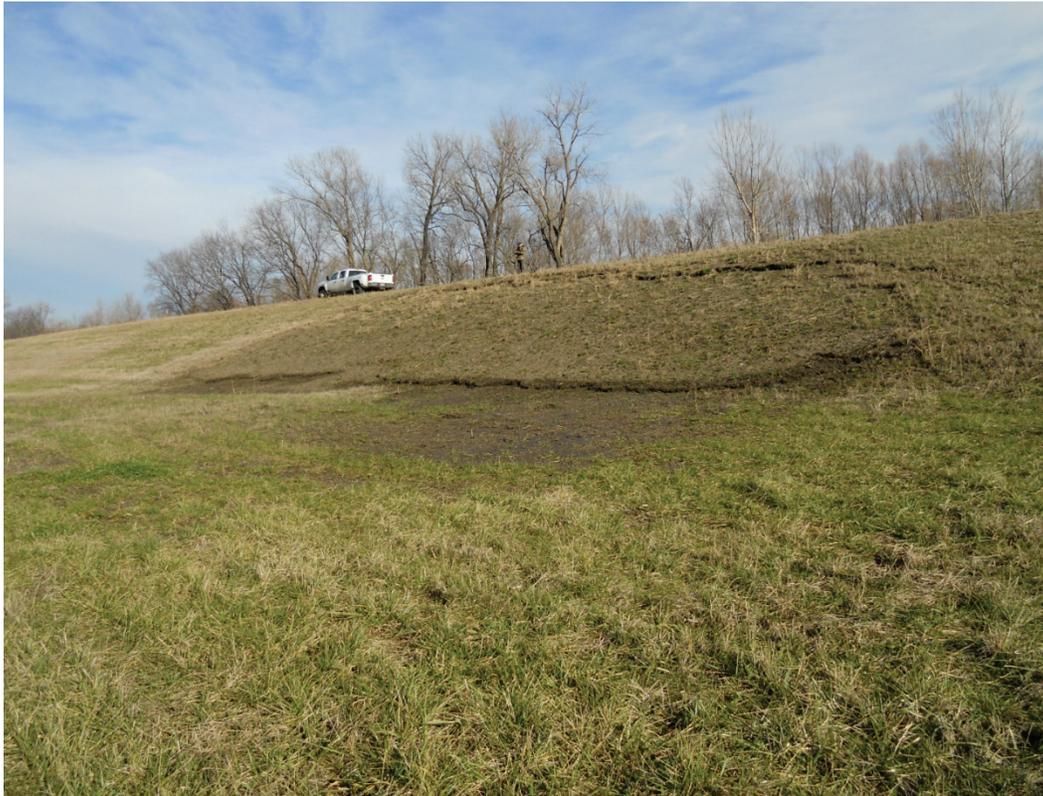
Figure 80. Shallow slide (location 168) developing on the landside slope. Slide incorporates the crown and toe of the levee at the northeast corner of the island. Note the seepage that has collected and the wet area at the toe. Probable levee through seepage occurring at this location. Several slides are present in this reach with very plastic soils used to build this section of the ring levee contributing to slide conditions.

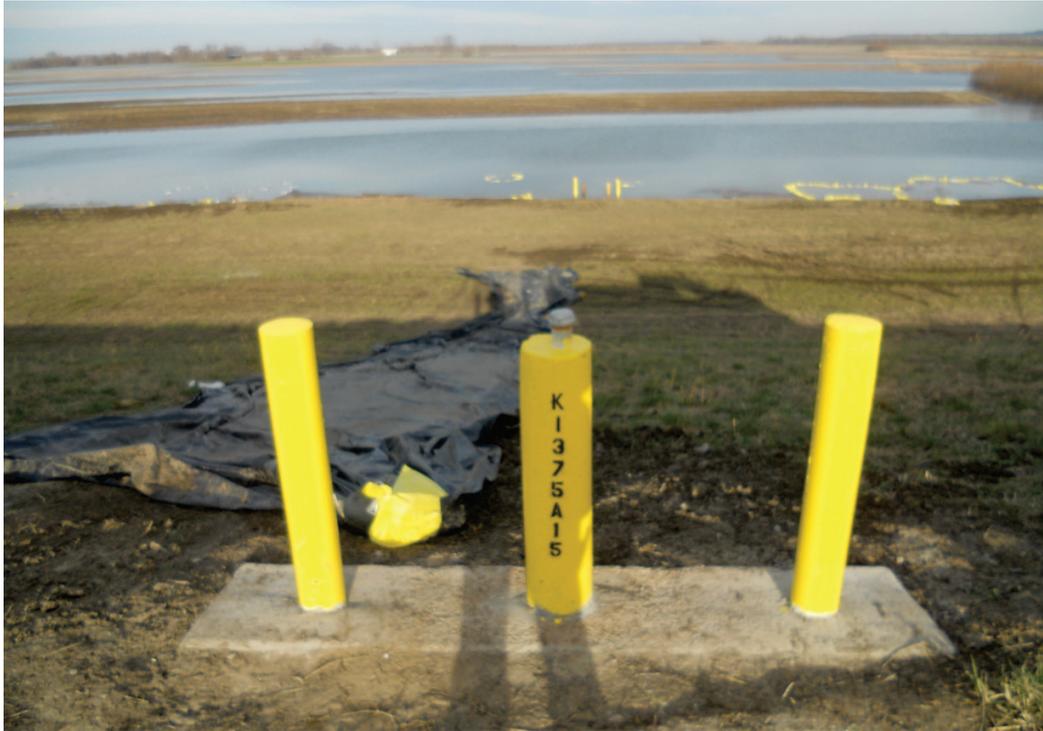
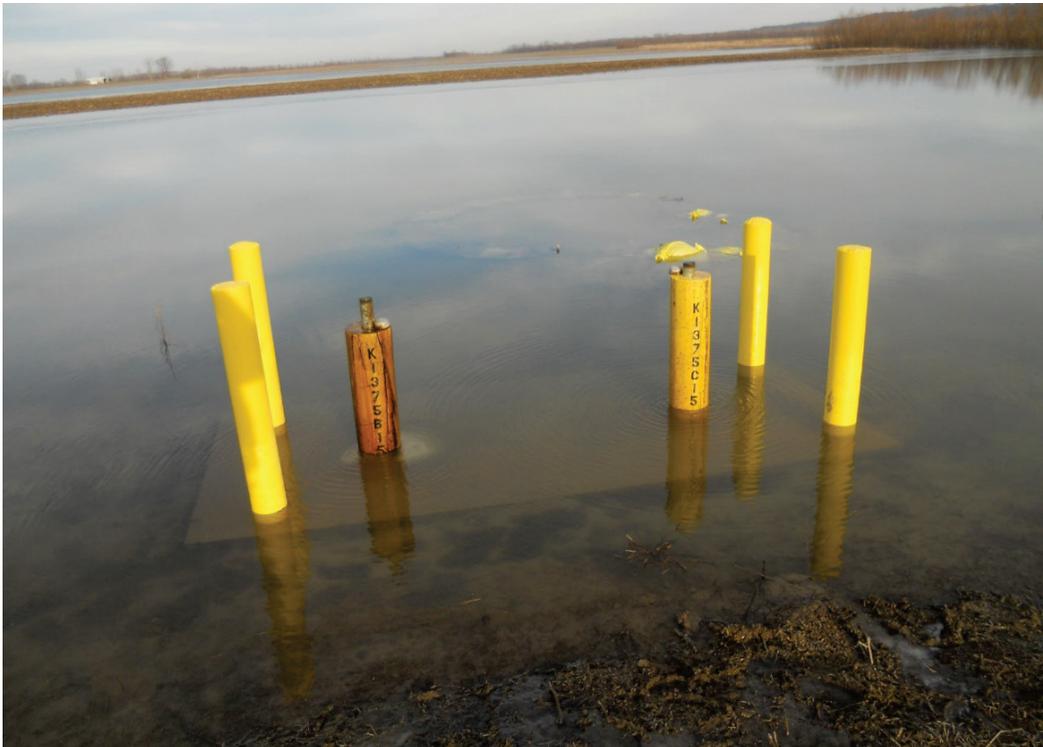
Figure 86. View of the KI-375-15 series (A, B, and C) piezometers.

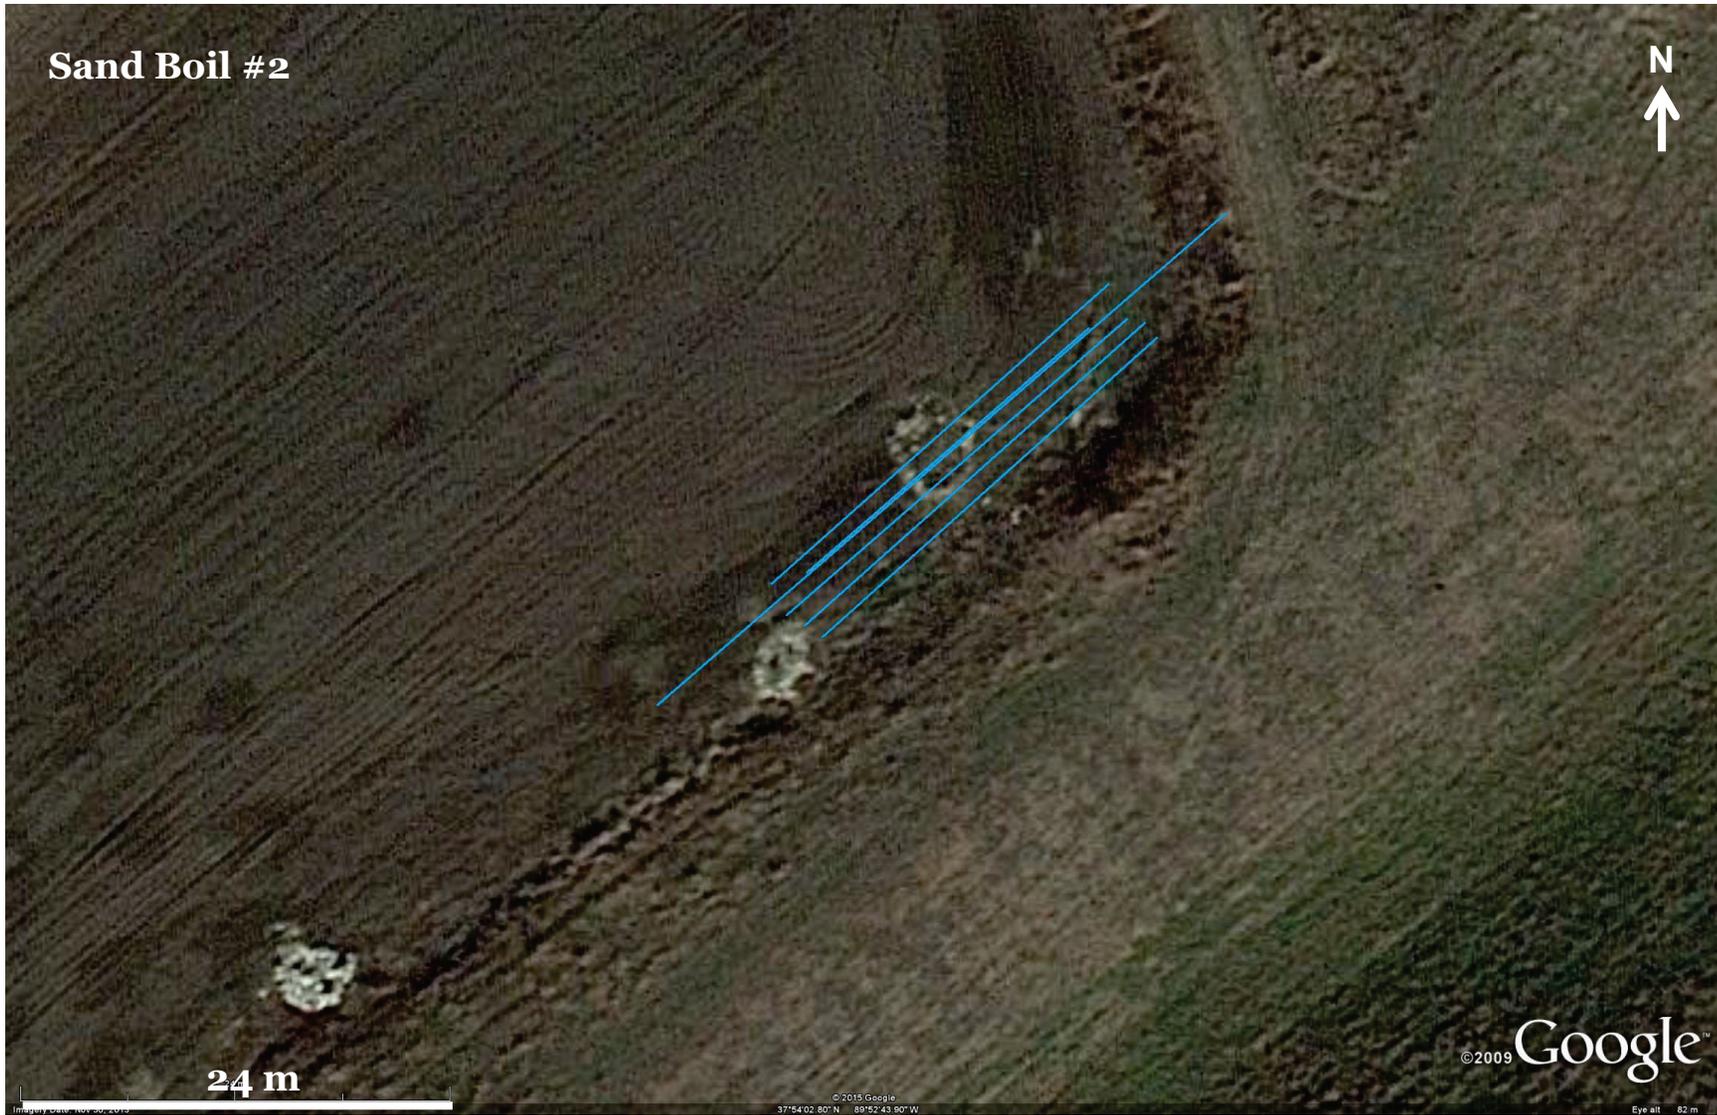
Figure E1. Close-up of the six ERT surveys conducted in the vicinity of boil #2.
